Glen Echo Creek

Post-spill Restoration and Monitoring Plan

East Bay Municipal Utility District

Horizon Water and Environment

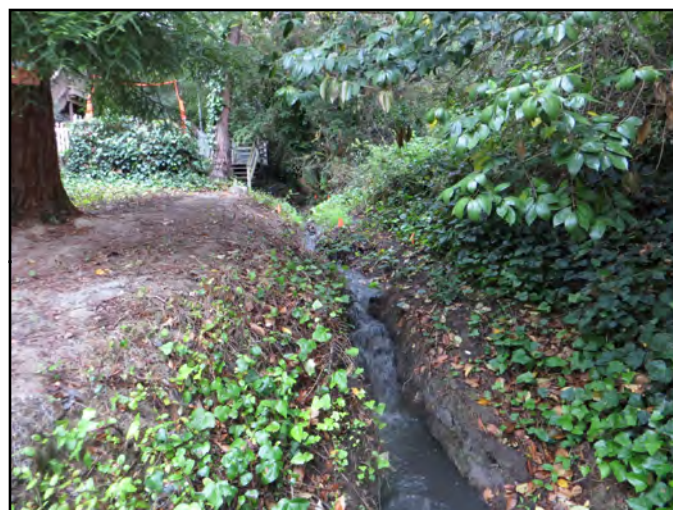
4. Main headcut

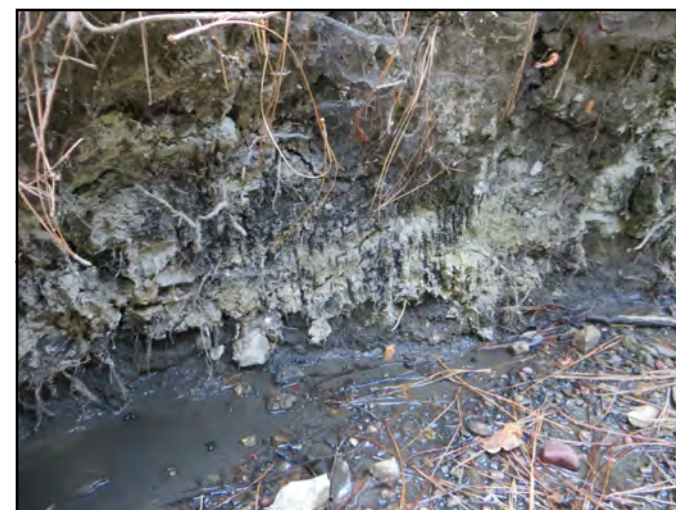
Residual cellular concrete noted in Reach 1 includes splatter on the banks (Figure 2, Photos 1 and 3). All of the splatter was observed on banks or rocks at or below bankfull¹ elevation. The area covered by residual concrete splatter, coating or staining is estimated to be 250 square feet (ft²). In all locations the coating of concrete appeared to be on the order of several millimeters thick.

3. Digging marks and splatter

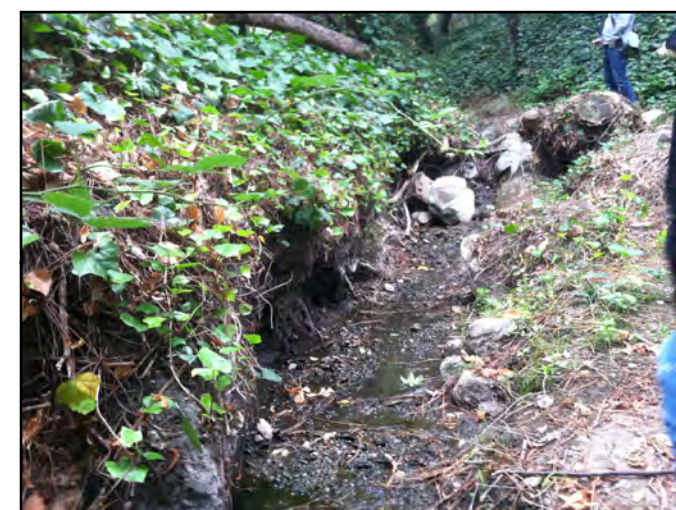
2. Bank erosion and headcut with large boulders

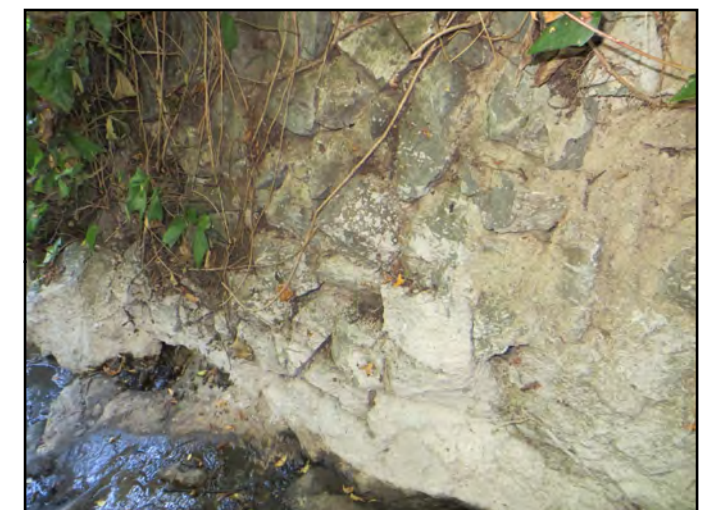
1. Splatter on banks

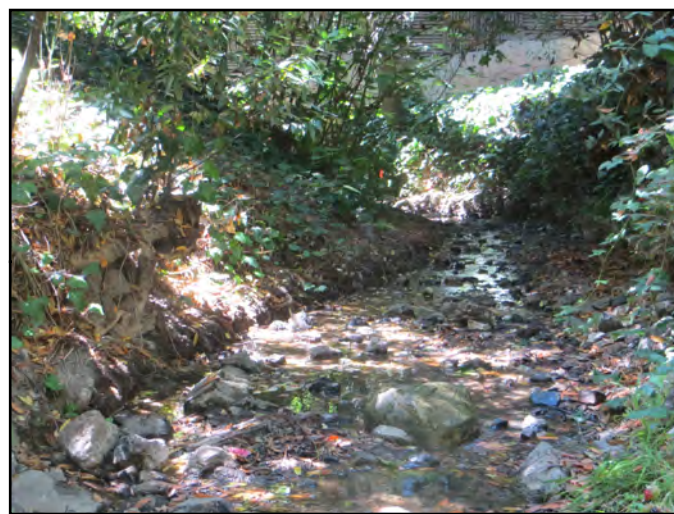
4. Minor bank excavation

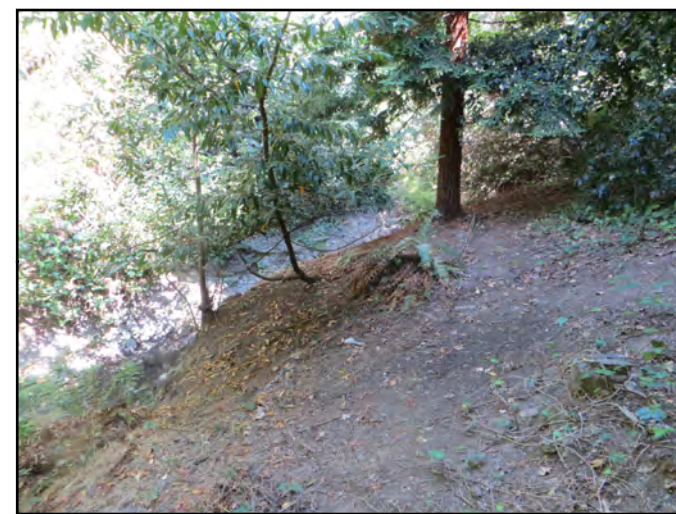
3. Trampling and compaction

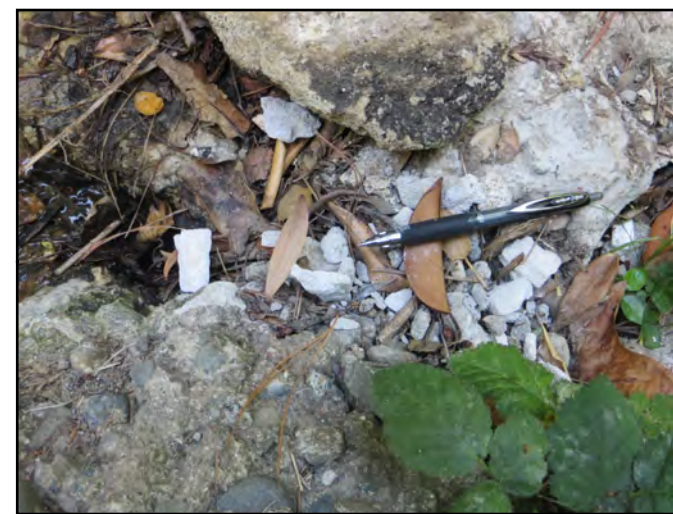
Residual cellular concrete noted in Reach 2 included intermittent concrete splatter and some fragments of concrete foam (Figure 3, Photos 1 and 2). All of the splatter was observed on banks or rocks at or below bankfull elevation. The area covered by residual concrete splatter, coating or staining was estimated to be 80 to 110 ft².

2. Concrete fragments

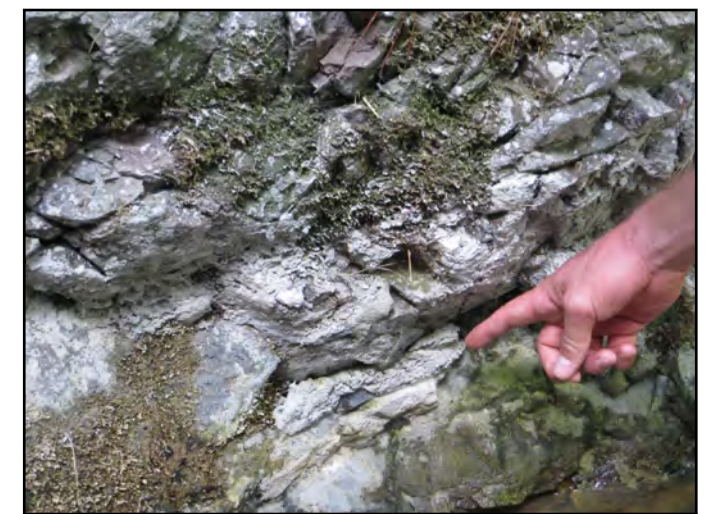
1. Concrete in bank

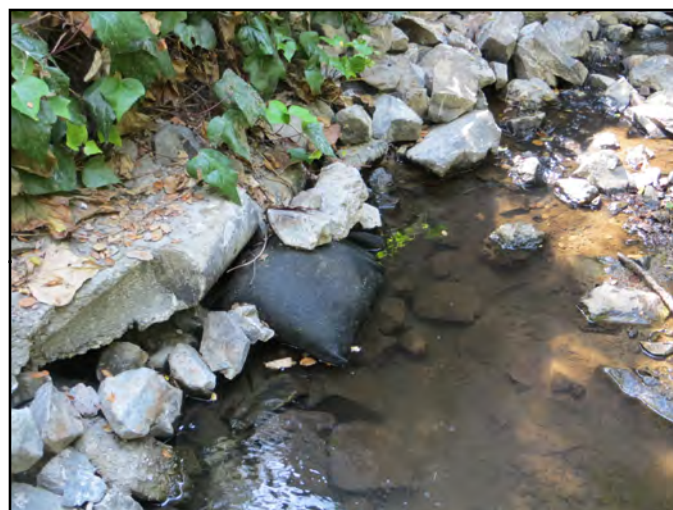
No instability in the channel profile was noted in this reach. Some minor undermining or excavation was noted at the base of the waterfall and on the left bank below the waterfall. Some gravel bags had been placed in these areas to fill voids in the banks (Figure 4).

4. Residual gravel bags

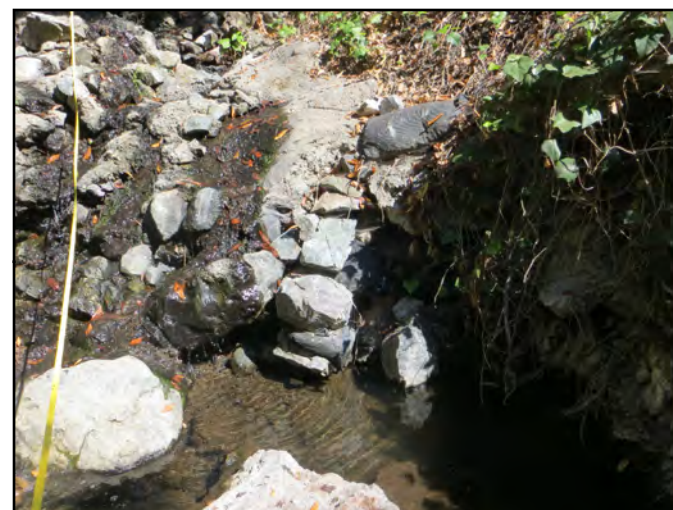
3. Base of waterfall

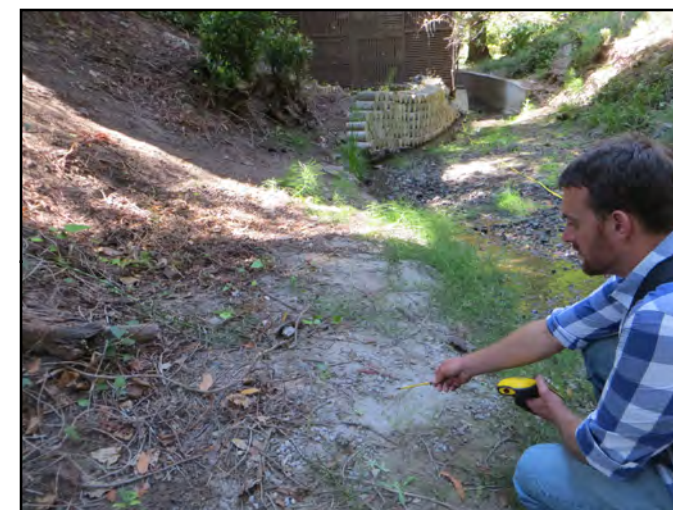
Residual cellular concrete noted in Reach 2b included intermittent concrete splatter on the banks. (Figure 4, Photos 1 and 2). The area covered by residual concrete splatter, coating, or staining was estimated to be 500 ft². In nearly all locations the coating of concrete appeared to be on the order of several millimeters thick. It is important to note that some of the residual concrete staining was observed on pre-existing concrete retaining walls or revetments in the channel. Medium to coarse

2. Upstream compaction

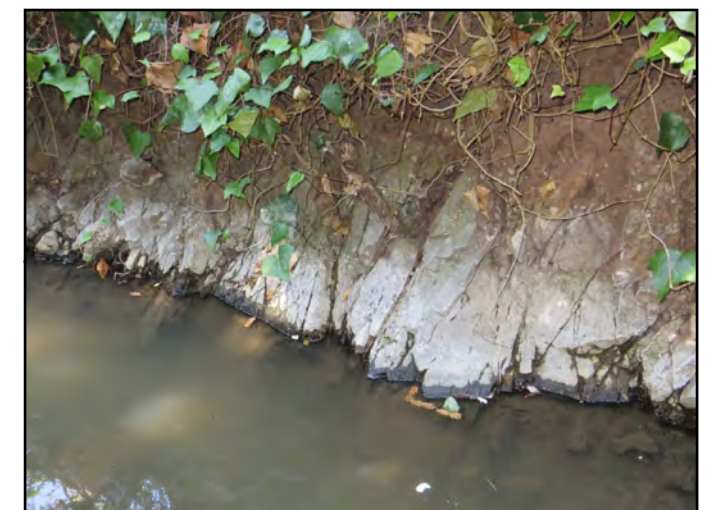
1. Staining

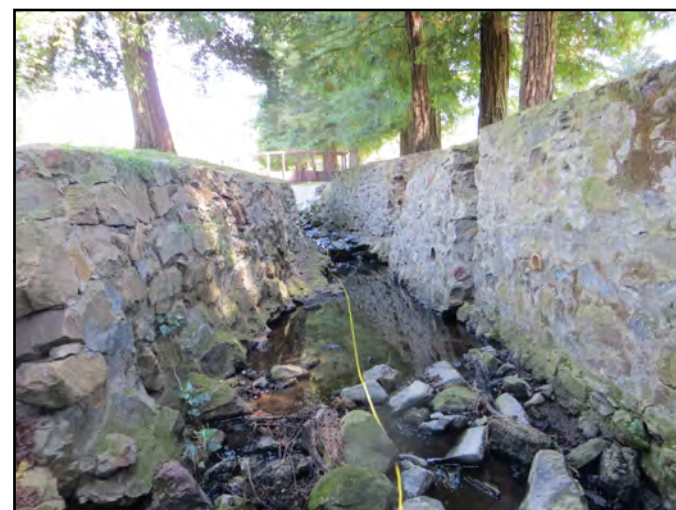
3. Looking upstream at small headcut

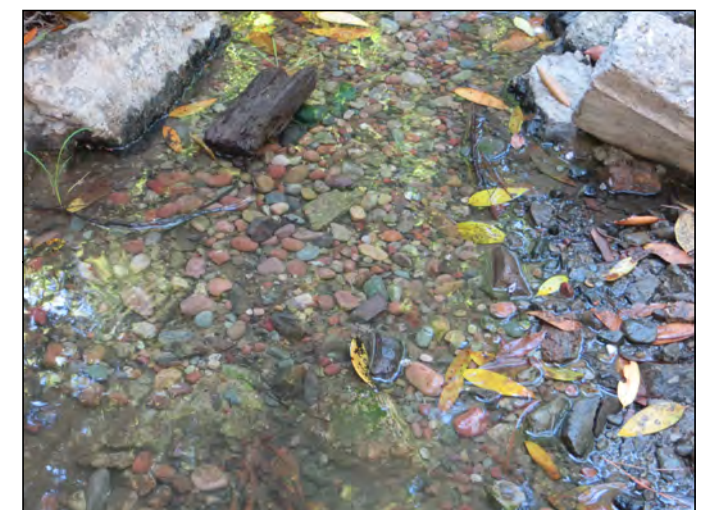
1. Existing streambed condition
