Pardee Reservoir
Calaveras County, California

Tunnel Leakage Report

July 2013

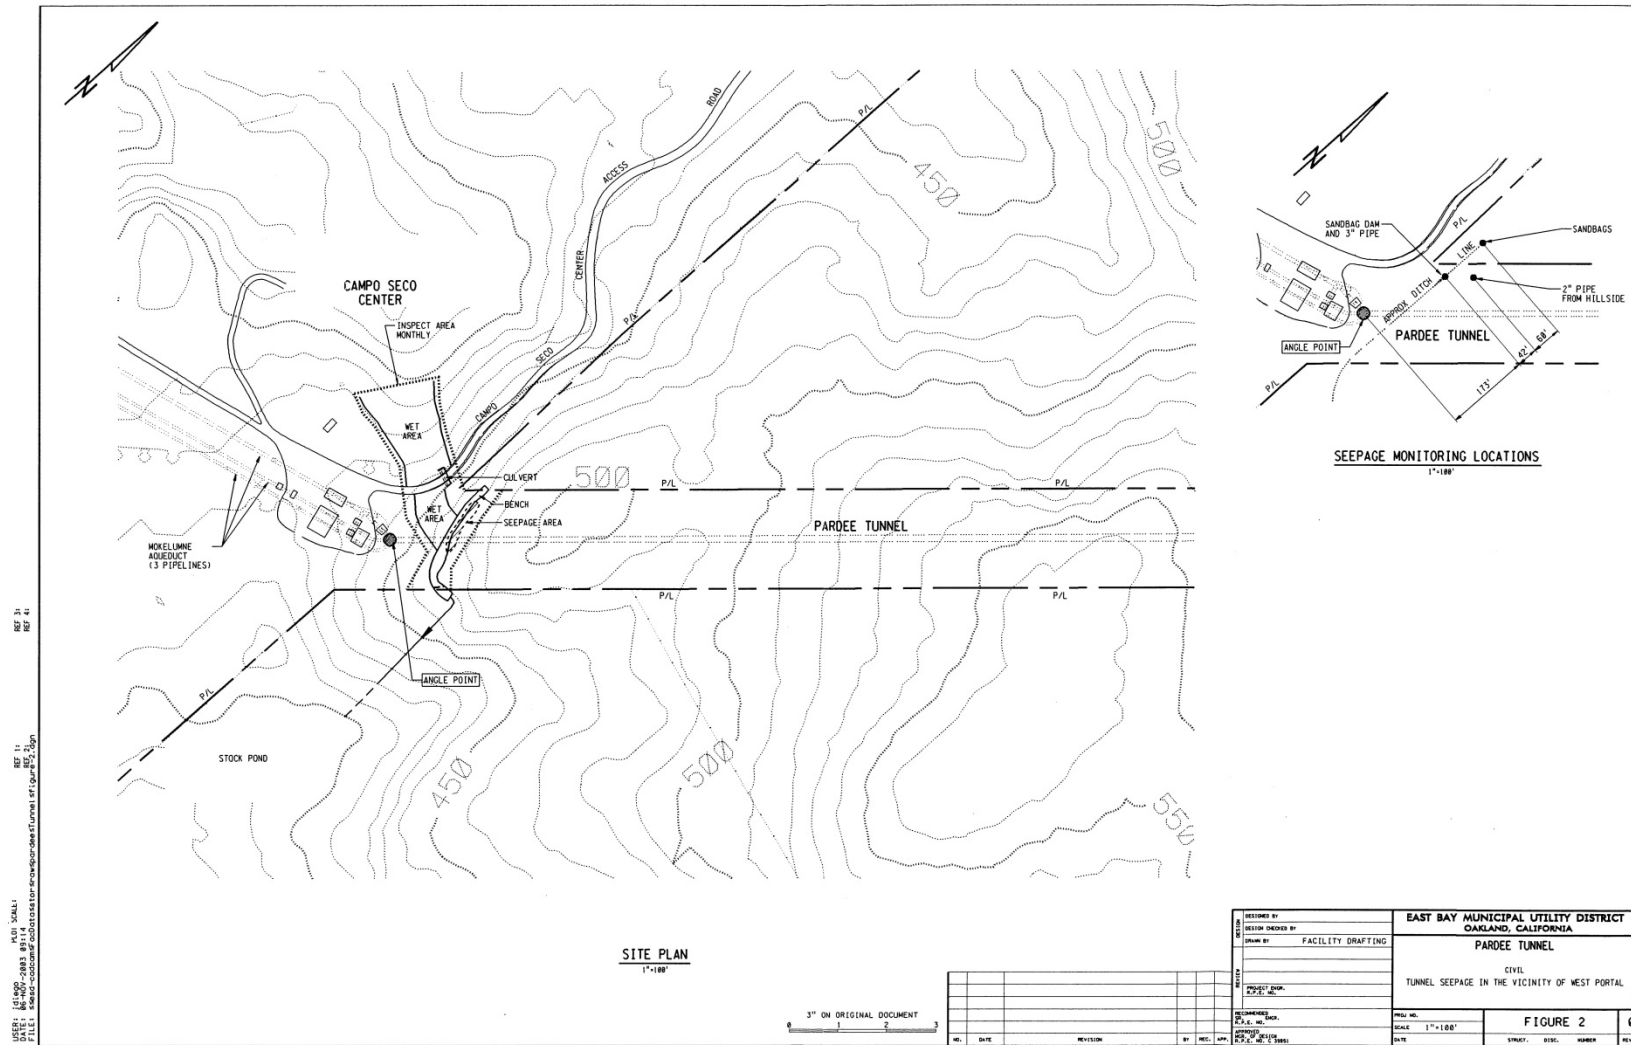
Figure 2. Pardee Tunnel: Plan at Campo Seco Center showing Seepage Areas

Mapping by EBMUD (2003) indicates the seepage area occurs on the west side of the spur ridge, north of the tunnel/portal area, at an elevation of about 470 feet as shown in Figure 2. The seepage area extends for about 100 feet, from approximately the centerline of the tunnel to the north, roughly along the same elevation. The seepage emanates from, or directly above, a topographic bench, which appears to be an old access or construction road above the portal. Much of the seepage flows down the slope to the west, where it enters a culvert and discharges on the west side of Campo Seco Center Access Road, creating a lush, green wetland area. Some of the seepage also flows to the south along the bench and is channeled into a stock pond on the south side of the Campo Seco facility. Based on field and office studies and laboratory testing, EBMUD (2003) concluded that the source of the seepage at the west portal is water from Pardee Tunnel.

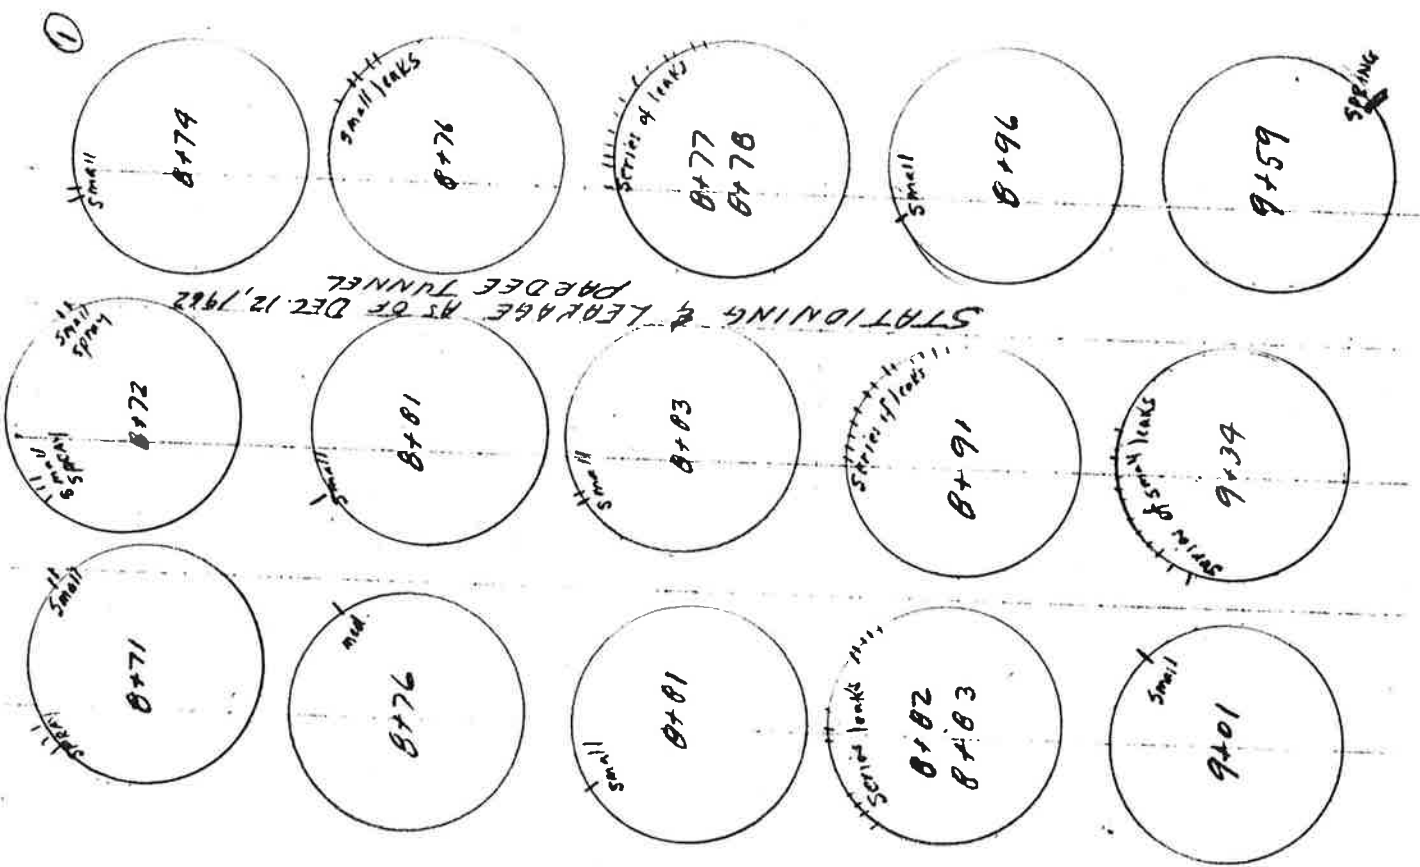
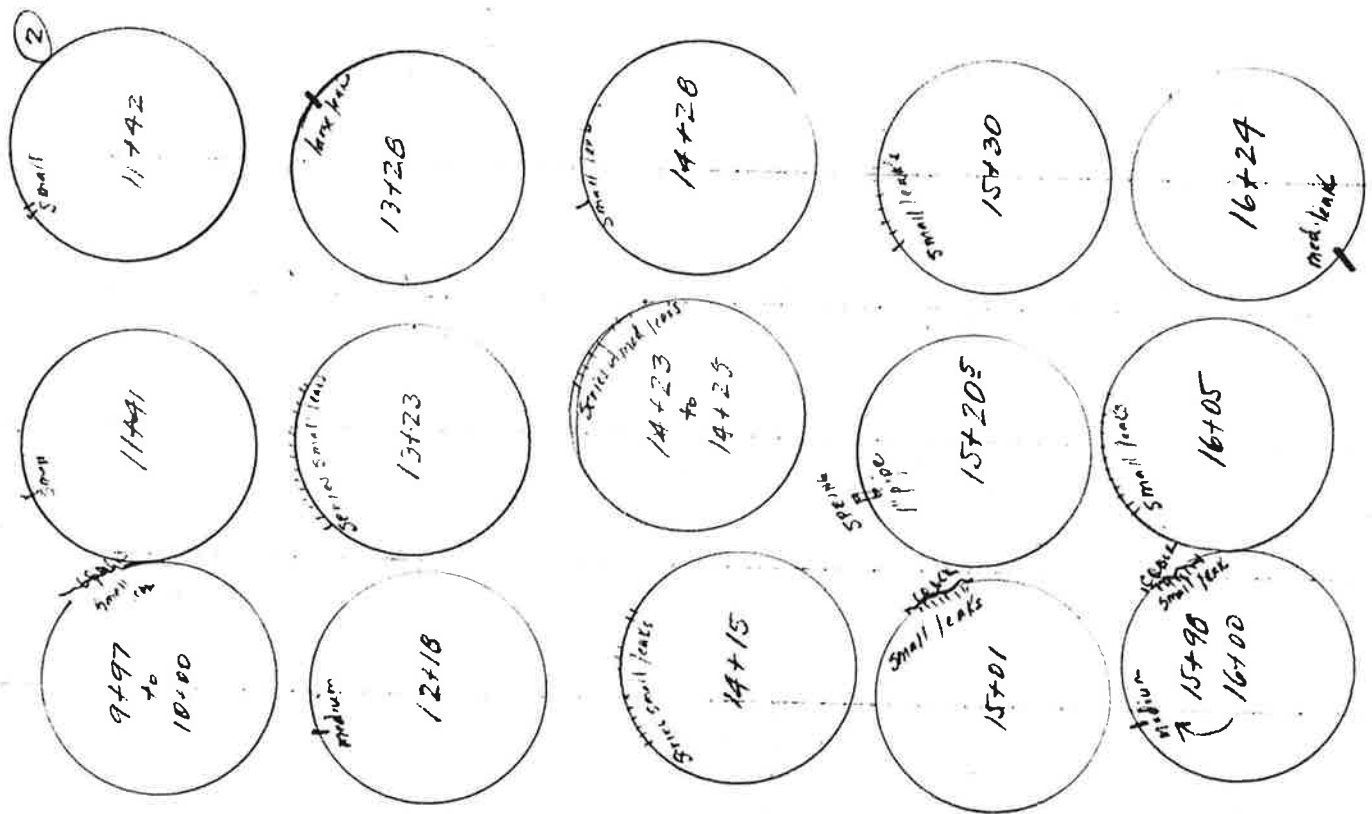
STATIONING & LEAKAGE AS OF DEC. 12, 1962

36+33
med

CRACKS
around
franklin
25+01

CRACKS
around
small
16+70

SPRAY
med
16+64
CRACKS ALL AROUND

small hole
25+00
25+01
