Exhibit G

Scope of Work

EBMUD 2024 Interceptor Rehabilitation Design Project Summary Map for RFP

South Interceptor Emergency Condition Assessment

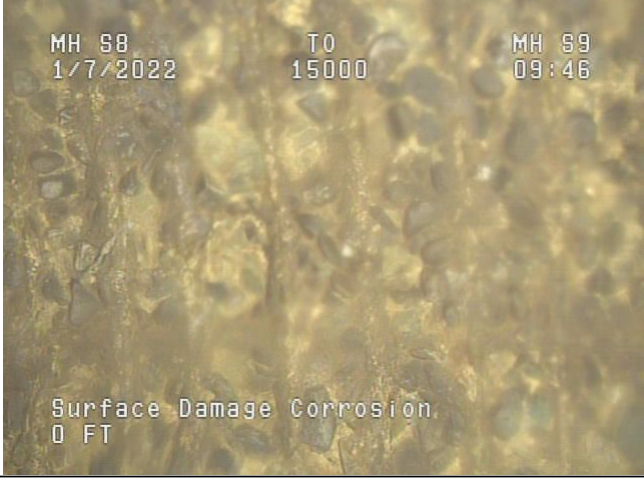
| Distance | Fault Observation | Time | Picture |
|---|---|---|--|
| 0.0 | Surface Damage Corrosion Position: 7 To 6 Severity: None Struct Weight: 3 | 00:01:39 | |

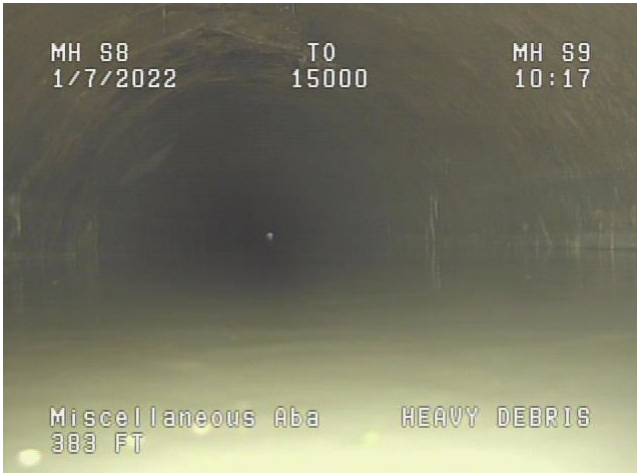
| Distance | Fault Observation | Time | Picture |
|---|---|---|--|
| 383.0 | <p style="text-align: center;"> Miscellaneous Abandoned Survey Severity: None Remarks: HEAVY DEBRIS </p> | 00:32:47 | <p style="font-size: small; color: gray;"> MH S8 T0 MH S9 1/7/2022 15000 10:17 </p> <p style="font-size: small; color: gray; position: absolute; bottom: 10px; left: 10px;"> Miscellaneous Aba HEAVY DEBRIS 383 FT </p> |

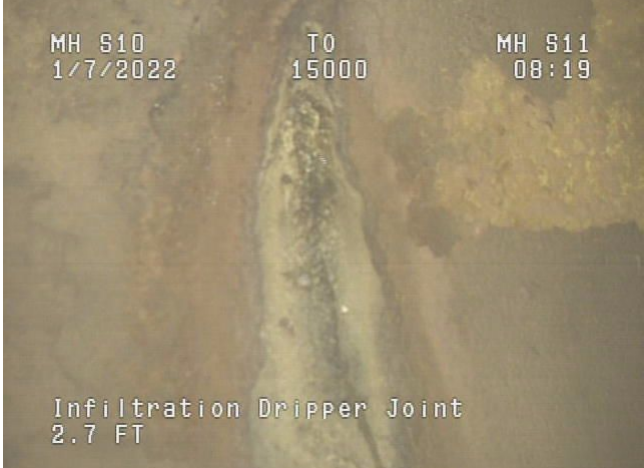
| Distance | Fault Observation | Time | Picture |
|---|---|---|--|
| 2.7 | Infiltration Dripper Joint Position: 11 To 12 Severity: None Joint Maint Weight: 3 | 00:00:52 | <p>MH S10 TO MH S11 1/7/2022 15000 08:19</p> <p>Infiltration Dripper Joint 2.7 FT</p> |

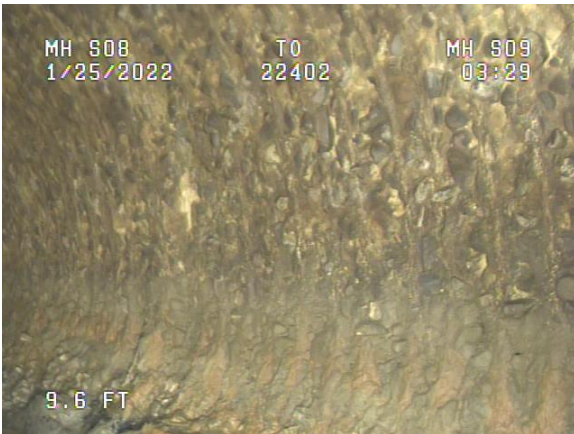
Photo 2-1. The pipe is in VANDA Level 5 condition at Stn. 0+09.6 from the 8:00 to 4:00 position.

1. Remove the sediment from the pipe with a closed loop pipe cleaning system.
2. Install a cured-in-place pipe (CIPP) liner at a minimum of 200 feet. Install a Weko Seal at the termination point of the CIPP.

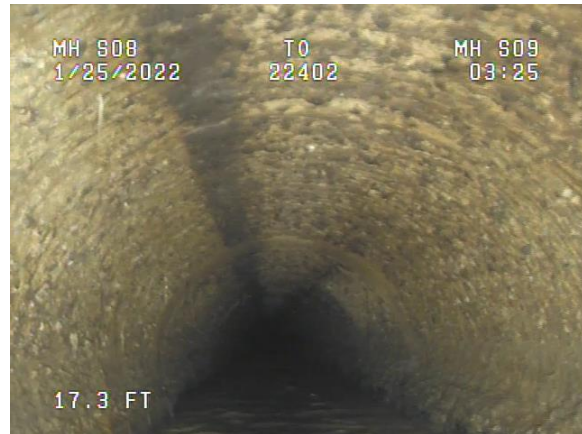
Photo 2-2. The pipe is in VANDA Level 5 condition from the 8:00 to 4:00 position at Stn. 0+17.3.

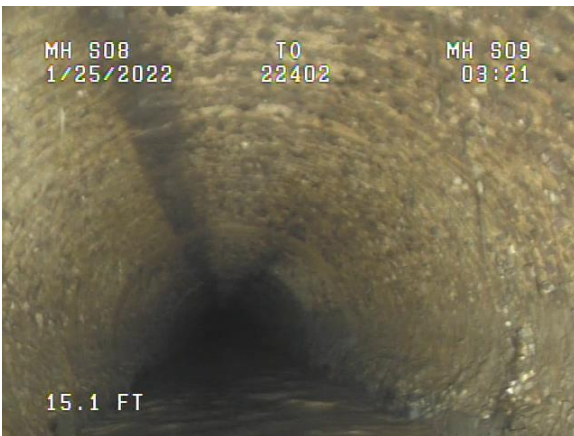
Photo 2-3. VANDA Level 5 condition at Stn. 0+15.1 from the 8:00 to 4:00 position.

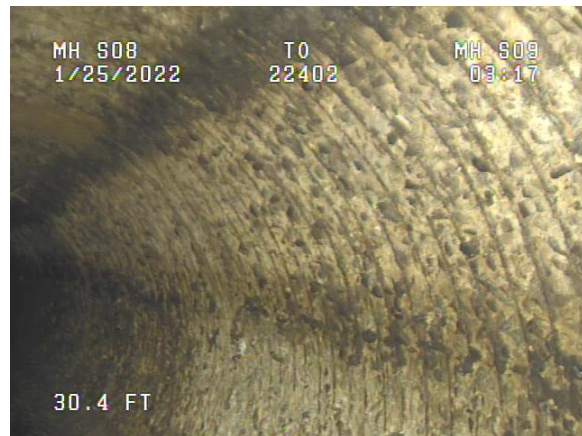
Photo 2-4. Exposed reinforcing steel at the 12:00 at Stn. 0+30.4.

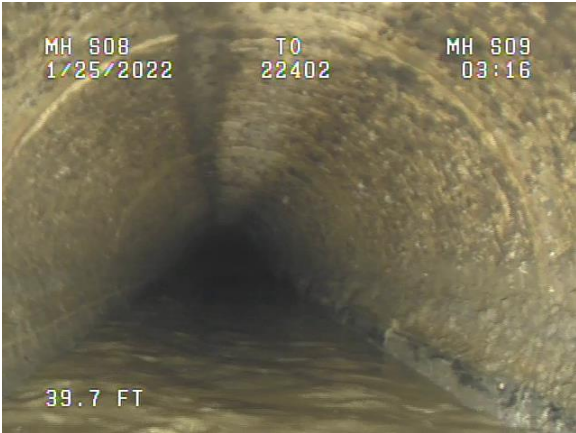
Photo 2-5. The pipe is in VANDA Level 4 condition from the 8:00 to 4:00 position at Stn. 0+39.7.

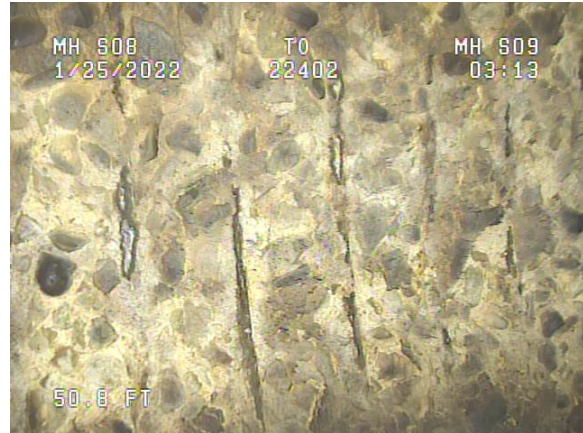
Photo 2-6. Exposed reinforcing steel at the 12:00 position at Stn. 0+50.8.

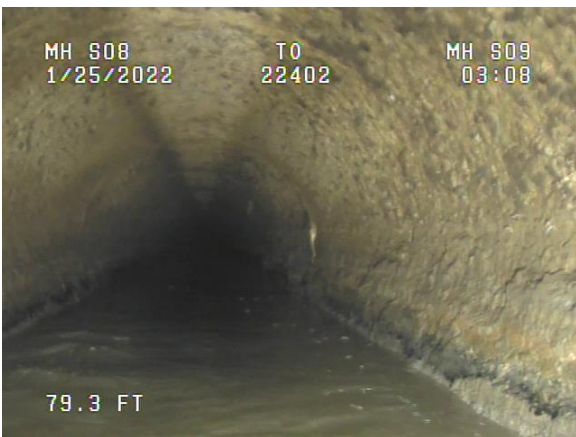
Photo 2-7. The pipe is in VANDA Level 3 condition at Stn. 0+79.3.

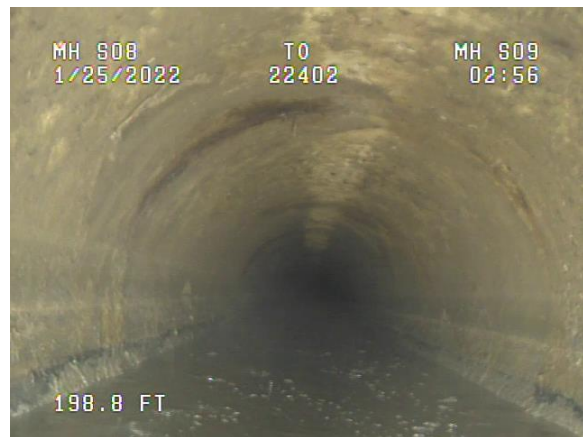
Photo 2-8. The pipe is in VANDA Level 2 condition at Stn. 1+98.8.

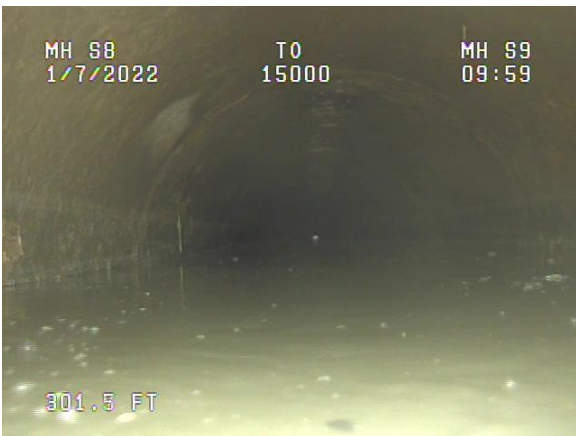
Photo 2-9. The pipe is in VANDA Level 2 condition at Stn. 3+01.5.

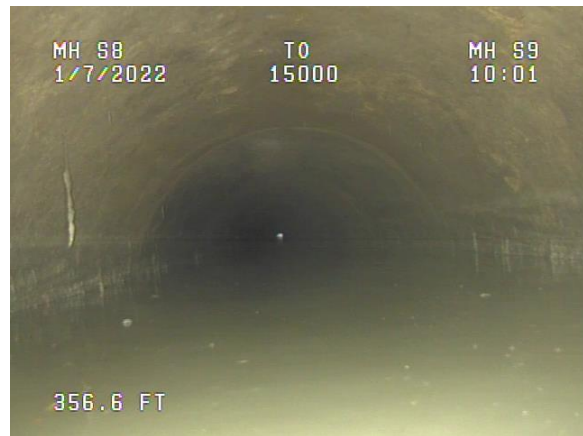
Photo 2-10. The pipe is in VANDA Level 2 condition at Stn. 3+56.6.

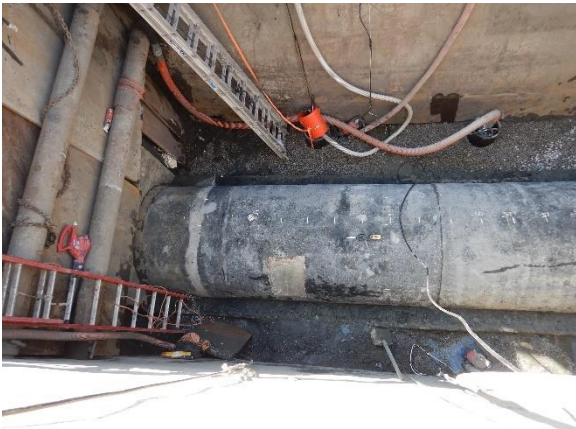
The top of the pipe was approximately 13 feet below grade and required trench shoring while excavation and repairs were performed. Approximately 6 feet downstream from the outer wall of MH S08, a 1 foot by 1-foot section of the pipe had collapsed during the excavation. The hole in the pipe was observed at the 2:30 clock position of the pipe at Stn. 0+06 as shown in Photo 2-11 and Photo 2-12.

Photo 2-11. The pipe wall at the 2:30 position at Sta. 0+06 was severely deteriorated and damaged.

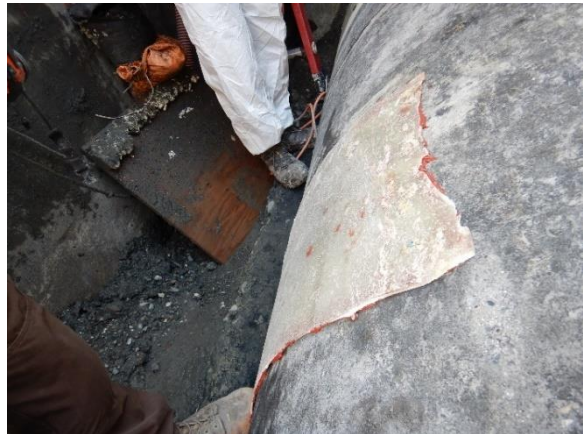
Photo 2-12. Patch over concrete breach before fiberglass repair.

EBMUD retained the services of Picon FRP, Inc. to install four fiberglass reinforcing layers on the first 13 feet of pipe downstream of MH S08 on Friday, February 4, 2022. Due to the visible cracking observed downstream of the first wrapped section, two fiberglass reinforcing layers were installed from Stn. 0+13 to Stn. 0+36 at the start of the following week before the concrete cap was installed over the pipe.

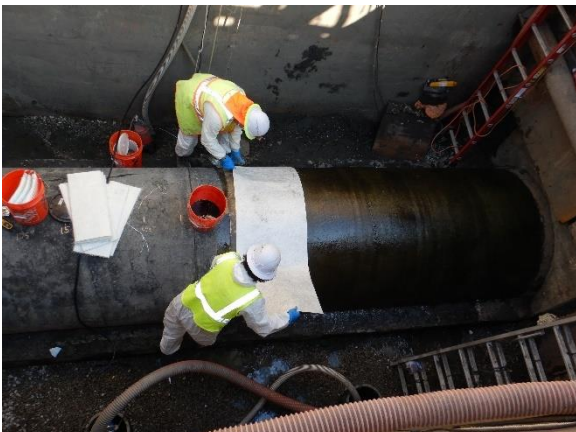
Photo 2-13. Fiberglass wrap layers were installed to reinforce the pipe.

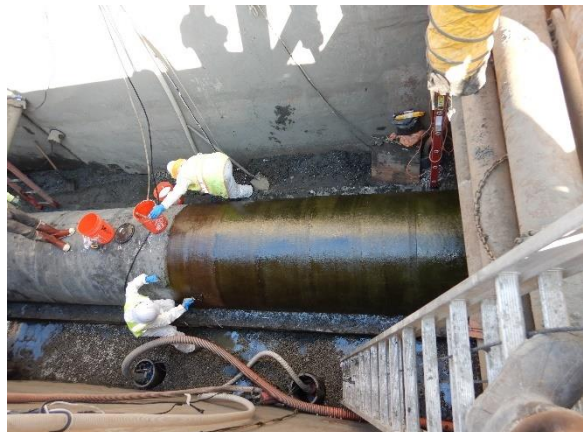
Photo 2-14. Up to 13 feet of pipe were wrapped with 4 layers of fiberglass reinforcing.

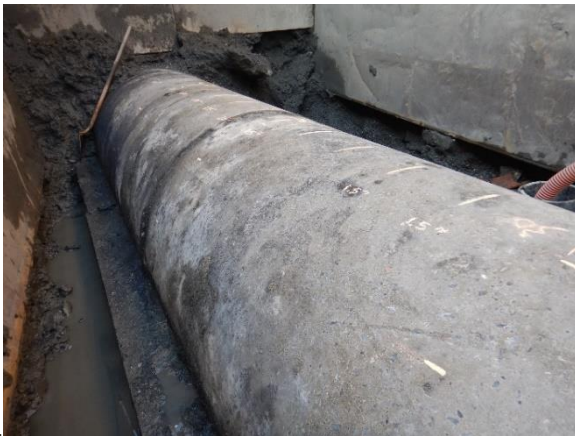
Photo 2-15. Exterior surface of pipe was in good condition.

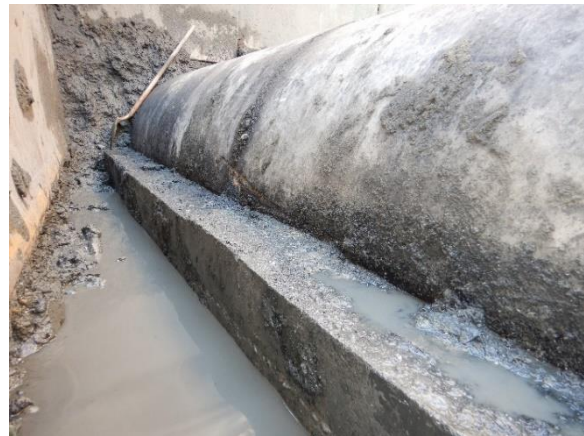
Photo 2-16 Pipe support cradle was in good condition.

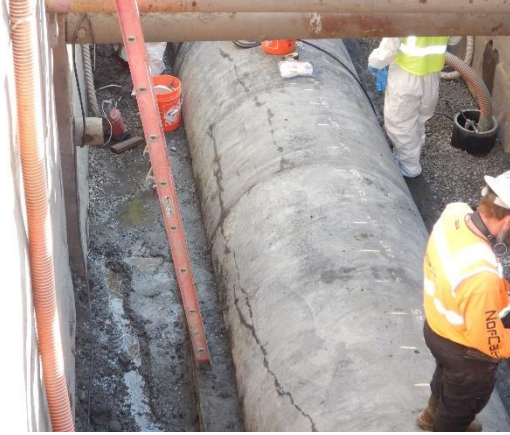
Photo 2-17. Overall view of longitudinal cracks at the 12:00 to 3:00 position from Stn. 0+13 to Stn. 0+36.

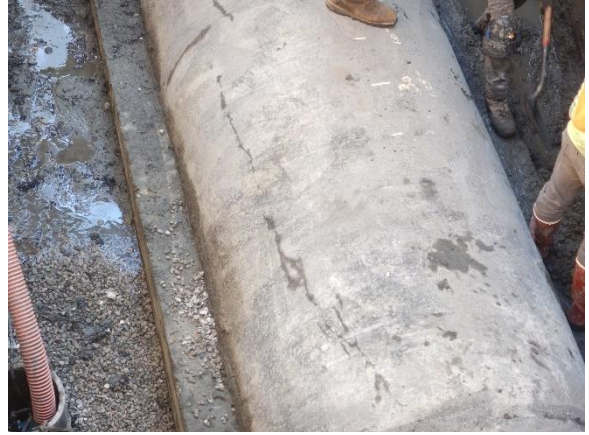
Photo 2-18. Longitudinal cracks at the 1:00 to 2:00 position from Stn. 0+28 to Stn. 0+36.
