**GEOLOGIC BACKGROUND REPORT
DINGEE RESERVOIR
OAKLAND, CALIFORNIA**

July 15, 2008
2163-3 L 28361

RE: Geologic Background Report
Dingee Reservoir
Oakland, California

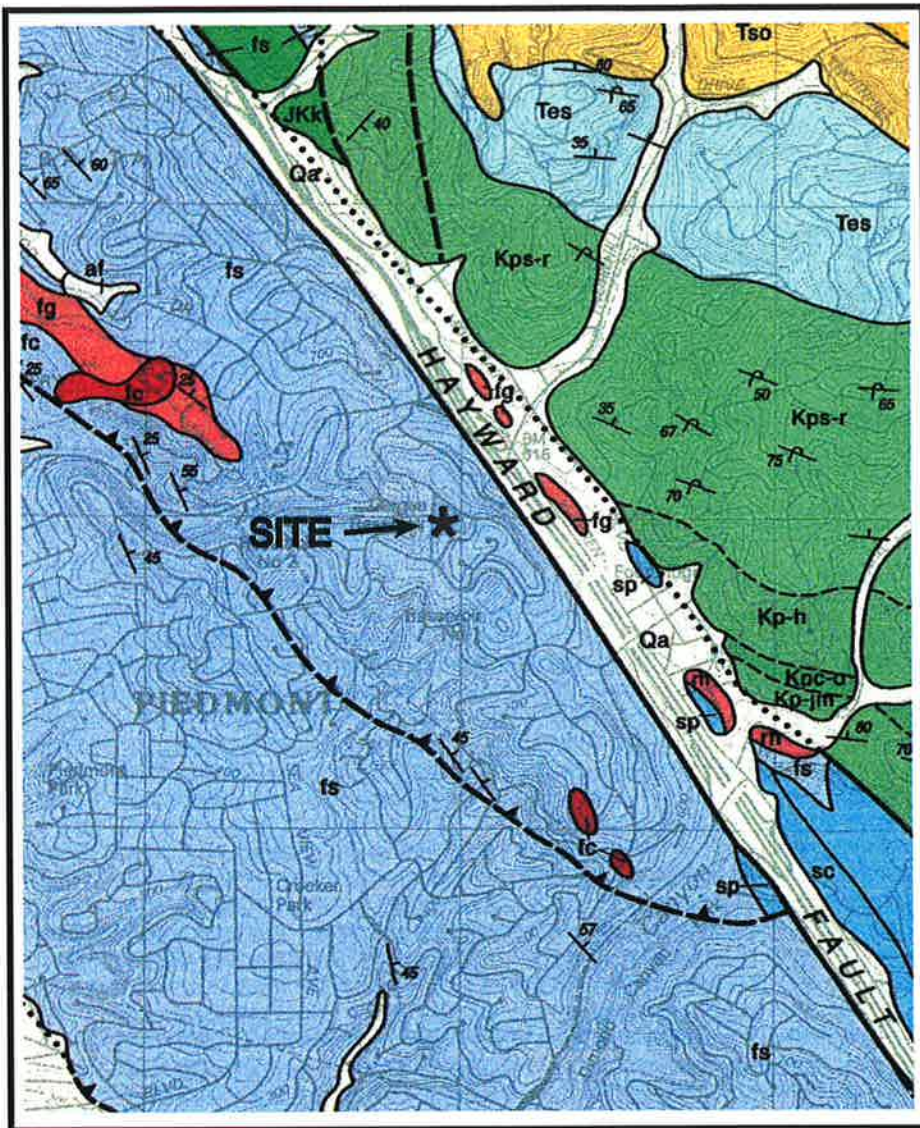
FIGURE
1

Dibblee (2005) shows that the site is underlain by greywacke sandstone of the Franciscan Assemblage. A portion of this map is reproduced on Figure 1. These rocks are described as massive to locally bedded, fine grained, hard, fractured, and locally sheared. The active trace of the Hayward fault is shown approximately 1,100 feet east of the fill embankment. No landslides are mapped within the site or vicinity. An unnamed thrust fault is shown trending northwestward through the area approximately 1900 feet southwest of the site. This thrust fault extends into the Berkeley area, where it is shown to be concealed by Quaternary-age alluvium, suggesting that the fault is inactive. To the south, the fault merges with the Hayward fault approximately, one mile southeast of the site.

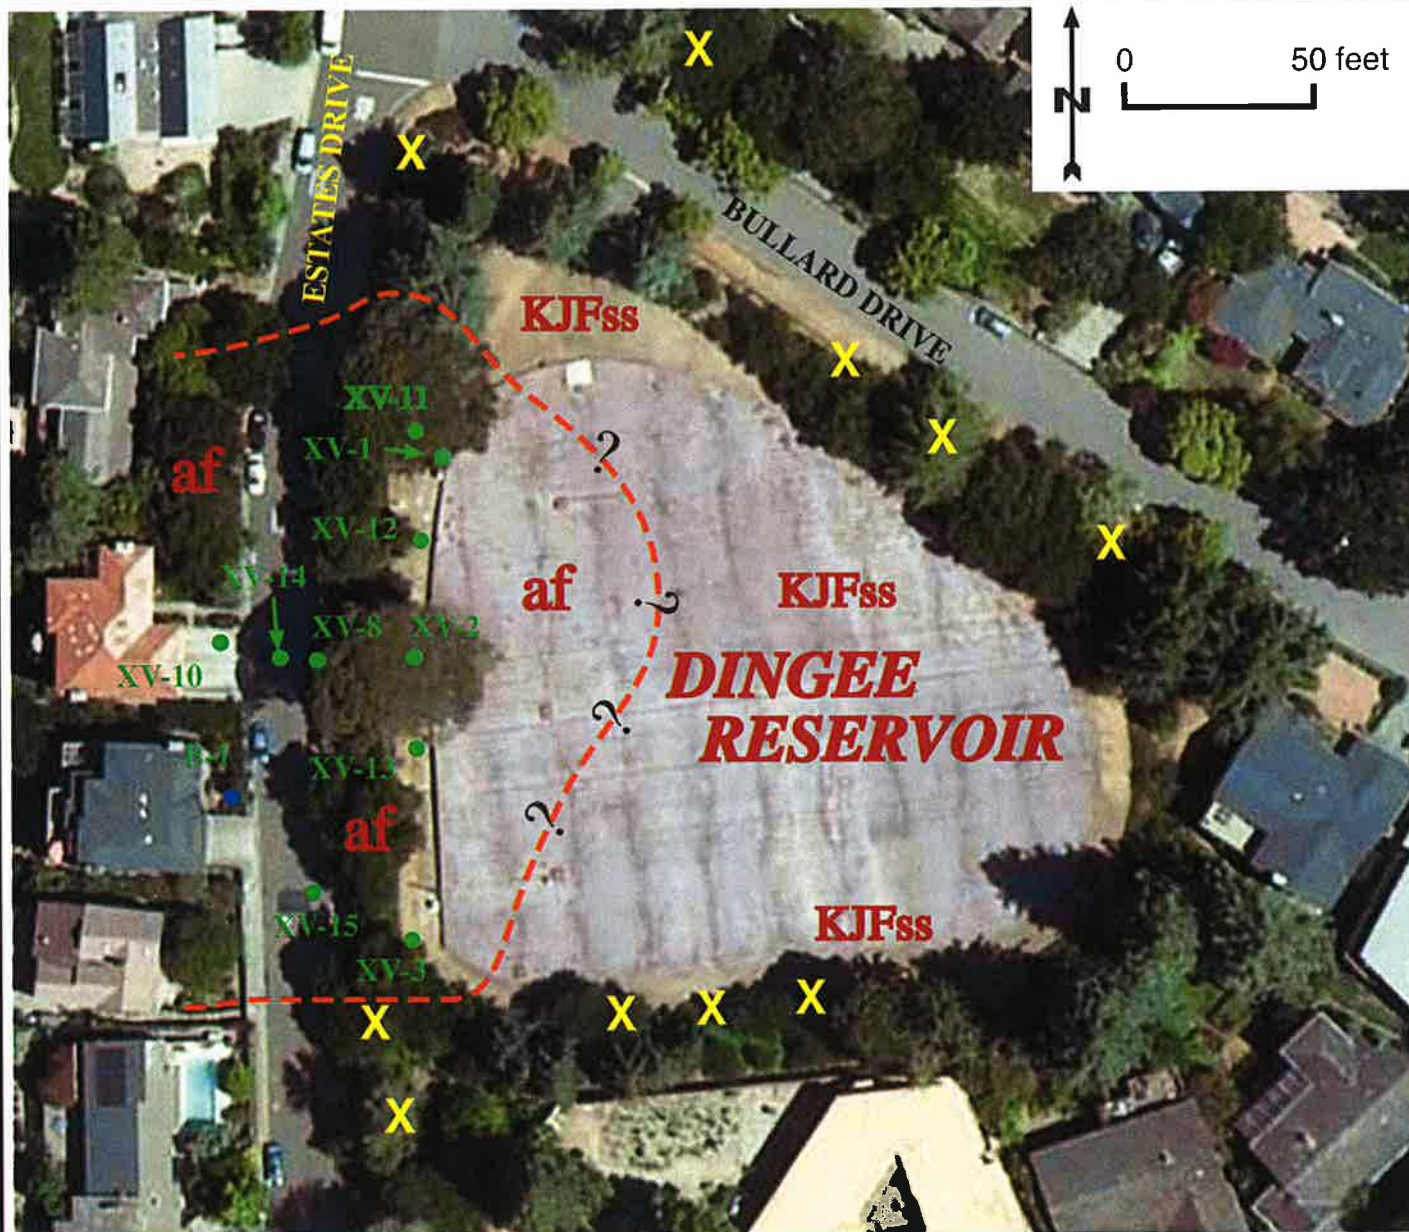
FIGURE

We performed a geologic reconnaissance of the site on April 15, 2008, and June 11, 2008. The reservoir is covered and most of the surrounding area is covered with varying amounts of vegetation. In addition, the surrounding lots are heavily developed. A number of sandstone outcrops were observed around the perimeter of the reservoir, as shown on Figure 2. The sandstone was typically yellowish brown in color, weak to moderately strong, moderately to closely fractured, and moderately to deeply weathered. The rock outcrops and our aerial photograph review suggest that most of the reservoir area is underlain by sandstone bedrock at a shallow depth. We found no evidence of landslides within or close to the reservoir.

Our evaluation found that the site is underlain principally by sandstone bedrock throughout the reservoir area. The presence of sandstone was confirmed in the majority of the subsurface borings in the area and by our own surface mapping of sandstone outcrops of the site vicinity (Figure 2). The western side of the reservoir consists of a large fill embankment consisting mainly of silty clay. The fill overlies a layer of native soil consisting principally of sandy to silty clay.
