SERVICE REPORT FOR UPPER BLOCK REPLACEMENT  
ENTERPRISE DGRS-46 ENGINE SERIAL NUMBER 82004-3063  
UNIT 2  
EAST BAY MUNICIPAL UTILITIES DISTRICT  
OAKLAND, CALIFORNIA

## INTRODUCTION

## SYNOPSIS

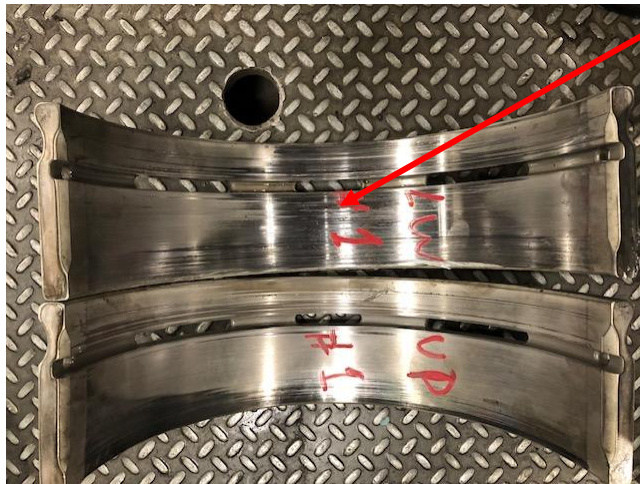
#1 Main bearing wear on upper and lower edge due to debris from damaged water pump drive gear

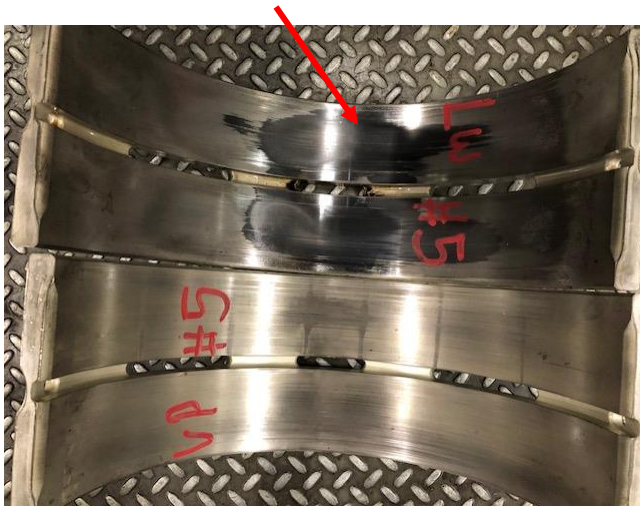
#5 Main bearing loading and overlay fatigue on lower shell

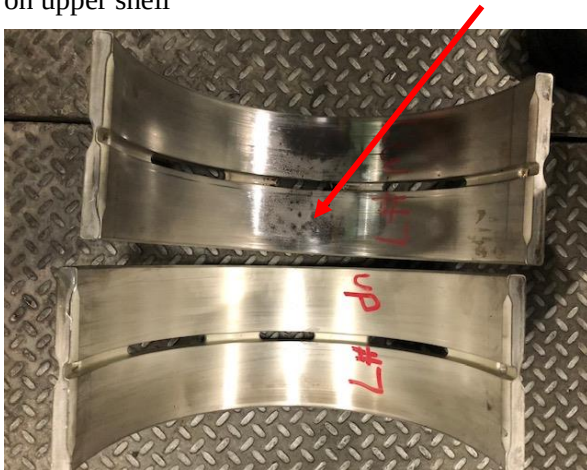
#7 Main bearing loading and overlay fatigue lower shell (normal wear pattern for service life). No wear on upper shell

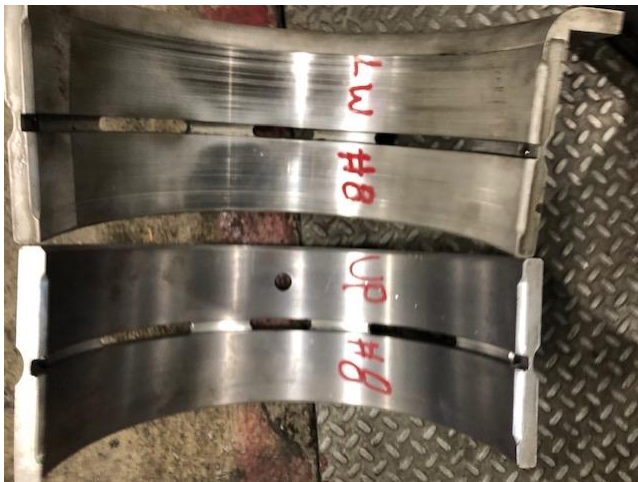
#8 Main bearing. Normal wear pattern for service life. No wear on upper shell

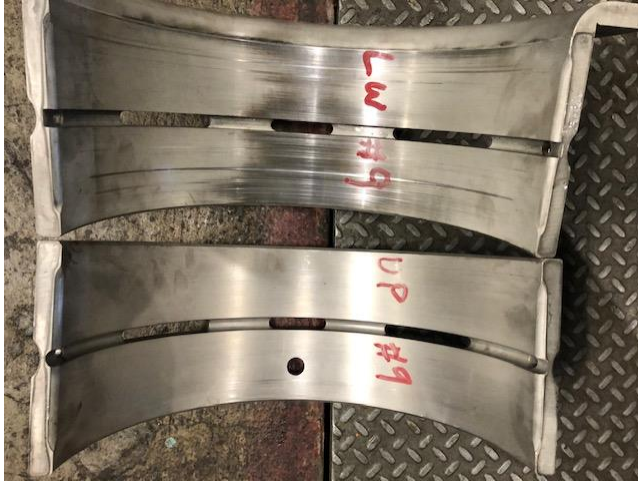
#9 Main bearing. Normal wear pattern for service life. No wear on upper shell. Good alignment to lower shell.

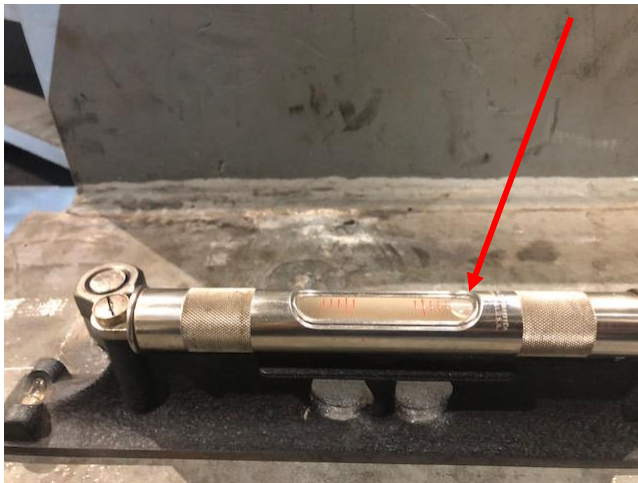
Starrett 98 series 12 inch machinist level bubble out of range center bracket upward to exhaust engine side

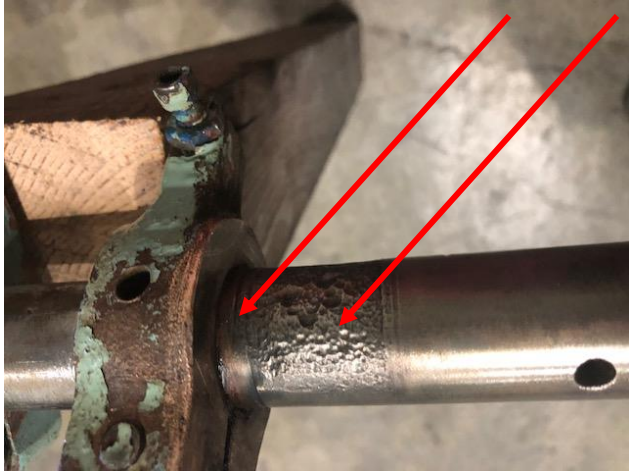
Corrosion beneath the #1 bushing coming from the governor control arm was found during cleaning of the fuel injector pump rack. The corrosion was deemed sufficient to account for reported erratic running on load changes in operation. (the corrosion would allow for angled linear motion of the rack in the bushing (excessive wear) instead of radial circular motion of the rack pulling the fuel pumps at intervals).

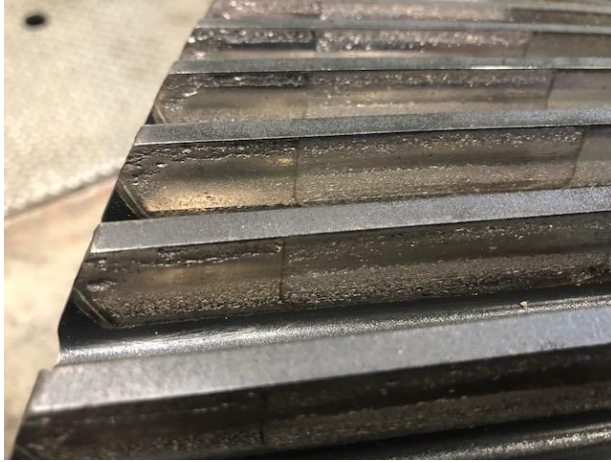
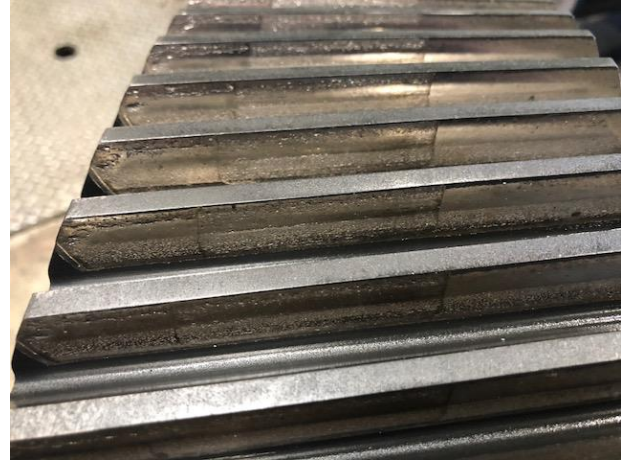
Idler Gear Damage

On September 7, 2018 an inspection of the idler gear was provided on Enterprise DGRS-46 engine serial number 84002-3063 (Unit 2), East Bay Municipal Utilities District, Power Generation Station, Oakland, California. The idler gear had a gear wear pattern corresponding to the oil pump drive gear and marginally out of specification gear backlash (.018 (specification .012 -.014)). Idler gear thrust measurements were also slightly excessive (.010 (specification .004 -.007) (A remnant of thin bronze shim was found on removing the idler from the idler stubshaft.) Hardness test on the gear faces of all the affected gears found the idler gear had 40 HRC with the crankshaft gear, camshaft gear, accessory drive gear, and oil pump drive gear having 55 HRC hardness. Determination to replace all gears in the gear train was based on Enterprise SIM 99 recommending replacing gears as a set by one manufacturer.

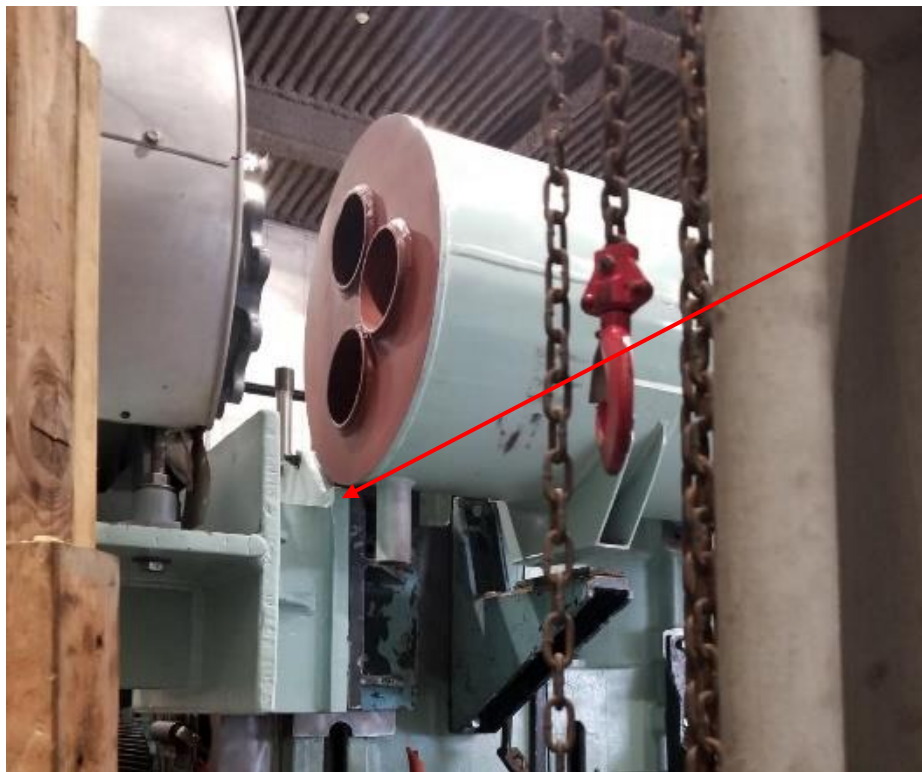
Reconfigured ABB  
turbocharger support  
bracket

The turbocharger support bracket had an as found curved surface for the turbocharger mounting points resulting in all 4 turbocharger mounting feet being soft (the mounting bolts were all double nutted to prevent looseness). A review of the turbocharger support bracket was done on 20 September 2018 using a Starrett series 98 12 inch machinist level. Planar deviation found the front center (outboard from the engine block) had a gradual rise of .050 from the exhaust side measured from the turbocharger mounting bolt hole to approximate center of the bracket and a rise of .060 on the camshaft side of the engine block from the turbocharger mounting bolt hole to approximate center of the bracket. The inboard side of the bracket had a rise of .015 on the exhaust of the engine block measured from the turbocharger mounting bolt hole to the approximate center of the bracket and a rise of .035 camshaft side of the engine block measured from the mounting bolt hole to the approximate center of the bracket. Level alignment found the plane of the mounting bolt holes was off level .015/ft on the exhaust of the engine block and .005/ft on the camshaft side of the engine block. The turbocharger platform was milled flat and remounted to the existing dowel holes.

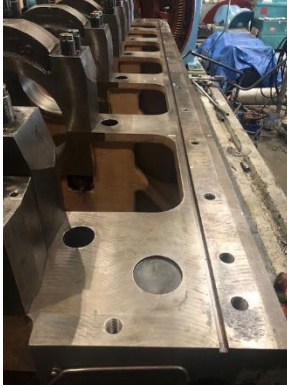
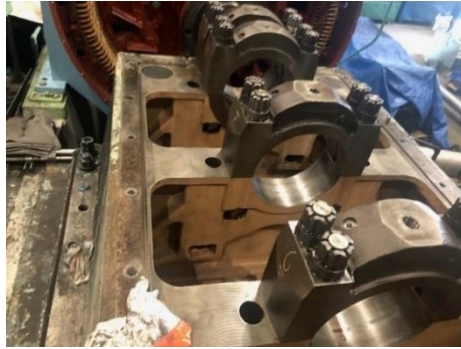
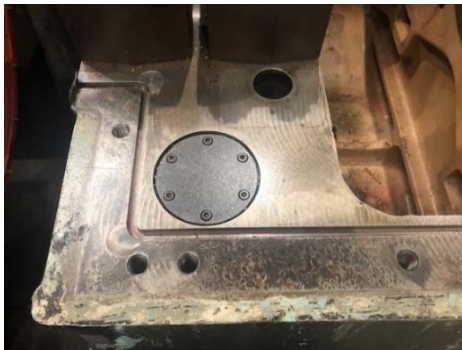
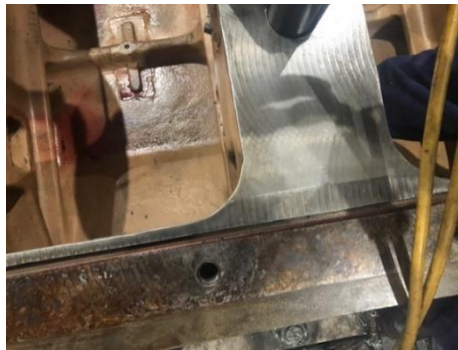
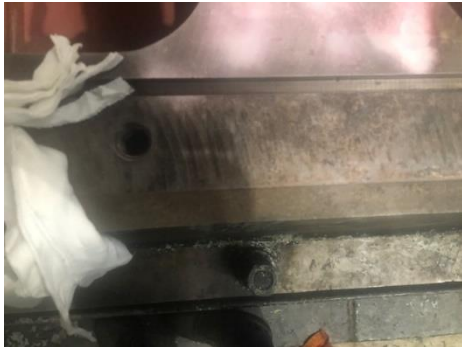
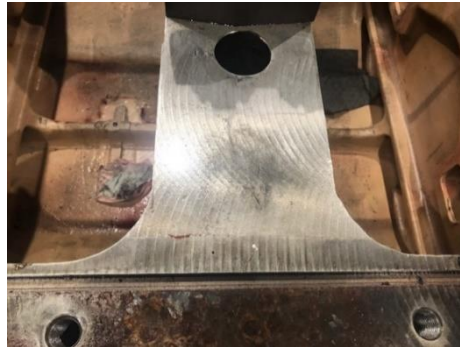
Fretting was found on the outside of the 'o'ring seal area on the bed plate. Areas were checked with a straight edge and machinist level.

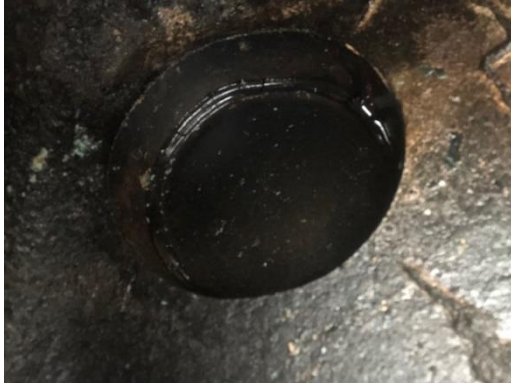
Right bank (intake side) front of engine expansion plug with overspray black paint and oil leak seen from bottom of bedplate through access holes.

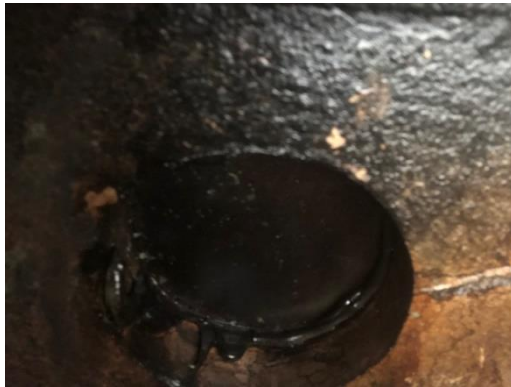
Left bank (exhaust side) expansion plug engine front with paint overspray and some signs of oil leak, viewed from bottom of bedplate through access holes.

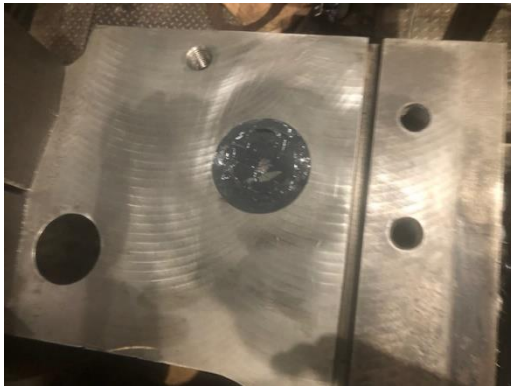
Right bank (intake side) engine front expansion plug with top filled with metal epoxy (JB Weld) to stop possible oil leaks.

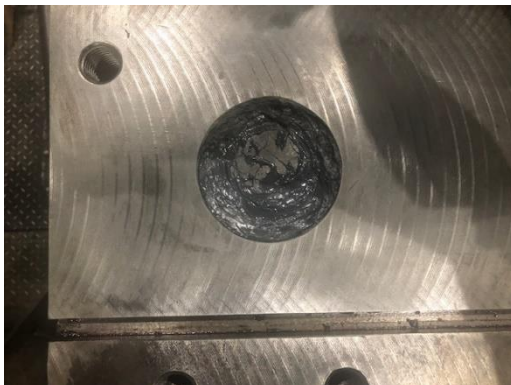
Left bank (exhaust side) engine front expansion plug with top filled with metal epoxy (JB Weld) to stop possible oil leaks.

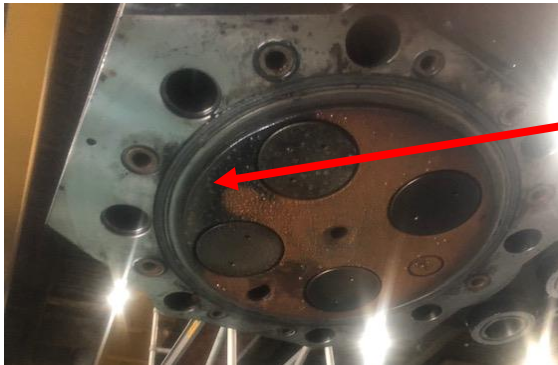
Replace #3 cylinder head for water leak found on blow down while searching for cause of crankcase pressure deviation. (expected crankcase pressure – 1 in crankcase pressure -.3 in at all loads). #3 cylinder head jet cell replaced twice before replacing cylinder head.

Water leak at exhaust

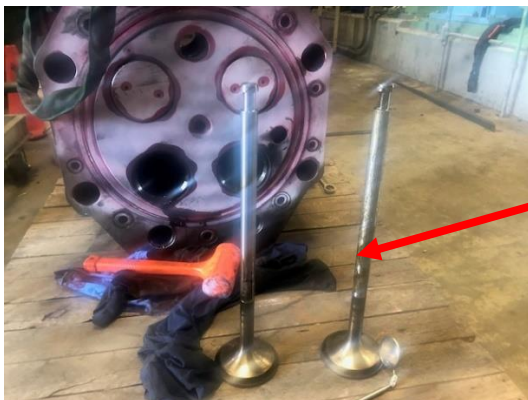
Oily water on valve stem

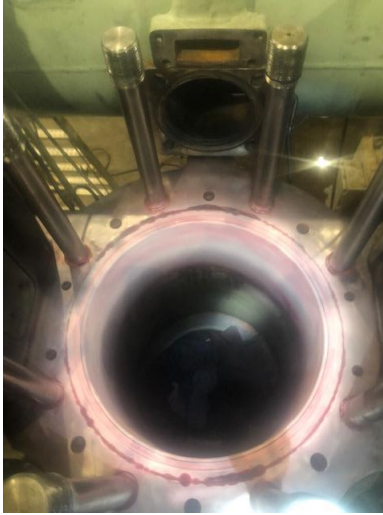
#3 cylinder upper bore die penetrant inspection with piston still in bore. (no sign of crack or leaks)

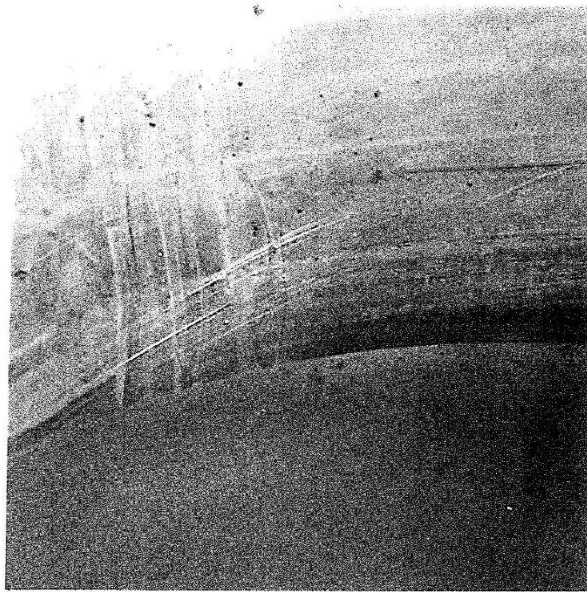
WATER STAINS

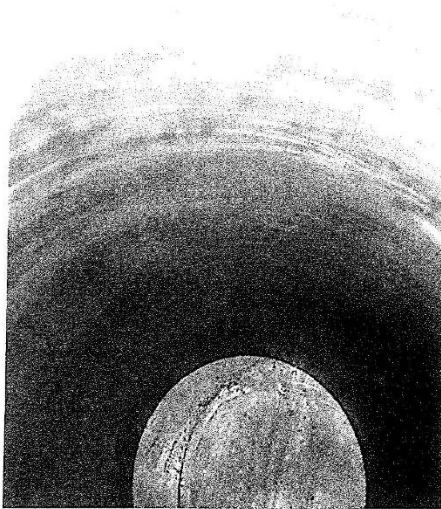
MINIMAL WEAR FOR SERVICE TIME

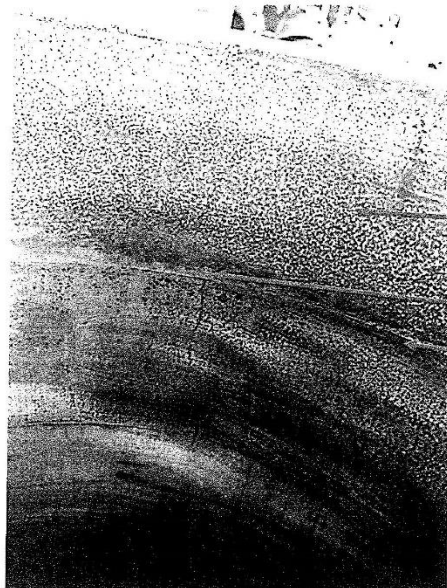
WATER STAIN FROM CYLINDER HEAD LEAK

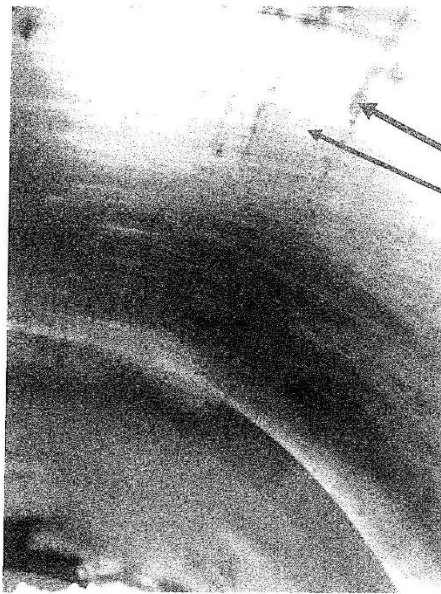
WATER STAINS

REMAINING CROSSHATCH

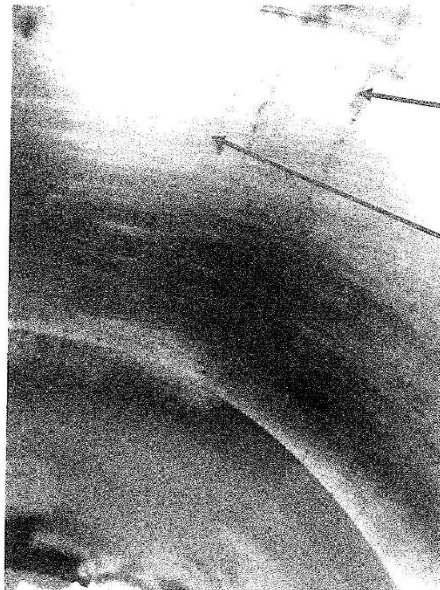
WATER STAINS

REMAINING CROSSHATCH

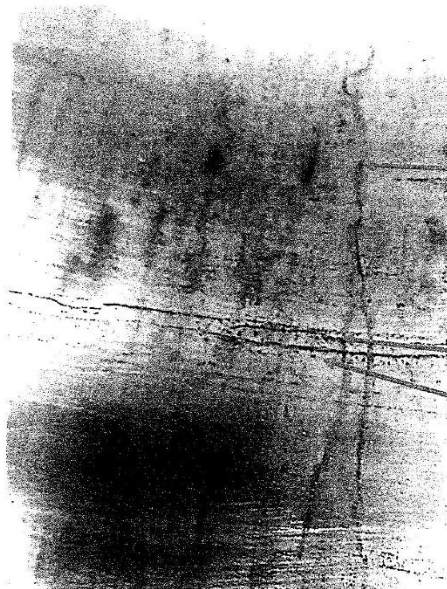
WATER STAINS

RING STOP (BOTTOM OF STROKE REVERSAL) CUT

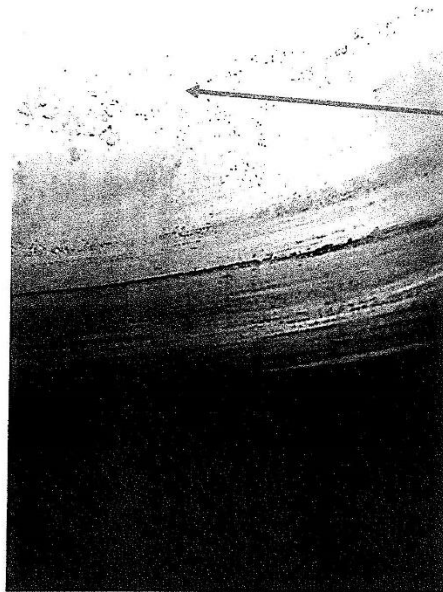
PITTING DAMAGE FROM WATER

RING STOP CUT

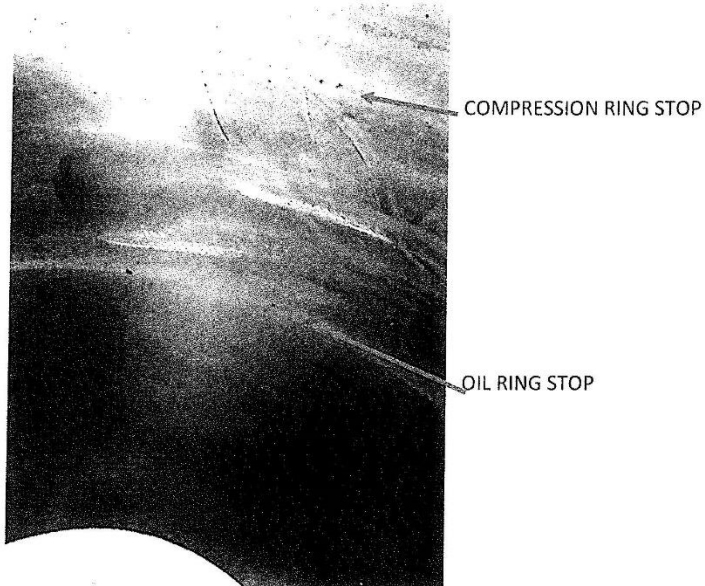
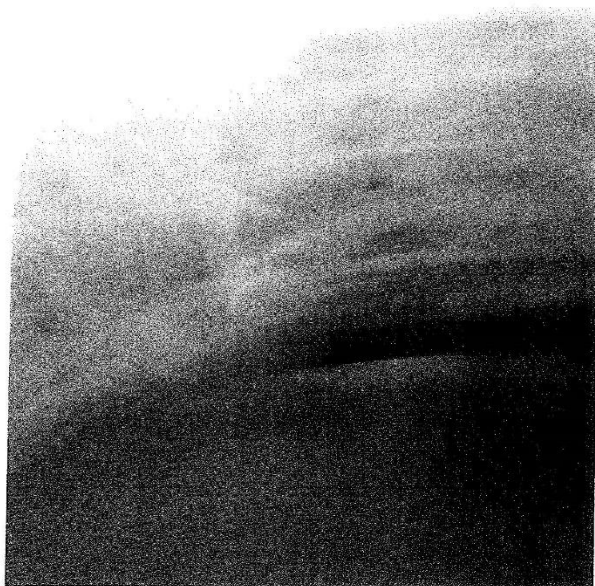
LOWER BORE SHOWS LITTLE WEAR
