# Safety Evaluation East Bay Municipal District Wastewater Treatment Plant

Client: Advanced Engine Technologies Corp.

**Submitted by:**  
**Jim Dyer, Principal Engineer**  
**Neil Holmgren, President**  
**09/22/2020**

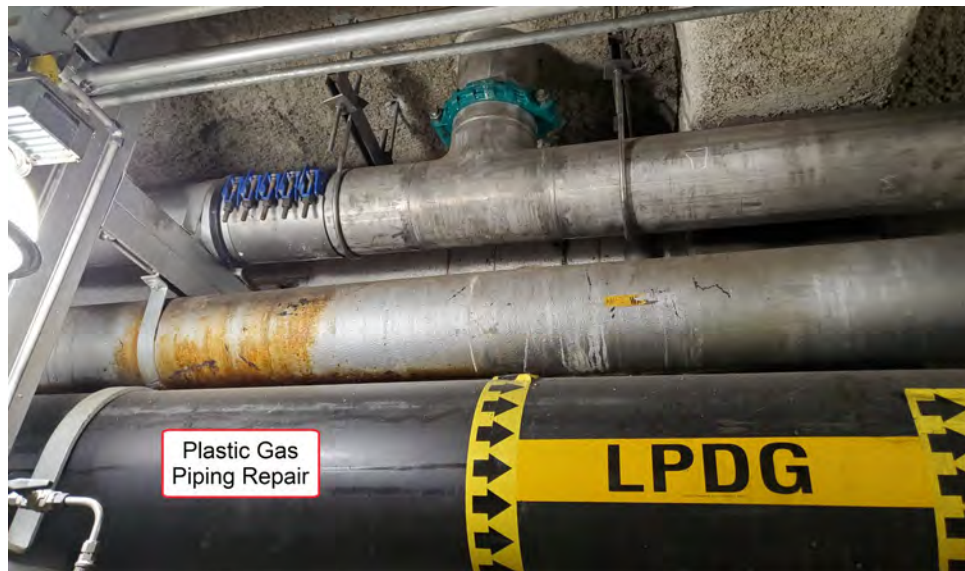
**Figure 1: LPDG Gas Piping**

*Figure 1* shows a section of Polyethylene (PE) piping used to replace the leaking carbon steel piping in the LPDG supply to the gas compressors located in the overhead of the basement on the East wall.

NFPA 37 identifies that “Plastic pipe shall not be used to carry fuel within a room housing an engine(s).”

The polyethylene section of piping in the engine room should be replaced with code compliant steel piping.

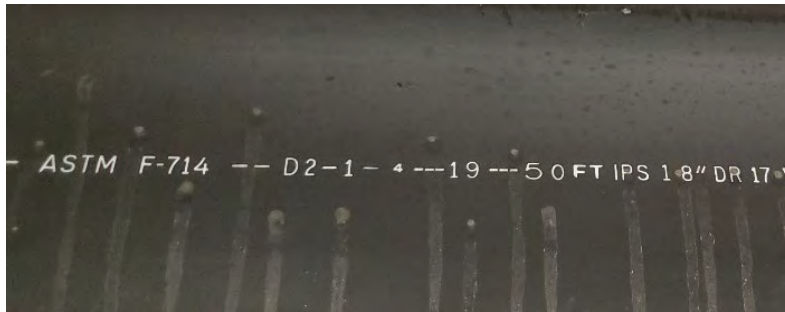
**Figure 2 – Installed LPDG Labeling**

Additionally, closer inspection of the PE piping showed that it was not compliant with NFPA 54. *Figure 2* shows the piping marked ASTM F-714. NFPA 54 states that PE piping used for fuel gas is required to be marked “gas” and “ASTM D2513”.

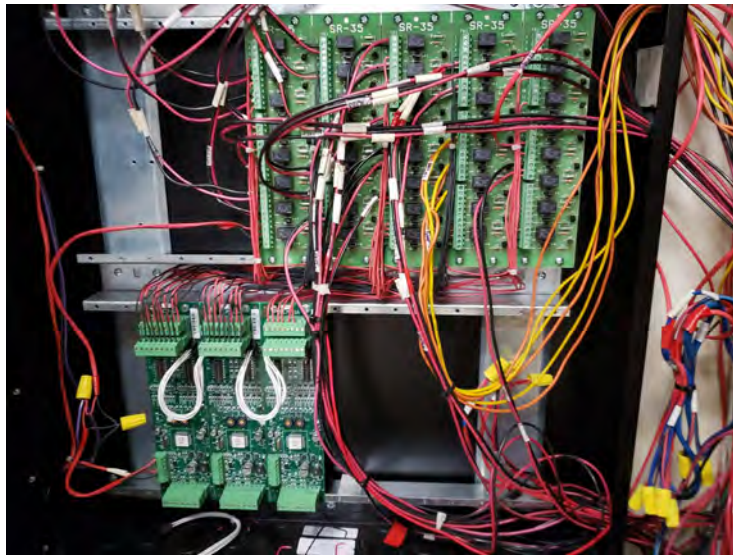
**Figure 3: PGS-1 Fire Detection Panel Internal Wiring**

While the incorrect (potentially out of date) drawings are a violation of the California Code of Regulations, perhaps more importantly, lack of reliable documentation in general leads to difficulty in system comprehension and troubleshooting for facility personnel.

A complete and accurate set of *as built* drawings are required to conform to code. Inspection of the panels, circuit tracing, and testing will be required to determine the "as-built" condition of the Fire Detection System. This is essential for plant personnel to understand the proper operation, have accurate expectations during testing or an emergency event, and troubleshoot the system should expectations not be met.

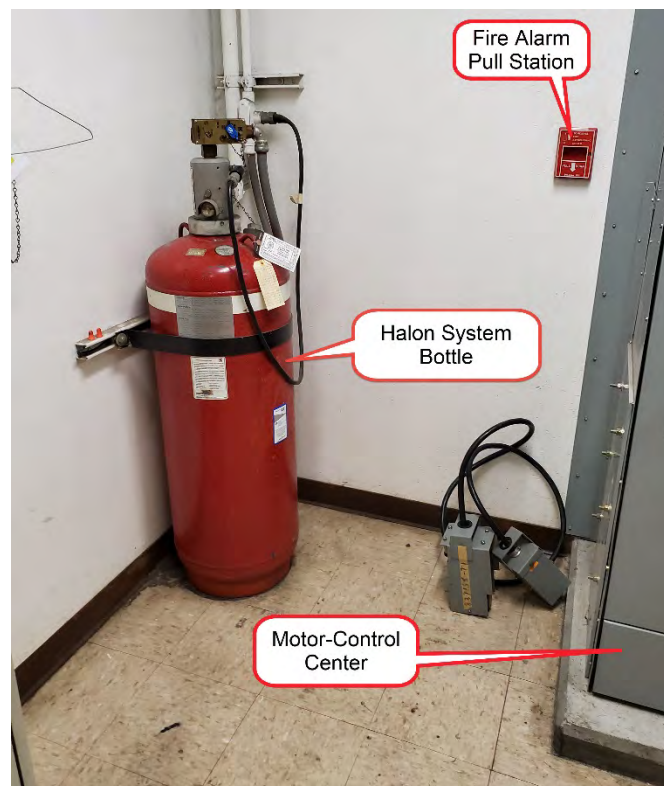
**Figure 4: PGS-1 Control Room Fire Alarm Pull Station**

California Code and NFPA requires the fire alarm manual pull stations be located within 5 feet of each exit from the protected space. The PGS-1 control room was modified with a new motor-control center installed against the south wall. When this was done, one of the exit doors for the control room was blocked by the new equipment. The fire alarm pull station was located adjacent to this abandoned door (*Figure 4*) that was covered by the motor-control center. The current exit from the control room is on the opposite side of motor control center outside of the 5 feet requirement. It there is not a pull station located adjacent to the door exiting to outside this pull station needs to be moved closer to the existing exit door.

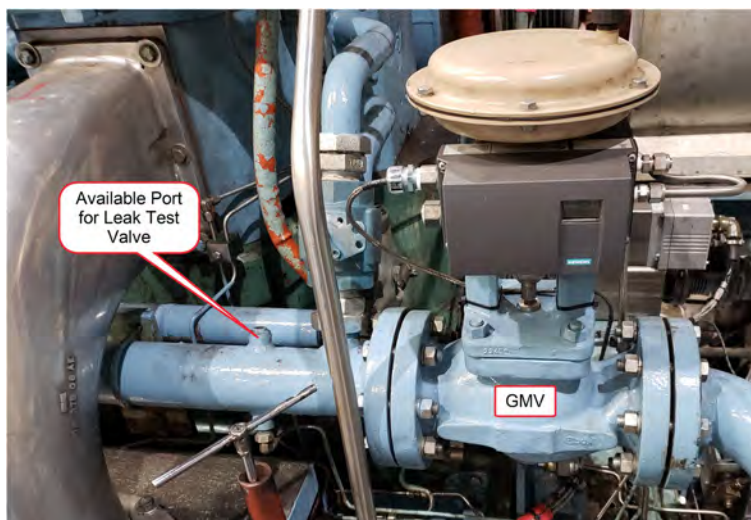
Figure 6: Engine Fuel Gas Metering Valve and Gas Header

No leak test valves were installed downstream of the GMVs, but each engine has an available port for installation (*Figure 6*). A leak detection valve is not required between the ASSVs because the upstream ASSV vents to the PGS-1 roof when closed.

Install valves and plugs in available port for Leak Test valves. This can be performed by plant personnel, likely with instrument valves and fittings available on site.

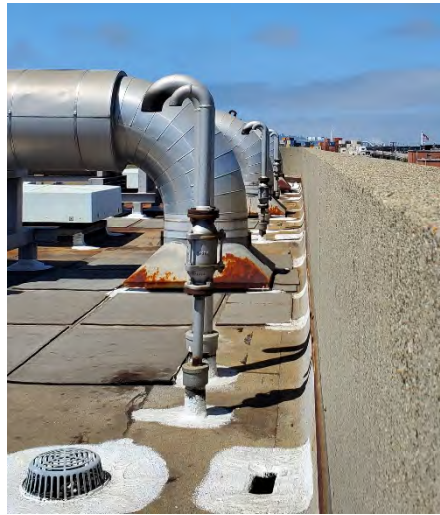
**Figure 7 – Engine Vent Piping**

NFPA 54 requires gas vents on the roof to terminate two feet above the highest part of the building that is within 10 feet. The engine fuel gas piping vents did not meet this requirement (*Figure 7*).

The engine fuel gas vents need to be raised to terminate two feet above the parapet. A spool piece can be installed between the flame arrestor and the gooseneck. This repair can likely be performed by plant personnel or a local mechanical contractor in regular employ of EBMUD.

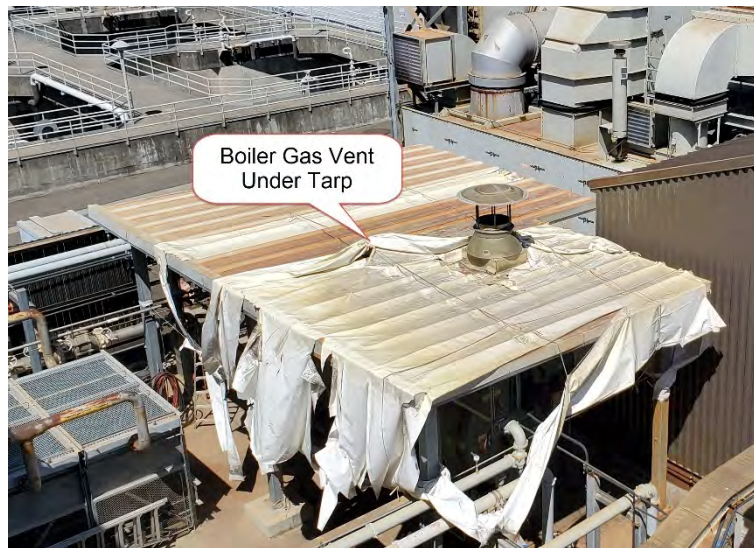
**Figure 8 – Boiler Gas Vent Terminates Under Tarp**

NFPA 54 requires gas vents on the roof to termination not be blocked or covered. The engine fuel gas piping vents did not meet this requirement due to the tarp installed in the boiler structure (*Figure 8*).

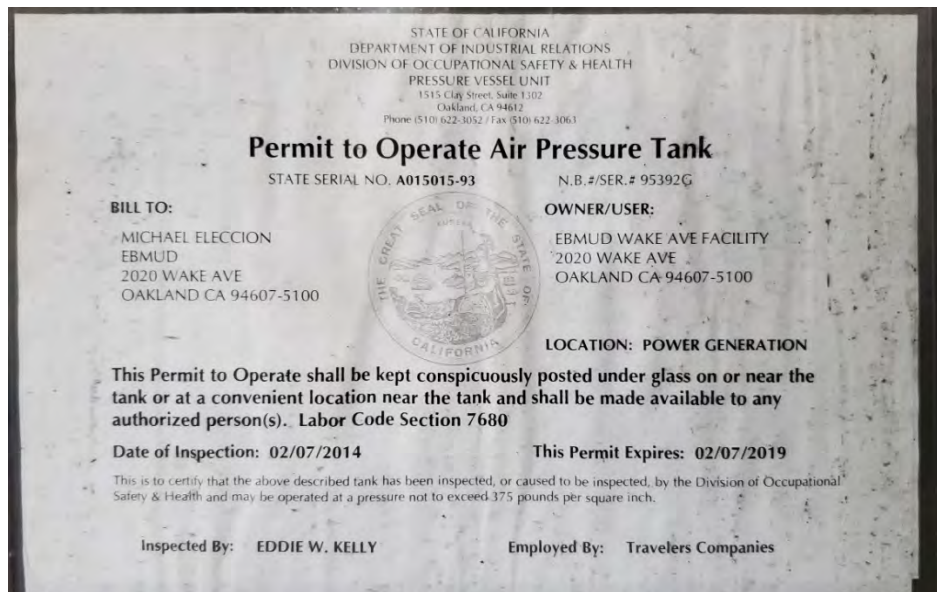
Figure 9: Air Pressure Tank Certificate

Air receivers were visually inspected. Two of the four had valid pressure tank permits, one permit had expired (*Figure 9*), and the last had no permit posted. California Labor Code 7684 states that “Each permit or a clear reproduced copy thereof shall be posted in a protective container in a conspicuous place on or near the tank...”

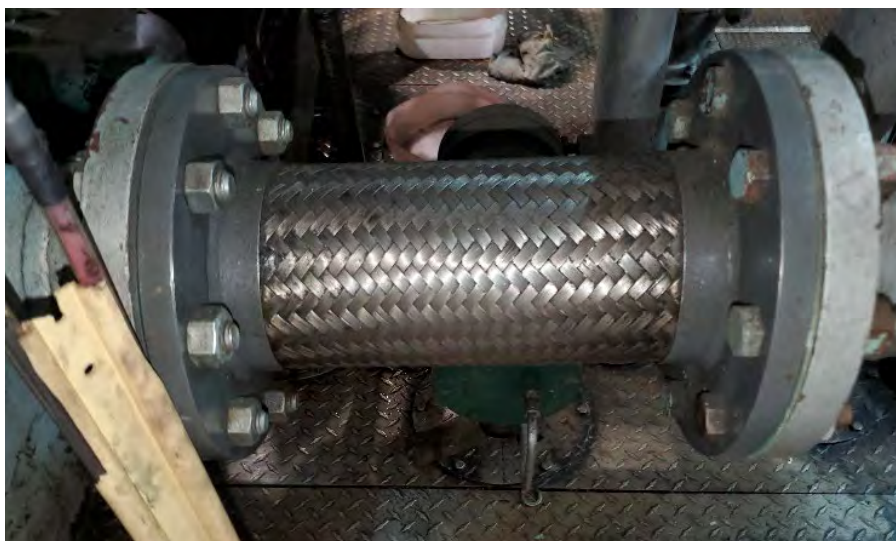
**Figure 10: Engine Fuel Gas Supply Hose**

For ESI, these are familiar Enterprise hoses and appear to be (or equivalent to) the OEM units. The NFPA code does not require the hoses be labeled, they simply need to be compliant with ANSI/CSA standards. Without a label, the only way to prove compliance is with documentation from the OEM and tracking of the part through inventory and installation. New hoses will come labeled as compliant.

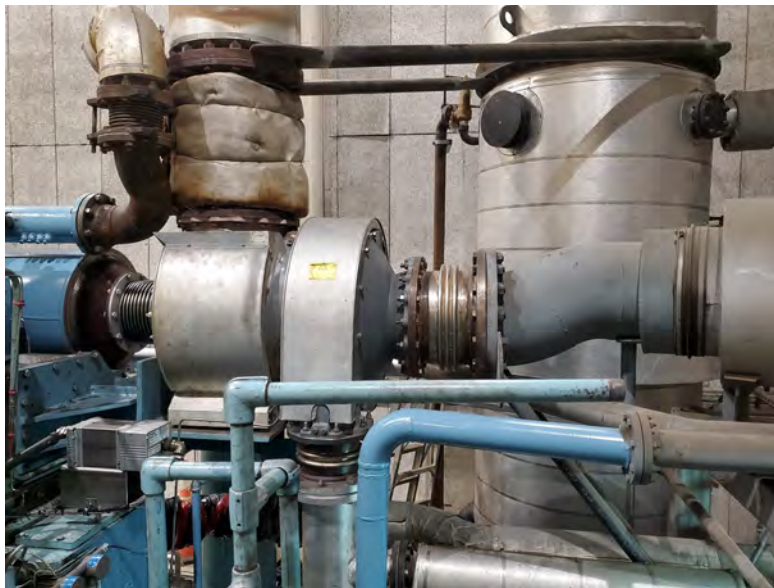
**Figure 11 - Uninsulated Elements of Exhaust and Jacket Water System**

It is common for pipe insulation to be degraded through routine wear and tear during engine maintenance and especially during an overhaul. The engines were missing insulation on the exhaust and jacket water systems. Discussions with plant personnel indicated that the piping will be insulated at the completion of the current overhauls.

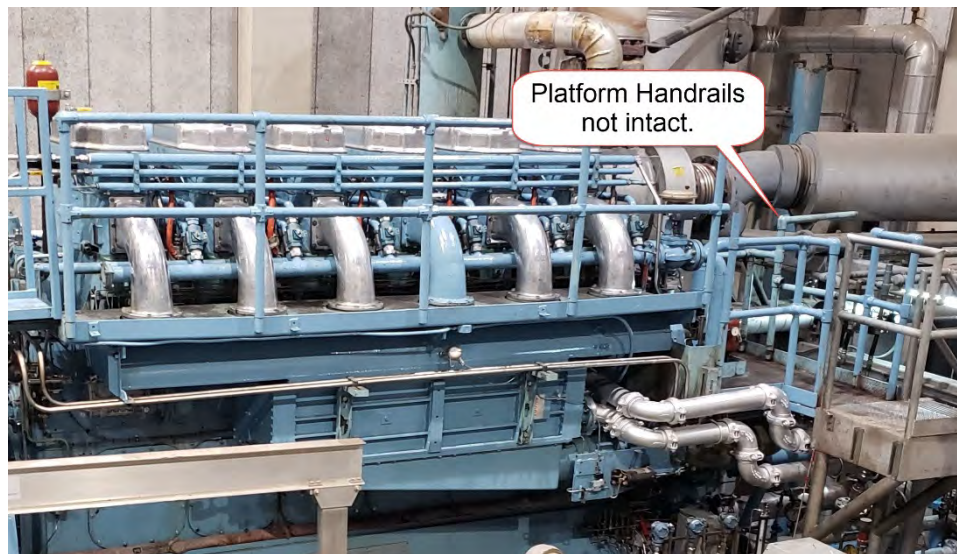
**Figure 12 - Platform Handrail not Correctly Installed**

The handrails on Engine 3 were not correctly installed on the gearcase end of the engine.

Missing components or improperly mounted handrails should be properly installed to reduce the risk of fall from the engine platform. This can be performed by plant personnel or by the party responsible for their disassembly.

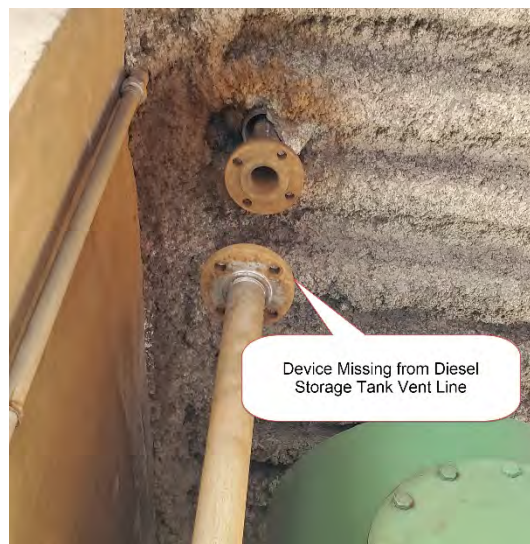
**Figure 13: Overhead of Gas Compressor Pad Showing Fuel Oil Tank Vent Pipe to Roof**

It appears that a flame arrestor (or other device) originally installed in the diesel fuel tank vent line has been removed and the piping now vents below the roof of the gas compressor pad (*Figure 13*). Code prohibits the venting on underground tanks to a location allowing the vapors to become trapped under the eaves of a building.

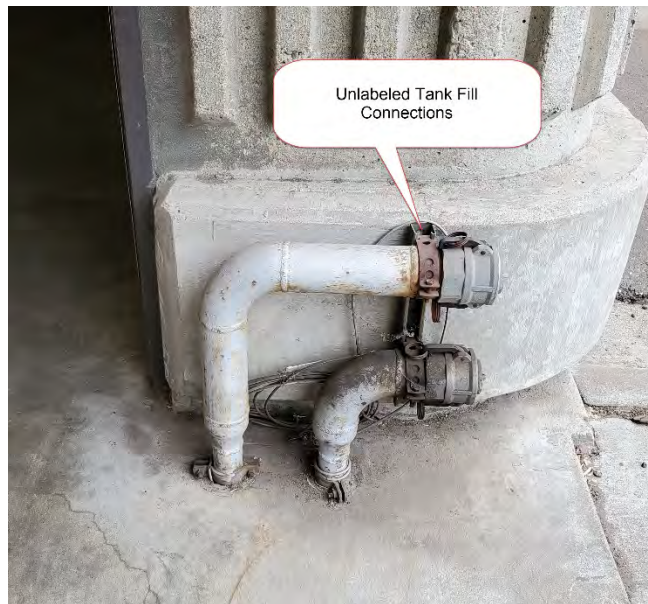
**Figure 14: Fuel Oil Tank Connections**

The diesel fuel tank loading connection is not marked to identify the product service (*Figure 14*). NFPA states, "Each loading and unloading riser shall be marked to identify the product for which it is to be used."

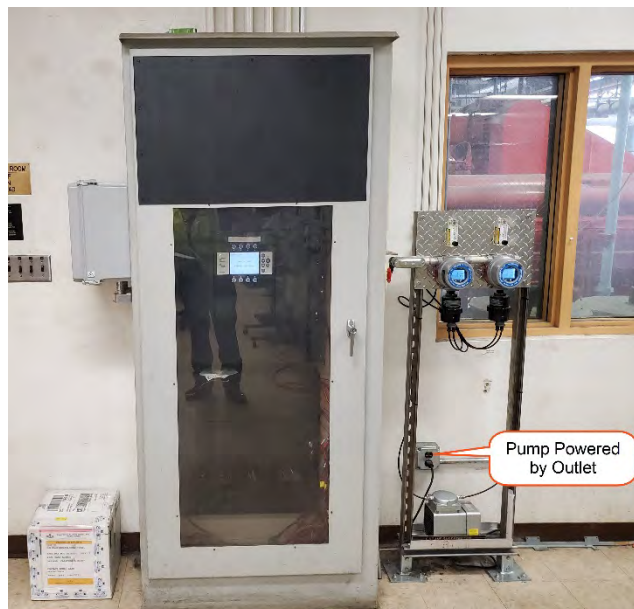
Figure 15: PGS-1 Fire Detection and Gas Detection Panels

Based on preliminary reports from Plant Personnel following the August 14 unplanned outage, the Gas Detection System indicated a “System Failure” when the control panel was deenergized after the loss of utility power. When power was restored, one of the detectors failed which prevented an engine start. The faulty gas detector was bypassed and the engines were started.

The Gas Detection Panel located in PGS-1 is powered from the L1 lighting distribution panel. The gas sampling pumps are powered through electrical receptacles (*Figure 15*). ESI recommends the trouble signal not initiate an engine shutdown or prevent a restart.

A redundant power supply should be installed to comply with NFPA recommendations and the trouble alarm (loss of power alarm) should not initiate a shutdown or prevent engine start.

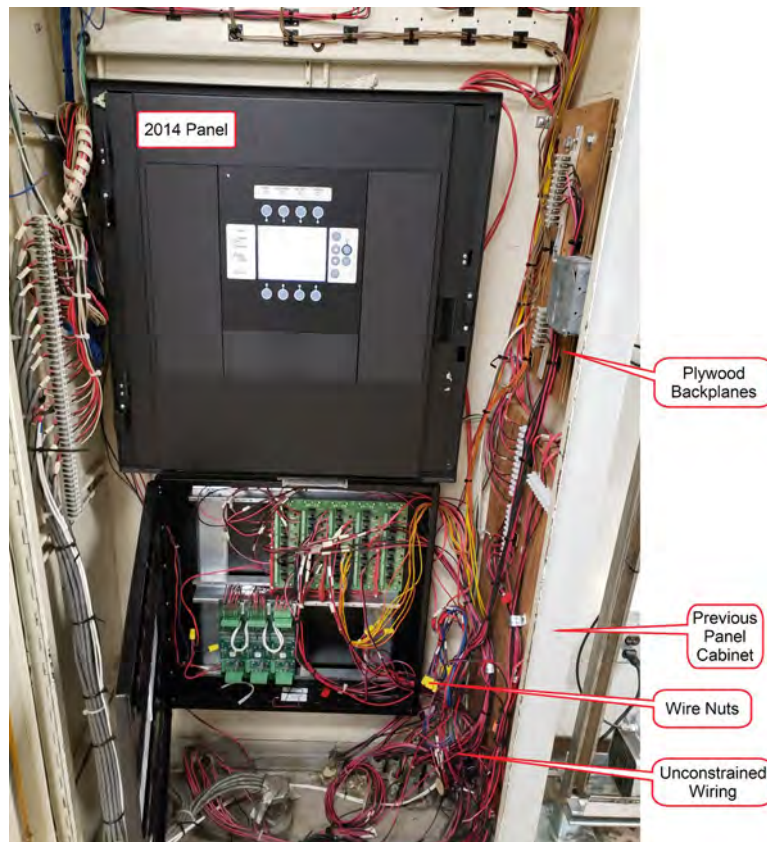
Figure 16: Internals of PGS-1 Fire Detection Panel

The Fire Detection System was upgraded in 2014. It appears that the new equipment was placed inside a previous system panel cabinet (*Figure 16*). The general condition of the wiring inside the panel was disarrayed. Specifics are detailed below.

The panel wiring layout should be cleaned up, wires relabeled as required, plywood backplanes replaced with DIN rail (or equivalent), terminal strips laid out logically to accommodate all wires (including spares), and Panduit (or equivalent) installed to neatly contain wiring. A new drawing should be produced that reflects the improvements.

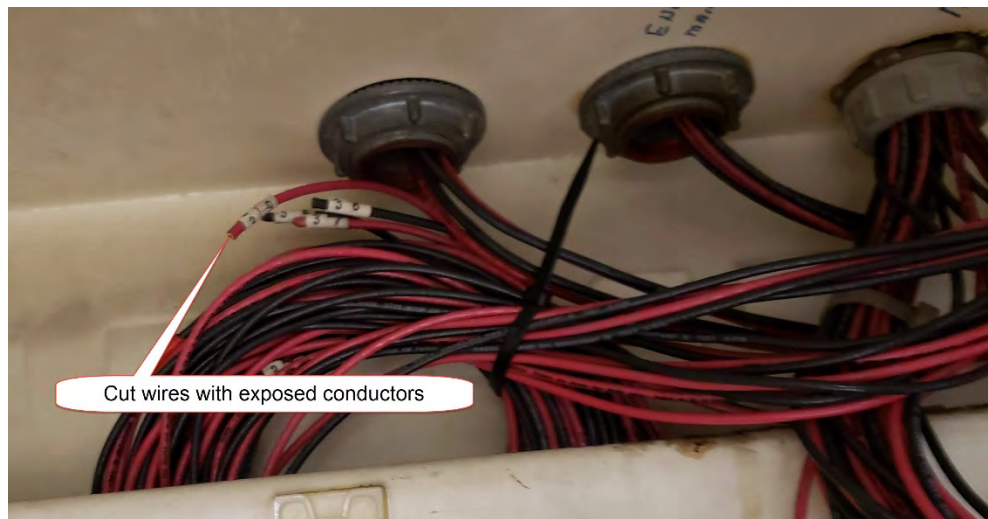
Figure 17: Severed Wires in PGS-1 Fire Detection Panel

Some conductors inside the Fire Detection Panel are no longer in use. There are unconstrained wires, cut with the conductors exposed (*Figure 17*). Wires removed from service should be either completely removed or terminated in a terminal strip to eliminate any chance of accidental grounding or energizing. If terminated in a terminal strip as a spare, drawings need to indicate where both ends of the wires are terminated and labels need to be installed on the conductors.

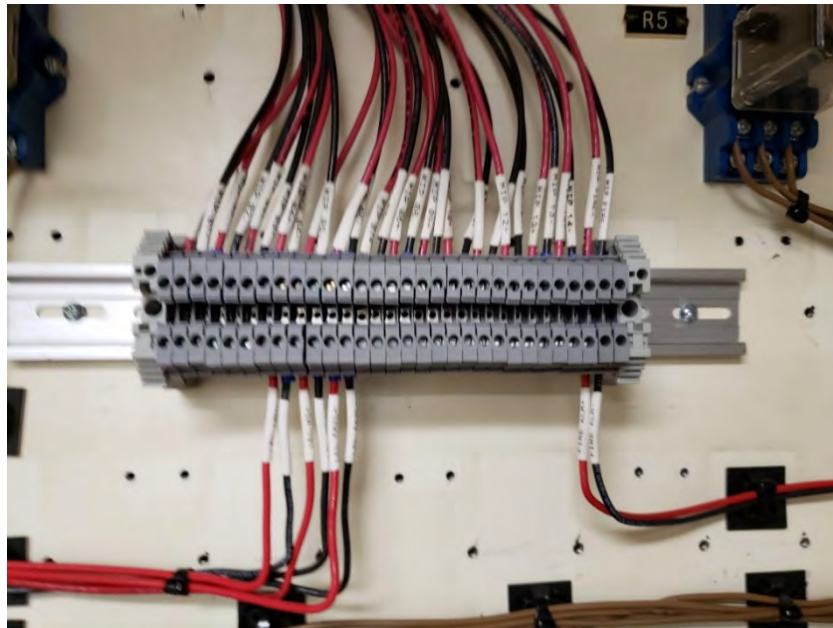
Figure 18: Terminal Strip in PGS-1 Fire Detection Panel

Some wires in the panel are dead ended at terminal strips (*Figure 18*). As stated above, this is acceptable for future expansion if the wires are labeled in the drawings. However, it is not known if these wires are spares or have been removed.

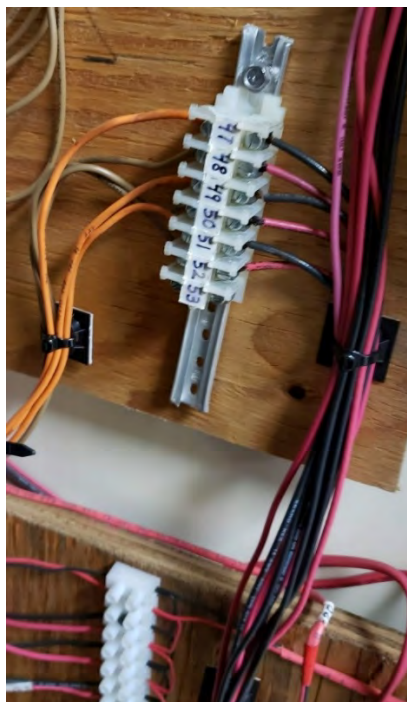
Figure 19: Plywood Backplane in PGS-1 Fire Detection Panel

There are two plywood backplane panels installed in the Fire Detection cabinet. It appears that these are used to mount terminal strips. Plywood is not a standard industrial panel material due to the risk of fire and the insulating properties prevent the backplane from acting as part of the panel ground system.

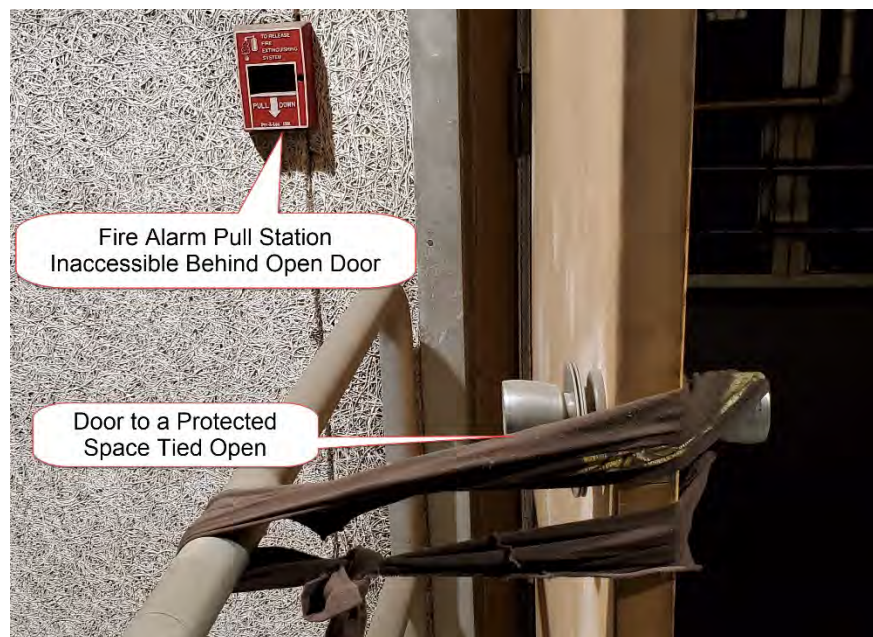
Figure 20: Exterior Door to Fuel Oil Day Tank Room

The fire alarm pull station at the exit to the Fuel Oil Day Tank room is in a difficult spot to access (*Figure 20*), especially with the door held open. ESi recommends changing the orientation of this pull station to the door for better access. Even if the door is kept shut, it could become stuck open during an emergency egress making it difficult to reach the pull station. The door can be hinged on the opposite side or the pull station moved to the other side of the door.

ESi recommends keeping all openings to protected spaces closed and relocating the manual pull station to the opposite side of the door.

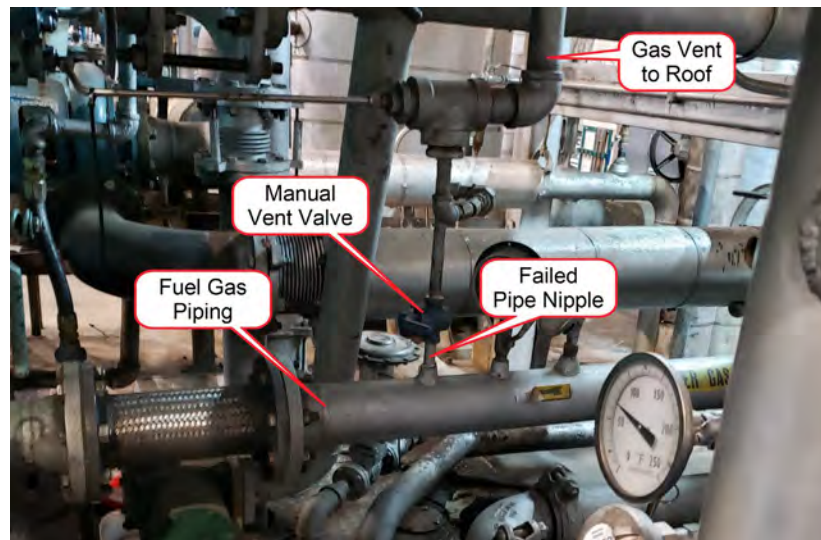
Figure 21: Engine 2 Fuel Gas Supply Piping

Discussions with plant personnel revealed that the piping for the manual gas vent on engine #2 failed at the pipe nipple between the fuel gas piping and the manual vent valve. The pipe nipple broke and separated the manual vent valve from the fuel gas line completely. As a result, pressurized fuel gas sprayed from the fuel gas line until the operator discovered the leak, switched the engine to diesel mode, and manually secured gas to the engine. The repair was performed prior to ESI's discussion with the operator.

While the failure mode was not identified conclusively (ESI did not examine the failed components), it was likely caused by vibration. This means that manual vent piping was not properly supported and/or isolated from vibration.

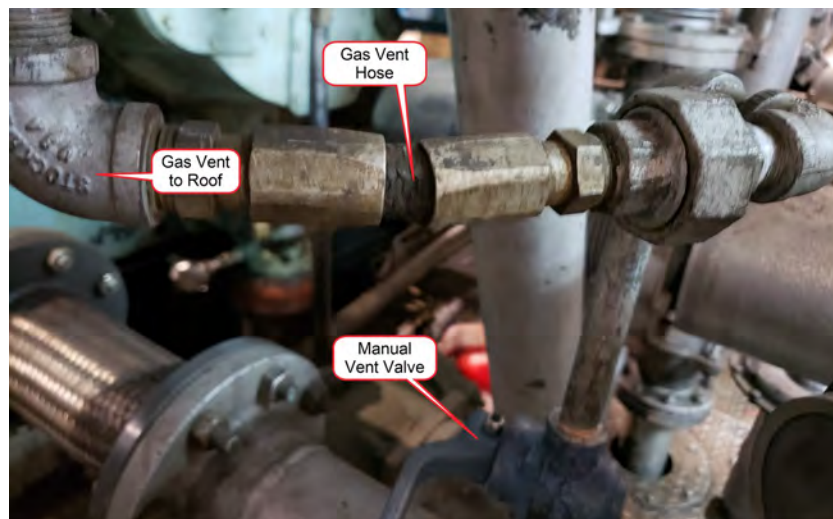
Figure 22: Engine 2 Fuel Gas Vent Line

The vent line downstream of the manual vent valve connects to the gas vent to the roof via a short hose (Figure 22). This hose is too short to provide any meaningful vibration isolation.

Proper installation will allow for more flexibility in the hose connection allowing for better vibration isolation.

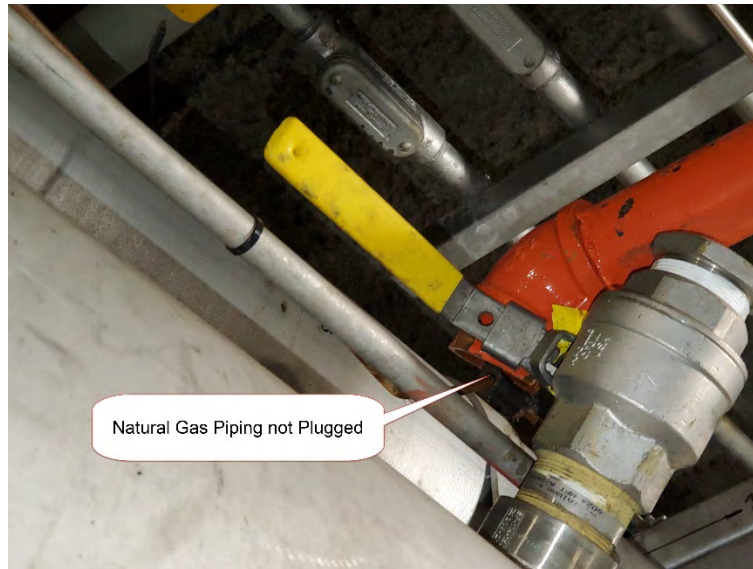
**Figure 24 - Natural Gas Piping Open to Engine Room**

The pipe connection between the natural gas supply and LPDG systems (located in the basement along the east wall) is disconnected and not plugged (*Figure 24*). The Natural Gas supply valve to the engine room is currently locked out and there is very little chance of leakage into the engine room. If the natural gas system is placed back in service, gas could flow into the machinery spaces if this pipe is not plugged. It is good practice to plug the natural gas piping to prevent inadvertent leaks and keep the piping clean.

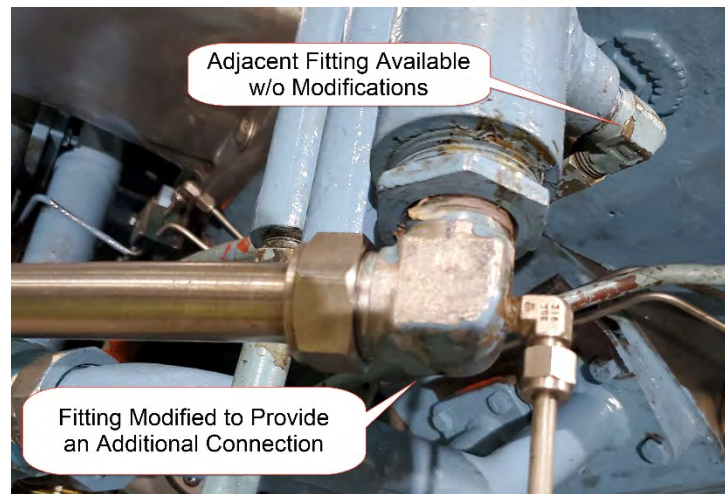
**Figure 25: Modified Fuel Oil Elbow**

The engine Fuel Oil system contained many modified fittings, mostly around the micro-pilot fuel system. These fittings are not installed as designed and little is known about the quality of the modification. Proper fitting selection from the Swagelok catalog could have been substituted for these modifications. *Figure 25* is a typical modification identified by ESI. It appears that the original fitting was drilled/tapped for insertion of a new fitting. In this case, there is an additional port that could have received the proper Swagelok fitting in lieu of modification to the elbow.

ESi recommends replacing these modified fittings with the proper selection of manufactured fittings as best practice.

Plant personnel can procure and replace modified fittings with manufactured fittings.

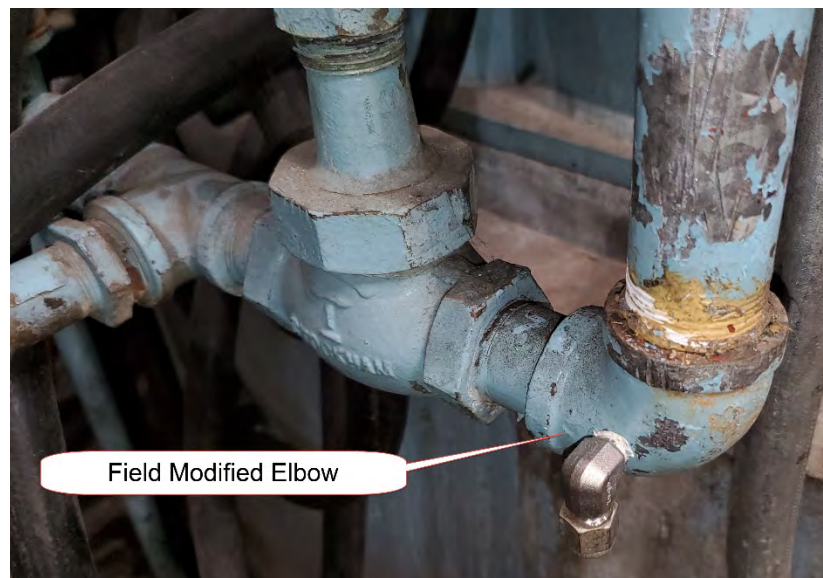
**Figure 26: Modified Cooling Water Elbow**

The cooling water systems contained modified fittings as well (*Figure 26*). These modification points can become sites for erosion or corrosion which can lead to leakage.

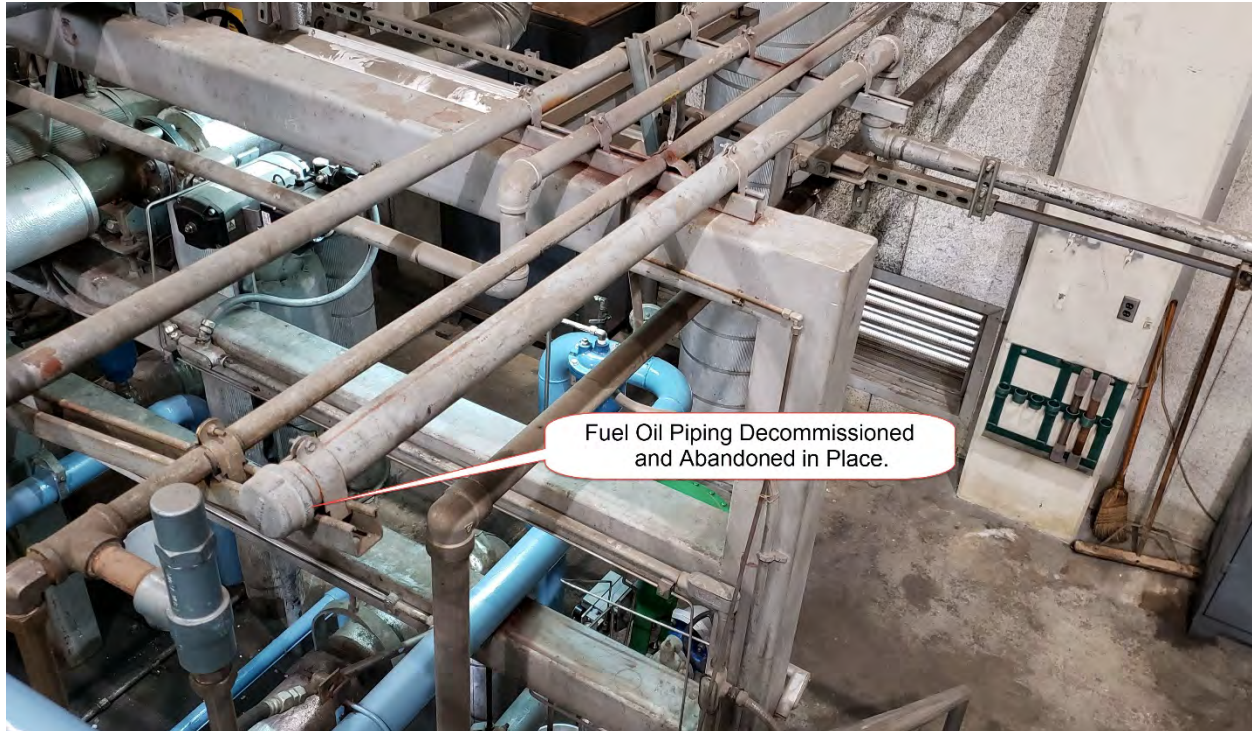
**Figure 27 - Decommissioned and Abandoned in Place Piping**

All three engines have decommissioned fuel piping abandoned in place (*Figure 27*). Best practice is to remove unused piping especially if it was used to carry environmentally sensitive fluids. This is done to reduce clutter, risk of leakage, possibility for inadvertent use, and potential for operator confusion.

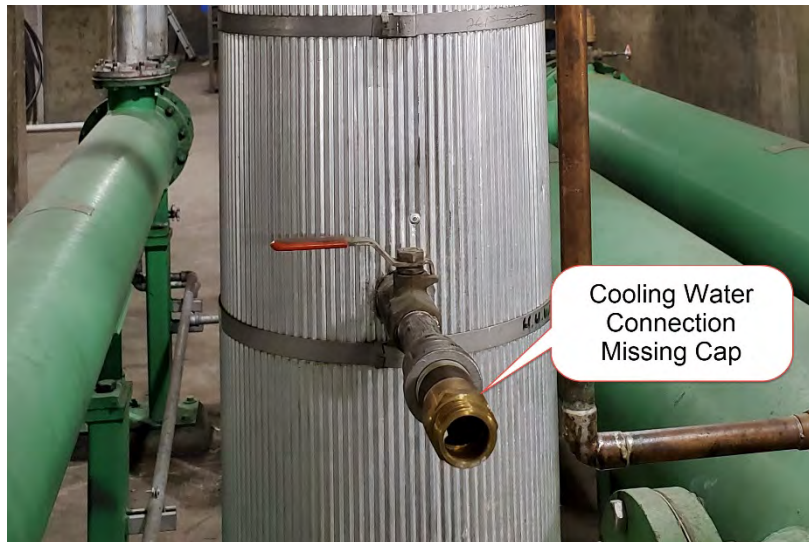
**Figure 28 - Cooling Water System Uncapped Connection**

The engine cooling water systems had valved connections that were not capped/plugged. Accidental opening of these valves can lead to burns to personnel or damage to equipment. It is common practice to provide double protection (Valve/Plug) to prevent accidental release of scalding water. *Figure 28* shows the connection to the engine cooling water system which was operating at a temperature exceeding 150°F.

Install caps/plugs on all valved connections open to atmosphere to prevent injury or damage to equipment.

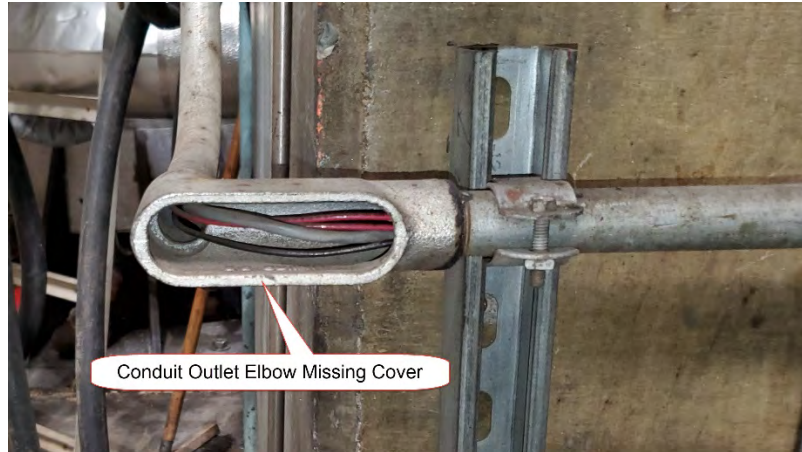
**Figure 29 – Conduit Elbow Missing Cover**

Conduit and junction box covers were missing. This is a common occurrence but should not become standard practice. This exposes conductors to the environment and can lead to accumulation of water, dirt, oil, and grease. Regular effort should be maintained to identify these locations for work orders to ensure the conduit integrity is maintained. The missing conduit elbow cap shown in *Figure 29* is located adjacent to the Engine #3 cooling water standpipe.

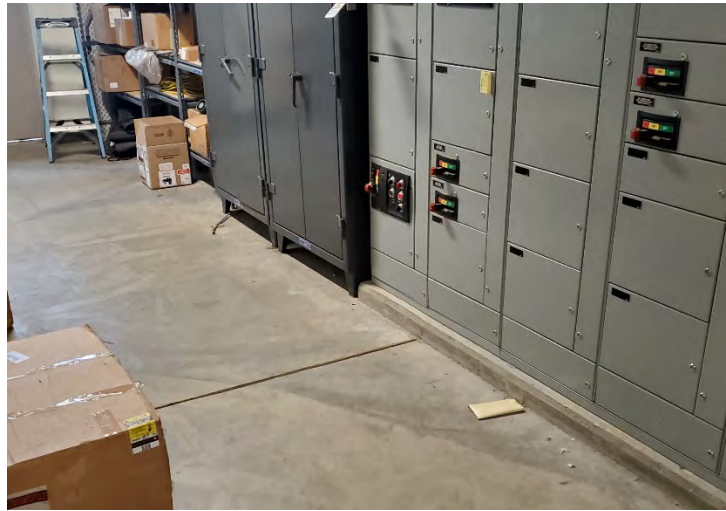
**Figure 30 – Panel without Electrical Safety Mat**

Insulating electrical mats should be used any time maintenance is conducted on a live electrical circuit. Code allows for the mats to be transported to the site of maintenance or permanently installed at the panels and switchboards. Best practice is to have mats permanently installed to reduce the burden of transporting the mats and reduce staging time for routine maintenance.

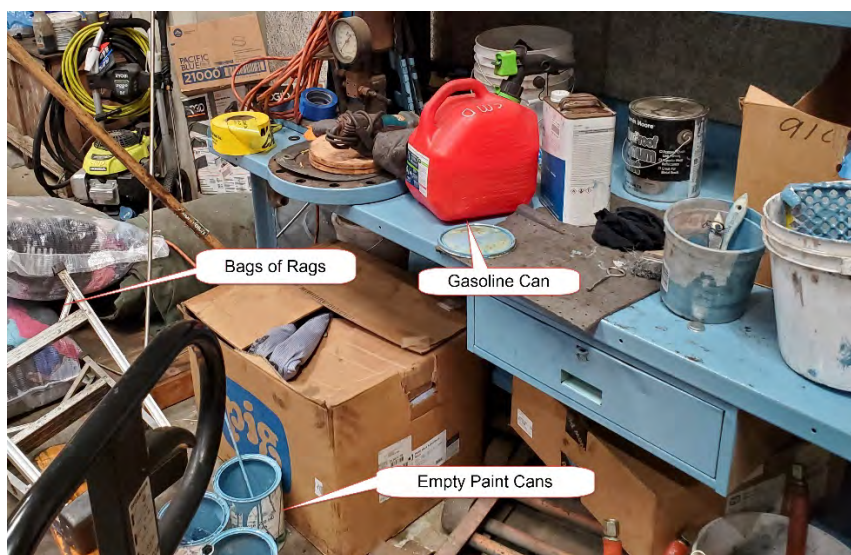
**Figure 31 - Gasoline Stored Adjacent to Combustibles**

A half-full gasoline can was found in the engine room on the fuel injector test bench adjacent to bags of rags and empty paint cans (*Figure 31*). Flammable liquids should be stored in a designated and secure location like a flammable liquid locker. Contractors can be asked to provide their own flammable liquids containment for extended projects onsite.

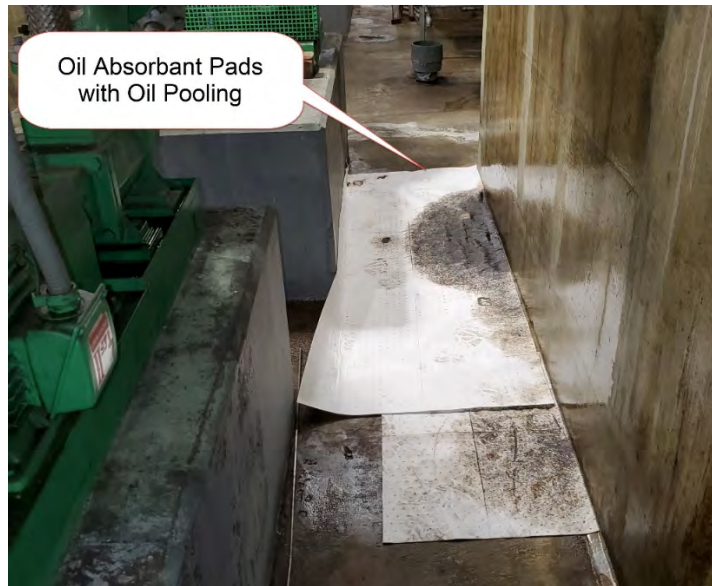
**Figure 32 - Oil Absorbent Pads in Basement**

Oil absorbent pads appeared to be in semi-permanent use in the basement adjacent to the engine foundation. Best practice is to locate and repair any oil leaks on the engine. ESI appreciates that is an arduous effort that requires constant attention. In the meantime, the use of oil absorbing materials is important to prevent slips and falls. The pads should be changed prior to oil saturation.

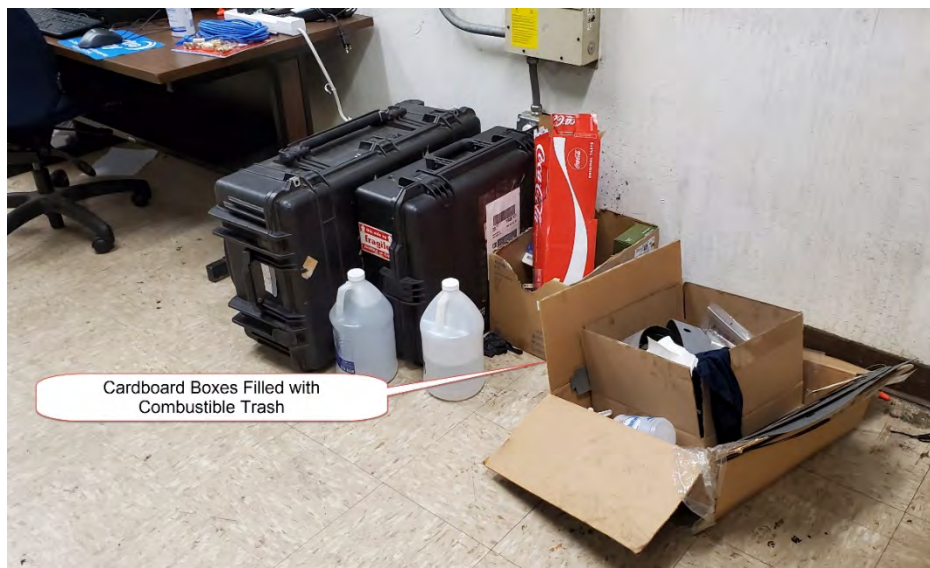
**Figure 33 - Trash and Debris Left by Contractors**

Some potentially combustible trash was found in the PGS-1 control room (*Figure 33*). Trash bins should be placed in spaces with heavy use by plant personnel and contractors. These bins need to be routinely emptied to prevent accumulation of refuse in places that it can tend to remain for long periods of time.

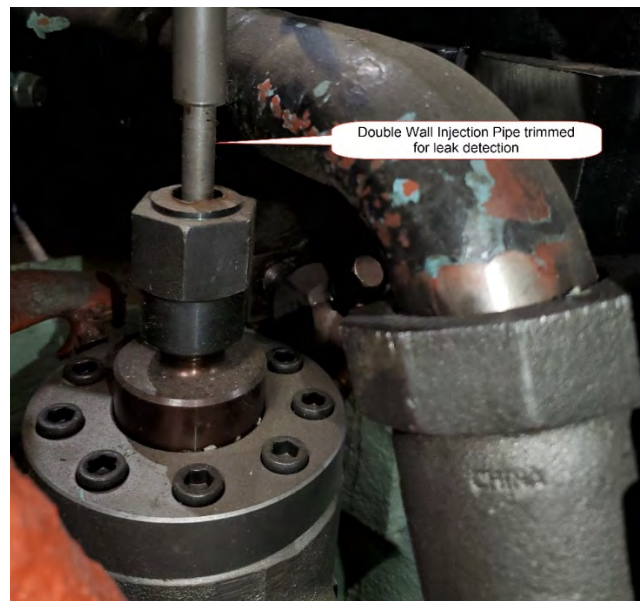
**Figure 36: Modified High Pressure Fuel Injection Line**

ESi observed that each engine's high-pressure fuel injection lines have been modified. These high-pressure fuel lines connect each cylinder's fuel injection jerk pump to the corresponding fuel injector. These are double-walled fuel lines that typically operate with fuel pressure near 3,200 psi. *Figure 36* shows how the outer tubing has been cut away to expose the void space between outer and inner tubes, just above the jerk pump. It is likely that this was done to detect a leak in the inner tube. Should a leak occur, fuel would be contained by the outer tubing (as long as the leak was not in the uncovered area) and fuel would be directed to drip down on the jerk pump and avoid spraying uncontrollably into the area around the engine. Operators would be able to see the fuel leakage and determine which fuel line has failed.

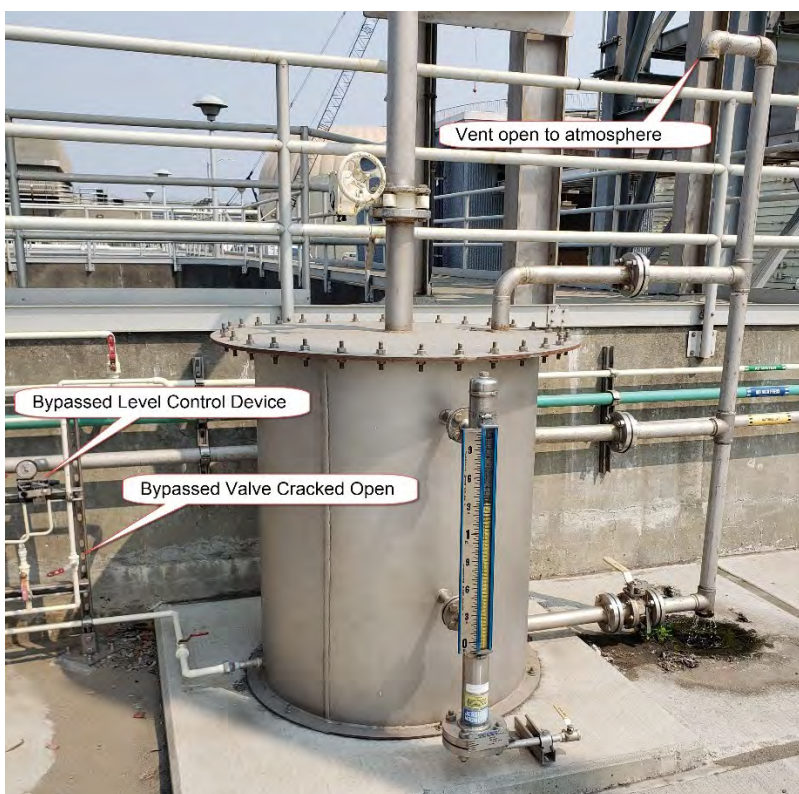
**Figure 38 - Condensate Drip Trap Observations**

The condensate trap (*Figure 38*) and drain installed adjacent to the new Low-Pressure Digester Gas (LPDG) flares presents some risks. Inspection revealed a steady trickle of water from the trap overflow. The automated level control is bypassed to provide constant make-up water to maintain level in the trap. This was likely a temporary solution, but it appears to have been in effect for quite some time. The automatic level control should be restored to operation.
