Project No.
9472.000.000

June 1, 2012

Subject: 39th Avenue Reservoir
4290 Maybelle Avenue
Oakland, California

GEOLOGIC REVIEW AND RECONNAISSANCE

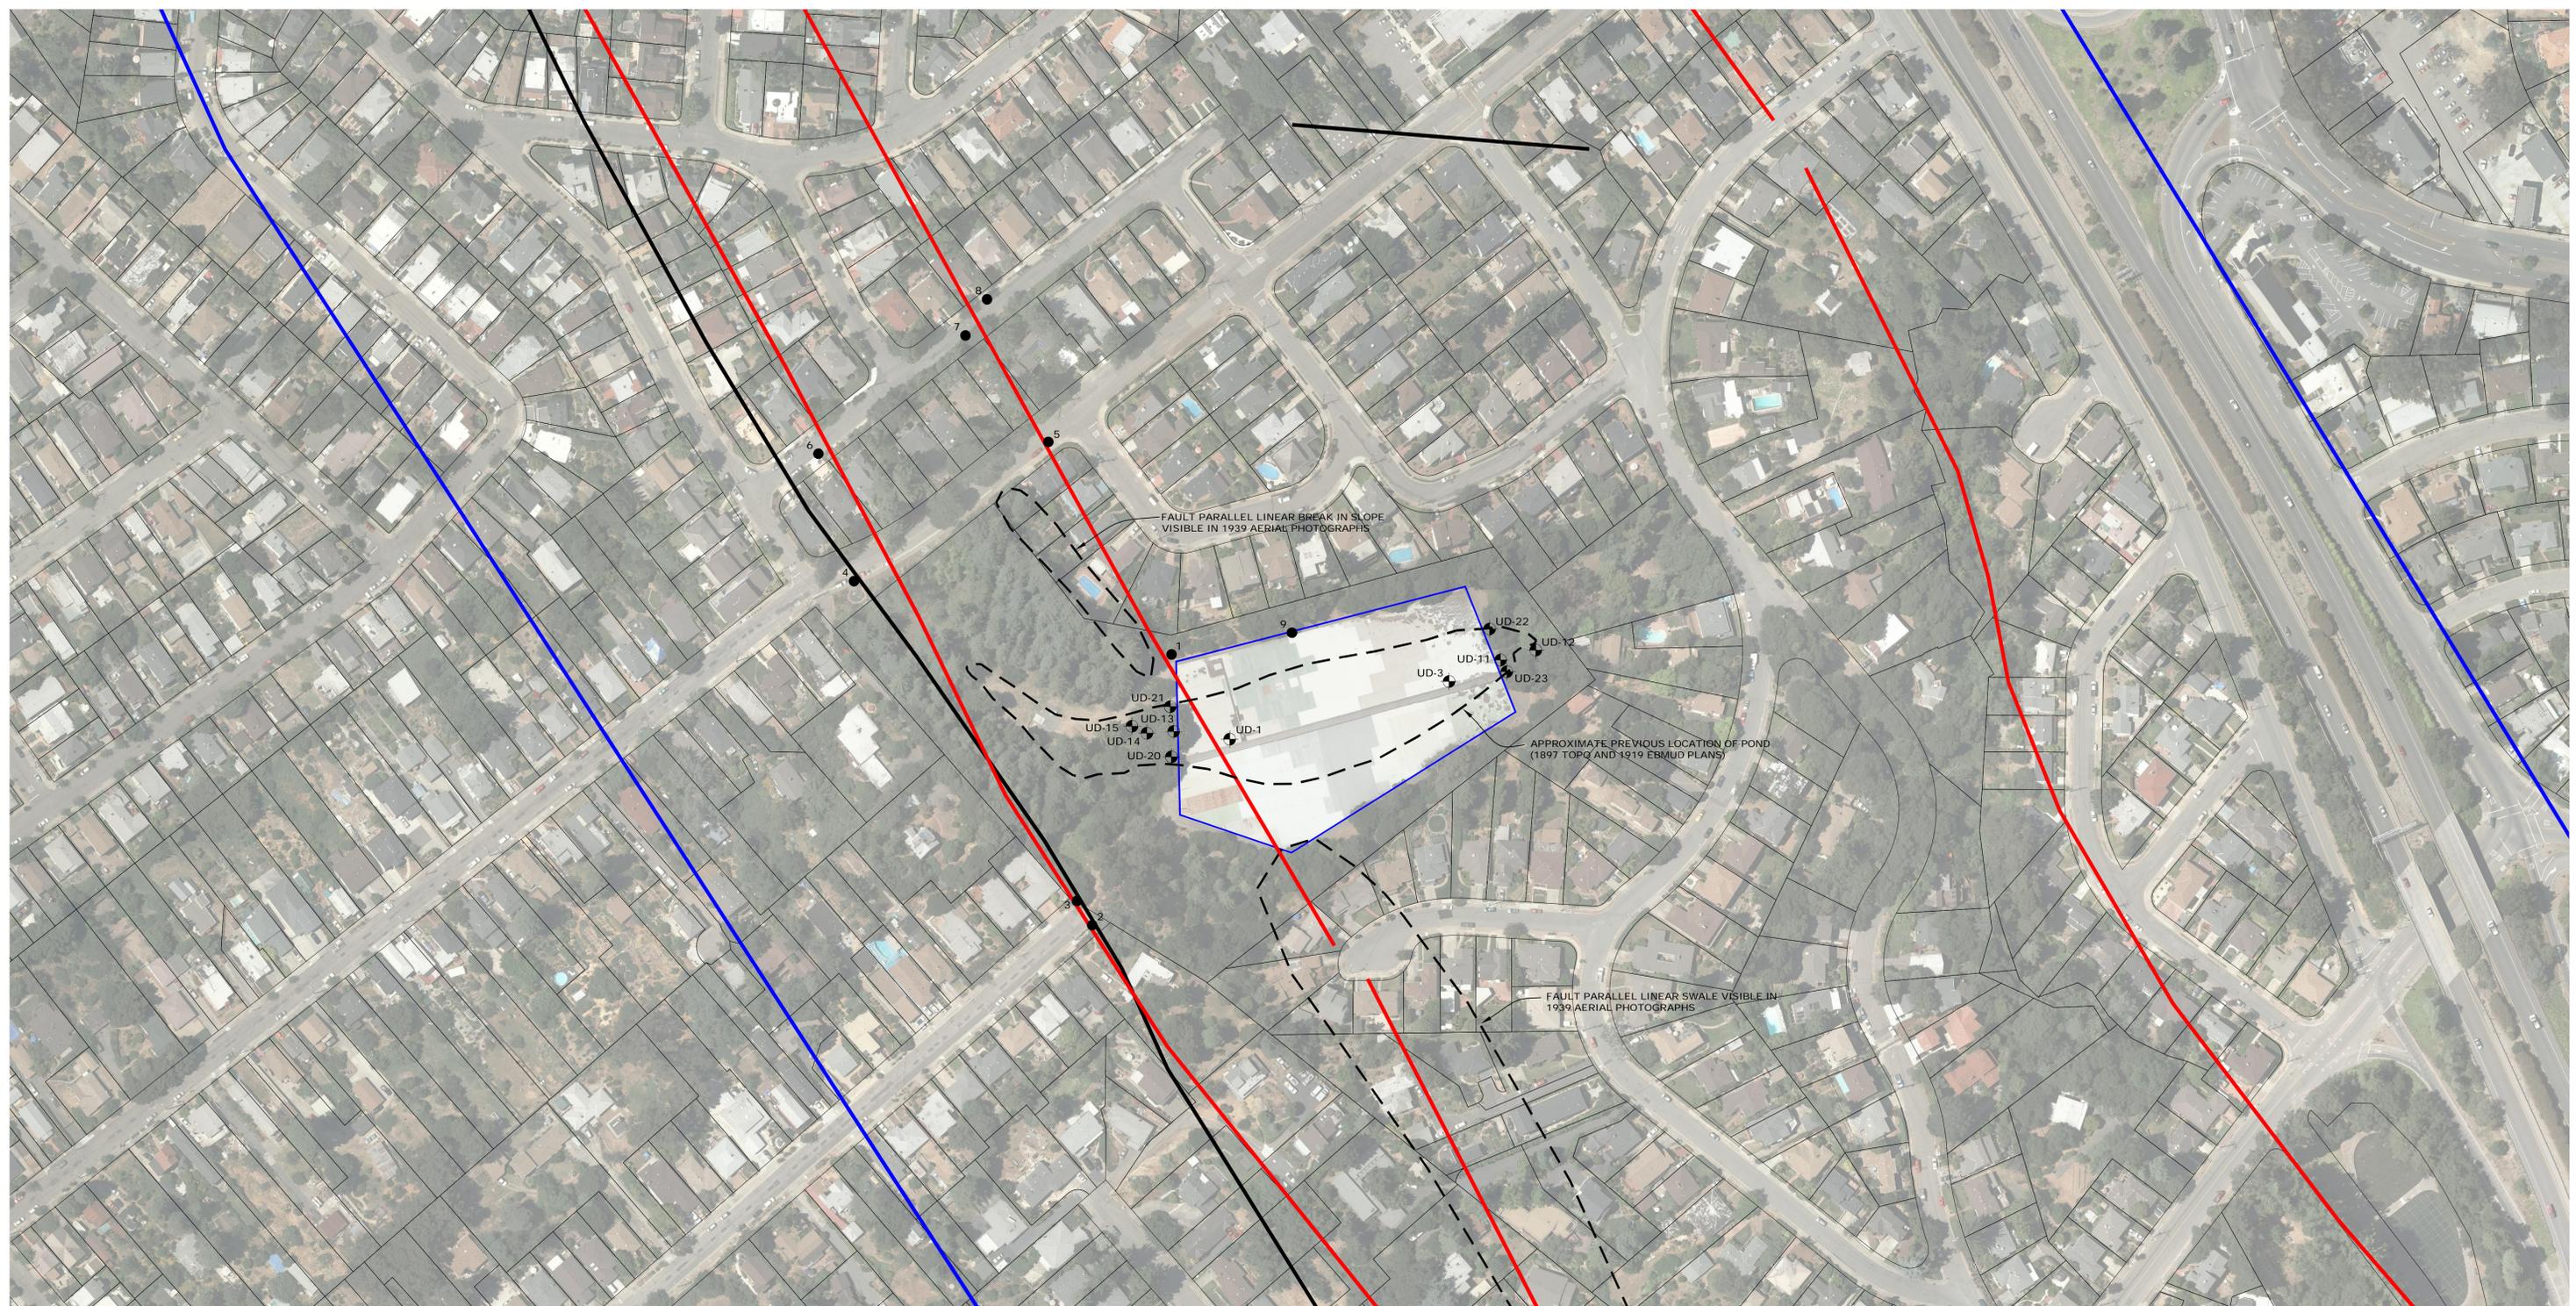
Based on our review of 1939 stereo paired aerial photographs covering the site we noted two distinct fault parallel features that correspond with the mapped fault trace that crosses the main dam. One of the features evident in the historic photos is a very distinct linear swale south of the reservoir that disappears abruptly at the southern edge of the reservoir (Figure 3). The other feature is a fault parallel break in slope north of the reservoir.

As discussed above, the Hayward fault is a creeping fault in this area. Common evidence of recent creep related fault movements include offset man-made features such as curbs, sidewalks, fences, walls etc. Other common features include systematic cracking within roadway pavements (left stepping en-echelon cracks), severely cracked and patched pavements and areas of chronic subsurface utility repair resulting from cracked and disrupted utilities. Observations from the reconnaissance are compiled on Figure 3 of this report.

- 1 ● APPROXIMATE LOCATION OF WATER SEEPAGE
- 2 ● APPROXIMATE LOCATION OF RIGHT LATERAL OFFSET CURB
- 3 ● APPROXIMATE LOCATION OF ROTATED CURB PANEL AND SEVERELY CRACKED SIDEWALK
- 4 ● APPROXIMATE LOCATION OF RIGHT LATERAL OFFSET CURB
- 5 ● APPROXIMATE LOCATION OF MINOR CURB DEFLECTION
- 6 ● APPROXIMATE LOCATION OF RIGHT LATERAL OFFSET CURB
- 7 ● APPROXIMATE LOCATION OF POSSIBLE OFFSET CURB AND SEVERE PAVEMENT DISTRESS
- 8 ● APPROXIMATE LOCATION OF RIGHT LATERAL OFFSET CURB
- 9 ● APPROXIMATE LOCATION OF MINOR SLUMP IN CUT SLOPE. WATER SEEPING FROM SLOPE AT TIME OF SITE VISIT

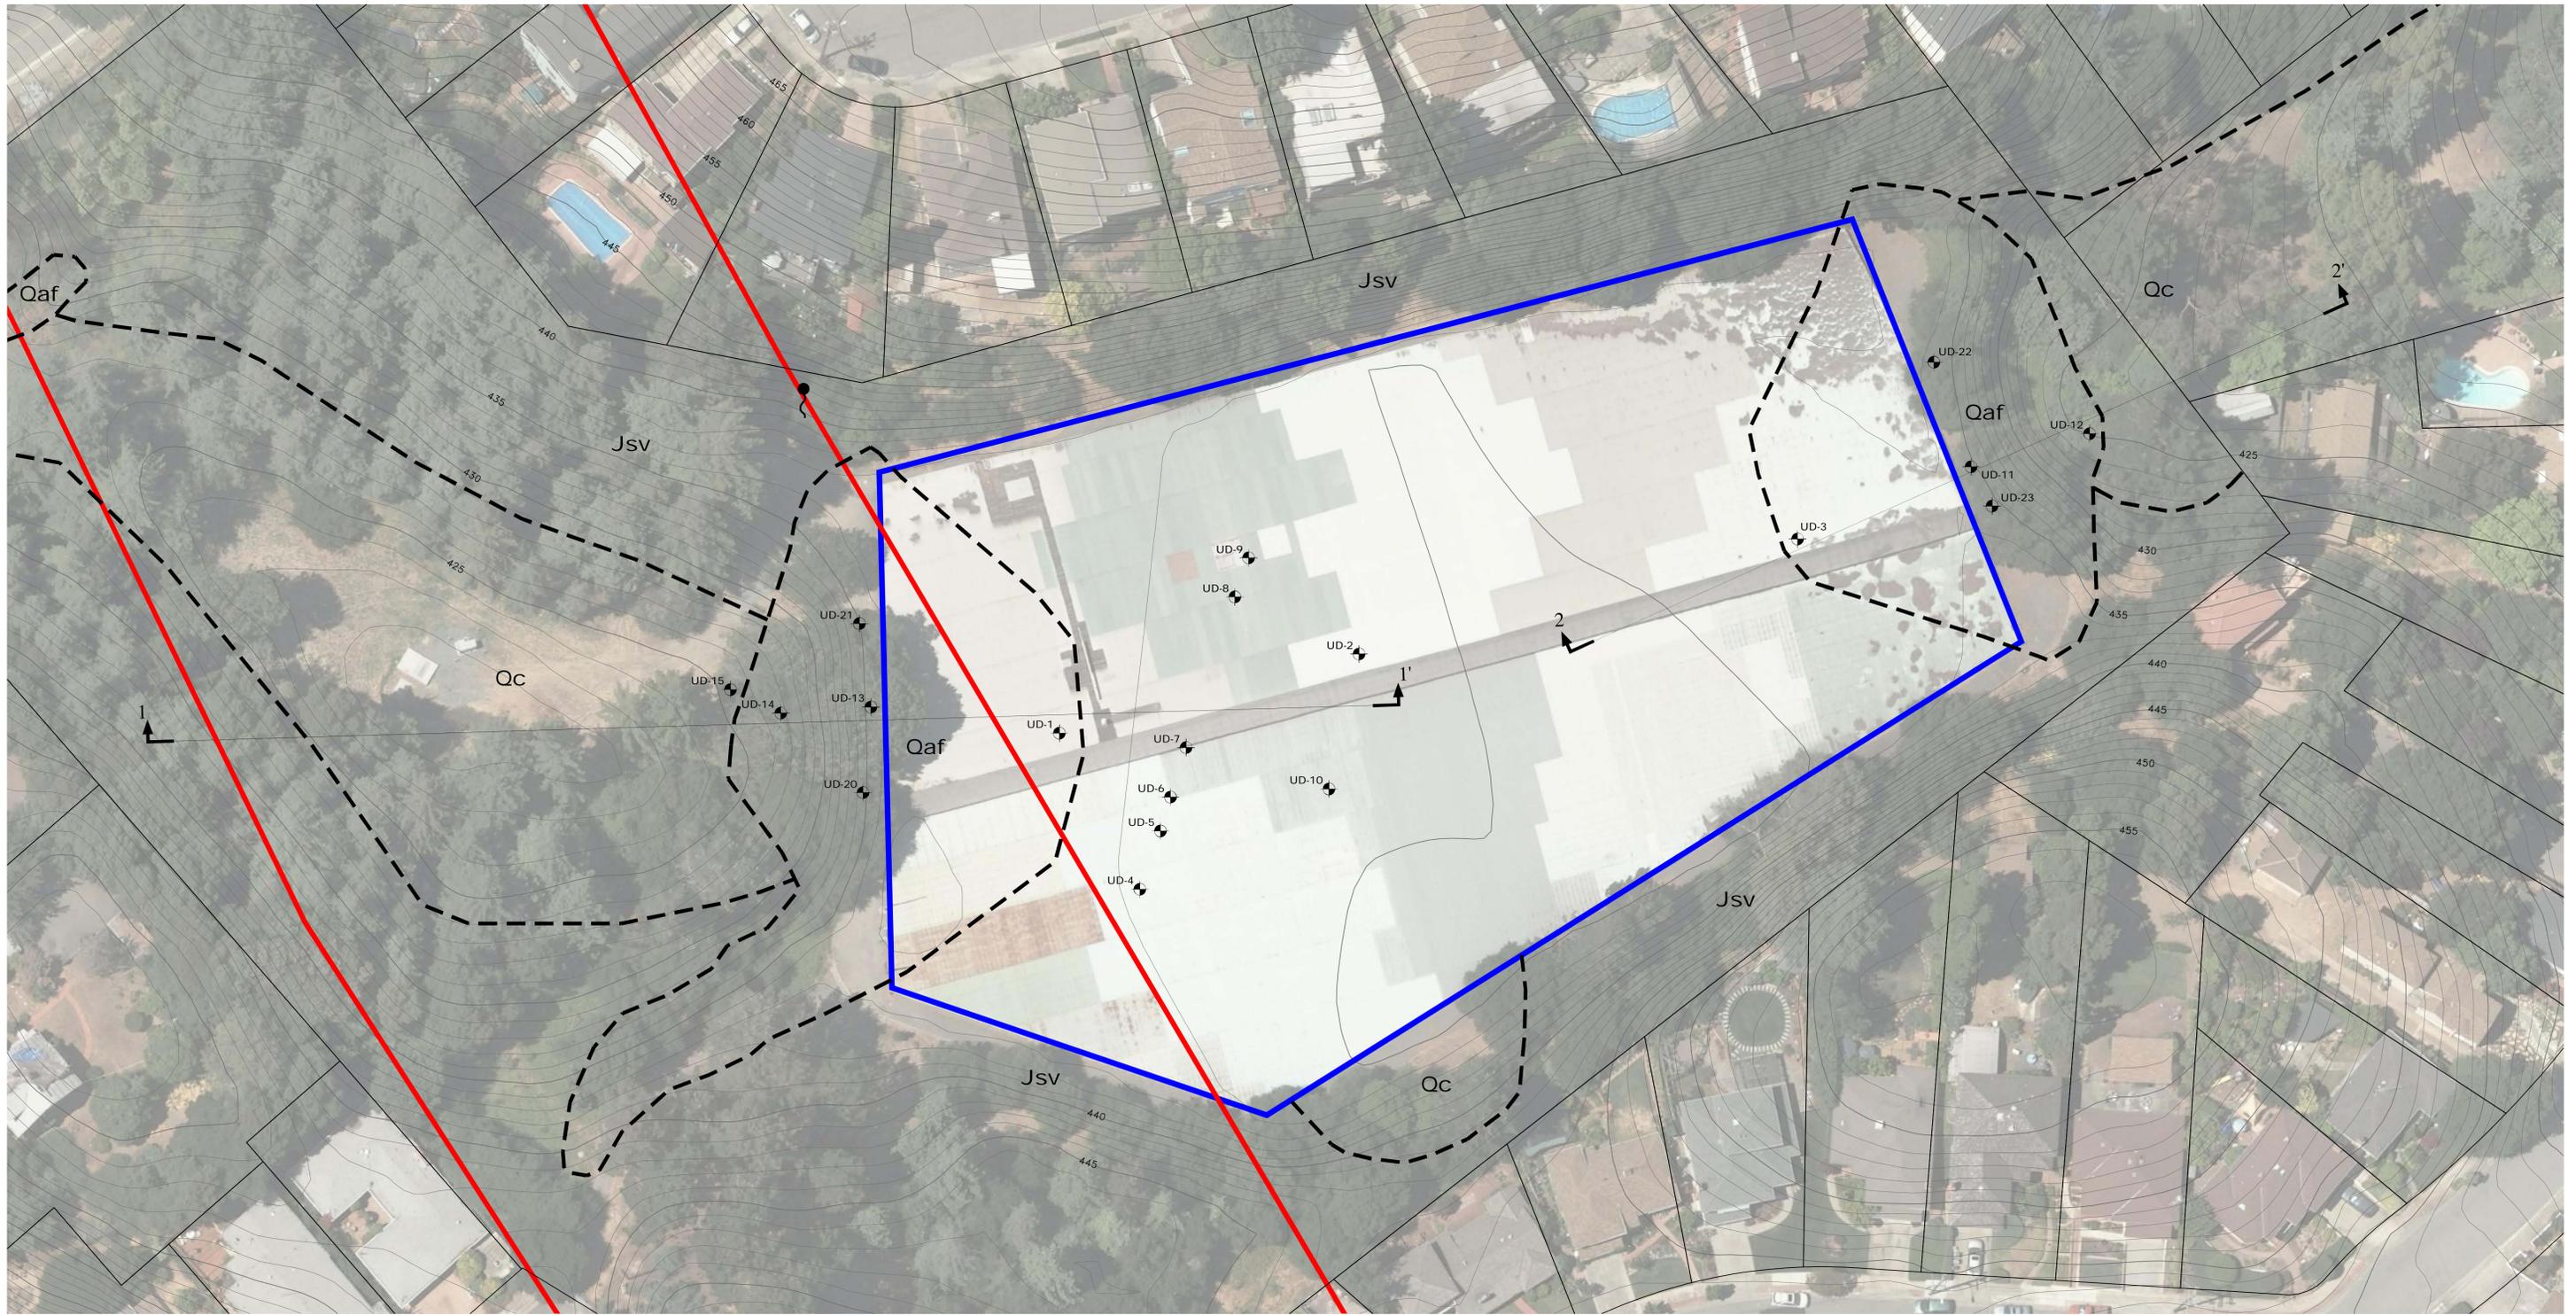
Of note, observation of a spring north of the main dam in the approximate mapped location of the Hayward fault was observed. This is noted because faults often form groundwater barriers and as a result, springs are often found along faults. In addition right lateral off-set curbs were observed on Dunsmuir Avenue located two streets north of the reservoir on the same approximate trend as the mapped trace of Hayward fault that crosses the main dam. Right lateral offset curbs and deflected curb-lines were also observed along the western AP mapped trace of the fault near the entrance gate to the reservoir at the end of Maybelle Avenue and on both 39th Ave and Dunsmuir Ave located north of the reservoir (see Figure 3). It should also be noted that no obvious signs of fault creep related movement was noted within the perimeter roadway around the reservoir or within the concrete exposed adjacent to the reservoir.

Based on our site reconnaissance and document review, the 39th Avenue Reservoir is located in a geologically active and structurally complex area within the Hayward Fault Zone. This zone is characterized by anastomosing and en echelon faults, synthetic shears, fault bound blocks and slivers, and various geomorphic features associated with strike slip faulting (i.e. sag ponds, shutter ridges, linear ridges, troughs and benches). The current AP Map delineates an active trace of the Hayward fault across the main dam of the reservoir and another trace approximately 170 feet west. The trace located west of the reservoir shows distinct and certain evidence of recent fault creep. The fault trace mapped through the dam shows less definitive evidence of fault creep however strong geomorphic evidence, spring activity and an offset curb towards the north provide strong evidence for the presence of a fault at this location.

- We recommend that (a) fault trench(es) be excavated across the mapped trace of the fault that crosses the main dam. Through fault trenching it should be possible to determine the existence and/or location of the fault and features associated with surface rupture. Due to the potential for elevated groundwater conditions, the location of the reservoir and property boundary constraints the logistics of fault trenching may be difficult and require significant planning.

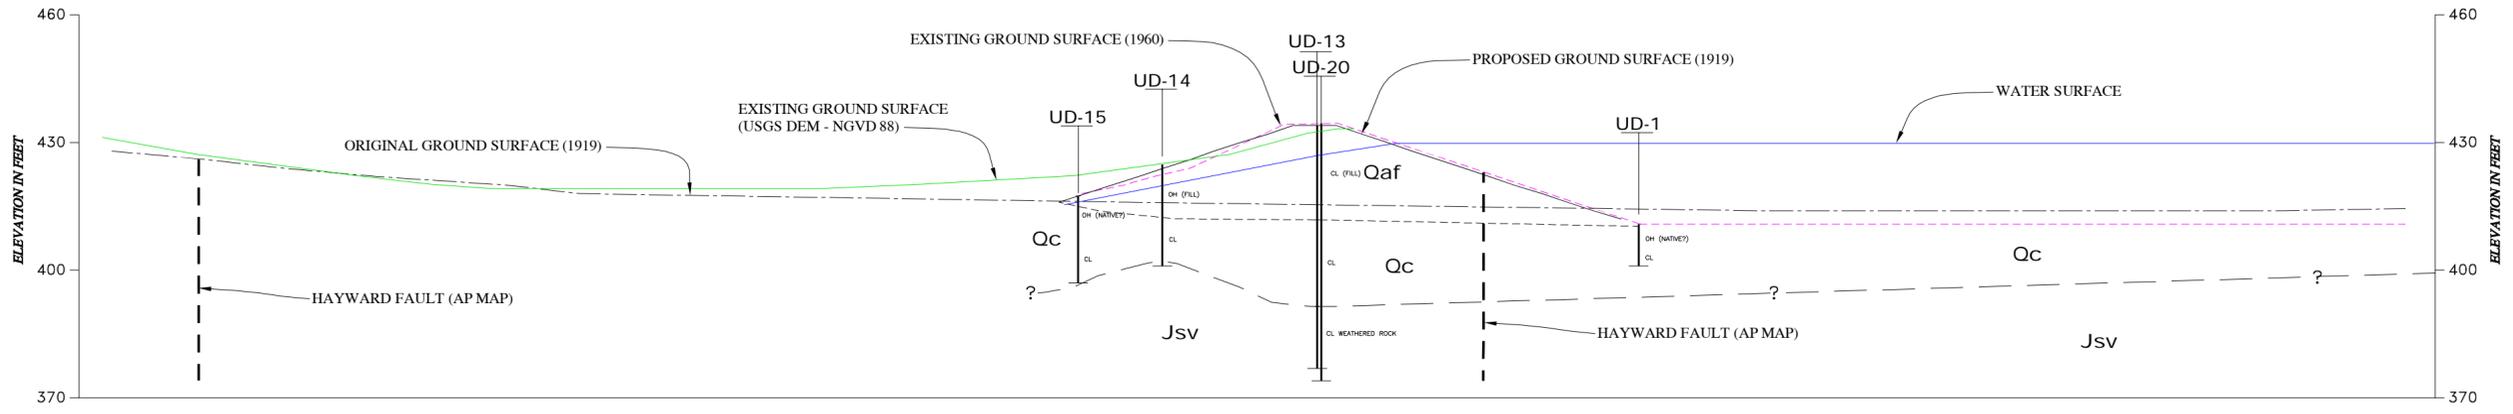
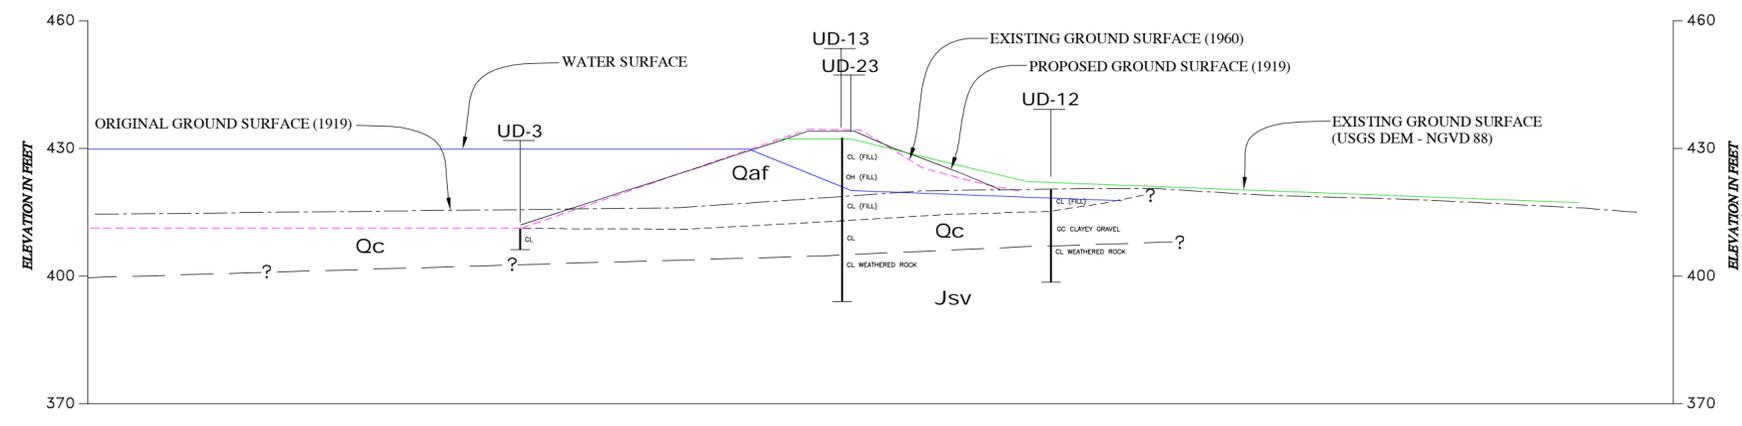
PROJECT NO: 9472.000.000	FIGURE NO.
SCALE: 1"=30'	5
DRAWN BY: PC	CHECKED BY: RS

(see attached Figure 5). Elevations in the cross sections are based on NGVD 29. Based on the existing subsurface boring data it appears that both of the dams were constructed directly on existing native clayey soils. Cross Section 1 indicates up to approximately 20 feet of native soil underlying the main dam fill embankment and Cross Section 2 indicates roughly 10 feet of native soil underlying the auxiliary dam fill embankment. Cross Section 1 crosses the two western mapped traces of the Hayward fault according to the State of California AP Map. One of the mapped traces projects through the reservoir side of the main dam fill embankment (Figure 5).

Piezometer data from 4 piezometers (UD-20, 21, 22 and 23) was provided for our review. The piezometer data from the two piezometers in the main dam (UD-20 and 21) appears to reflect very closely changes in the reservoir water level. There is less correlation between the water level in the reservoir and the piezometers in the auxiliary dam (UD-22 and 23). The approximate average groundwater elevations from the piezometers were used in both of the cross sections (Figure 5).

Based on the existing subsurface boring data it appears that both of the dams were constructed directly on 10 to 20 feet of existing native clayey soils. The depth to bedrock and thickness of native soil downslope away from the toe of the dams is not known based on the available information.

- We also recommend that additional borings be drilled at the site to constrain subsurface conditions and geometries downslope of the reservoir dams. The previous boring at the toe of the main dam did not encounter bedrock and no borings were drilled downslope of the reservoir dams. Because of this we recommend that one boring be drilled roughly 30 feet downslope of the toe of each of the reservoir dams and that at least one boring be drilled at the lowest point at the toe of the main dam to determine depth to bedrock. We suggest that continuously sampled borings be considered due to the potential presence of thin weak soil layers, and high quality samples should be recovered for strength testing.

- We recommend that seismic slope stability analysis be performed to evaluate the stability of the main dam and auxiliary dam embankments under seismic loading.
- We also recommend that if through exploration it is determined that a fault crosses the reservoir or embankments that analysis be performed to evaluate the effects of anticipated fault rupture displacement on the integrity of the reservoir and the stability of the embankment dam.
