**TENTH INTERNATIONAL CONGRESS
ON LARGE DAMS**

QUESTION N° 38

Q. 38
R. 28

SOME UNUSUAL ASPECTS OF DAM SAFETY STUDIES IN WESTERN UNITED STATES (*)

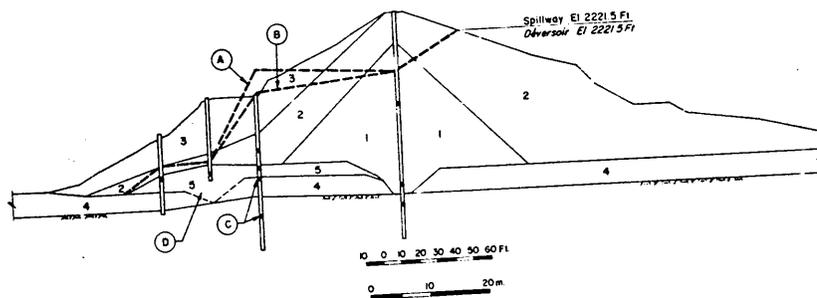
Fig. 2

Seepage at the downstream toe and groin lines of the dam had been a continuing problem for many years. As part of a safety investigation conducted in 1964, a number of exploratory holes were drilled and piezometers installed to measure seepage pressures in the downstream section of the embankment and foundations. It was discovered

Section of dam and foundation. Case D.

that unusually high seepage pressures had developed in the embankment and foundation as shown in Figure 2 by Piezometric Line B for the embankment and Piezometric Line A for the foundation. It was apparent that reservoir water was bypassing the central cutoff through fractures in the foundation rock. A partial cutoff through the gravel layer near the downstream toe resulted either from a pinching out of the gravel bed, or the presence of a remnant of a starter dike used in the initial placement of hydraulic fill. Stability analyses indicated the computed safety factor of the downstream slope to be precariously low under normal full-pool conditions, and less than unity in the event of an earthquake with a maximum acceleration of only 0.1 gravity. The need for immediate remedial measures was evident; and a number of alternative schemes were considered for relieving the inordinately high seepage pressures by drainage, grouting the bedrock under the core, or buttressing the downstream slope by construction of a substantial rock berm. The latter method proved to be the most feasible, and a rock fill of sufficient size to develop an ample safety factor was placed on the downstream slope to permit the dam to remain safety in service.

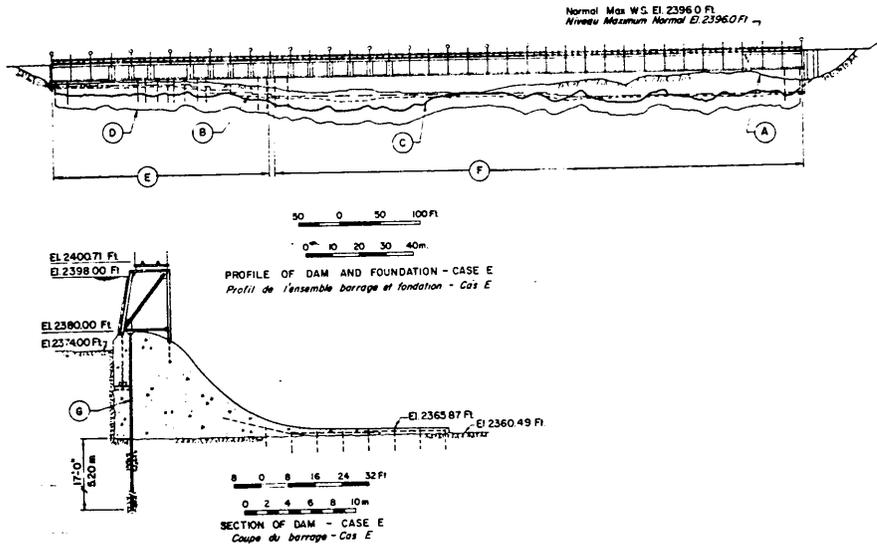
Fig. 3

An investigation was made of this structure in 1966 as part of a routine safety check of a number of structures belonging to the same owner. The geologic conditions at the site are satisfactory and the dam in general is structurally sound. The spillway is capable of passing 1.4 times the maximum flood or record. The probable maximum flood, however, was calculated to be about 2.3 times the maximum flood of record, and would overtop the dam by about 2.4 feet (73 cm). Three core holes were drilled to sample the concrete and foundation, and to install piezometers to measure uplift pressures. Stability analyses were performed to determine stresses at the upstream and downstream faces, and overturning safety factors with respect to the base of the dam and a possible unbonded construction joint at about midheight of the concrete section. The calculated overturning safety factors for normal operating conditions were above 1.0; but, for the abnormal conditions of a probable maximum flood loading or that of normal full pool coincident with an earthquake having a maximum acceleration of 0.1 gravity, the calculated safety factors were slightly less than unity. Although the possibility of occurrence of the abnormal loading conditions was believed to be remote, it was considered prudent to take remedial measures to increase the stability against overturning and decrease the tension in the concrete at the upstream face. As shown on Figure 3, this was accomplished by installing post-tensioned steel

tendons spaced 5 feet to 12 feet (1.53 m to 3.65 m) on centers near the upstream face, which extended vertically through the dam and were anchored firmly in the foundation rock.

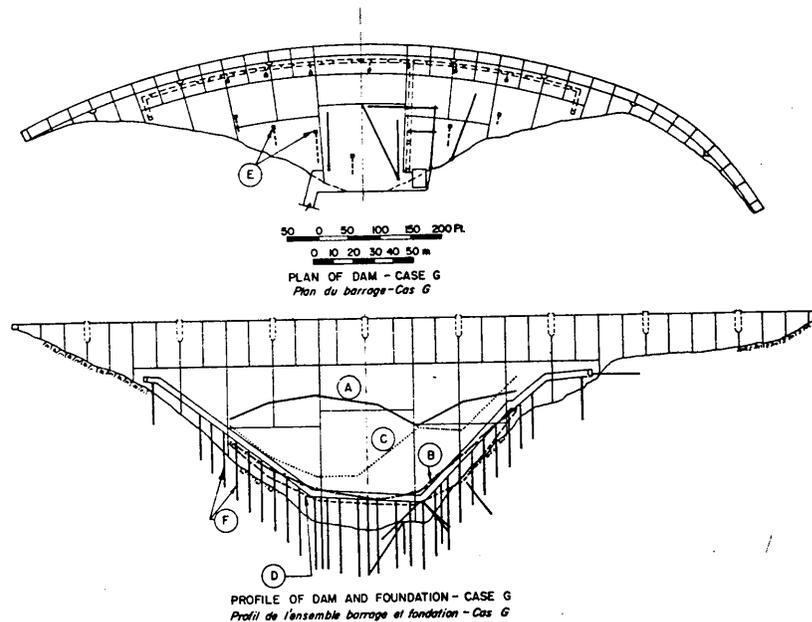
Fig. 4

Stability analyses using the original design uplift assumptions indicated 27.8 psi (1.95 kg/cm²) compression at the heel of the dam and an overturning safety factor of 1.96 for normal pool loading conditions. When the measured uplift pressures were utilized in the same type of analysis, the stress at the heel was 68.8 psi (4.82 kg/cm²) tension, and the overturning safety factor dropped to 1.25. Even more drastic changes in stresses and safety factors were indicated when seismic forces were also considered. The low safety factors made it

The required additional drainage of the foundation was accomplished by drilling 38 three-inch-(7.62 cm)-diameter drain wells from the interior gallery and downstream toe, as shown in Figure 4. After consideration of the geometry of the joint system in the foundation rock, it was estimated that the required depth of drain wells installed from the main gallery should be about 75 feet (22.9 m) into rock at the middle of the dam and reduce to 50 feet (15.3 m) toward the abutments. Slant holes of various lengths drilled from the toe, relieved local zones of high pressure caused by deep flows which bypassed the upstream well line. The new drain wells were very effective, as indicated on Figure 4, and the reduction in uplift pressure was as great as could possibly be achieved, since most of the new drains could discharge only into the existing drainage gallery in the dam.
