Olivia Chen Consultants, Inc.

August 26, 1997

Subject: Pardee Dam, South Spillway Modification
Geologic Mapping, Scour Holes
OCC Project No. J1057

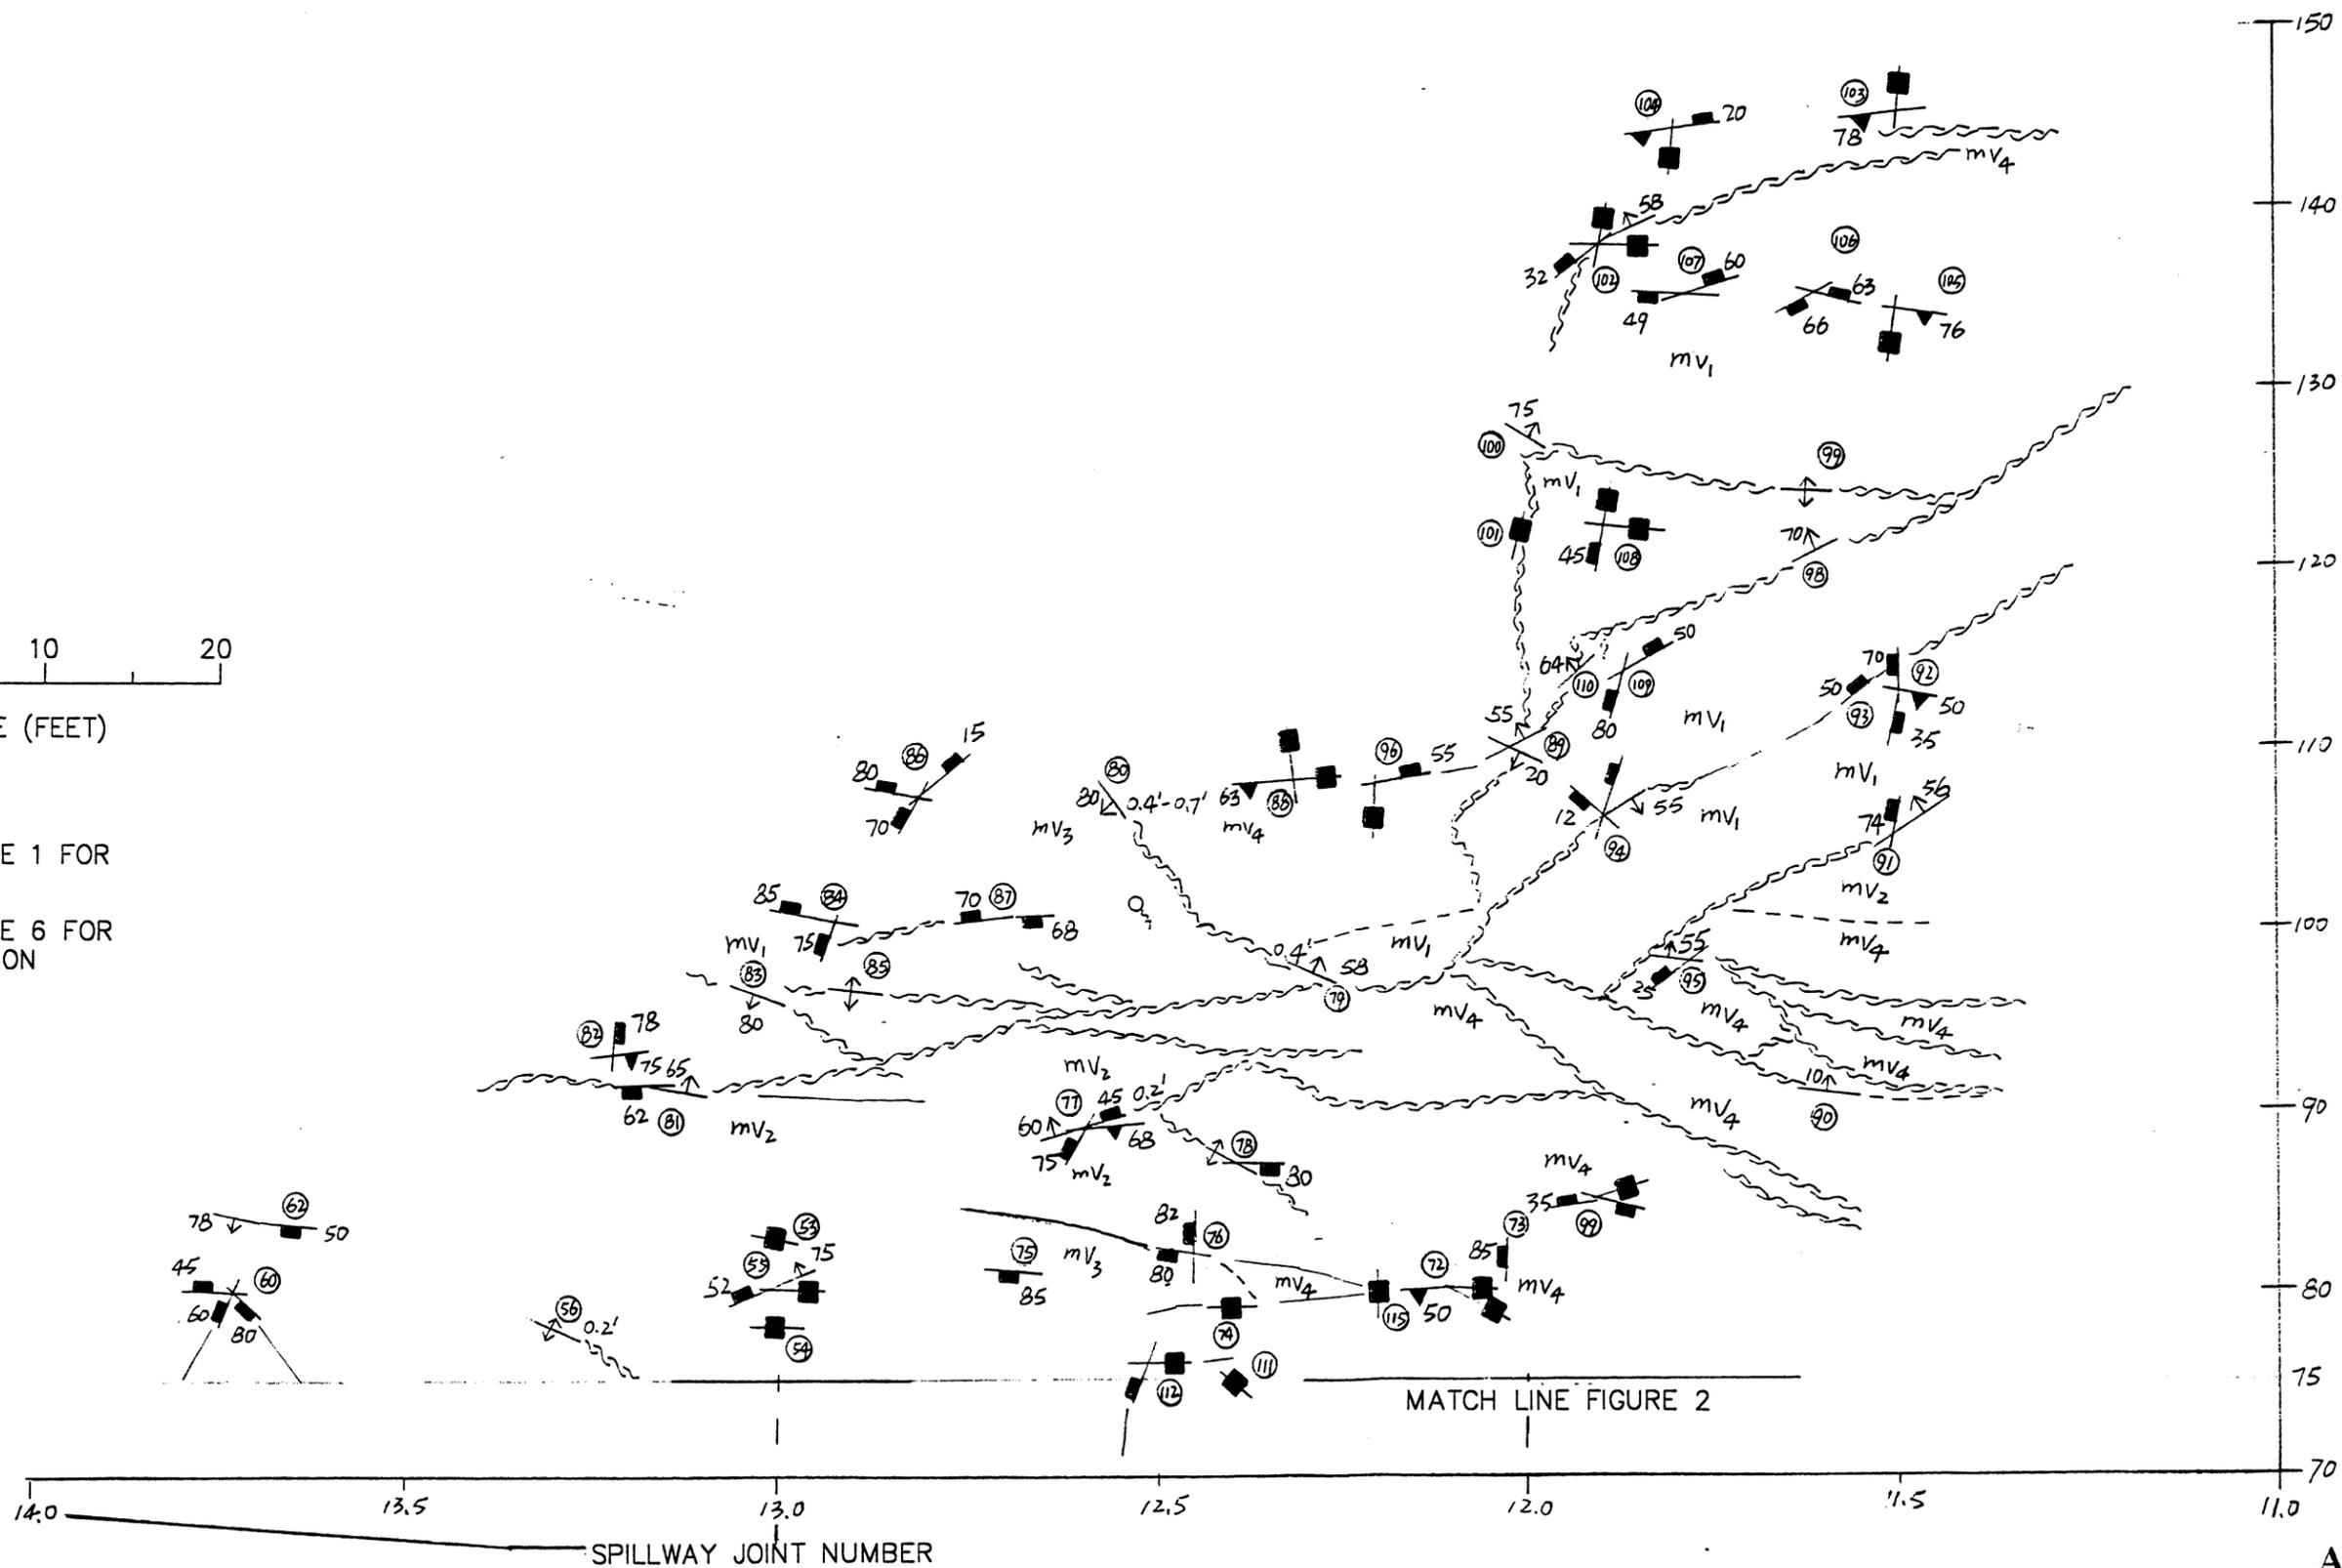
Figure
3

GEOLOGIC MAP
SOUTH SCOUR HOLE

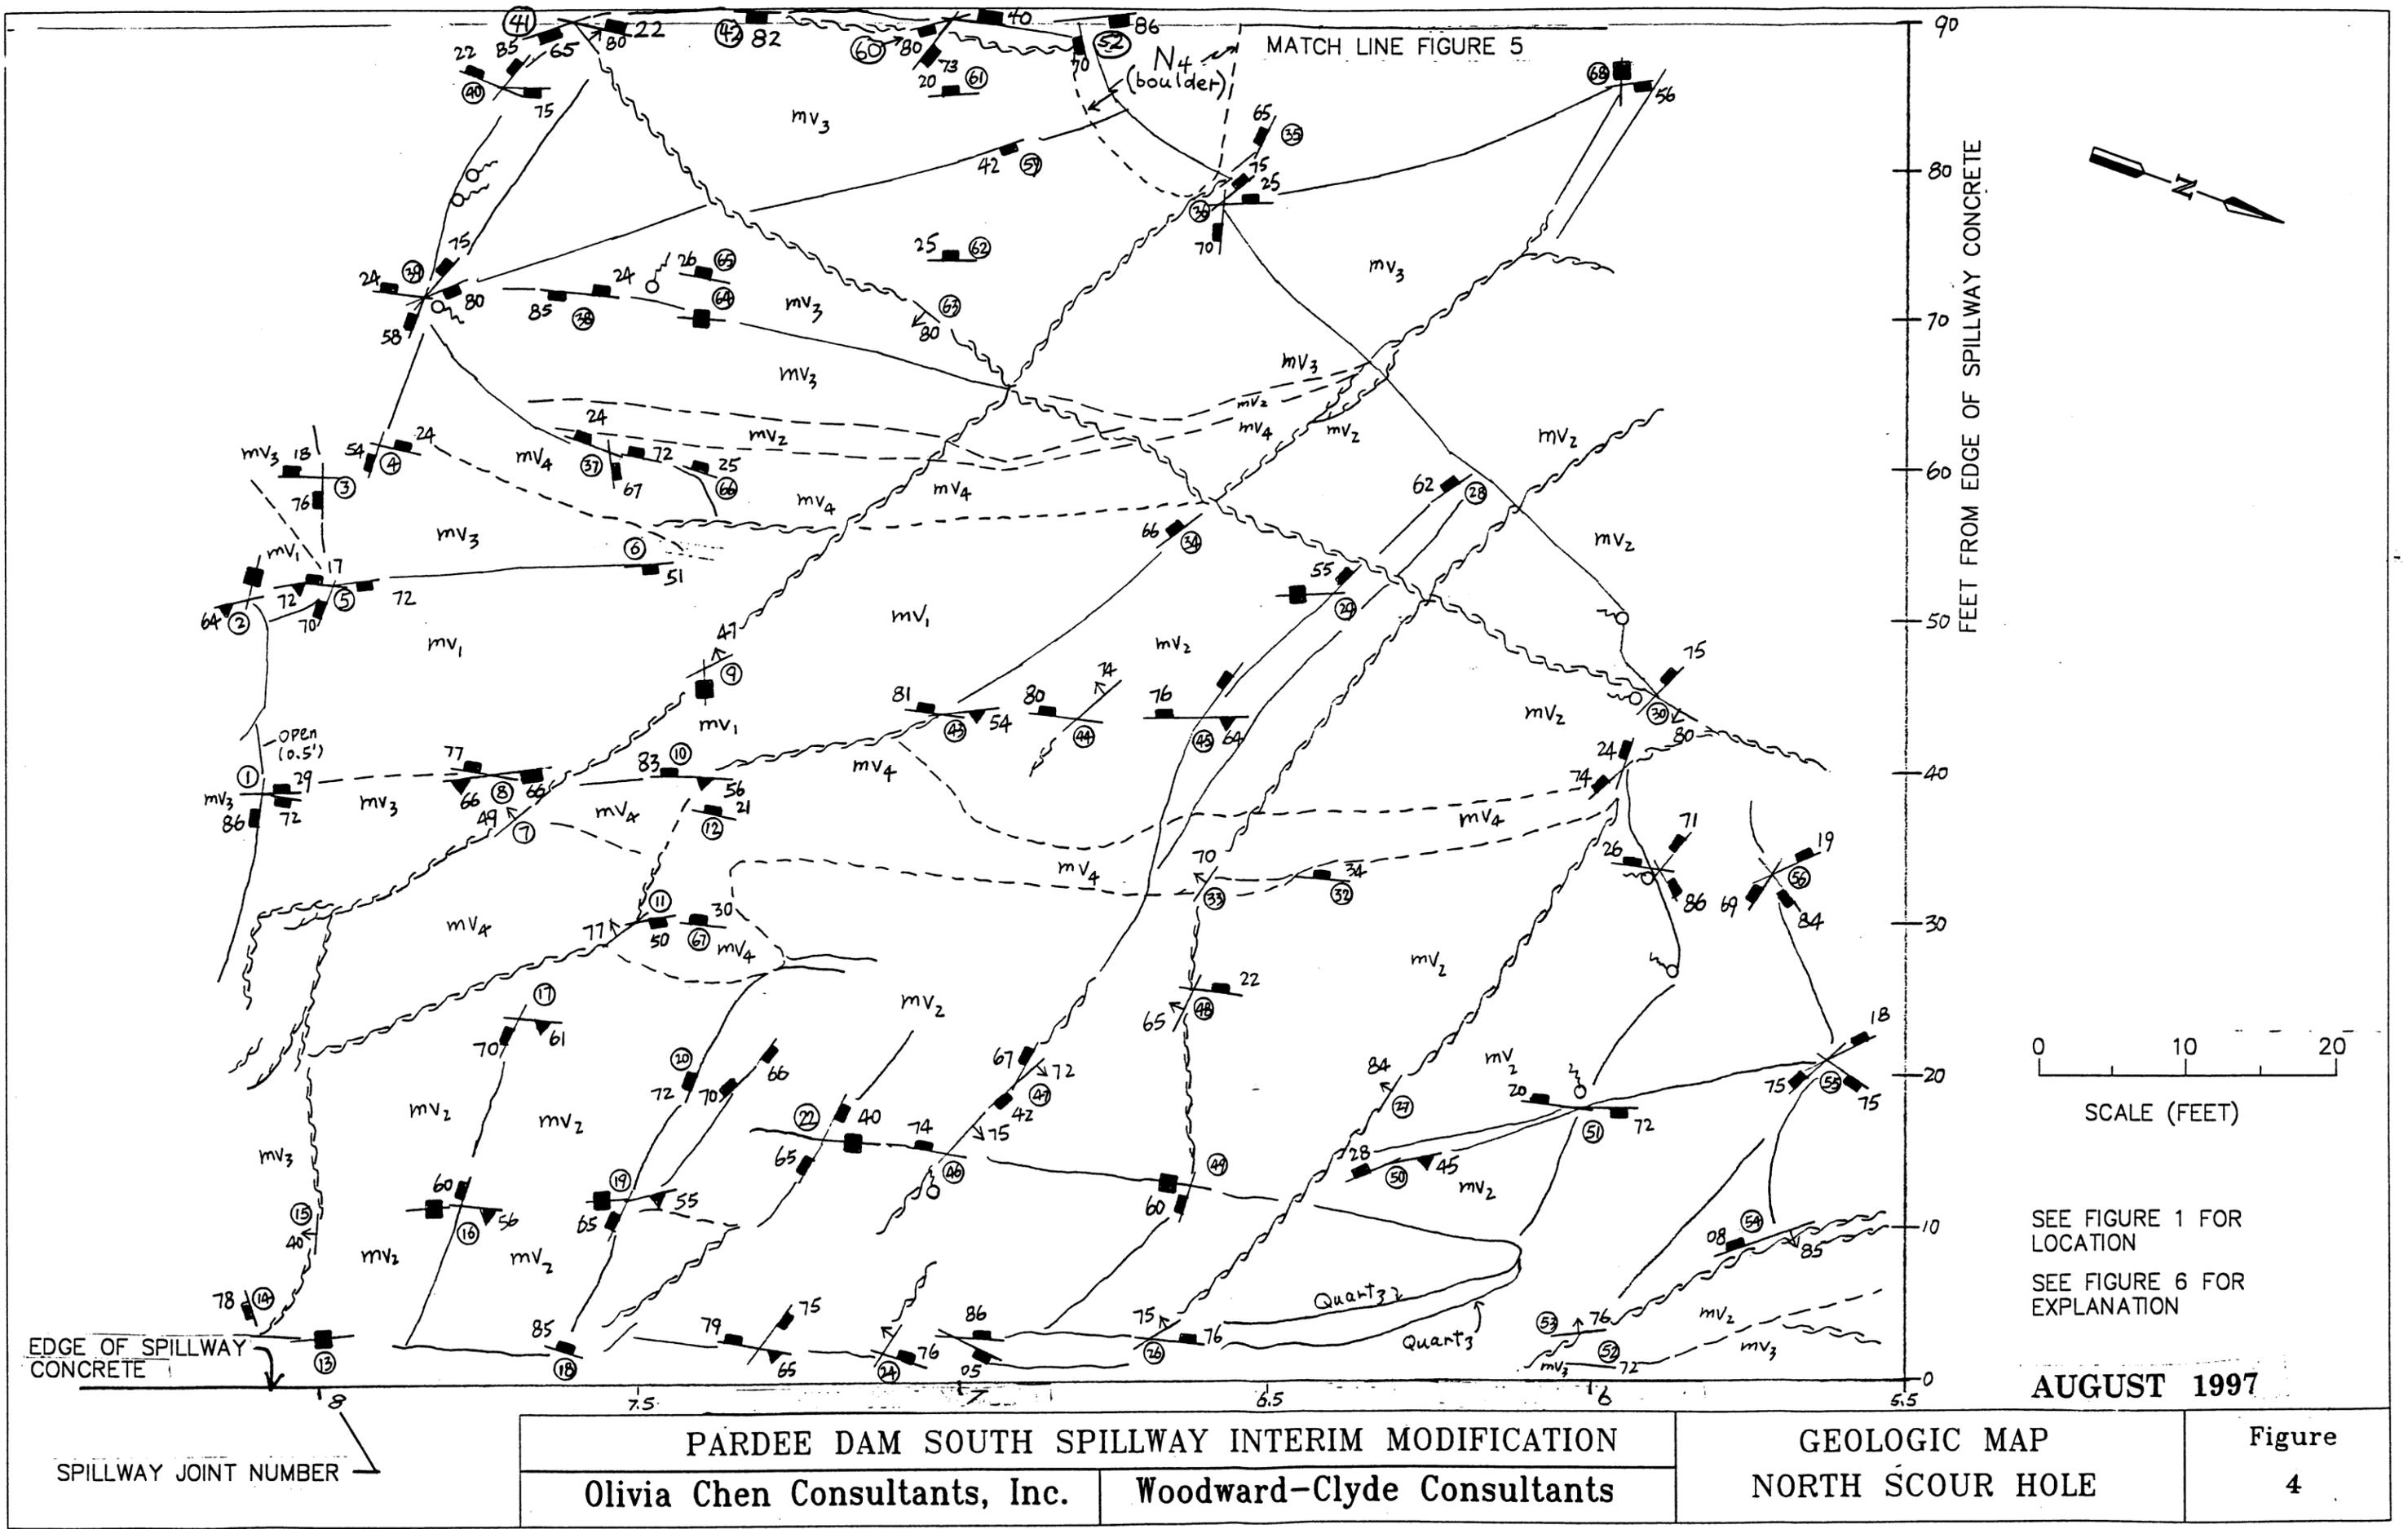
Figure
 4

GEOLOGIC MAP
 NORTH SCOUR HOLE

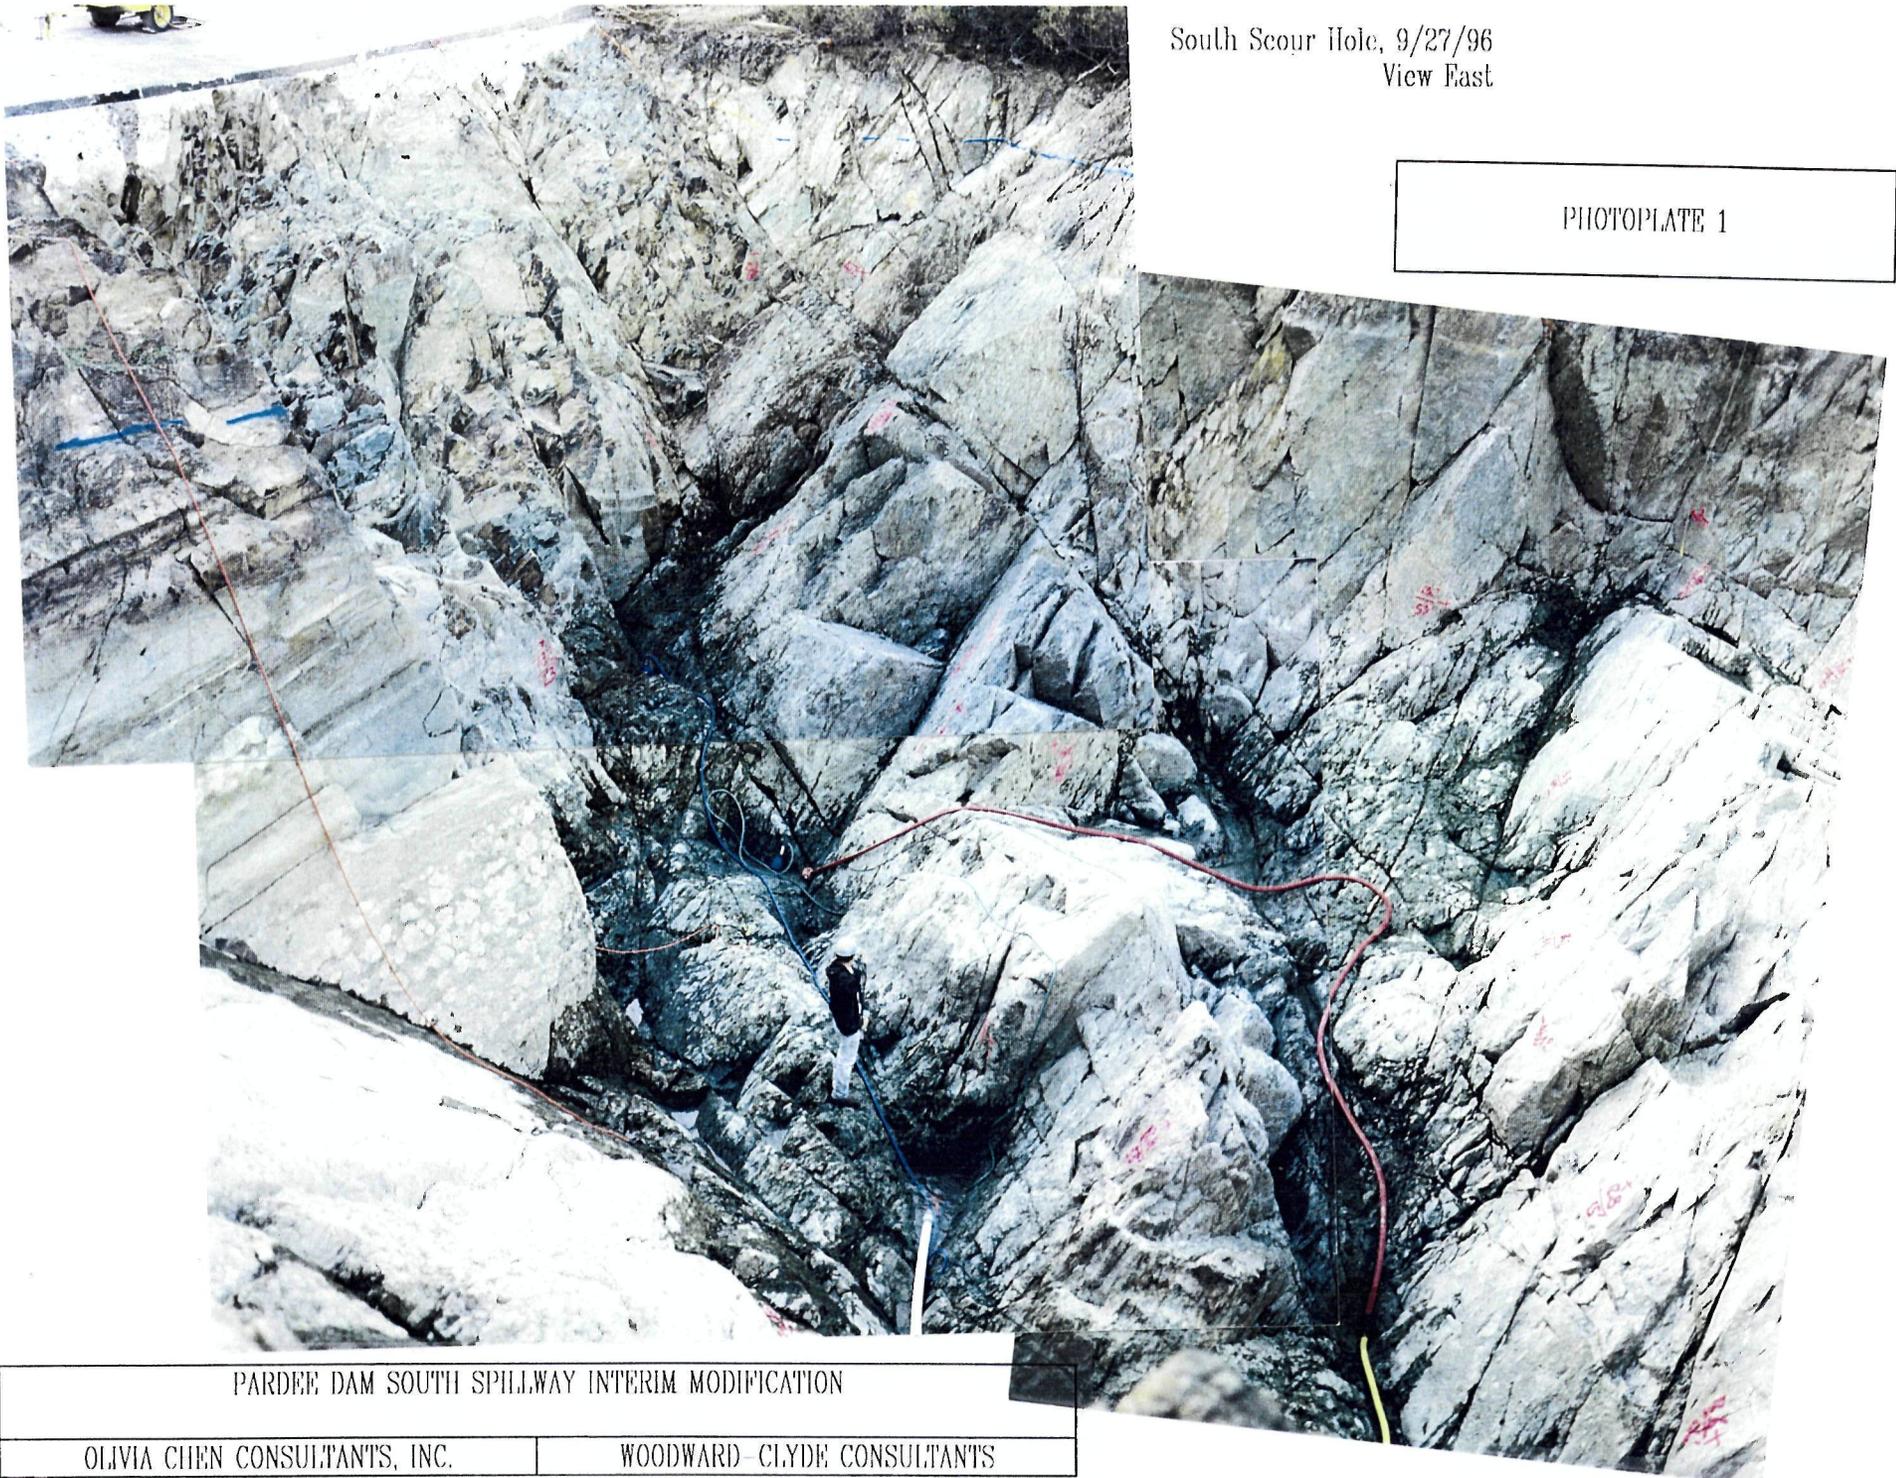
PHOTOPLATE 1

South Scour Hole, 9/27/96
View East

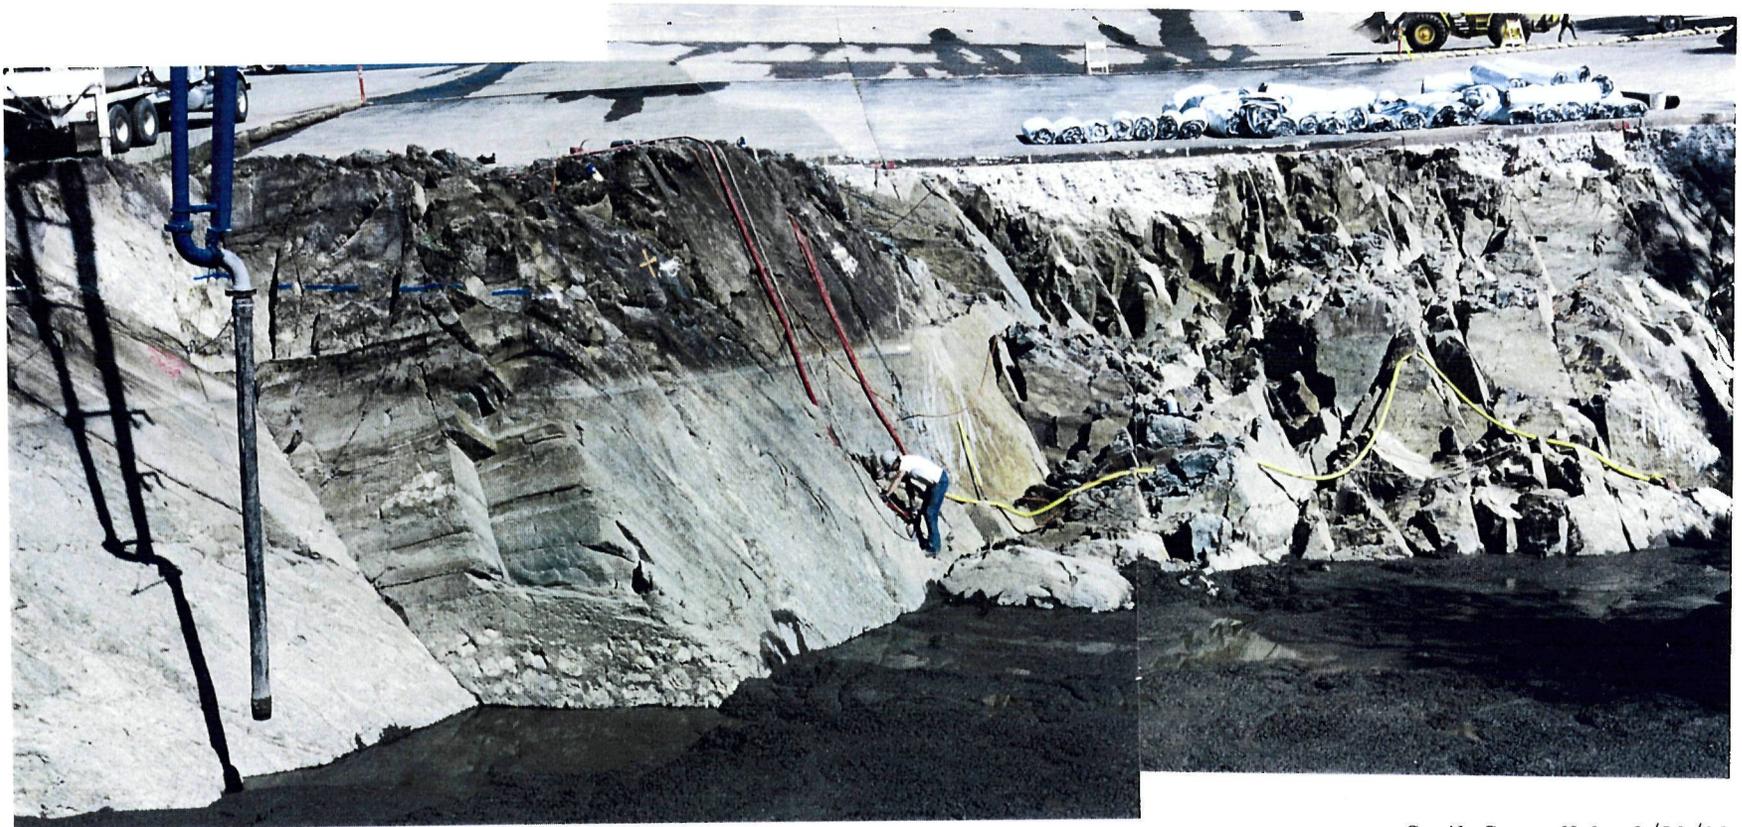
PHOTOPLATE 2

South Scour Hole, 9/30/96
View Northeast

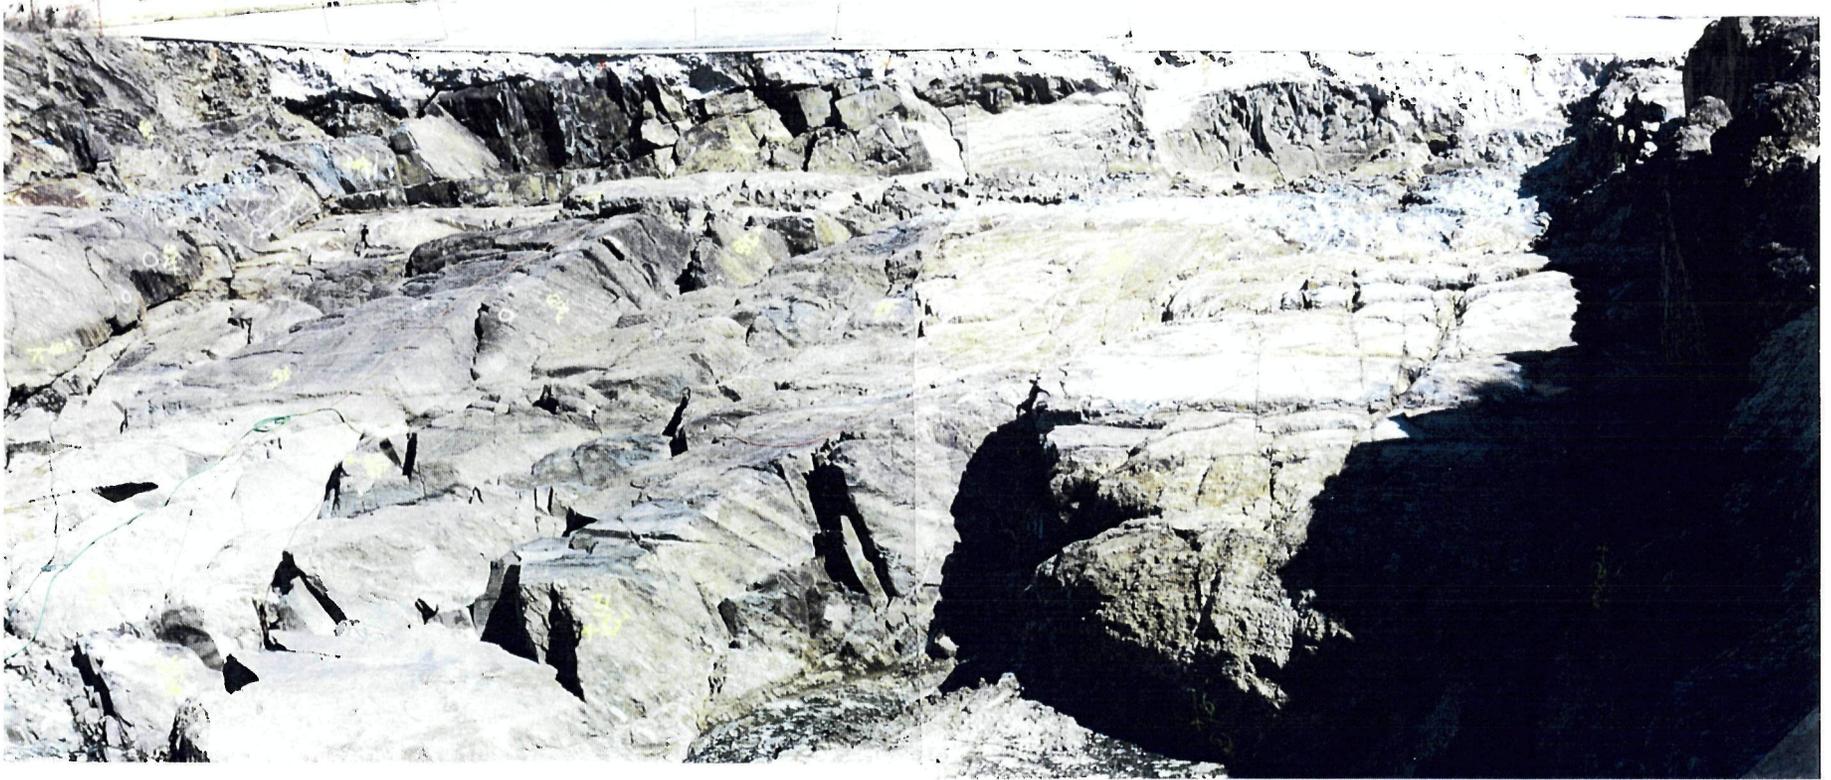
North Scour Hole, 10/9/96
View Northeast/Upstream
Prominent Joint Surface

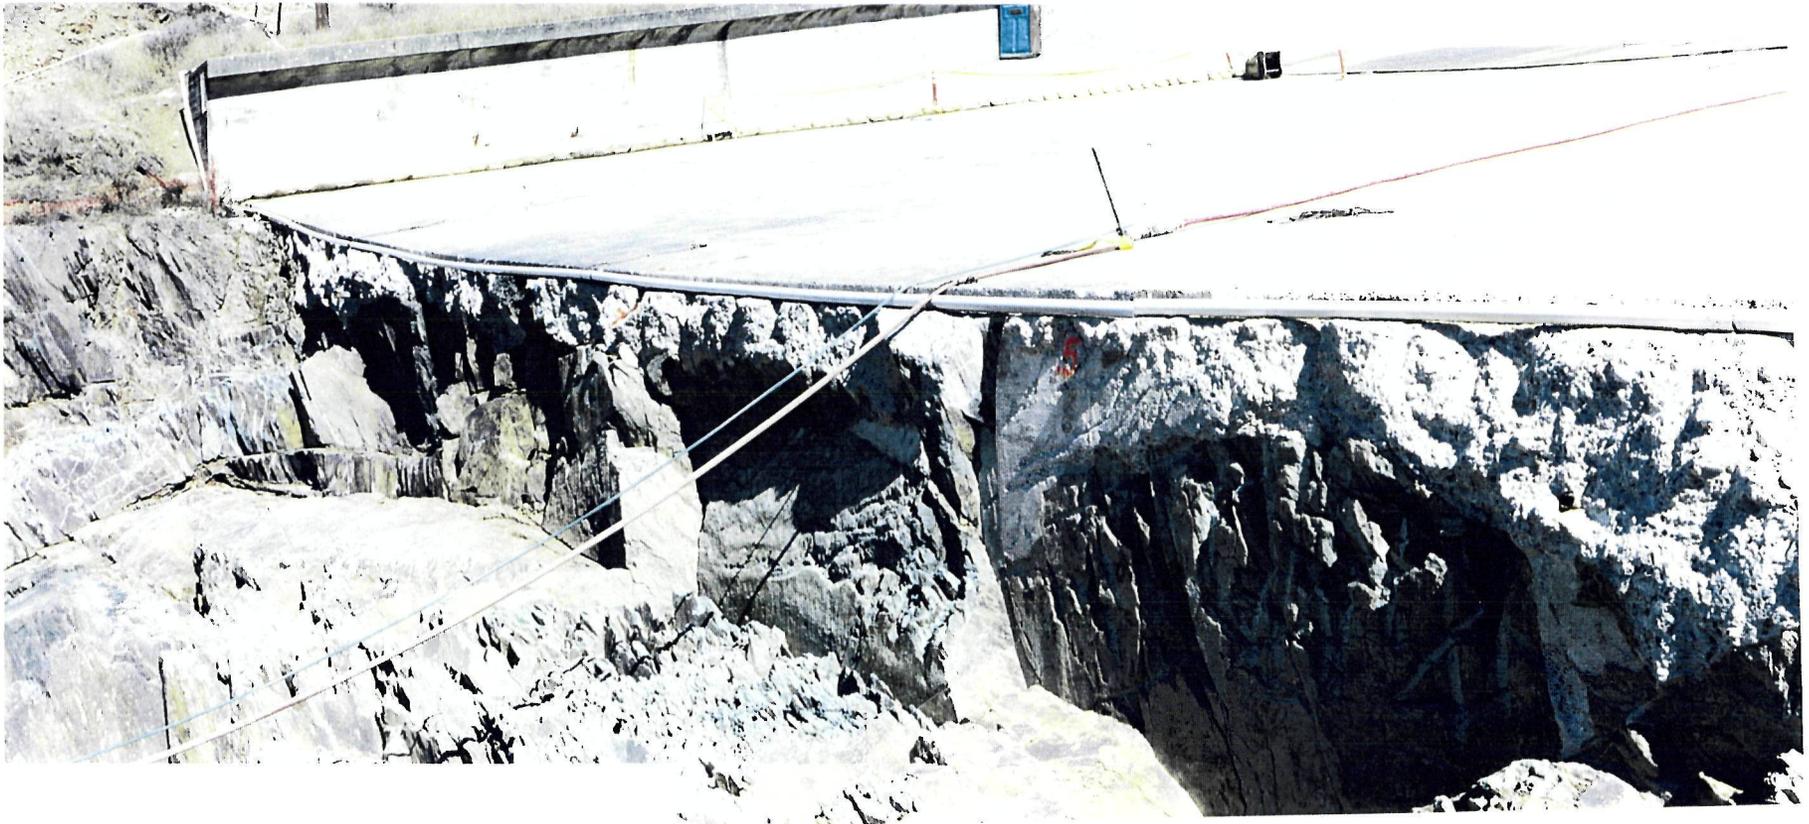
North Scour Hole, 10/8/96

View North-Northeast

Concrete/Rock Contact at Upstream Edge of Scour Hole; Spillway Joint Number 5 Center of Photo

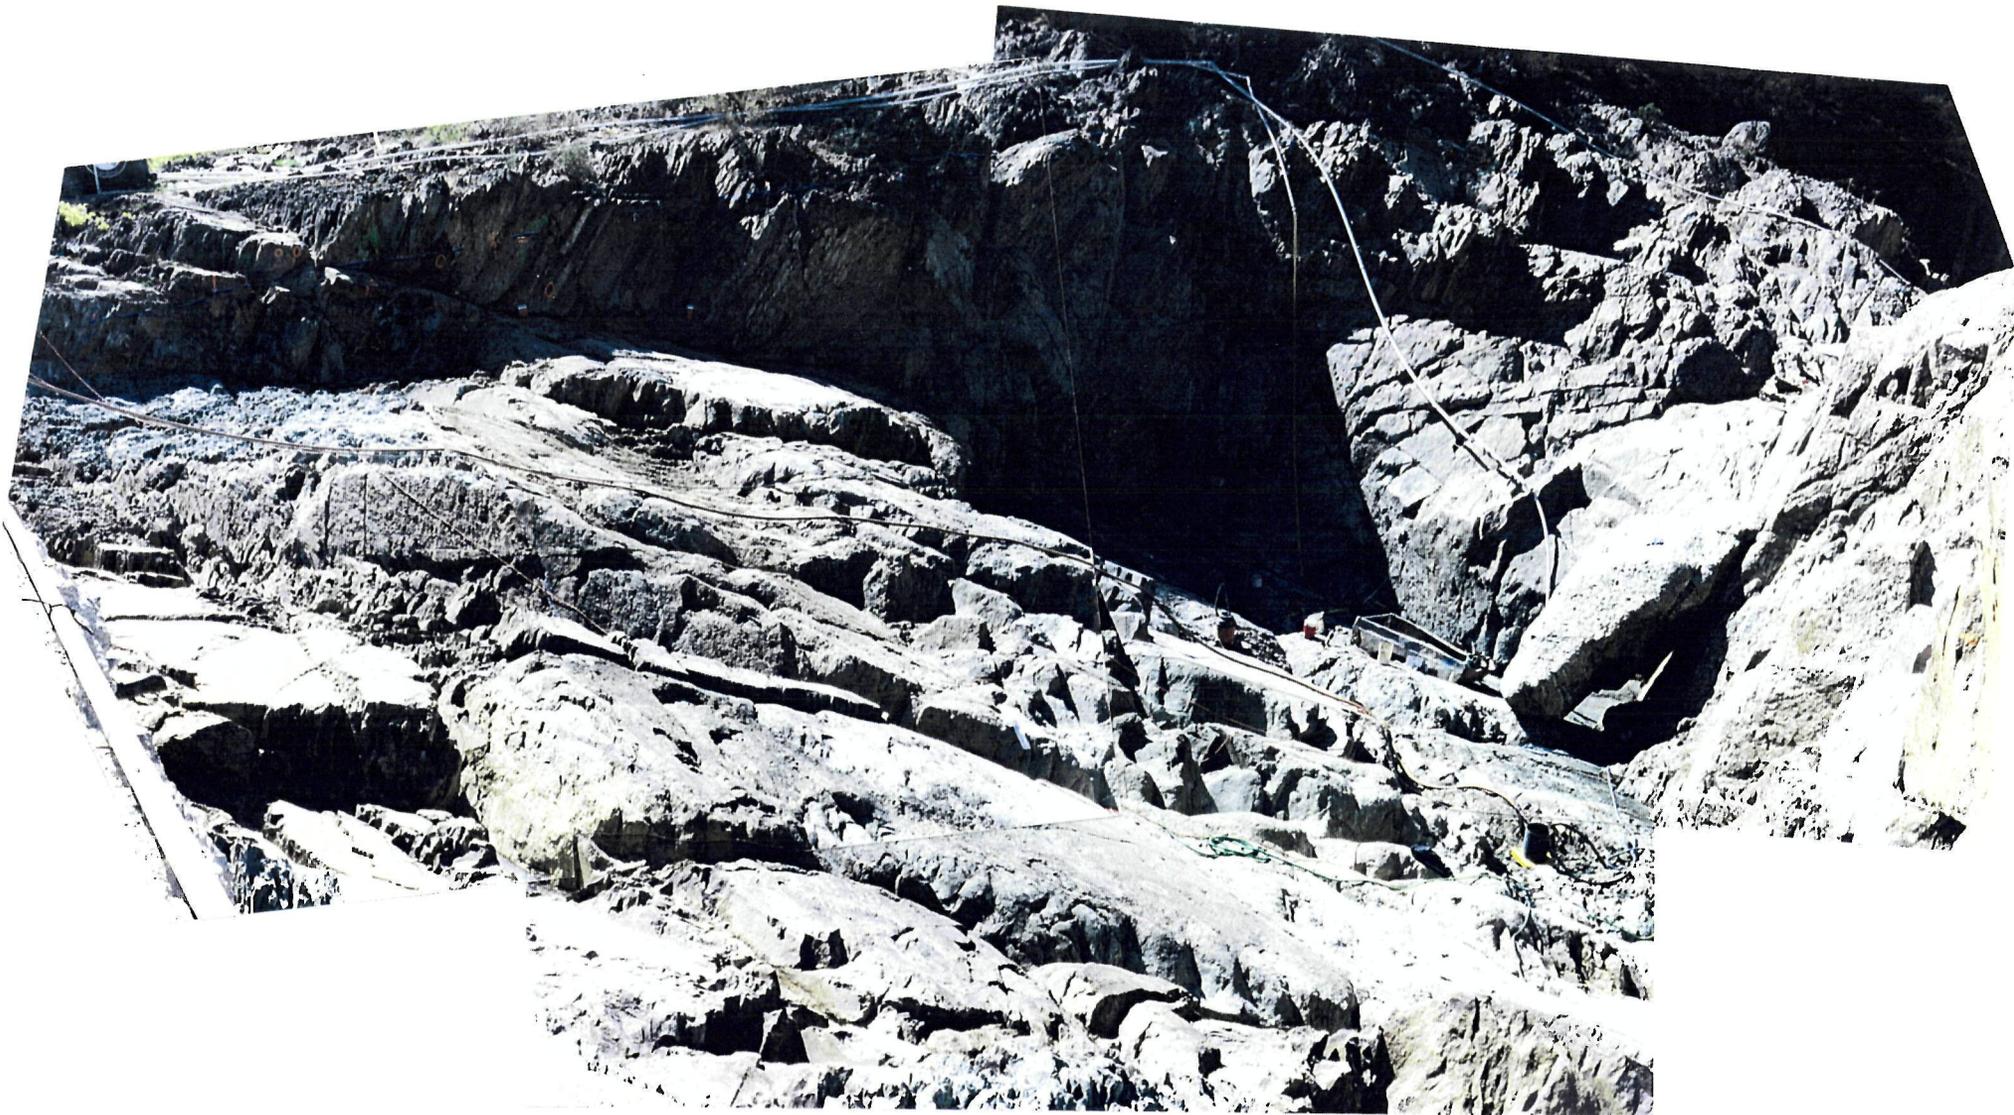
North Scour Hole, 10/8/96
View South, Downstream to Right.; Prominent Joint Surfaces; Boulder N-4 Center Right
