EXHIBIT F

REFERENCE MATERIAL

(Excerpts) Seismic Evaluation Administrative Building and Laboratory East Bay Municipal Utility District

Main Wastewater Treatment Plant Seismic Structural Evaluation and Conceptual Design Project

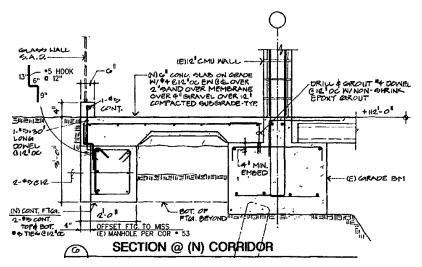
Figure 16: Lab Corridor Addition

The lab corridor addition is a light frame greenhouse-like structure located at the east side of the original Lab building. The glass wall (shown in Figure 16) sits on 3-foot wide spread footing foundation without piles. The addition does not significantly impact the seismic performance of the lab building, however, if subjected to a significant permanent ground deformation, the structure may separate from the lab building.

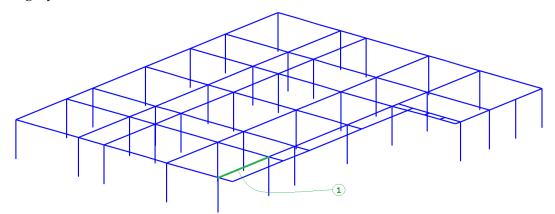
Figure 117: North Lab Addition – Identified Vulnerabilities

The finite element models show that most steel elements have DCRs below the m-factors and meet the acceptance criteria for Risk Category IV. However, for the fixed and flexible base finite element models, one beam (highlighted in Figure 117) shows DCR exceeding the m-factor for the BSE-1E case. Nevertheless, the North Lab addition meets the code-based acceptance criteria for Risk Category I & II.

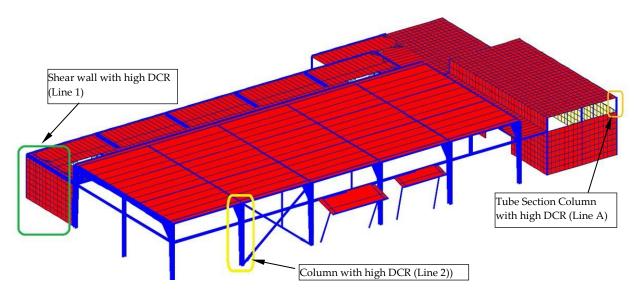
Figure 66: Field Services Building – Identified Vulnerably

There are large relative displacements between the lower roof of the corridor and the upper roof of the locker room resulting from the lack of shear walls with lateral resistance provided only by the steel tube sections (shown in Figure 66). Damage to the windows is likely and this could be a life safety hazard. Stiffening of the steel tube columns under the roof for BSE-2E event is recommended.

The bending capacity of the grade foundation beam is insufficient for passive soil pressure loading in East-West direction (see Section 5.1.5).

There are no connections between the foundations of the original building and the extensions; therefore, separation of the building sections of FSB due to an estimated 6 inches of lateral spread will result in damage to the steel elements connecting the extensions to the original building. Soil improvement to reduce liquefaction-induced lateral spread hazard or structurally tying the building sections together are possible options for mitigating this hazard.

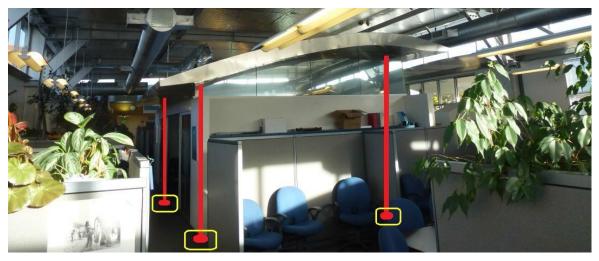
Figure 7: Field Services Building – Conference Room Column Base Retrofit

The conference room is a standalone partition structure within the building that currently does not have a complete lateral load resisting system. The structure is vulnerable to ground shaking in the north-south direction due to lack of moment connection at the base. Retrofitting the four column bases (shown in Figure 7) of the conference room structure to make moment connection in both directions will reduce its seismic vulnerability. With this retrofit, the structure will have acceptable strength, however, the drift at the canopy level will still be high. High drifts can result in glass breakage. Bracing between columns or other means of stiffening the system can be considered to reduce drift and the potential for glass breakage. However, additions may impact current access and aesthetics. The option of making the column to canopy beam moment resisting in both north-south and east-west direction is not considered feasible.

The structure of the conference room has an inadequate lateral load resisting system. The steel pipe columns are pin-connected to the base and to the canopy. Columns should have a fixed-base connection for adequate moment transfer to create a complete lateral load resisting system.

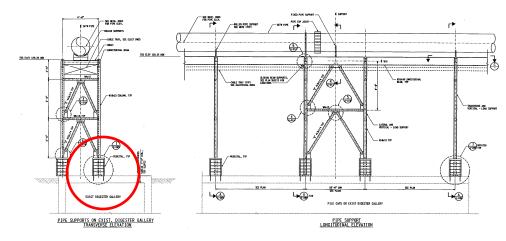
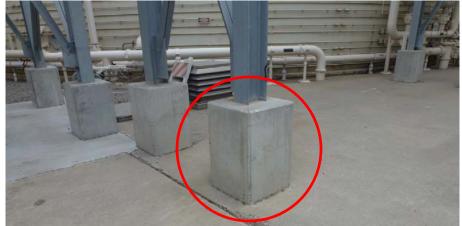
- Digester gallery slab is overstressed at 3 out of 17 overhead pipe chase supports
- Consequences
 - Damage to digester gallery roof
 - Damage or tilting of overhead pipe chase
 - Damage to gas pipe and other pipelines in gallery and on chase
