EAST BAY MUNICIPAL UTILITY DISTRICT

SUBJECT: Orinda Water Treatment Plant Disinfection and Chemical Systems Safety Improvements Project Update

2026 Triannual Progress Report No. 1

Specification 2139: Orinda Water Treatment Plant (WTP) Disinfection and Chemical Safety Systems Improvement Project

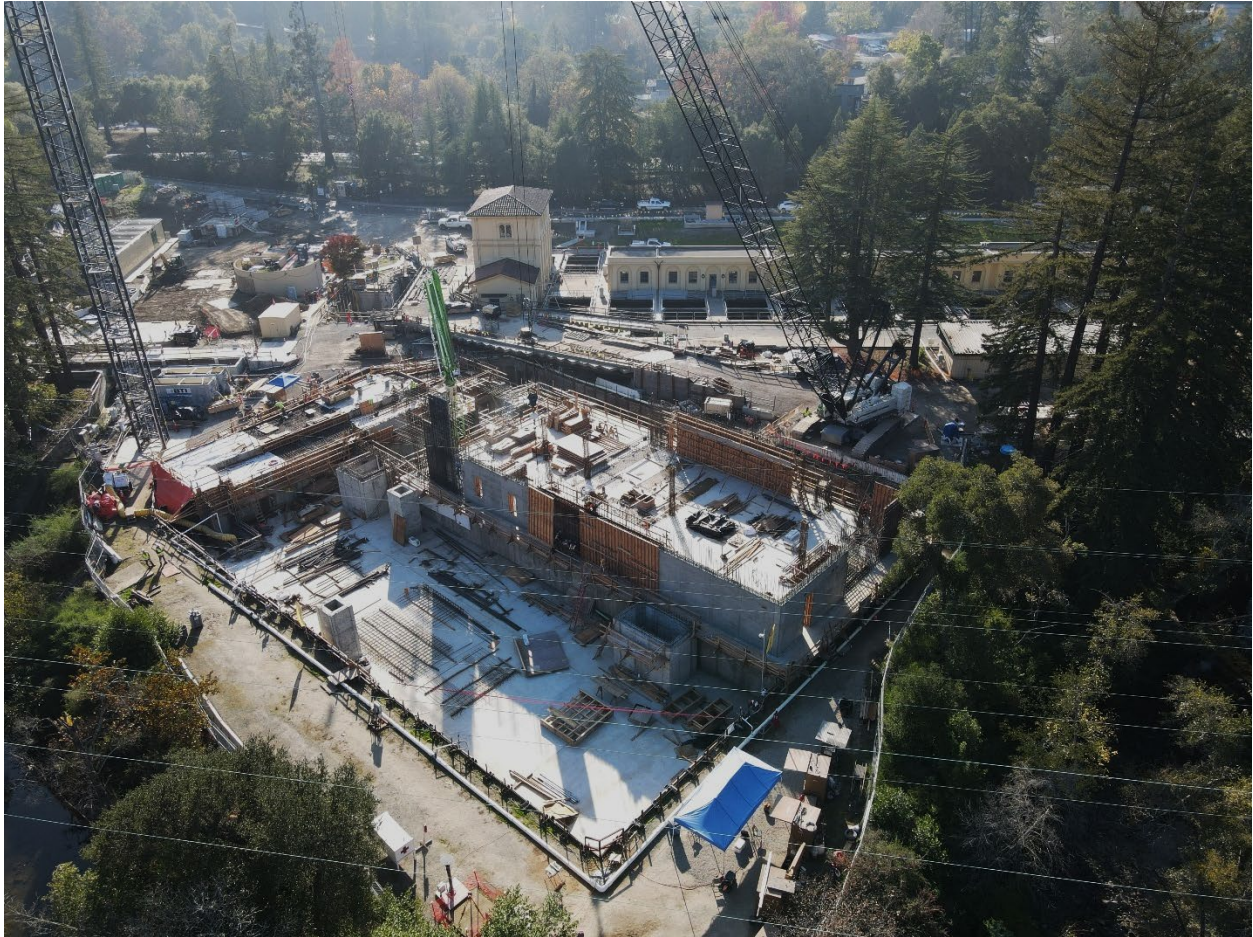
Figure 1 – Aerial View of UV-CCB Facility

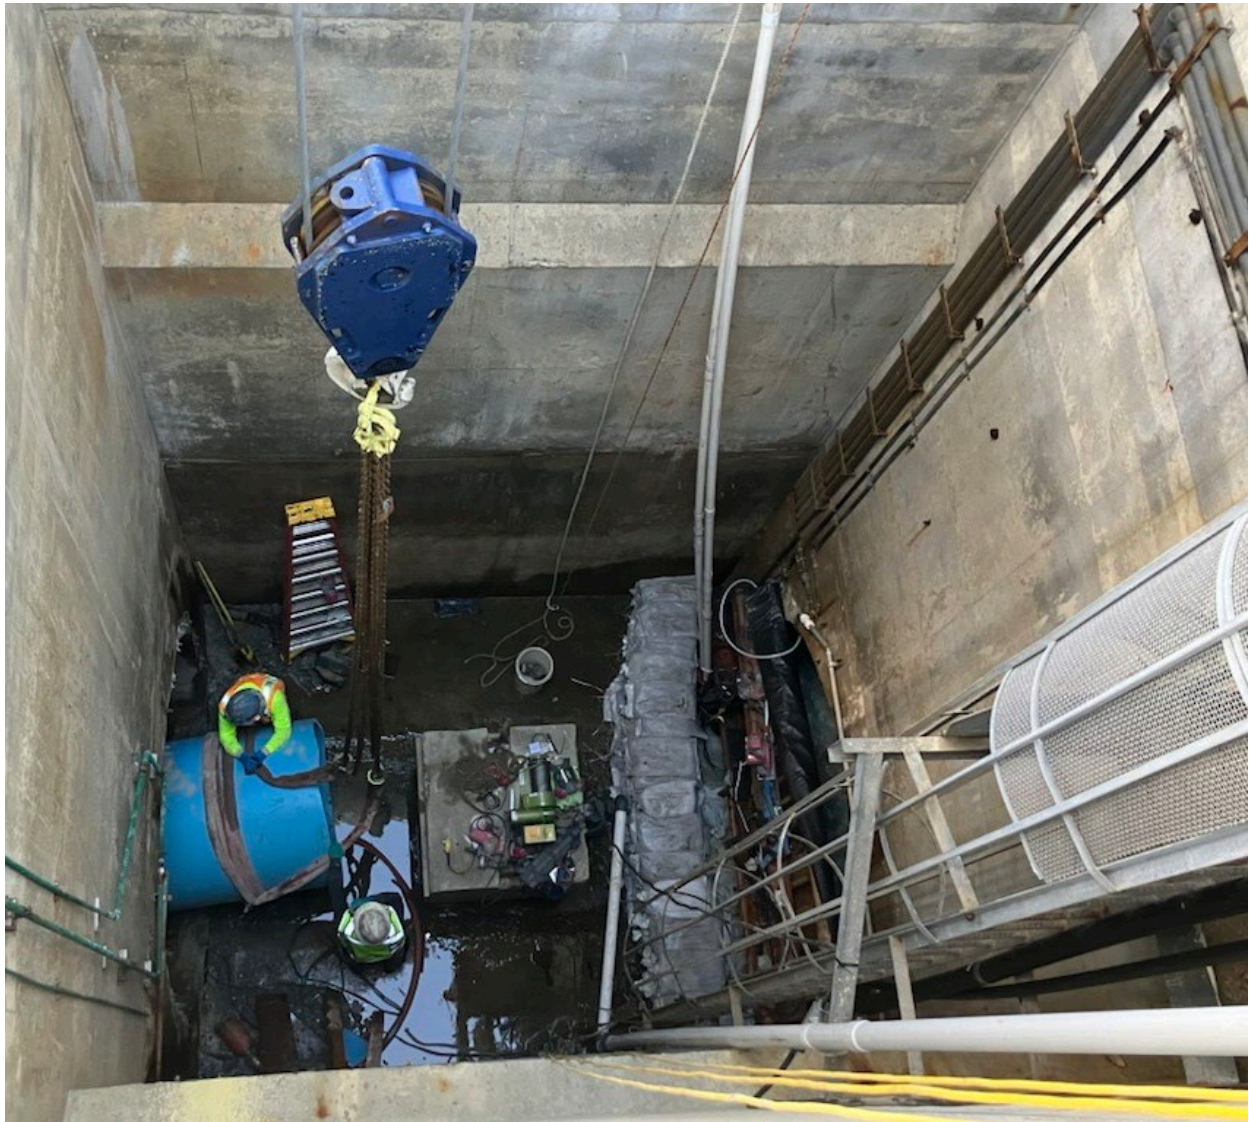
Figure 2 – Claremont Tunnel Access Shaft: view looking down as workers install slings around 48-inch Effluent 1 bypass piping in preparation for crane lift of the pipe out of the tunnel.

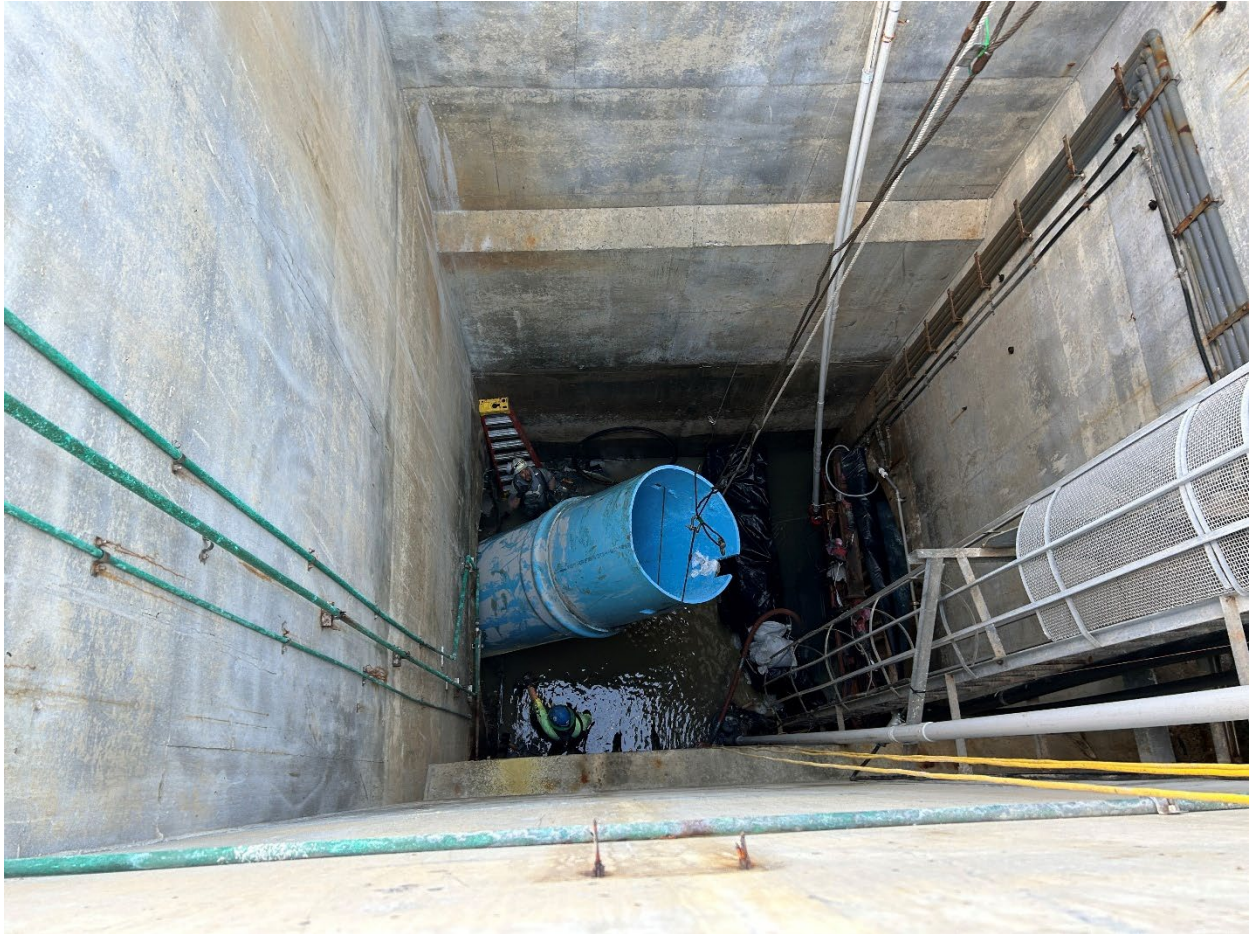
Figure 3 – Claremont Tunnel Access Shaft: view looking down as crane lifts 48-inch Effluent 1 bypass piping out of the tunnel.

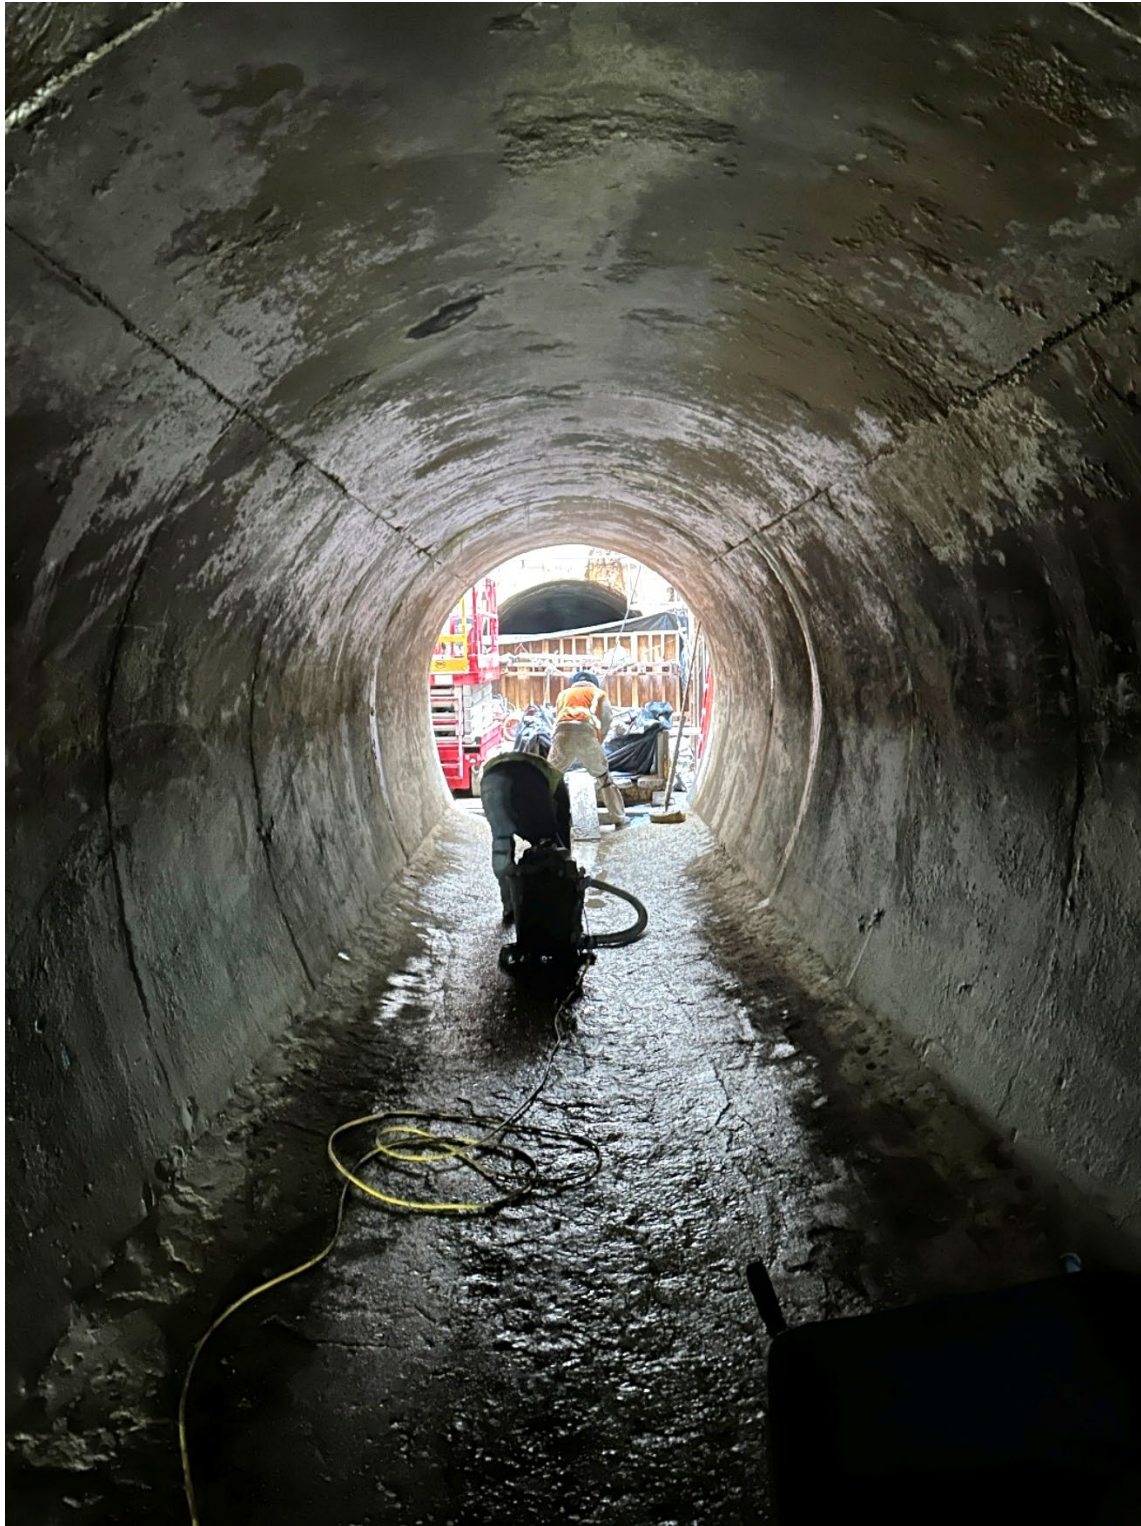
Figure 4 – Claremont Tunnel: view looking down length of the tunnel as workers clean it out in preparation for disinfection and return to service to end the outage.

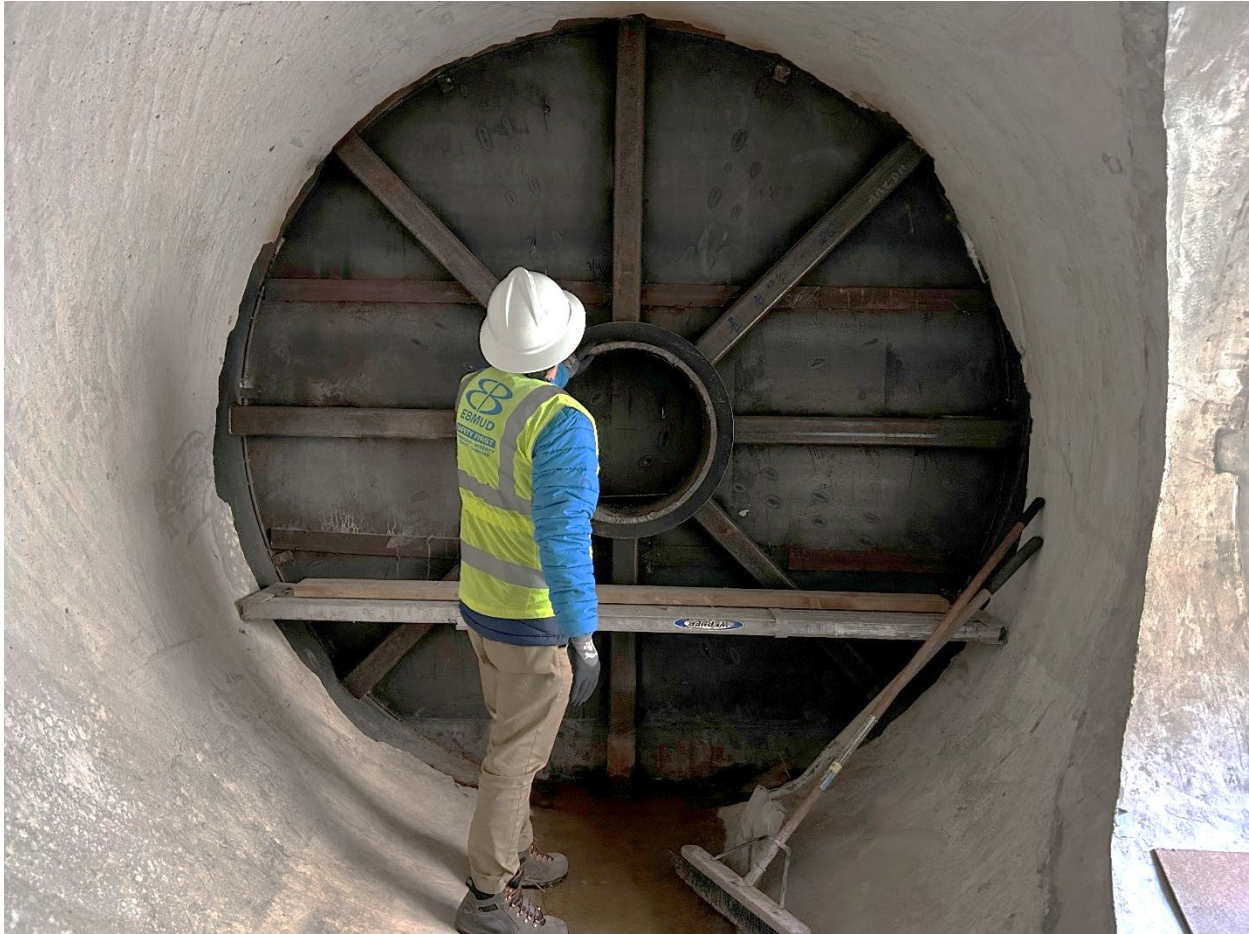
Figure 5 – Engineer inspecting 108-inch steel bulkhead installed for hydrostatic testing of the UV Influent Channel.

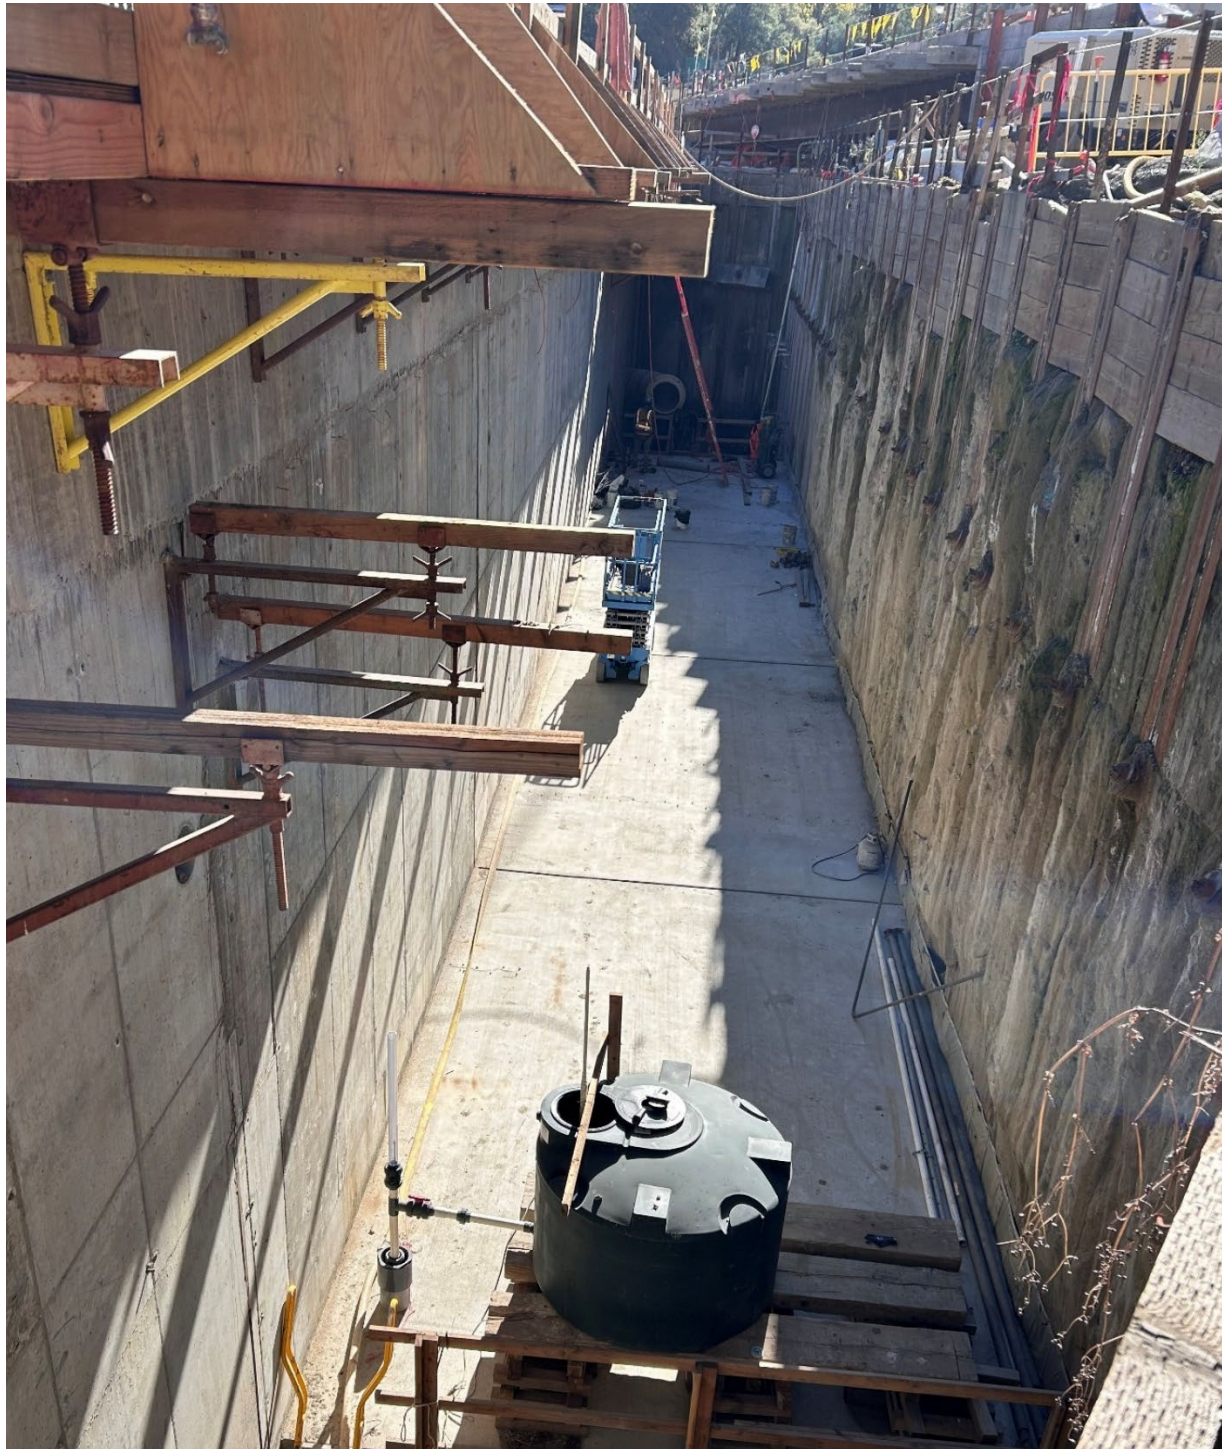
Figure 6 – Black plastic water reservoir providing static water level for hydrostatic water testing of the UV Influent Channel located underneath the concrete slab which the reservoir is resting upon.

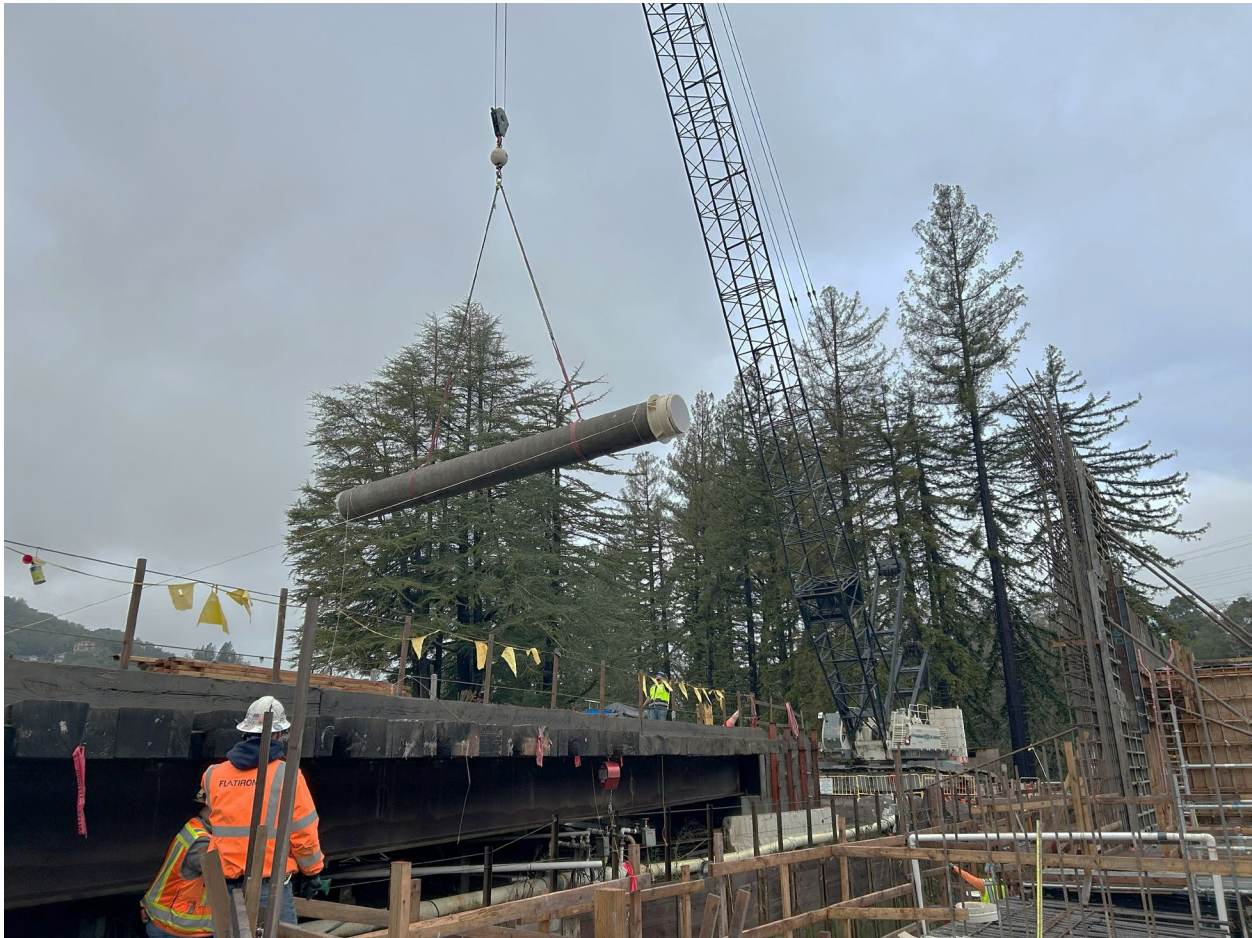
Figure 8 – Crawler crane lifting 40-foot segment of 36-inch LAF1 Wasteway steel piping from the temporary bridge into the trench located below.

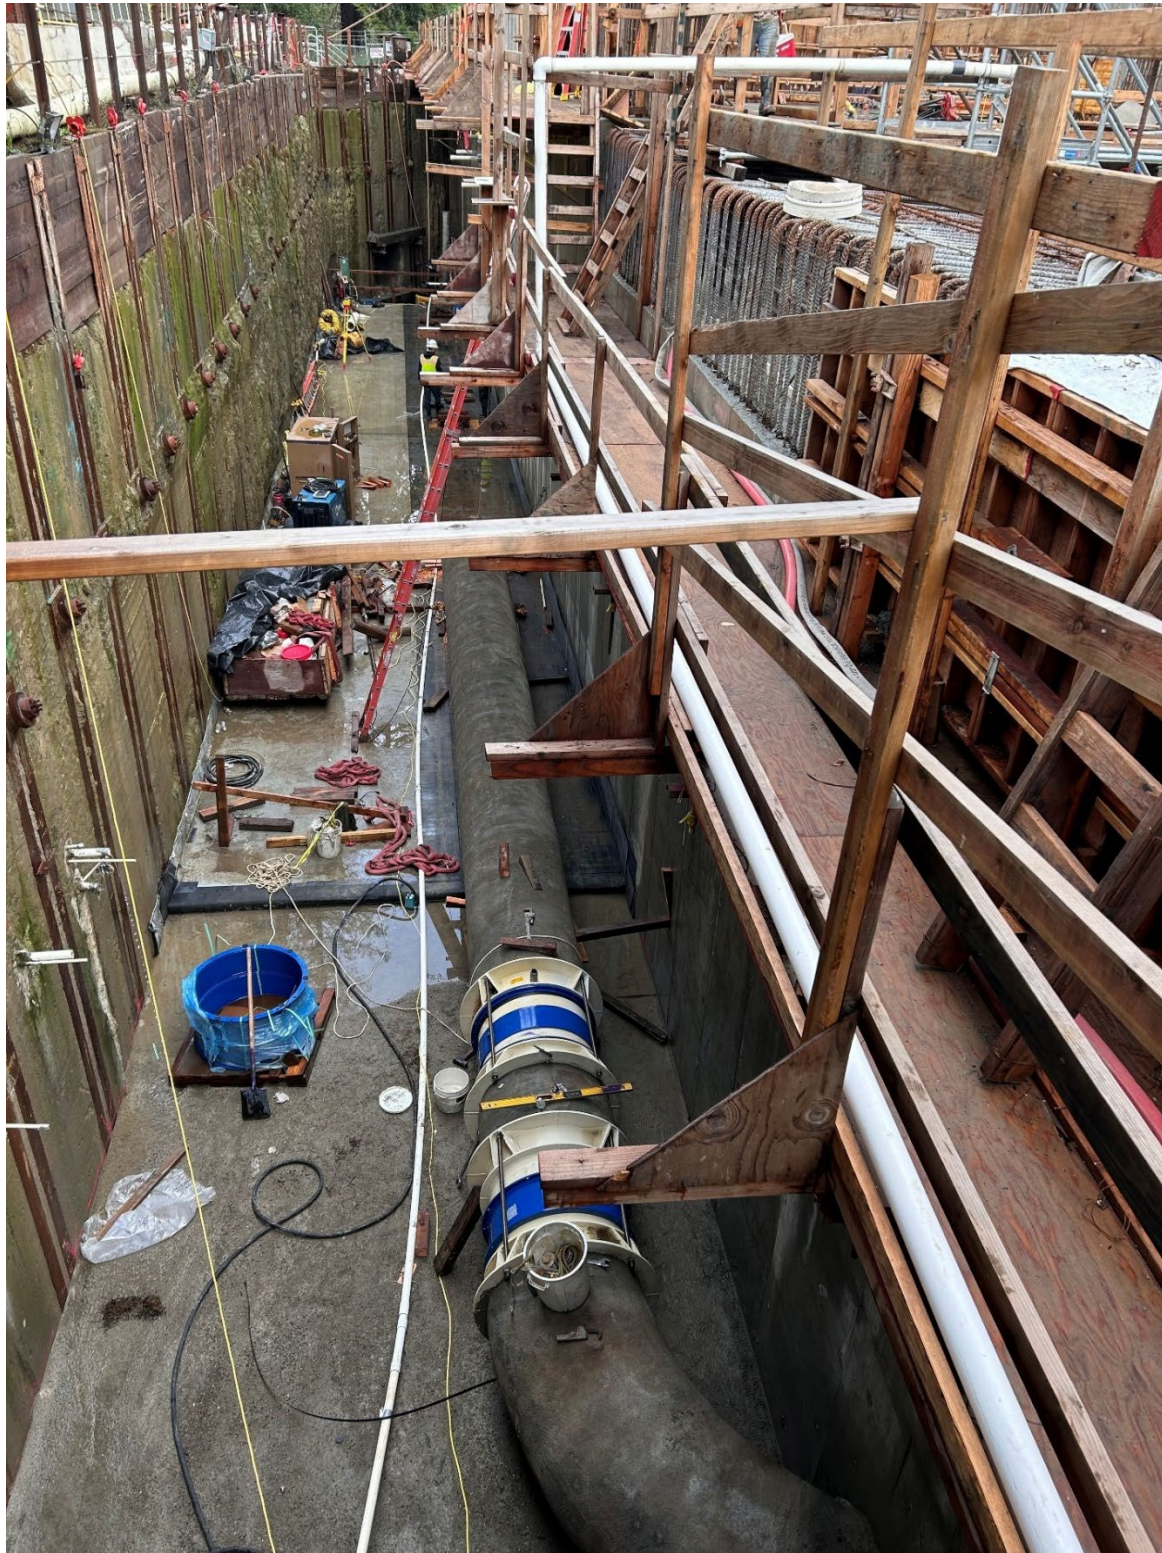
Figure 9 – 36-inch LAF1 Wasteway steel piping installed on the roof of the UV Influent Channel.

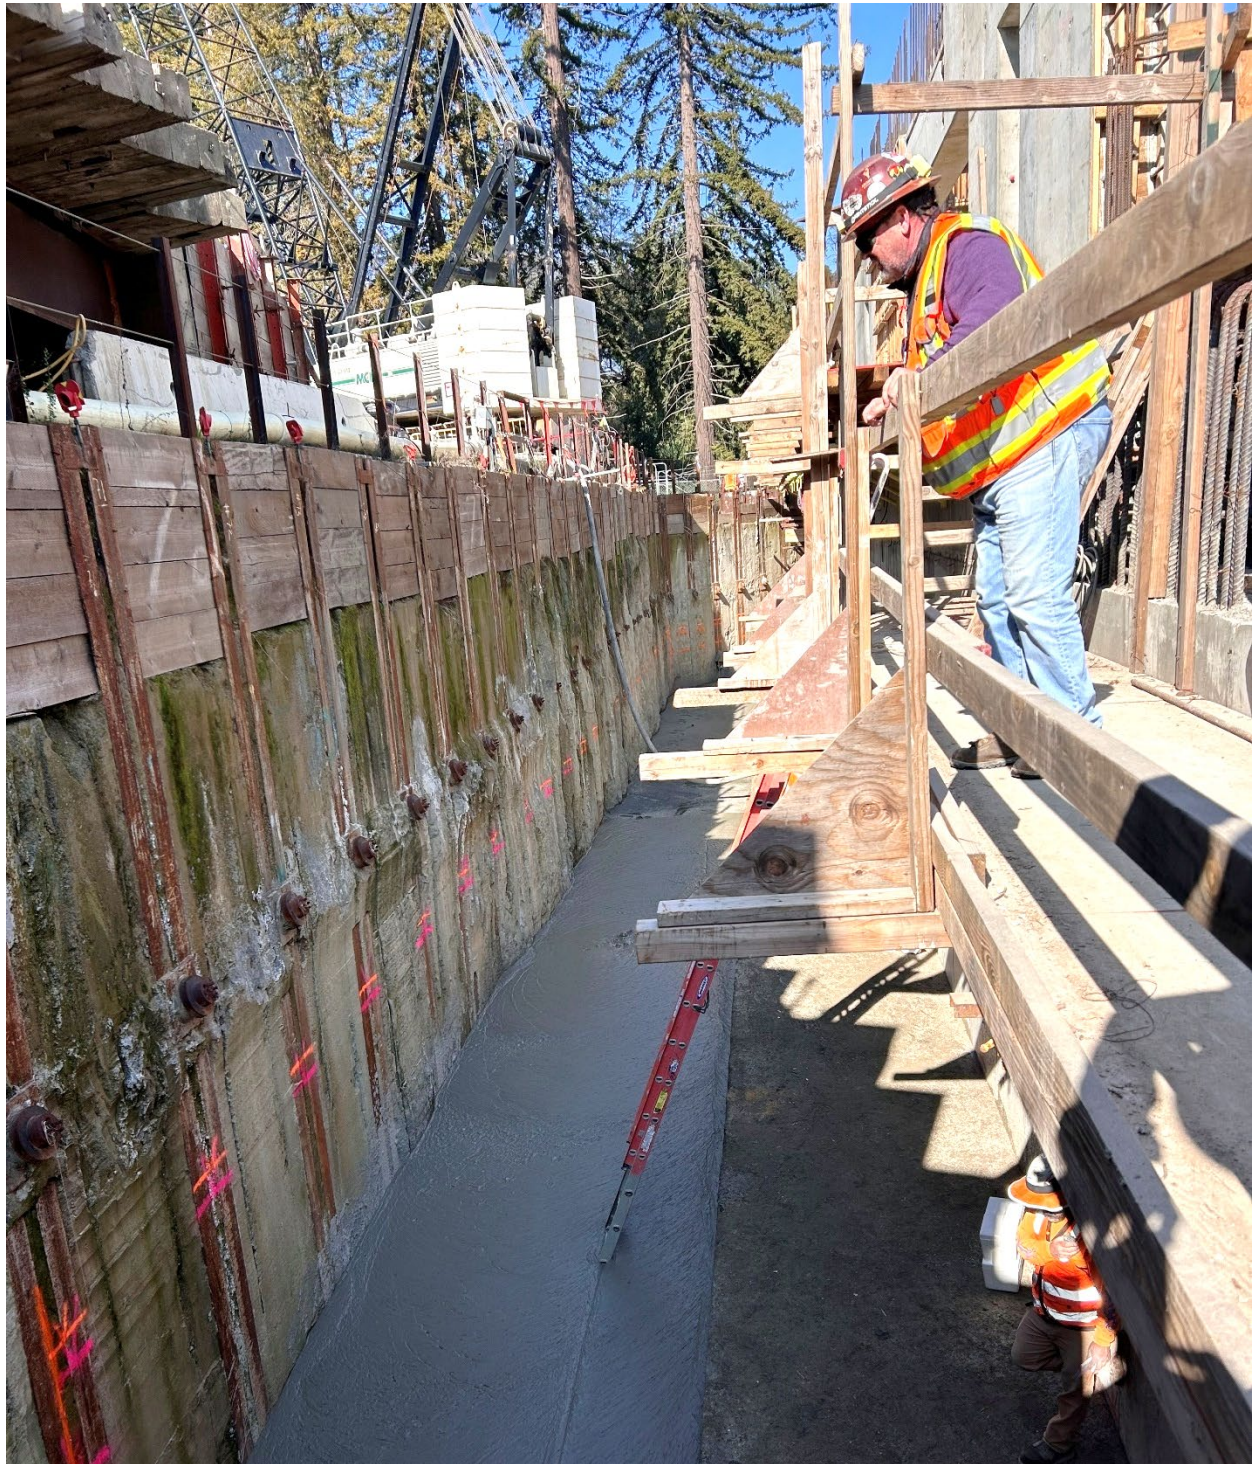
Figure 10 – Inspector watching workers below place flowable fill to bury 36-inch LAF1 Wasteway steel piping and UV Influent Channel.

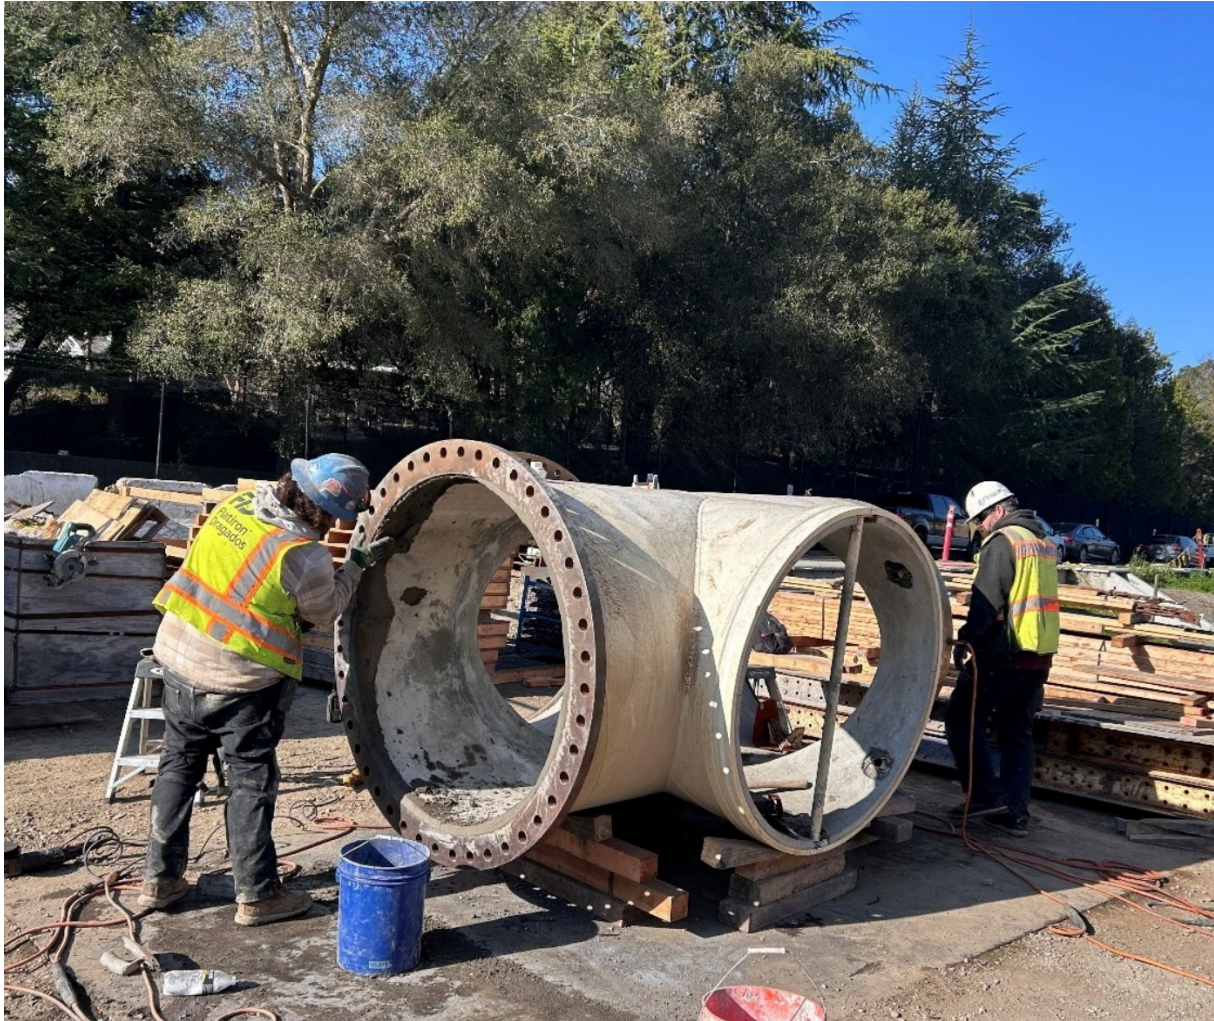
Figure 11 – Workers applying protective mortar lining inside special 48-inch steel piping piece for LAPP2 suction piping.

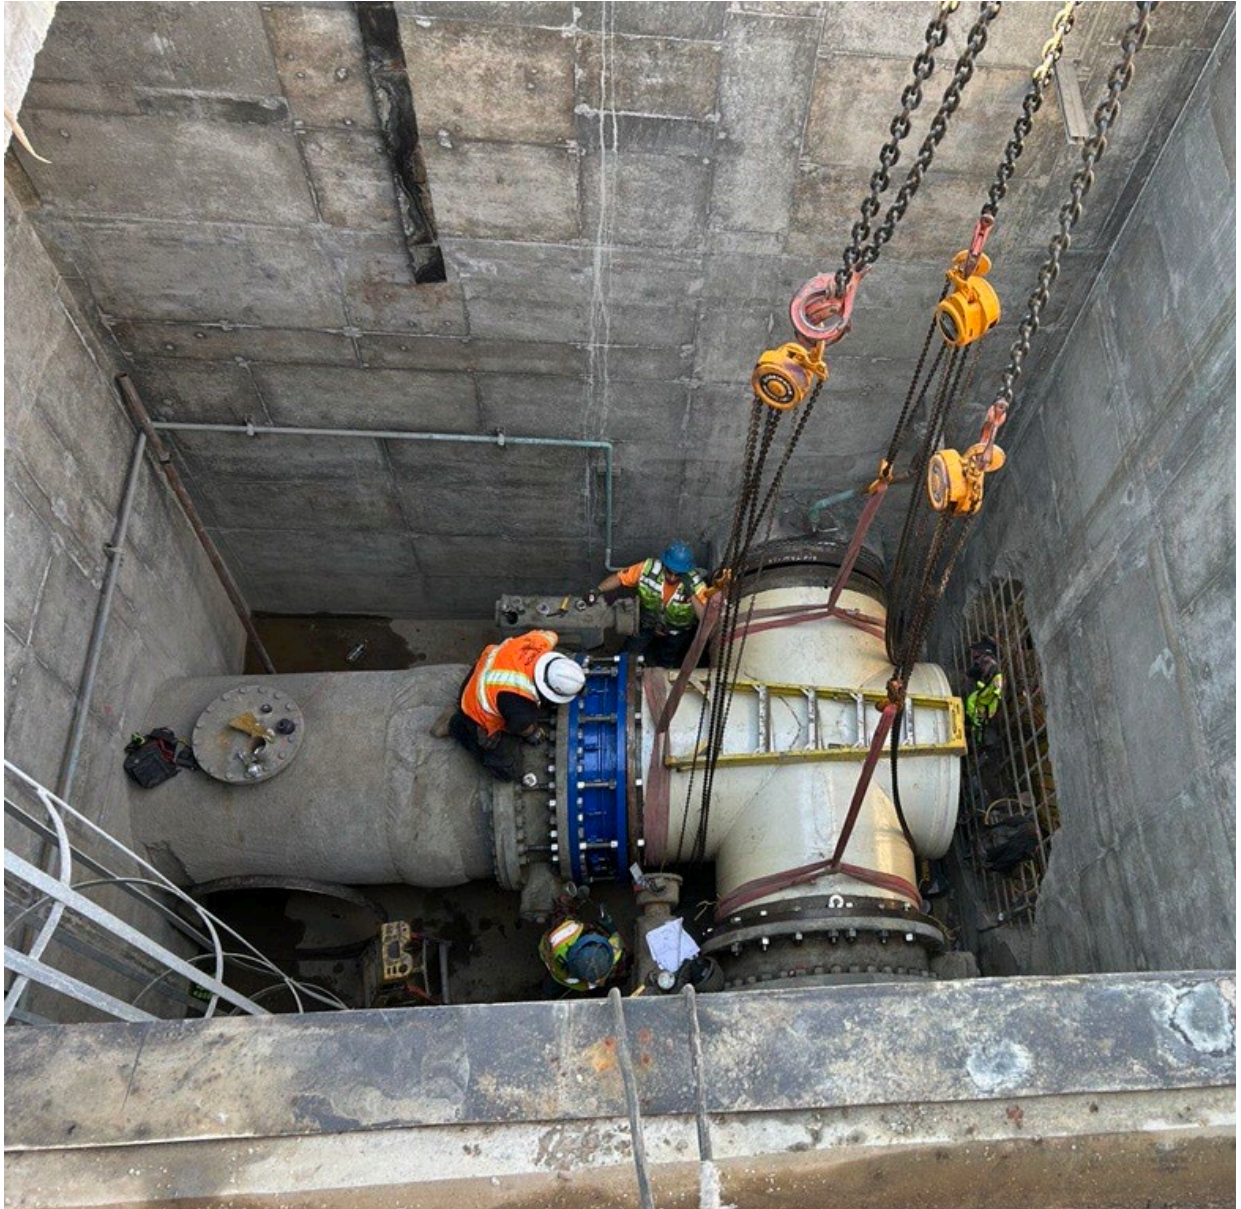
Figure 12 – View looking down into LAPP2 suction piping vault of workers positioning special 48-inch steel piping piece with the aid of a crane located above.

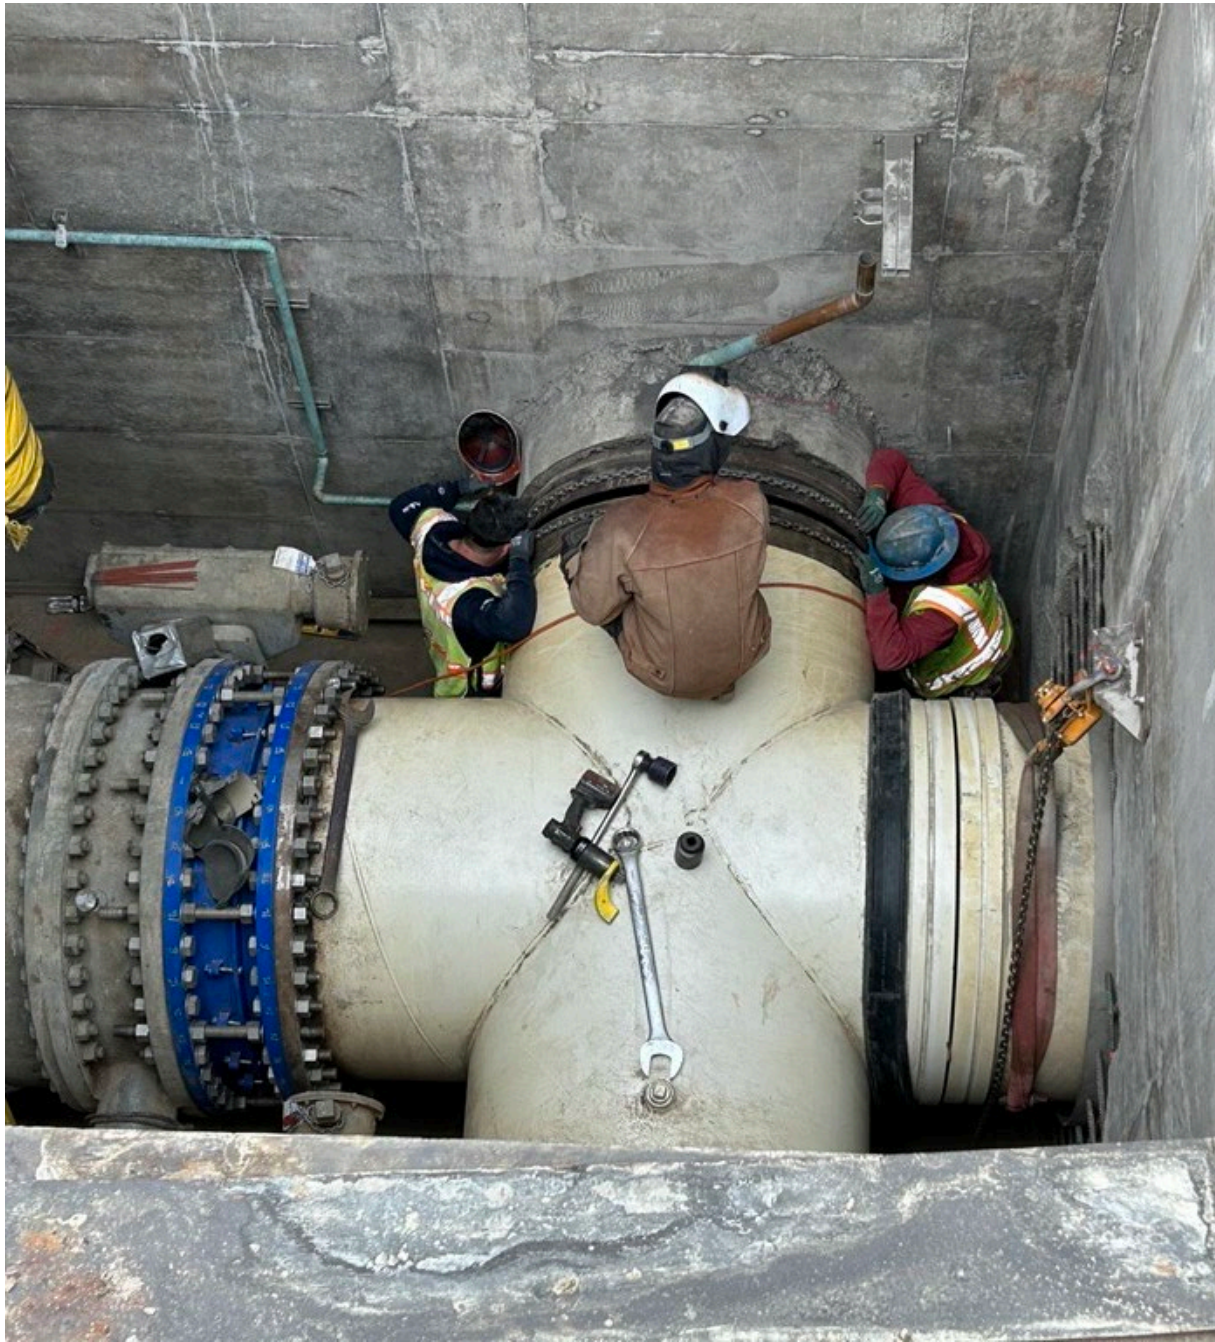
Figure 13 – Workers connecting special 48-inch steel piping piece to existing piping using a welded butt strap connection.

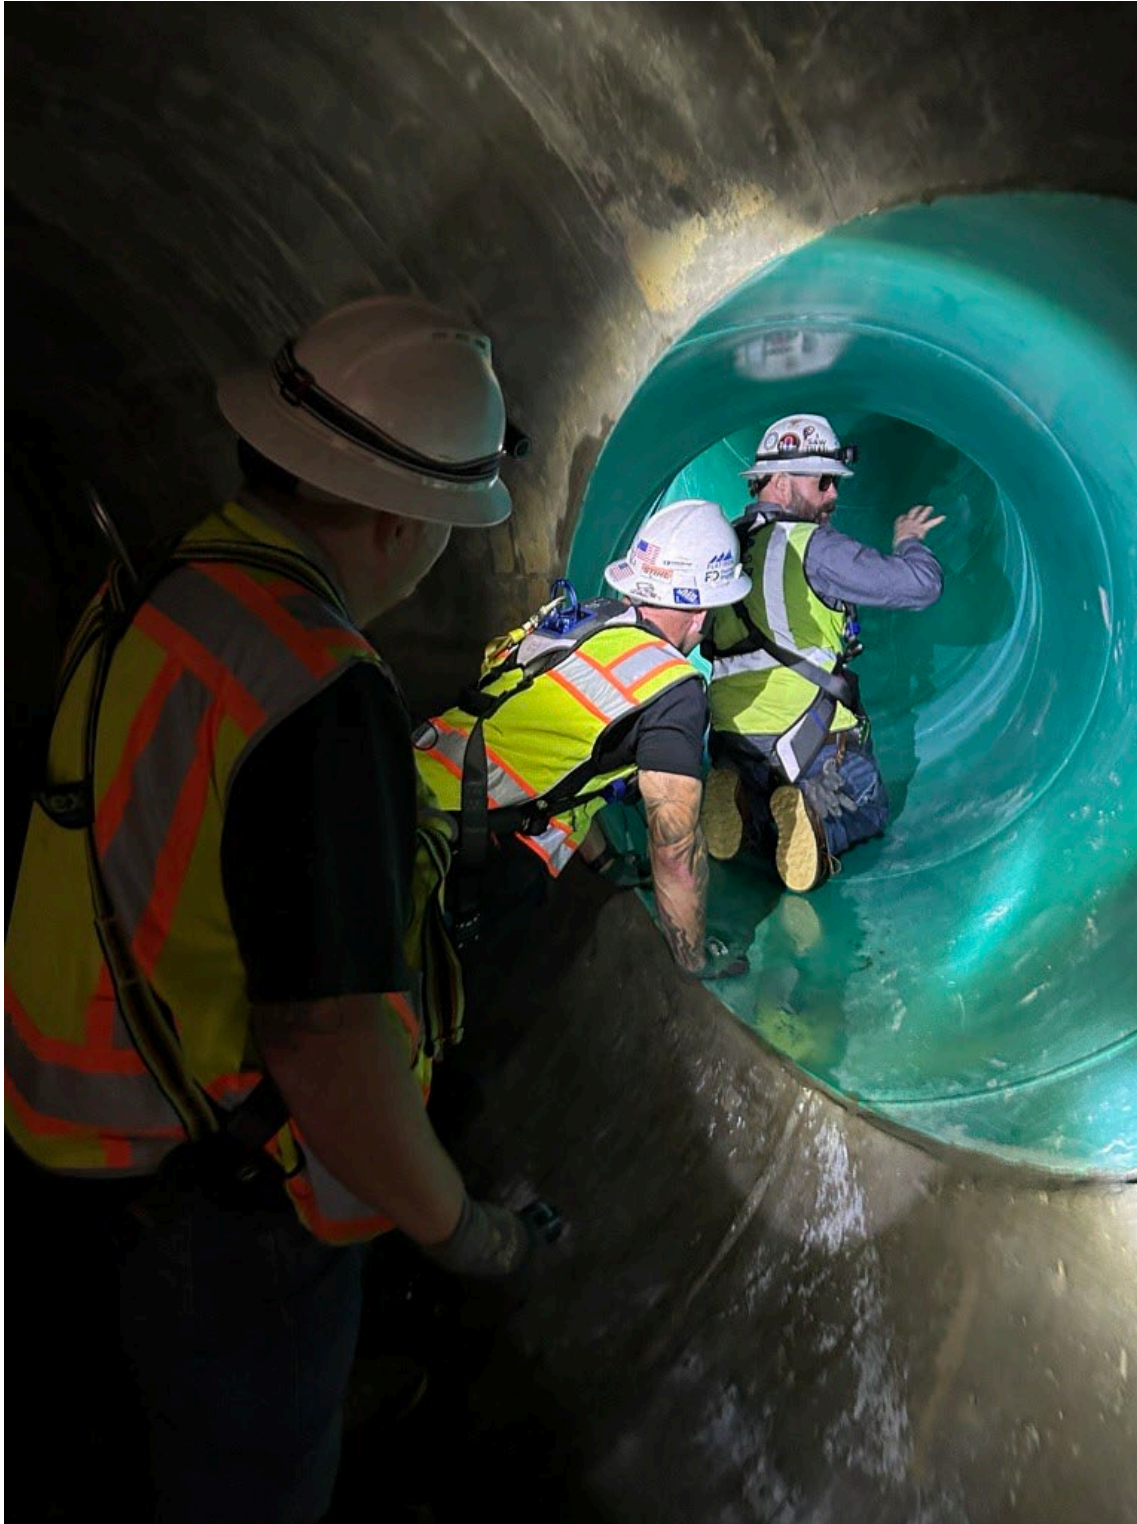
Figure 14 – Inspector kneeling in 48-inch branch line providing feedback to contractor’s staff who are standing inside 108-inch Effluent 1 steel piping.

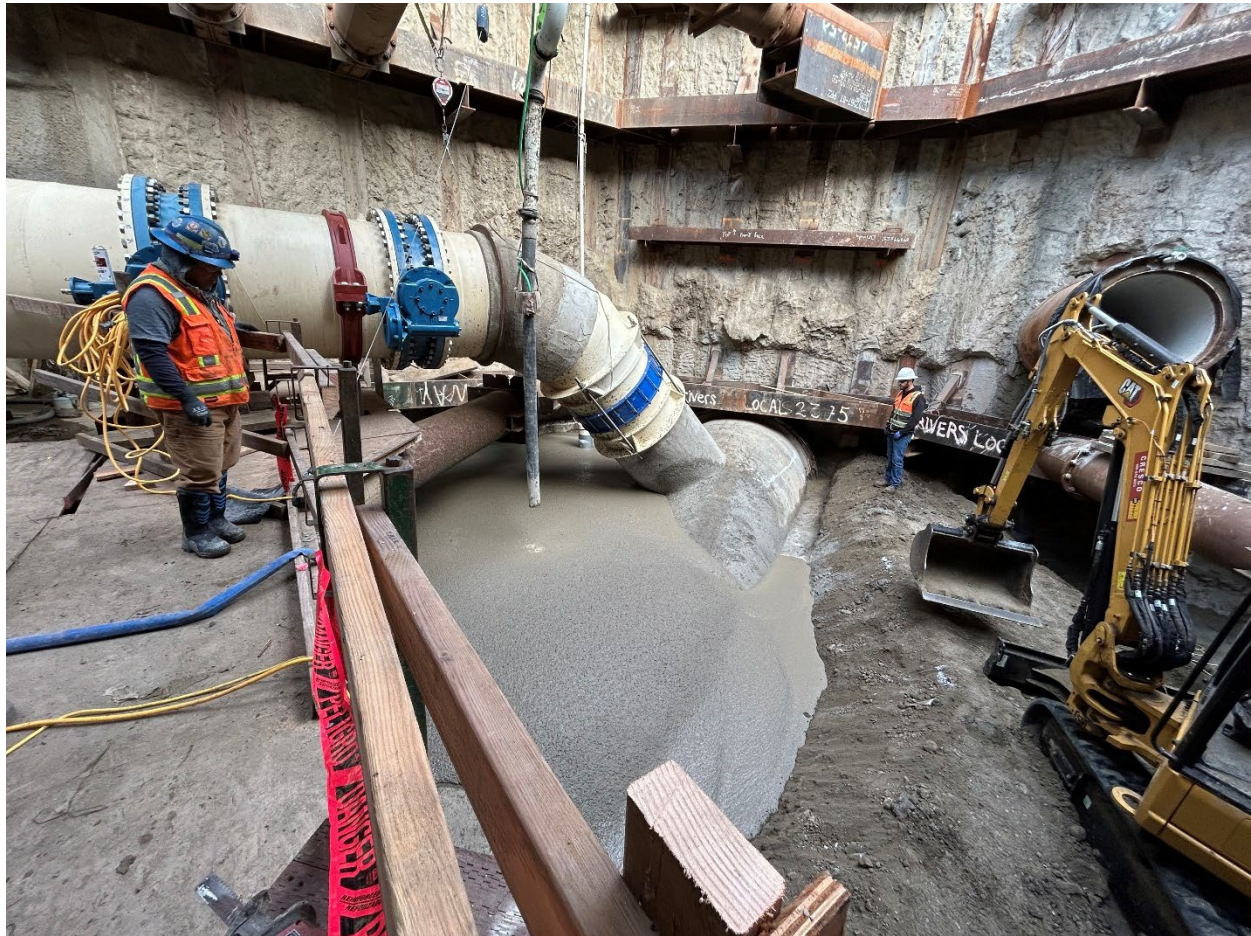
Figure 15 – Workers backfilling 108-inch Effluent 1 steel piping with flowable fill inside the Effluent 1 excavation.

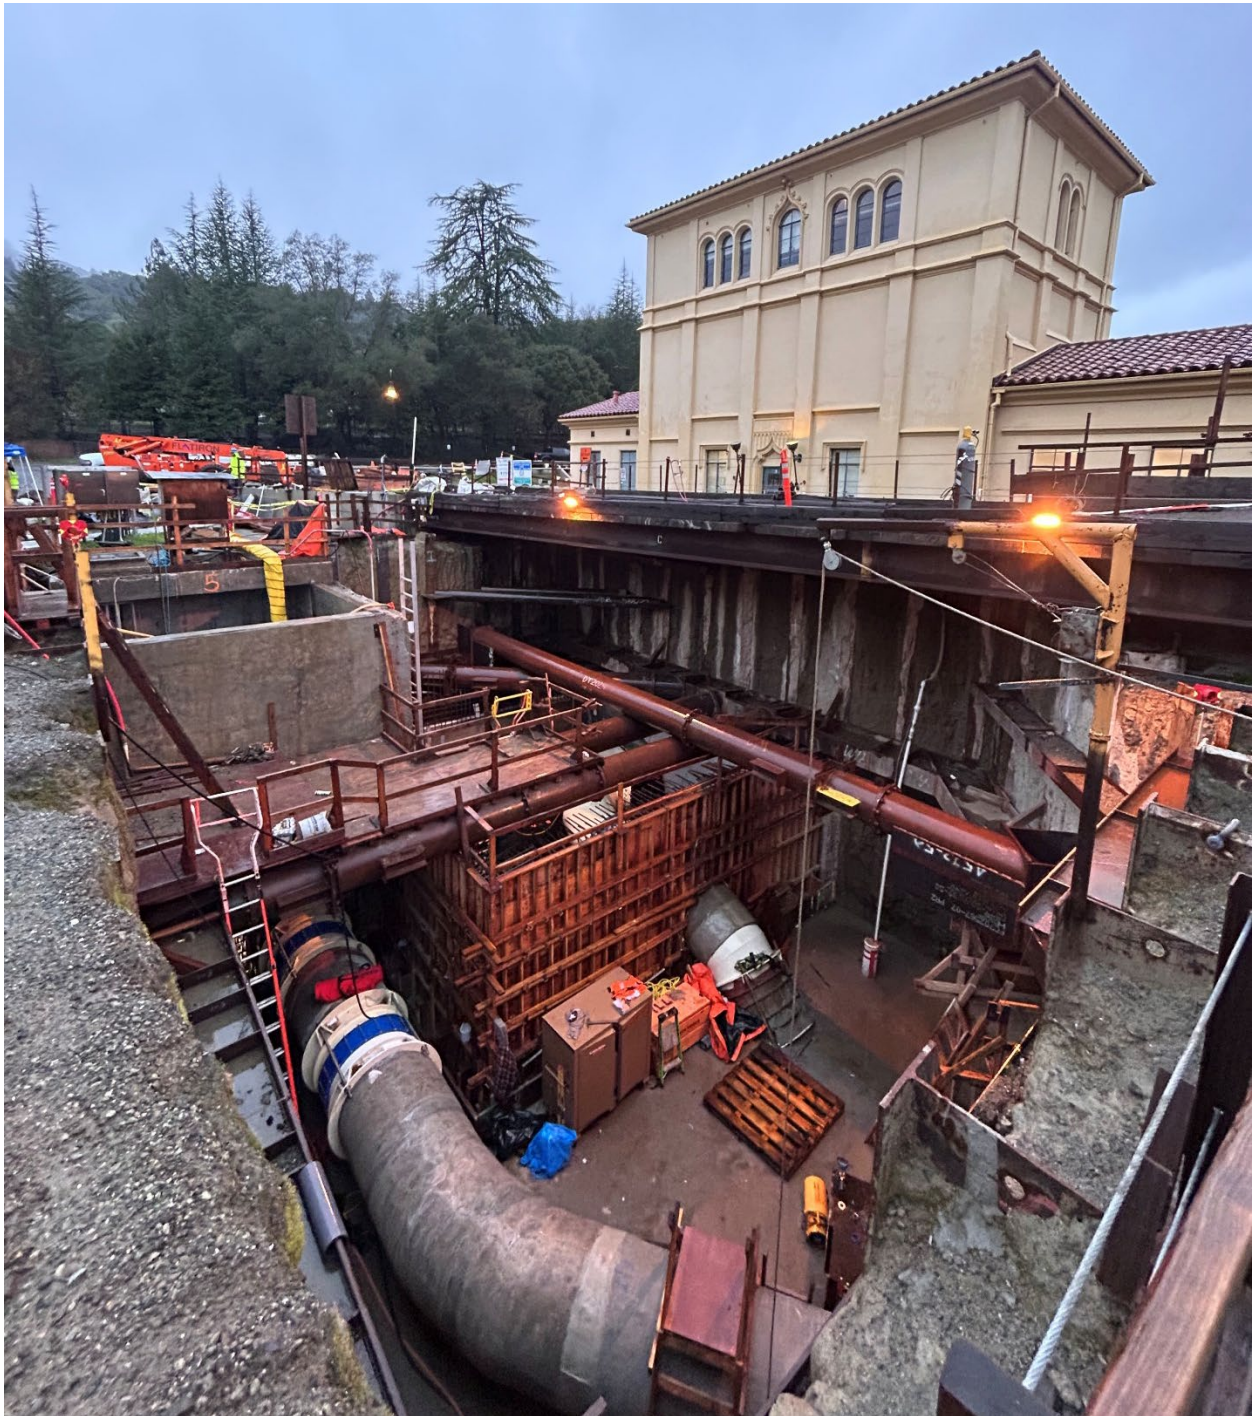
Figure 16 – View looking down into Effluent 1 excavation showing piping completed and wooden wall forms in the foreground which will provide temporary support for future underground Effluent 1 vault walls.
