EAST BAY MUNICIPAL UTILITY DISTRICT

SUBJECT: Orinda Water Treatment Plant Disinfection and Chemical Systems Safety Improvements Project Update

2026 Triannual Progress Report No. 1

Specification 2139: Orinda Water Treatment Plant (WTP) Disinfection and Chemical Safety Systems Improvement Project

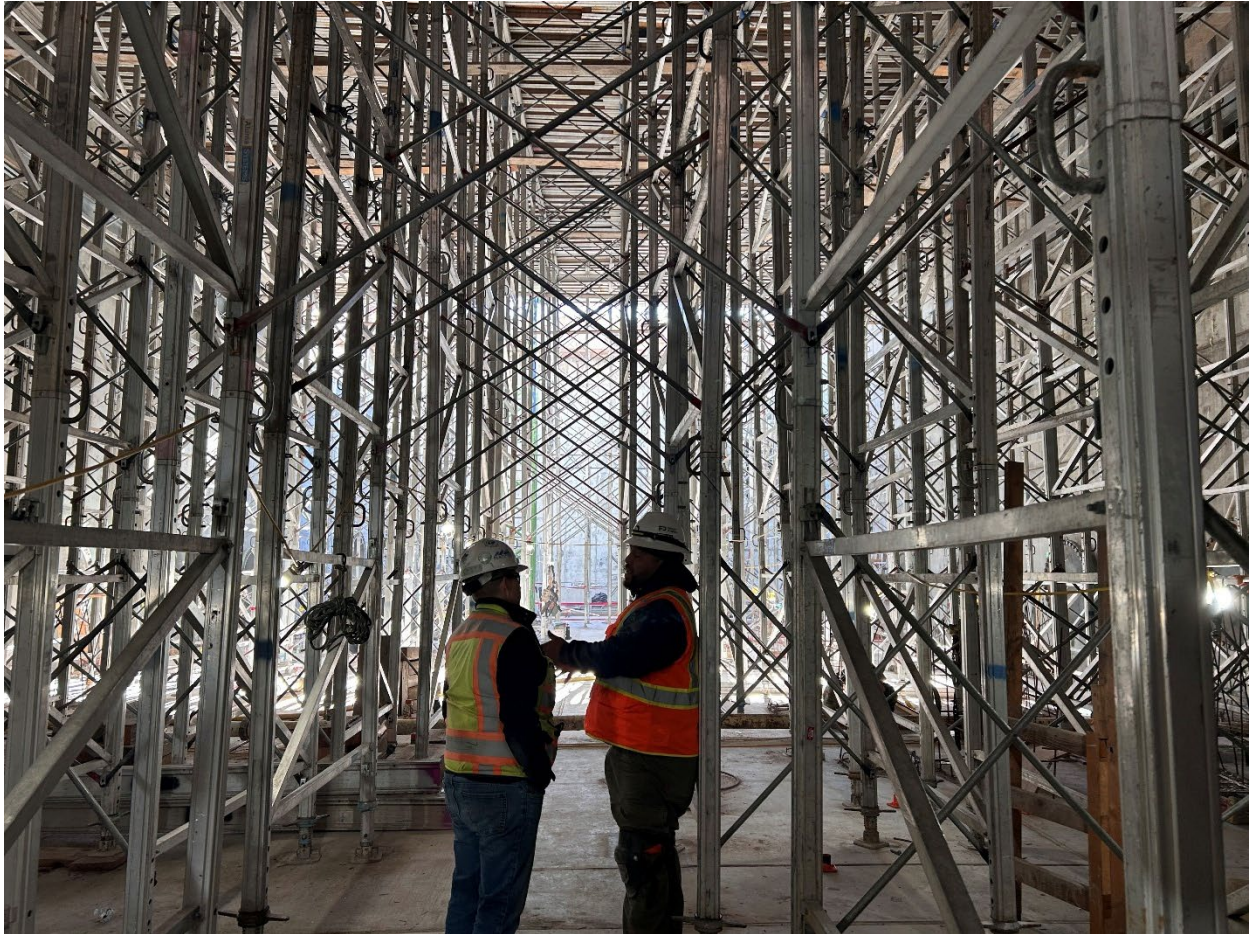
Figure 17 – View looking down the length of the UV Room with scaffolding towers providing temporary support for placement of the UV Room concrete roof slab, located 25-feet above the floor.

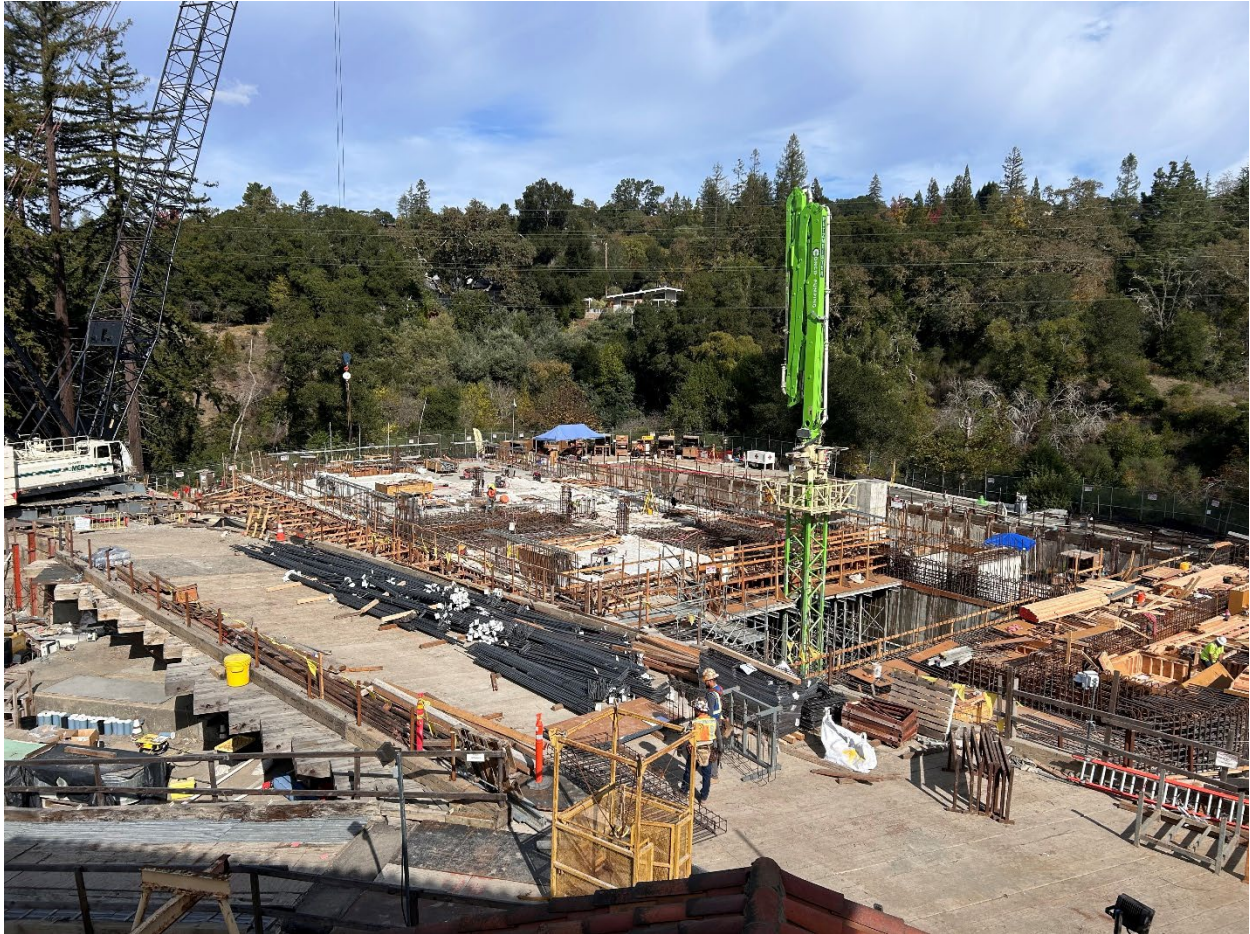
Figure 18 – View of the completed UV Room concrete roof slab which serves as the ground level floor for the future MAUVE Building.

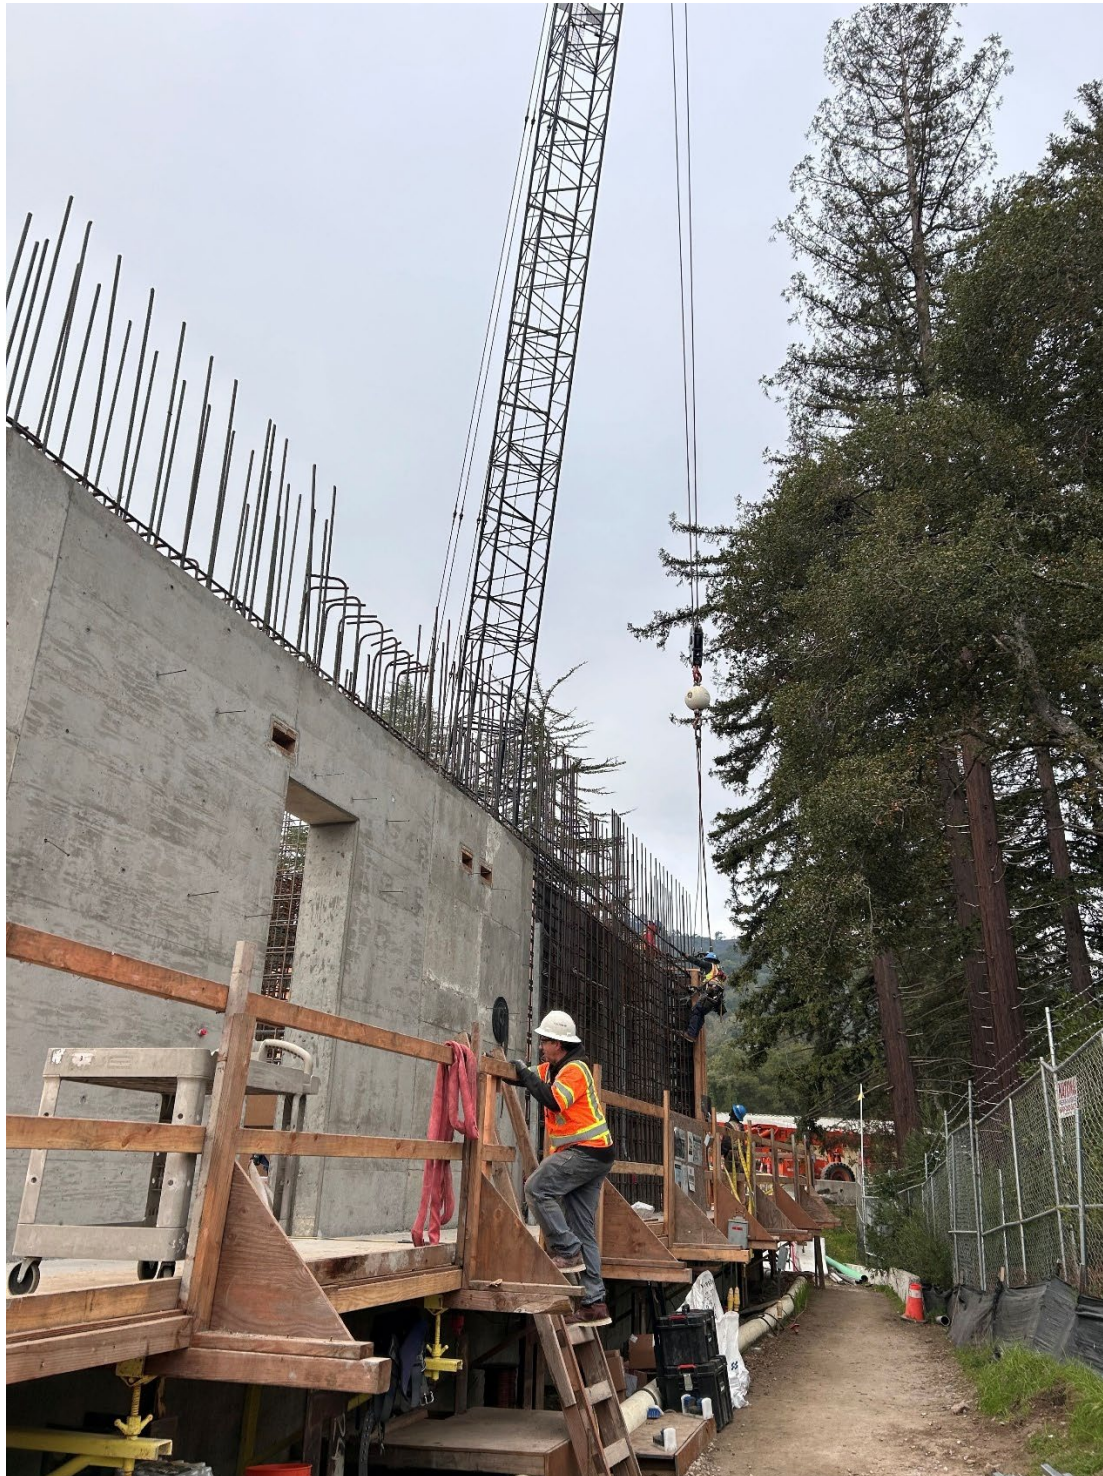
Figure 19 – Worker climbing onto the temporary catwalk which provides access for construction of the first level reinforced concrete walls for the future MAUVE Building.

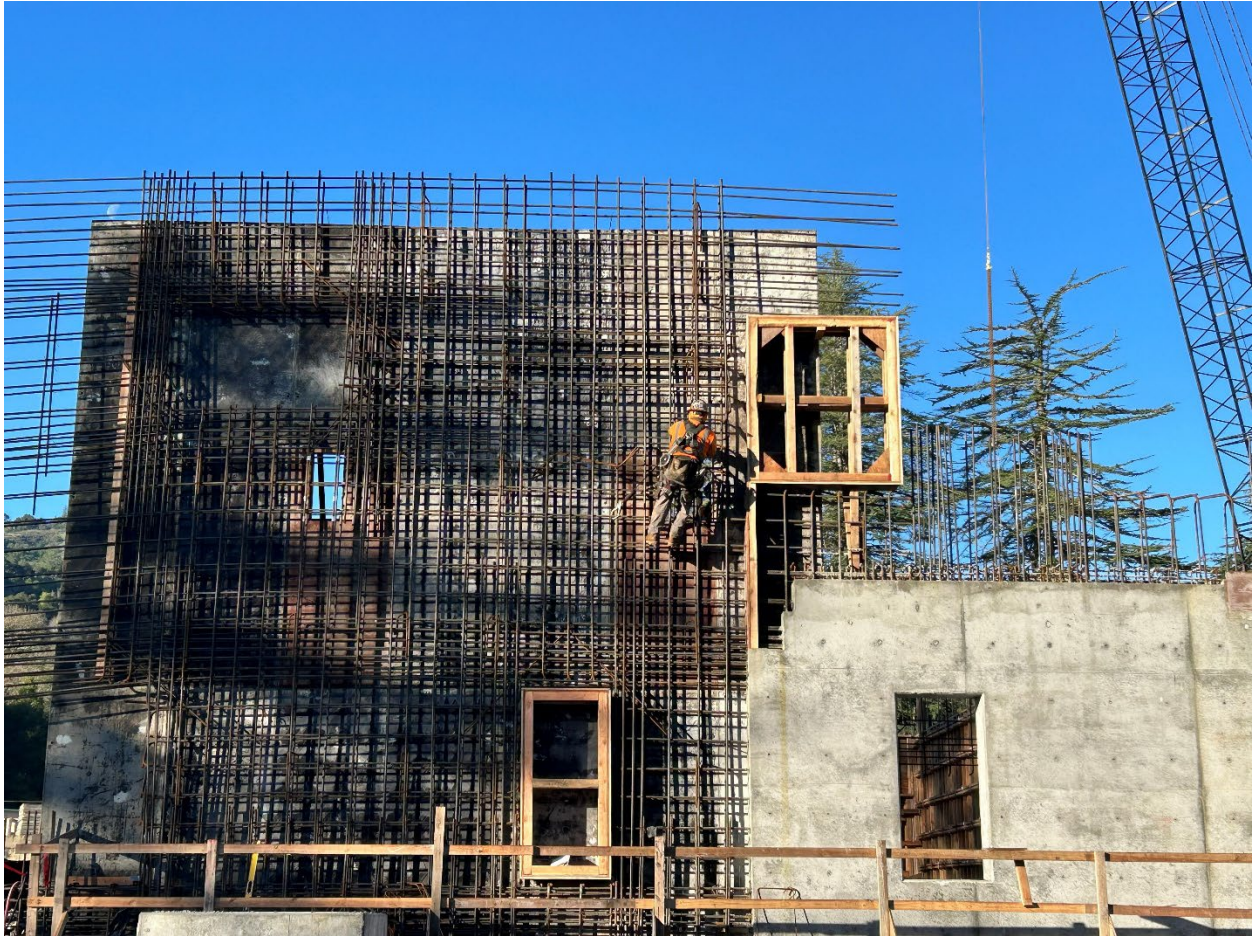
Figure 20 – Worker connecting reinforcing steel for full height concrete wall which will serve as the exterior wall for the first two floors of the future MAUVE Building.

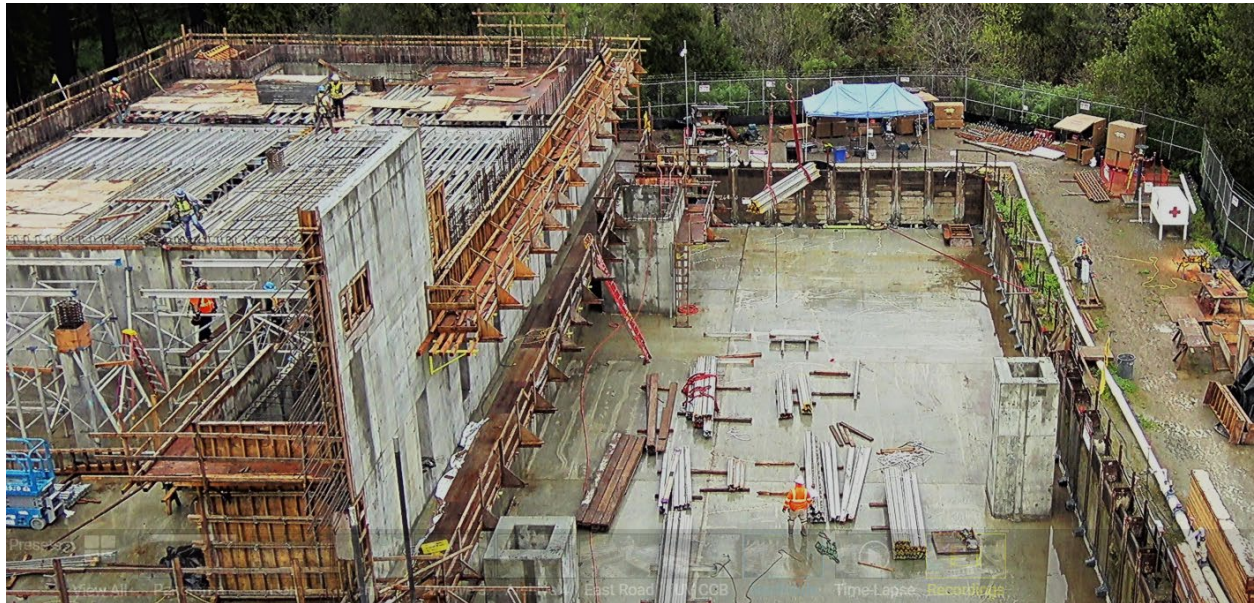
Figure 20 – Aerial view of UV-CCB Facility. On the left, workers are placing temporary scaffolding and decking support for reinforced concrete deck which will serve as the support for the second floor of the future MAUVE Building. On the right, there is a depressed concrete slab which is the roof of the underground CCB. This structure will be buried in soil soon. In the meantime, workers are staging materials for the operation happening on the left side of the photo.

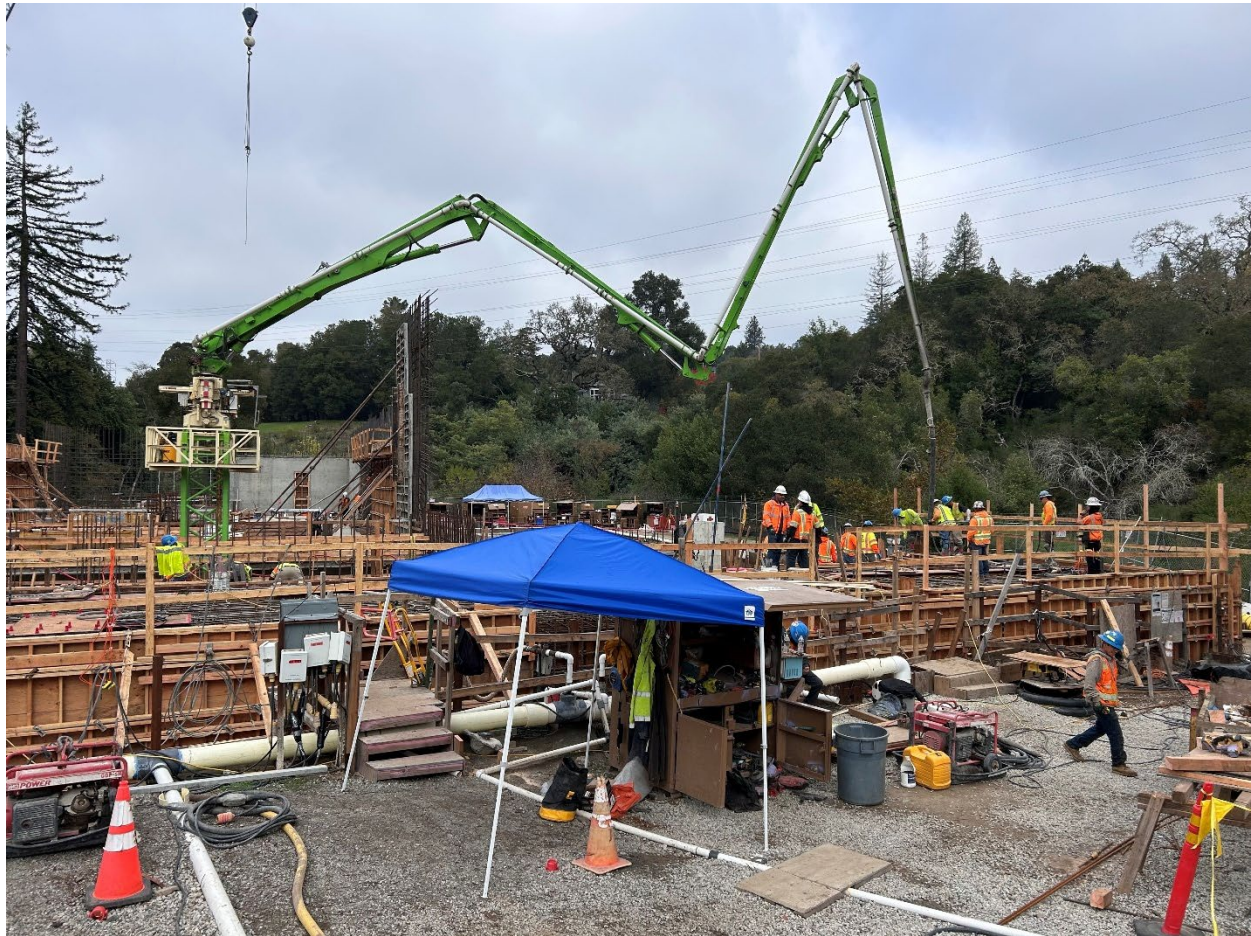
Figure 21 – Workers completing the final concrete pour for the roof of the Effluent Weir Structure with the aid of the green telescoping concrete pump.

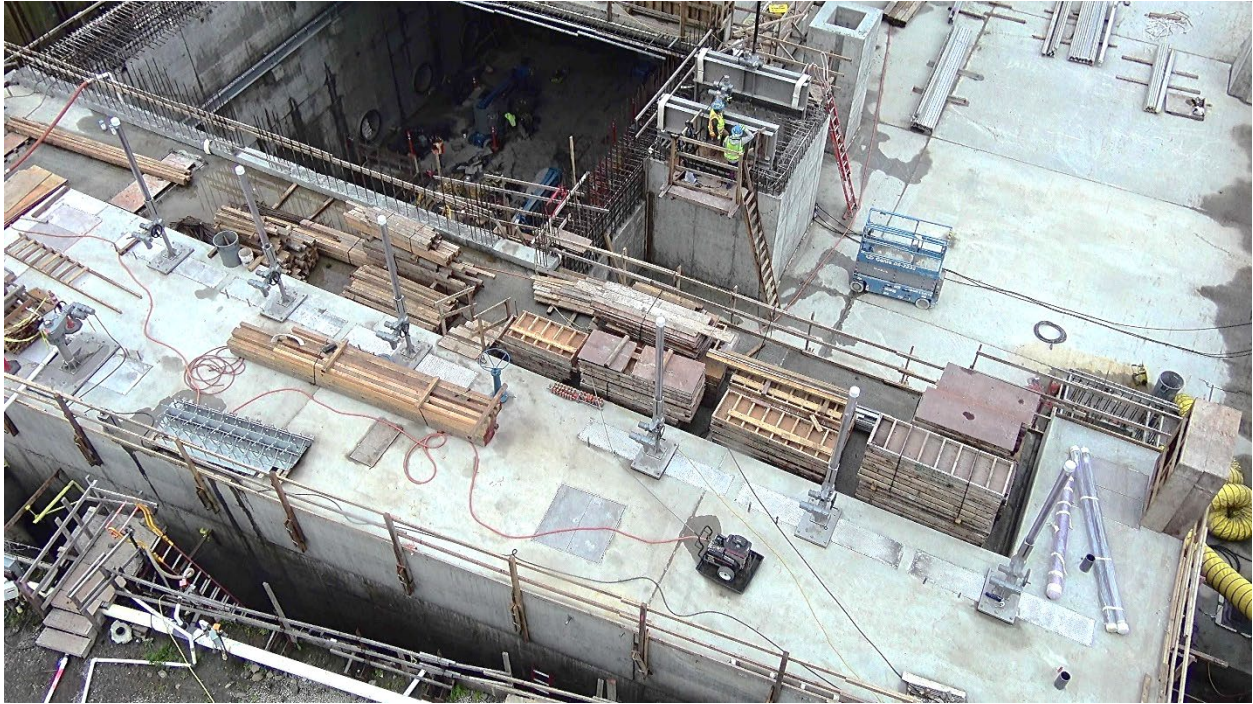
Figure 22 – Aerial view of the completed Effluent Weir Structure with the tall stems of the 6 effluent weir gates extending up out of the roof.

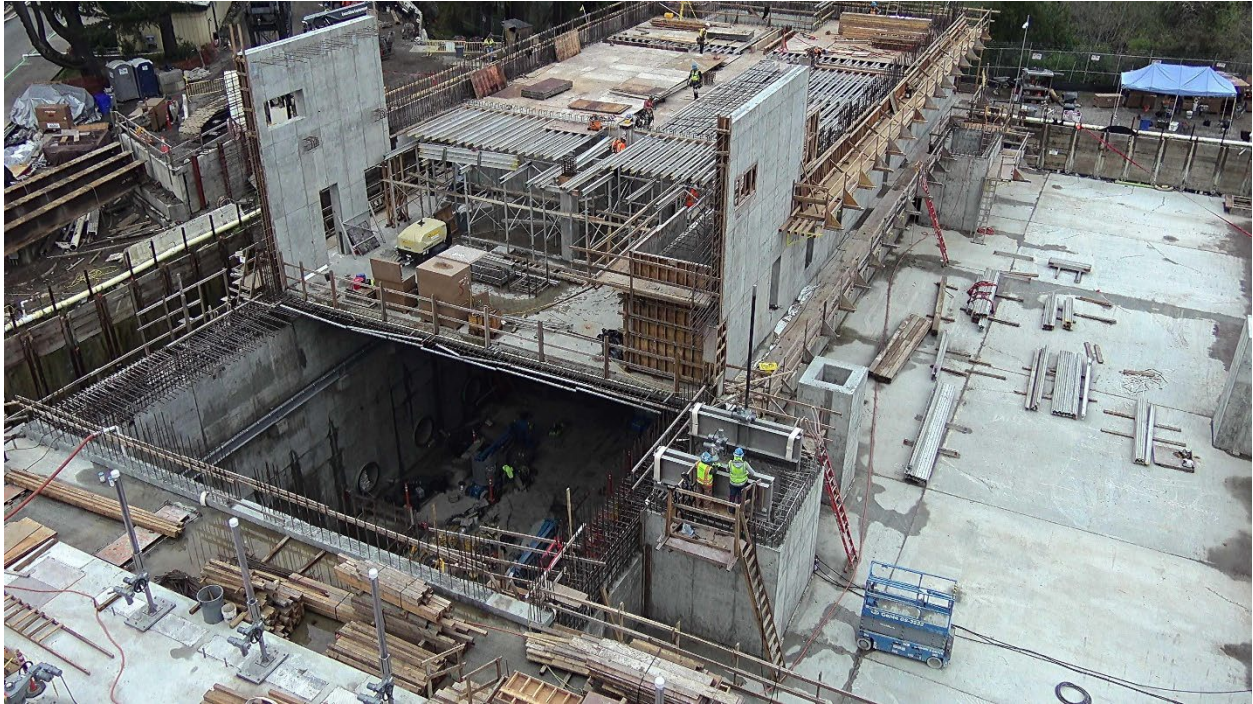
Figure 23 – Aerial view of the UV-CCB Facility. The contractor is only building the north end of the MAUVE Building at this point to maintain clear access for bringing materials into the UV Room below through the large opening shown in the lower left of the photo.

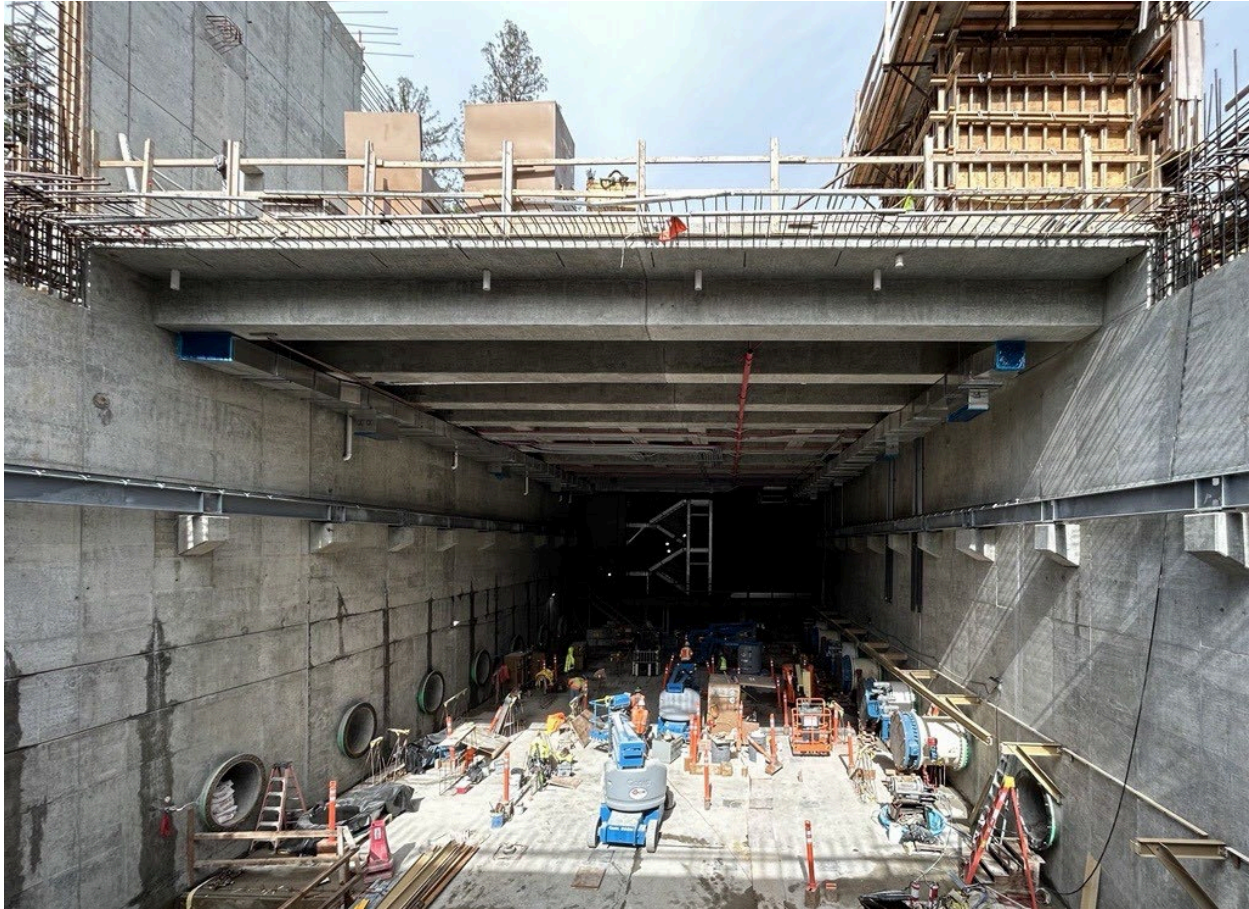
Figure 24 – View looking down the length of the UV Room showing the temporary scaffolding towers removed.

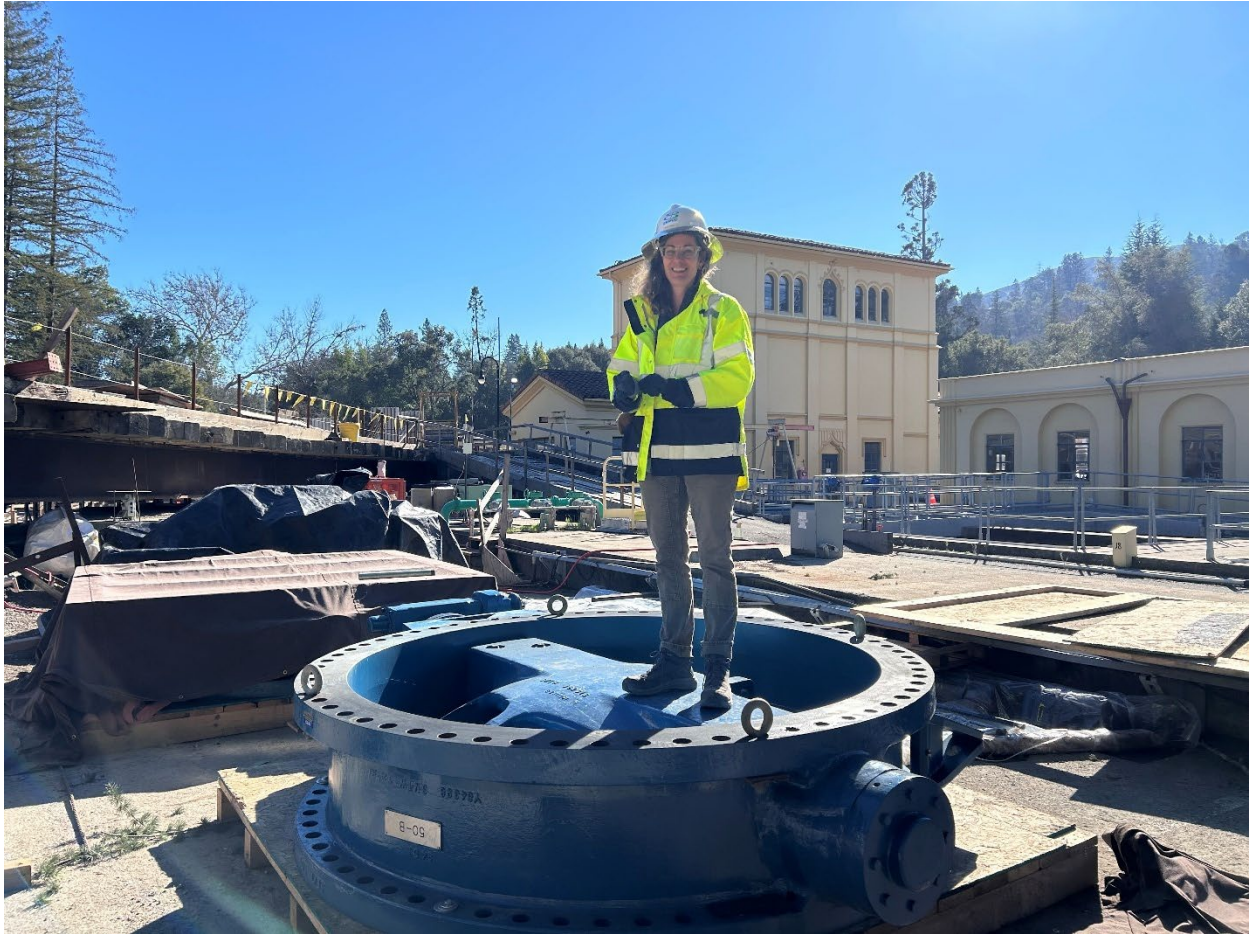
Figure 26 – Engineer standing on top of 84-inch valve to show scale. The valve will be placed in the UV Room for hydraulic isolation of the bypass piping.

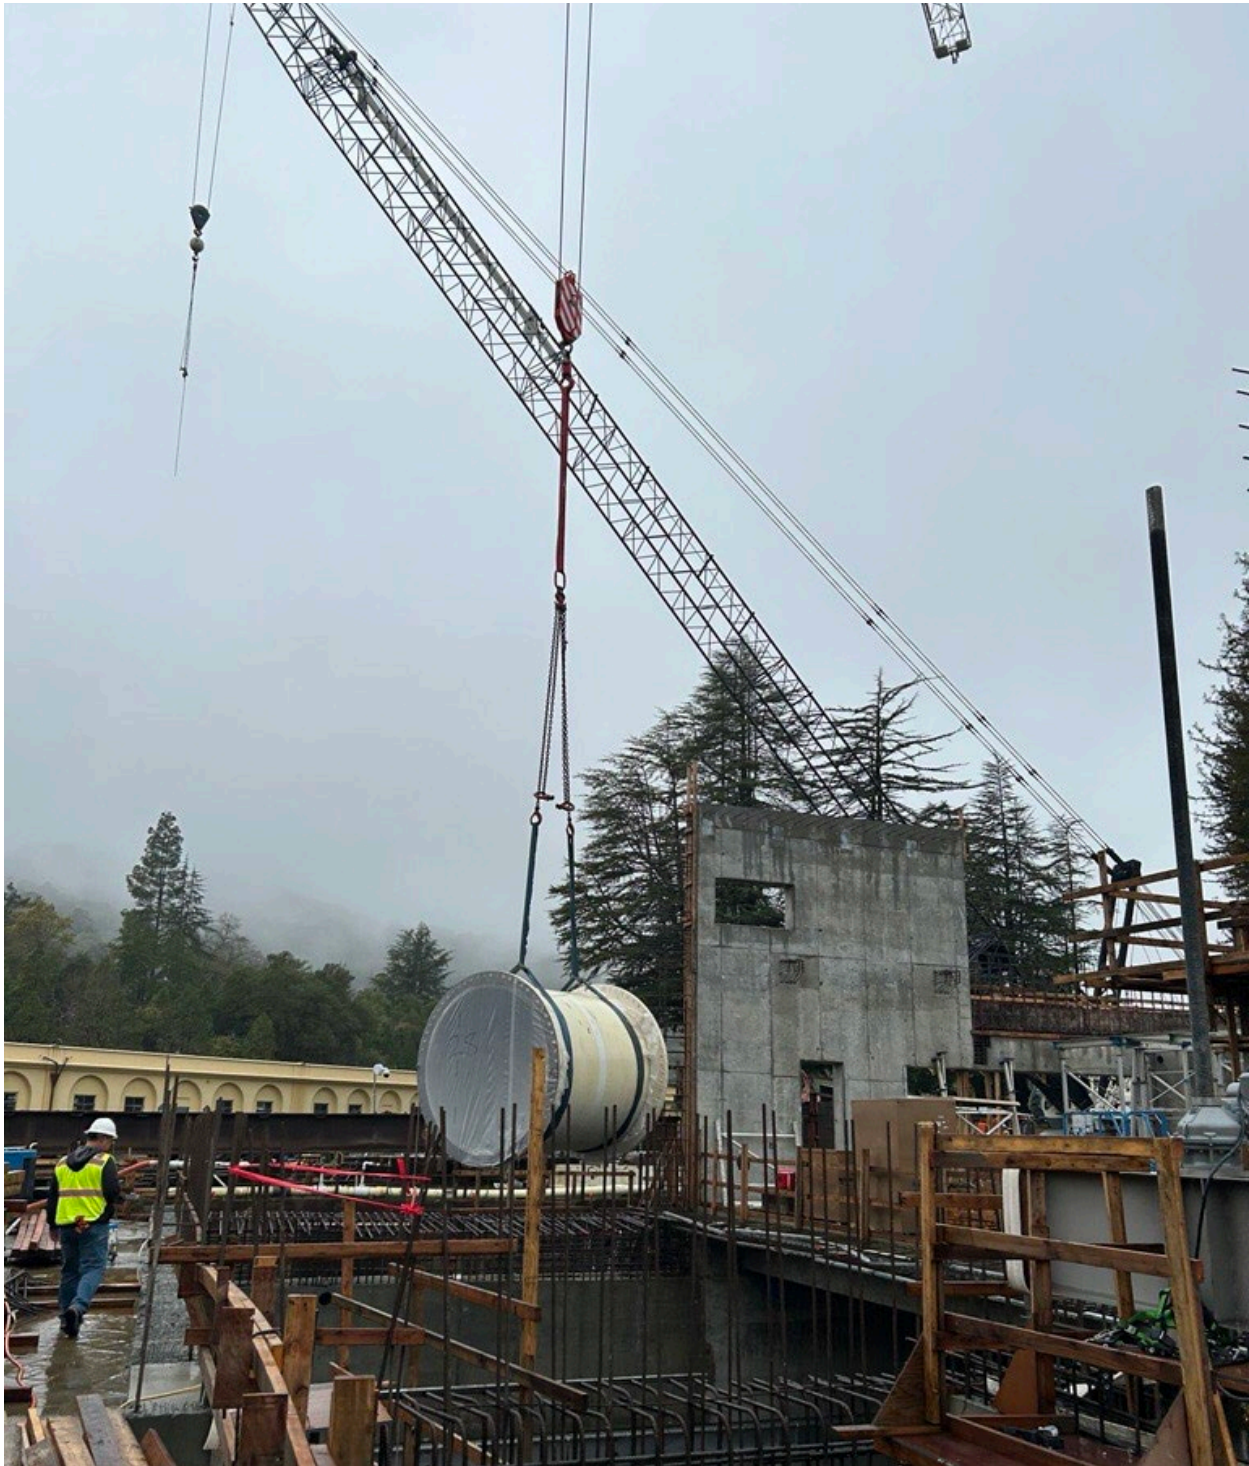
Figure 27 – Crane lowering 84-inch steel bypass piping into the UV Room below.

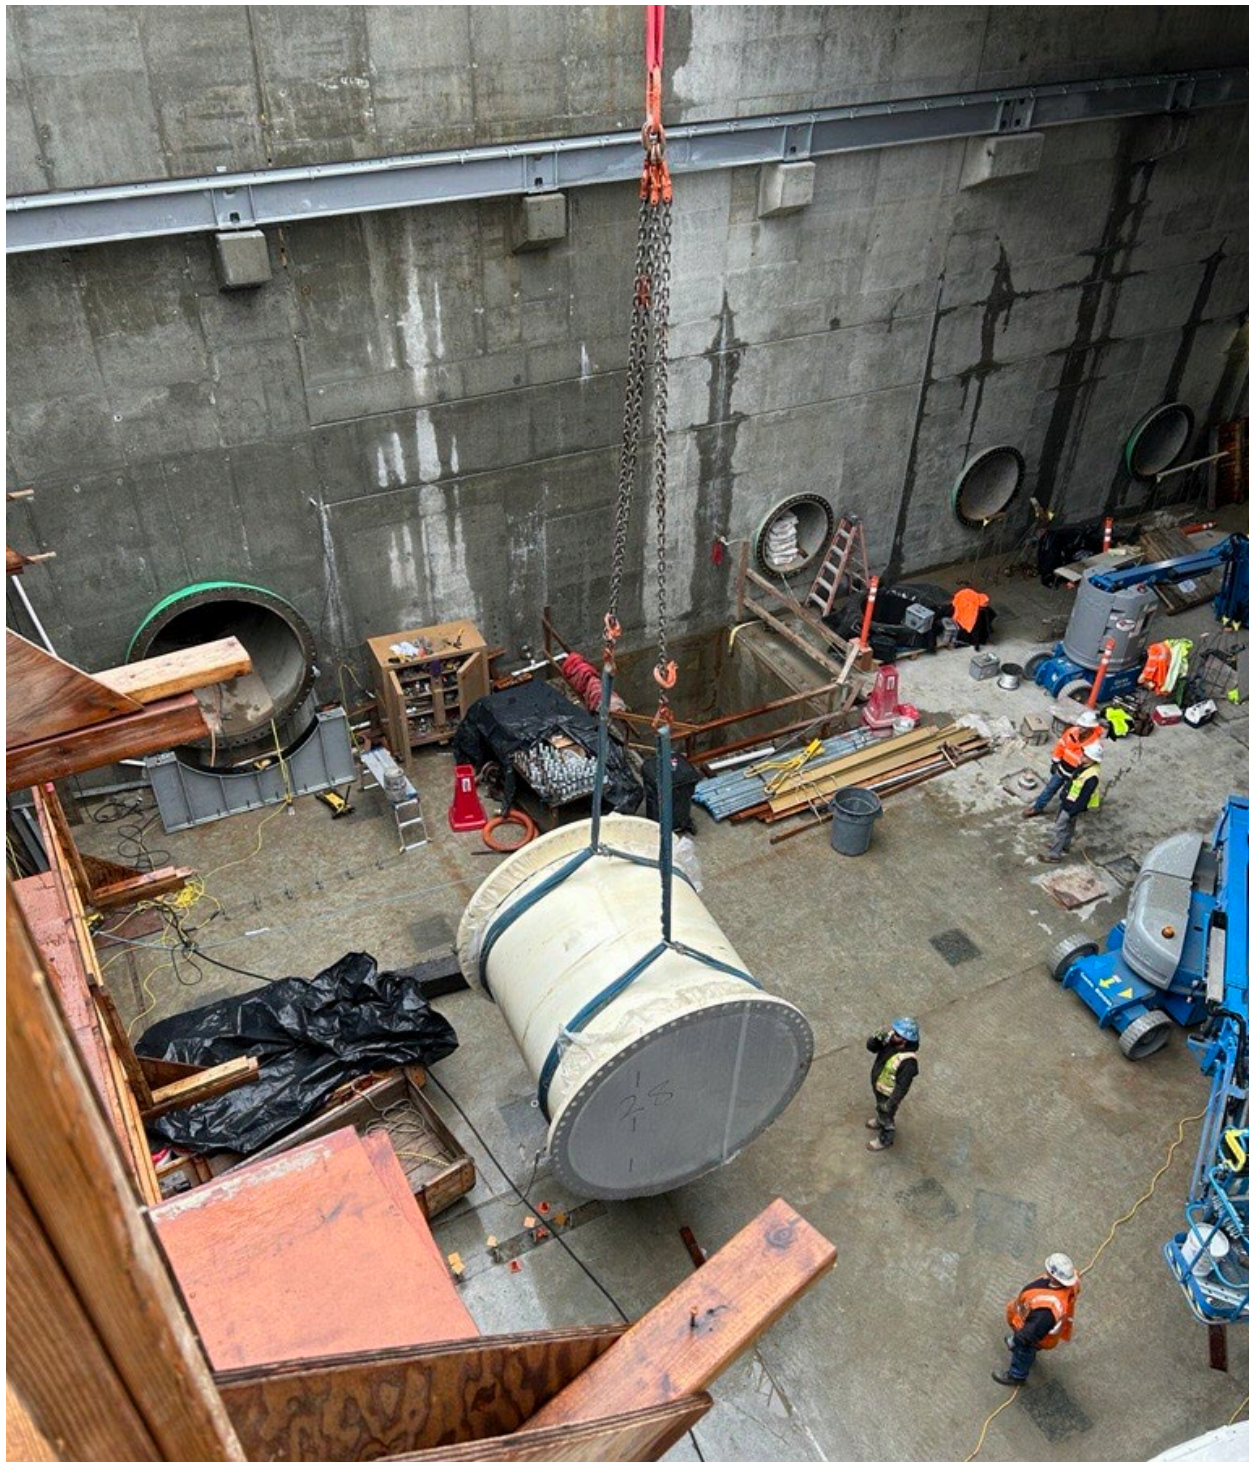
Figure 29 – Crane lowering 84-inch steel bypass piping into the UV Room with the aid of workers serving as spotters.

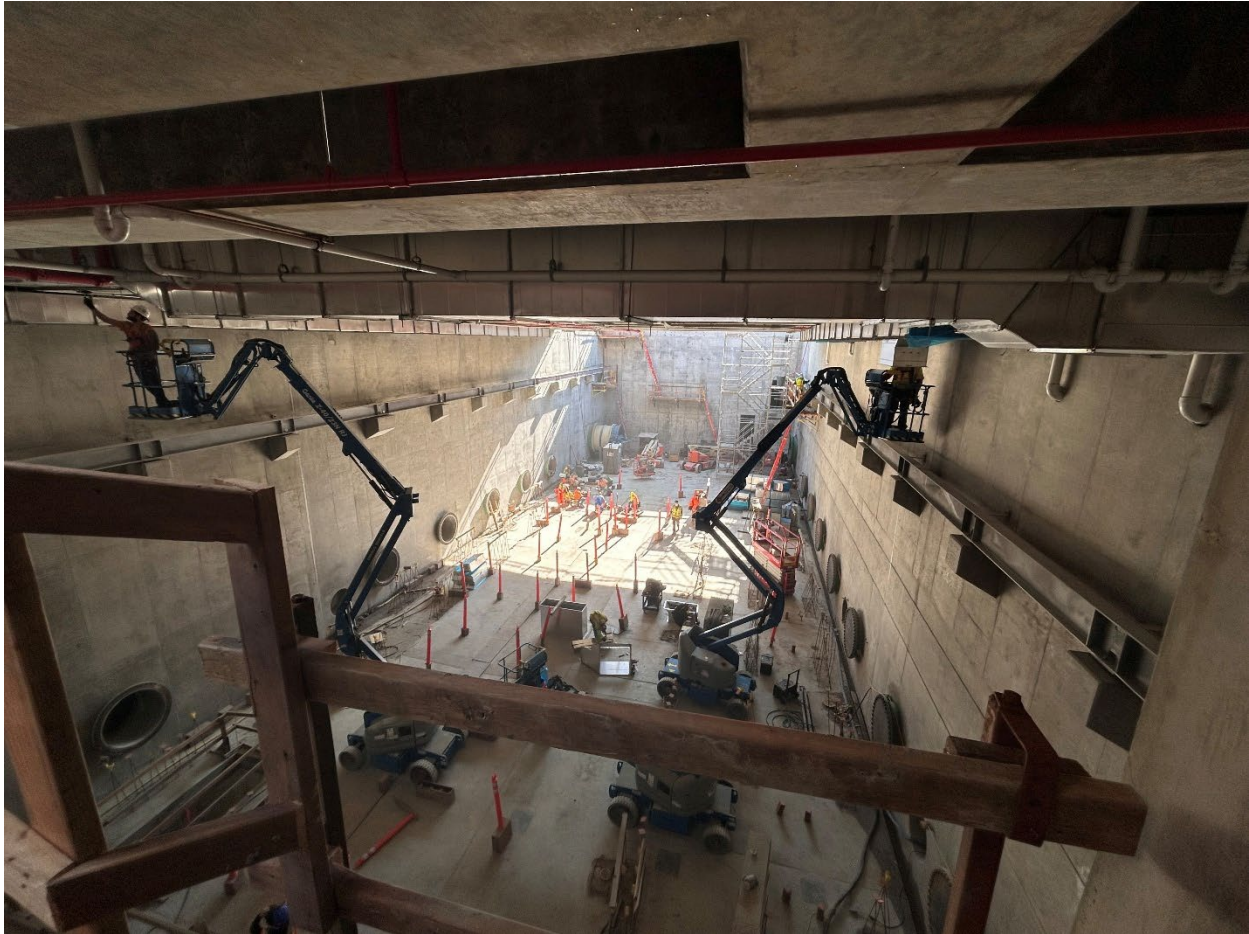
Figure 30 – View looking down the length of the UV Room (opposite direction from Figure 24) showing workers on telescoping lifts installing mechanical, electrical, and plumbing on the ceiling.

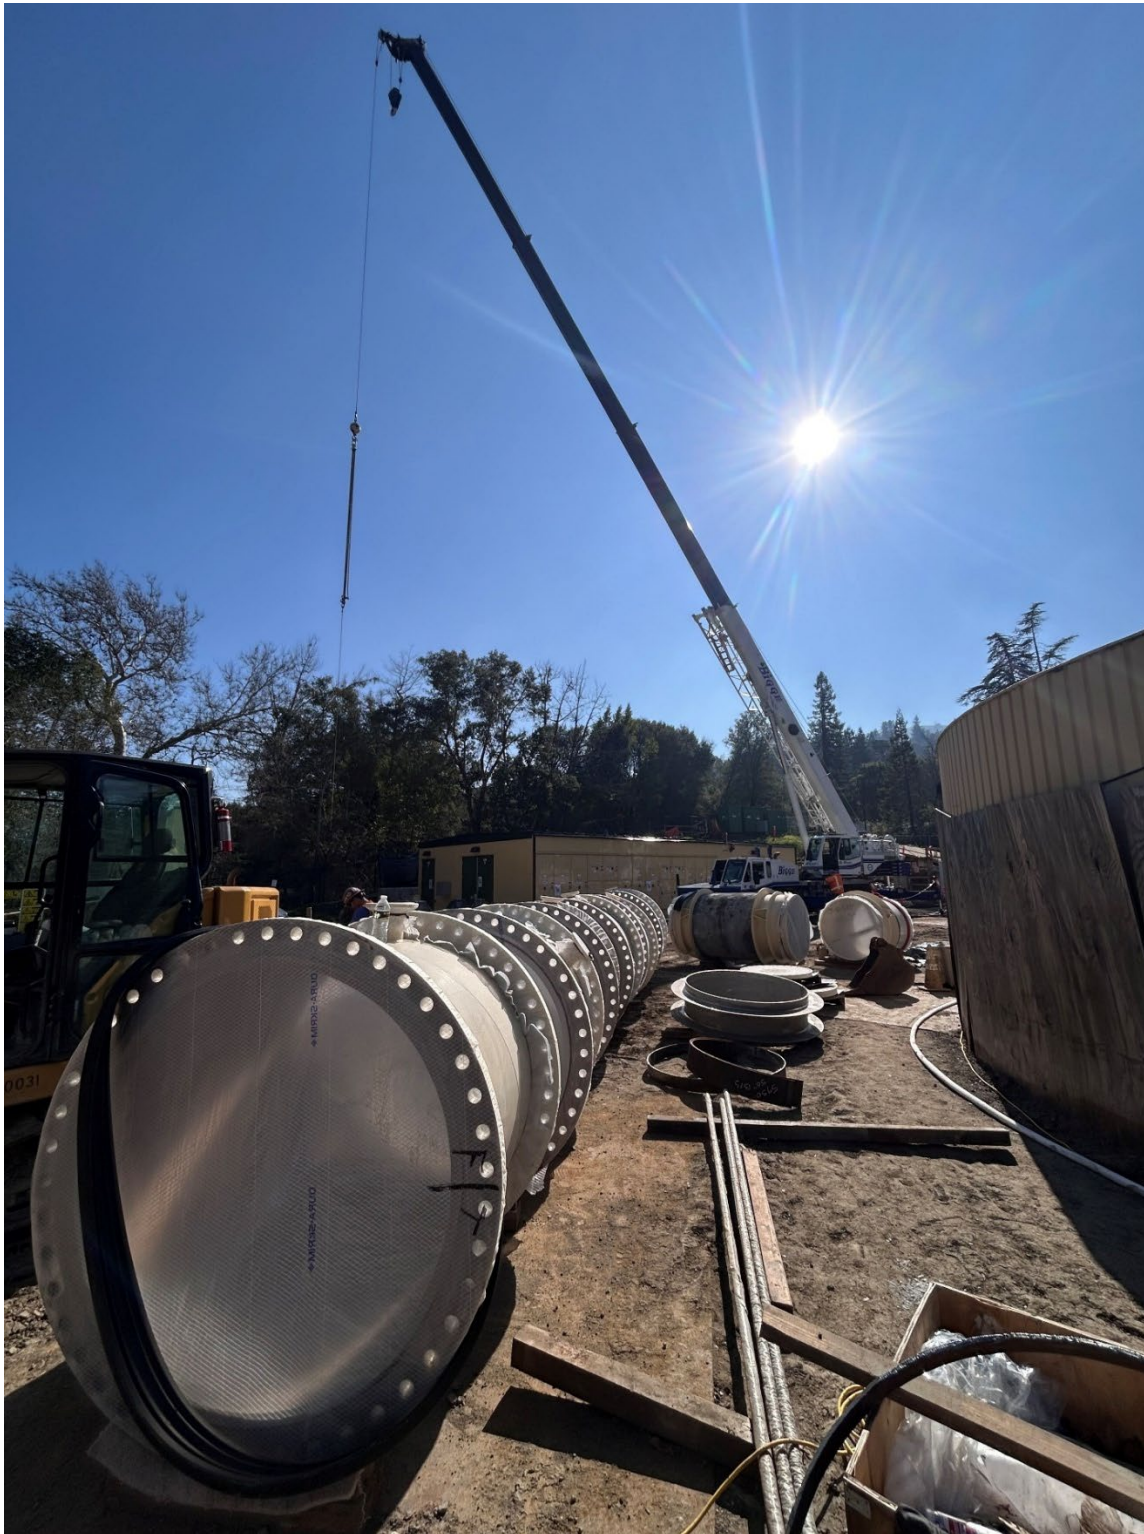
Figure 31 – Crane in the background ready to lift 48-inch fabricated steel piping segments which into the UV Room.

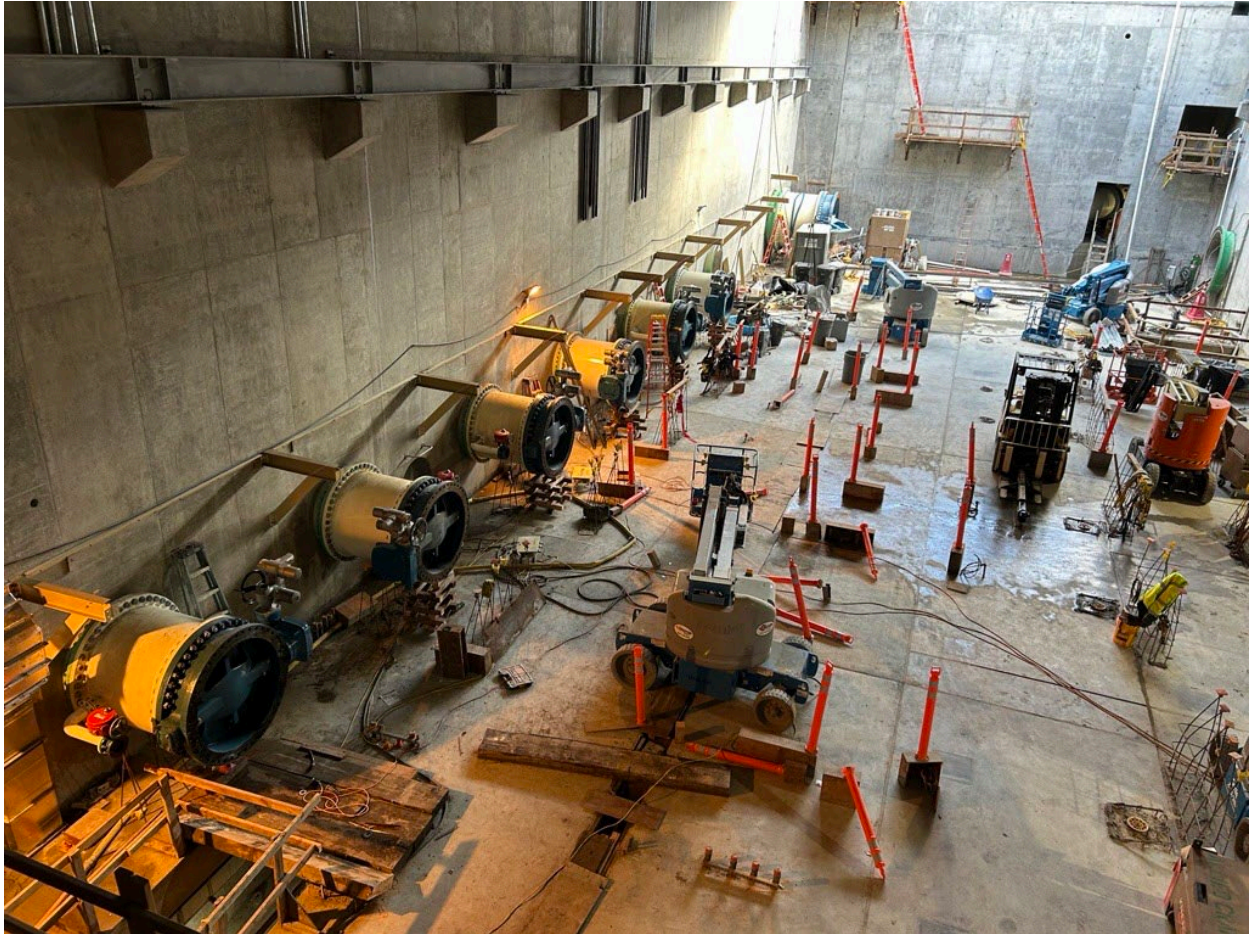
Figure 32 – 48-inch fabricated steel piping segments installed with isolation valves in the UV Room. Each of the six piping segments will be part of the six UV trains which will extend across the UV Room floor in the future.

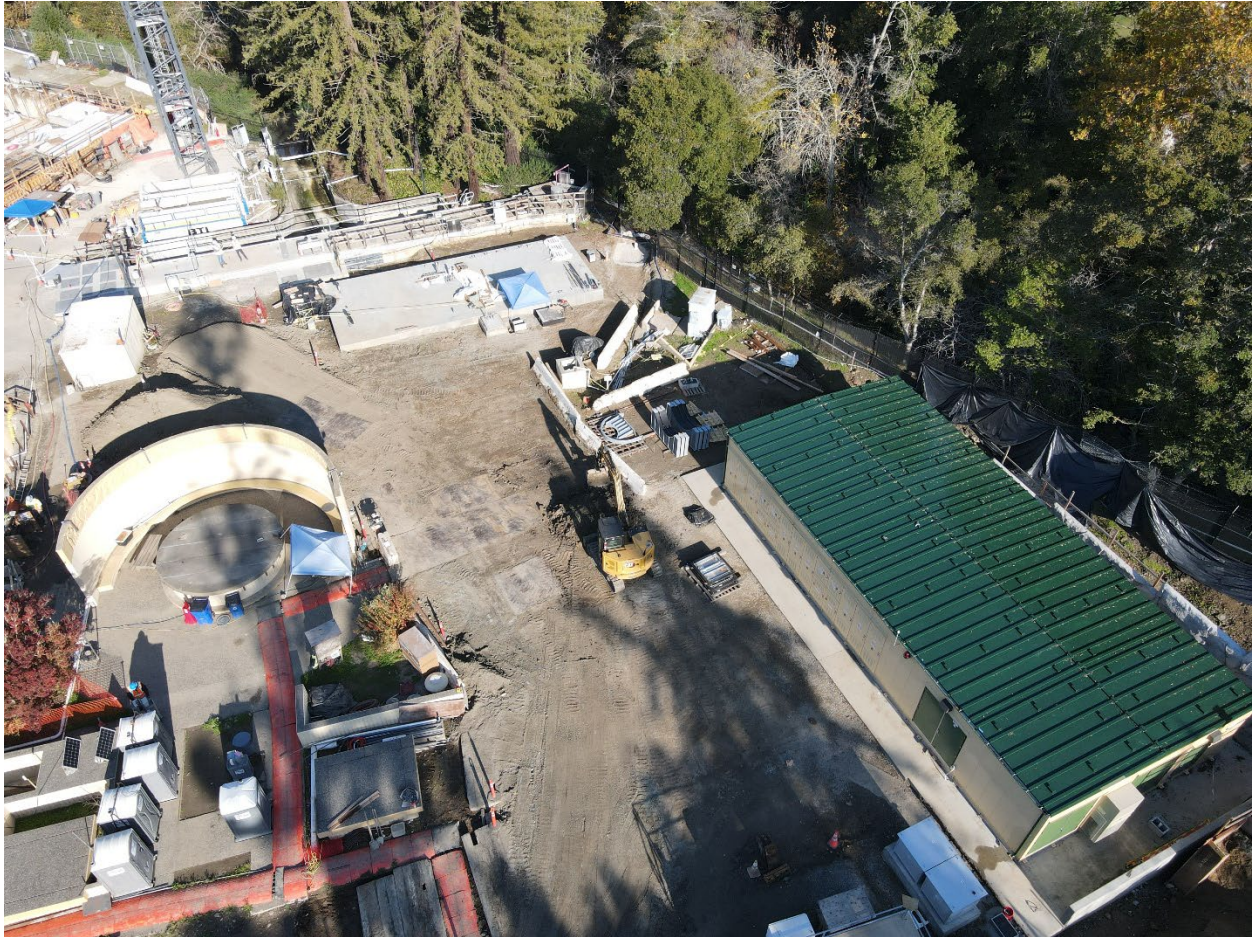
Figure 33 – Aerial view of completed SEB on the right and empty concrete pad, in the background, ready to receive the pre-fabricated LAPB.

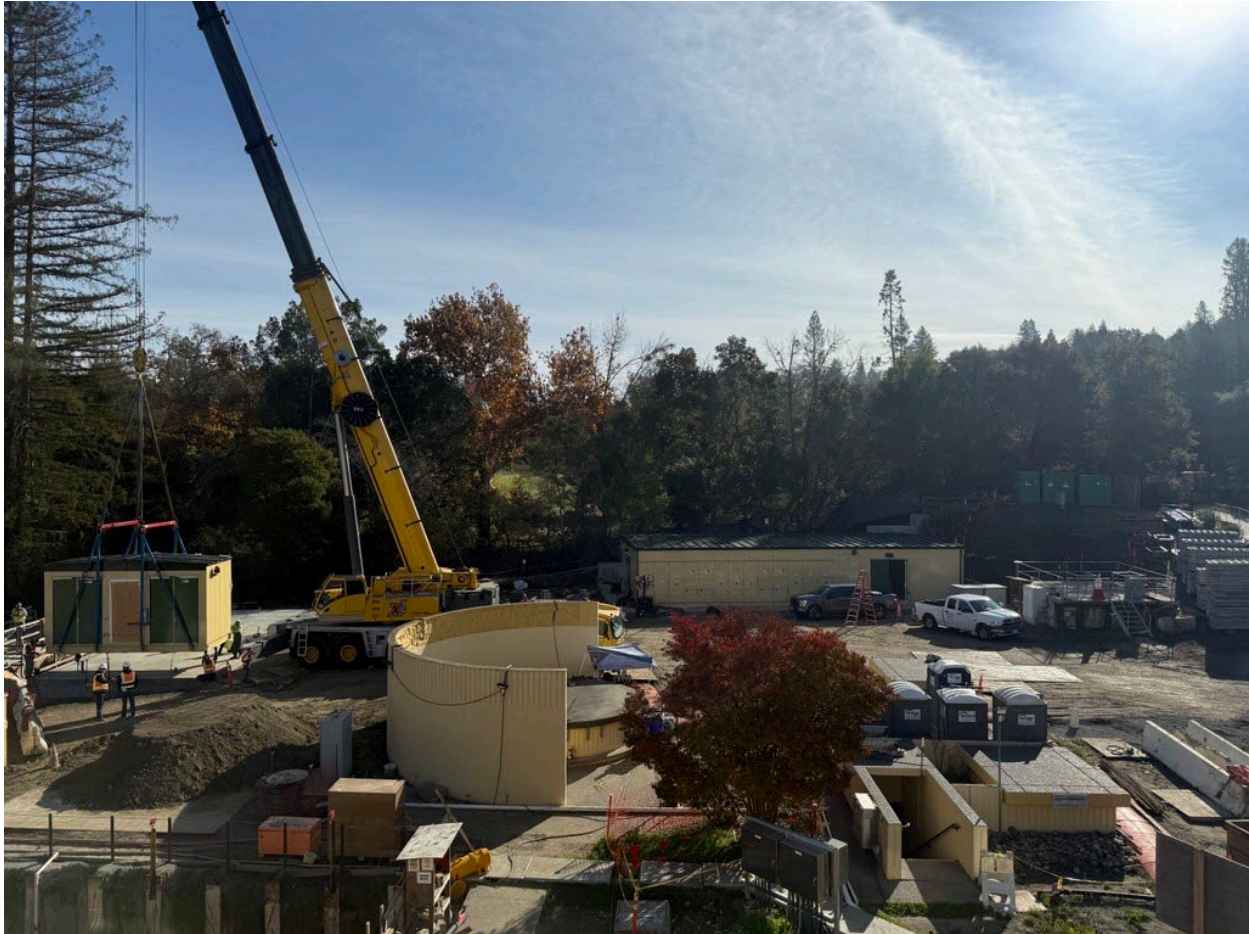
Figure 34 – View of crane lifting first segment of the pre-fabricated LAPB on the left side of the photo.

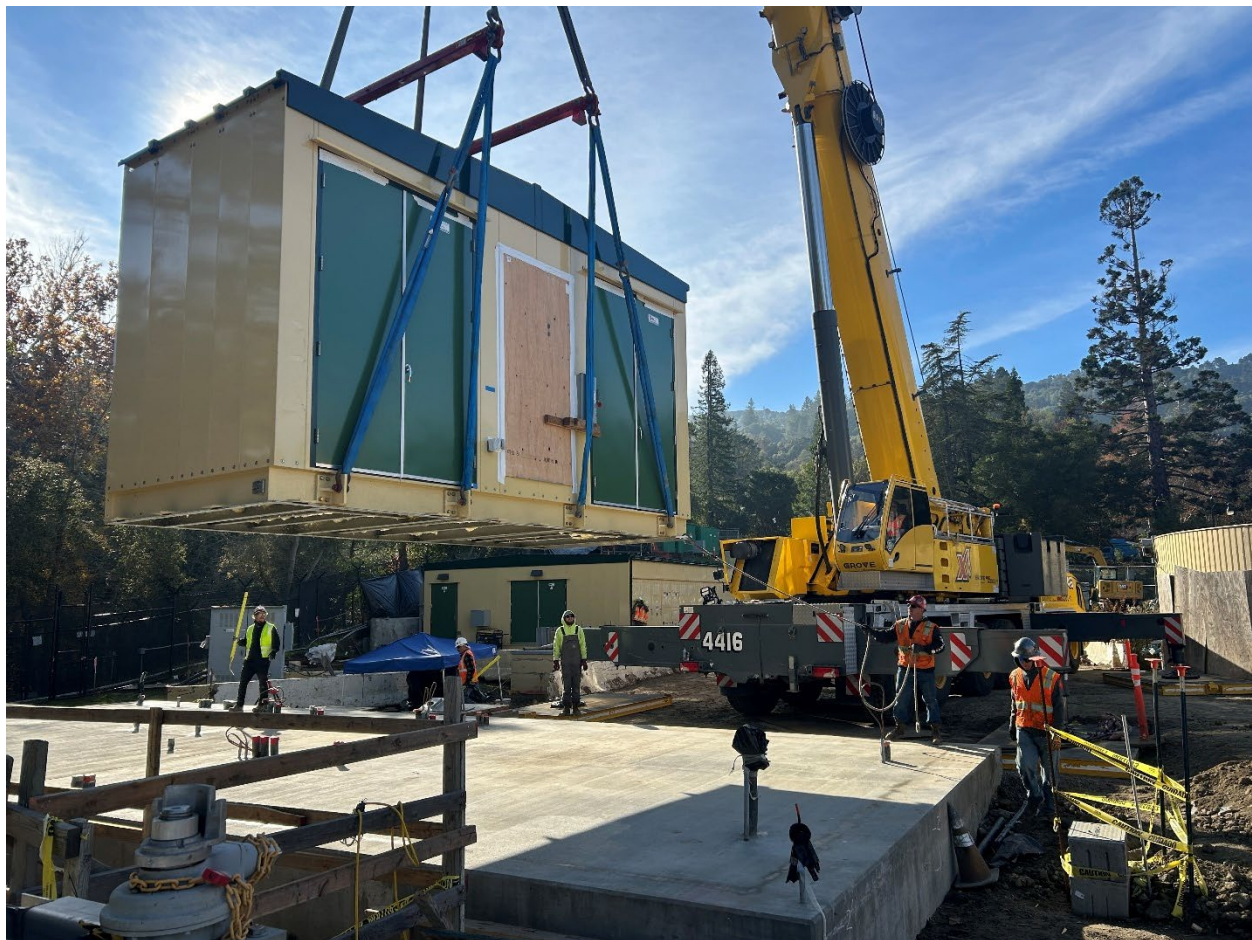
Figure 35 – Closeup view of crane lifting first segment of the pre-fabricated LAPB onto the prepared concrete foundation.
