EAST BAY MUNICIPAL UTILITY DISTRICT

SUBJECT: Orinda Water Treatment Plant Disinfection and Chemical Systems Safety Improvements Project Update

2026 Triannual Progress Report No. 1

Specification 2139: Orinda Water Treatment Plant (WTP) Disinfection and Chemical Safety Systems Improvement Project

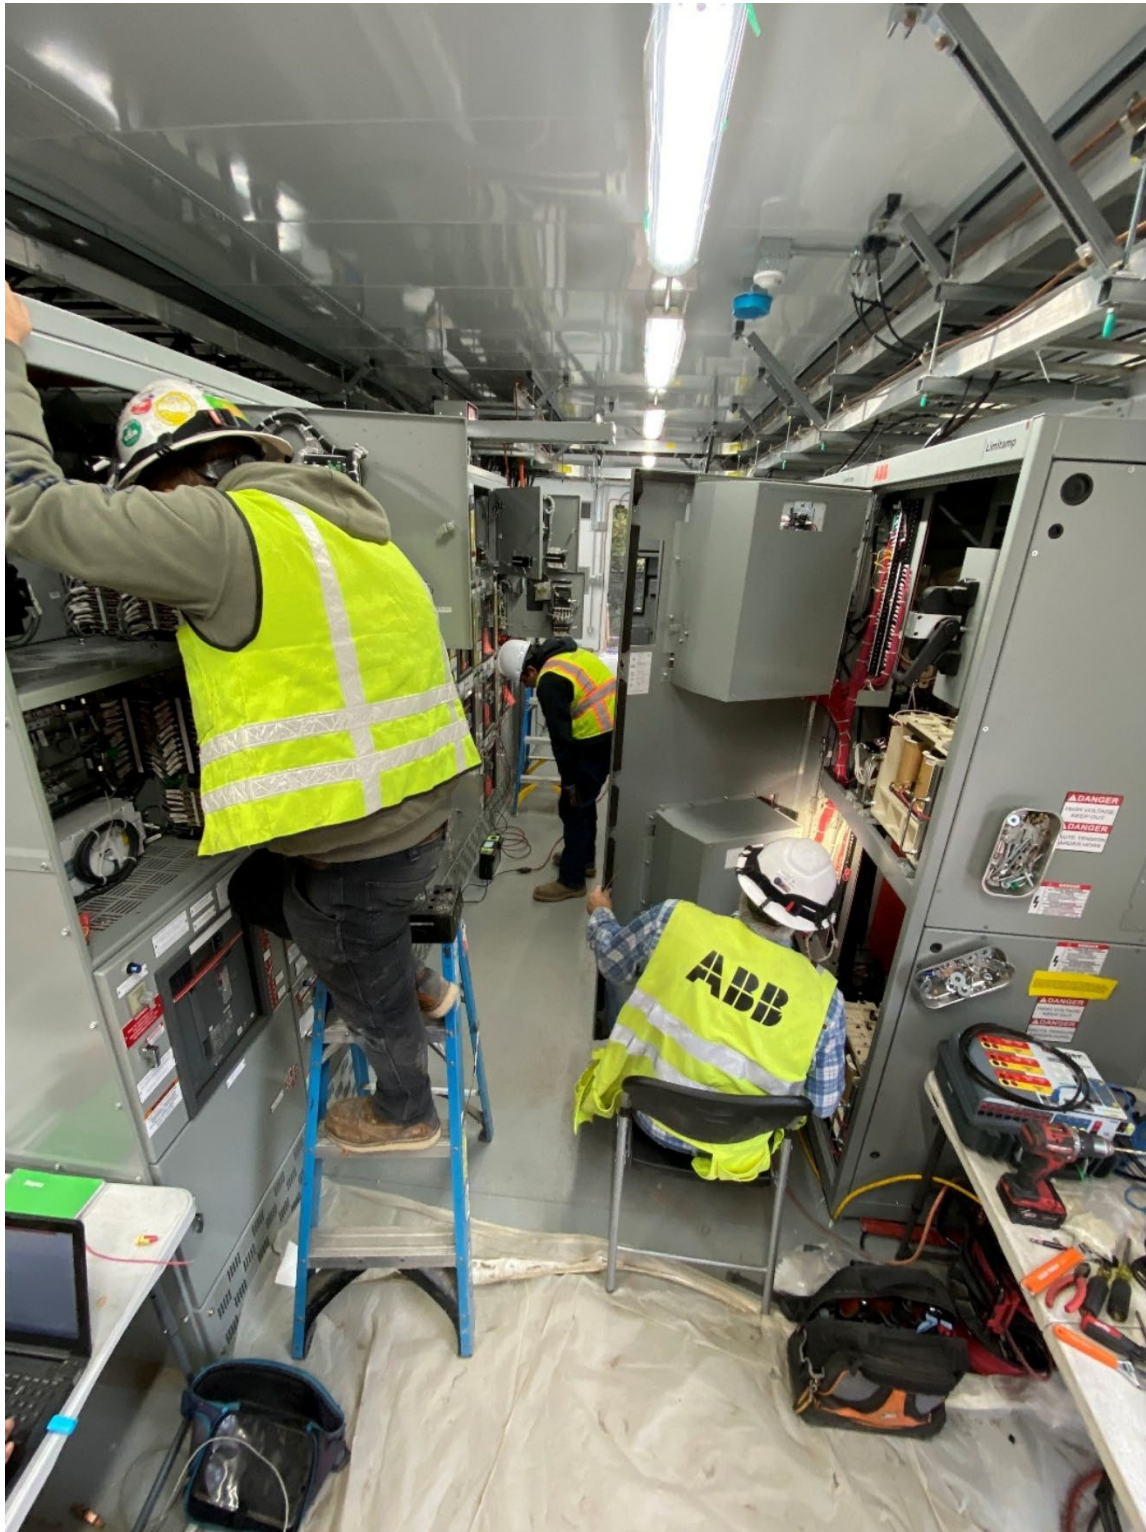
Figure 36 – Electricians completing reconnection and wiring of electrical gear inside the pre-fabricated LAPB.

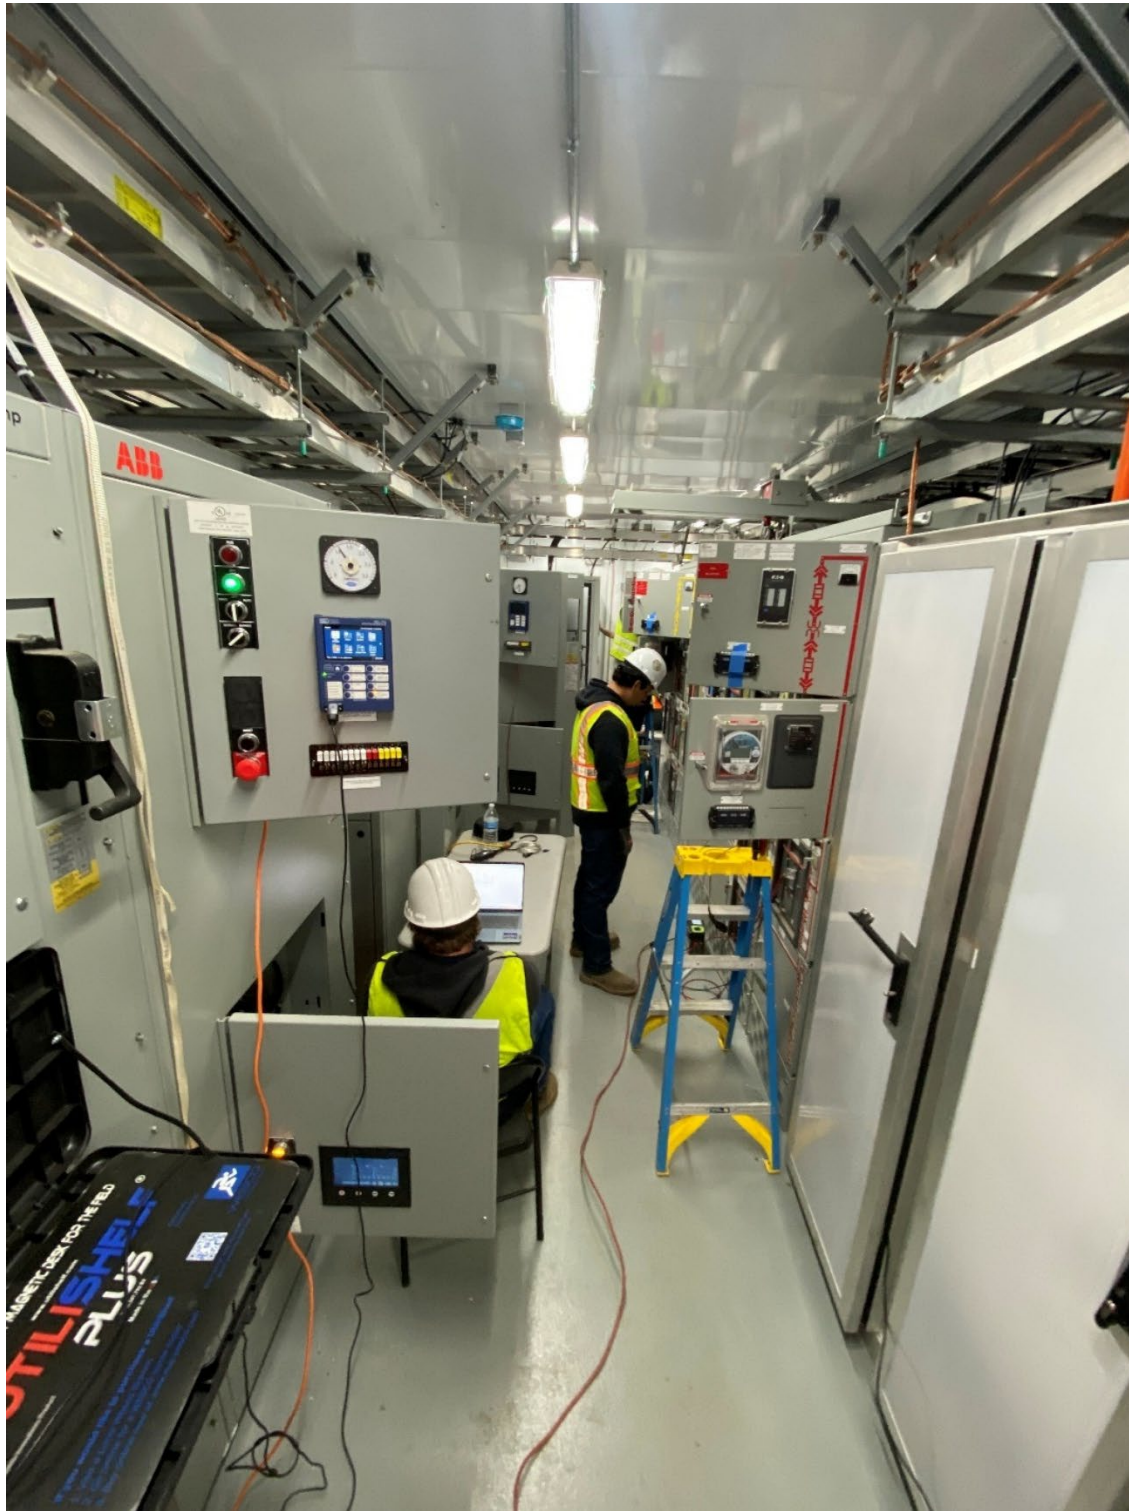
Figure 37 – Engineers performing testing of electrical gear inside the pre-fabricated LAPB.

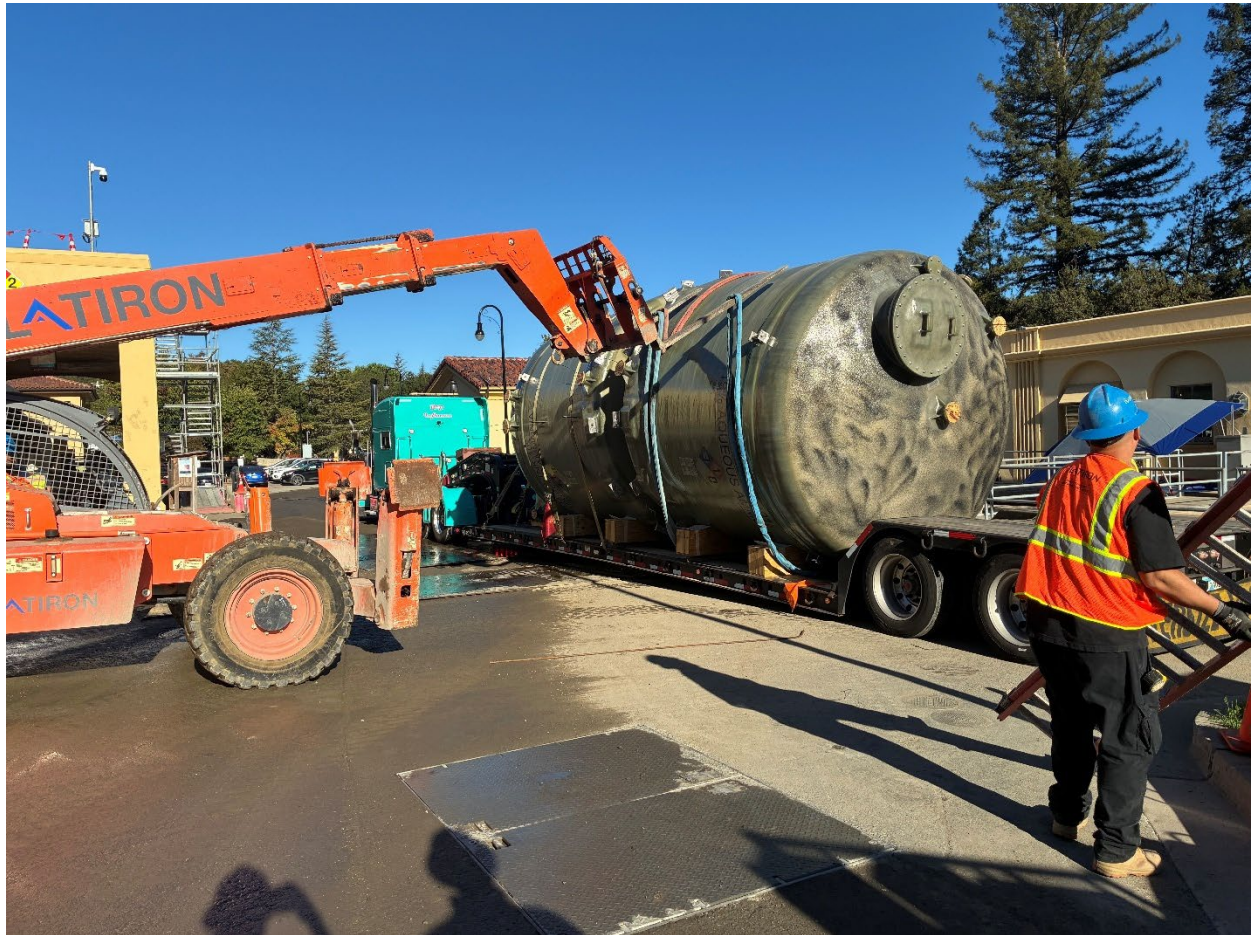
Figure 38 – Workers unloading fiberglass reinforced plastic chemical tanks from a delivery truck.

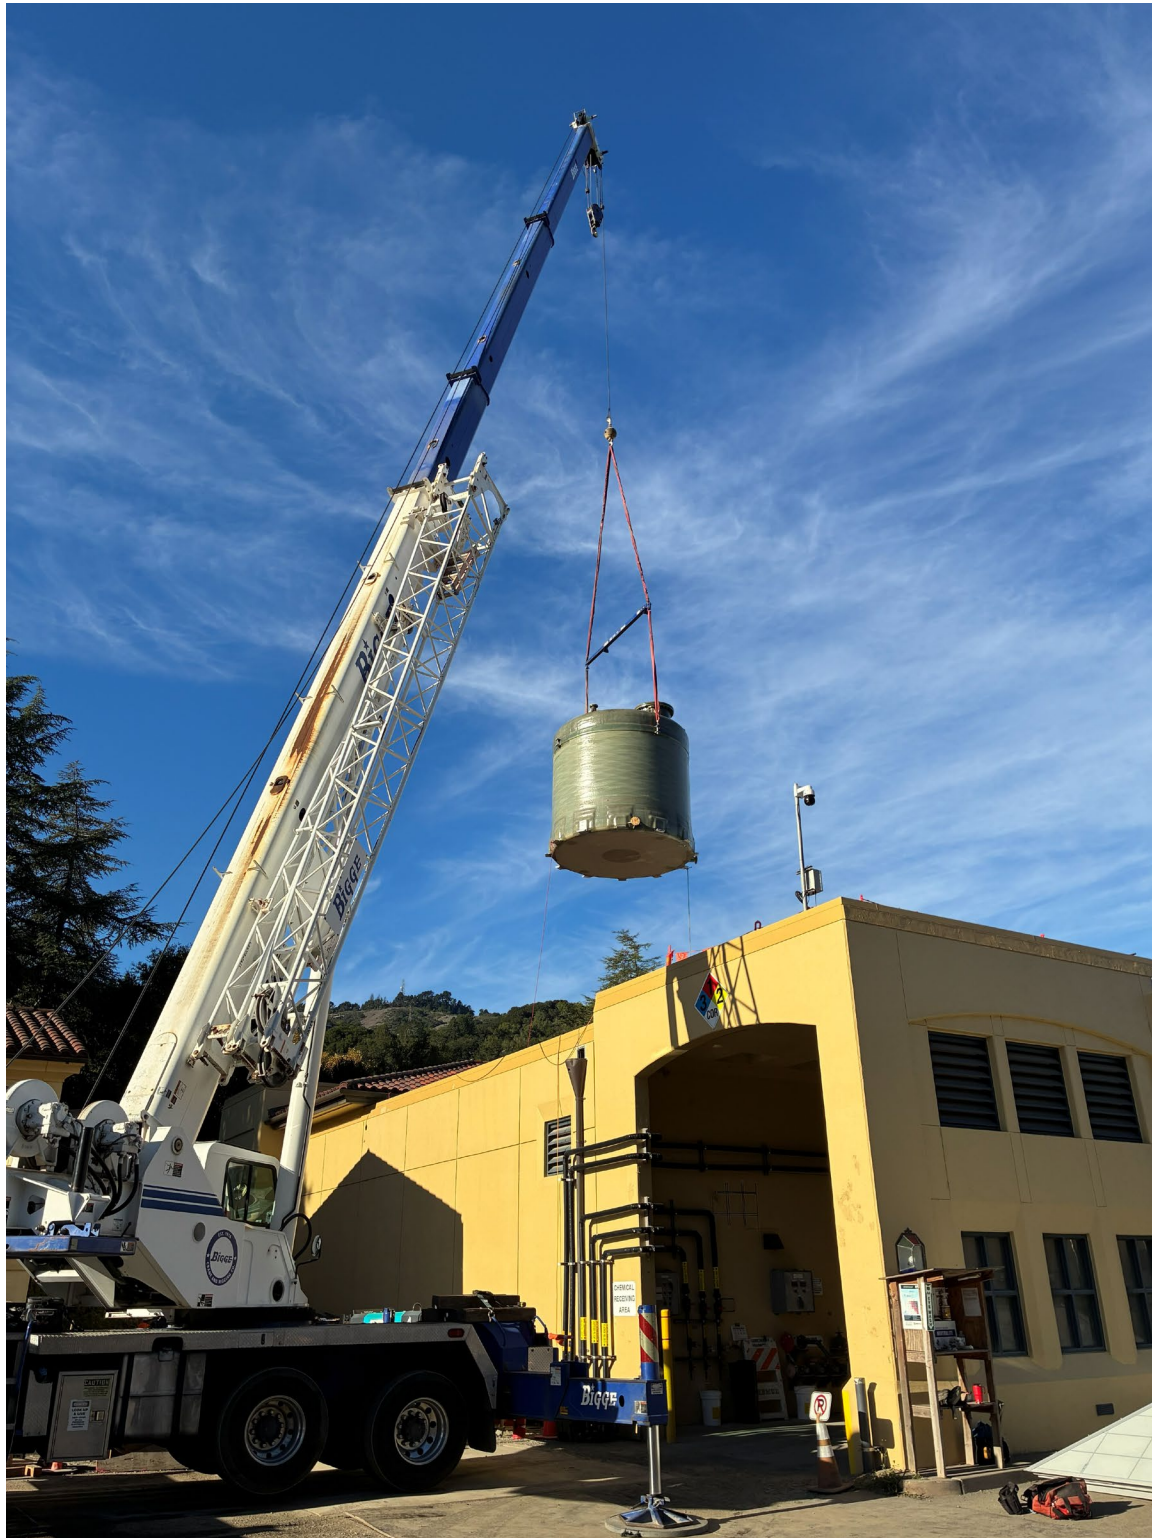
Figure 39 – Crane lowering fiberglass reinforced plastic chemical tank into Chemical Building through the roof opening.

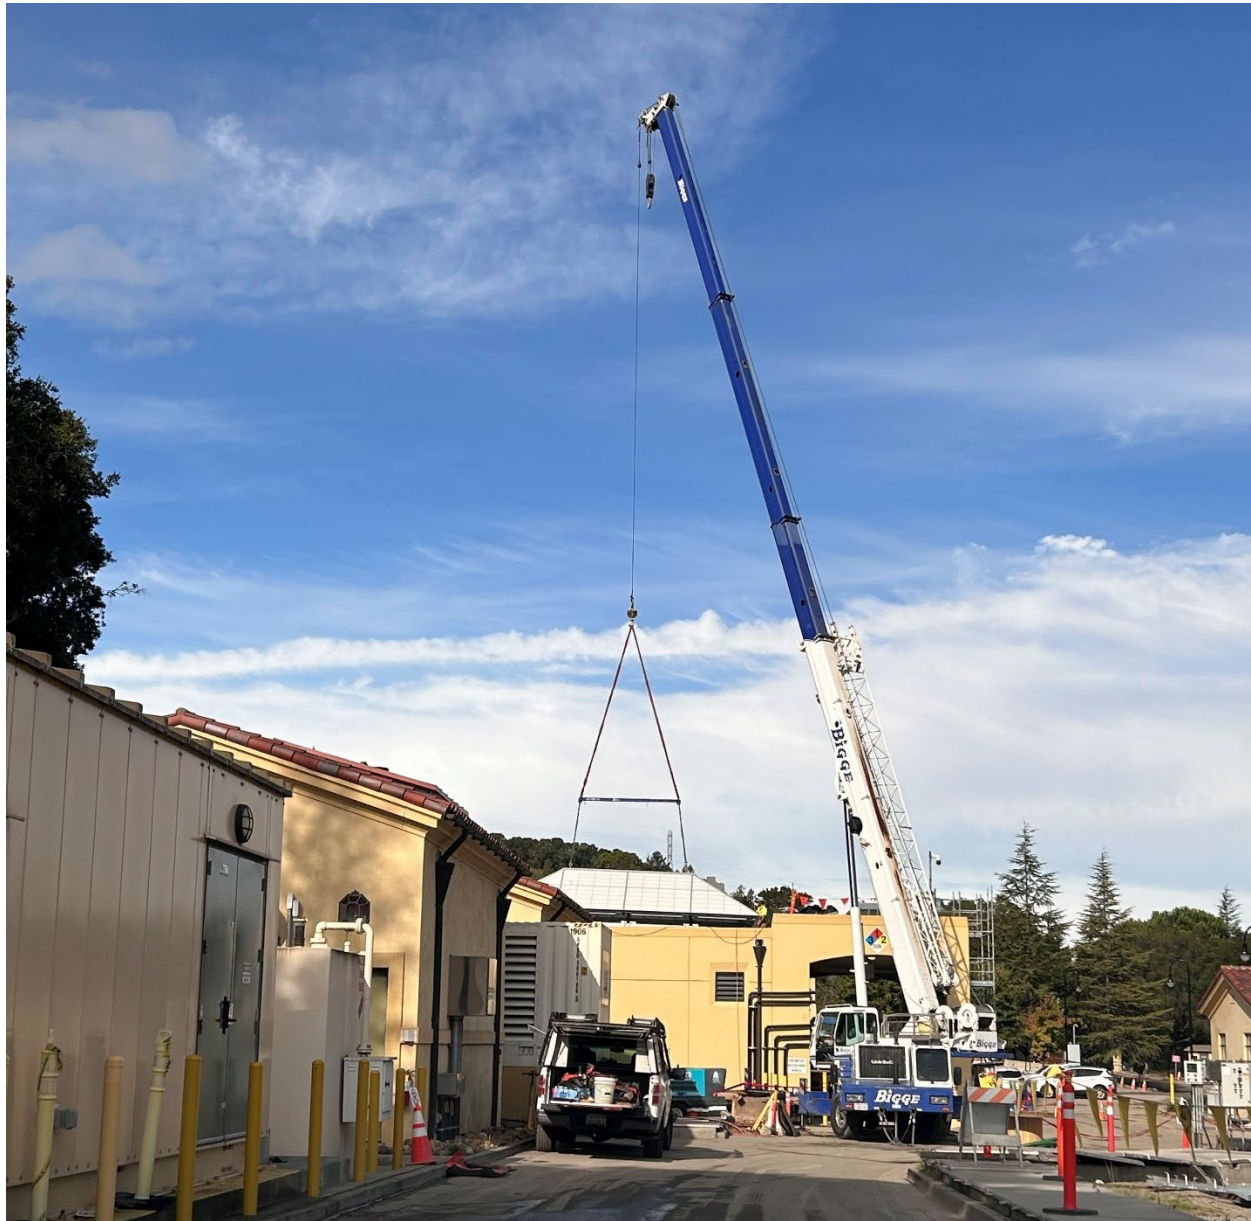
Figure 40 – Crane lowering skylight to close Chemical Building roof opening.

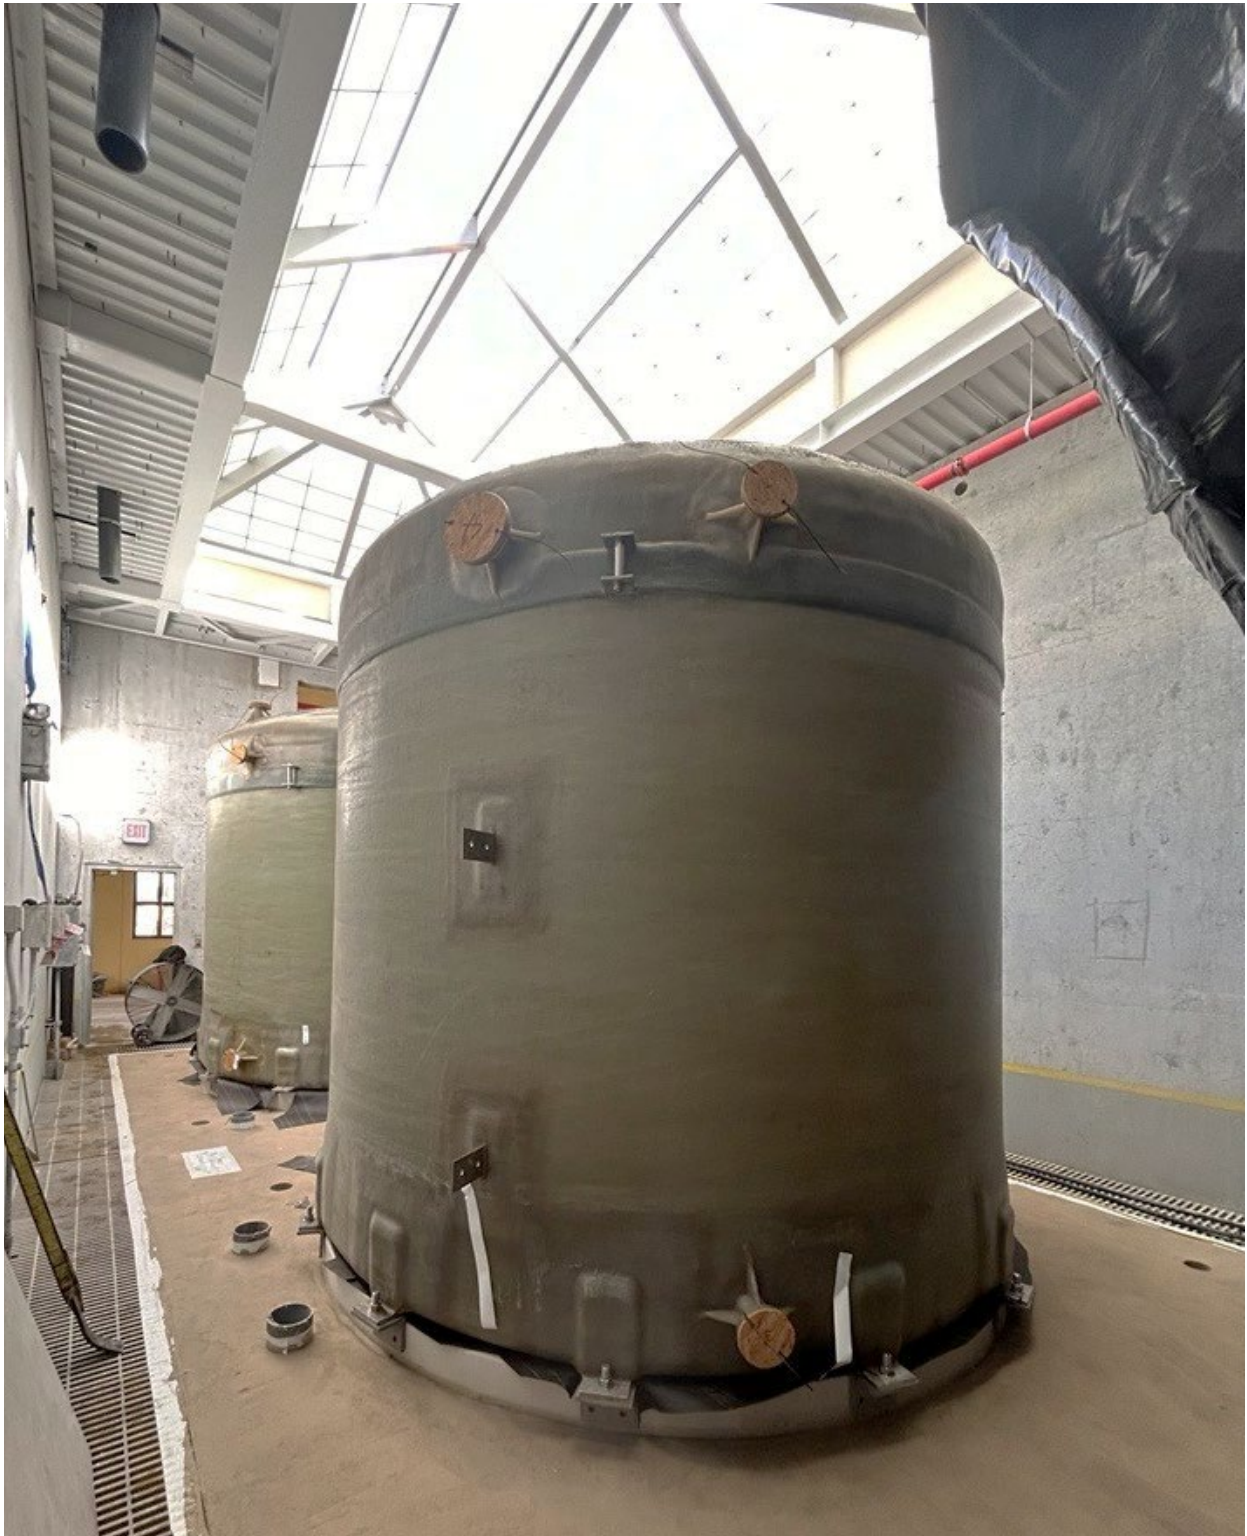
Figure 41 – New fiberglass reinforced plastic chemical tanks and skylights installed in the Chemical Building.

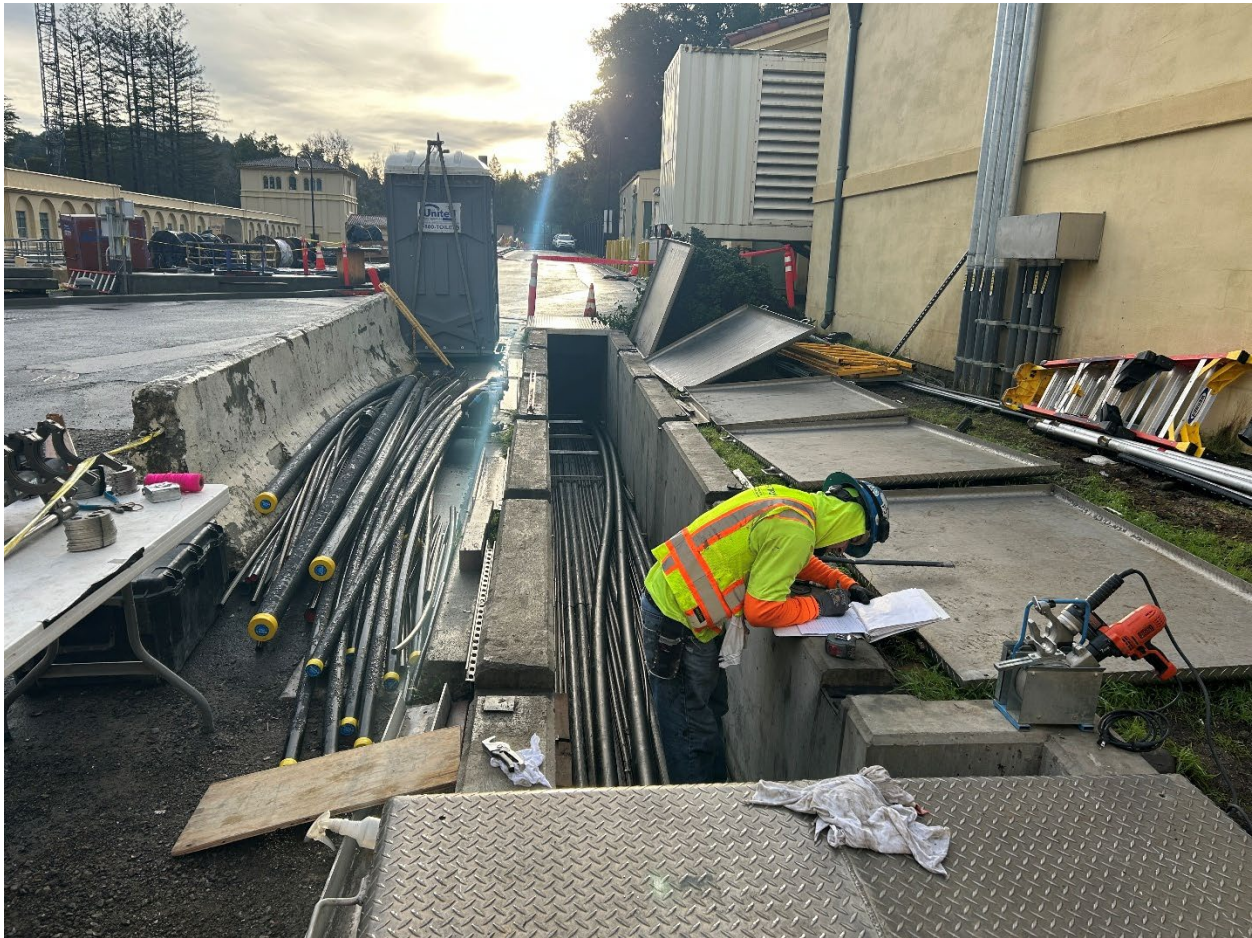
Figure 42 – Worker installing high density polyurethane chemical piping in a pipe trench.

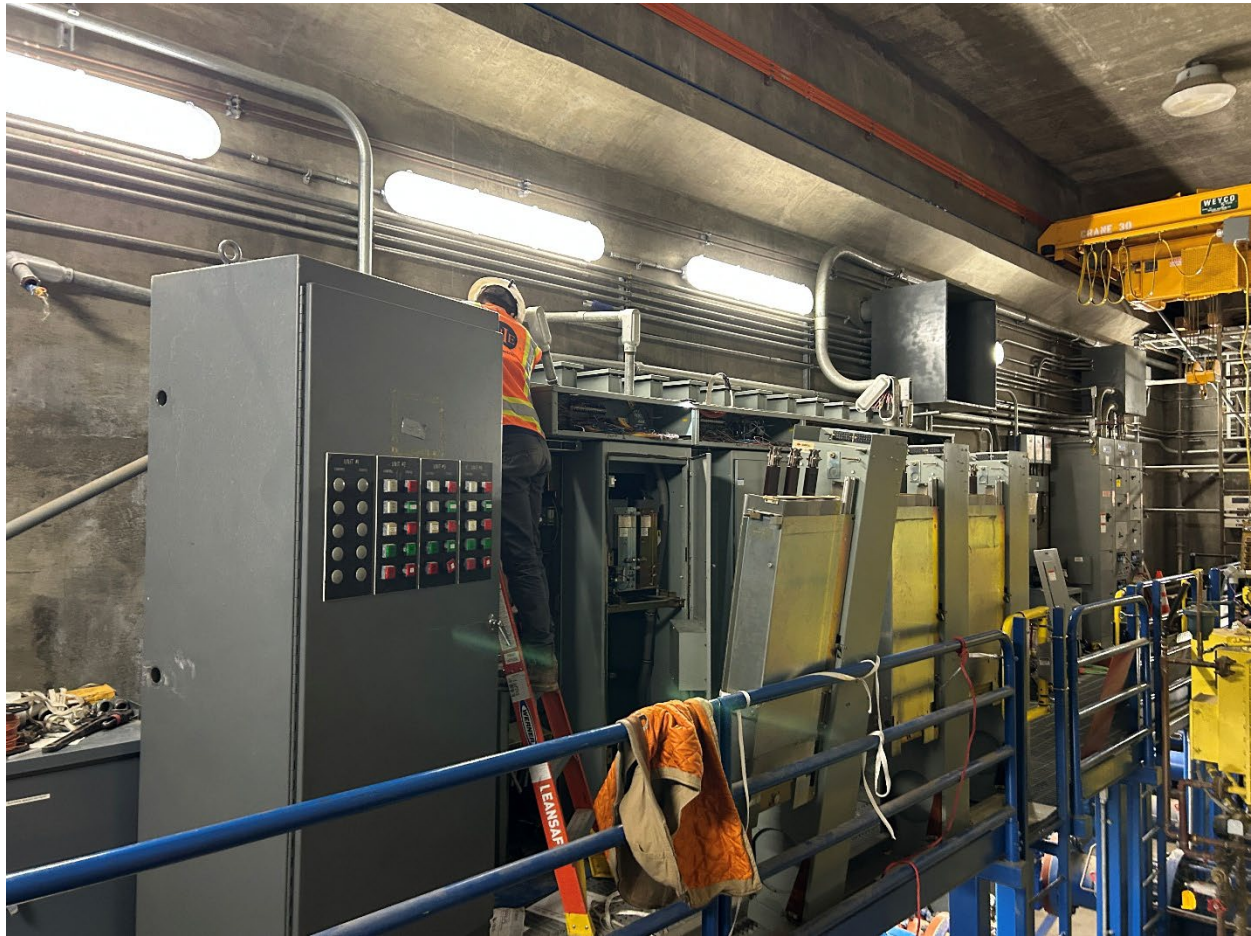
Figure 43 – Worker demolishing old electrical gear in LAPP2.

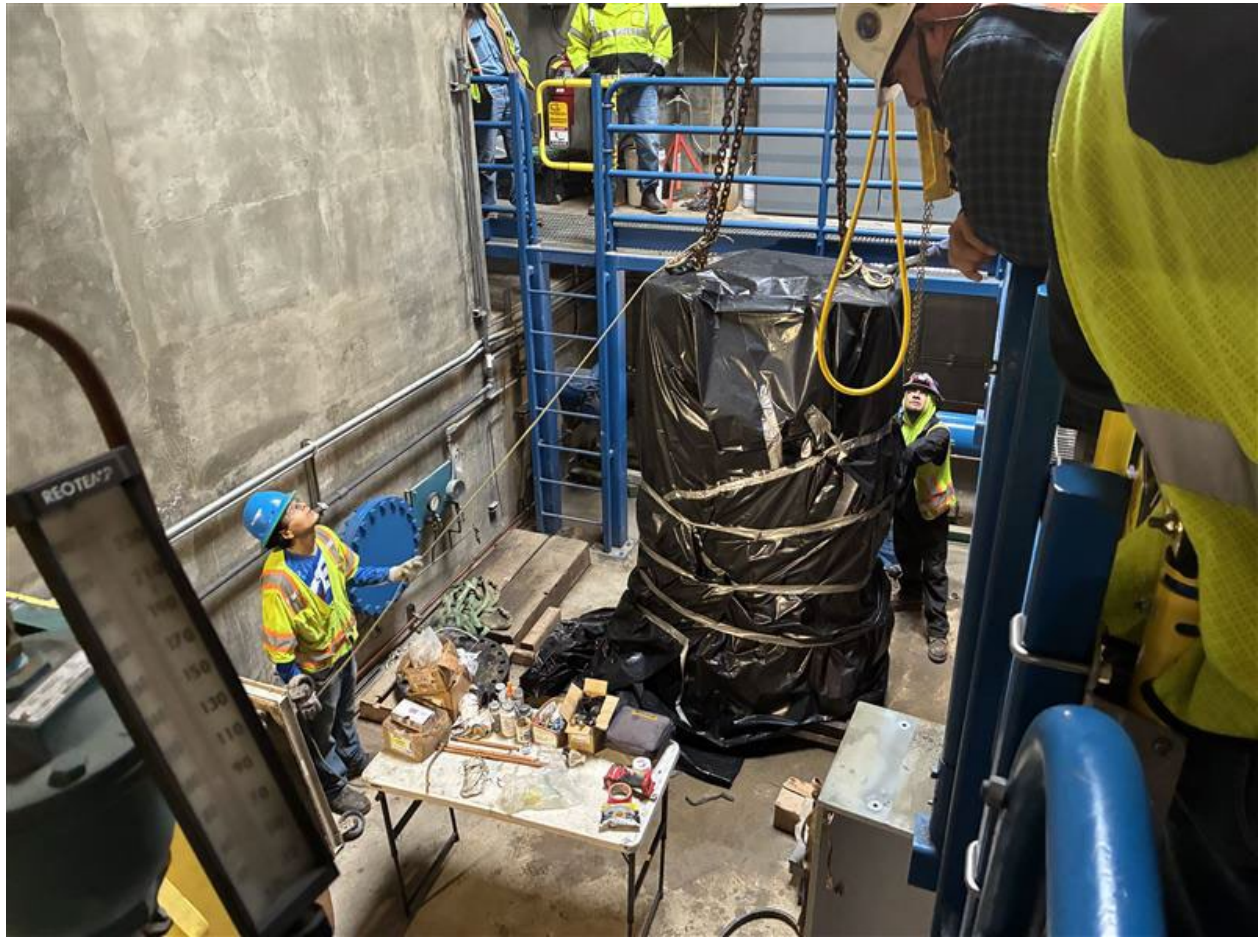
Figure 44 – Worker preparing for a crane lift of old electrical gear out the roof of LAPP2.

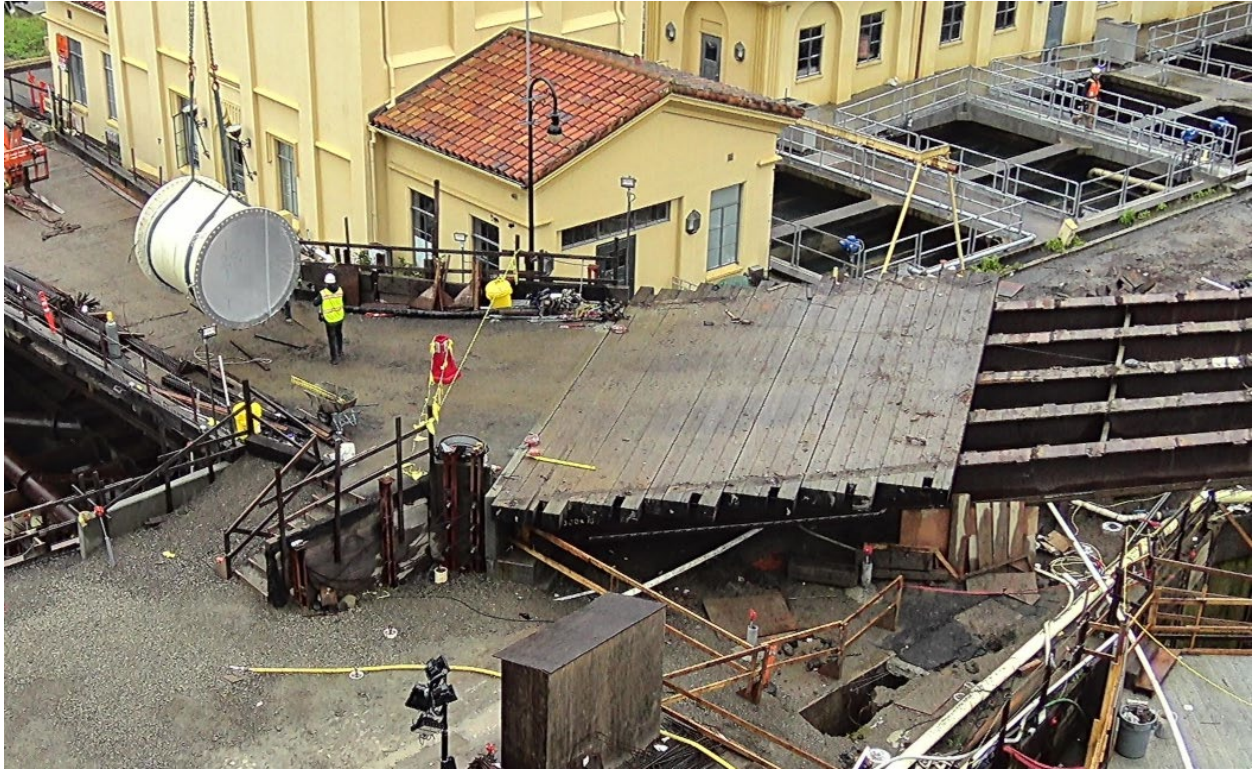
Figure 45 – UV-CCB Facility temporary bridge in partially demolished state.

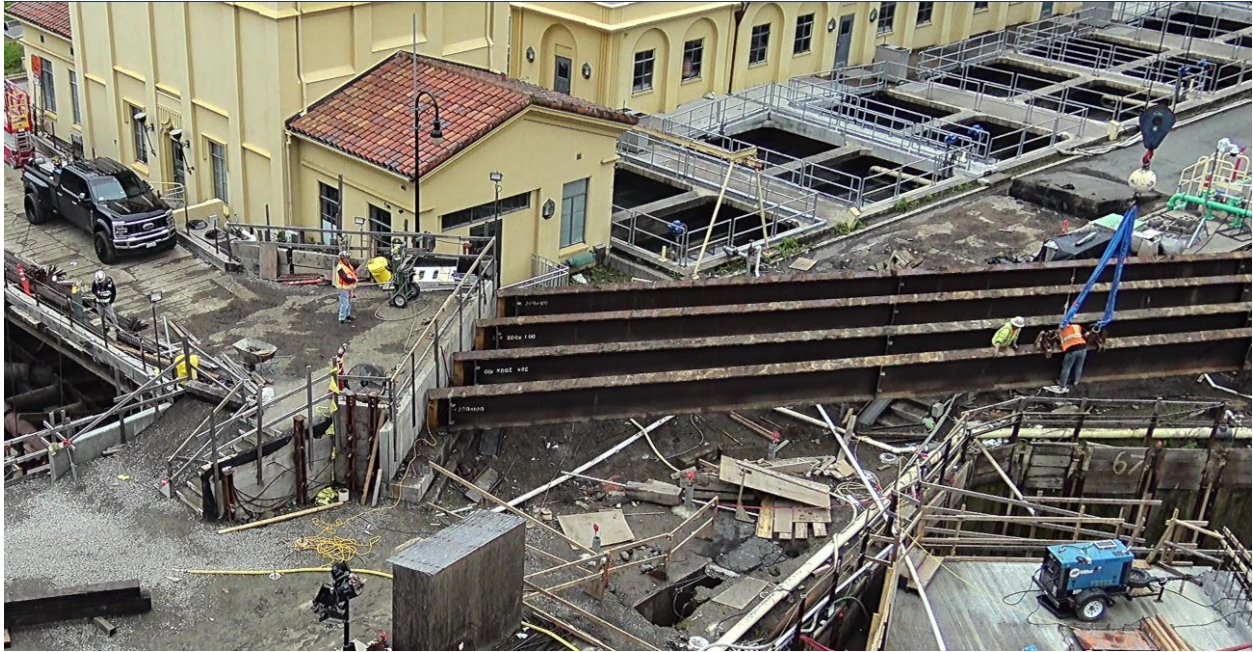
Figure 46 – Workers attaching crane sling to roadway beam of UV-CCB Facility temporary bridge in preparation for removal.
