## EAST BAY MUNICIPAL UTILITY DISTRICT

SUBJECT: Orinda Water Treatment Plant (WTP) Disinfection and Chemical Systems Safety Improvements Project Update

## **2026 Triannual Progress Report No. 2**

### **Specification 2139: Orinda Water Treatment Plant (WTP) Disinfection and Chemical Safety Systems Improvement Project (CSSIP)**

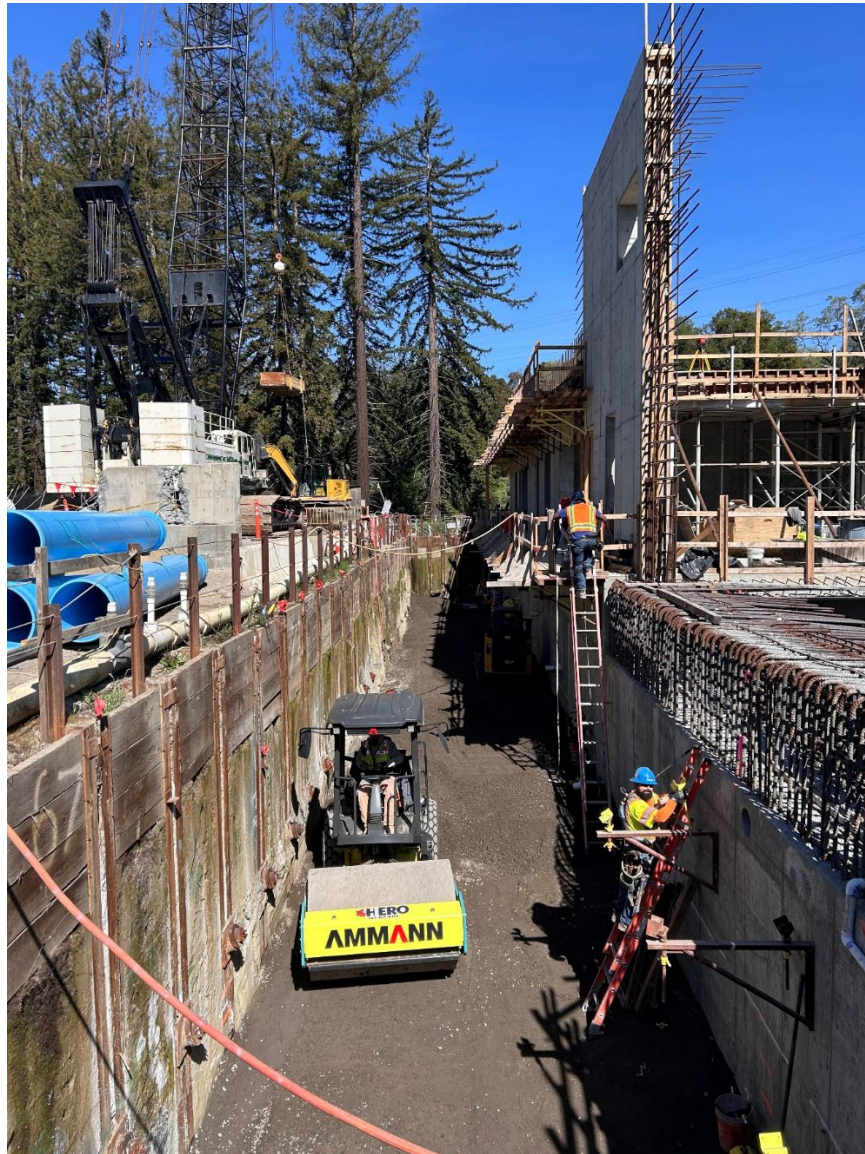
*Figure 1 – View of workers placing and compacting engineered fill above the UV Inlet Channel in preparation for underground utilities for the MAUVE building.*

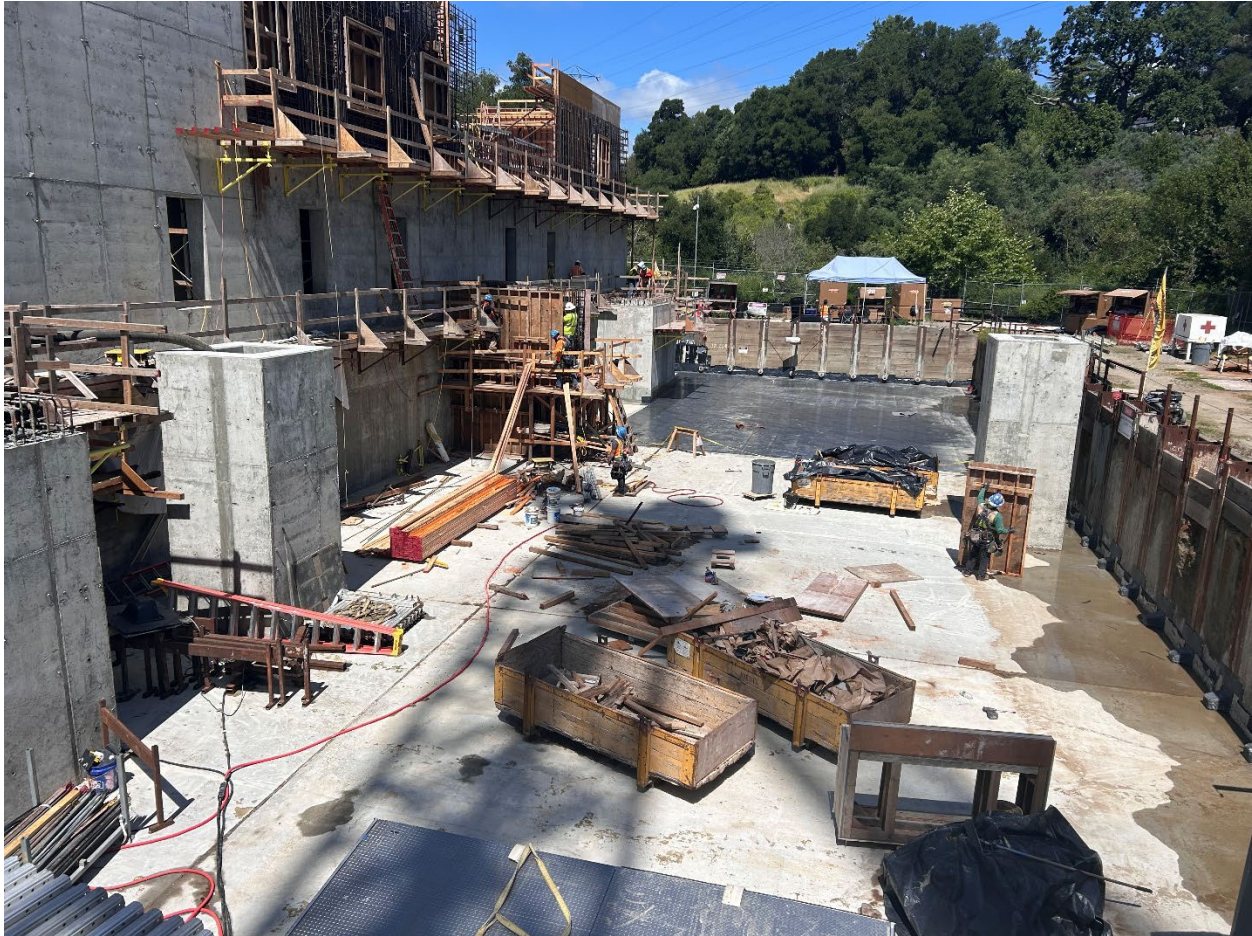
*Figure 2 – View of workers installing black waterproofing material on the concrete roof of the Chlorine Contact Basin (CCB) which will be buried below the ground surface. The concrete ‘chimneys’ are the some of the accessways for the underground CCB.*

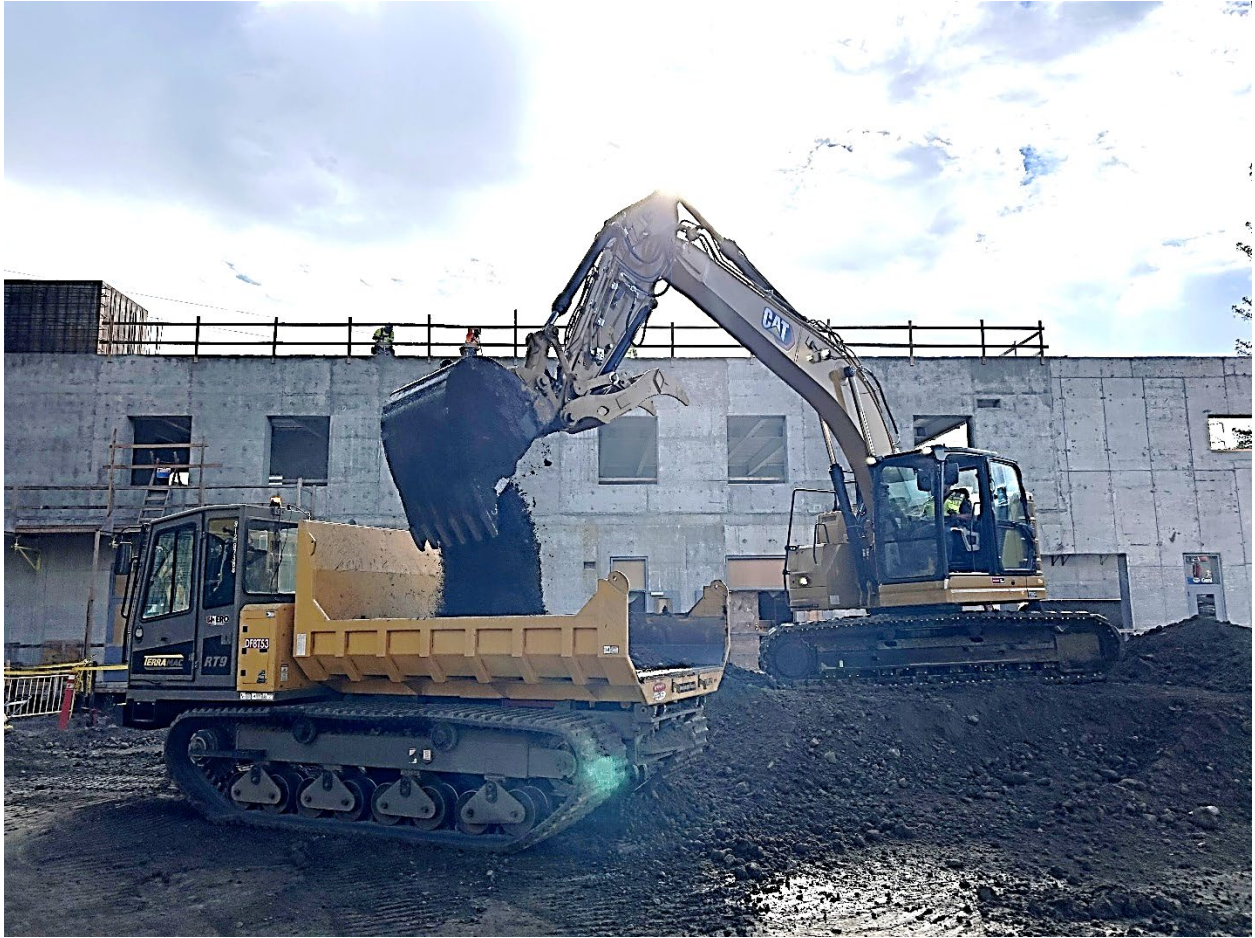
*Figure 3 – View of an excavator filling a miniature dump truck with engineered fill which will cover the buried CCB.*

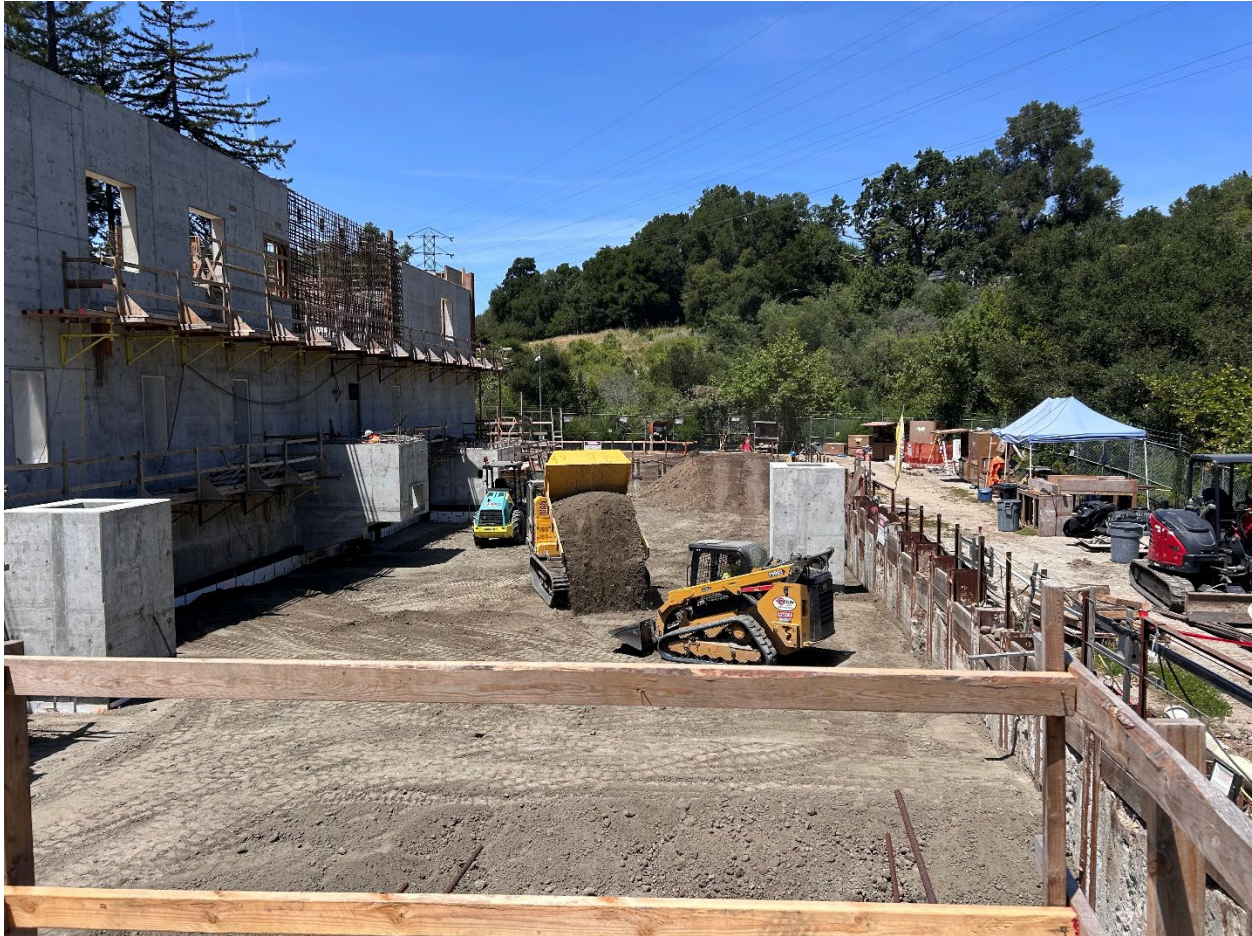
*Figure 4 – View of workers burying the underground CCB. The photo shows a miniature dump truck emptying engineered-fill with other machinery redistributing and compacting the backfill in place.*

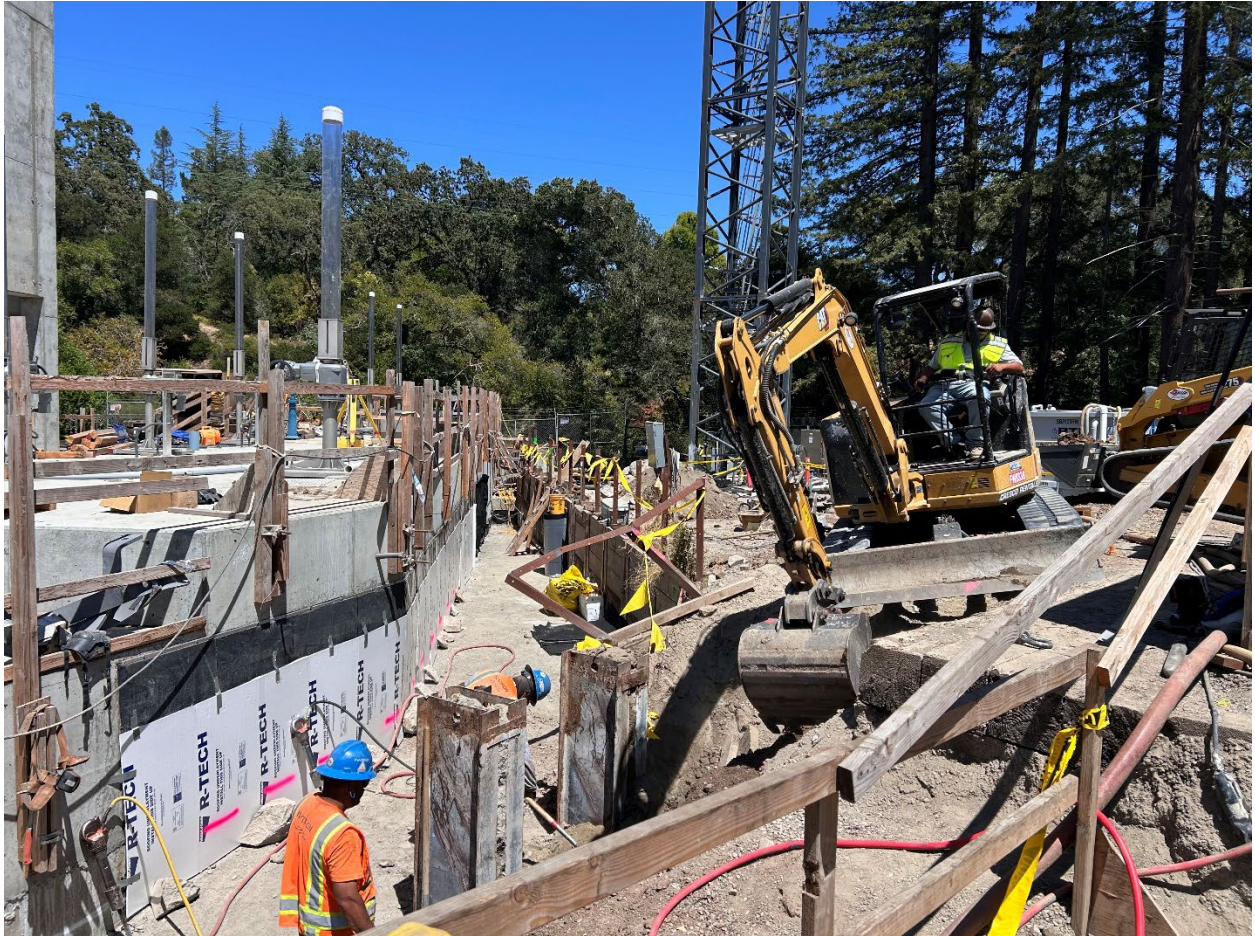
*Figure 5 – View of workers excavating the top six feet of the engineered shoring system which supported the 65-foot deep excavation. This part of the shoring system is being removed to allow for installation of underground utilities. The walls of the underground Effluent Weir Structure can be seen behind the workers.*

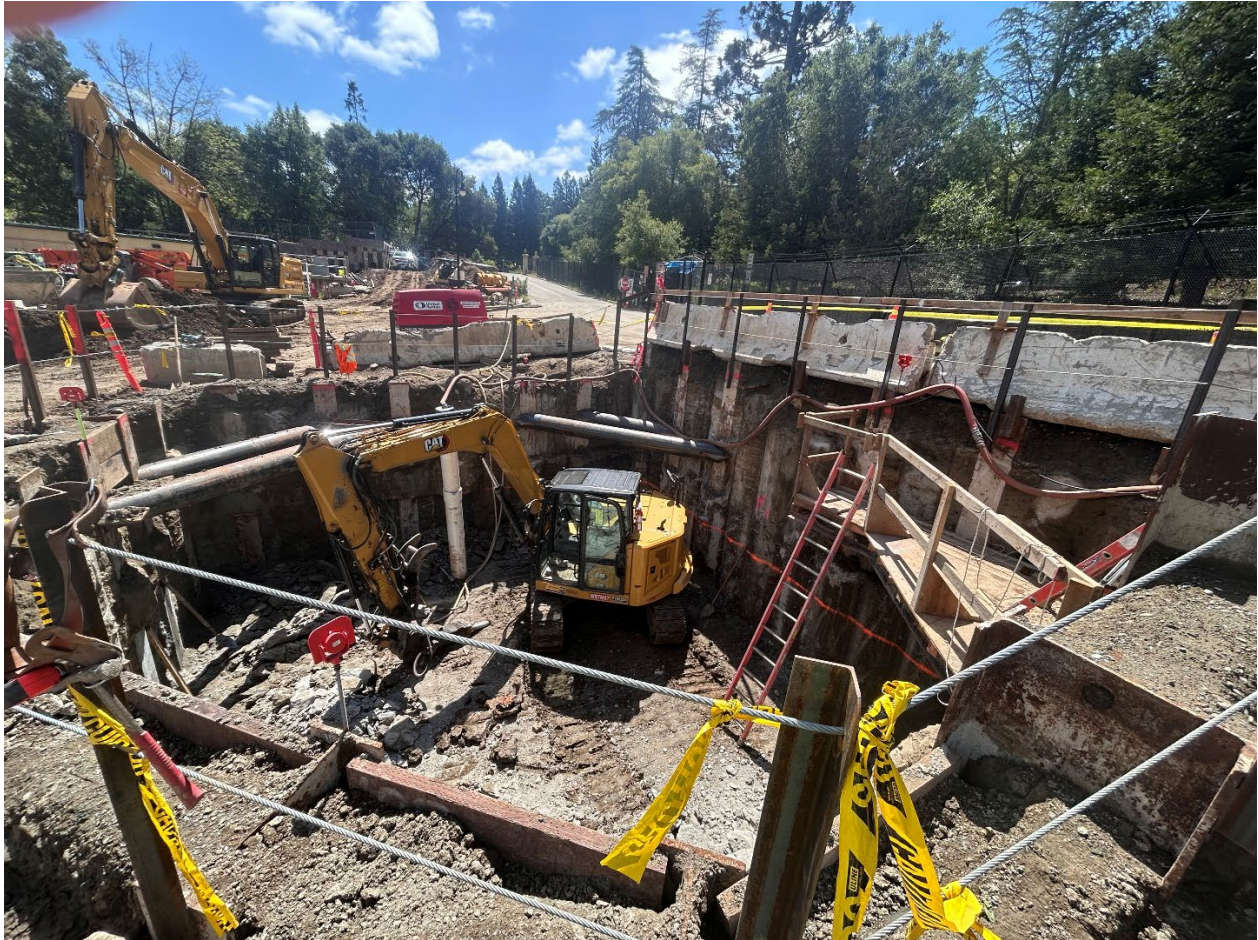
*Figure 6 – View of workers beginning the excavation of the Effluent 2 engineered shoring system. The excavation is where the project will make the final piping connection to allow the water to flow from the existing water treatment plant to the new part of the plant.*

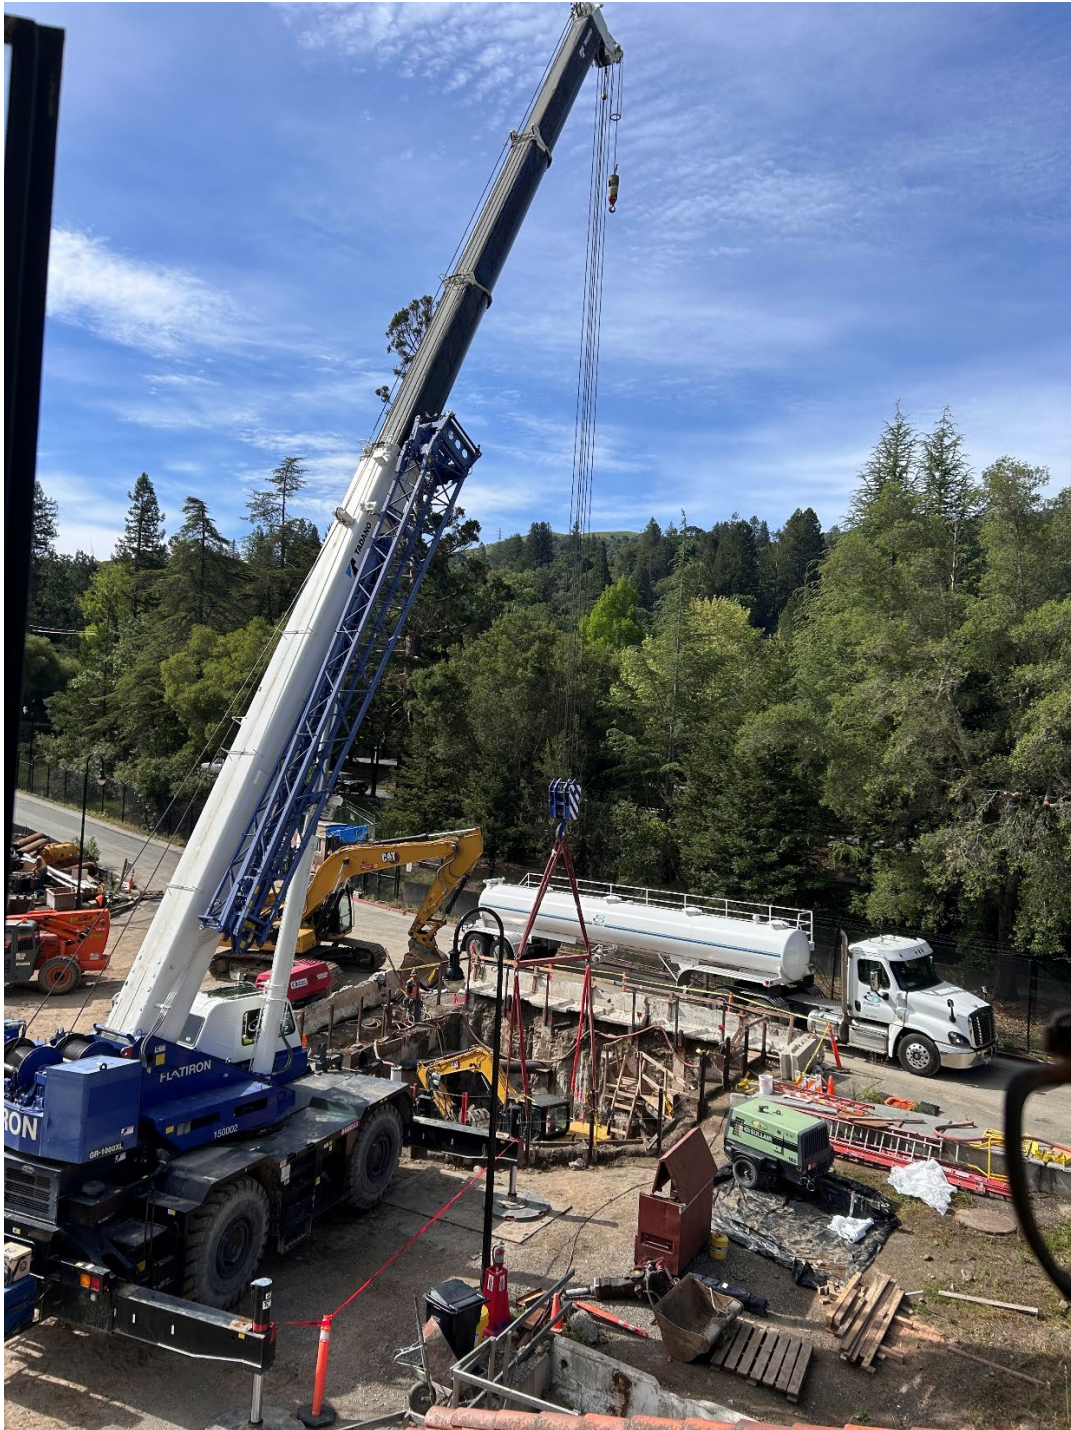
*Figure 7 – View of rough terrain crane lifting an excavator from the Effluent 2 excavation to allow the ironworkers to install the next level of excavation bracing. This excavation requires six levels of bracing to get to the bottom of the 40-foot-deep excavation where the piping connections will be made. Note the EBMUD truck adjacent to the excavation showing the challenges of constructing the project at a water treatment plant which operates 24/7.*

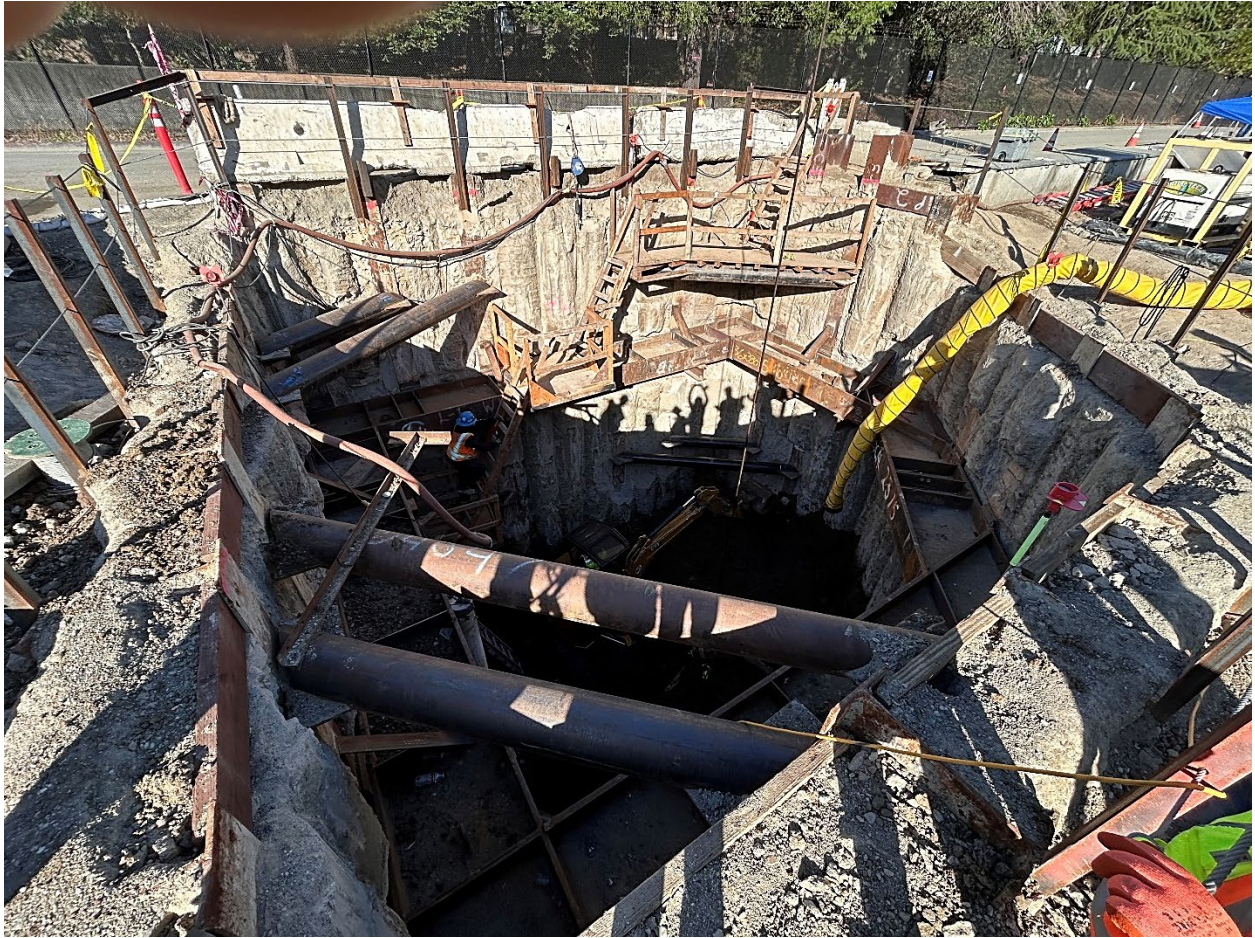
*Figure 8 – View looking down into the Effluent 2 excavation with the multiple layers of bracing supporting the excavation walls and adjacent roadway.*

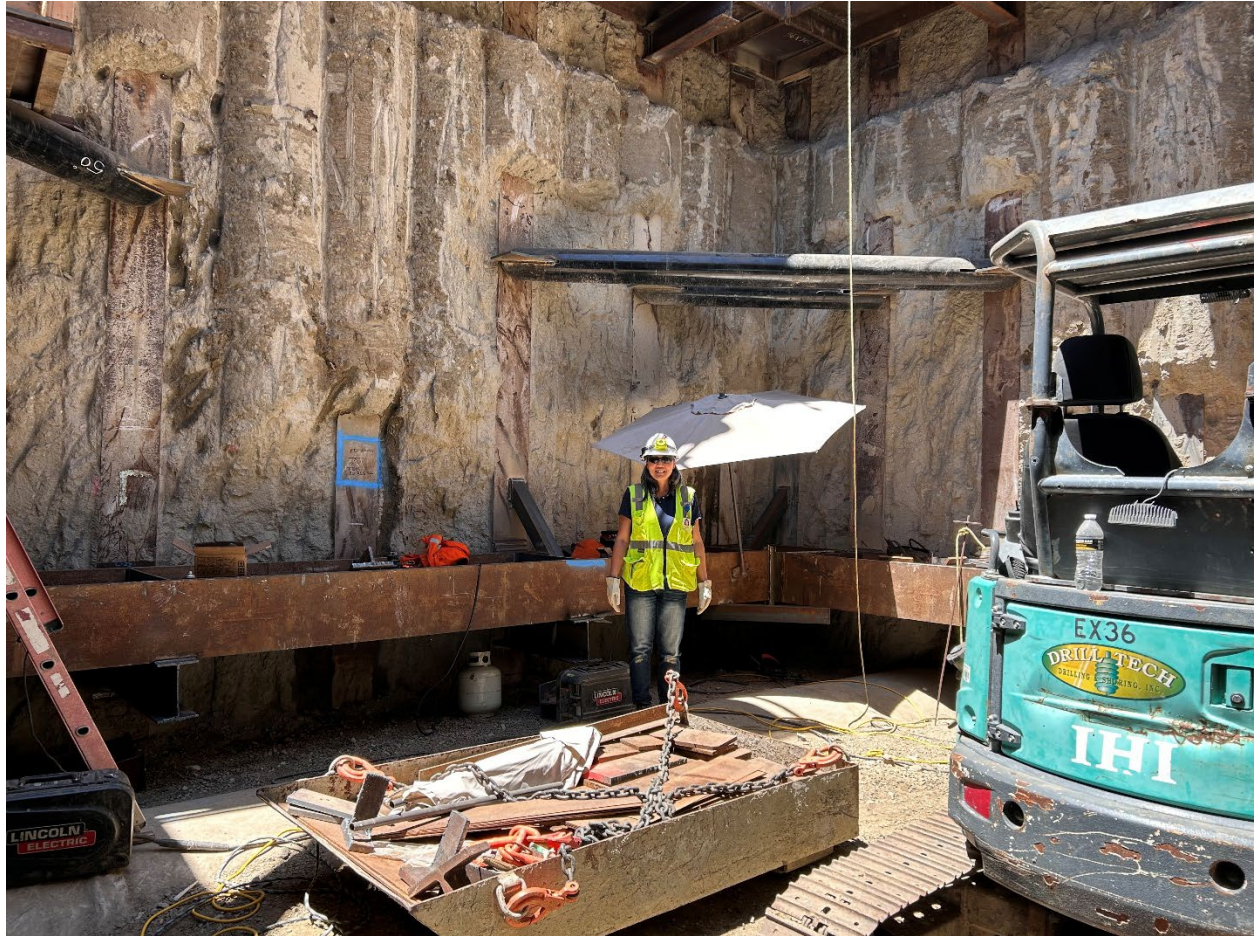
*Figure 9— Engineer performing inspection at the interim bottom of the Effluent 2 excavation. The engineer is standing adjacent to the existing 78-inch Effluent 2 pipeline which must be evaluated and field measured accurately to complete the design and fabrication of the connecting pipeline. The excavation will continue another 15 feet below the feet of the engineer to fully expose the existing Effluent 2 pipeline and the new Effluent 2 connection tunnel.*

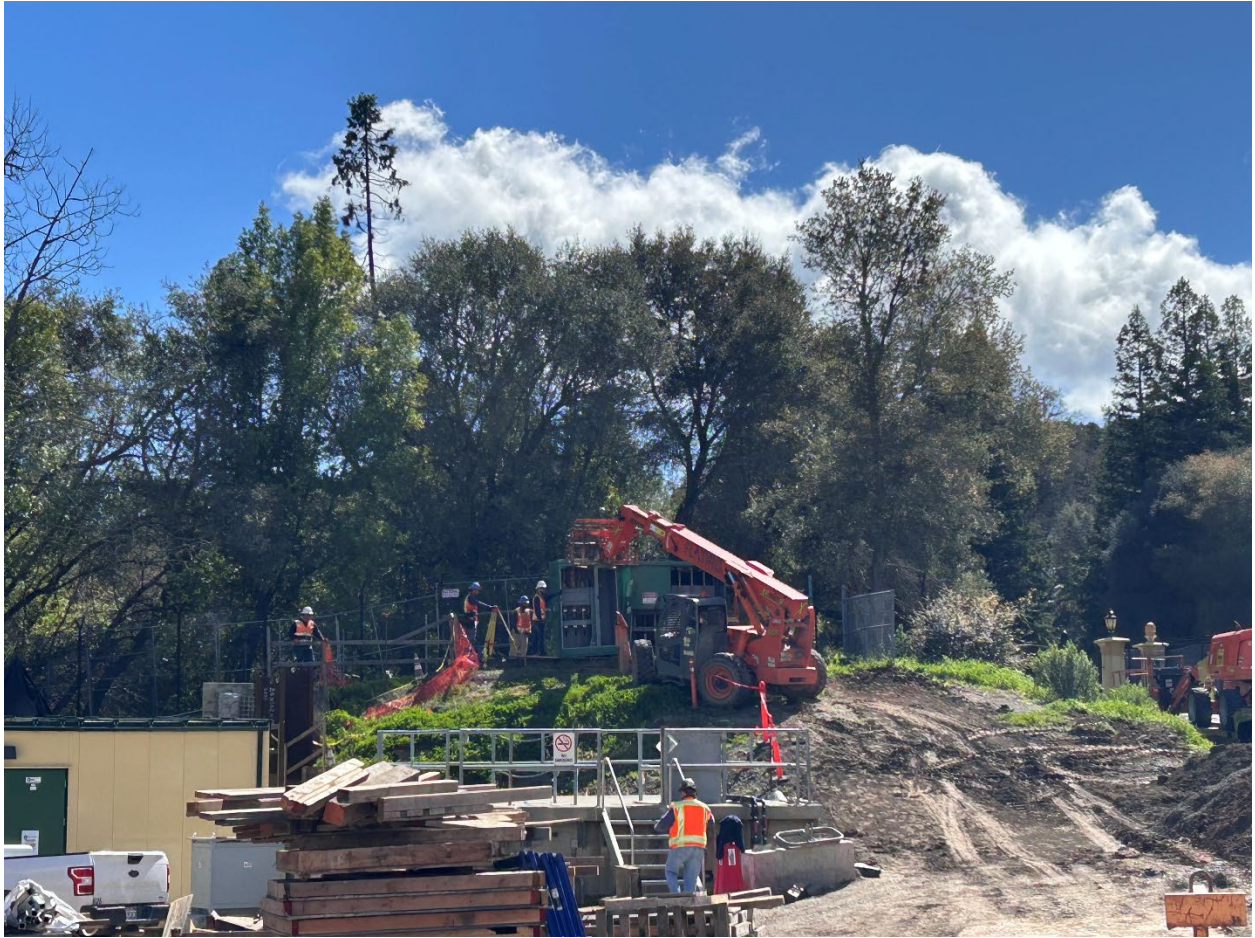
*Figure 10 – View of electricians demolishing the transformer for Los Altos Pumping Plant No. 2 in preparation for constructing the foundation for the new emergency generator.*

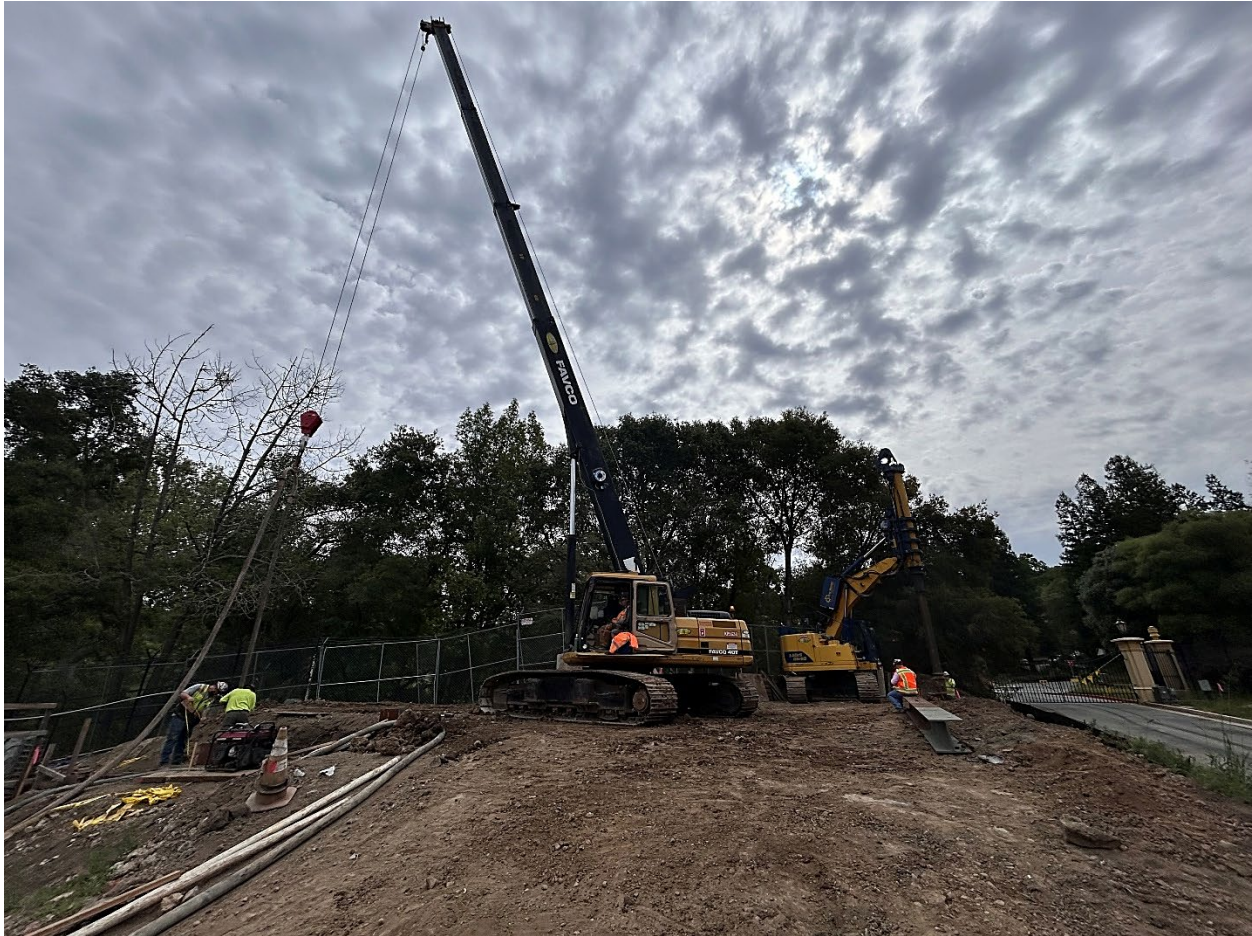
*Figure 11 – View of carpenters drilling holes and installing underground beams in holes. The beams are part of the retaining wall system which allows the hillside to be supported while it is excavated down to a level surface.*

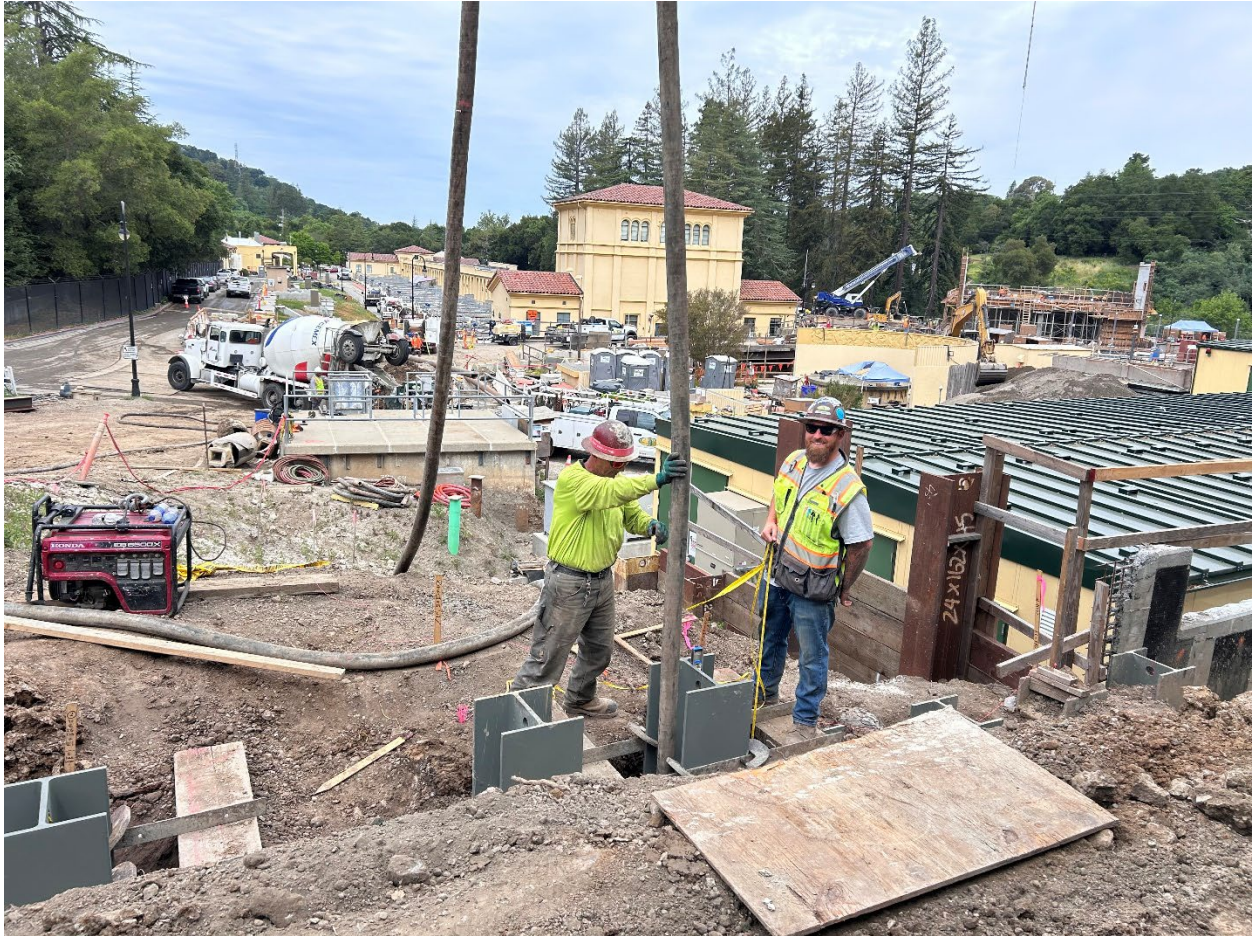
*Figure 12 – Closeup view of carpenters placing concrete around underground beams as part of the retaining walls which will support the hillside during excavation.*

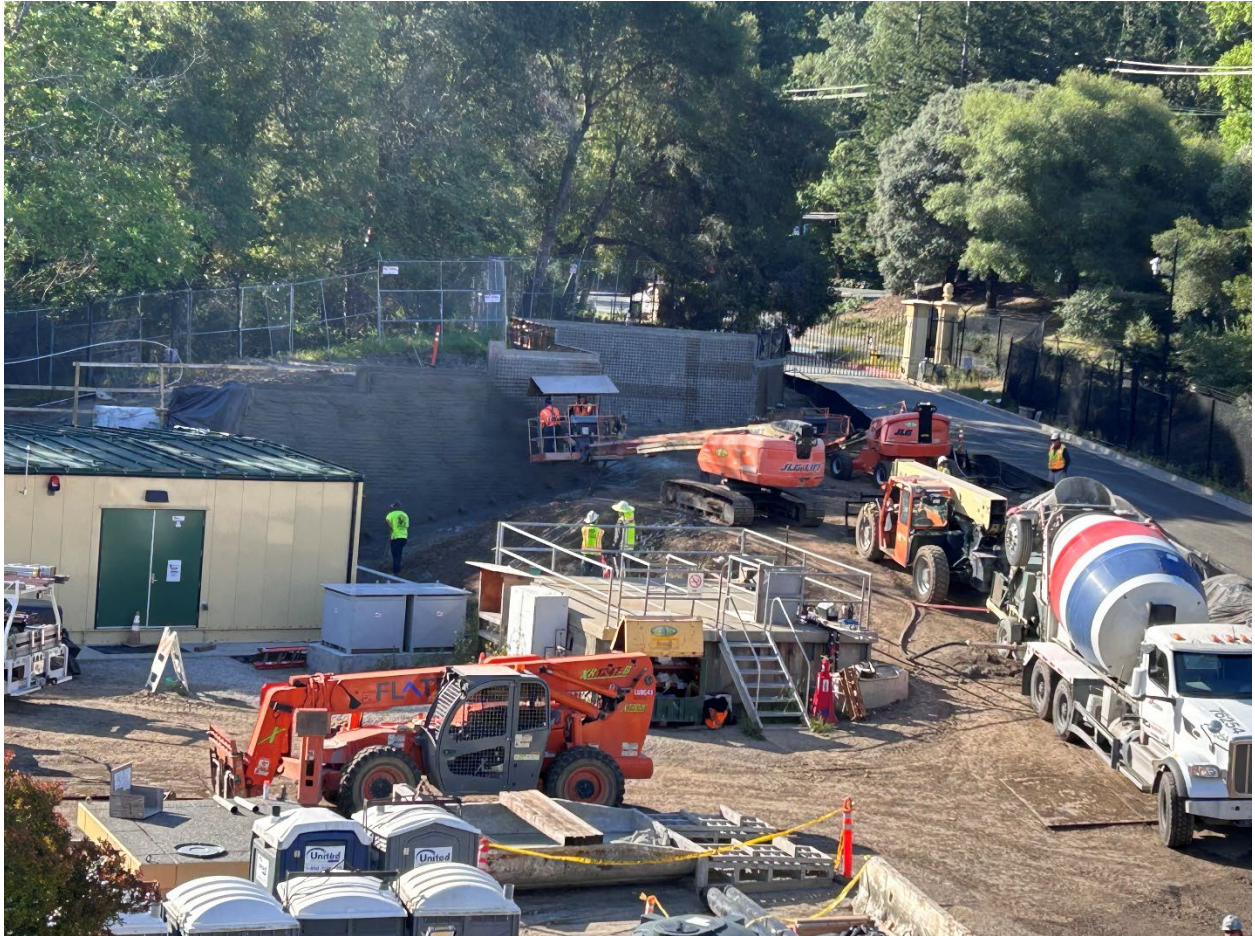
*Figure 13 – View of retaining walls after excavation of the hillside. The workers on the manlift are applying shotcrete to the retaining walls to strengthen them. The level area created by the excavation is the location of foundation for the future emergency generator.*

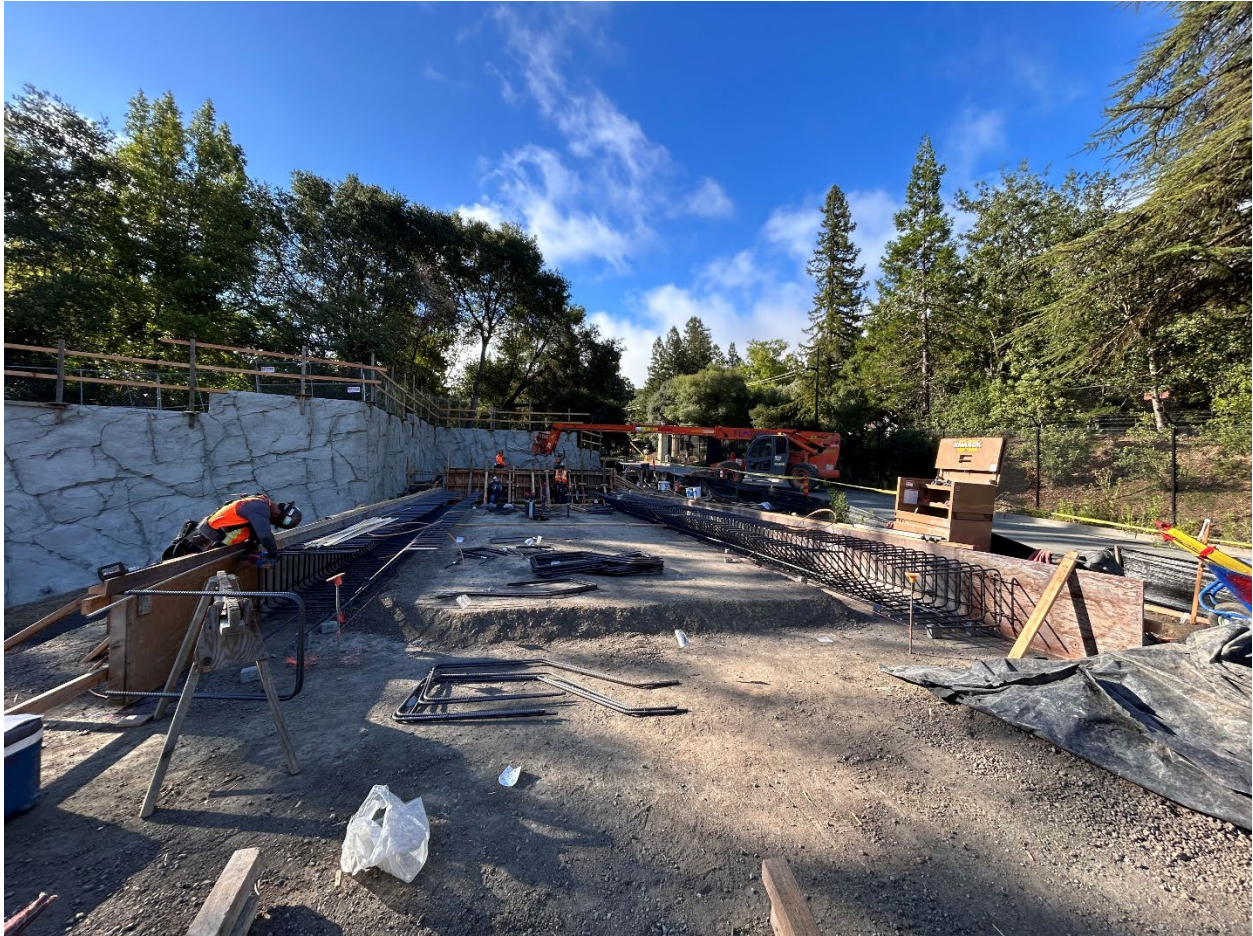
*Figure 14 – View of ironworkers placing reinforcing steel for the concrete foundation which will support the future emergency generator. The decorative face of the retaining wall can be seen behind the workers.*

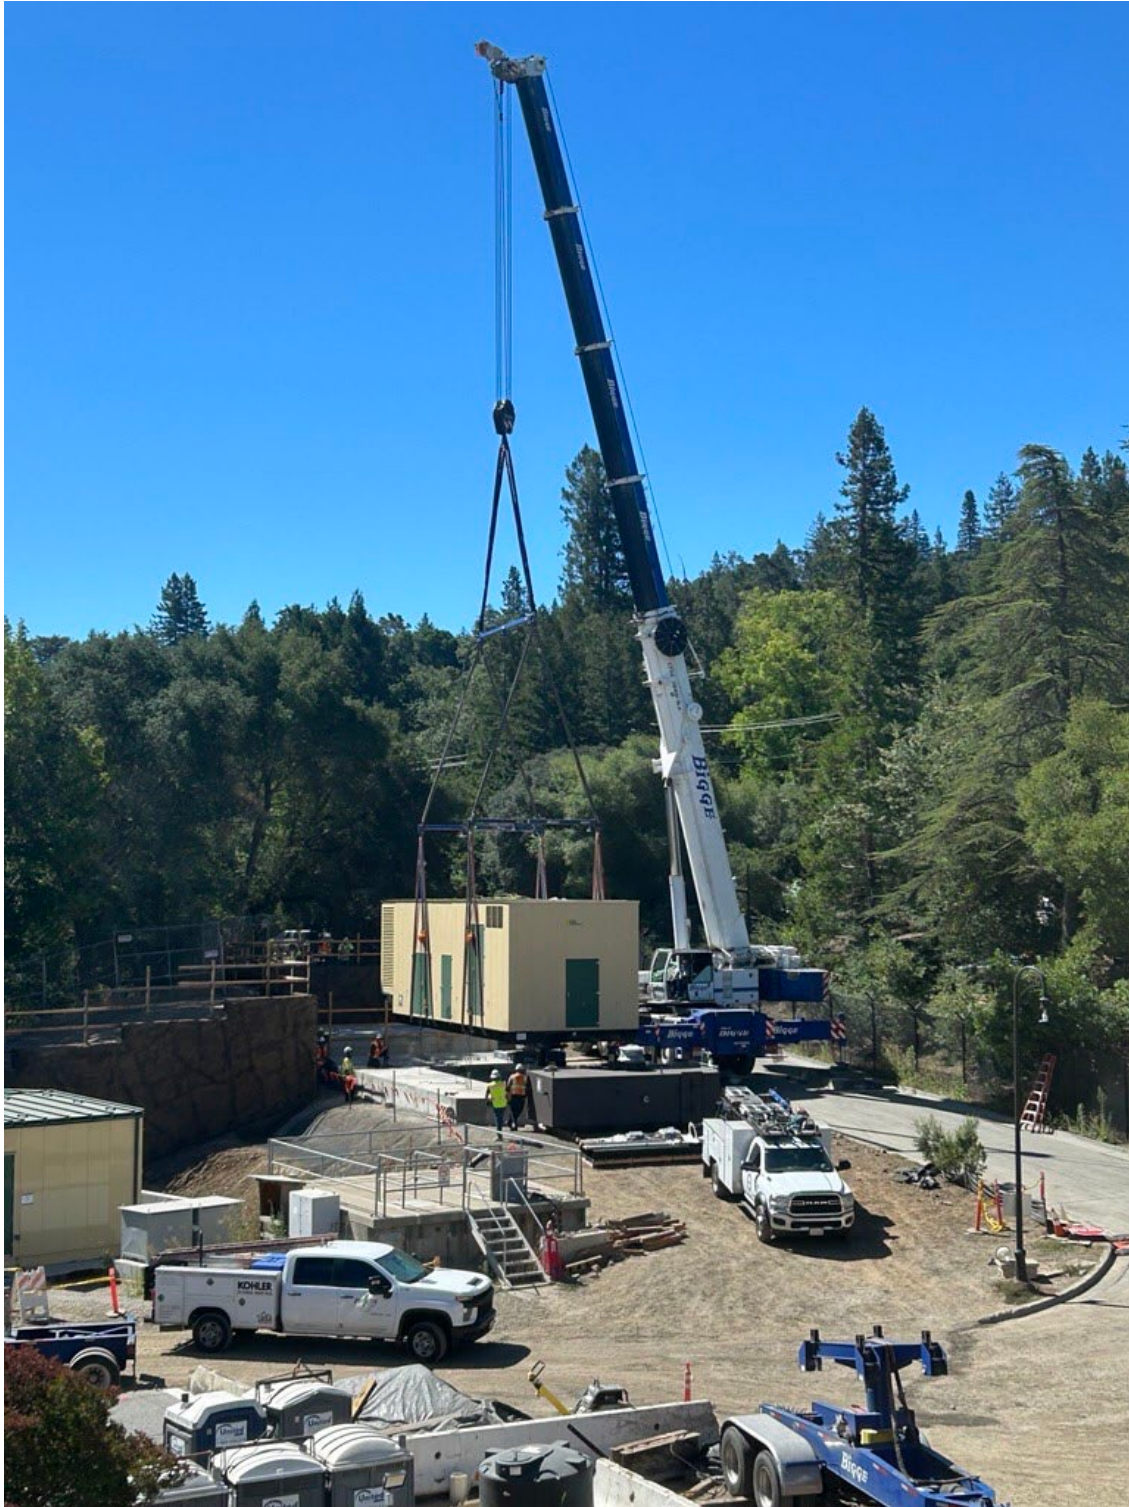
*Figure 15 – View of crane lifting 2.5 megawatt emergency standby generator onto its concrete foundation pad.*

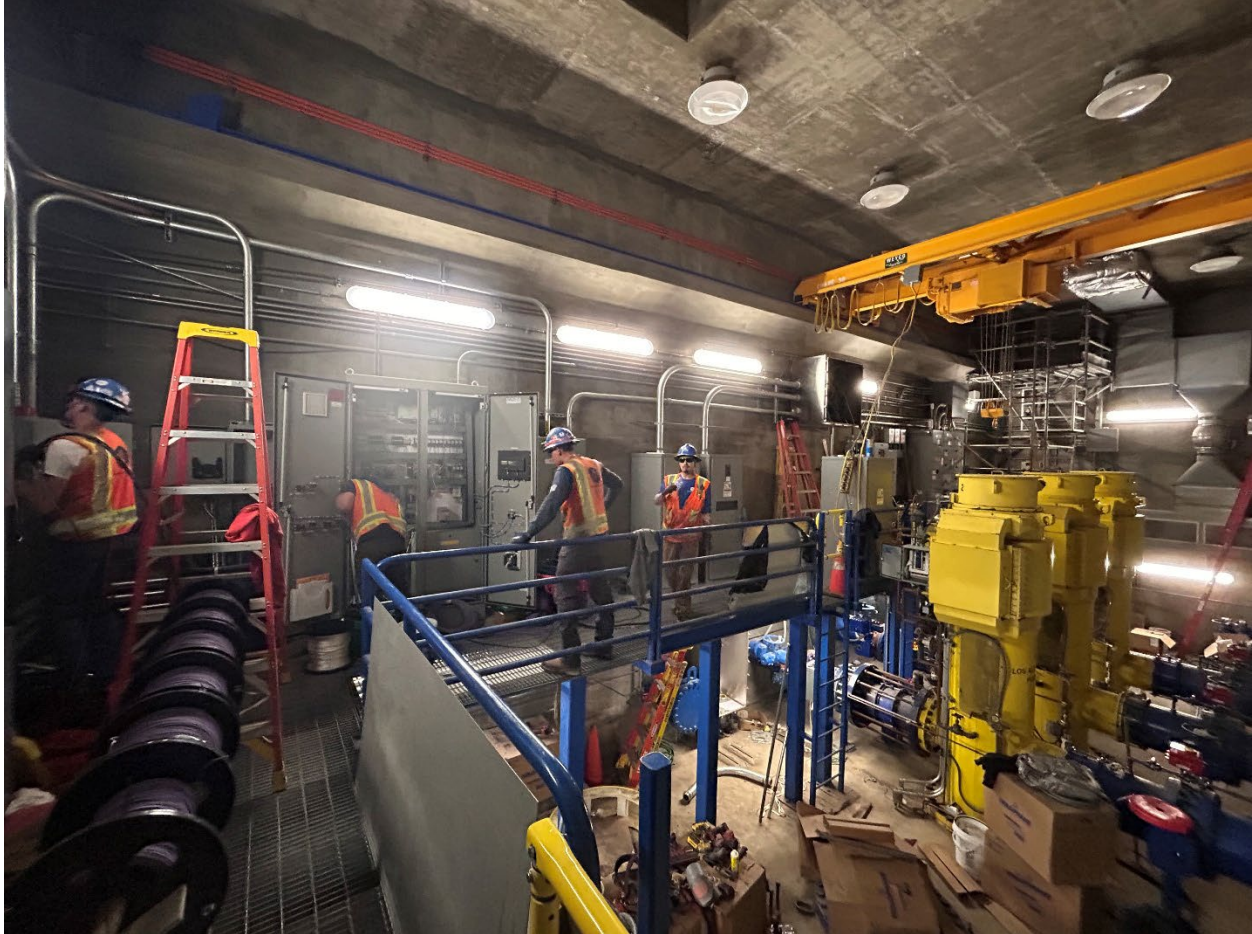
*Figure 16 – Electricians installing medium voltage switching equipment in the underground Los Altos Pumping Plant No. 2. This pumping plant is located 40 feet below the ground surface at the Orinda WTP.*

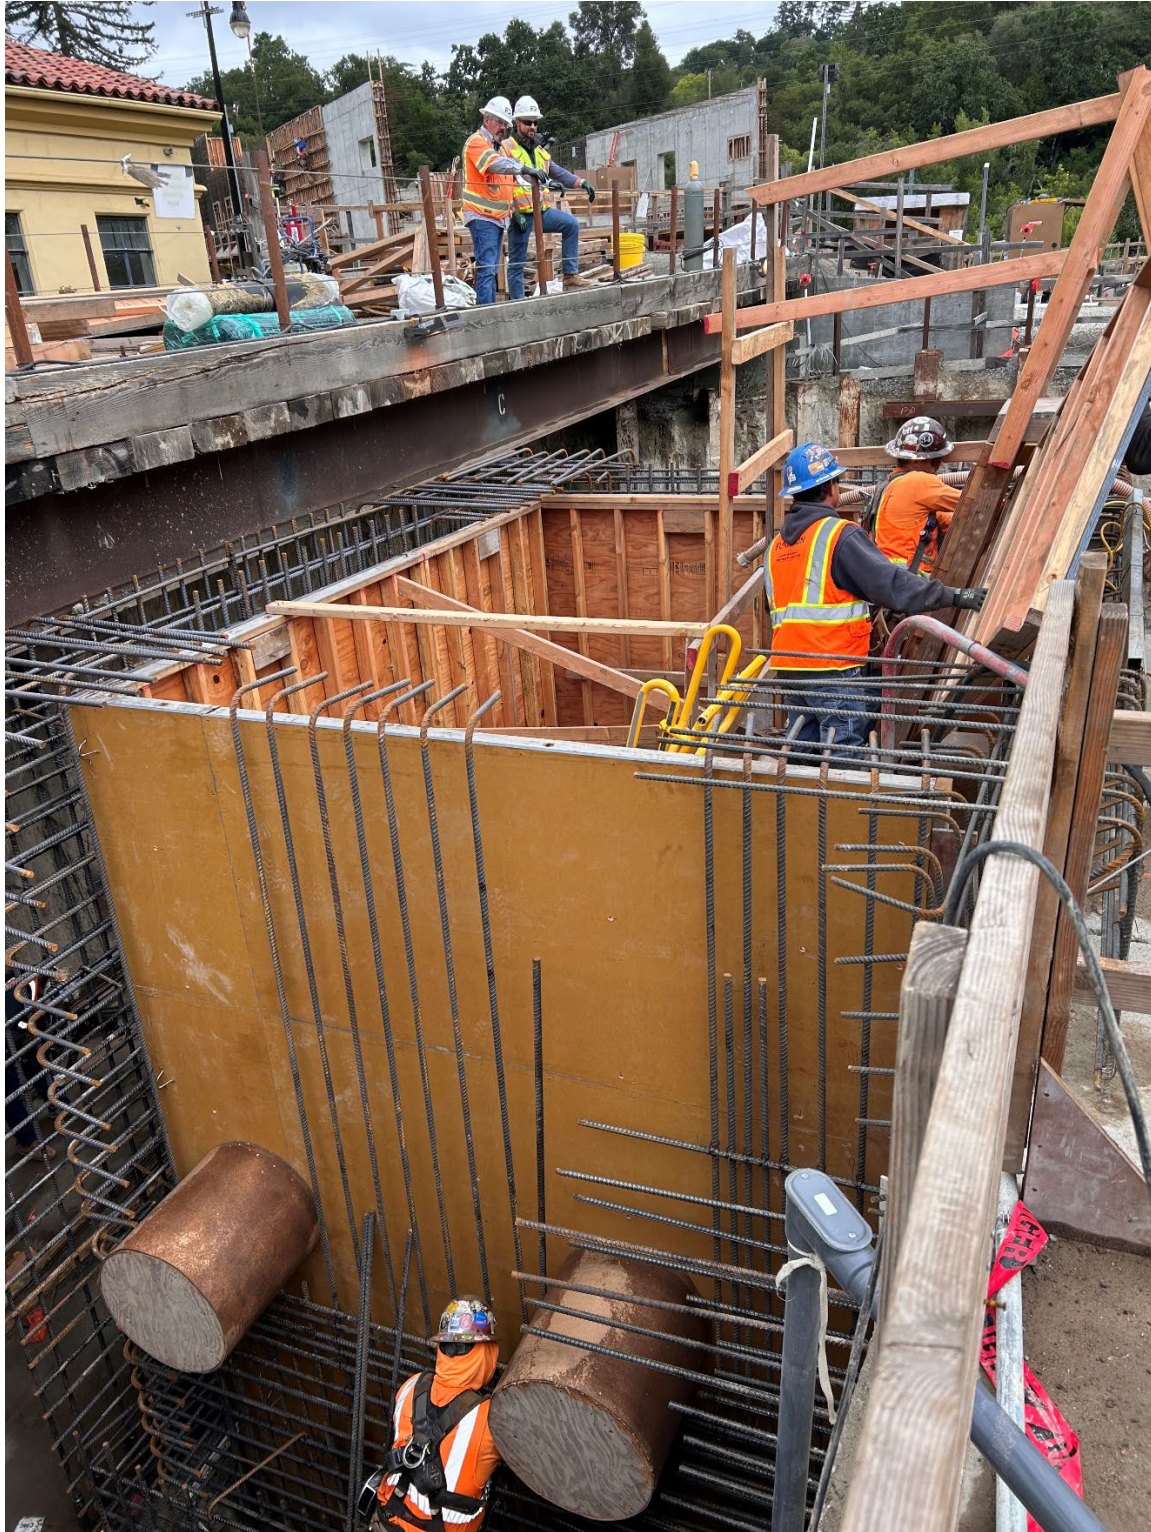
*Figure 17 – View of the ironworkers installing rebar for the final wall segments for the underground Effluent 1 Valve Vault.*
