## EAST BAY MUNICIPAL UTILITY DISTRICT

SUBJECT: Orinda Water Treatment Plant (WTP) Disinfection and Chemical Systems Safety Improvements Project Update

## **2026 Triannual Progress Report No. 2**

### **Specification 2139: Orinda Water Treatment Plant (WTP) Disinfection and Chemical Safety Systems Improvement Project (CSSIP)**

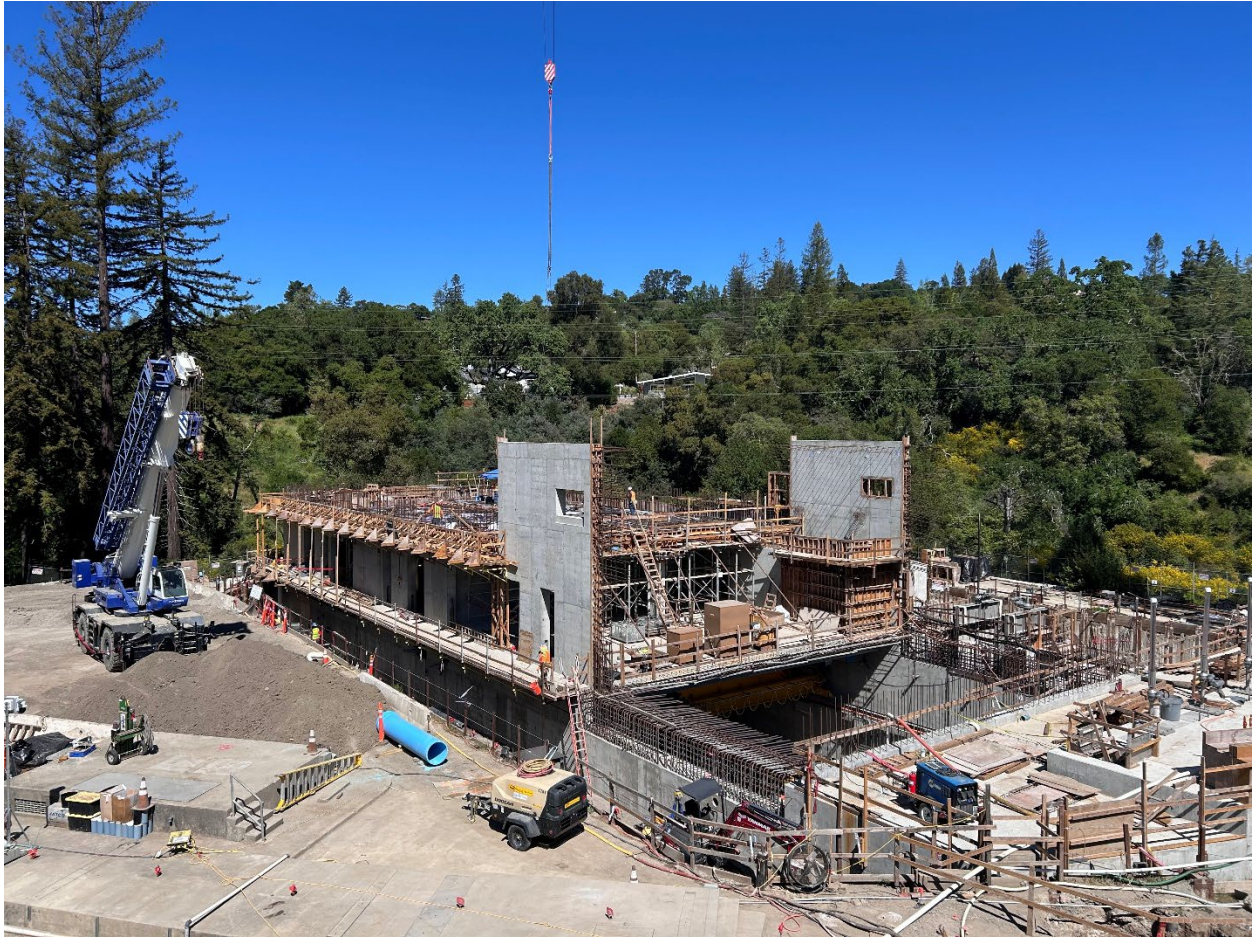
*Figure 19 – View of the first floor of the MAUVE Building north end under construction. The building is constructed in two segments. The large opening in the MAUVE Building concrete floor in the foreground serves as easy access for very large piping into the UV Room located 30-feet below the floor.*

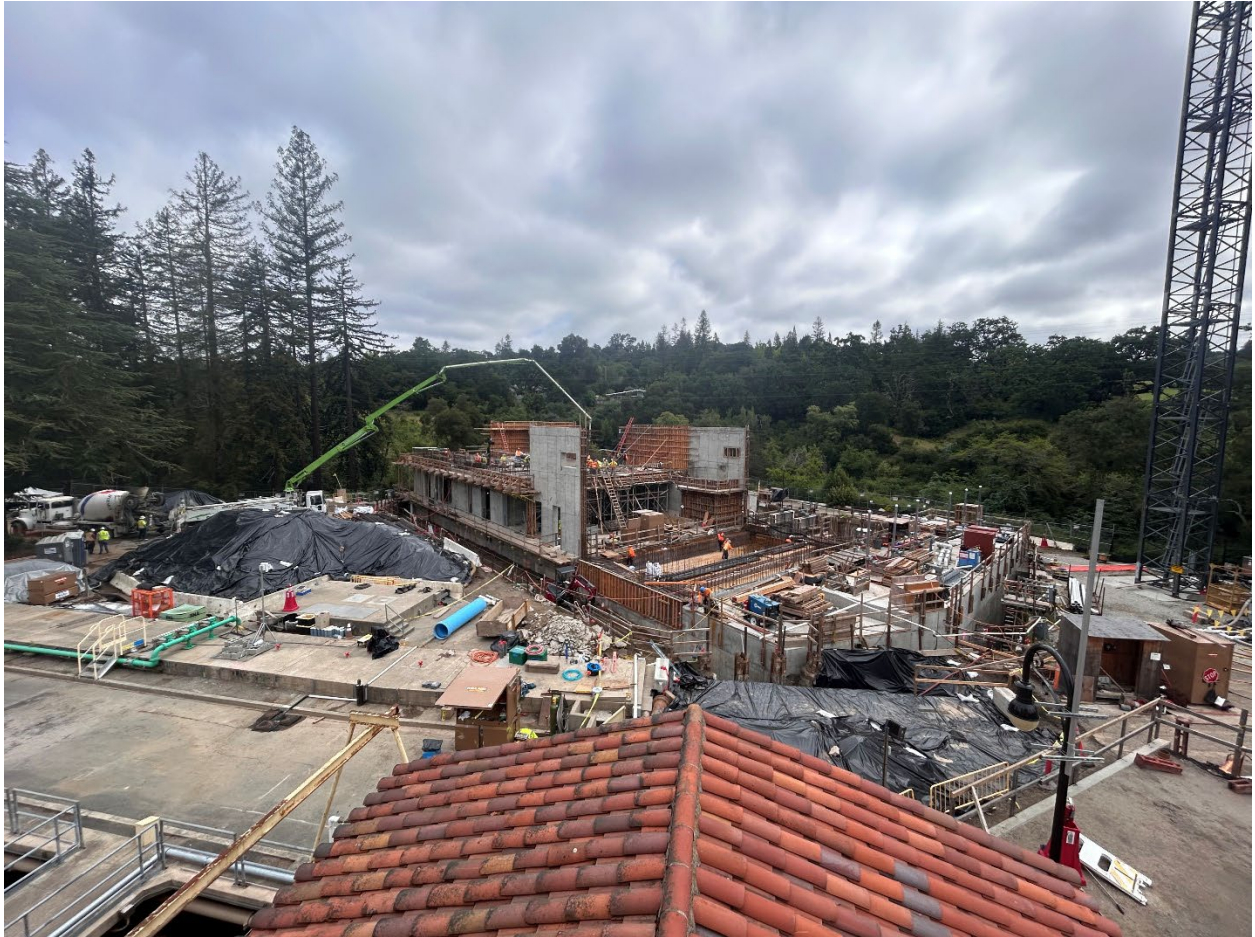
*Figure 20 – View of the MAUVE Building under construction. The green articulating boom in the photo is pumping concrete from the concrete trucks to the wall forms for the second floor.*

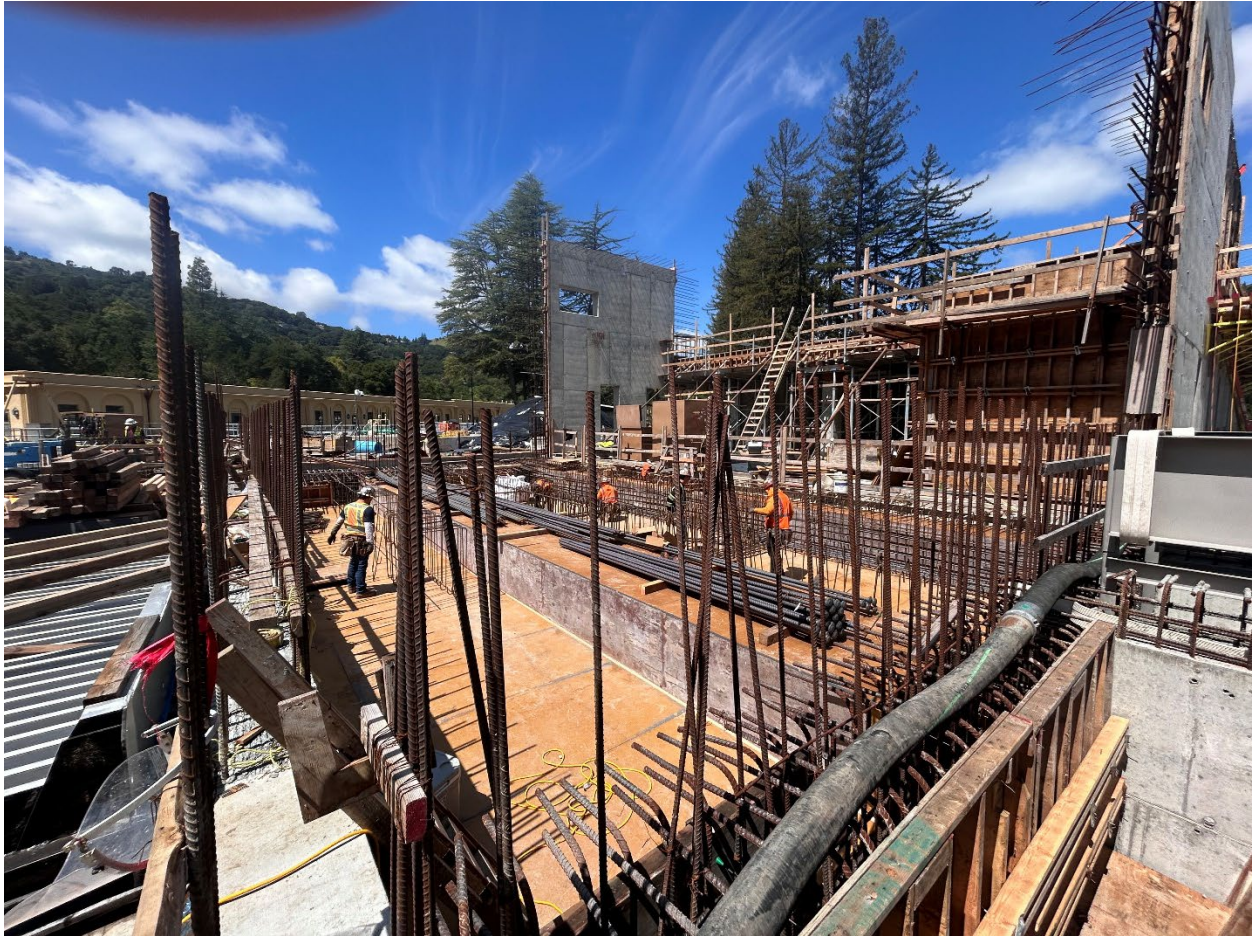
*Figure 21 – Ironworkers installing rebar on wood decking for the MAUVE Building floor. This is the MAUVE Building south end.*

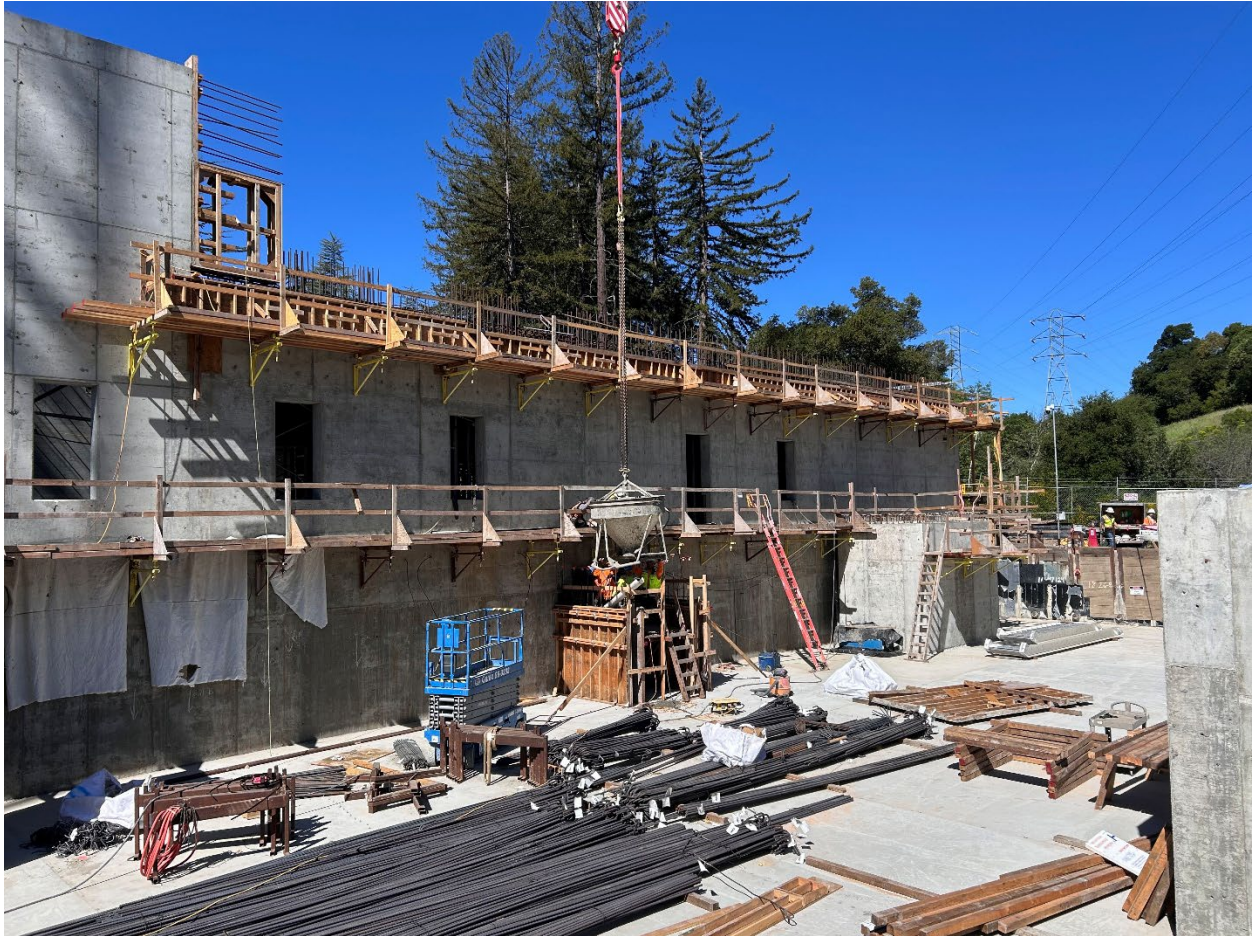
*Figure 22 – Laborers using a large hopper to place concrete with the aid of the tower crane on the backside of the MAUVE Building. Hard-to-access areas such as this require special concrete placement techniques.*

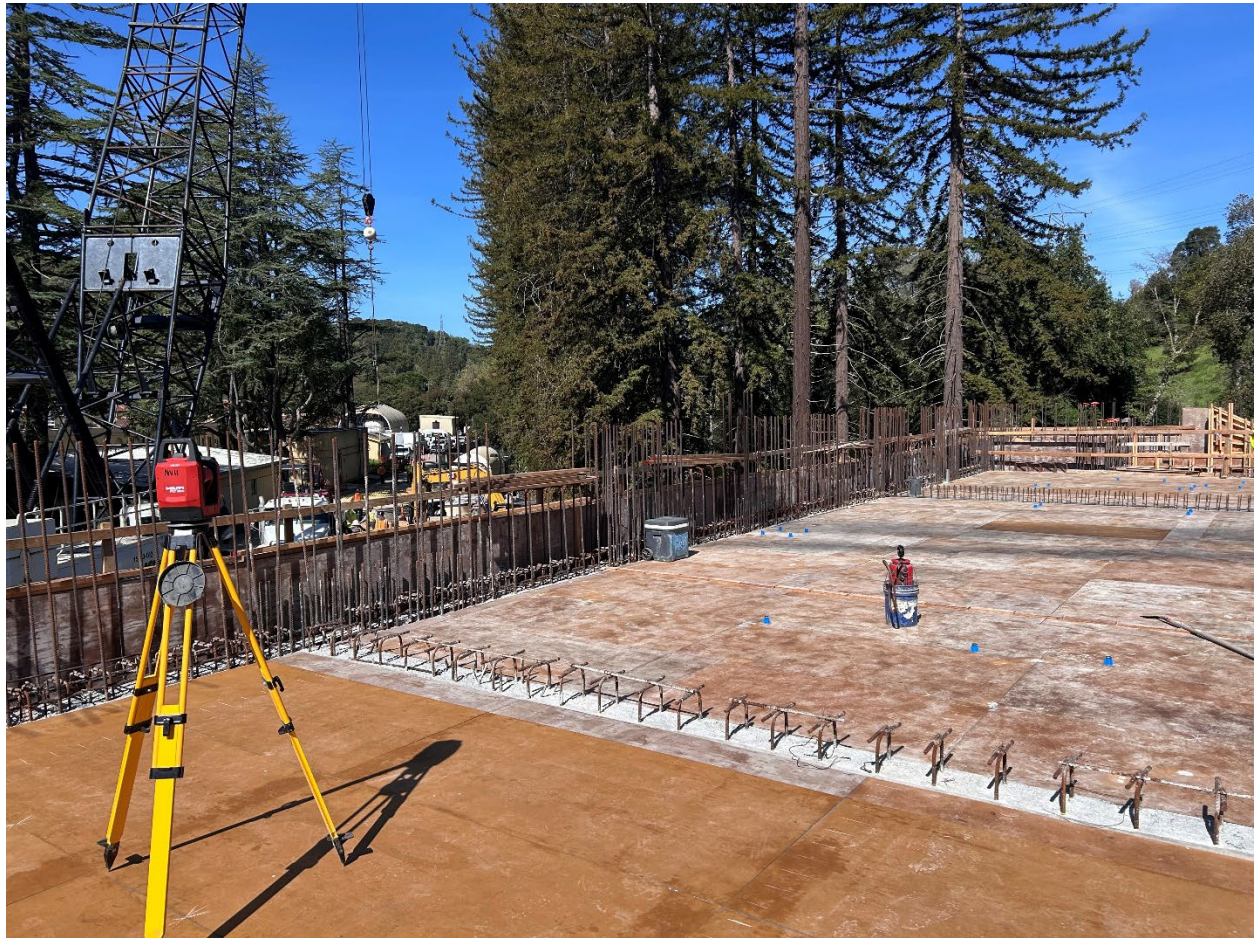
*Figure 23 – View of the wood decking which will support the reinforced concrete for the MAUVE Building second floor.*

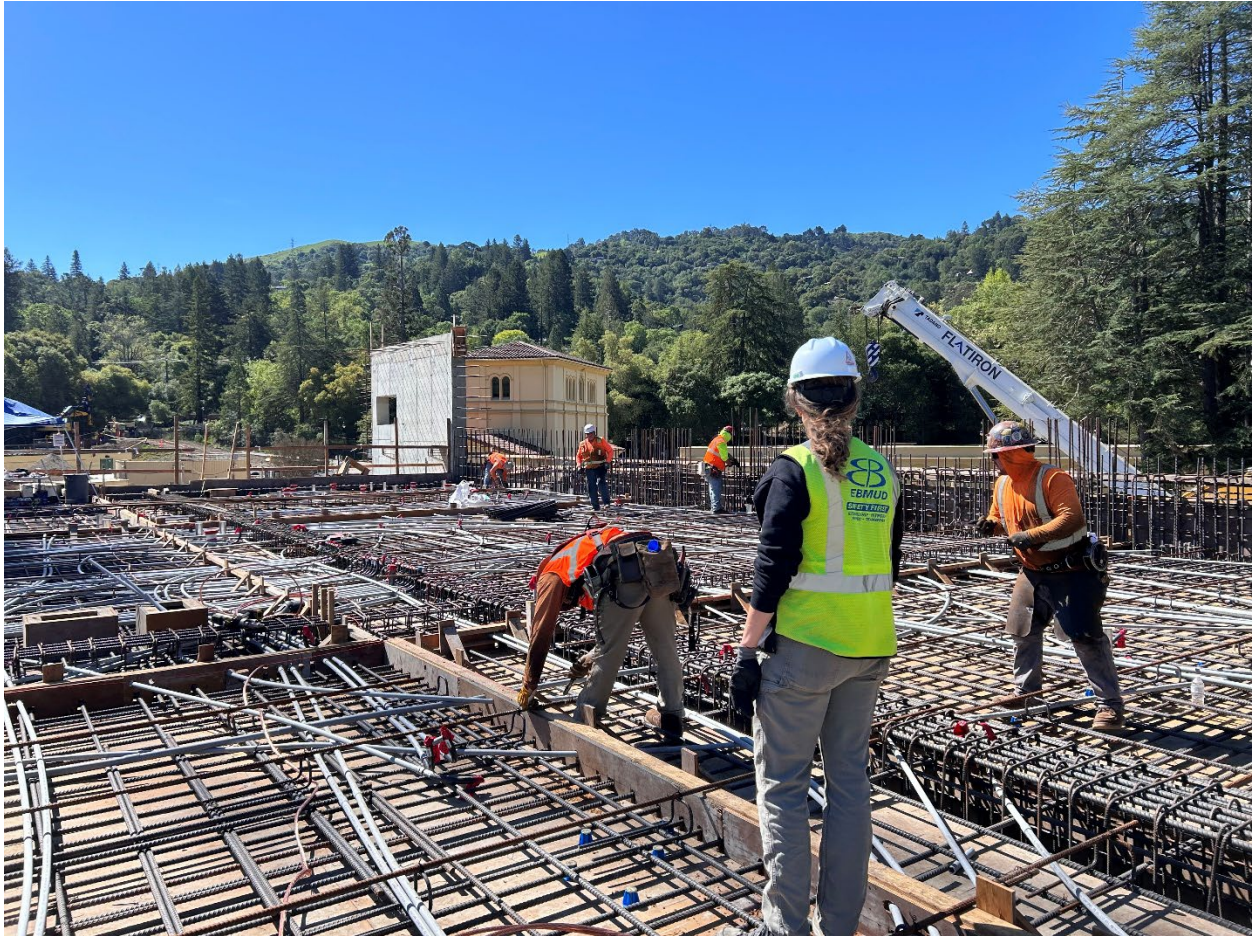
*Figure 24 – Engineer inspecting ironworkers as they place the second layer of reinforcing steel for the second floor of the MAUVE Building north end.*

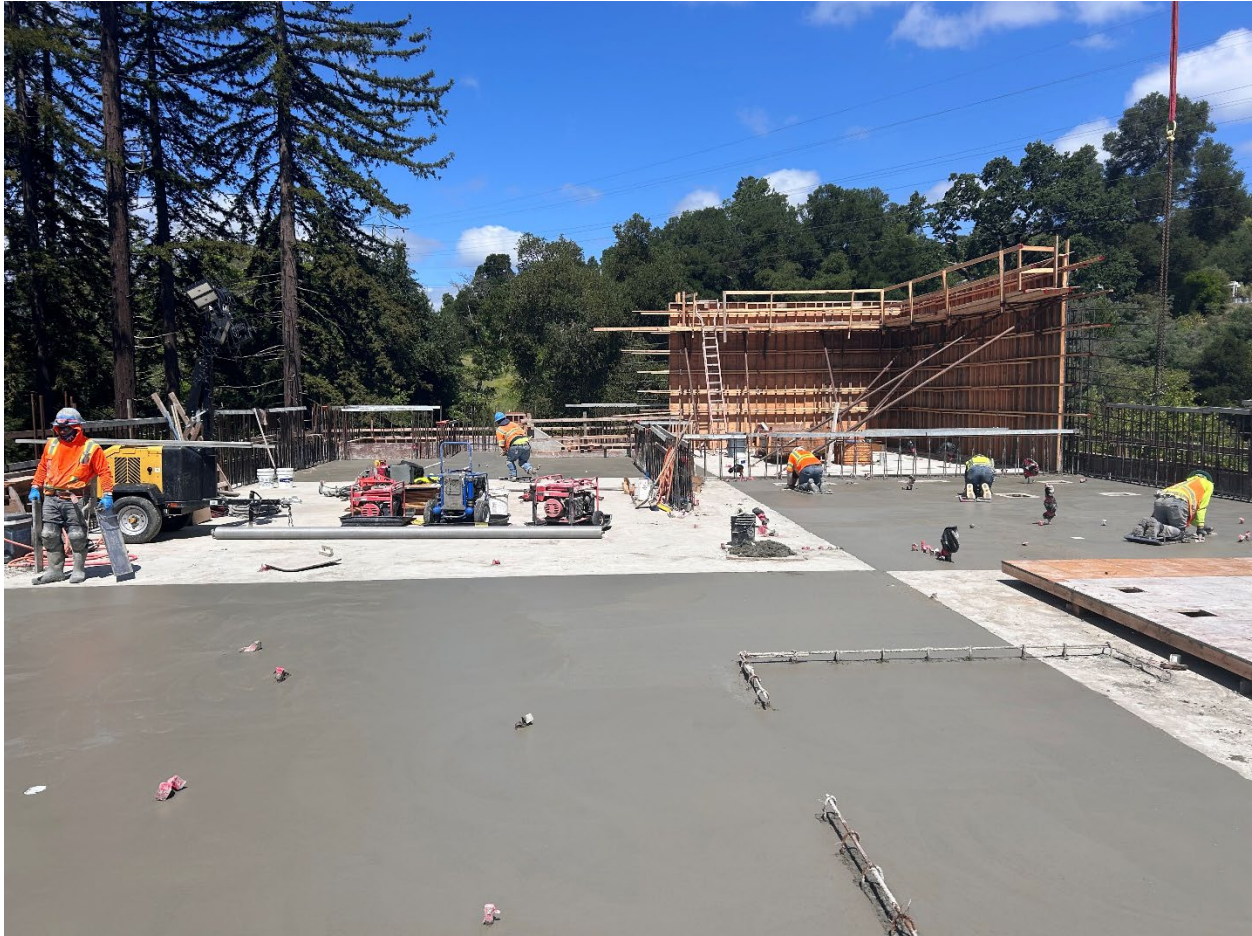
*Figure 25 – Workers finishing concrete for the second floor of the MAUVE Building north end.*

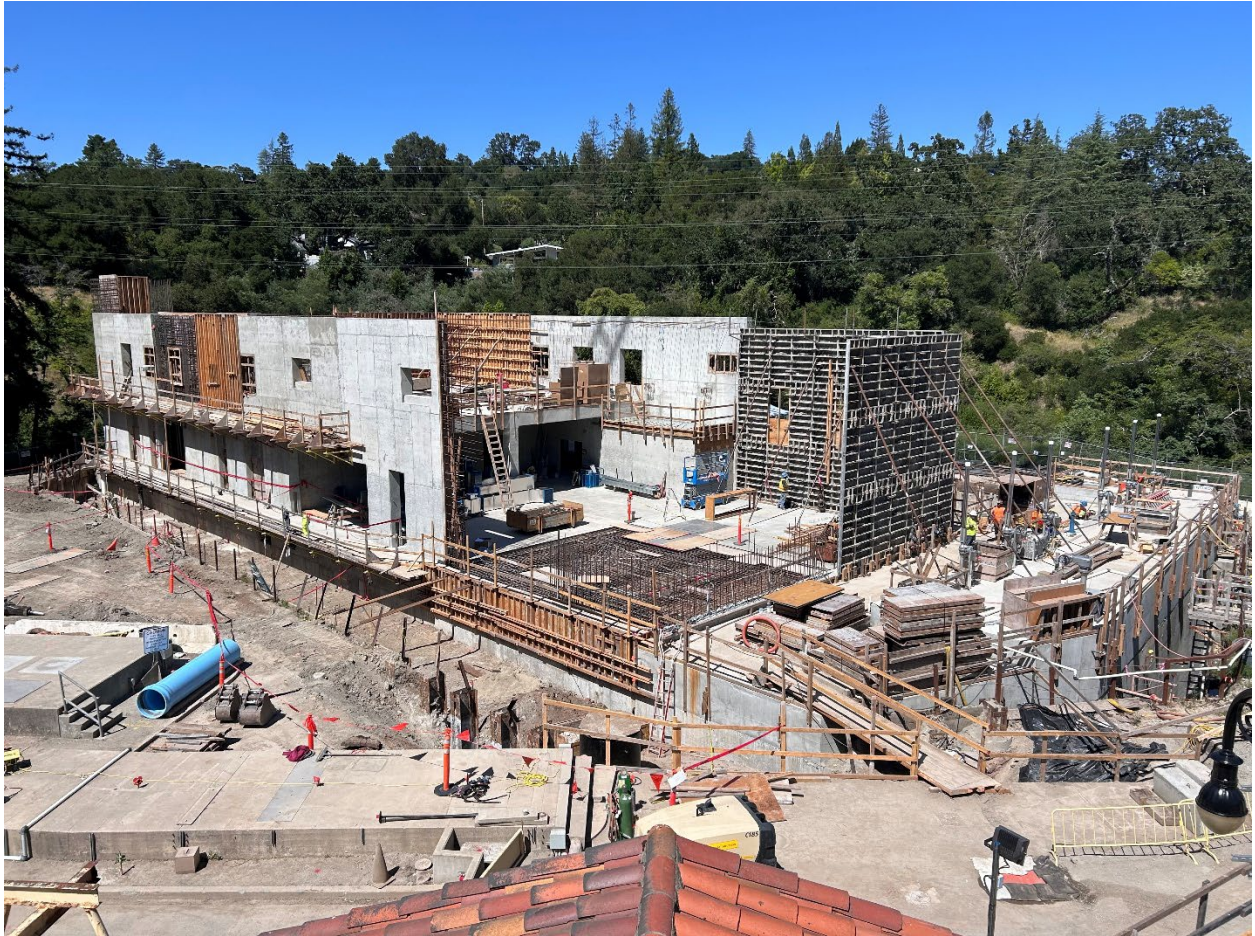
*Figure 26 – View of the MAUVE Building south end walls under construction.*

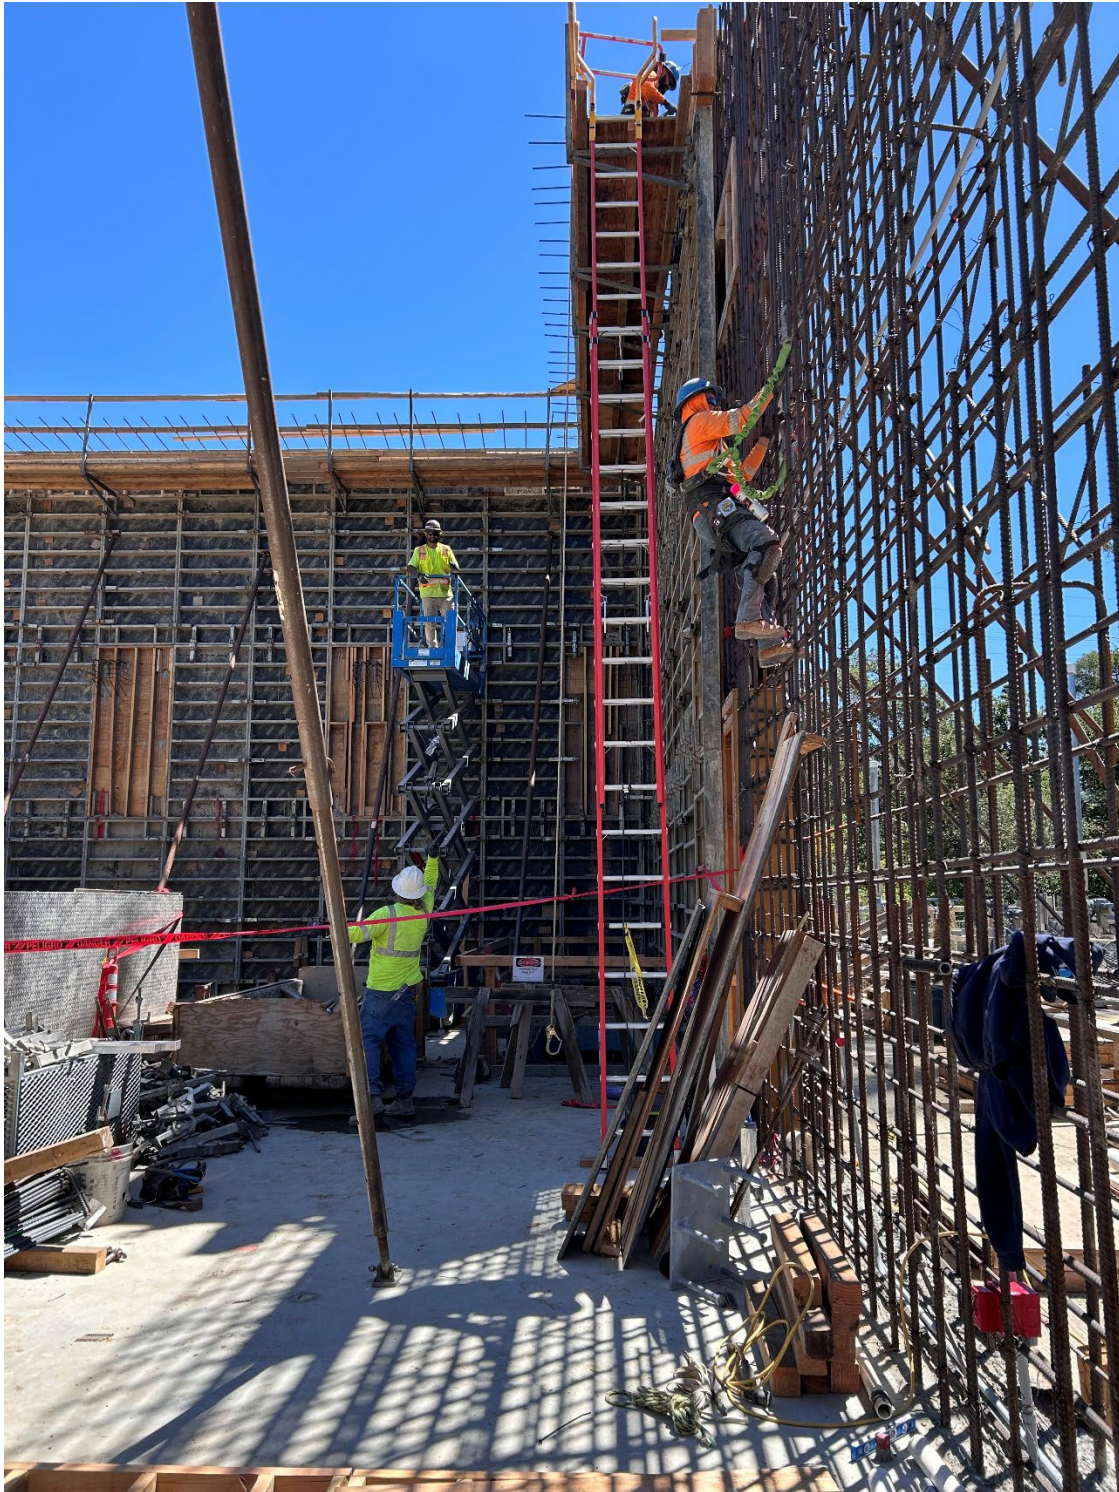
*Figure 27 – Ironworker placing reinforcing steel wall curtain for MAUVE Building south end concrete walls.*

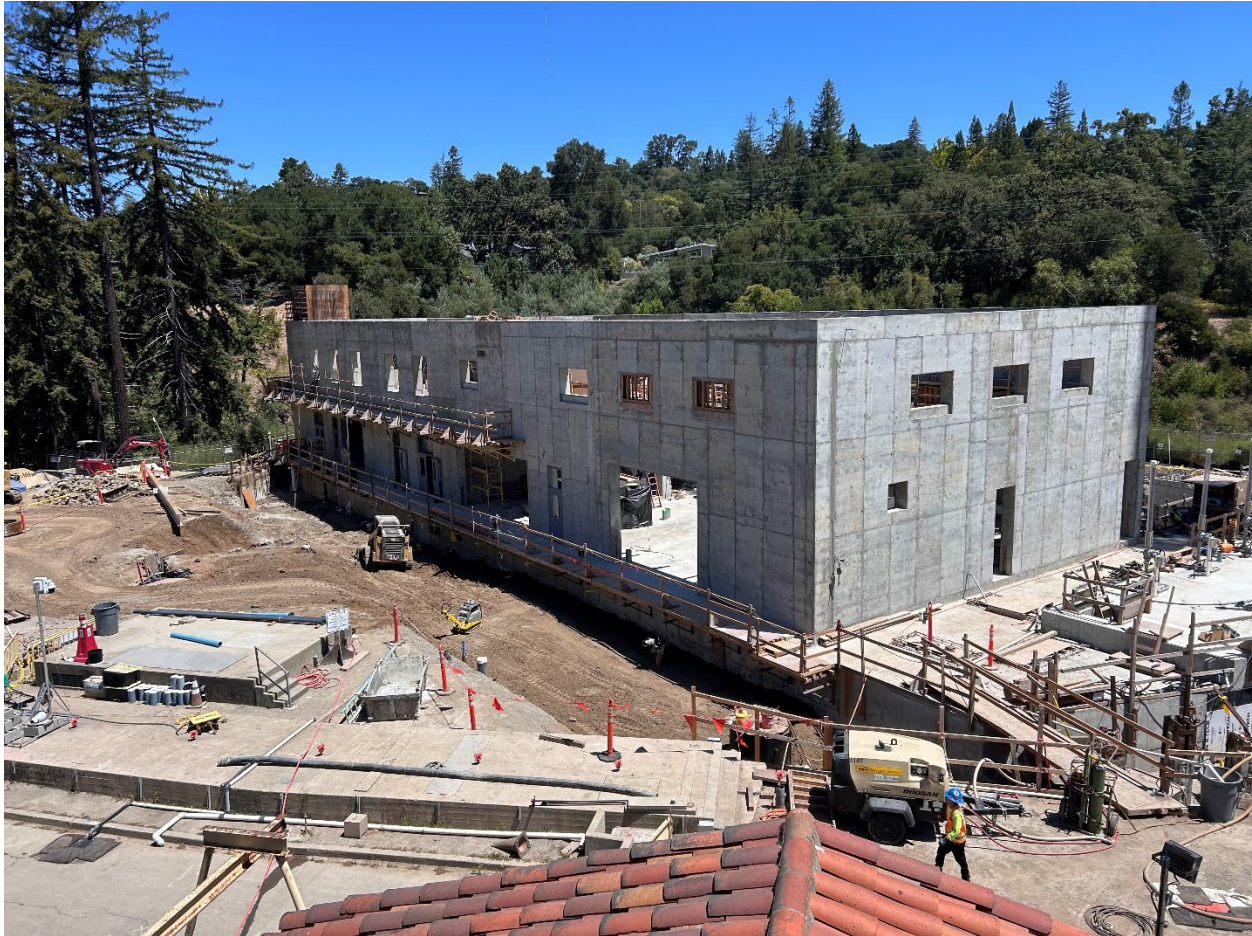
*Figure 28 – View of MAUVE Building concrete shell completed. This includes both the south and north ends.*

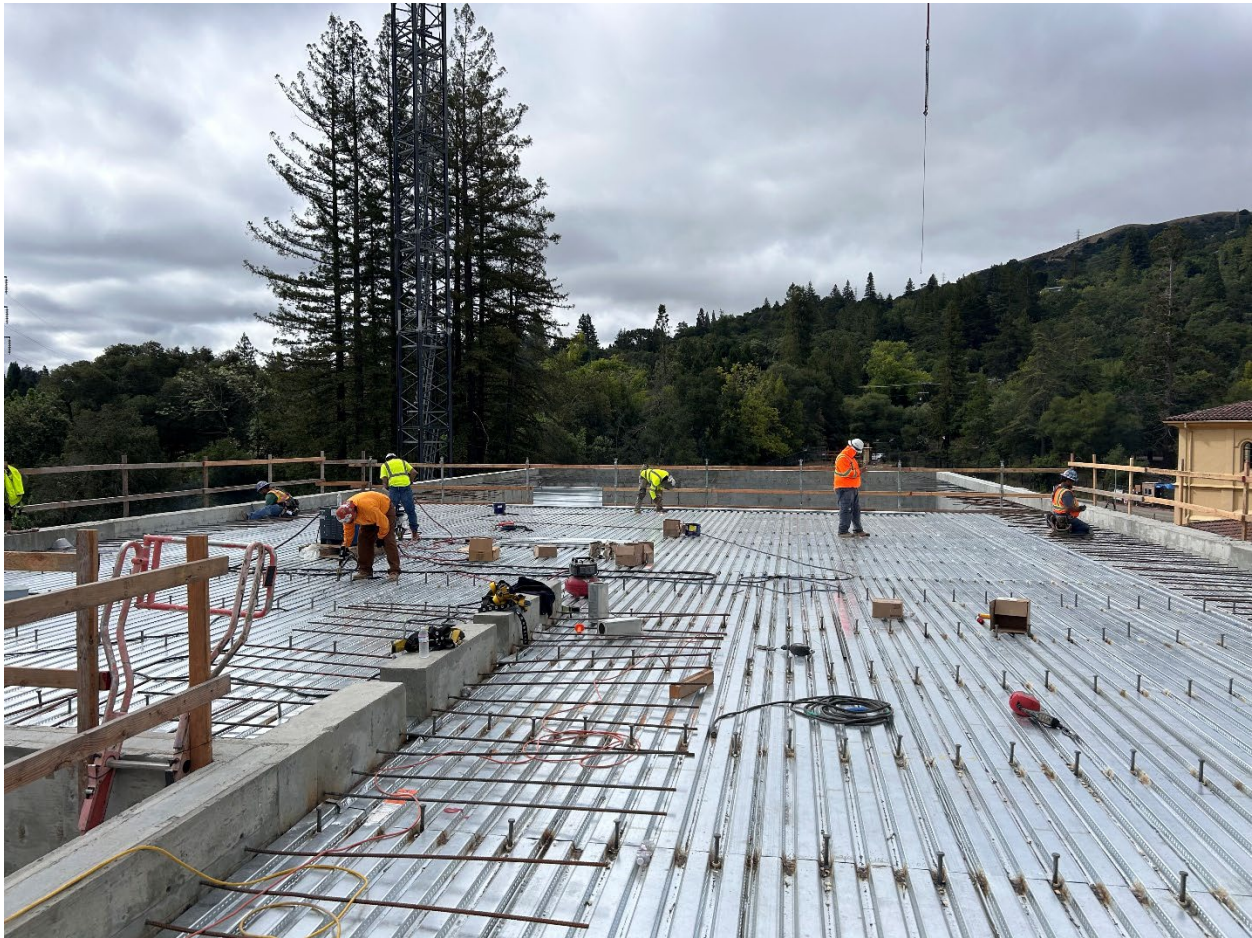
*Figure 29 – View of ironworkers placing metal pan deck which will support the MAUVE Building north end roof.*

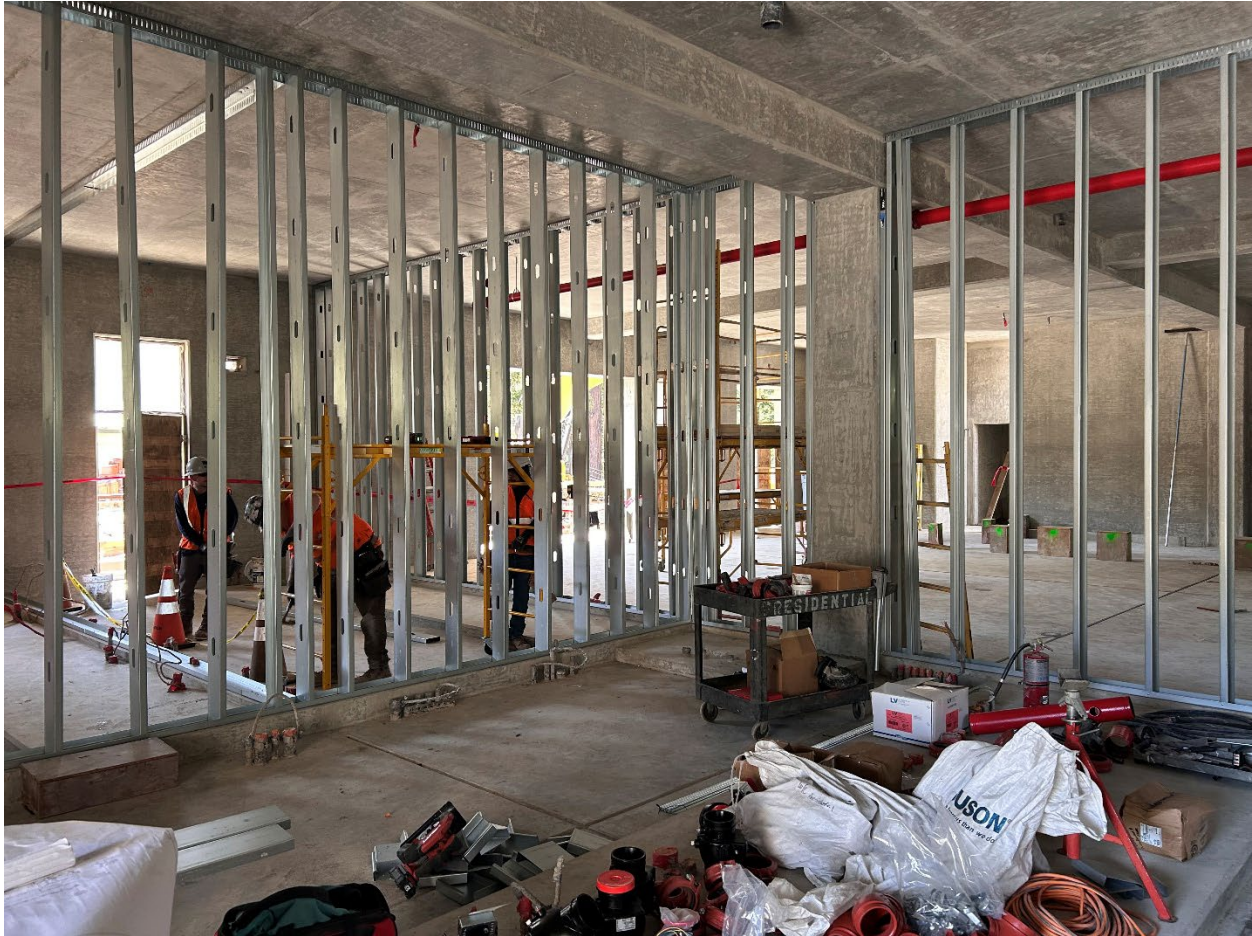
*Figure 30 – View of carpenters installing metal stud interior walls on the first floor of the north end.*

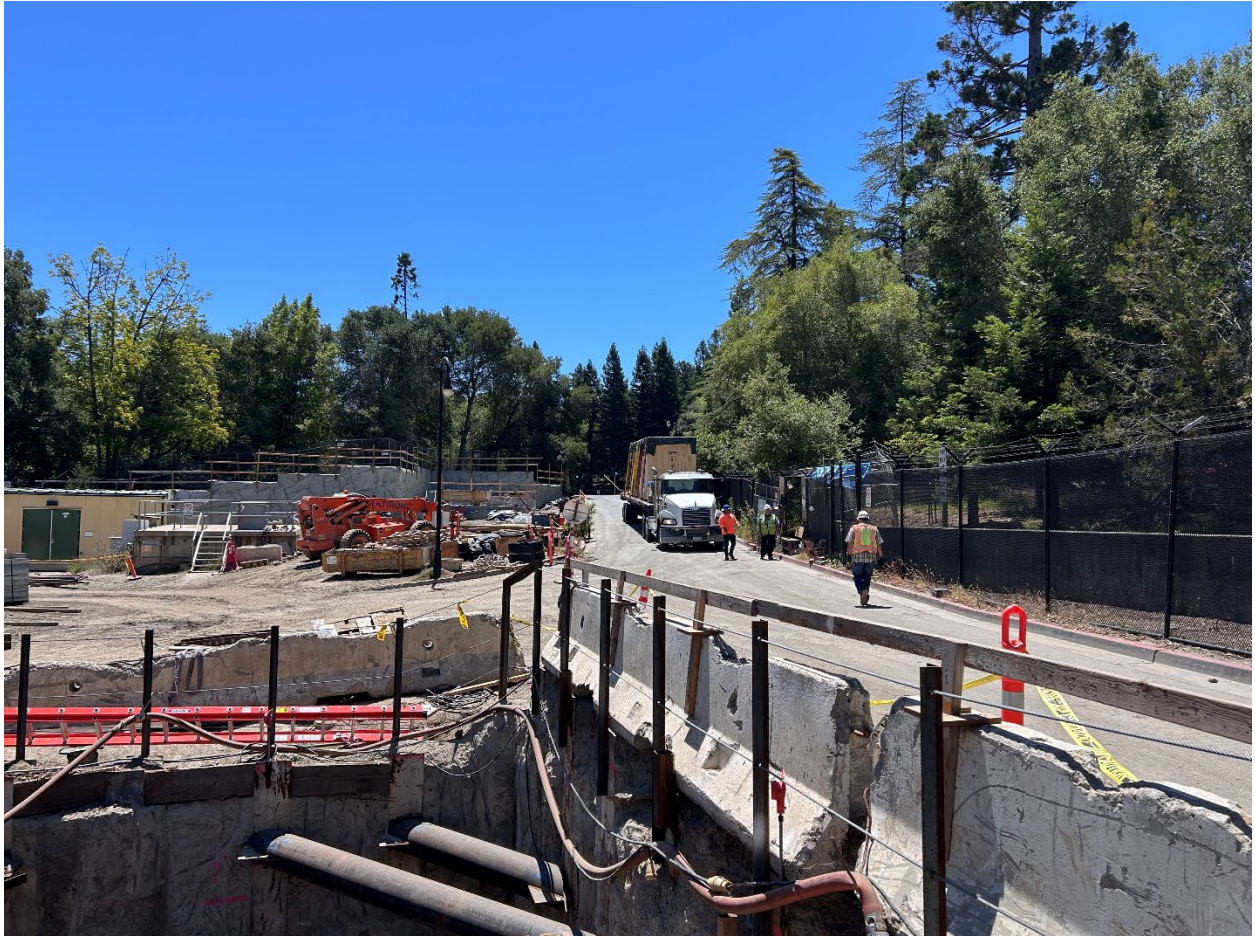
*Figure 31 – View of big rig truck delivering the first two UV disinfection vessels from Germany. The District initiated procurement of these vessels six years ago.*

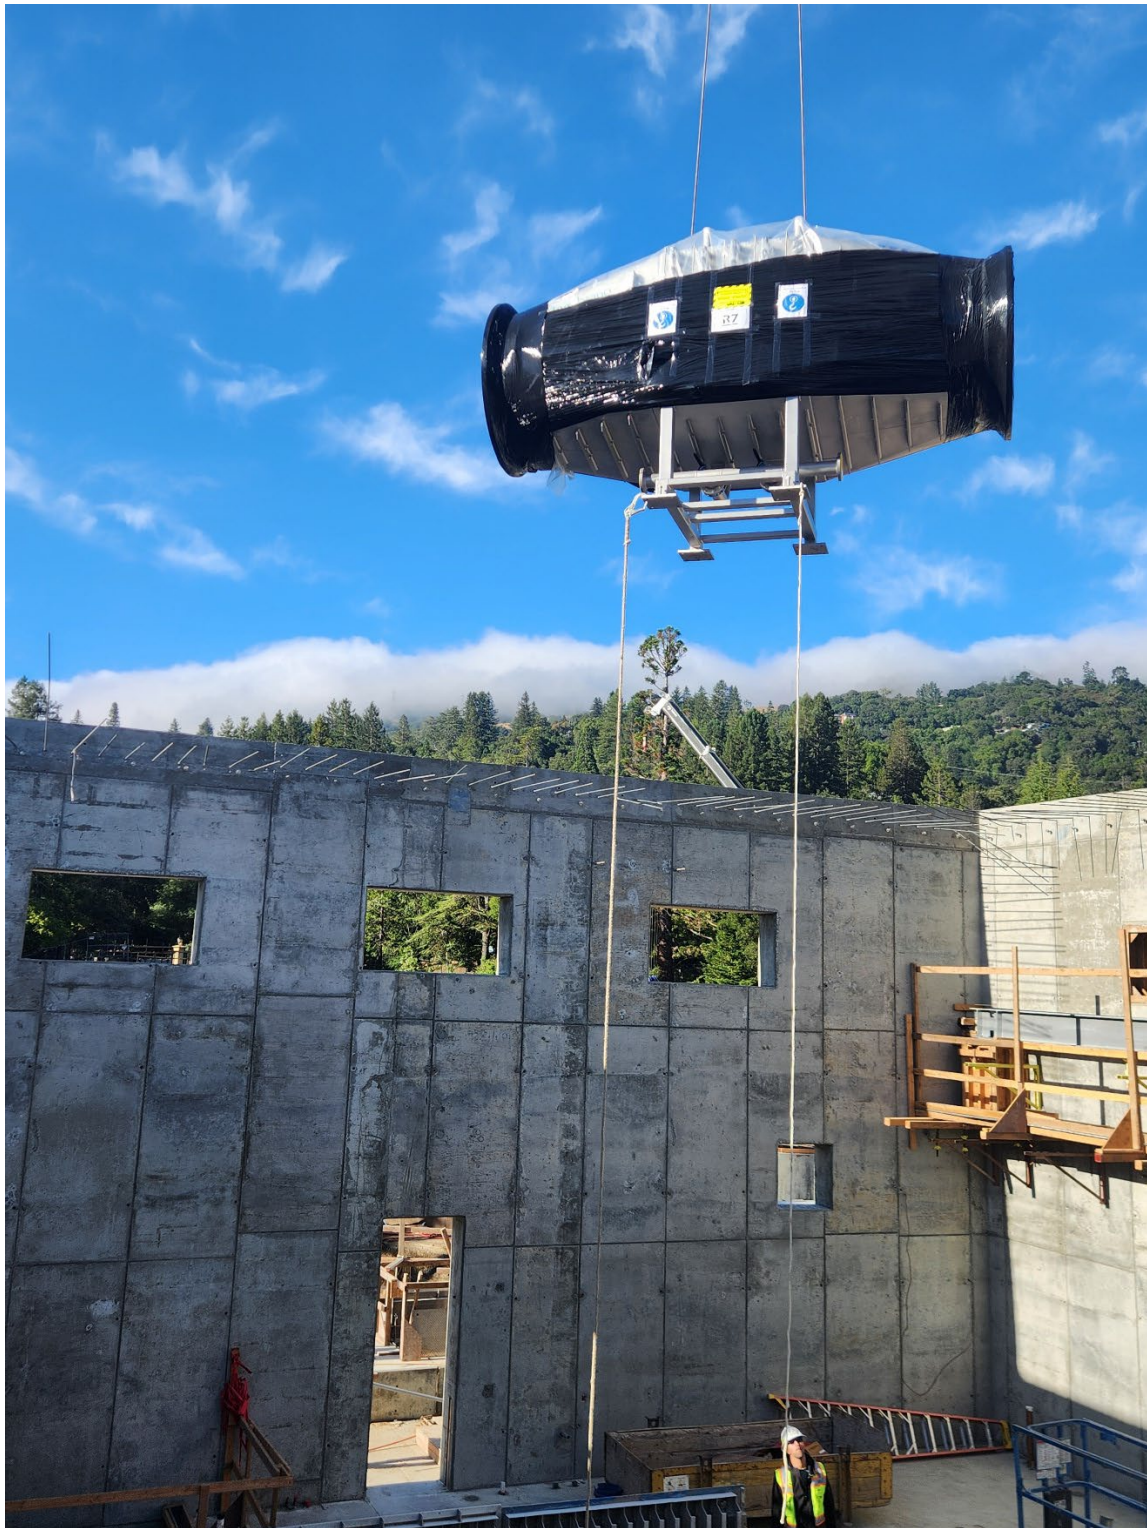
*Figure 32 – View of crane lifting first ultraviolet disinfection vessels into the MAUVE Building.*

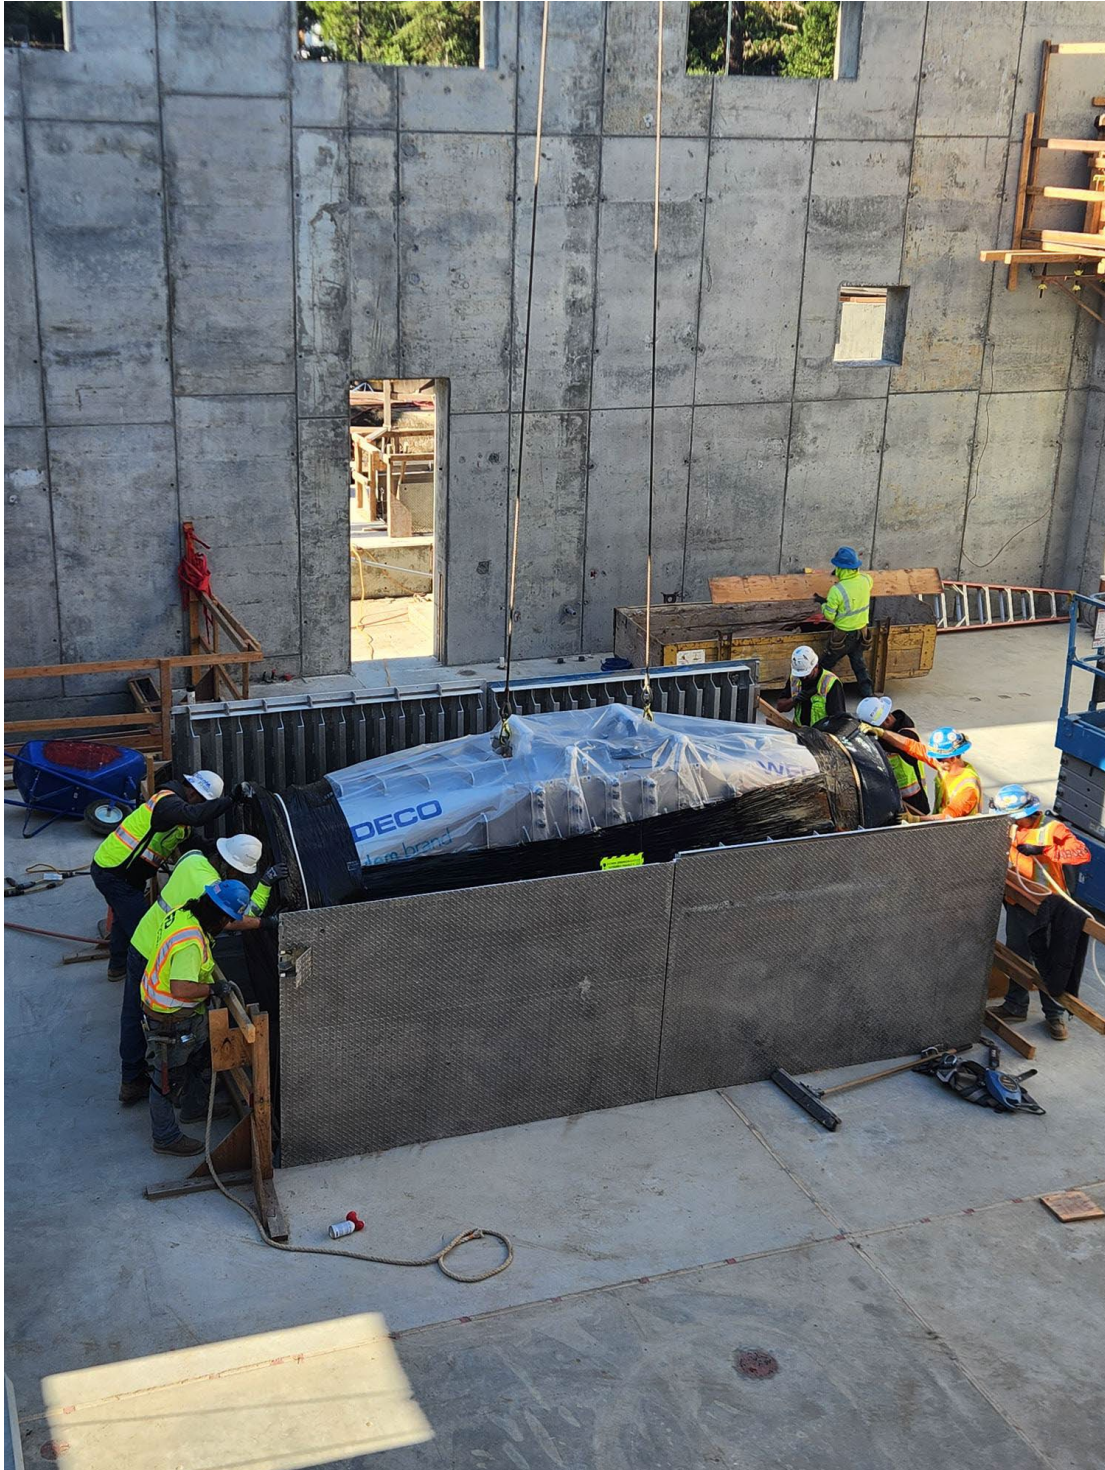
*Figure 33 – Closeup view of crane lowering first UV disinfection vessel through the access hatch in the first floor of the MAUVE Building with the careful guiding hands of many workers.*

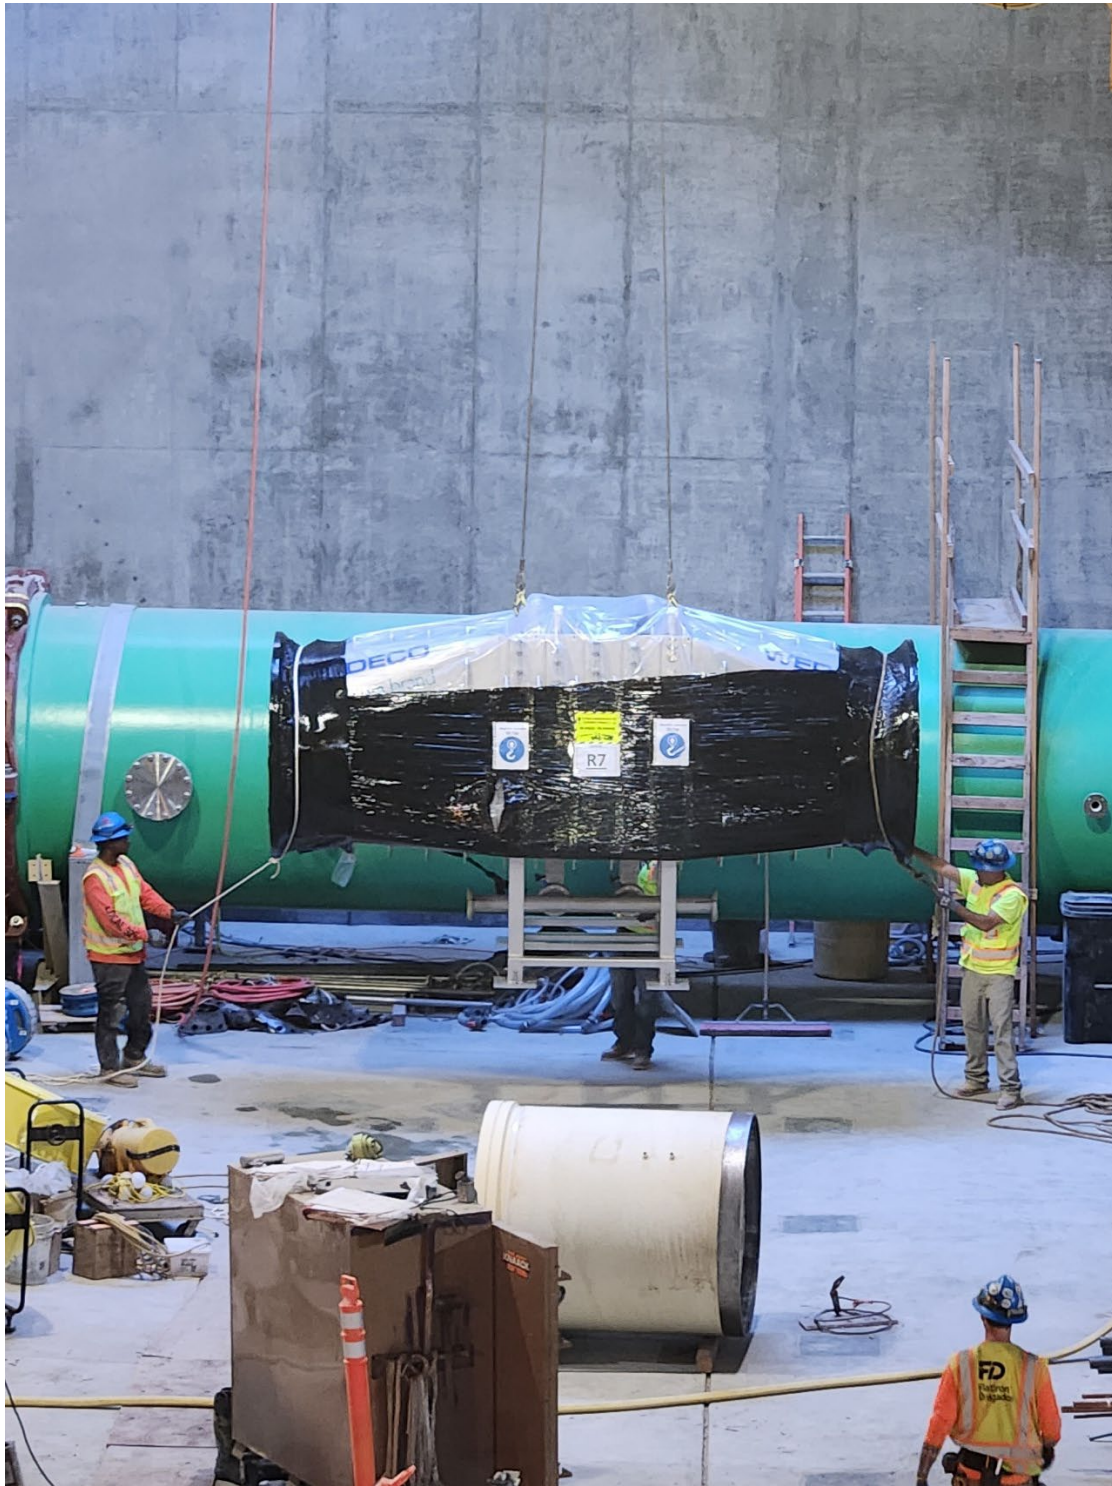
*Figure 34 – Closeup view of crane lowering first UV disinfection vessel onto the floor of the UV Room. The access hatch in the first floor of the MAUVE Building is above the workers. The 84-inch green bypass piping can be seen in the background.*

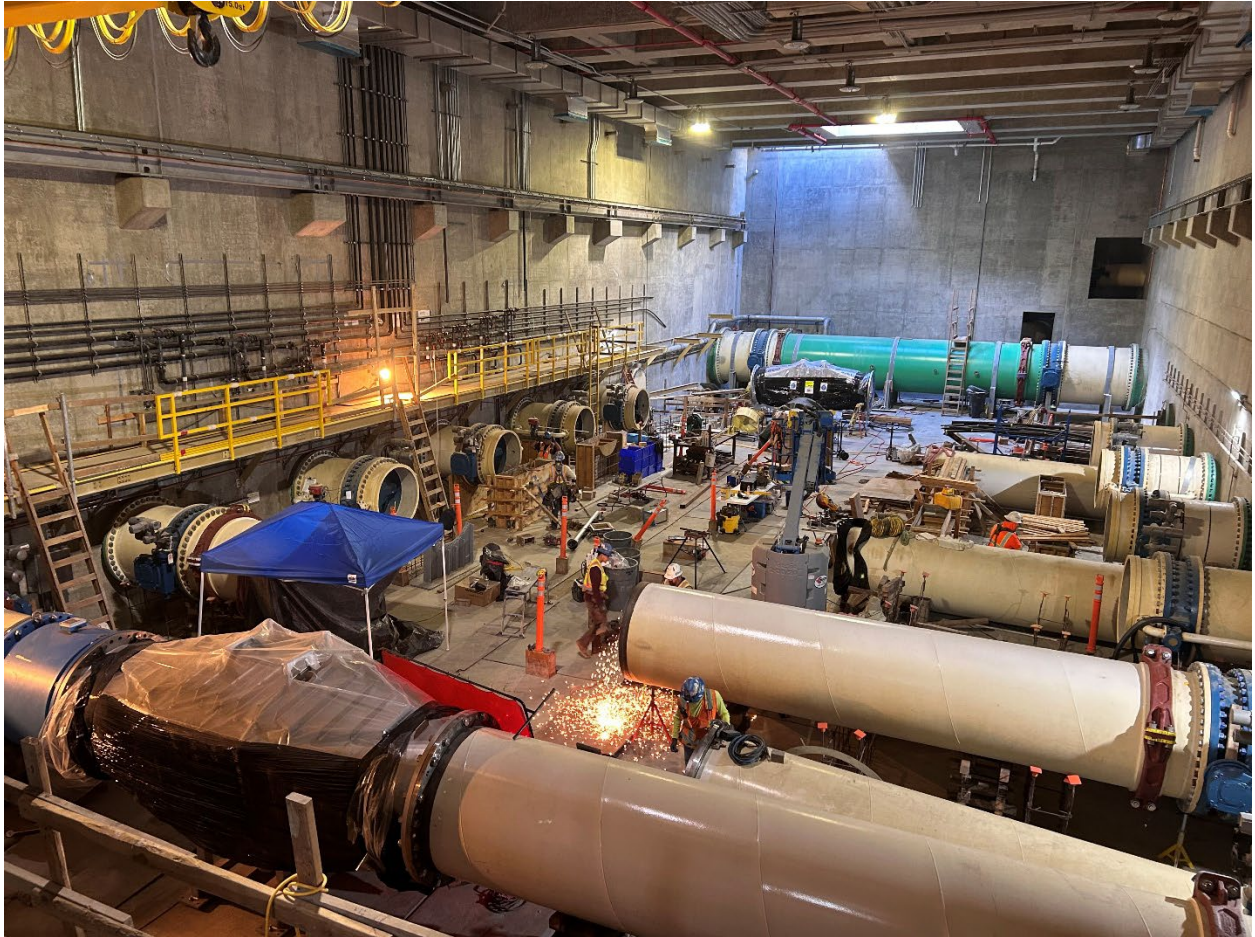
*Figure 35 – Pipefitters installing connecting piping to the first UV disinfection vessel in the UV Room.*
