**EAST BAY MUNICIPAL UTILITY DISTRICT
QUARRY SITE RESTORATION PROJECT
WETLAND DELINEATION REPORT**

JULY 2021

This Wetland Delineation Report (report) presents the results of an assessment of jurisdictional waters for the East Bay Municipal Utility District (EBMUD) Quarry Site Restoration Project (Project). EBMUD is considering the property as a permanent storage site for trench soils and for long-term restoration opportunities. This delineation was conducted to determine the water features within the approximately 3-acre survey area that are within the jurisdictions of the following agencies:

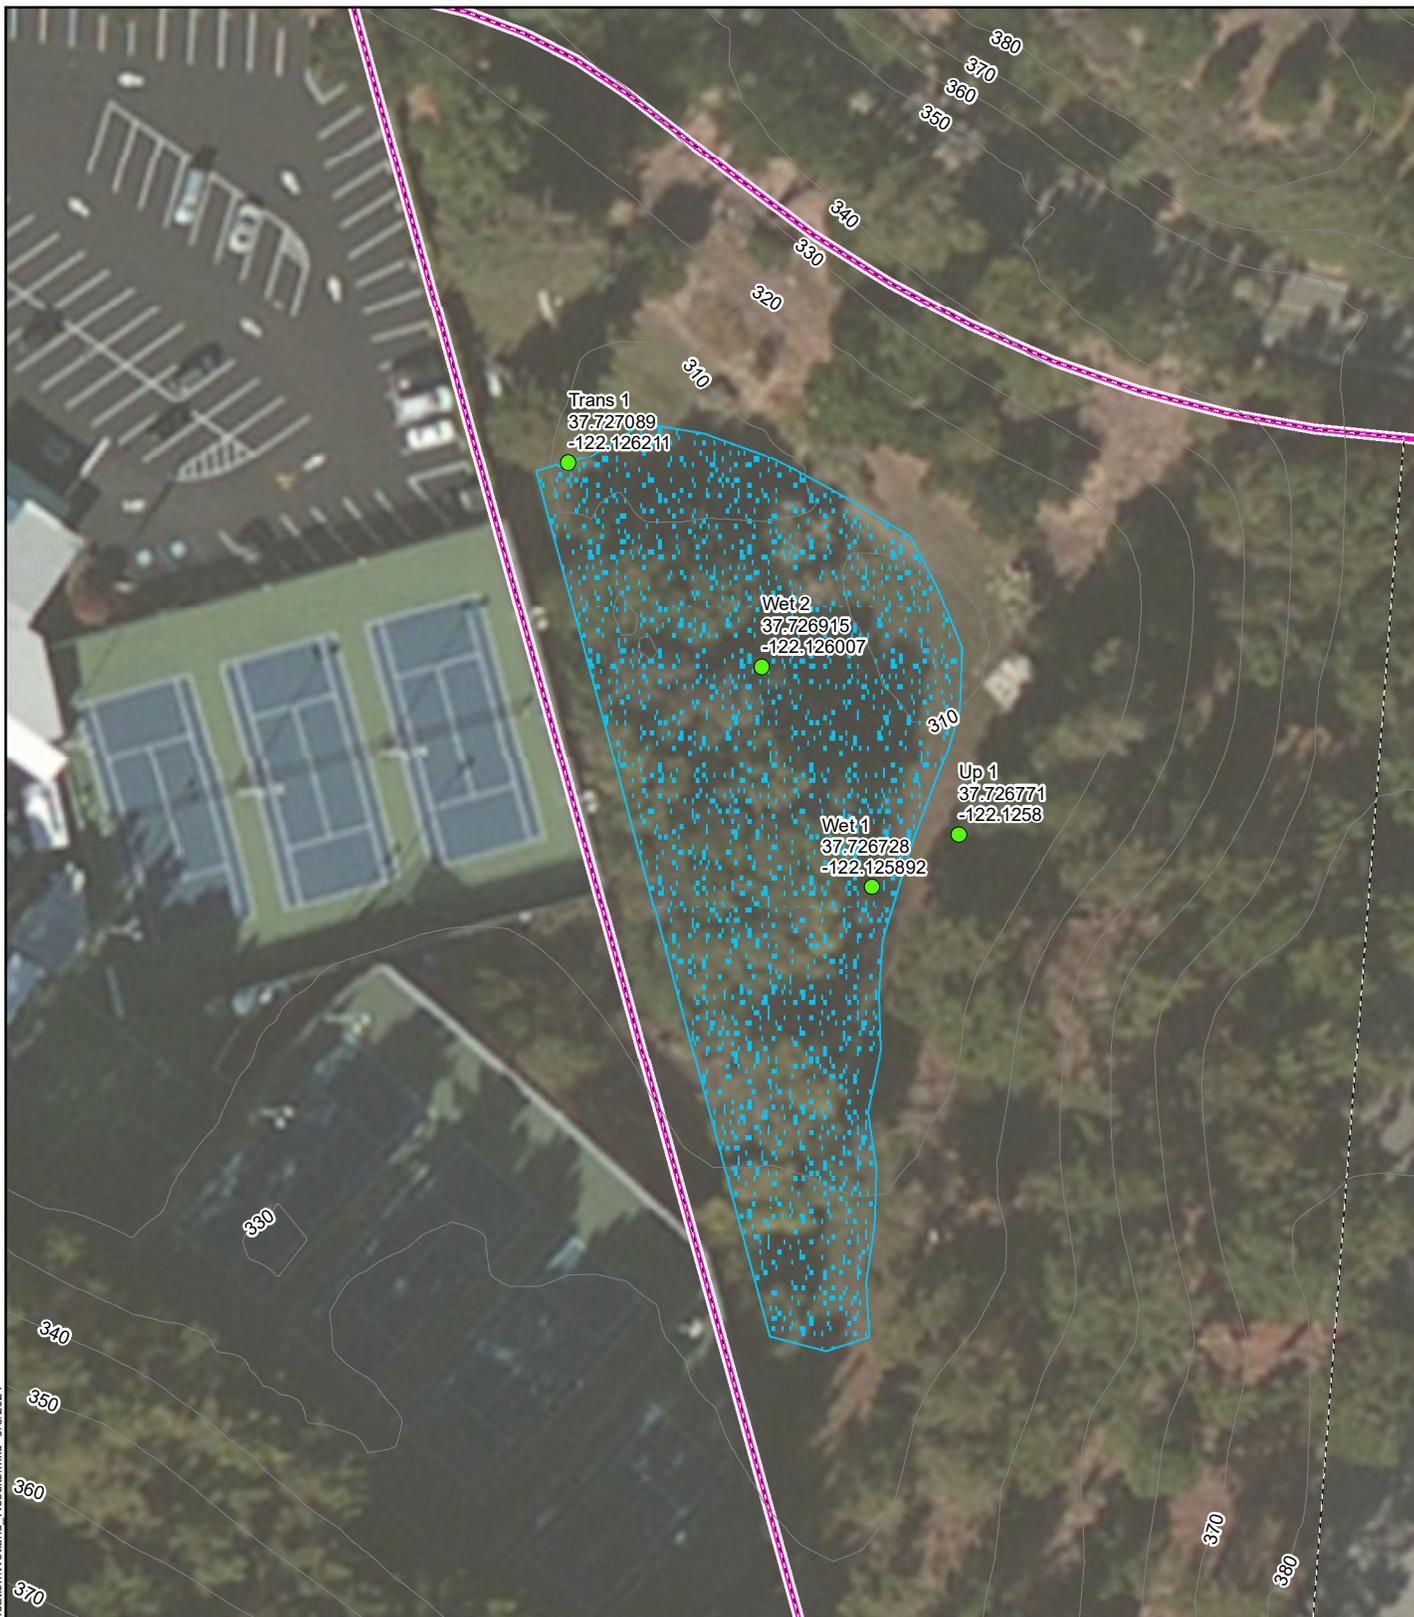
Figure 2: Wetland Delineation Results Map

One seasonal forested wetland feature was mapped within the survey area, as depicted in **Figure 2: Wetland Delineation Results Map** and as shown in **Table 1: Wetlands within the Survey Area**. Of the four sampling points from which data were collected, two sampling points (i.e., Wet 2 and Wet 1) were determined to be in the wetland. Sampling point Wet 2 represented the conditions within the majority of the wetland. Sampling point Wet 1 was located on the periphery of the wetland and represented a different vegetation community and hydrological conditions. Sampling point Trans 1 was collected in the approximate location where the wetland transitioned into an upland. Sampling point Up 1 was located in a clear upland area that had no wetland indicators.

Based on current regulations, this wetland is not under the jurisdiction of the United States Army Corps of Engineers or the California Department of Fish and Wildlife

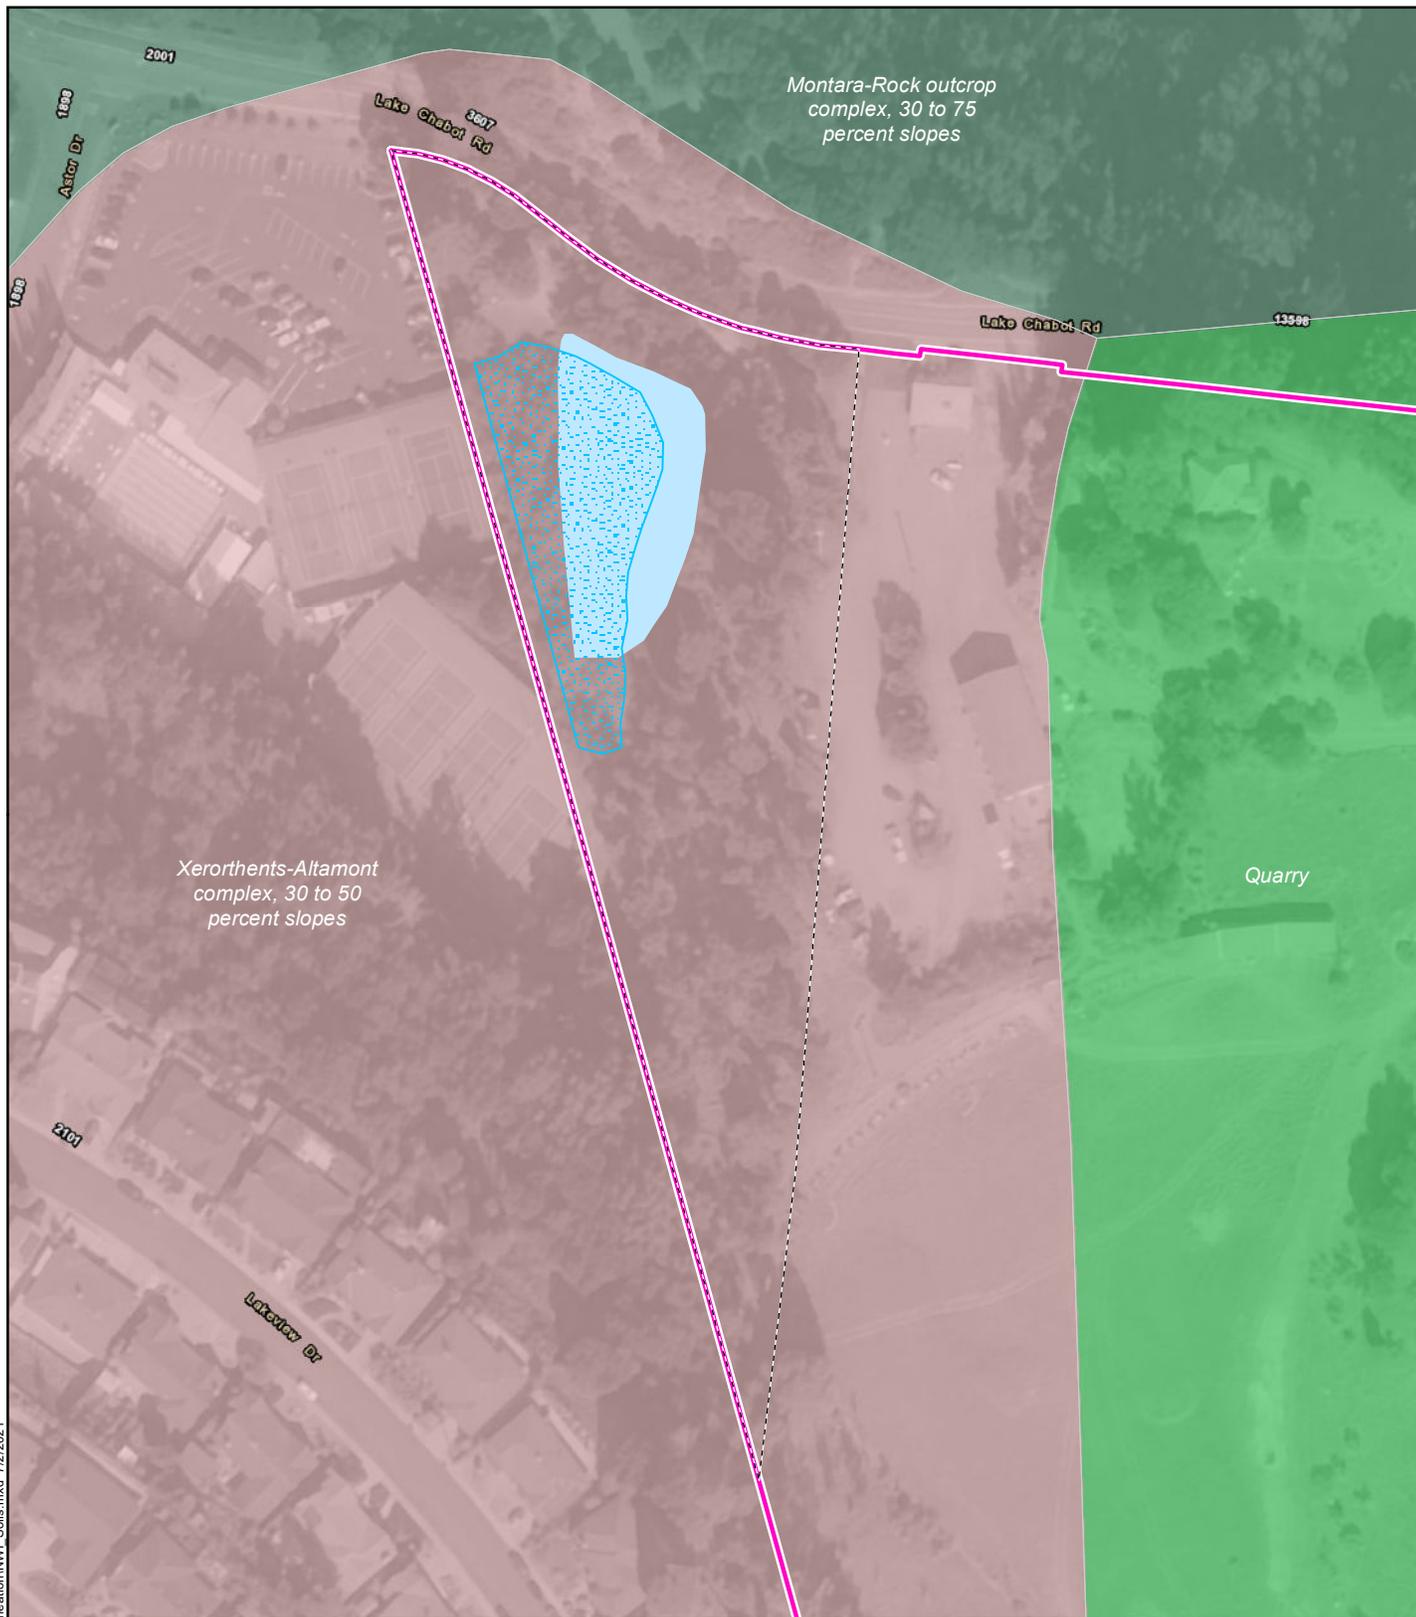
Figure 3: Soils and NWI Map

The NRCS soil type and NWI classification of the survey area are shown in **Figure 3: Soils and NWI Map**. The wetland determination data forms used in the delineations are provided in **Attachment A: Wetland Determination Data Forms**. Photographs of the survey area and sampling points are included in **Attachment B: Photographs**. The plant species observed in the survey area are presented in **Attachment C: Plant List**. The USACE's Aquatic Resources Spreadsheet for the project is provided in **Attachment D: Aquatic Resources Spreadsheet**. Detailed descriptions of each sampling point are provided in the following subsections.

1. Based on current regulations, this wetland is not under the jurisdiction of the United States Army Corps of Engineers or the California Department of Fish and Wildlife

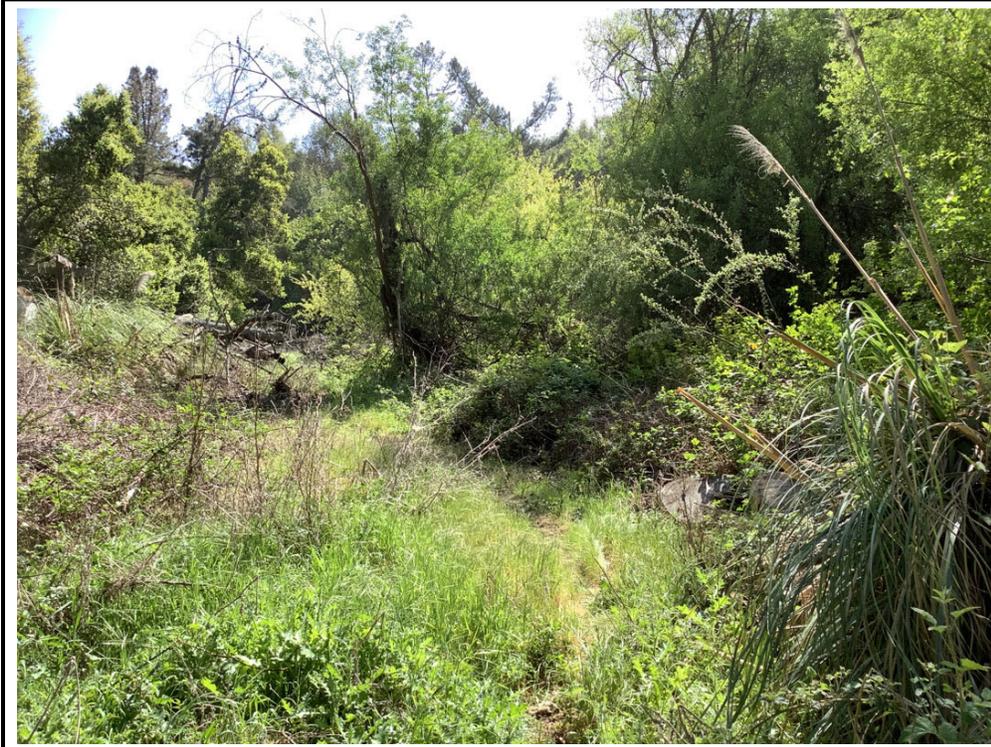
Photograph 1:
General site
photo, facing
south. The
forested wetland
is shown in the
right side of the
photograph, and
the toe of the
slope shown on
the left side of
the photograph.

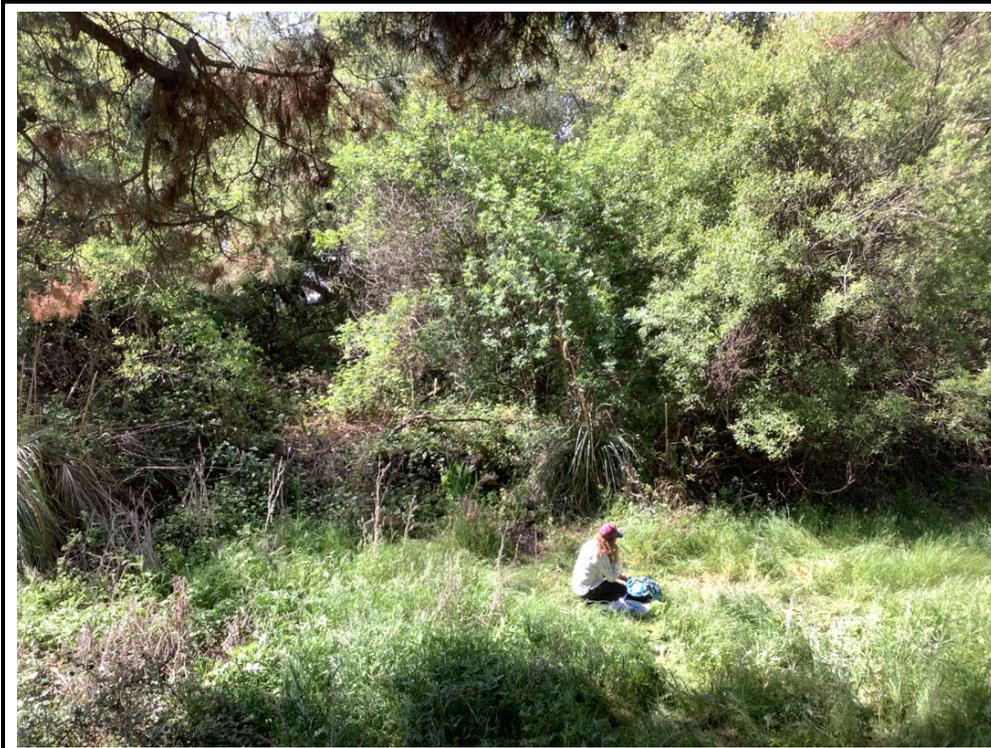
Photograph 2:
General site
photo, facing
west, with the
forested wetland
in the
background.

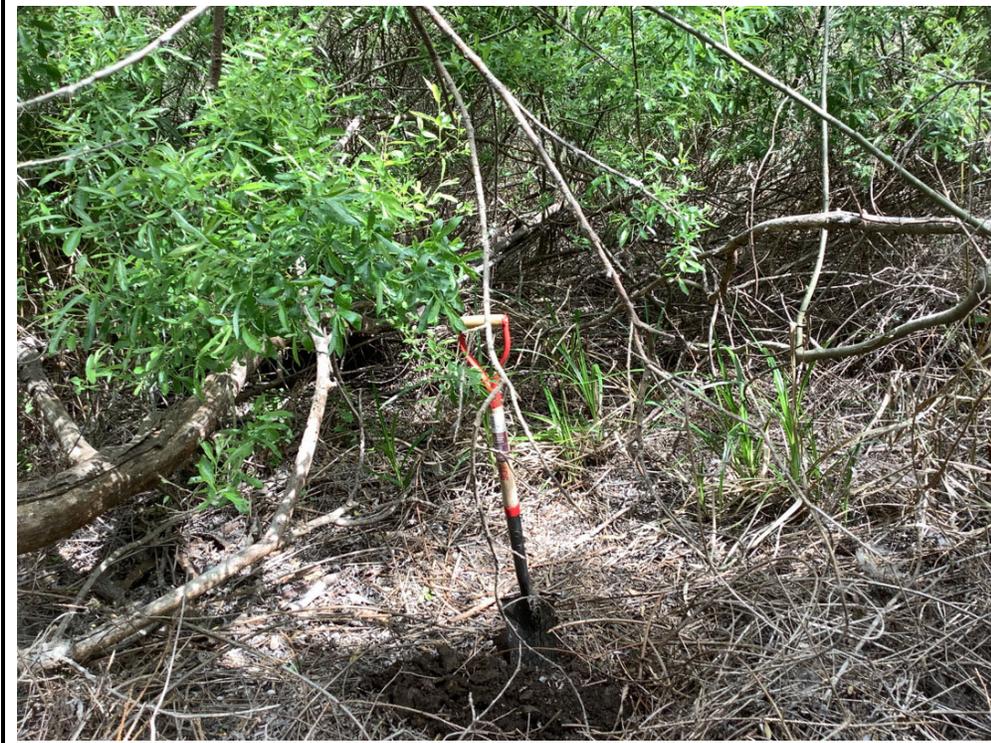
Sampling point Wet 2 represents the vegetation, soil, and hydrology conditions in the majority of the wetland. Based on the indicators, the area represented by Wet 2 was approximately 0.48 acre of seasonal forested wetland. The local relief of the wetland was flat and the slope was 0 percent, but the wetland was located at the toe of a steep slope to the east.

The dominant vegetation was arroyo willow (FACW), California blackberry (*Rubus ursinus*; FAC), and pampas grass (*Cortaderia* sp.; FACU). California bulrush (*Schoenoplectus californicus*; OBL) was also present. The vegetation passed the dominance test and the prevalence index, indicating that it is hydrophytic.

Photograph 3:
View of
sampling point
Wet 2, facing
north.

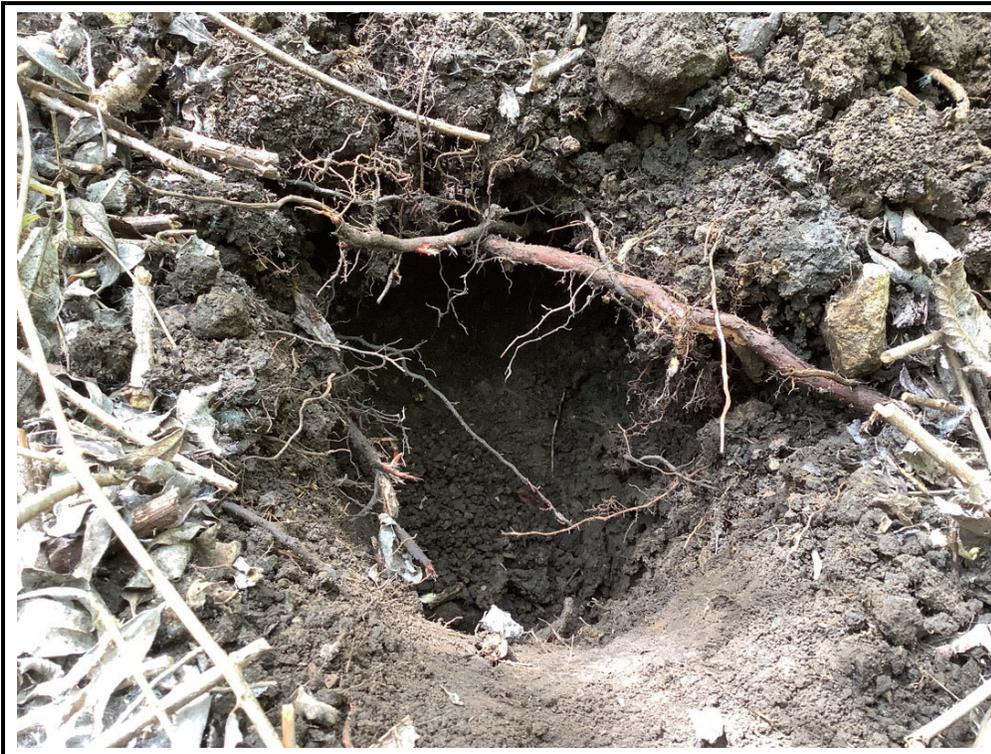
of the 11-inch-deep soil sample was very dark gray (10YR 3/1) with 5-percent redox concentrations in the matrix. The texture was silty clay loam, and the hydric soil indicator was redox dark surface (F6).

Photograph 4:
View of the Wet
2 soil pit.

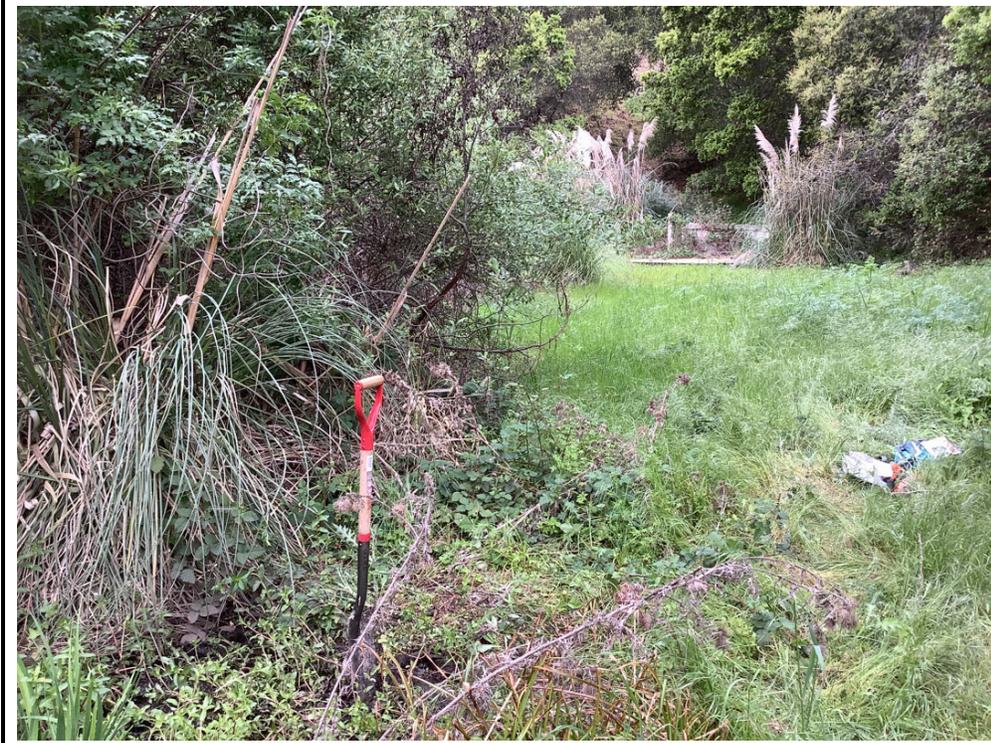
Sampling point Wet 1 represents a different vegetation community, soil type, and hydrology within the larger wetland typified by Wet 2. This sampling point is located on the periphery of the wetland. The area represented by Wet 1 was approximately 2 square feet (i.e., less than 0.001 acre). The local relief at the sampling point was flat and the slope was 0 percent, but the site was located at the toe of a steep slope.

The vegetation at this sampling point was dominated by the herb stratum, and species were relatively evenly distributed. The one dominant plant species was American brooklime (*Veronica americana*; OBL). Wild strawberry (*Fragaria vesca*; UPL), California blackberry, English ivy (*Hedera helix*; FACU), pampas grass, ripgut brome (*Bromus diandrus*; NL), and California bulrush were also present. Approximately 53 percent of the sampling plot contained bare ground. The vegetation passed the dominance test, indicating that it was hydrophytic.

The wetland hydrology indicators at this sampling point were Surface Water (A1), High Water Table (A2), and Saturation (A3). The surface water only covered an area of approximately 2 square feet. The high water table in this small area indicates the presence of a small seep, but this perennial wetland is in a flat area, so the water does not appear to feed the larger seasonal wetland described in **Section 5.0.0 Wet 2** in a meaningful way. Although this very small area may be perennially saturated, it was not delineated as a separate feature because it was part of the seasonal forested wetland feature.

Photograph 5:
View of
sampling point
Wet 1, facing
north.

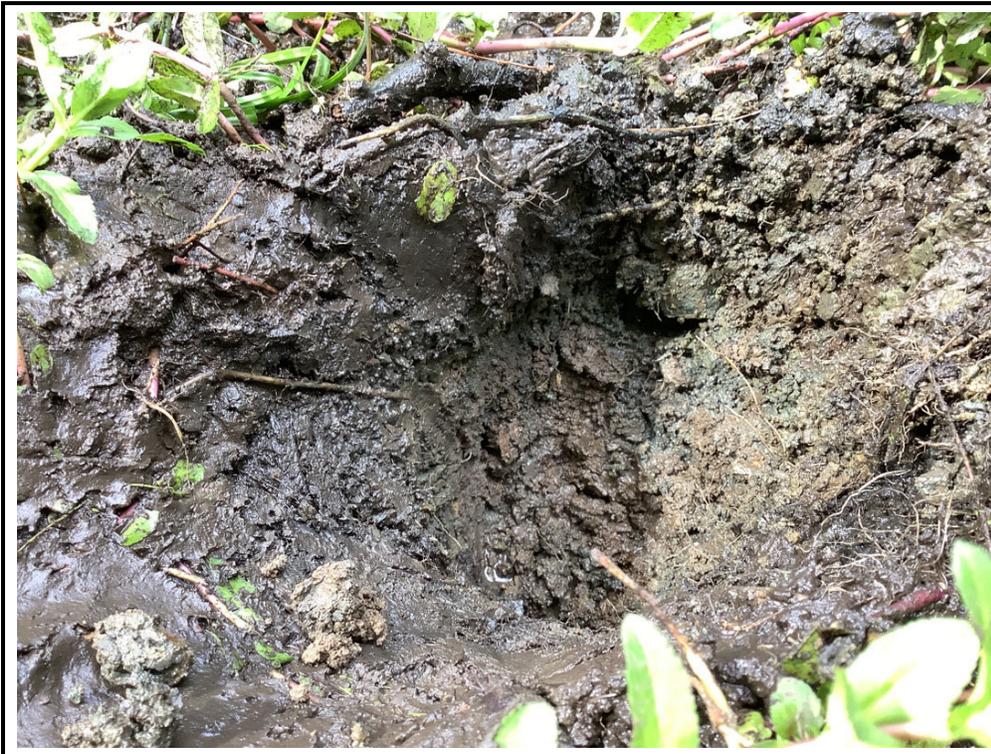
The soil map unit (i.e., Xerorthents-Altamont complex, 30- to 50-percent slopes) is not considered hydric, based on the Soil Data Access Hydric Soils List (NRCS 2021a). The entire 10-inch soil profile was saturated by groundwater. The soil color was dusky red (10YR 3/2), with no redox features. The texture was sandy loam, and no hydric soil indicators were present.

Photograph 6:
View of the Wet
1 soil pit.

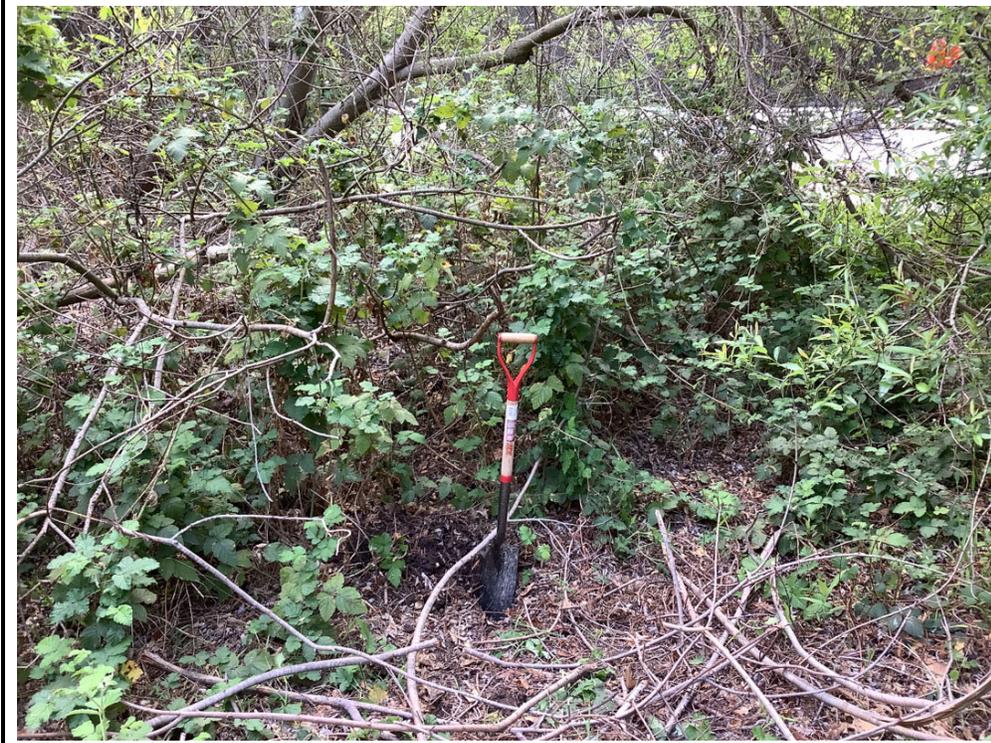
Sampling point Trans 1 was collected at the northern edge of the seasonal forested wetland, where it transitioned into an upland and met only one of the wetland parameters. The local relief at the sampling point was flat, and the slope was 0 percent. The sampling point was located at the toe of a very short and slight slope.

The vegetation was sparse and dominated by California blackberry and arroyo willow, with a very small percent cover of rice grass (*Stipa* sp.; NL). Bare ground covered approximately 82 percent of the sampling plot. The vegetation passed the dominance test and the prevalence index, indicating that it is hydrophytic.

Photograph 7:
View of
sampling point
Trans 1, facing
southwest.

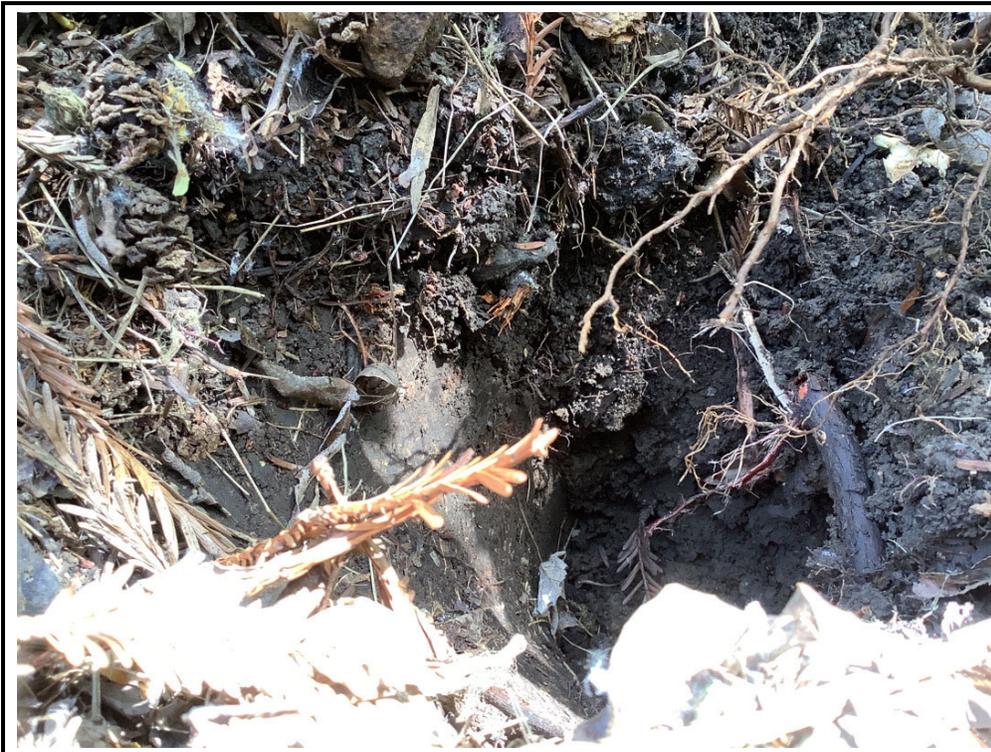
The soil map unit (i.e., Xerorthents-Altamont complex, 30- to 50-percent slopes) is not considered hydric, based on the Soil Data Access Hydric Soils List (NRCS 2021a). The soil sample was dusky red (10YR 3/2) and contained no redox features. The texture was loamy sand and did not have clear hydric indicators.

Photograph 8:
View of the
Trans 1 soil pit.

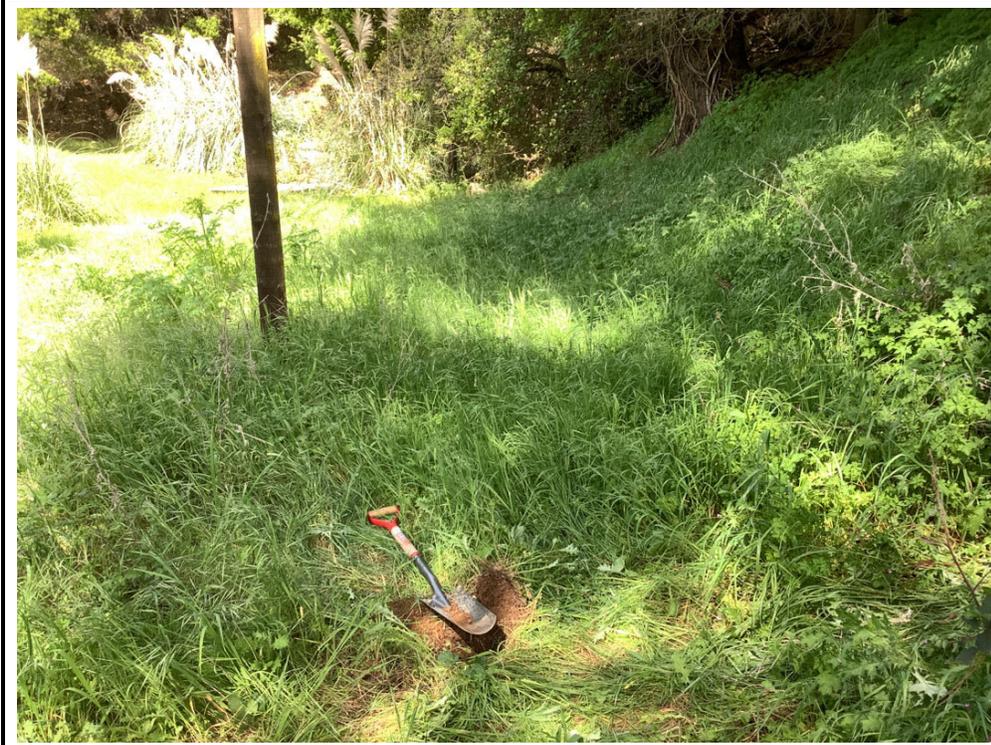
Sampling point Up 1 is an upland reference point located to the east of the wetland. The local relief was flat, and the slope was approximately 3 percent.

The vegetation was dense and covered primarily with non-native upland forbs. Dominant species were riggut brome and short fruited filaree (*Erodium brachycarpum*; NL), with lower covers of bull thistle (*Cirsium vulgare*; FACU), foxtail barley (*Hordeum murinum*; FACU), California blackberry, Himalayan blackberry (*Rubus armeniacus*; FAC), and poison oak (*Toxicodendron diversilobum*; FACU). The vegetation did not meet the conditions to be considered hydrophytic.

Photograph 9:
View of
sampling point
Up 1, facing
north.

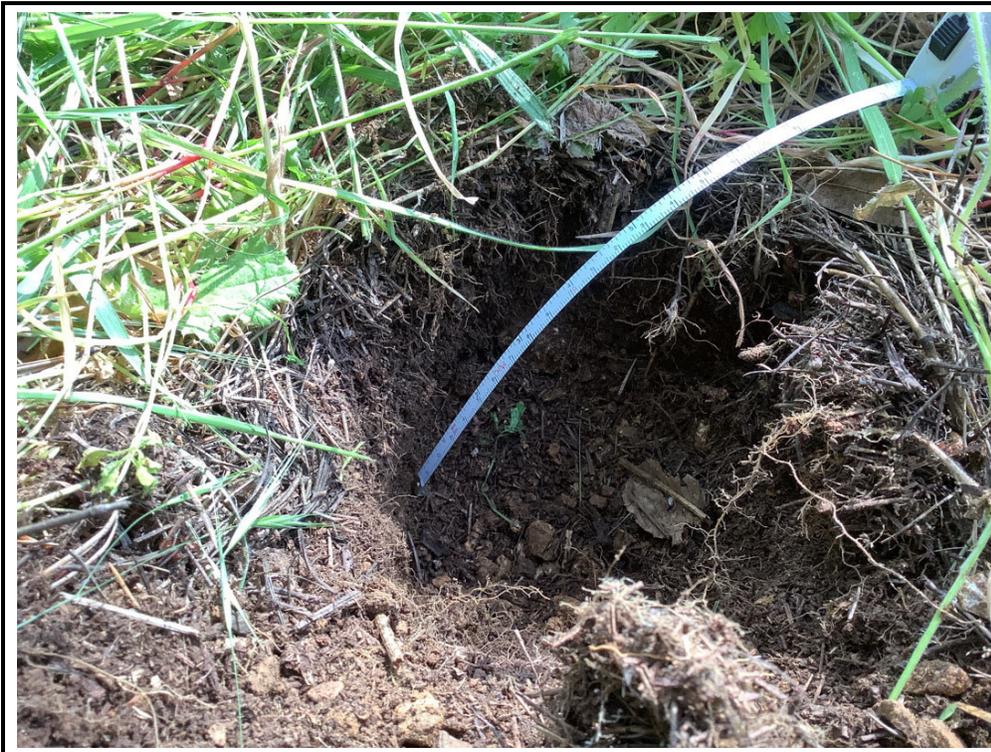
The soil map unit (i.e., Xerorthents-Altamont complex, 30- to 50-percent slopes) is not considered hydric, based on the Soil Data Access Hydric Soils List (NRCS 2021a). The soil was so rocky that the pit could only be dug to 4 inches. The soil sample was dusky red (10YR 3/3) with no redox features. The texture was loamy sand; the soil also contained a significant amount of organic content and had a similar consistency to a dry, peaty potting soil.

Photograph 10:
View of the Up 1
soil pit.
