RE: Mexican Gulch Slope Stability Study

Surface Displacement Rate of a Deep Seated Bedrock Topple at
Mexican Gulch
Calaveras County, California

D. Scott Kieffer
May 10, 1995

Submitted in partial satisfaction of 3 units of CE 299

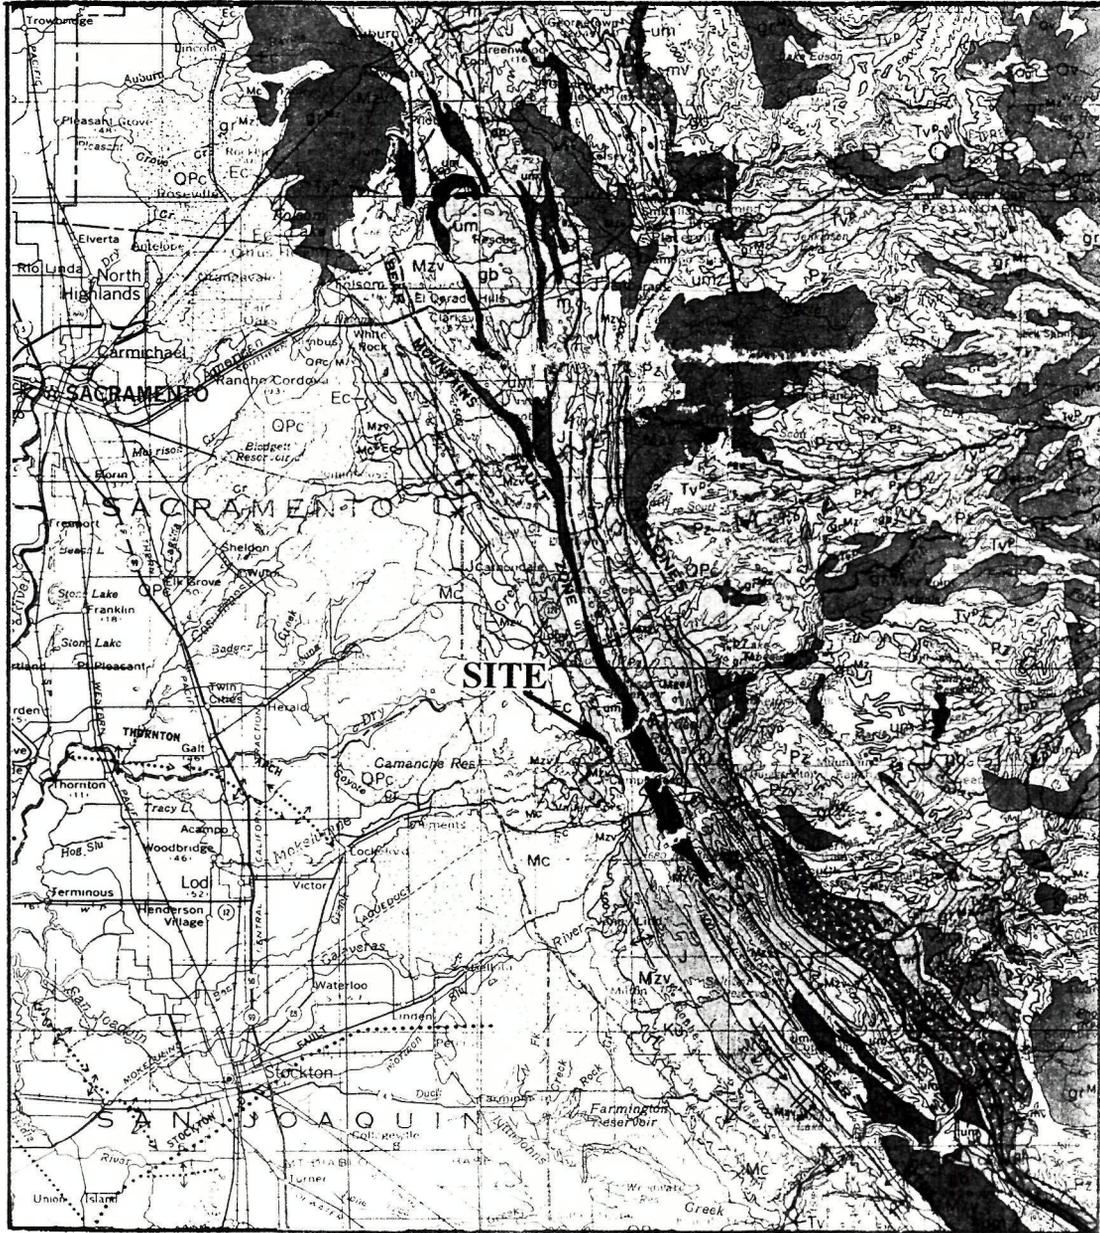
FIGURE 1
Regional Geologic Map

The Pardee Dam facilities are located in the western structural block of the western Sierra Nevada metamorphic belt (Clark, 1964). The western structural block includes the region between the Bear Mountains fault zone, located 1-3/4 miles to the east, and the boundary between the Great Valley and Sierra Nevada geomorphic provinces, located about 12 miles to the west (Figure 1).

Mexican Gulch is the outlet channel for the South Spillway of Pardee Dam, located on the Mokelumne River about 35 miles southeast of Sacramento, California (Figure 1). Pardee Reservoir is owned and operated by the East Bay Municipal Utility District (EBMUD), and it is a significant water source for industrial and municipal use in the east San Francisco Bay area. Since completion of the dam facilities in 1929, overflow spillway discharges have dramatically altered the morphology of Mexican Gulch. Recent downcutting and oversteepening of the channel banks has triggered several large scale landslides in strongly foliated, highly discontinuous crystalline metamorphic rocks.

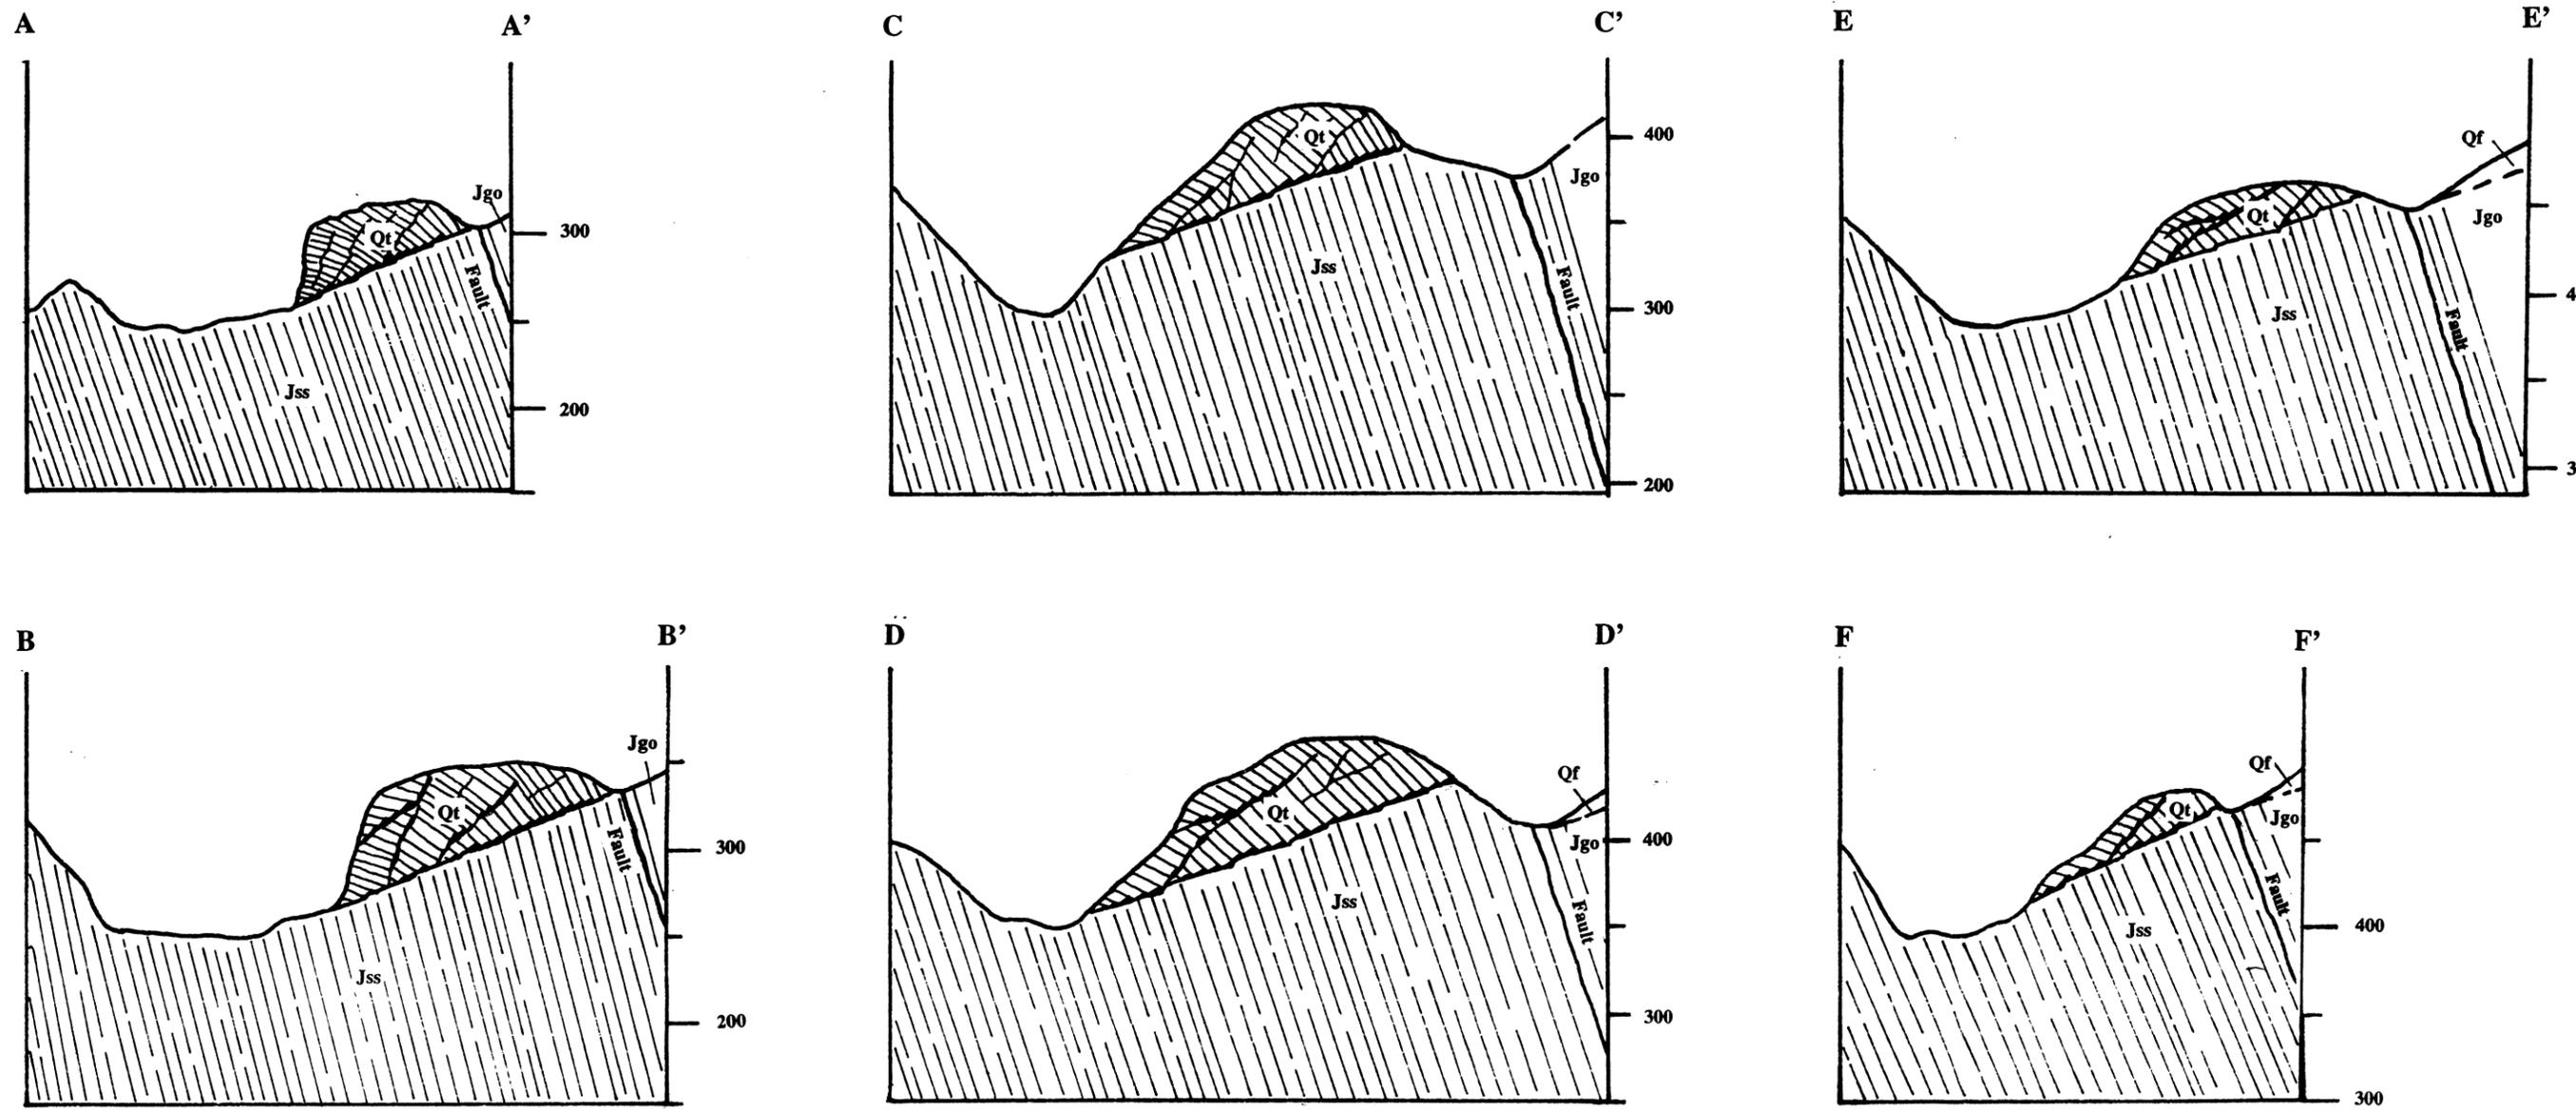
FIGURE 3
Subsurface Cross Sections AA' through FF'

Scale: 1 inch = 100 feet (horizontal = vertical)

The study area is structurally situated on a steep, northeastern-dipping fold limb. Relict bedding is not apparent in most exposures but generally appears to parallel foliation. As shown on Figure 2, a foliation-parallel bedrock fault occurs within the Salt Springs Slate, adjacent to the conformable contact with the Gopher Ridge Volcanics. An interpretation of subsurface geologic conditions in the study area is presented on Subsurface Cross Sections AA' through FF' (Figure 3).

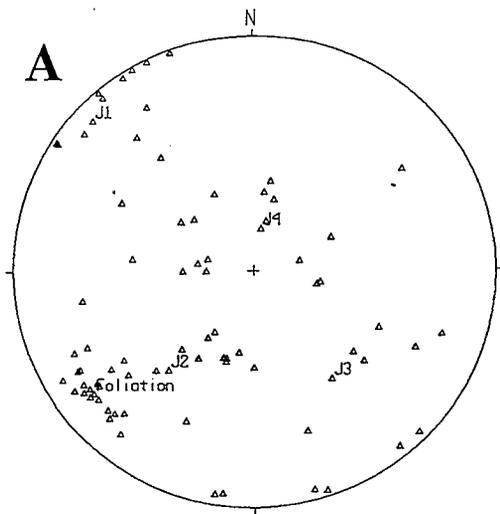
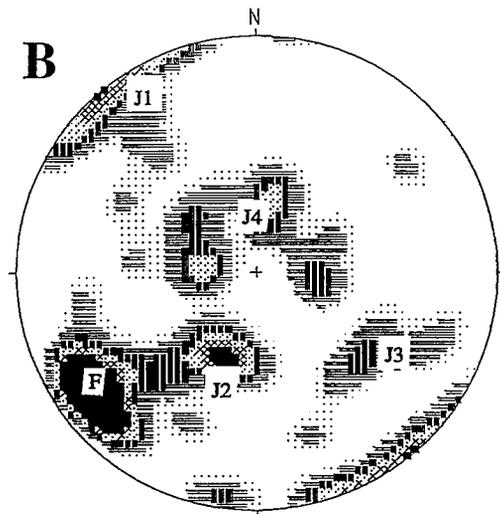
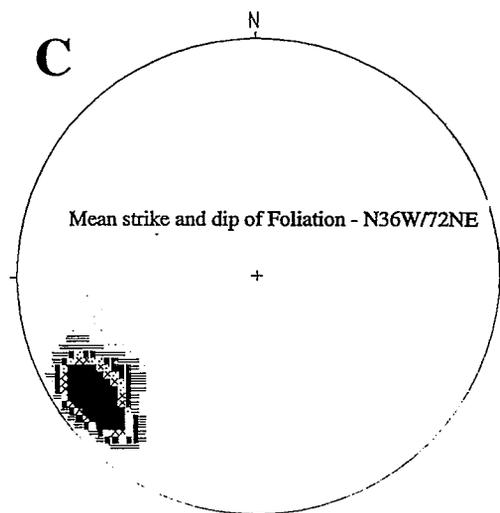
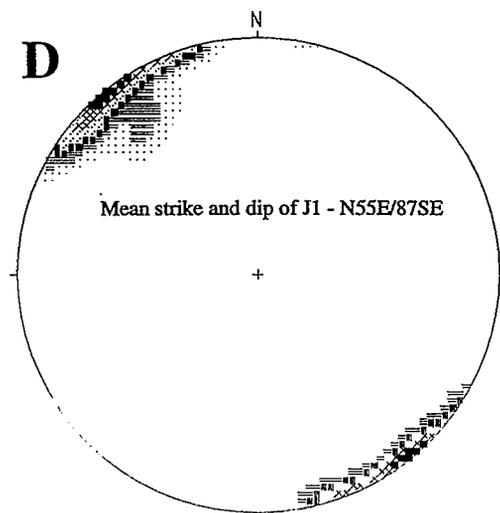
FIGURE 4 - In place rock mass fabric bordering rock topple (lower hemisphere Schmidt projections, spherical Gaussian distributions). A) Discontinuity poles; B) Discontinuity pole density distribution with key to pole concentrations; F = foliation, J_n = joint set n; C) Foliation pole density distribution; D) J₁ pole density distribution.

Approximately 100 structural measurements were statistically analyzed to characterize the in-place rock mass fabric in the study area. As shown on the joint orientation survey data (Figure 4A through 4H), the rock mass is highly discontinuous, with pronounced foliation and four recognizable joint sets. The foliation-parallel fault zone is continuous through the study area.

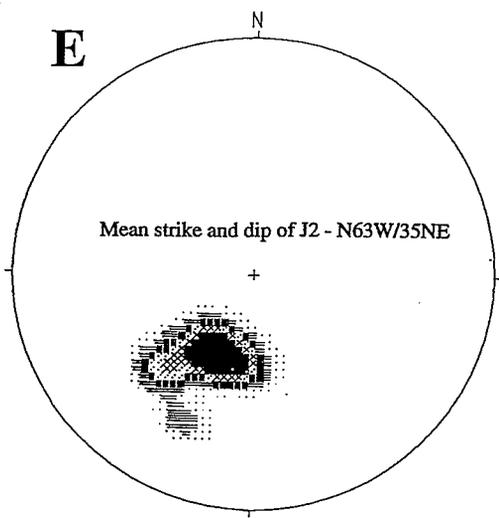
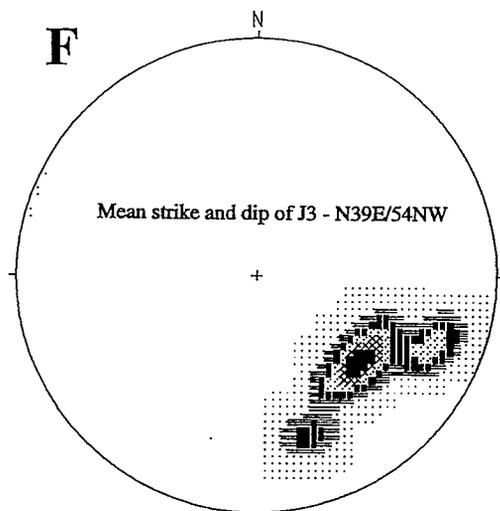
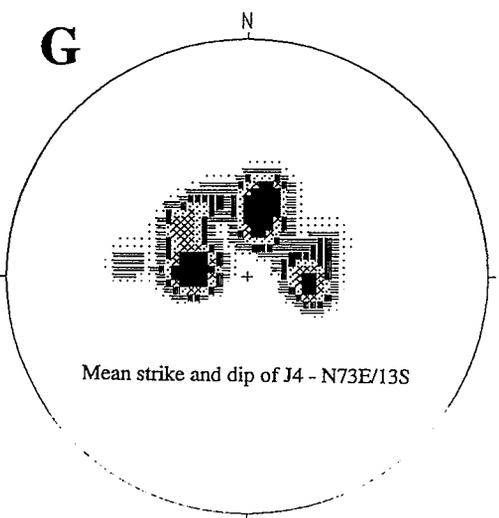
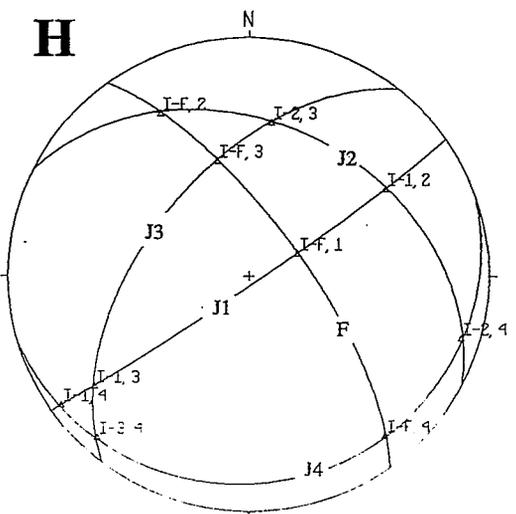
Bearing and Plunge of mean discontinuity intersections

IF,1 -	N72E/72	I1,3 -	S53W/21
IF,2 -	N29W/22	I1,4 -	S54W/4
IF,3 -	N15W/48	I2,3 -	N8E/35
IF,4 -	S40E/12	I2,4 -	S73E/7
I1,2 -	N57E/32	I3,4 -	S42W/6

FIGURE 4 (continued) - E) J₂ pole density distribution; F) J₃ pole density distribution; G) J₄ pole density distribution; H) Mean discontinuity planes; IF_n = line of intersection between foliation and joint set n; I_{n,m} = line of intersection between joint sets n and m.

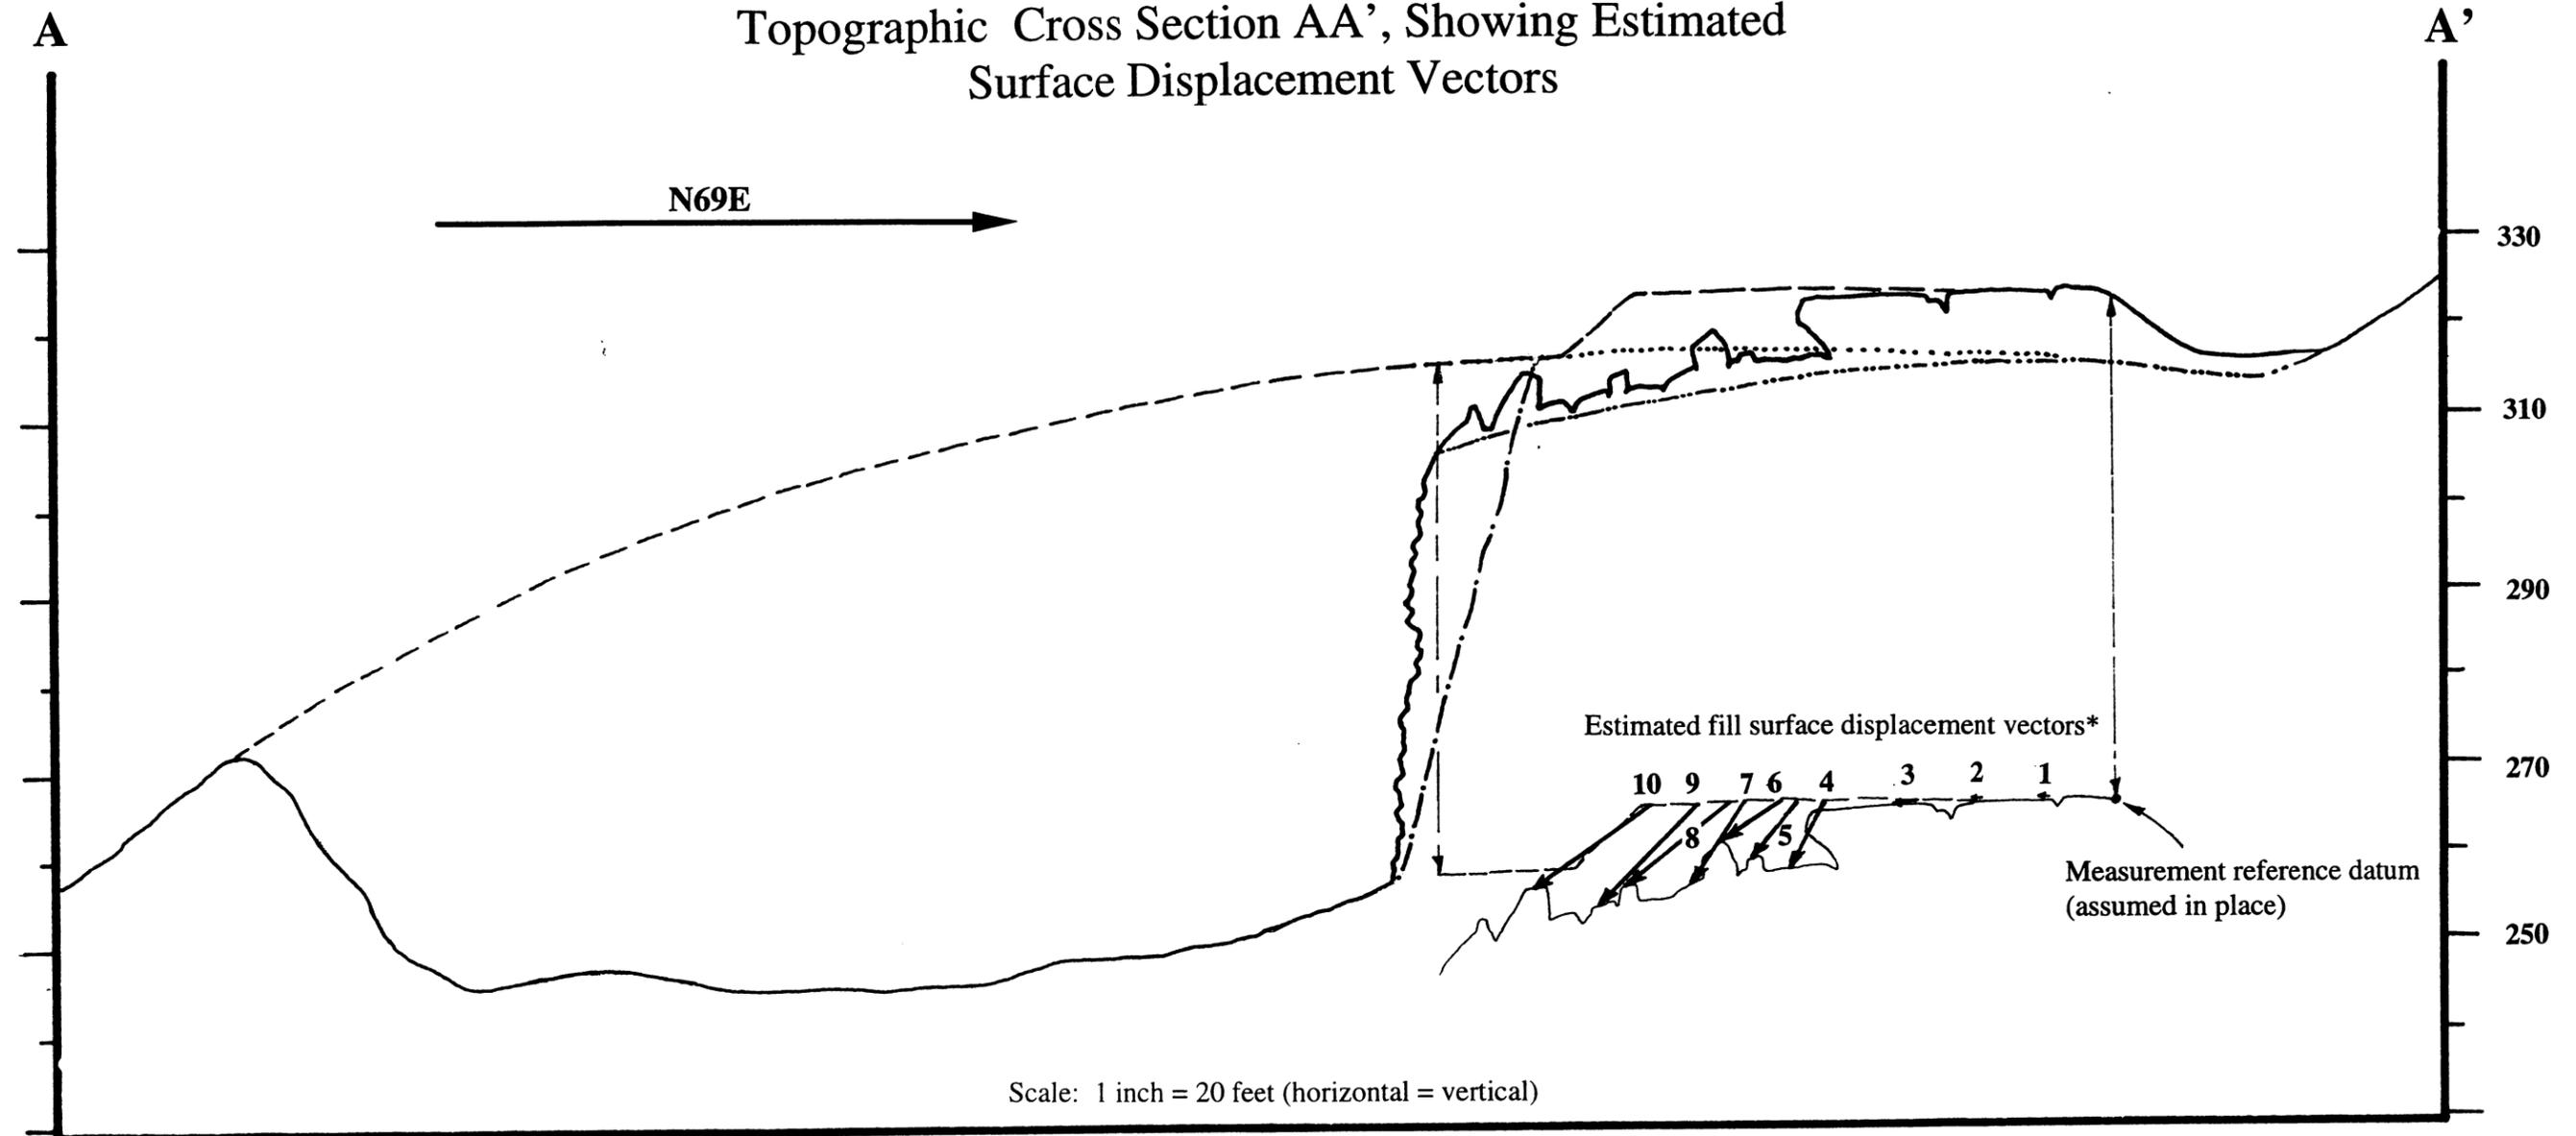
FIGURE 8

Topographic Cross Section AA', Showing Estimated Surface Displacement Vectors

*Note: Fill surface displacement vectors determined by constructing a balanced cross section from survey data. Displacement vector numbers correspond to the displacements presented on Figure 7.

As shown on Figure 7, maximum horizontal and vertical displacements of 15 and 9.5 feet, respectively, are estimated. The displacement vectors of several points along the assumed original fill surface, as shown on Figure 8, indicate that vertical displacement

components, resultant displacement magnitudes and angular rotations of fill blocks increase in a direction toward the free slope face.

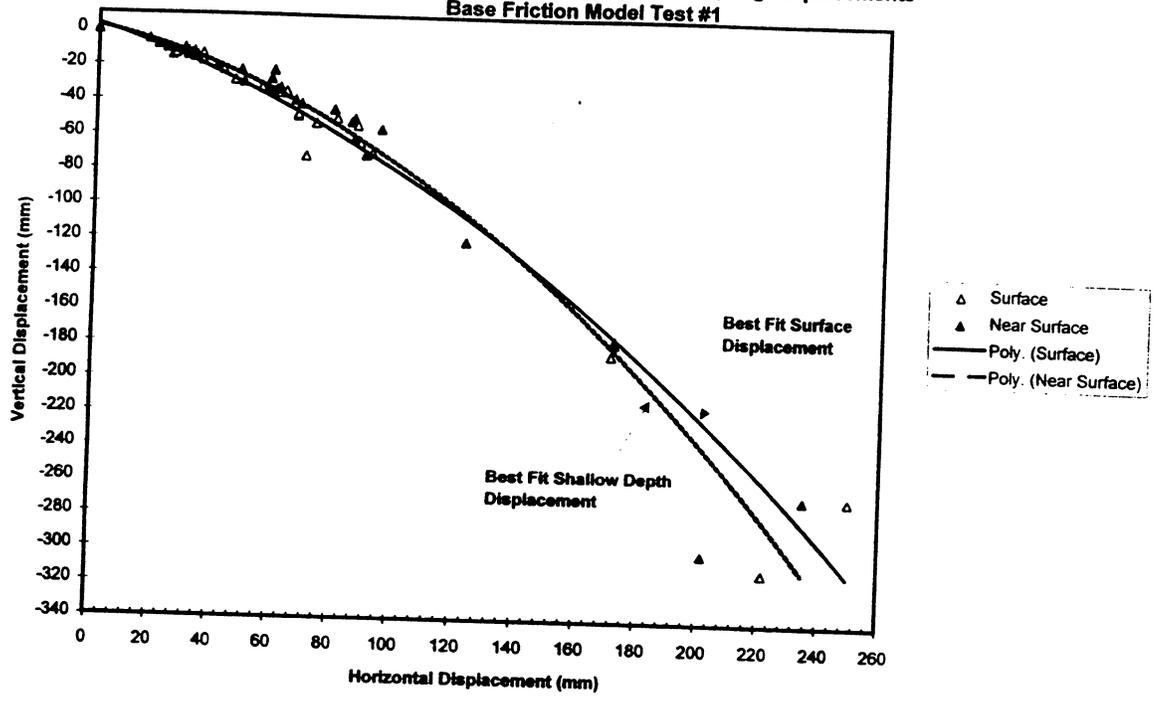
FIGURE 9A
Comparison of Surface and Shallow Depth Toppling Displacements
Base Friction Model Test #1

Displacements of points along the fill surface and corresponding points along the top of the modeled bedrock surface were measured throughout four model tests. In each test, the slope angle and height, discontinuity orientation and fill thickness were slightly varied. The results of displacement measurements for individual tests are shown on Figures 9A through 9D, and the combined results from all model tests are shown on Figure 9E.

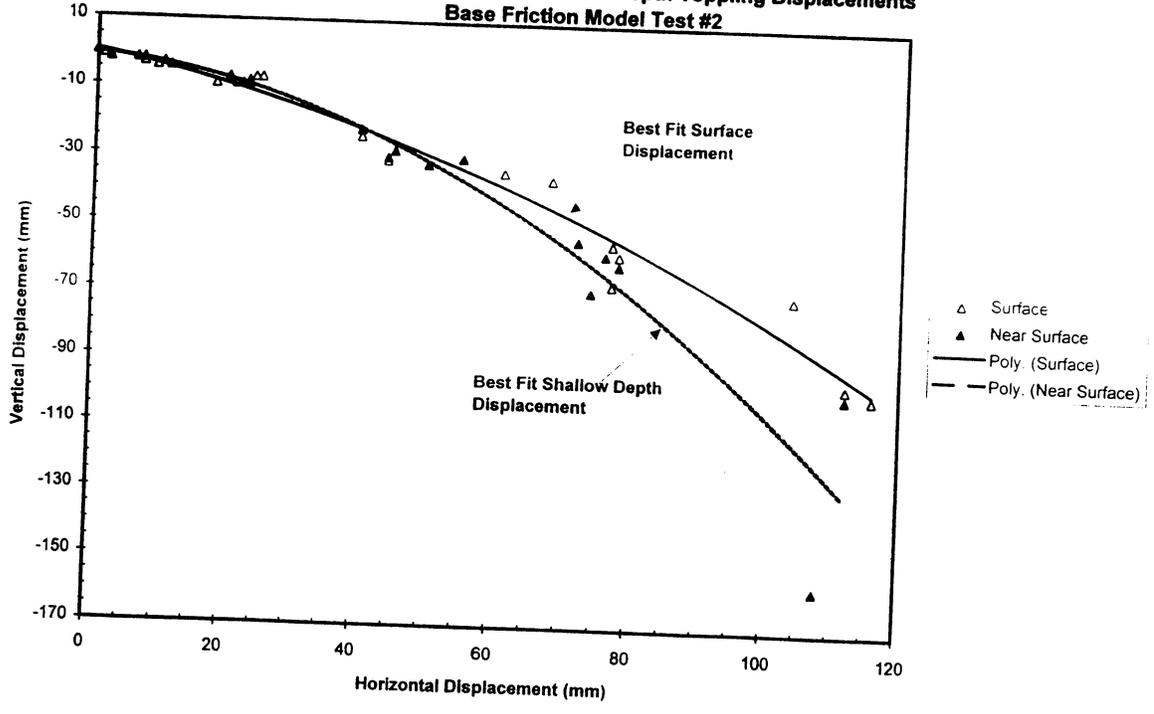
FIGURE 9B
Comparison of Surface and Shallow Depth Toppling Displacements
Base Friction Model Test #2

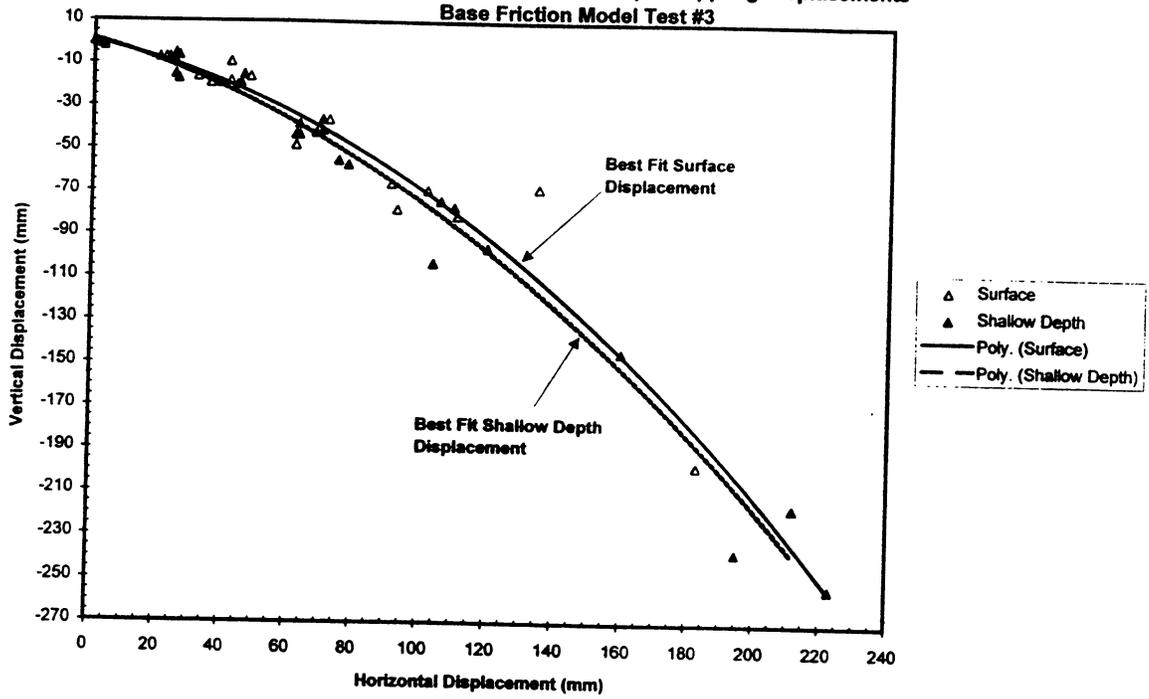
FIGURE 9C
Comparison of Surface and Shallow Depth Toppling Displacements
Base Friction Model Test #3

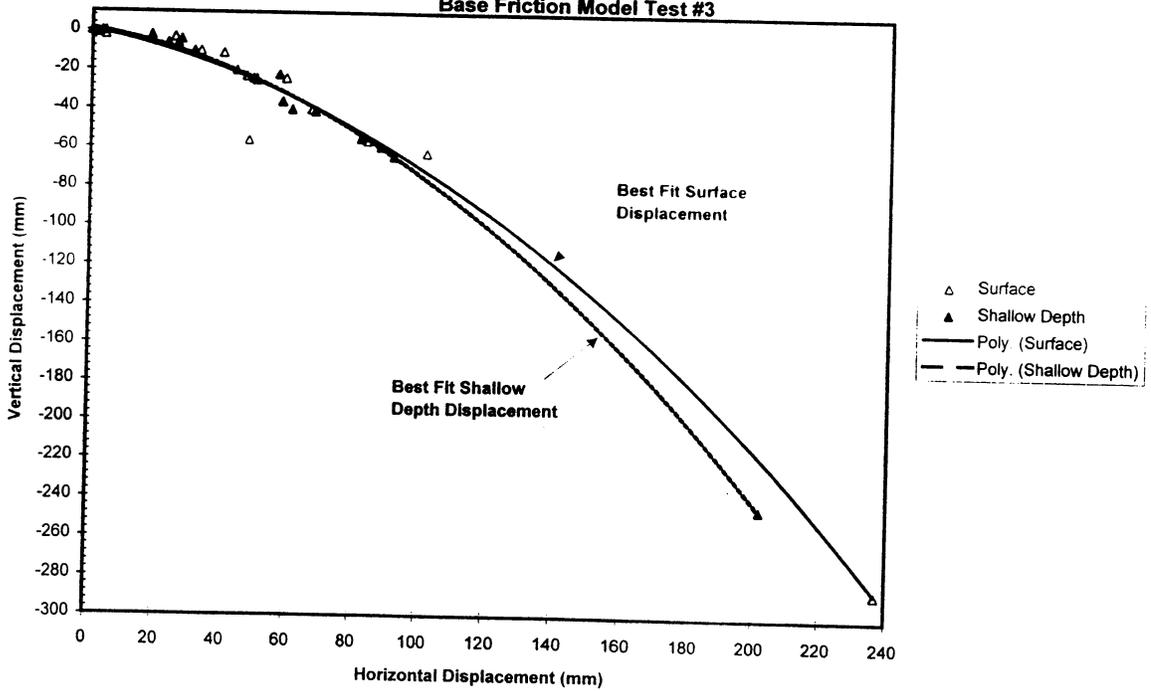
FIGURE 9D
Comparison of Surface and Shallow Depth Toppling Displacements
Base Friction Model Test #3

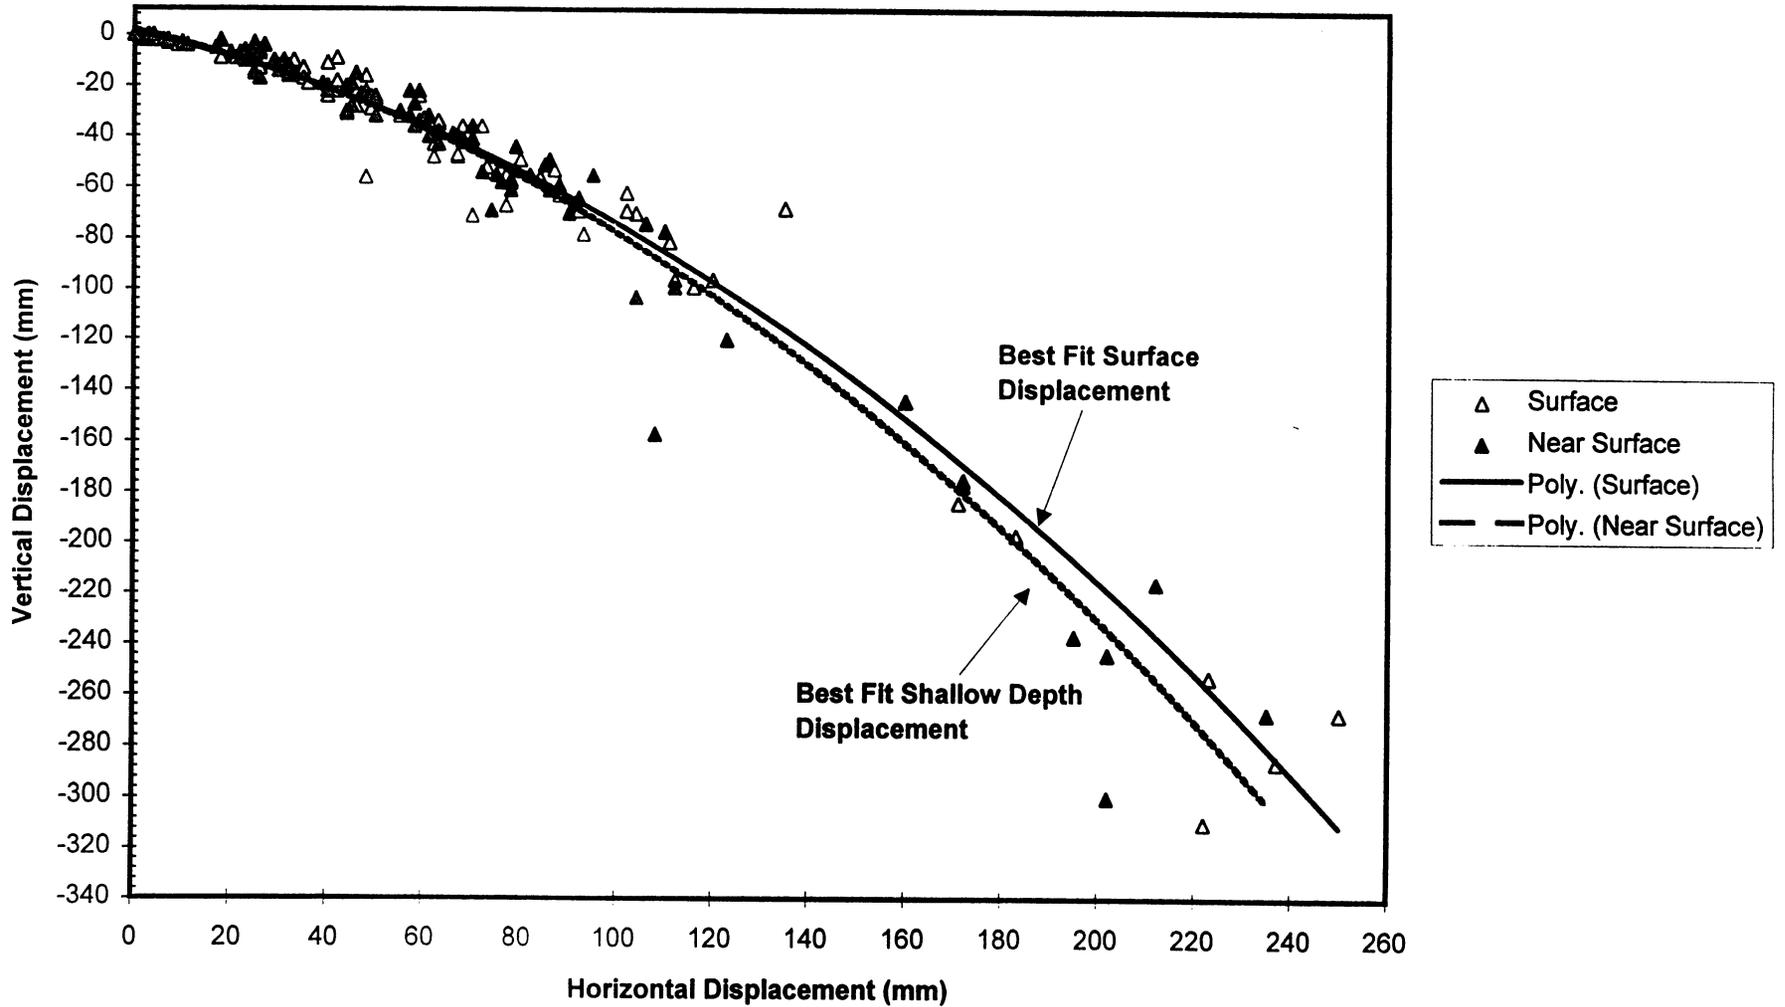
FIGURE 9E
Comparison of Surface and Shallow Depth Toppling Displacements
Combined Base Friction Model Test Results

In all tests, surface displacements and shallow depth displacements (at the top of the modeled bedrock surface) were essentially equivalent for small to moderate deformations. At high deformations; however, the vertical components of bedrock displacements were consistently up to 30% greater than the vertical components of corresponding fill surface displacements, and the horizontal components of bedrock displacements were consistently up to 10% less than the horizontal components of corresponding surface displacements. The combined results of the physical model tests, as shown on Figure 9E, suggest that the surface displacements may be a good approximation of underlying bedrock displacements for varying slope configurations at low to moderate deformations.

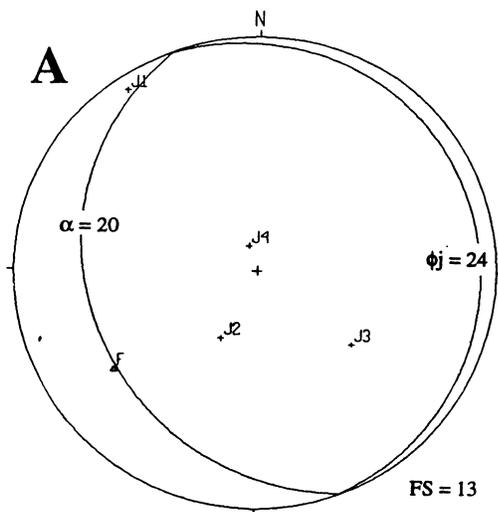
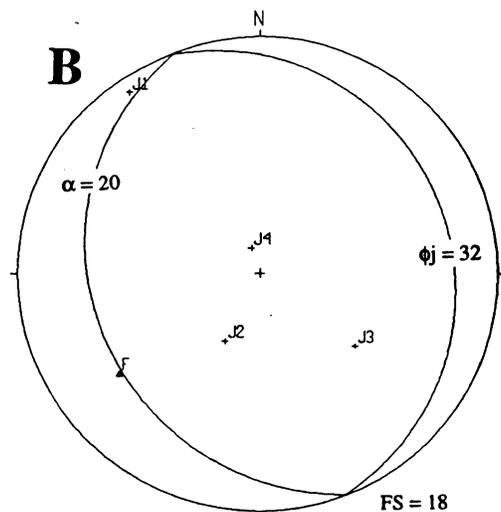
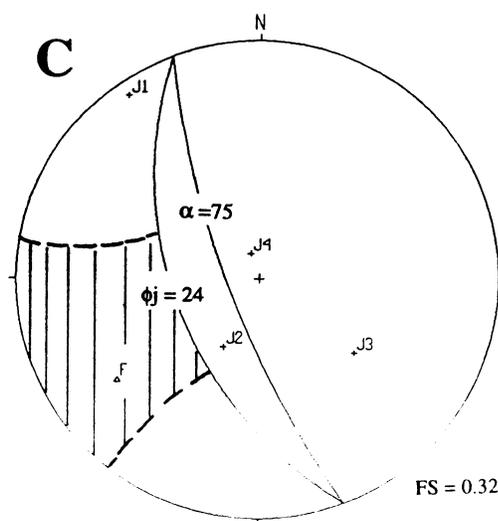
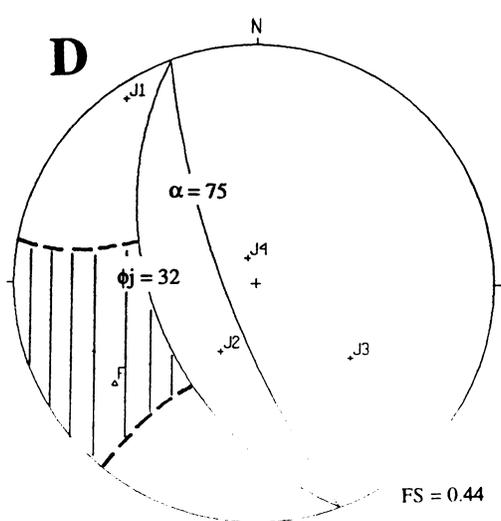
FIGURE 10 - Limit equilibrium stability analysis of toppling failure (lower hemisphere Wulff projections). Toppling failure is kinematically possible with respect to a discontinuity when the pole to the corresponding discontinuity plots within the ruled region. Factors of safety computed by the relation $FS = \tan\phi_j / \tan\phi_{j,required}$, where $\phi_{j,required}$ represents the joint friction angle required for limiting equilibrium. Foliation = F; joint set n = Jn; joint friction angle = ϕ_j ; slope angle = α (degrees); FS = factor of safety with respect to foliation. A) and B) Stability with respect to estimated original slope configuration; C) and D) Stability with respect to estimated slope configuration following excavation from spillway outlets.

Limit equilibrium analyses were conducted to evaluate the historical stability of the existing rock topple along Cross Section AA'. The stability analysis was conducted with respect to the in-place rock mass structure for the estimated slope configurations before and after the 1950 flood, and for the existing slope configuration.

The stability analysis indicates that interlayer slip along foliation in the area of Cross Section AA' was not kinematically possible under the original slope configuration. This conclusion is supported by existing in-place foliation near the southwestern end of Cross Section AA' (deformation should be apparent in this outcrop if toppling had occurred prior to the 1950 flood). Excavation of the Salt Springs Slate during the 1950 flood oversteepened the hillside and permitted interlayer flexural slip to develop.

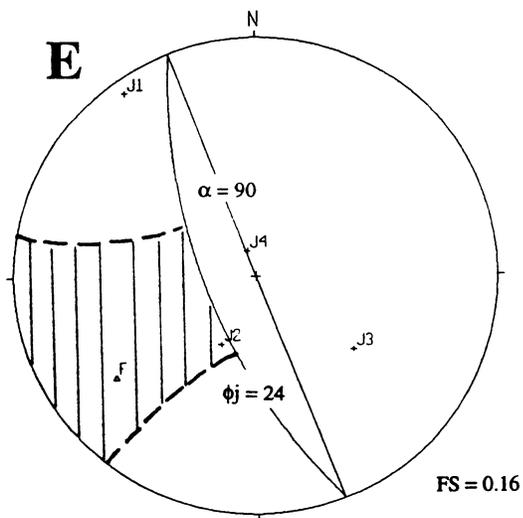
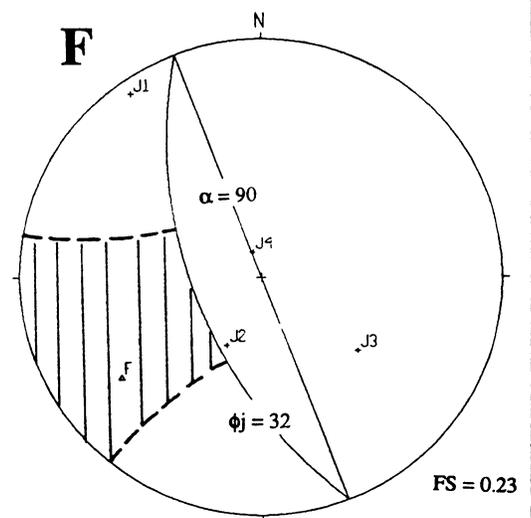
FIGURE 10 (continued) - E) and F) Stability with respect to existing slope configuration.

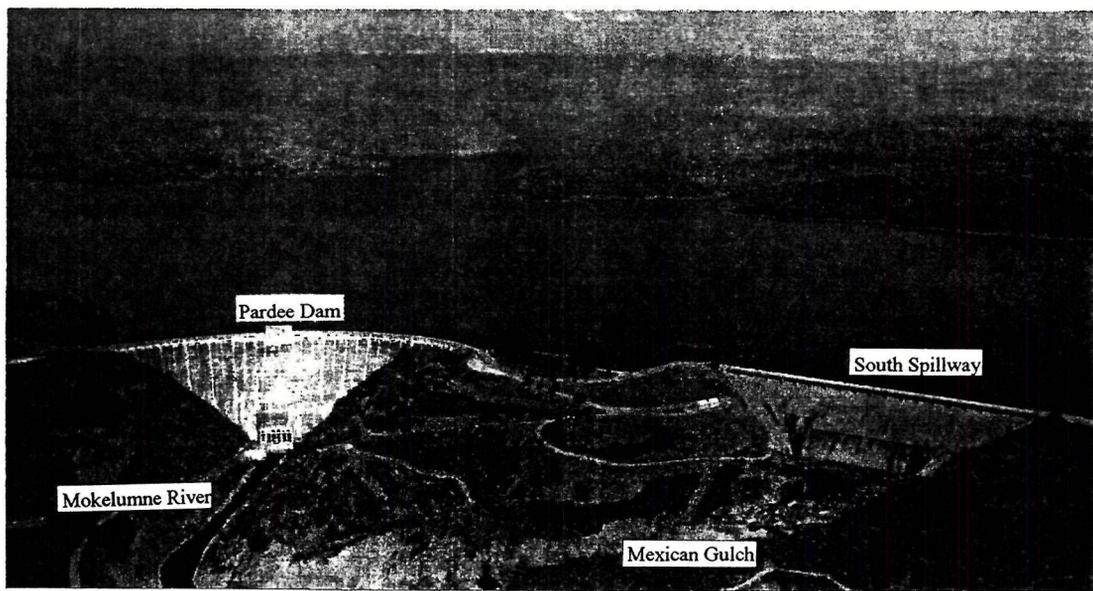
PHOTO 1 - Aerial site overview, looking eastward (photograph: Woodward Clyde Consultants, 1994)

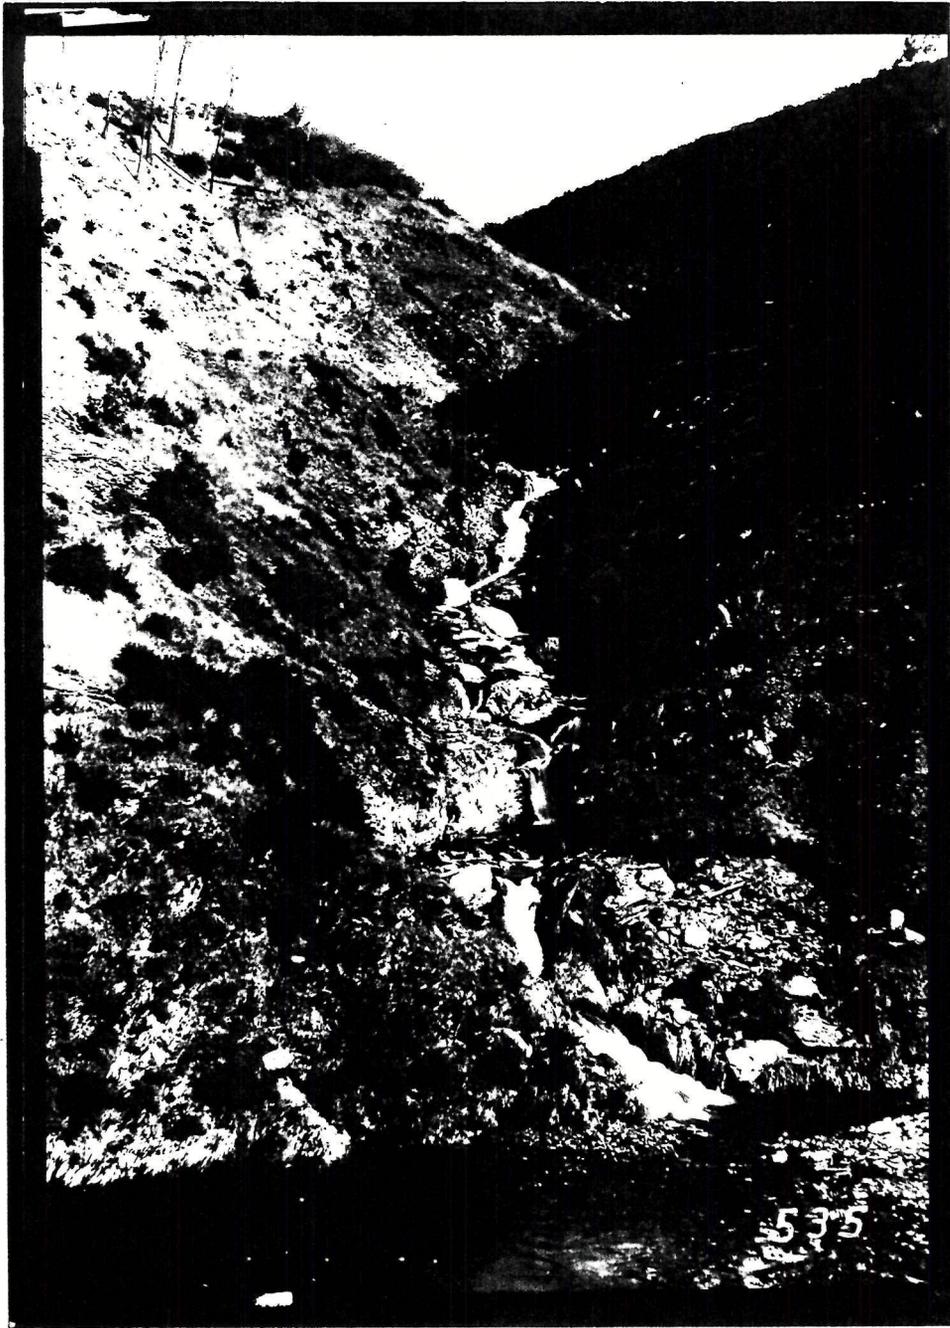
PHOTO 2- View of Mexican Gulch - first spill from south spillway, May 11, 1930.

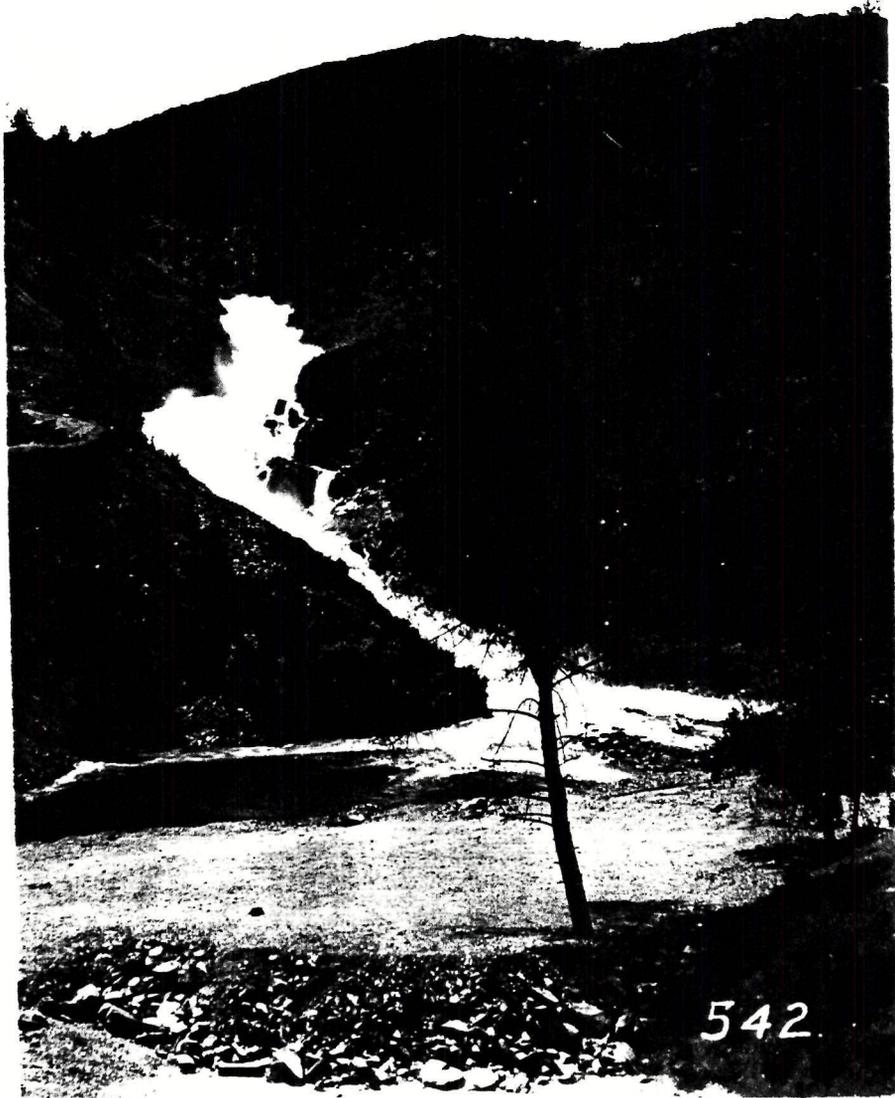
PHOTO 3- Mexican Gulch, June 7, 1930; 1600 c.f.s. flow. Note road fill and car at left of photo.

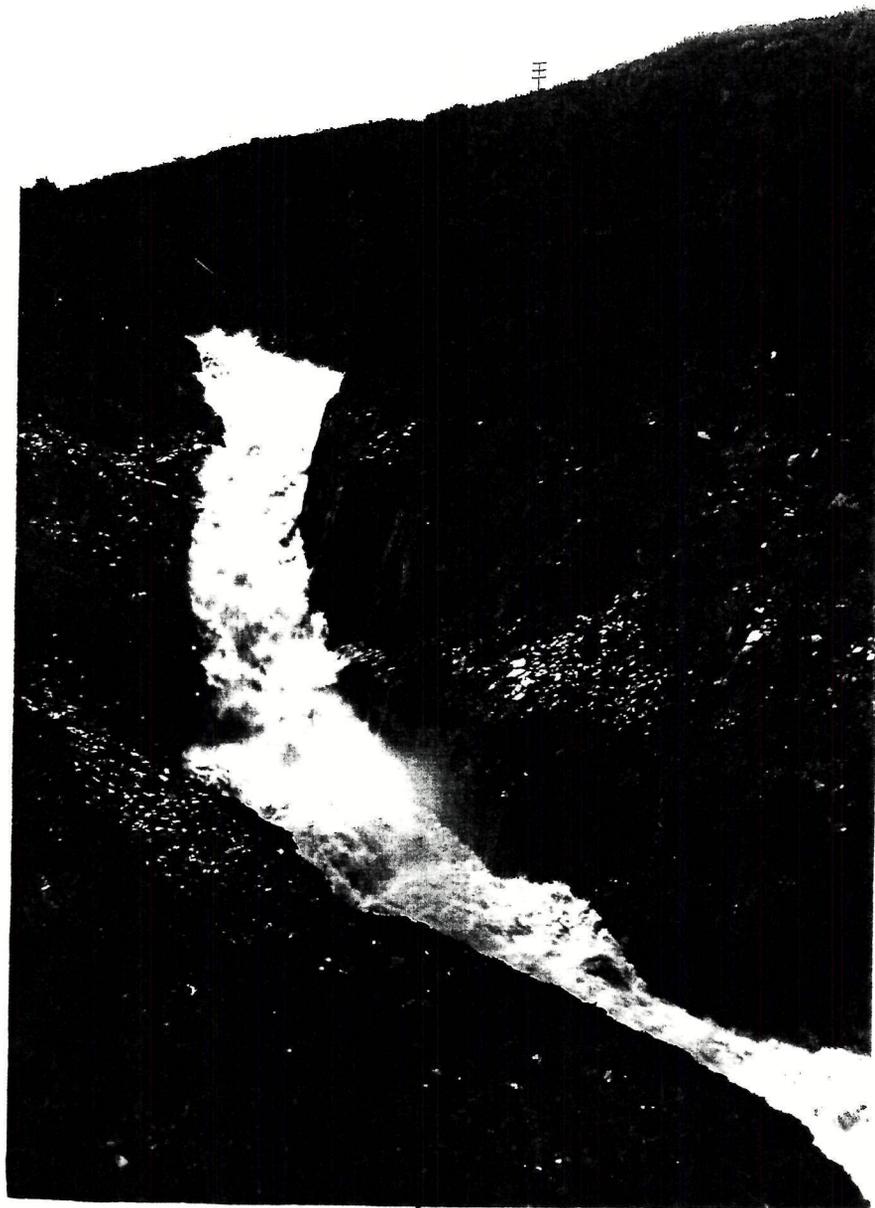
PHOTO 4 - Mexican Gulch, May 12, 1935; 1100 c.f.s flow. Note right channel bend in lower portion of photo.

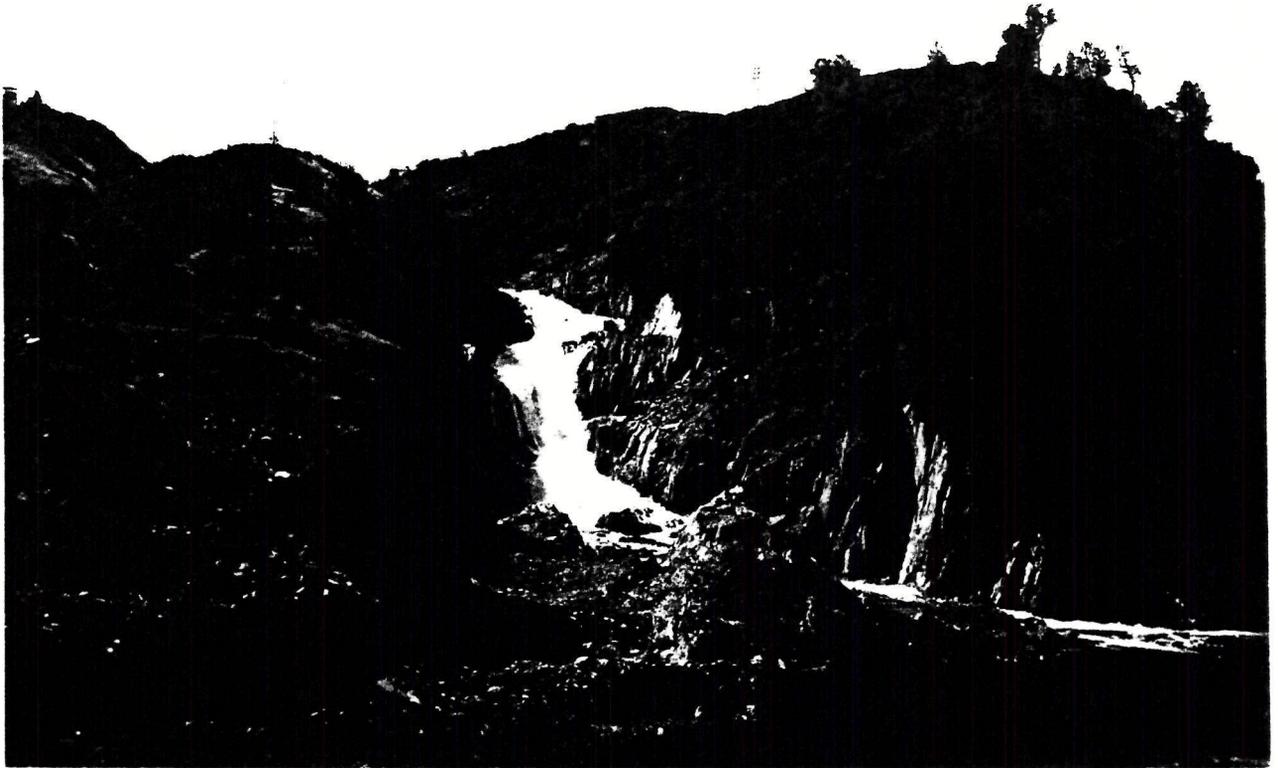
PHOTO 5 - Mexican Gulch, January, 1969. Note hydraulic excavation of rock mass in lower center of photo (compare to right channel bend in photo 3). Note road fill in left center of photo, dipping about 20 degrees toward channel.
