RE: Mexican Gulch Slope Stability Study

Surface Displacement Rate of a Deep Seated Bedrock Topple at
Mexican Gulch
Calaveras County, California

D. Scott Kieffer
May 10, 1995

Submitted in partial satisfaction of 3 units of CE 299

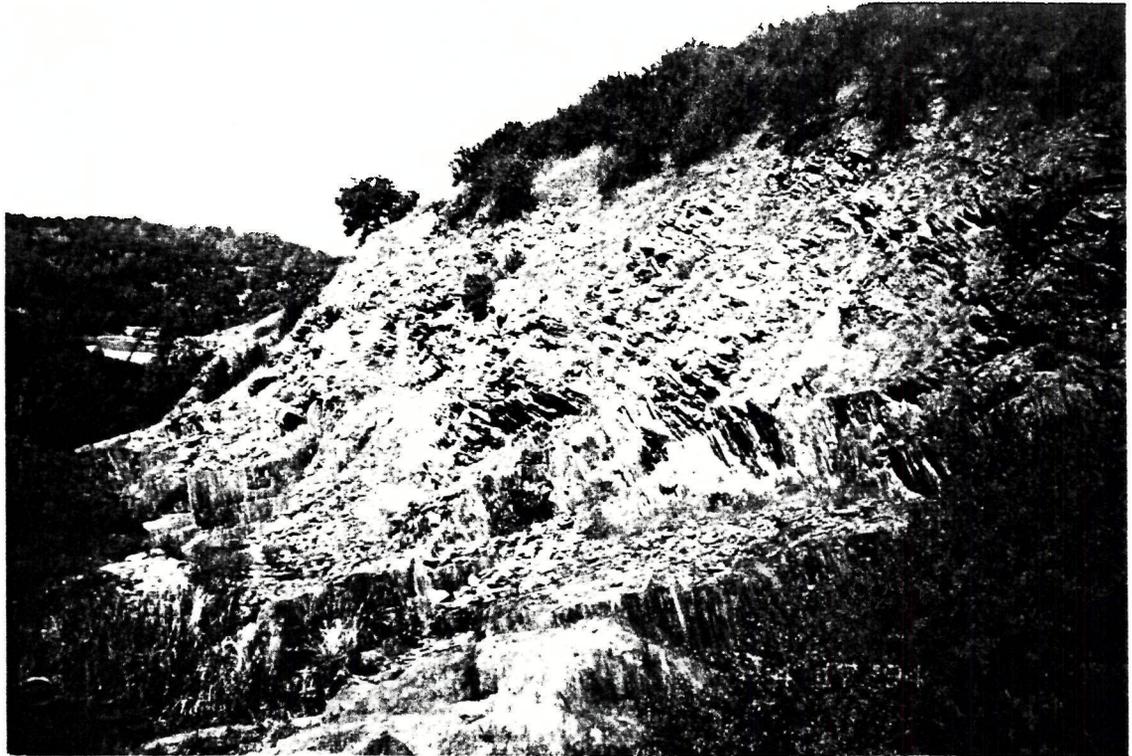
PHOTO 6- Deep seated rock topple in phyllite, view downstream Mexican Gulch. Brown material is deeply weathered, gray material is moderately weathered. Note discordance of foliation along gray/brown contact.

Rock Topple (Qt) The subject rock topple, as shown on Figure 2 and Photographs 6 through 11, is exposed along the northeastern slope of Mexican Gulch, entirely within the highly weathered Salt Springs Slate. The rock topple exhibits a block flexure failure mode, characterized by pseudo-continuous flexure of long columns through accumulated motions along cross joints (Goodman and Bray, 1976). The topple mass is approximately 1,000 feet long, with an average width of 150 feet and an approximate volume of 150,000 cubic yards. The topple consists of loose blocks of highly weathered Salt Springs Slate with little to no

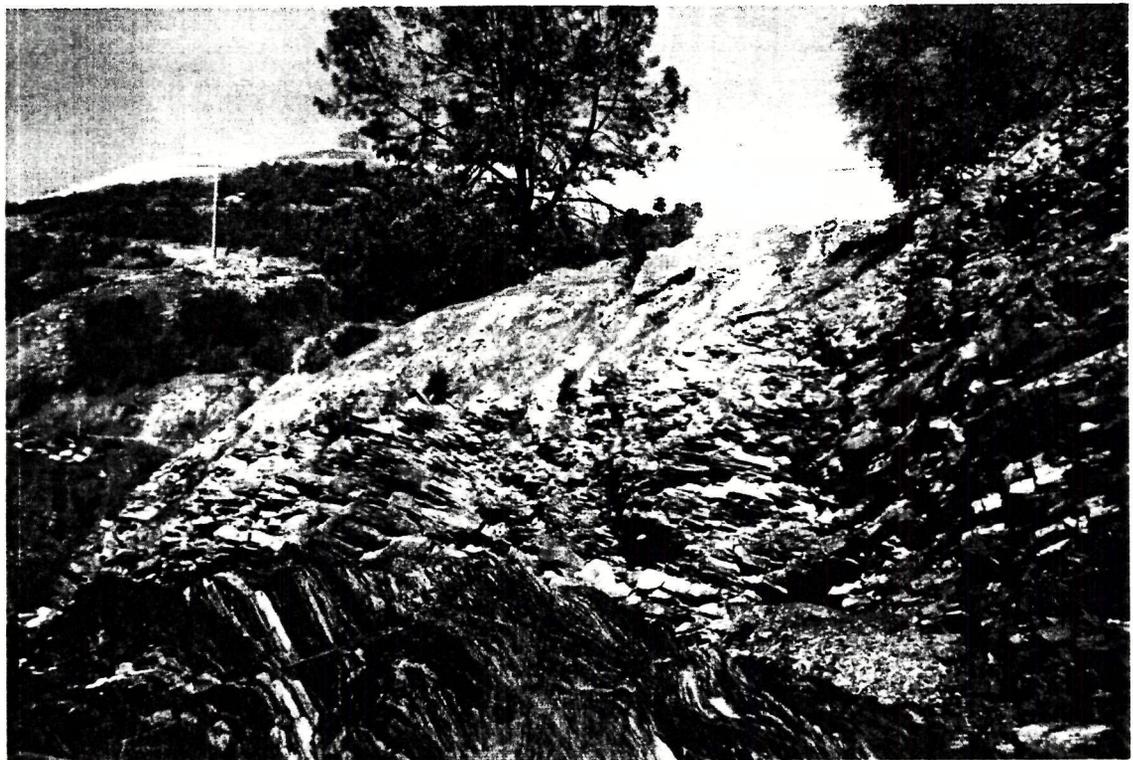
PHOTO 7- Deep seated rock topple in phyllite, view downstream Mexican Gulch, near confluence with Mokelumne River. Note block of fill material beneath center of dam.

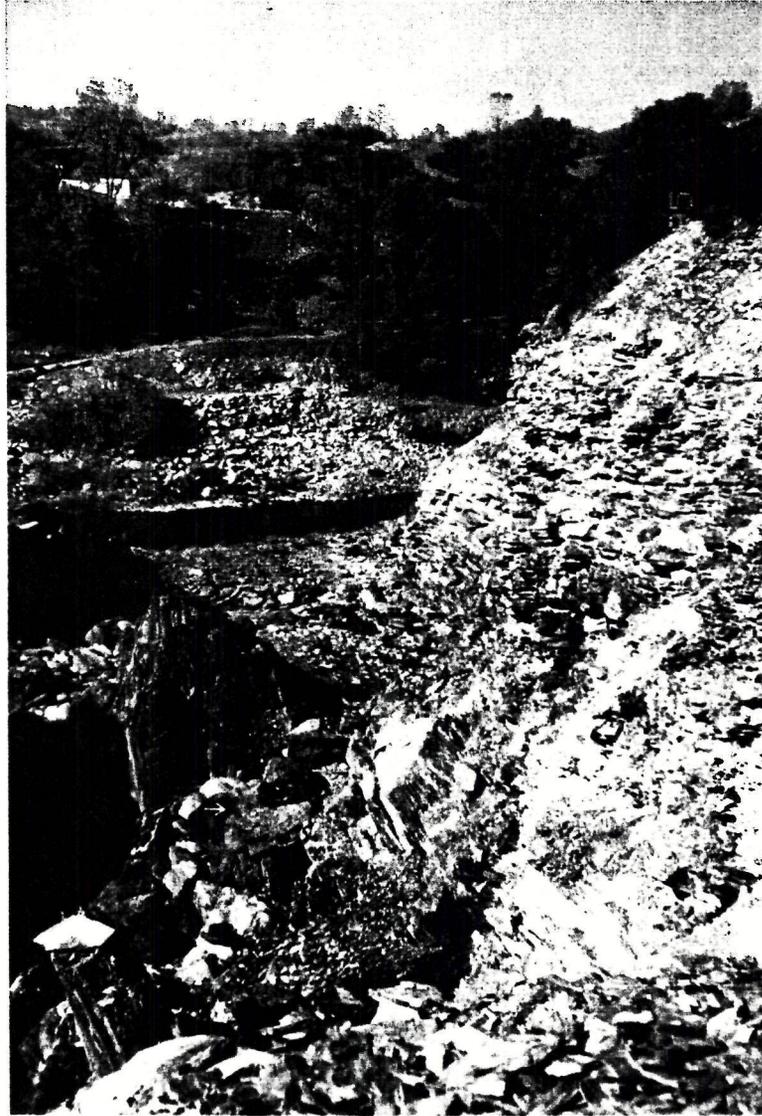
PHOTO 8 - Deep seated rock topple, view downstream Mexican Gulch at confluence with Mokelumne River. Note discordance of foliation between the gray (moderately weathered) and brown (deeply weathered) phyllite.

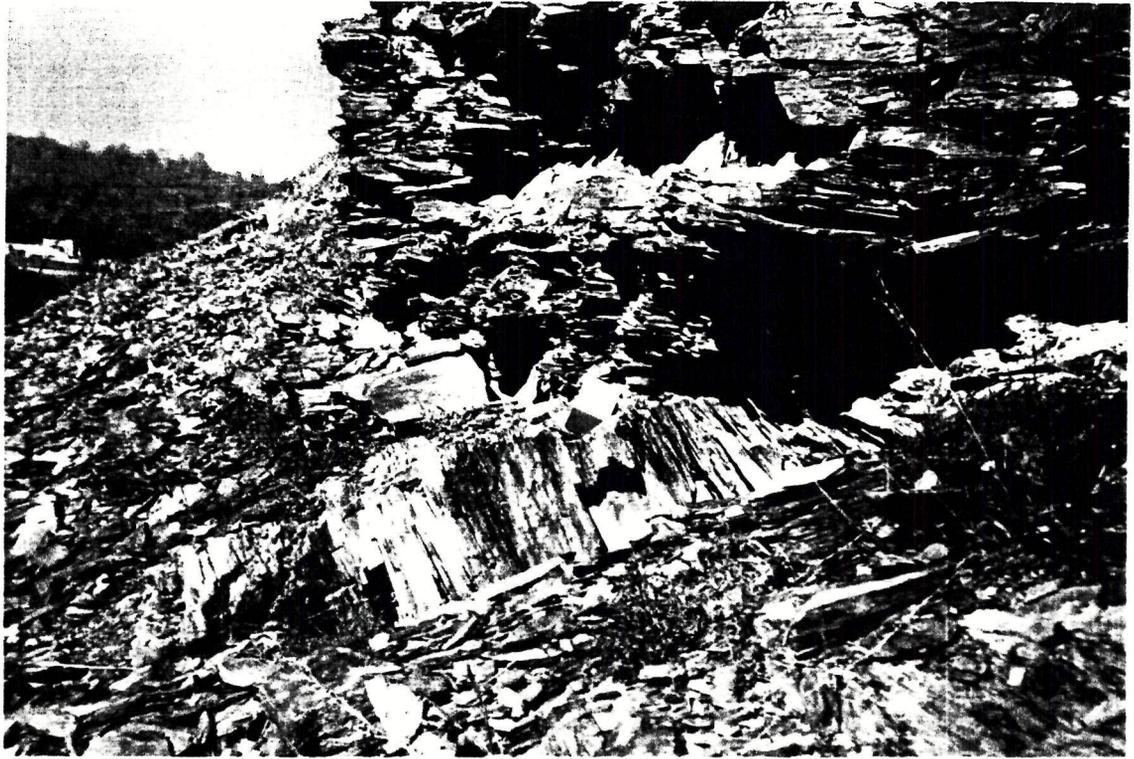
PHOTO 10 - Typical exposure of basal failure hinge.

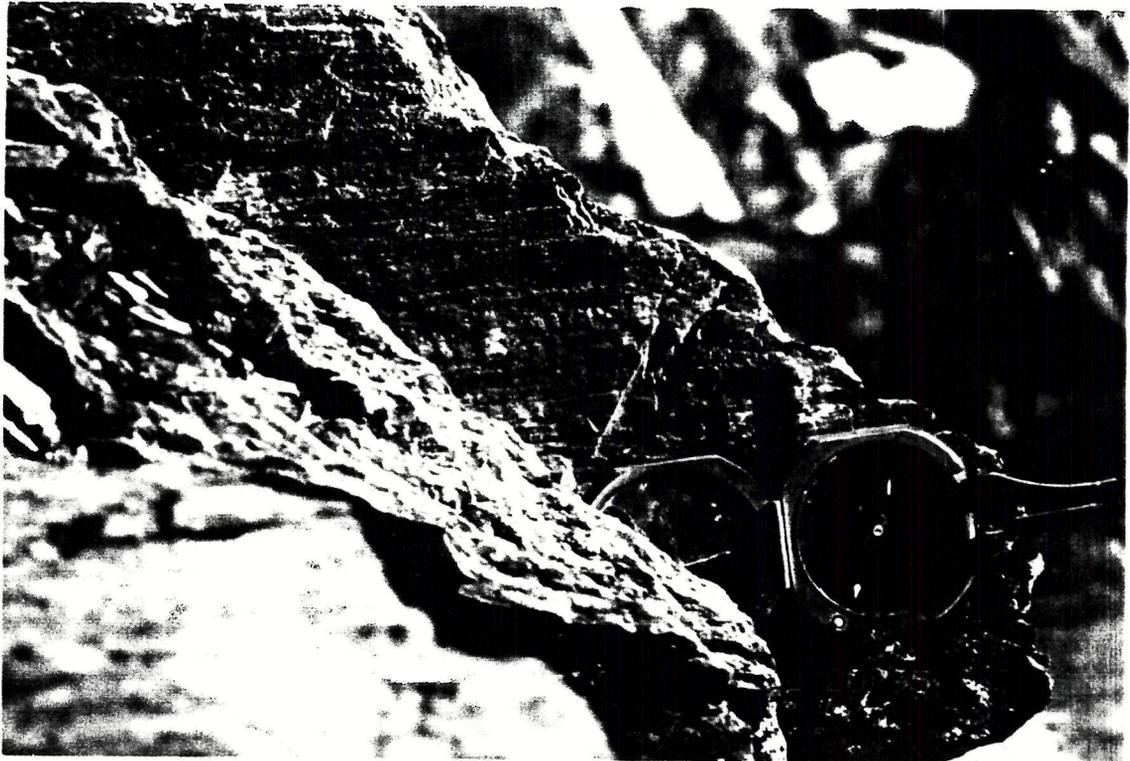
PHOTO 11 - Slickensides in rock topple mass formed by flexural slip along foliation.

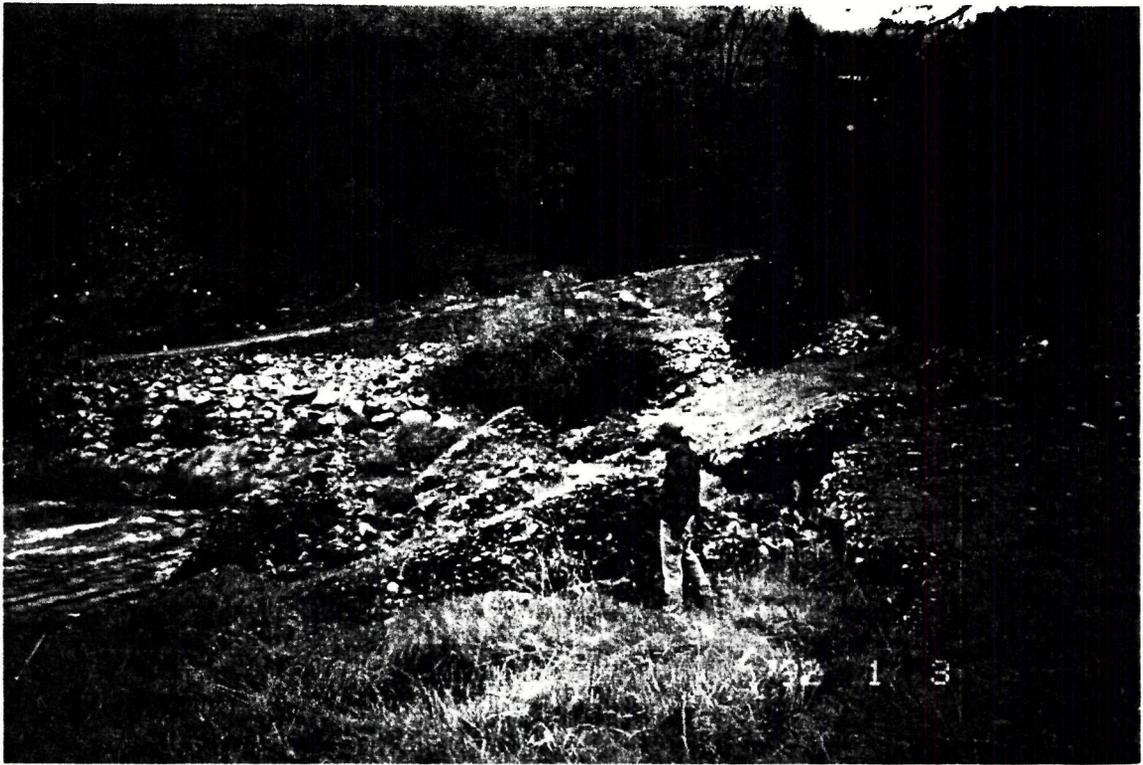
PHOTO 12 Surface displacement of fill overlying phyllite bedrock, along Subsurface Cross Section AA' (Figure 6). Note progressive rotation of fill blocks in direction of channel.

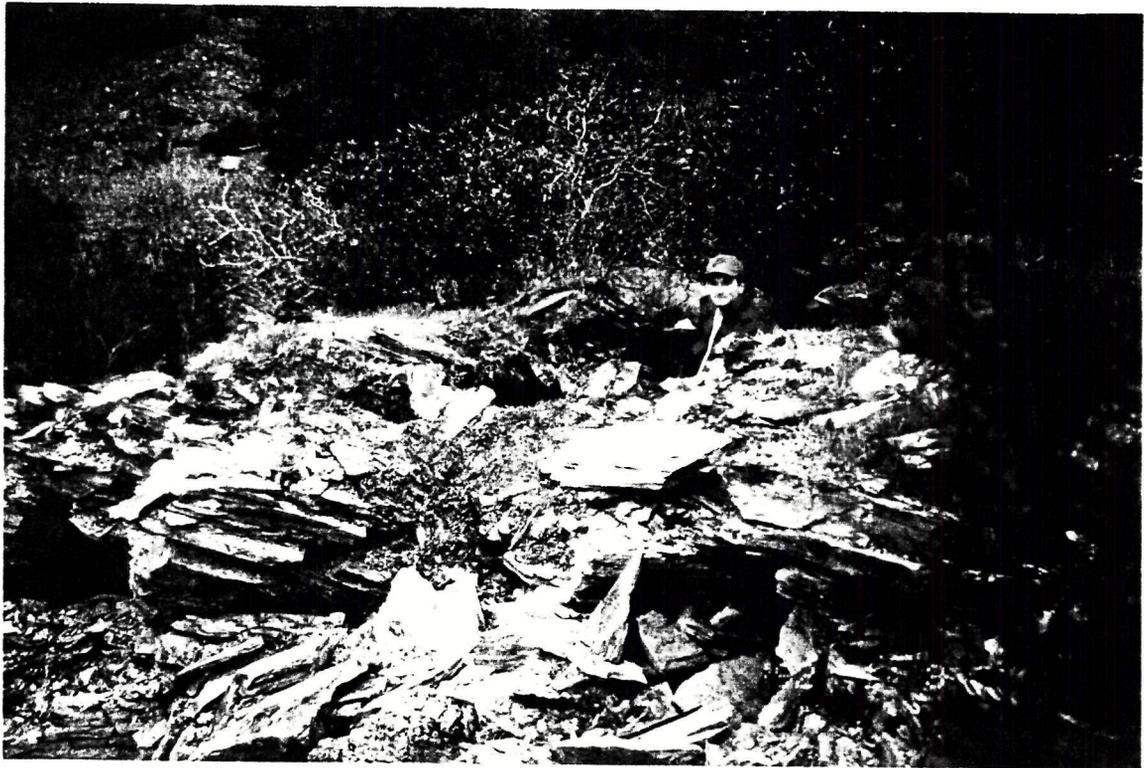
PHOTO 13 - Tension crack in phyllite bedrock, near crest of deep seated rock topple.

Active surface displacement of the rock topple has produced numerous reverse facing scarps and gapping tension cracks in the crest area of the toppling mass (Photographs 13 and 15). In the vicinity of Cross Section AA', surface displacement has produced a series of subparallel tension cracks in a cap of fill material along the northeastern side of Mexican Gulch (Photographs 12 and 14). The fill and underlying highly weathered Salt Springs Slate in this area appear to have toppled in response to the recent erosion of Mexican Gulch. The flood event that modified channel morphology and permitted toppling to initiate in this area can be identified from historical photographs. It is thereby possible to estimate the maximum average fill surface displacement rate along Cross Section AA' (Figure 6) by dividing the estimated resultant displacement by the time interval over which toppling has been a kinematically-permissible failure mode.

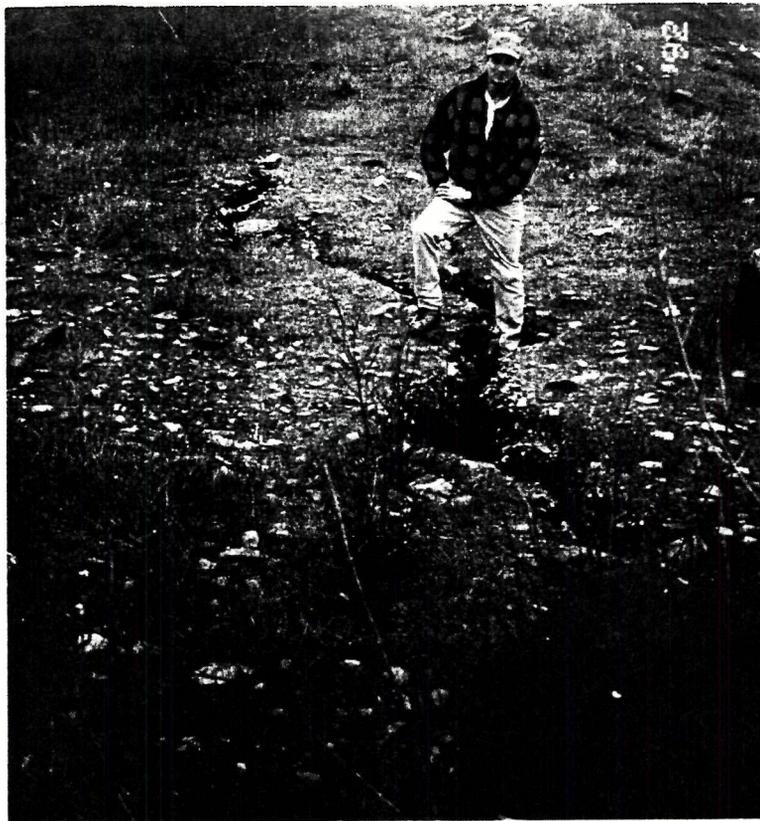
PHOTO 14- Tension crack in fill material, along Subsurface Cross Section AA' (Figure 6).

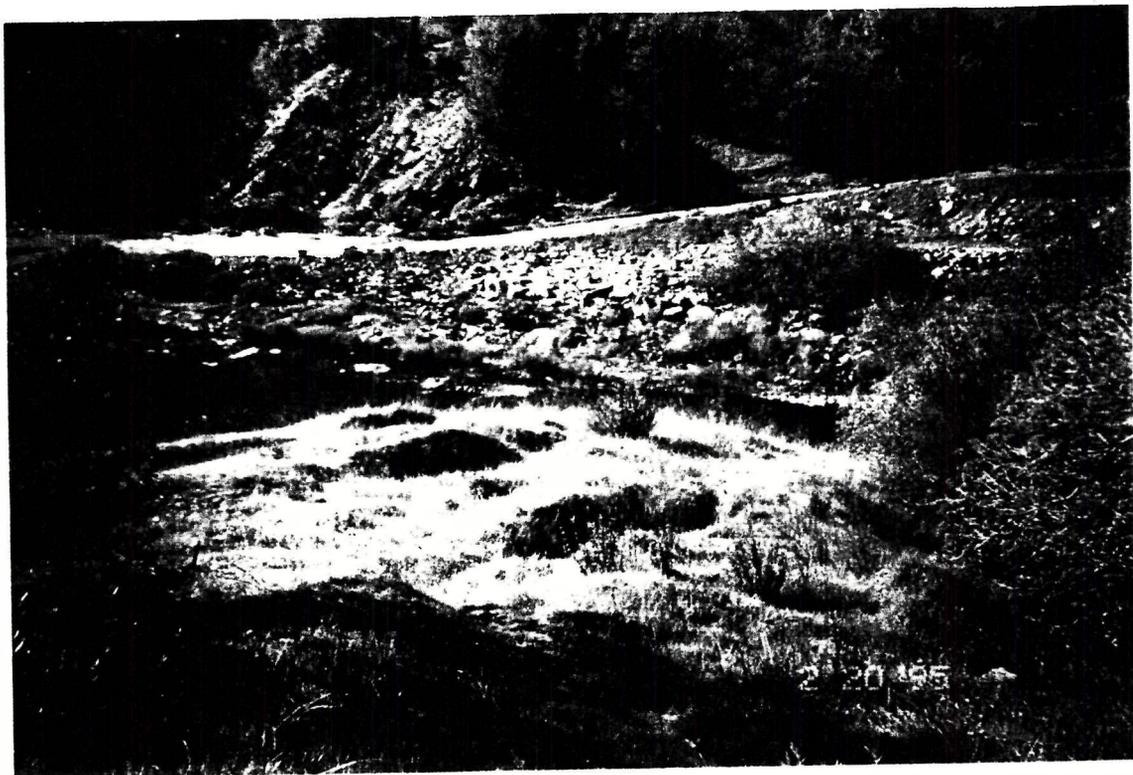
PHOTO 15- Reverse facing scarps (downdropped in direction opposite to free slope face) along crest area of deep seated topple, with approximately 2 feet maximum relief.

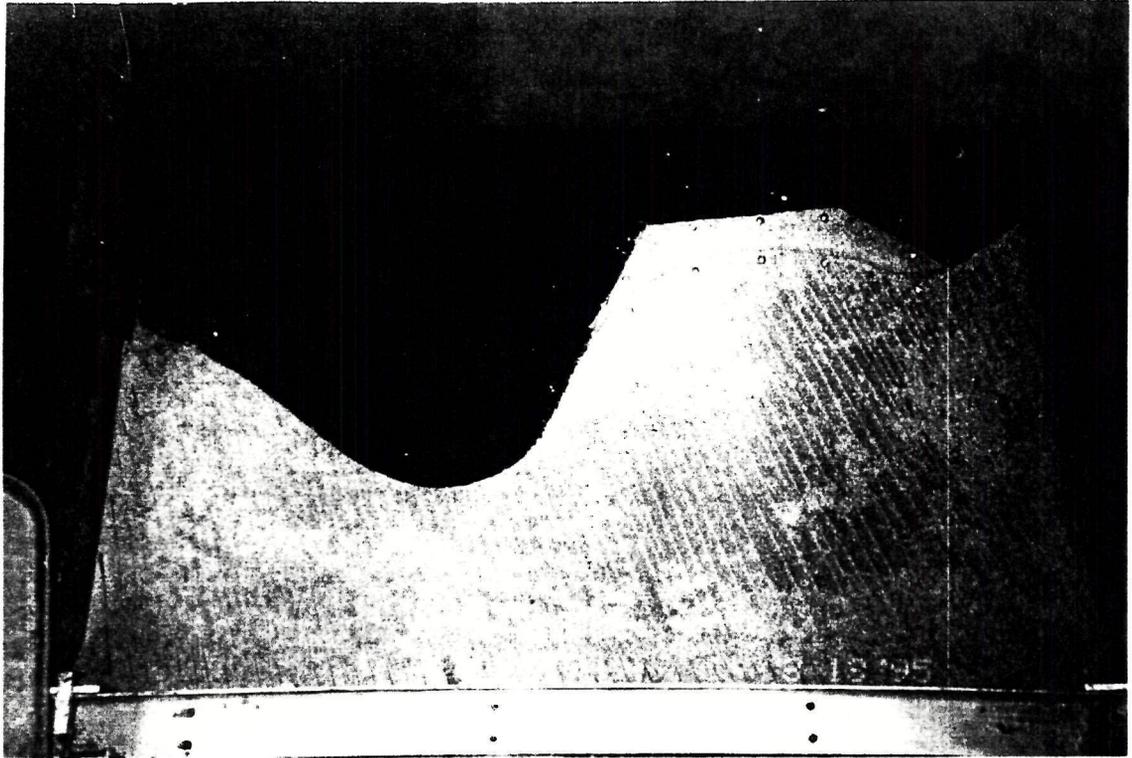
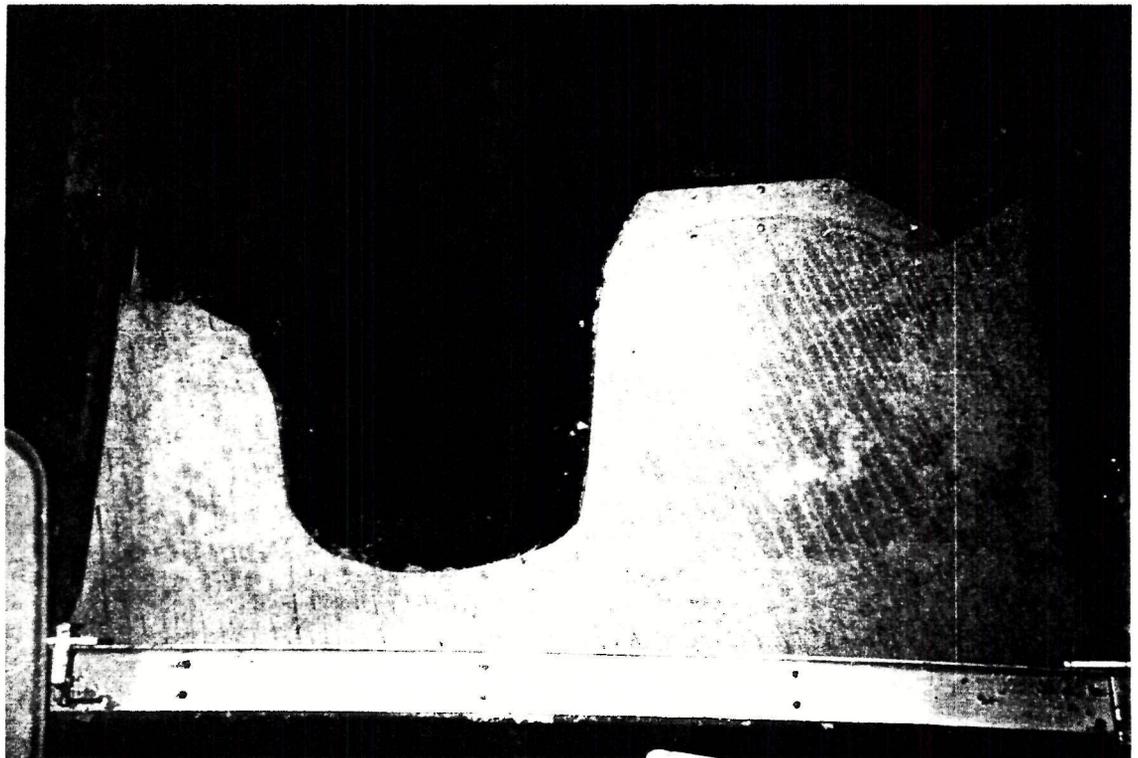
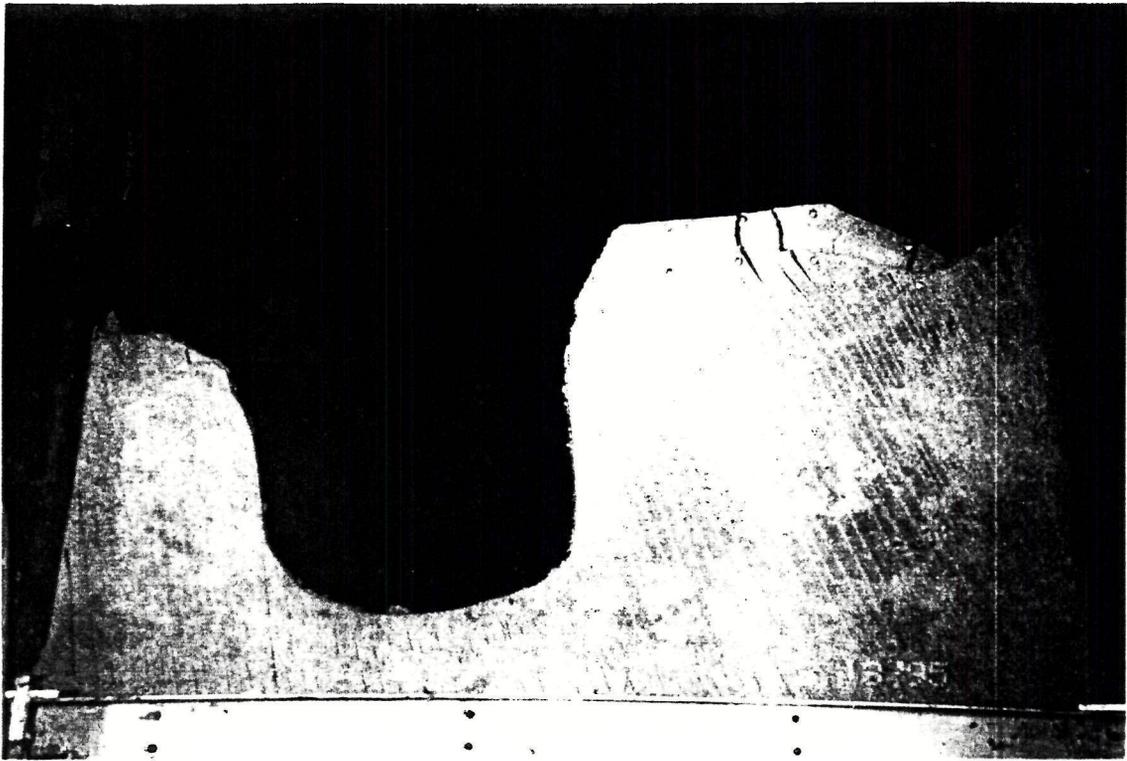
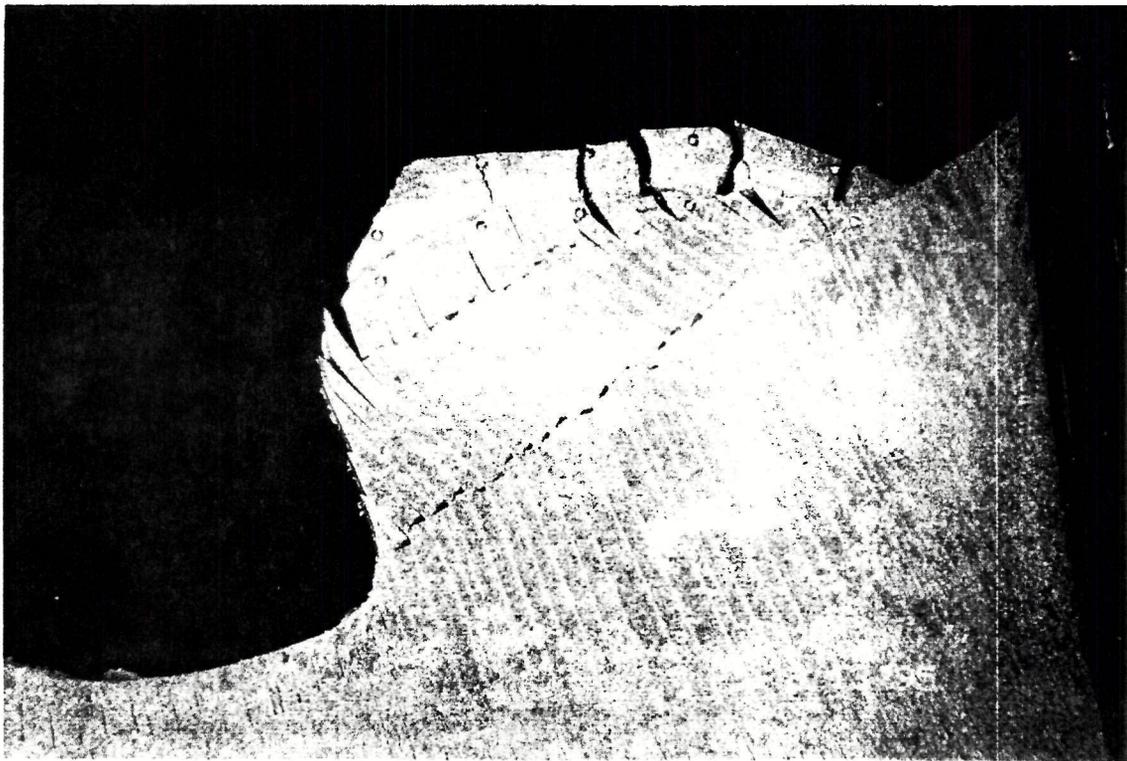
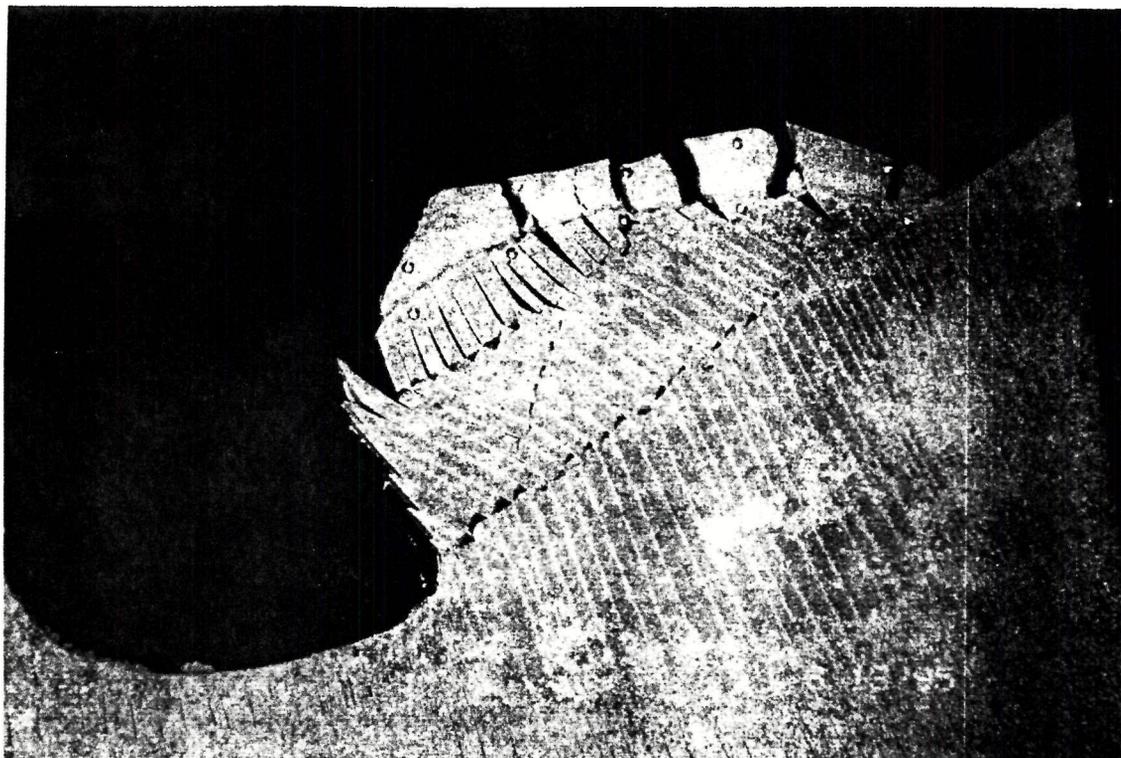
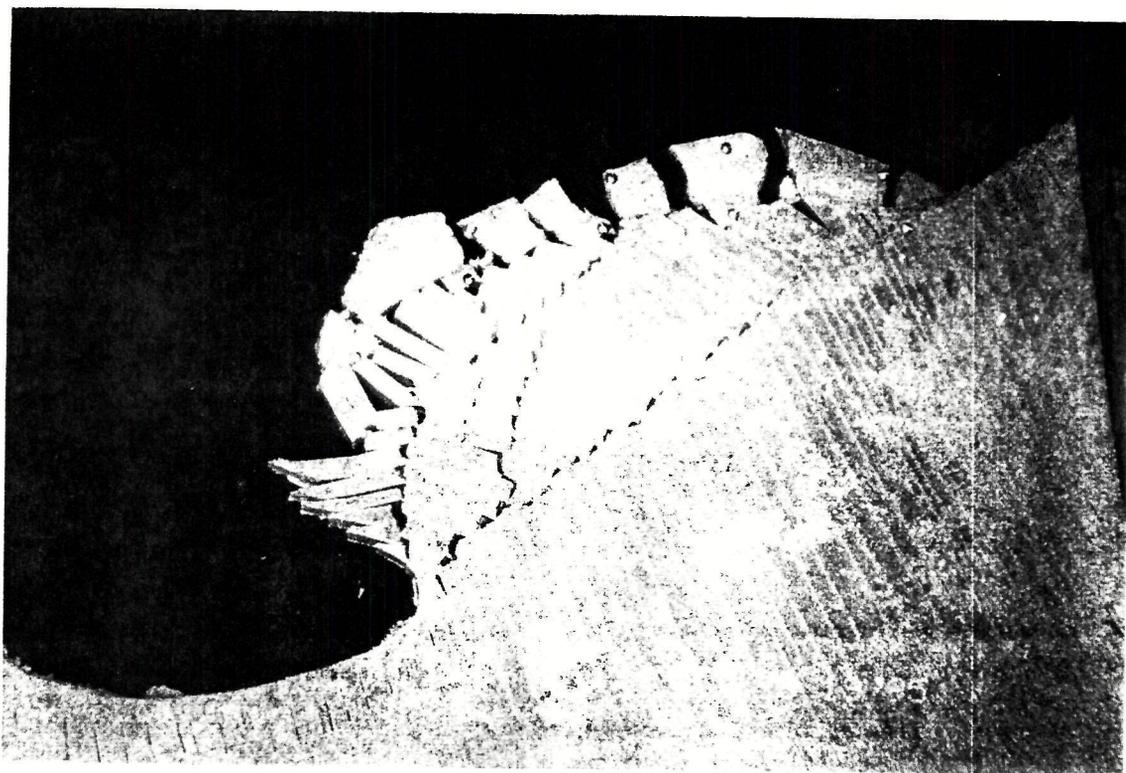
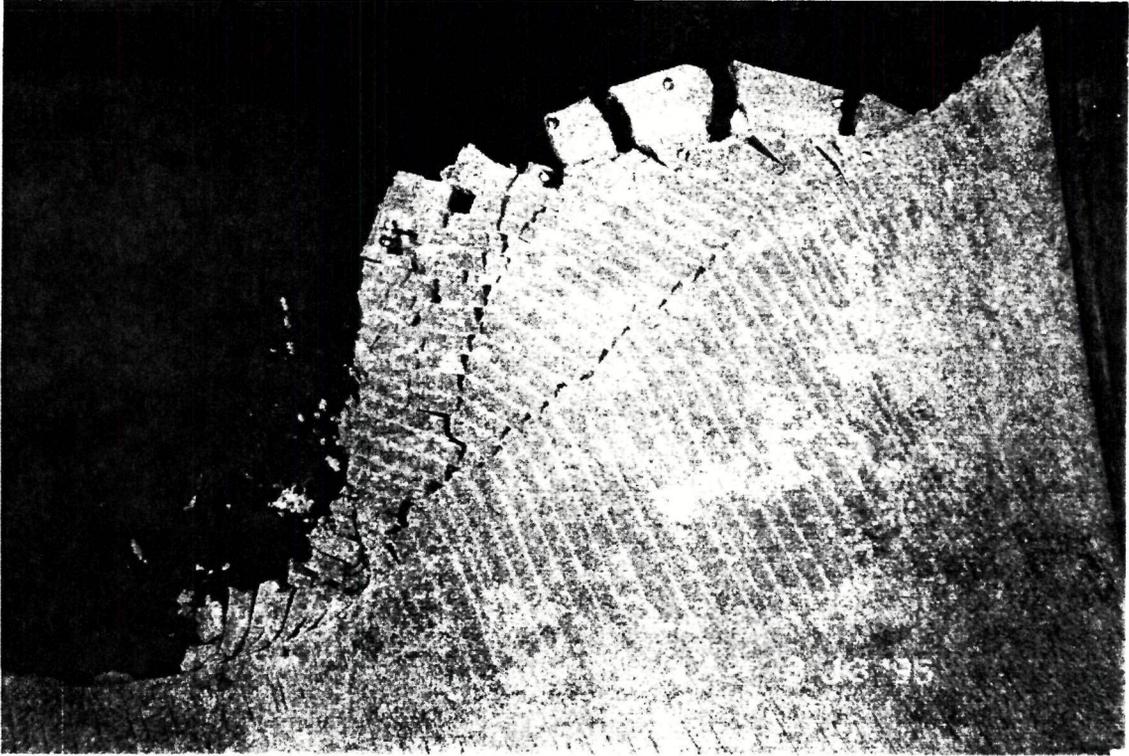
PHOTOS 16 A through 16G - Representative base friction model test, comparing surface and shallow depth toppling displacements. A) Simulation of original slope configuration, prior to spillway outlets (slope configuration stable under model conditions). Silver dots represent points of measured displacements throughout test.; B) Simulation of hydraulic excavation resulting from spill outlets; C through E (following pages) - progressive deformation of modeled bedrock and overlying fill. Compare photo 16 G to Subsurface Cross Section AA' (Figure 6) .

In order to determine whether displacements at the fill surface can be related to displacements of the underlying bedrock surface, base friction model tests (Goodman, 1976) were conducted to simulate the kinematics of the observed field failure. The fill and bedrock model materials consisted of a mixture of flour, sand and cooking oil. Thinly spaced discontinuities were impressed into the Salt Springs Slate model material to simulate foliation, and the fill model material consisted of a notably weaker, continuous mixture. The initial configuration of a typical base friction test is shown on Photograph 16A, followed by excavation and progressive failure in Photographs 16B through 16G.
