2019 Dam Safety Program Annual Report

Planning Committee

August 13, 2019

Main Wastewater Treatment Plant Odor Control Program Update

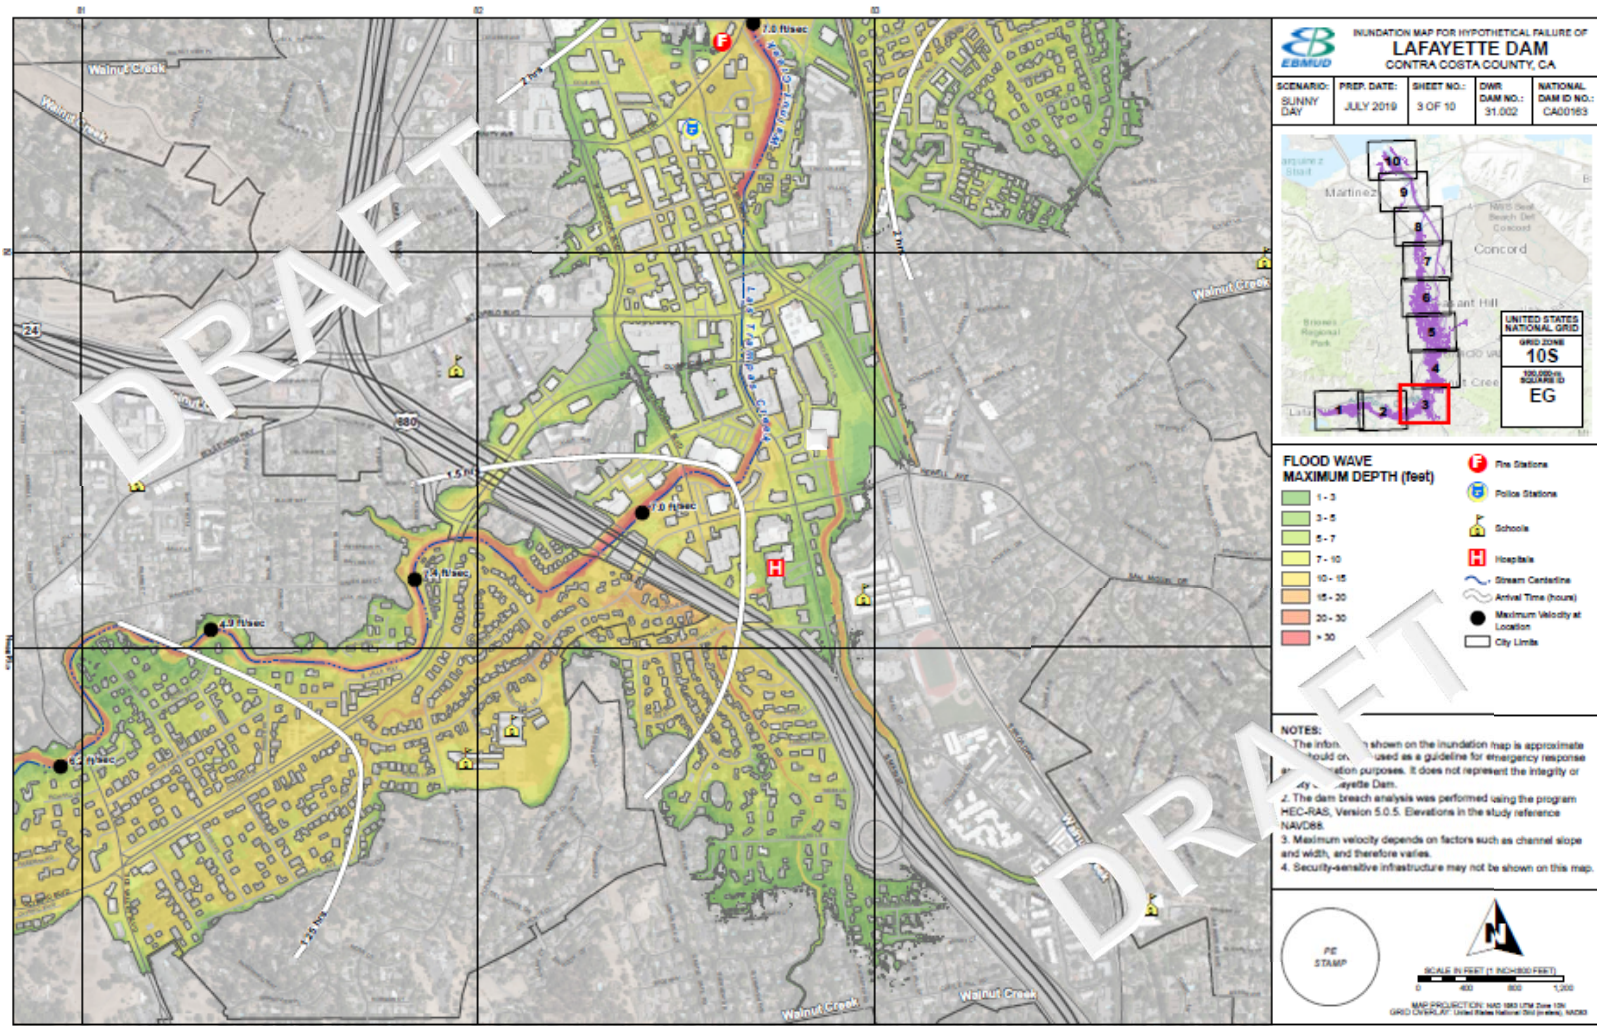
Sample Inundation Map

- DWR adopted permanent map regulations in November 2018
- District plans terminal reservoir map submittal in October 2019 with open cut and Mokelumne dams to follow

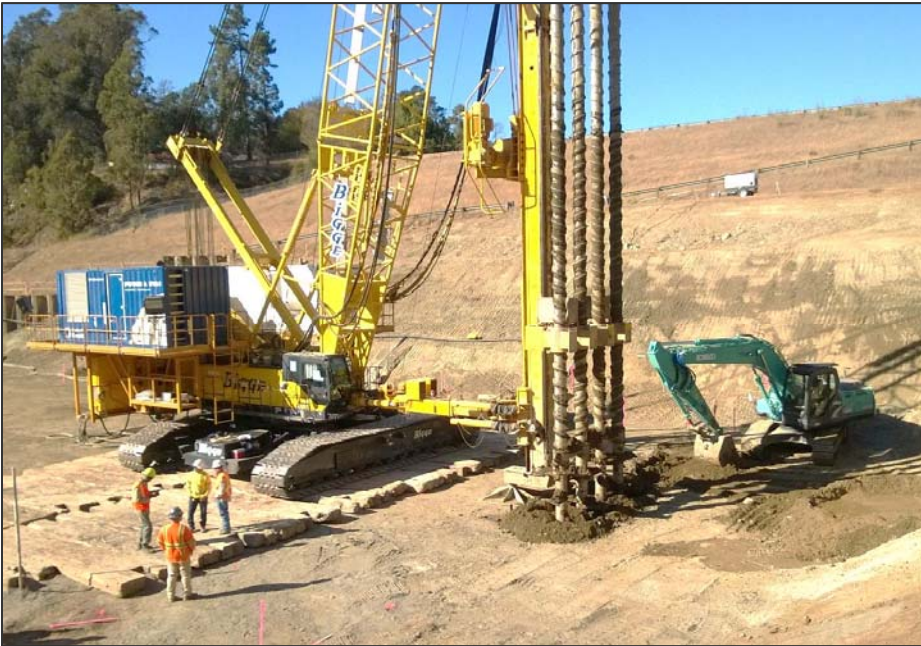
Chabot Dam & USL Outlet Tower

Chabot Dam Seismic Upgrade:

Cement Deep Soil Mixing, buttress, drainage trench, tower upgrades

Partially funded by \$5M DWR Grant

Construction completed October 2017

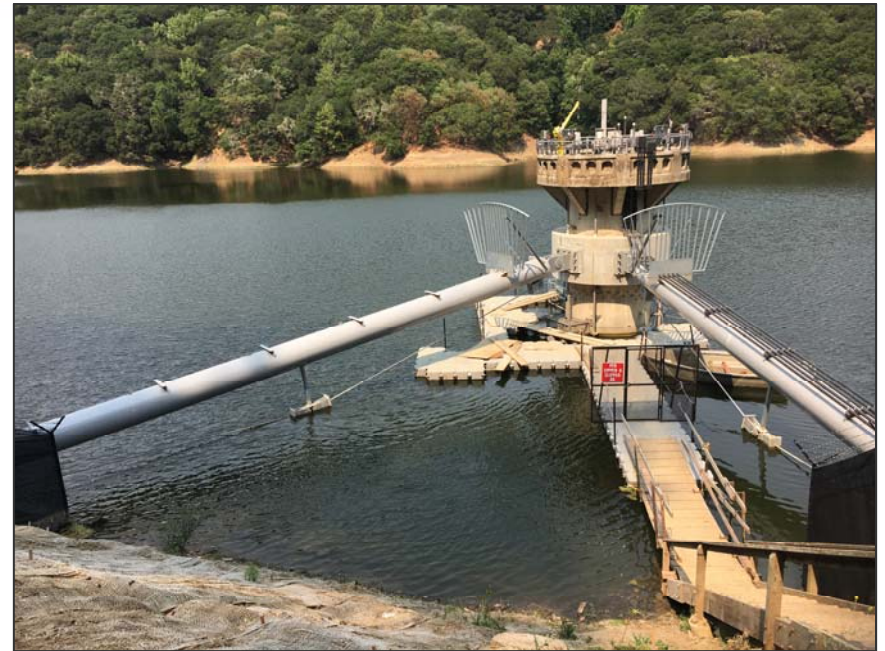
USL Tower

Completed in September 2018

Tower braces provide seismic stability

Mechanical, electrical, and controls improvements to improve reliability

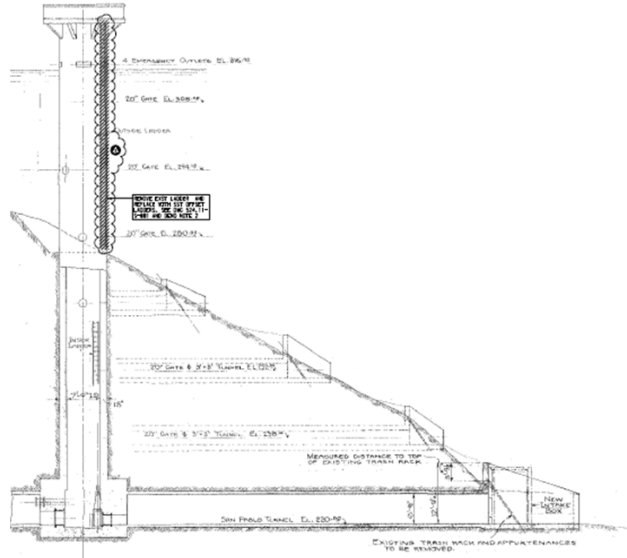
San Pablo Tower

Installed isolation valve to prevent uncontrolled release through the San Pablo Tunnel

Added tunnel access shaft improvements with new ladder at the tower

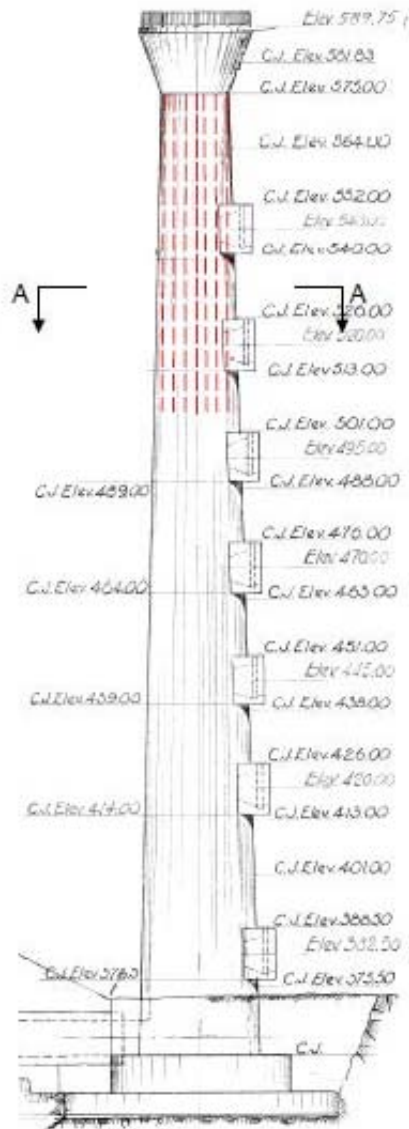
Briones Tower

- Reinforcement required at top of tower. Design concept submitted to DSOD for review
- CEQA Completed
- Streambed alteration permit approved by CDFW. US Army Corps of Engineers and Regional Water Quality Permits Pending

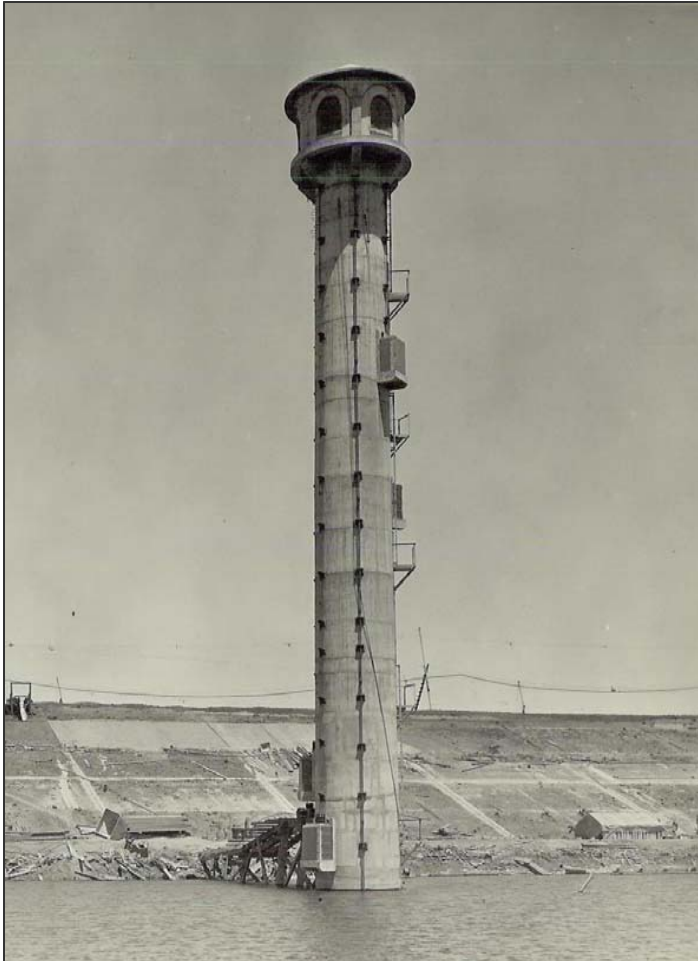
Lafayette Tower

- Performed geotechnical investigation, concrete testing, historic and environmental surveys
- Shortening the tower most effectively addresses seismic vulnerabilities
- CEQA analysis and permitting beginning, along with public outreach

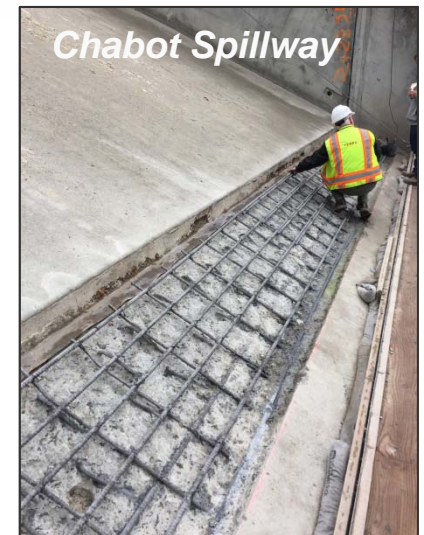
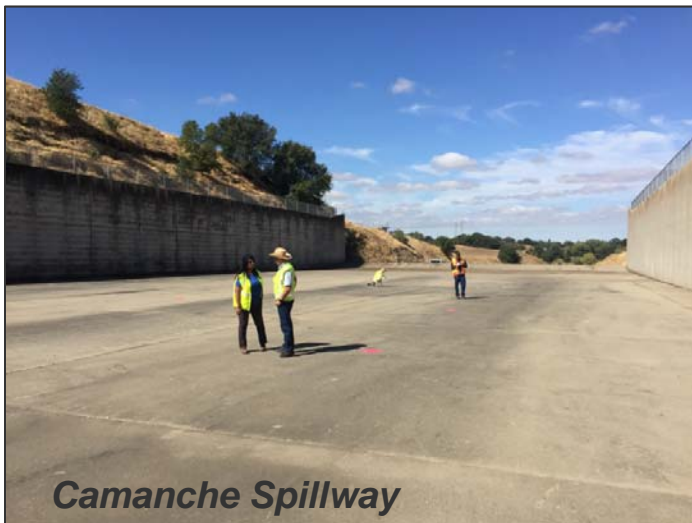
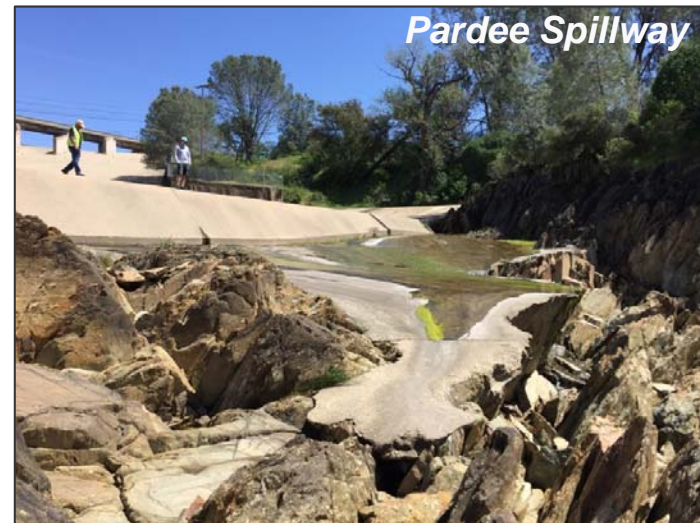
Spillway Condition Assessments

- Comprehensive evaluation of terminal and Mokelumne spillways
- March 2019 – Submitted Terminal Reservoir Spillway Condition Assessment Reports to the State Division of Safety of Dams (DSOD)
- December 2019 – Planned submittal of Camanche report

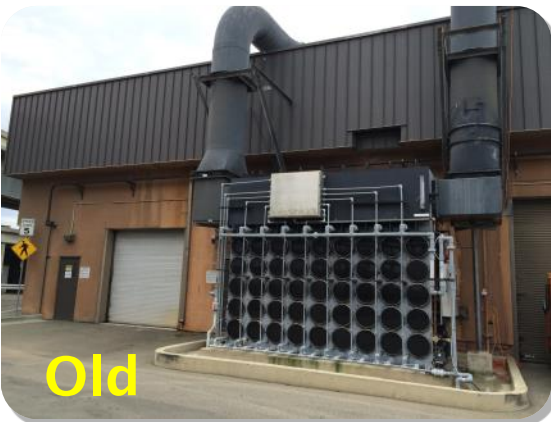
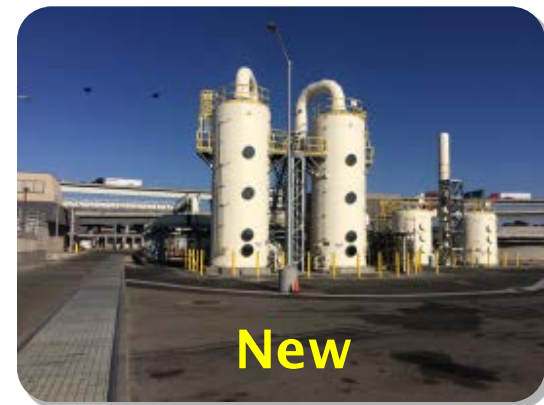
Upgraded Odor Control System for Influent Pump Station

Operational
January 2019

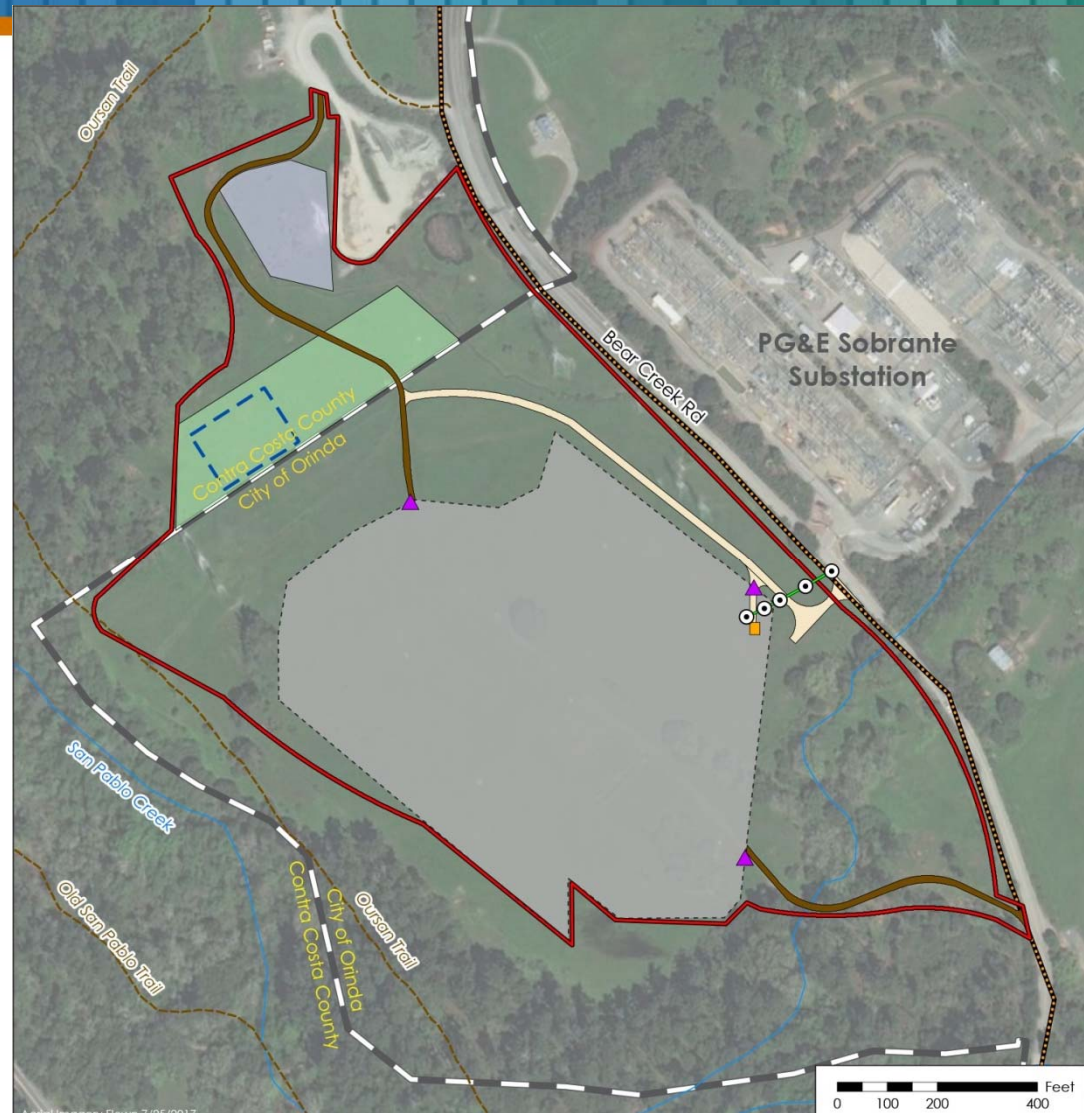
Conceptual Site Plan

5 MW project would:

Be limited to ~20 acres of EBMUD's 29,000 acres of local watershed

Minimize visual impacts by co-locating with PG&E's substation and addition of vegetative screening.

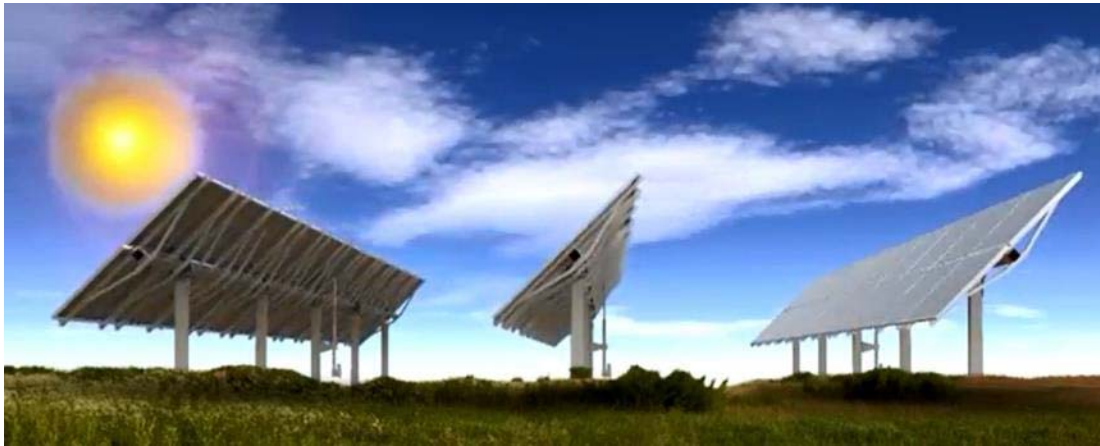
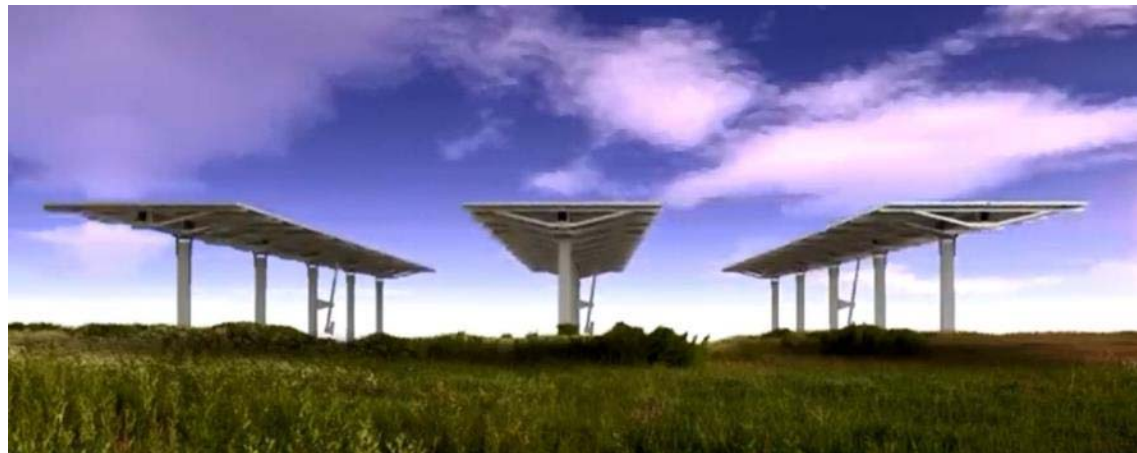
Single Axis PV Tracker

Sun Tracking

Flat - Mid-Day & Evening
