Glen Echo Creek

Post-spill Restoration and Monitoring Plan

East Bay Municipal Utility District

Horizon Water and Environment

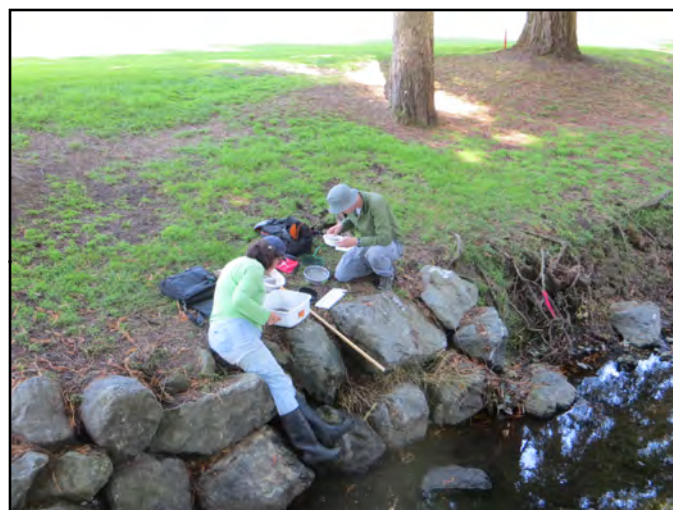
4. Benthic invertebrate sampling station

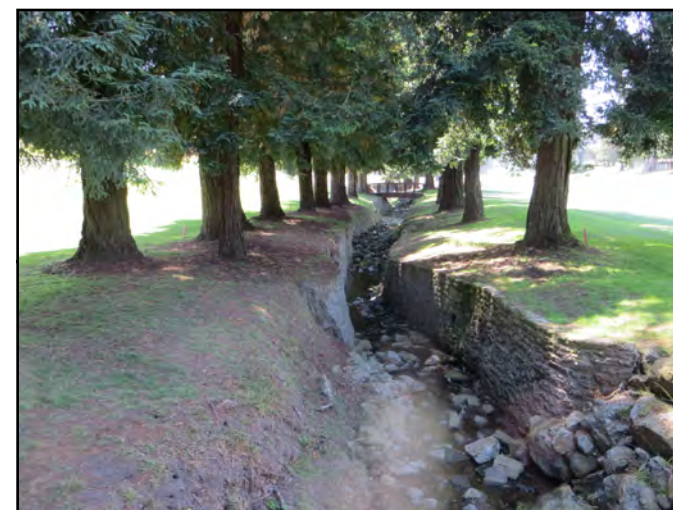
2. Looking downstream

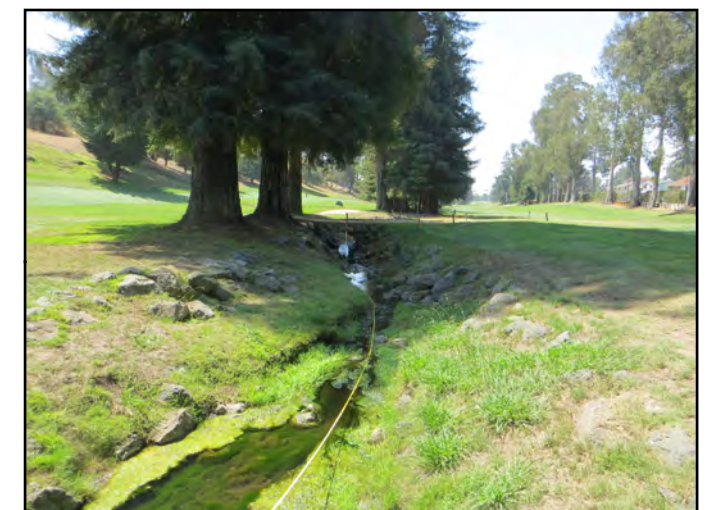
1. Looking downstream from the top of R3

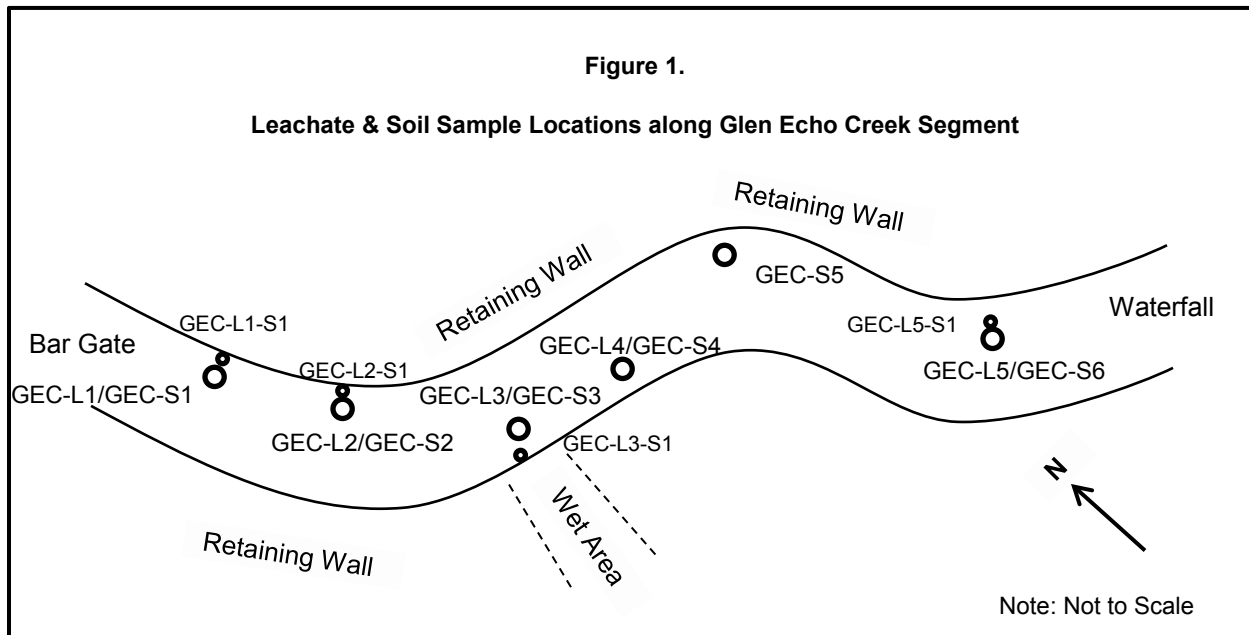
- GEC-L1: Approximately 9 feet upstream of the bar gate, east side of the creek; pH = 7.61
- GEC-L1-S1: Step-out from GEC-L1, approximately 1-2 feet further east; pH = 7.61
- GEC-L2: Approximately 6 feet upstream from GEC-L1, east side of the creek; pH = 10.30
- GEC-L2-S1: Step-out from GEC-L2, approximately 1-2 feet further east; pH = 9.88 – 10.34
- GEC-L3: Approximately 16 feet upstream of GEC-L2, wet bank on west side of the creek; pH = 7.05
- GEC-L3-S1: Step-out from GEC-L3, approximately 1-2 feet further west; pH = 7.04
- GEC-L4: Approximately 6 feet upstream of GEC-L3, west side of creek; pH = 7.93
- GEC-L5: Approximately 25 feet upstream of GEC-L4, east side of creek; pH = 10.44
- GEC-L5-S1: Step-out from GEC-L5, approximately 1-2 feet further east; pH = 9.94

- GEC-S1-6 & GEC-S1-12 (refusal at 12 inches bgs); pH = 7.8 & 7.9, respectively
- GEC-S2-6 & GEC-S2-12 (refusal at 12 inches bgs); pH = 9.7 & 8.3, respectively
- GEC-S3-6, GEC-S3-12, & GEC-S3-18; pH = 7.5, 7.4, & 7.2, respectively
- GEC-S4-6 (refusal at 6 inches bgs); pH = 7.5
- GEC-S5-6 & GEC-S5-10 (refusal at 10 inches bgs) ; pH = 8.8 & 8.3, respectively
- GEC-S6-6 (refusal at 6 inches bgs); pH = 9.9

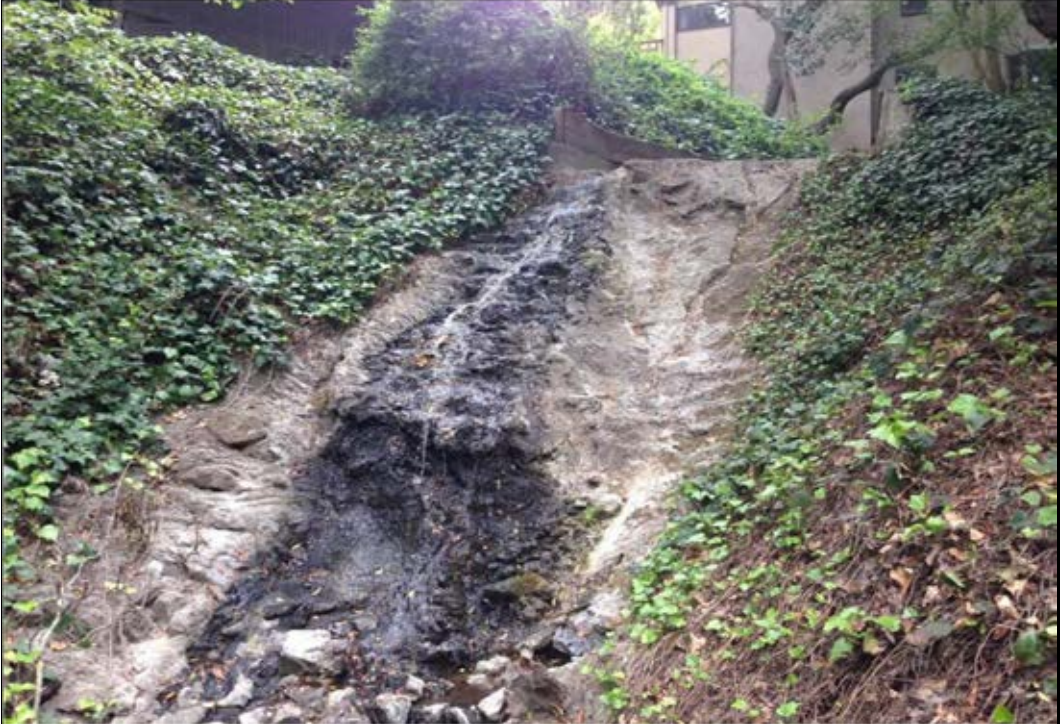
Photo Number / File Name:	1 / IMG_3048.JPG	Date / Time:	2015-06-15 / 12:26
<u>Direction Facing</u> Southeast

<u>Caption</u> Overview of evaluated segment of Glen Echo Creek; waterfall at south end.

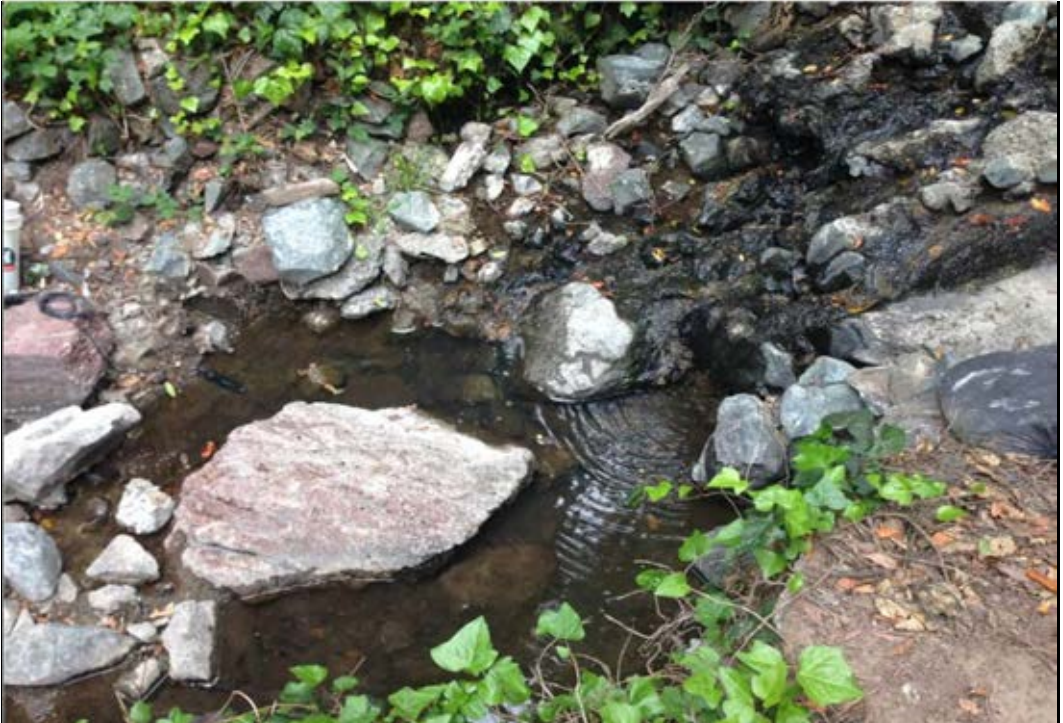
Photo Number / File Name:	2 / IMG_3050.JPG	Date / Time:	2015-06-15 / 12:26
<u>Direction Facing</u> East & Down

<u>Caption</u> Overview of evaluated segment of Glen Echo Creek; base of waterfall at south end.

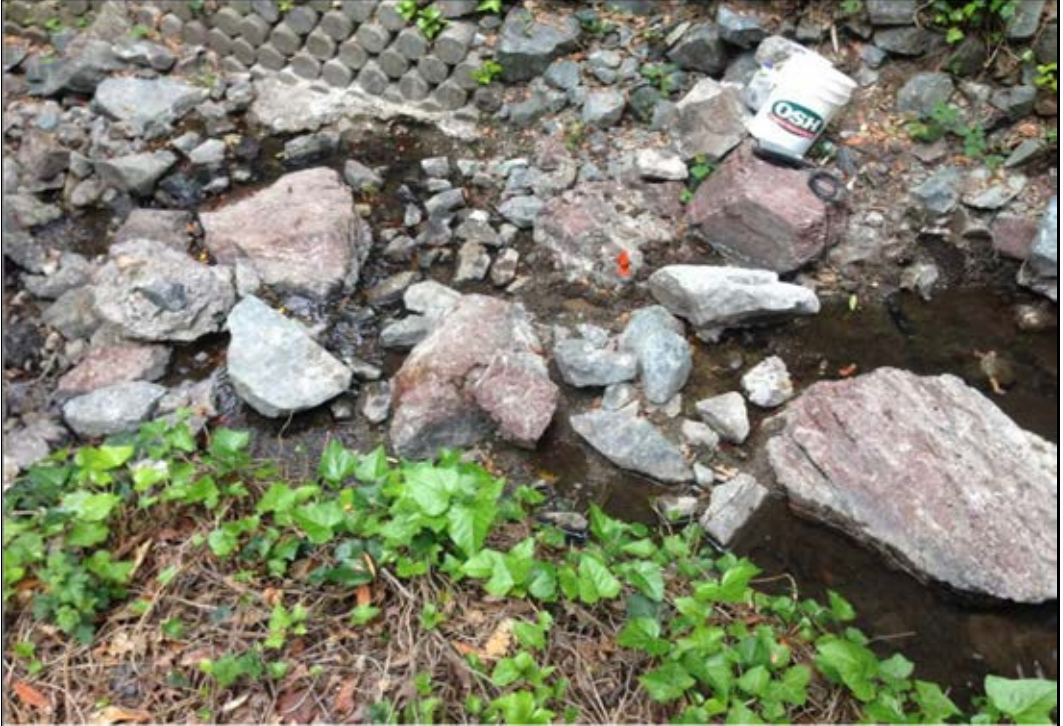
Photo Number / File Name:	3 / IMG_3051.JPG	Date / Time:	2015-06-15 / 12:26
<u>Direction Facing</u> Northeast & Down

<u>Caption</u> Overview of evaluated segment of Glen Echo Creek; southern portion of creek segment.

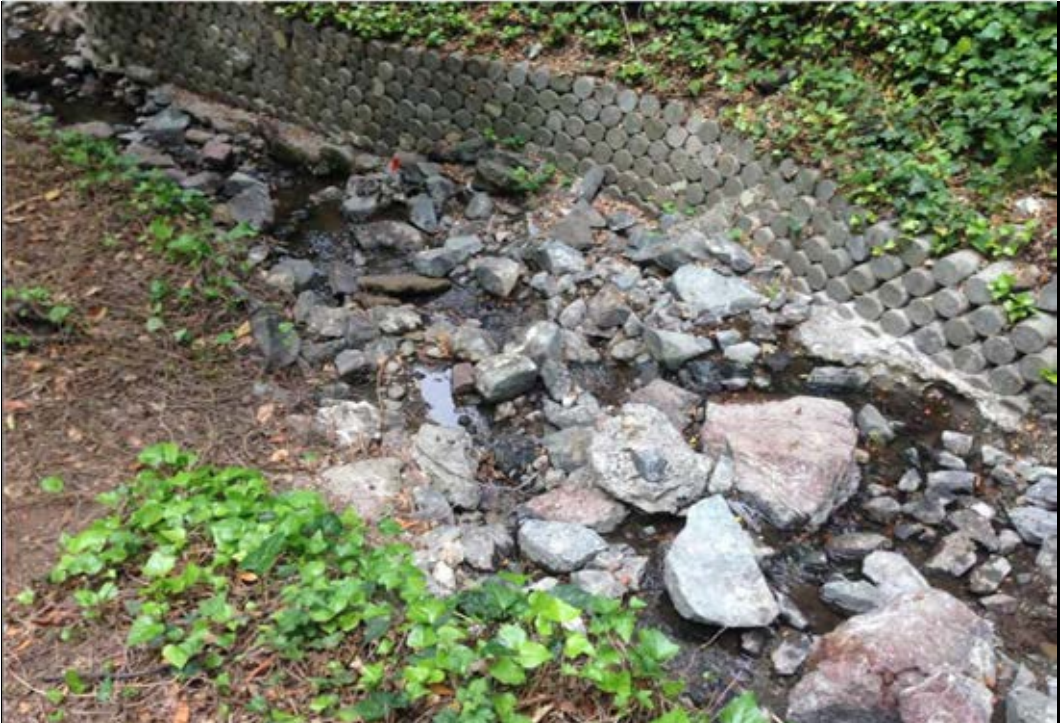
Photo Number / File Name:	4 / IMG_3052.JPG	Date / Time:	2015-06-15 / 12:27
<u>Direction Facing</u> North & Down

<u>Caption</u> Overview of evaluated segment of Glen Echo Creek; middle portion of creek segment with retaining wall along east bank.

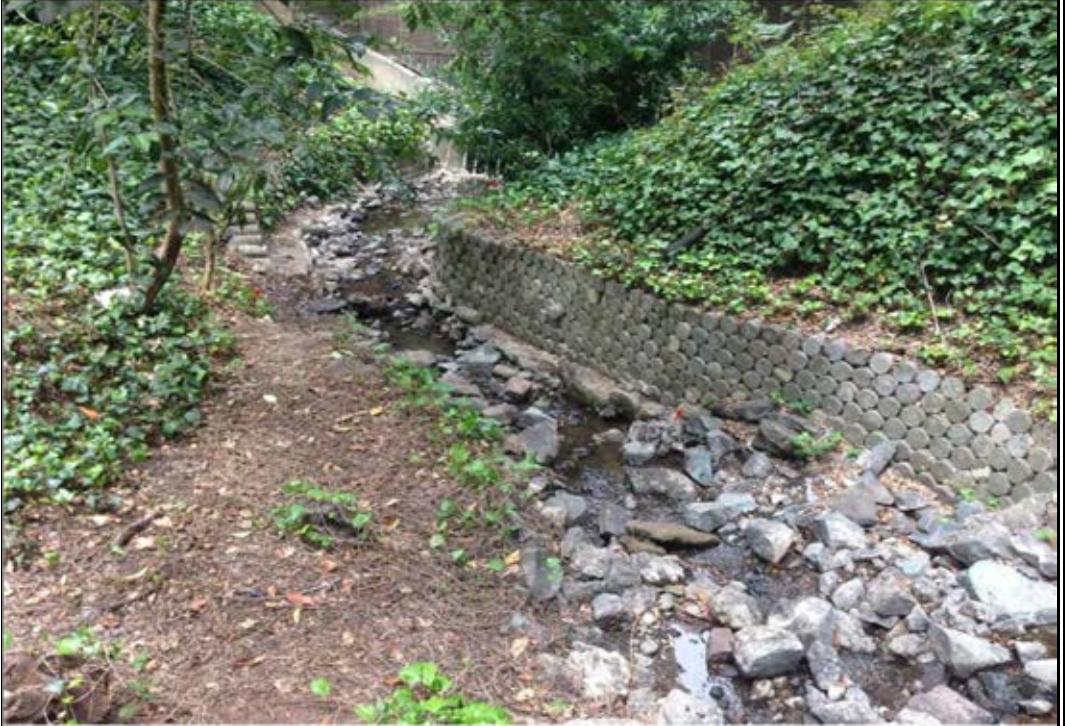
Photo Number / File Name:	5 / IMG_3053.JPG	Date / Time:	2015-06-15 / 12:27
<u>Direction Facing</u> Northwest

<u>Caption</u> Overview of evaluated segment of Glen Echo Creek; northern portion of creek segment and bar gate.

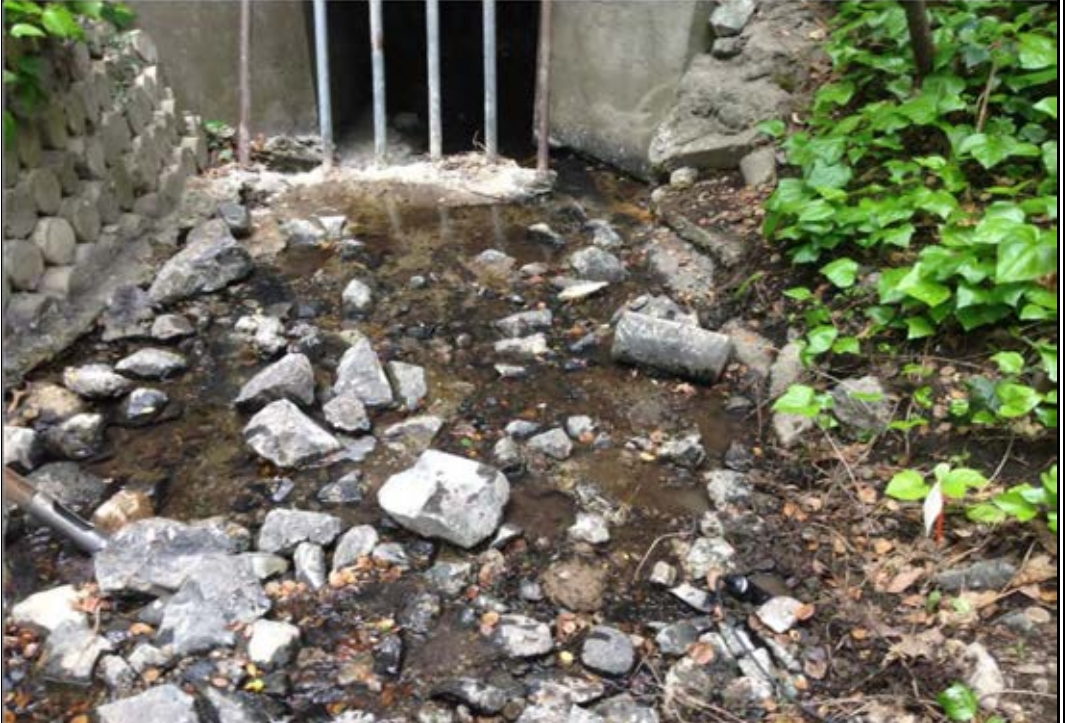
Photo Number / File Name:	6 / IMG_3030.JPG	Date / Time:	2015-06-15 / 09:56
<u>Direction Facing</u> Northwest

<u>Caption</u> Leachate and soil sample location "GEC-L1/S1", indicated by flag and pH probe at location.

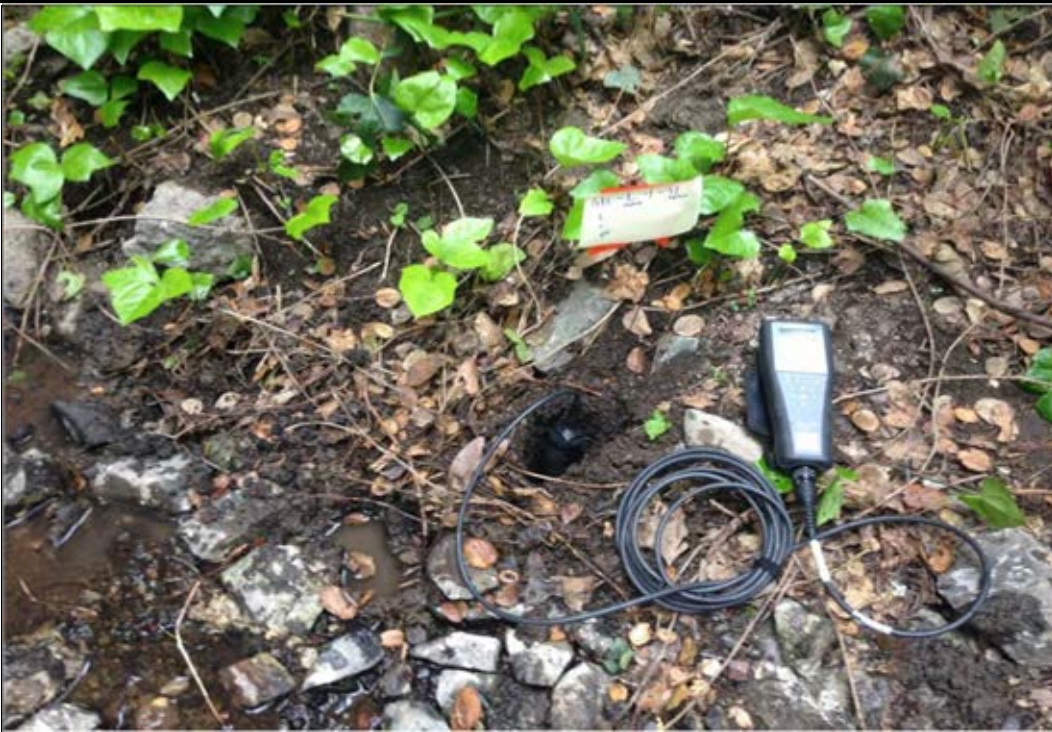
Photo Number / File Name:	7 / IMG_3032.JPG	Date / Time:	2015-06-15 / 10:08
<u>Direction Facing</u> Northeast & Down

<u>Caption</u> Leachate step-out location "GEC-L1-S1", approximately 1-2 feet away from leachate location "GEC-L1".

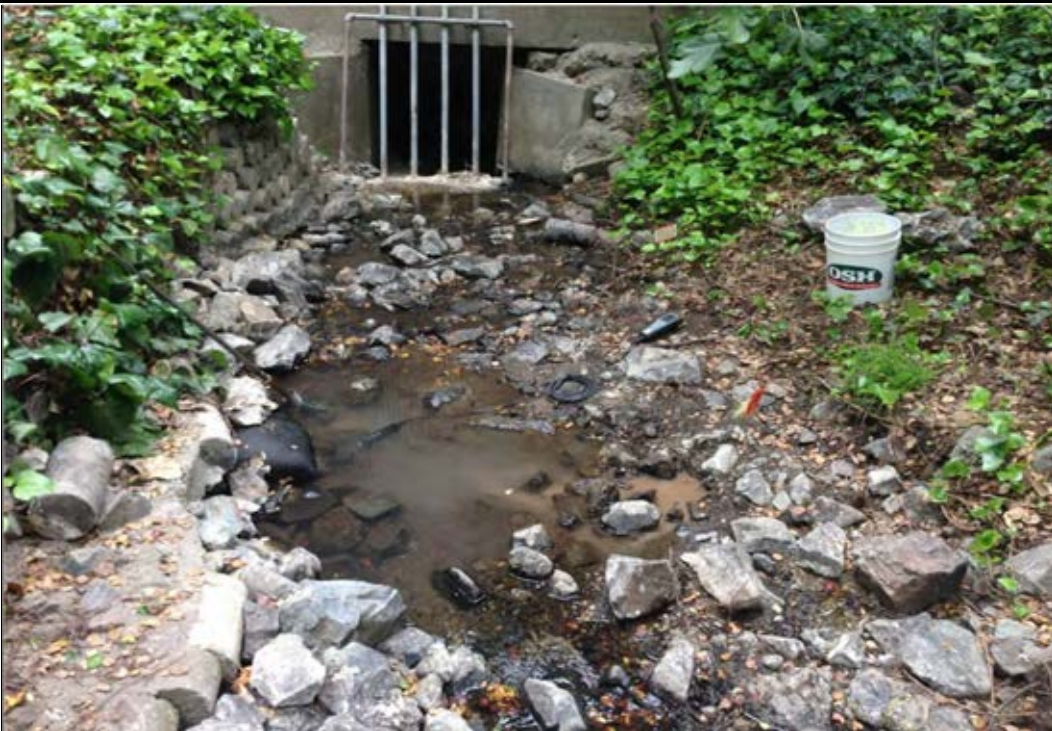
Photo Number / File Name:	8 / IMG_3036.JPG	Date / Time:	2015-06-15 / 10:22
<u>Direction Facing</u> Northwest

<u>Caption</u> Leachate and soil sample location "GEC-L2/S2", at approximate location of previous CADFW and EBMUD pH leachate tests.

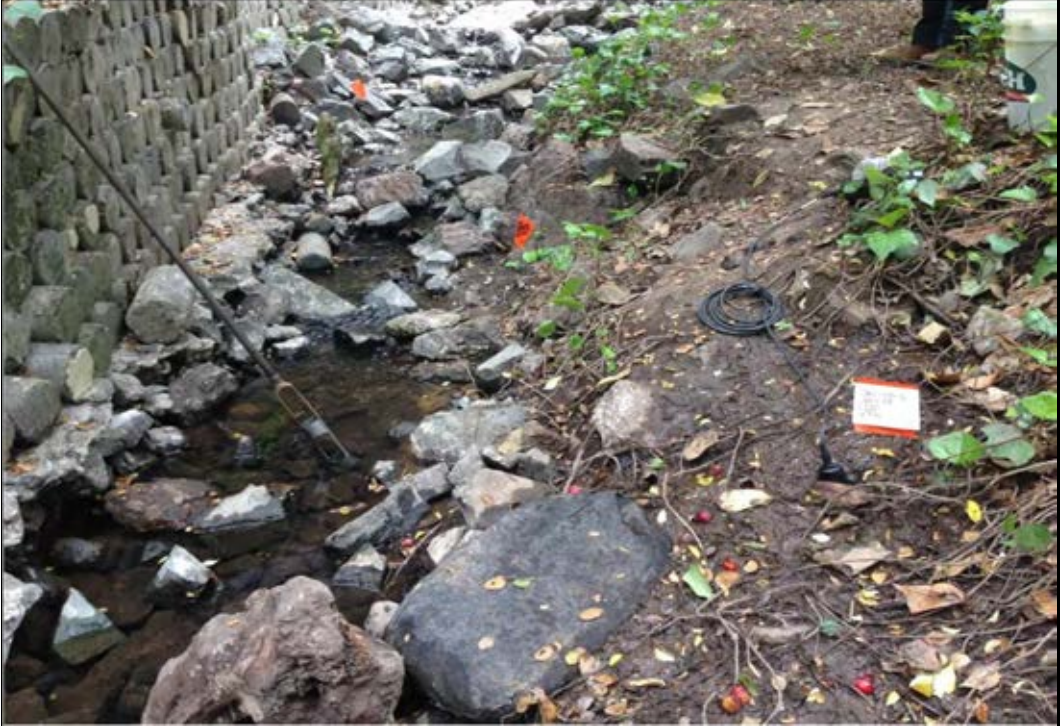
Photo Number / File Name:	9 / IMG_3038.JPG	Date / Time:	2015-06-15 / 10:55
<u>Direction Facing</u> Southeast

<u>Caption</u> Leachate and soil sample location "GEC-L3/S3", in a wet zone on the west bank of the creek.

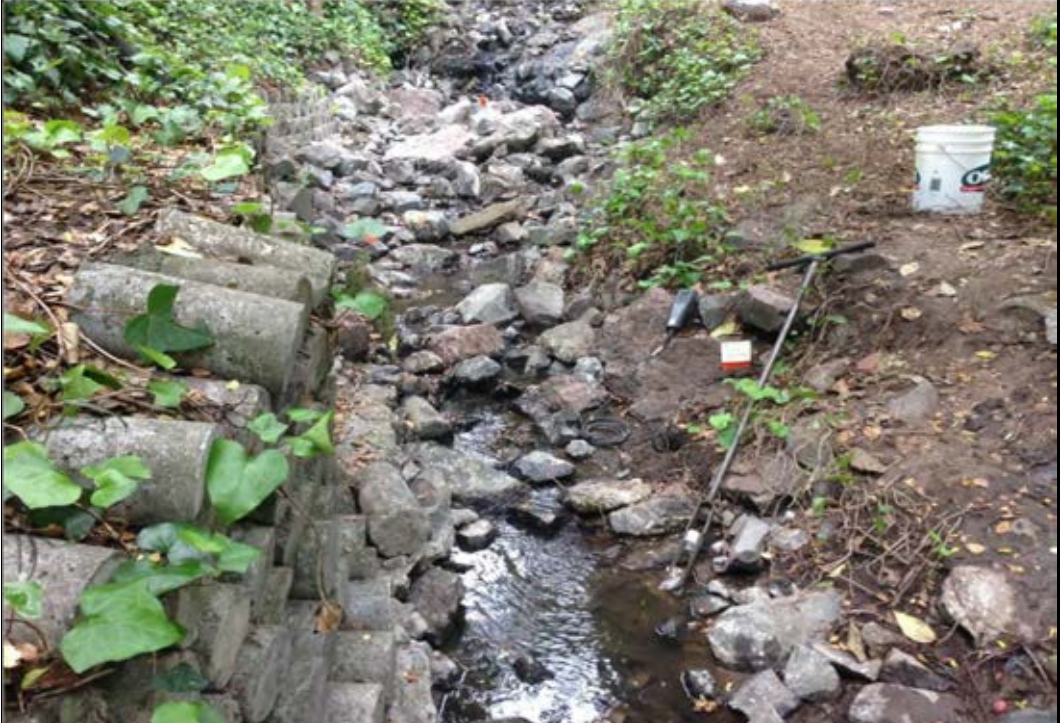
Photo Number / File Name:	10 / IMG_3042.JPG	Date / Time:	2015-06-15 / 11:14
<u>Direction Facing</u> Southeast

<u>Caption</u> Leachate and soil sample location "GEC-L4/S4".

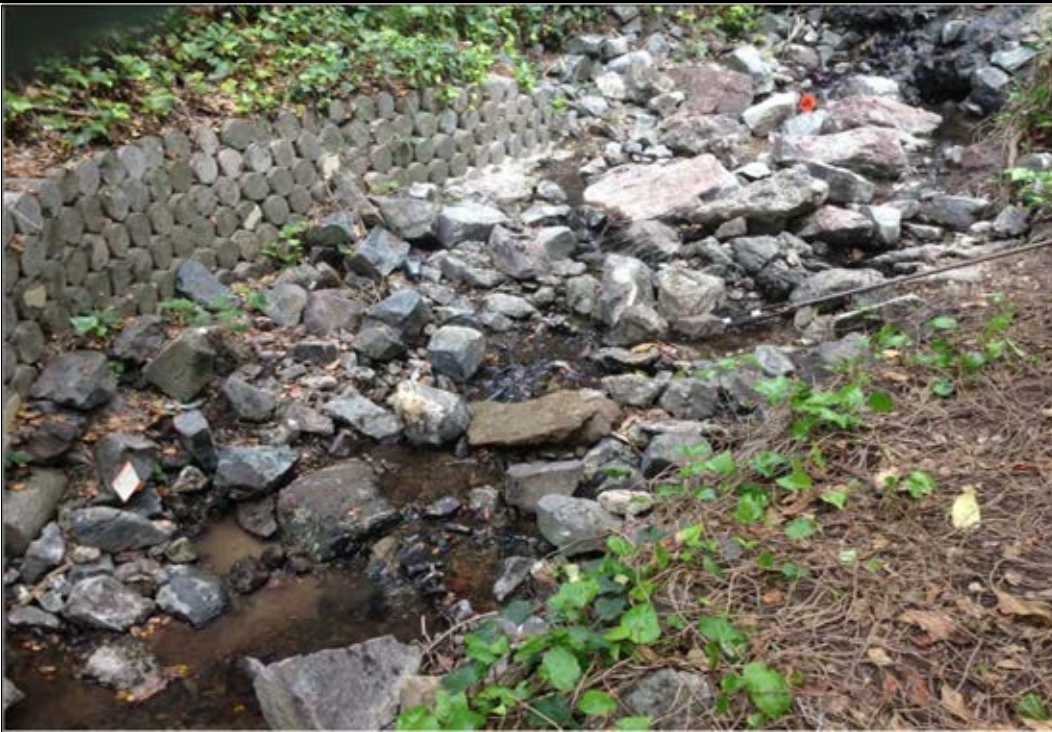
Photo Number / File Name:	11 / IMG_3044.JPG	Date / Time:	2015-06-15 / 11:26
<u>Direction Facing</u> East

<u>Caption</u> Soil sample location "GEC-S5" (left flag) and leachate and soil sample location "GEC-L5/S6" (right flag).

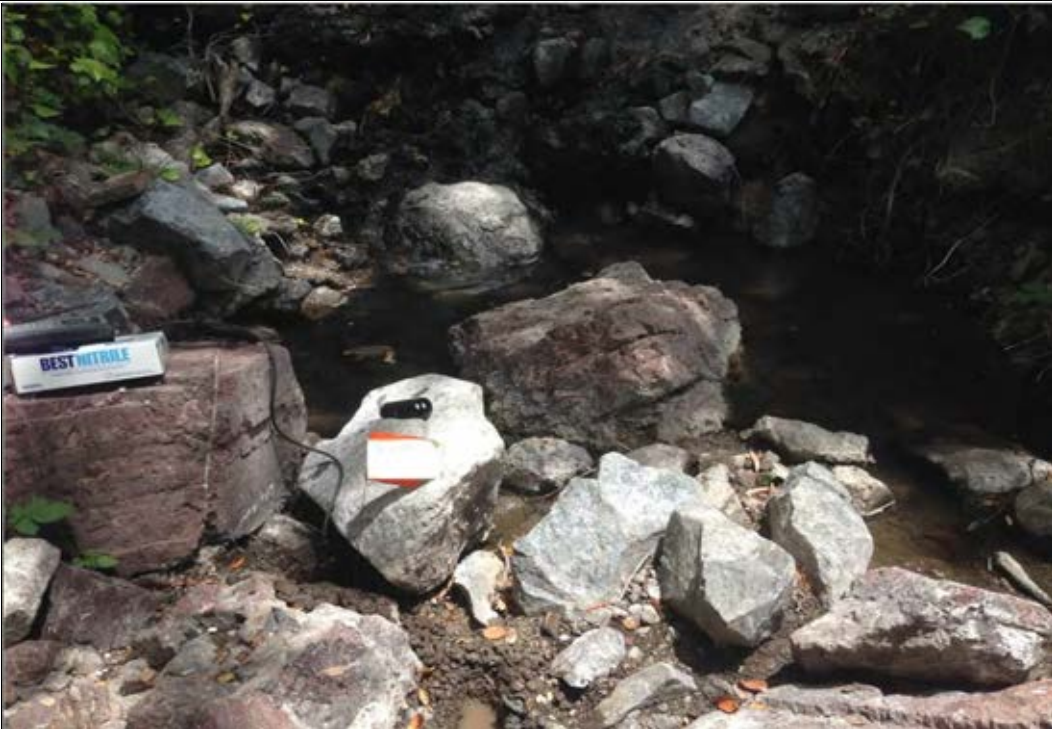
Photo Number / File Name:	12 / IMG_3055.JPG	Date / Time:	2015-06-15 / 13:40
<u>Direction Facing</u> Southeast

<u>Caption</u> Leachate step-out location "GEC-L5-S1" (at flag), approximately 1-2 feet away from leachate and soil sample location "GEC-L5/S6" (visible near bottom center of photograph).
