Pardee Reservoir
Calaveras County, California

Tunnel Leakage Report

July 2013

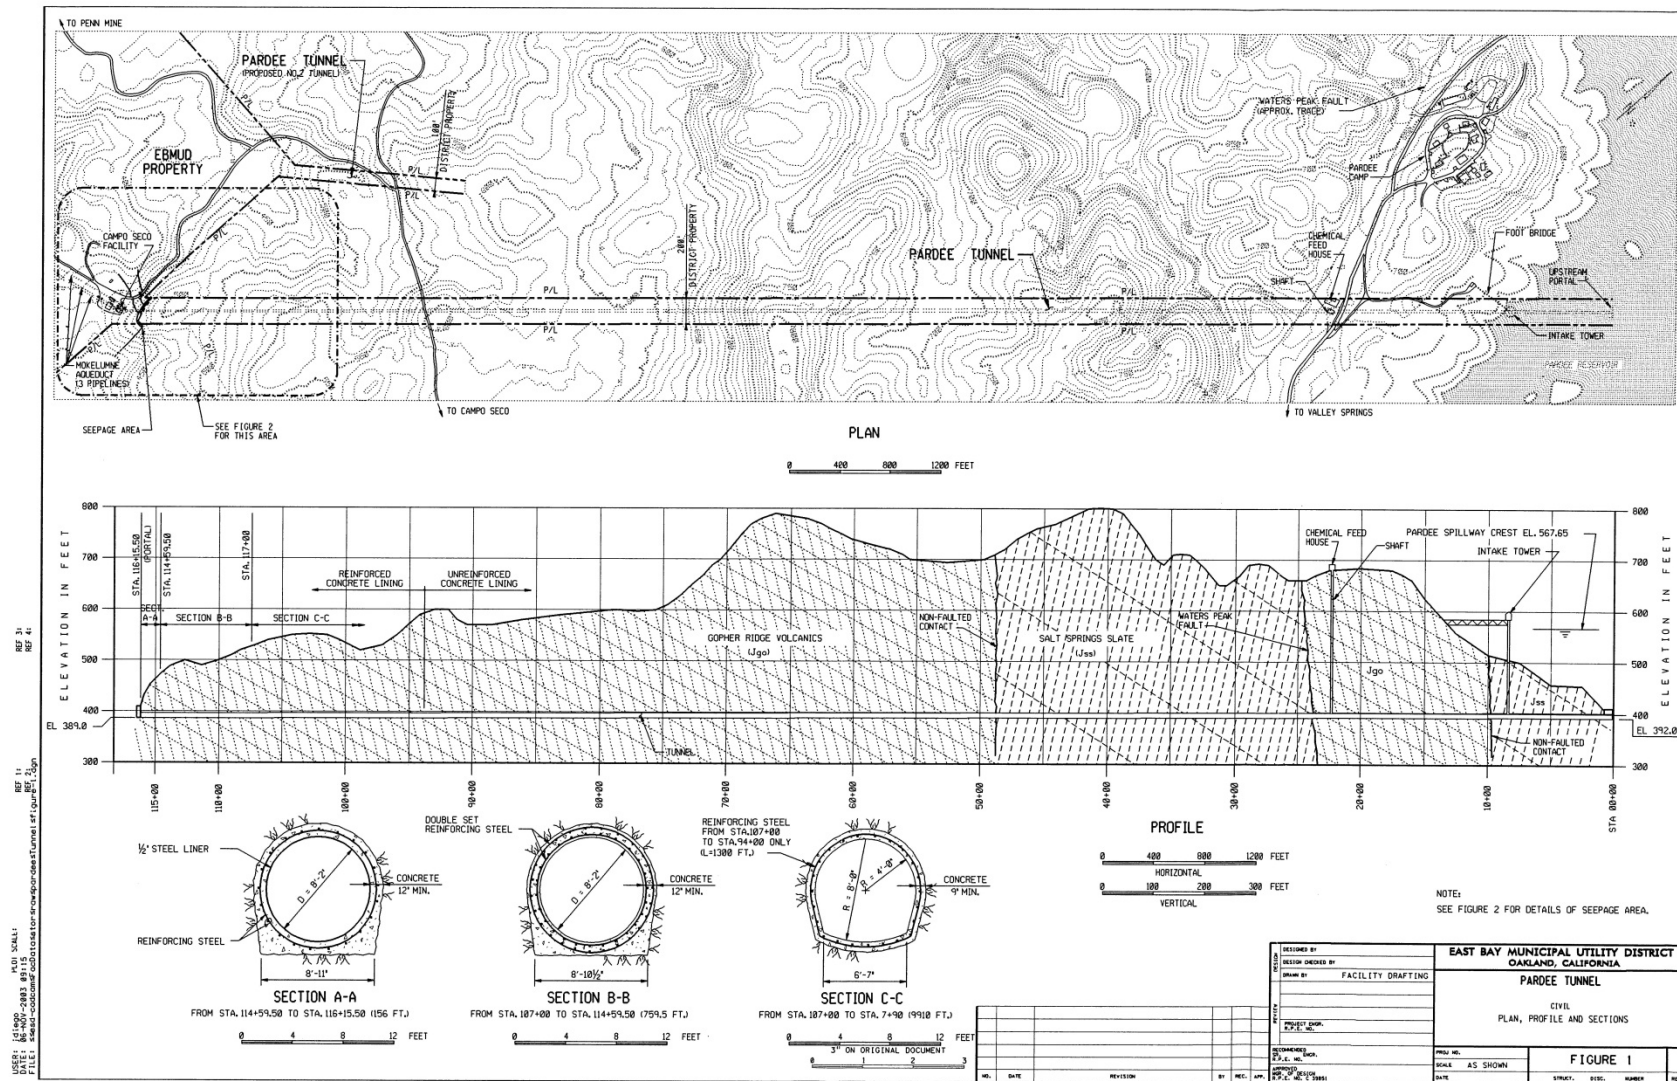
Figure 1. Pardee Tunnel: Existing Outlet Works Plan, Profile, and Sections

The majority of the tunnel concrete lining is unreinforced except for the reach at the west portal, as indicated in Figure 1. Between Sta. 94+00 and Sta. 107+00, the horseshoe section is reinforced with a single layer of reinforcing, while from Sta. 107+00 to Sta. 116+15 the circular tunnel cross section is reinforced with a double layer of reinforcing. The westernmost 156 feet of the tunnel (from Sta. 114+59 to Sta. 116+15) is lined with a 0.5-inch-thick steel liner. In 1950 additional concrete lining was installed between Sta. 23+64 and Sta. 23+96.

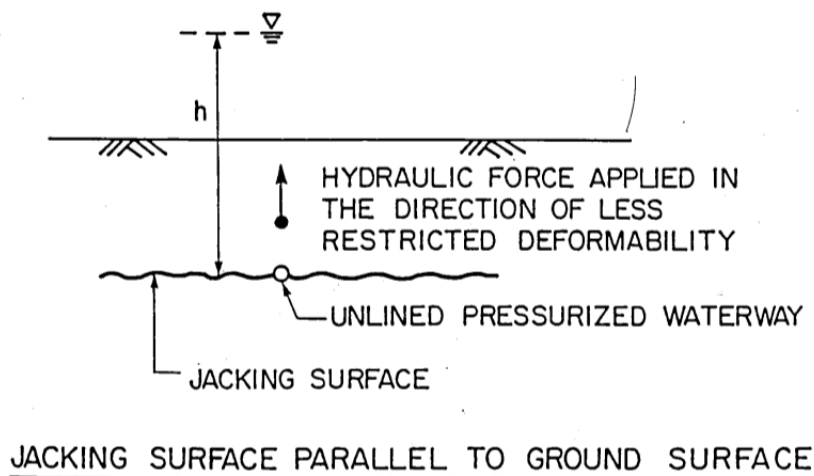
Figure 3. Vertical Confinement Condition

One approach to determine the likelihood of hydraulic jacking is to assess the amount of vertical cover (overburden) that will provide vertical confinement to the pressure tunnel. This approach is presented by Brekke and Ripley (1987). The criterion assumes that the vertical stress is equal to the weight of the overburden, and therefore, hydraulic jacking can be prevented if the depth of cover is greater than the internal tunnel head. Using this concept, a factor of safety against hydraulic jacking of horizontal features can be developed (as shown in Figure 3).

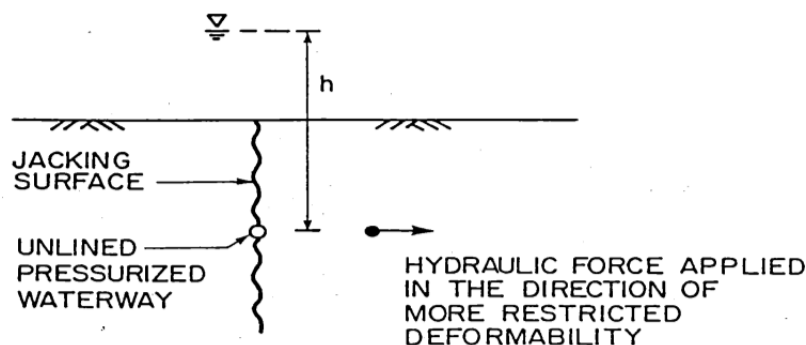
Figure 4. Horizontal Confinement Condition

In addition to vertical confinement, lateral confinement must also be assessed to determine the potential for hydraulic jacking. To determine the potential for hydraulic jacking of vertical features (as shown in Figure 4), two parameters must be considered: lateral rock cover and in situ horizontal stresses. Lateral rock cover can be an issue when steep topography exists adjacent to a tunnel. A procedure similar to the one used to determine the minimum overburden criteria (discussed in Section 5.1.1) can be used to determine the minimum lateral cover. In situ horizontal stresses must also be considered for lateral confinement, particularly when the ratio of horizontal stresses to vertical stresses is less than one. The horizontal stress state at a point depends on the type of ground; in soils it is generally lower than the vertical stress ($k_0 < 1$), while in rock the presence of residual stresses locked into the rock can cause it to be higher than the vertical stress ($k_0 > 1$). The factor of safety against hydraulic jacking of vertical features can be developed by adapting equation (1) to account for this ratio:
