SERVICE REPORT FOR UPPER BLOCK REPLACEMENT  
ENTERPRISE DGRS-46 ENGINE SERIAL NUMBER 82004-3063  
UNIT 2  
EAST BAY MUNICIPAL UTILITIES DISTRICT  
OAKLAND, CALIFORNIA

## INTRODUCTION

## SYNOPSIS

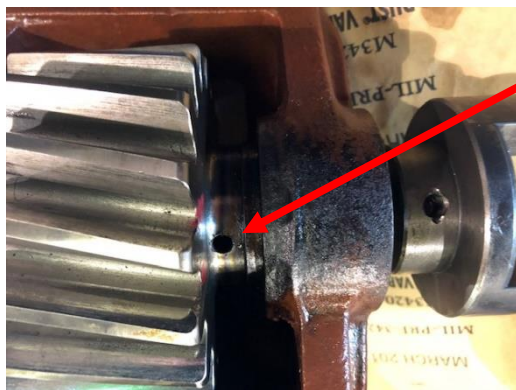
On 5 November 2018 inspection and discovery of excessive heat and seized gear on the shaft on the accessory drive gear was found on Enterprise DRS-46 engine serial number 82004-3063, Unit 2, Power Generation Station, East Bay Municipal Utility District, Oakland, California. The accessory drive gear was removed as part of a gear train replacement following review of damage to the idler gear. Review of the damage to the accessory drive gear found the shaft and bushings were seized and turned together in the gear carrier housing. Disassembly of the gear and carrier found the bushings had seized to the gear sides possibly attributed to the failure of the water pump gear (water pump gear hardened face failed as a granular grit). Fine scratches are found on the faces of both bushings (should be smooth after years of operating in lubrication). The gear and shaft are pinned together and turn independent of the bushings which have an inference fit in the gear carrier (shaft turns in the bushings). Oil is supplied to the gear carrier via ¼ inch tubing from a small manifold at the top right side (facing the front of the engine) and fed into the shaft to bushing clearance (.001-.003 in) via internal drillings to a groove around the bushing to gear carrier housing fit and into a port to the shaft.

Bushing and gear with coked oil (oil cokes at 260° F) on gear carrier housing.

Replace the accessory drive gear, bushings and hardware in the accessory drive gear carrier.

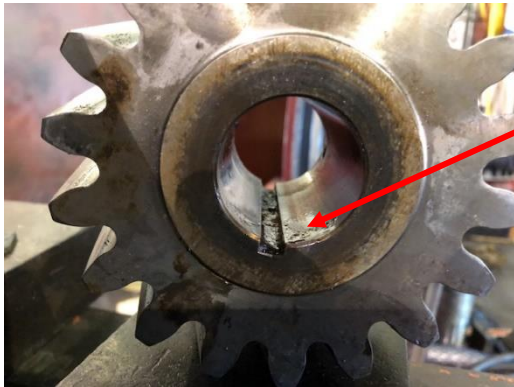
Rear side of gear blue steel and heat pitting (seized area).

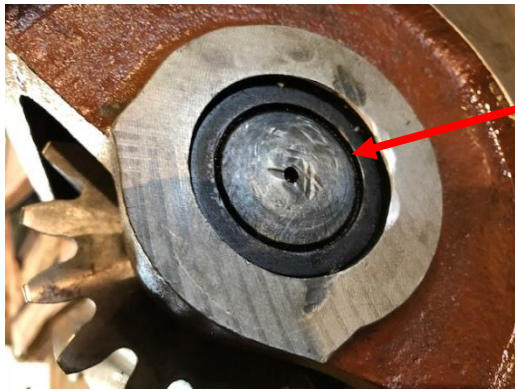
Bushing and shaft seized together with coked oil between the shaft and bushing.

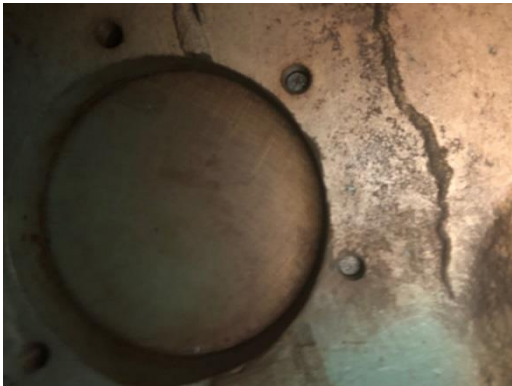
Left bank (exhaust side) flywheel side core plug viewed from bottom of bedplate through access holes, no signs of oil leak.

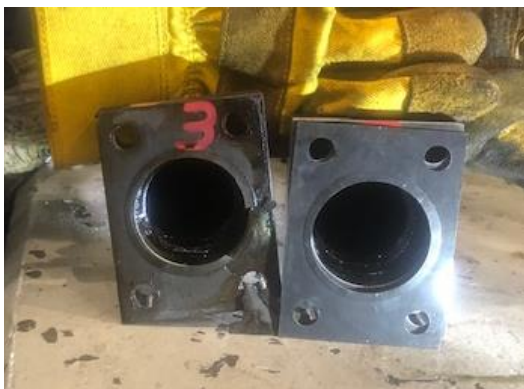
#2 TURBOCHARGER DRAIN

Remove turbocharger drain lines from Unit #2 and #3 to find a reported missing orifice plate to reduce oil flow drain and raise oil pressure in the turbocharger. No orifice plates were found in either turbocharger drain line. The drain lines were put back on to Units #2 and #3 and #3 restarted. #3 air intake horn was removed and resealed on Unit #2. Fuel injection line clamps were installed on the 6 fuel injection lines to the fuel injectors on Unit #2. Provided are pictures of the turbocharger drain lines from Units #2 and #3.

Units #2 and #3 turbocharger drain line pipes.

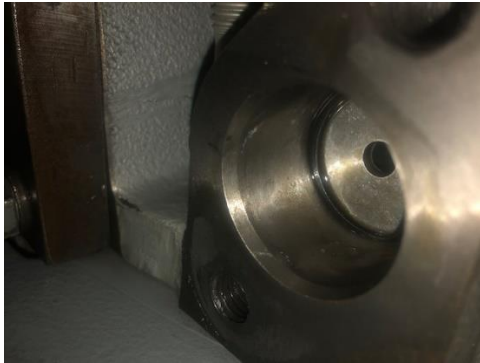
Unit 2 inlet oil supply orifice.

Remove turbocharger inlet supply lines on Units #2 and #3 to access inlet orifice. Compare sizes of inlet orifices and remove and open unit #2 orifice to .375 in. Reinstall inlet oil supply orifice on unit #2 and supply lines to units #2 and #3.
