# Safety Evaluation East Bay Municipal District Wastewater Treatment Plant

Client: Advanced Engine Technologies Corp.

**Submitted by:**  
**Jim Dyer, Principal Engineer**  
**Neil Holmgren, President**  
**09/22/2020**

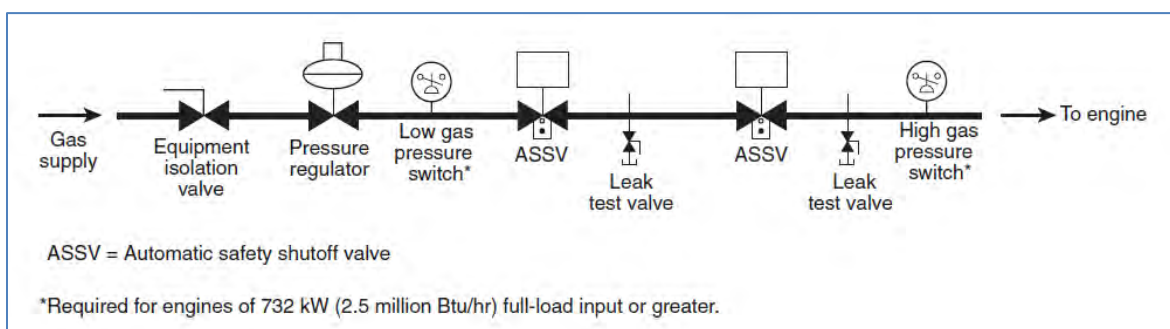
Figure 5 - NFPA 37 Fuel Gas Supply Arrangement

A manual leak test valve is required for each automatic safety shutoff valve (ASSV). The purpose of leak test valves is to prove positive closure of ASSVs. The ASSVs for the Enterprise engines are the Block and Vent (B&V) valves and the Gas Metering Valves (GMV). The leak test valves are typically small, instrument valves plugged at the outlet. *Figure 5* shows the required component arrangement to comply with NFPA 37 code for engines with outputs greater than 732 kW.

No leak test valves were installed downstream of the GMVs, but each engine has an available port for installation (*Figure 6*). A leak detection valve is not required between the ASSVs because the upstream ASSV vents to the PGS-1 roof when closed.

Install valves and plugs in available port for Leak Test valves. This can be performed by plant personnel, likely with instrument valves and fittings available on site.

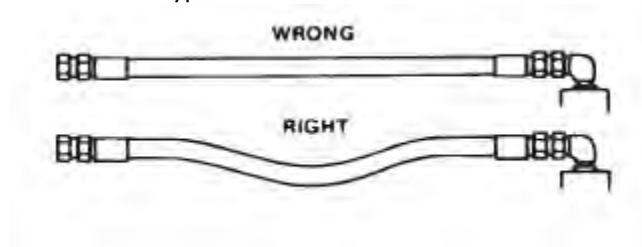
**Figure 23: Proper Hose Connection**

The vent line downstream of the manual vent valve connects to the gas vent to the roof via a short hose (Figure 22). This hose is too short to provide any meaningful vibration isolation.

For a hose to provide vibration protection, there needs to be room for the hose to move. Most hose manufactures will require a curve, belly, or “S” to be present in the hose after installation. *Figure 23* depicts an installation recommendation from a typical manufacturer.

Proper installation will allow for more flexibility in the hose connection allowing for better vibration isolation.

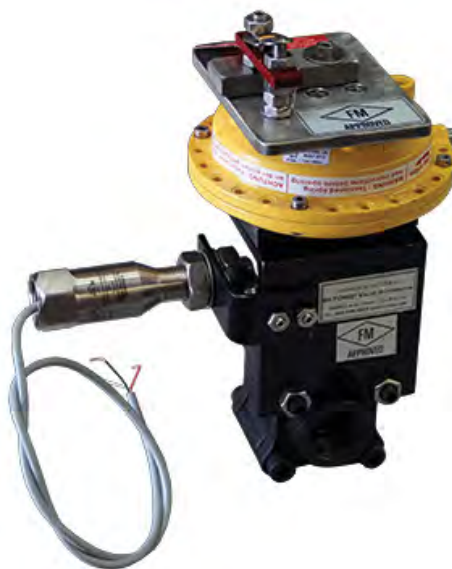
Figure 34: BiTorq Fusible Link Valve

These valves can be installed in the fuel systems (Fuel Oil and Fuel Gas) to stop the fuel flow in case of an engine room fire. It is common to install these valves at the point where the fuel enters the engine room, but it may also be beneficial to include them at each engine in case of an engine or generator fire. *Figure 34* shows thermal valves being installed at another facility adjacent to the engines to quickly secure fuel in the case of engine fire.

These valves are not required for your facility. They do offer a passive form of fire protection to ensure that fuel is quickly shut off should there be an engine/generator fire or a fire elsewhere in the engine room. EBMUD can evaluate this as an option for future upgrades.

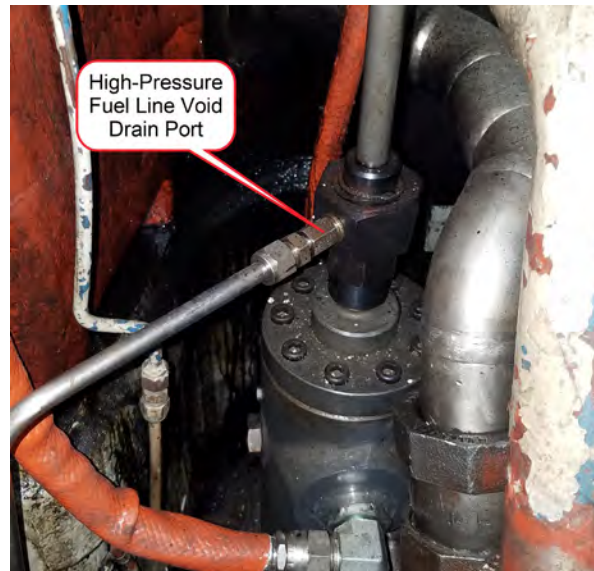
**Figure 37: High Pressure Fuel Line with Drain Port (From Another Site)**

Maritime regulations require diesel engines to collect any fuel leakage from the void space between double-wall high-pressure lines and provide a detection alarm. Because of this maritime requirement, the technology is common and offered by the OEM. For Enterprise, the system consists of a similar double-walled high-pressure line between the jerk pump and the injector with a drain port for the void space (*Figure 37*).

All the high-pressure line drain ports are plumbed to a single collection tank with a level switch to provide an alarm should the level rise.

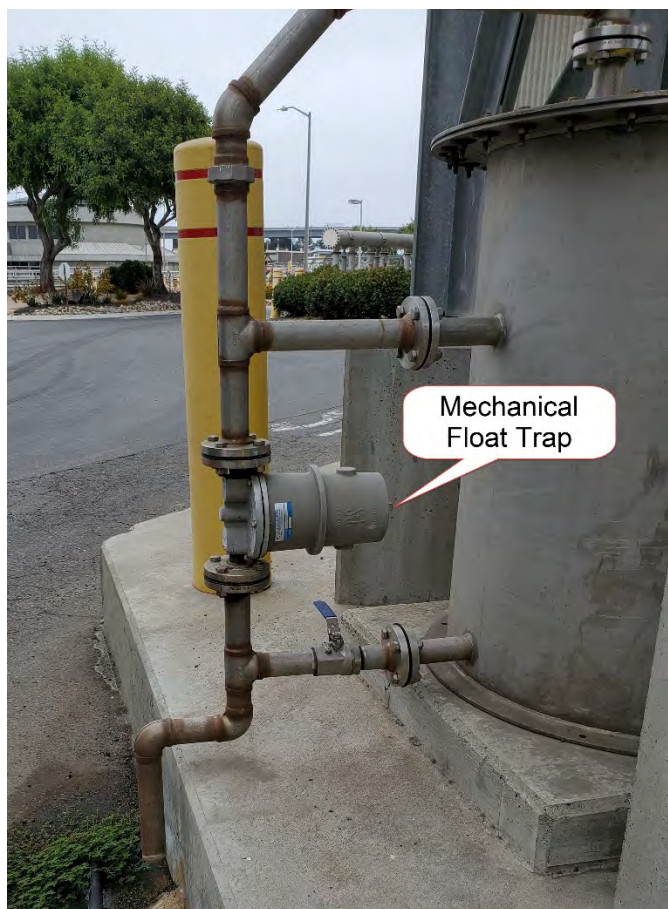
**Figure 39 - Similar Condensate Drip Trap with Mechanical Float Installed in Overflow Leg**

Another condensate trap was inspected at EBMUD (*Figure 39*). This unit contained a float trap on the overflow leg above the drain.

ESi's scope of work focused upon our core expertise in PGS-1. ESi could review the system in greater detail and provide recommendations for the condensate trap repairs, but as it was outside of ESi's scope of work, we have simply provided the cost for replacement with an approved trap at this time. This pricing can be compared with the necessary repairs.
