Project No.
9472.000.000

June 1, 2012

Subject: 39th Avenue Reservoir
4290 Maybelle Avenue
Oakland, California

GEOLOGIC REVIEW AND RECONNAISSANCE

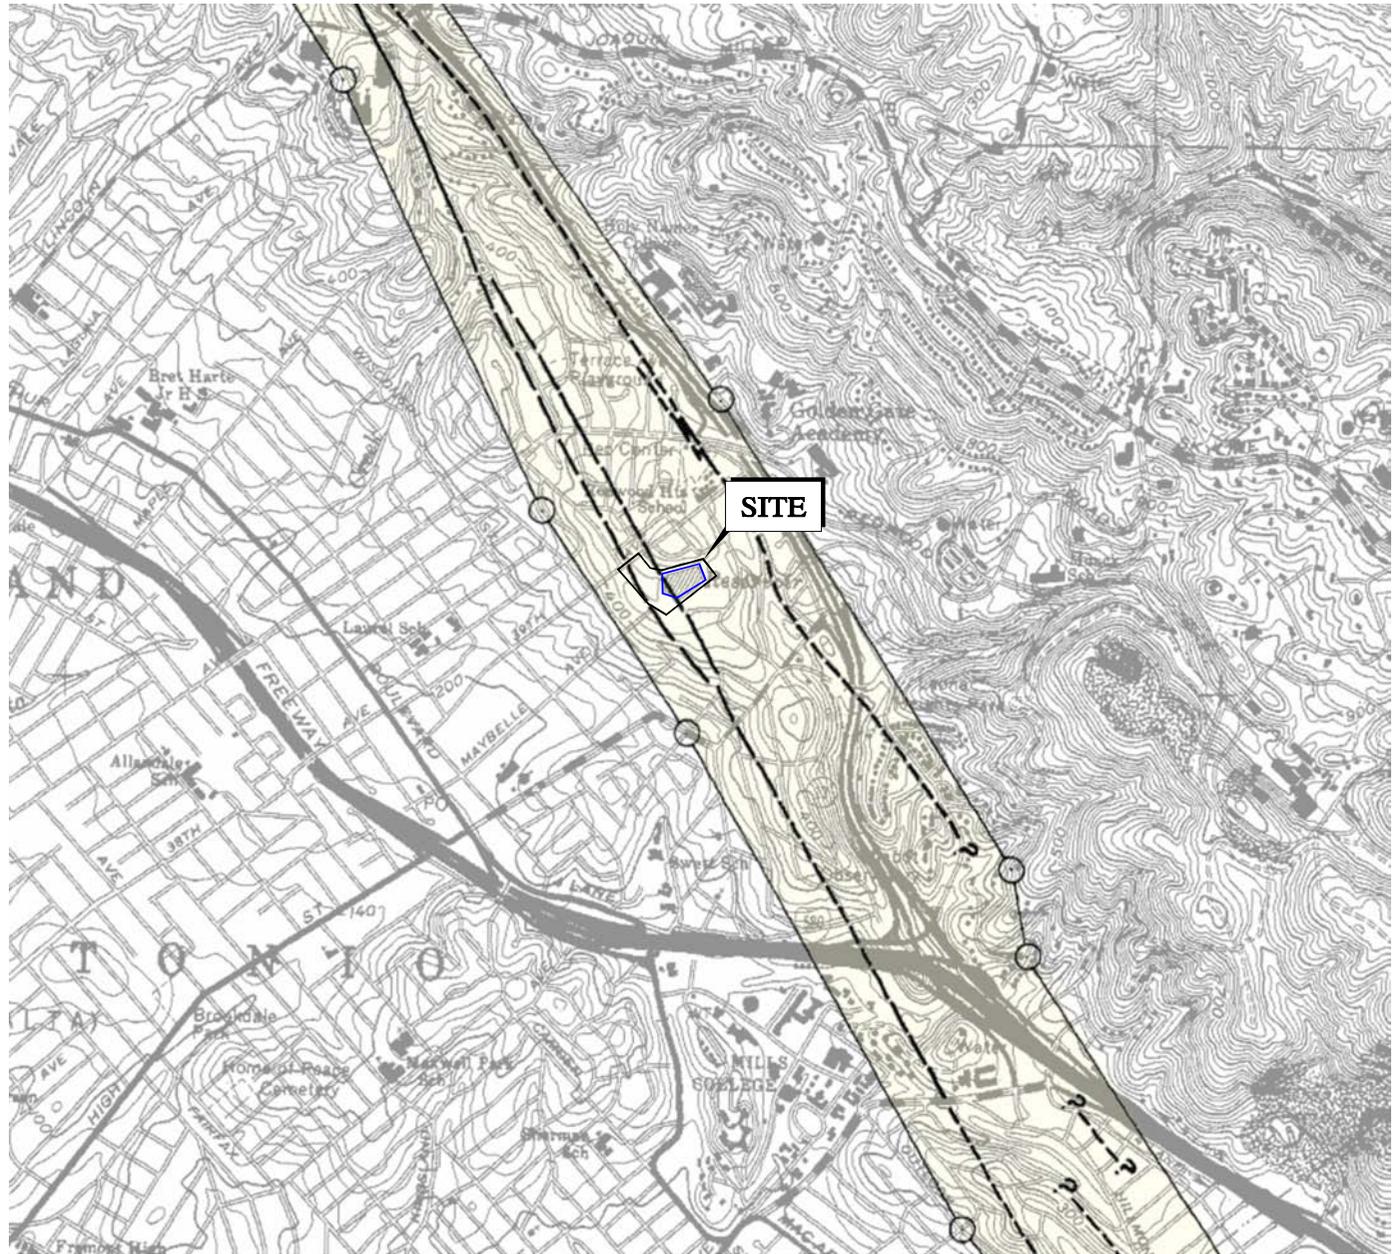
- 1 ● APPROXIMATE LOCATION OF WATER SEEPAGE
- 2 ● APPROXIMATE LOCATION OF RIGHT LATERAL OFFSET CURB
- 3 ● APPROXIMATE LOCATION OF ROTATED CURB PANEL AND SEVERELY CRACKED SIDEWALK
- 4 ● APPROXIMATE LOCATION OF RIGHT LATERAL OFFSET CURB
- 5 ● APPROXIMATE LOCATION OF MINOR CURB DEFLECTION
- 6 ● APPROXIMATE LOCATION OF RIGHT LATERAL OFFSET CURB
- 7 ● APPROXIMATE LOCATION OF POSSIBLE OFFSET CURB AND SEVERE PAVEMENT DISTRESS
- 8 ● APPROXIMATE LOCATION OF RIGHT LATERAL OFFSET CURB
- 9 ● APPROXIMATE LOCATION OF MINOR SLUMP IN CUT SLOPE. WATER SEEPING FROM SLOPE AT TIME OF SITE VISIT
