EXHIBIT F

REFERENCE MATERIAL

(Excerpts) Seismic Evaluation Administrative Building and Laboratory East Bay Municipal Utility District

Main Wastewater Treatment Plant Seismic Structural Evaluation and Conceptual Design Project

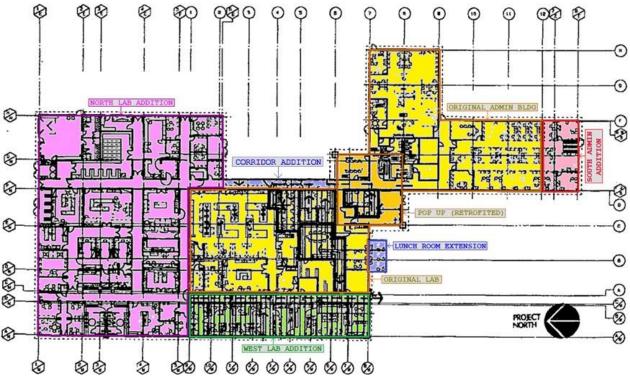
Figure 1: Admin/Lab Buildings - Plan View Showing the Building Parts

The Admin and Lab building is a complex structure consisting of the original Admin building, the original Lab building, the Pop-Up structure, the West Lab addition, the North Lab addition, and the South Admin addition. Plan view of the entire structure, with the various additions highlighted, is shown in Figure 1. The North and South elevations of the building are shown in Figure 2 with photographs of the building exterior shown in Figure 3 through Figure 7.

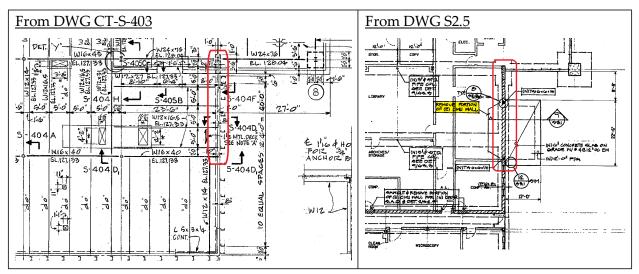
Figure 15: Lunch Room Extension

The lunch room extension is a light frame greenhouse-like structure located at the south portion of the original Lab building. While the extension itself does not significantly impact the seismic performance of the building, a portion of the original lab exterior wall was removed (Figure 15, right) to connect the extension to the rest of the building. This results in a potential vulnerability as the exterior masonry walls are load bearing element of the gravity system and are needed to support steel beams from the roof structure as shown in Figure 15 (left). Furthermore, a note on drawing DWG CT-S-413 states "the masonry walls are designed as shear walls and shall not be altered without the approval of the engineer". It is not clear if this note was followed prior to addition of the lunch room extension.

The lunch room extension is a light frame greenhouse-like structure located at the south portion of the original Lab building. While the extension itself does not significantly impact the seismic performance of the overall building, a portion of the original lab exterior wall was removed to connect the extension to the rest of the building shown as (2) on Figure 116. The available drawings do not show details of any strengthening of the wall prior to the removal of the existing wall piers to create access to the lunch room extension. It is recommended to confirm that no strengthening of the wall section was performed. Lack of any strengthening creates stress concentrations around the large opening. DCR for the wall in this area exceeds the m-factor for both the fixed base and the flexible base models and the building does not meet the acceptance criteria for Risk Category IV or that for Risk Category I & II.

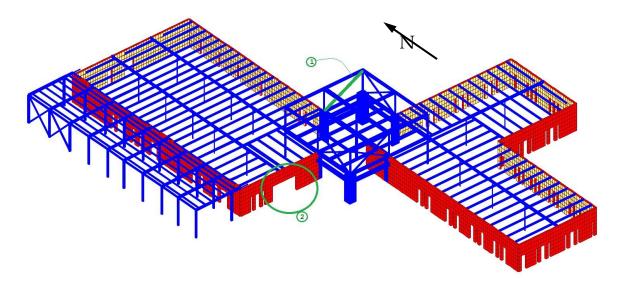
Figure 116: Original Building – Identified Vulnerabilities

The vulnerabilities of the above ground structure are shown in Figure 116.

There are 4 steel braces at the second floor of the Pop-Up structure. Three of the braces are TS8x4x1/4 X-braces. The fourth brace is single diagonal TS7x7x5/16 shown as (1) on Figure 116. For the fixed base model, multiple steel members of the Pop-Up structure are overstressed with DCR exceeding the m-factor for LS (BSE-2E) and IO (BSE-1E). However, results from the flexible

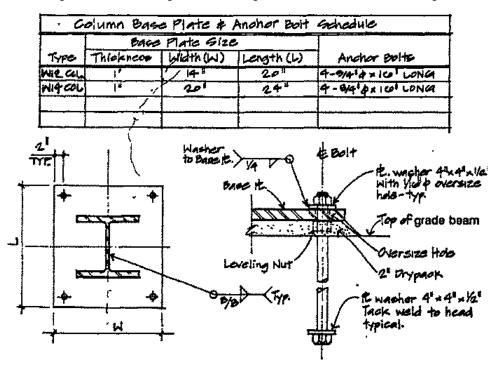
Figure 118: Base Plate and Anchor Bolt Detail

The base plate detail for the moment frame column connection to the foundation, shown in Figure 118, is inadequate to transfer bending moment from the column to the foundations. If the column base is considered pinned, the roof drifts will be unacceptable and the ponding between the

Similar to the North Lab addition, the base plate detail is not adequate to transfer the bending moment from the column to the foundations. The three retrofit option identified for the North Lab Addition are also feasible for the South Admin Addition; however, due to the relatively small footprint of the South Admin Addition, Option 1 may be the preferred option in this case.

- 1. Structurally connect the North Lab Addition and the Original structure (similar to the connection of the West Lab Addition to the Original structure). However, due to the size of the North Lab Addition, such a retrofit may impact the overall structural response.
- 2. Add additional structural elements such as shear walls or braced frames to stiffen the North Lab Addition.
- 3. Retrofit the column base plate connections (at each column base) to fully develop the imposed moments and forces from the moment resisting frames.

Out of these three options, it is our opinion that Options 2 and 3 are less disruptive.

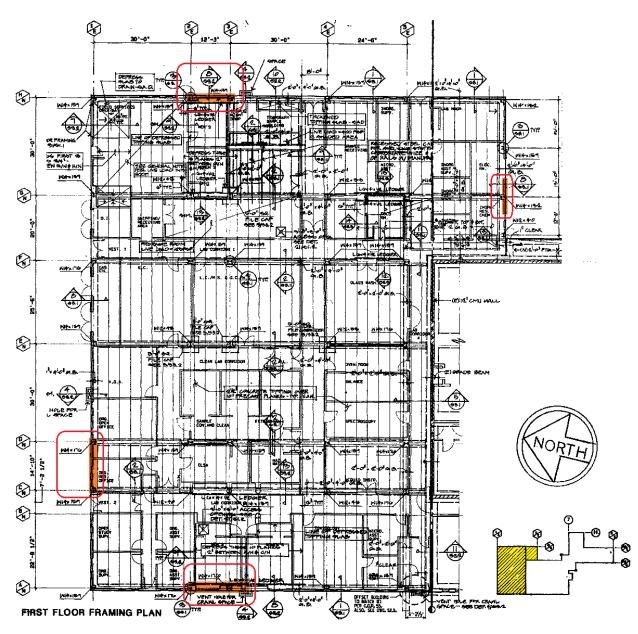
Figure 4: North Lab Addition – Framing Plan Showing the New Shear Walls

Four new 12-inch thick shear walls are added to exterior walls of the building. The shear walls are shown on the building framing plan in Figure 4 and on the pile layout plan in Figure 5. The photos of the four new shear walls over the building façade are shown in Figure 6. The locations of the east, west and north shear walls were selected so that the ends of the walls are over double pile locations. The location of the south wall is selected so it will not interfere with the doors and windows along the south face. The north and west shear walls will require covering of some windows. The east and west shear walls are 12.25-feet long and the north and south walls are 14.83-feet and 8.67-feet long, respectively.

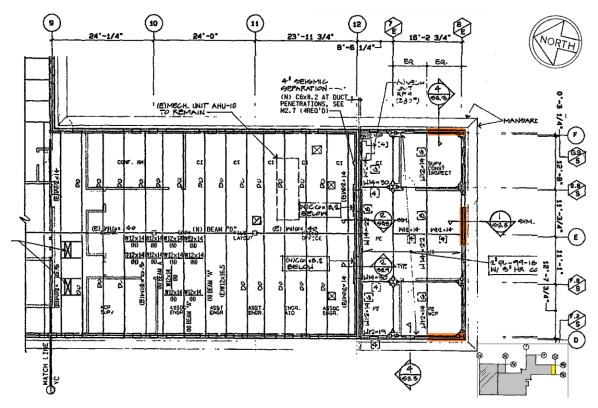
Figure 7: South Admin Addition – Framing Plan Showing the New Shear Walls

Three new 8-inch thick shear walls are added to each exterior wall of the building. The shear walls are shown on the building framing plan in Figure 7 and on the pile layout plan in Figure 8. The photos of the two of the new shear walls over the building façade are shown in Figure 9. The locations of the east, west and south shear walls are selected such that the corners of each shear wall are on top of a pile group rather than a single pile. All three shear walls are approximately 8-feet long. No shear walls will require covering of doors or large windows. The location of the south wall is selected so it will not interfere with the doors and windows.

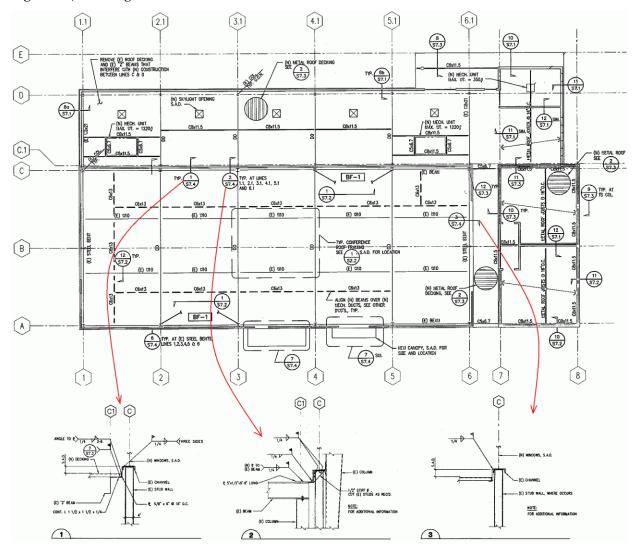
Figure 12: FSB – Connections between the Parts

The roof for all structural sections consists of flexible metal deck diaphragms. The roof diaphragms transfer the loads to the lateral load resisting structural elements. For the original garage structure, the lateral load resisting system consists of moment resisting frames in north-south direction and two X-braces in east-west direction. For the storage building, the corridor and the locker room, the lateral load resisting system consists of plywood shear walls over cold-formed steel wall studs. The original garage is connected to the various additions (as shown in Figure 12) forming one continuous structure for seismic load transfer.

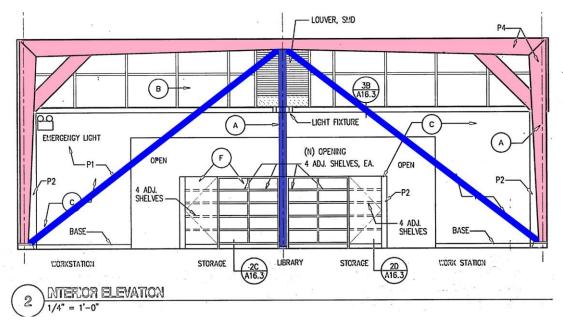
Figure 2: Field Services Building – Retrofit Option No. 1

- Option 1: Add additional structural braces (as shown in Figure 2) to two of the six frames of the original structure. The new braces are added to the frame at the west wall and the frame between the original building and the locker room. This option will satisfy the drift requirements for both Risk Category IV and Risk Category I & II. However, this option may require new foundations (possibly piles) and could create accessibility issues as well as disruption of building function during construction.

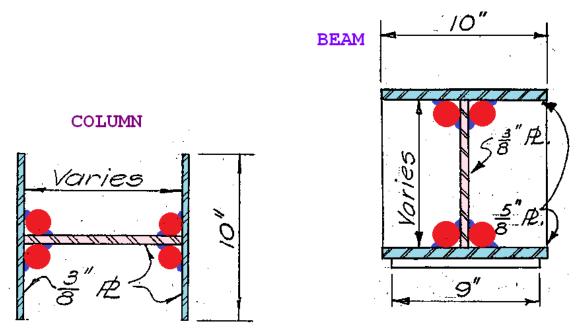
Figure 3: Field Services Building – Retrofit Option No. 2

- 2. Option 2: The cross-sections of the primary moment frames are stiffened by welding 4-#10 rebars at the web to flange connection (as shown in Figure 3) of the columns and the beams. Other options such as adding steel plates to the flanges instead of rebars could also be considered. This option will not require foundation modifications and will not create accessibility issues; however, every single frame will need to be retrofitted, which will cause disruption throughout the building interior and will impact building function during construction. This option will satisfy the drift requirements for Risk Category I & II only.

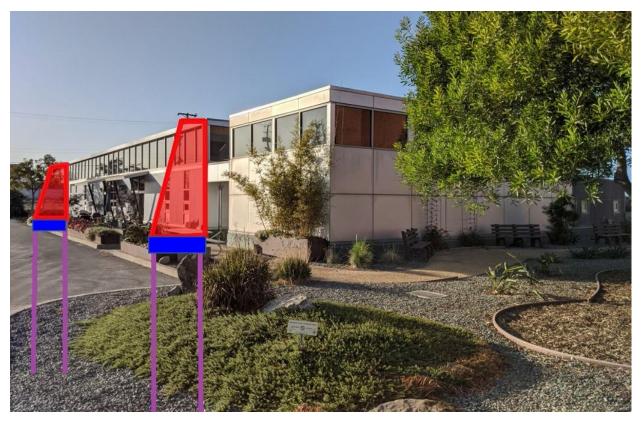
Figure 4: Field Services Building – Retrofit Option No. 3

- 3. Option 3: Add two exterior buttress walls (as shown in Figure 4) at the south elevation of the building. The new walls will be connected to the south-west and south-east columns of the original building. This option will satisfy the drift requirements for both Risk Category IV and Risk Category I & II. This option will require new piles foundations and will change the architectural appearance of the building, but it will be least disruptive to the interior functions of the building. However, it may create some accessibility issues during construction because one of the buttress wall will be located close to one of the building entrances.

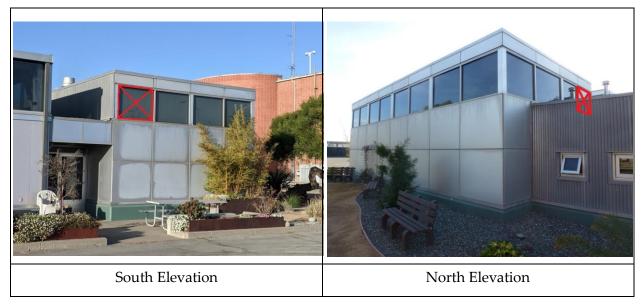
Figure 5: Field Services Building – Extending Shear Walls at Locker Room

There are large relative displacements between the lower roof of the corridor and the upper roof of the locker room resulting from the lack of shear walls with lateral resistance provided only by the steel tube sections (shown in Figure 66). Damage to the windows is likely and this could be a life safety hazard. Stiffening of the steel tube columns under the roof for BSE-2E event is recommended.

At the locker room add new shear walls and extended to the roof as shown in Figure 5. Alternatively, stiffening tube columns is an option but not preferred as it will be more costly and disruptive.

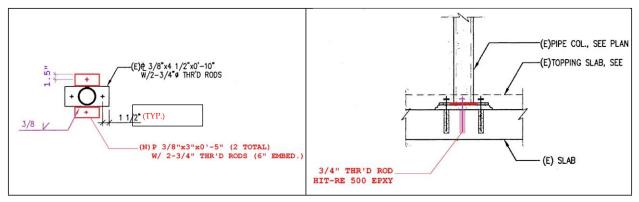
Figure 40: FSB – Conference Room Column Connections – Retrofit

The structure of the conference room has an inadequate lateral load resisting system. The steel pipe columns are pin-connected to the base and to the canopy. Columns should have a fixed-base connection for adequate moment transfer to create a complete lateral load resisting system.

The conference room is a standalone partition structure within the building that currently does not have a complete lateral load resisting system. The structure is vulnerable to ground shaking in the north-south direction due to lack of moment connection at the base. Retrofitting the four column bases (shown in Figure 7) of the conference room structure to make moment connection in both directions will reduce its seismic vulnerability. With this retrofit, the structure will have acceptable strength, however, the drift at the canopy level will still be high. High drifts can result in glass breakage. Bracing between columns or other means of stiffening the system can be considered to reduce drift and the potential for glass breakage. However, additions may impact current access and aesthetics. The option of making the column to canopy beam moment resisting in both north-south and east-west direction is not considered feasible.

The retrofit of the four column bases as shown in Figure 40.

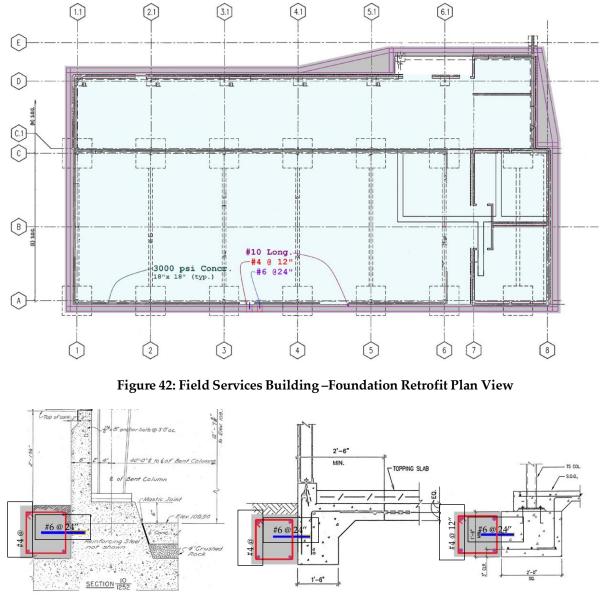
There are no connections between the foundations of the original building and the extensions; therefore, separation of the building sections of FSB due to an estimated 6 inches of lateral spread will result in damage to the steel elements connecting the extensions to the original building. Soil improvement to reduce liquefaction-induced lateral spread hazard or structurally tying the building sections together are possible options for mitigating this hazard.

The capacity of the foundation beams on the East and West sides of the building are insufficient to withstand PGD from liquefaction-induced lateral spread (assuming that the lateral spread direction is not exactly parallel to the building foundations). Also, the foundation of the north addition is not tied to the foundation of the original building and will separate under the estimated PGD. A foundation ring (Figure 42 and Figure 43) around the building is designed to retrofit the foundations and to tie the foundation of the original building and the additions.

To increase the capacity of the foundation beam and to prevent separation, all around foundation beam (as shown in Figure 10) is added. The lateral spread PGD is in the direction toward the nearby body of water (Bay) which would predominately cause loading on the north and south side foundation beams. However, since the lateral spread direction is not exactly perpendicular to the building's north-south axis, the east-west foundations beams may see a component of lateral spread. The geotechnical report (AGS, 2020) shows that relatively small ground deformation results in full passive pressure, which will load the east-west foundation beams.
