Local Hazard Mitigation Plan 2018

East Bay Municipal Utility District

The East Bay Municipal Utility District’s (EBMUD) 2018 Local Hazard Mitigation Plan (2018 LHMP) is an update to its 2011 Local Hazard Mitigation Plan (2011 LHMP) and reflects EBMUD’s most current system upgrades, improvements, and mitigation measures to reduce the community’s exposure to hazards and to improve the reliability of its services to the public.

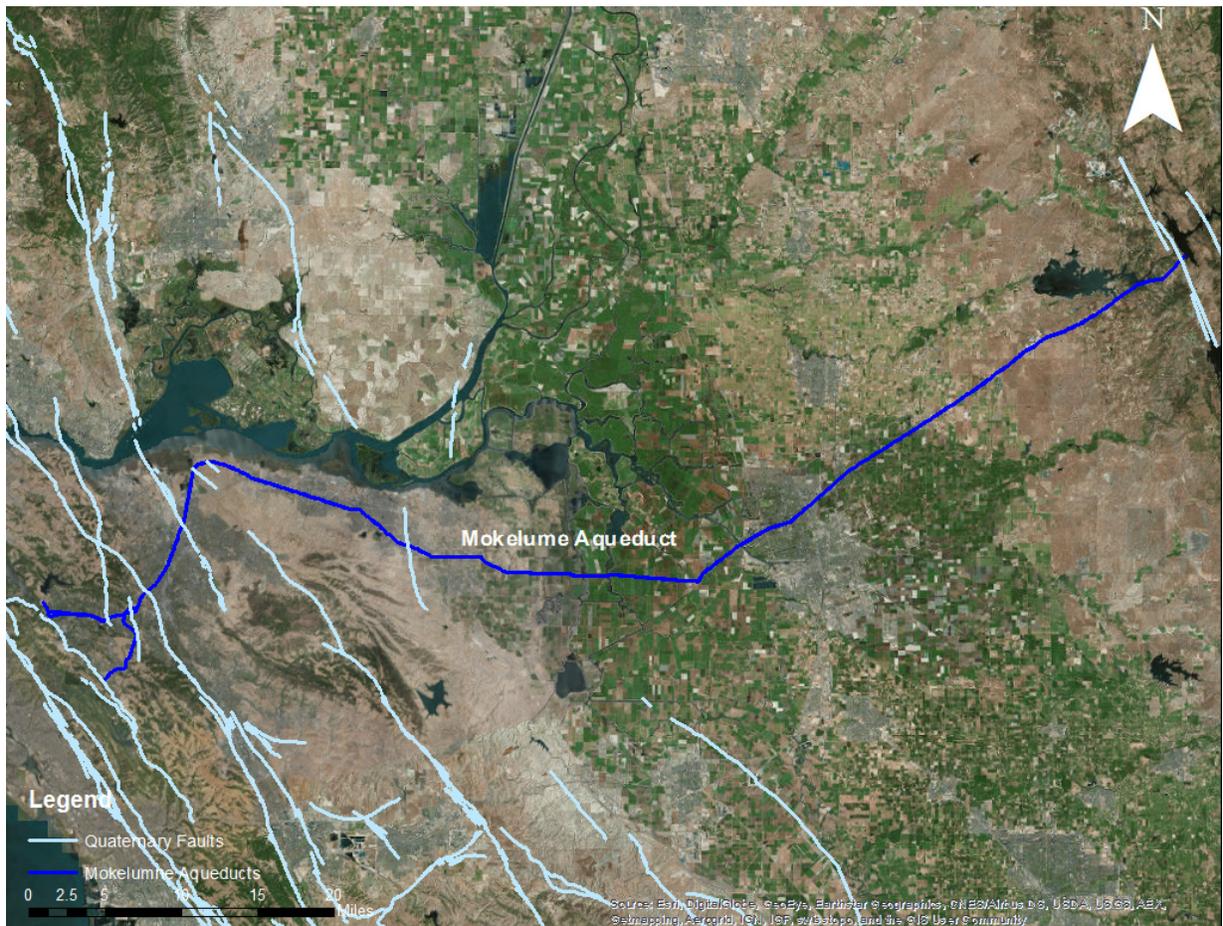
Figure 4.3. Mokelumne Aqueduct

Near the community of Clements, the Mokelumne Aqueducts are joined by the Freeport Regional Water Authority/Folsom South Canal Connection (FRWA/FSCC) system, a system of pumping plants and pipelines that delivers water from the Sacramento River to the Mokelumne Aqueducts, which supplements the Mokelumne River supply during drought periods.

Once the Mokelumne Aqueducts water reaches the EBMUD service area in Walnut Creek, it is delivered directly to water treatment plants or transferred into one of five terminal storage reservoirs located in the EBMUD service area.

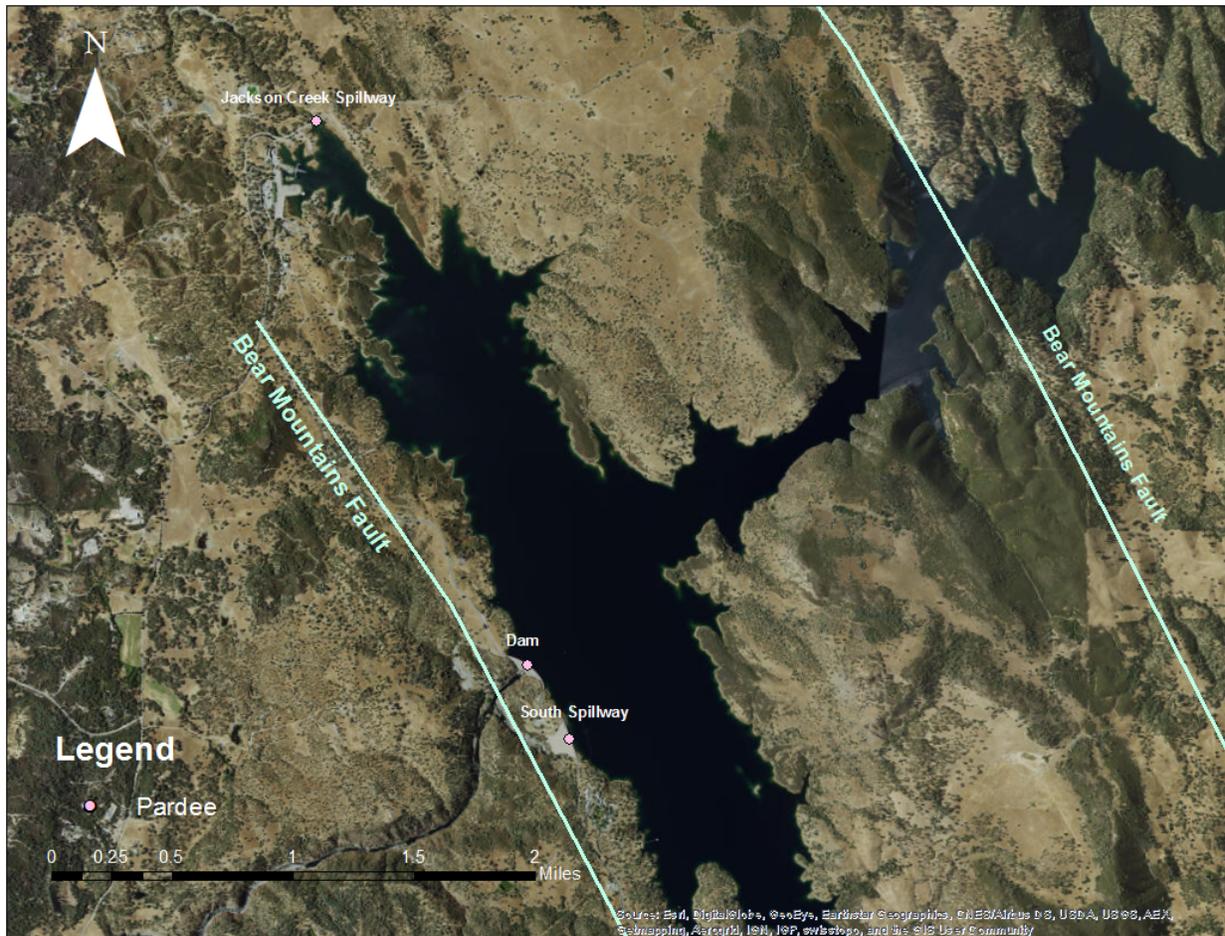
Figure 4.4. Pardee Reservoir and Dam

Pardee Reservoir storage capacity is 203,795 acre-feet at elevation 567.65 feet (local datum) the spillway crest elevation. At this elevation, the reservoir has a surface area of about 2,200 acres (3.4 square miles) and 37 miles of shoreline. The total drainage area above Pardee Dam is approximately 577 square miles.

The dam is classified as “High Hazard Potential” under the Federal Energy Regulatory Commission (FERC) Guidelines.

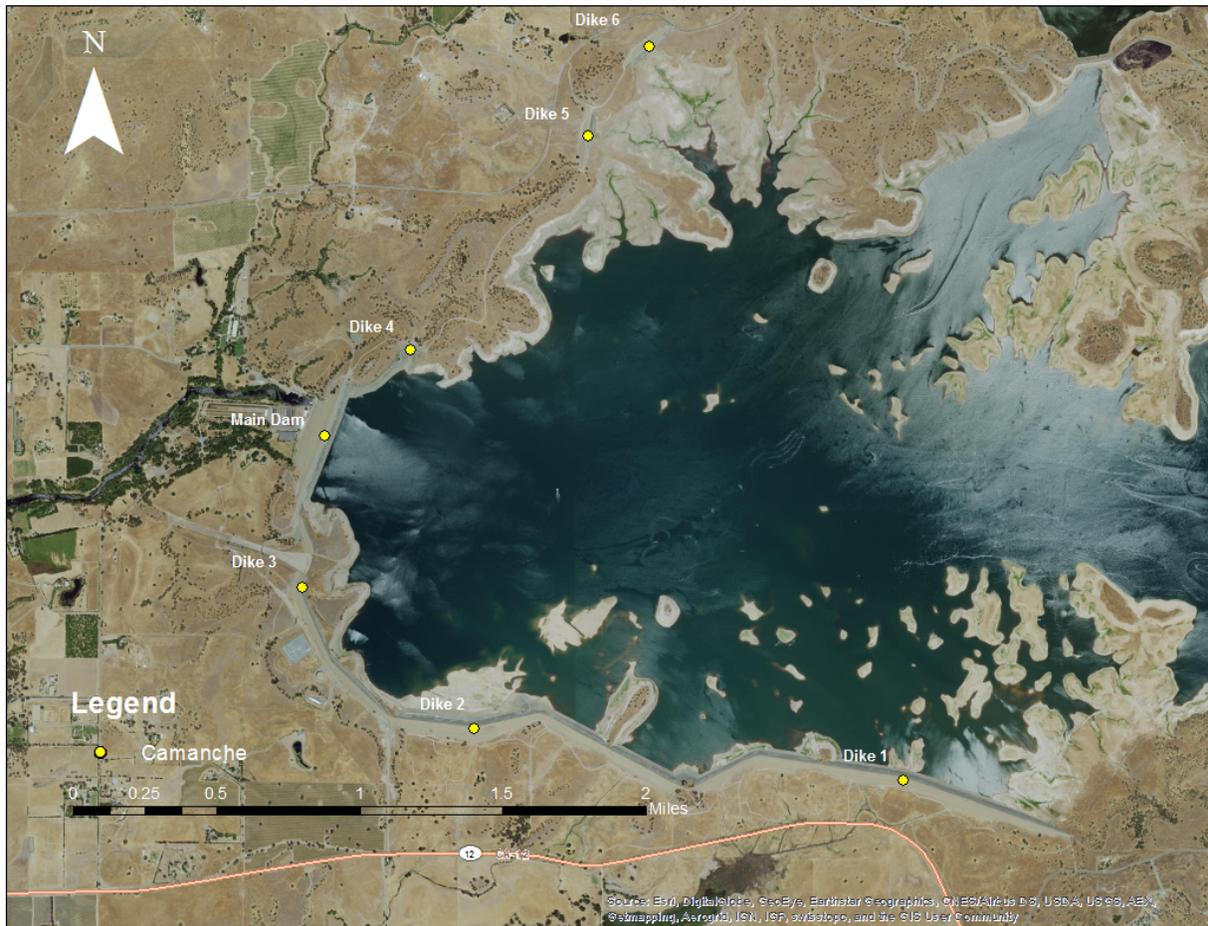
Figure 4.5. Camanche Reservoir

Camanche Reservoir, with a storage capacity of 417,124 acre-feet at spillway crest elevation of 235.5 feet, was completed in 1964 to provide for multiple beneficial uses. When at spill elevation, the reservoir has a surface area of about 7,400 acres. The drainage area above the reservoir is 620 square miles. The reservoir is located within Amador, Calaveras, and San Joaquin Counties, California, on the Mokelumne River approximately 14 miles east of the community of Lodi. The reservoir is created by a main dam and six earth dikes: three on the north side and three on the south side. An un-gated concrete overflow spillway is located south of the main dam. A three-unit 10.7 megawatt powerhouse is at the base of the main dam.

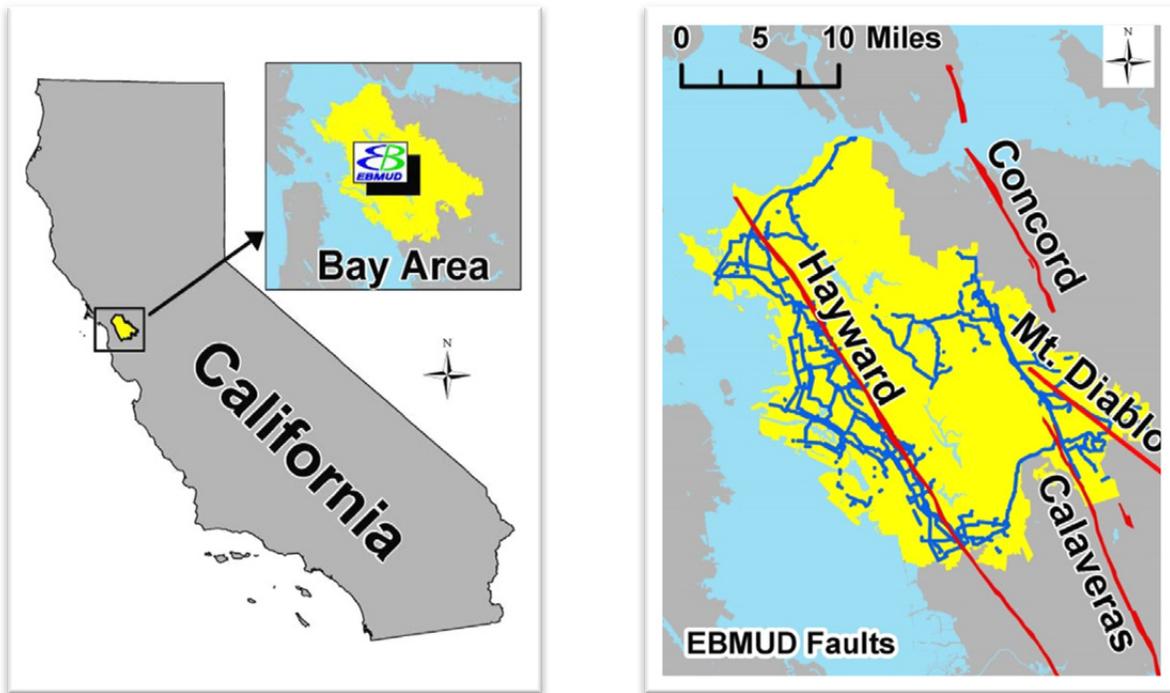
Figure 5.1. EBMUD Service Area and Faults

EBMUD’s service area is located in a highly active seismic area east of the San Francisco Bay. Figure 5.1 respectively show the location of the EBMUD service area and the active faults (red lines) within the large diameter pipeline (blue lines) service area. These faults include the Hayward, Mt. Diablo Thrust, Calaveras, and Concord Faults. Although outside the service area, the San Andreas Fault will also subject pipelines to significant ground motions.

The highly active Hayward Fault dominates the EBMUD risk profile. The Hayward Fault is capable of Mw 7.05 earthquake with a 140-year major event return cycle. The fault has a maximum earthquake of Mw 7.25 with several thousand year return period. With the last major earthquake occurring in 1868 (149 years ago), the next major quake is due at any time. The economic losses from a similar earthquake occurring today would likely exceed \$165 billion in damages (Brocher, 2008) in the Bay Area.

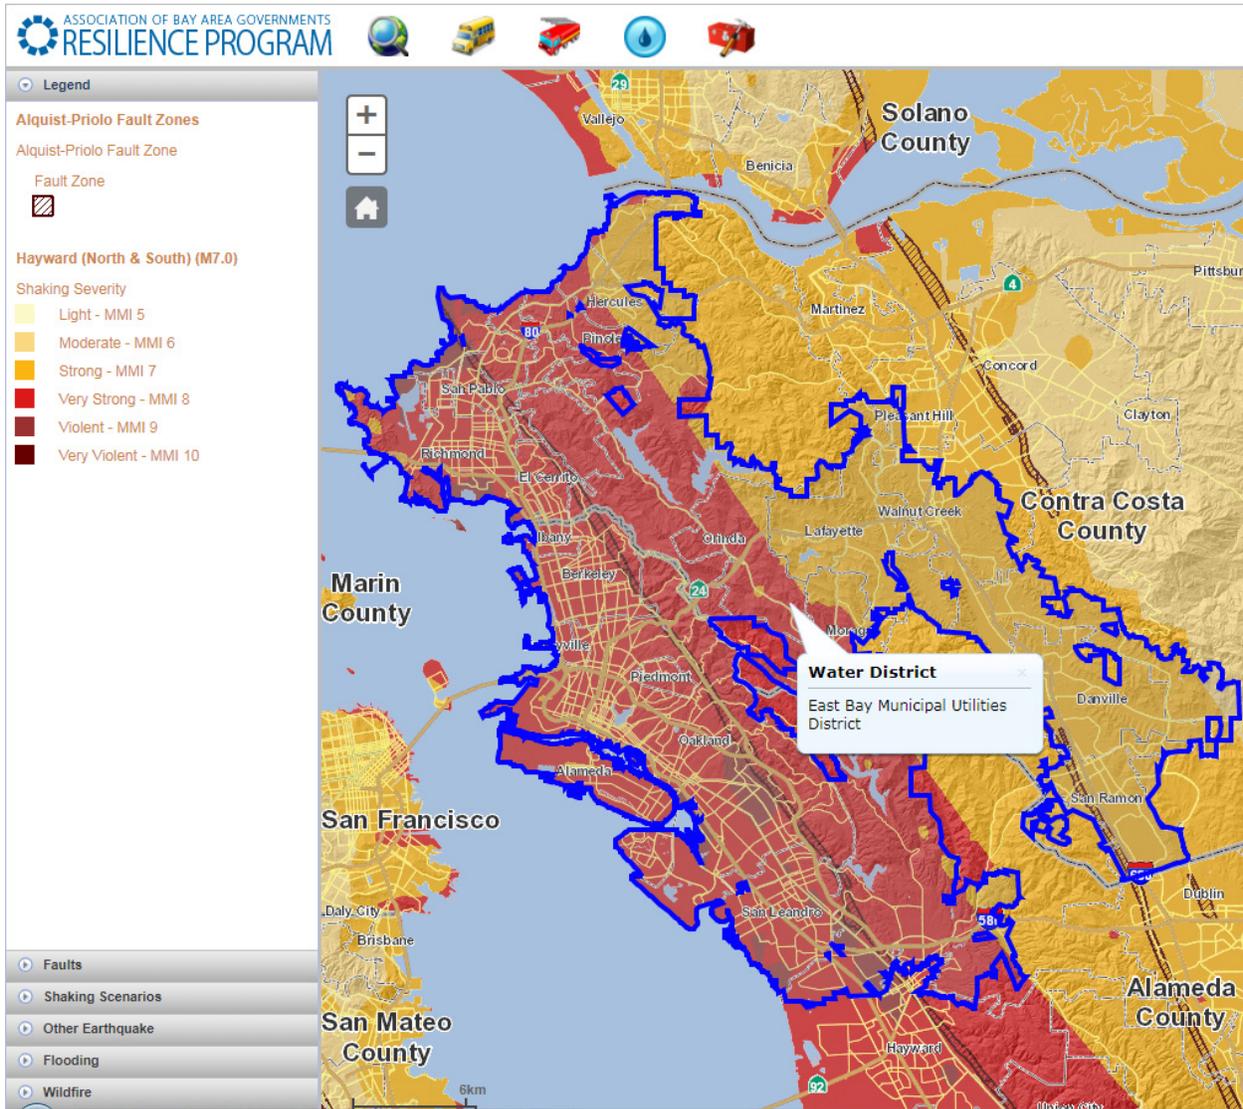
Figure 5.2. Hayward (North and South) – Mw 7.0 Shaking Earthquake Induced Liquefaction

The map shows the shaking severity level for the majority of EBMUD's service area. A magnitude Mw 7.0 earthquake on the Hayward fault would result in shaking severity levels ranging from strong to very violent for most of the service area as shown in **Error! Reference source not found.** below.

For EBMUD water and wastewater system facilities, 87% (999 of 1,154 facilities) are exposed to extremely high ground shaking levels (peak accelerations greater than 60% g with a 10% chance of being exceeded in the next 50 years). An additional 19% (218 of 1154 facilities) are exposed to high ground shaking levels (peak accelerations greater than 50% g), while 1% (15 of 1,154 facilities) are exposed to peak accelerations greater than 40% g. Only 3% (33 of 1,154 facilities) are exposed to moderate shaking (peak accelerations of greater than 30% g). A Shaking Hazard Map is available on the ABAG Resilience Program website: <http://resilience.abag.ca.gov/earthquakes/#FAULTS>.

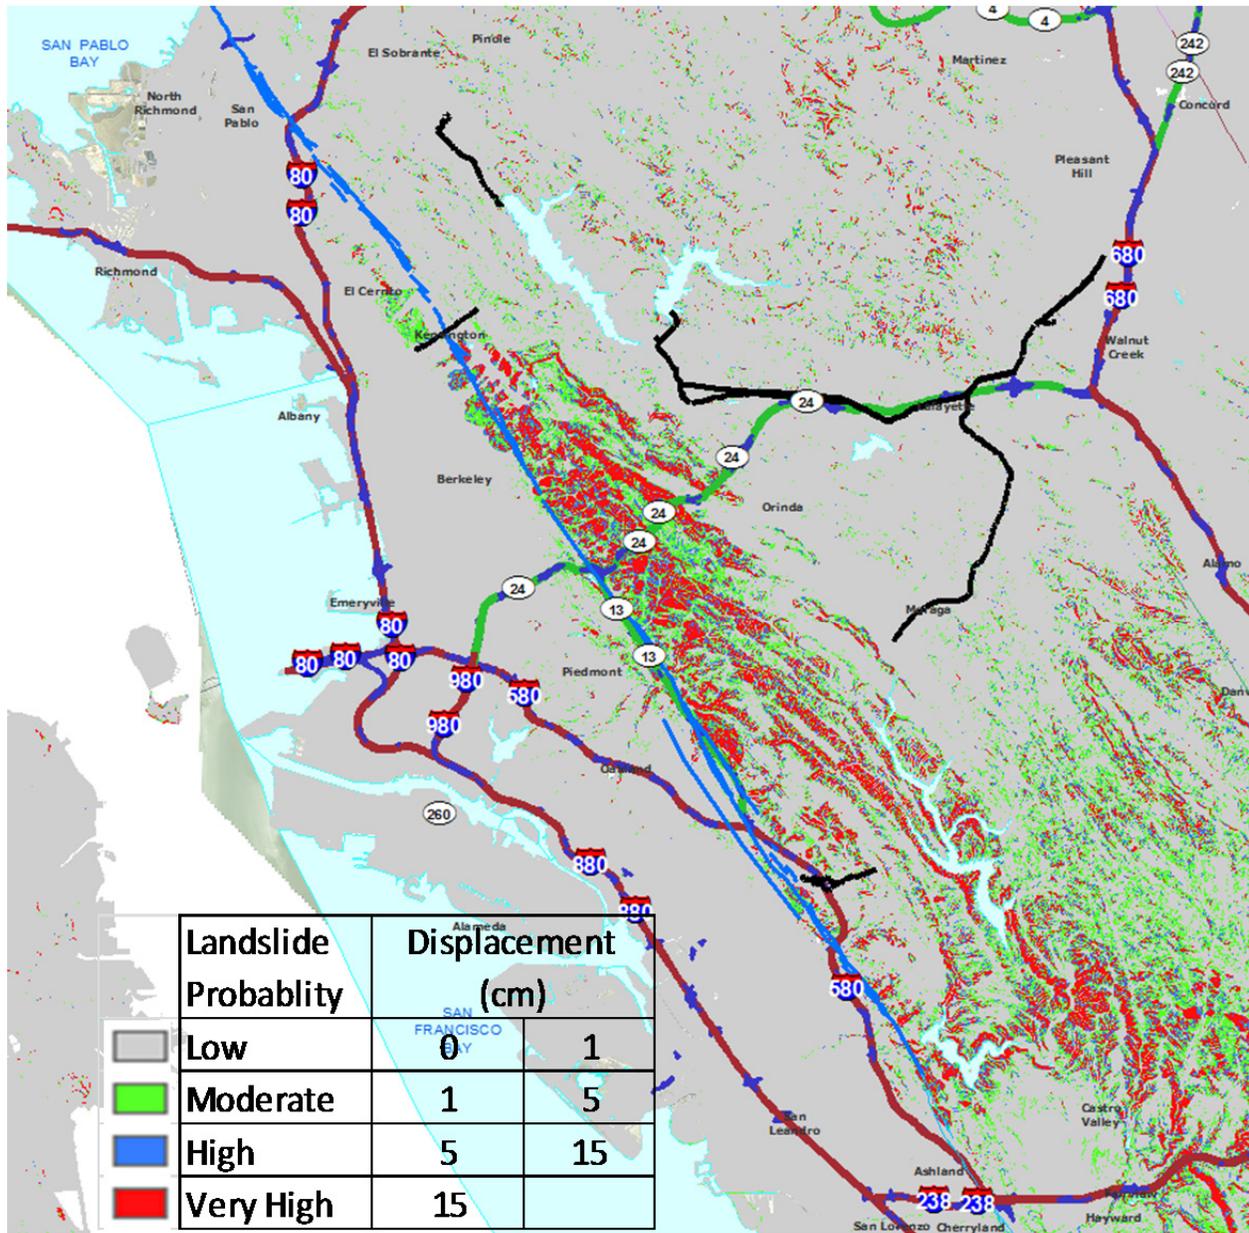
Figure 5.3. USGS Earthquake Induced Landslide Probability and Estimated Displacements for Scenario – Mw 7.05

Figure 5.3 below and was obtained from recent USGS publication in May 2017 and is available from the following URL:

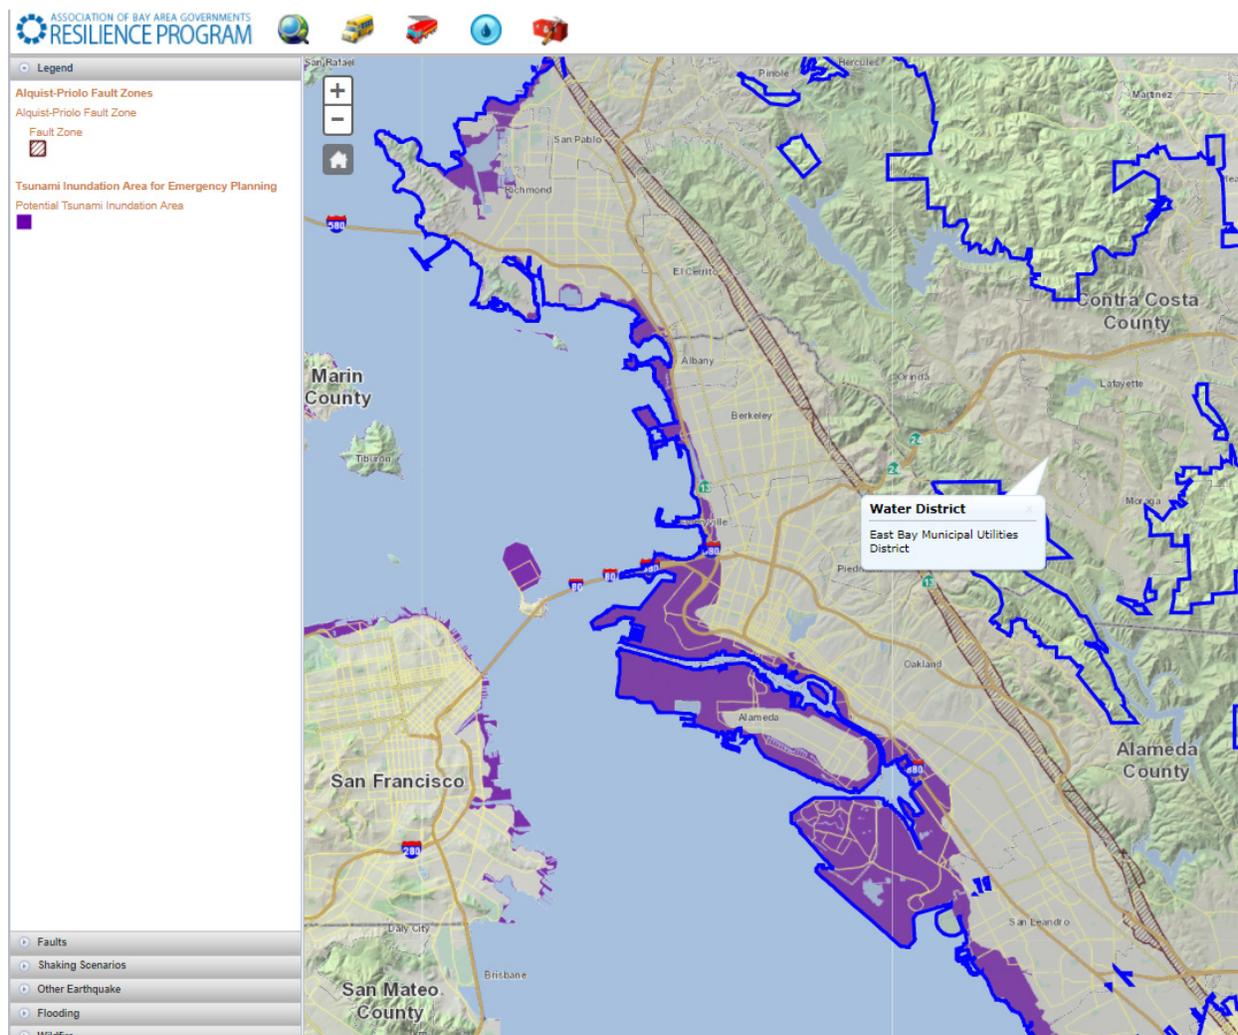
Figure 5.4. Tsunami Inundation for EBMUD Service Area

The MWWTP specifically evaluated two scenarios in 2014 – An Eastern Aleutians, Alaska Mw 9.2 earthquake and a Mw 7.0 rupture of the offshore Point Reyes Thrust Fault. The Alaskan earthquake scenario would provide approximately 5 hours to evacuate before the arrival of the wave. The Point Reyes earthquake would arrive in tens of minutes, giving little or no time to evacuate but water levels are not expected to be high enough to flood facilities. There is a Tsunami Response Plan in place for the MWWTP and all other low lying areas that are within the mapped Tsunami Hazard areas (see Figure 5.4).

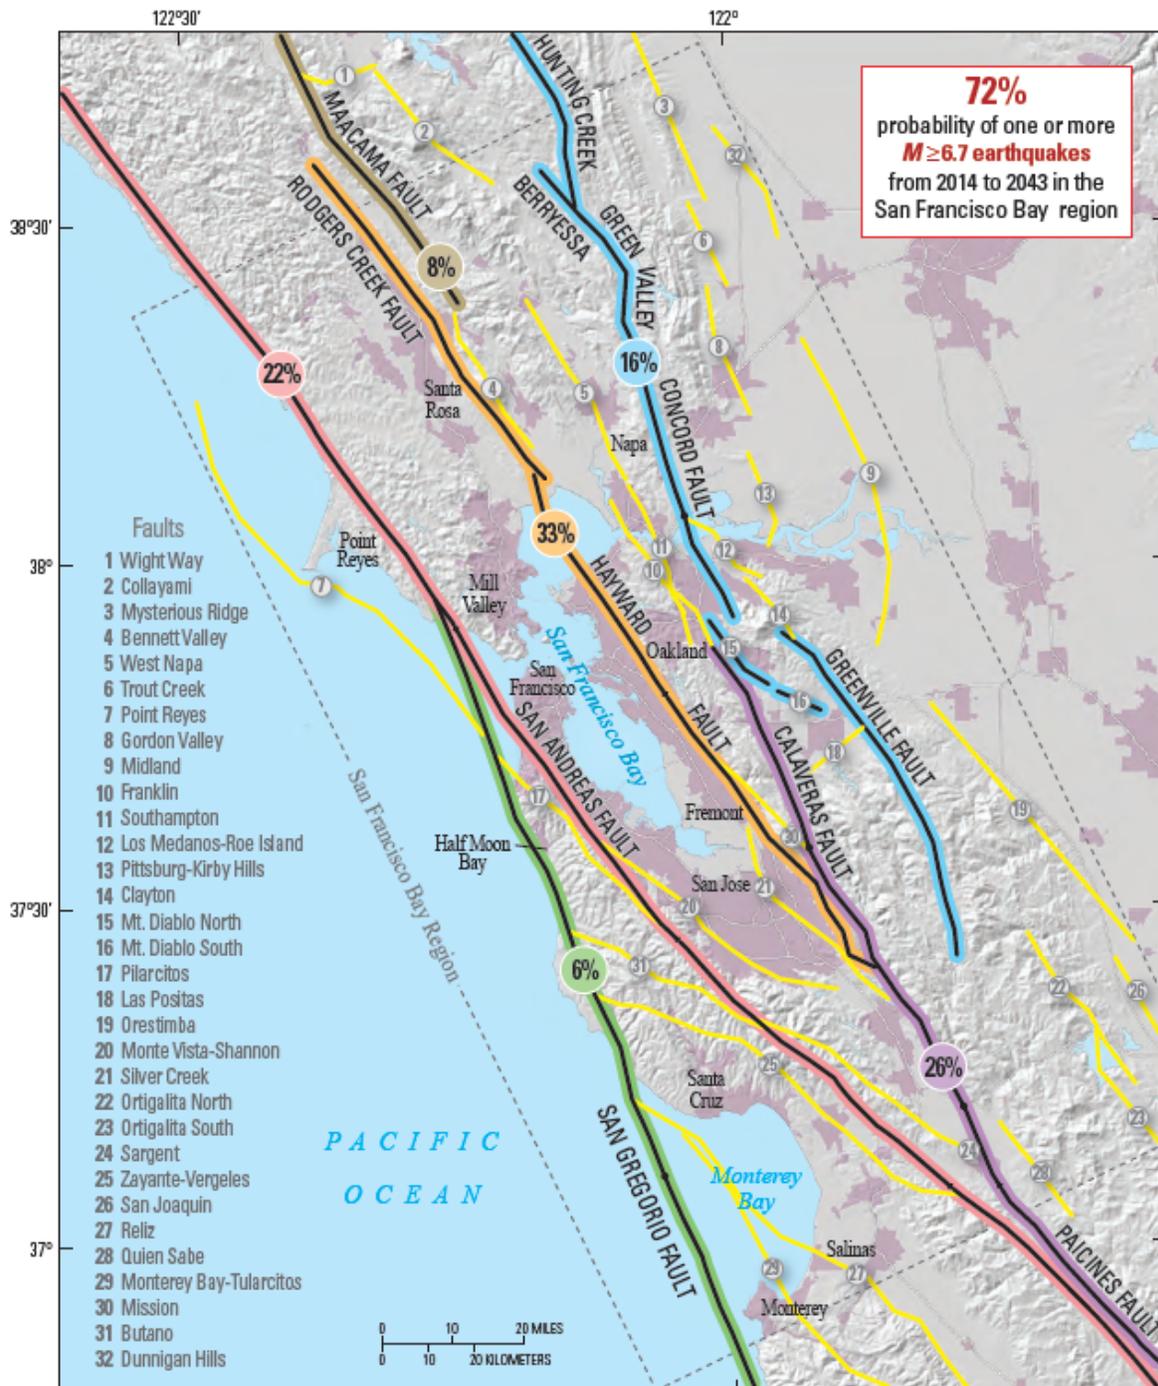
Figure 5.5. Regional Faults

Figure 5.5 below depicts the major faults in the Bay Area and their associated probability of occurrence of one or more Mw 6.7 or greater earthquake from 2014 to 2043. There is a 72% probability of experiencing such an event in the San Francisco Bay Region. The Hayward-Rodgers Creek fault system has the highest probability (33%) for a large rupture (Mw>6.7) on the major faults in the region.

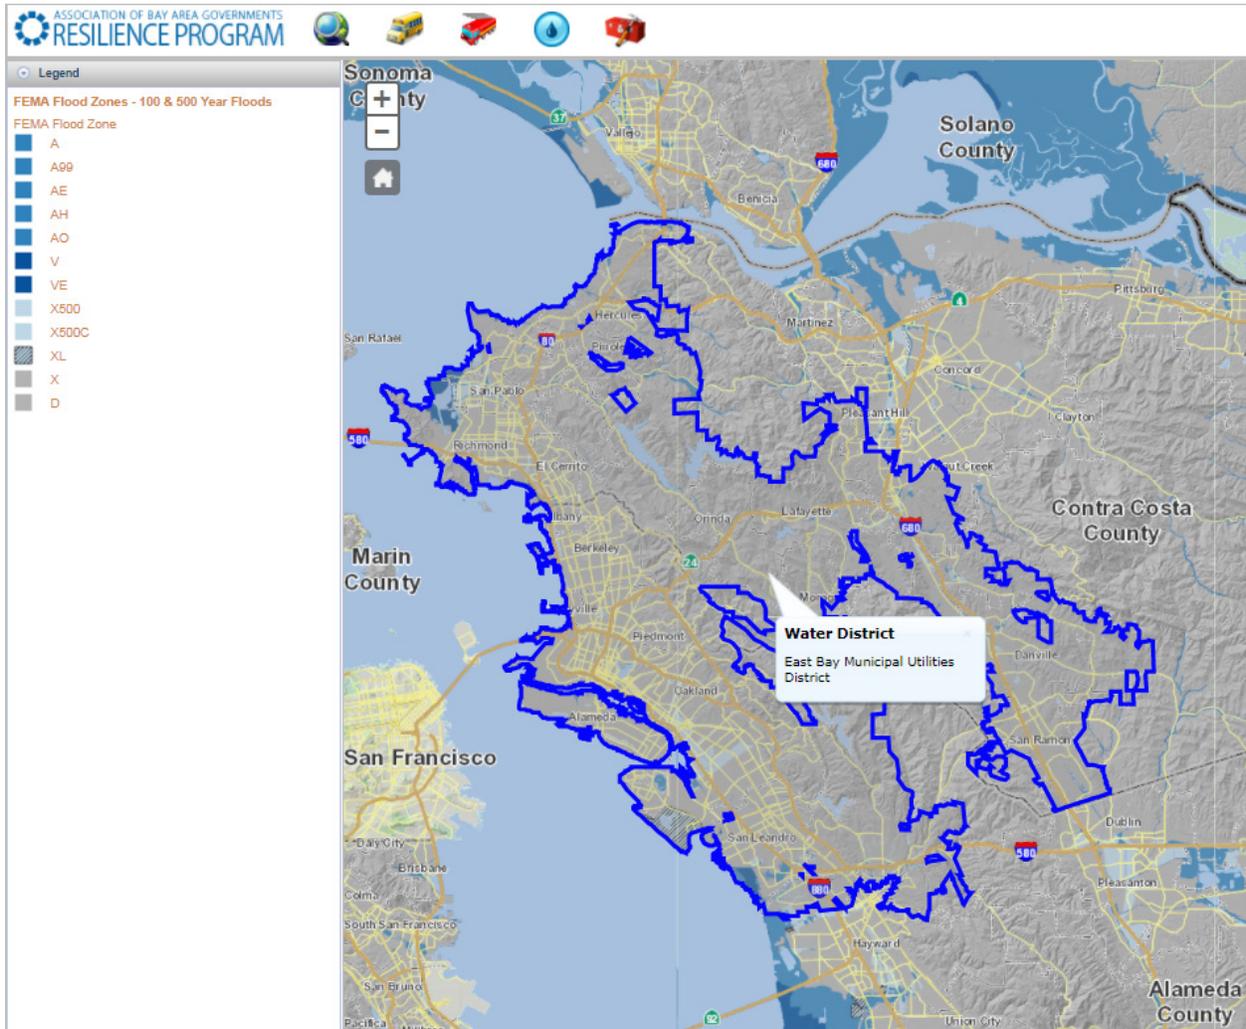
Figure 5.6. EBMUD Service Boundary Flood Zone

FEMA prepares 100-year flood maps, called the Flood Insurance Rate Maps (FIRMs), which indicate floodplain boundaries and are the common reference when describing flood hazards. Figure 5.6 below, prepared by the Association of Bay Area Governments Resilience Program, (<http://gis.abag.ca.gov/website/Hazards/?hlyr=femaZones>) shows the FEMA flood zone within EBMUD service boundary.

Special Flood Hazard Areas (SFHA) are defined as the area that will be inundated by the flood event having a 1-percent chance of being equaled or exceeded in any given year. The 1-percent annual chance flood is also referred to as the base flood or 100-year flood, shown in Figure 5.6 above labeled Zone A, Zone AO, Zone AH, Zone AE, Zone A99, Zone V, and Zone VE. Moderate flood hazard areas, labeled Zone X (shaded) are also shown on the FIRM, and are the areas between the limits of the base flood and the 0.2-percent-annual-chance (or 500-year) flood.

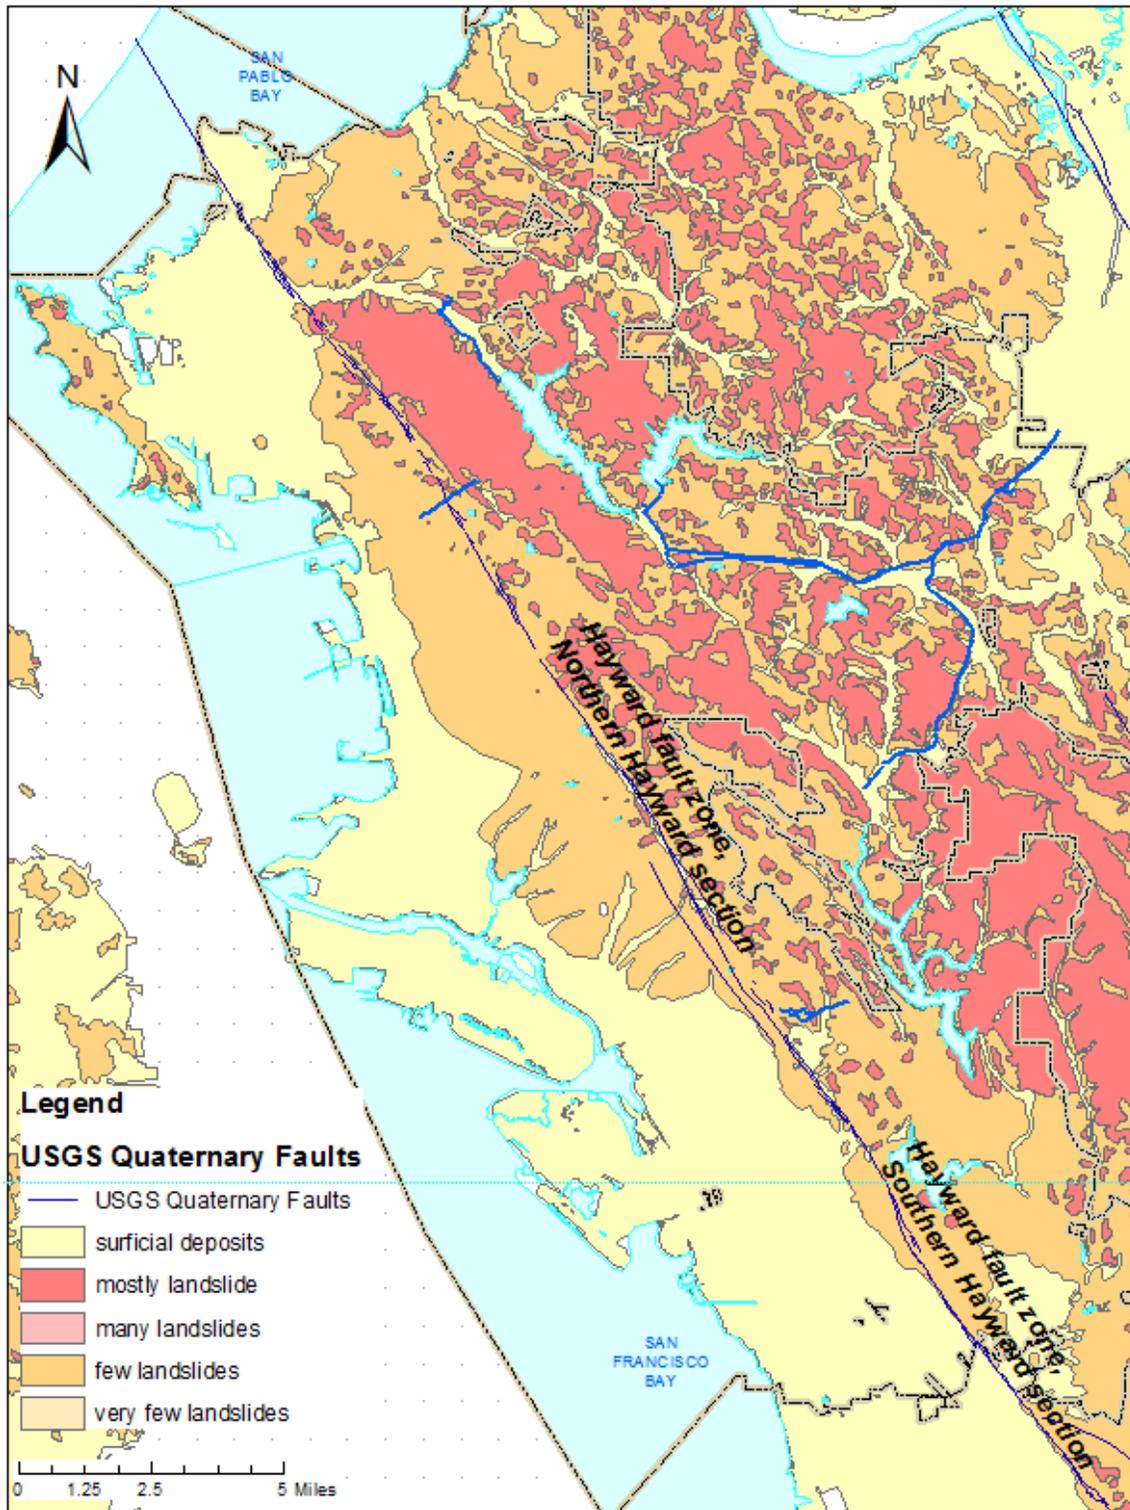
Figure 5.8. Deep Seated Landslide in EBMUD Service Area

Reference: Susceptibility to Deep-Seated Landslides in California, 2011, C. J. Wills, F. G. Perez and C. I. Gutierrez (California Geological Survey), Susceptibility to Deep-Seated Landslides in California, 2011.

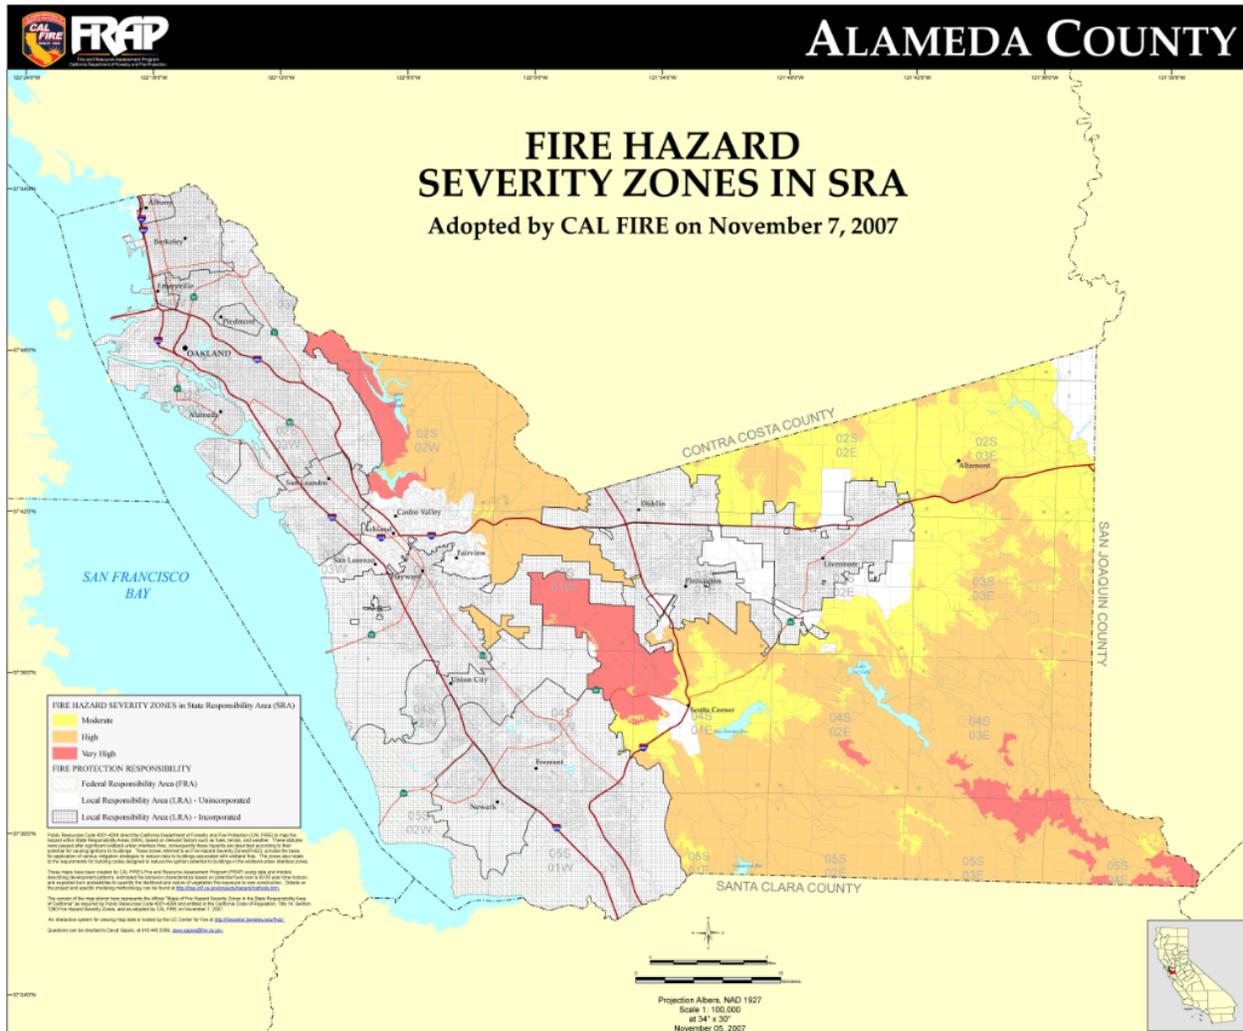
Figure 5.9. Alameda County Fire Hazard Severity Zones

Figure 5.9 through Figure 5.12 shows areas adjacent to reservoirs in the EBMUD service boundary (i.e. Briones, San Pablo, and Upper San Leandro) and areas surrounding Mokelumne River watershed to be in high to very high fire hazard zones. As stated earlier, from 1989 through 2009, EBMUD staff responded to 349 fires in the Mokelumne River watershed within or adjacent to EBMUD property. Therefore, the probability of wildfire in EBMUD service boundary and Mokelumne River watershed is highly likely.

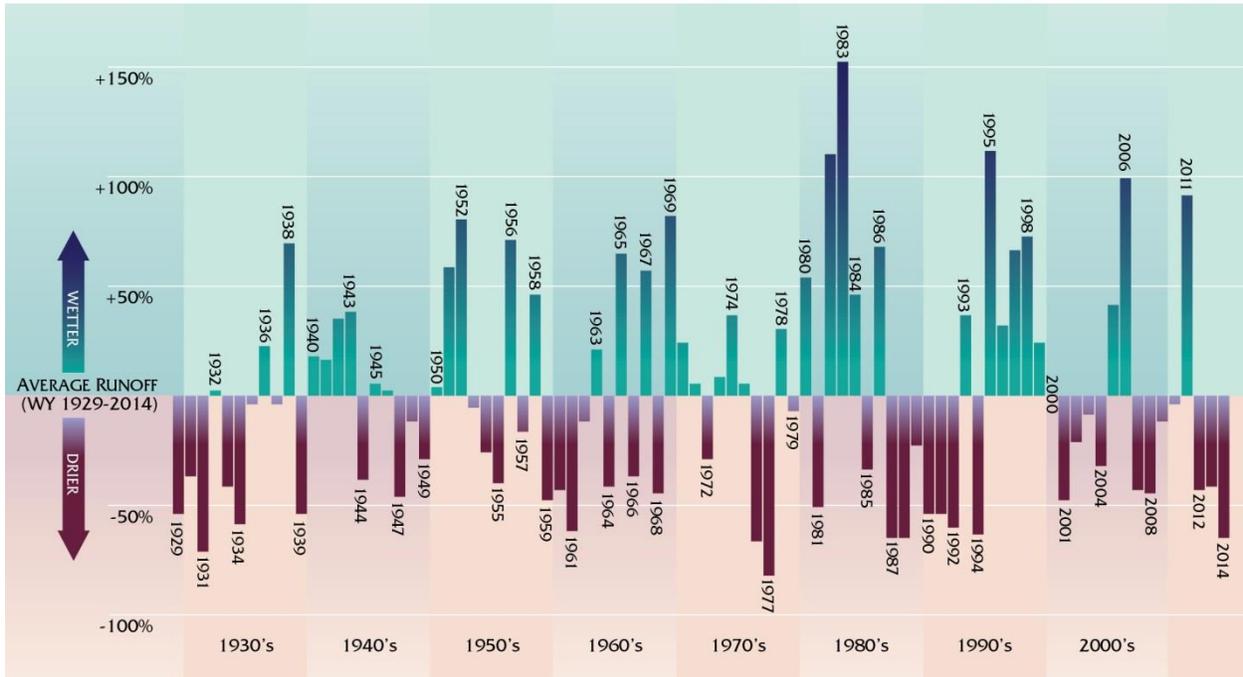
Figure 5.13. Variability in Runoff in the Mokelumne Watershed (1929-2015)

diminished the supply of water available to EBMUD’s customers. Figure 5.13, which includes data from the 2014-2015 drought, illustrates the variability in runoff in the Mokelumne Watershed since 1929.

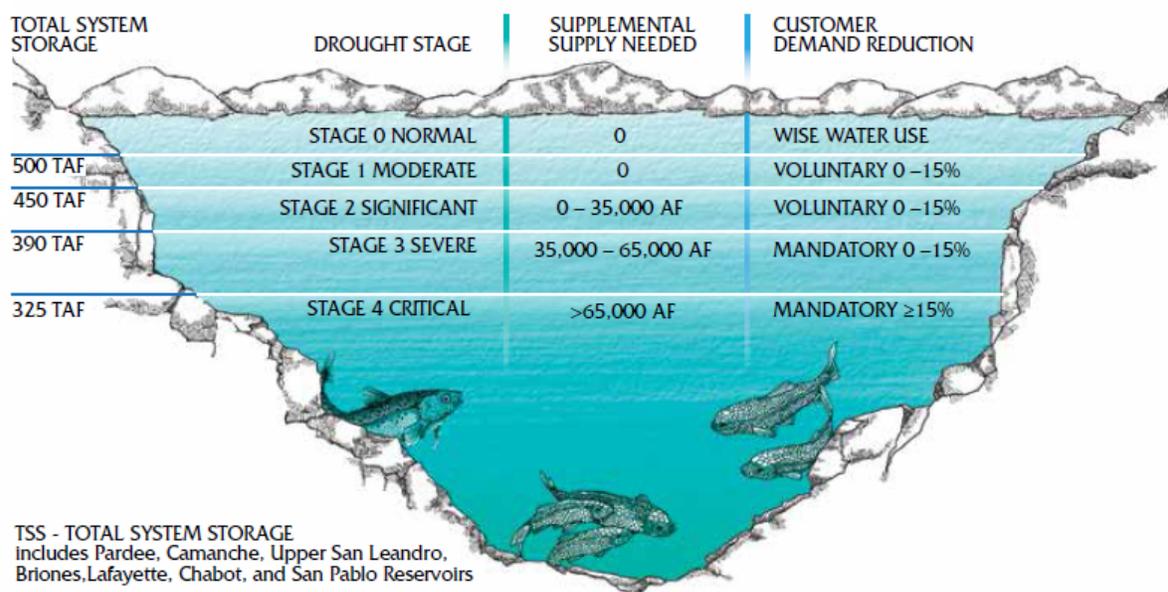
Figure 5.14. EBMUD’s Demand Management Program Guidelines¹

A central component of the District’s policy in this area is the District’s Demand Management Program (DMP) guidelines. Figure 5.14 below is an excerpt from EBMUD’s 2015 UWMP that depicts the DMP guidelines. Under the DMP guidelines Drought Stage 1 is initiated when the projected end-of-September Total System Storage is equal to 500 thousand acre-feet (TAF) or less. Note that this criterion incorporates both aspects of supply *and* demand into a forecasted storage threshold in each water year that is used to trigger a “drought” condition. This is the same criterion that defines eligibility criteria for the District’s CVP supply as defined by the District’s Long-Term Renewal Contract with USBR (Contract No. 14-06-200-5183A-LTR1).

For the purposes of estimating drought frequency, EBMUD defines a “drought” using the projected end-of-September Total System Storage criteria equal to 500 TAF. We can determine the frequency of time above and below this threshold by running the Districts’ water resources planning simulation model (EBMUDSIM) under existing conditions. Model results show that there are 27 years (29 percent or approximately 3 in 10 years) over the historical period of

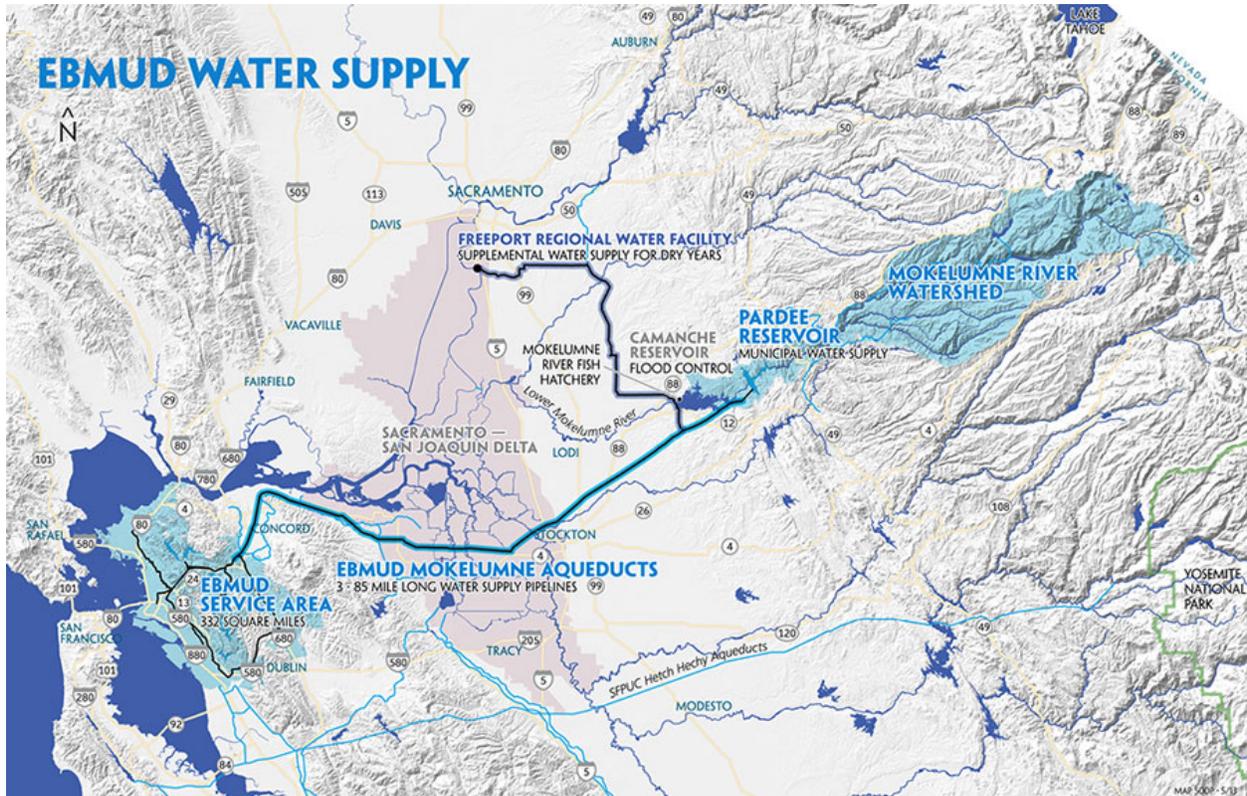
Figure 10.1. EBMUD Water Supply

EBMUD's water supply system consists of reservoirs, aqueducts, treatment plants, and distribution facilities from the Mokelumne River Basin in the Sierra Nevada, to the East San Francisco Bay Area

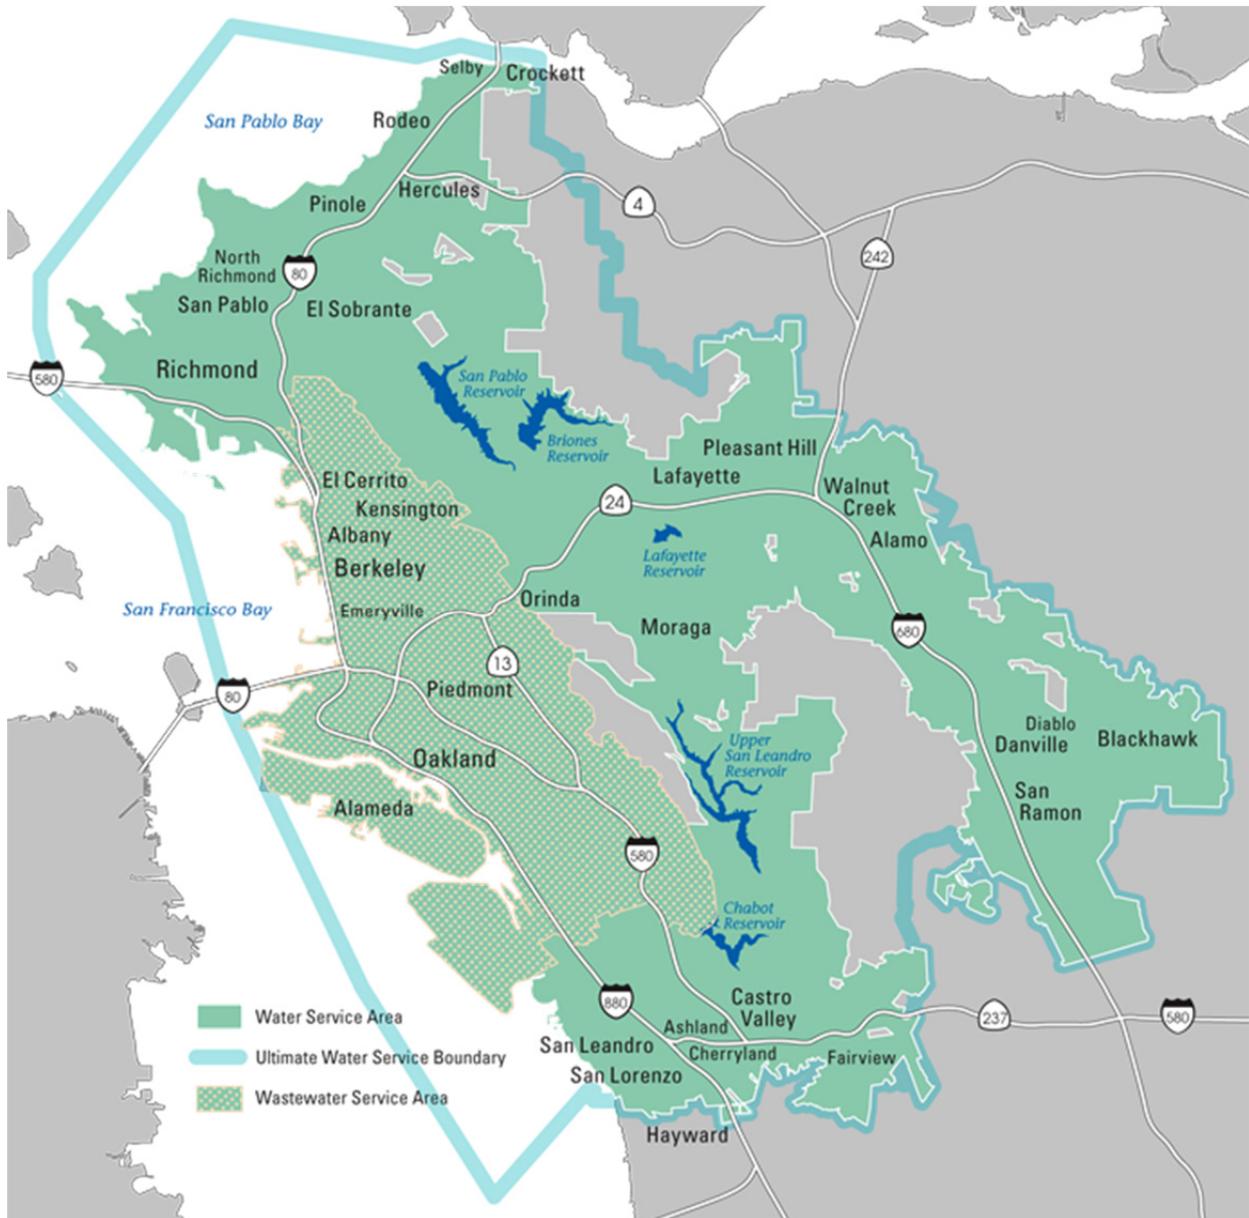
Figure 10.2. EBMUD’s Service Area

EBMUD's water system serves approximately 1.4 million people in a 331-square-mile area extending from Crockett on the north, southward to San Lorenzo (encompassing the major cities of Oakland and Berkeley), eastward from San Francisco to Walnut Creek, and south through the San Ramon Valley. Our wastewater system serves approximately 680,000 people in an 88-square-mile area of Alameda and Contra Costa counties along the Bay's east shore, extending from Richmond on the north, southward to Oakland.
