GEOTECHNICAL ENGINEERING STUDY

TOMATO STAND FISH PASSAGE PROJECT

PINOLE CREEK WATERSHED CULVERT REPLACEMENT

ATLAS PROJECT NO. 91-68538-PW

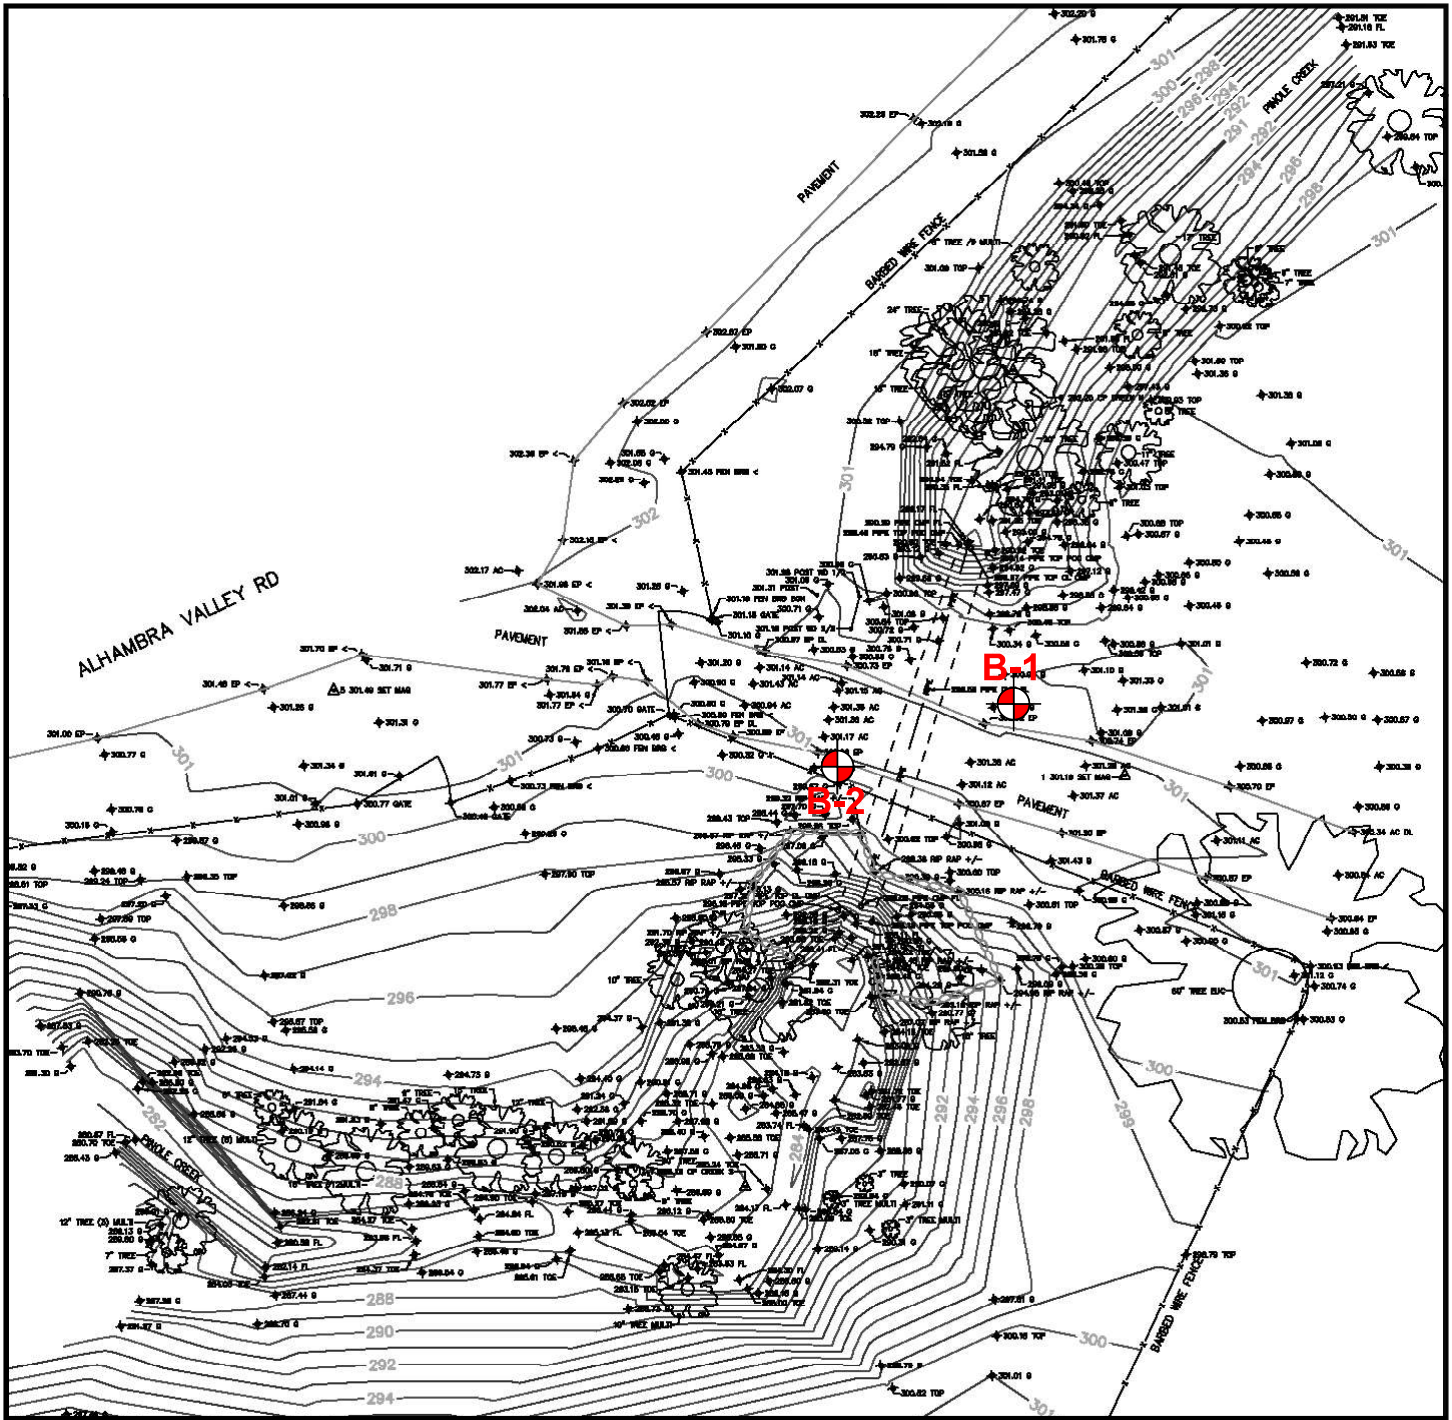
2

B-1

In order to characterize the subsurface conditions beneath the proposed improvement area, a field exploration program was conducted, which consisted of drilling two test borings, designated as B-1 and B-2, on July 11, 2024. The borings were located to satisfy the project requirements and to facilitate an interpretation of the subsurface soil profile across the project site. The location of the borings relative to the proposed improvements are shown on Plate 2.
