FINAL REPORT
VOLUME 1: MAIN REPORT
October 2005

DYNAMIC STABILITY ANALYSIS OF CHABOT DAM

Alameda County, California

**Subject: Dynamic Stability of Chabot Dam
Final Engineering Report**

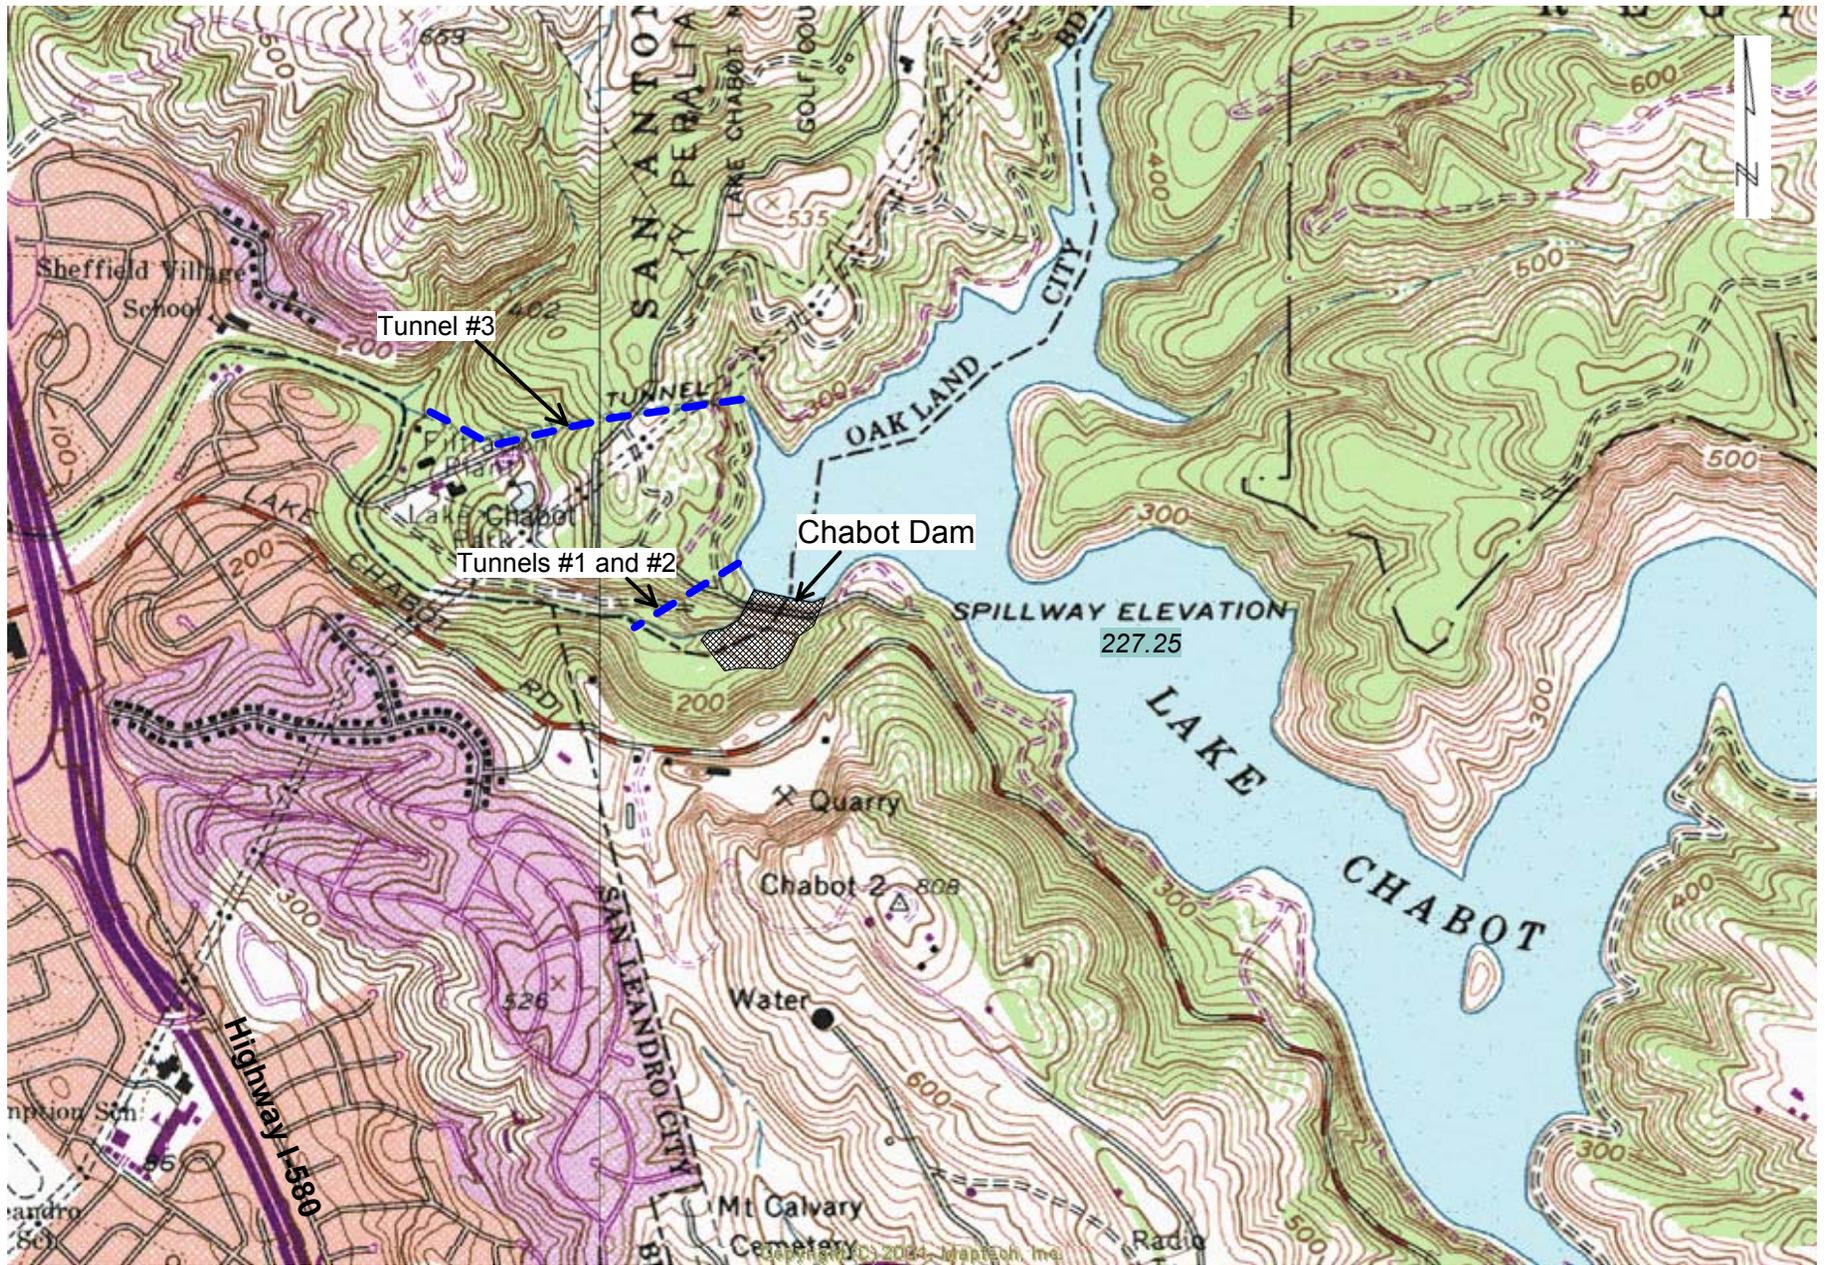
Project No. 26814536	Chabot Dam Seismic Stability	Location of Chabot Dam	Figure 3-1
URS

The dam and reservoir are situated on San Leandro Creek in a narrow canyon in the East Bay hills, approximately nine miles southeast of Oakland and about two miles northeast of San Leandro. The site location is shown on Figure 3-1.

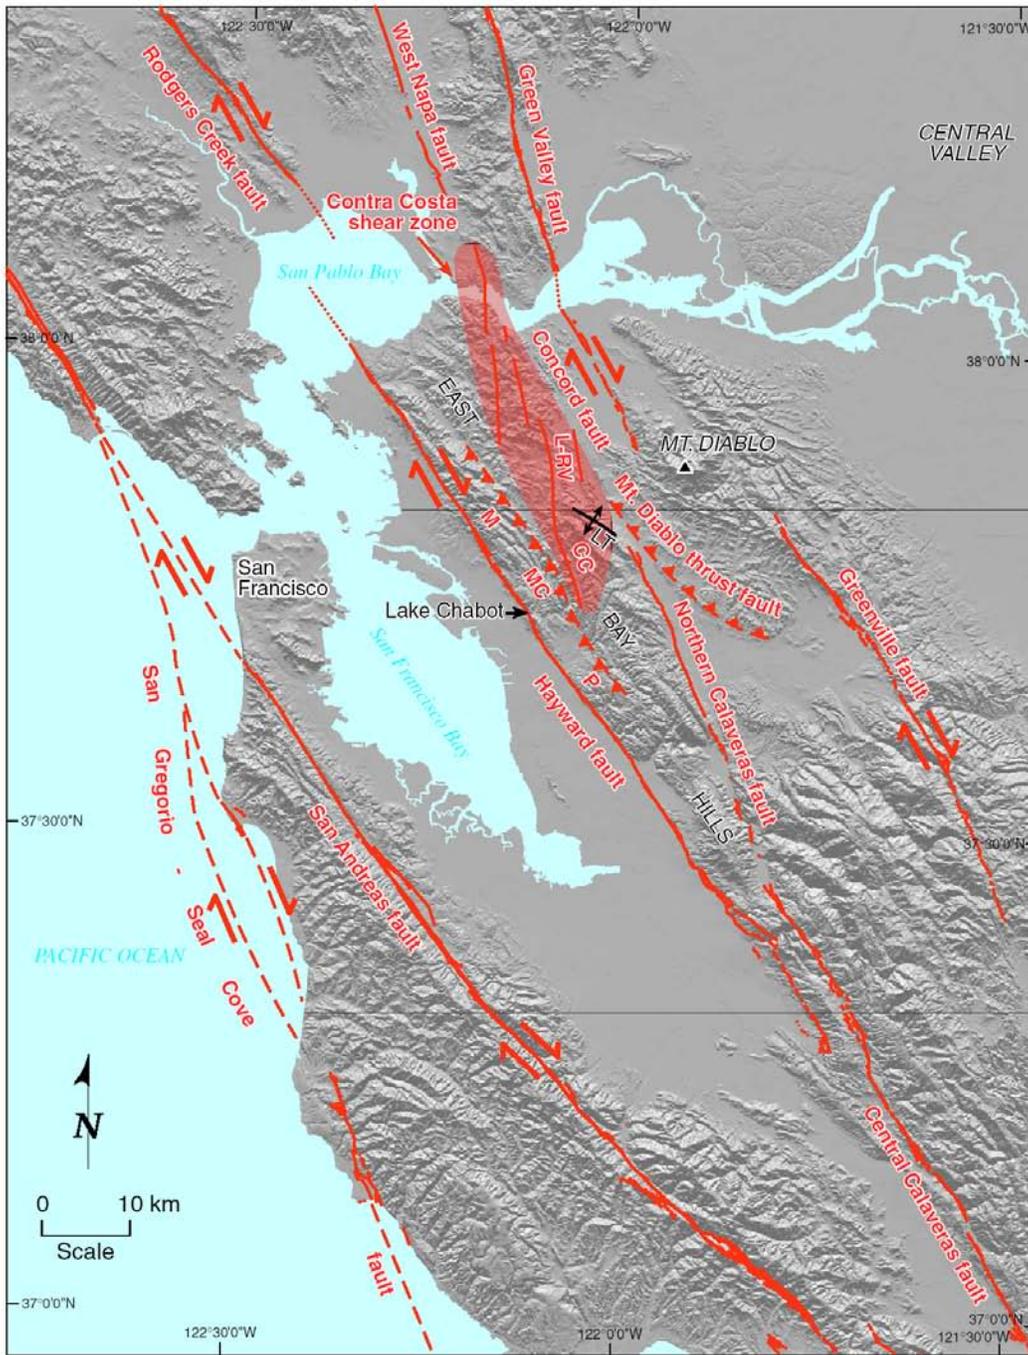
Project No. 26814536	Seismic Sources Map	Figure 6-1
	Chabot Dam Seismic Stability

Explanation		
	Strike-slip fault	
	Thrust or reverse fault (teeth on hanging wall; dashed where blind or approximately located)	
	Anticline	
	L-RV Lafayette-Reliez Valley faults	MC Miller Creek fault
	CC Cull Canyon fault	P Palomares fault
	M Moraga fault	LT Las Trampas anticline
	Faults and lineaments of the Contra Costa shear zone

The Hayward-Rodgers Creek fault is located about 0.5 kilometers (km) west of the dam site. This fault was the source of an estimated M6.8 earthquake on 21 October 1868. The Northern Calaveras fault, located about 13 km east of the dam, has a historical record of small earthquakes. However, paleoseismic trenching studies indicate that the fault has produced multiple surface ruptures during late Quaternary time. Other active faults within 50 km of the dam that are considered as potential sources of future large earthquakes include the San Andreas, San Gregorio-Seal Cove, Greenville, Mt. Diablo and Concord-Green Valley faults. The locations of potential seismic sources in the region are shown in Figure 6-1.

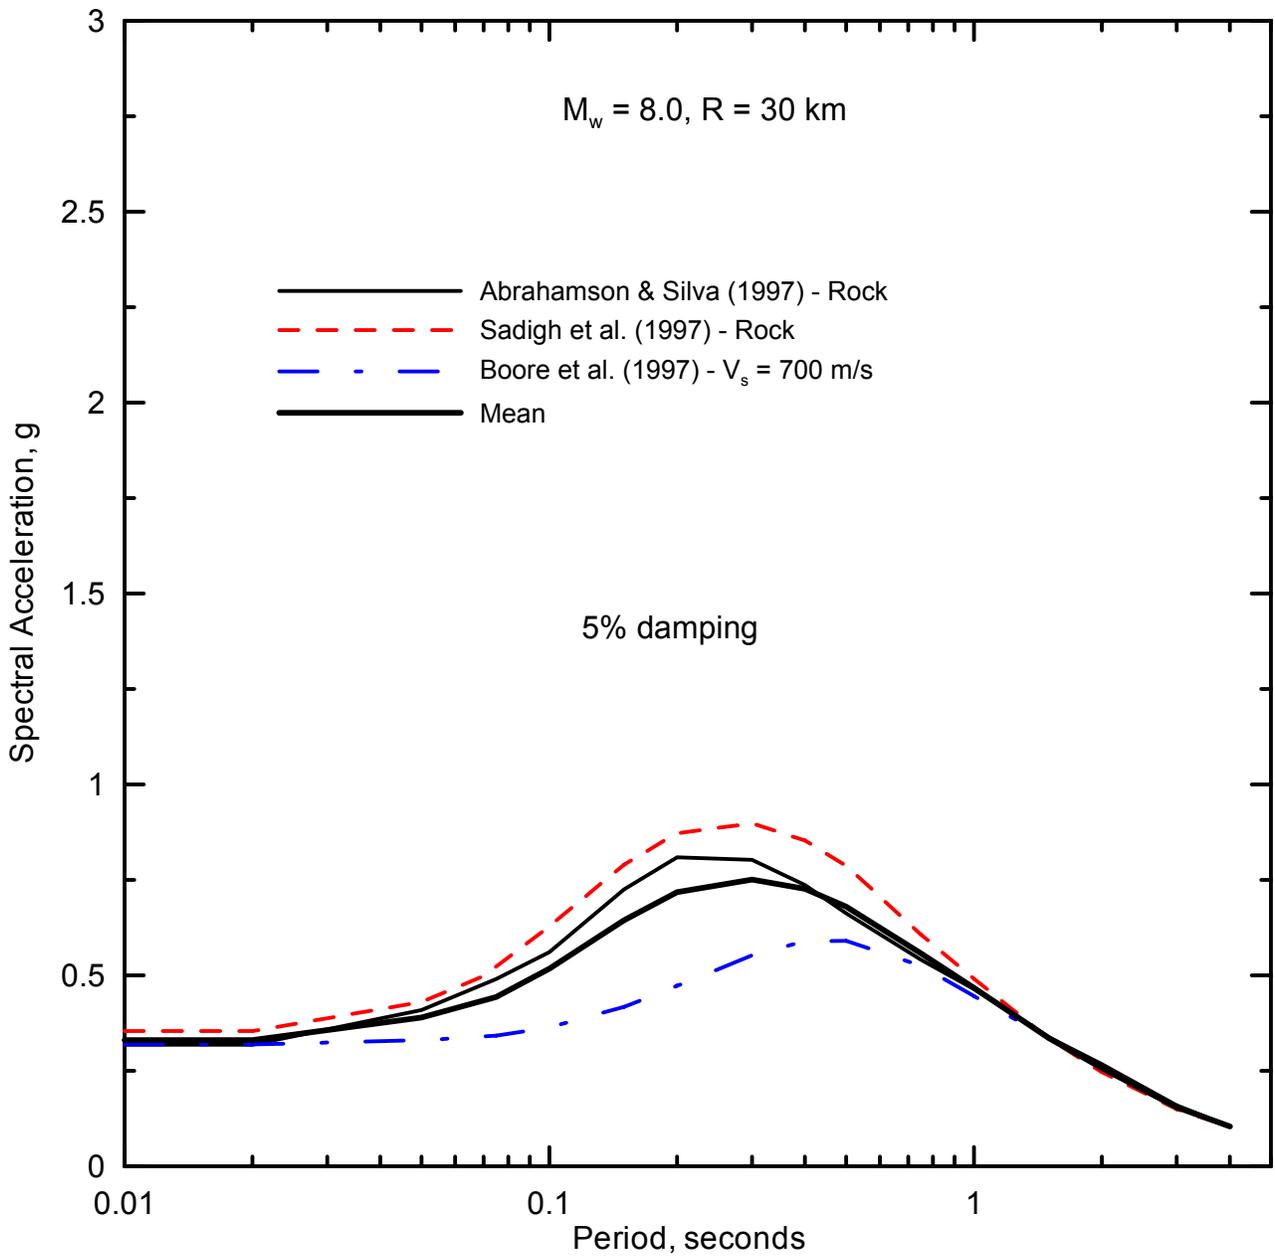
Figure
6-3

Calculated 84th-percentile Acceleration Response
Spectra for San Andreas Fault MCE

Given the estimated slip rates on the Hayward and San Andreas faults (about 9 and 24 mm/year, respectively) and the consequence class weight associated with the dam, the DSOD Consequence Hazard Matrix dictates the use of 84th-percentile ground motions for deterministic analysis. Figure 6-2 shows the 84th-percentile horizontal acceleration response spectra calculated using the three selected attenuation relationships for the MCE on the Hayward-Rodgers Creek fault. A similar plot for the MCE on the San Andreas fault is shown in Figure 6-3.

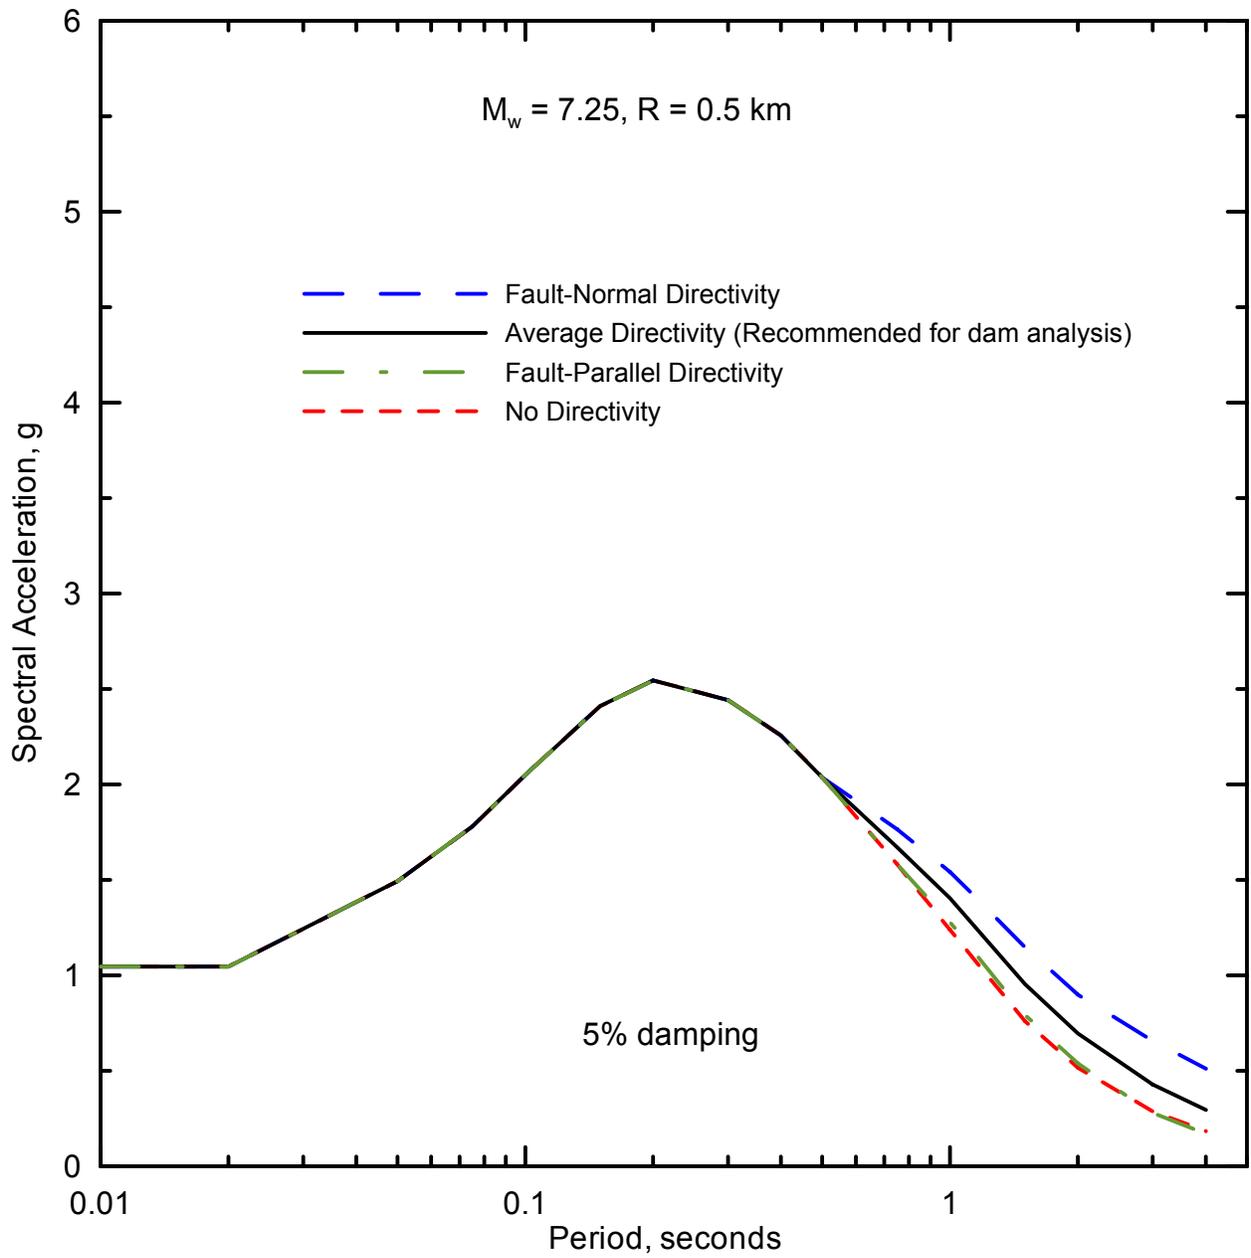
**Design Acceleration Response Spectra
 for Hayward-Rodgers Creek Fault MCE**

The design response spectra for the dam were developed from the results of the deterministic analysis, modified for fault rupture directivity effects. Figures 6-4 and 6-5 show the mean 84th-percentile horizontal acceleration response spectra for MCEs on the Hayward and San Andreas faults, respectively. These figures also show the response spectra modified for average, fault-normal, and fault-parallel directivity. Figure 6-4 illustrates that the fault-parallel response spectrum calculated for the MCE on the Hayward fault is similar to that without directivity effects. For the MCE on the San Andreas fault, however, the calculated fault-parallel response spectrum is higher than the average spectrum without directivity effects (see Figure 6-5).

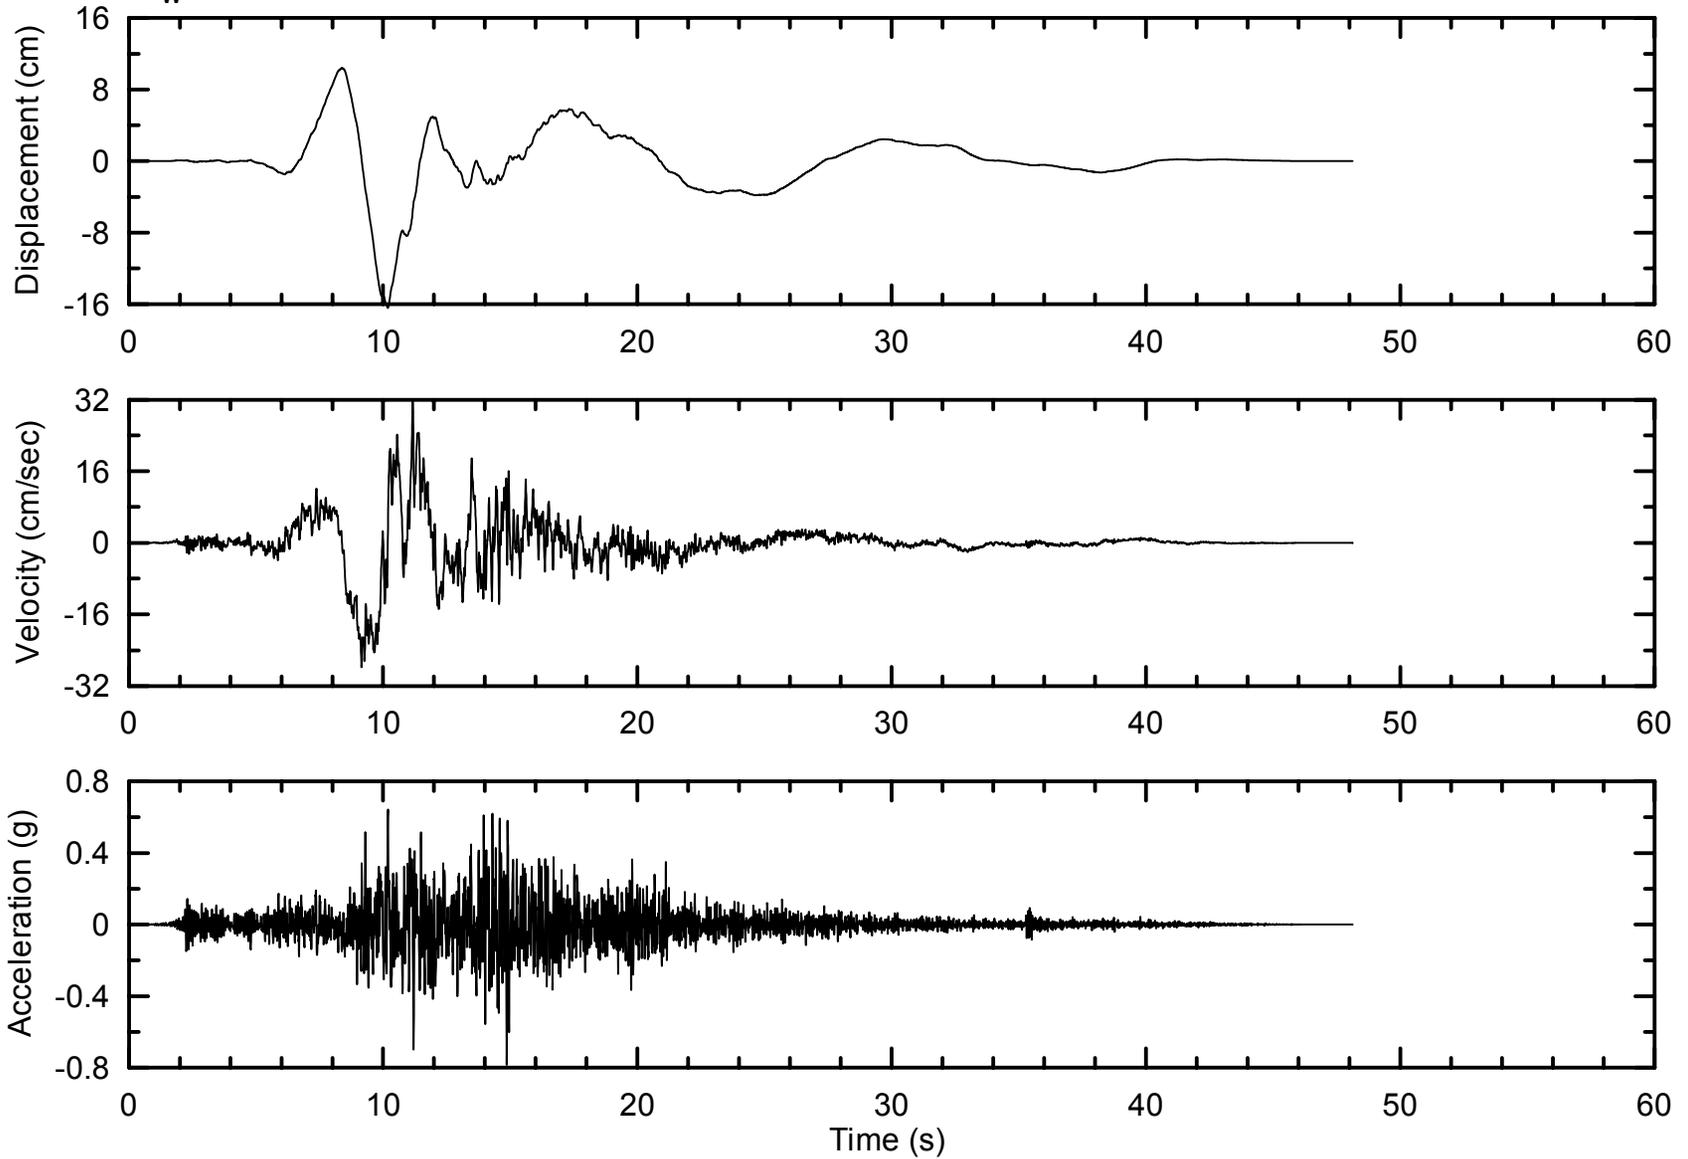
1992 Landers, CA Earthquake Time History
 at Lucerne Valley Station,
 $M_W = 7.3$, $R = 2.0$ km

Project No. 26814536	Chabot Dam Seismic Stability	Recorded Time History 1992 Landers, CA Earthquake at Lucerne Valley Station, Horizontal Component, 000 deg.	Figure 6-6
URS

To evaluate the sensitivity of the dam's dynamic analysis to the time history details, two acceleration time histories were developed for the Hayward fault MCE. The time histories were based on the 270-degree and the 0-degree components of the Lucerne Valley record of the 1992 Landers earthquake. The 360-degree component of the Carlo record from the 2002 Denali earthquake was used for the San Andreas fault MCE. The key characteristics of the recorded time histories are shown in Table 6-5. The recorded acceleration, velocity and displacement time histories and the corresponding 5%-damped acceleration response spectra are plotted in Figures 6-6 through 6-11.

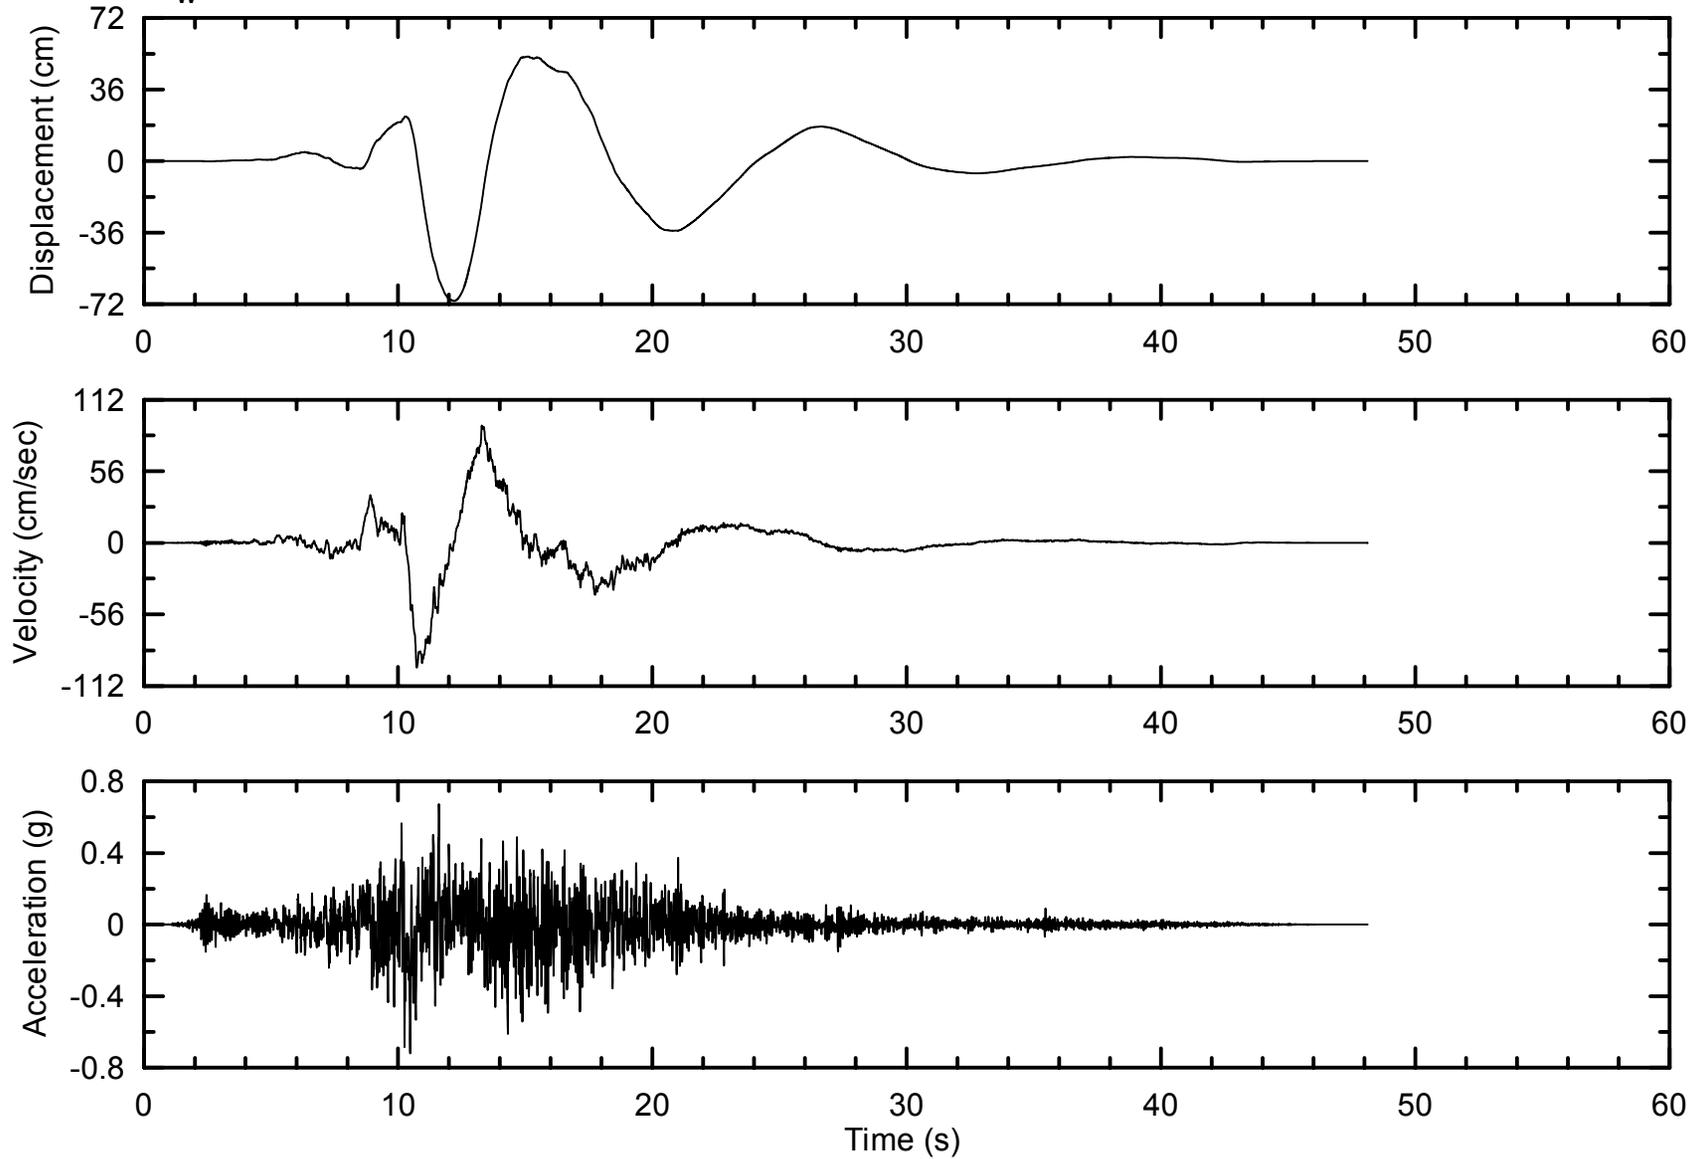
1992 Landers, CA Earthquake Time History
 at Lucerne Valley Station,
 $M_w = 7.3$, $R = 2.0$ km

Project No. 26814536	Chabot Dam Seismic Stability	Recorded Time History 1992 Landers, CA Earthquake at Lucerne Valley Station, Horizontal Component, 270 deg.	Figure 6-8
URS

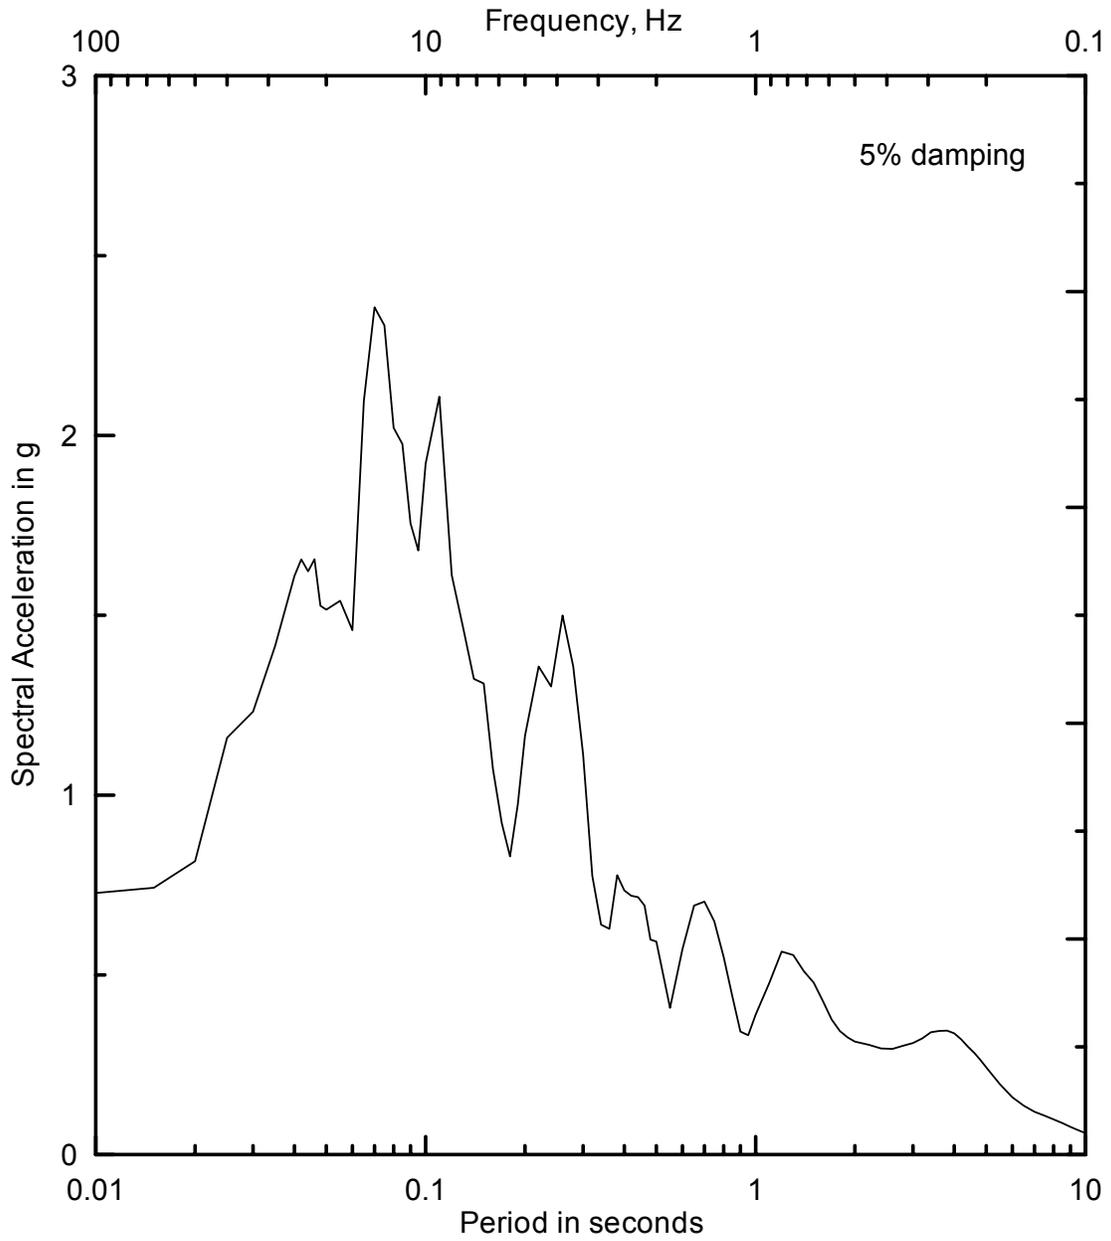
URS	Project No. 26814536	Acceleration Response Spectra 1992 Landers, CA Earthquake at Lucerne Valley Station, Horizontal Component 270 deg.	Figure
	Chabot Dam Seismic Stability		6-9

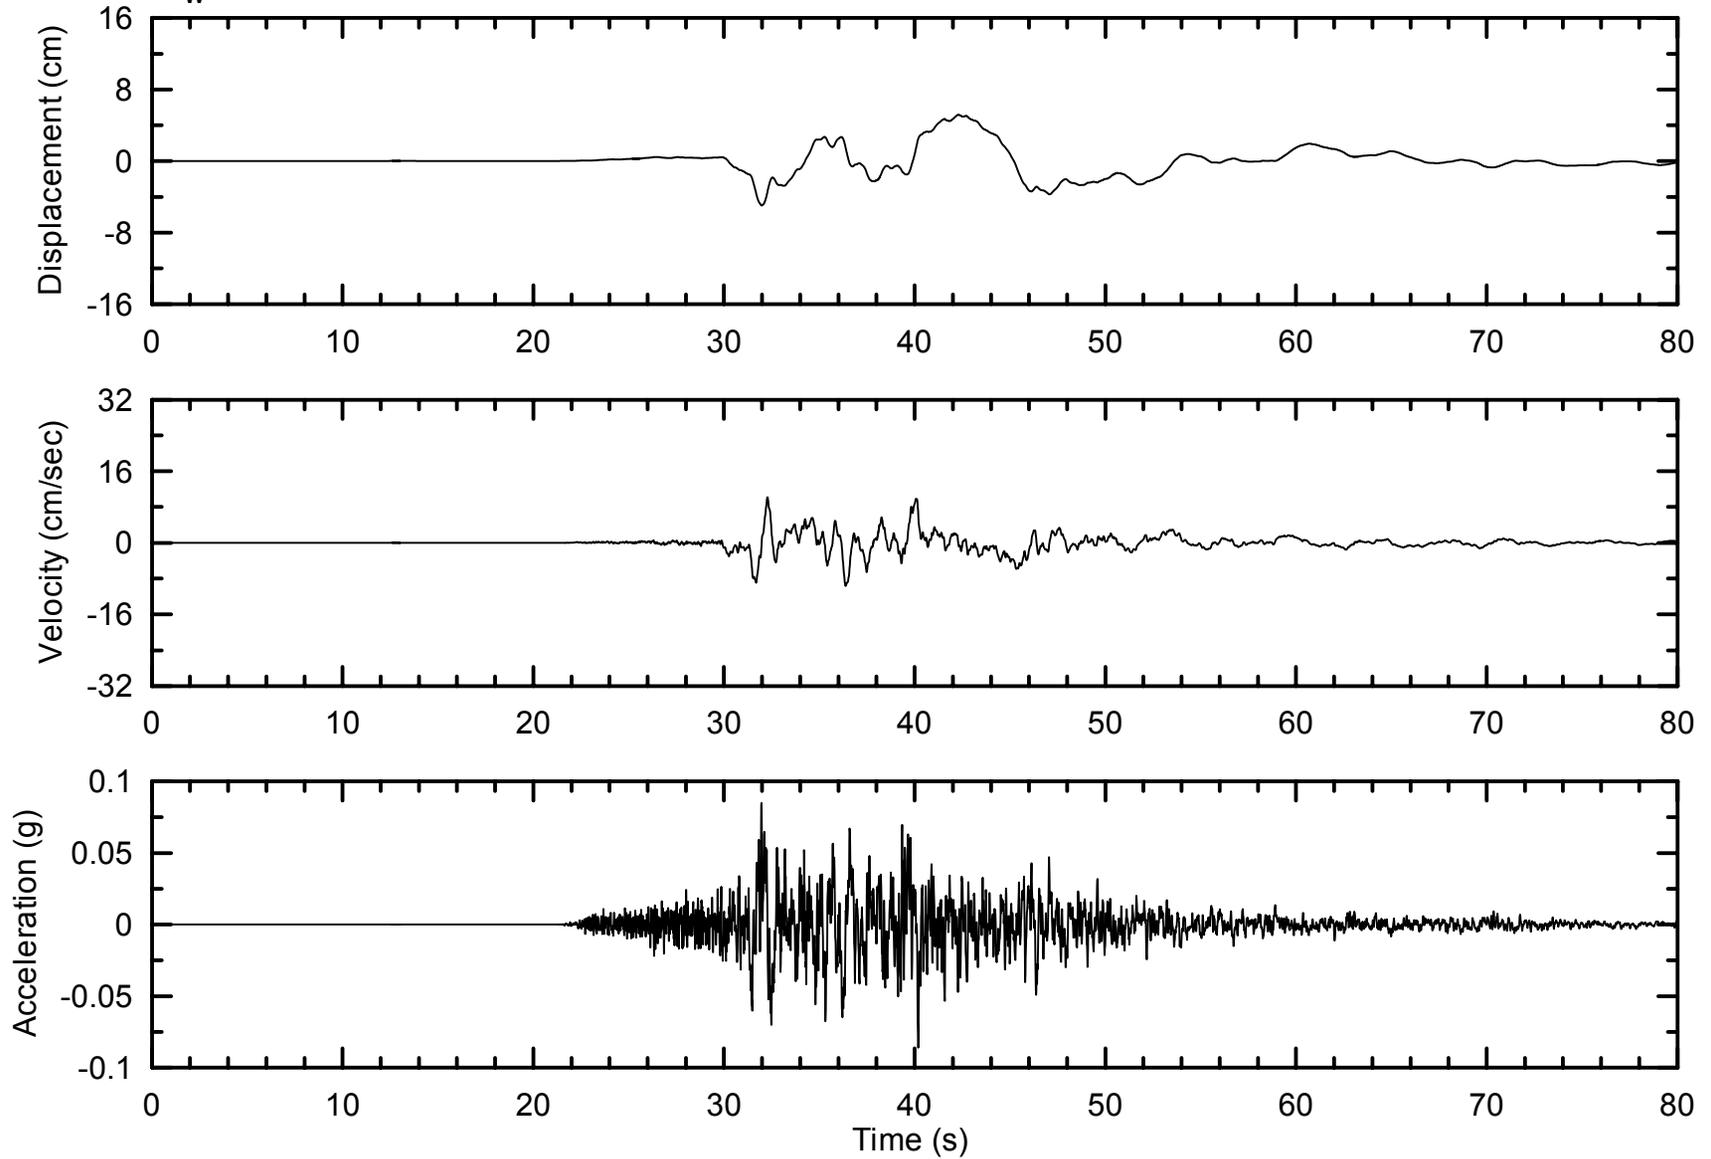
Figure
6-10

2002 Denali, Alaska Earthquake Time History
 Recorded at Carlo, Alaska Station,
 $M_W = 7.9$, $R = 64$ km

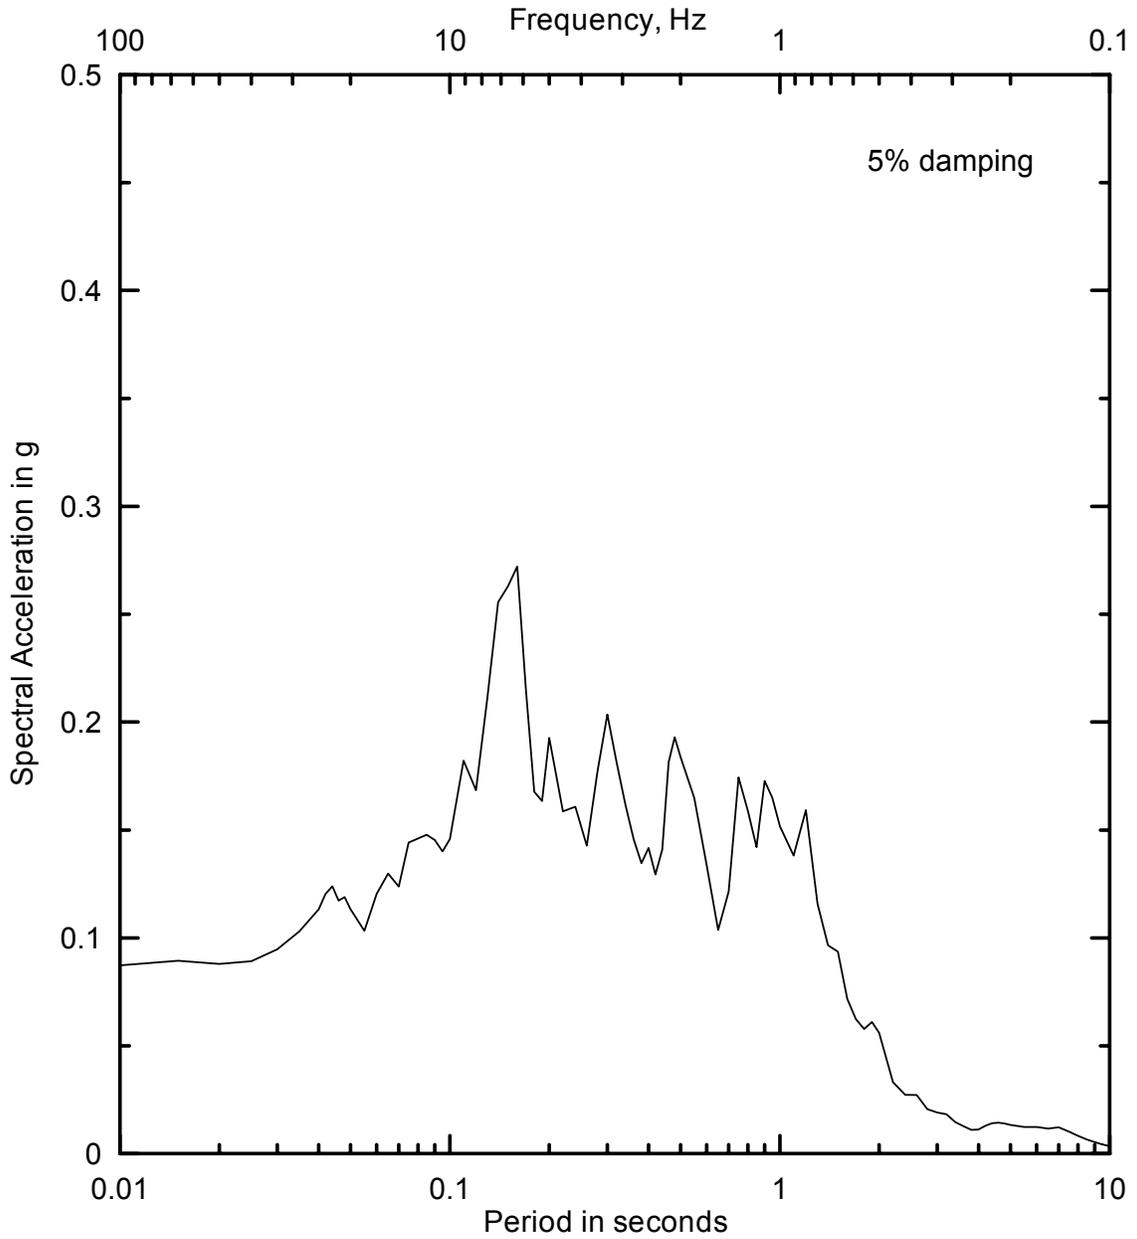
URS	Project No. 26814536	Acceleration Response Spectra 2002 Denali, Alaska Earthquake at Carlo, Alaska Station, Horizontal Component 360 deg.	Figure
	Chabot Dam Seismic Stability		6-11

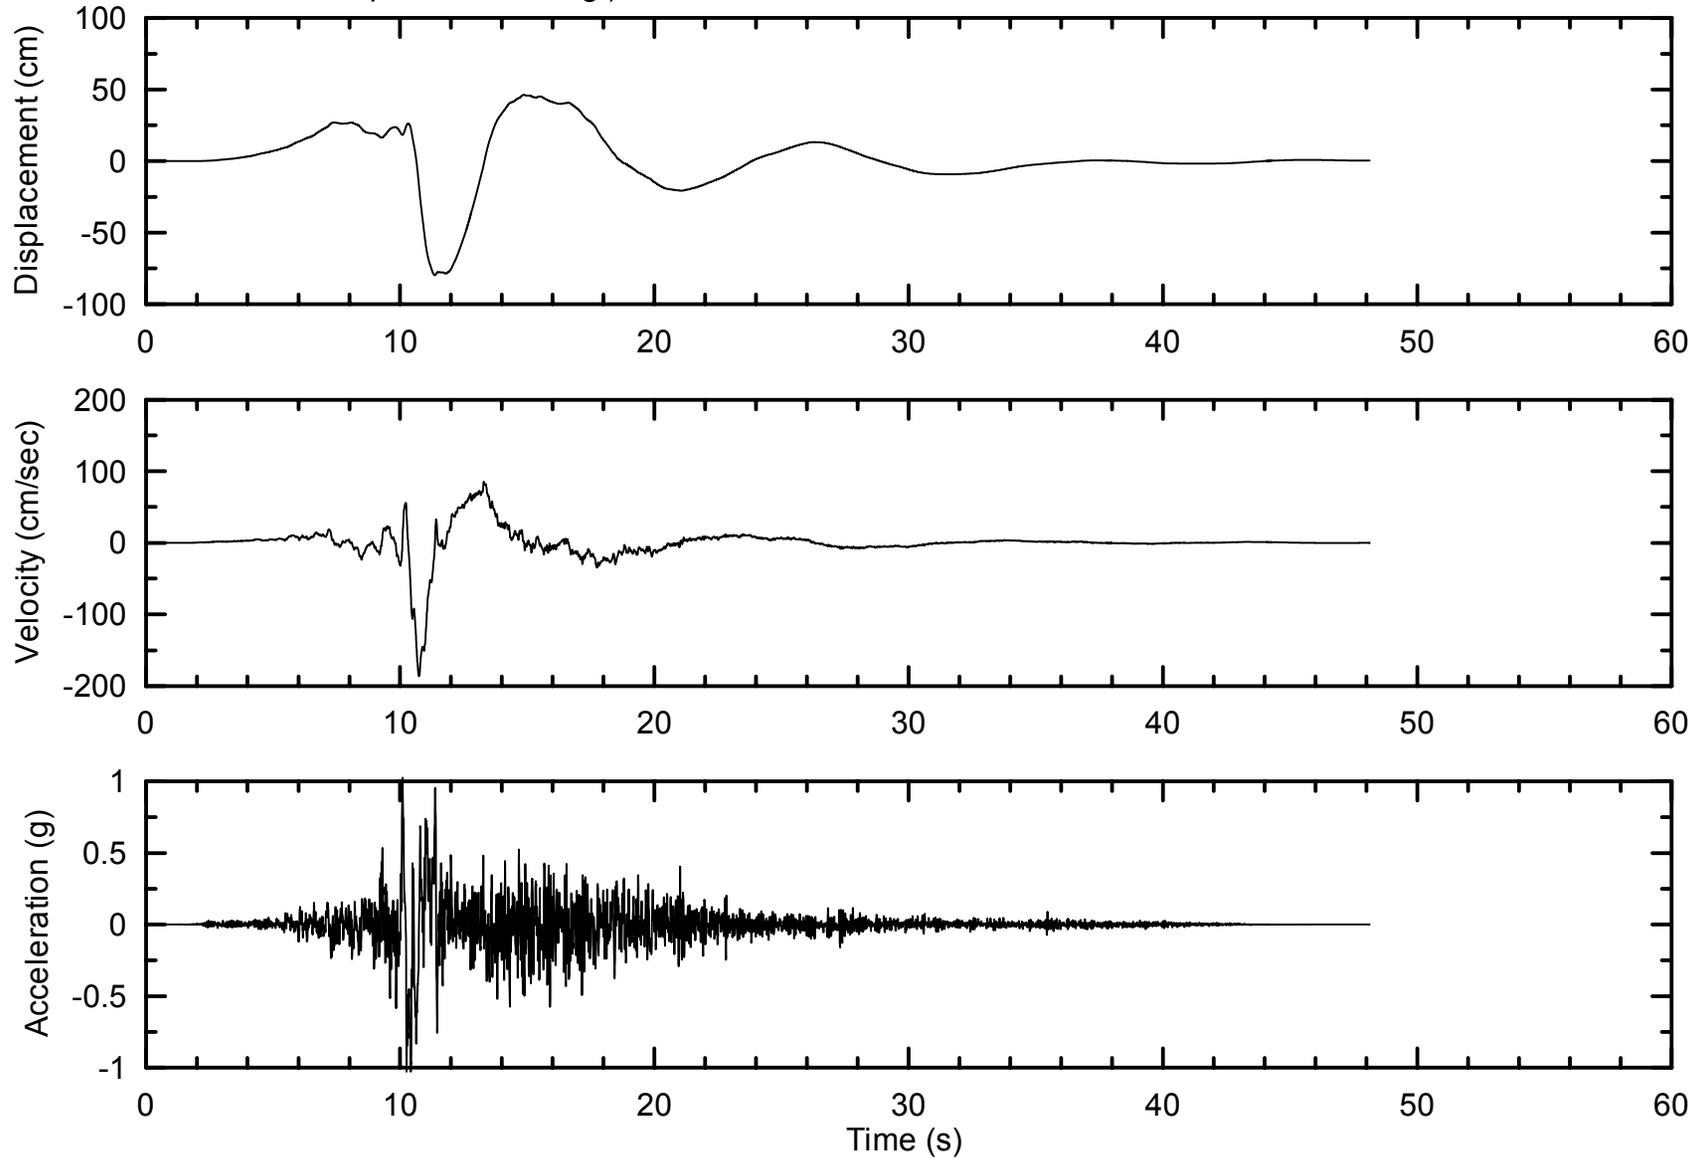
Hayward - Rodgers Creek Fault Event - Recommended Time History No.1
 (Modified from 1992 Landers, CA Earthquake - Lucerne Valley Station,
 Horizontal Component, 270 deg.)

Project No. 26814536	Chabot Dam Seismic Stability	Hayward - Rodgers Creek Fault MCE Recommended Time History No.1	Figure 6-12
URS

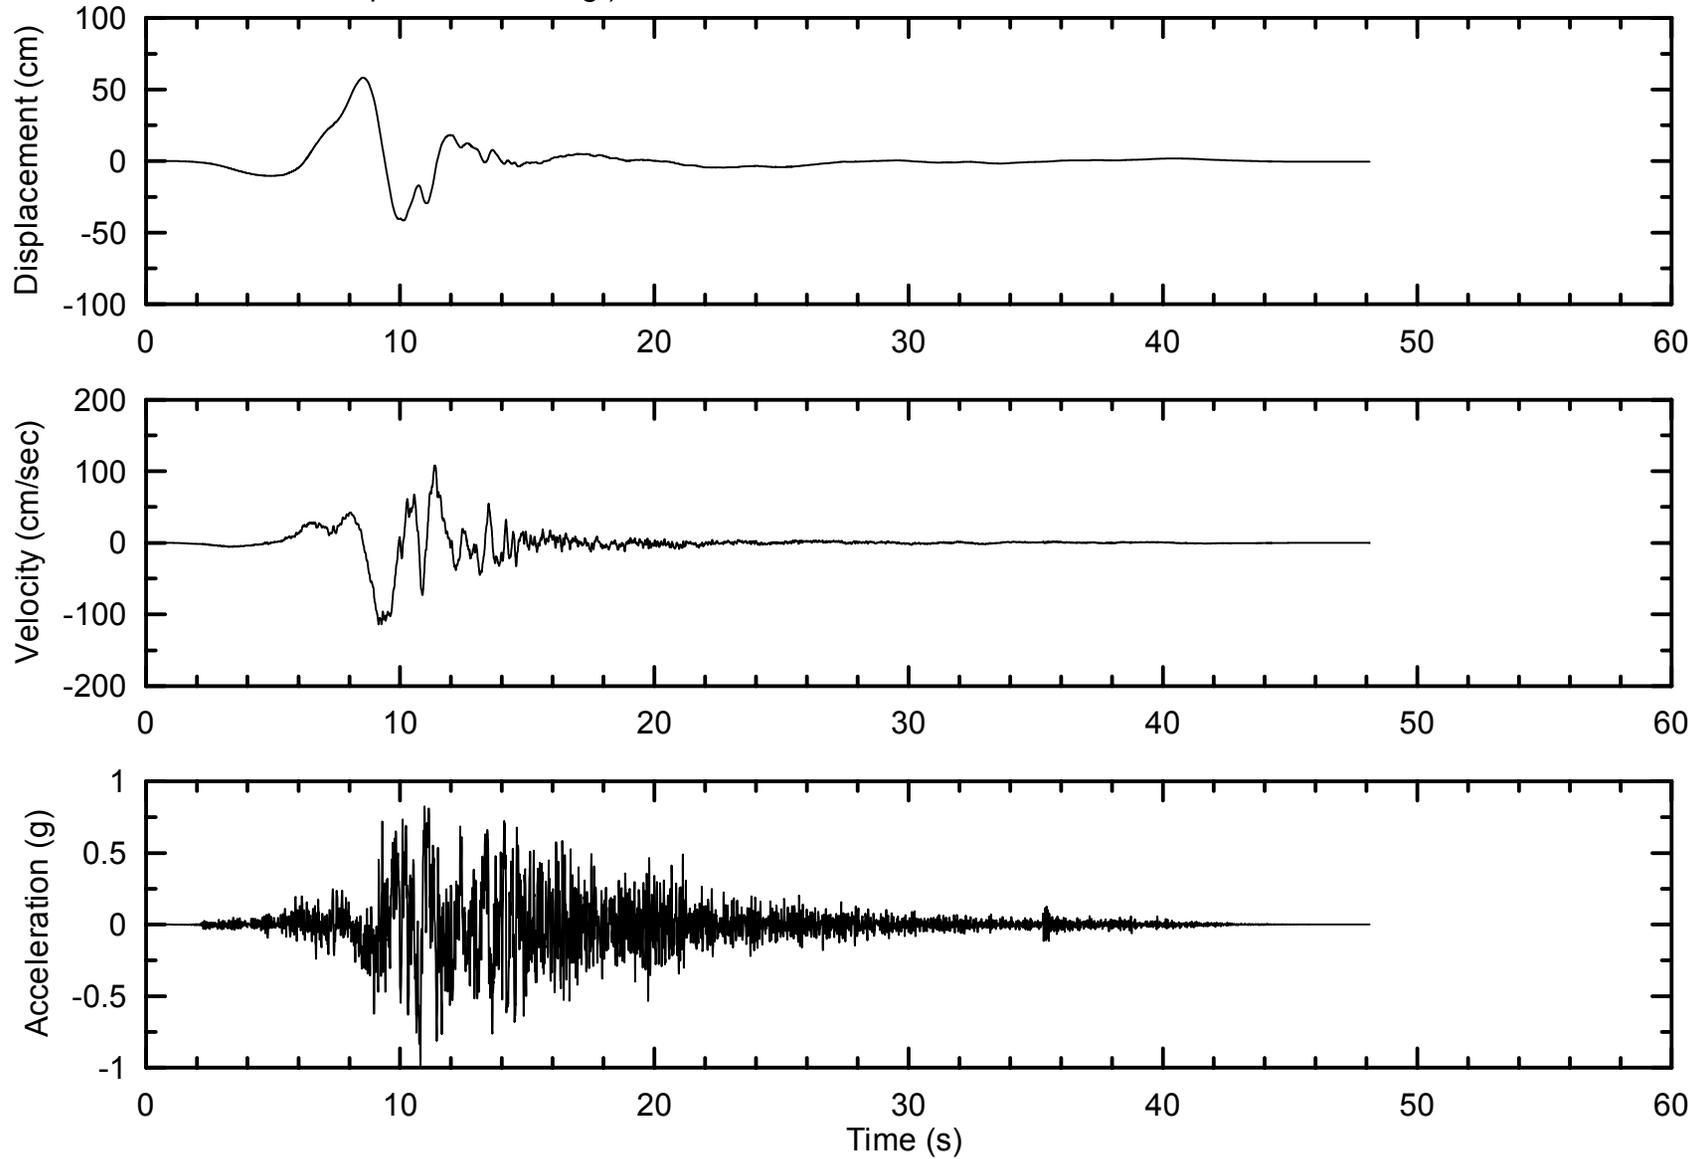
Hayward - Rodgers Creek Fault Event - Recommended Time History No.2
 (Modified from 1992 Landers, CA Earthquake - Lucerne Valley Station,
 Horizontal Component, 000 deg.)

Project No. 26814536	Chabot Dam Seismic Stability	Hayward - Rodgers Creek Fault MCE Recommended Time History No.2	Figure 6-13
URS

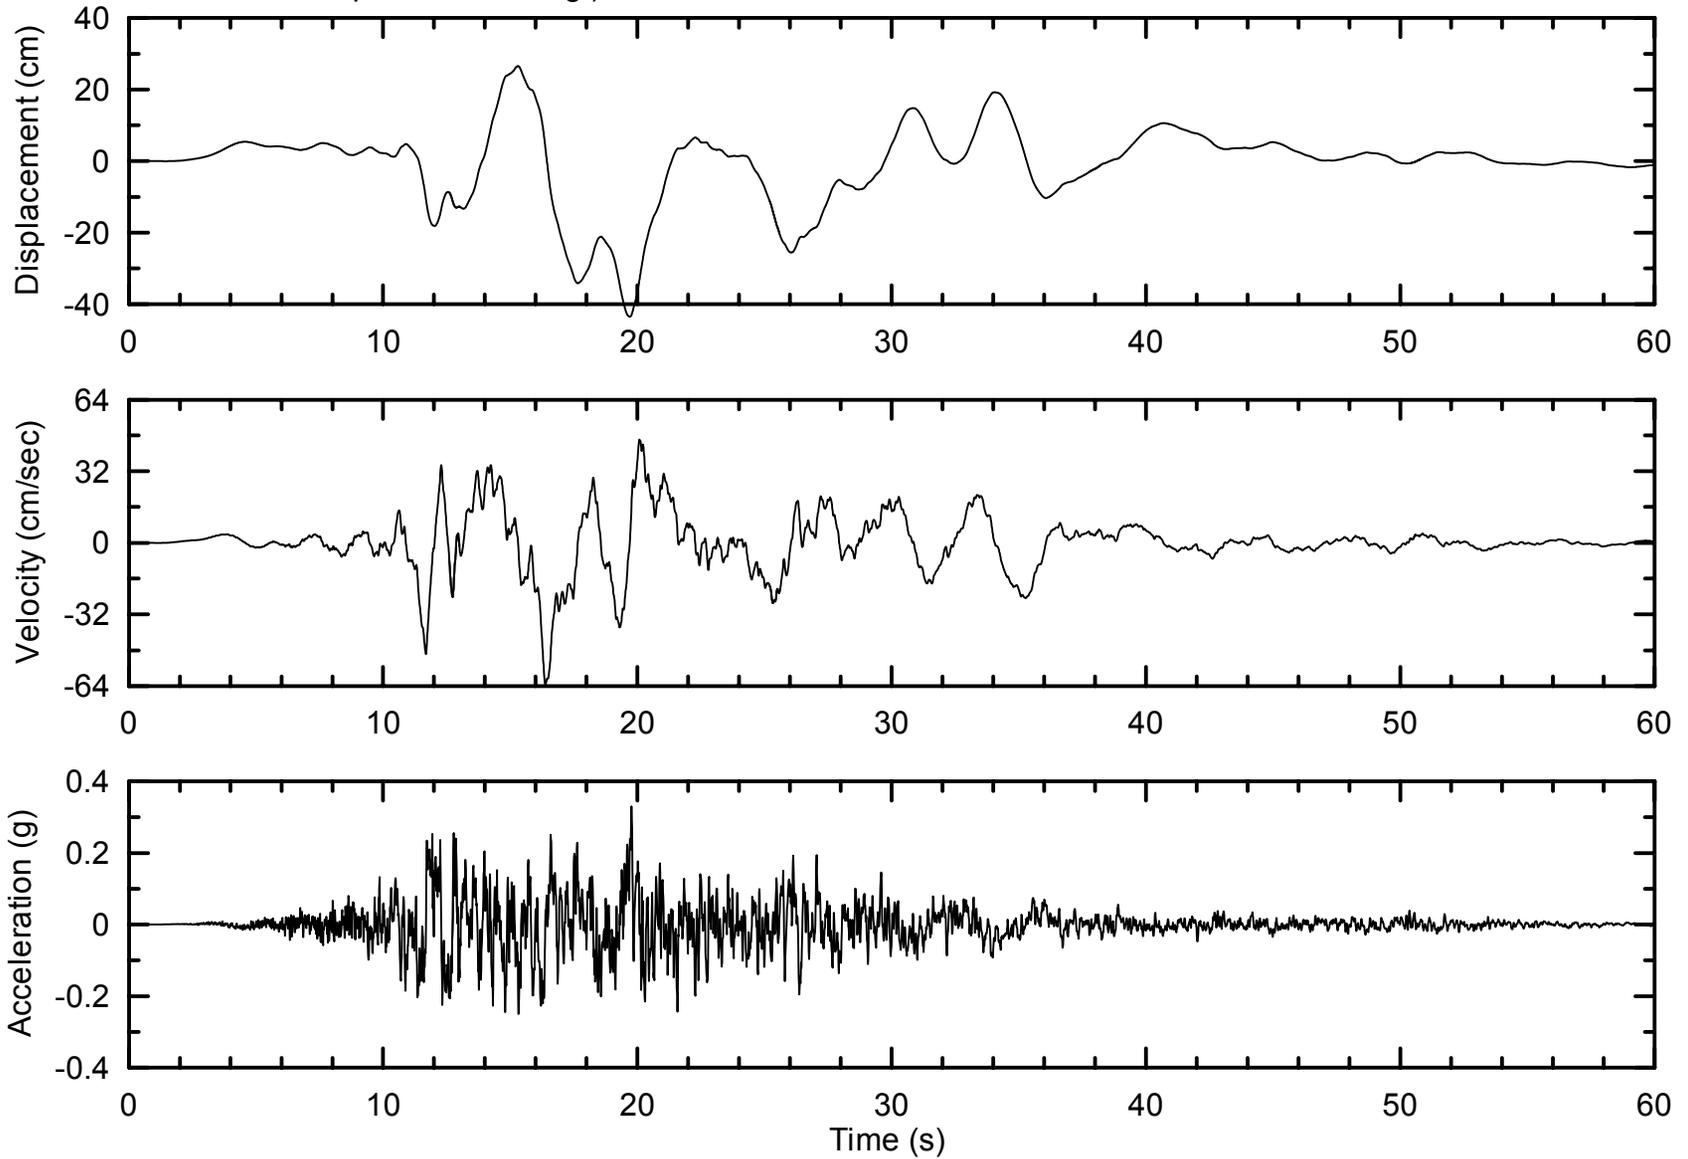
San Andreas Fault Event - Recommended Time History
 (Modified from 2002 Denali, Alaska Earthquake - Carlo, Alaska Station,
 Horizontal Component, 360 deg.)

Project No. 26814536	Chabot Dam Seismic Stability	San Andreas Fault MCE Recommended Time History	Figure 6-15
URS
