FINAL REPORT
VOLUME 1: MAIN REPORT
October 2005

DYNAMIC STABILITY ANALYSIS OF CHABOT DAM

Alameda County, California

**Subject: Dynamic Stability of Chabot Dam
Final Engineering Report**

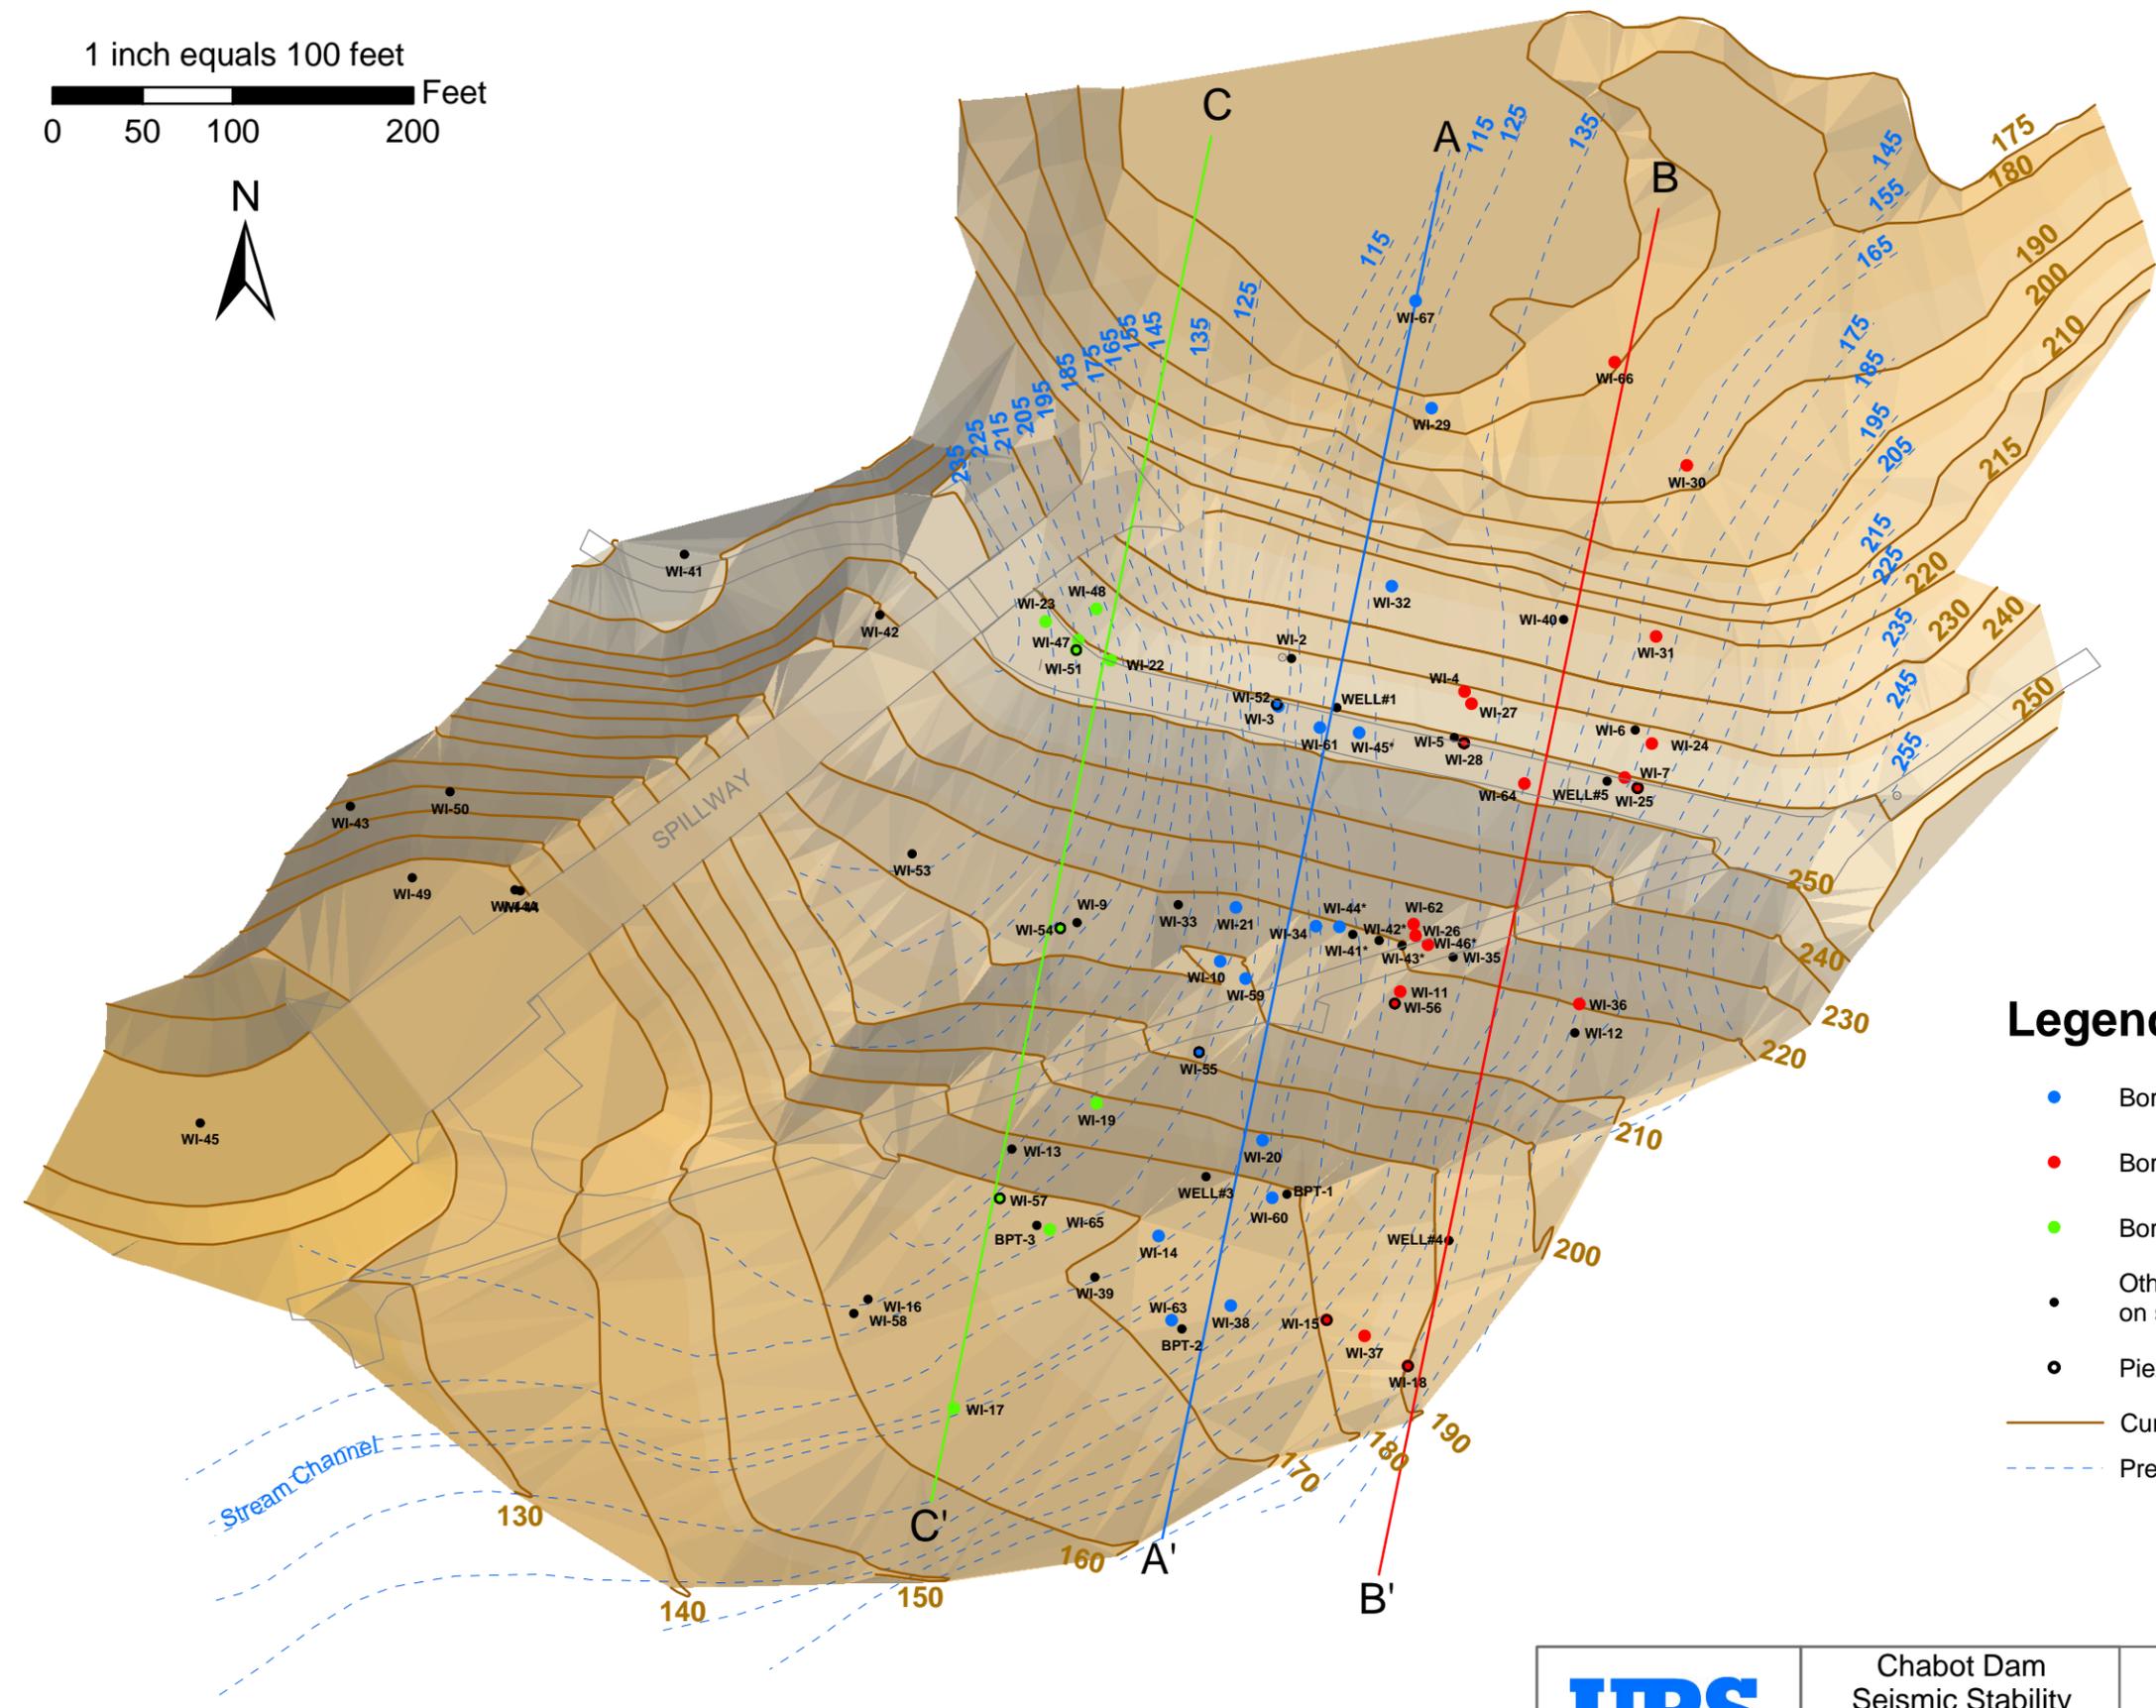
Chabot Dam Seismic Stability	Plan View of Dam and Cross-sections	Figure 7-1
	26814536

This section presents the geotechnical characterization of the embankment and foundation conditions. The characterization consisted of three main elements: 1) identifying the material zones that make up the embankment and foundation, 2) characterizing their engineering properties, and 3) defining the groundwater conditions and location of the phreatic surface for analysis. This work was based on the field and laboratory investigations conducted as part of this study, and on the data from previous investigations of the dam. Piezometric data provided by EBMUD were used in characterizing the groundwater conditions within the dam. The locations of the borings and piezometers used to characterize the site conditions are shown in Figure 7-1, along with the locations of three cross-sections used to illustrate the dam conditions .

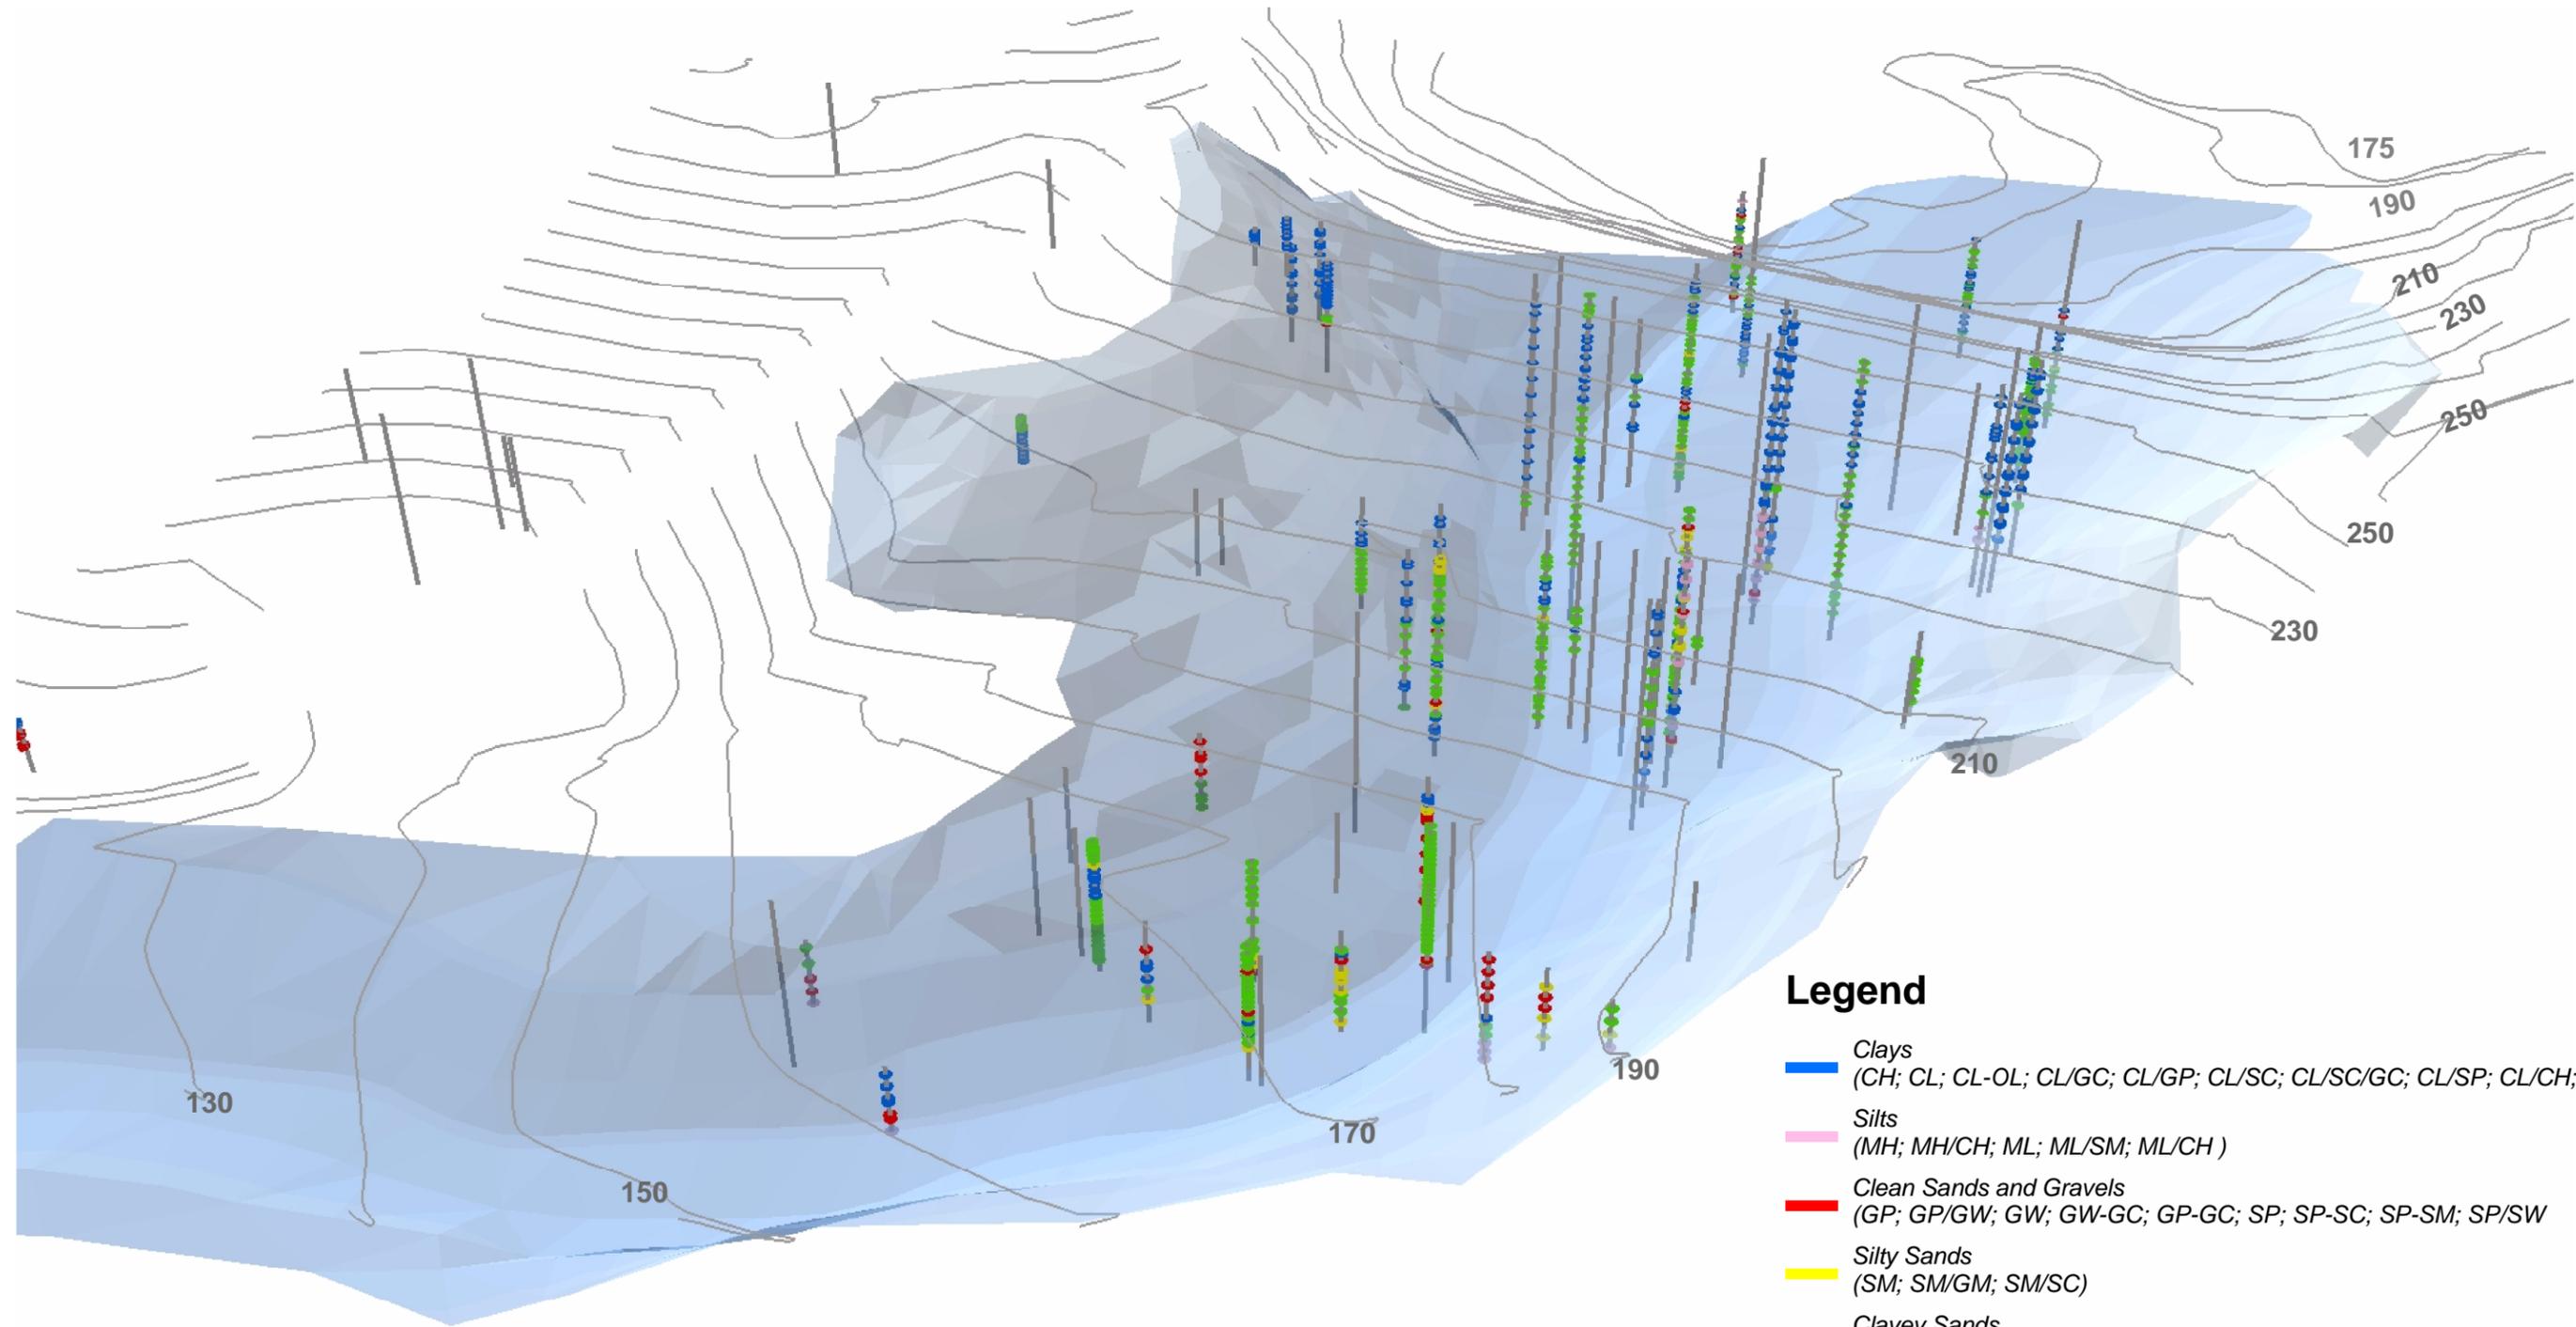
URS	Chabot Dam Seismic Stability	GIS Model - Distribution of Soil Types in Embankment and Foundation	Figure 7-2
	26814536

As part of the geotechnical characterization work, the subsurface data were incorporated into a 3-D GIS model. The GIS model helped visualize the 3-D geometry of the dam, as well as the spatial distribution of the borings and SPT sampling, soil classifications, and foundation soil thickness. A graphical view of the model is presented in Figure 7-2. The electronic data for the model were previously submitted to EBMUD in the form of shape files. Additional details on the GIS model are presented in Appendix I.

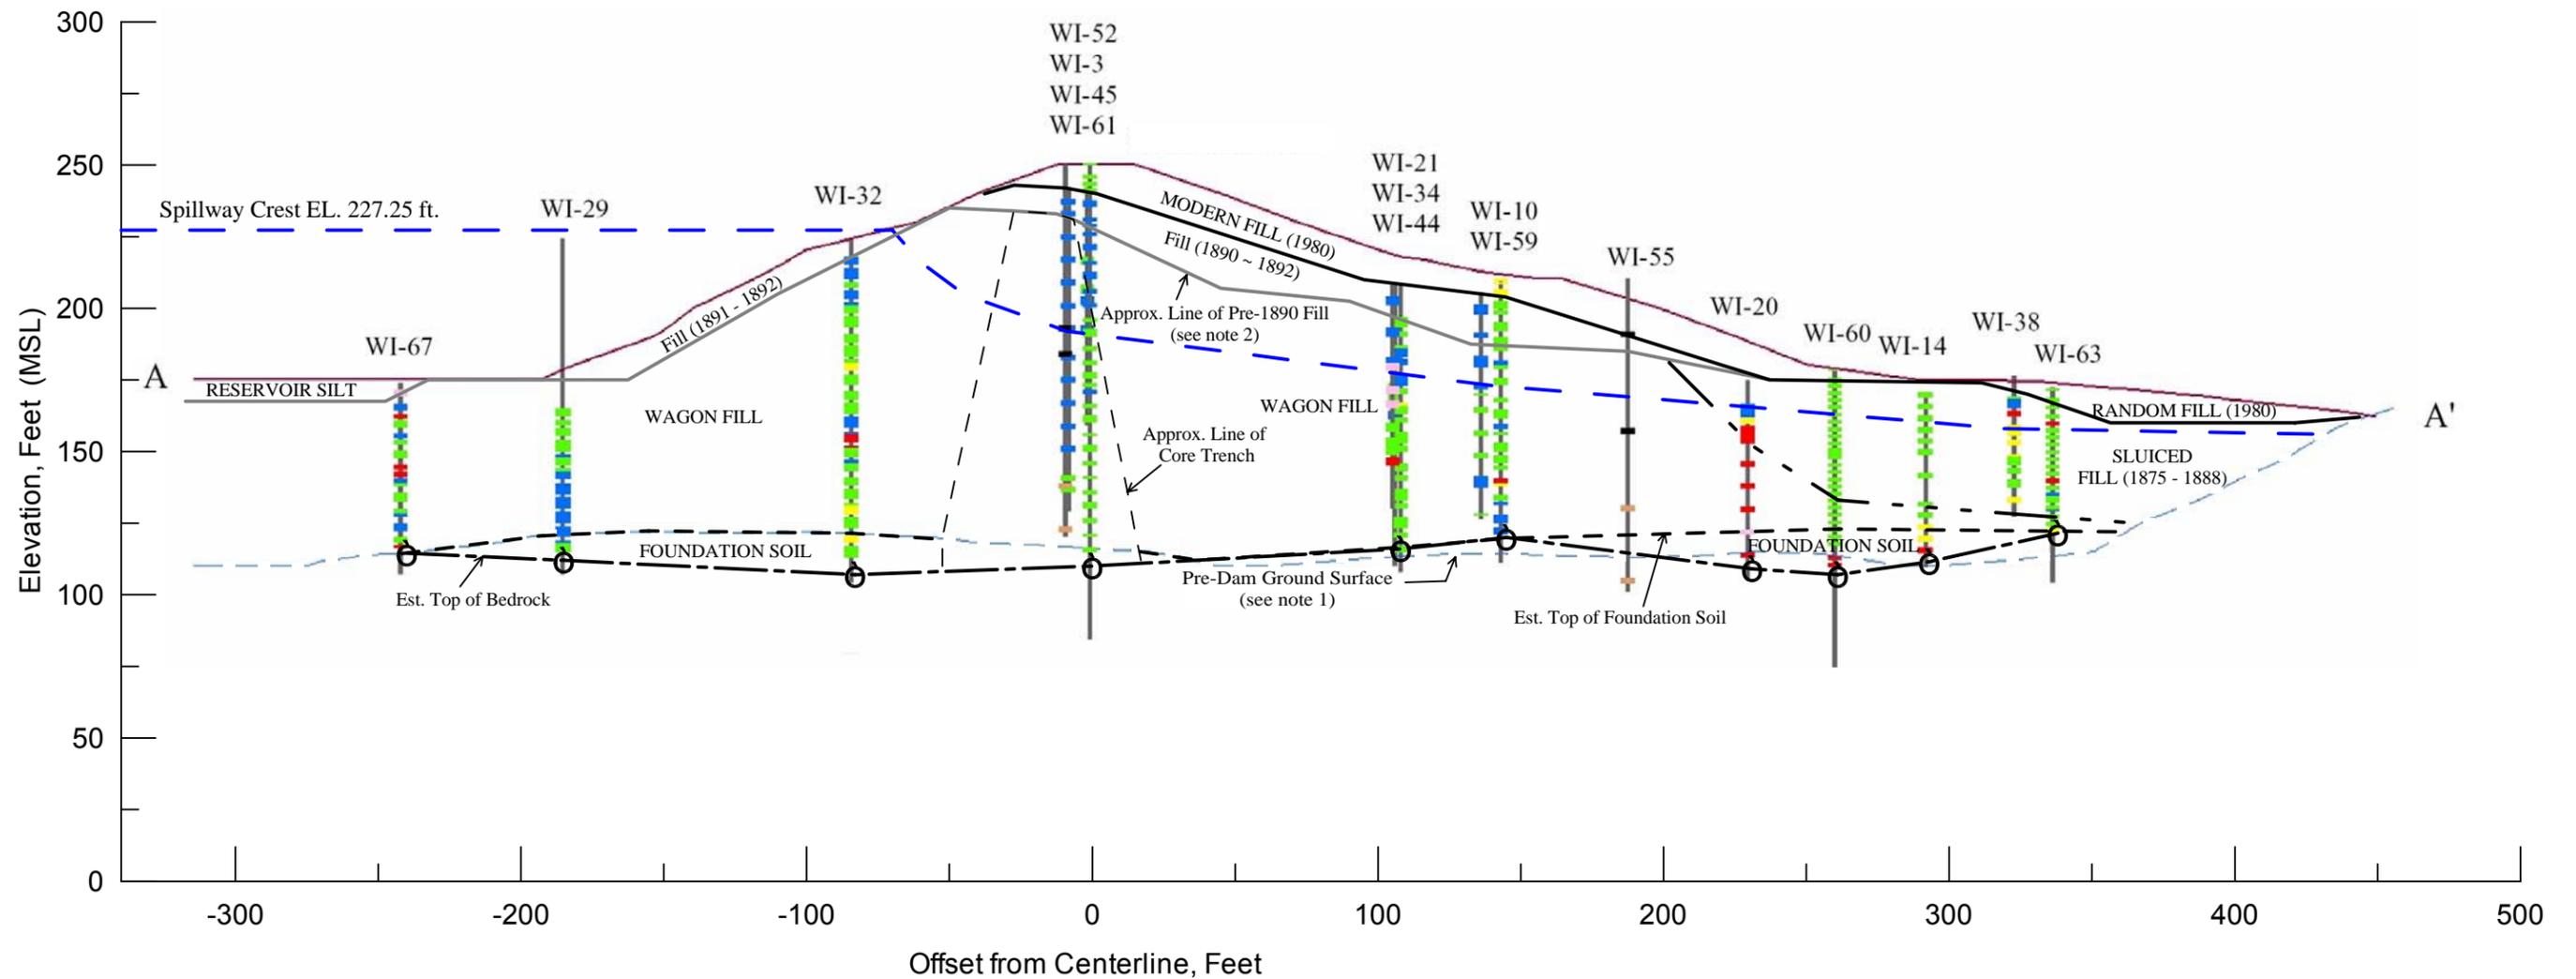
Project No. 26814536	Chabot Dam Seismic Stability	Cross Section A - A'	FIGURE 7-3
URS

In order to develop a model of the material zonation in the dam and foundation, three interpretive cross-sections were prepared based on data from selected borings in the GIS model and on topographic data obtained at various times in the dam's history. These sections are shown in Figures 7-3, 7-4 and 7-5. Some zone boundaries cannot be located with certainty, for example the contact between the wagon fill and the sluiced fill in the downstream shell. As shown in Figure 7-3, boring WI-20 contains a significant portion of sandy and gravelly material that could potentially be sluiced fill. The interpretive sections shown in these figures present a best estimate of the zonation within the dam embankment and foundation. The uncertainty regarding the boundary between the sluiced fill and wagon fill is further discussed in Section 9.

As shown in Figures 7-3 and 7-4, the boring data suggest that clayey soils are in fact more predominant in the central portion of the wagon fill, at least in the upper part of the embankment above about Elevation 200. Thus, the wagon fill can be separated into three subzones, consisting of the upstream wagon fill, downstream wagon fill, and central wagon fill. However, the available data indicate that the overall material characteristics and engineering properties of the wagon fill are relatively similar from upstream to downstream.

Pockets of gravels and sands and silty sands were also occasionally found in the wagon fill. The log of boring WI-20 suggests that there is a zone of gravelly sands present near the downstream limit of the wagon fill (Figure 7-3). However, no laboratory gradations were obtained on the materials to confirm the field logs. Based on the material descriptions in the field logs, it is possible that this boring encountered the sluiced fill. It is also possible that the boring encountered a granular pocket within the wagon fill, given the high densities measured in the soil samples.

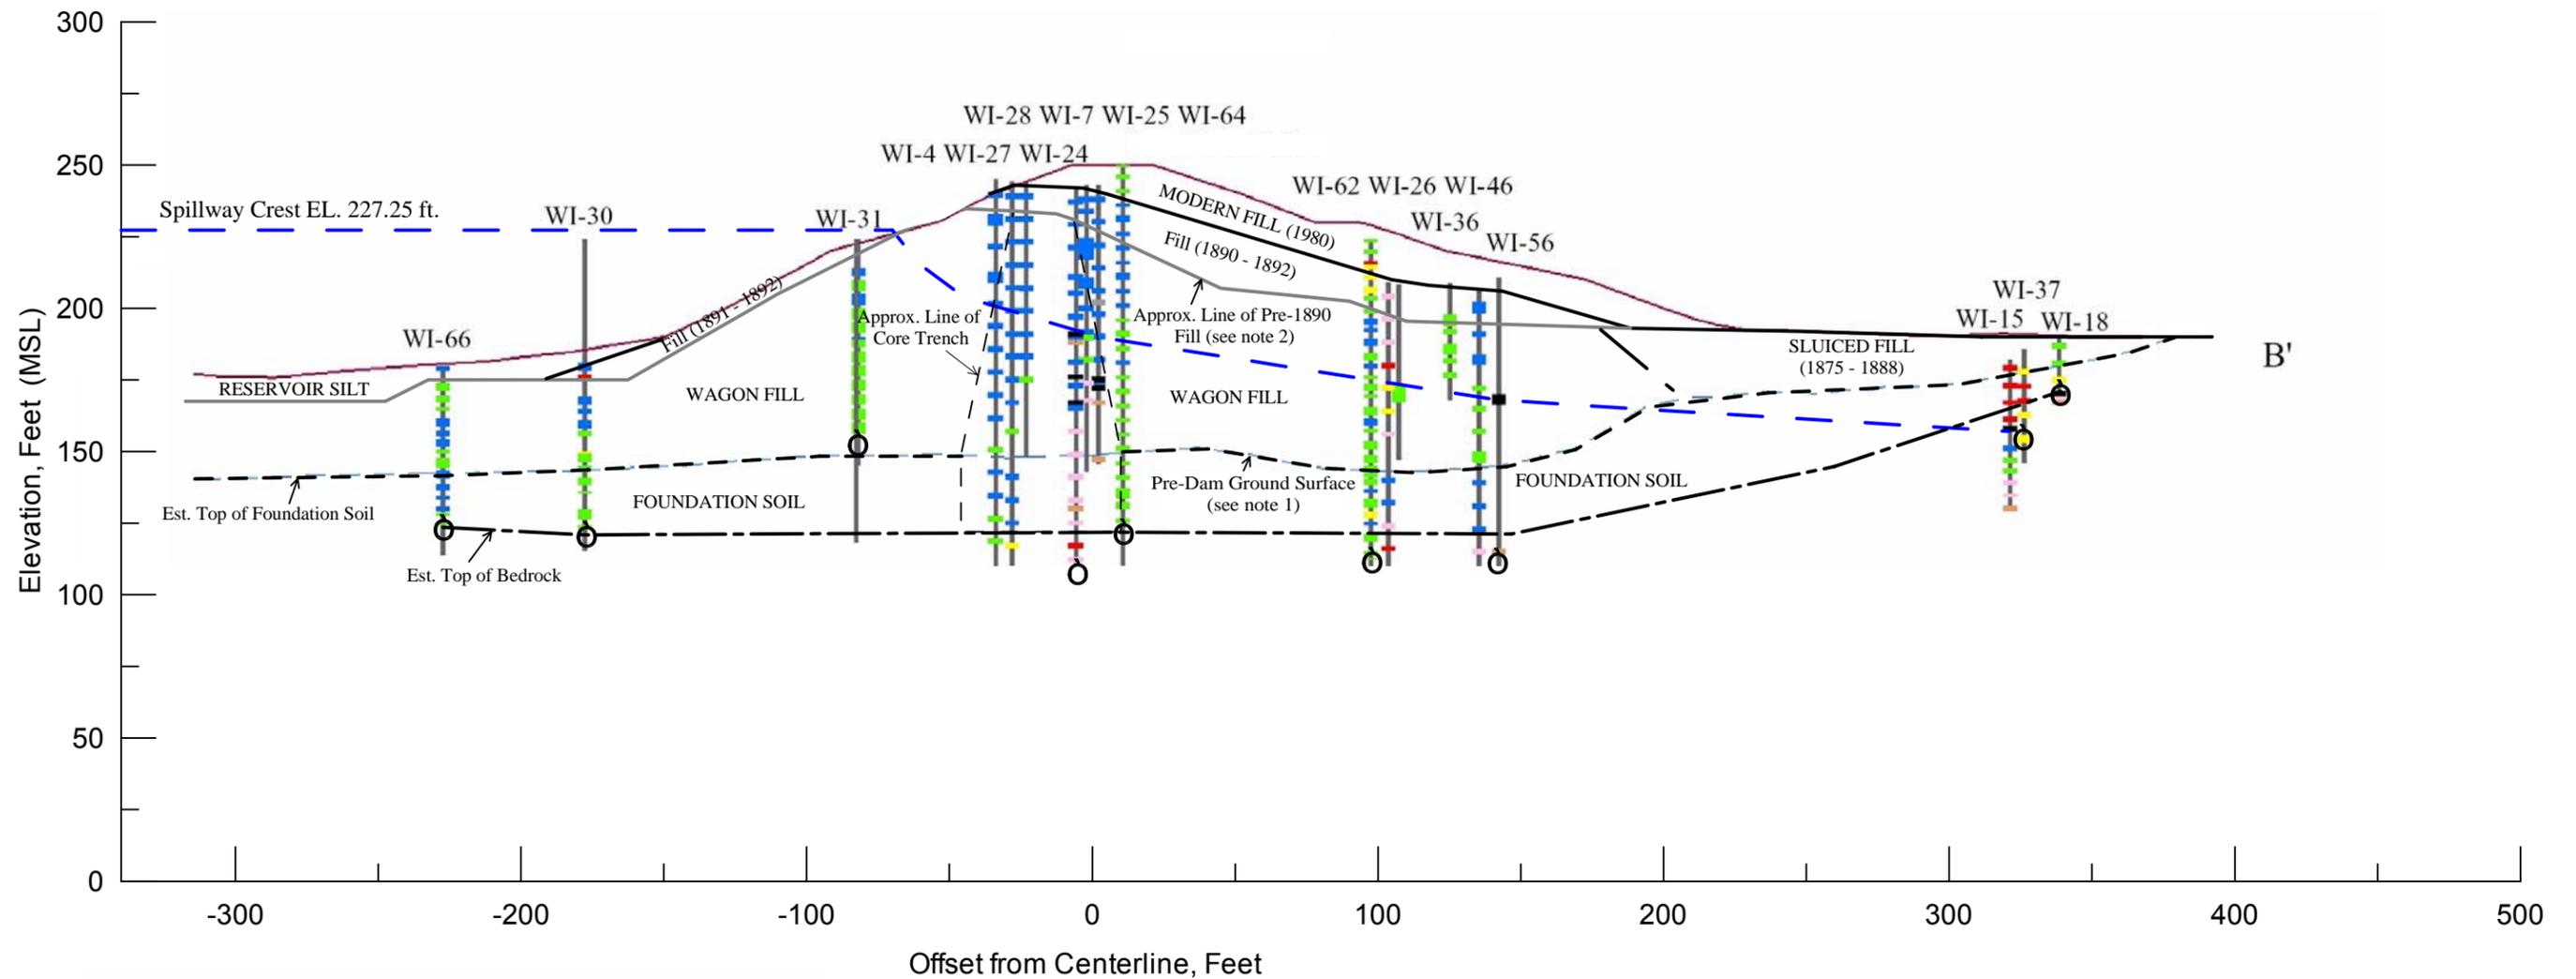
Project No. 26814536	Chabot Dam Seismic Stability	Cross Section B - B'	FIGURE 7-4
URS

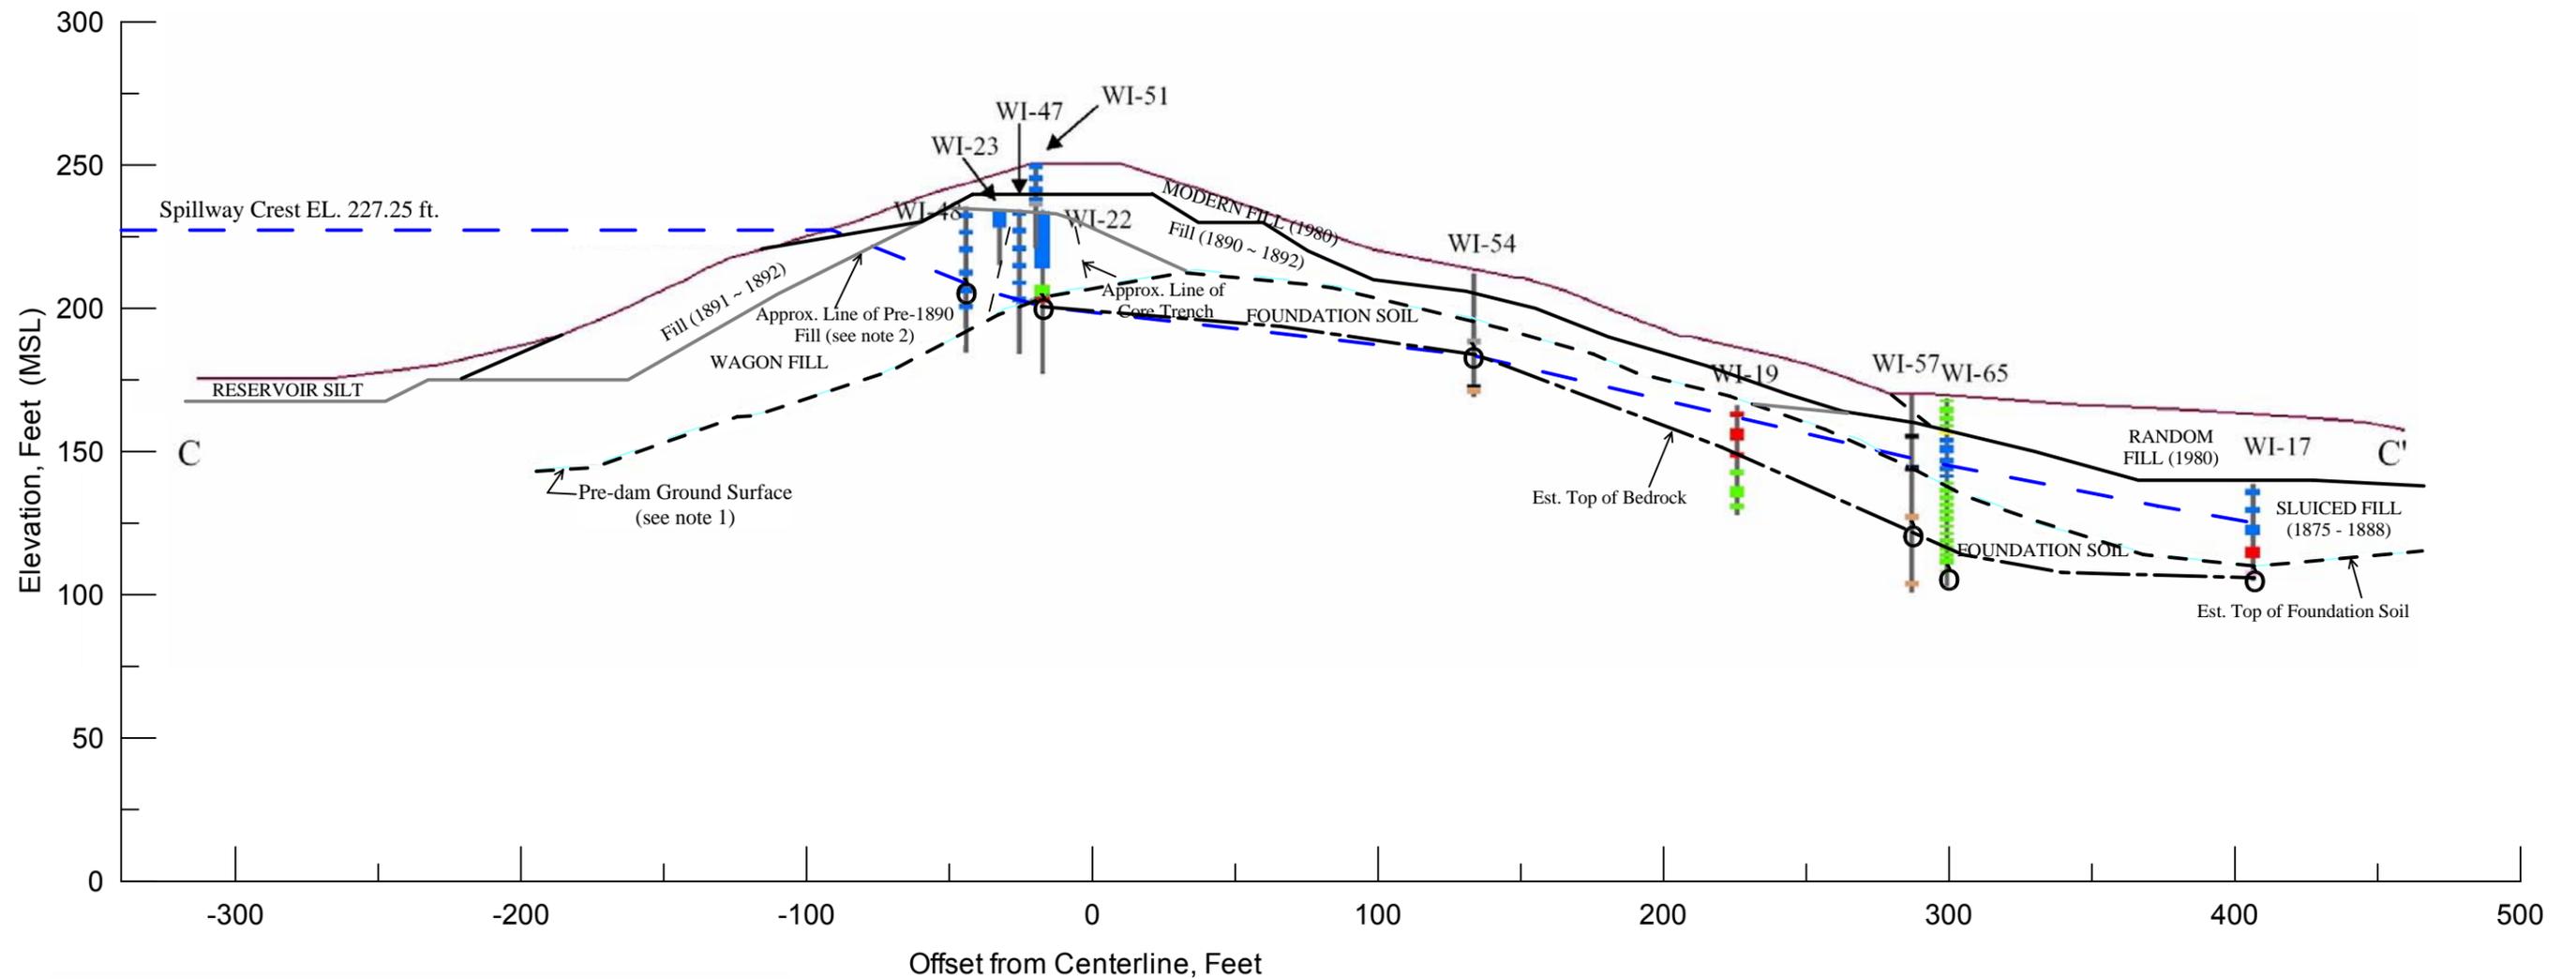
Project No. 26814536	Chabot Dam Seismic Stability	Cross Section C - C'	FIGURE 7-5
URS

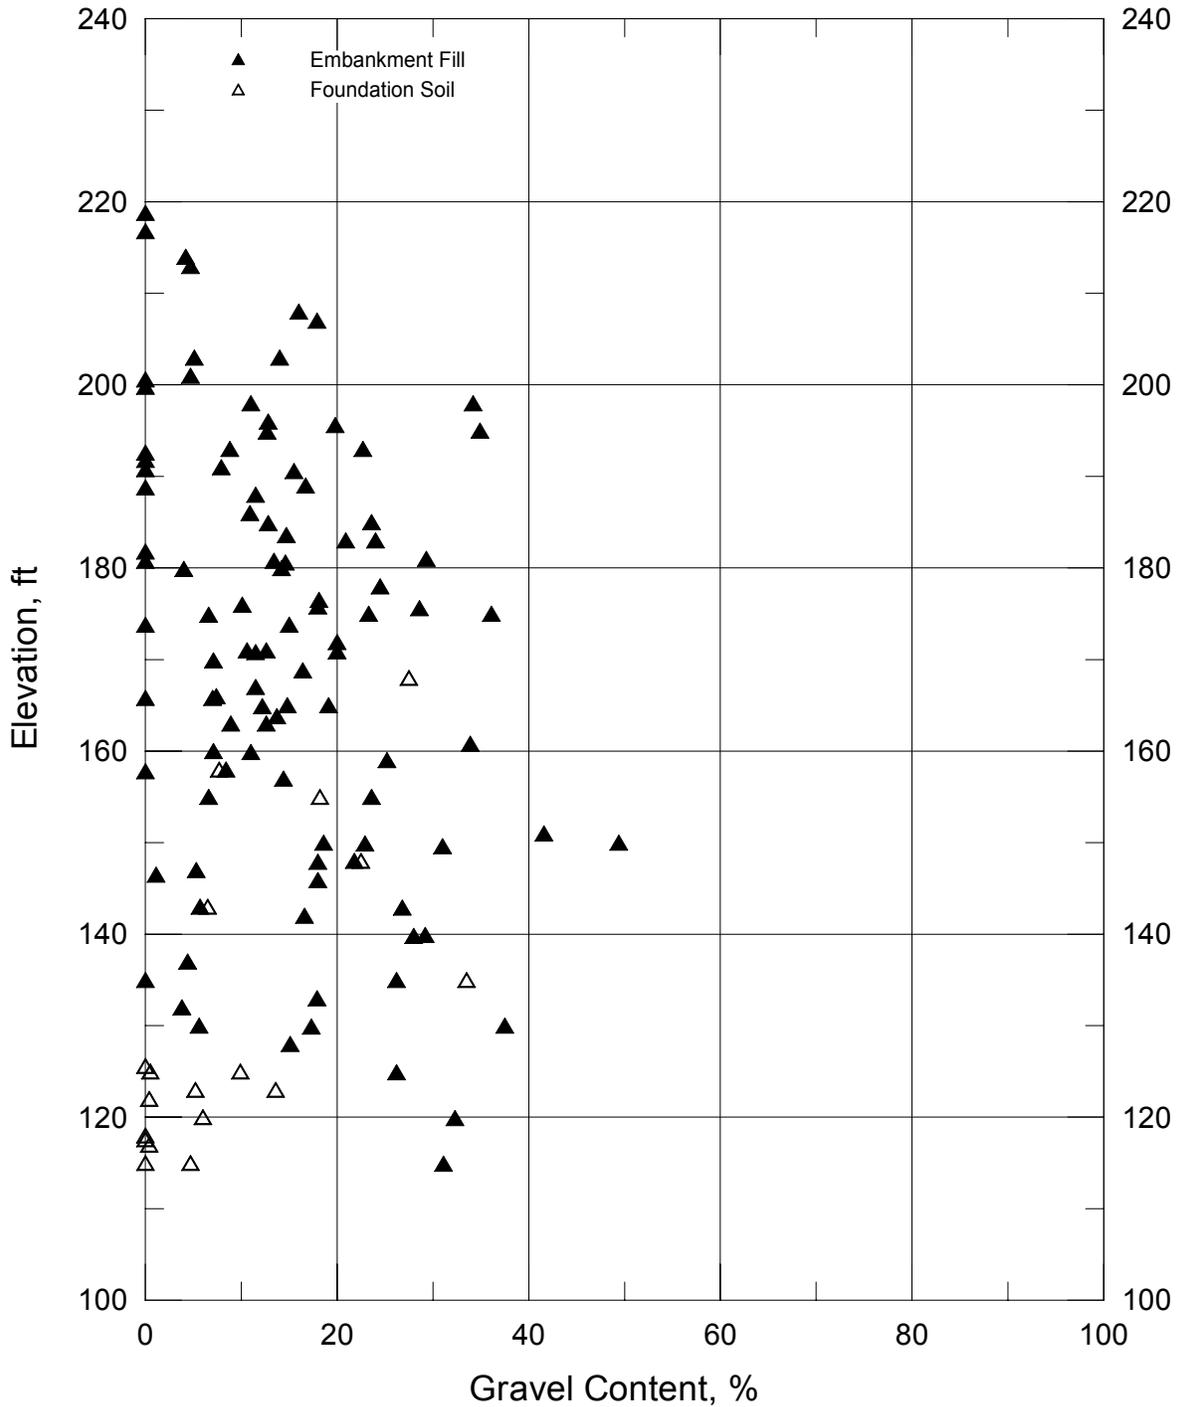
Figure
7-9

Chabot Dam - Gravel Content of Different Soil Types

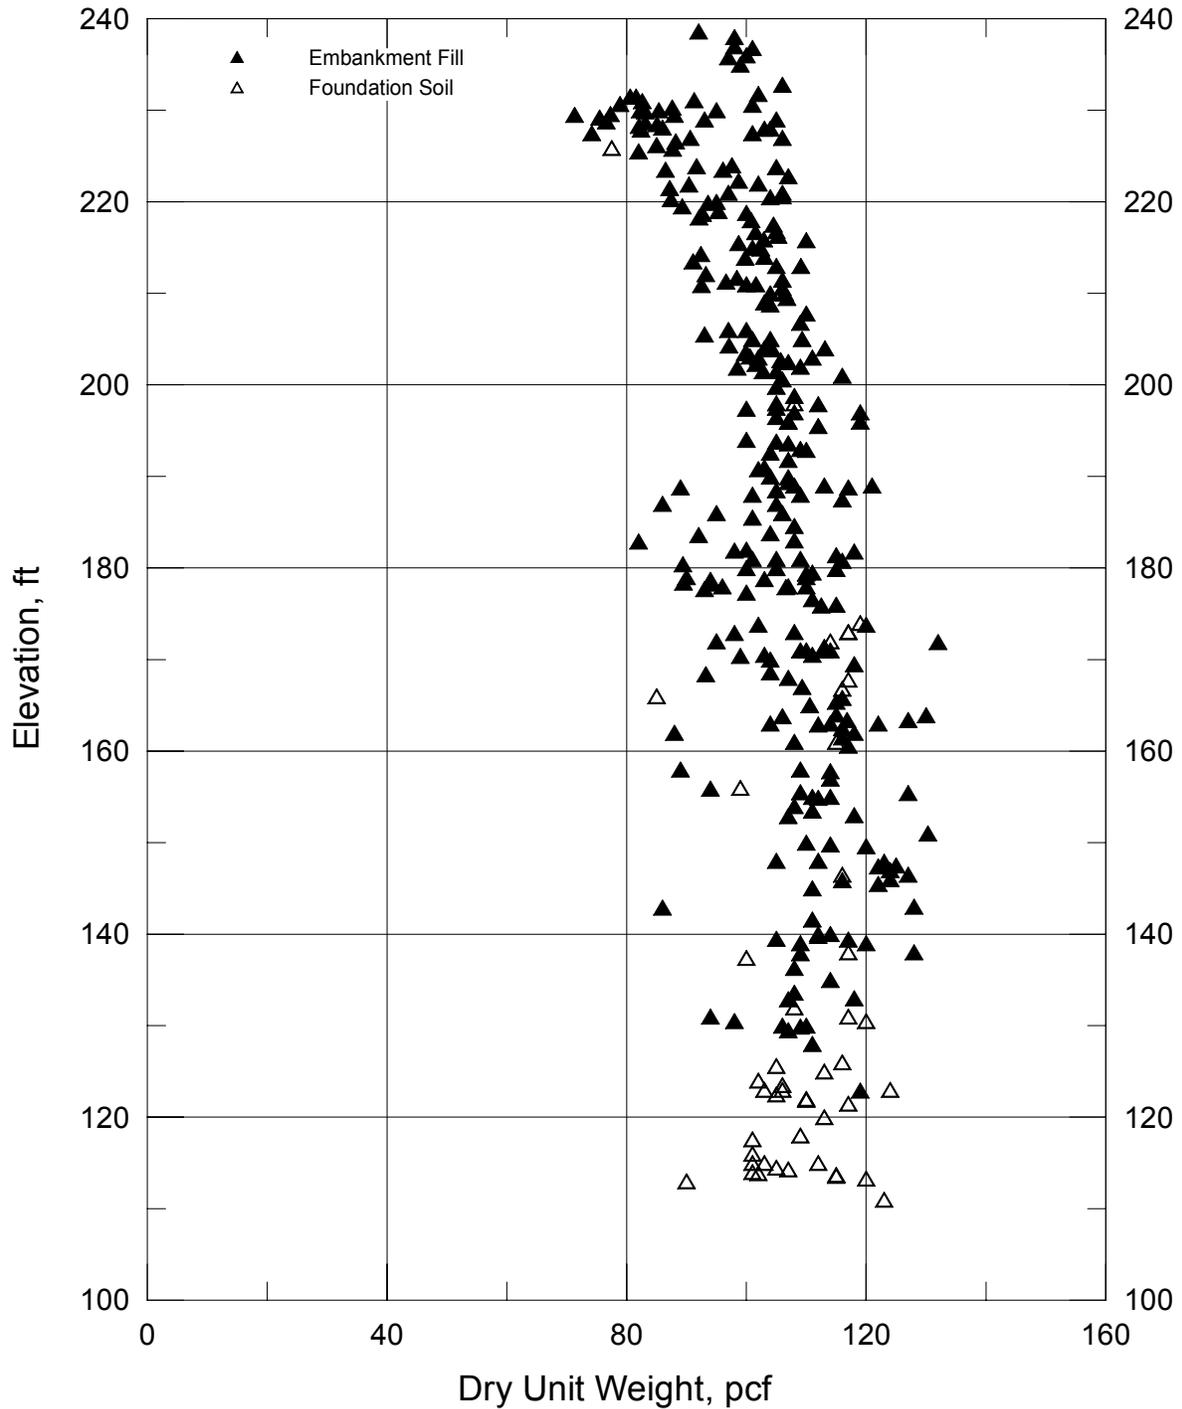
Figure
7-18

Chabot Dam - Dry Unit Weight of Different Soil Types

Figures 7-18 and 7-19 present dry unit weight data for the wagon fill materials from this and previous investigations, respectively. The data from the current investigation show a relatively uniform range of dry densities with elevation whereas the data from previous investigations show a wider range, a lower average, and a trend of decreasing dry density above Elevation 200. These differences are probably associated with the following factors: 1) the data from previous investigations includes a larger number of samples taken at higher elevations near the spillway where predominantly clayey materials were placed at higher water contents, and 2) the data from previous investigations were mainly from 2-inch diameter samples while the data from the current investigation came from 2.8-inch and 2.5-inch diameter samples, which have less disturbance. Similar trends are illustrated in Figures 7-20 and 21, which present moisture content data. An apparent higher average moisture content above Elevation 200 is visible by comparing the data from previous investigations with the current investigation data. Figure 7-22 shows that the total unit weight of the wagon fill materials ranges between about 120 and 145 pounds per cubic foot (pcf) and is relatively uniform with elevation.

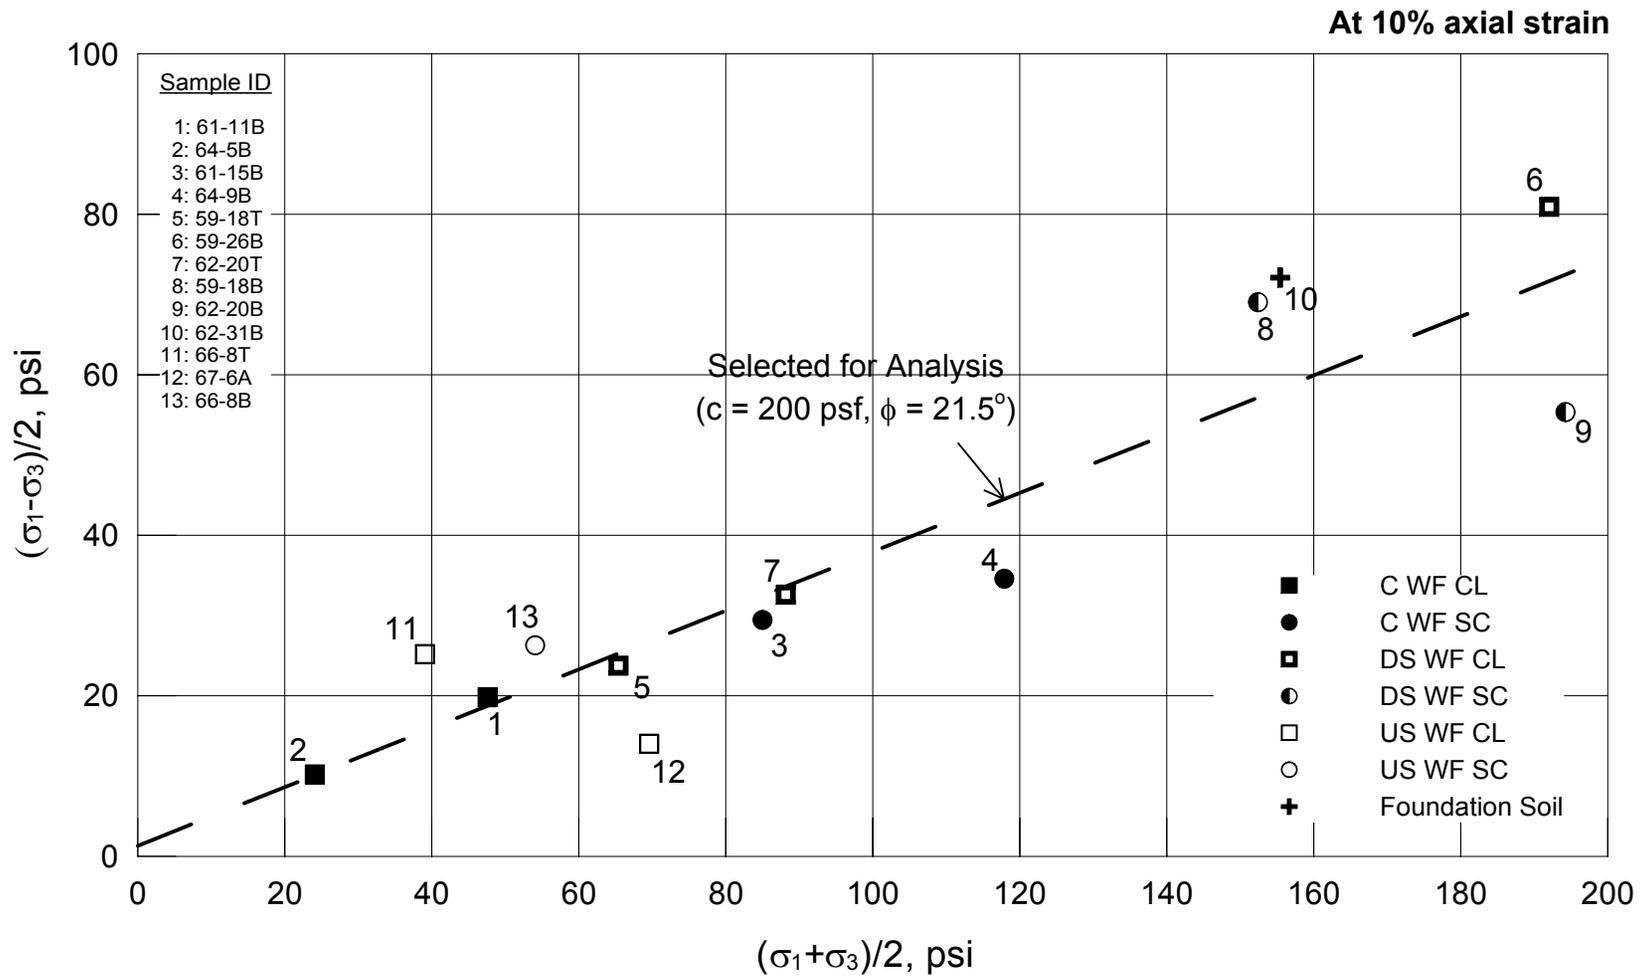
Project No. 26814536	Chabot Dam Seismic Stability	Wagon Fill Total Shear Strength from ICU Triaxial Compression Tests	Figure 7-24
URS

The results of the tests in terms of total stress-path parameters are shown in Figure 7-24. Again, the data supports using the same total strength parameters for the central, upstream, and downstream portions of the wagon fill. The test results can be represented by a total friction angle of 21.5° and a cohesion intercept of 200 pounds per square foot (psf).

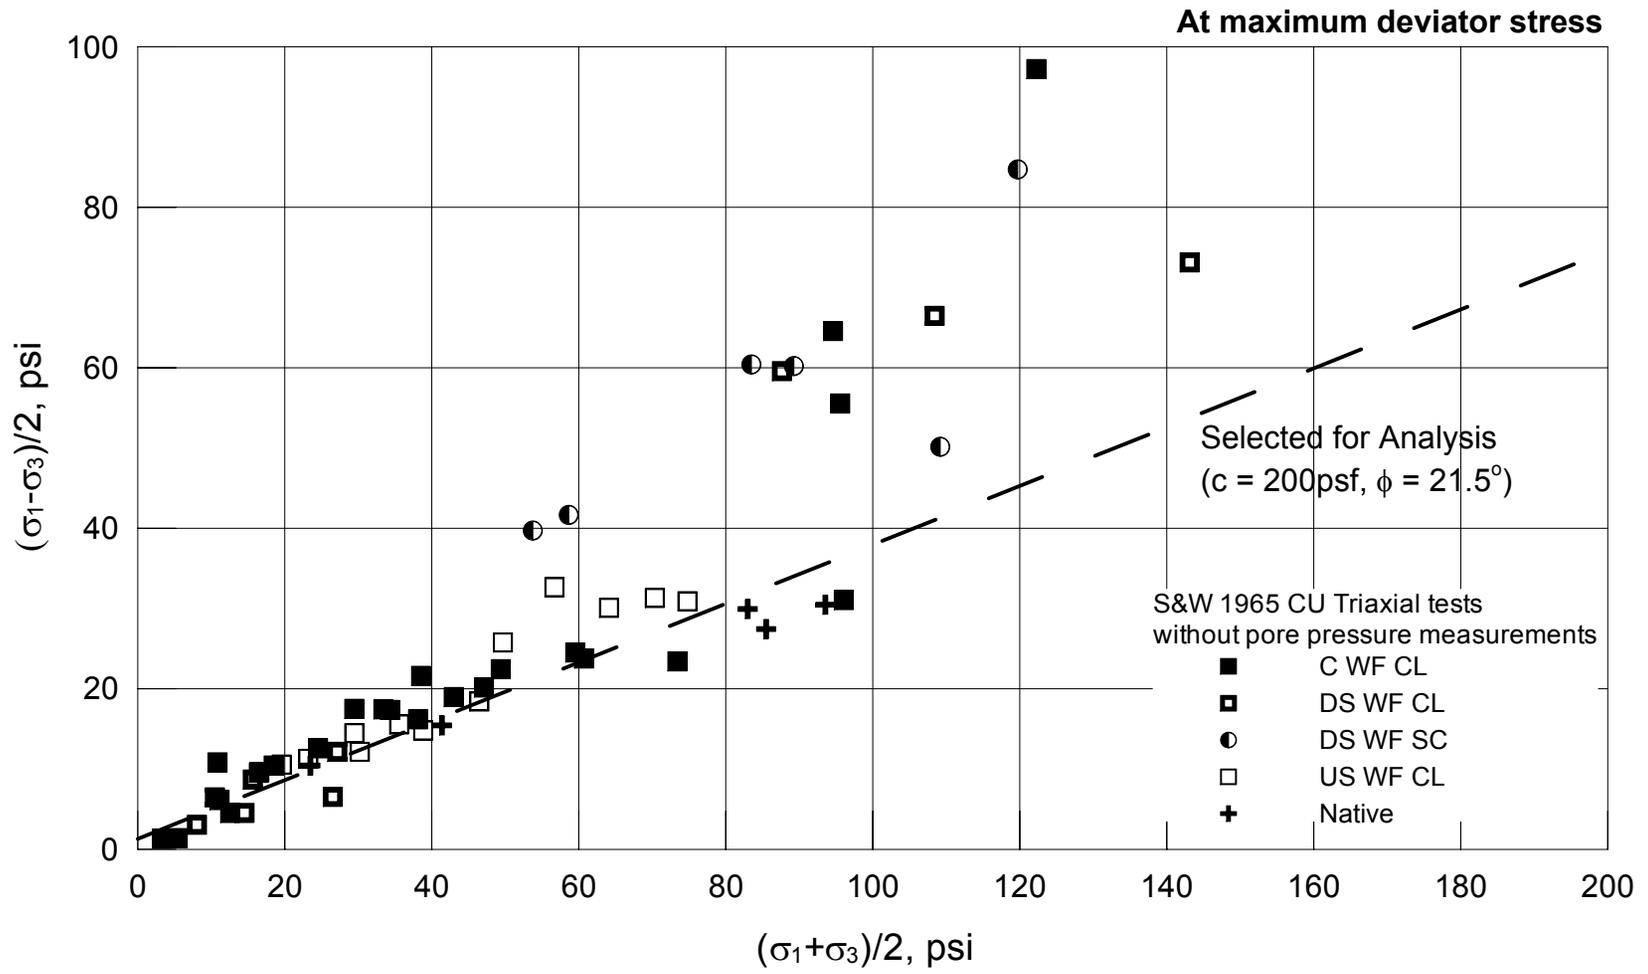
Project No. 26814536	Chabot Dam Seismic Stability	Wagon Fill Total Shear Strength from S&W CU Triaxial Compression Tests on Modified California Samples	Figure 7-27
URS

only be interpreted in terms of total stresses because of the lack of pore pressure measurements. Nonetheless, the results of these tests are compared in Figure 7-27 with the representative total strength parameters selected based on the current tests. As shown, the selected total strength parameters fit reasonably well with the data for most of the CL samples tested, especially at lower confining pressures.
