FINAL REPORT
VOLUME 1: MAIN REPORT
October 2005

DYNAMIC STABILITY ANALYSIS OF CHABOT DAM

Alameda County, California

**Subject: Dynamic Stability of Chabot Dam
Final Engineering Report**

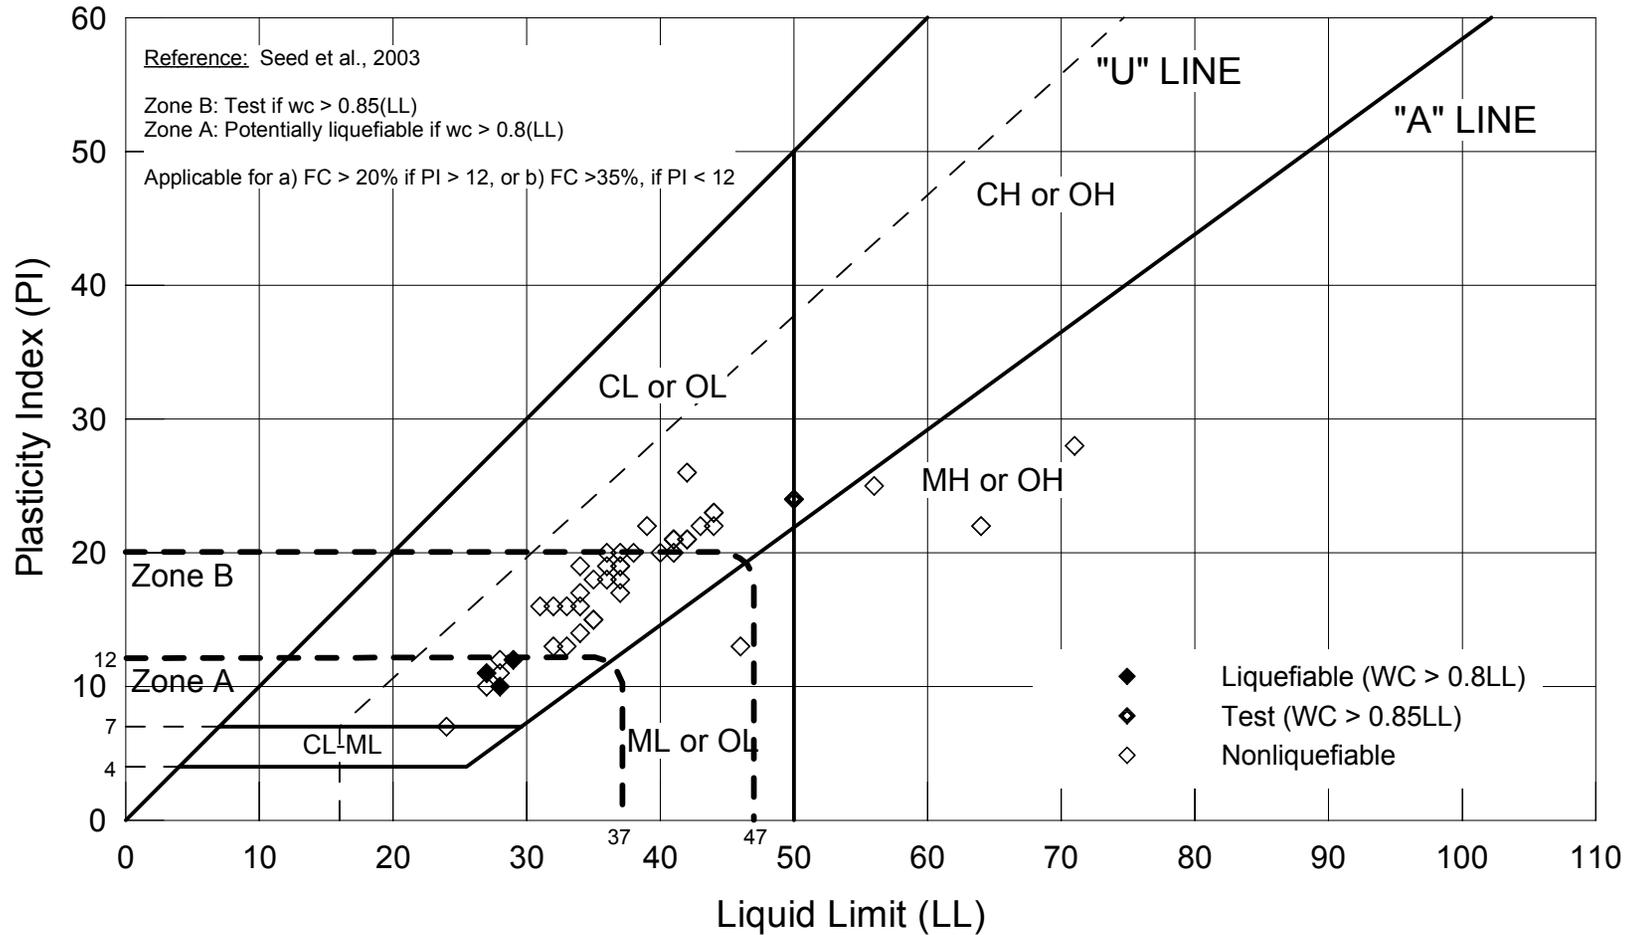
Project No. 26814536	Chabot Dam Seismic Stability	Liquefaction Susceptibility Chart WI-59, 61, 62, 64, 66 and 67 Wagon Fill Zone	Figure 7-28
URS

As shown in Figure 7-28, the bulk of the sandy clays and clayey sands in the wagon fill are not susceptible to liquefaction, based on comparison of the water content and the liquid limit. On average, the water content of the materials (15 to 25%) is significantly lower than the liquid limit (25 to 45%). Although some pockets of sands and silty sands are present, they are of limited extent and thus, will not affect the overall strength of the wagon fill zone significantly.

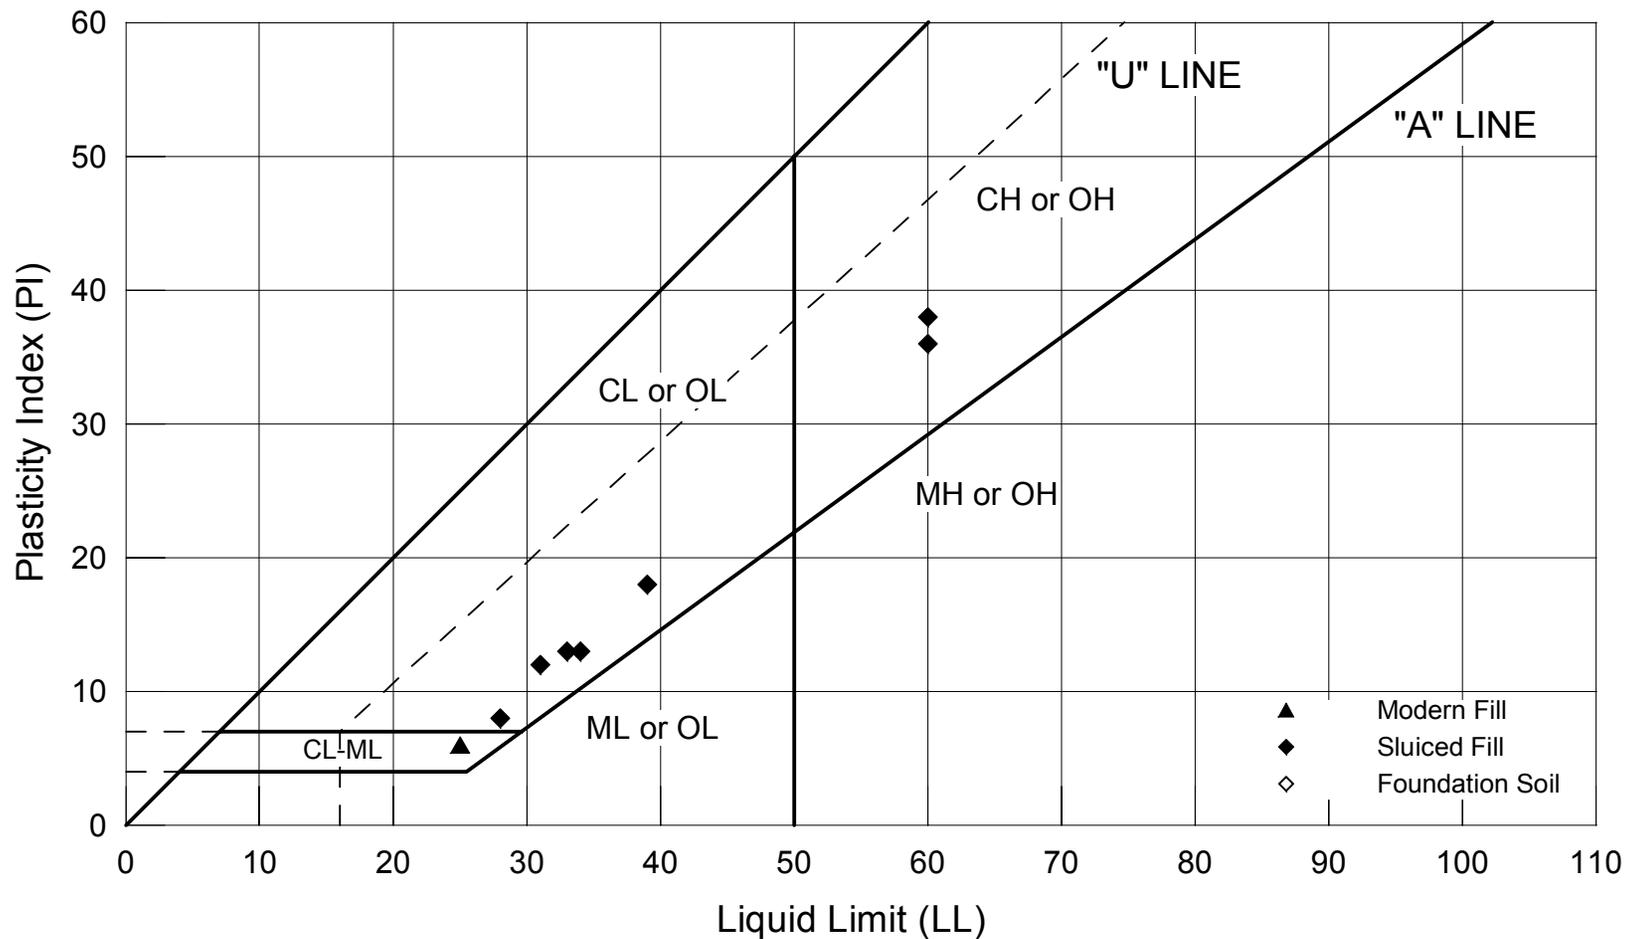
Project No. 26814536	Chabot Dam Seismic Stability	Plasticity from Borings WI-60, 63 and 65 Sluiced Fill Zone	Figure 7-34
URS

Figures 7-34 and 7-35 summarize the measured Atterberg limits of the fines fraction. In general, the data on the sluiced fill from this and previous investigations are consistent.

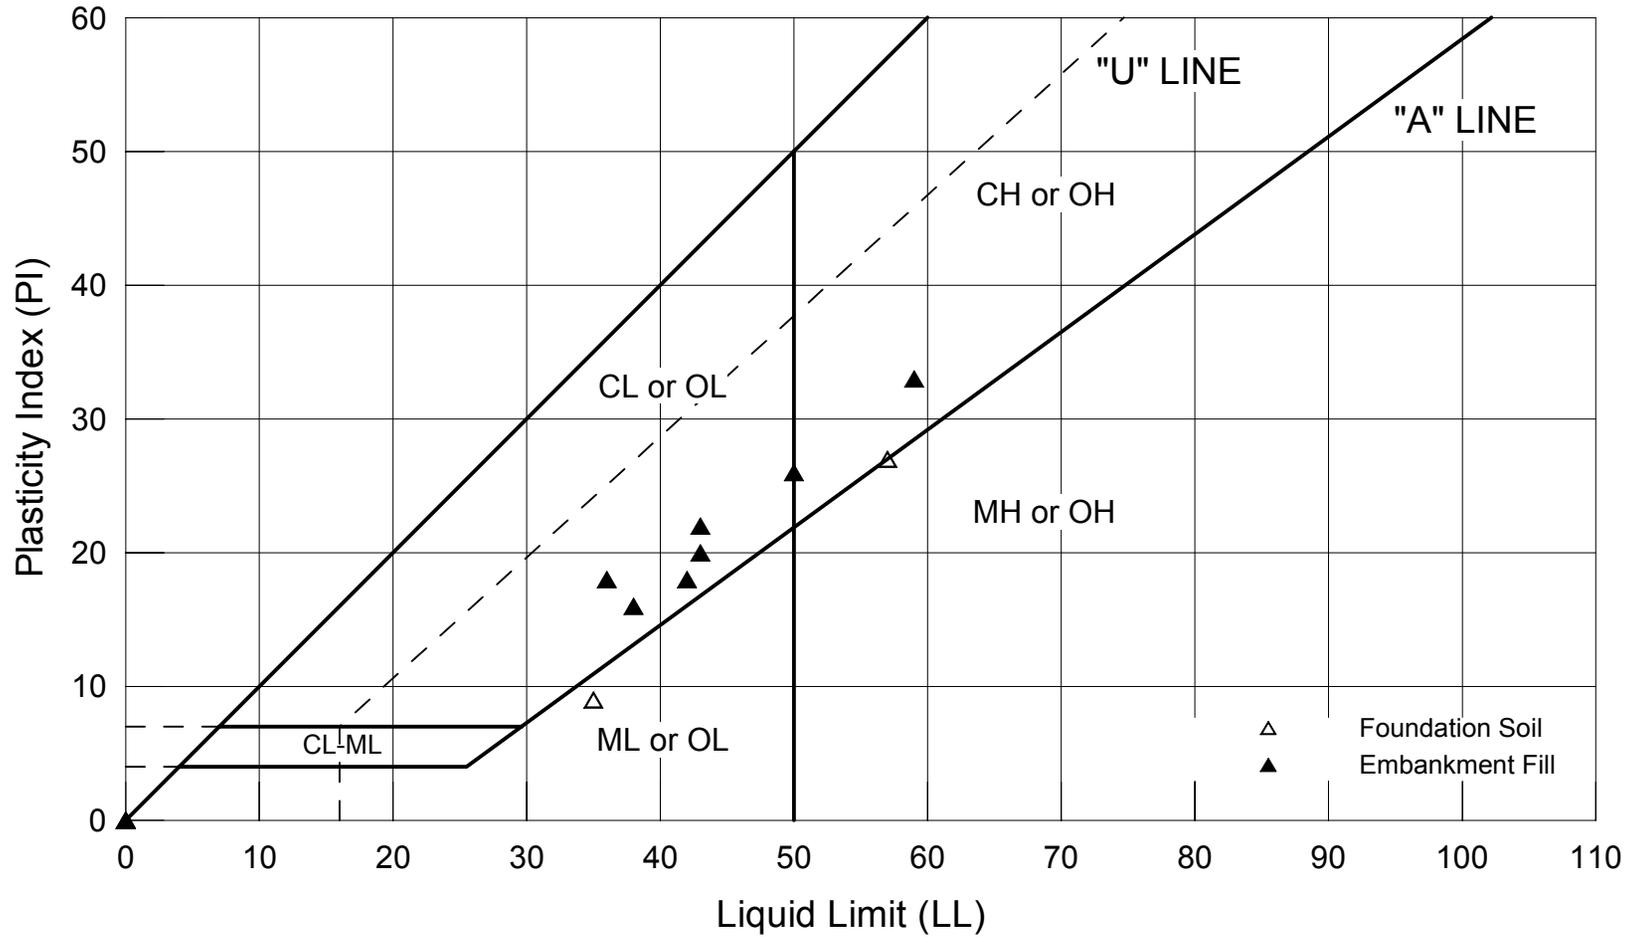
Project No. 26814536	Chabot Dam Seismic Stability	Plasticity from Previous Borings in Sluiced Fill Zone	Figure
URS			7-35

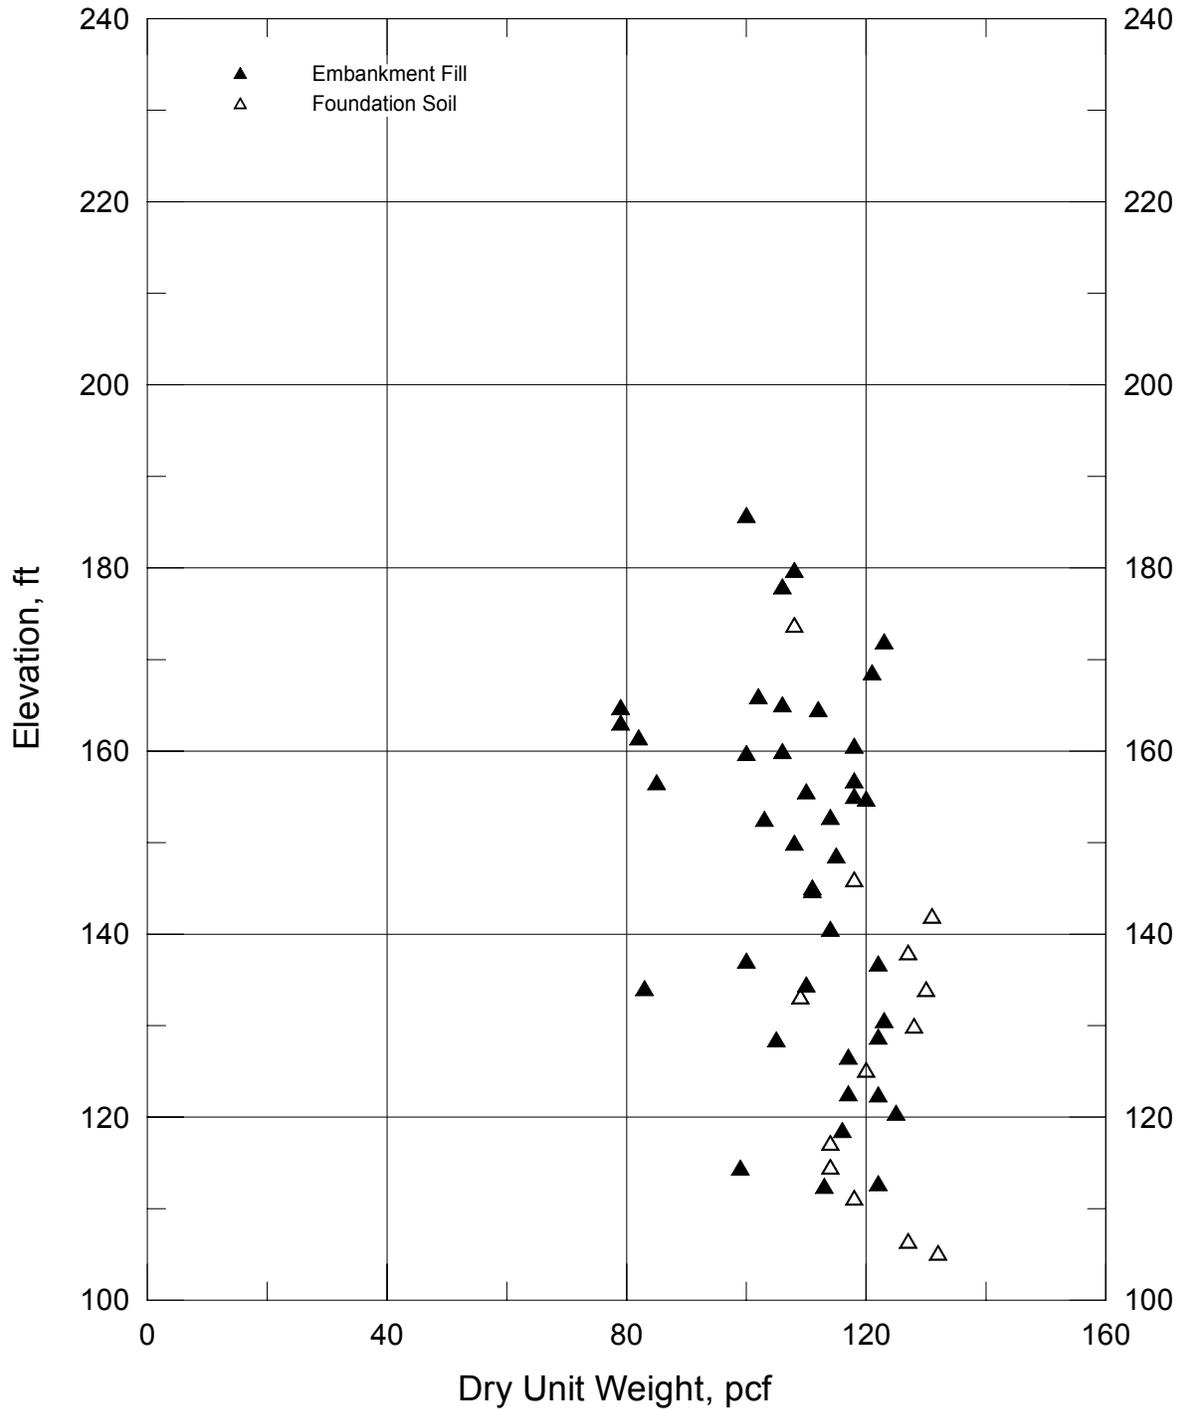
Figure
7-36

Chabot Dam - Dry Unit Weight of Different Soil Types

Few measurements of the sliced fill density and moisture content were performed for this investigation because of sample disturbance. Figures 7-36 and 7-37 summarize the dry unit weights and moisture contents measured in previous investigations. The corresponding total unit weights are shown in Figure 7-38. The dry unit weight of the sluiced fill generally ranges from about 100 to 125 pcf while the moisture content ranges from about 10 to 40% and the total unit weight ranges from about 110 to 145 pcf.

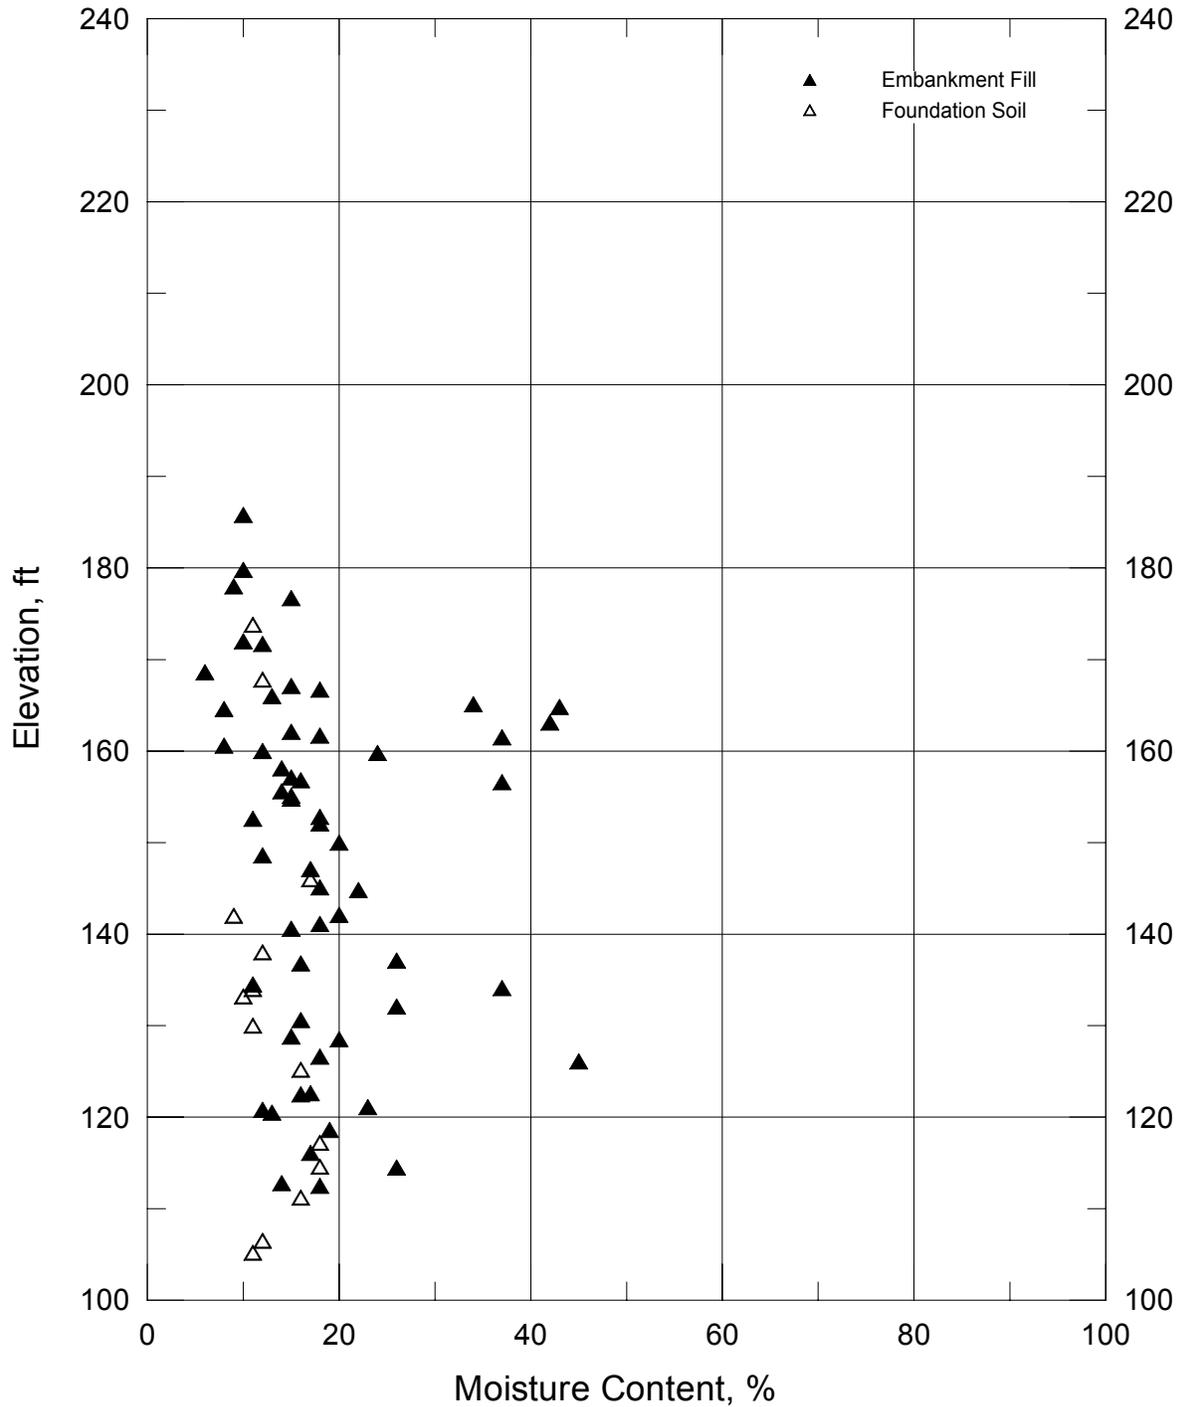
Figure
7-37

Chabot Dam - Moisture Content of Different Soil Types

**Moisture Content
From Previous Borings in Sluiced Fill Zone**

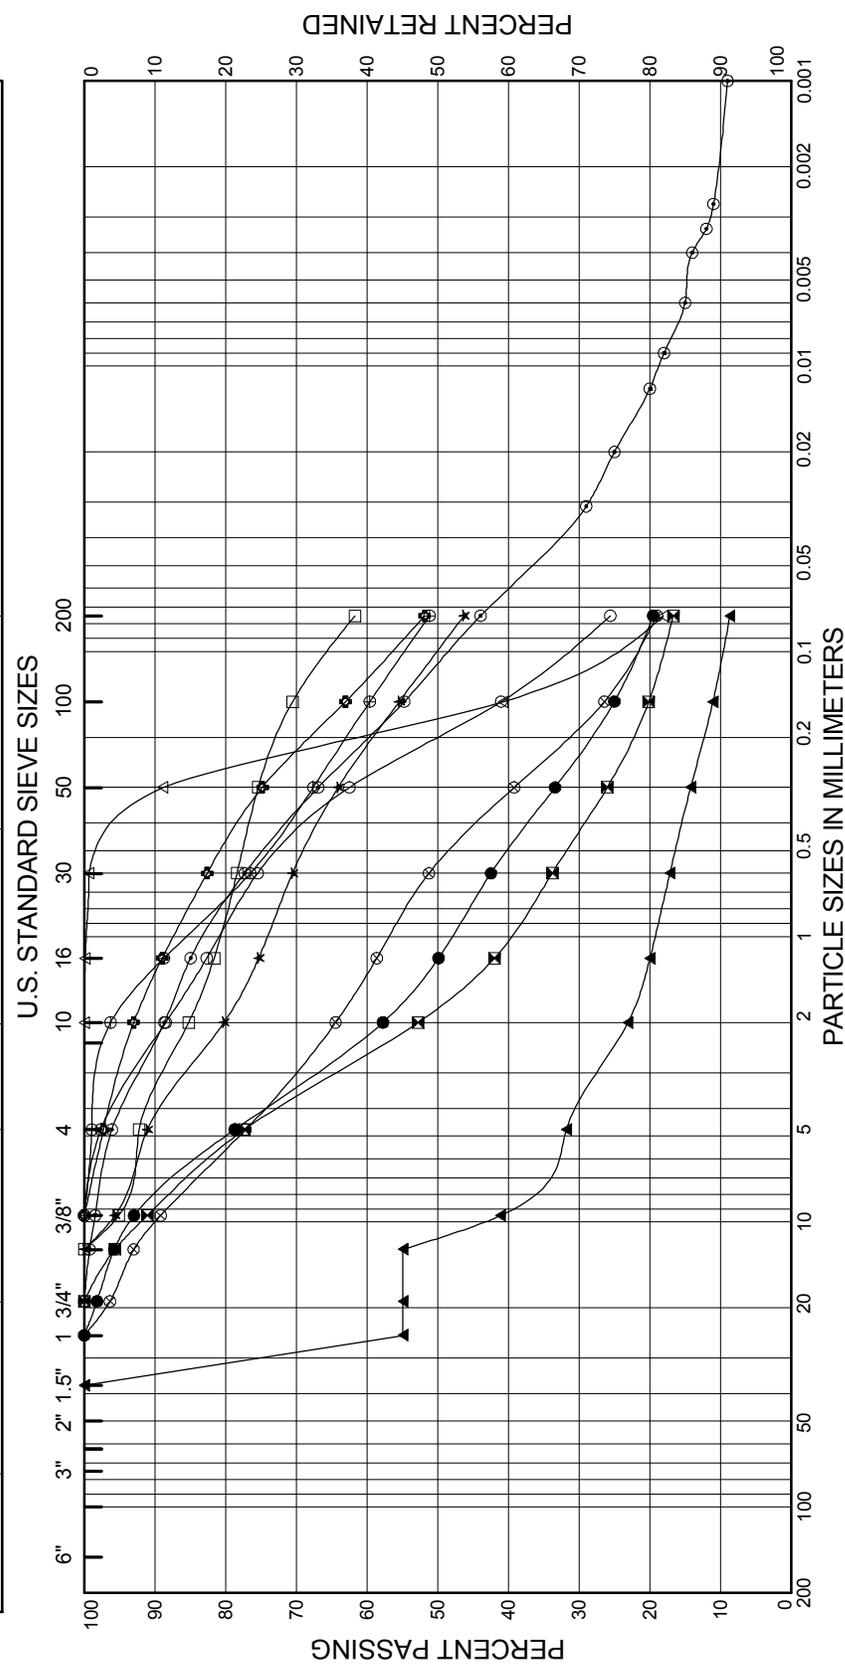
BORING NUMBER	DEPTH (FT)	SAMPLE NUMBER	SYMBOL	DESCRIPTION
WI-60	59.5-61	24	●	Clayey Sand with Gravel (SC)
WI-60	67.5-68.5	27B	⊠	Clayey Sand with Gravel (SC)
WI-60	69.5-71	28	▲	Poorly Graded Gravel with Clay (GP-GC)
WI-62	93.5-95	30	★	Clayey Sand (SC)
WI-62	97.5-100	31B	⊕	Silty Sand (SM)
WI-62	100-101.5	32	⊙	Sandy Clay (CL)
WI-62	105.5-107	34	○	Clayey Sand (SC)
WI-65	55-56.5	23	△	Clayey Sand (SC)
WI-65	57.5-59	25	⊗	Clayey Sand with Gravel (SC)
WI-66	39-40	16B	⊕	Sandy Clay (CL)
WI-66	46-47.5	18	□	Sandy Clay (CL)

GRADATION OF FOUNDATION SOIL

Figure 7-39 shows the gradations of samples of the foundation soils obtained during the current investigation. Comparison of this figure with Figures 7-6, 7-7, and 7-8 shows that the range of gradations of the foundation soils is very similar to that of the wagon fill materials. The laboratory test data from this and previous investigations indicate that other engineering characteristics of the foundation soils are also very similar to those of the wagon fill. This is shown in the plots of index and strength properties of the wagon fill, which also show results for the foundation soils (Figures 7-9 through 7-37). On this basis, the material properties of the foundation soils for analysis are assumed to be the same as those of the wagon fill.

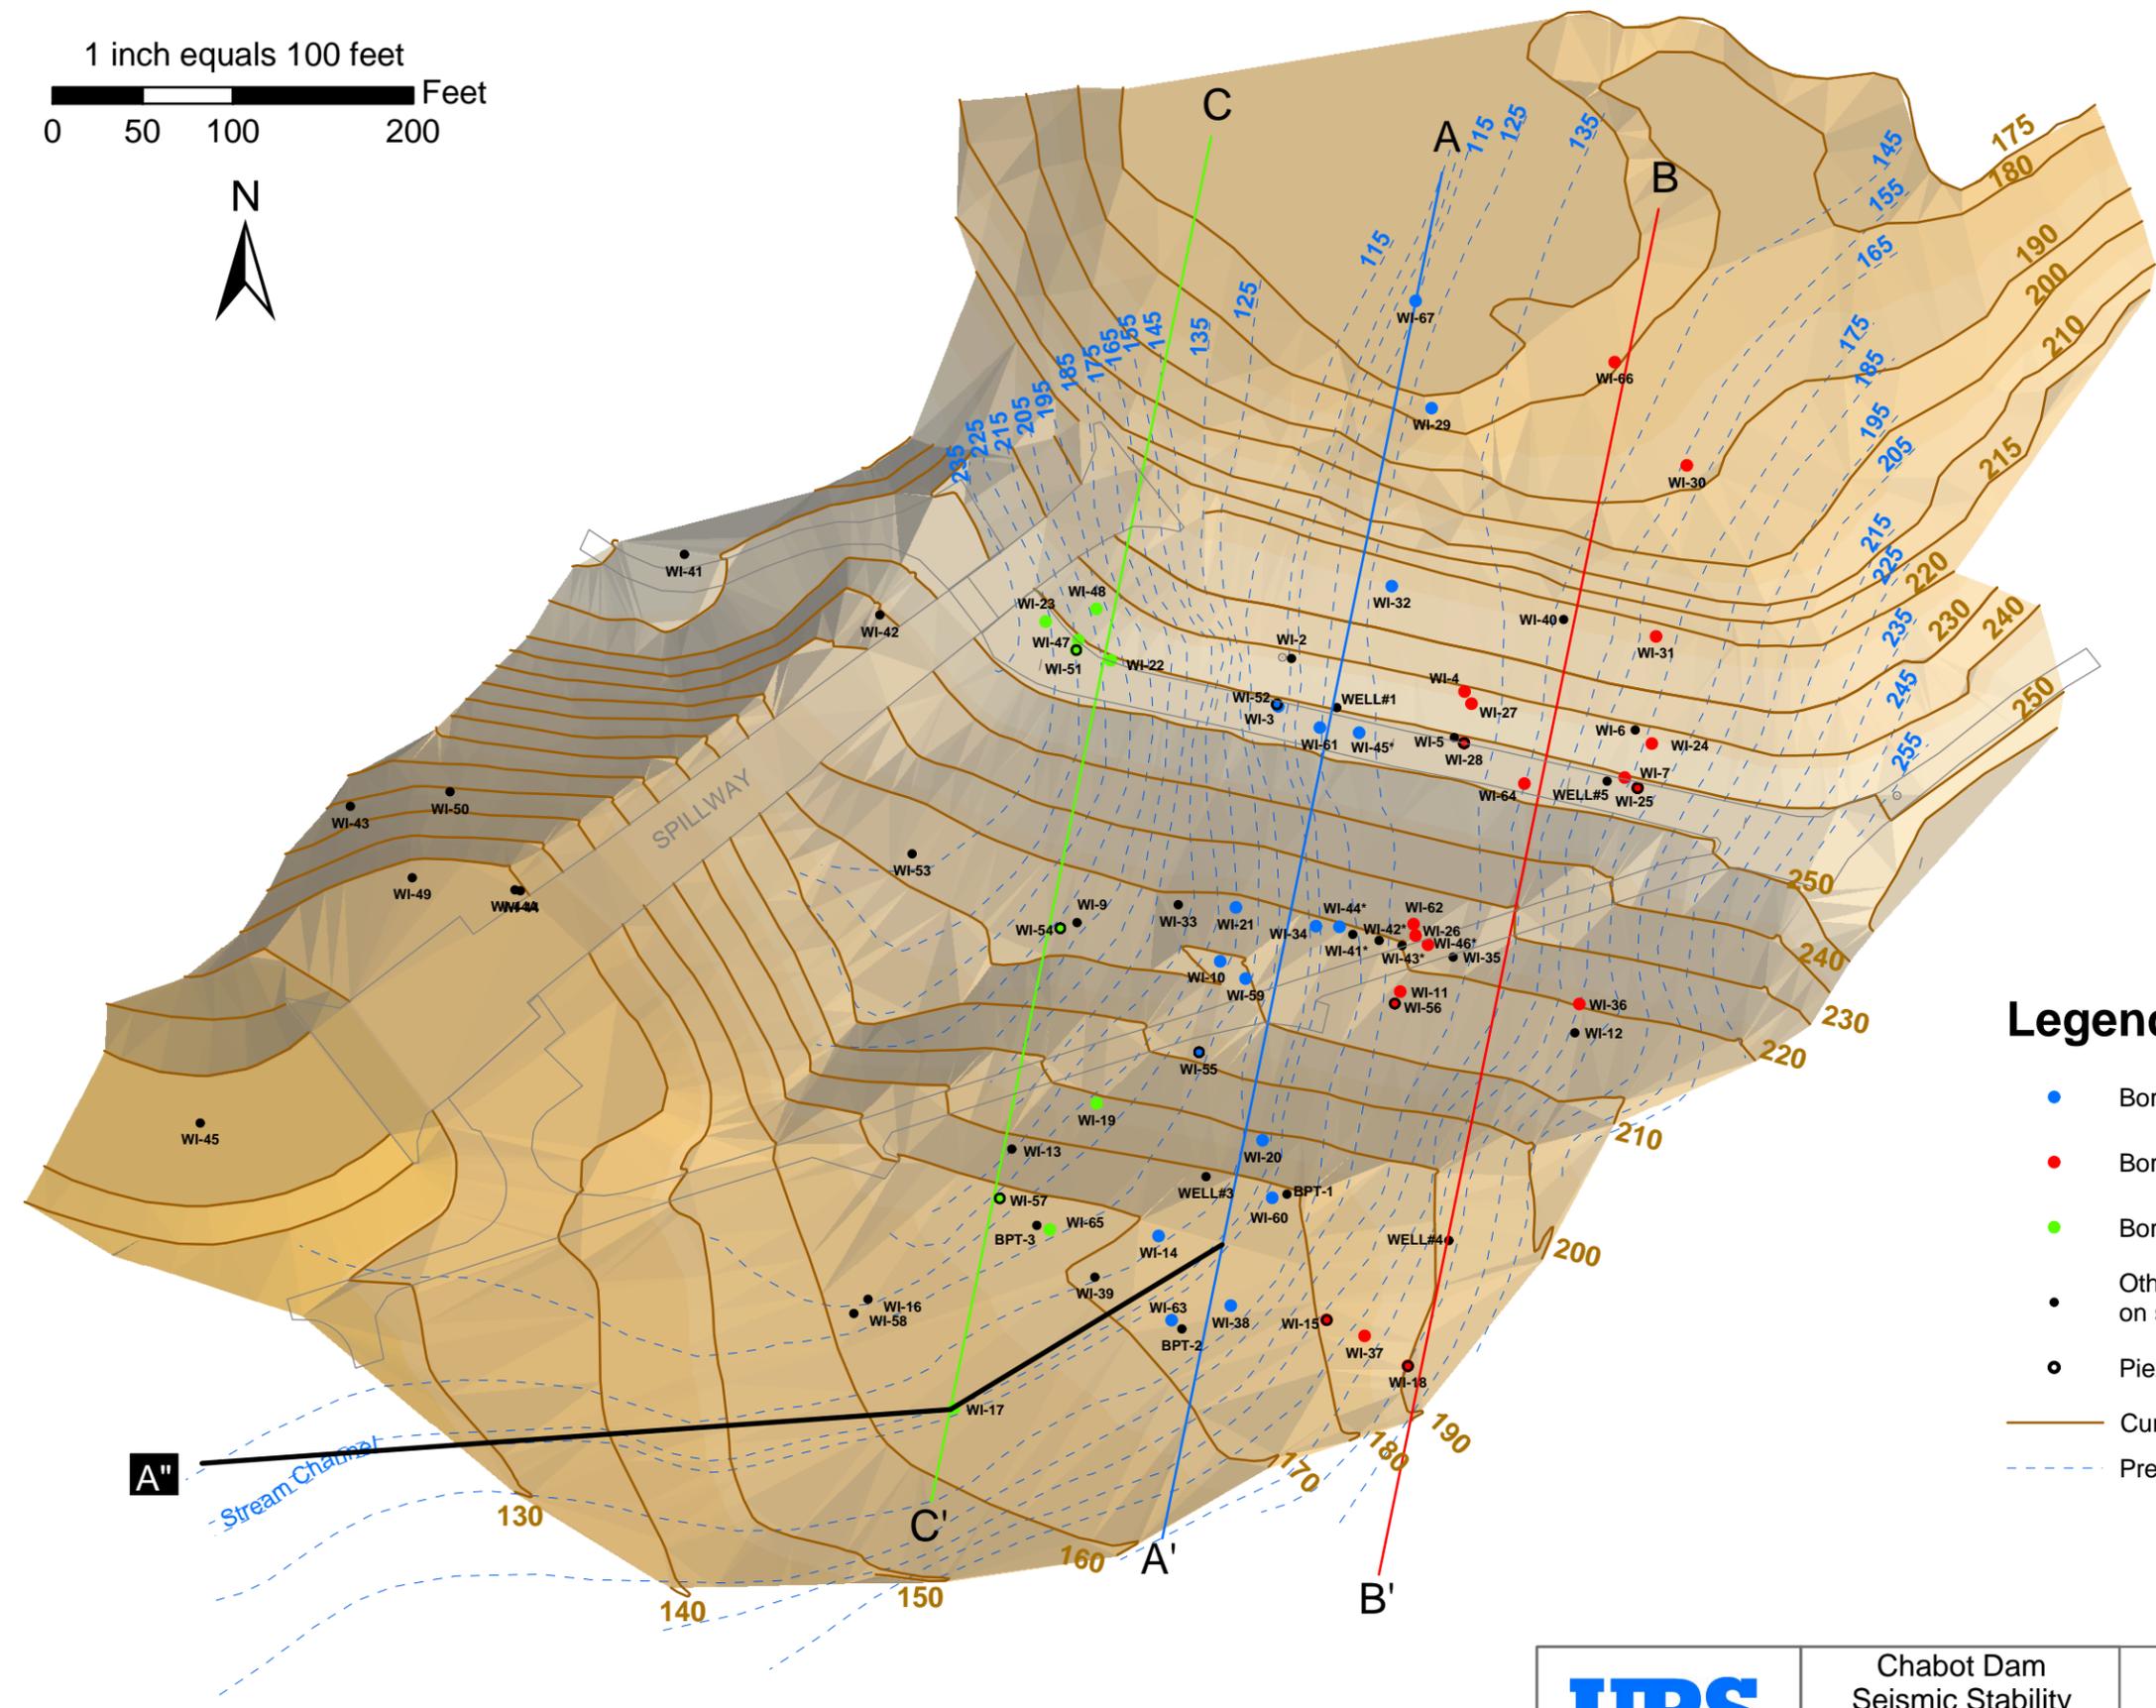
- Borings shown on Section A-A'
- Borings shown on Section B-B'
- Borings shown on Section C-C'
- Other borings, not shown on sections
- Piezometer
- Current ground surface contours (ft)
- - - Pre-dam ground surface contours (ft)

Chabot Dam Seismic Stability	Plan View of Dam and Analysis Cross-sections	Figure 9-1
	26814536

We performed analyses on two basic idealized cross-sections, labeled A-A' and B-B' in Figure 9-1. These sections are shown in Figures 9-2 and 9-3. They were developed based on the subsurface information shown in Figures 7-3 and 7-4. Modified versions of these sections were also analyzed to consider uncertainty in the geometry of some of the dam zones. A modified section A-A' is shown in Figure 9-4. This modification reflects uncertainty in the location of the boundary between the wagon fill and the sluiced fill (WF/SF boundary).

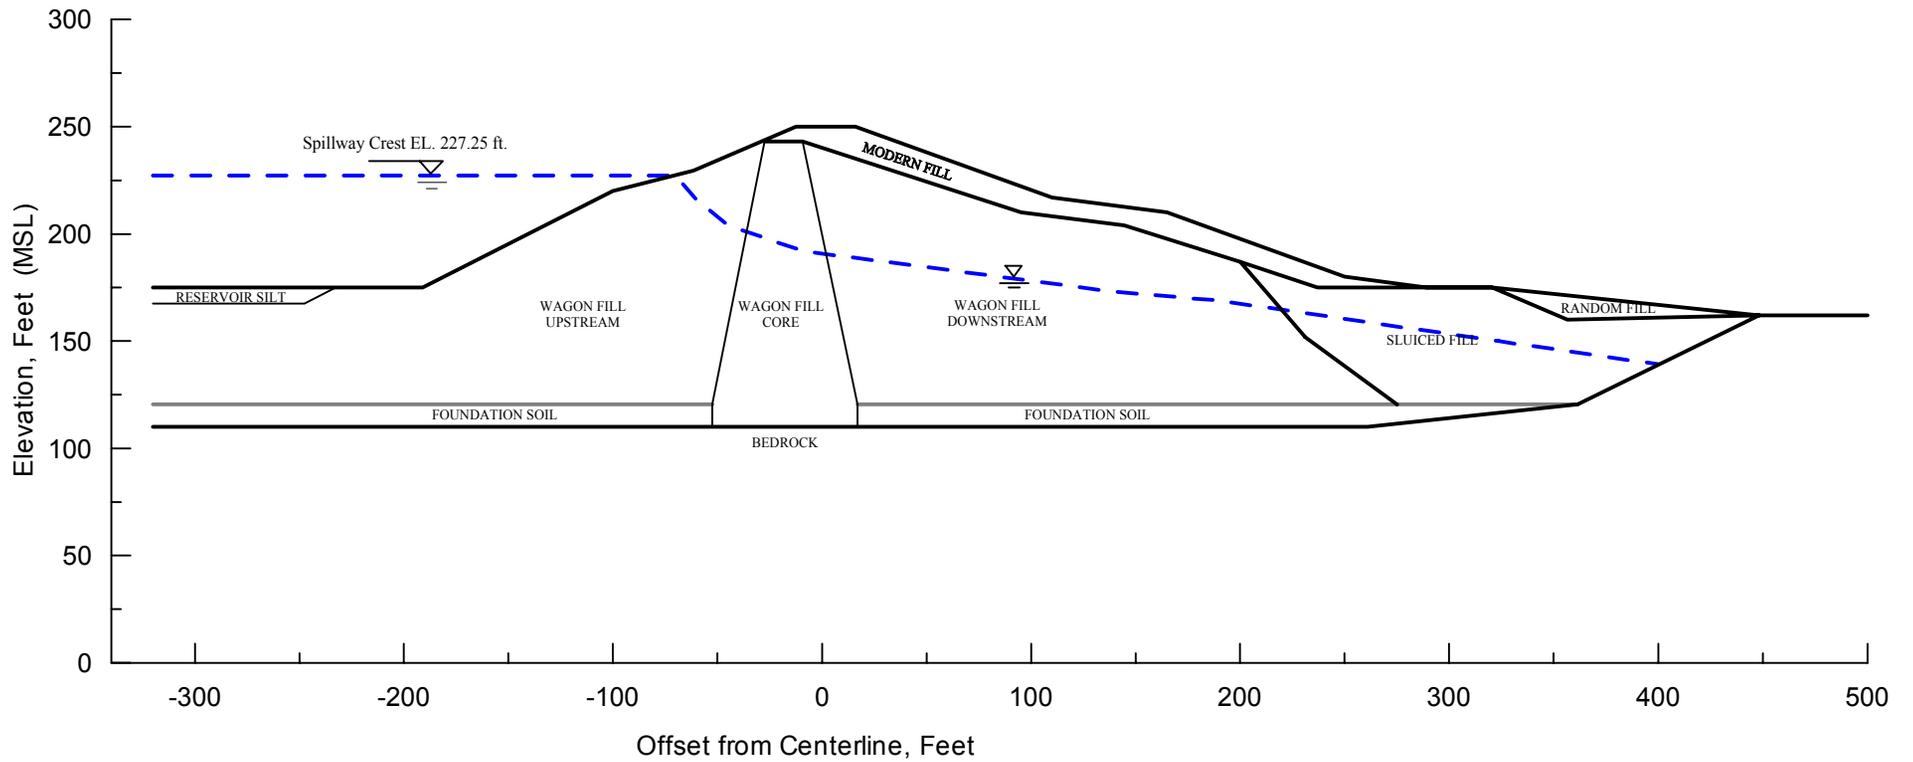
Project No. 26814536	Chabot Dam Seismic Stability Analysis	Idealized Cross Section A-A' for Stability Analysis	Figure 9-2
URS

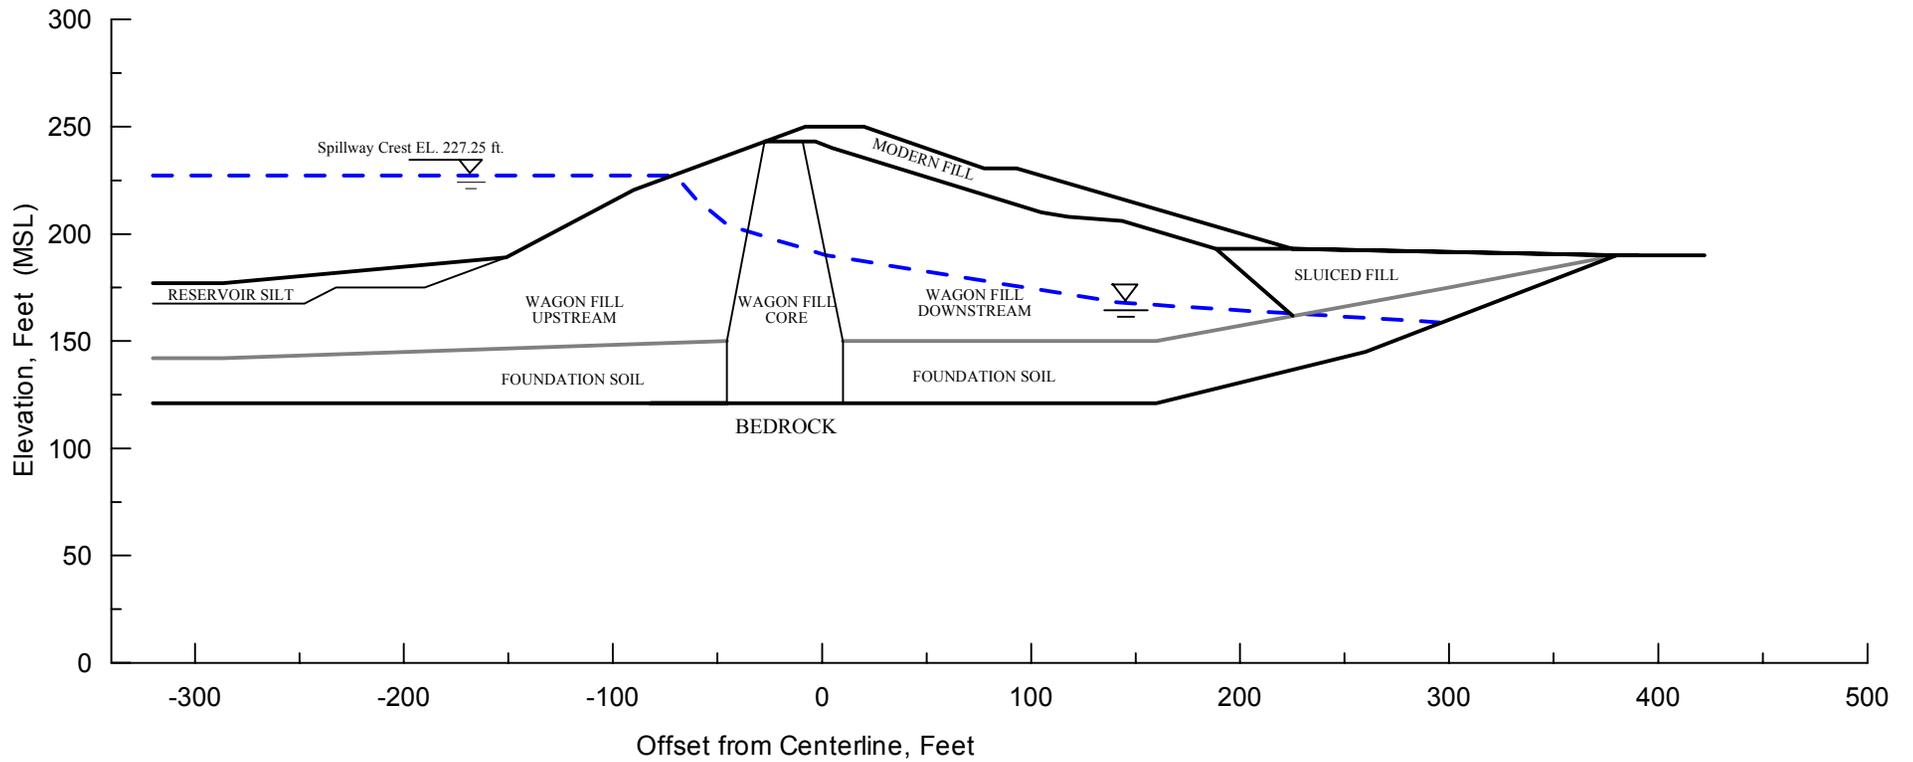
Project No. 26814536	Chabot Dam Seismic Stability Analysis	Idealized Cross Section B-B' for Stability Analysis	Figure 9-3
URS

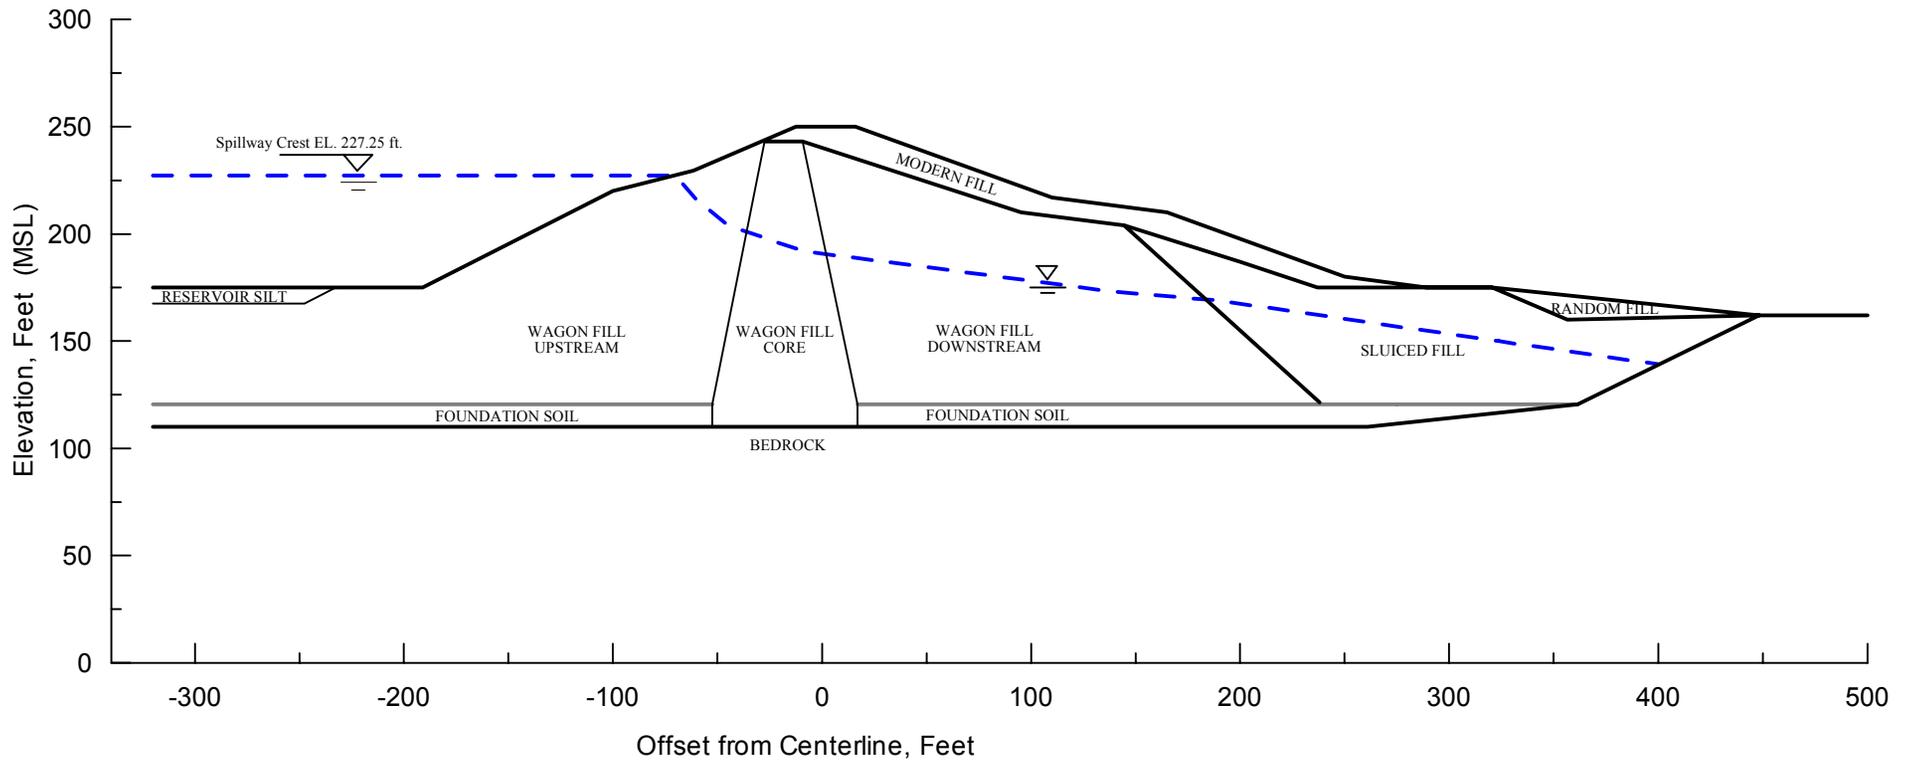
Project No. 26814536	Chabot Dam Seismic Stability Analysis	Modified Cross Section A - A' for Stability Analysis	Figure 9-4
URS

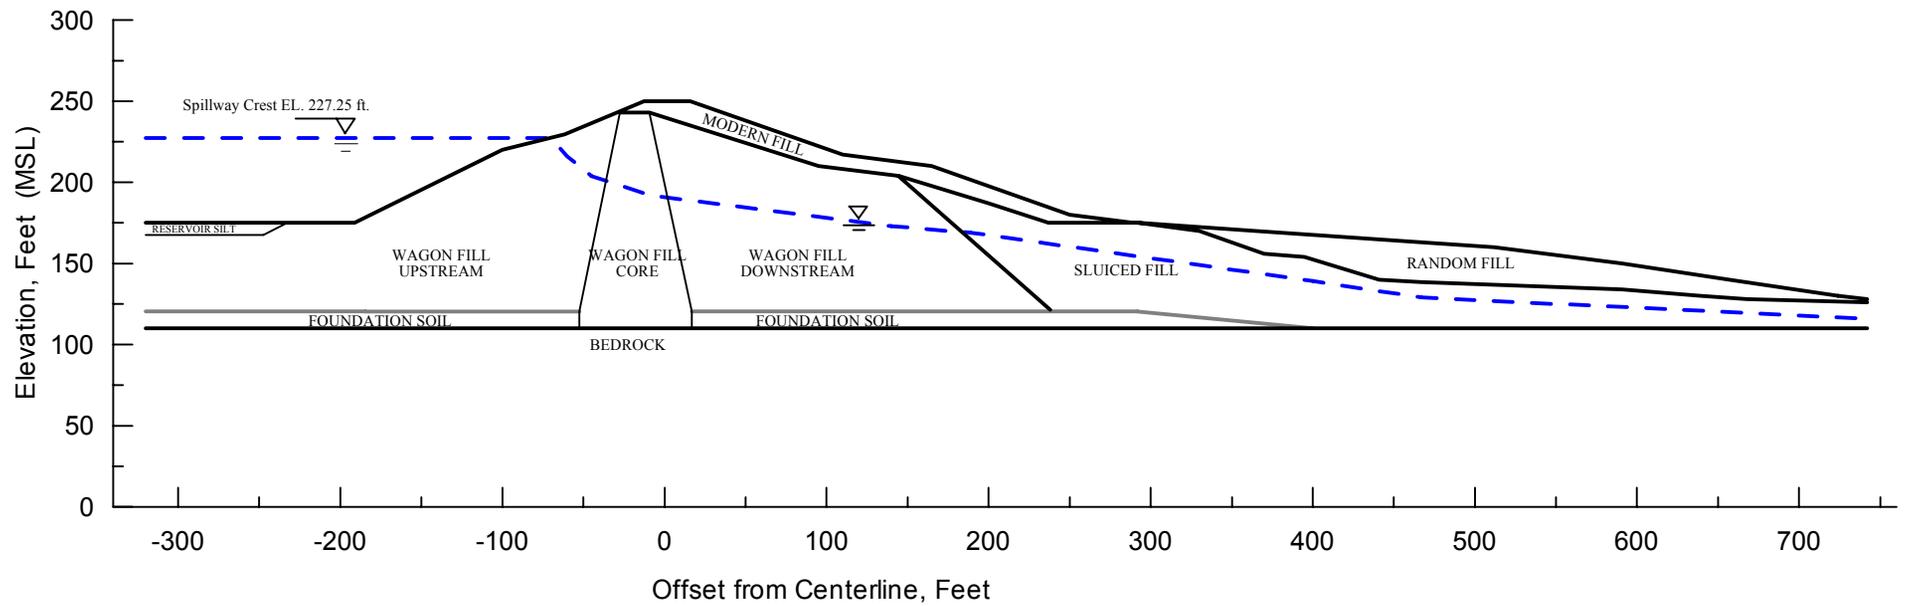
Project No. 26814536	Chabot Dam Seismic Stability Analysis	Composite Downstream Section A - A" for Stability Analysis	Figure 9-5
URS

Composite section A-A", shown in Figure 9-5, was developed to evaluate the effects on dam stability of the curved stream channel downstream of the dam. In composite section A-A", the top of the sluiced fill is obtained from District drawing No. 6948-G-1.05, which shows the topography prior to the 1980 dam modification, and the surface of the random fill is obtained from District drawing No. 6948-G-1.03.1, which shows the as-built topography after the dam modification. In addition, we assumed that the bedrock elevation remains constant and that the phreatic surface is essentially parallel to the top surface of the sluiced fill in the downstream direction. The WF/SF boundary was adopted from modified section A-A', which is more conservative than the preferred section A-A'.

The analysis results for composite section A-A'' are presented in Figure 9-14. As expected, the computed FS for the downstream slope under pre-earthquake conditions are generally similar to those computed for modified section A-A'. Pseudo-static analyses were not performed for Section A-A'' because the yield acceleration coefficients should be similar to those computed for modified section A-A'.

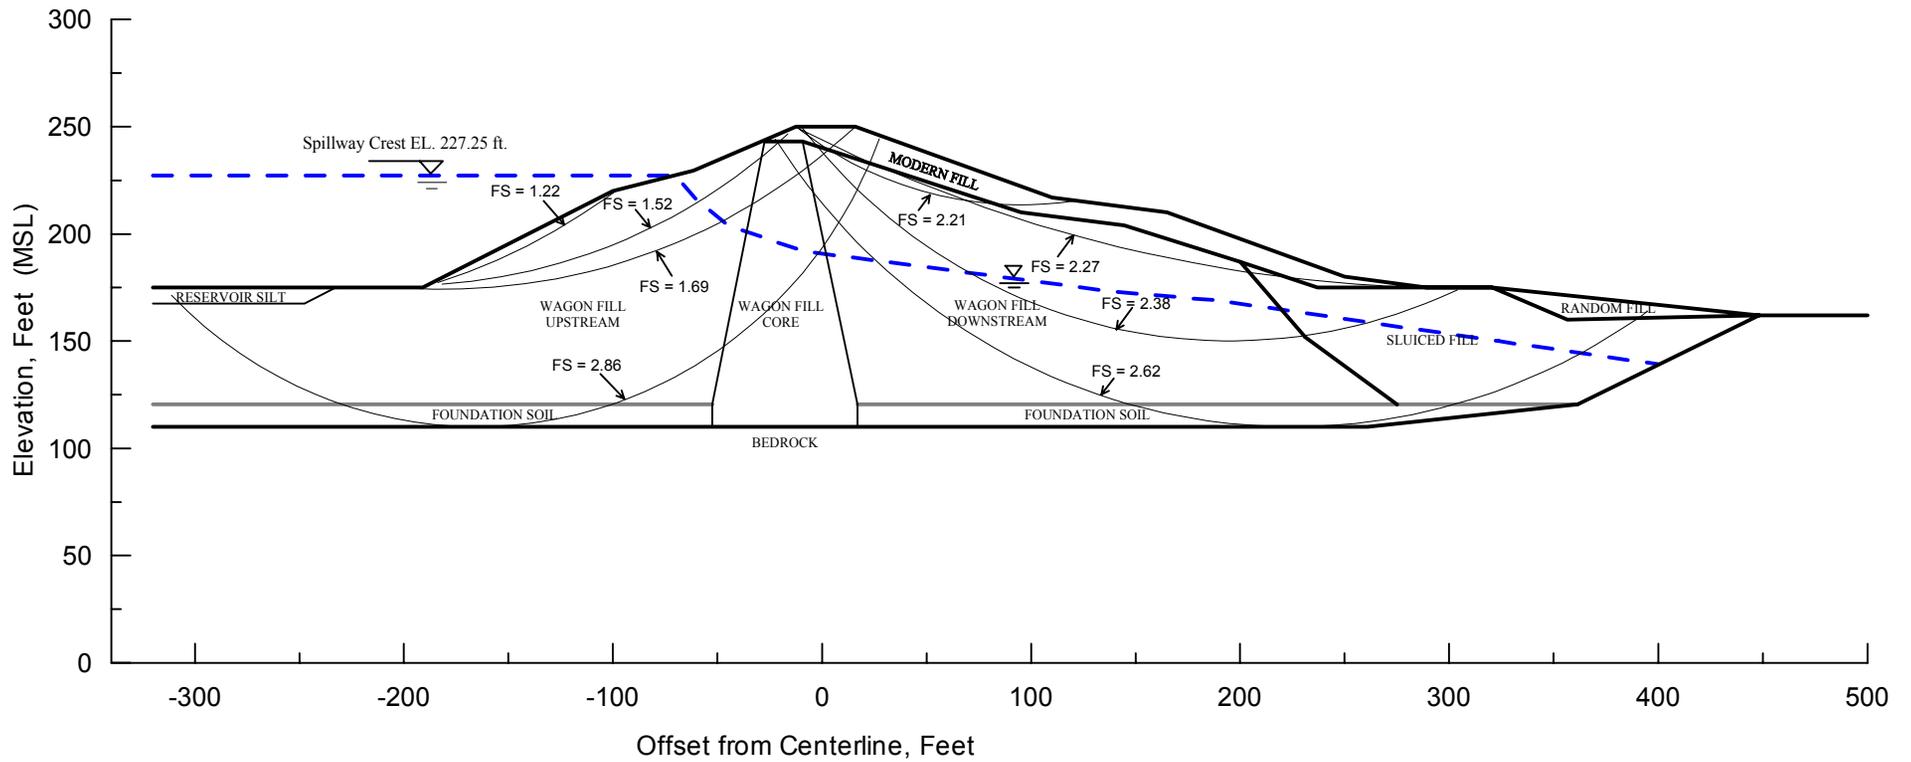
Project No. 26814536	Chabot Dam Seismic Stability Analysis	Static Stability Analysis Long-Term Condition Cross Section A-A'	Figure
URS			9-6

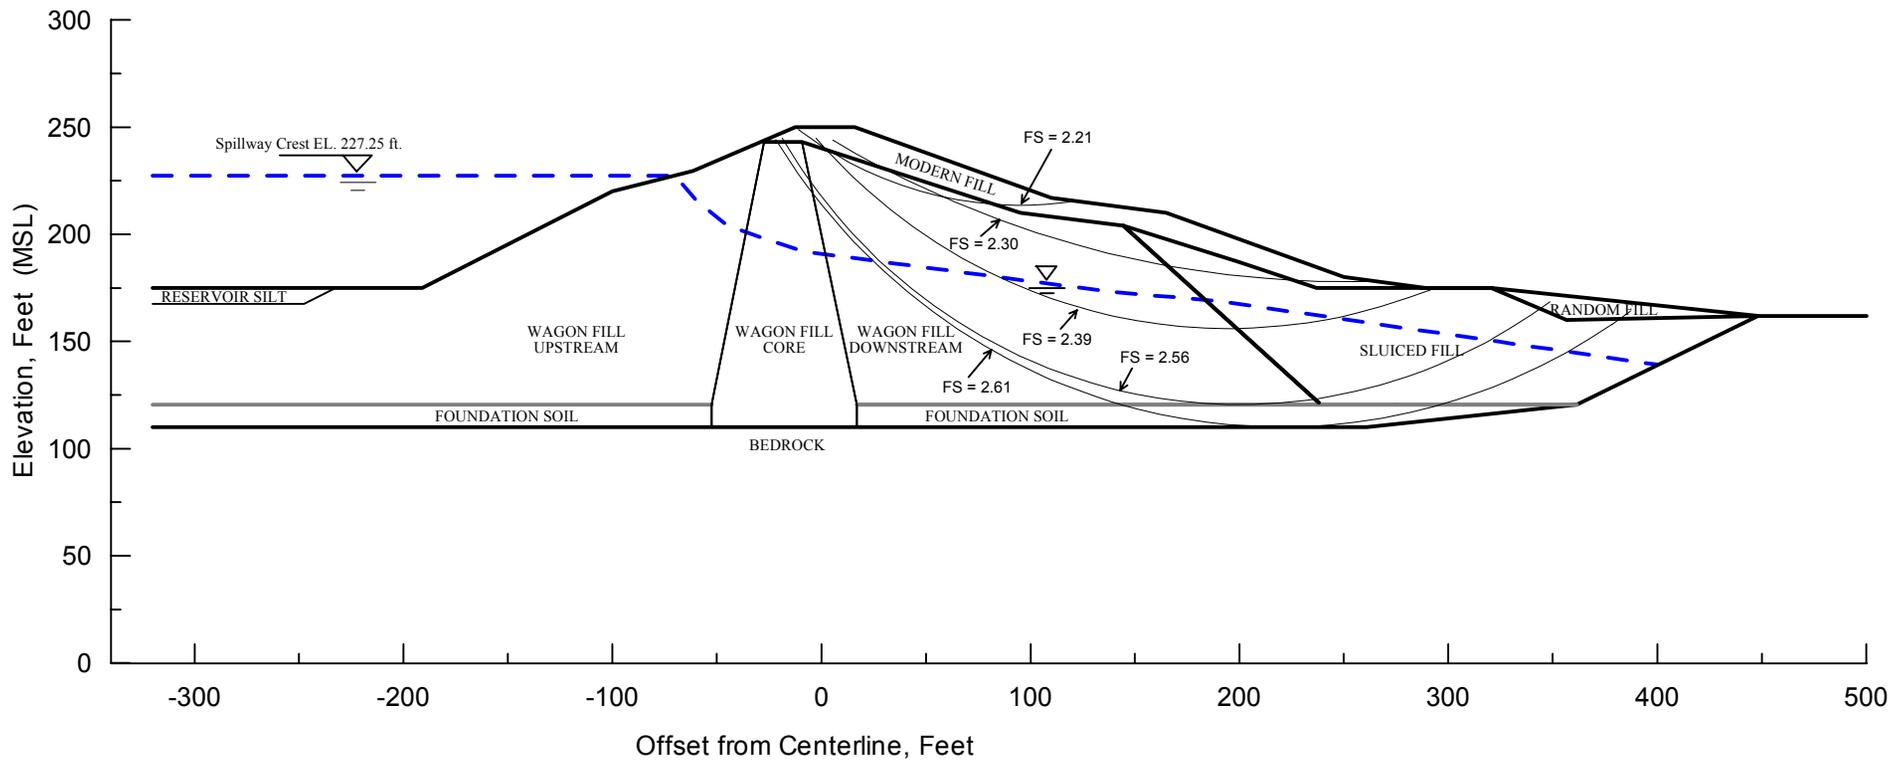
Project No. 26814536	Chabot Dam Seismic Stability Analysis	Static Stability Analysis Long-Term Condition Modified Cross Section A - A'	Figure 9-7
URS
