FINAL REPORT
VOLUME 1: MAIN REPORT
October 2005

DYNAMIC STABILITY ANALYSIS OF CHABOT DAM

Alameda County, California

**Subject: Dynamic Stability of Chabot Dam
Final Engineering Report**

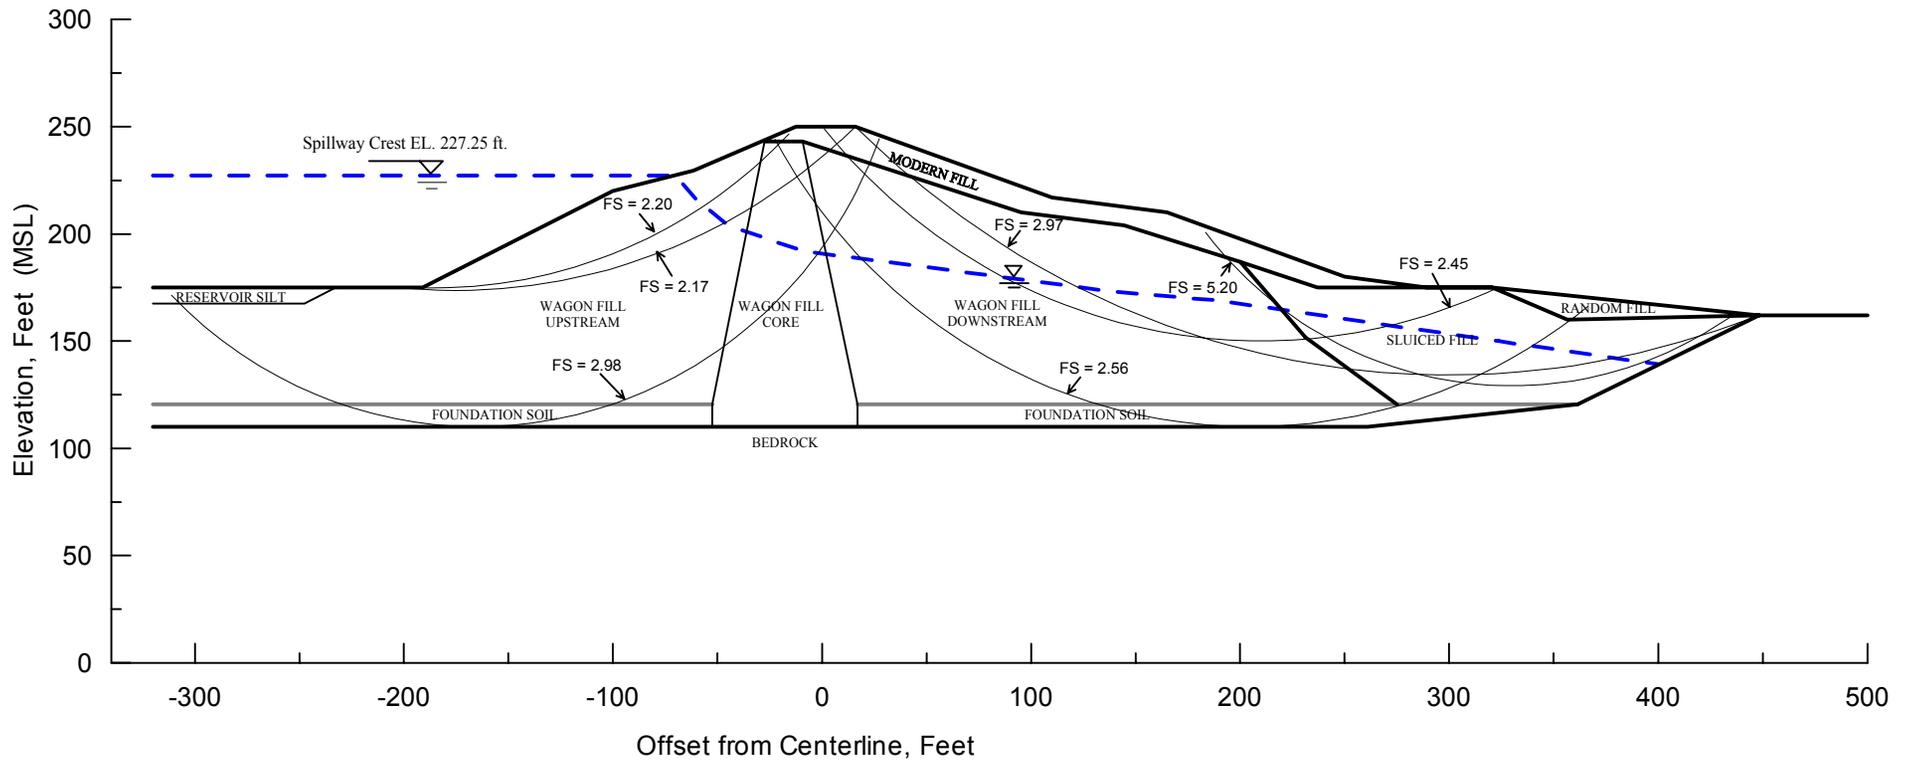
Project No. 26814536	Chabot Dam Seismic Stability Analysis	Seismic Stability Analysis Pre-Earthquake Condition Cross Section A-A'	Figure 9-8
URS

For the pre-earthquake loading condition, the computed FS values for deep-seated sliding surfaces are between 2.5 and 3.0 for the upstream and downstream slopes (Figures 9-8 and 9-9). For sliding surfaces passing through the crest and the upstream toe, the computed FS values are about 2.2 (Figure 9-8). For Section A-A' under pseudo-static loading, the computed yield acceleration coefficients (K_y) are equal to or greater than 0.35 for the downstream slope when pre-earthquake strengths are used (Figure 9-10). For the upstream slope, the computed values of K_y for a deep-seated sliding surface and a sliding surface through the crest and the upstream toe are 0.37 and 0.28, respectively. For modified section A-A', the computed values of FS and K_y are similar to those for Section A-A' under pre-earthquake loading (Figure 9-11).

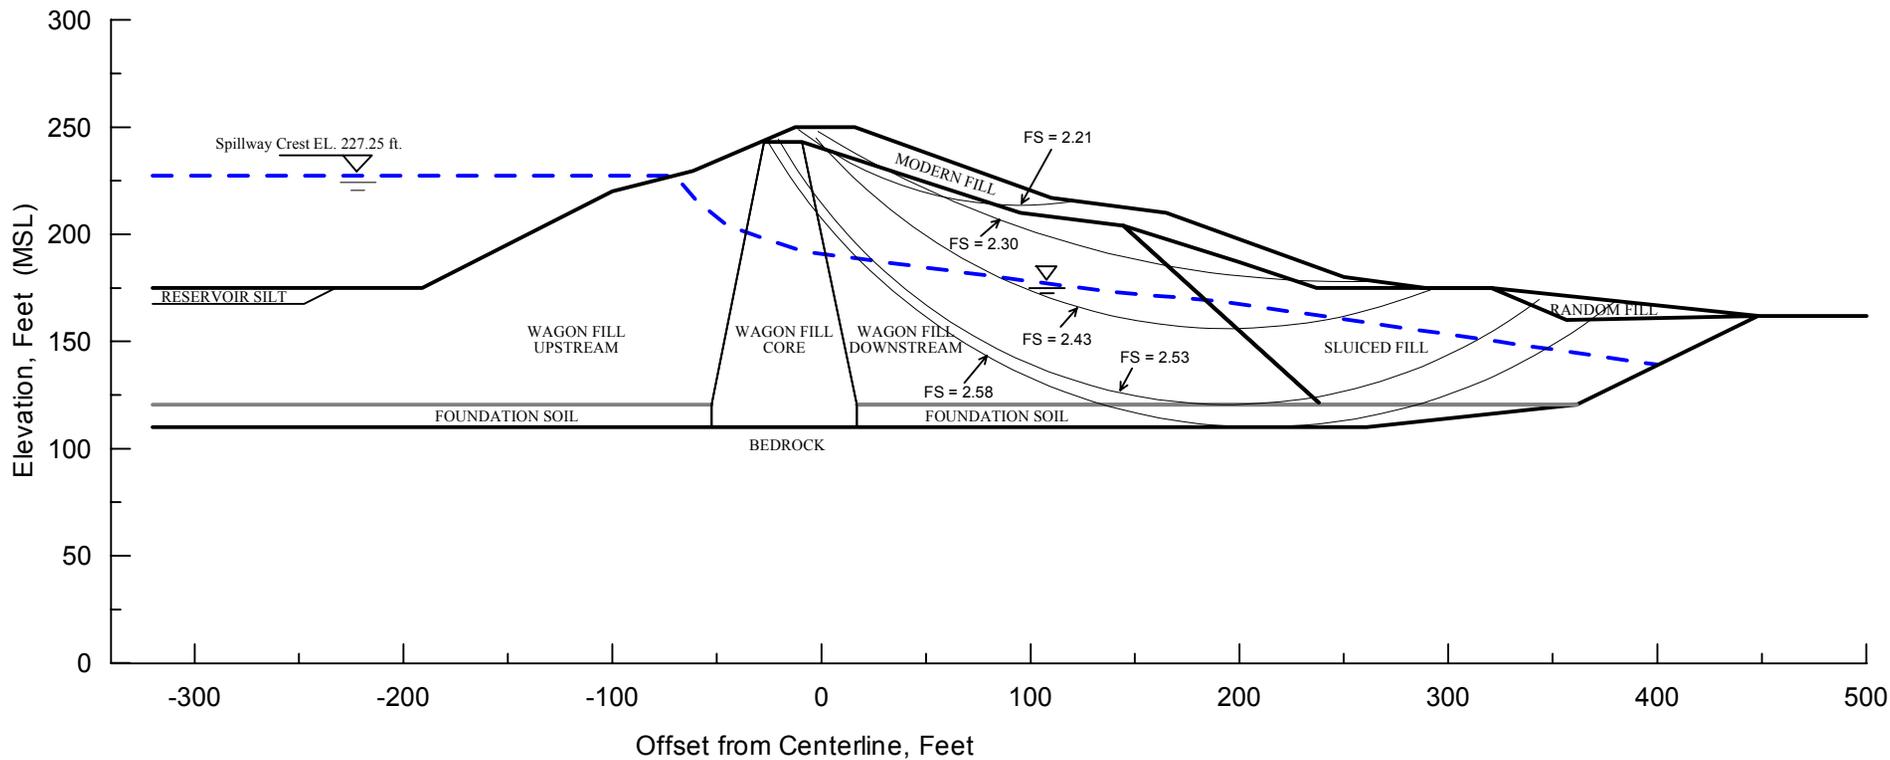
Project No. 26814536	Chabot Dam Seismic Stability Analysis	Seismic Stability Analysis Pre-Earthquake Condition Modified Cross Section A - A'	Figure
URS			9-9

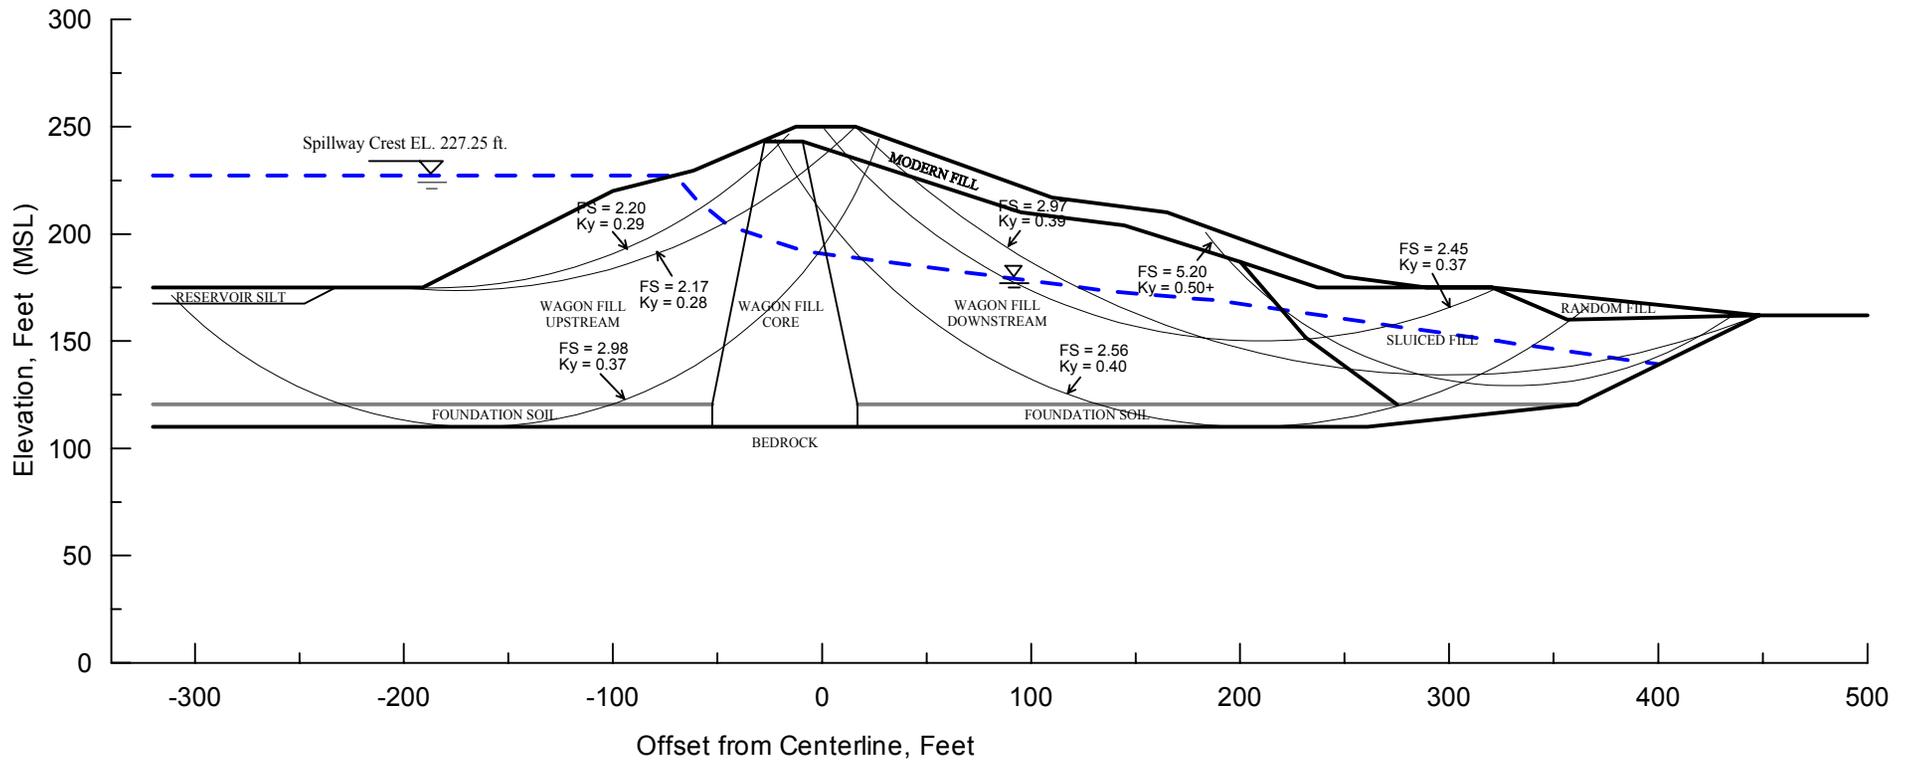
Project No. 26814536	Chabot Dam Seismic Stability Analysis	Seismic Stability Analysis Pseudo-Static Loading (Pre-Earthquake Strengths) Cross Section A-A'	Figure
URS			9-10

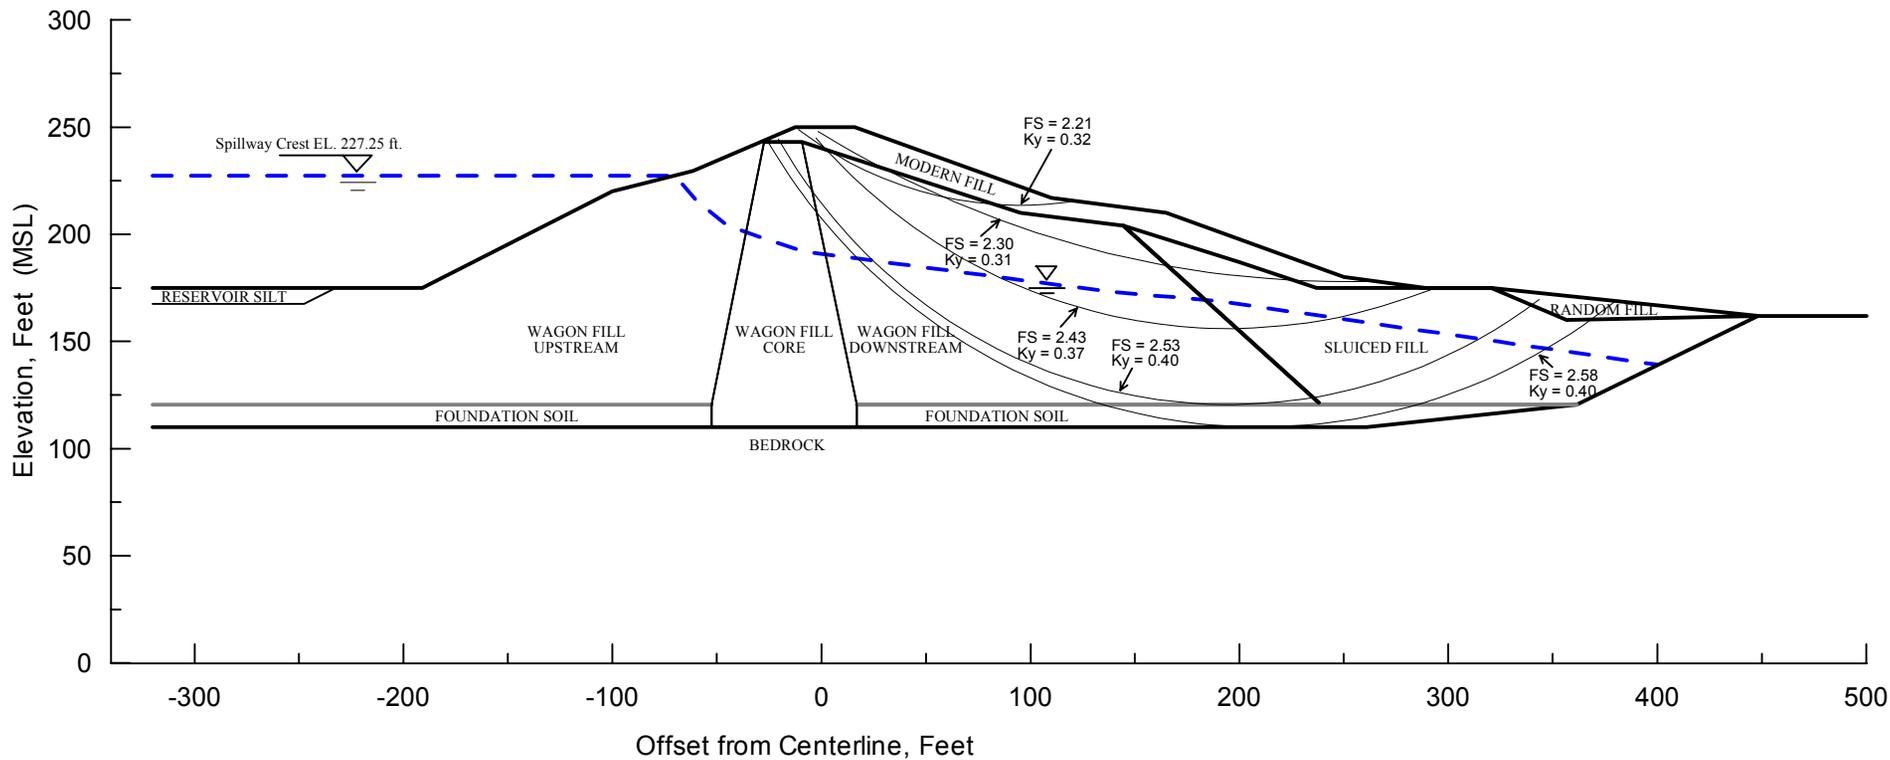
Project No. 26814536	Chabot Dam Seismic Stability Analysis	Seismic Stability Analysis Pseudo-Static Loading (Pre-Earthquake Strengths) Modified Cross Section A - A'	Figure
URS			9-11

There is some uncertainty regarding the location of the downstream boundary between the wagon fill and the sluiced fill. Limited Newmark-type deformation analyses were performed on Modified Section A-A' (Figure 9-4) to examine the sensitivity of the calculated deformations to

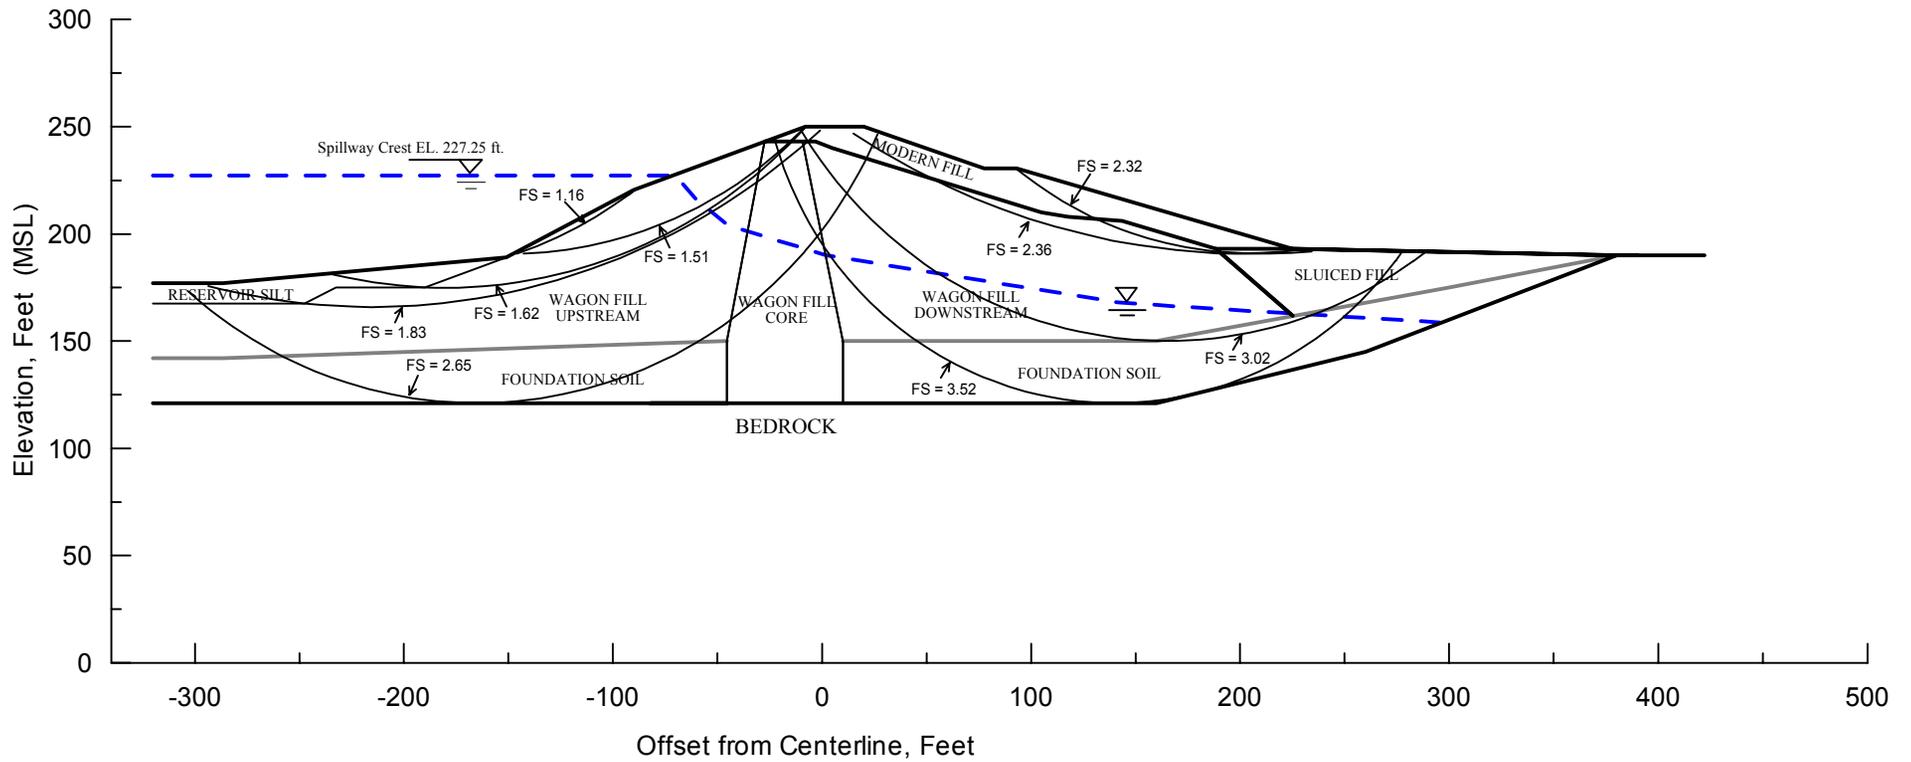
Project No. 26814536	Chabot Dam Seismic Stability Analysis	Static Stability Analysis Long-Term Condition Cross Section B-B'	Figure 9-12
URS

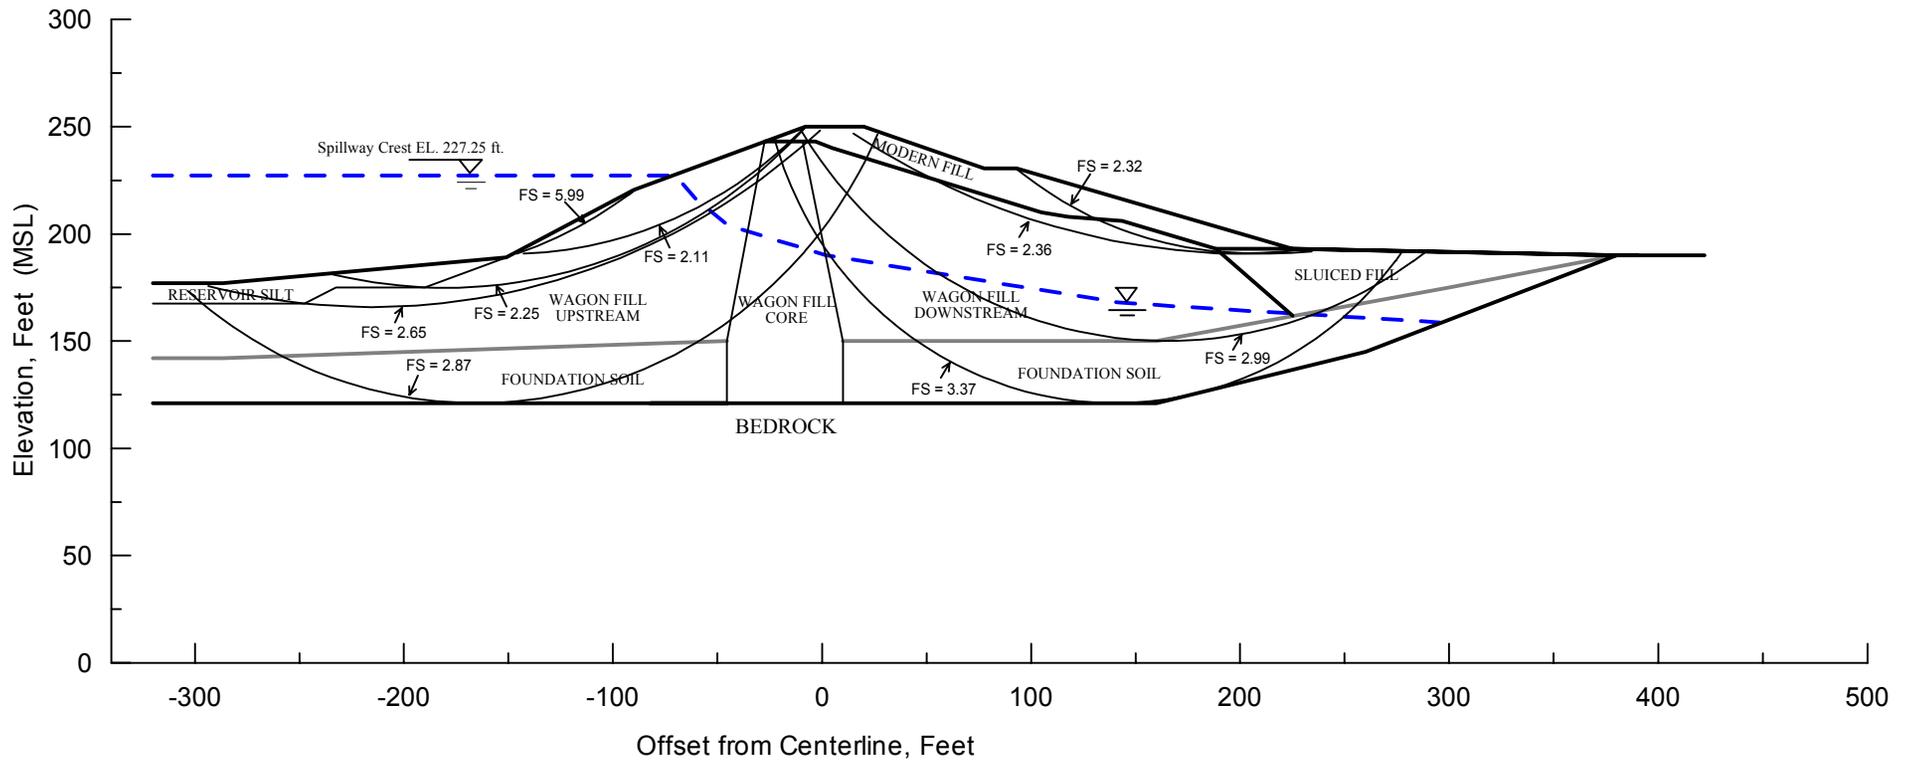
Project No. 26814536	Chabot Dam Seismic Stability Analysis	Seismic Stability Analysis Pre-Earthquake Condition Cross Section B-B'	Figure 9-13
URS

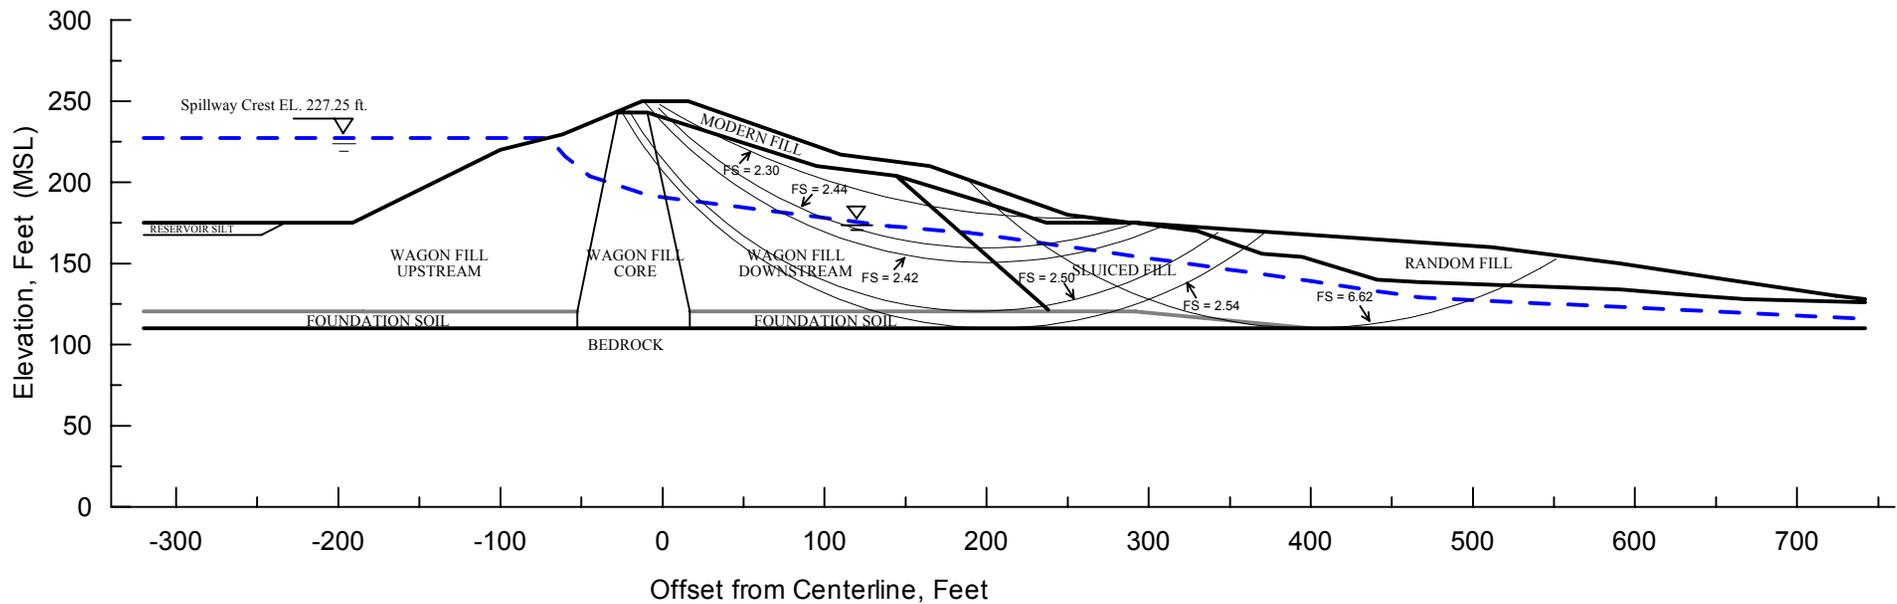
Project No. 26814536	Chabot Dam Seismic Stability Analysis	Seismic Stability Analysis Pre-Earthquake Condition Downstream Section A - A"	Figure
URS			9-14

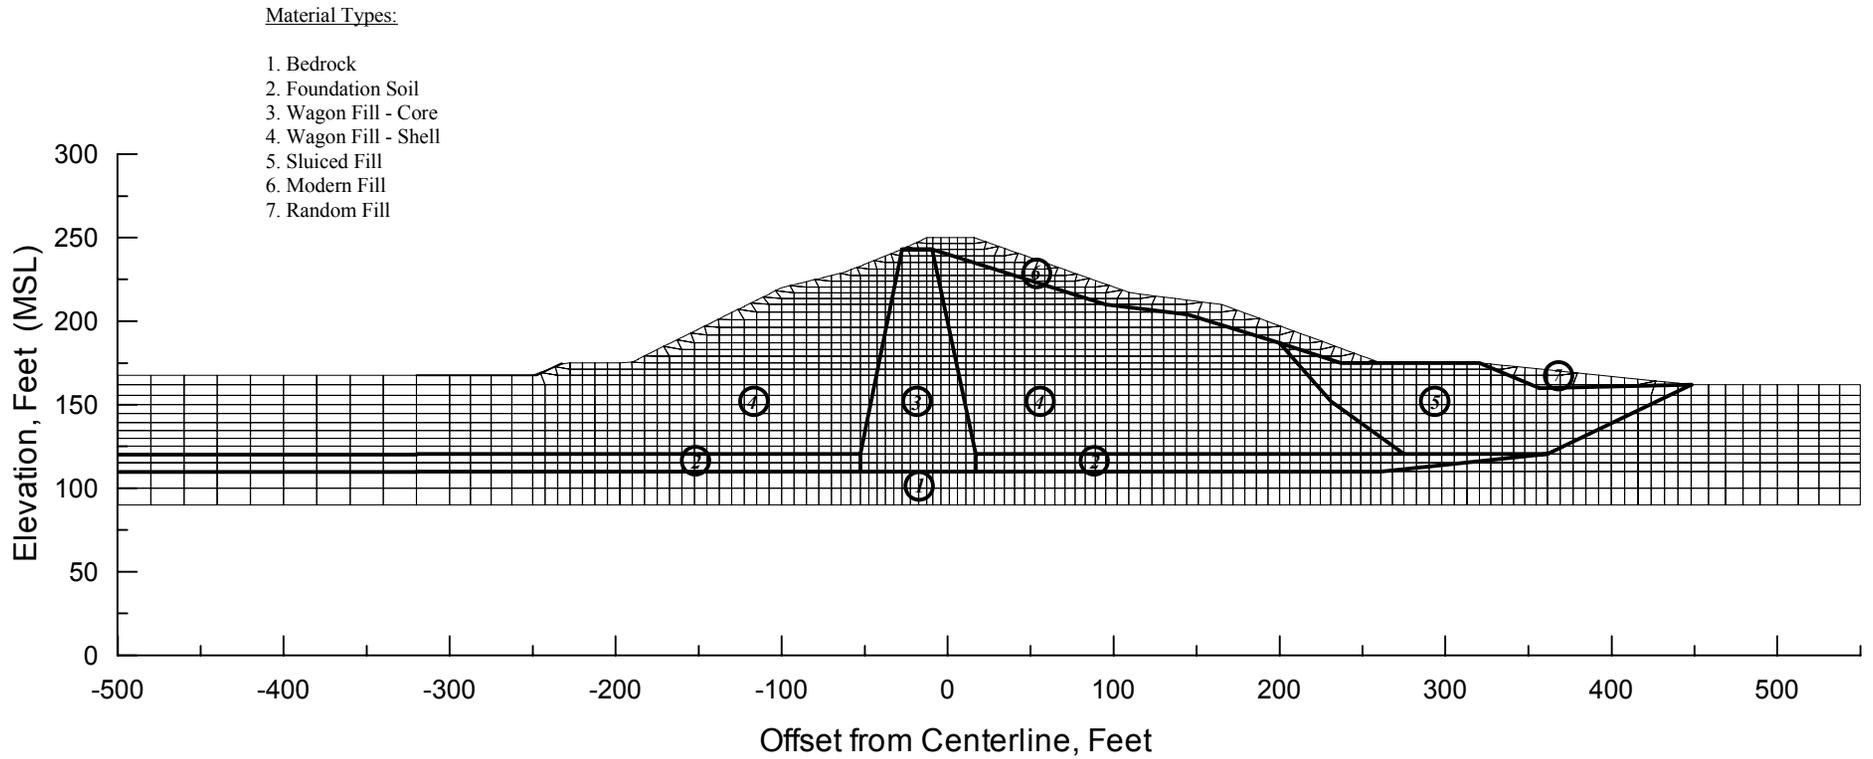
Project No. 26814536	Chabot Dam Seismic Stability Analysis	Finite Element/Difference Mesh Cross Section A - A'	Figure
URS			10-1

The dynamic response analyses were performed on idealized Section A-A', which corresponds to the maximum section of the dam. This section was shown to be the most critical section of the planar sections studied in the static and pseudo-static analyses. This section was also judged to be the most representative for assessing the seismic deformations of the dam. The section was discretized using the finite element mesh shown in Figure 10-1. A transmitting boundary was specified along the base of the model to simulate the unbounded extent of the foundation bedrock beneath the dam. The mesh was extended in the upstream and downstream directions to minimize the effects of side boundary reflections on the dam response, and "horizontal roller" supports were specified for the side boundaries to allow free movement in the horizontal direction. The calculated site response near the boundaries was compared with the free-field response computed with computer program SHAKE (Schnabel et al, 1972), to confirm that the boundary effects are small.

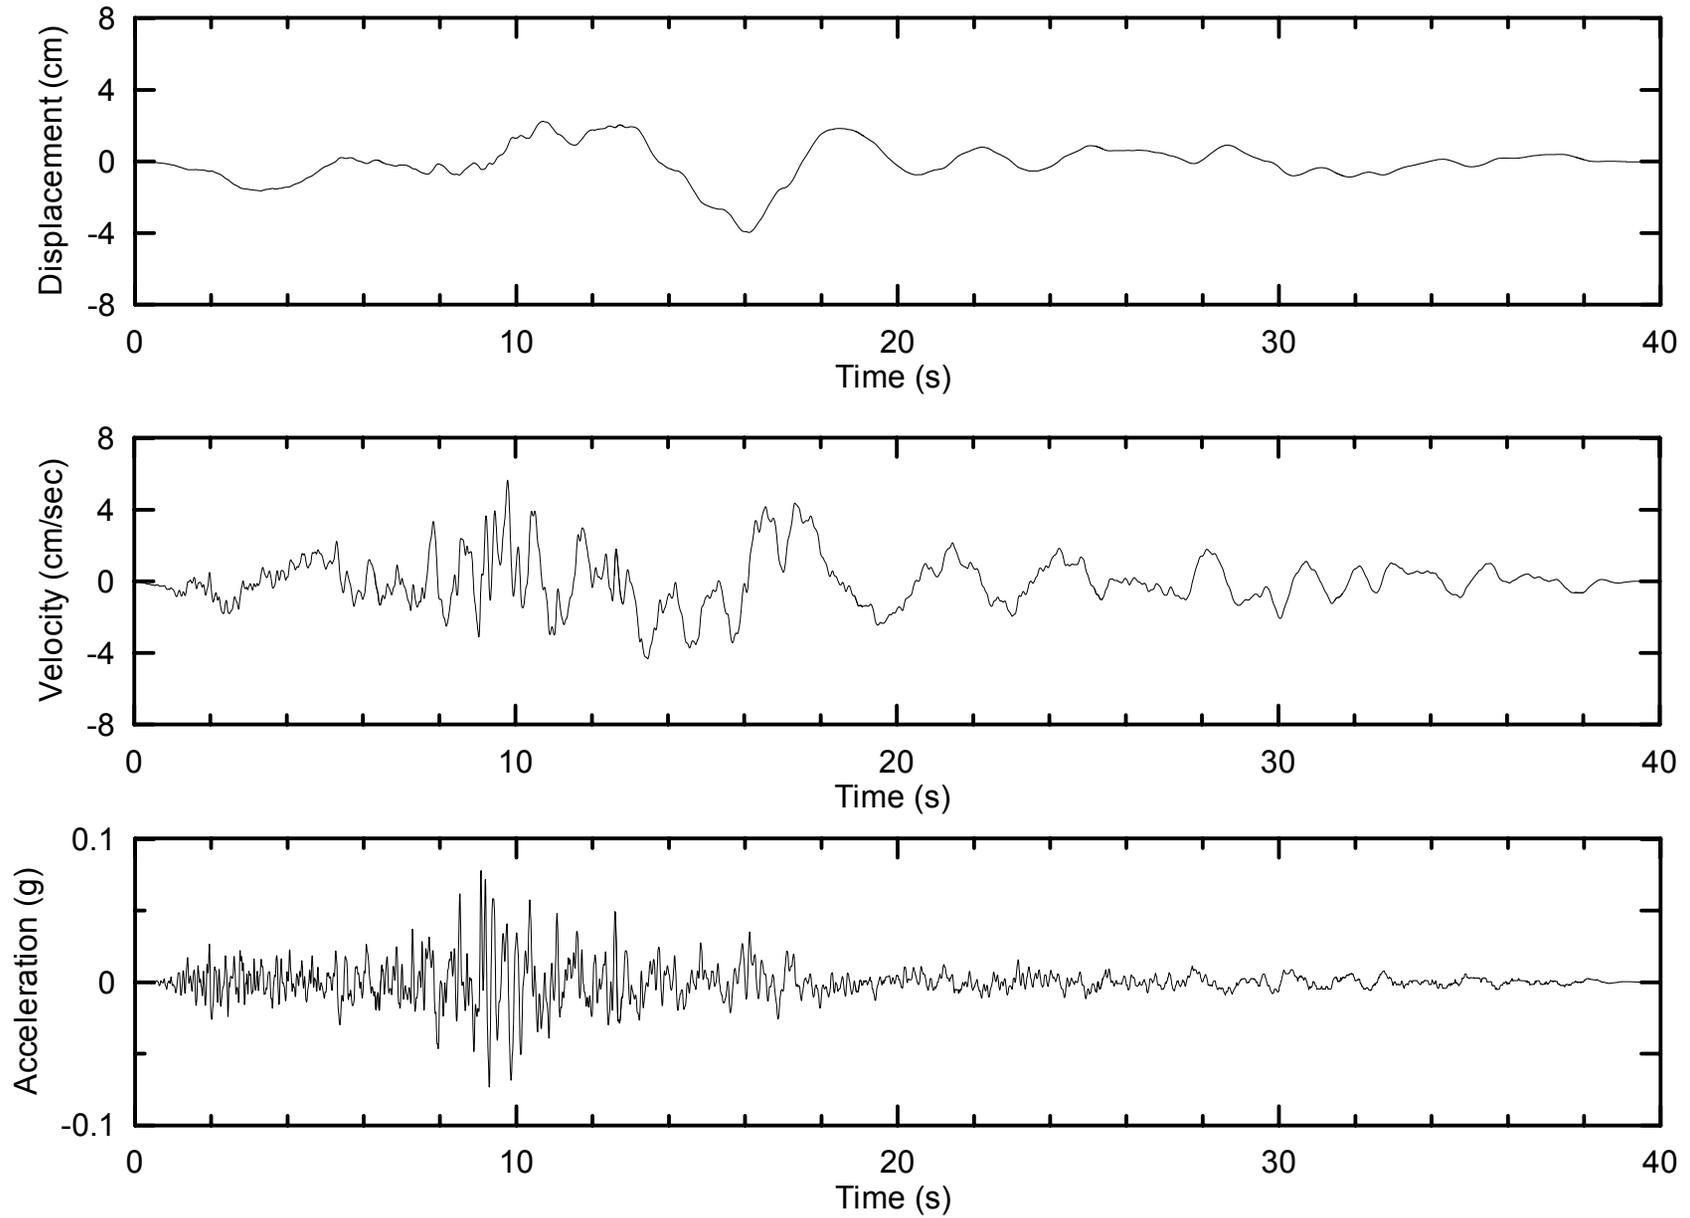
Project No. 26814536	Chabot Dam Seismic Stability Analysis	1989 Loma Prieta Earthquake Acceleration Time History (CSUH Stadium A3E000)	Figure 10-2
URS

The response of the dam was also analyzed for the estimated motions during the 1989 Loma Prieta earthquake. Based on the ground motion records obtained during that earthquake, the motions recorded at the California State University at Hayward Stadium were assumed to be reasonably representative of the motions that occurred at the dam site during the earthquake. The time history used in the analyses to represent the earthquake motions is shown in Figure 10-2. The calculated performance was compared against the known performance of the dam during that earthquake as a check of the analysis procedures and models.

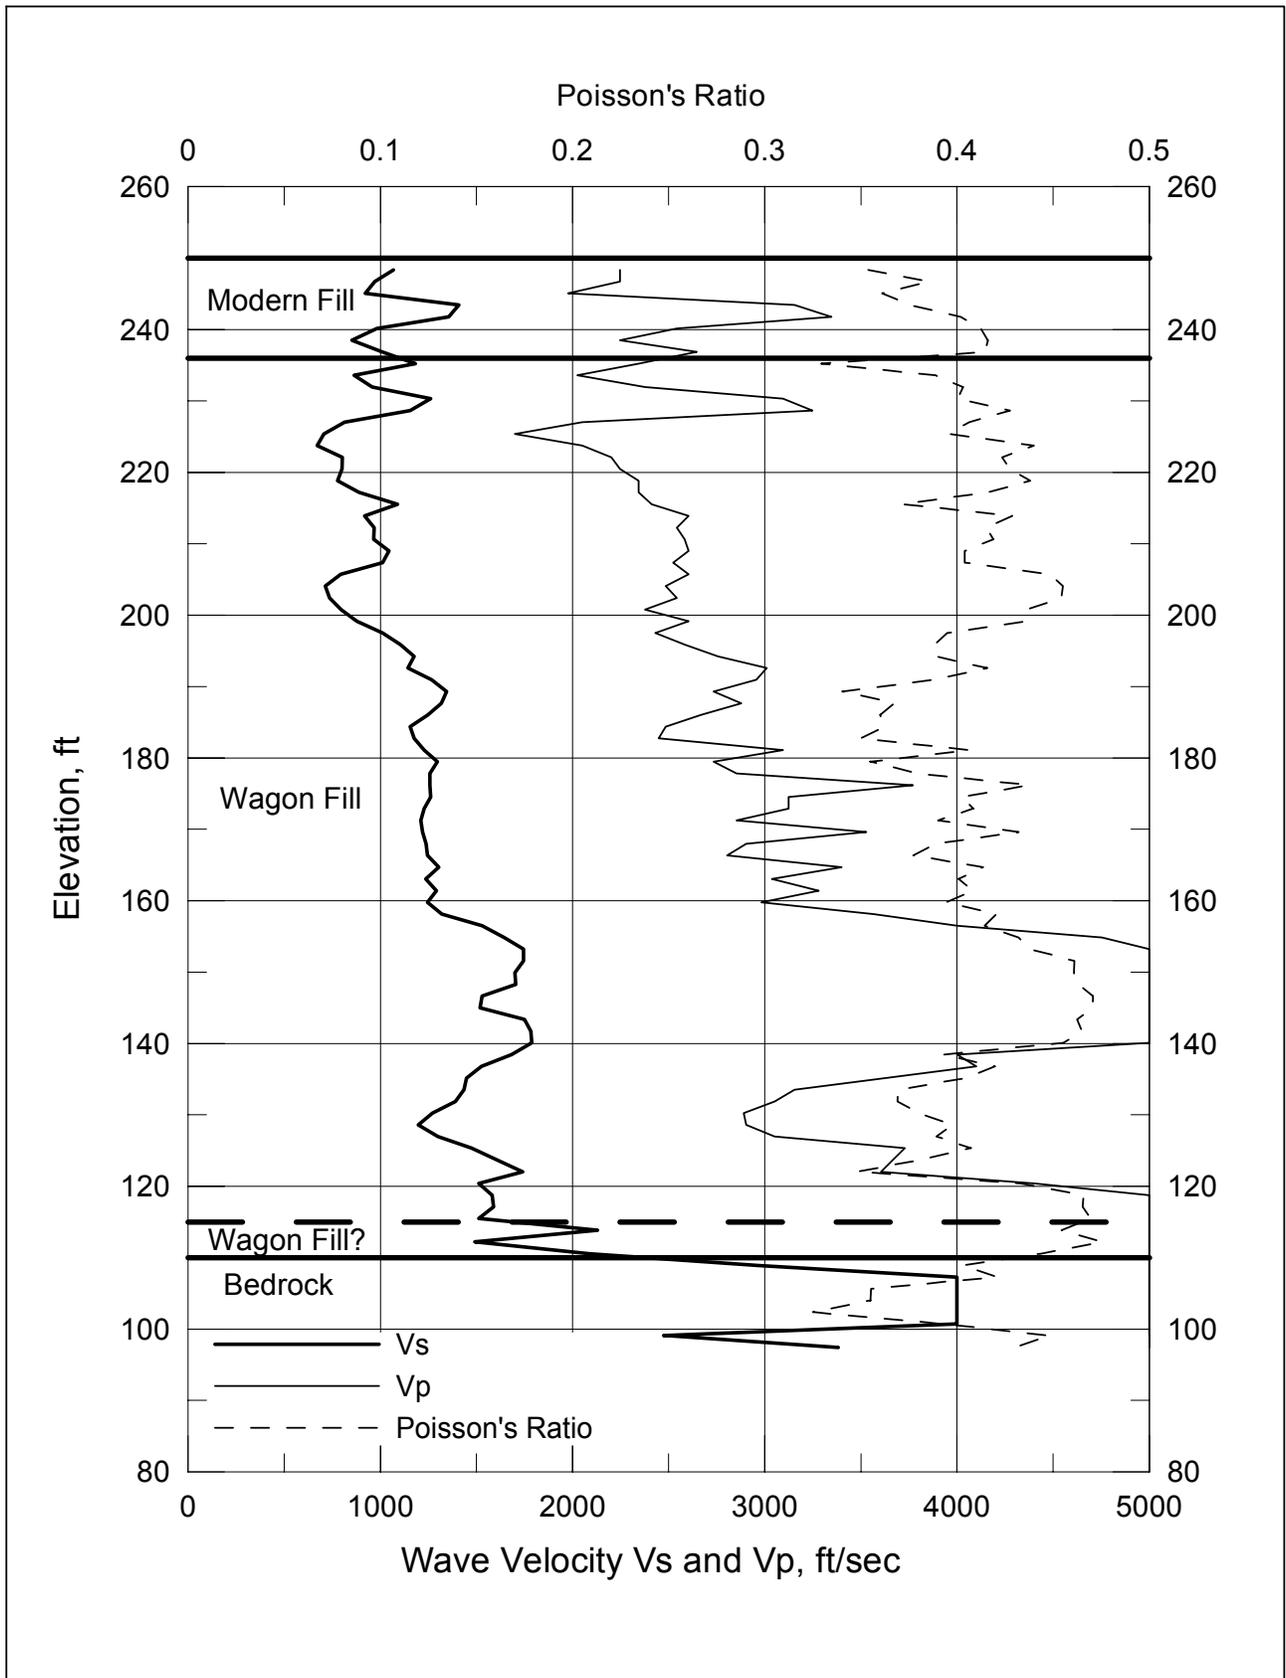
URS	Project No. 26814536	Seismic Wave Velocity Profiles and Stratigraphy of Boring WI-61	Figure
	Chabot Dam Seismic Stability		10-3

Figure 10-3 shows that, on the average, the shear wave velocity in the central wagon fill increases gradually with depth from about 900 fps at Elevation 230 to about 1500 fps at the bottom of the fill. Similar trends are observed in the measurements made in the downstream wagon fill and were used to develop a model of the seismic shear wave velocities of those materials.

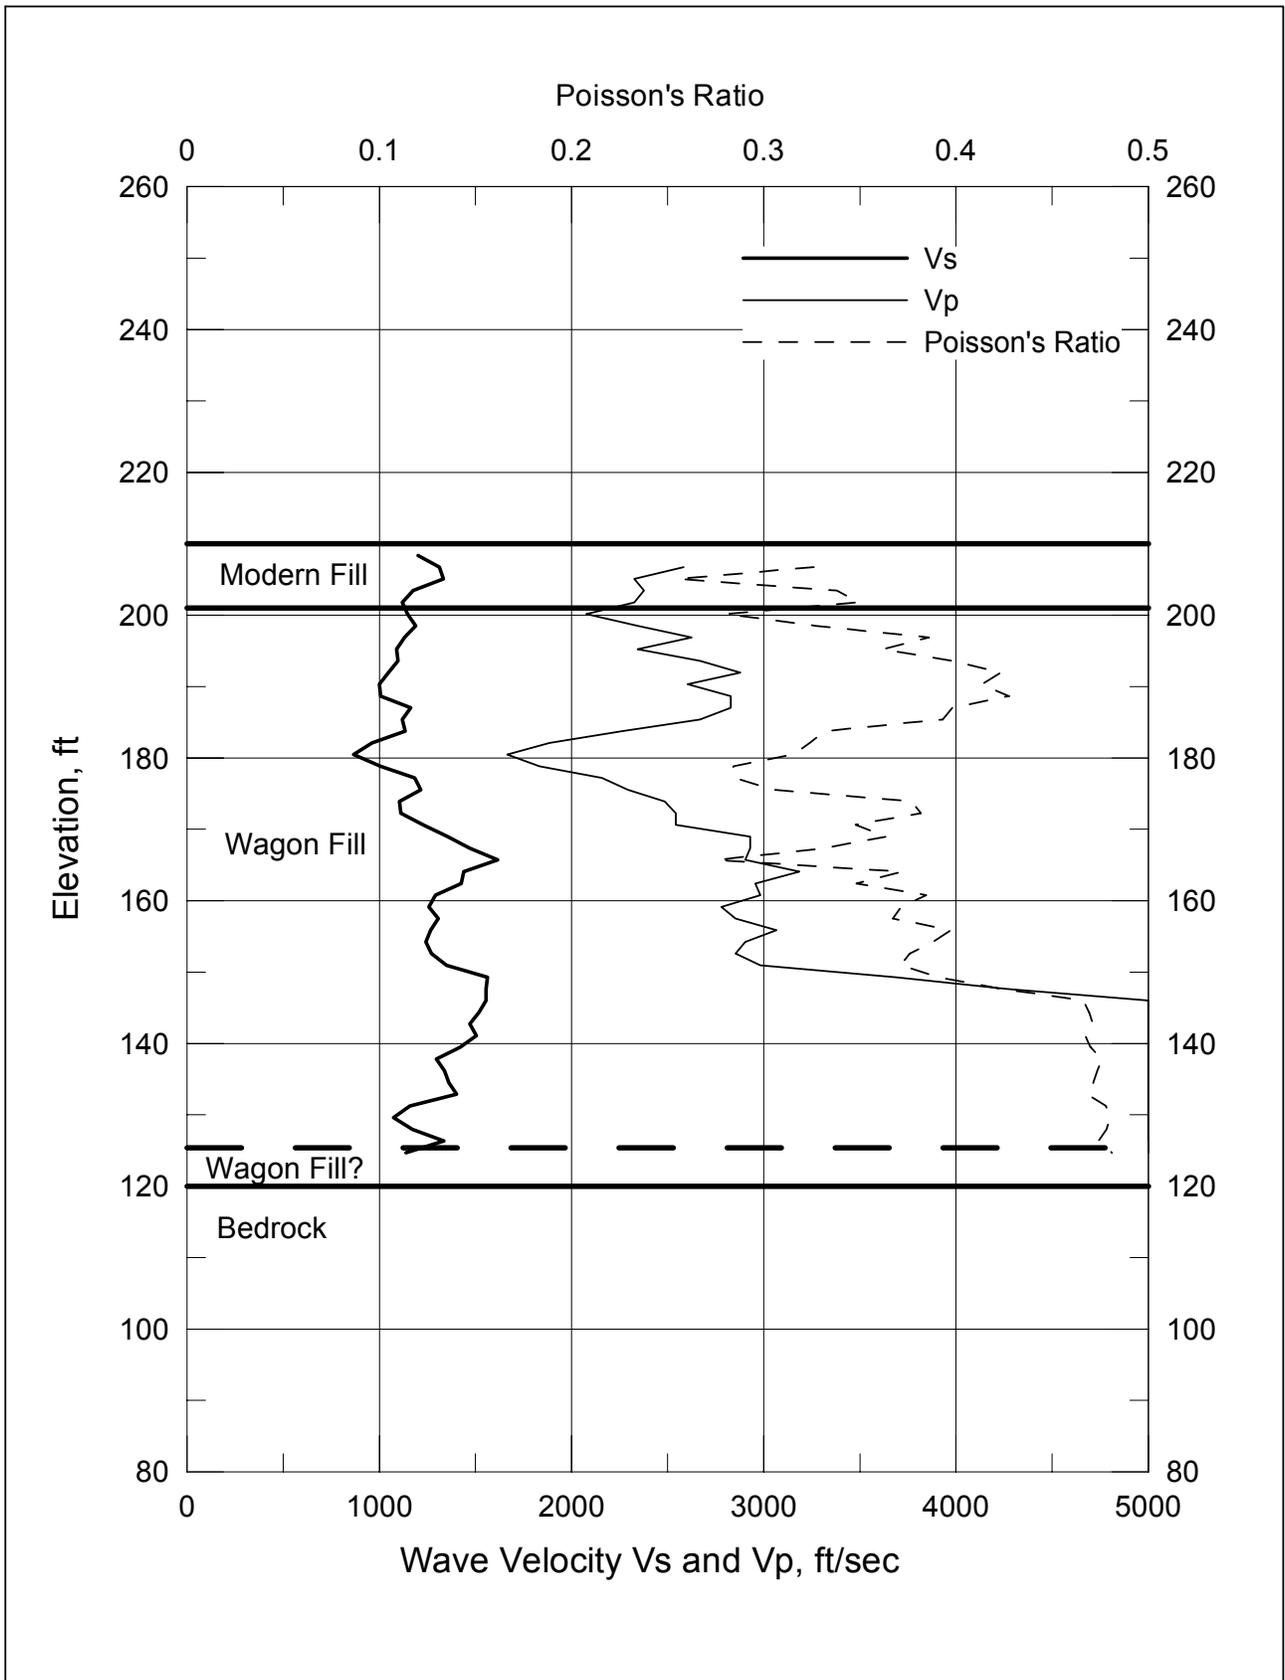
URS	Project No. 26814536	Seismic Wave Velocity Profiles and Stratigraphy of Boring WI-59	Figure
	Chabot Dam Seismic Stability		10-4

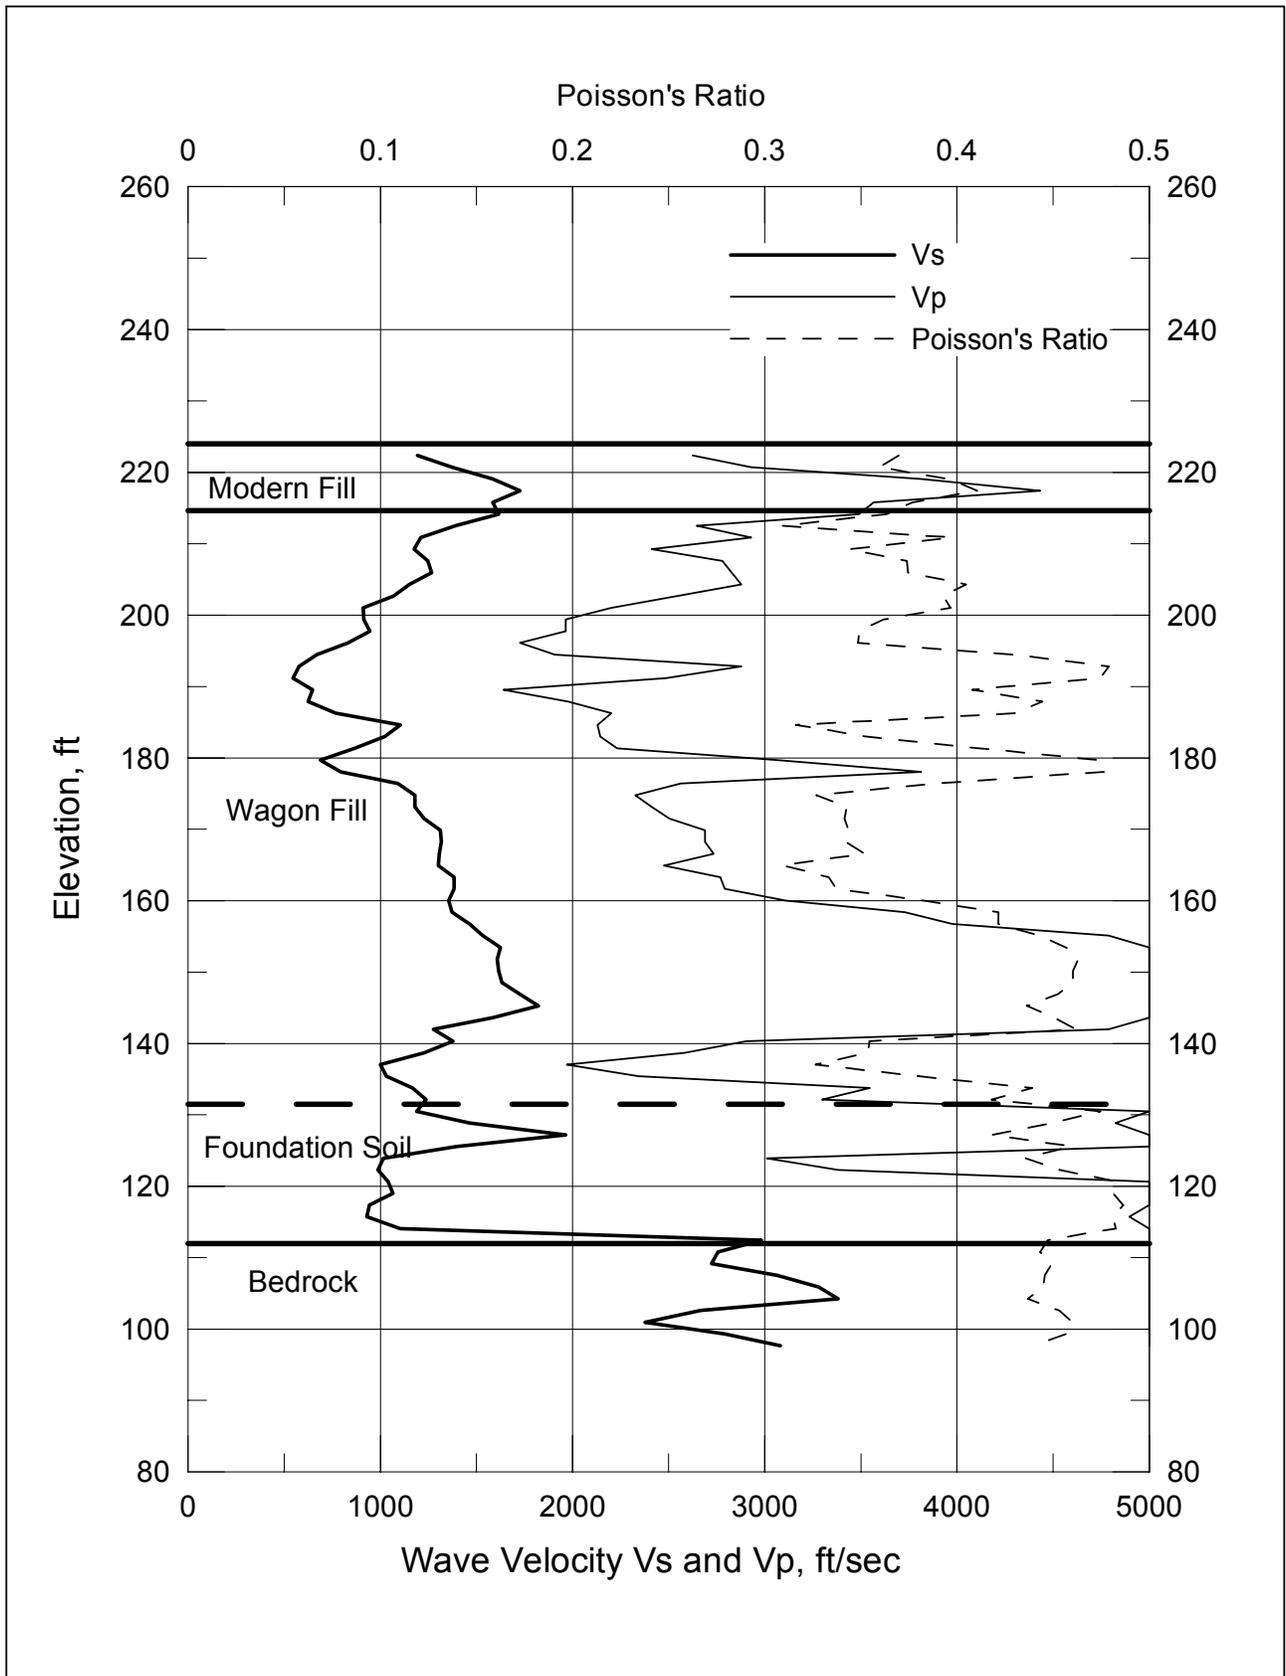
URS	Project No. 26814536	Seismic Wave Velocity Profiles and Stratigraphy of Boring WI-62	Figure
	Chabot Dam Seismic Stability		10-5
