FINAL REPORT
VOLUME 1: MAIN REPORT
October 2005

DYNAMIC STABILITY ANALYSIS OF CHABOT DAM

Alameda County, California

**Subject: Dynamic Stability of Chabot Dam
Final Engineering Report**

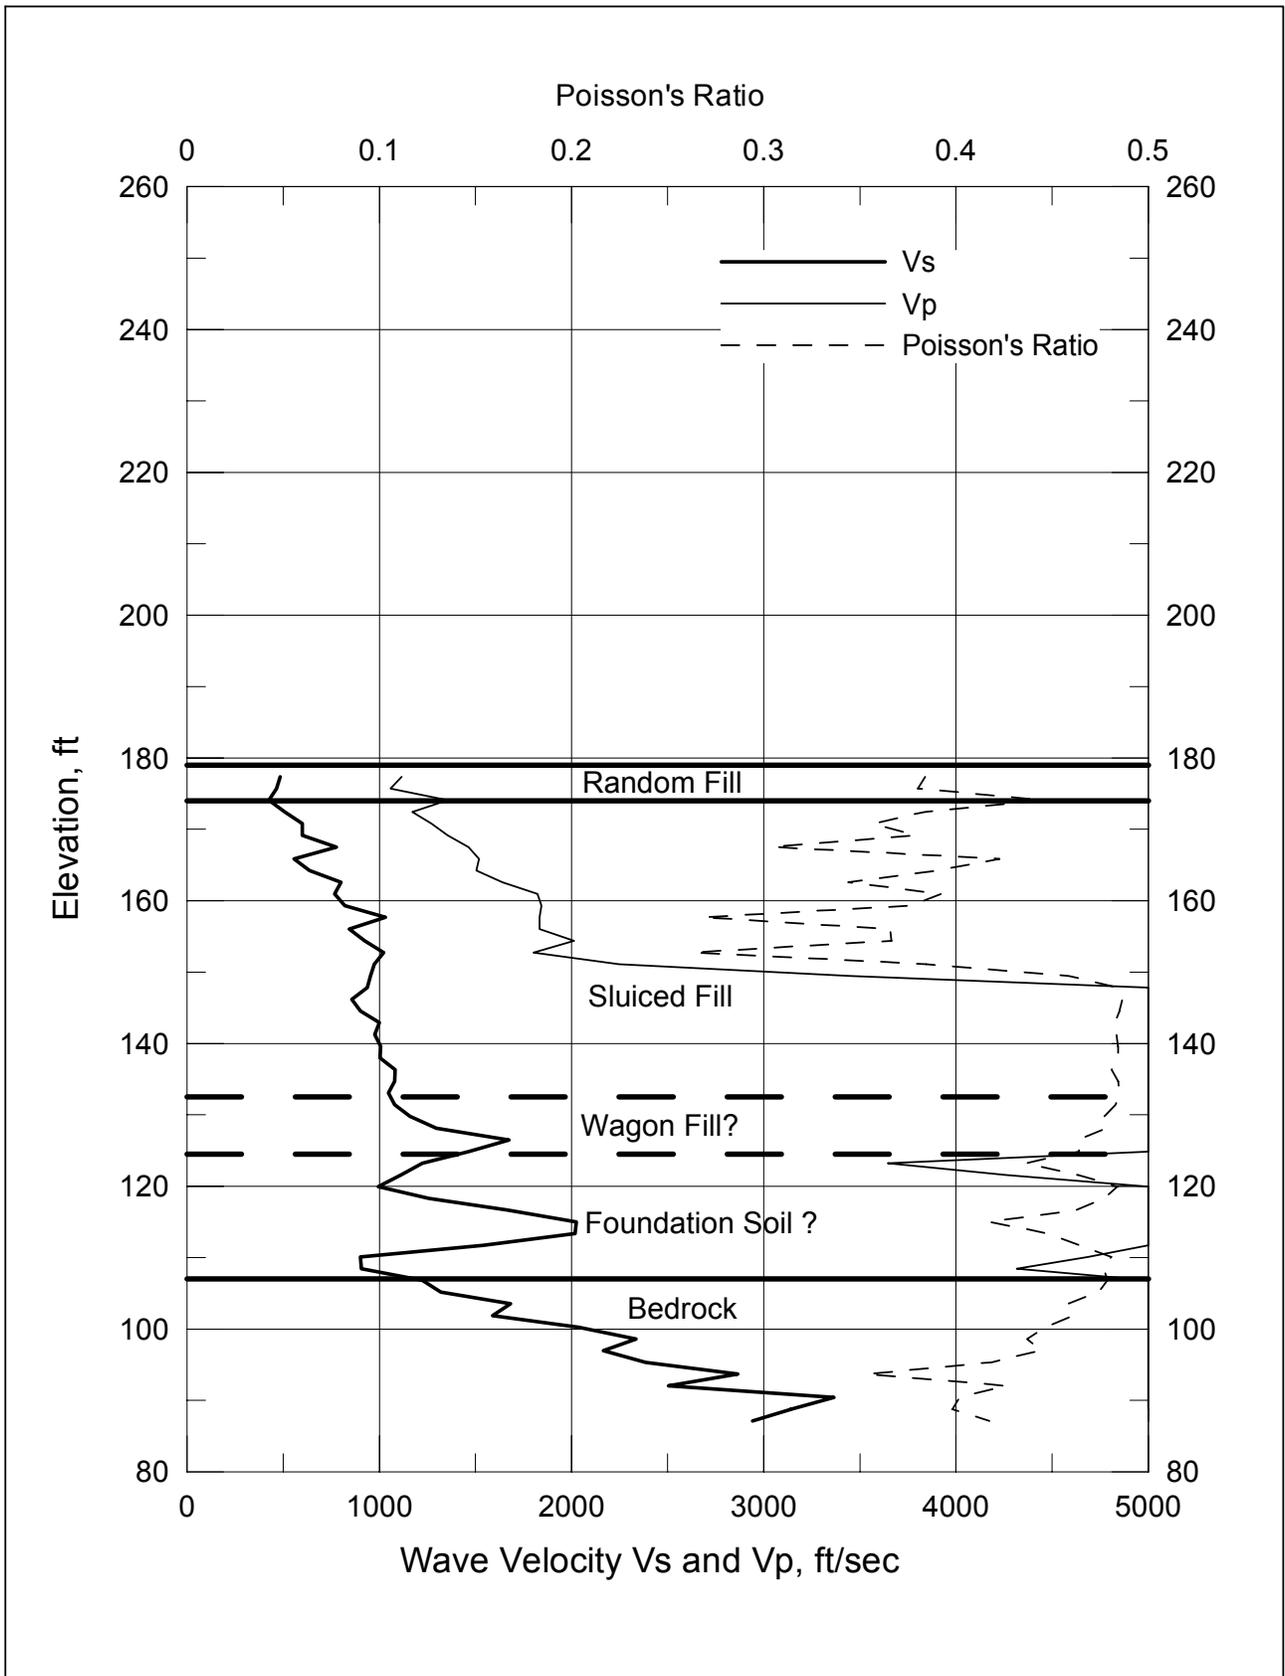
URS	Project No. 26814536	Seismic Wave Velocity Profiles and Stratigraphy of Boring WI-60	Figure
	Chabot Dam Seismic Stability		10-6

Figure 10-6 shows the seismic velocities measured in boring WI-60 through the sluiced fill. The figure shows that the shear wave velocity of the materials increases gradually with depth from about 500 fps near the surface to 1000 fps at the bottom of the fill.

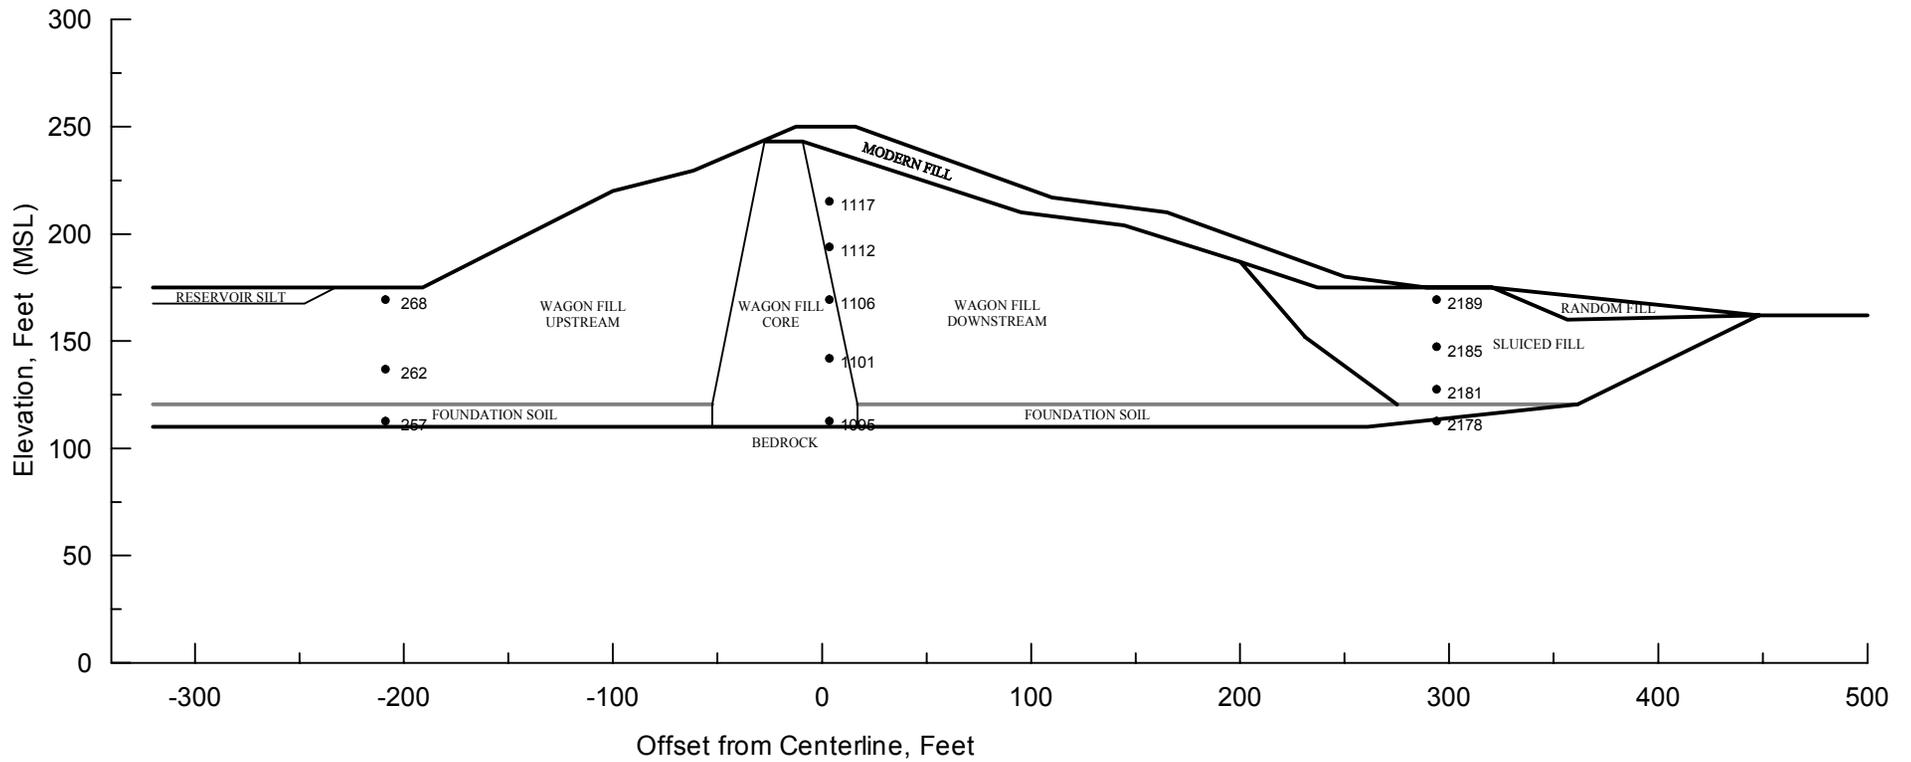
• 257 – Element number

Project No. 26814536	Chabot Dam Seismic Stability Analysis	Selected Element Locations For Stress Time-history Plots QUAD4M Analysis	Figure 10-7
URS

The results of the QUAD4M analyses are presented in terms of: a) time histories of shear stress at the elements shown in Figure 10-7, b) acceleration outputs for the nodal points shown in Figure 10-8, and c) time histories of average mass acceleration for the sliding blocks shown in Figure 10-9. In addition, peak horizontal shear stresses were output throughout the model. Those shear stresses were used to calculate the earthquake-induced cyclic stress ratio (CSR) in the embankment and foundation materials. CSR is defined as the ratio of the average cyclic shear stress to the initial effective overburden stress.

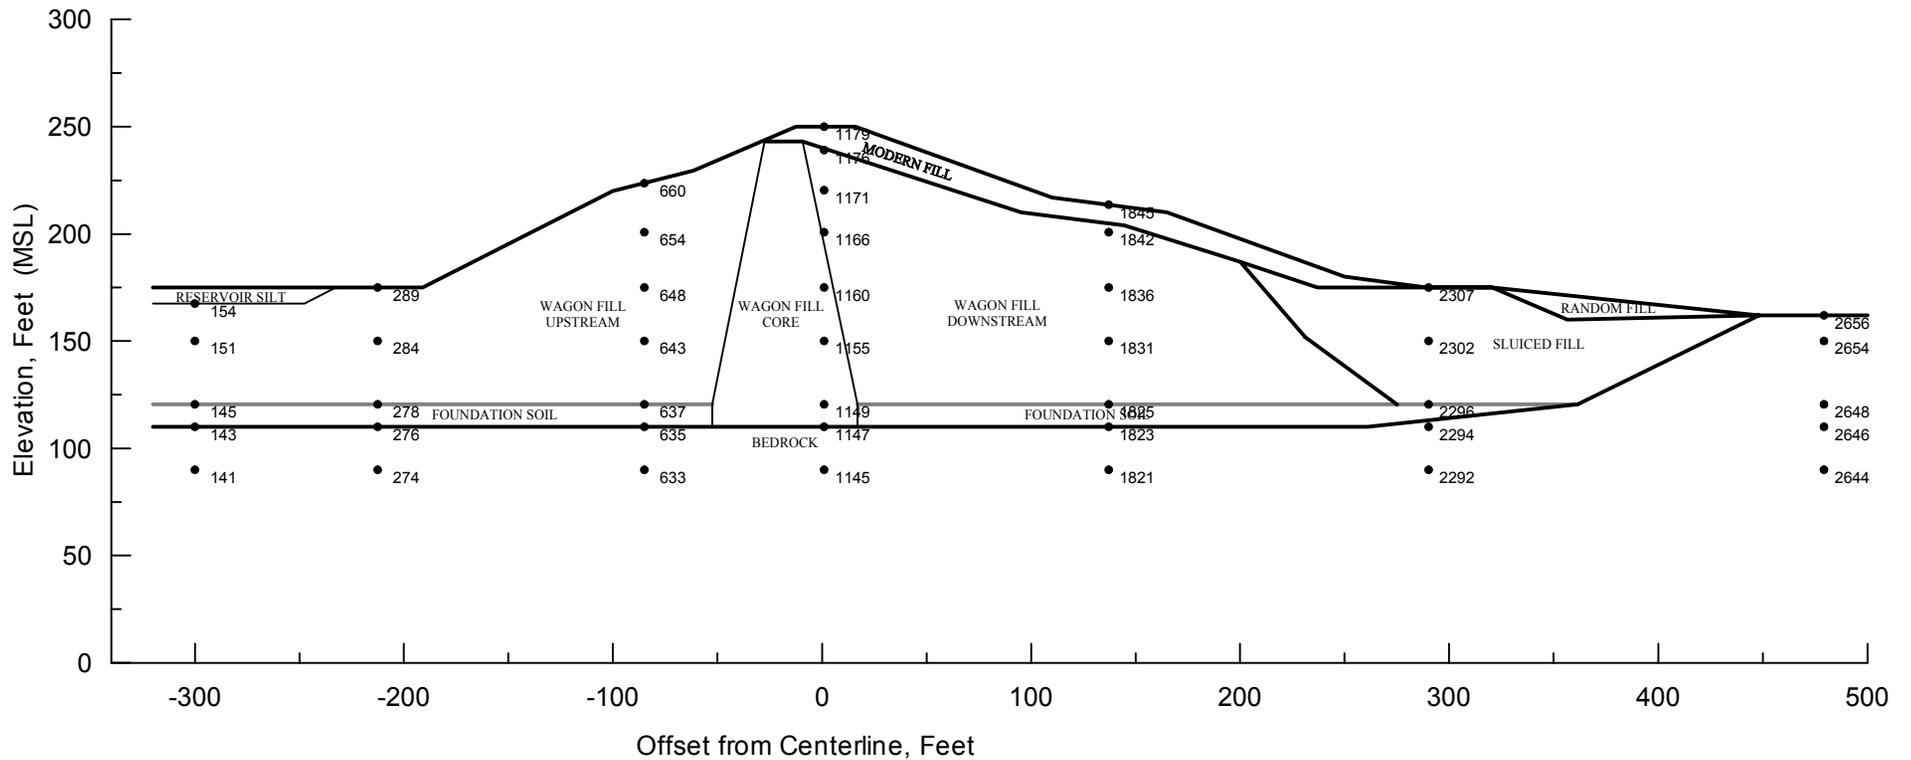
Project No. 26814536	Chabot Dam Seismic Stability Analysis	Selected Nodal Points For Acceleration Outputs QUAD4M Analysis	Figure 10-8
URS

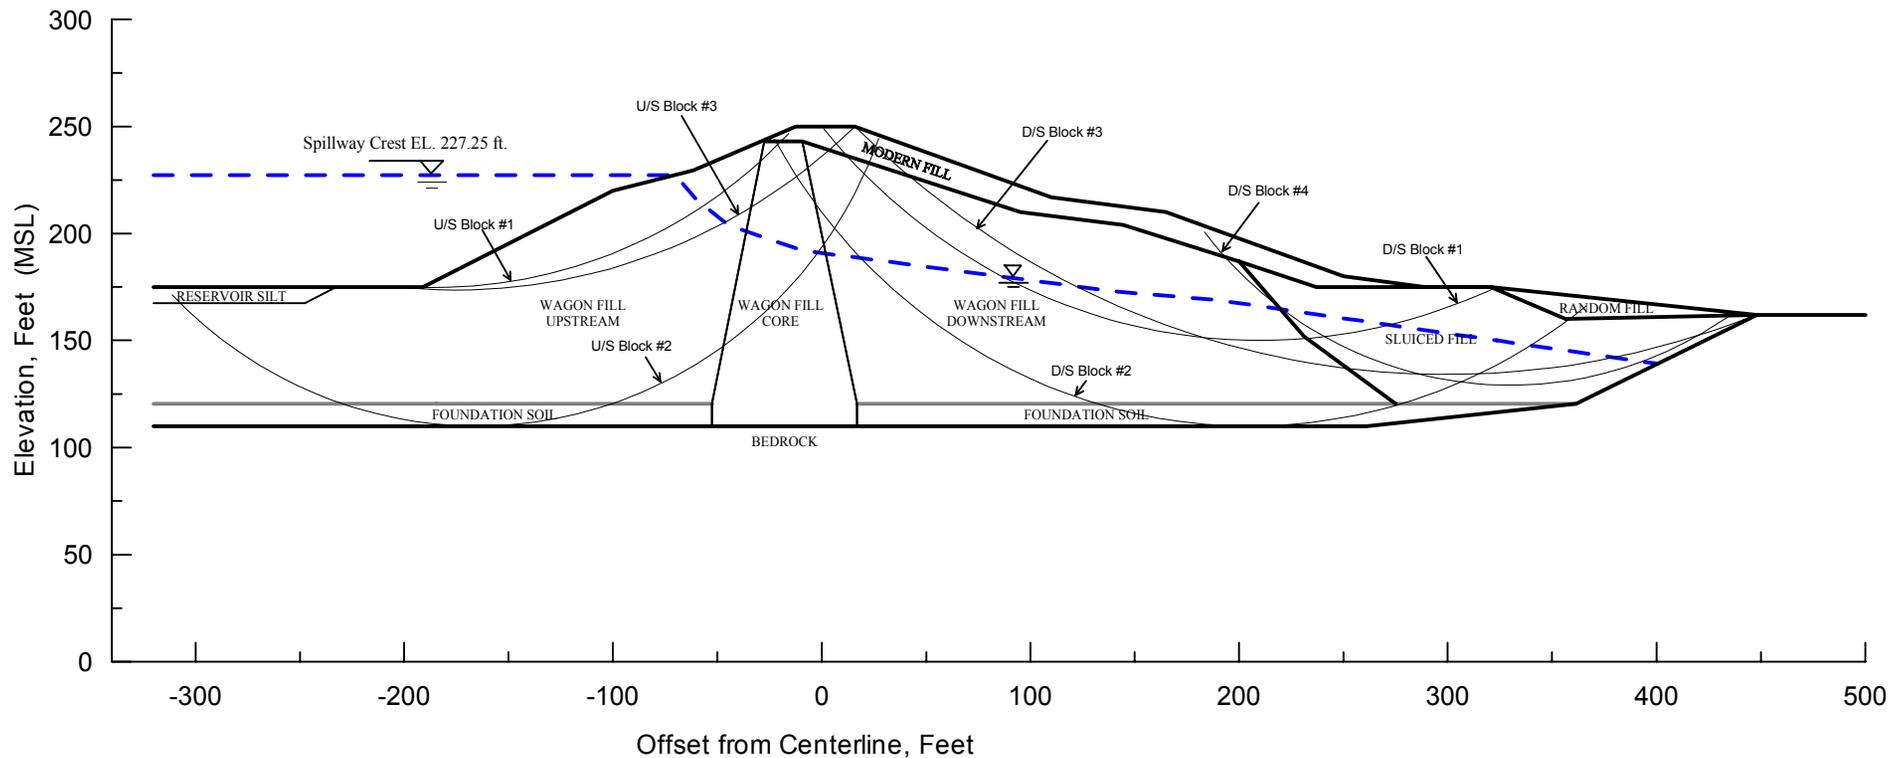
Project No. 26814536	Chabot Dam Seismic Stability Analysis	Sliding Blocks for Newmark Deformation Analyses Cross Section A-A'	Figure
URS			10-9

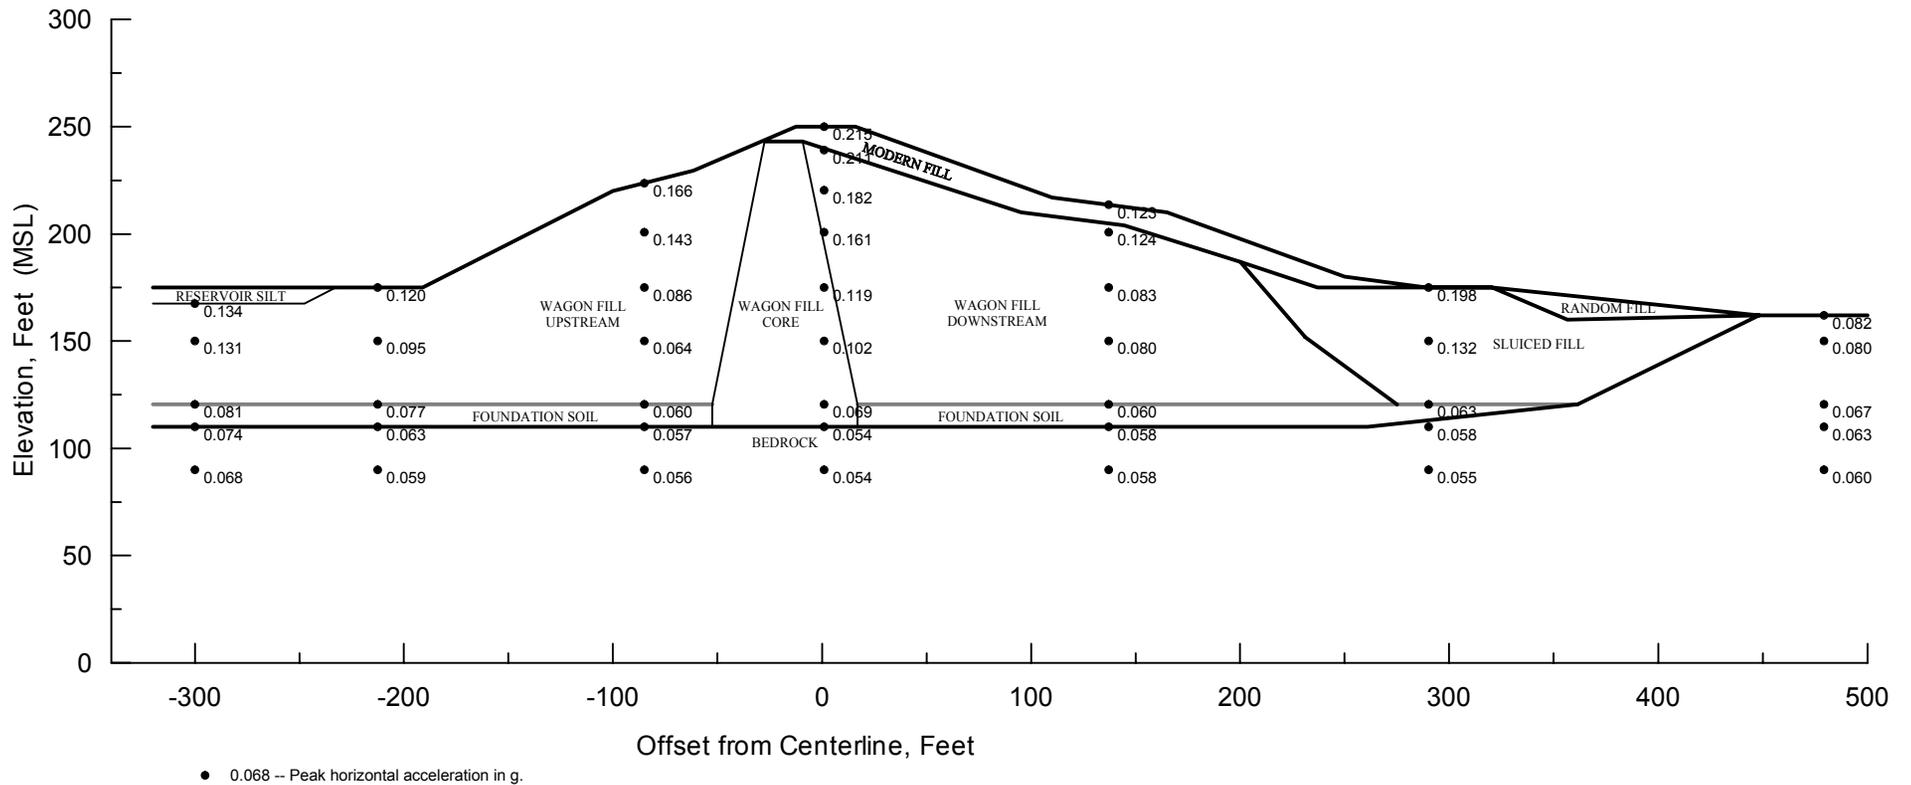
Project No. 26814536	Chabot Dam Seismic Stability Analysis	Peak Horizontal Acceleration QUAD4M Analysis 1989 Loma Prieta Earthquake	Figure 10-10
URS

The dynamic response analysis results are presented in Figures 10-10 through 10-24. The results of the analyses for the Loma Prieta earthquake are presented first, followed by the results for the Hayward and San Andreas events.

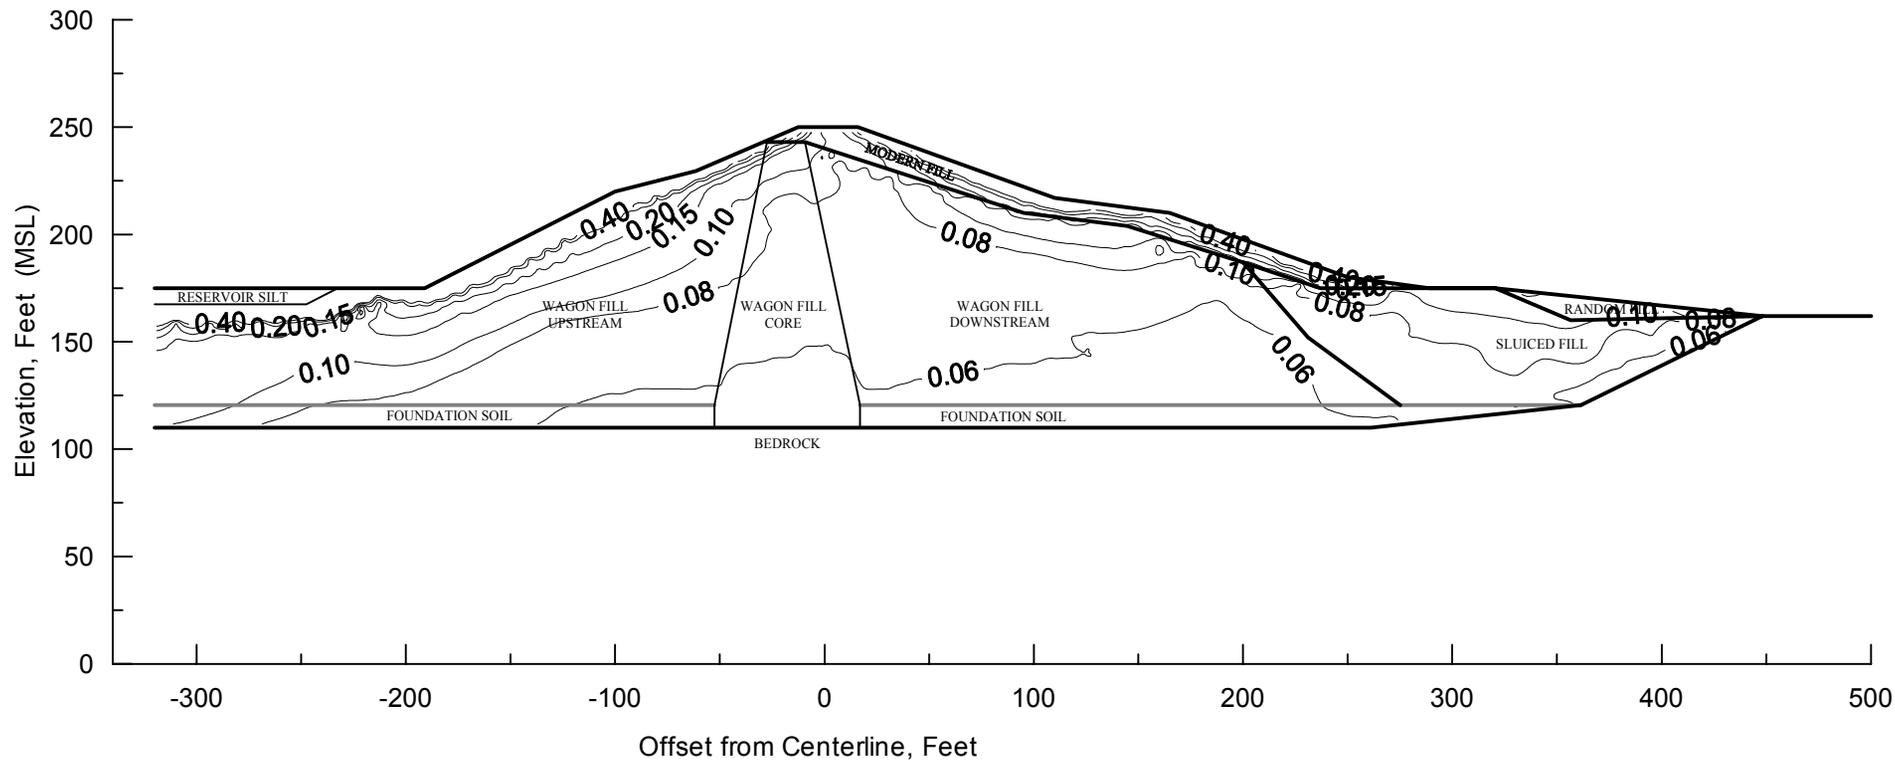
Project No. 26814536	Chabot Dam Seismic Stability Analysis	Cyclic Stress Ratio QUAD4M Analysis	Figure
URS		1989 Loma Prieta Earthquake	10-11

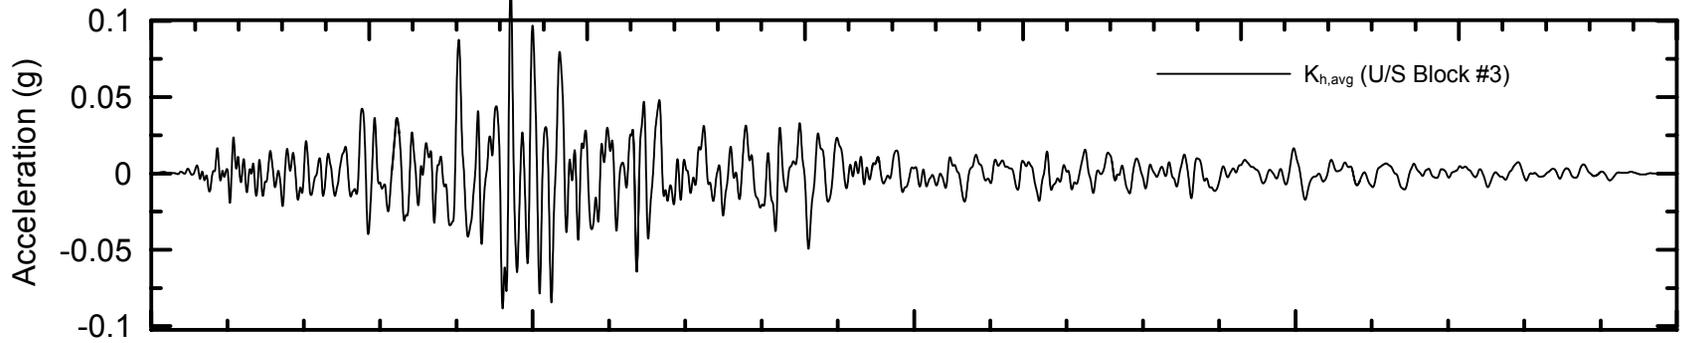
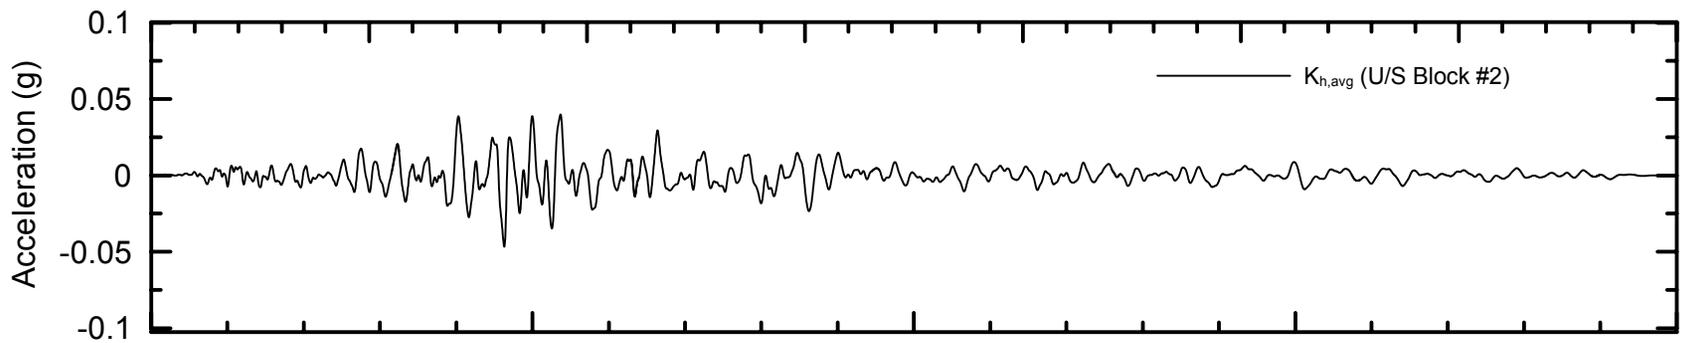
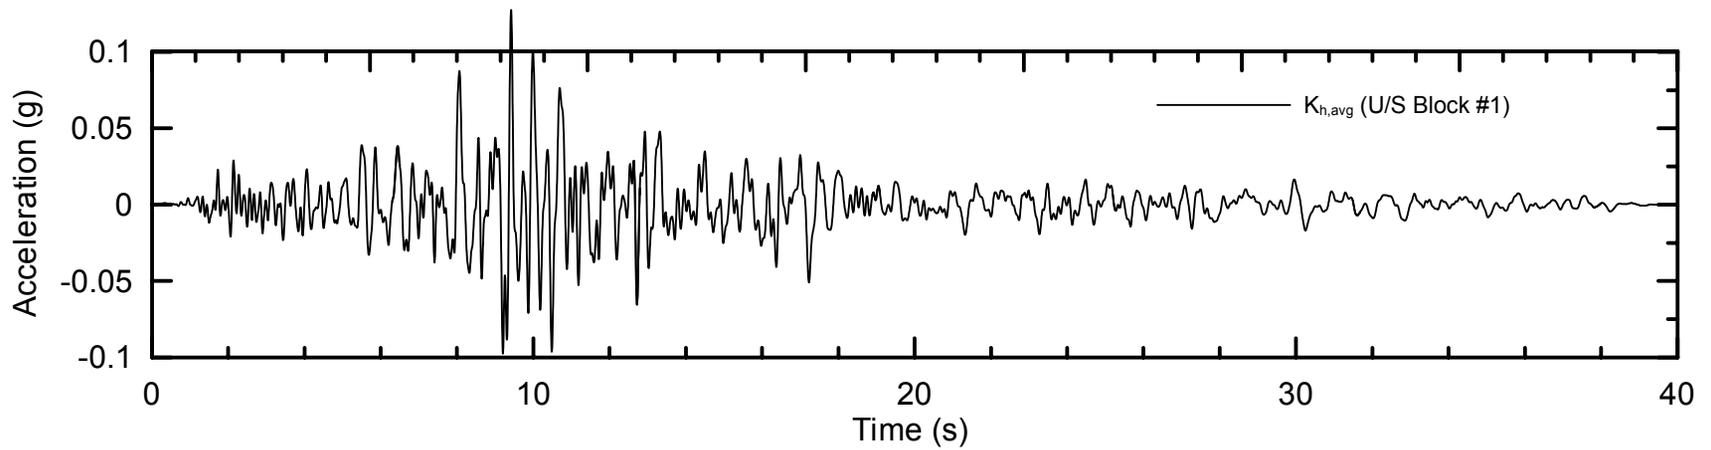
Project No. 26814536	Chabot Dam Seismic Stability Analysis	Average Mass Acceleration Upstream Sliding Blocks QUAD4M Analysis 1989 Loma Prieta Earthquake	Figure 10-12
URS

For the Loma Prieta earthquake, little strength degradation is expected during the earthquake and the peak mass acceleration for each block (see Figures 10-12 through 10-14) is less than the corresponding yield acceleration (see Figure 9-10). Thus, the calculated deformations are nil, and it may be concluded that the calculated dynamic response and seismic deformations from the Newmark-type analyses are in good agreement with the known performance of the dam during that earthquake.

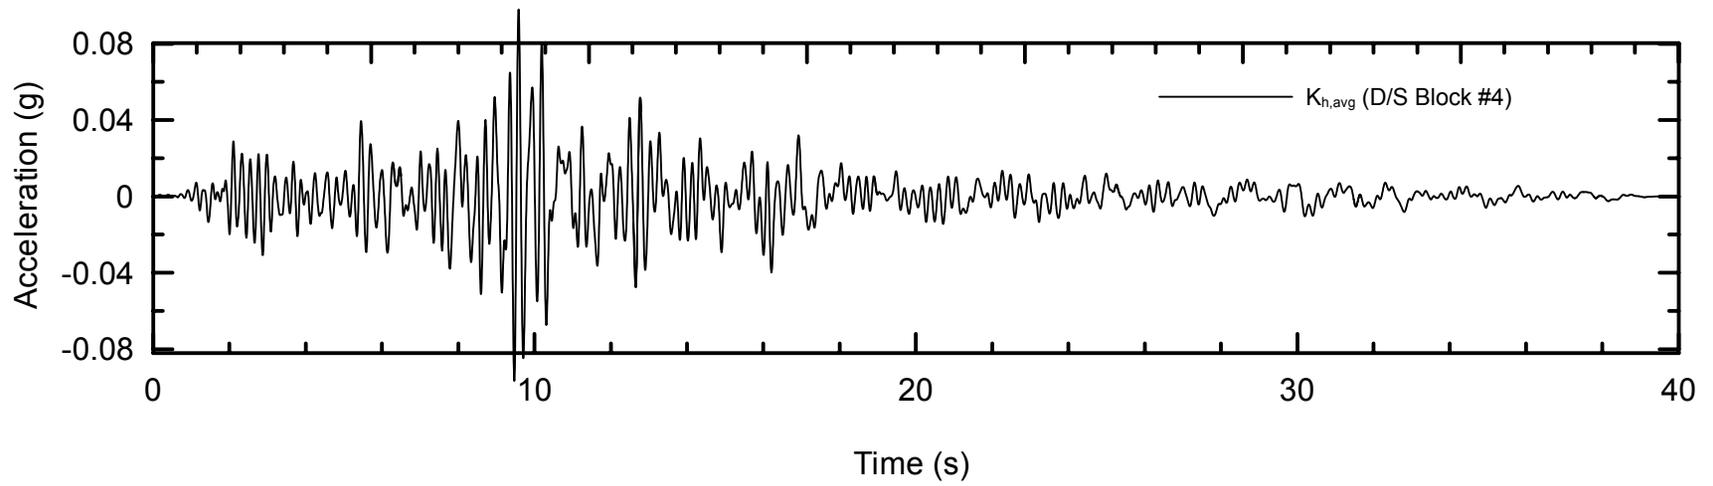
Project No. 26814536	Chabot Dam Seismic Stability Analysis	Average Mass Acceleration Downstream Sliding Block #4 QUAD4M Analysis	Figure
URS		1989 Loma Prieta Earthquake	10-14

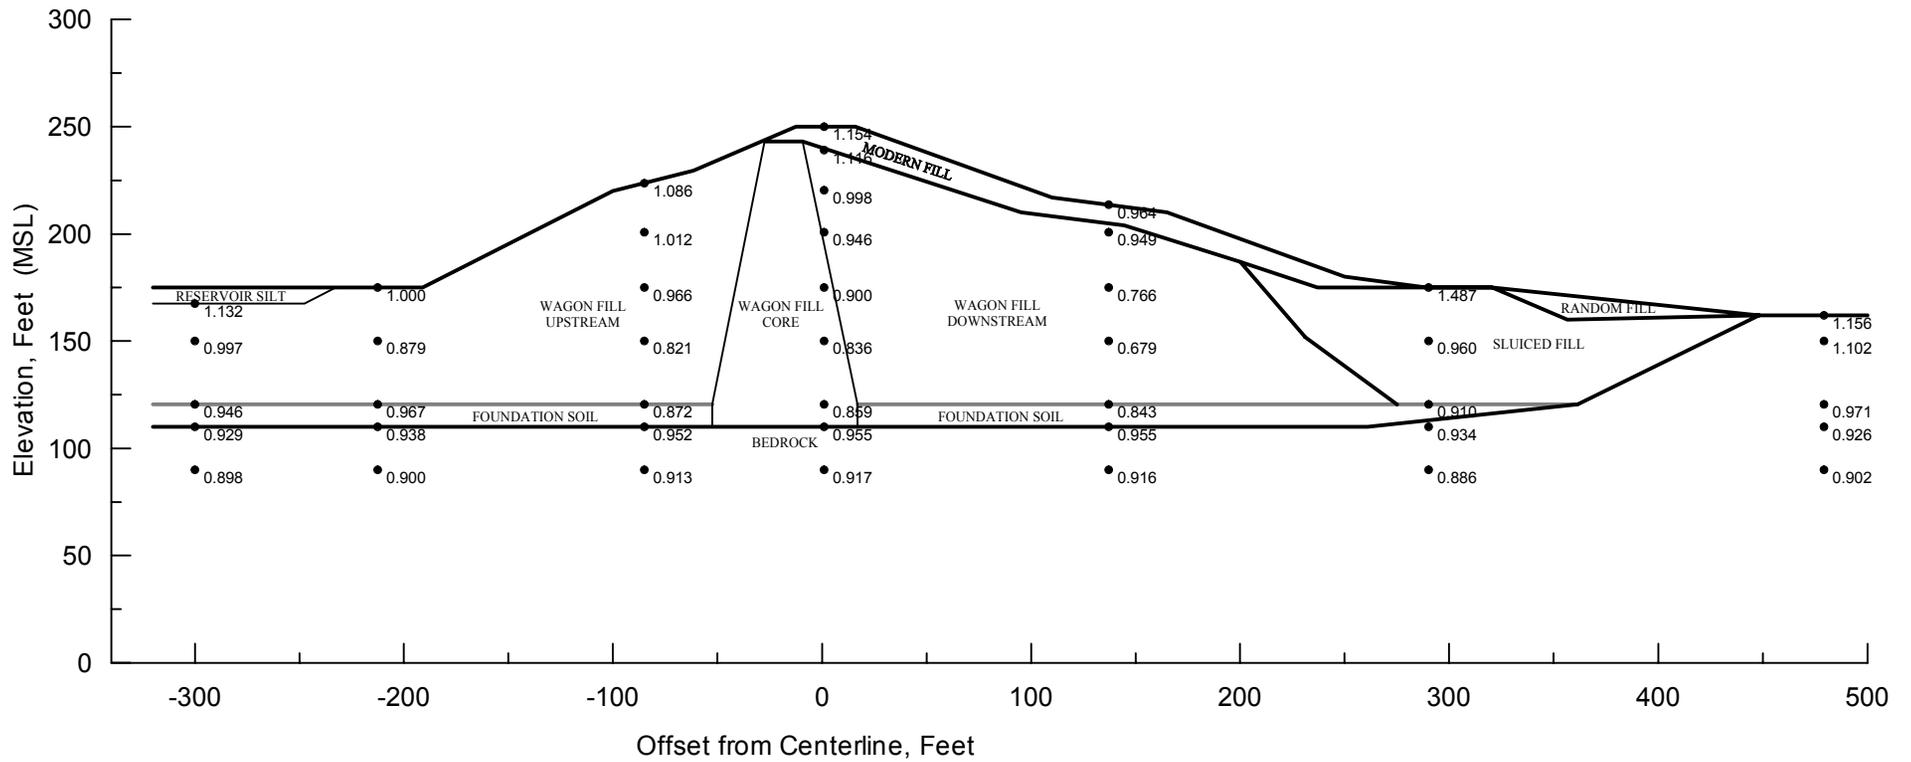
● 0.898 -- Peak horizontal acceleration in g.

Project No. 26814536	Chabot Dam Seismic Stability Analysis	Peak Horizontal Acceleration QUAD4M Analysis Hayward Fault MCE TH #1	Figure 10-15
URS

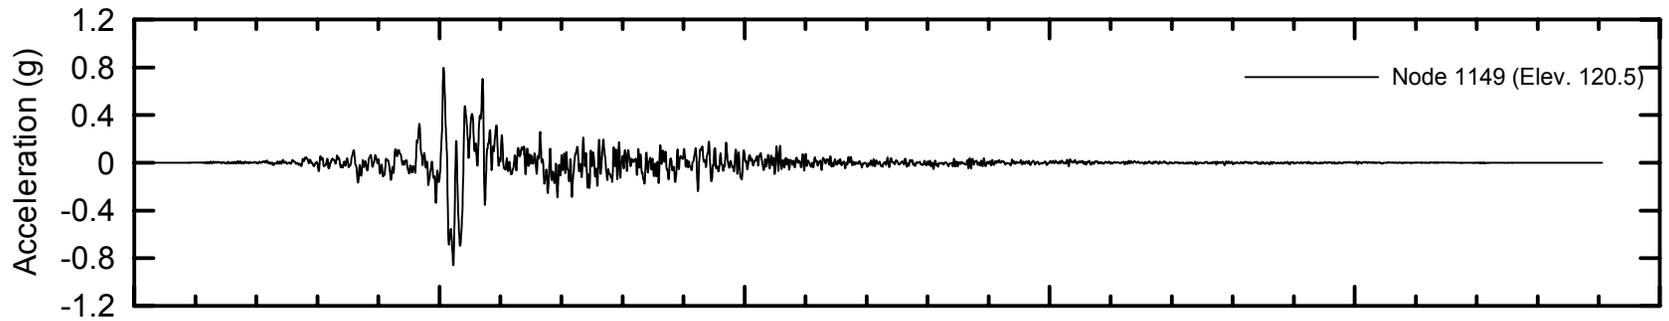
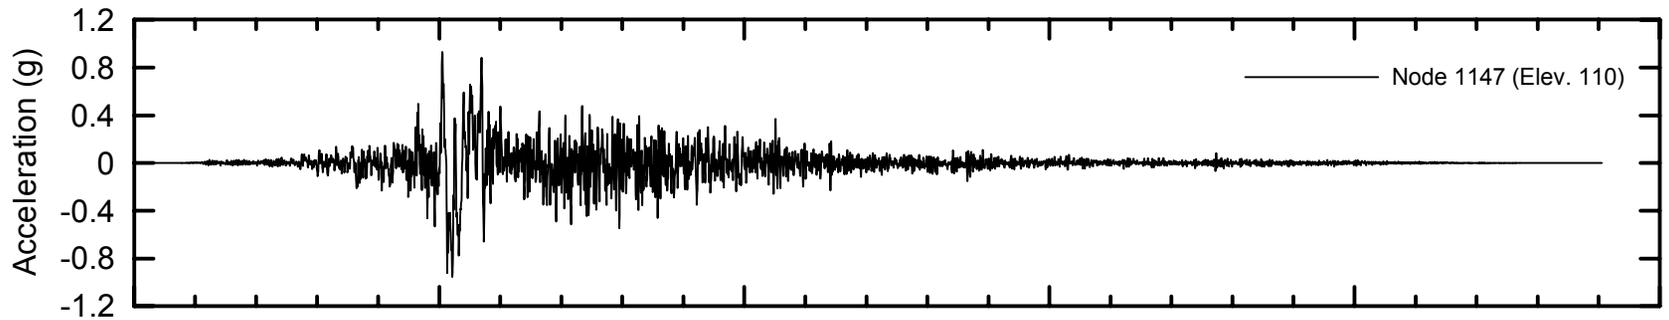
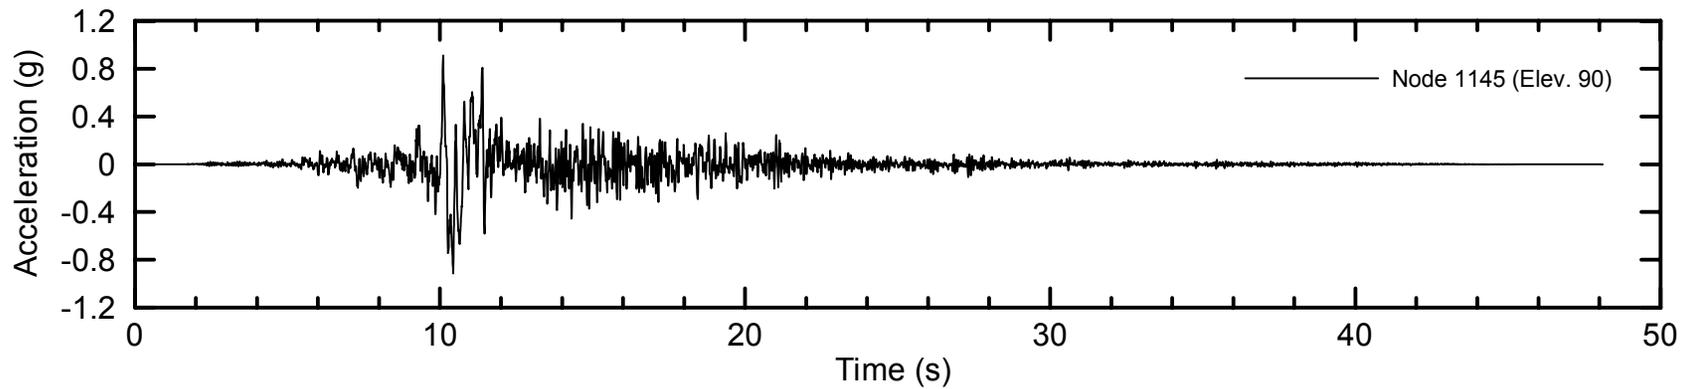
Project No. 26814536	Chabot Dam Seismic Stability Analysis	Acceleration Time History Beneath Crest Nodes 1145, 1147 and 1149 Hayward Fault MCE TH #1	Figure
URS			10-16

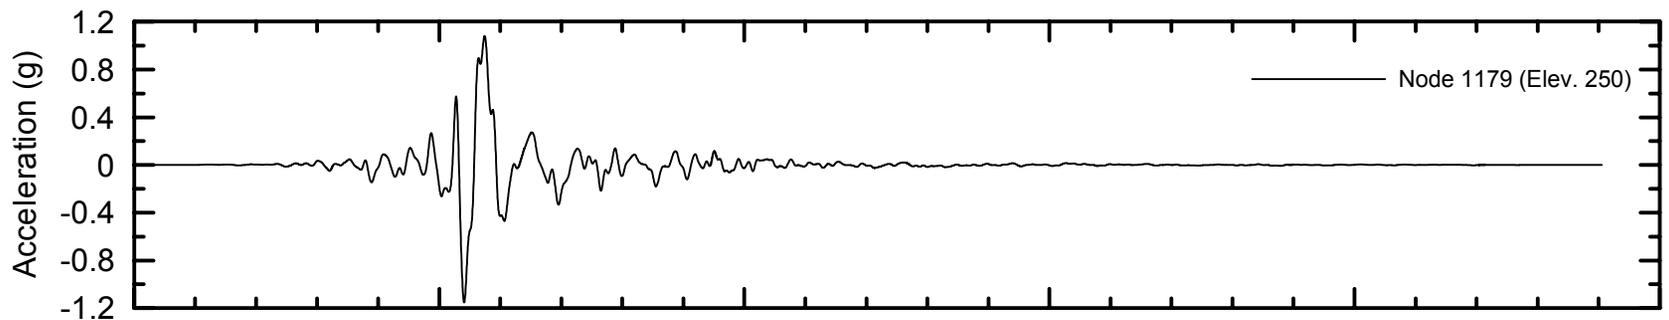
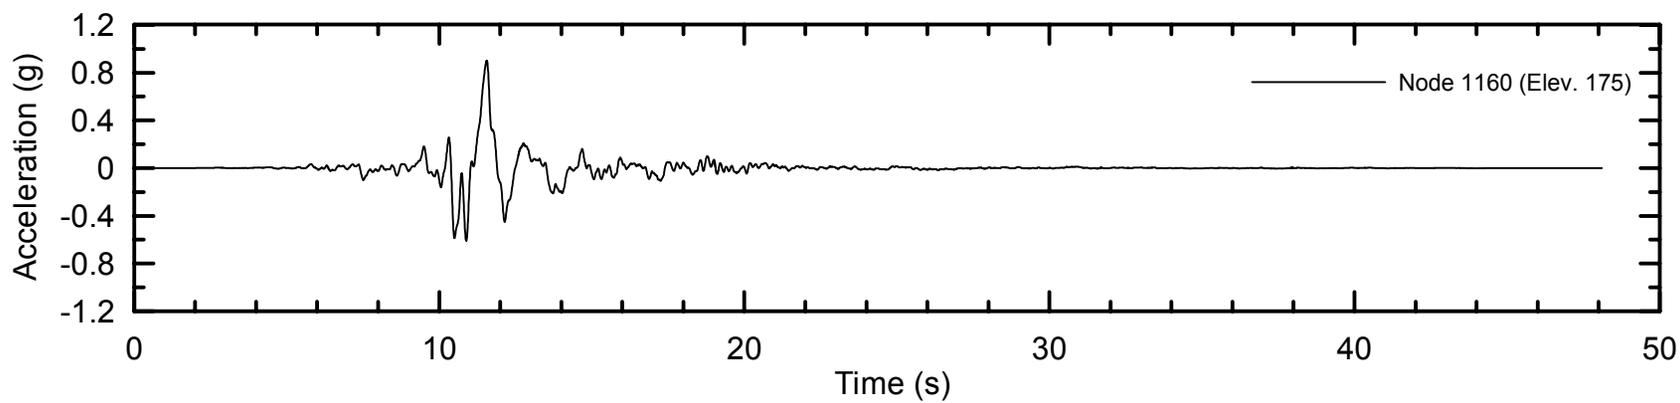
Project No. 26814536	Chabot Dam Seismic Stability Analysis	Acceleration Time History Beneath Crest Nodes 1160 and 1179	Figure 10-17
URS		Hayward Fault MCE TH #1

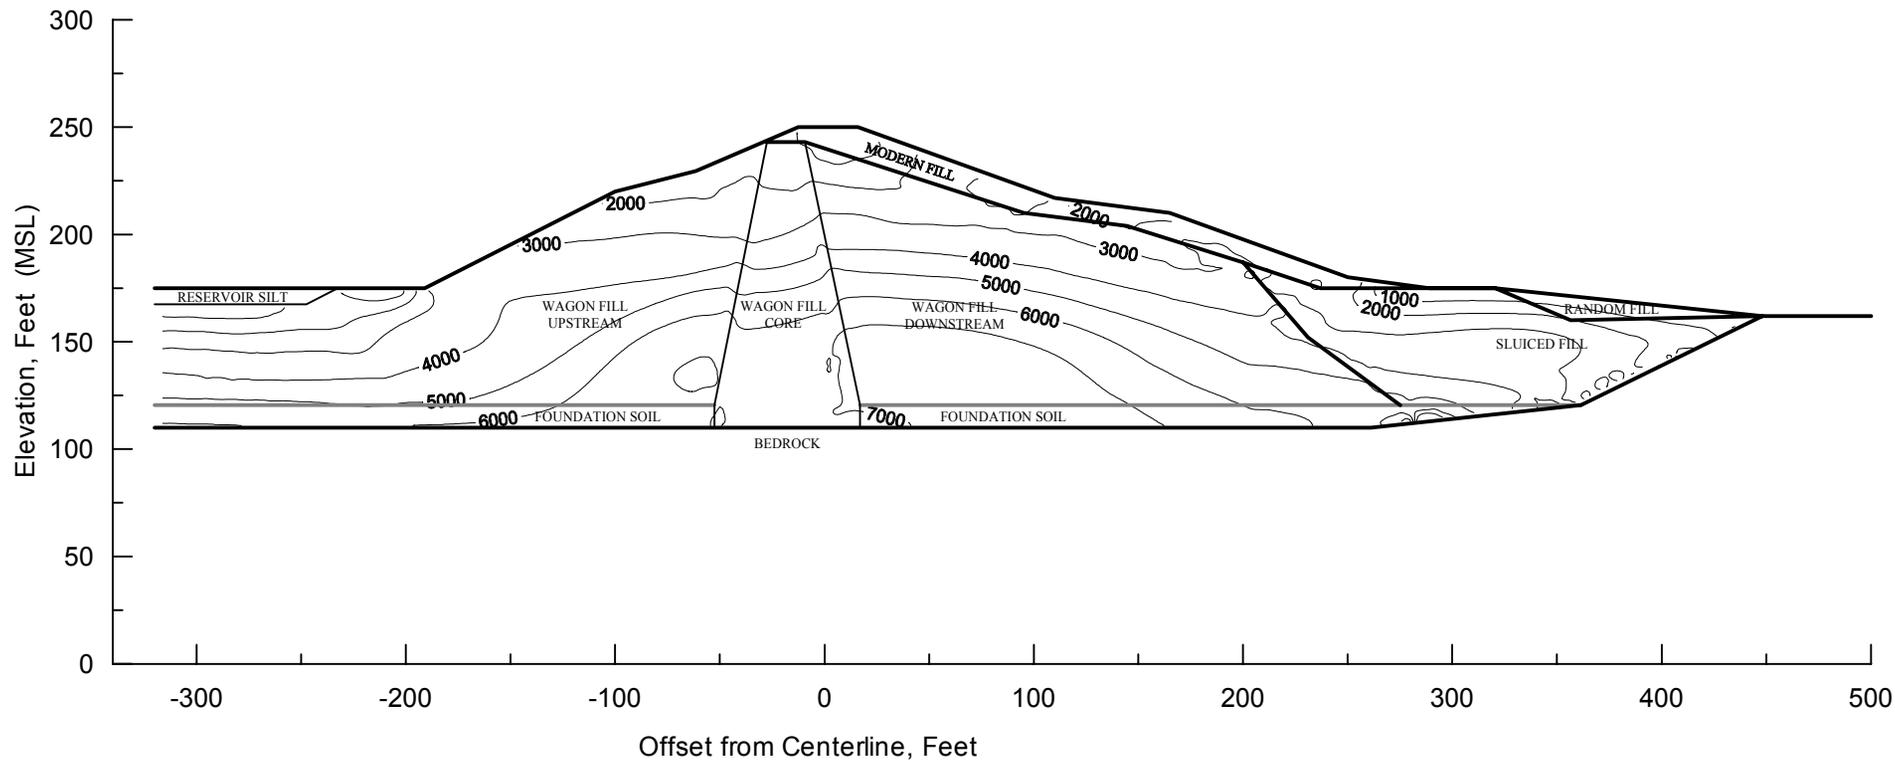
Notes: Peak shear stress contour values in pounds per square foot (psf)

Project No. 26814536	Chabot Dam Seismic Stability Analysis	Peak Shear Stress QUAD4M Analysis Hayward Fault MCE TH #1	Figure 10-18
URS

Figure 10-21 shows contours of cyclic stress ratio calculated from the peak shear stresses shown in Figure 10-18. The time histories of average mass acceleration for the selected sliding blocks used in the Newmark-type deformation analyses are shown in Section 11.

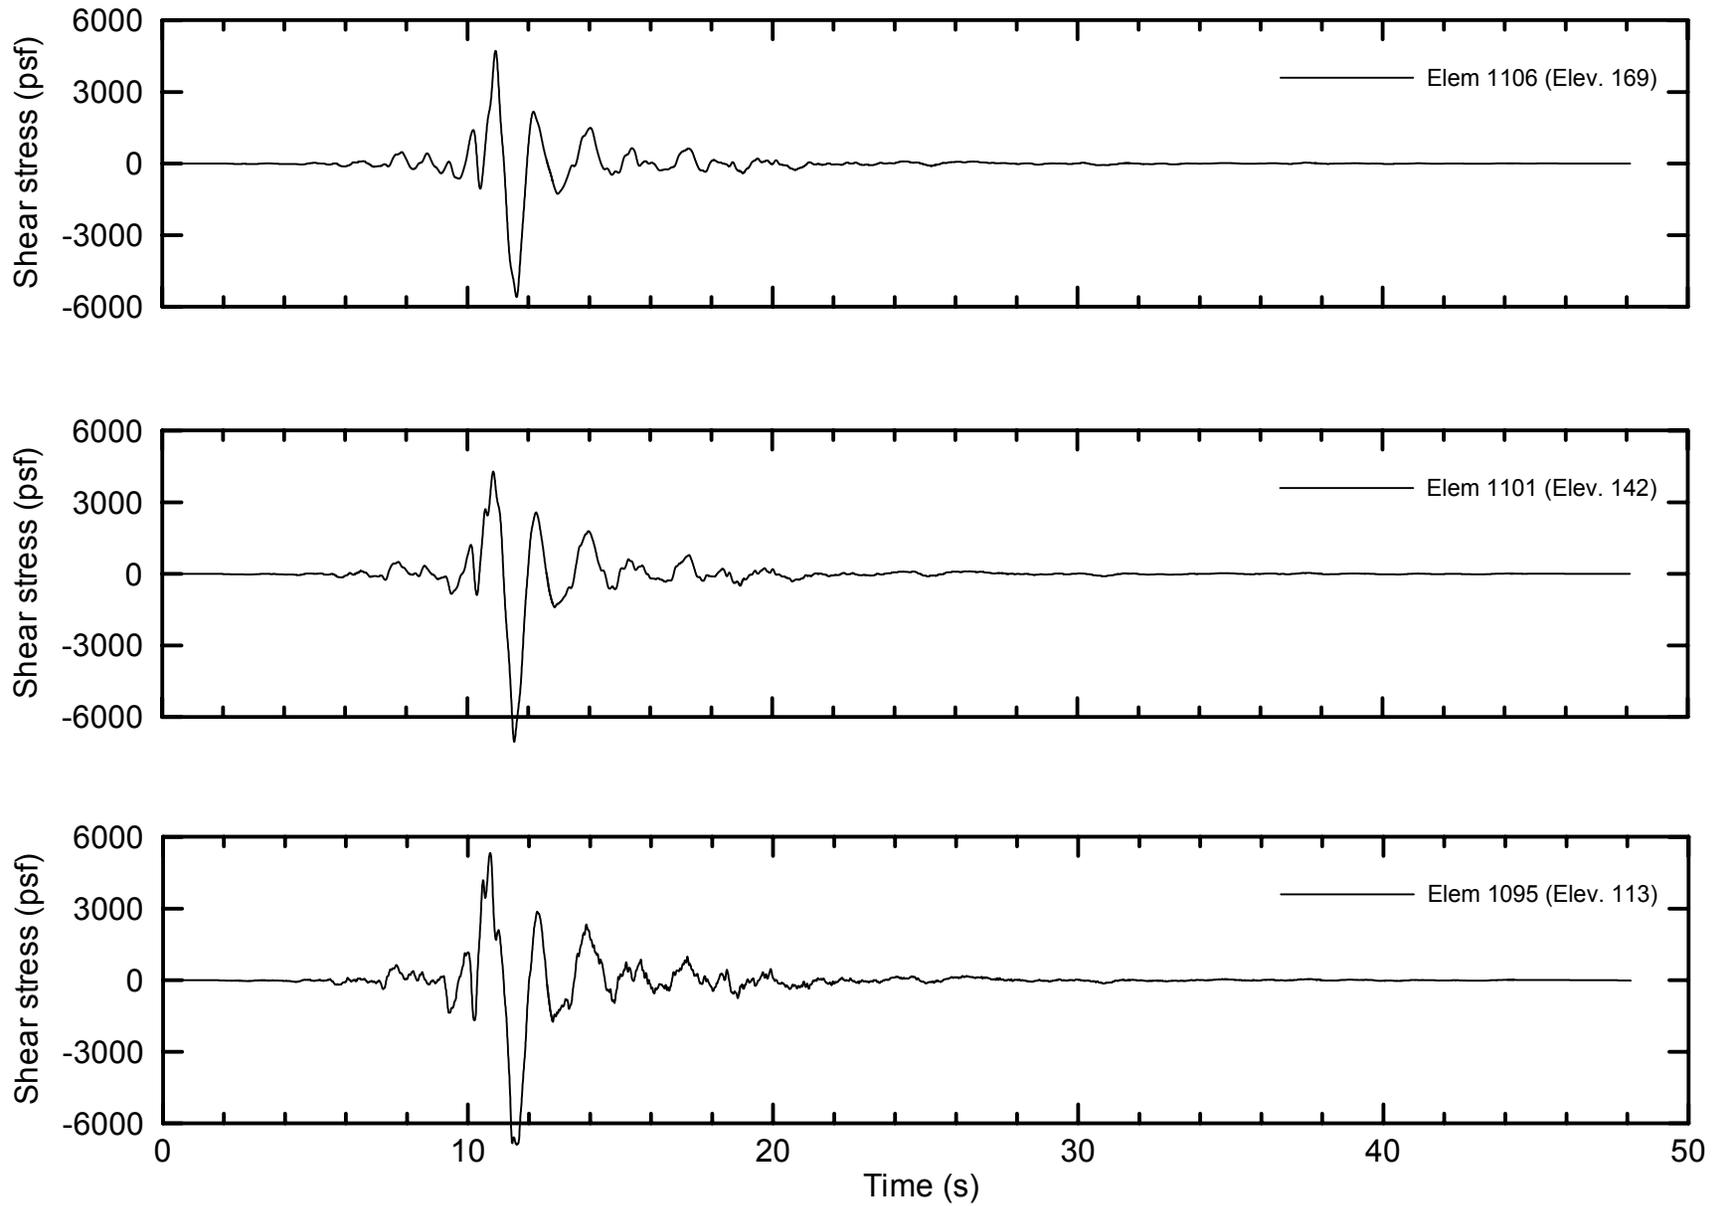
Project No. 26814536	Chabot Dam Seismic Stability Analysis	Shear Stress Time History Beneath Crest Elements 1095, 1101, and 1106 Hayward Fault MCE TH #1	Figure
URS			10-19

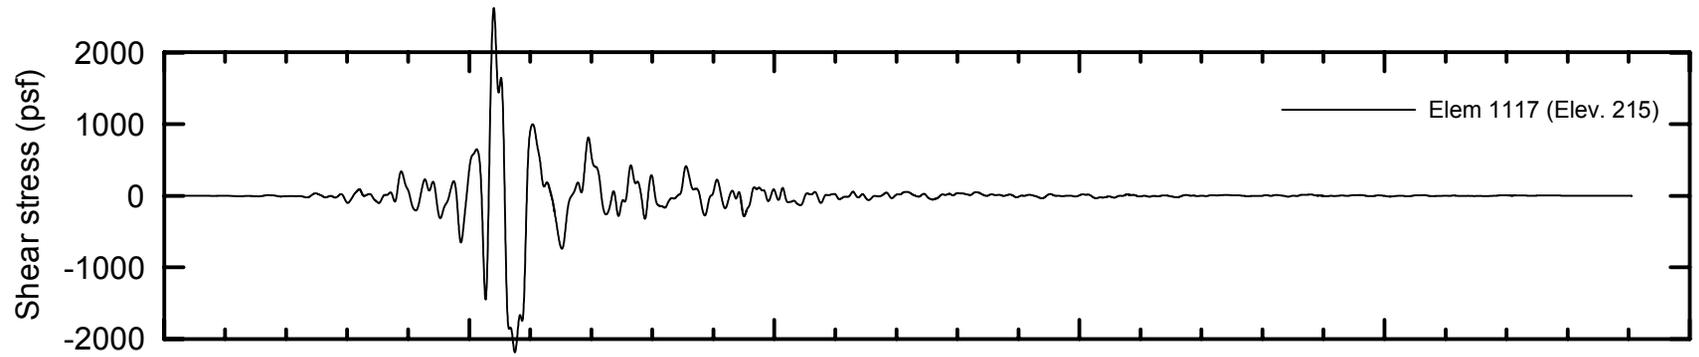
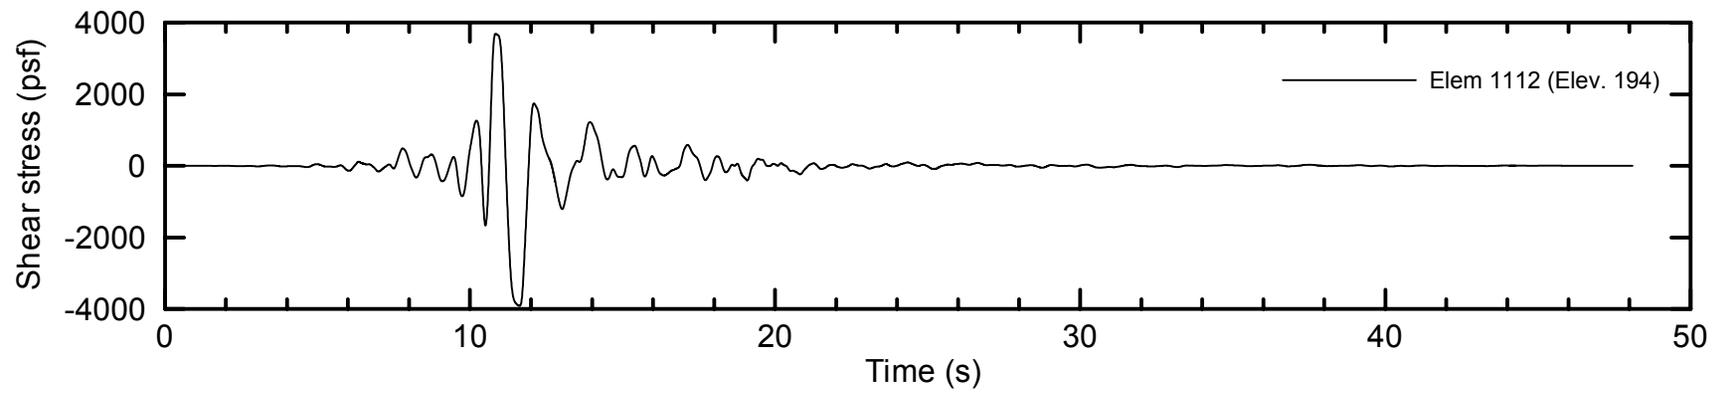
Project No. 26814536	Chabot Dam Seismic Stability Analysis	Shear Stress Time History Beneath Crest Elements 1112 and 1117 Hayward Fault MCE TH #1	Figure
URS			10-20
