FINAL REPORT
VOLUME 1: MAIN REPORT
October 2005

DYNAMIC STABILITY ANALYSIS OF CHABOT DAM

Alameda County, California

**Subject: Dynamic Stability of Chabot Dam
Final Engineering Report**

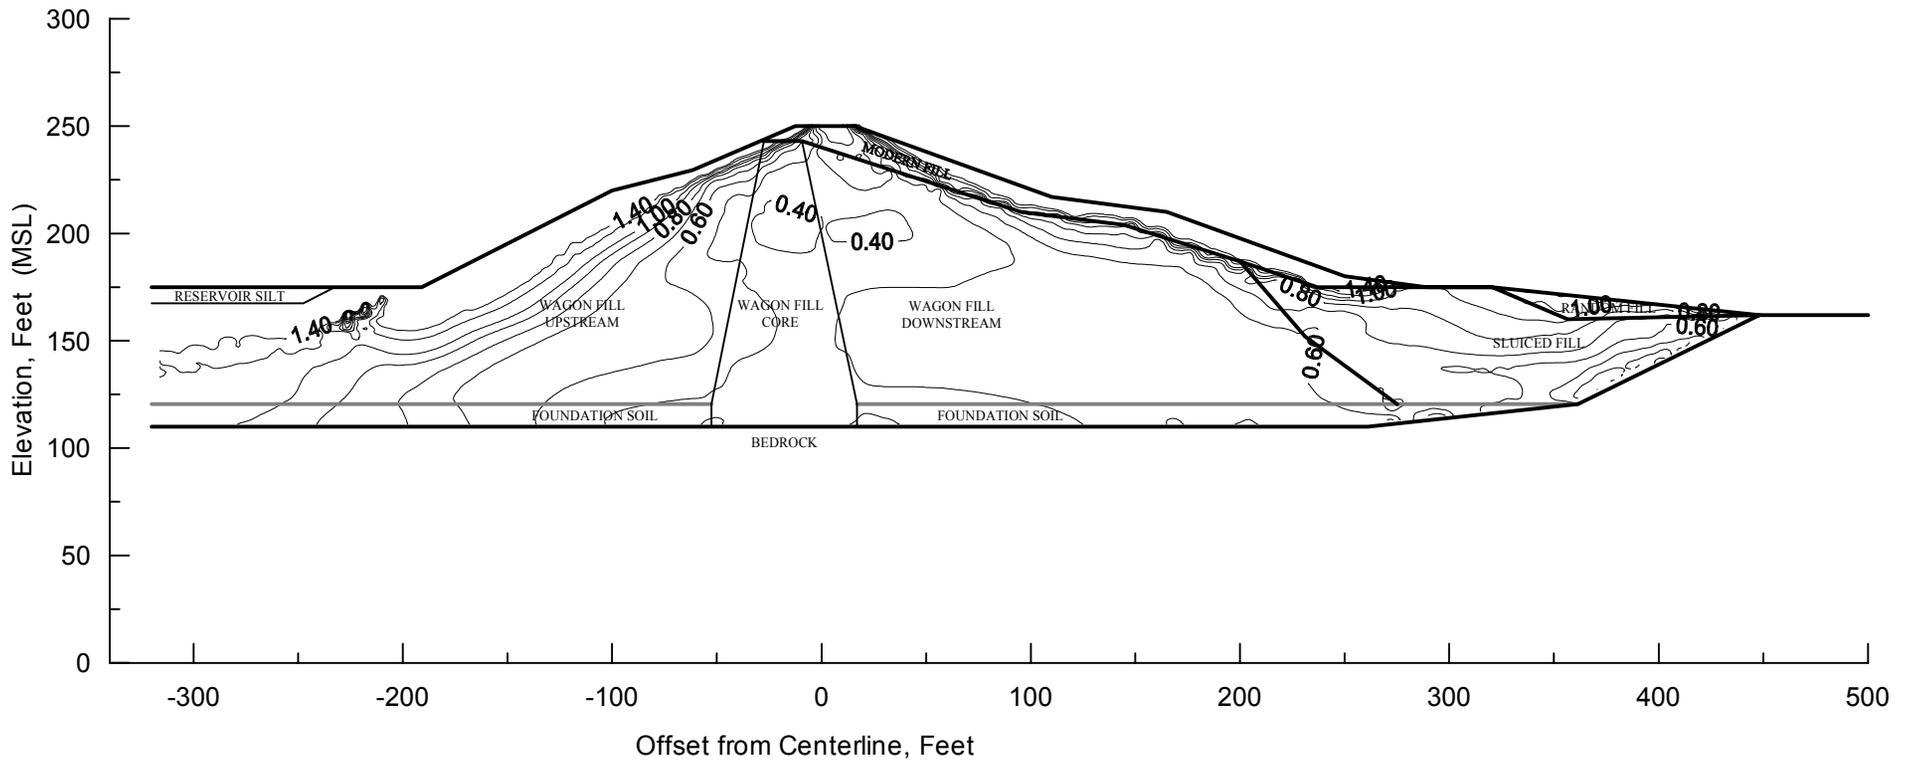
Project No. 26814536	Chabot Dam Seismic Stability Analysis	Cyclic Stress Ratio QUAD4M Analysis Hayward Fault MCE TH #1	Figure 10-21
URS

Figure 10-21 shows contours of cyclic stress ratio calculated from the peak shear stresses shown in Figure 10-18. The time histories of average mass acceleration for the selected sliding blocks used in the Newmark-type deformation analyses are shown in Section 11.

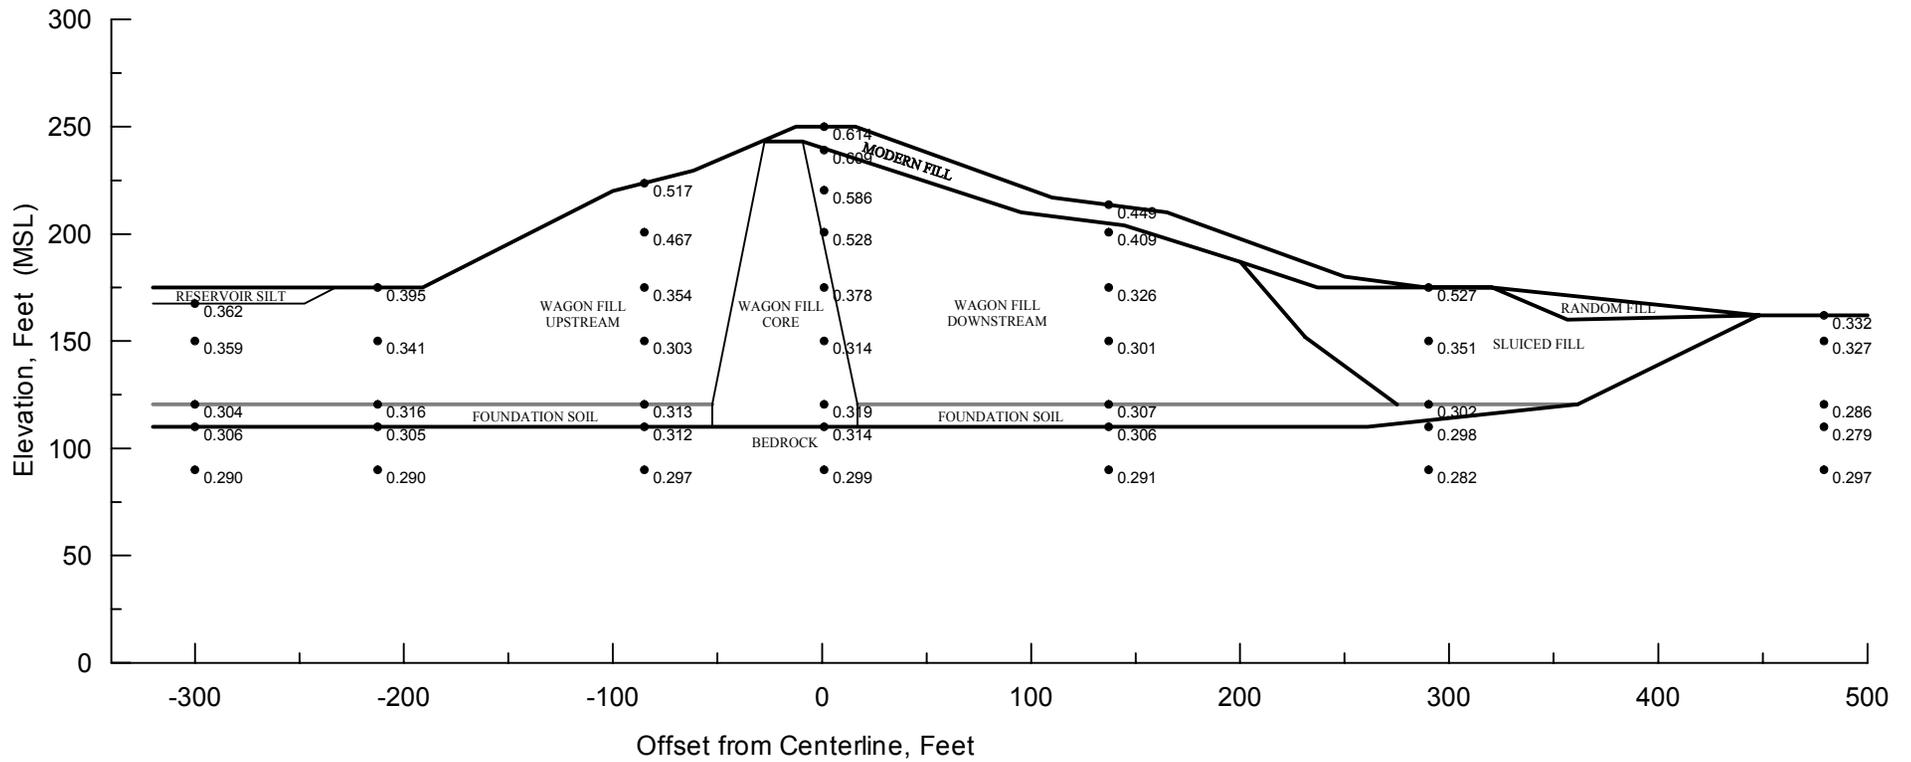
• 0.290 -- Peak horizontal acceleration in g.

Project No. 26814536	Chabot Dam Seismic Stability Analysis	Peak Horizontal Acceleration QUAD4M Analysis San Andreas Fault MCE	Figure
URS			10-22

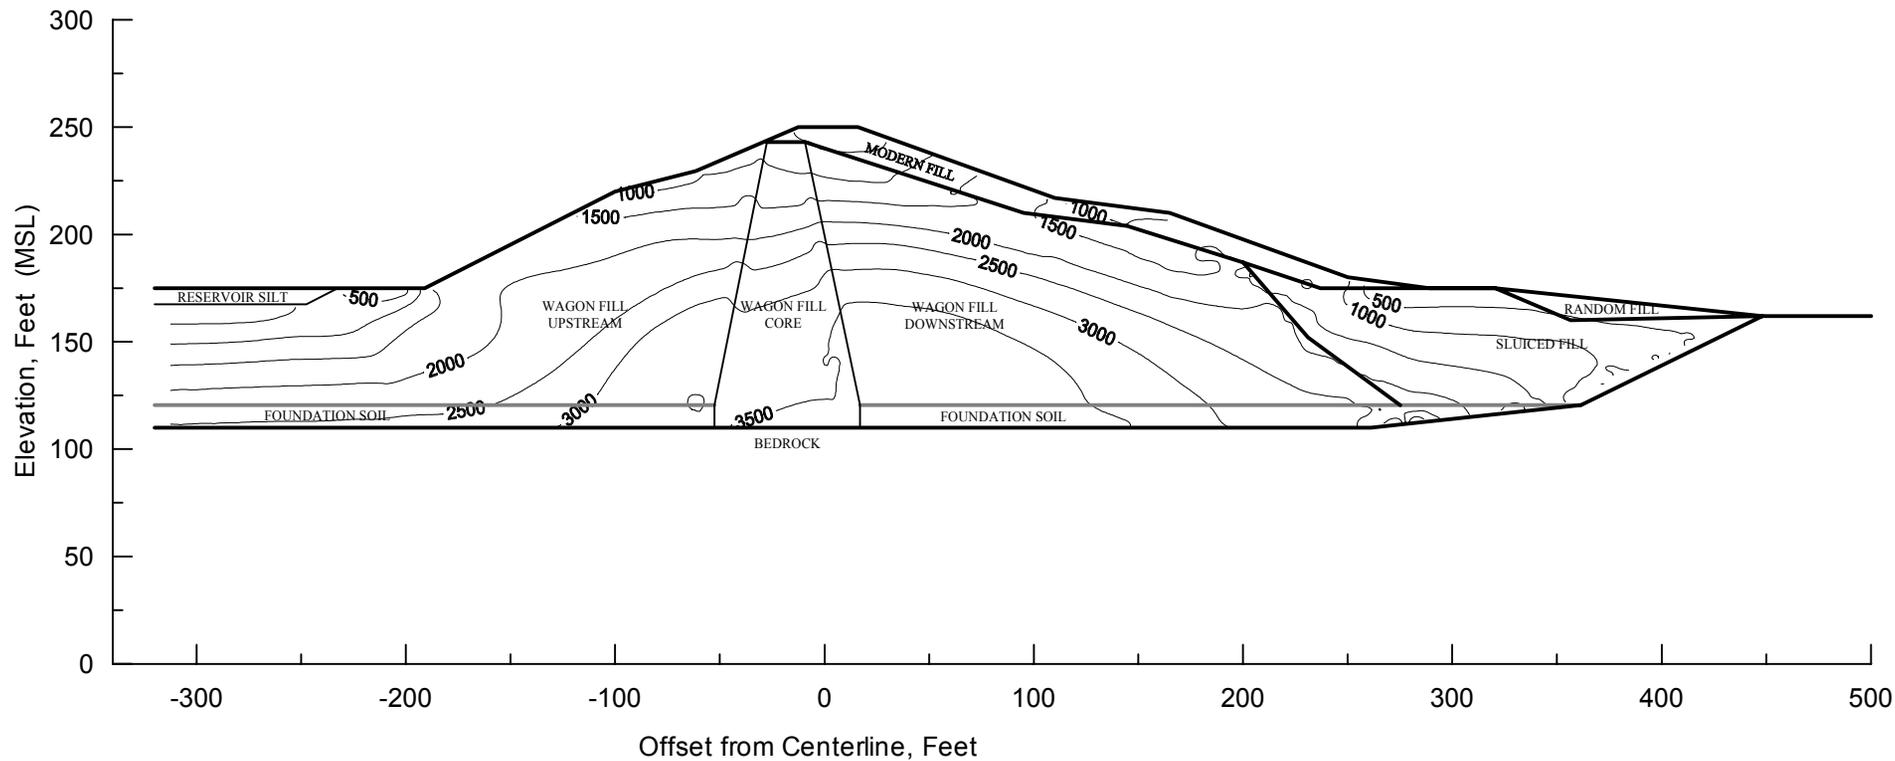
Note: Peak shear stress contour values in pounds per square foot (psf).

Project No. 26814536	Chabot Dam Seismic Stability Analysis	Peak Shear Stress QUAD4M Analysis San Andreas Fault MCE	Figure 10-23
URS

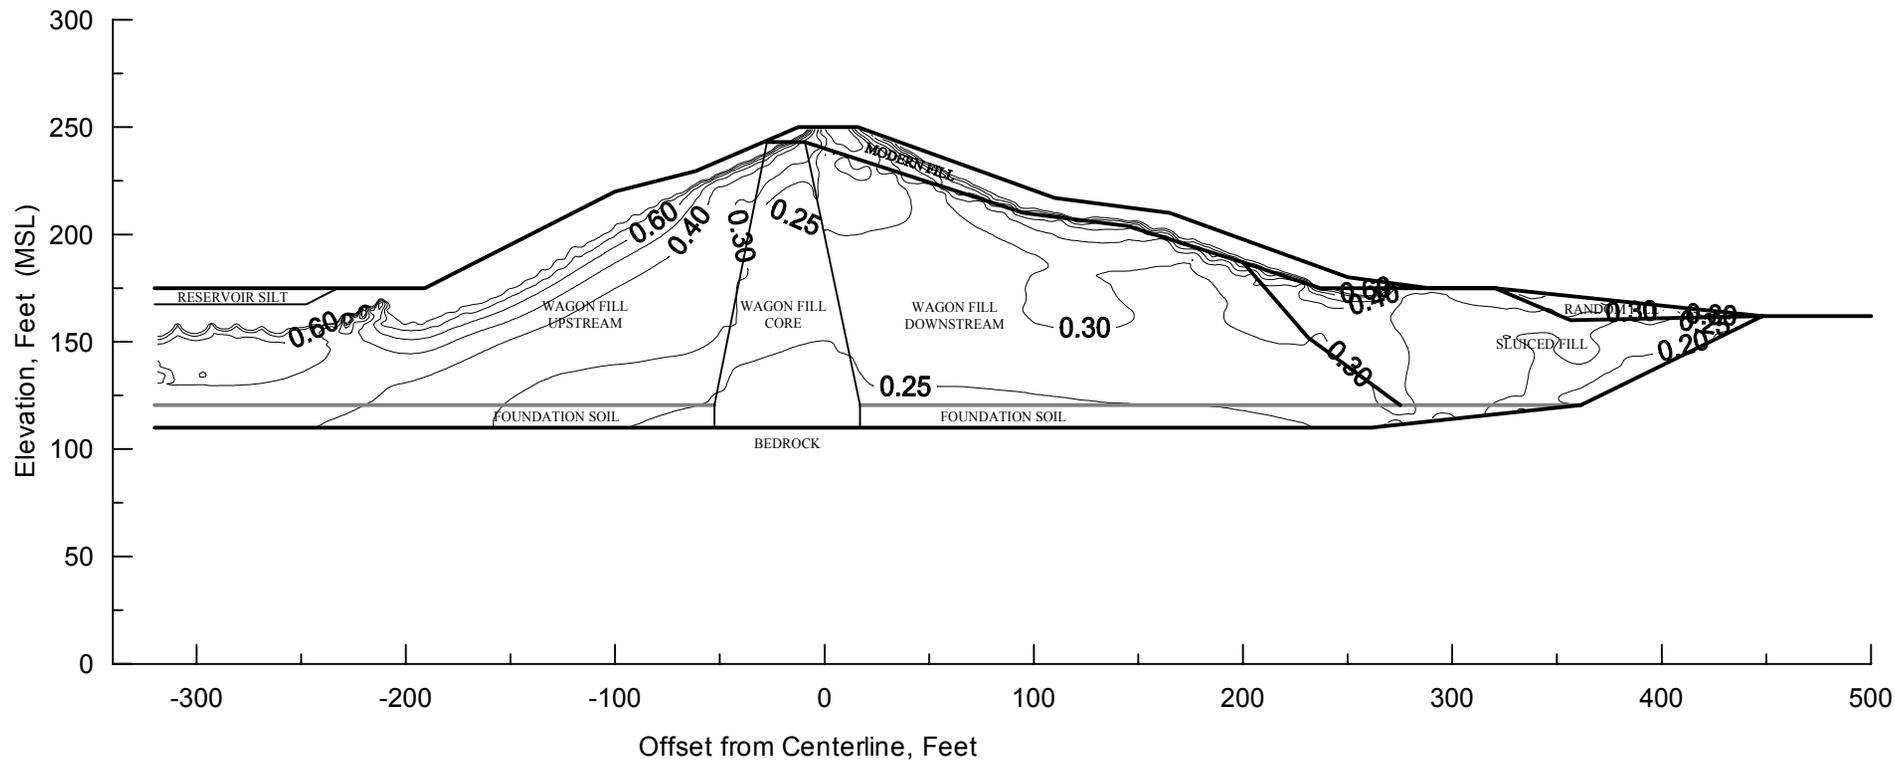
Project No. 26814536	Chabot Dam Seismic Stability Analysis	Cyclic Stress Ratio QUAD4M Analysis San Andreas Fault MCE	Figure 10-24
URS

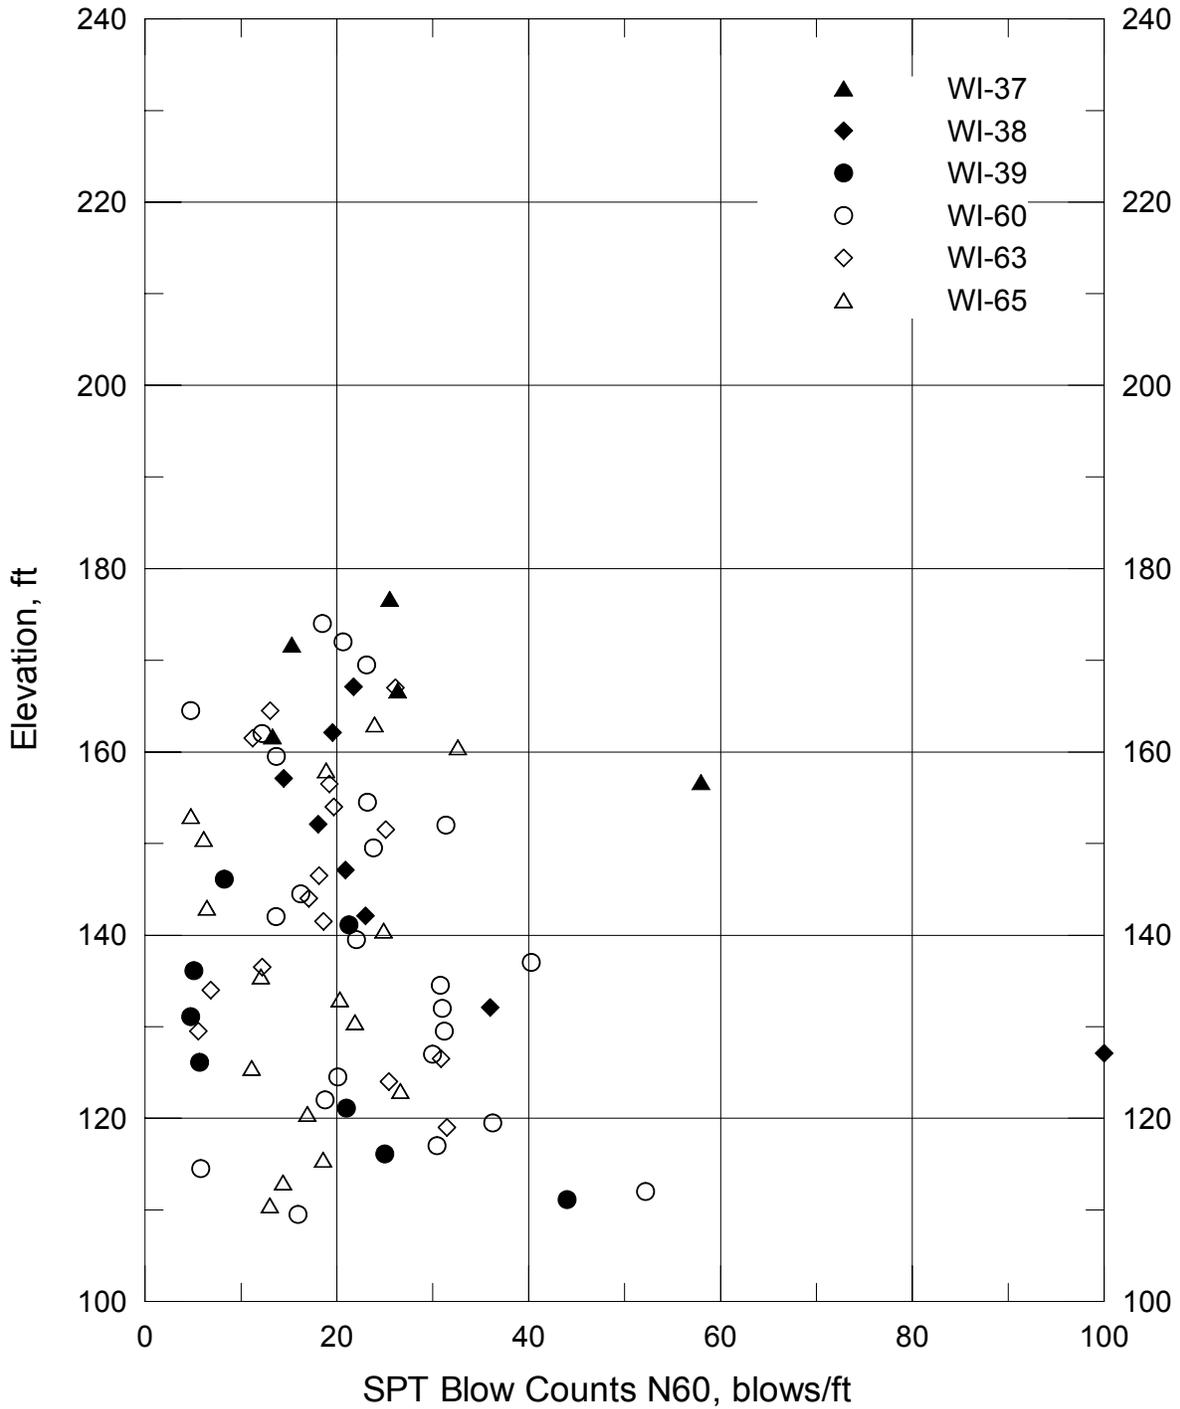
Chabot Dam - SPT blow counts from borings WI-37, 38, 39, 60, 63, and 65

SPT blow counts in the bedrock, or affected by the bedrock, are excluded.

URS	Project No. 26814536	SPT Blow Counts N60 From Borings in Sluiced Fill Zone	Figure
	Chabot Dam Seismic Stability		11-2

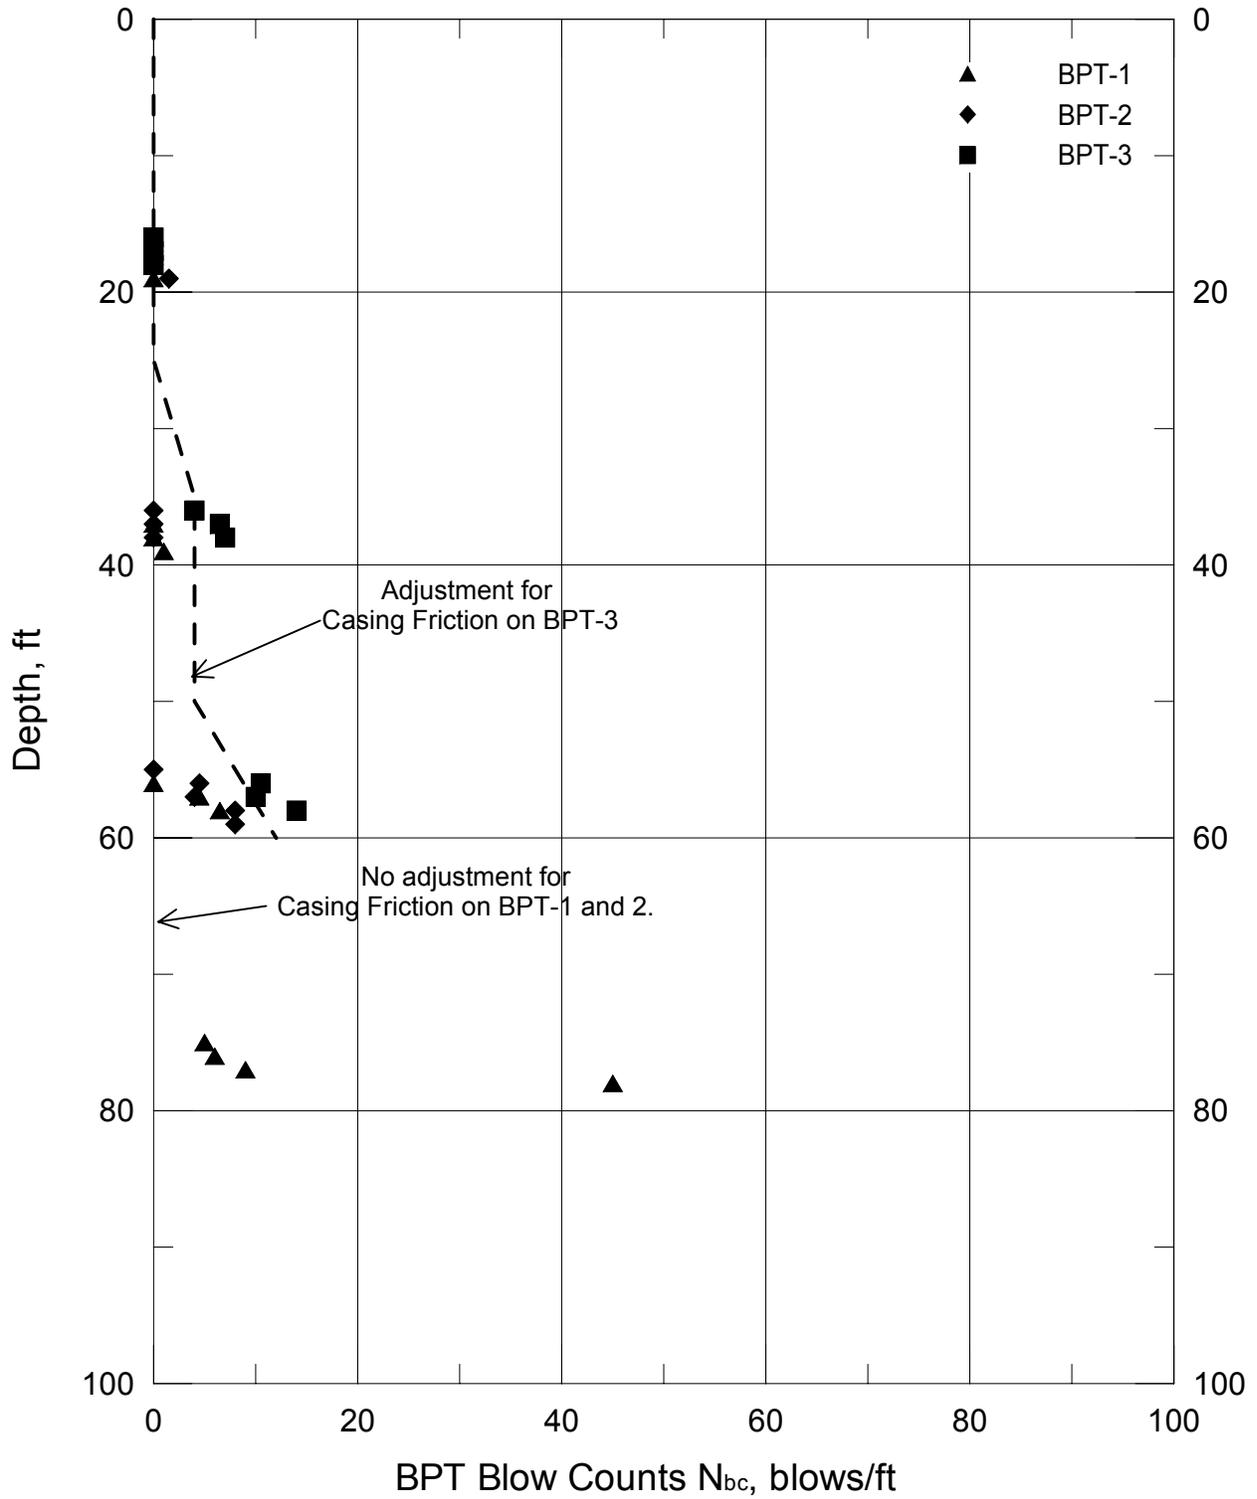
Figure
11-3

Chabot Dam - Becker Hammer Penetration Test Redrives

The BPT testing procedure is described in Section 4 and in Appendix B. Re-drive tests were performed to estimate the effects of casing friction on the BPT blow counts. These tests indicated that casing friction in soundings BPT-1 and 2 was negligible. A small amount of casing friction was observed in sounding BPT-3. The corresponding adjustments to the blow counts are shown in Figure 11-3.

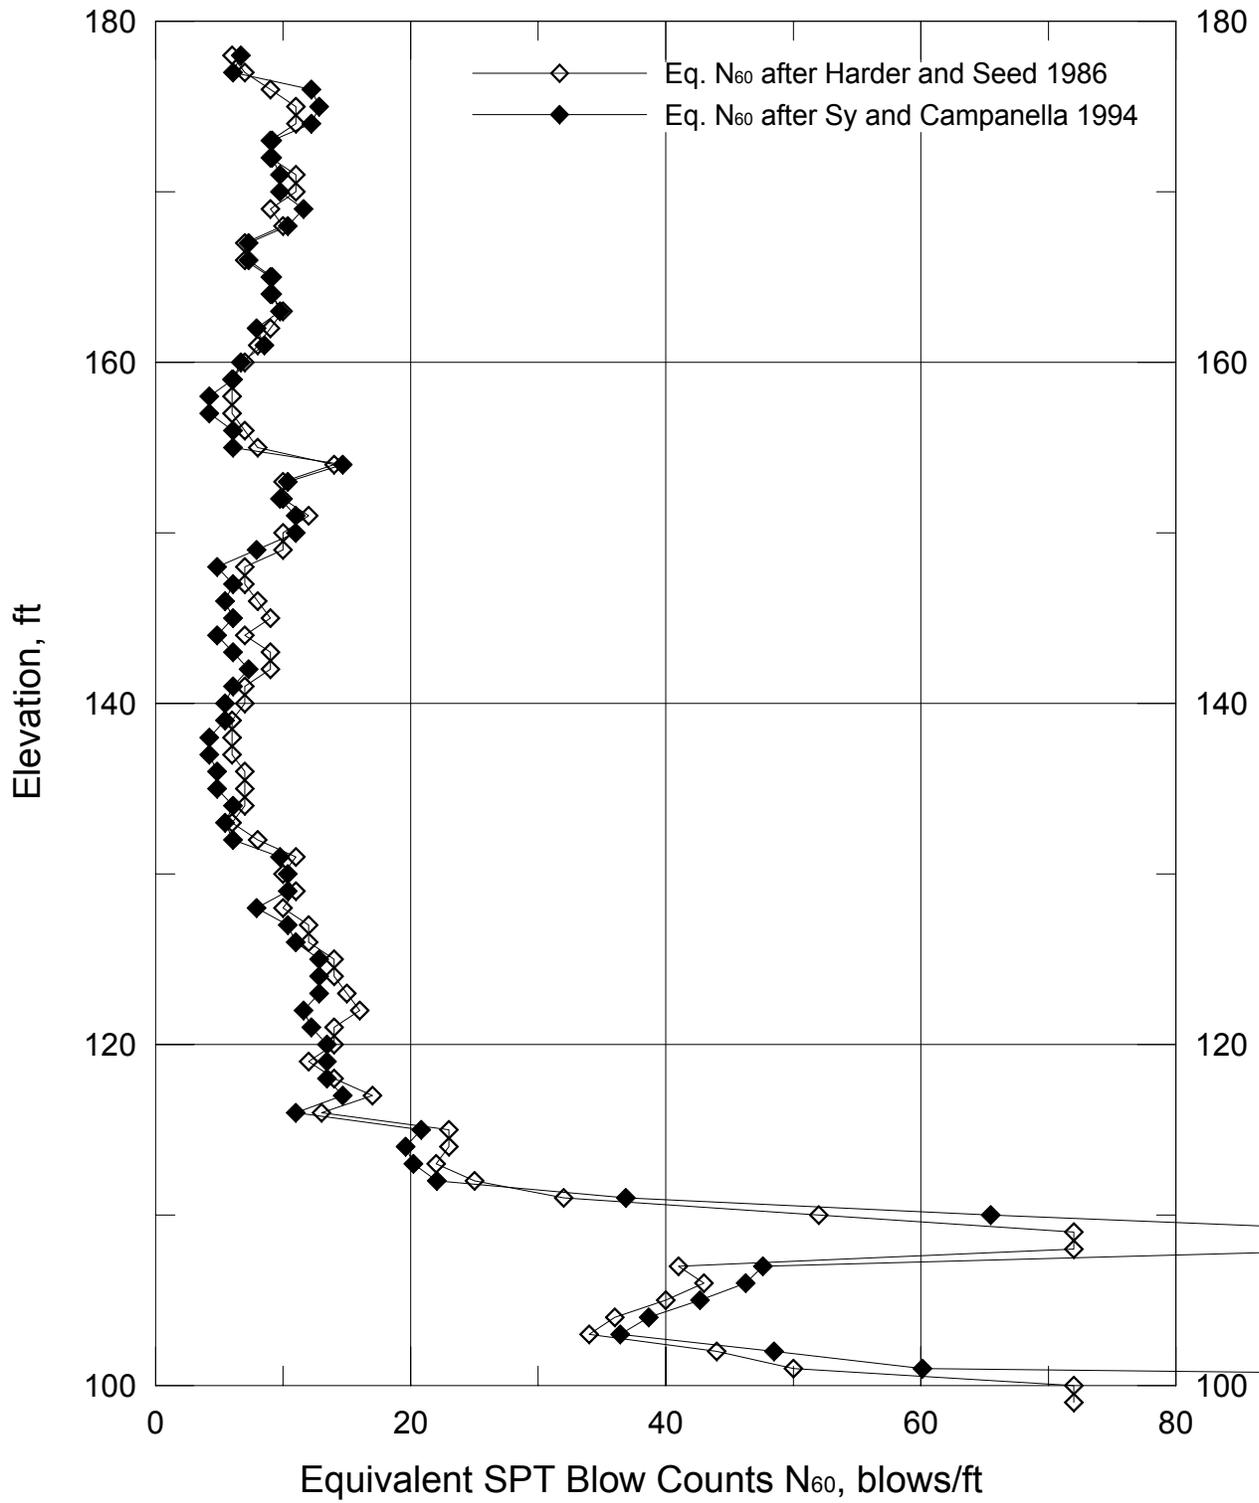
Chabot Dam BPT-1 Blow Counts

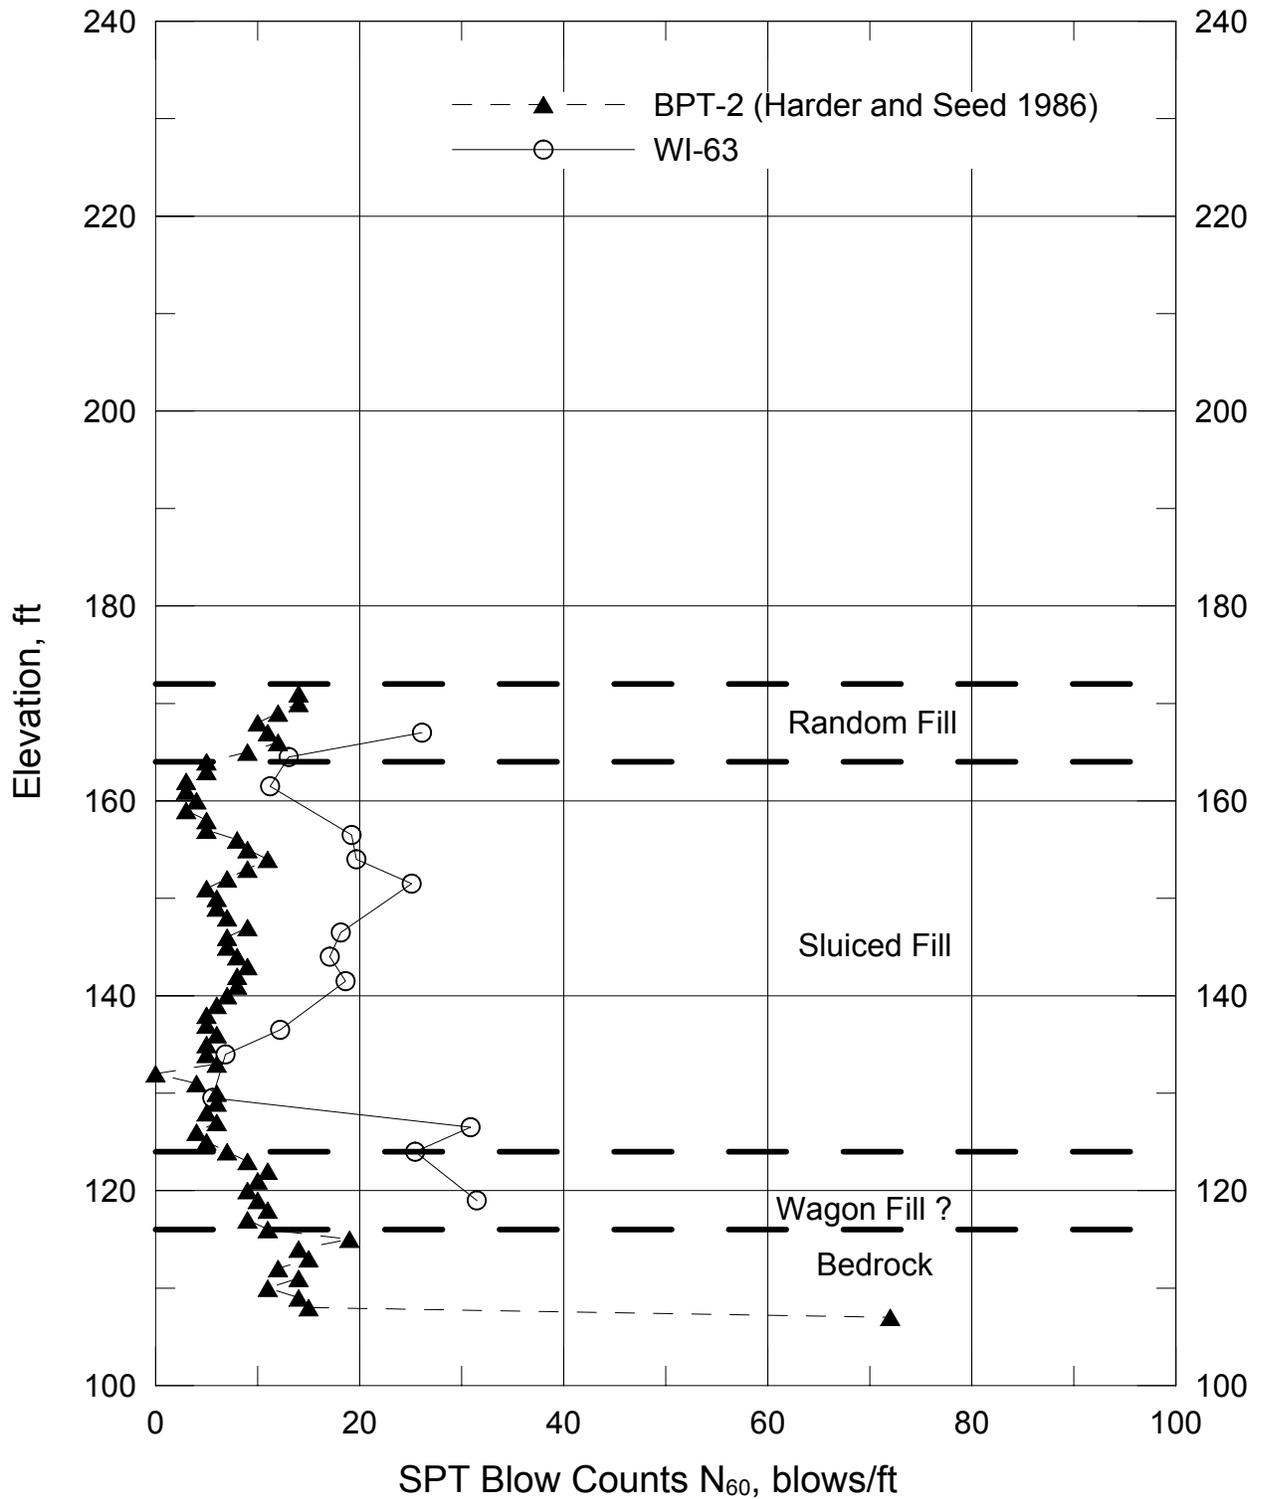
Figure
11-5

Chabot Dam Borings WI-63 and BPT-2

Note:
Stratigraphy is inferred from BPT resistance and boring log of WI-63

Figures 11-5 through 11-7 compare the equivalent SPT blow counts obtained from the BPT soundings with the SPT blow counts measured in the rotary-wash borings. It may be seen that the blow counts from the SPT borings are significantly higher than those obtained from the BPT

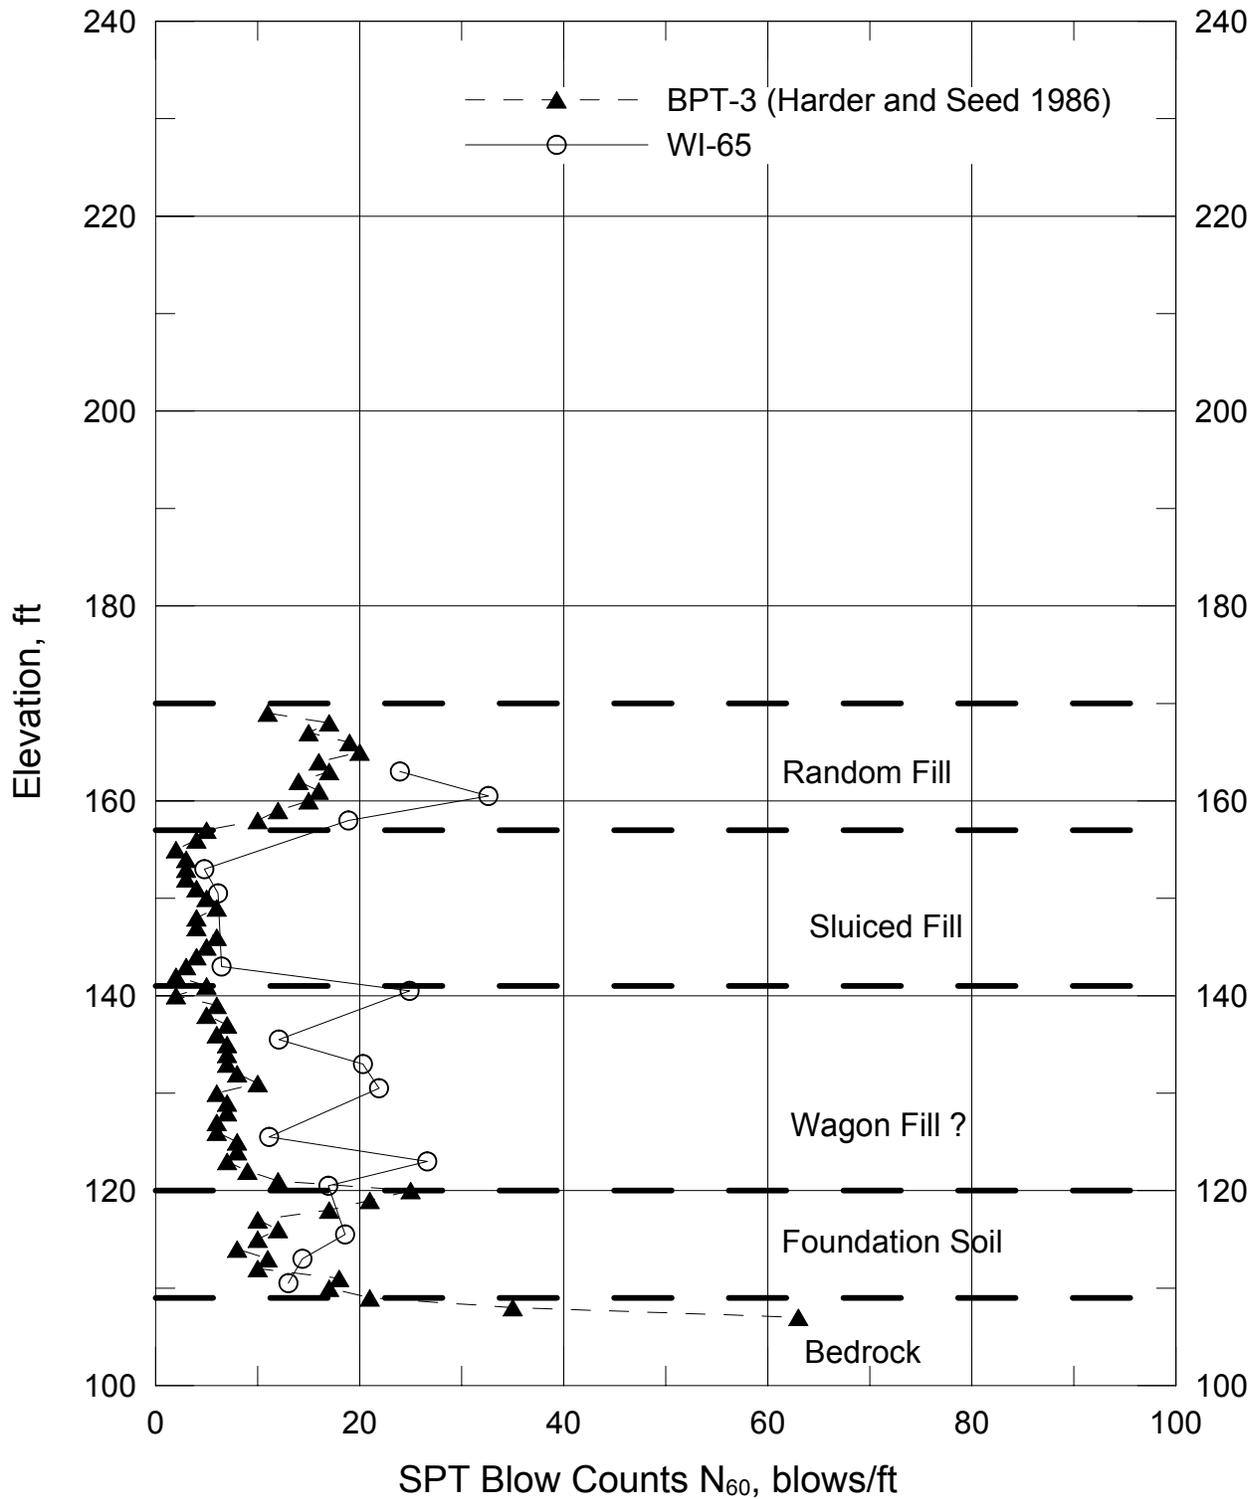
Chabot Dam Borings WI-65 and BPT-3

Note:
Stratigraphy is inferred from BPT resistace and boring log of WI-65.

URS	Project No. 26814536	SPT Resistance N_{60} From Borings WI-65 and BPT-3	Figure
	Chabot Dam Seismic Stability		11-7

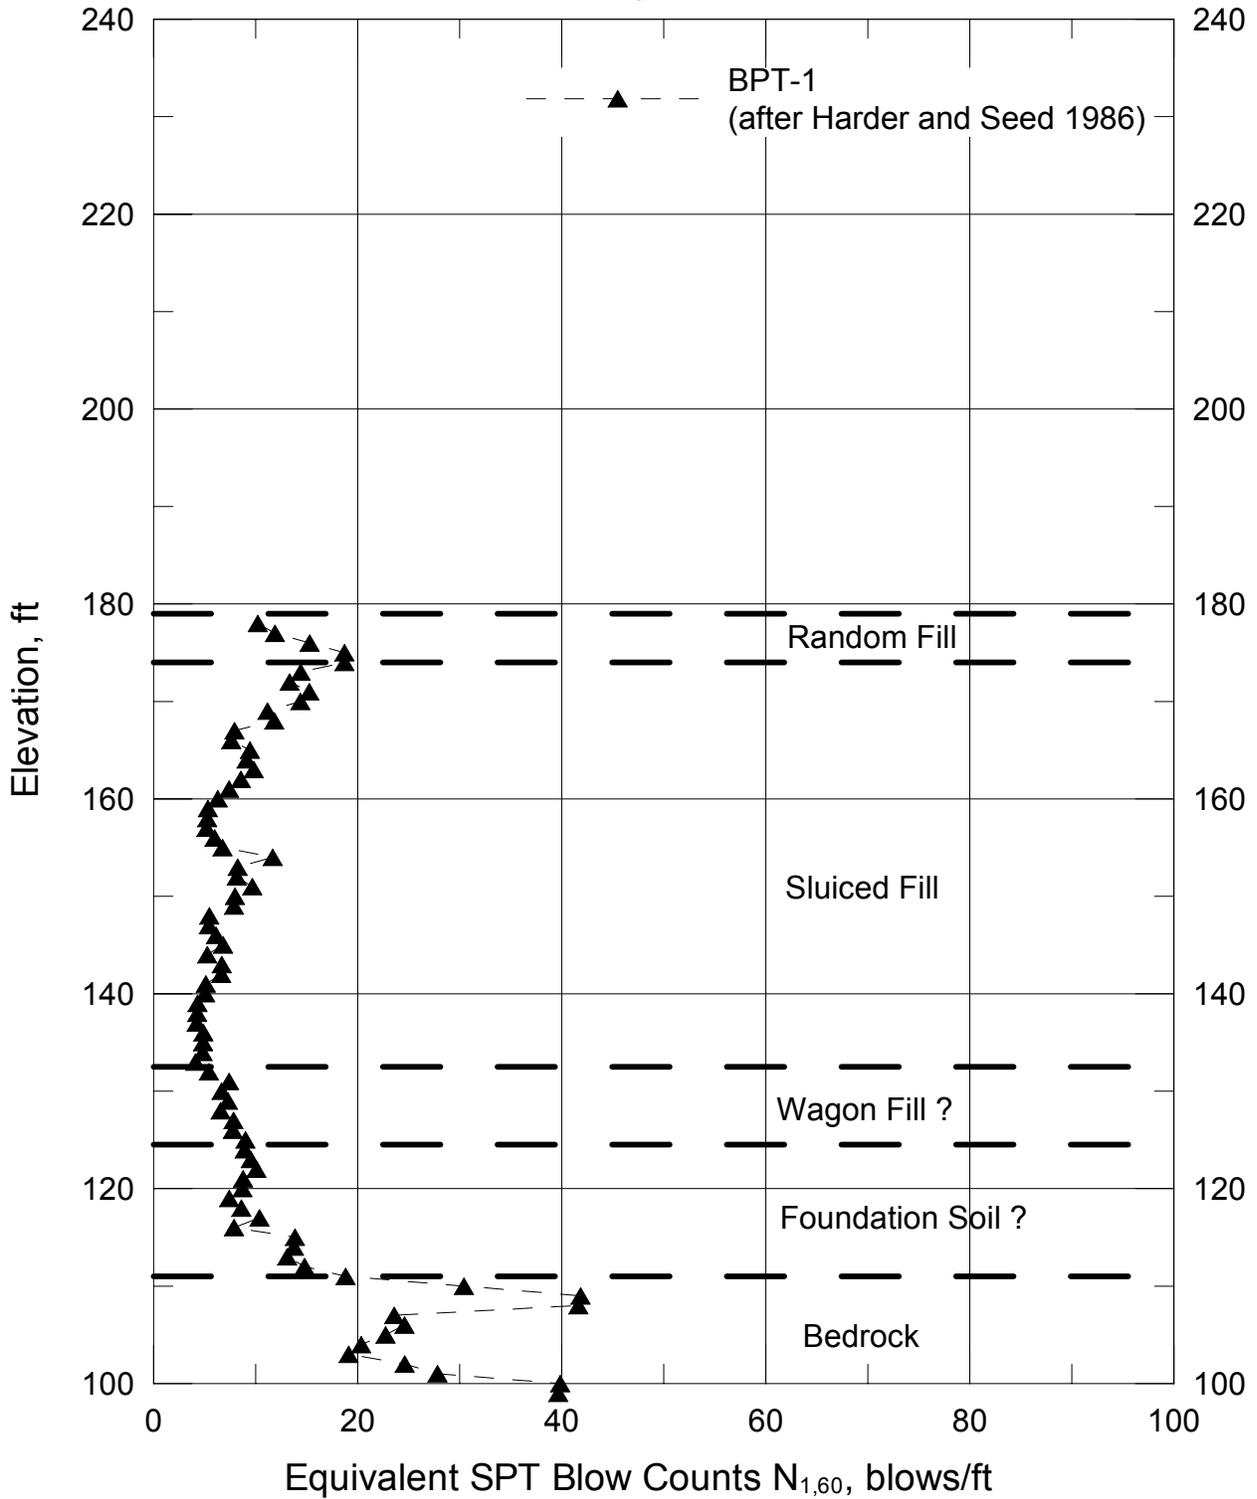
Chabot Dam Boring BPT-1

Note:
Stratigraphy is inferred from BPT resistance and boring log of WI-60.

URS	Project No. 26814536	Equivalent SPT $N_{1,60}$ and Stratigraphy From Boring BPT-1	Figure
	Chabot Dam Seismic Stability		11-8

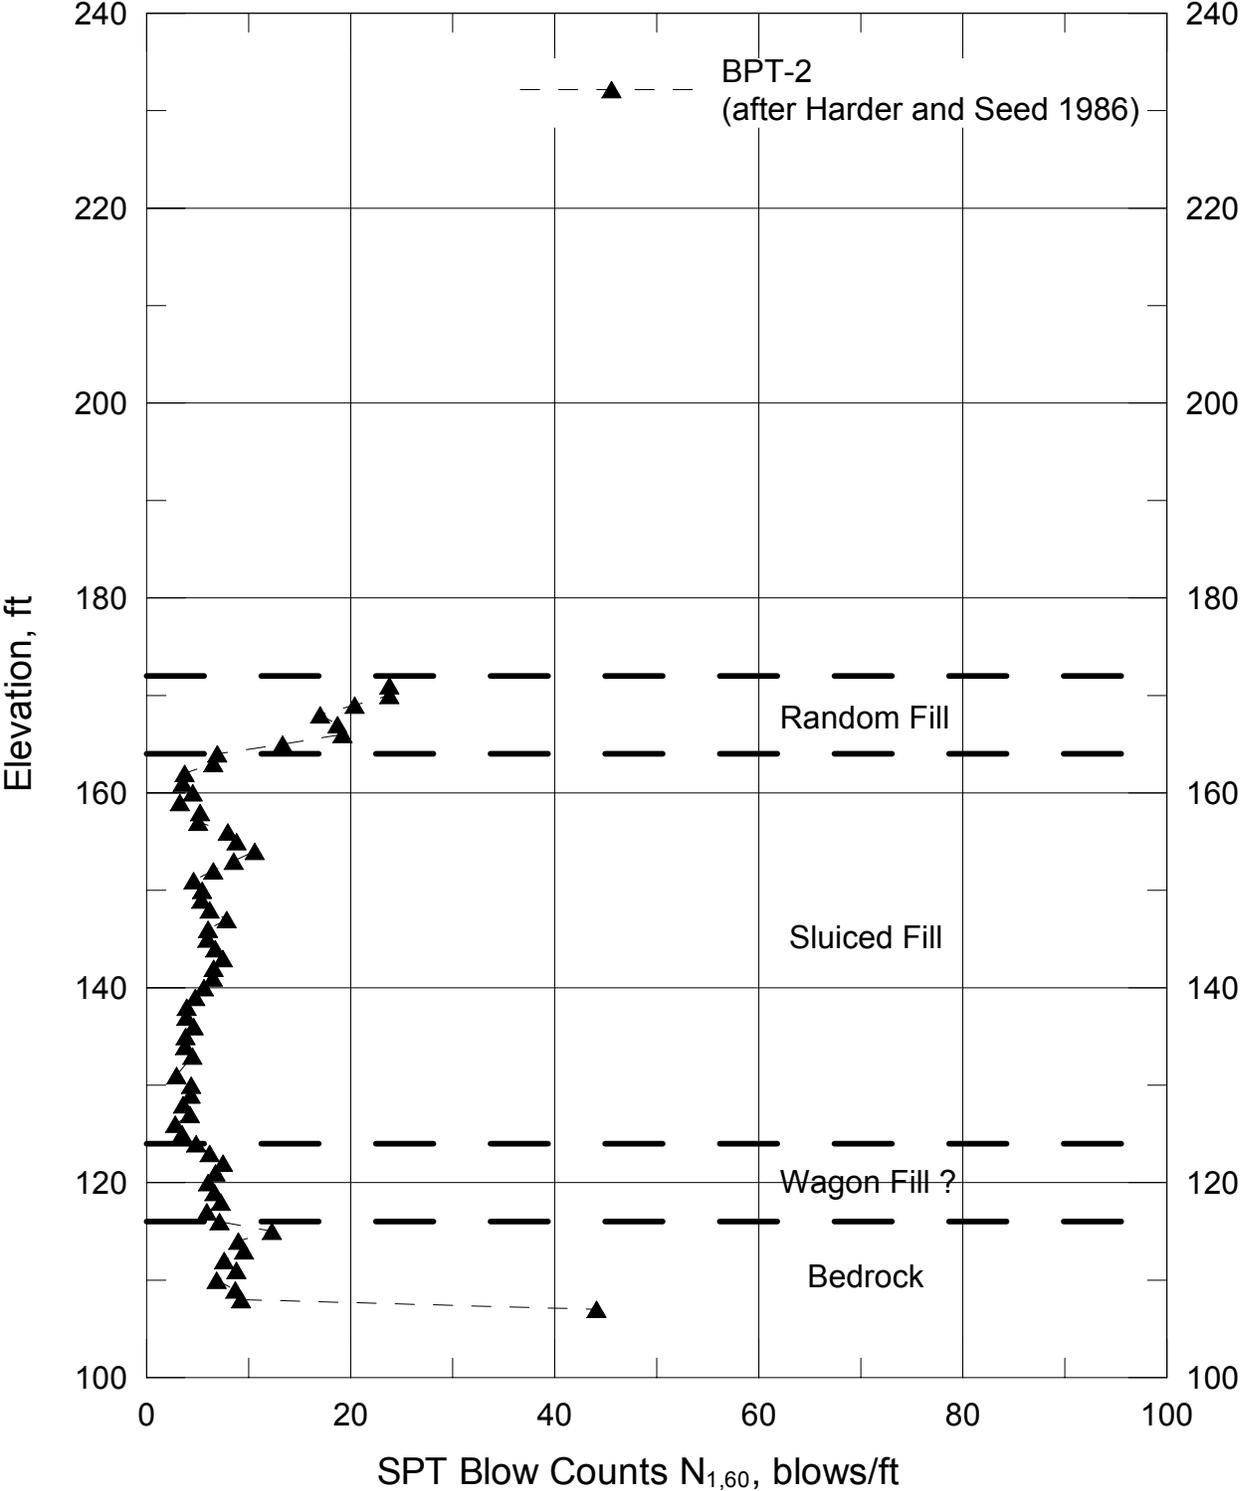
Chabot Dam Boring BPT-2

Note:
Stratigraphy is inferred from BPT resistance and boring log of WI-63

URS	Project No. 26814536	Equivalent SPT $N_{1,60}$ and Stratigraphy From Boring BPT-2	Figure
	Chabot Dam Seismic Stability		11-9

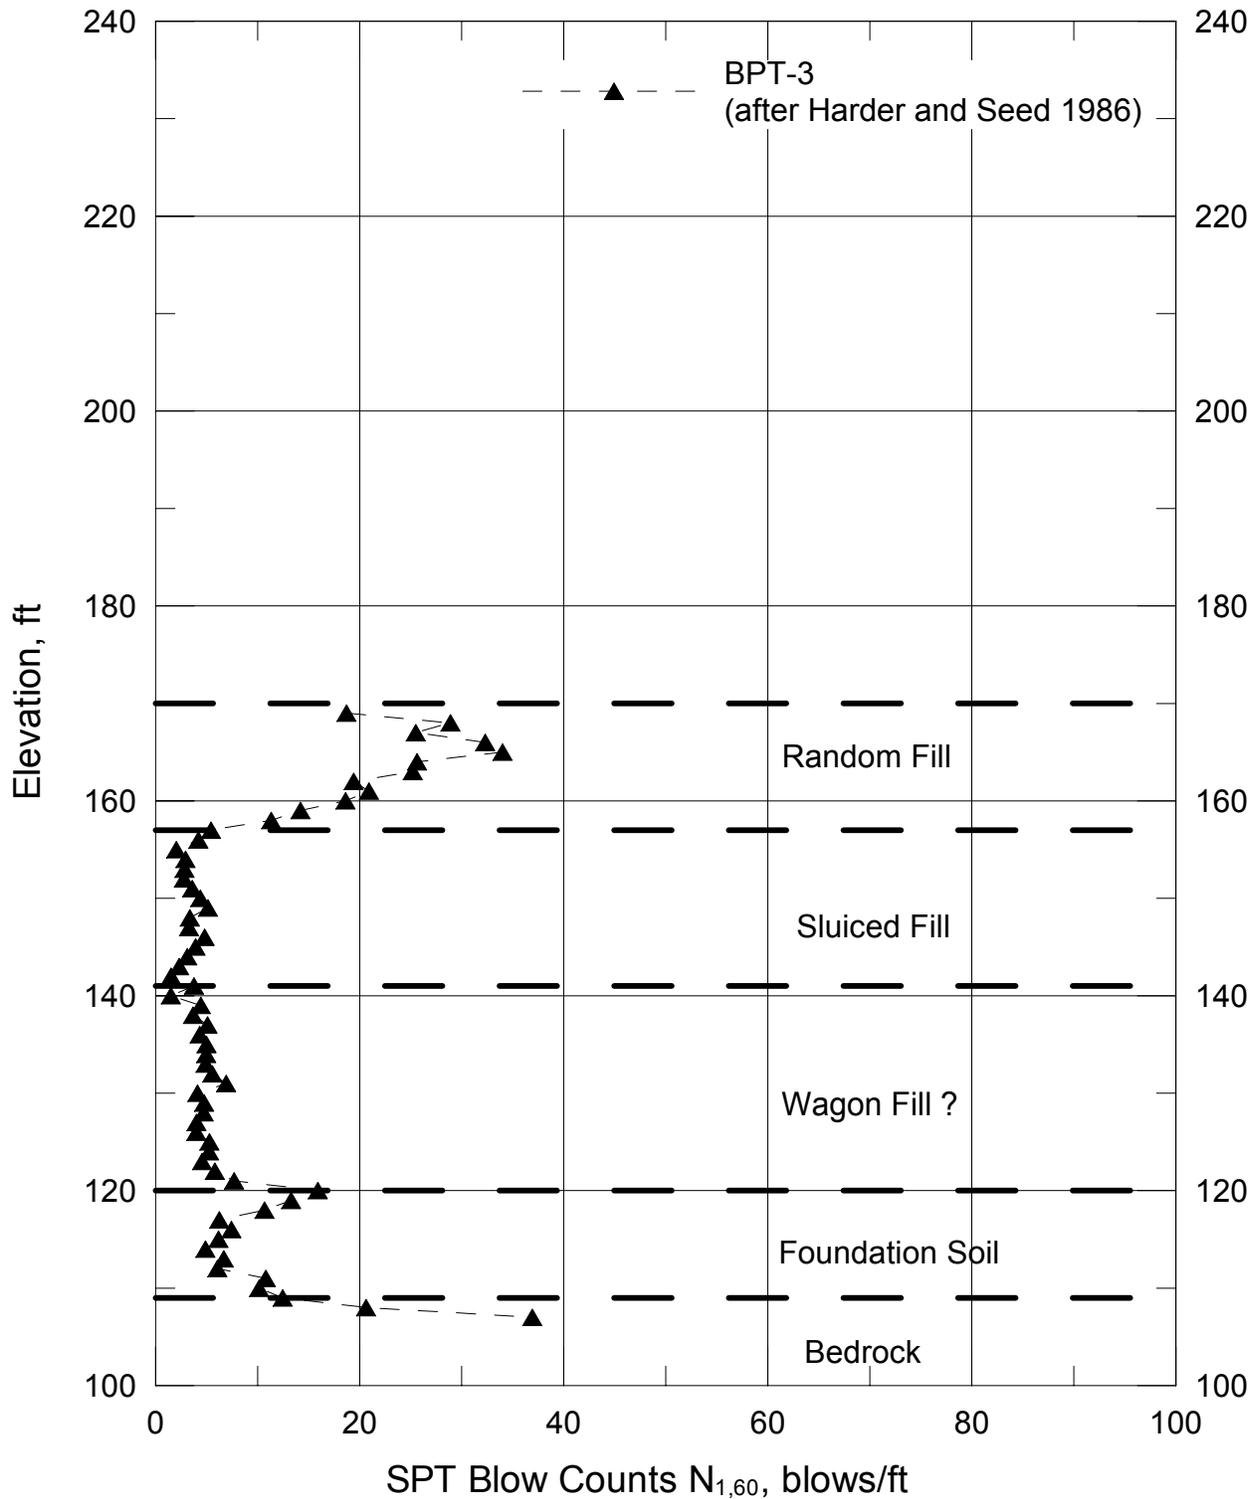
Chabot Dam Boring BPT-3

Note:
Stratigraphy is inferred from BPT resistance and boring log of WI-65.

URS	Project No. 26814536	Equivalent SPT $N_{1,60}$ and Stratigraphy From Boring BPT-3	Figure
	Chabot Dam Seismic Stability		11-10

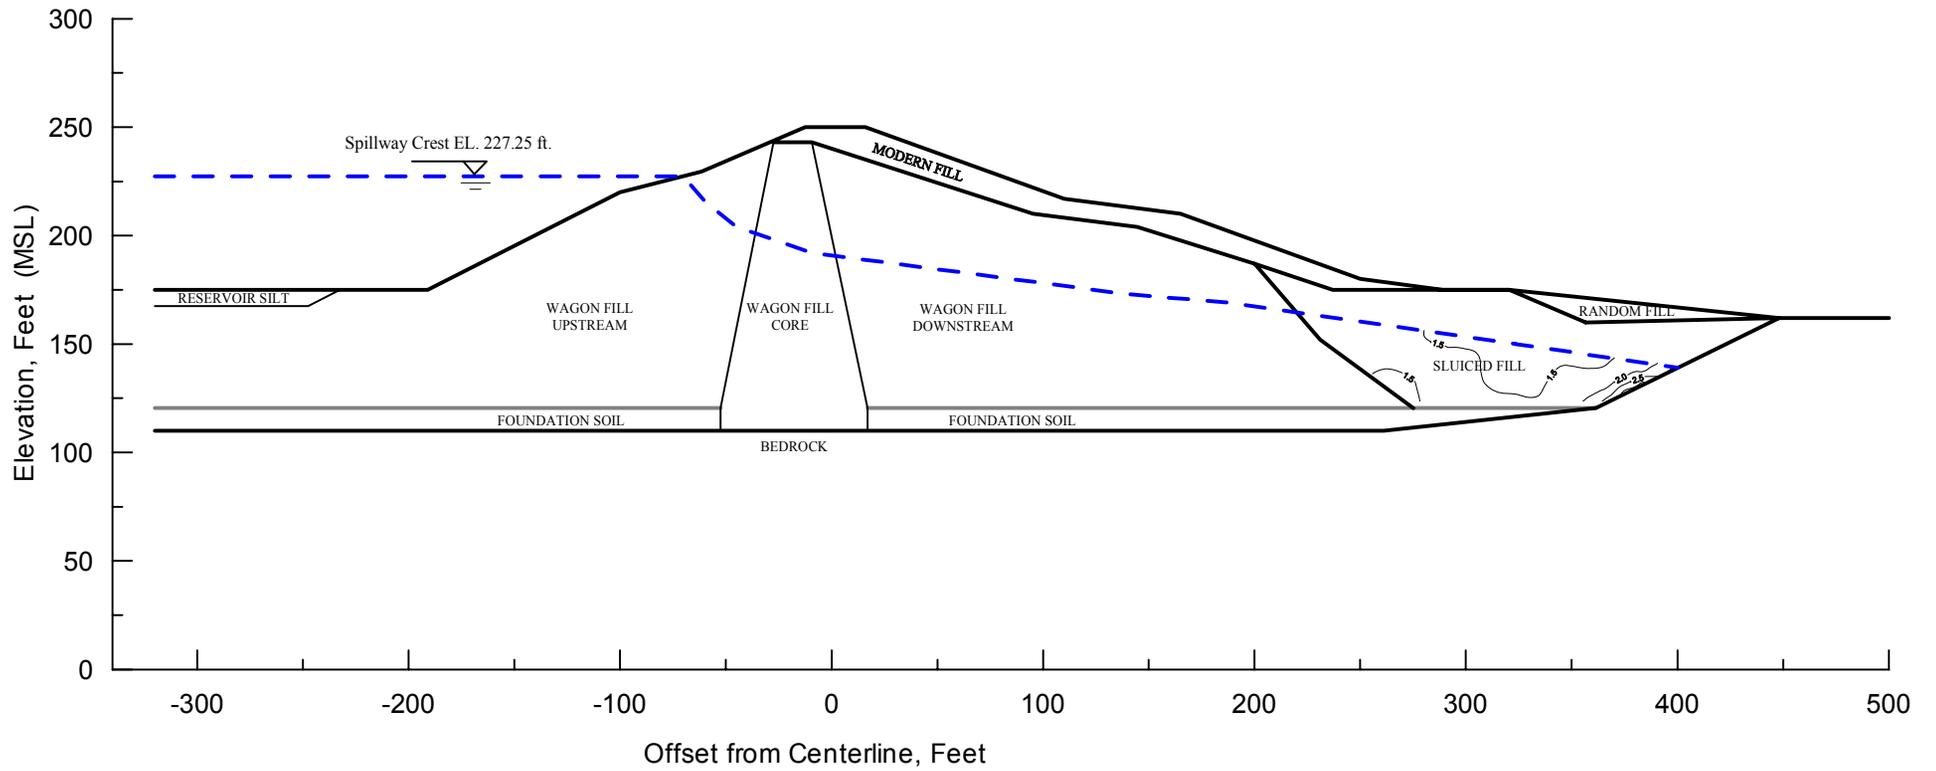
Project No. 26814536	Chabot Dam Seismic Stability Analysis	Factors of Safety against Liquefaction in Sluiced Fill 1989 Loma Prieta Earthquake	Figure
URS			11-11
