FINAL REPORT
VOLUME 1: MAIN REPORT
October 2005

DYNAMIC STABILITY ANALYSIS OF CHABOT DAM

Alameda County, California

**Subject: Dynamic Stability of Chabot Dam
Final Engineering Report**

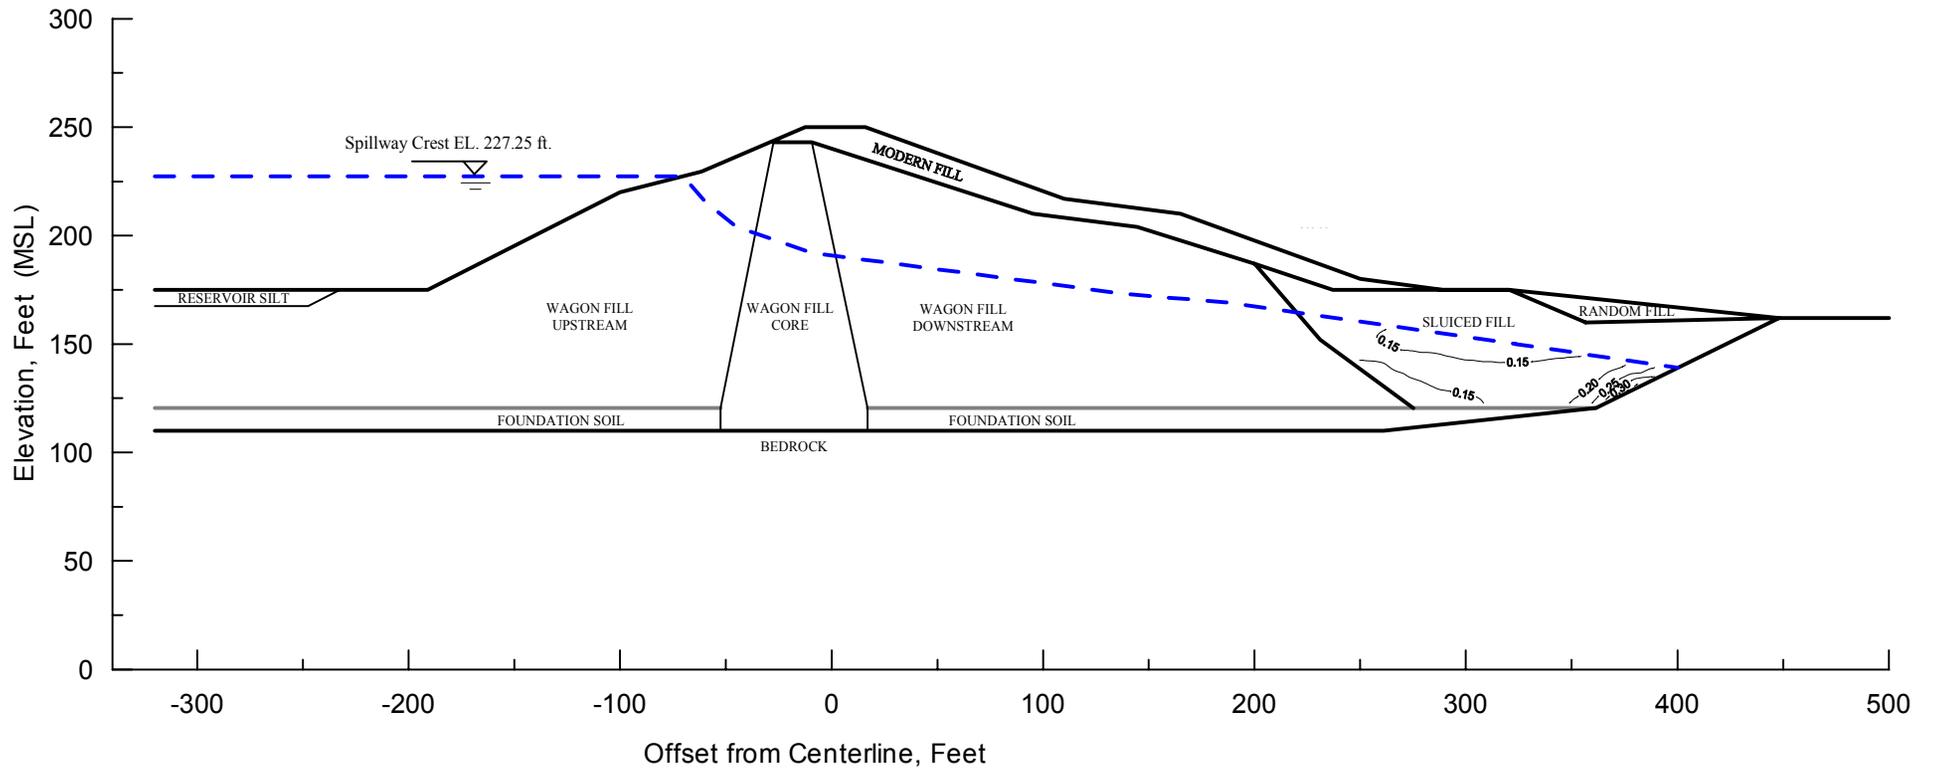
Project No. 26814536	Chabot Dam Seismic Stability Analysis	Factors of Safety against Liquefaction in Sluiced Fill Hayward Fault MCE TH #1	Figure
URS			11-12

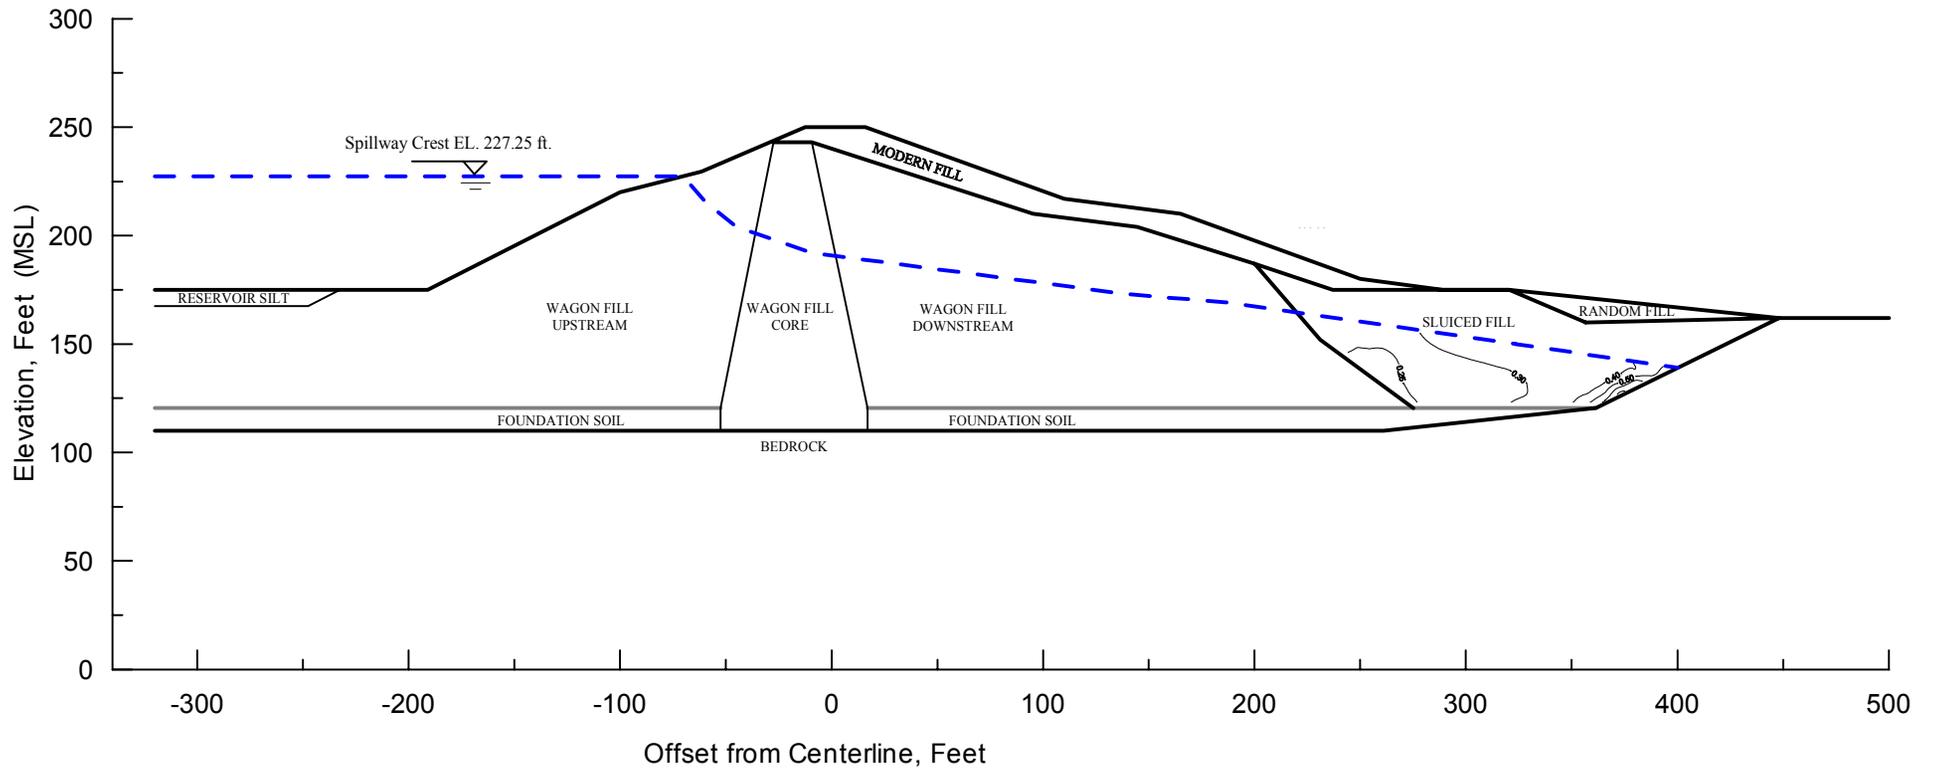
Project No. 26814536	Chabot Dam Seismic Stability Analysis	Factors of Safety against Liquefaction in Sluiced Fill San Andreas Fault MCE	Figure
URS			11-13

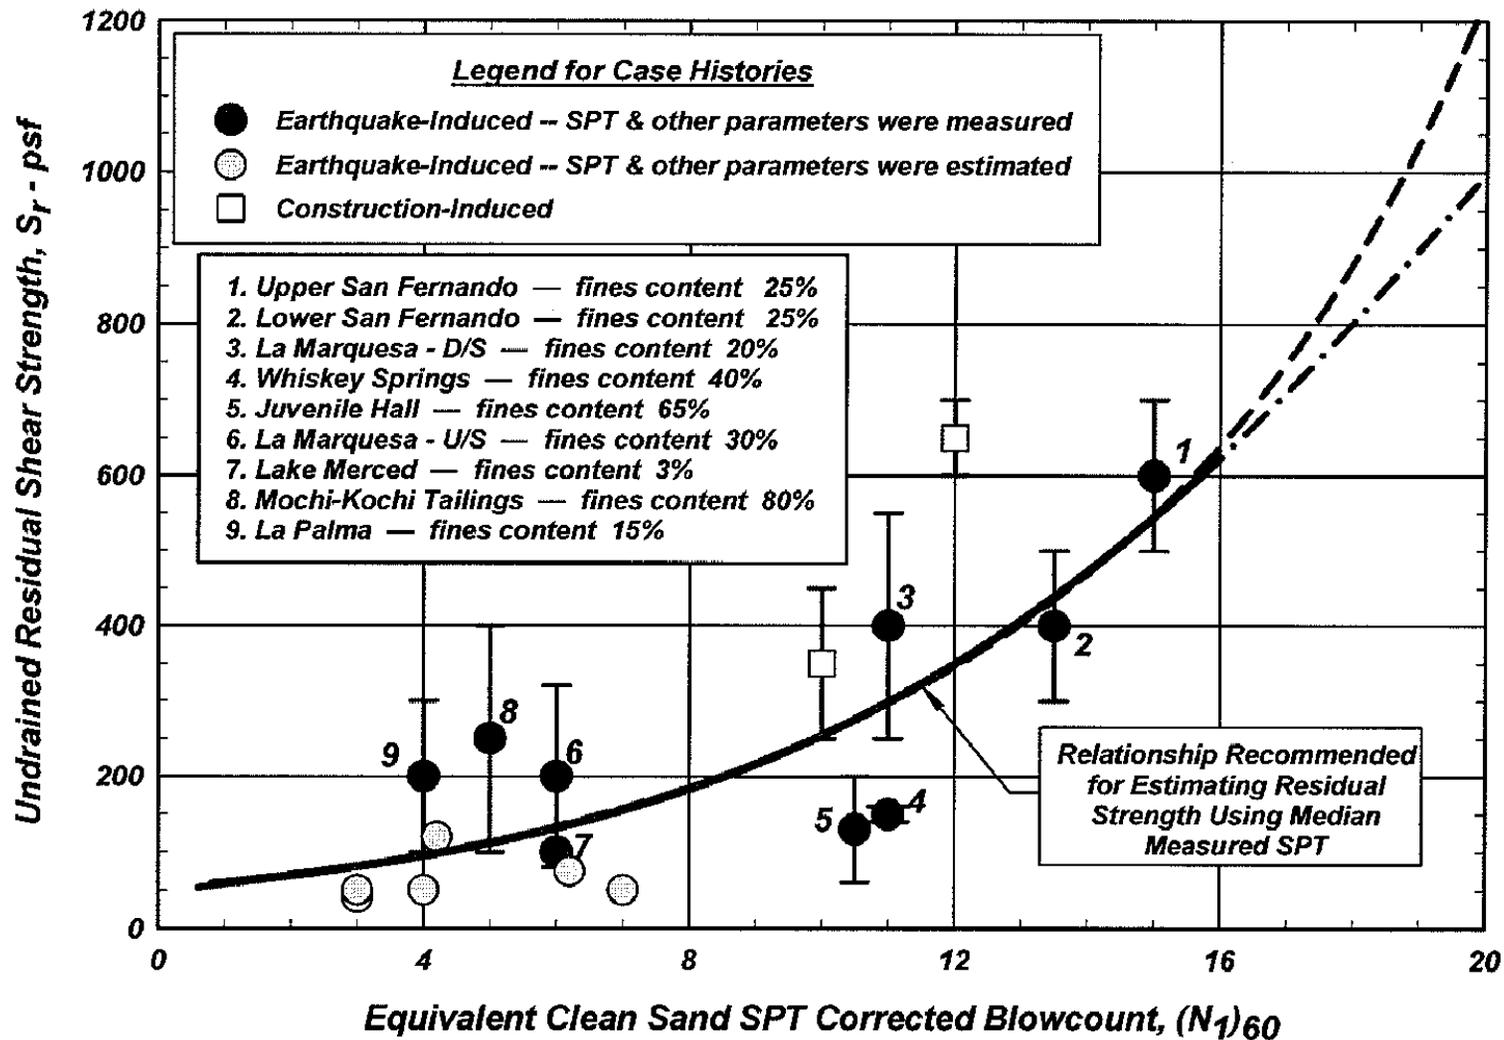
Curve Recommended by Hendron & Idriss in 1997

Curve Modified by Idriss in 2002

Project No. 26814536	Chabot Dam Seismic Stability	Correlation between Undrained Residual Strength and Equivalent Clean Sand SPT Corrected Blow Counts (Idriss, 2002)	Figure
URS			11-14

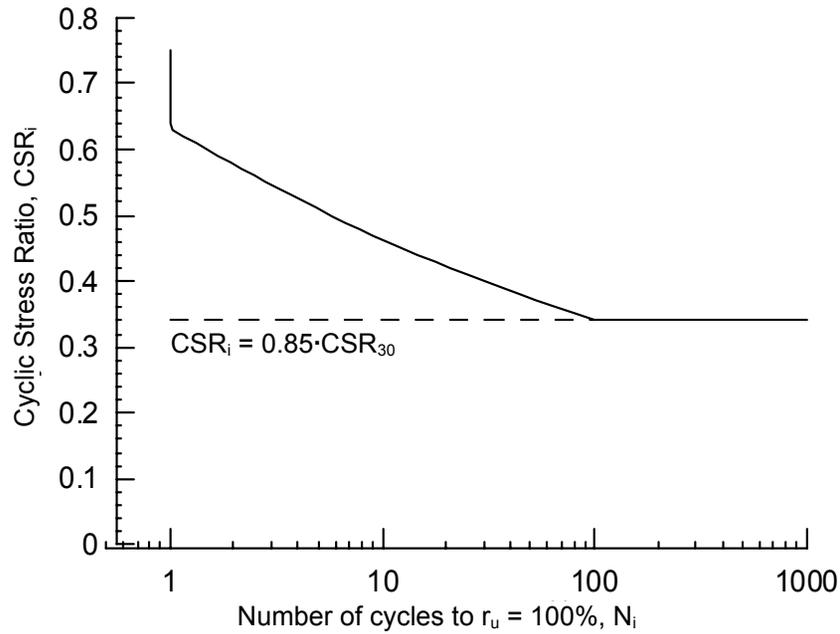
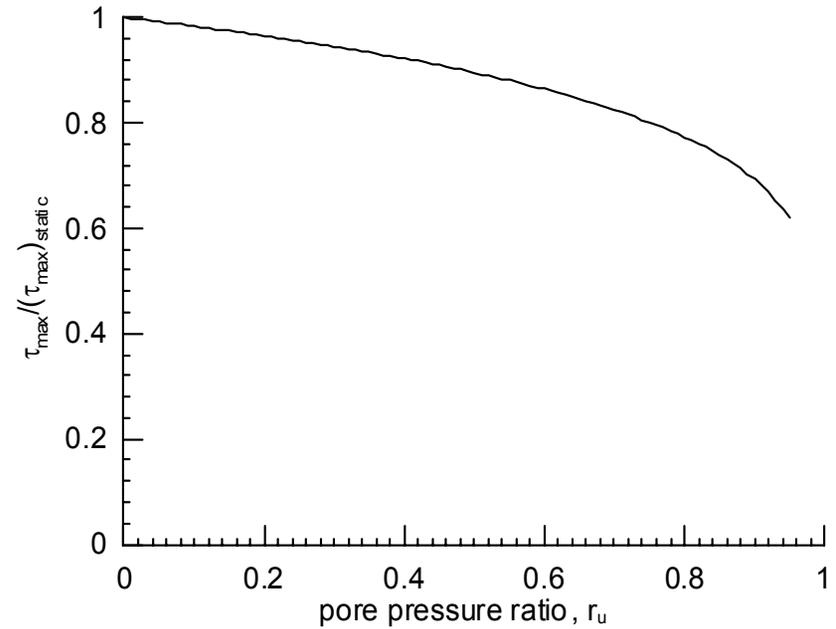
Cyclic Strength
 $CSR_{30} = 0.4$

$$N_i = 30 \left(\frac{CSR_{30}}{CSR_i} \right)^{7.41} \quad 1 \leq N_i \leq 100$$

$$\frac{\tau_{max}}{(\tau_{max})_{static}} = (1 - r_u)^{0.16}$$

Cyclic Strength and Undrained
Strength Degradation of Saturated
Wagon Fill and Foundation Soils

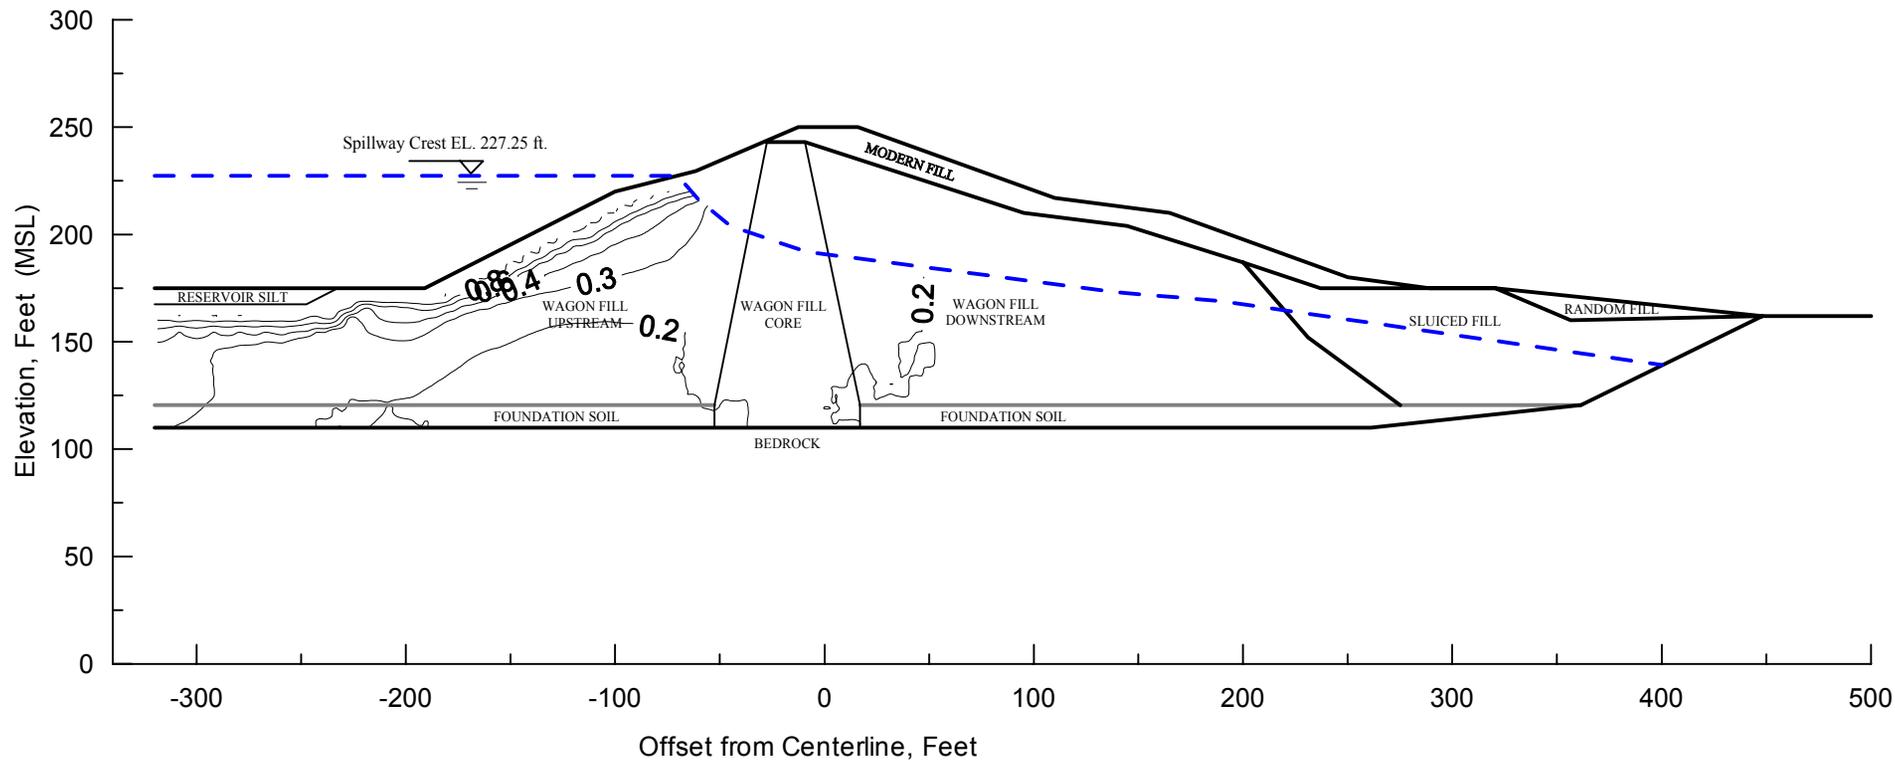
Project No. 26814536	Chabot Dam Seismic Stability Analysis	Excess Pore Pressure Ratio in Wagon Fill and Foundation Soils 1989 Loma Prieta Earthquake	Figure 11-16
URS

The calculated excess pore pressure ratios in the saturated wagon fill and foundation soils for the Loma Prieta earthquake are shown in Figure 11-16. These results indicate that low excess pore pressures (less than about 40%) would have developed in these materials during that earthquake, as was actually observed. As shown in Figure 11-15, the low calculated pore pressures are associated with a small reduction in post-cyclic undrained strength (less than about 10%).

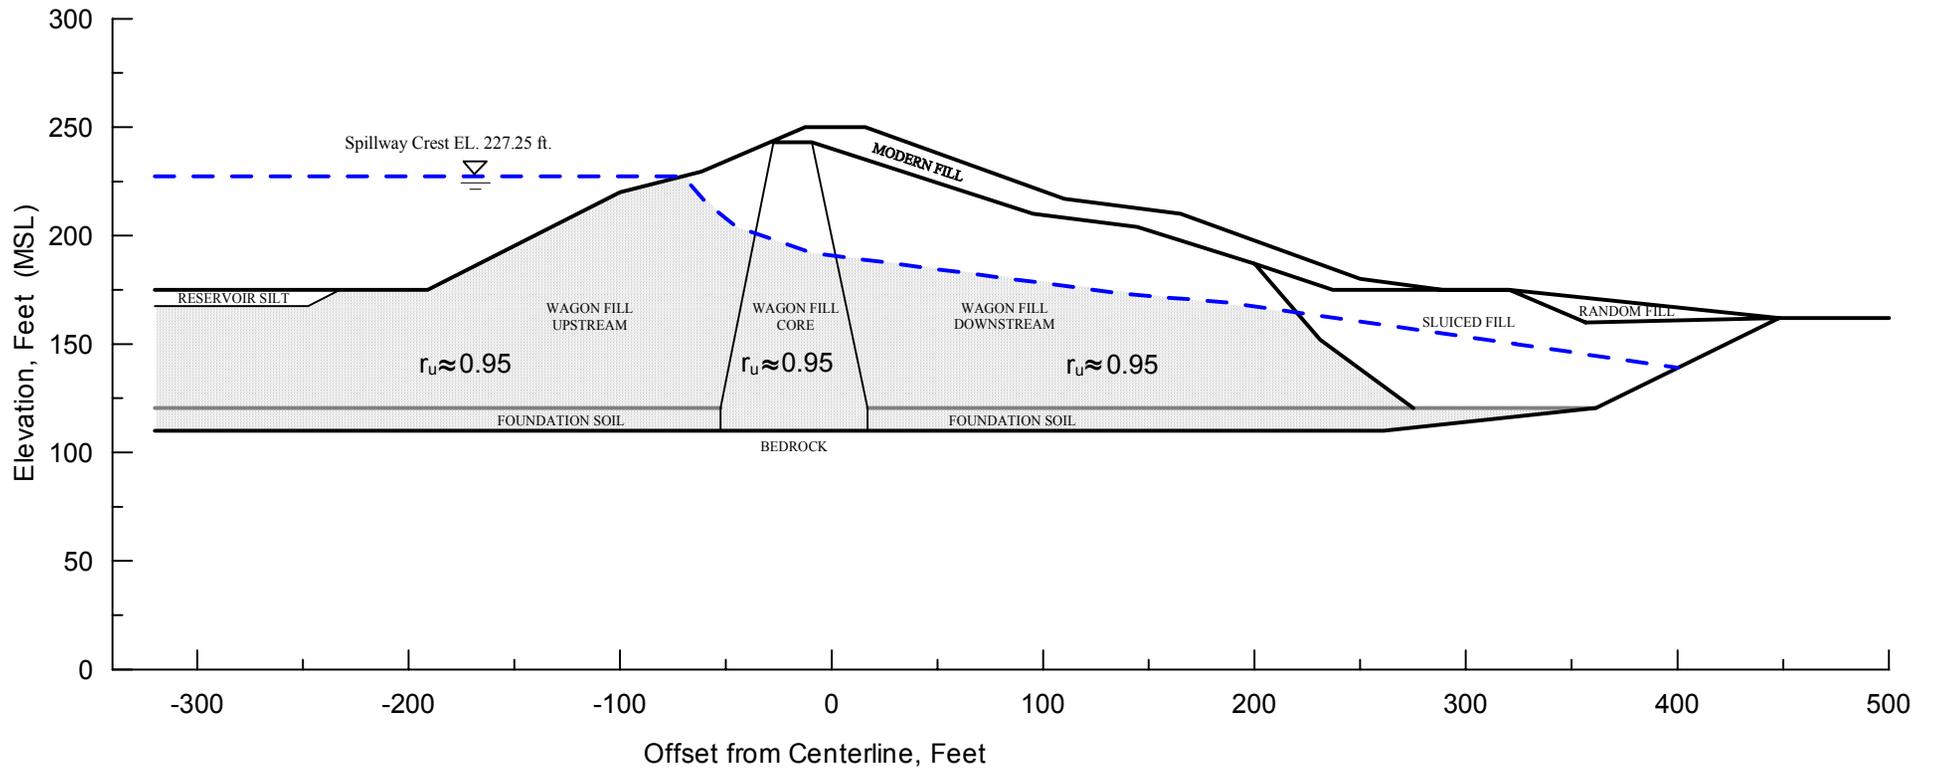
Note: Calculated excess pore pressure ratio in the shaded zone reaches the approximate maximum value estimated from the cyclic strength tests.

Project No. 26814536	Chabot Dam Seismic Stability Analysis	Excess Pore Pressure Ratio in Wagon Fill and Foundation Soils Hayward Fault MCE TH #1	Figure
URS			11-17

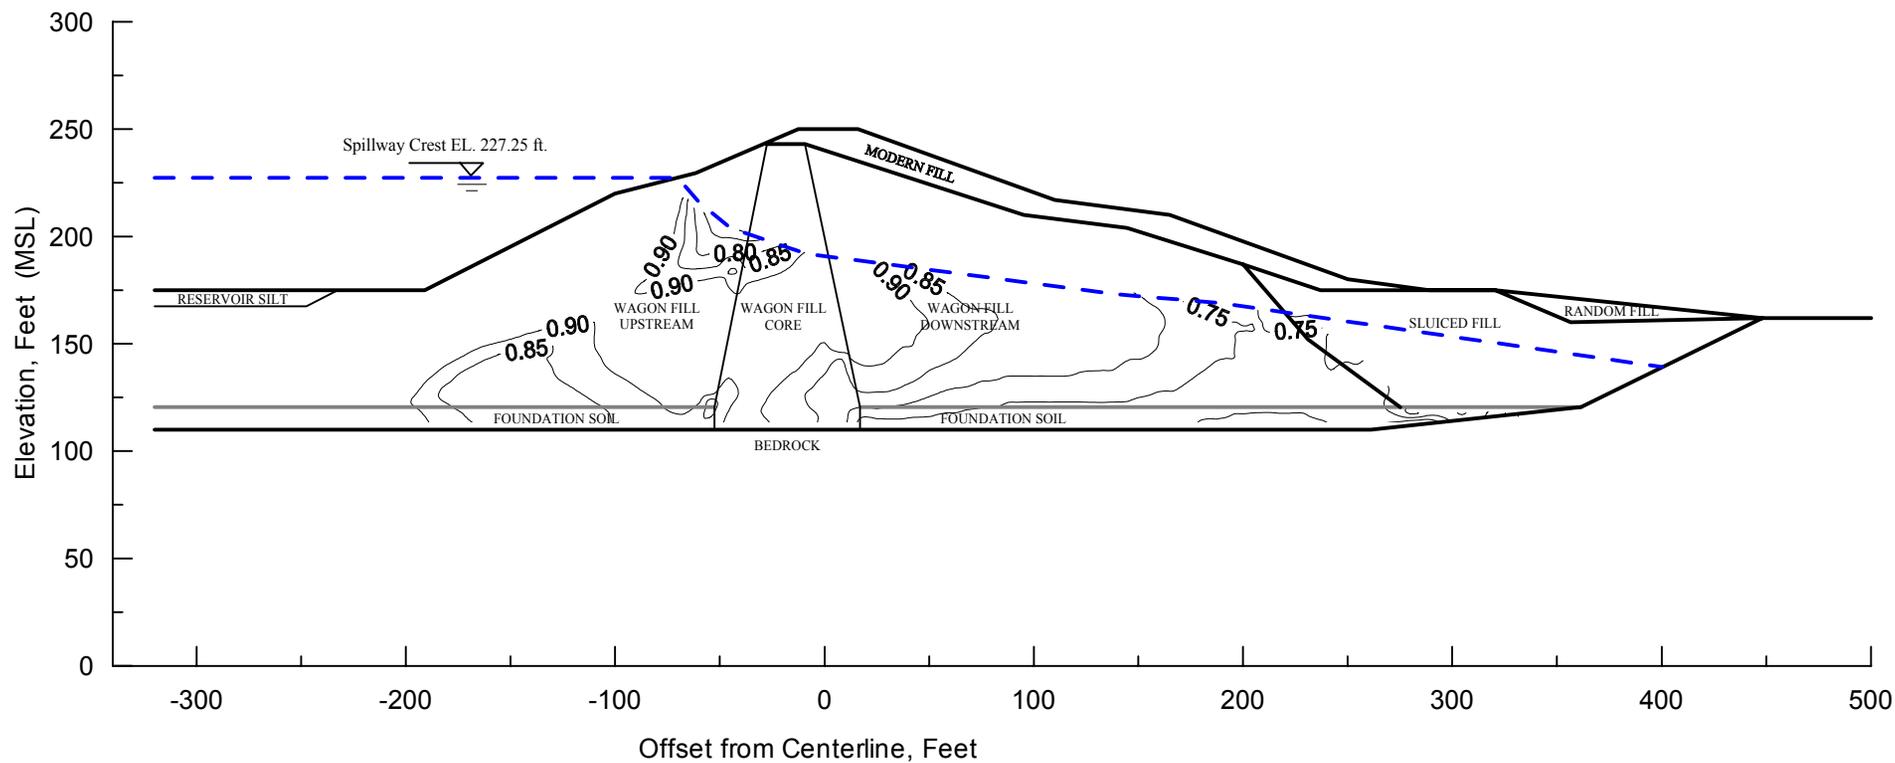
Project No. 26814536	Chabot Dam Seismic Stability Analysis	Excess Pore Pressure Ratio in Wagon Fill and Foundation Soils San Andreas Fault MCE	Figure
URS			11-18

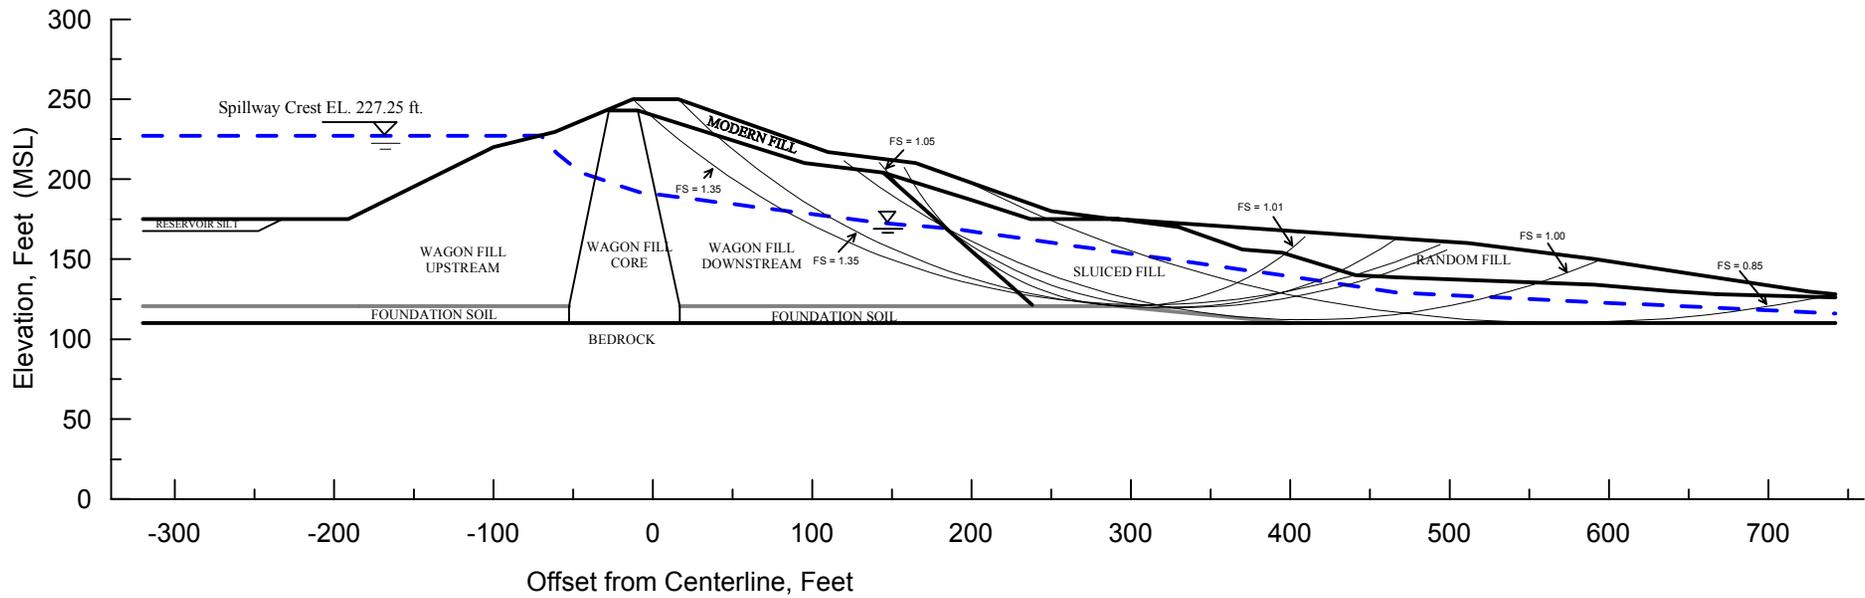
Project No. 26814536	Chabot Dam Seismic Stability Analysis	Seismic Stability Analysis Post-Earthquake Condition Downstream Section A-A" Hayward Fault MCE	Figure 11-19
URS

To evaluate the potential for instability of the sluiced fill in the direction of the stream channel downstream of the dam, post-earthquake stability analyses for the Hayward Fault MCE were performed using composite section A-A". The results of these analyses are presented in Figure 11-19. The calculated factors of safety for sliding surfaces within the downstream sluiced fill zone are close to or below 1.0, indicating that calculation of a yield acceleration is not pertinent. These results indicate that there is a potential for downstream displacements of the sluiced fill during and after the Hayward Fault MCE. Because adequate factors of safety are

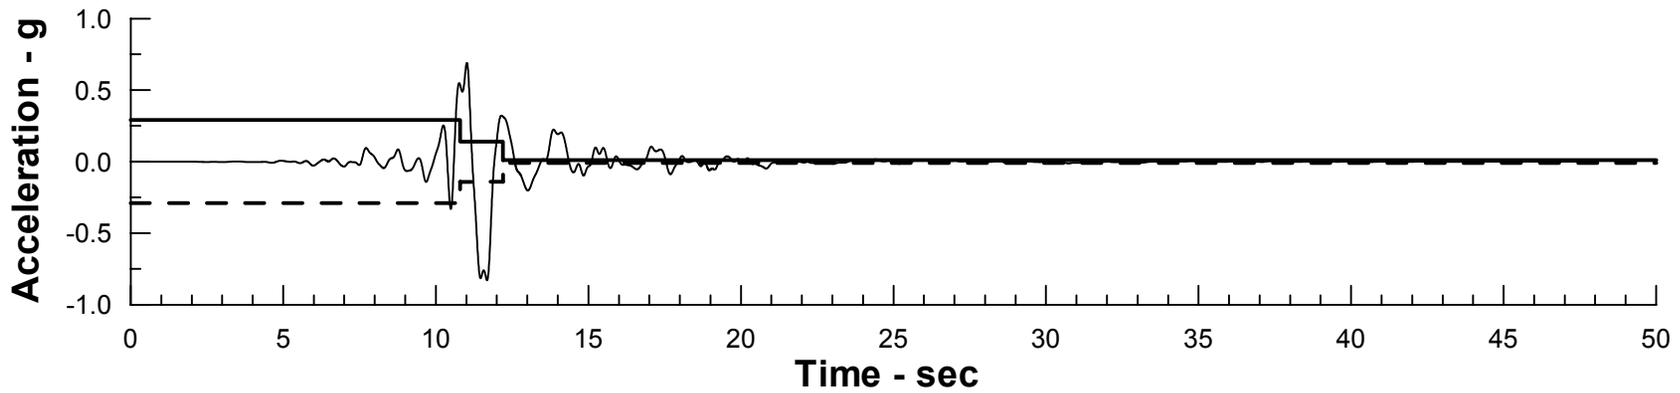
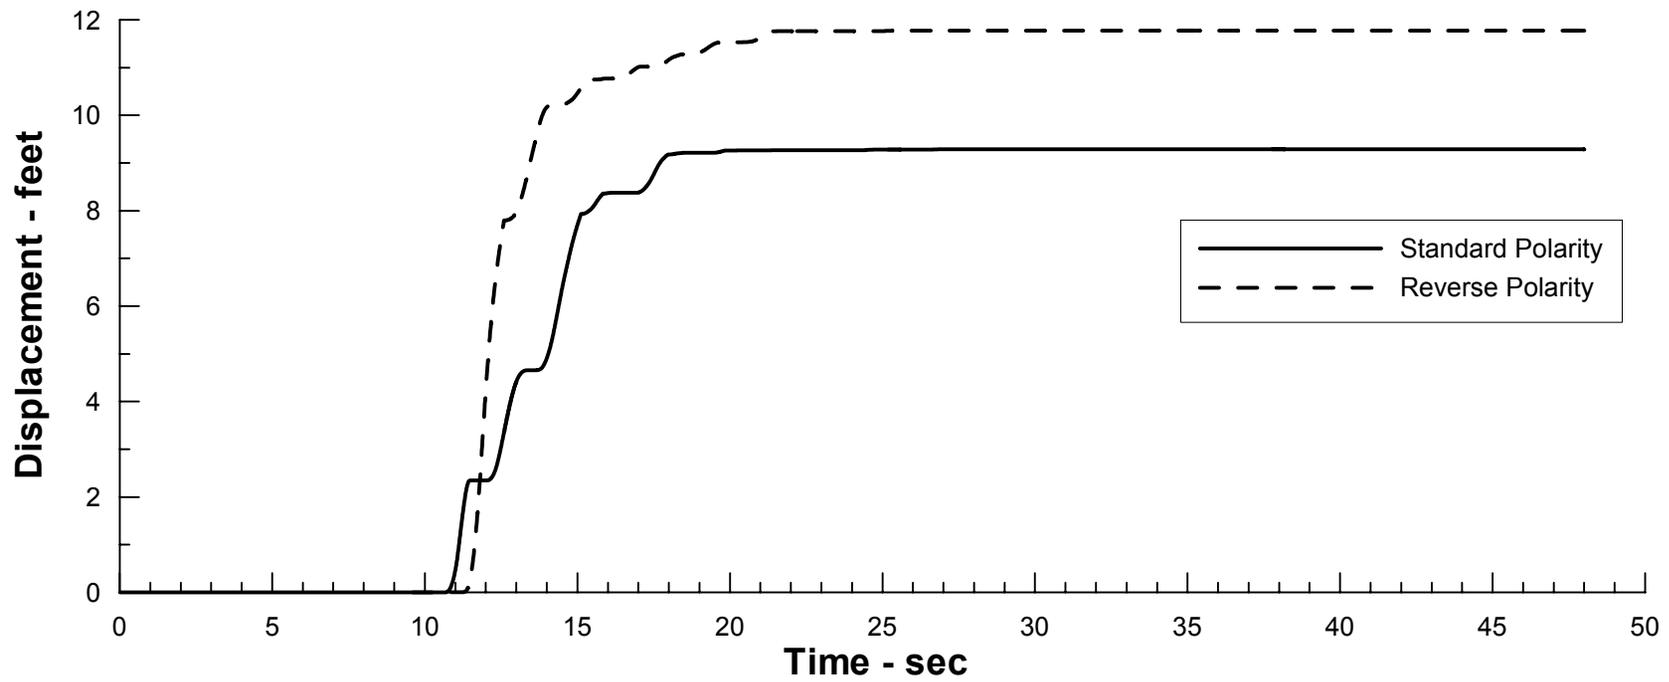
Project No. 26814536	Chabot Dam Seismic Stability Analysis	Newmark Deformation Analysis Calculated Displacement U/S Block #1 Hayward Fault MCE TH #1	Figure 11-20
URS

The Newmark-type deformation analyses results are presented in Figures 11-20 through 11-34. The calculated displacements are summarized in Table 11-3. These calculated displacements correspond to horizontal translation of the center of mass of each sliding block. The

The displacements calculated for Hayward event are shown in Figures 11-20 through 11-26. Horizontal displacements of 6 to 9 feet are calculated for upstream block No. 3. Based on the geometry of the block, such displacements would correspond to downward vertical displacements of the crest of 4 to 6 feet. Somewhat larger horizontal displacements (9 to 12 feet) are calculated for upstream block No. 1, but this block does not reach across the dam crest. Horizontal displacements of about 4 feet are calculated for downstream Block No. 4, which approximately encompasses the body of the sluiced fill. Horizontal displacements of less than 3 feet are calculated for other downstream blocks and for a deep-seated upstream block.

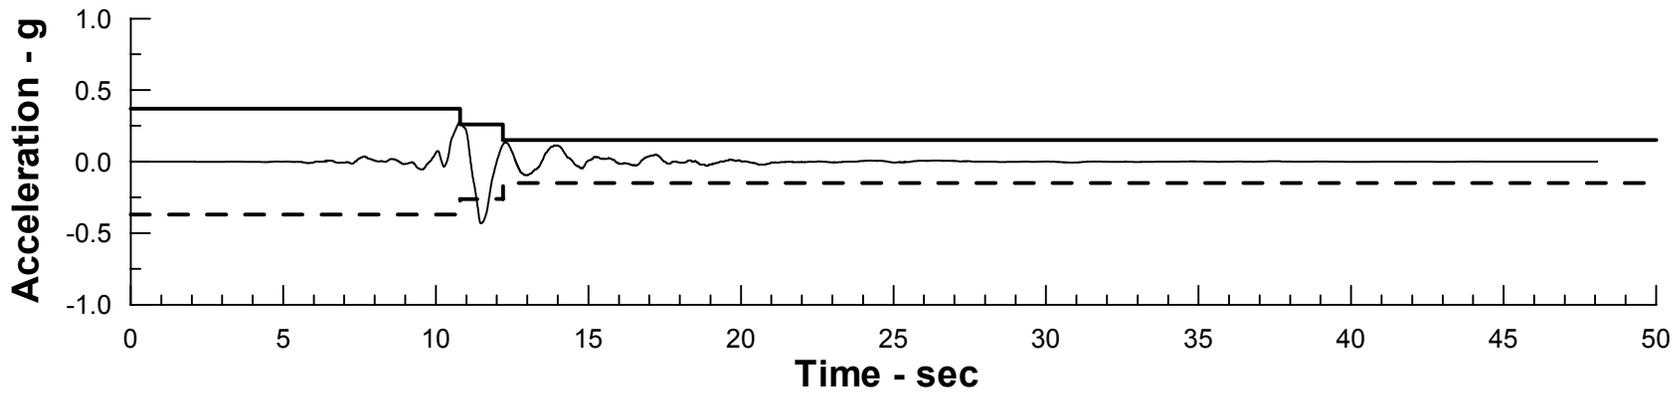
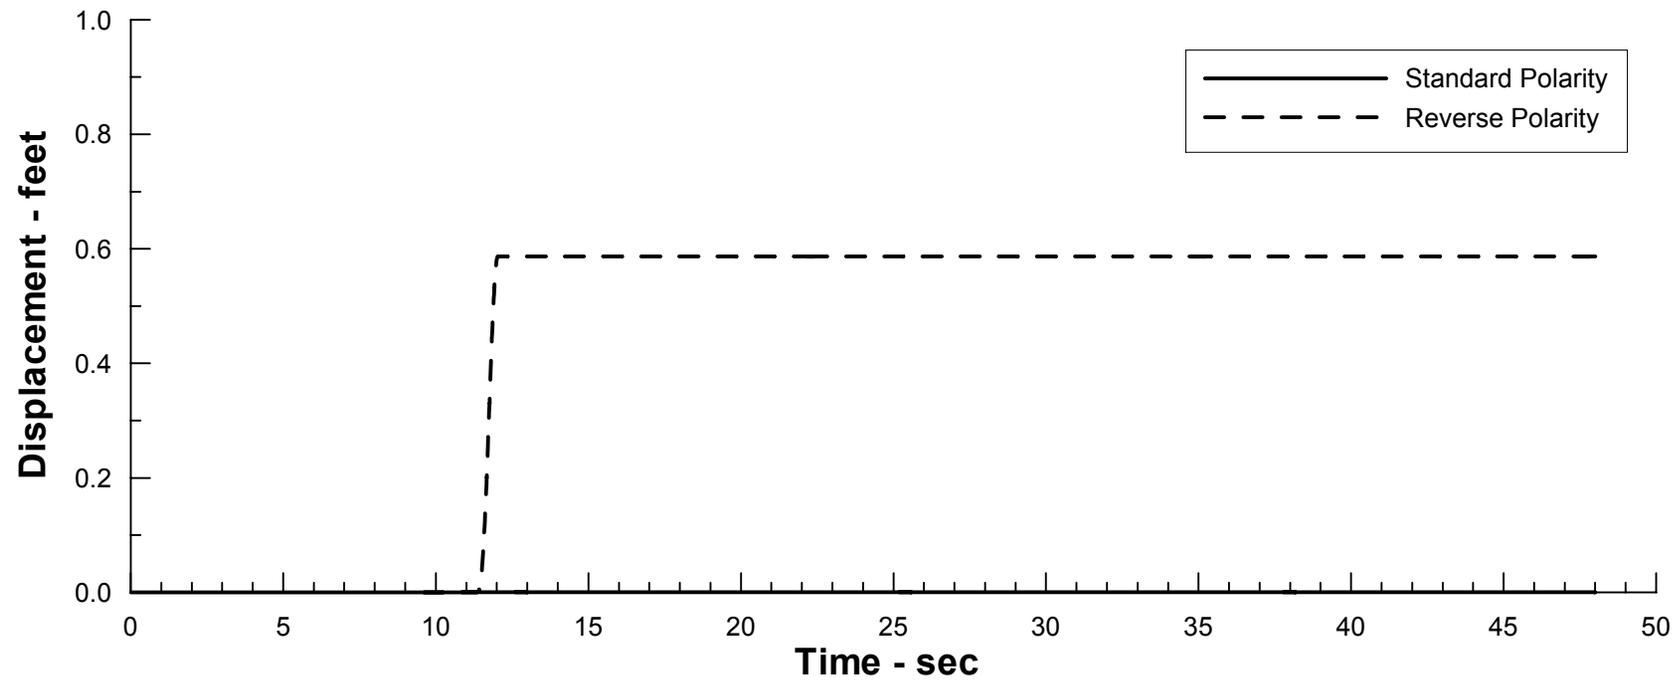
Project No. 26814536	Chabot Dam Seismic Stability Analysis	Newmark Deformation Analysis Calculated Displacement U/S Block #2 Hayward Fault MCE TH #1	Figure
URS			11-21

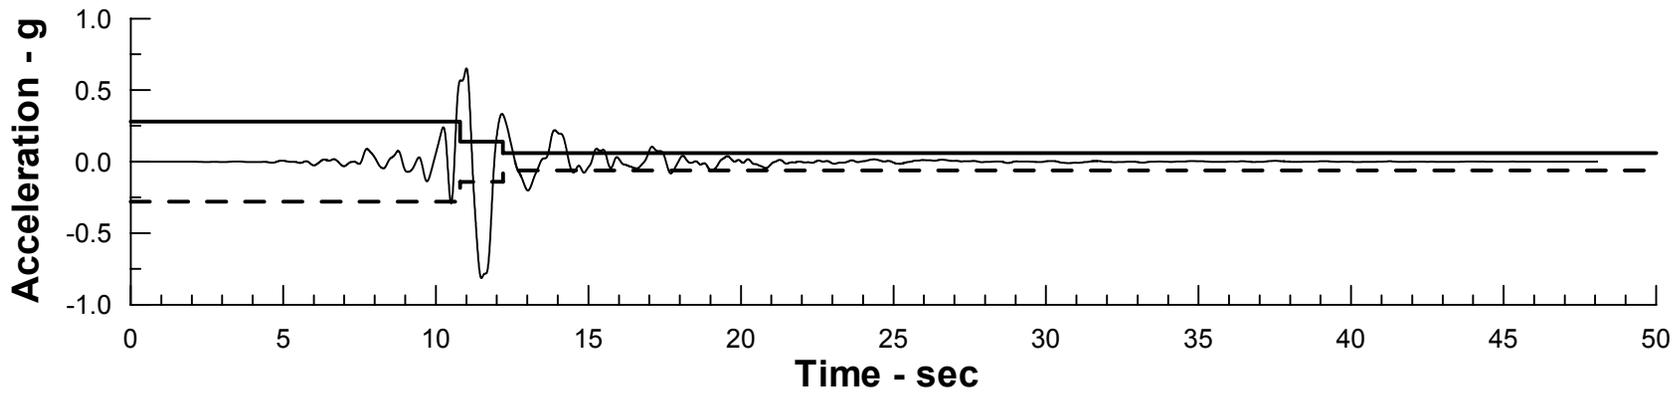
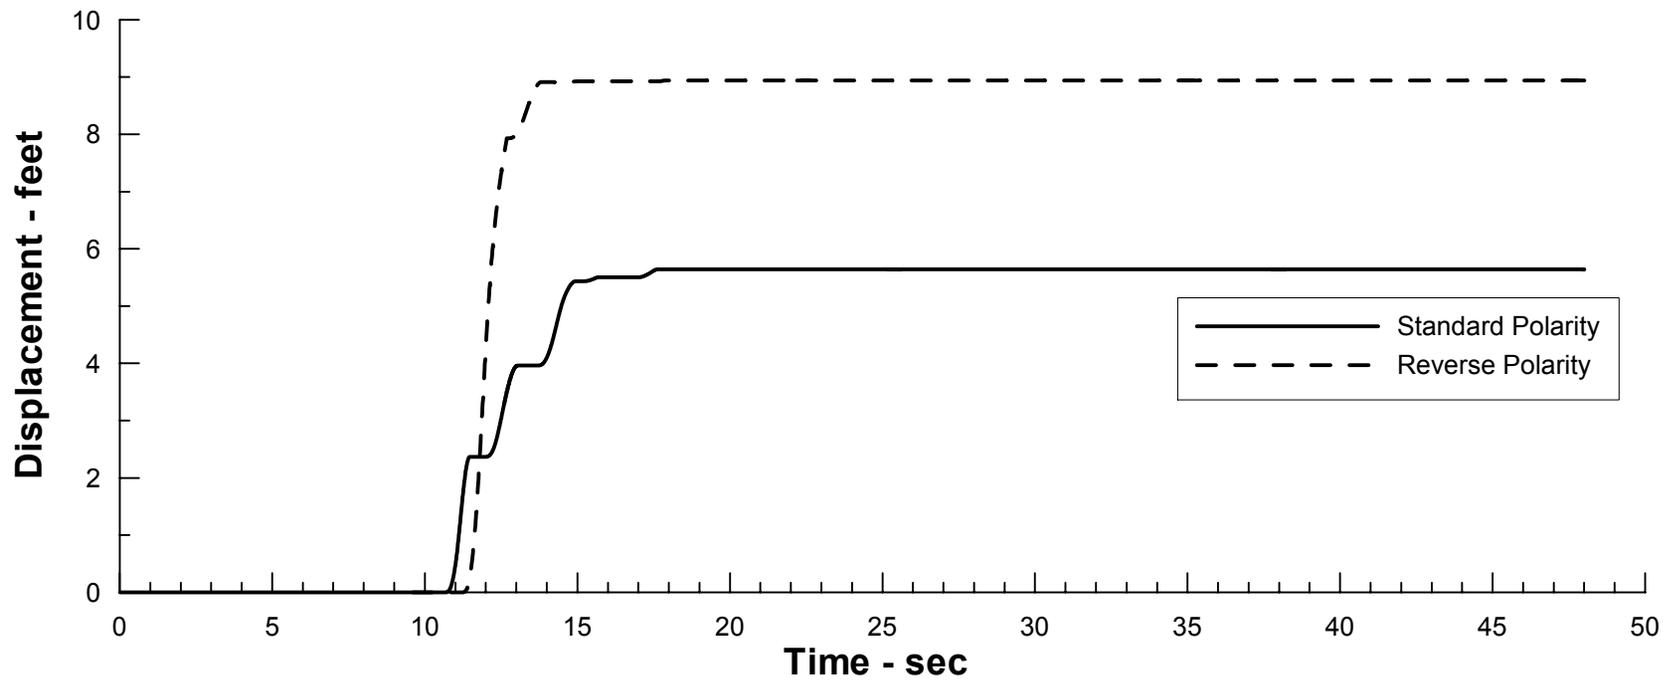
Project No. 26814536	Chabot Dam Seismic Stability Analysis	Newmark Deformation Analysis Calculated Displacement U/S Block #3 Hayward Fault MCE TH #1	Figure
URS			11-22

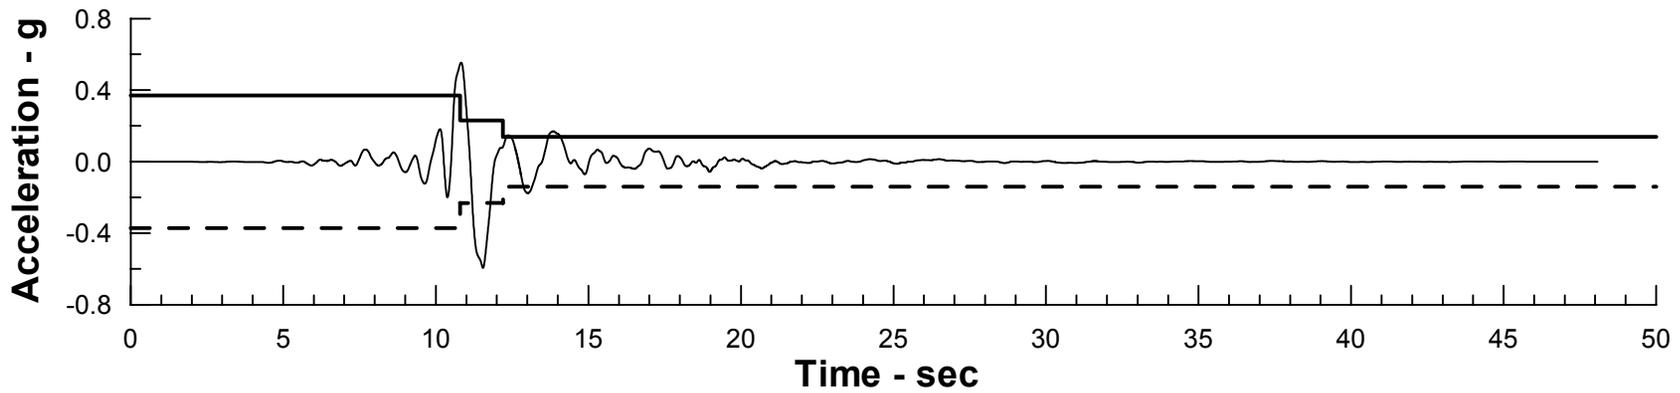
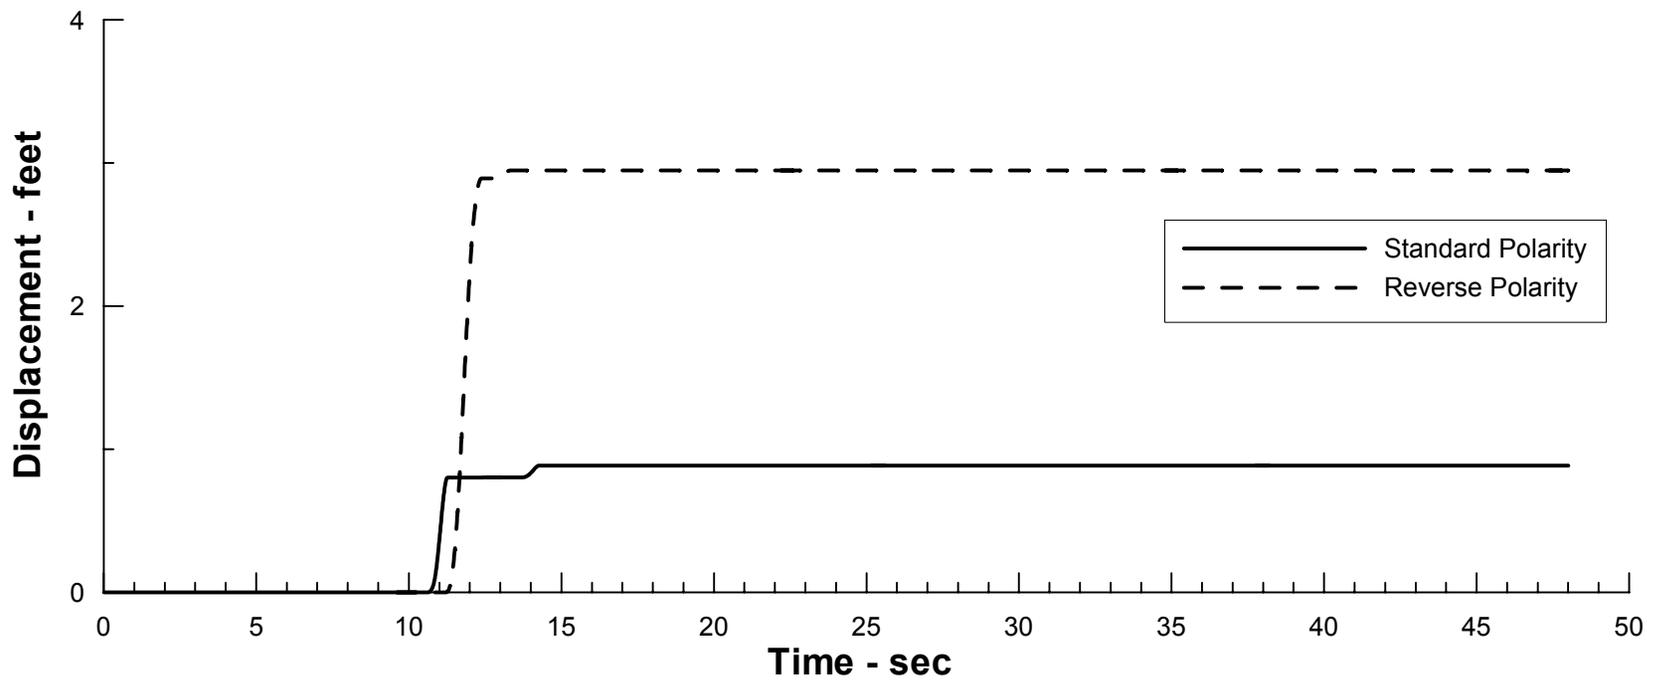
Project No. 26814536	Chabot Dam Seismic Stability Analysis	Newmark Deformation Analysis Calculated Displacement D/S Block #1	Figure 11-23
URS		Hayward Fault MCE TH #1

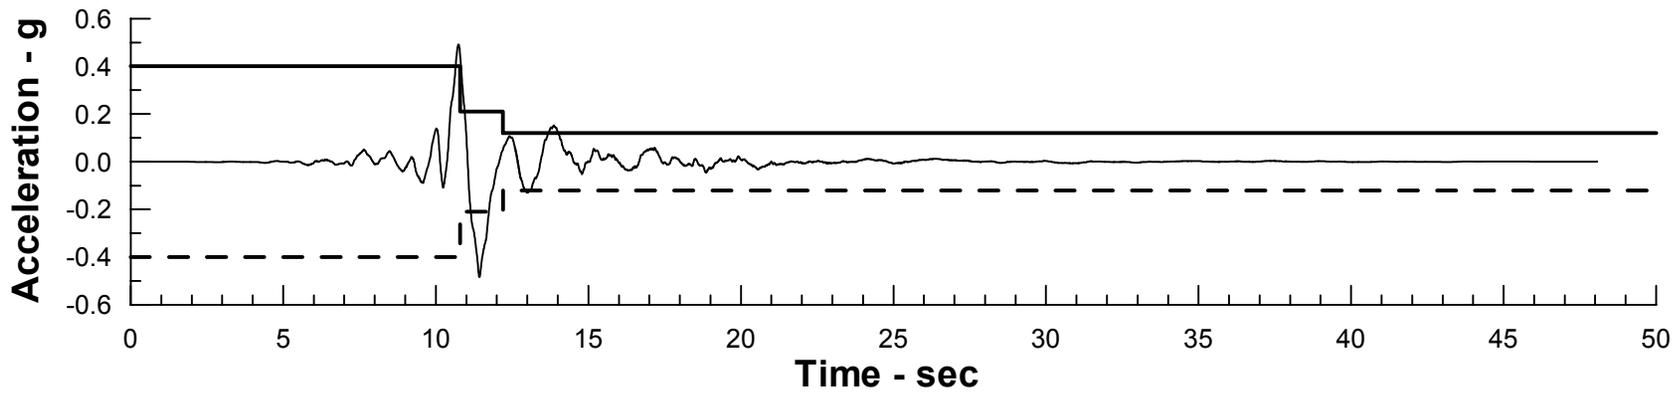
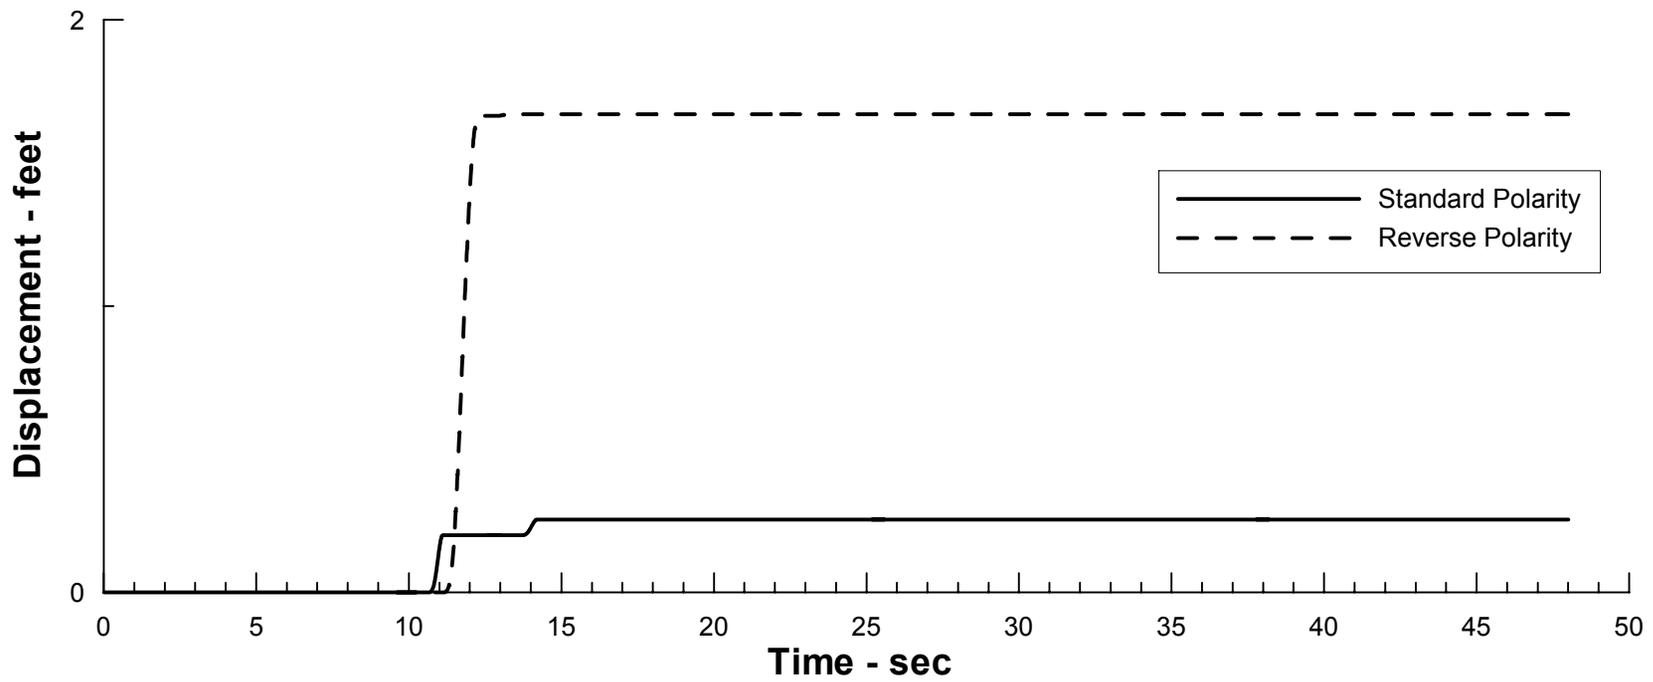
Project No. 26814536	Chabot Dam Seismic Stability Analysis	Newmark Deformation Analysis Calculated Displacement D/S Block #2 Hayward Fault MCE TH #1	Figure
URS			11-24
