FINAL REPORT
VOLUME 1: MAIN REPORT
October 2005

DYNAMIC STABILITY ANALYSIS OF CHABOT DAM

Alameda County, California

**Subject: Dynamic Stability of Chabot Dam
Final Engineering Report**

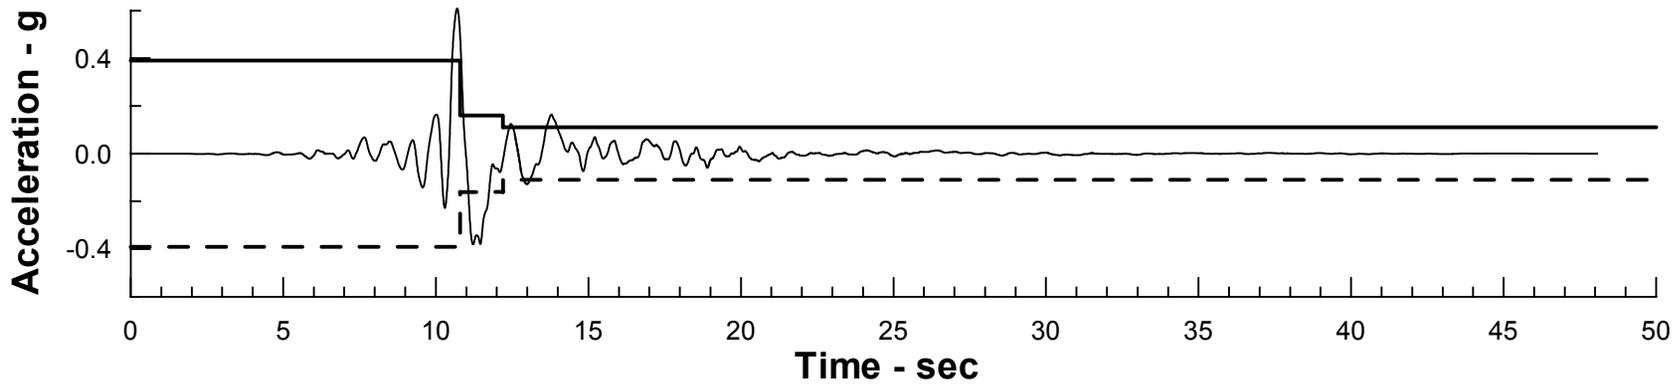
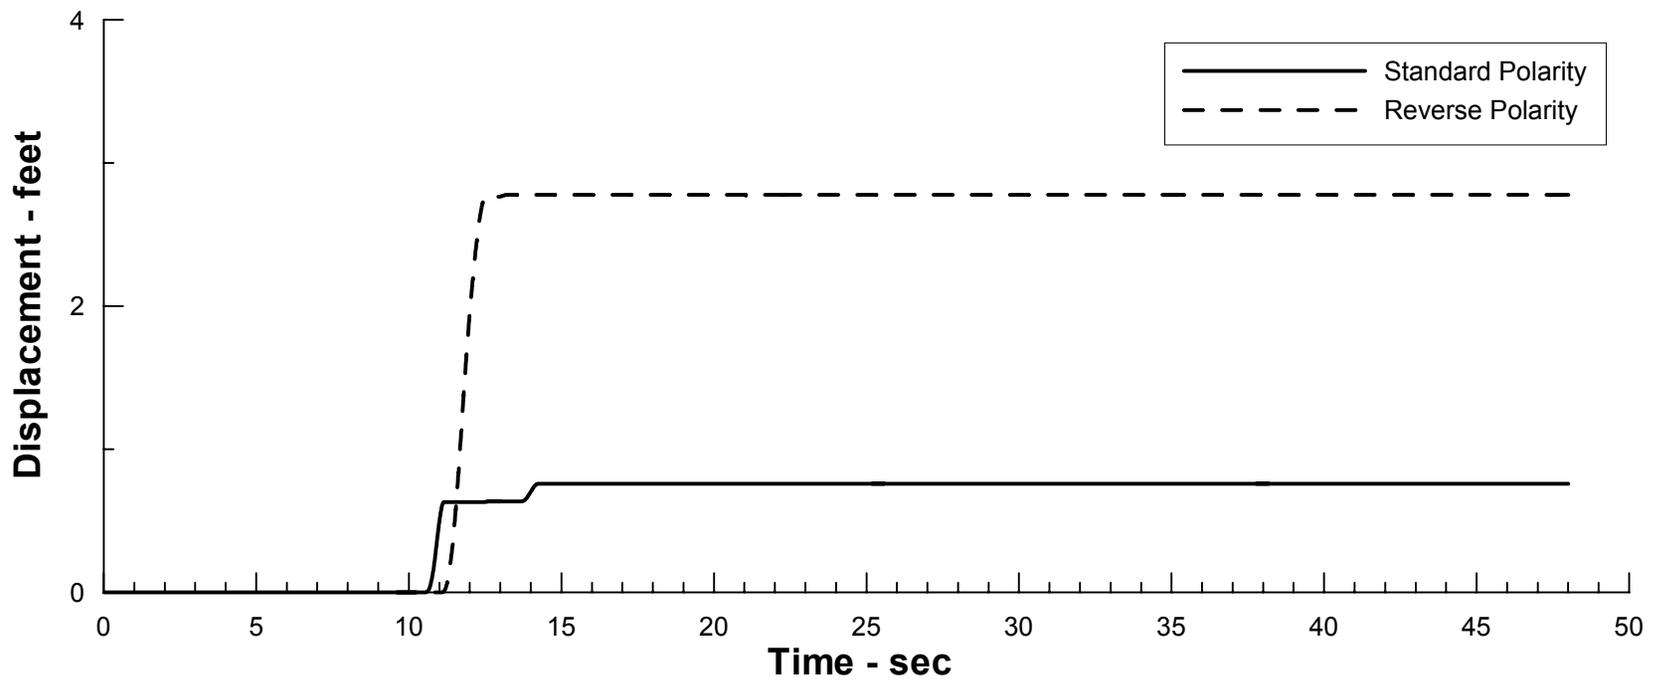
Project No. 26814536	Chabot Dam Seismic Stability Analysis	Newmark Deformation Analysis Calculated Displacement D/S Block #3	Figure 11-25
URS		Hayward Fault MCE TH #1

The Newmark-type deformation analyses results are presented in Figures 11-20 through 11-34. The calculated displacements are summarized in Table 11-3. These calculated displacements correspond to horizontal translation of the center of mass of each sliding block. The

The displacements calculated for Hayward event are shown in Figures 11-20 through 11-26. Horizontal displacements of 6 to 9 feet are calculated for upstream block No. 3. Based on the geometry of the block, such displacements would correspond to downward vertical displacements of the crest of 4 to 6 feet. Somewhat larger horizontal displacements (9 to 12 feet) are calculated for upstream block No. 1, but this block does not reach across the dam crest. Horizontal displacements of about 4 feet are calculated for downstream Block No. 4, which approximately encompasses the body of the sluiced fill. Horizontal displacements of less than 3 feet are calculated for other downstream blocks and for a deep-seated upstream block.

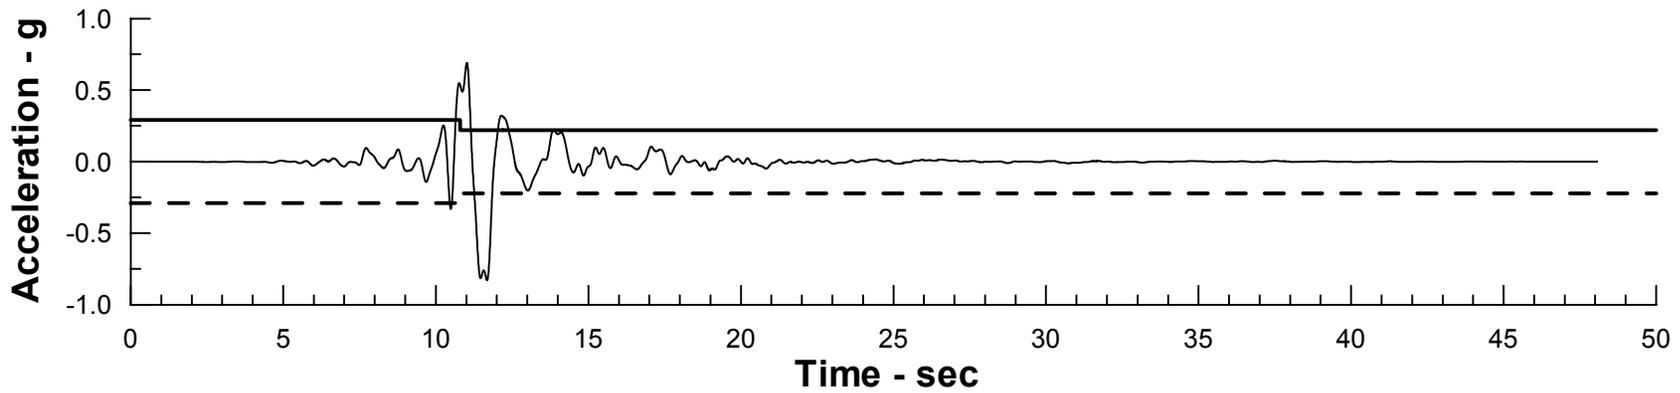
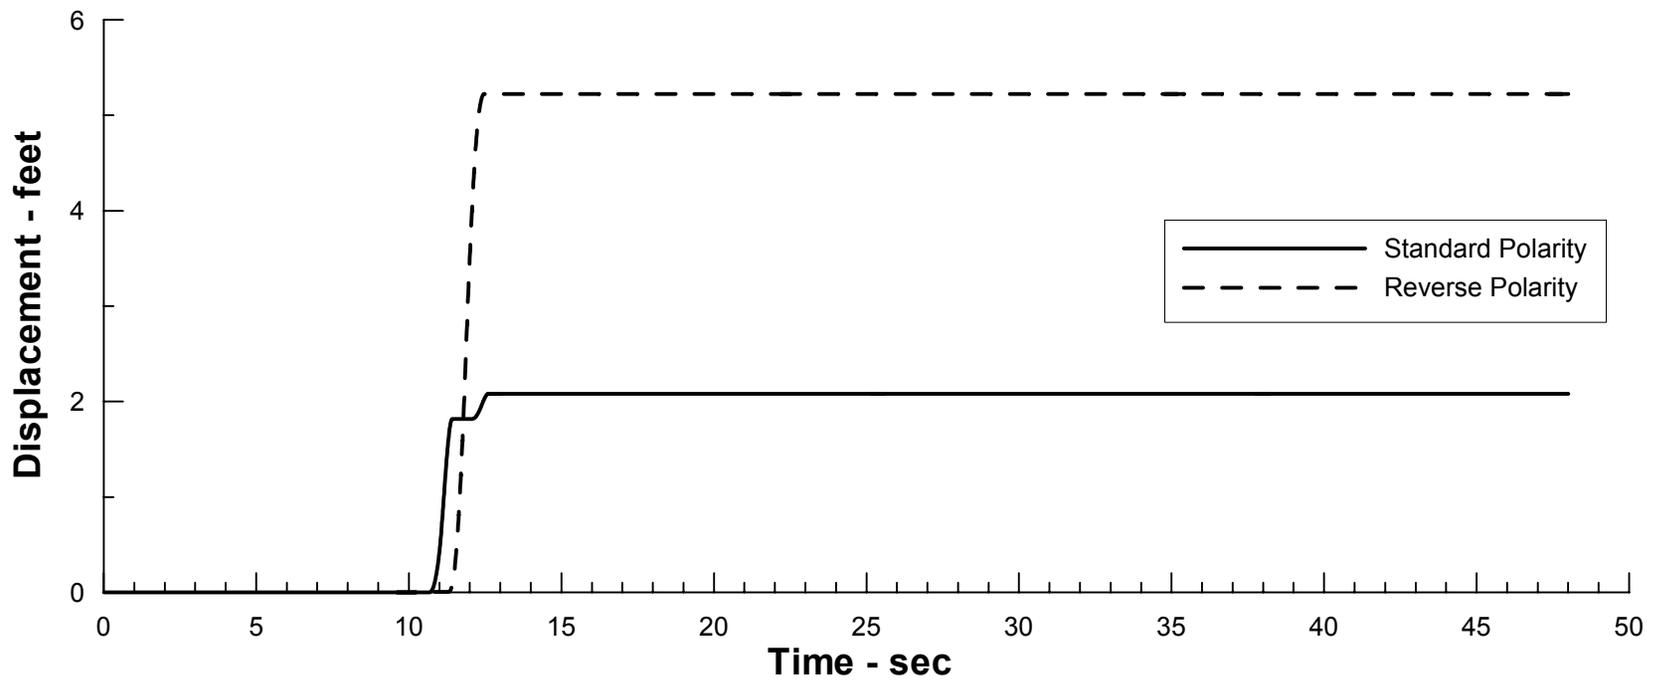
Project No. 26814536	Chabot Dam Seismic Stability Analysis	Newmark Deformation Analysis Calculated Displacement U/S Block #1	Figure 11-27
URS		Hayward Fault MCE TH #1 (10% Max. Strength Reduction)

Parametric analyses were also performed based on the amount of strength degradation calculated from the FLAC analyses, which is discussed in Section 12. These latter analyses indicate that cyclic degradation will result in a reduction in strength of no more than about 10 percent over a large portion of the wagon fill. This reduction is expected to occur during the strong phase of shaking. Accordingly, the parametric analyses were performed for selected sliding blocks using time histories of yield acceleration that incorporate a 10 percent strength reduction (see Table 11-3) early in the strong phase of shaking. The results of these analyses are shown in Figures 11-27 through 11-29. As shown in Figures 11-27 and 11-28, the calculated horizontal displacements for upstream blocks Nos. 1 and 3 are less than about 5 feet. Such displacements correspond to a vertical downward displacement of the crest less than about 3.5 feet.

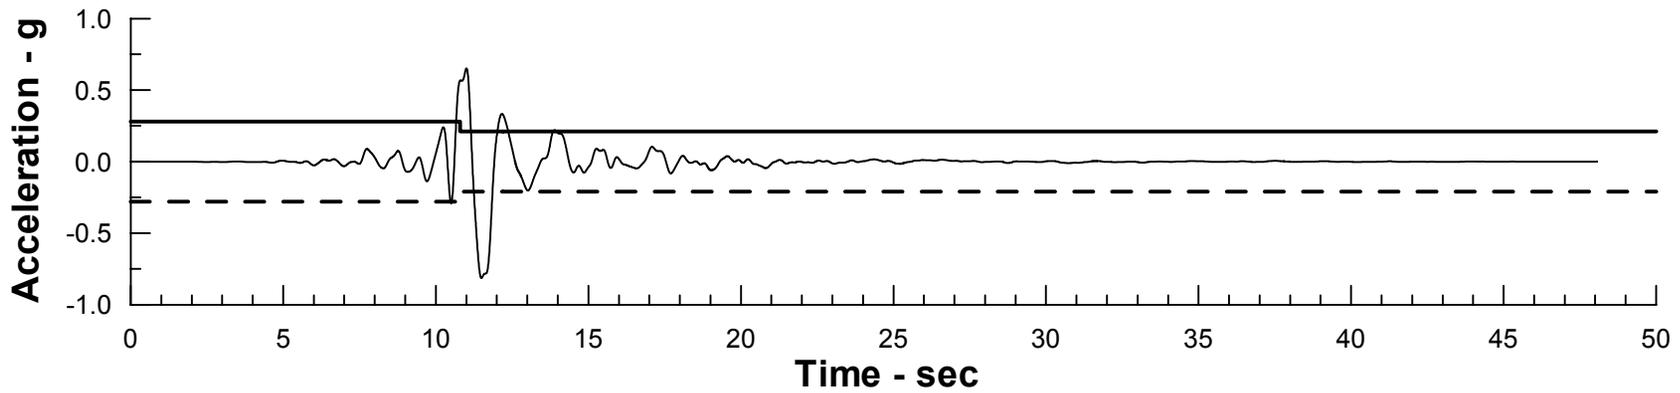
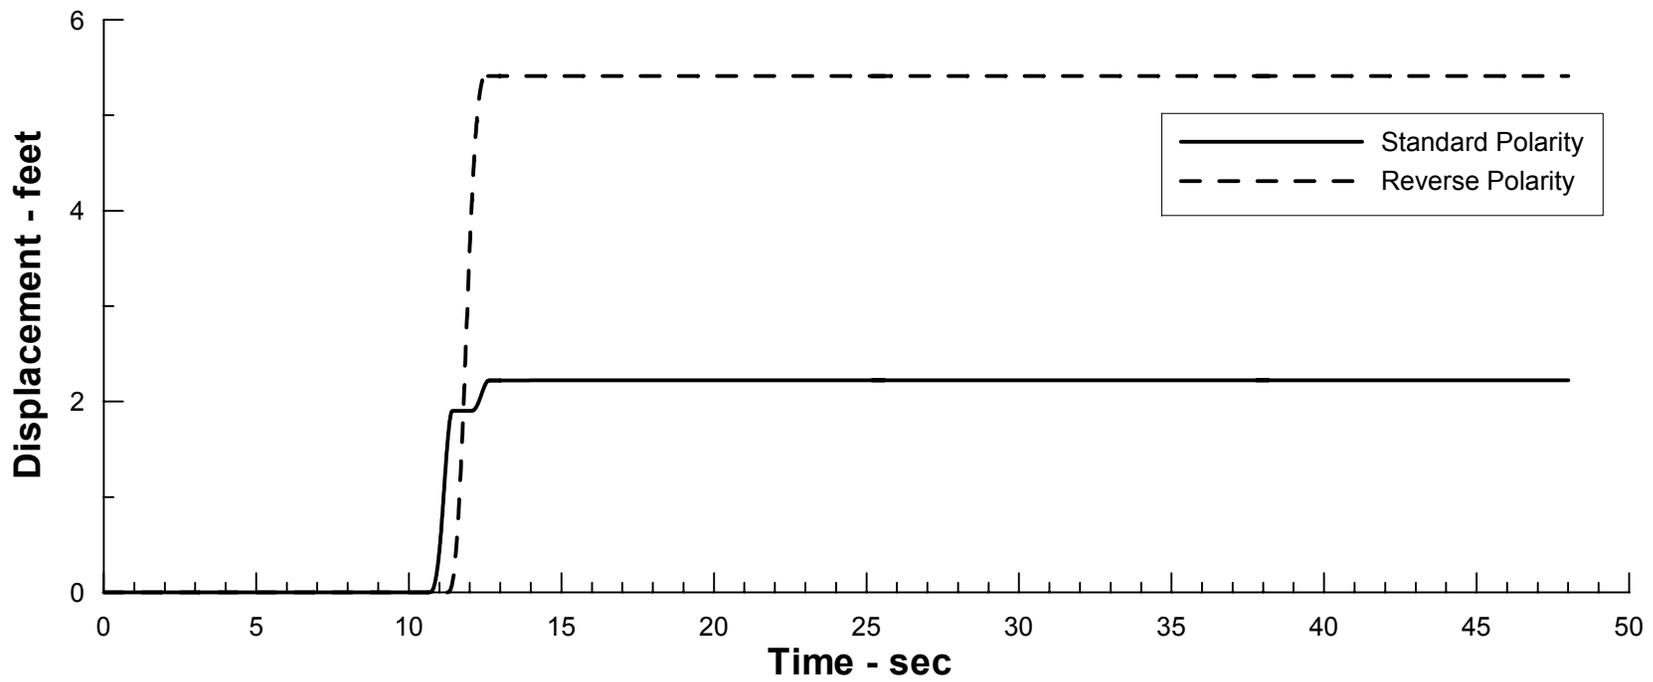
Project No. 26814536	Chabot Dam Seismic Stability Analysis	Newmark Deformation Analysis Calculated Displacement U/S Block #3 Hayward Fault MCE TH #1 (10% Max. Strength Reduction)	Figure
URS			11-28

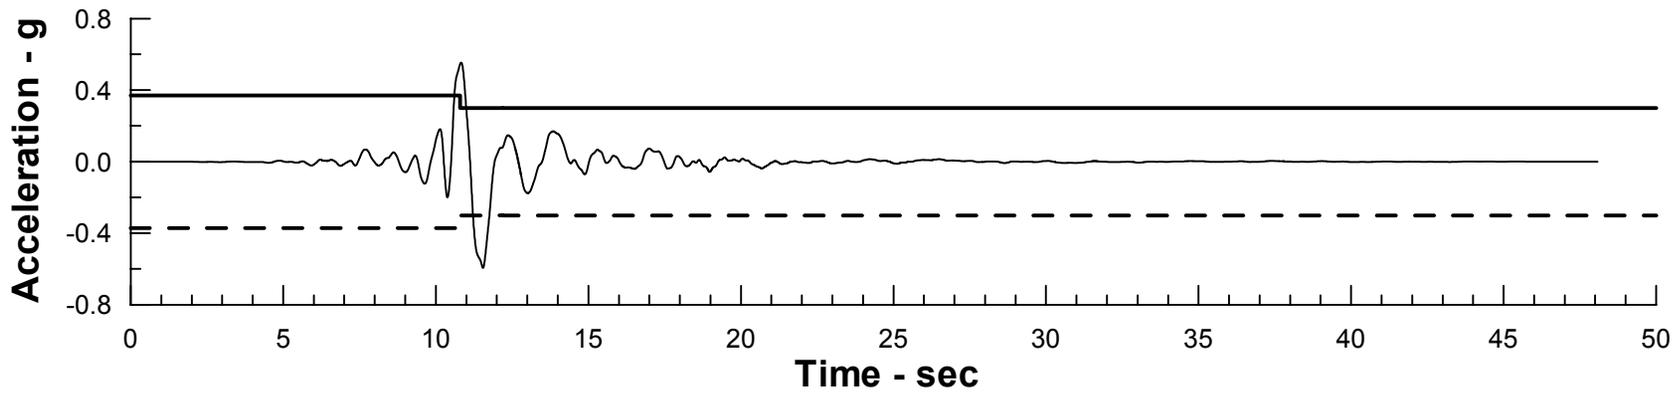
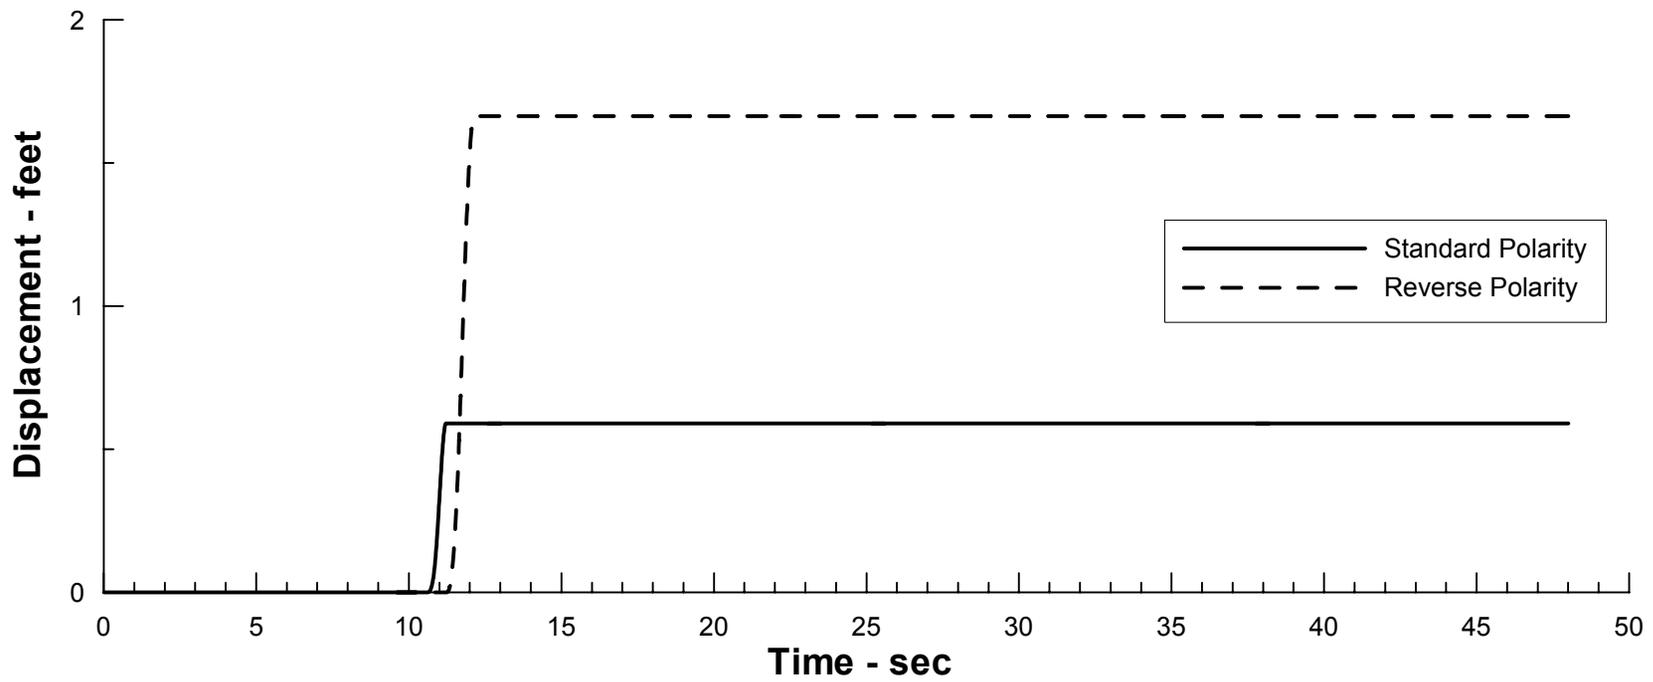
Project No. 26814536	Chabot Dam Seismic Stability Analysis	Newmark Deformation Analysis Calculated Displacement D/S Block #1 Hayward Fault MCE TH #1 (10% Max. Strength Reduction)	Figure
URS			11-29

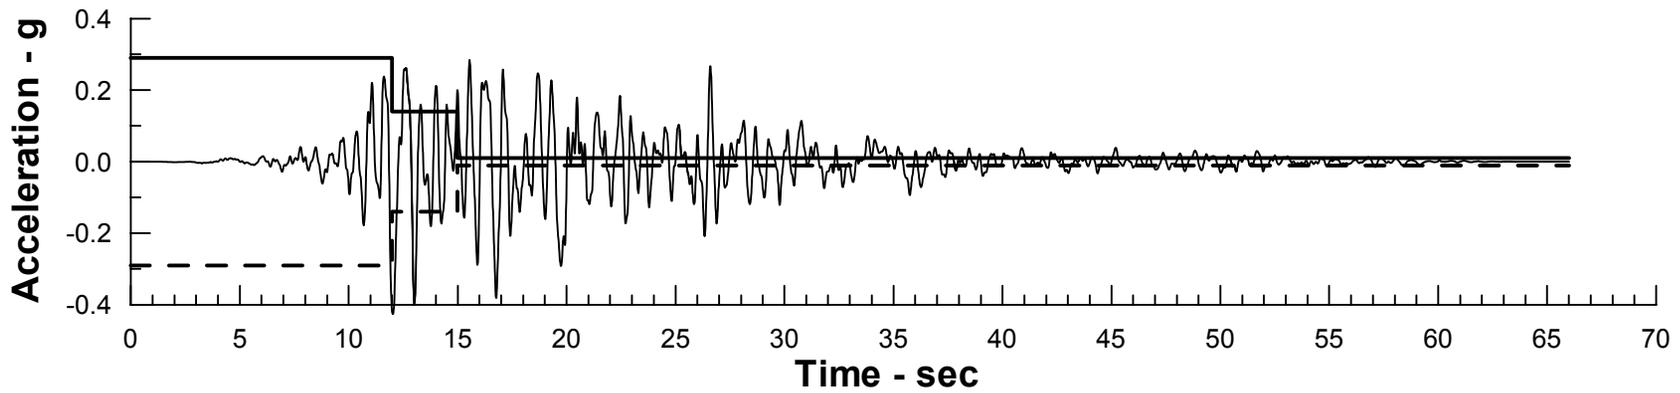
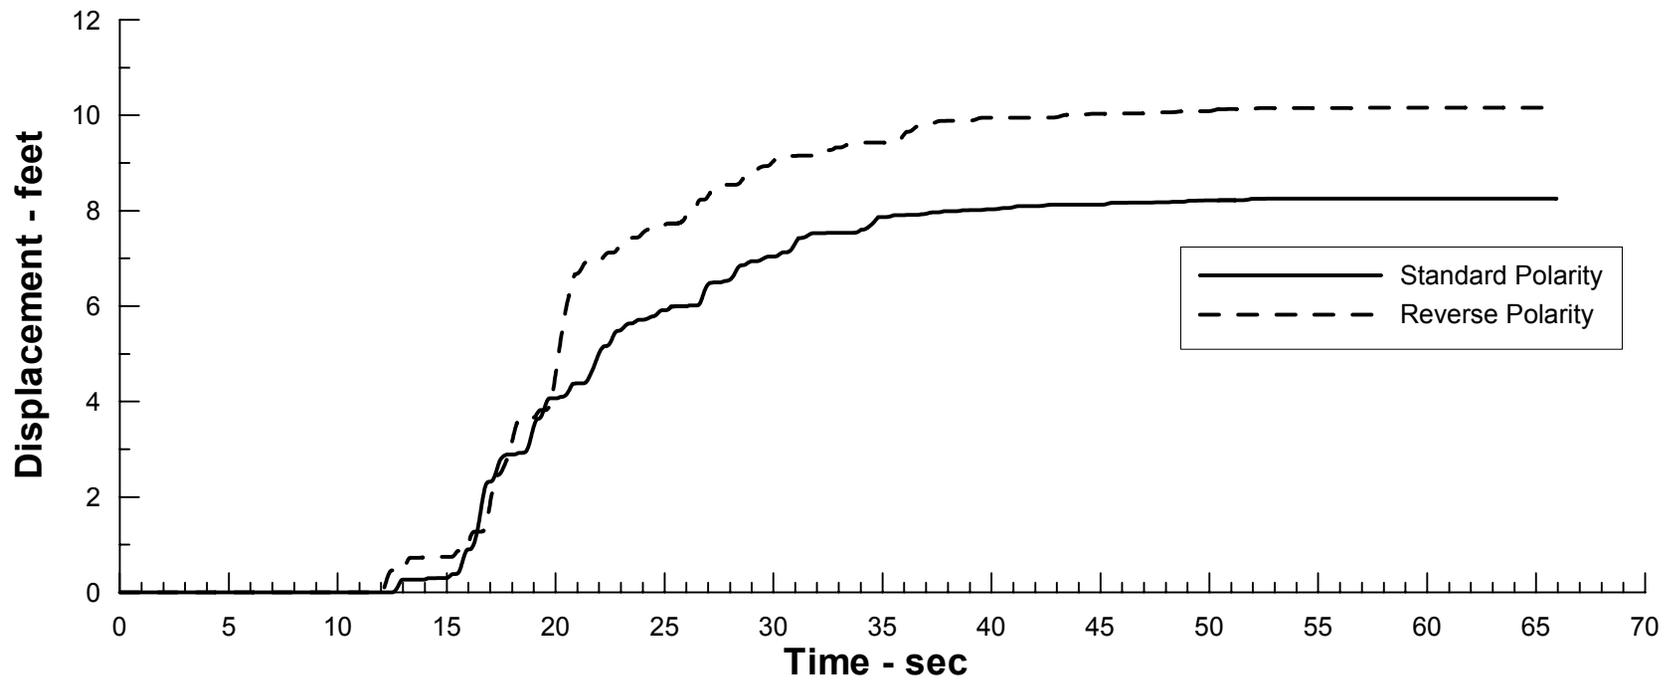
Project No. 26814536	Chabot Dam Seismic Stability Analysis	Newmark Deformation Analysis Calculated Displacement U/S Block #1 San Andreas Fault MCE	Figure 11-30
URS

The displacements calculated for the San Andreas event are shown in Figures 11-30 through 11-34. It may be seen that the calculated dam deformations for the San Andreas event are lower than those for the Hayward event. Thus, the results of the analyses indicate that the San Andreas event is less critical than the Hayward event regarding the seismic stability of the dam.

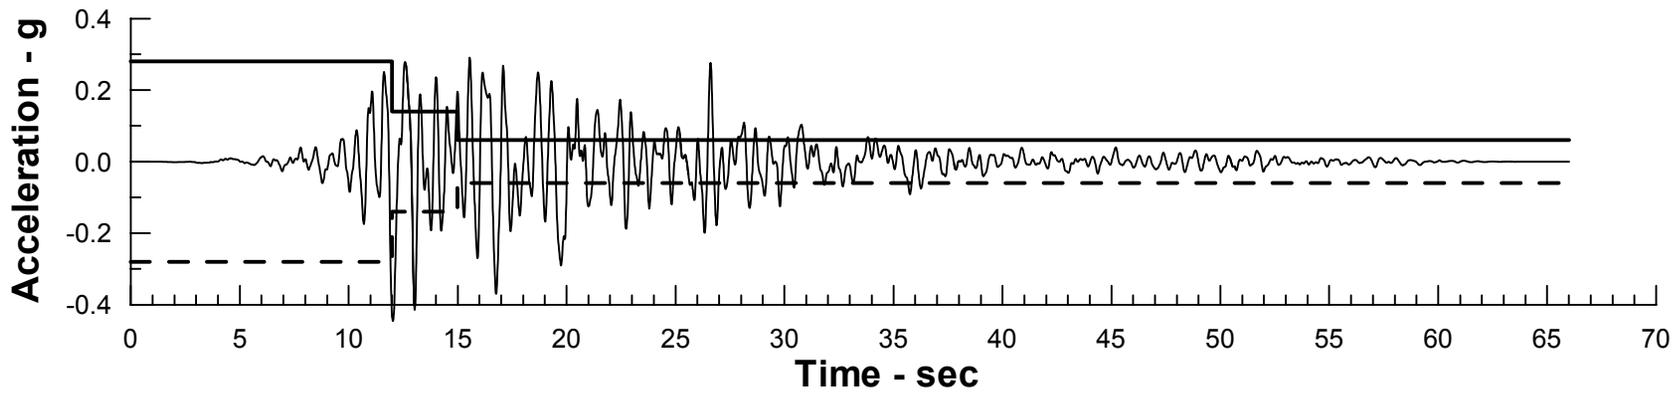
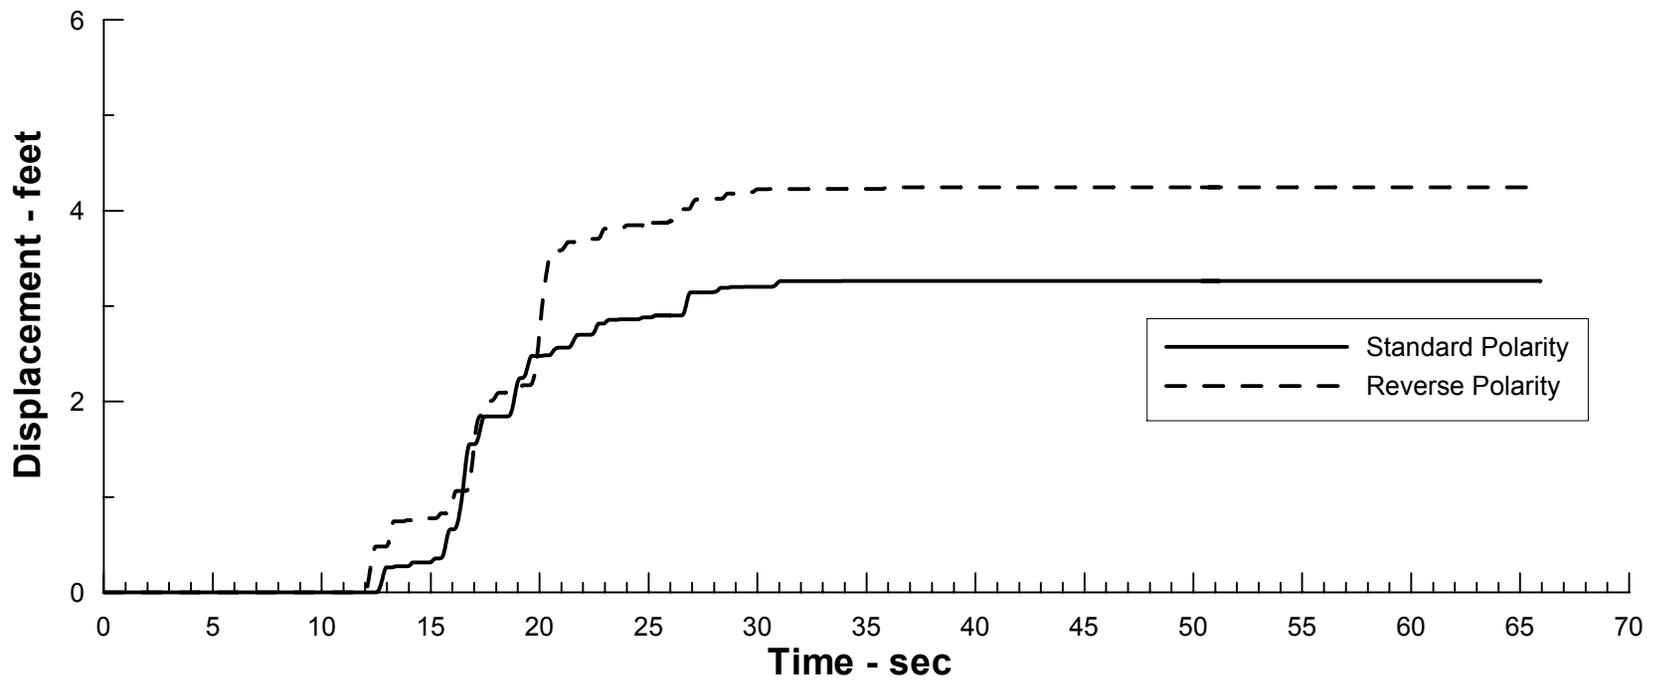
Project No. 26814536	Chabot Dam Seismic Stability Analysis	Newmark Deformation Analysis Calculated Displacement U/S Block #3 San Andreas Fault MCE	Figure
URS			11-31

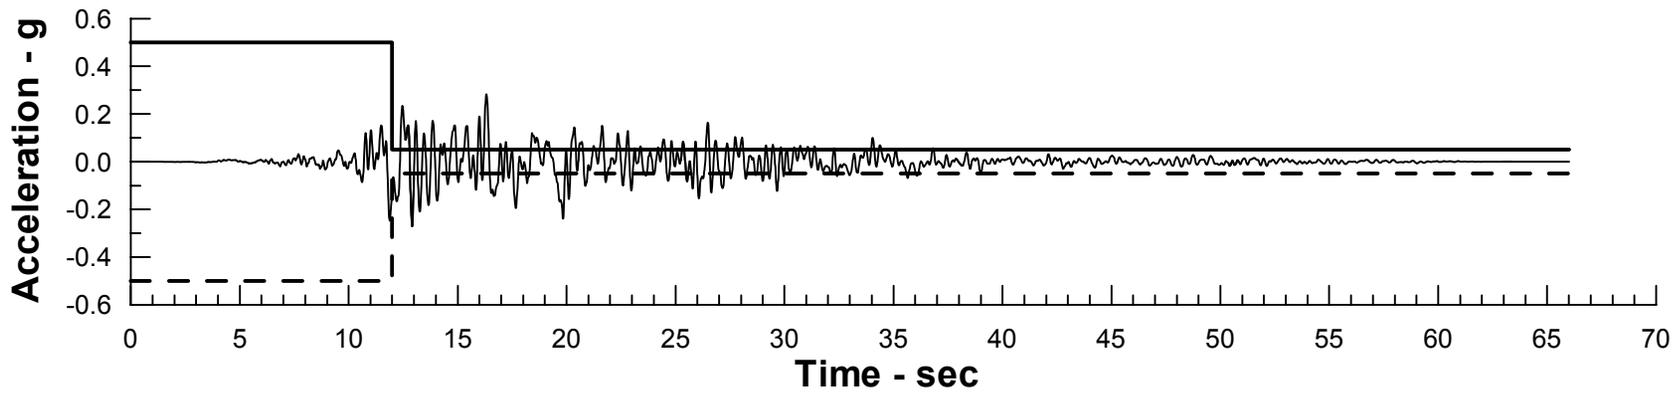
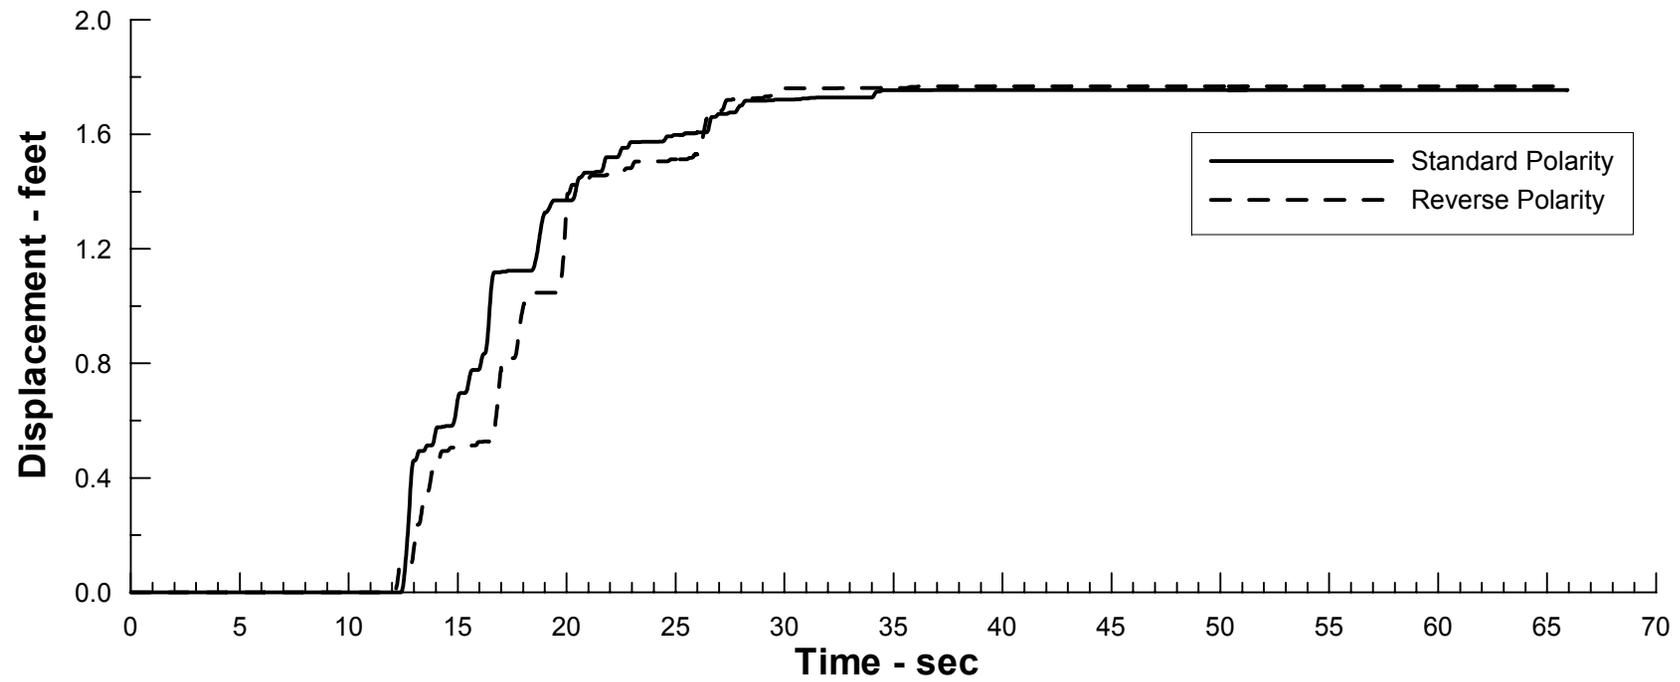
Project No. 26814536	Chabot Dam Seismic Stability Analysis	Newmark Deformation Analysis Calculated Displacement D/S Block #4 San Andreas Fault MCE	Figure 11-32
URS

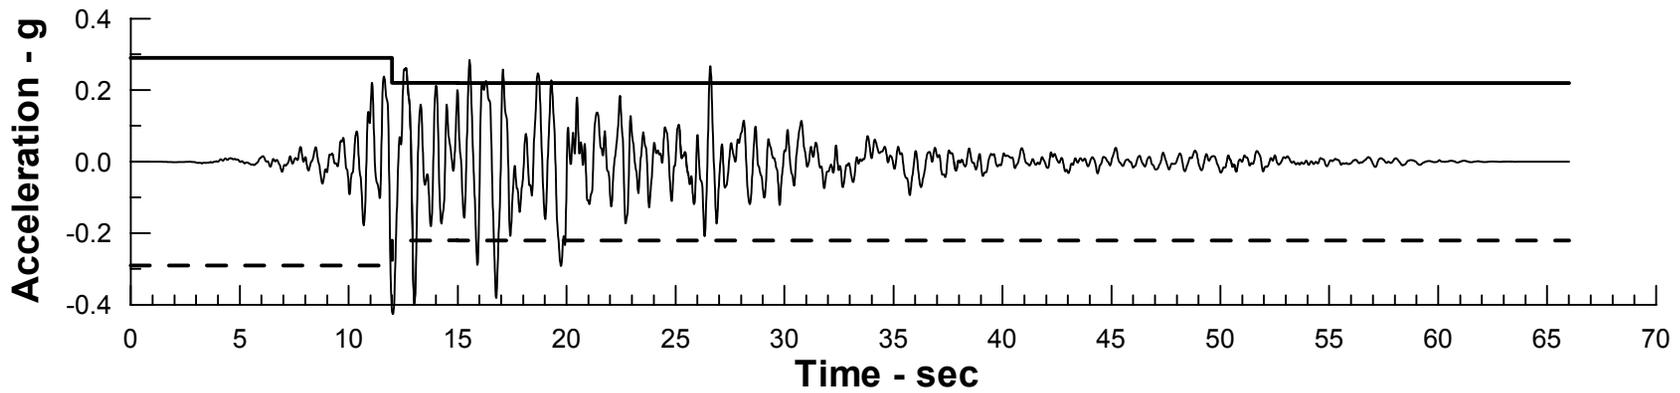
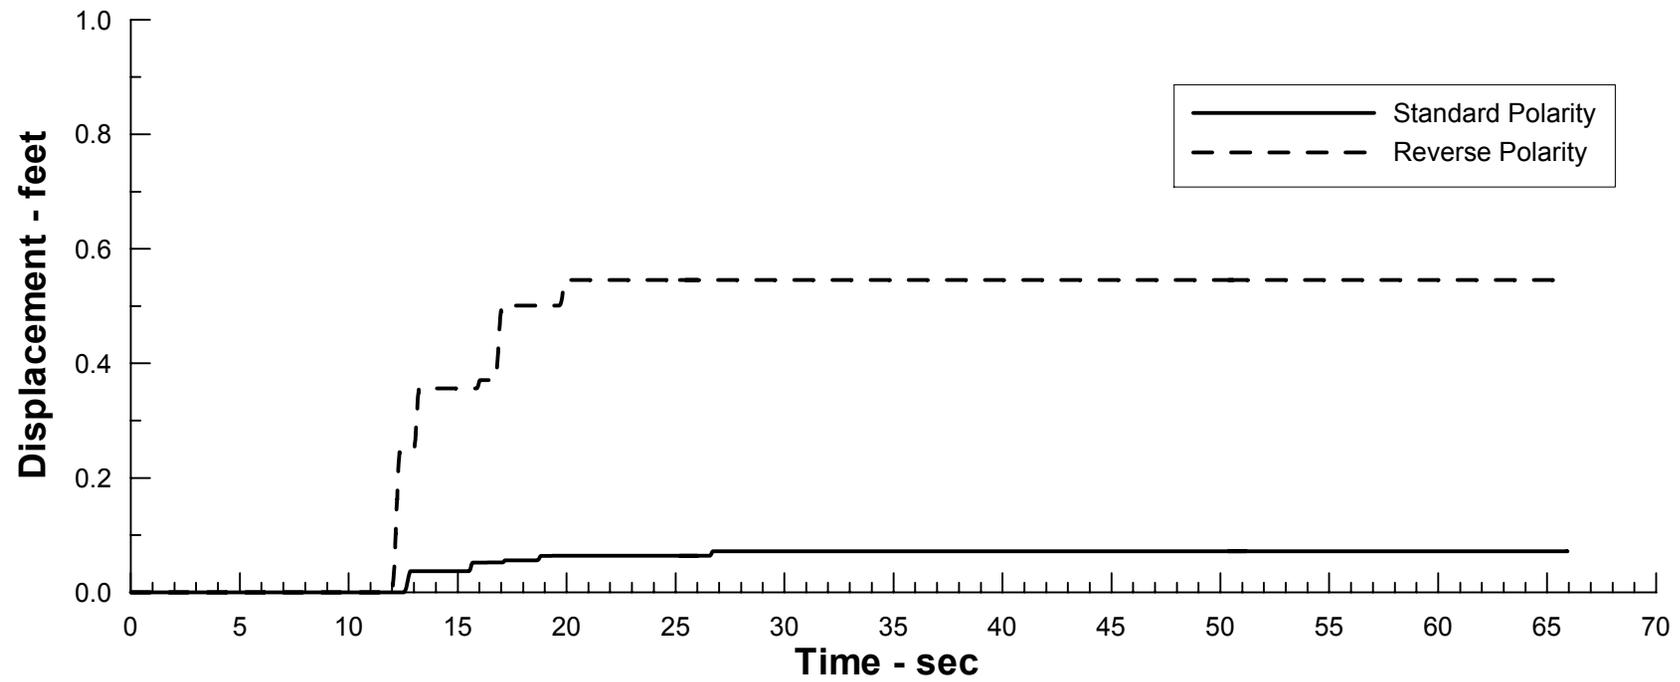
Project No. 26814536	Chabot Dam Seismic Stability Analysis	Newmark Deformation Analysis Calculated Displacement U/S Block #1	Figure
URS		San Andreas Fault MCE (10% Max. Strength Reduction)	11-33

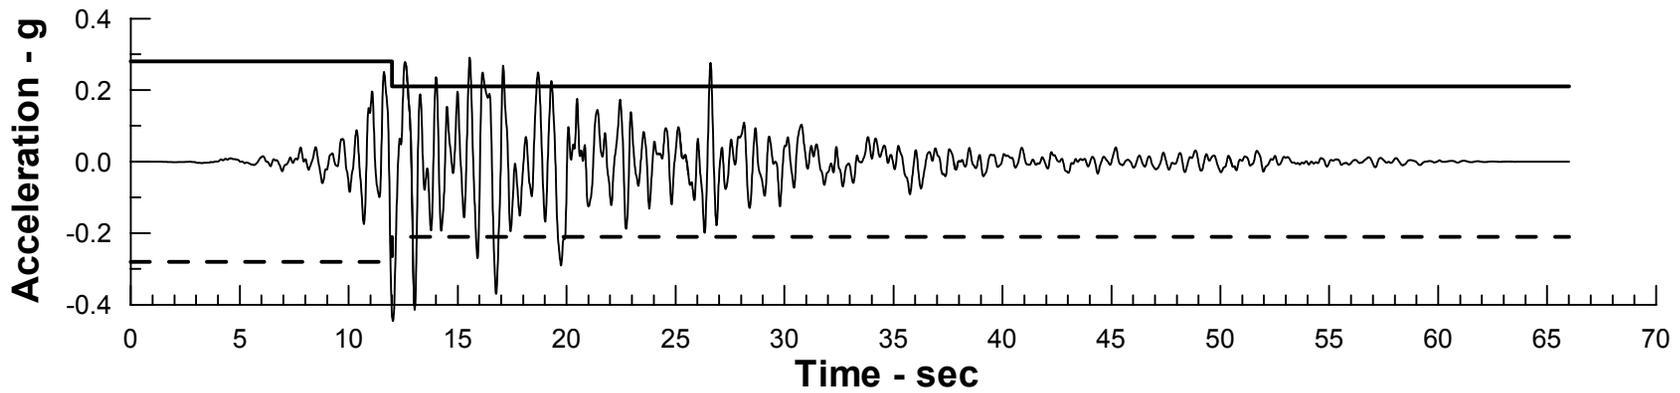
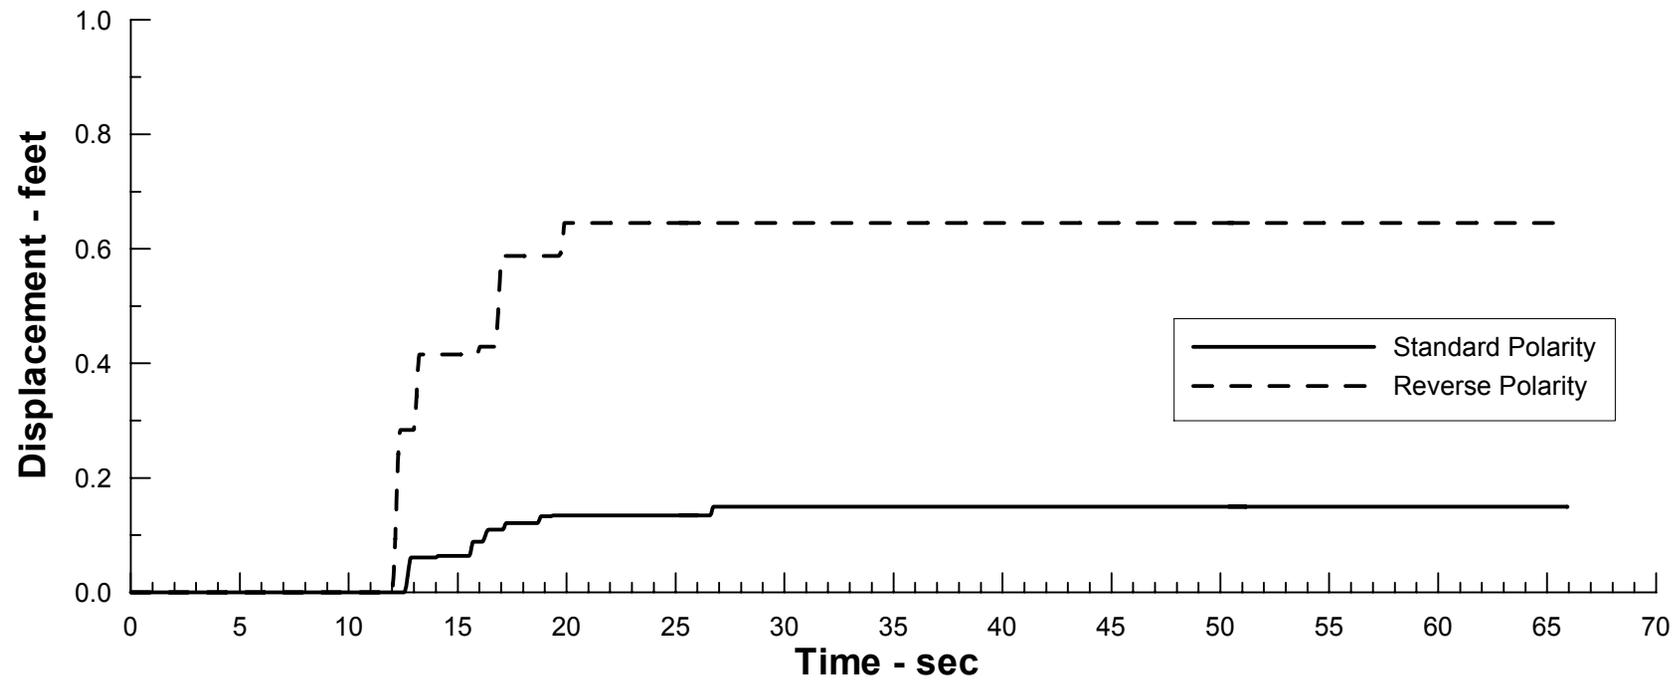
Project No. 26814536	Chabot Dam Seismic Stability Analysis	Newmark Deformation Analysis Calculated Displacement U/S Block #3 San Andreas Fault MCE (10% Max. Strength Reduction)	Figure
URS			11-34

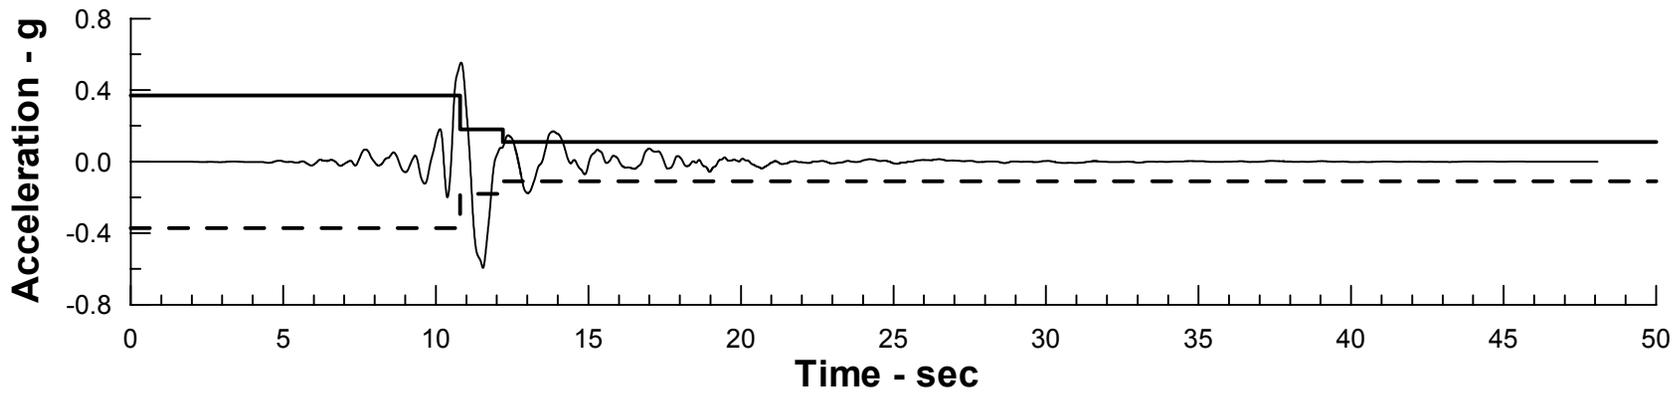
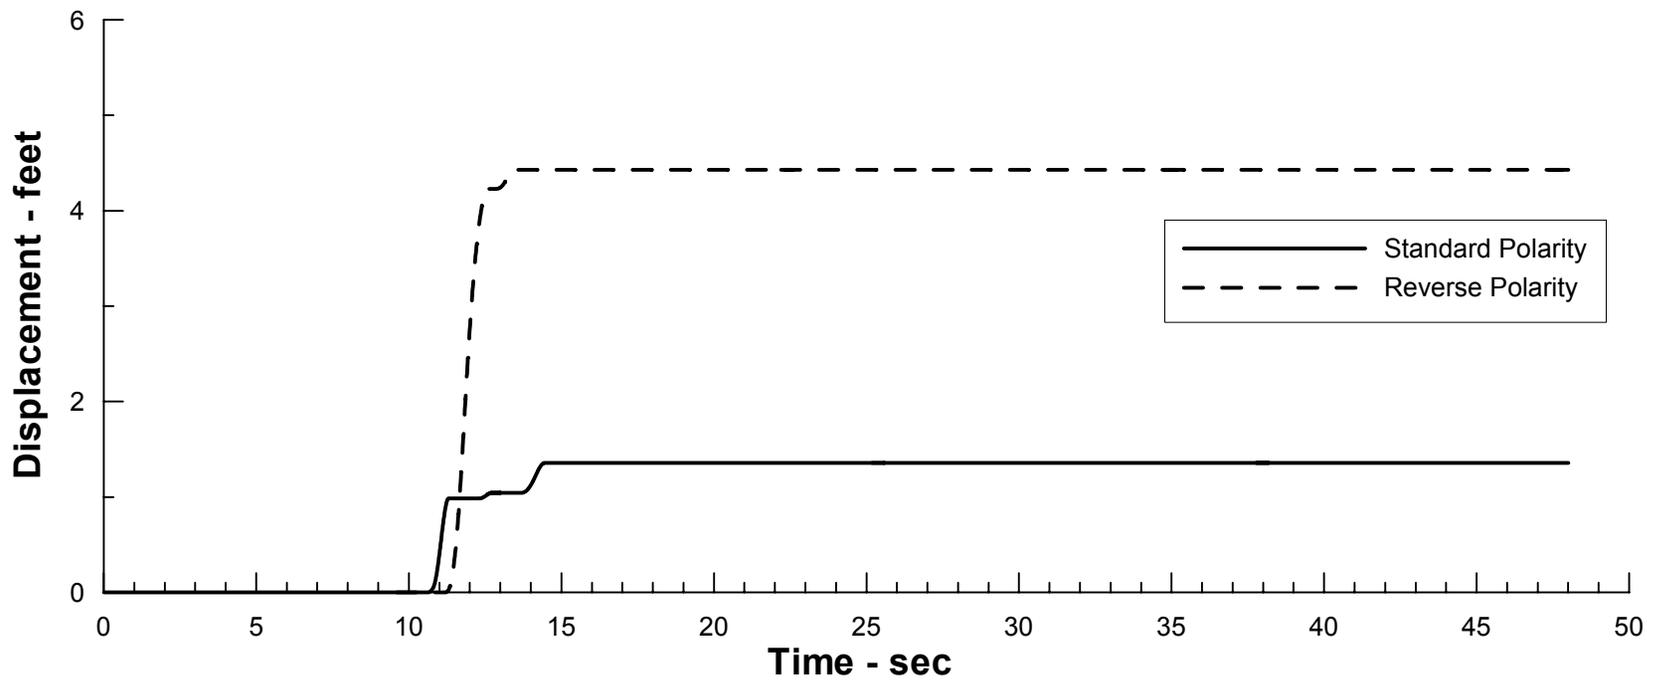
Project No. 26814536	Chabot Dam Seismic Stability Analysis	Newmark Deformation Analysis Calculated Displacement D/S Block #1 (Modified Section A-A') Hayward Fault MCE TH #1	Figure 11-35
URS

the location of that boundary. The results of those analyses are illustrated in Figures 11-35 and 11-36 and are summarized in Table 11-4. They indicate that the calculated downstream deformations are not highly sensitive to the location of the wagon fill/sluced fill boundary.

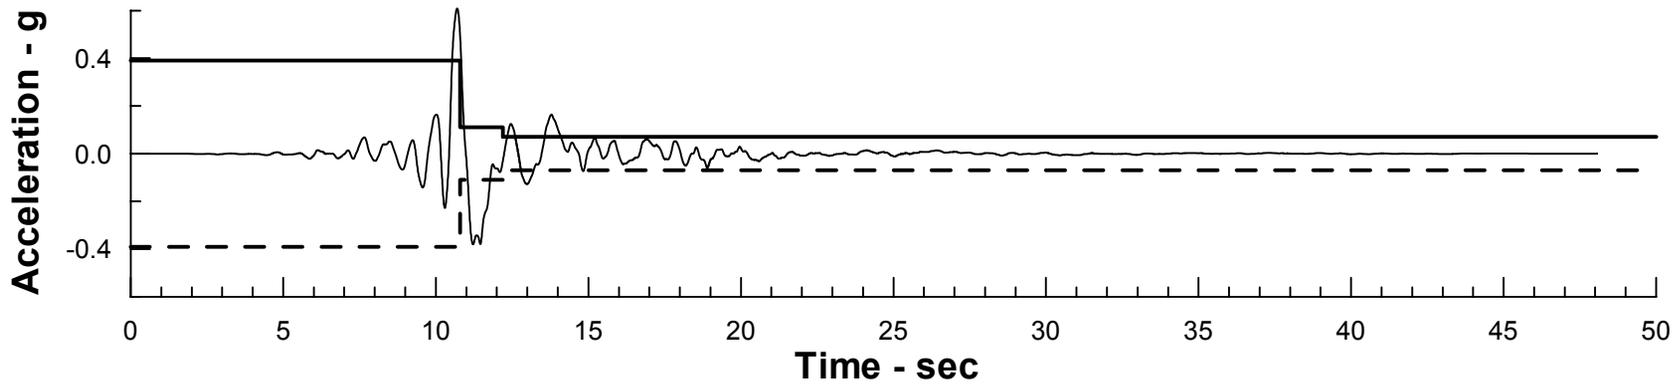
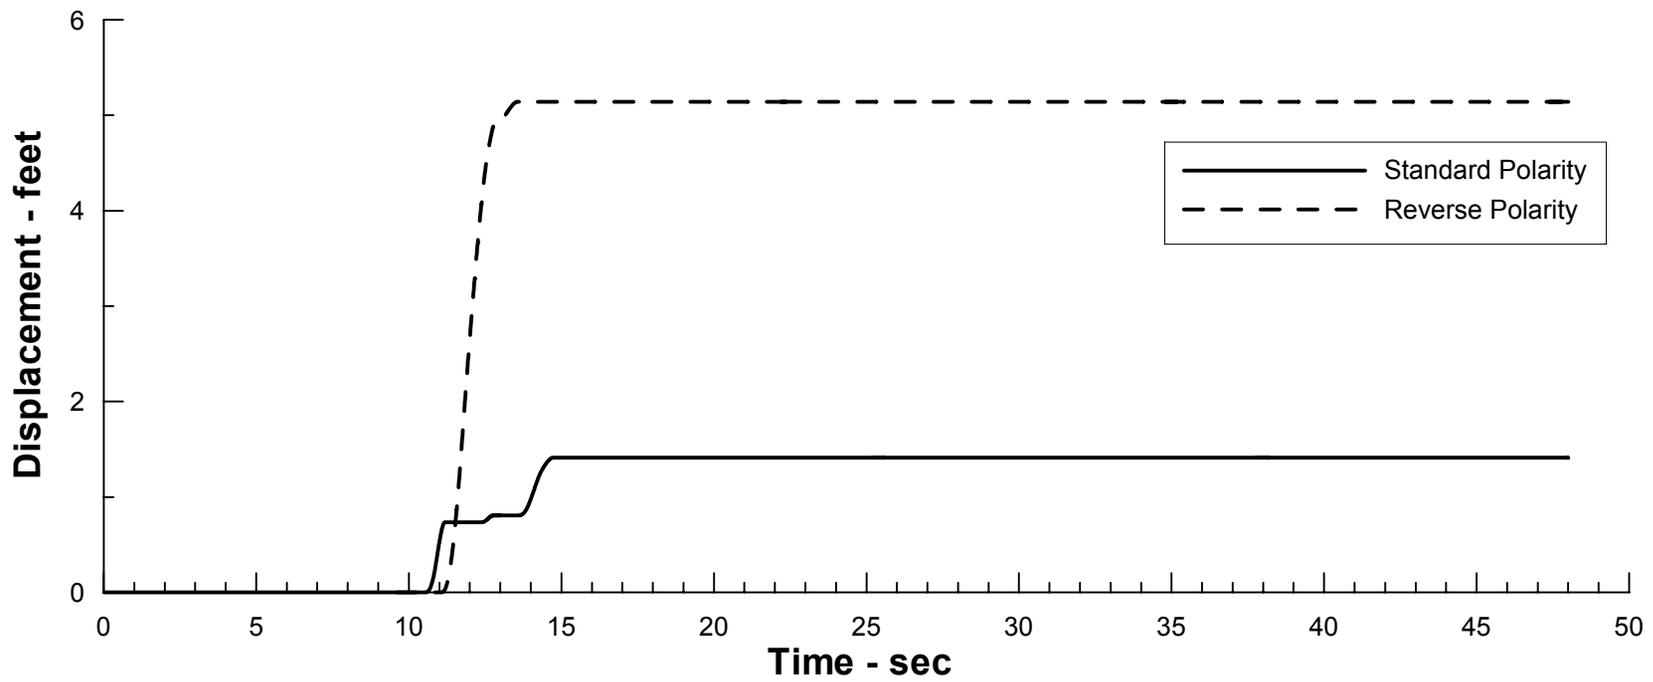
Project No. 26814536	Chabot Dam Seismic Stability Analysis	Newmark Deformation Analysis Calculated Displacement D/S Block #3 (Modified Section A-A') Hayward Fault MCE TH #1	Figure 11-36
URS

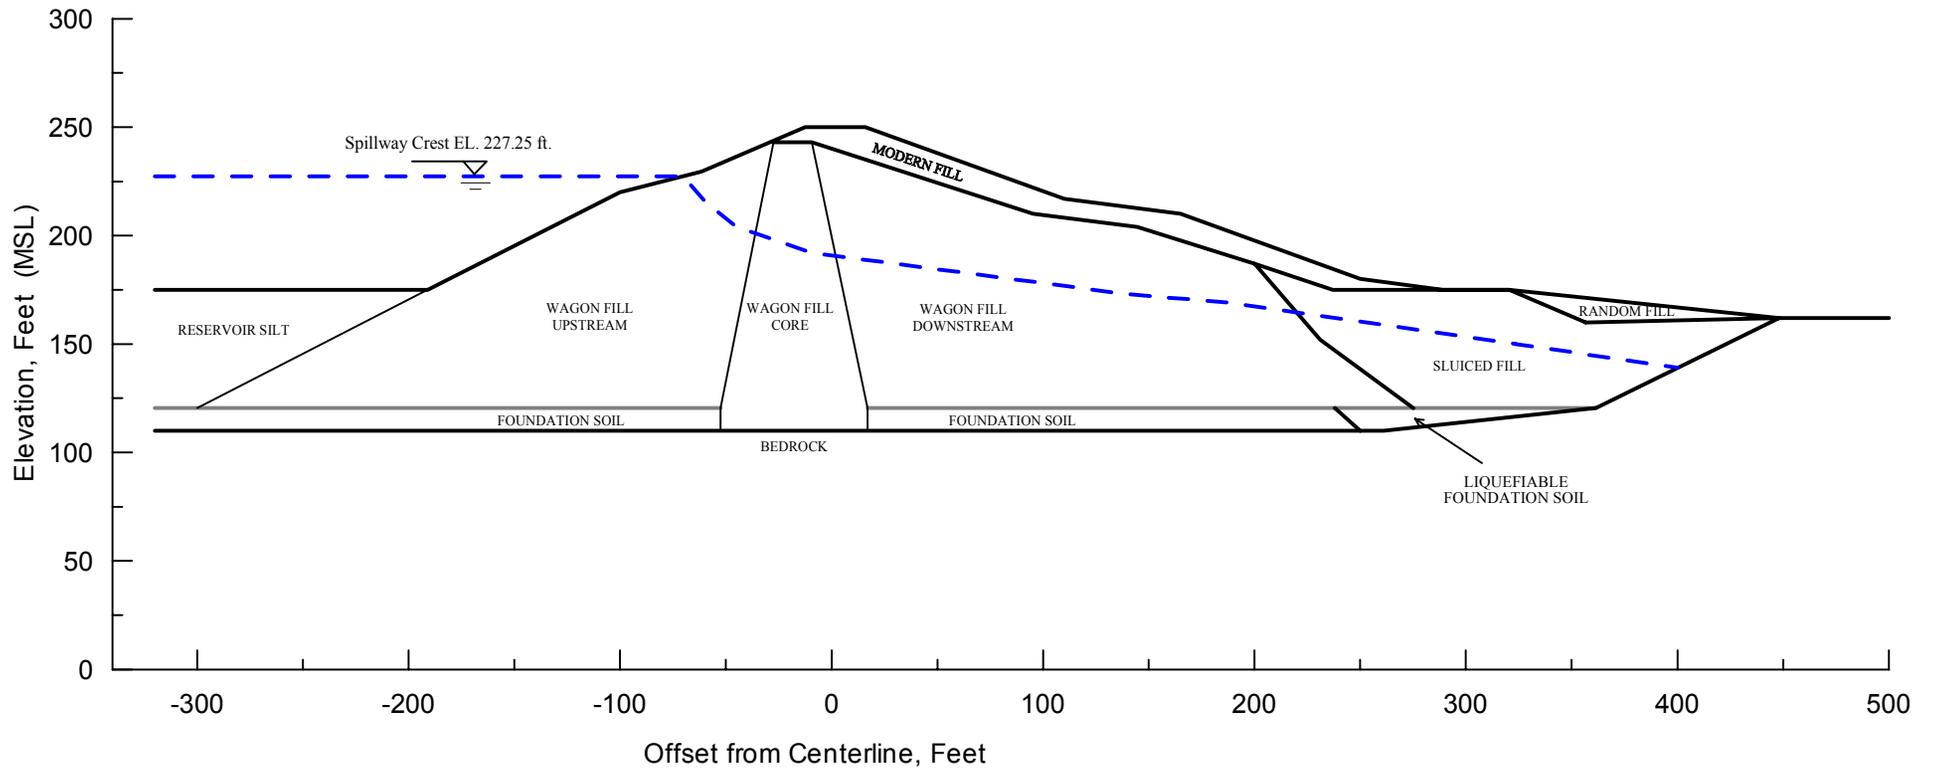
Project No. 26814536	Chabot Dam Seismic Stability Analysis	Alternative Cross Section A - A' for Stability Analysis	Figure
URS			11-37

To evaluate the effects of potential liquefaction in the foundation soils beneath the sluced fill these soils were modeled with the same properties as the overlying sluced fill in alternative cross section A-A' (see Figure 11-37). The same change was also implemented in an alternative to modified section A-A', as shown in Figure 11-41. The results of Newmark-type deformation analyses to check those effects are shown in Figures 11-41 through 11-44, and are summarized in Table 11-4. The results indicate that the potential for liquefaction in the foundation soils beneath the sluced fill does not have a significant effect on the calculated deformations.

1. Obtained from Section A-A' by moving wagon fill/sluiced fill boundary upstream (Figure 9-4).
2. Obtained from Section A-A' by assuming upstream limit of wagon fill at 2:1 slope to top of foundation soil, and assuming foundation soil beneath sluice fill is liquefiable (Figure 11-37).
3. Combination of Modified Section A-A' and Alternative Section A-A' (Figure 11-41).
