FINAL REPORT
VOLUME 1: MAIN REPORT
October 2005

DYNAMIC STABILITY ANALYSIS OF CHABOT DAM

Alameda County, California

**Subject: Dynamic Stability of Chabot Dam
Final Engineering Report**

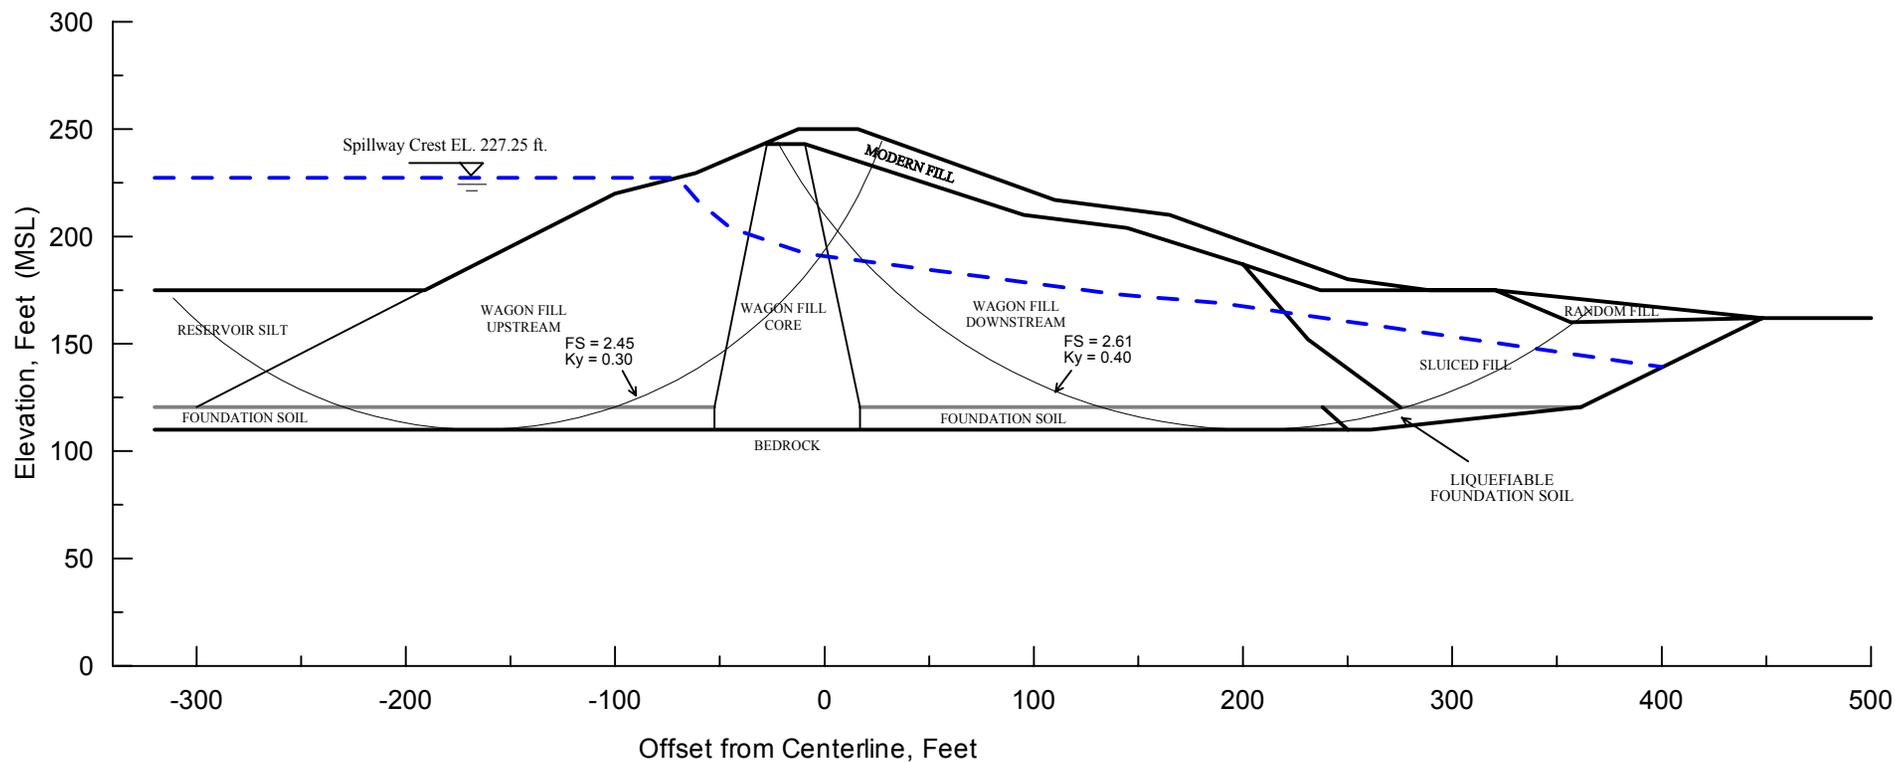
Project No. 26814536	Chabot Dam Seismic Stability Analysis	Seismic Stability Analysis Pre-Earthquake Condition Alternative Cross Section A - A'	Figure
URS			11-38

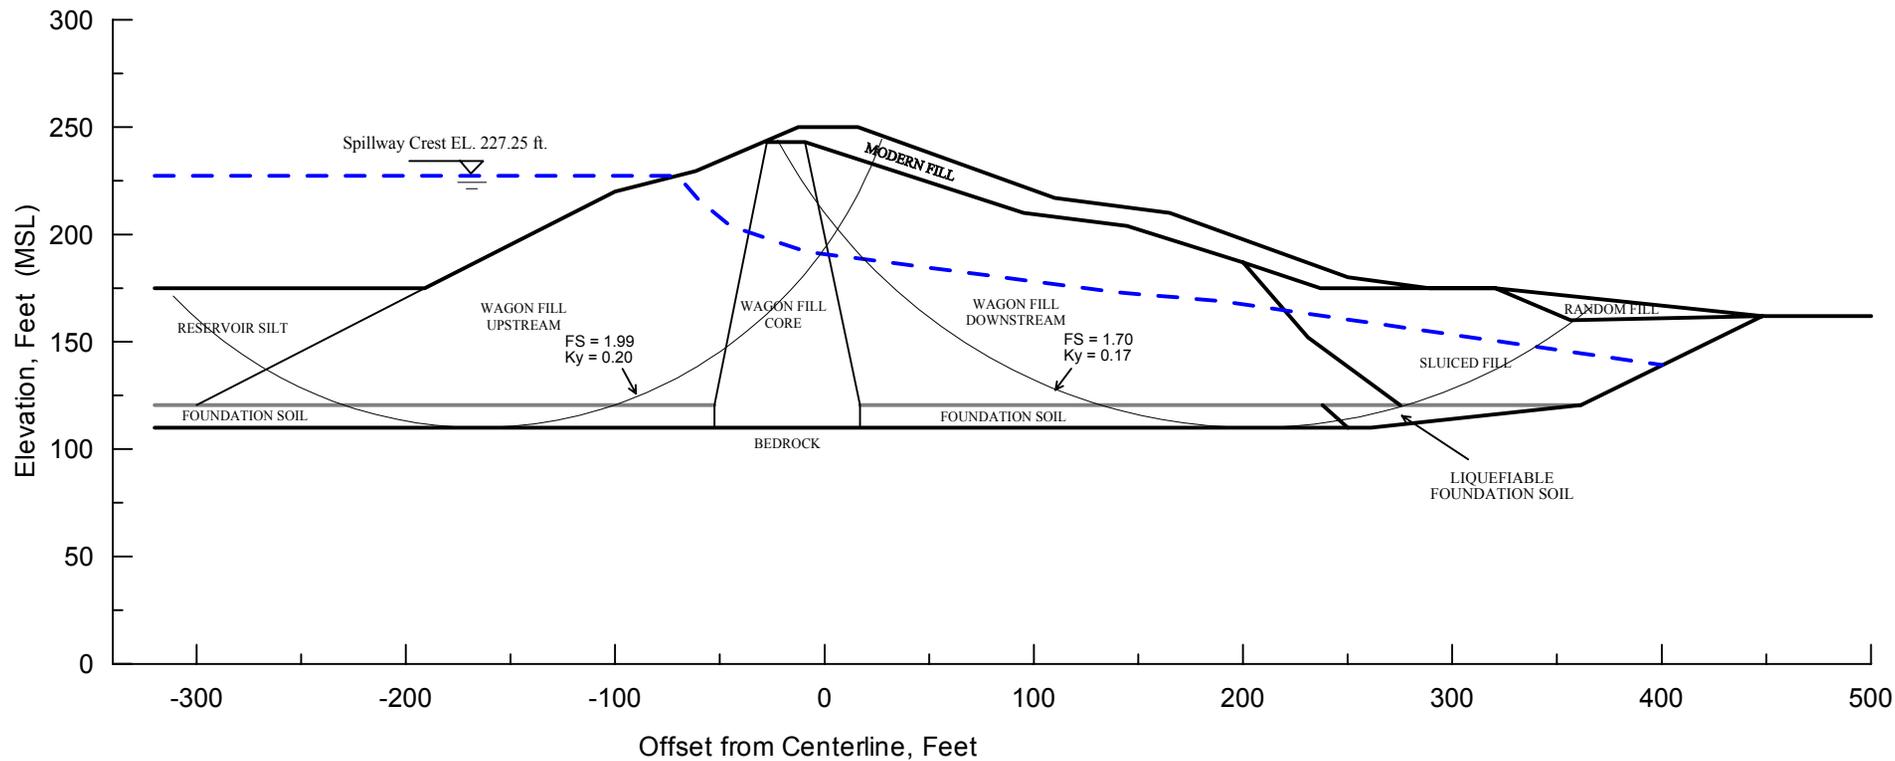
Project No. 26814536	Chabot Dam Seismic Stability Analysis	Seismic Stability Analysis Condition with 20% Strength Reduction Alternative Cross Section A - A'	Figure
URS			11-39

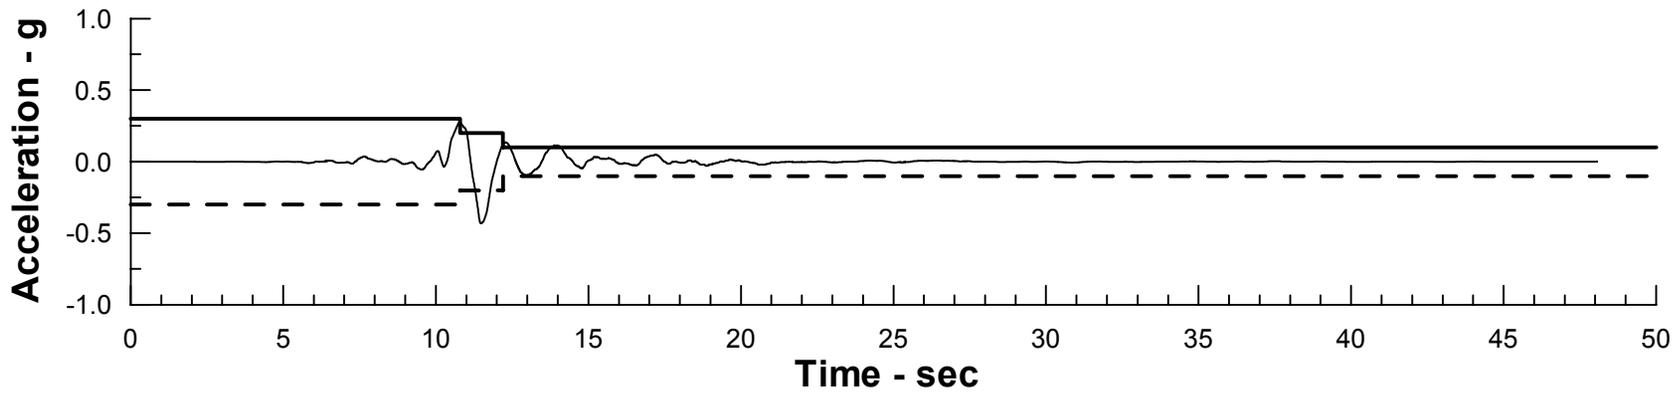
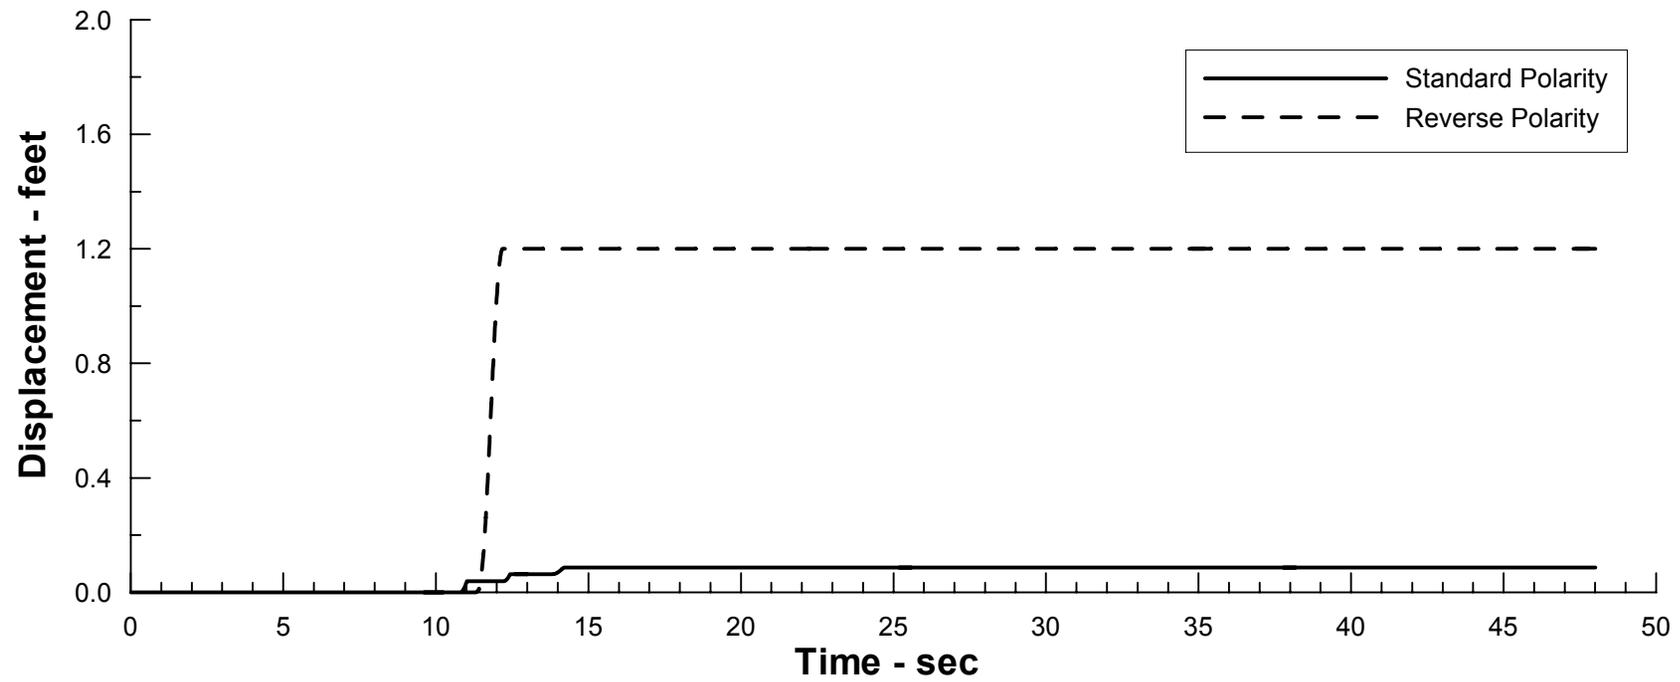
Project No. 26814536	Chabot Dam Seismic Stability Analysis	Alternative Cross Section A-A' Calculated Displacement U/S Block #2 Hayward MCE Time-history #1	FIGURE 11-40
URS

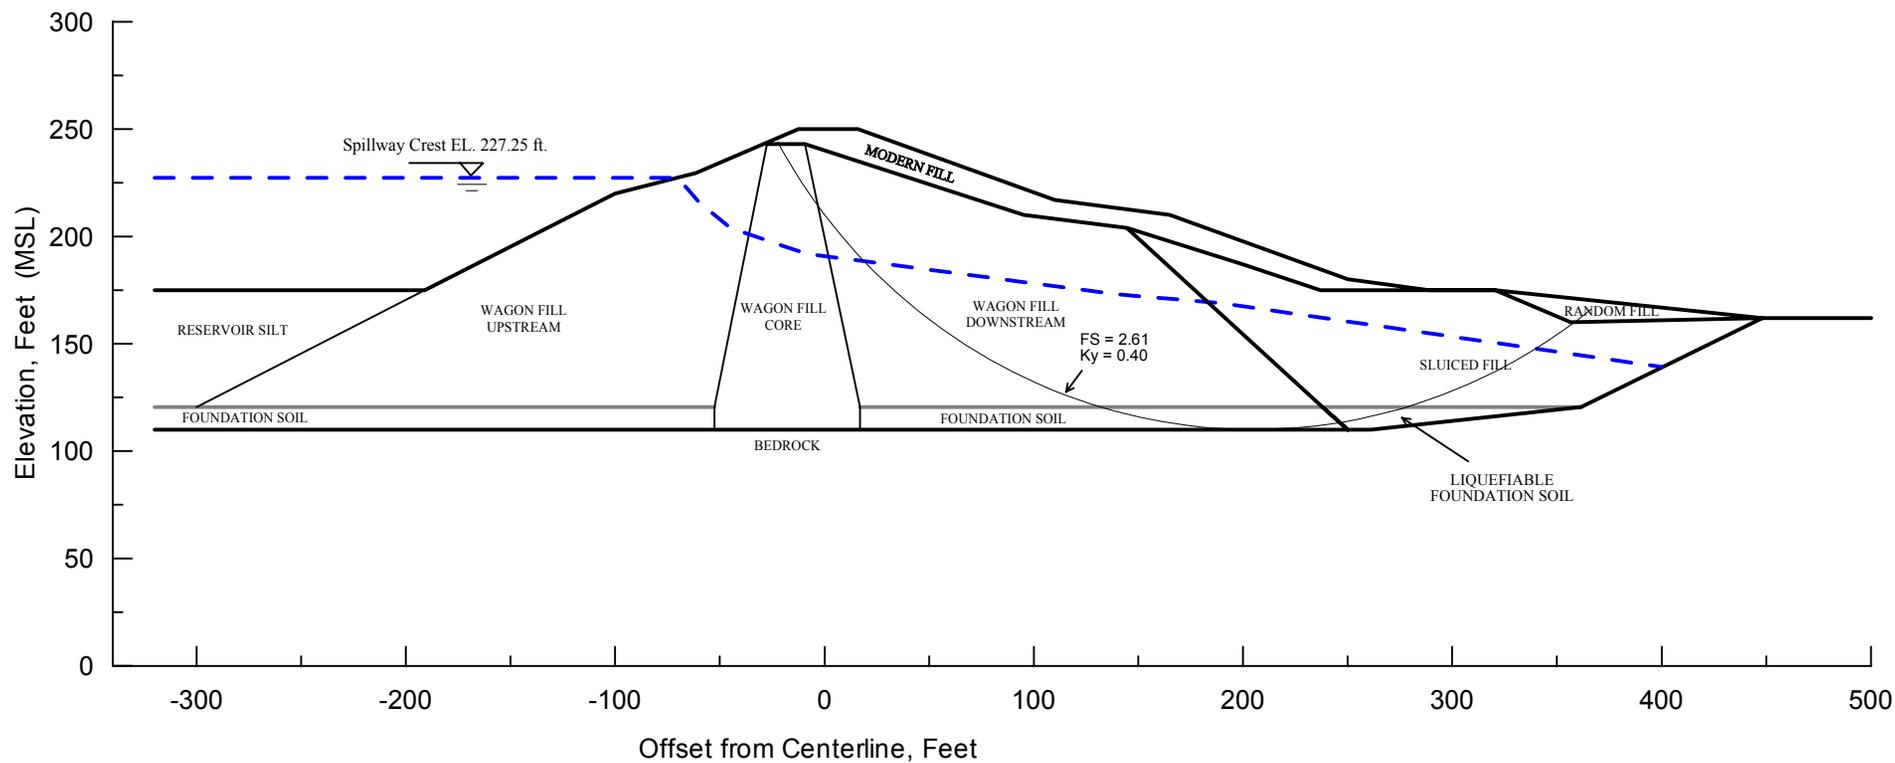
Project No. 26814536	Chabot Dam Seismic Stability Analysis	Seismic Stability Analysis Pre-Earthquake Condition Alternative Modified Section A - A'	Figure 11-41
URS

1. Obtained from Section A-A' by moving wagon fill/sluiced fill boundary upstream (Figure 9-4).
2. Obtained from Section A-A' by assuming upstream limit of wagon fill at 2:1 slope to top of foundation soil, and assuming foundation soil beneath sluice fill is liquefiable (Figure 11-37).
3. Combination of Modified Section A-A' and Alternative Section A-A' (Figure 11-41).

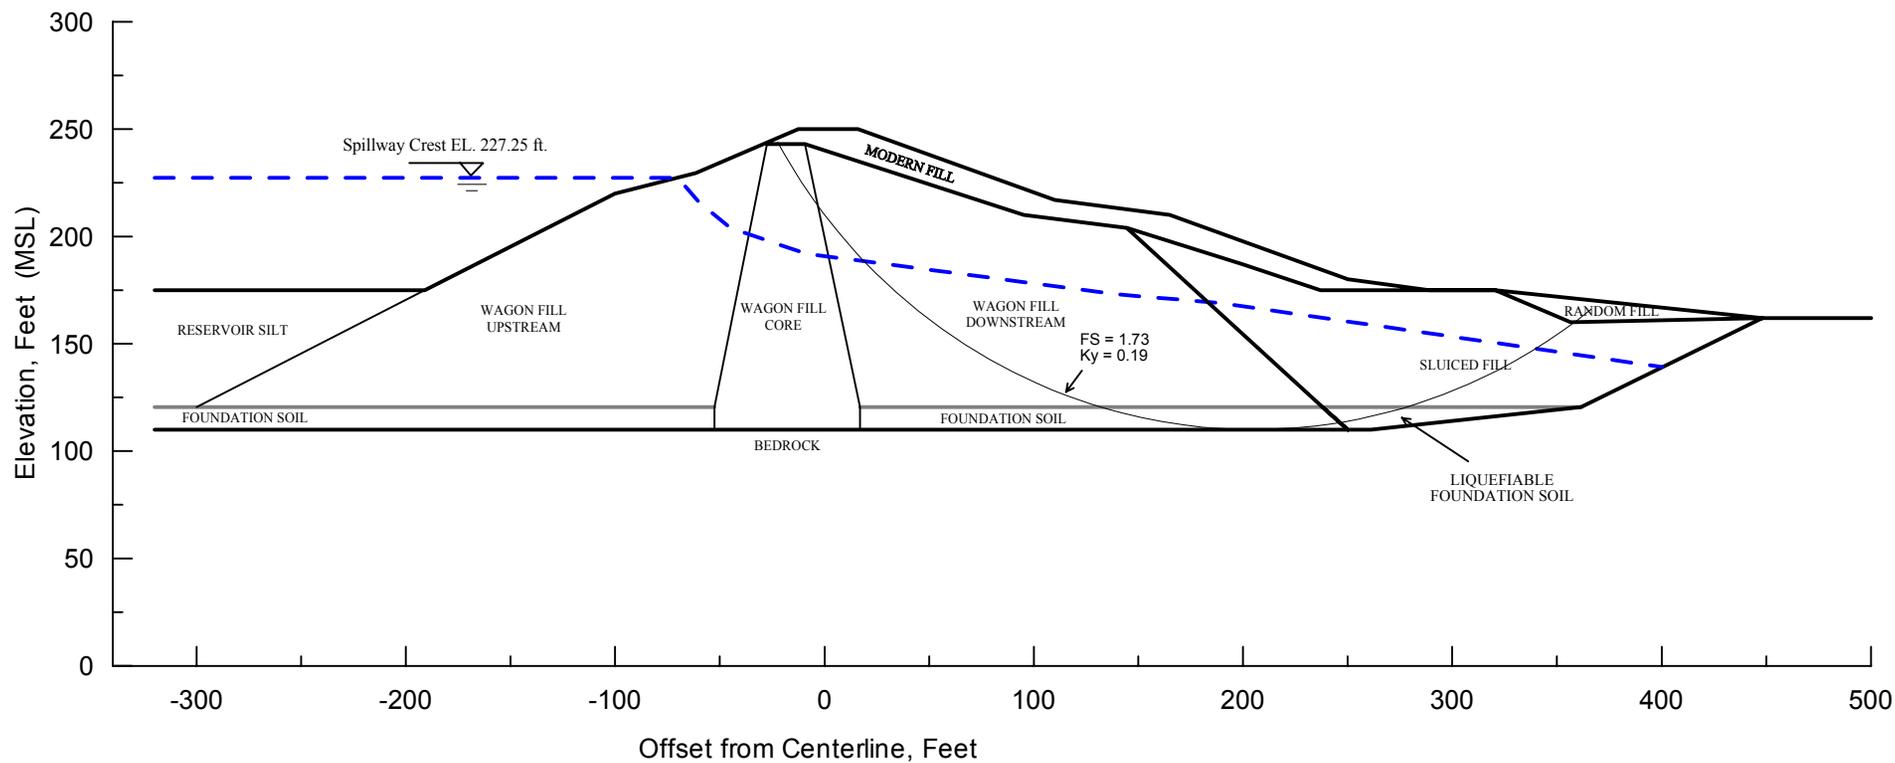
Project No. 26814536	Chabot Dam Seismic Stability Analysis	Seismic Stability Analysis Condition with 20% Strength Reduction Alternative Modified Section A - A'	Figure 11-42
URS

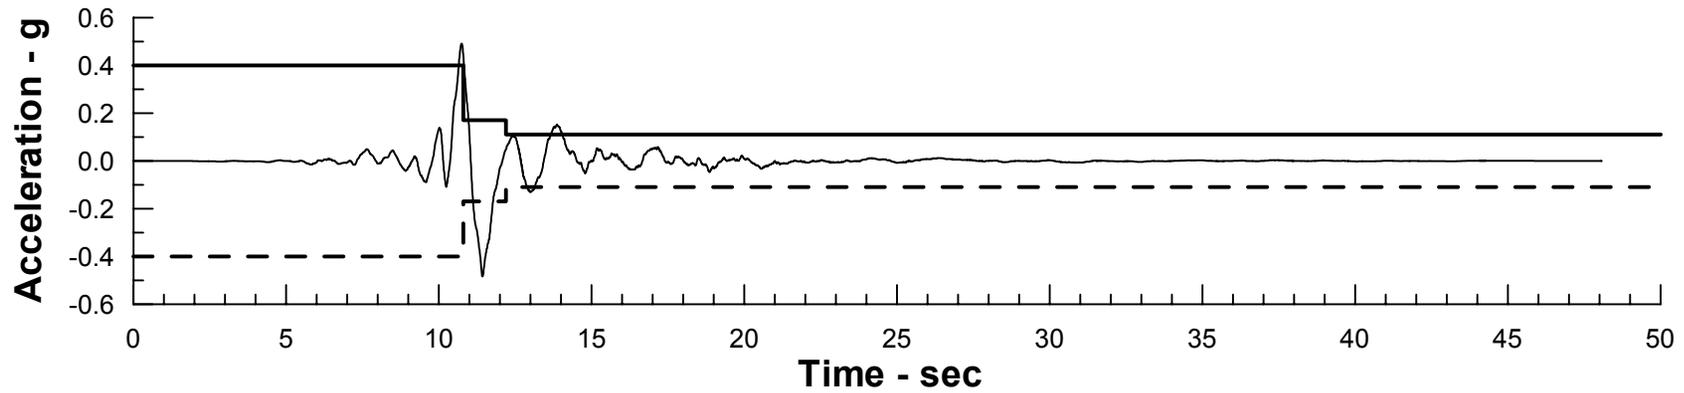
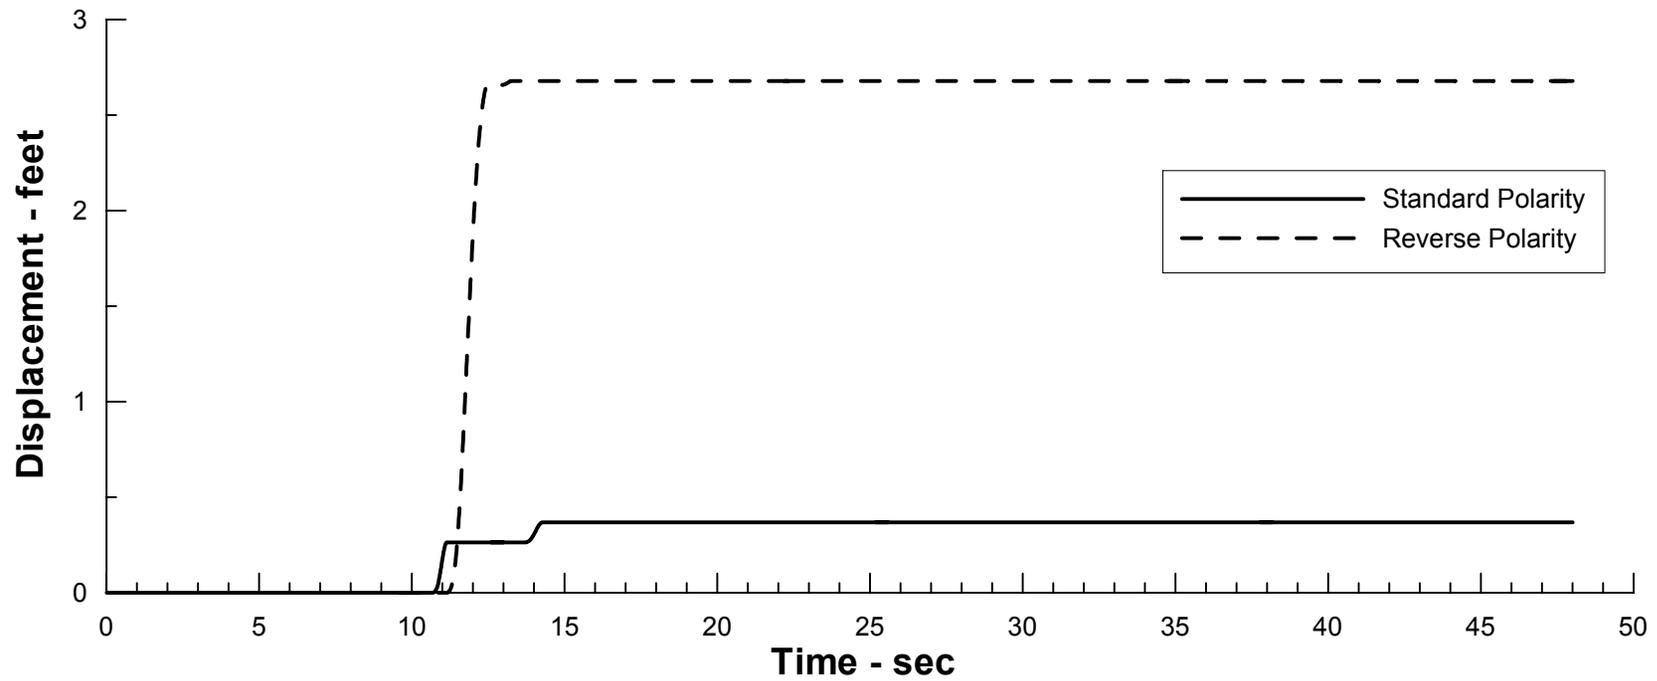
Project No. 26814536	Chabot Dam Seismic Stability Analysis	Alternative Cross Section A-A' Calculated Displacement D/S Block #2 Hayward MCE Time-history #1	Figure 11-43
URS

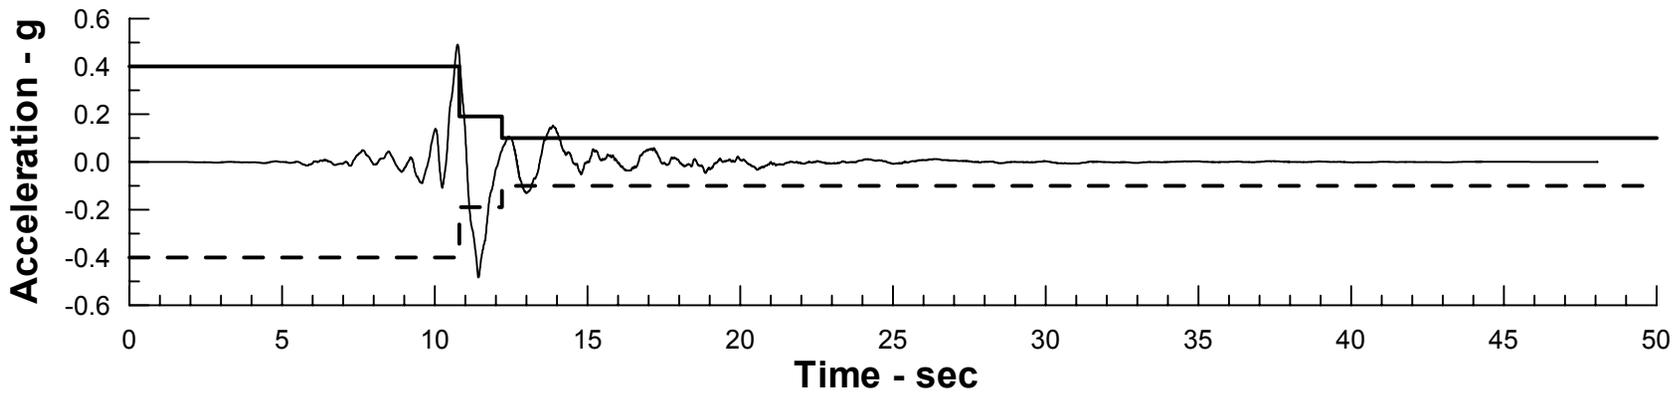
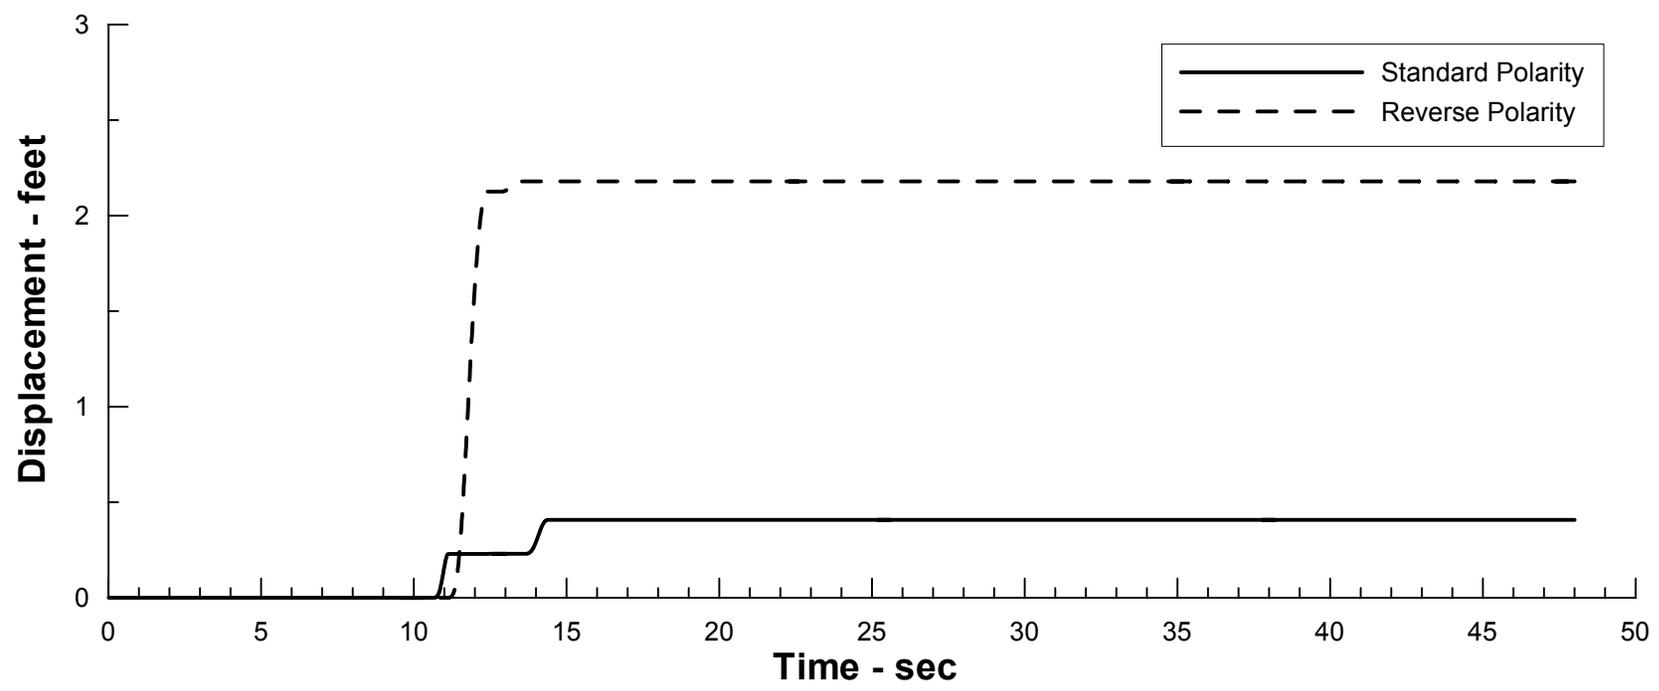
Project No. 26814536	Chabot Dam Seismic Stability Analysis	Alternative Modified Section A-A' Calculated Displacement D/S Block #2	Figure 11-44
URS		Hayward MCE Time-history #1

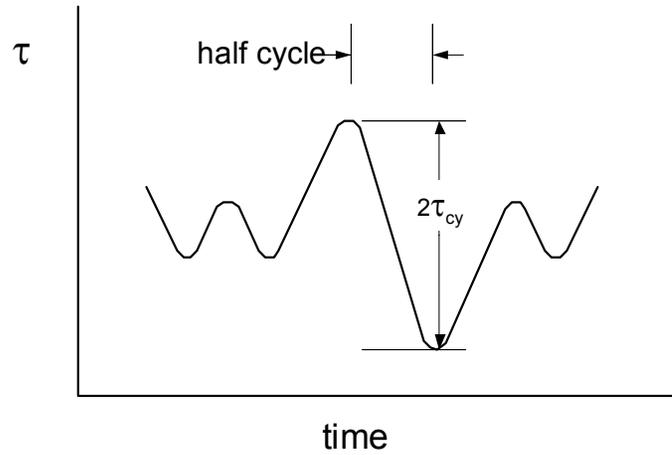
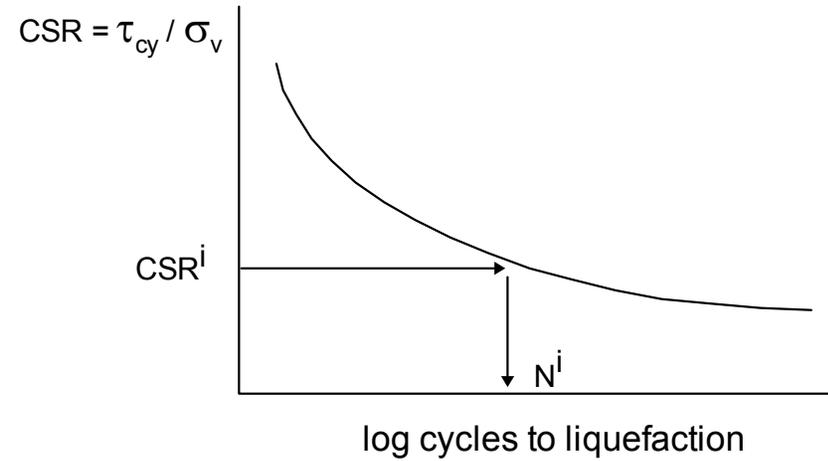
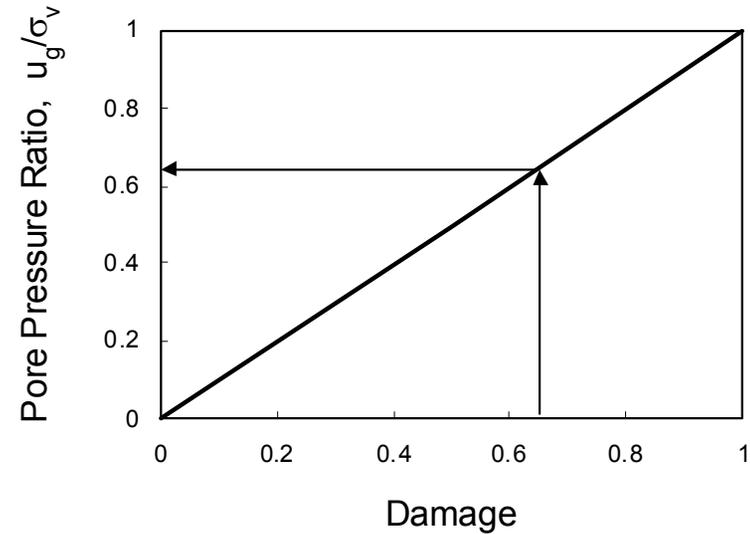
$$\Delta D^i = 0.5 / N_L^i$$

$$D = \sum \Delta D^i$$

Project No. 26814536	Chabot Dam Seismic Stability Analysis	FLAC Analysis Pore Pressure Generation Model	Figure 12-1
URS

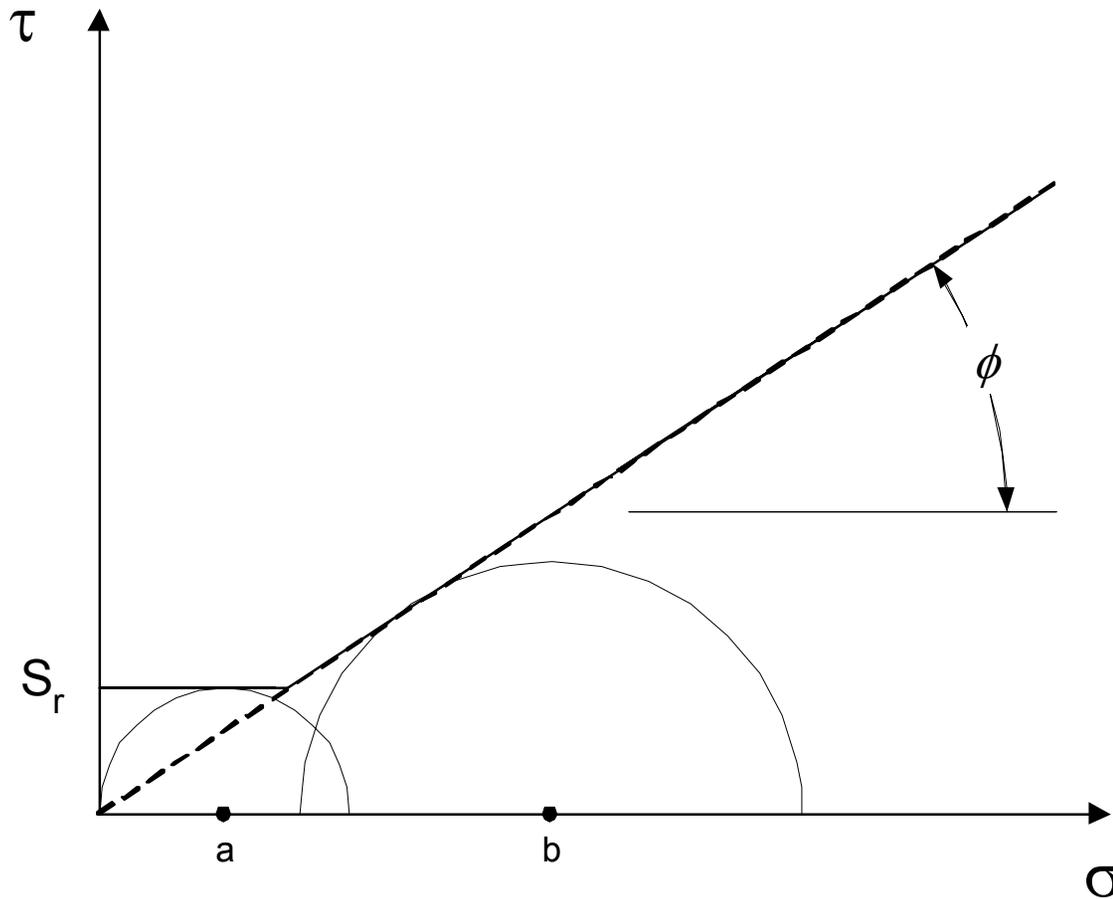
Project No. 26814536	Chabot Dam Seismic Stability Analysis	Mohr-Coulomb and Residual Strength Envelope	Figure
URS			12-2

strength of the material by using a bi-linear failure envelope as shown in Figure 12-2. The cyclic resistance of the saturated sluiced fill was modeled using the relationship shown in Figure 12-3. The models for cyclic strength and undrained strength degradation of the saturated wagon fill and foundation soils are illustrated in Figure 12-4. The strength degradation of those materials is expressed through the ratio of post-cyclic strength to pre-cyclic (i.e. static) strength as a function of excess pore pressure ratio (see Section 11).

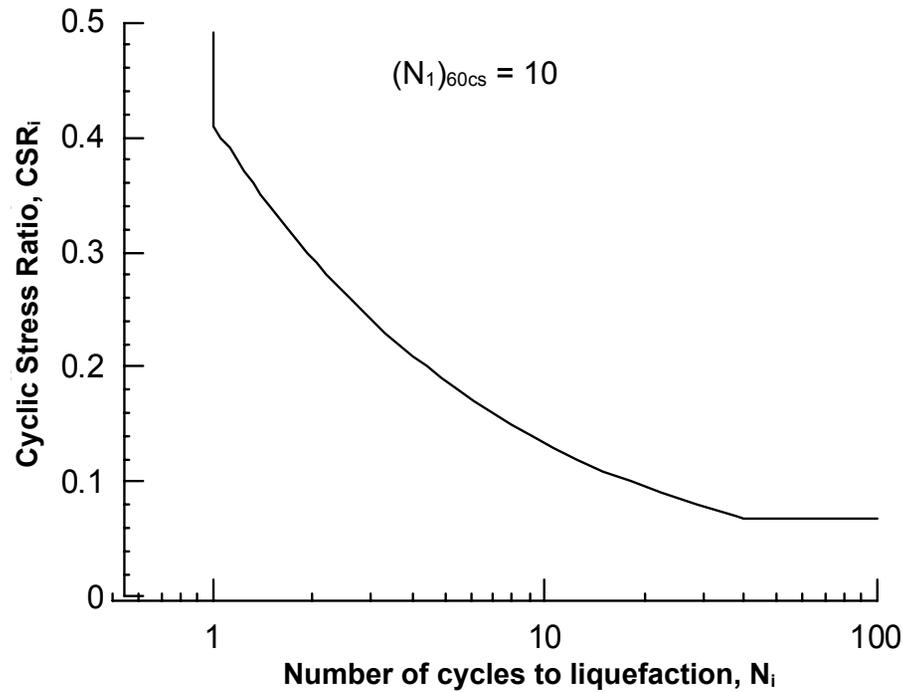
$$N_i = 15 \left(\frac{CSR_{15}}{CSR_i} \right)^{2.05} \quad 1 \leq N_i \leq 40$$

where $CSR_{15} = 0.11$

Project No. 26814536	Chabot Dam Seismic Stability Analysis	Cyclic Strength of Saturated Sluiced Fill	Figure
URS			12-3

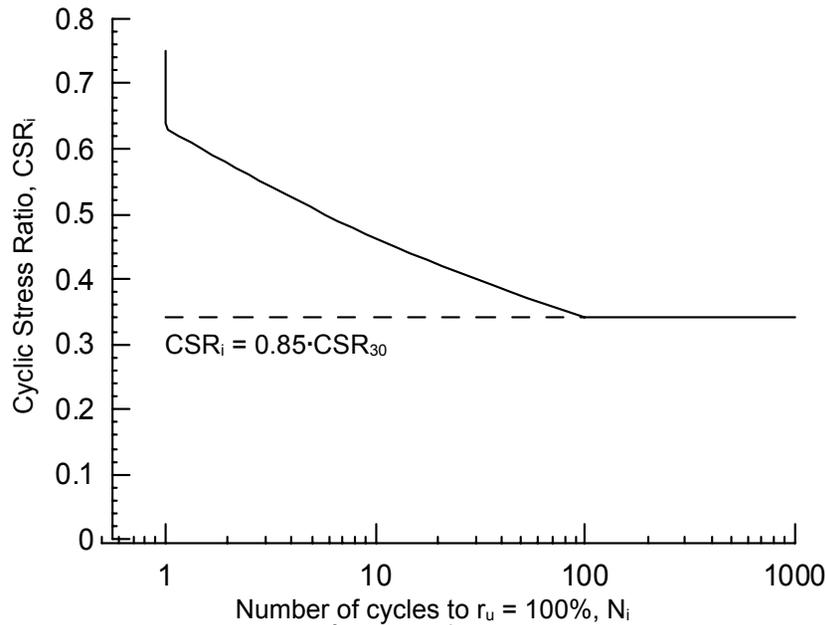
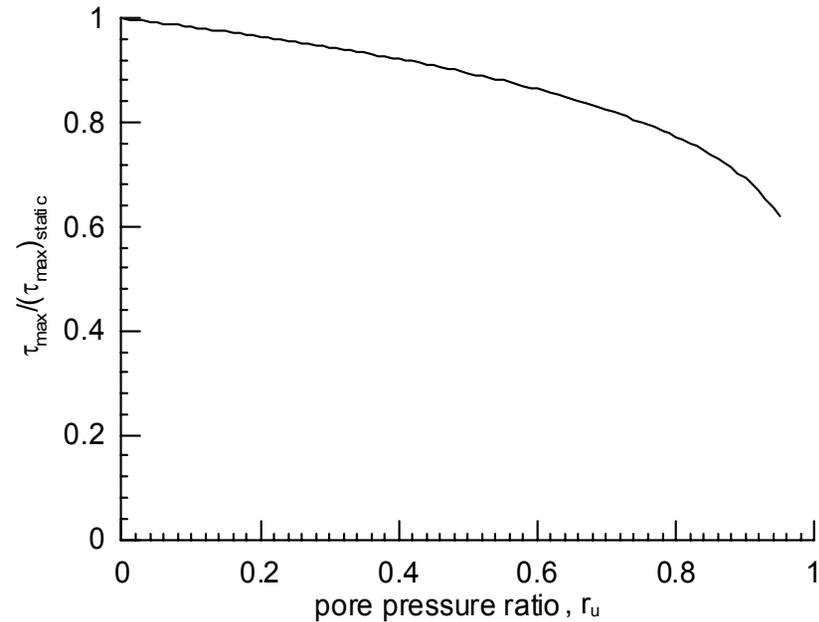
$$N_i = 30 \left(\frac{CSR_{30}}{CSR_i} \right)^{7.41} \quad 1 \leq N_i \leq 100$$

$$\frac{\tau_{max}}{(\tau_{max})_{static}} = (1 - r_u)^{0.16}$$

Project No. 26814536	Chabot Dam Seismic Stability Analysis	Cyclic Strength and Undrained Strength Degradation of Saturated Wagon Fill and Foundation Soils	Figure 12-4
URS

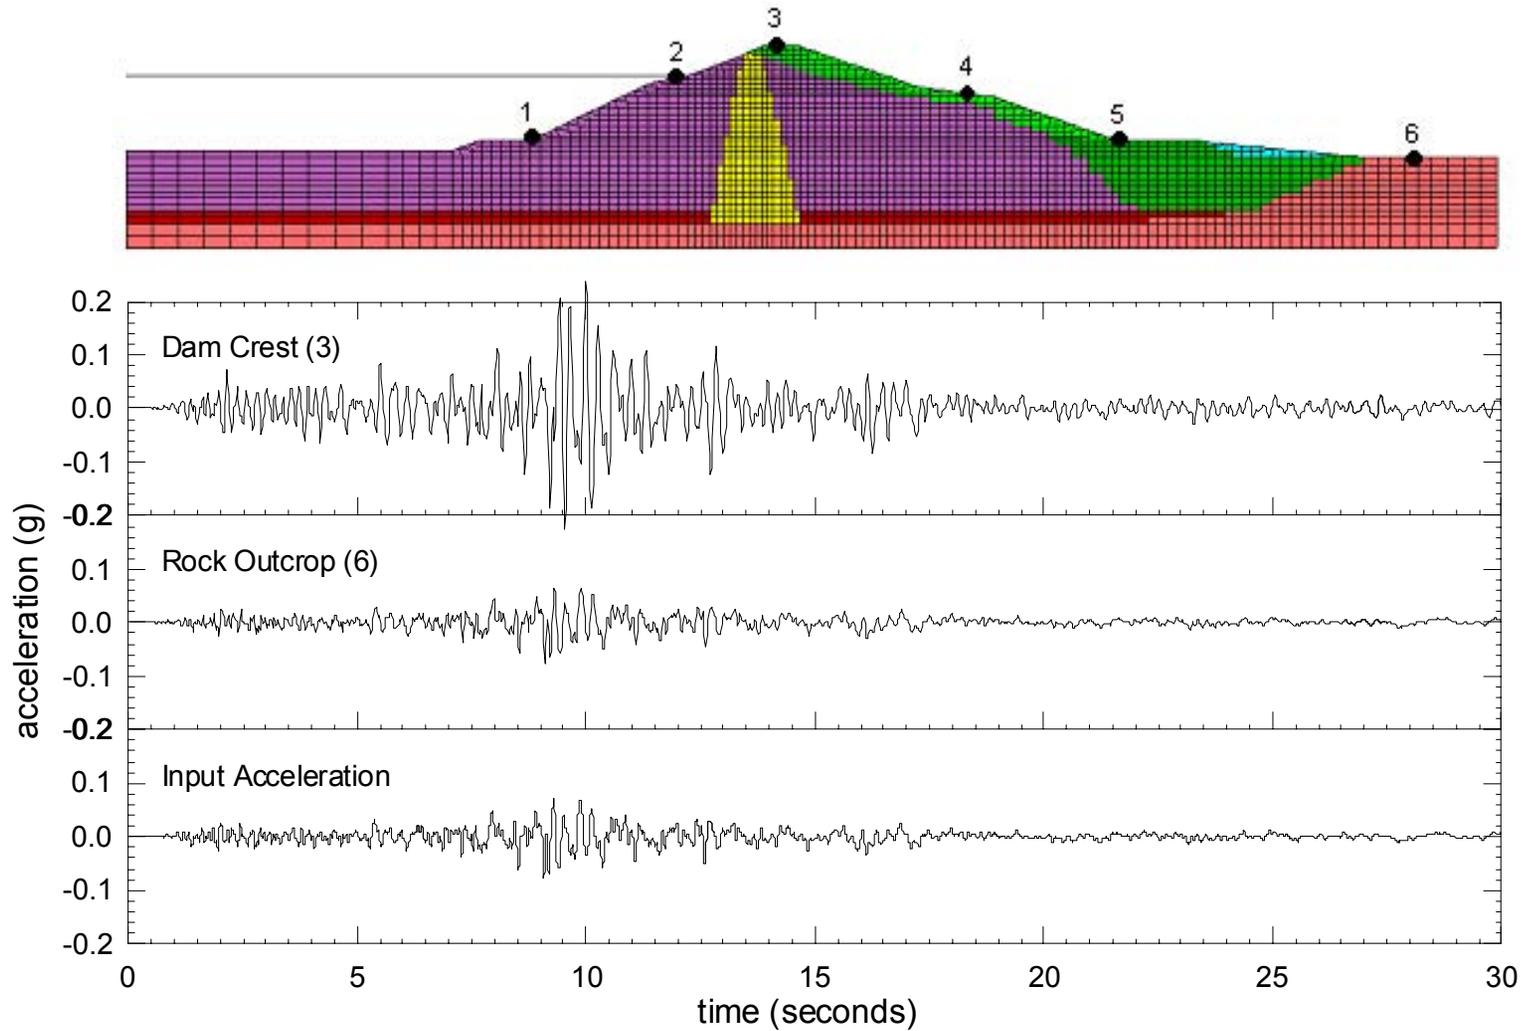
Project No. 26814536	Chabot Dam Seismic Stability Analysis	Acceleration at Dam Crest and Rock Outcrop 1989 Loma Prieta Earthquake	Figure 12-5
URS

The analysis results for the 1989 Loma Prieta earthquake are presented in Figures 12-5 through 8. Figure 12-5 shows the calculated acceleration time histories at the crest and at the downstream rock surface together with the input time history. The maximum calculated excess pore pressure ratio in the sluiced fill is shown in Figure 12-6. The cyclic strength degradation of the wagon fill is shown in Figure 12-7. The calculated displacement vectors after the earthquake are presented in Figure 12-8. As shown in these figures, the analyses result in low excess pore pressures in the sluiced fill, little degradation of the wagon fill, and very small displacements of the dam. These results are in good agreement with the observed performance of the dam during the earthquake.

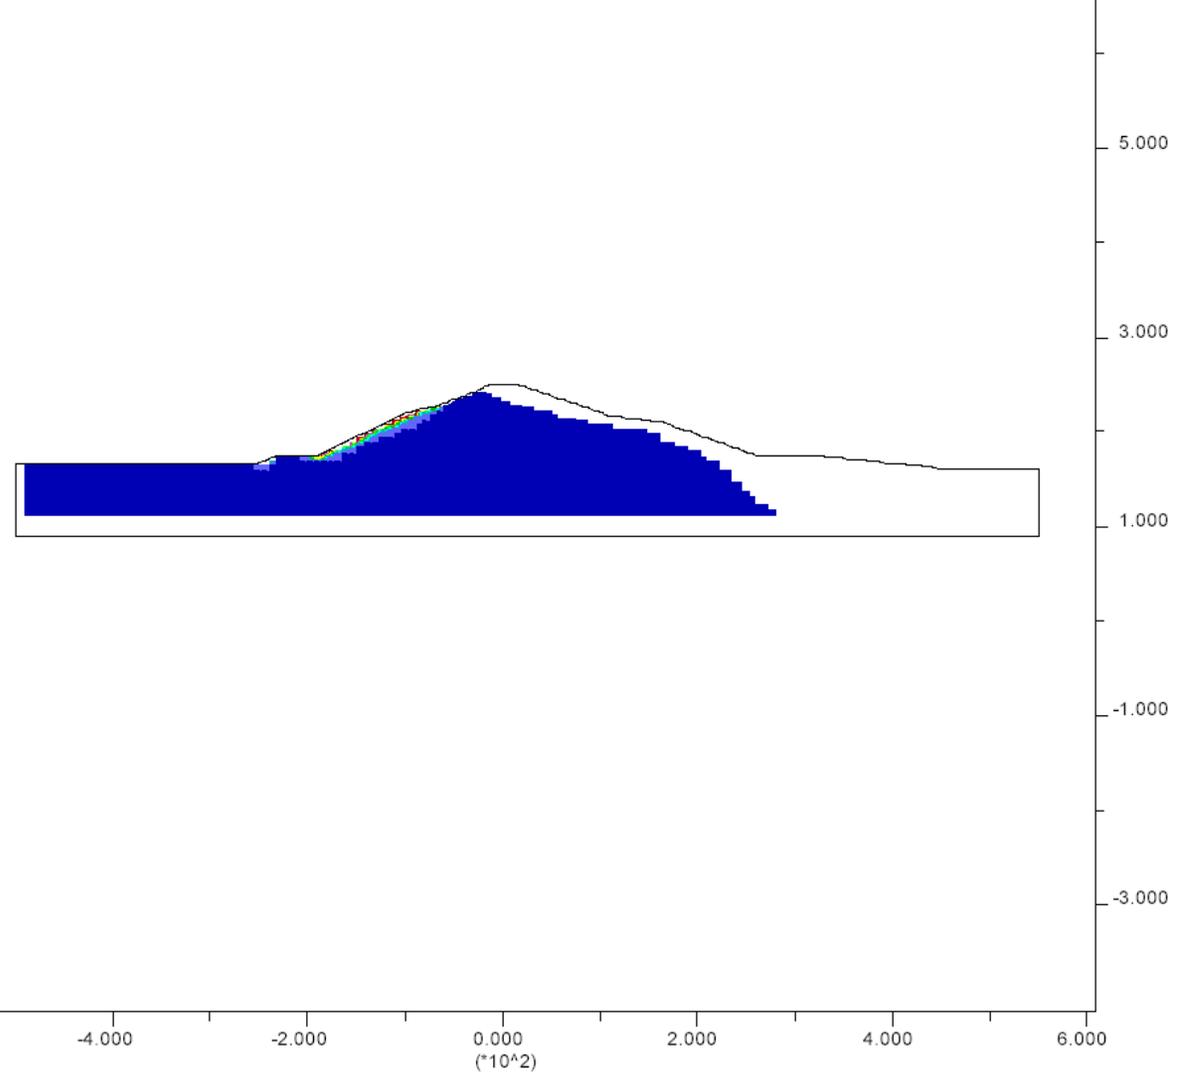
Project No. 26814536	Chabot Dam Seismic Stability Analysis	Cyclic Degradation of Wagon Fill and Foundation Soils 1989 Loma Prieta Earthquake	Figure 12-7
URS

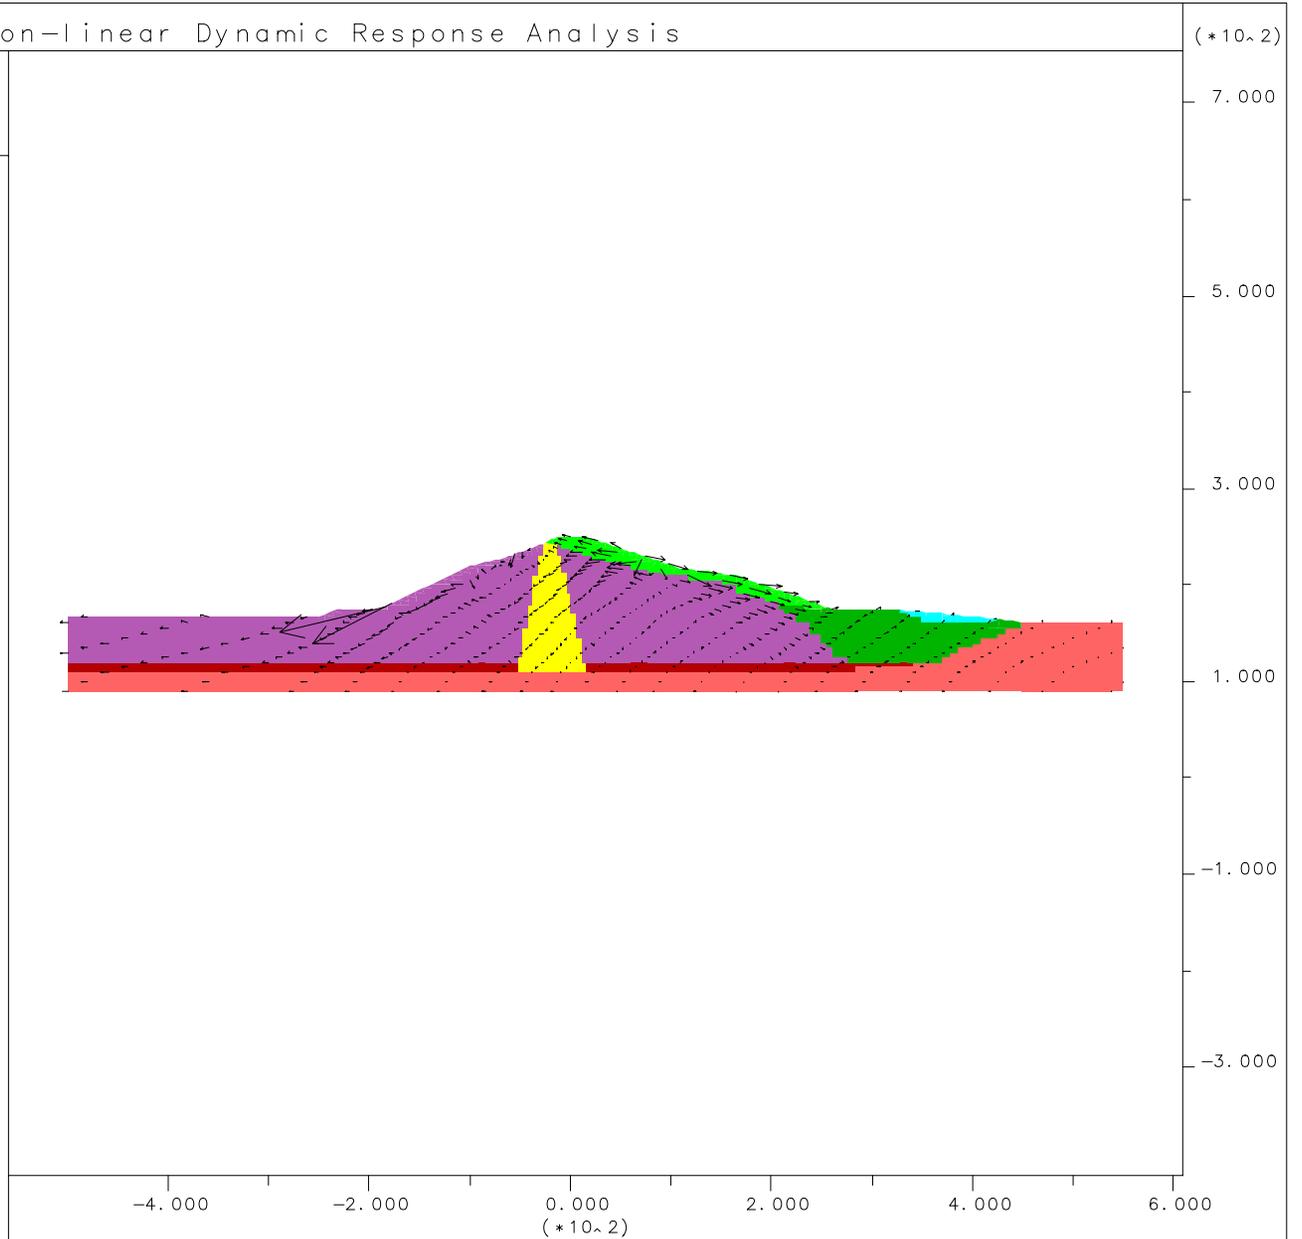
Project No. 26814536	Chabot Dam Seismic Stability Analysis	Calculated Displacement Vectors 1989 Loma Prieta Earthquake	Figure 12-8
URS

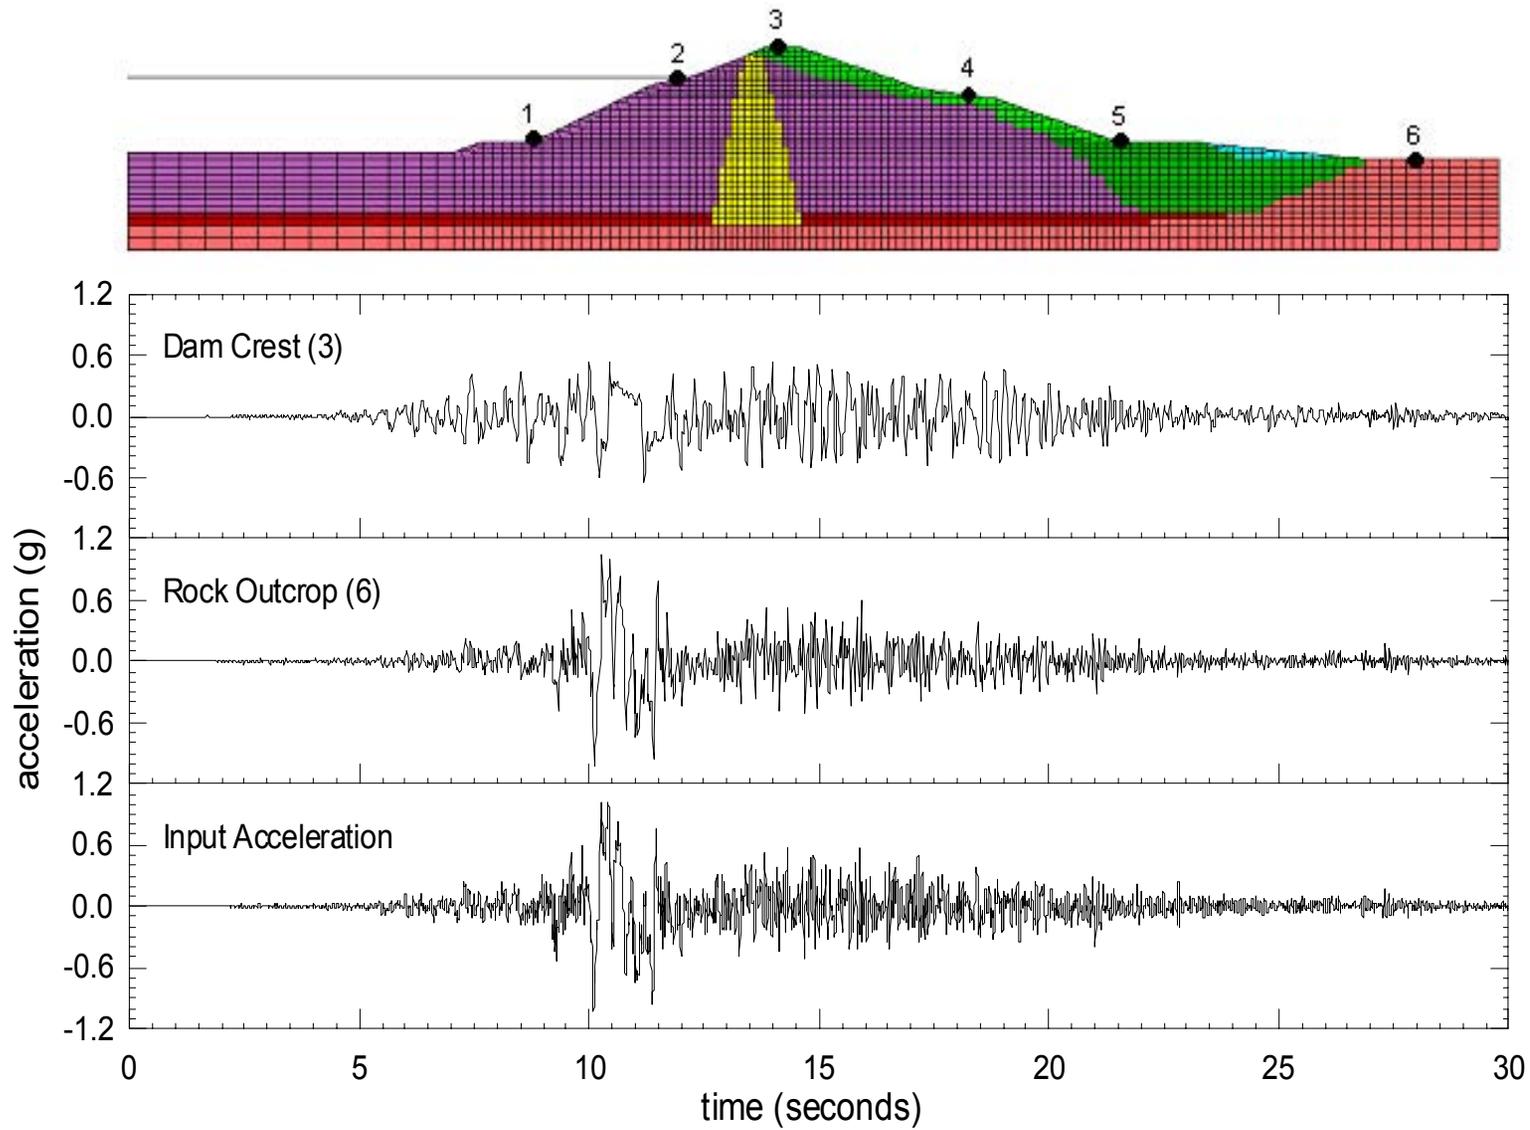
Project No. 26814536	Chabot Dam Seismic Stability Analysis	Acceleration at Dam Crest and Rock Outcrop Hayward Fault MCE TH #1	Figure
URS			12-9

The analysis results for the Hayward event are shown in Figures 12-9 through 12-16. Figure 12-9 shows the calculated acceleration time histories at the crest and at the downstream rock surface together with the input time history. Figure 12-10 shows calculated time histories of excess pore pressure ratio in the sluiced fill and of cyclic strength degradation in the wagon fill. These results indicate that the development of excess pore pressures in the sluiced fill will begin early during the shaking and that those materials will reach a state of initial liquefaction after about 10 seconds of shaking. Cyclic degradation of the wagon fill is calculated to occur during the strong phase of shaking between about 10.5 and 12 seconds. As shown in Figure 12-11, a maximum strength reduction of about 40% is calculated in the upstream zone beyond the toe of the embankment and in a small zone at the bottom of the core beneath the crest. However, the calculated amount of maximum cyclic strength degradation of the saturated fill over a large portion of the dam averages less than about 10%.
