FINAL REPORT
VOLUME 1: MAIN REPORT
October 2005

DYNAMIC STABILITY ANALYSIS OF CHABOT DAM

Alameda County, California

**Subject: Dynamic Stability of Chabot Dam
Final Engineering Report**

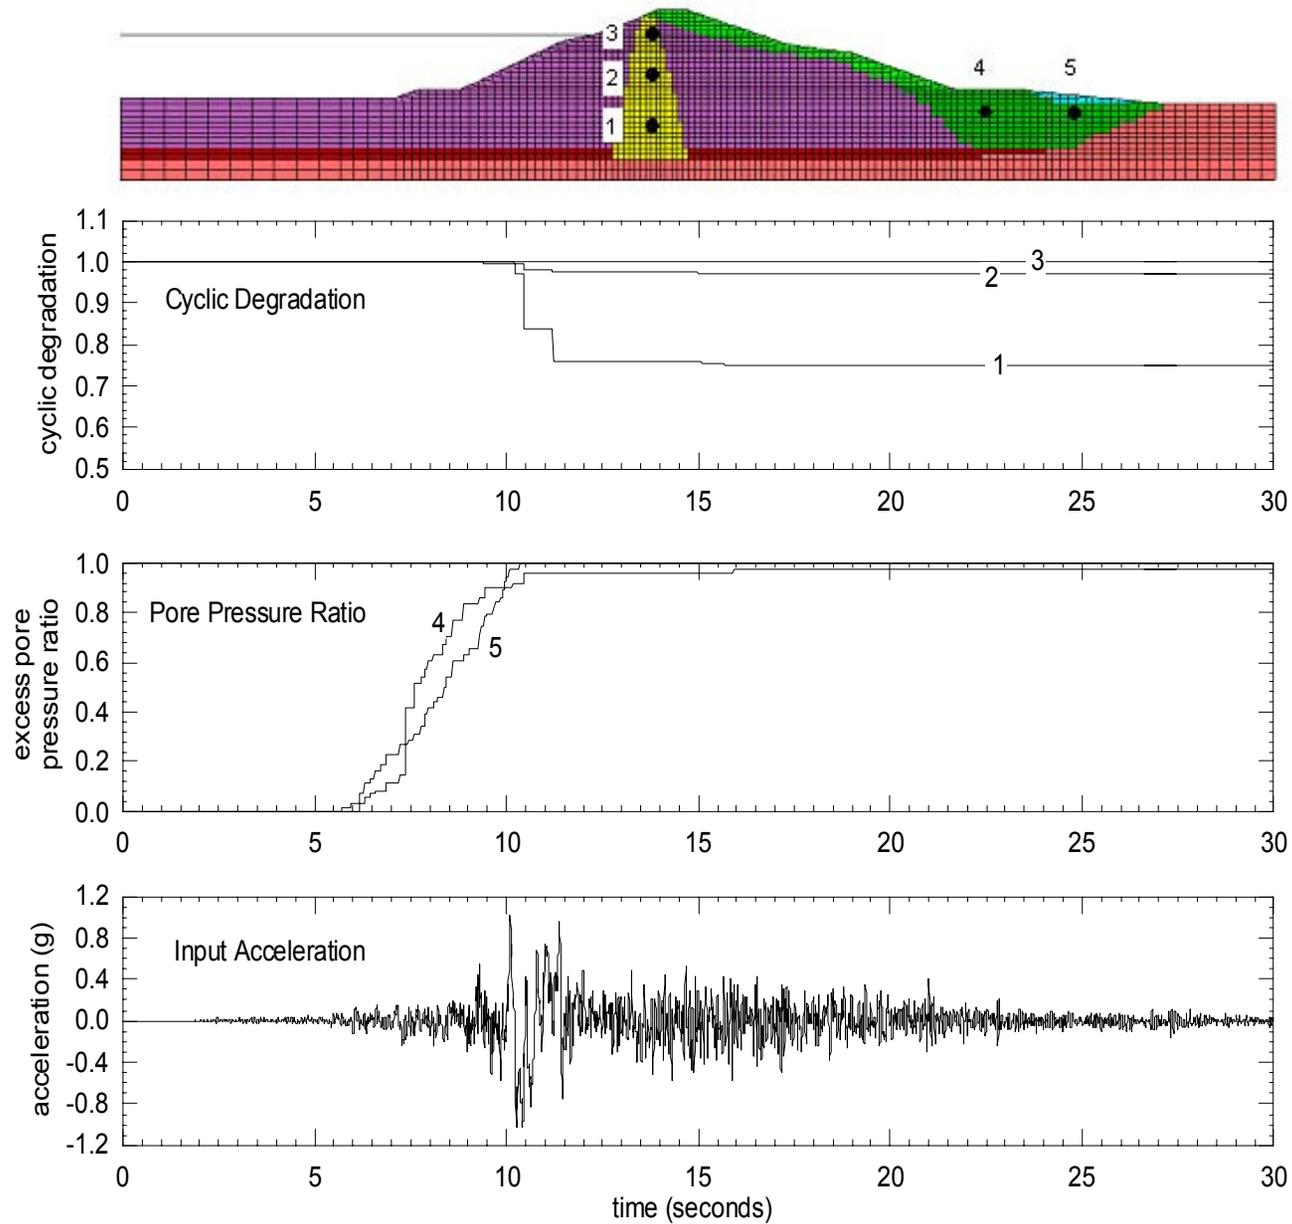
Project No. 26814536	Chabot Dam Seismic Stability Analysis	Time Histories of Cyclic Degradation and Pore Pressure Ratio Hayward Fault MCE TH #1	Figure 12-10
URS

The analysis results for the Hayward event are shown in Figures 12-9 through 12-16. Figure 12-9 shows the calculated acceleration time histories at the crest and at the downstream rock surface together with the input time history. Figure 12-10 shows calculated time histories of excess pore pressure ratio in the sluiced fill and of cyclic strength degradation in the wagon fill. These results indicate that the development of excess pore pressures in the sluiced fill will begin early during the shaking and that those materials will reach a state of initial liquefaction after about 10 seconds of shaking. Cyclic degradation of the wagon fill is calculated to occur during the strong phase of shaking between about 10.5 and 12 seconds. As shown in Figure 12-11, a maximum strength reduction of about 40% is calculated in the upstream zone beyond the toe of the embankment and in a small zone at the bottom of the core beneath the crest. However, the calculated amount of maximum cyclic strength degradation of the saturated fill over a large portion of the dam averages less than about 10%.

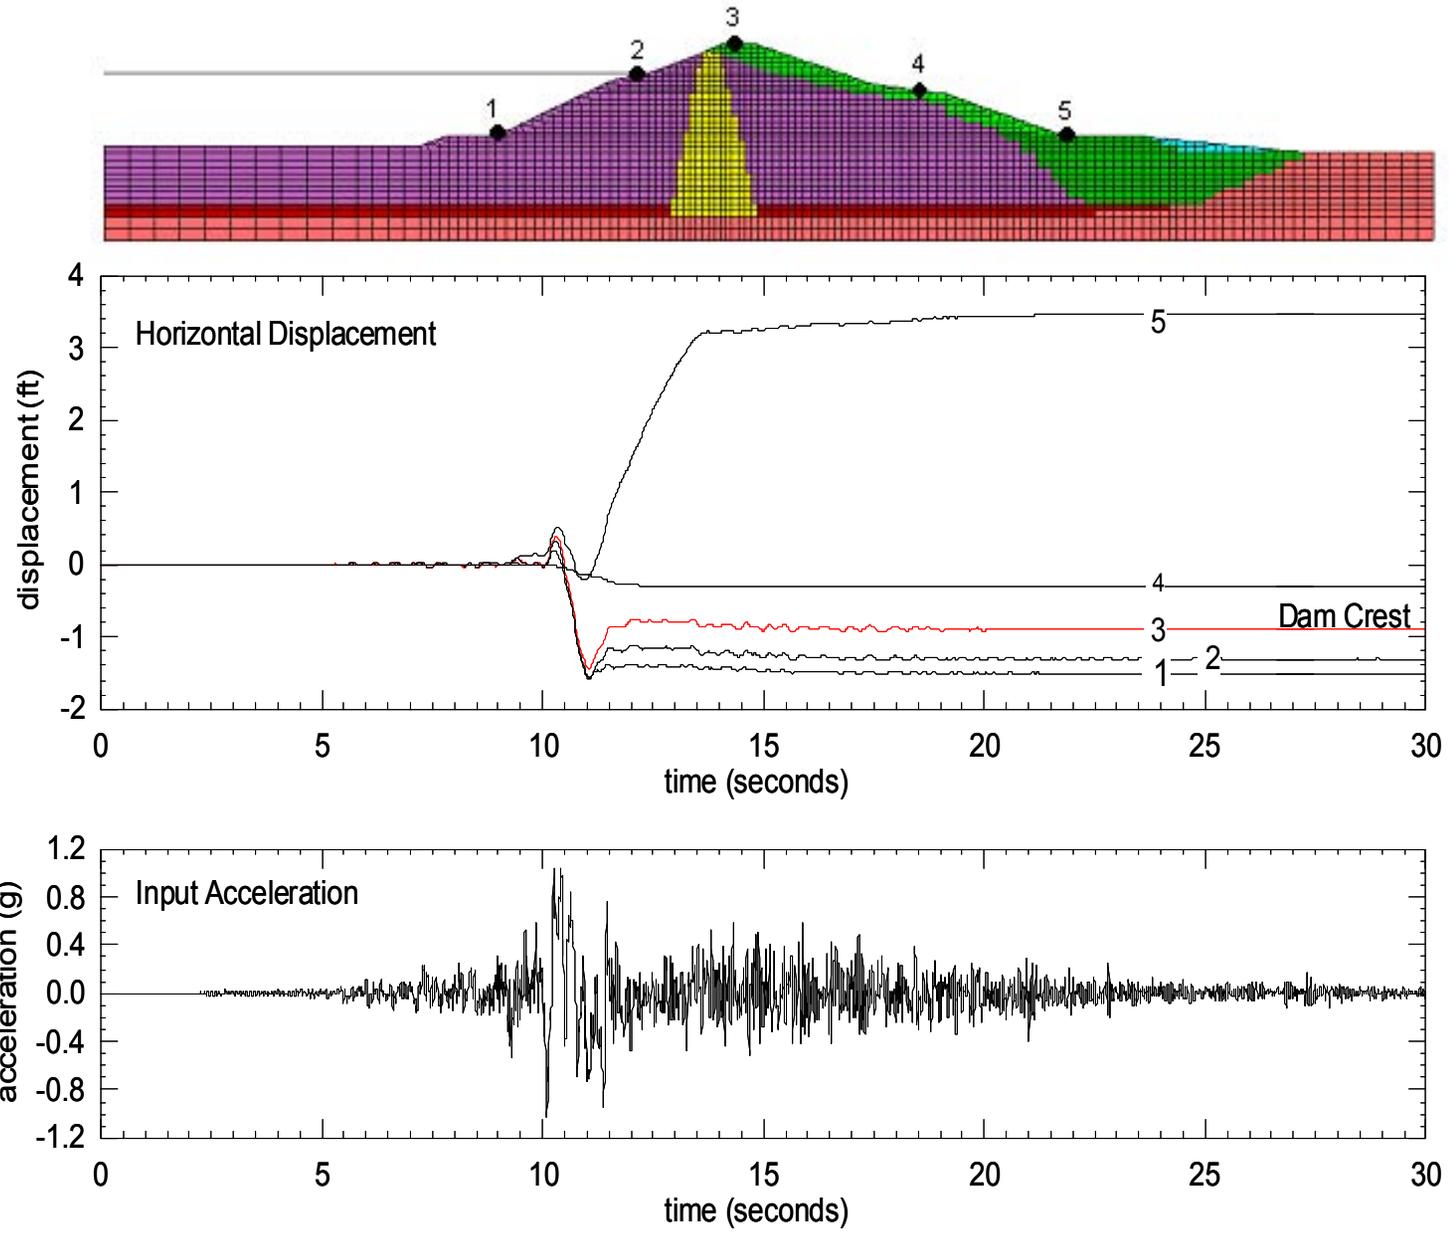
Project No. 26814536	Chabot Dam Seismic Stability Analysis	Calculated Horizontal Displacement Time Histories Hayward Fault MCE TH #1	Figure 12-13
URS

Figure 12-12 shows the calculated displacement vectors throughout the dam after the earthquake. Figures 12-13 and 12-14 show calculated time histories of horizontal and vertical displacements

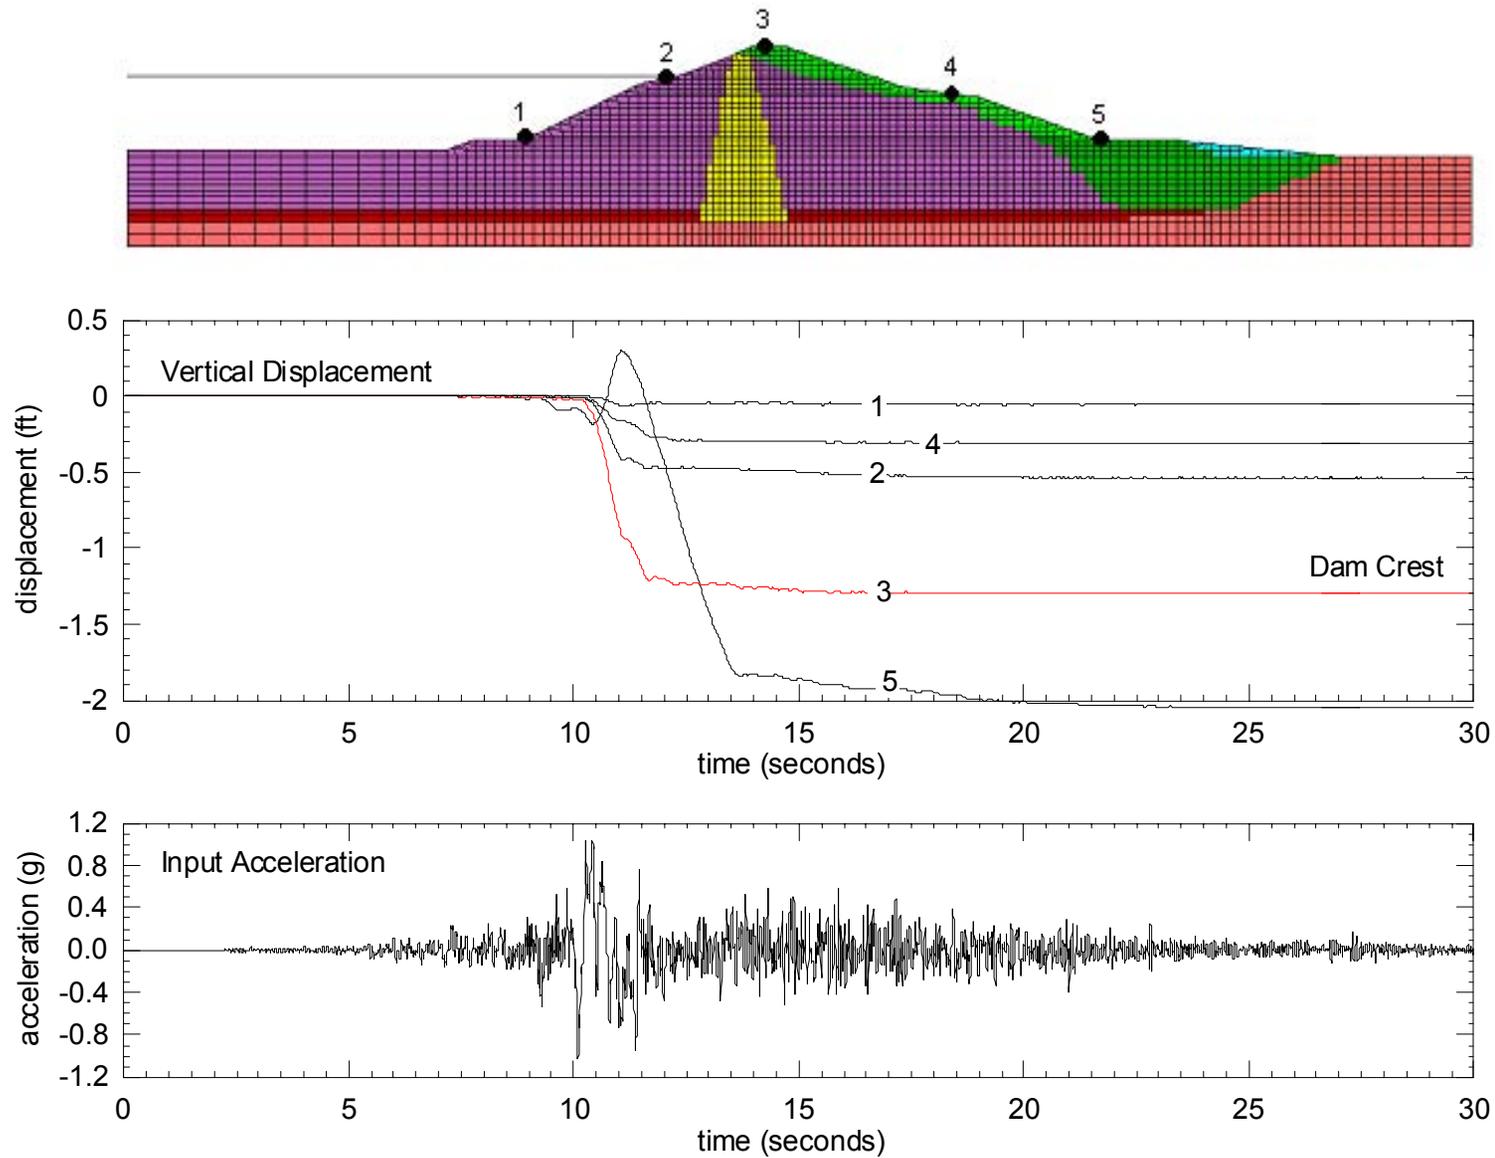
Project No. 26814536	Chabot Dam Seismic Stability Analysis	Calculated Vertical Displacement Time Histories Hayward Fault MCE TH #1	Figure 12-14
URS
