FINAL REPORT

Dynamic Stability Analysis of Estates Dam

Oakland, California

NOVEMBER 2006

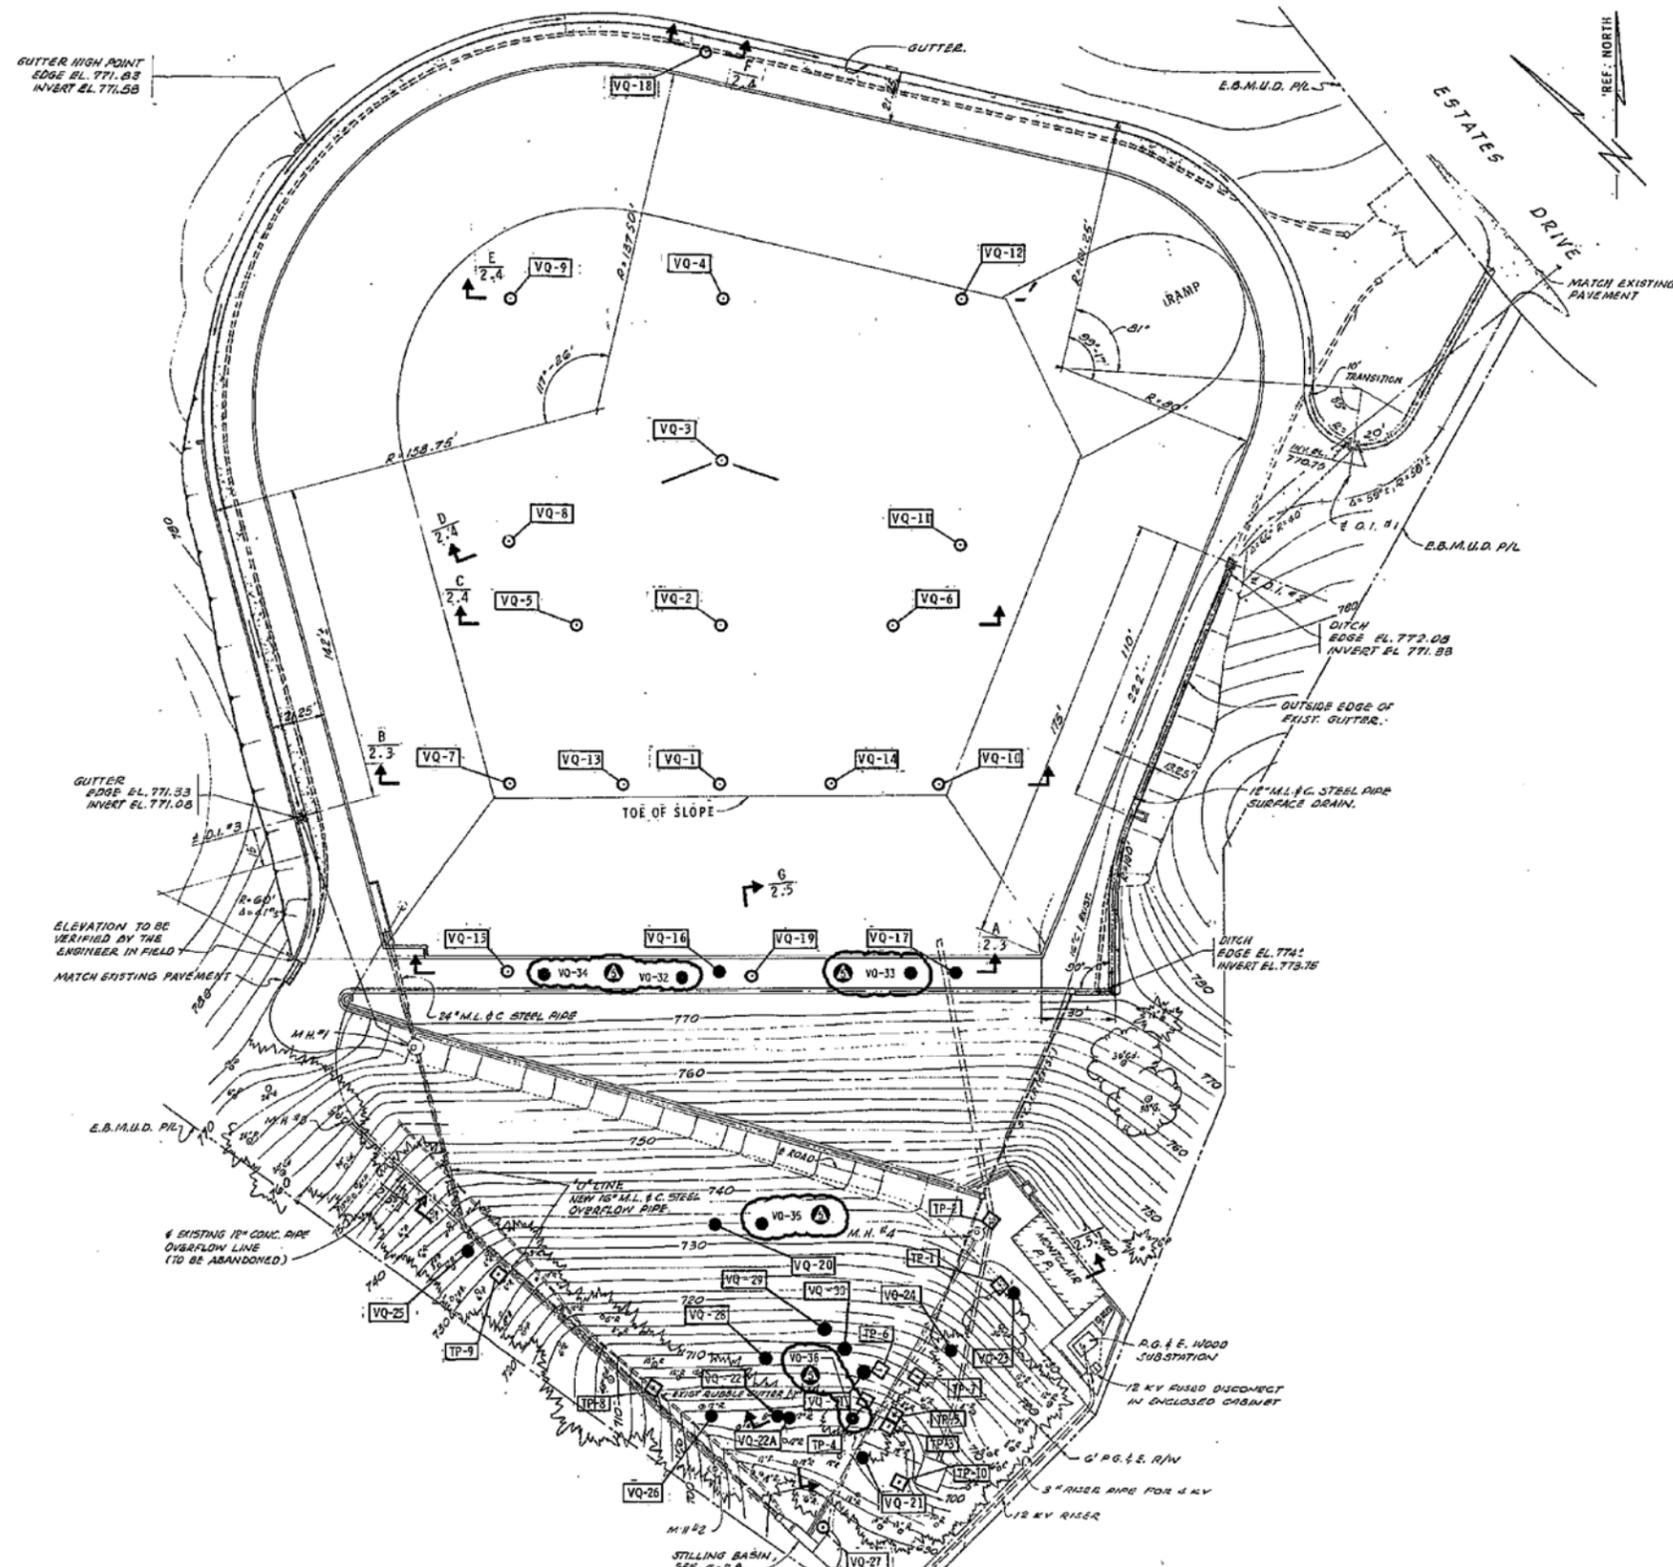
Project No. 26814957	Estates Dam Seismic Stability	Locations of Previous Field Explorations	FIGURE 4-1
URS

EBMUD Drawing No. 4394-G-2.2, Site Topography - Boring Locations, dated July 12, 1966, last revised in 1999.

The objective of the field and laboratory investigations was to supplement the available geotechnical data for the seismic stability re-evaluation of the dam. Previous studies of the dam's stability have also included field and laboratory investigations. The locations of the borings from previous studies are shown in Figure 4-1. Of the existing borings in the embankment, only a few were judged to be reliable. Thus, additional field and laboratory investigations were undertaken for this study to supplement the existing data and to better characterize the materials in the dam and its foundation for the analyses of seismic stability. The investigation program that was carried out for this purpose is described below.

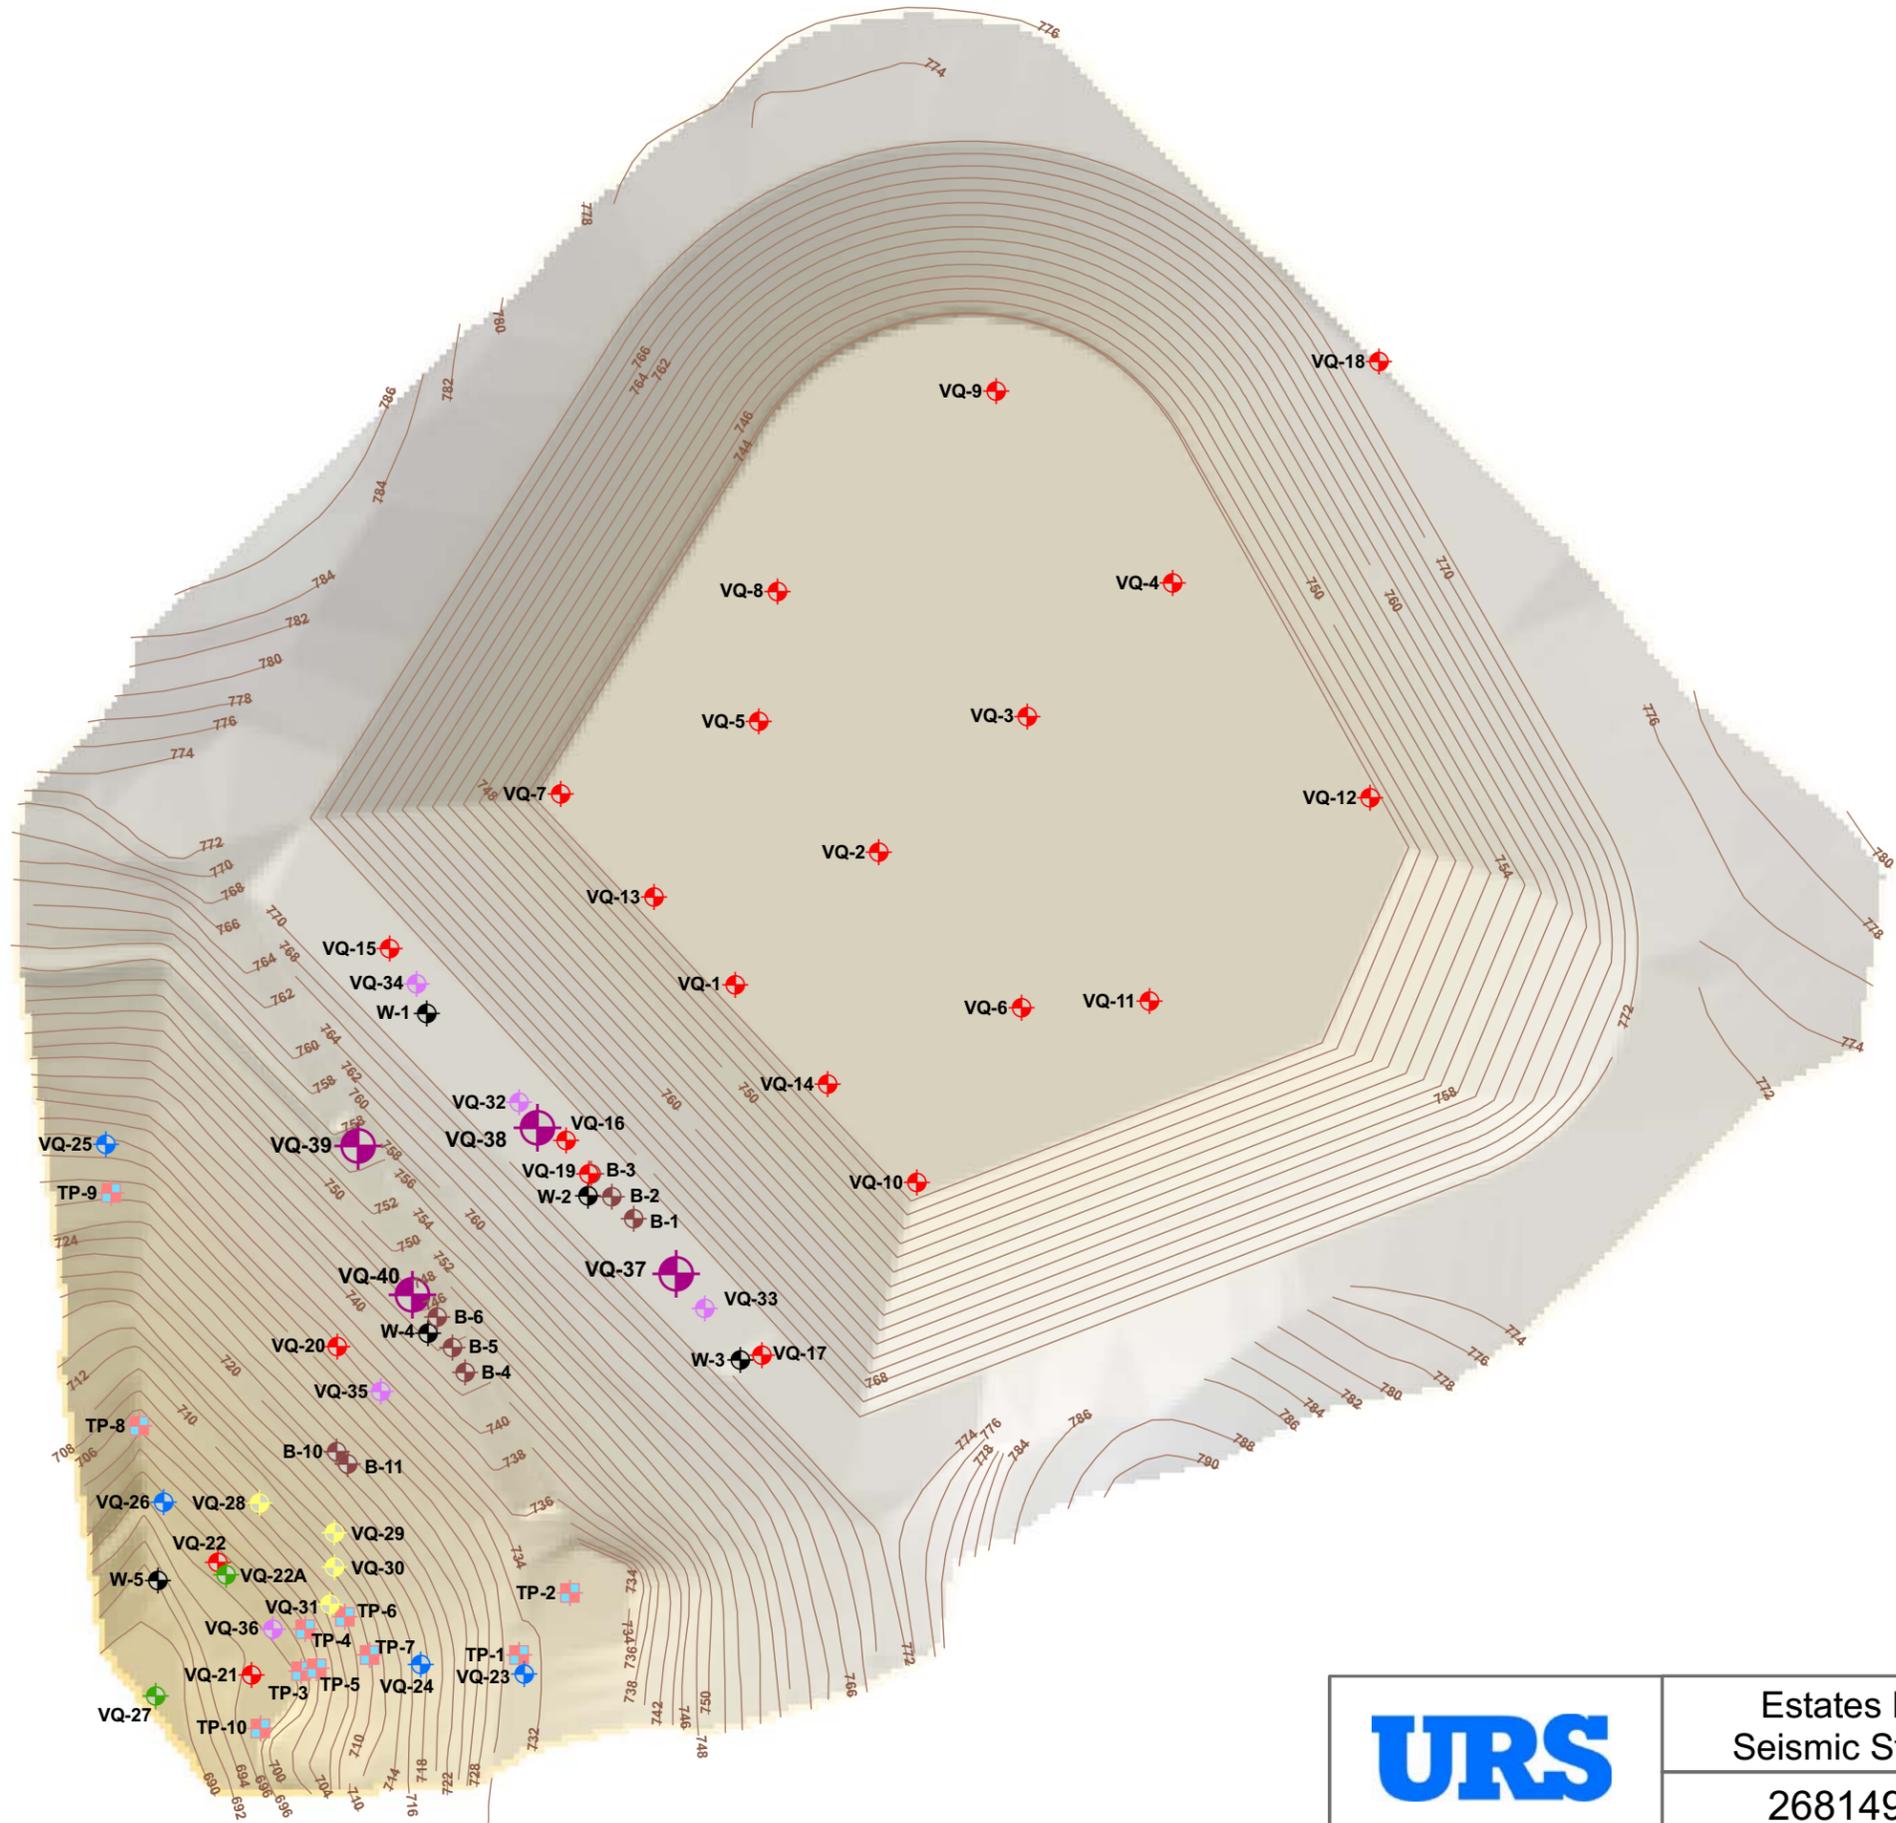
Estates Dam Seismic Stability	Locations of Field Explorations	Figure 4-2
	26814957

- EBMUD; 1939 (wells)
- EBMUD for S&W study; 1962-1965
- S&W; 1965
- EBMUD for S&W study; 1965 (test pits)
- EBMUD for S&W study; 1965
- EBMUD; 1976
- Wahler Associates; 1978
- EBMUD, 1999 (piezometers)
- URS, 2005

The field investigation program included exploratory borings, hammer energy measurements, and downhole geophysical surveys. The details of these elements of work are described in the following sections. The boring logs and test data reports are presented in Appendices A through C. The boring depths and materials encountered are summarized in Table 4-1. The locations of the borings drilled for this study are shown in Figure 4-2, along with the locations of previous borings.

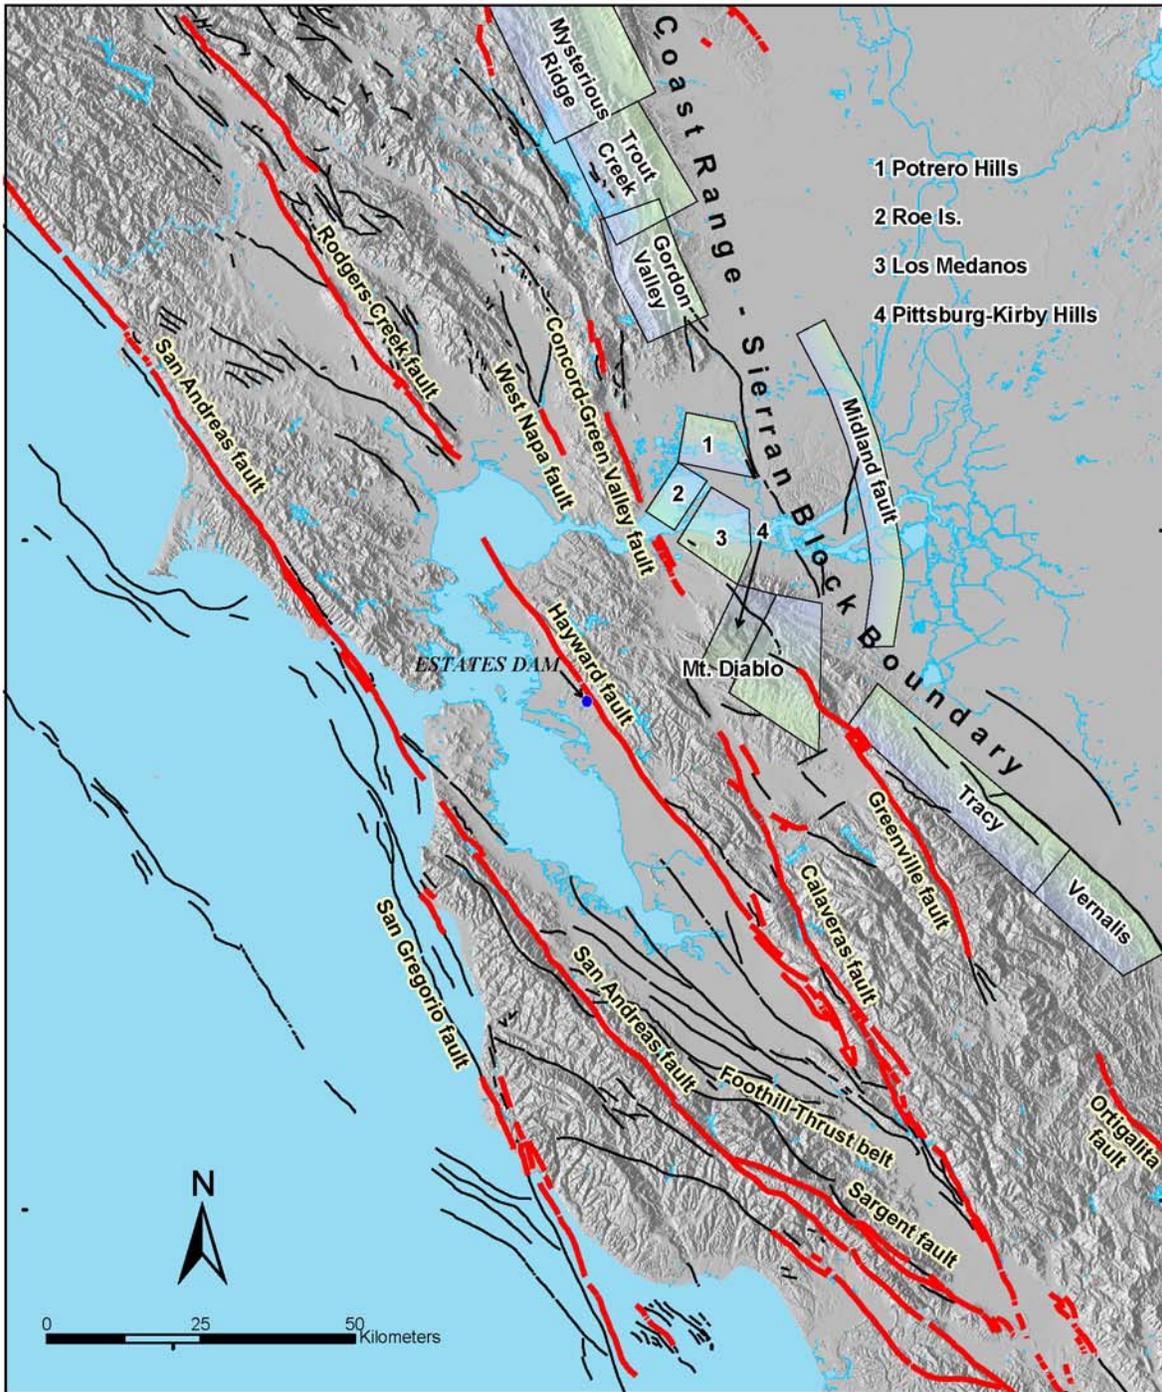
Figure
 6-1

- Holocene faults
- Pre-Holocene faults

Map of Regional
 Seismic Sources

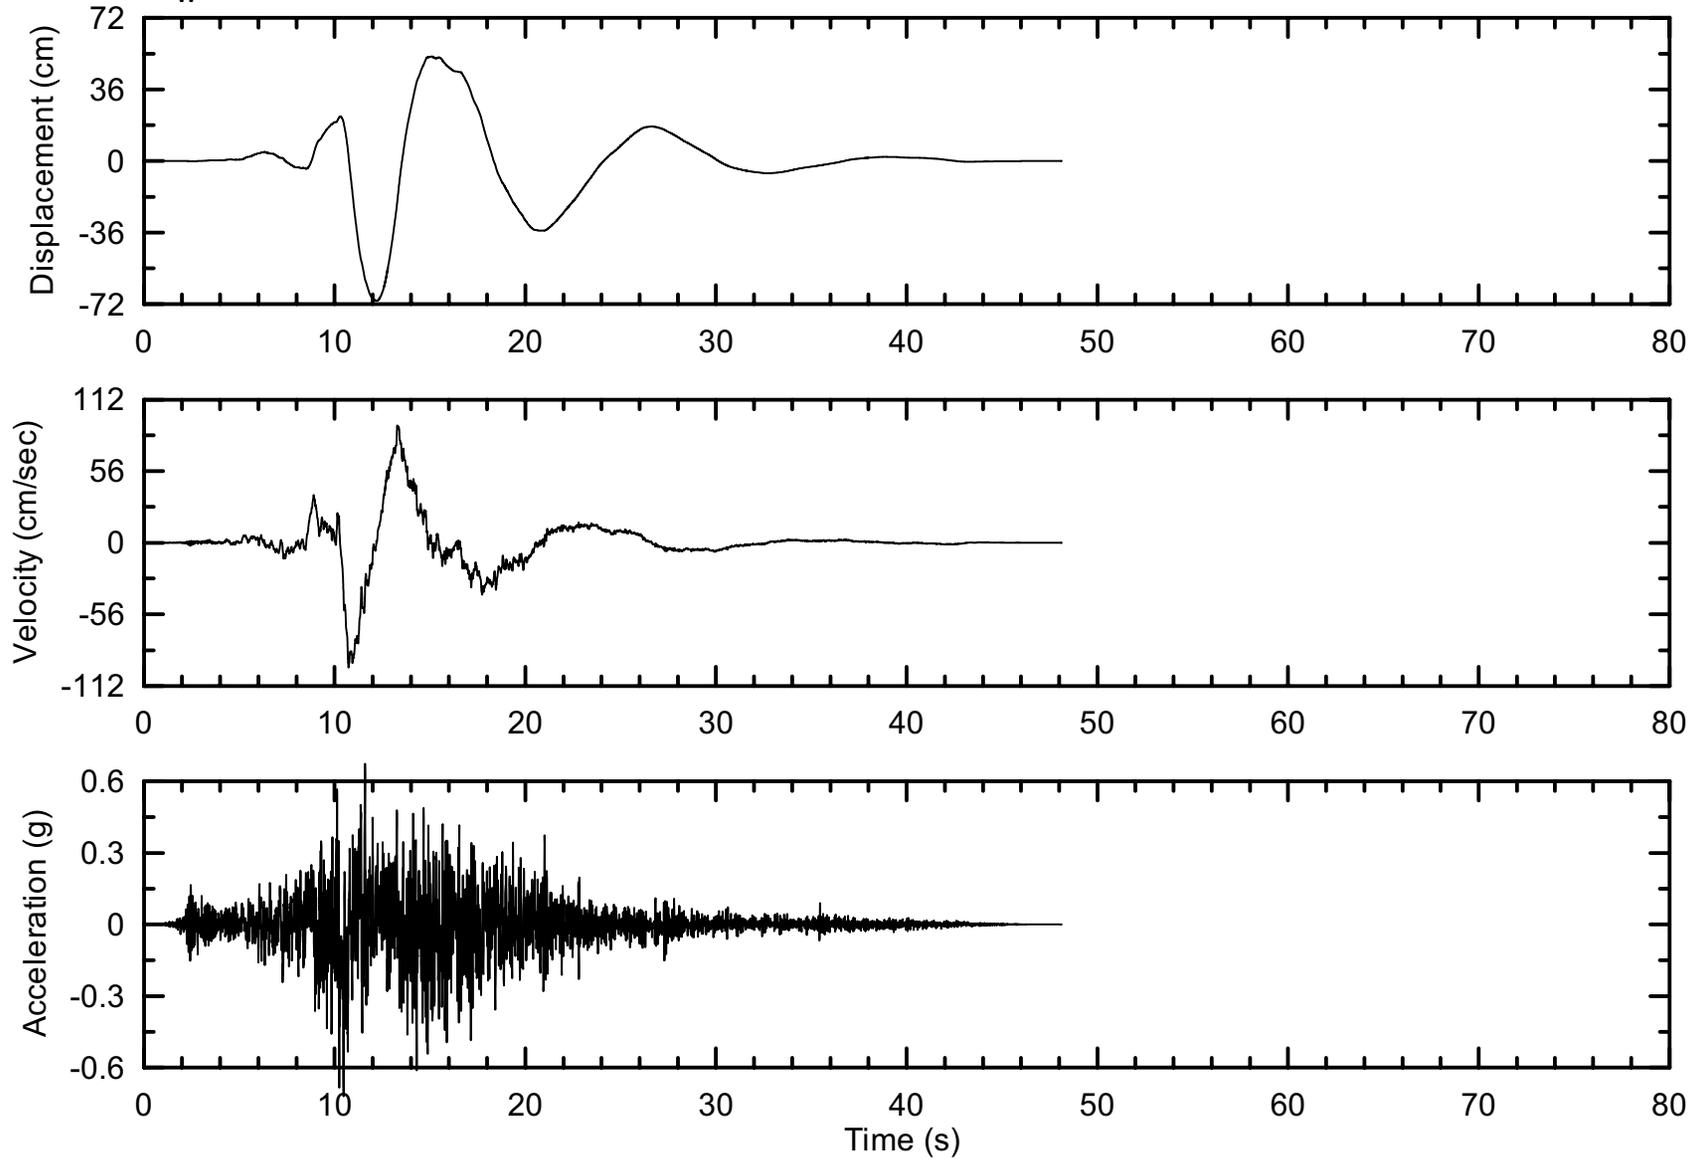
1992 Landers, CA Earthquake Time History
 at Lucerne Valley Station,
 $M_w = 7.3$, $R = 2.0$ km

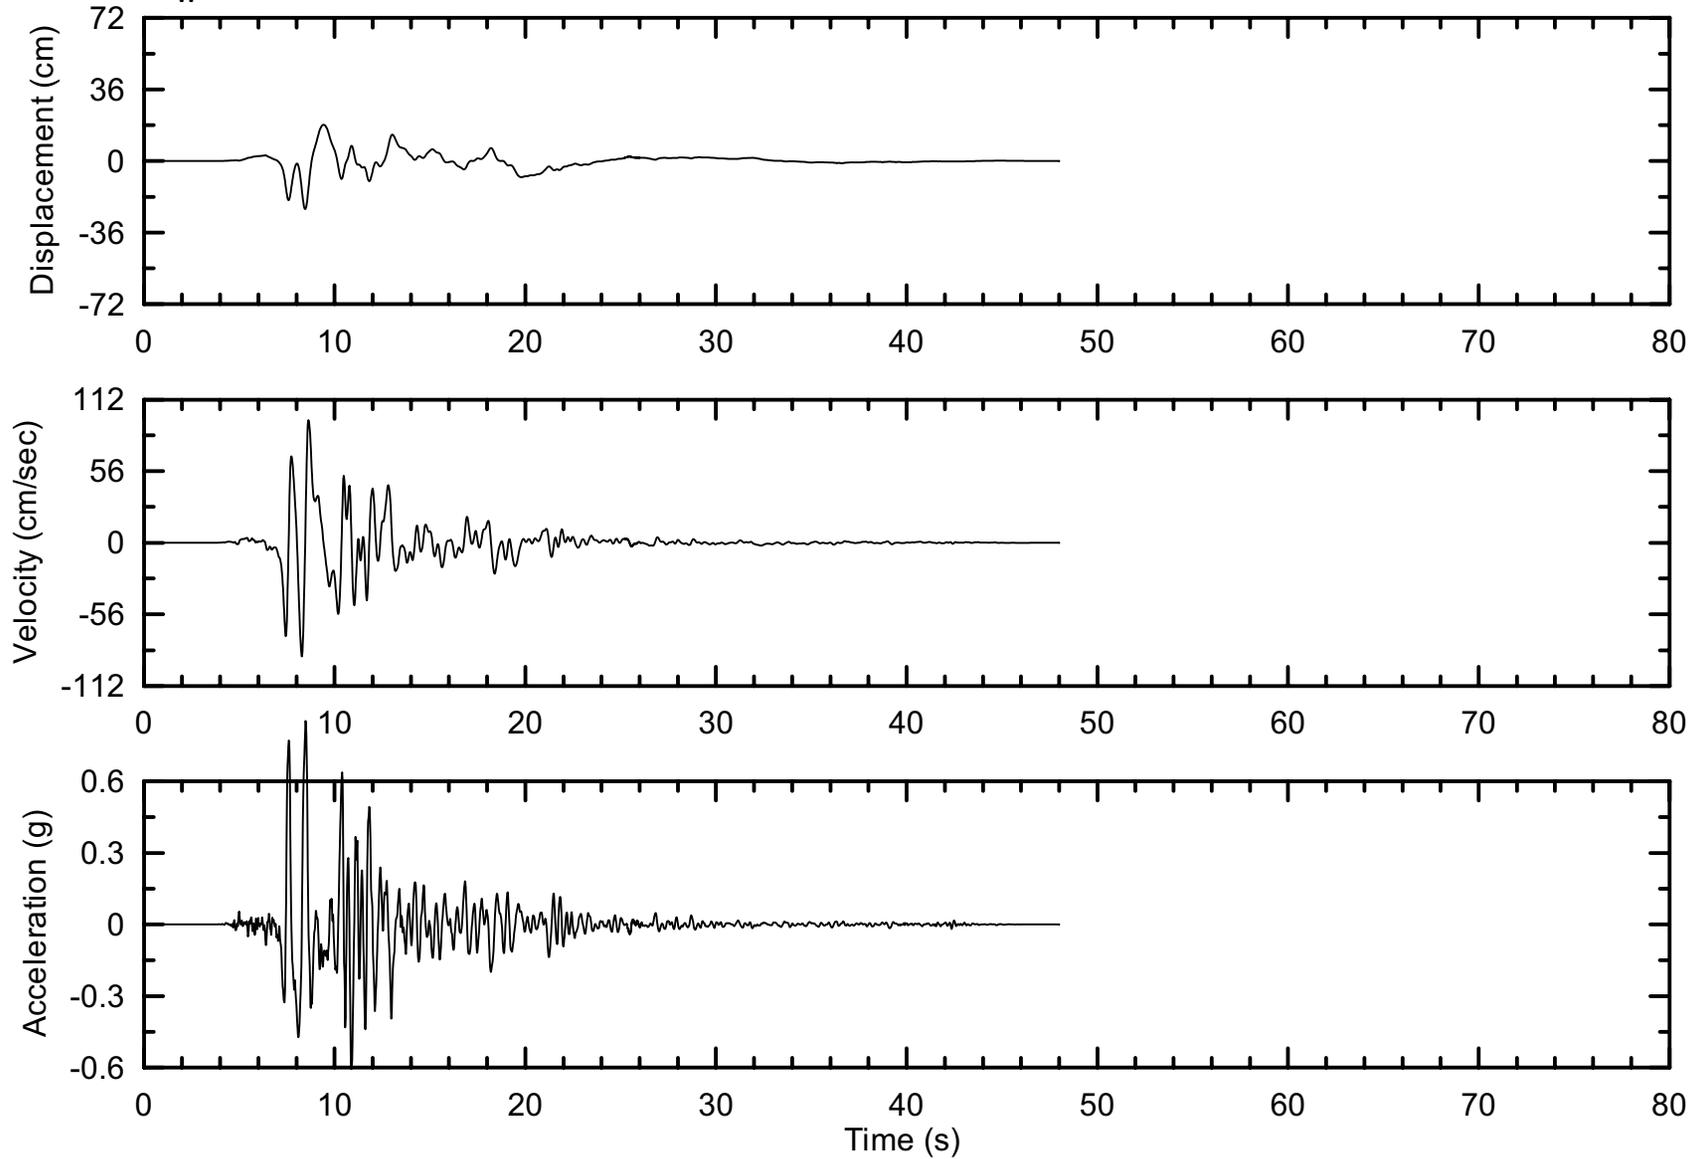
1995 Kobe, Japan Earthquake Time History
 at KJMA Station,
 $M_w = 6.9$, $R = 0.6$ km

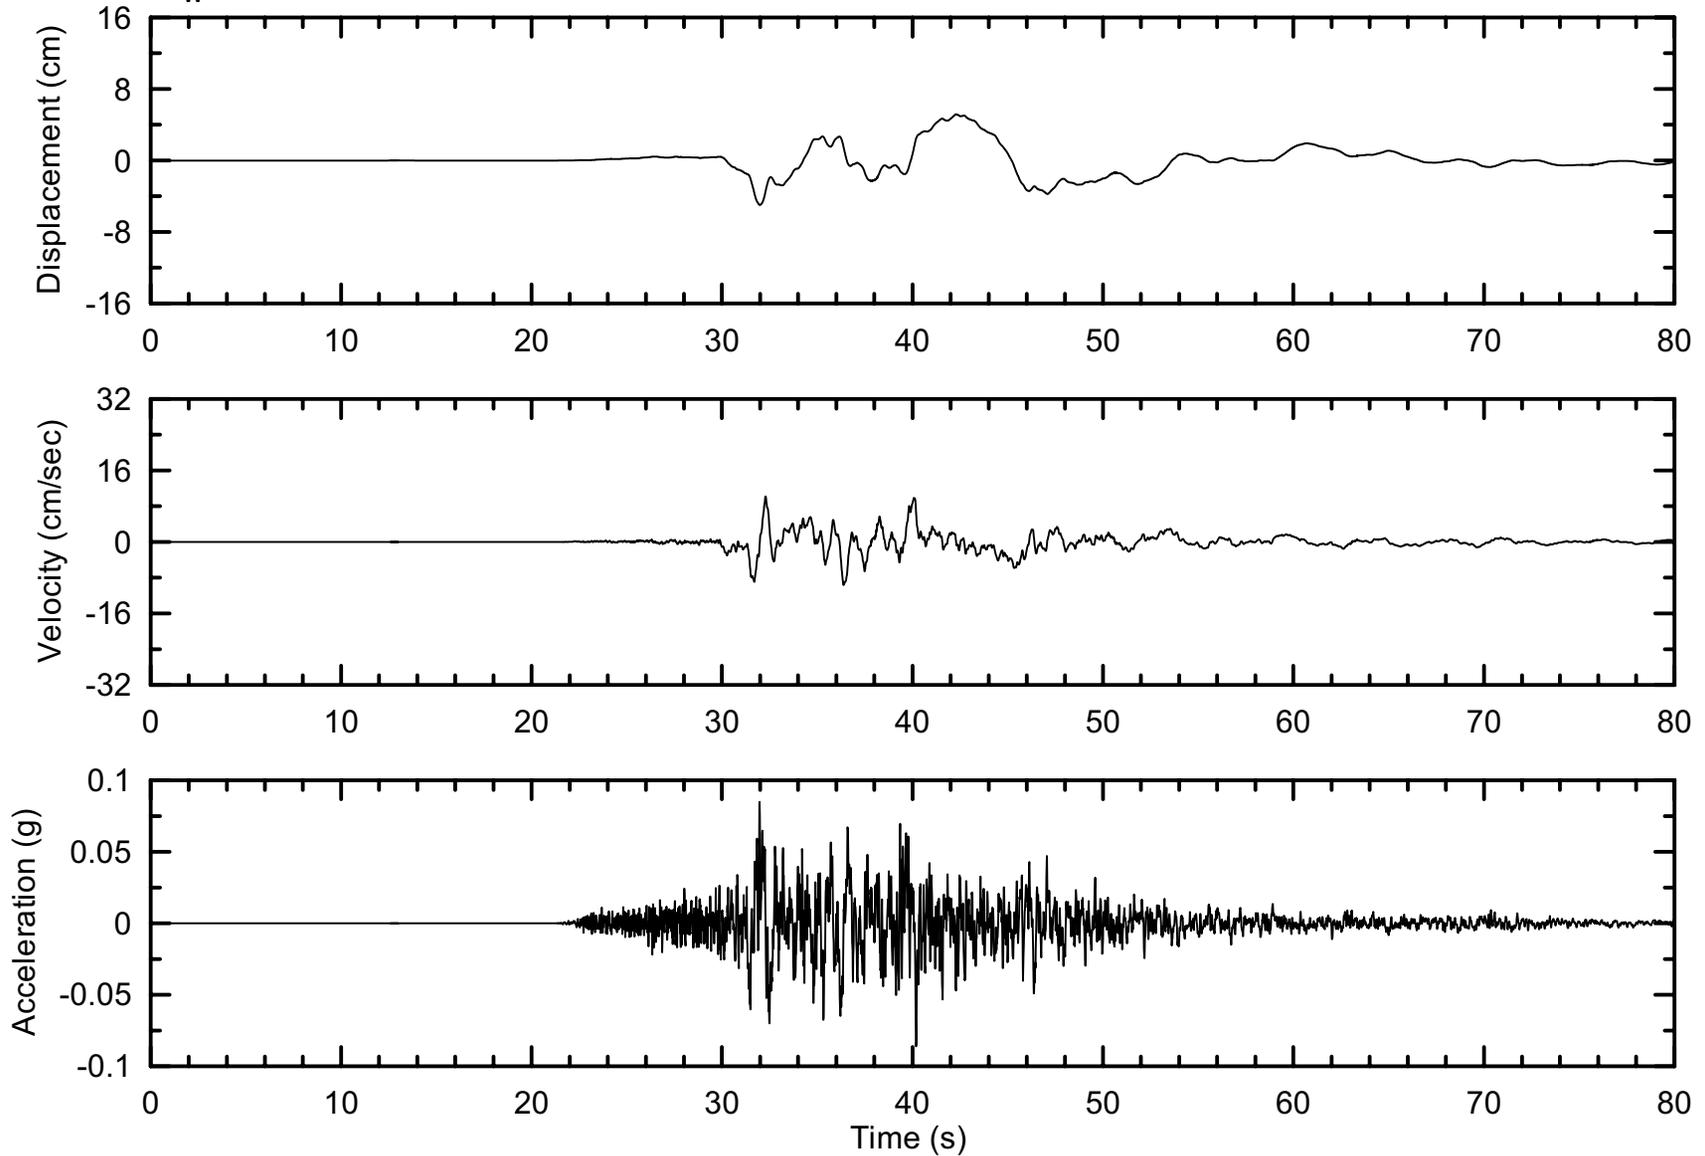
2002 Denali, Alaska Earthquake Time History
 Recorded at Carlo, Alaska Station,
 $M_w = 7.9$, $R = 64$ km

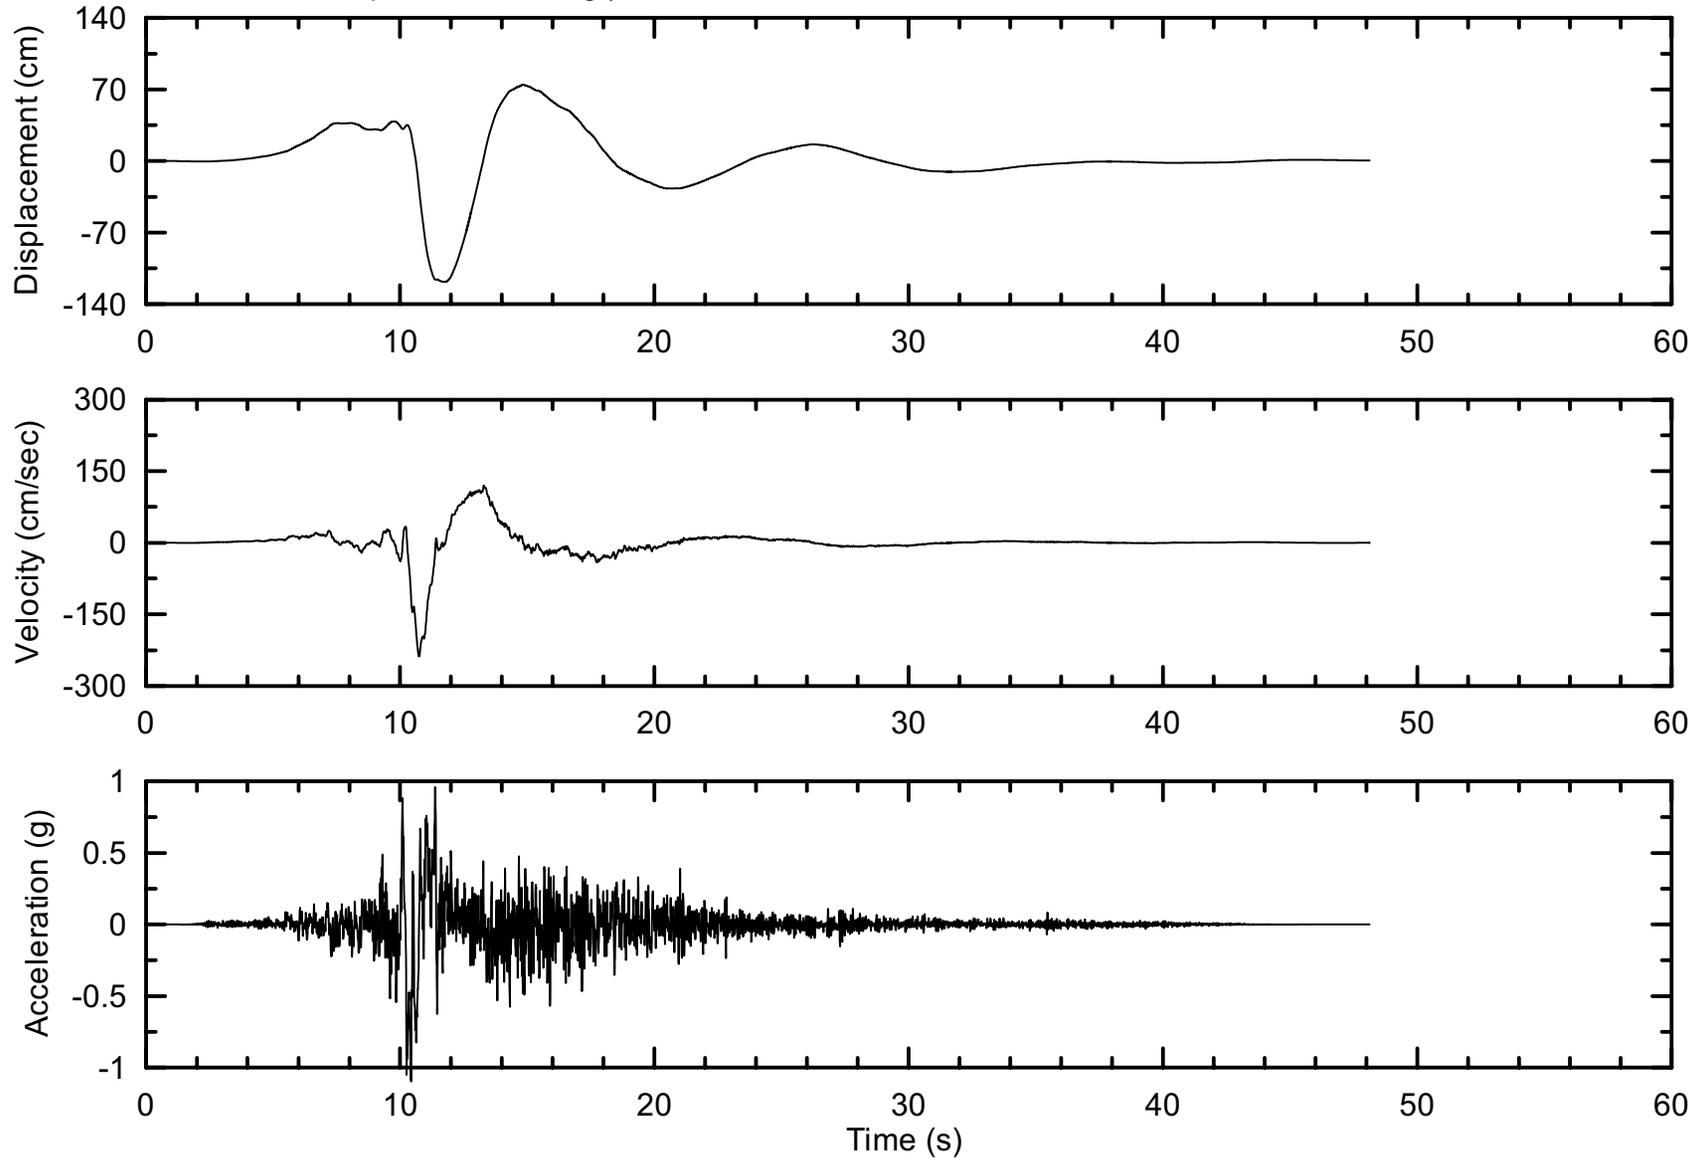
Project No. 26814957	Estates Dam Seismic Stability	Hayward - Rodgers Creek Fault Event Recommended Time History # 1	Figure 6-12
URS

Hayward - Rodgers Creek Fault Event - Recommended Time History #1
 (Modified from 1992 Landers, CA Earthquake - Lucerne Valley Station,
 Horizontal Component, 270 deg.)

The recommended time histories and comparisons between their response spectra and the target spectra are shown in Figures 6-12 through 6-16. Figures 6-12 and 6-13 show the two recommended time histories for the Hayward fault MCE. The spectra for those time histories are compared with the target spectrum in Figure 6-14. Figure 6-15 shows the recommended time history for the San Andreas fault MCE. Its spectrum is compared with the target spectrum in Figure 6-16. As shown in Figures 6-14 and 6-16, the spectra for the recommended time histories match the target spectra reasonably well.

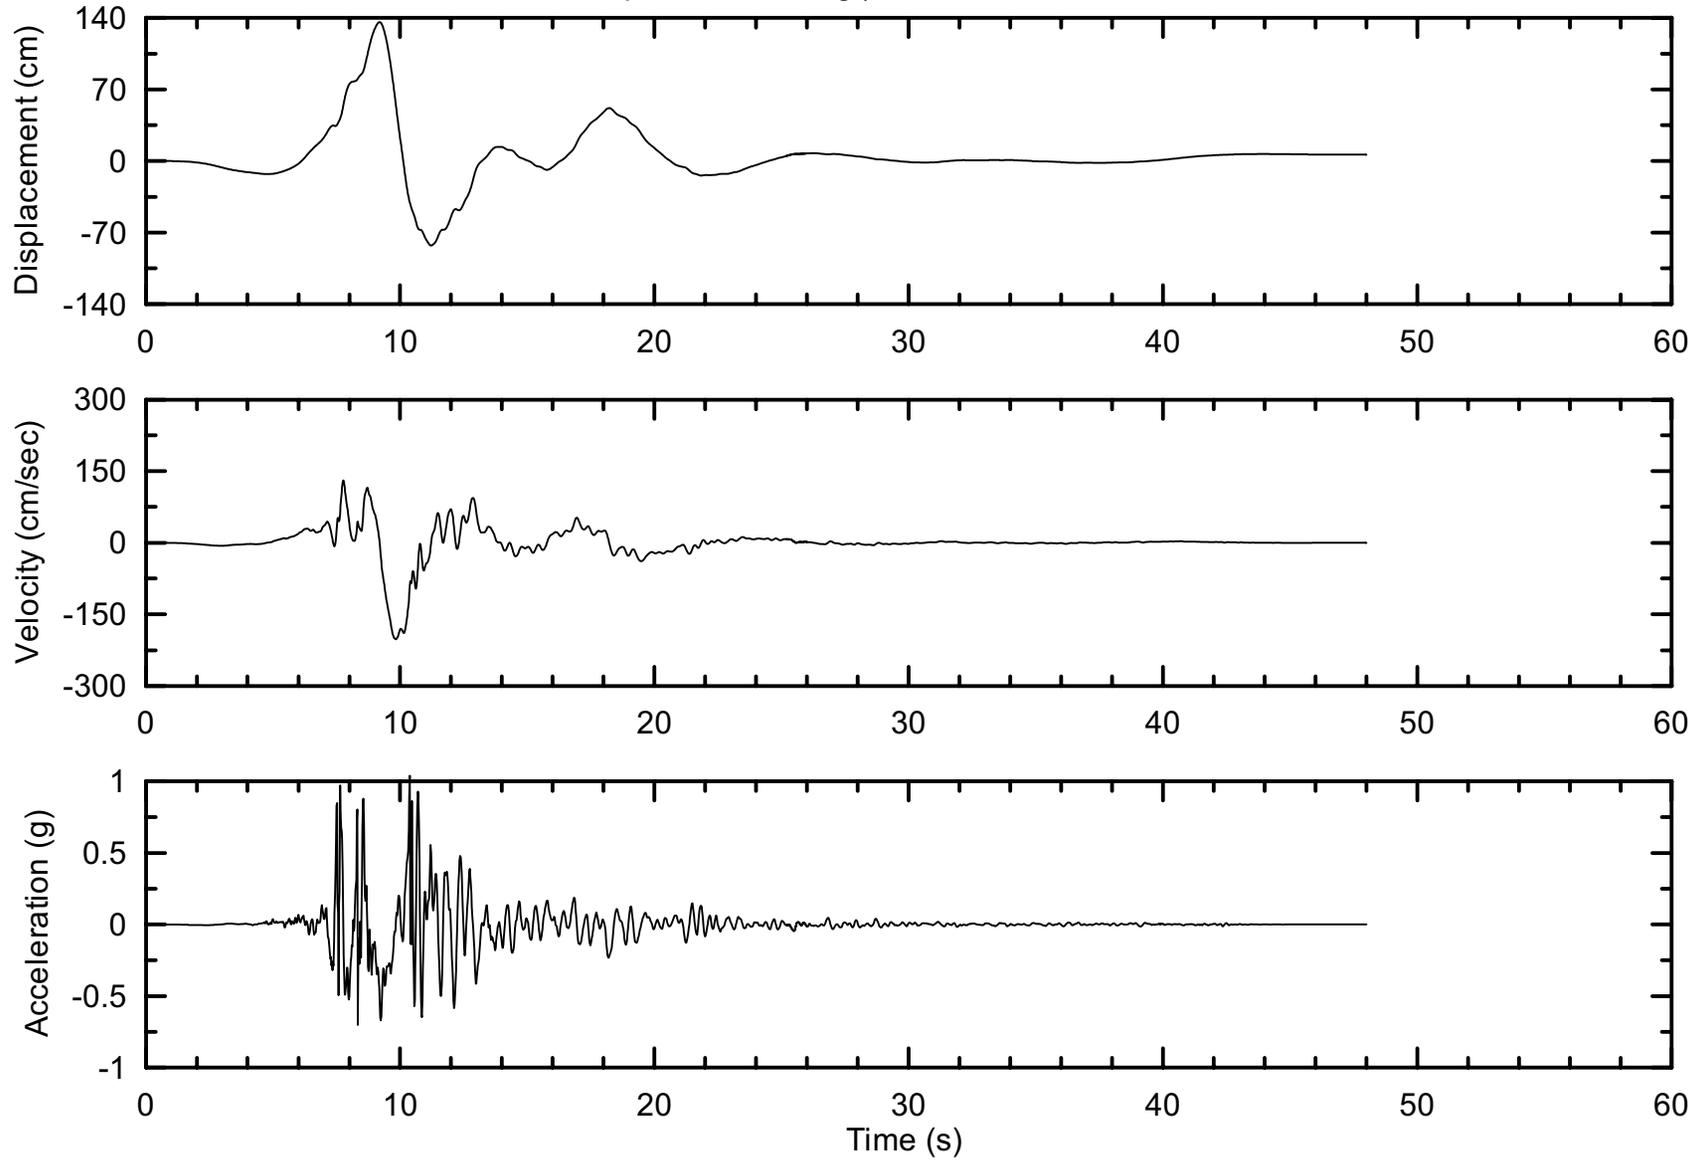
Project No. 26814957	Estates Dam Seismic Stability	Hayward - Rodgers Creek Fault Event Recommended Time History #2	Figure 6-13
URS

Hayward - Rodgers Creek Fault Event - Recommended Time History # 2
 (Modified from 1995 Kobe, Japan Earthquake
 at KJMA Station, Horizontal Component, 142 deg.)

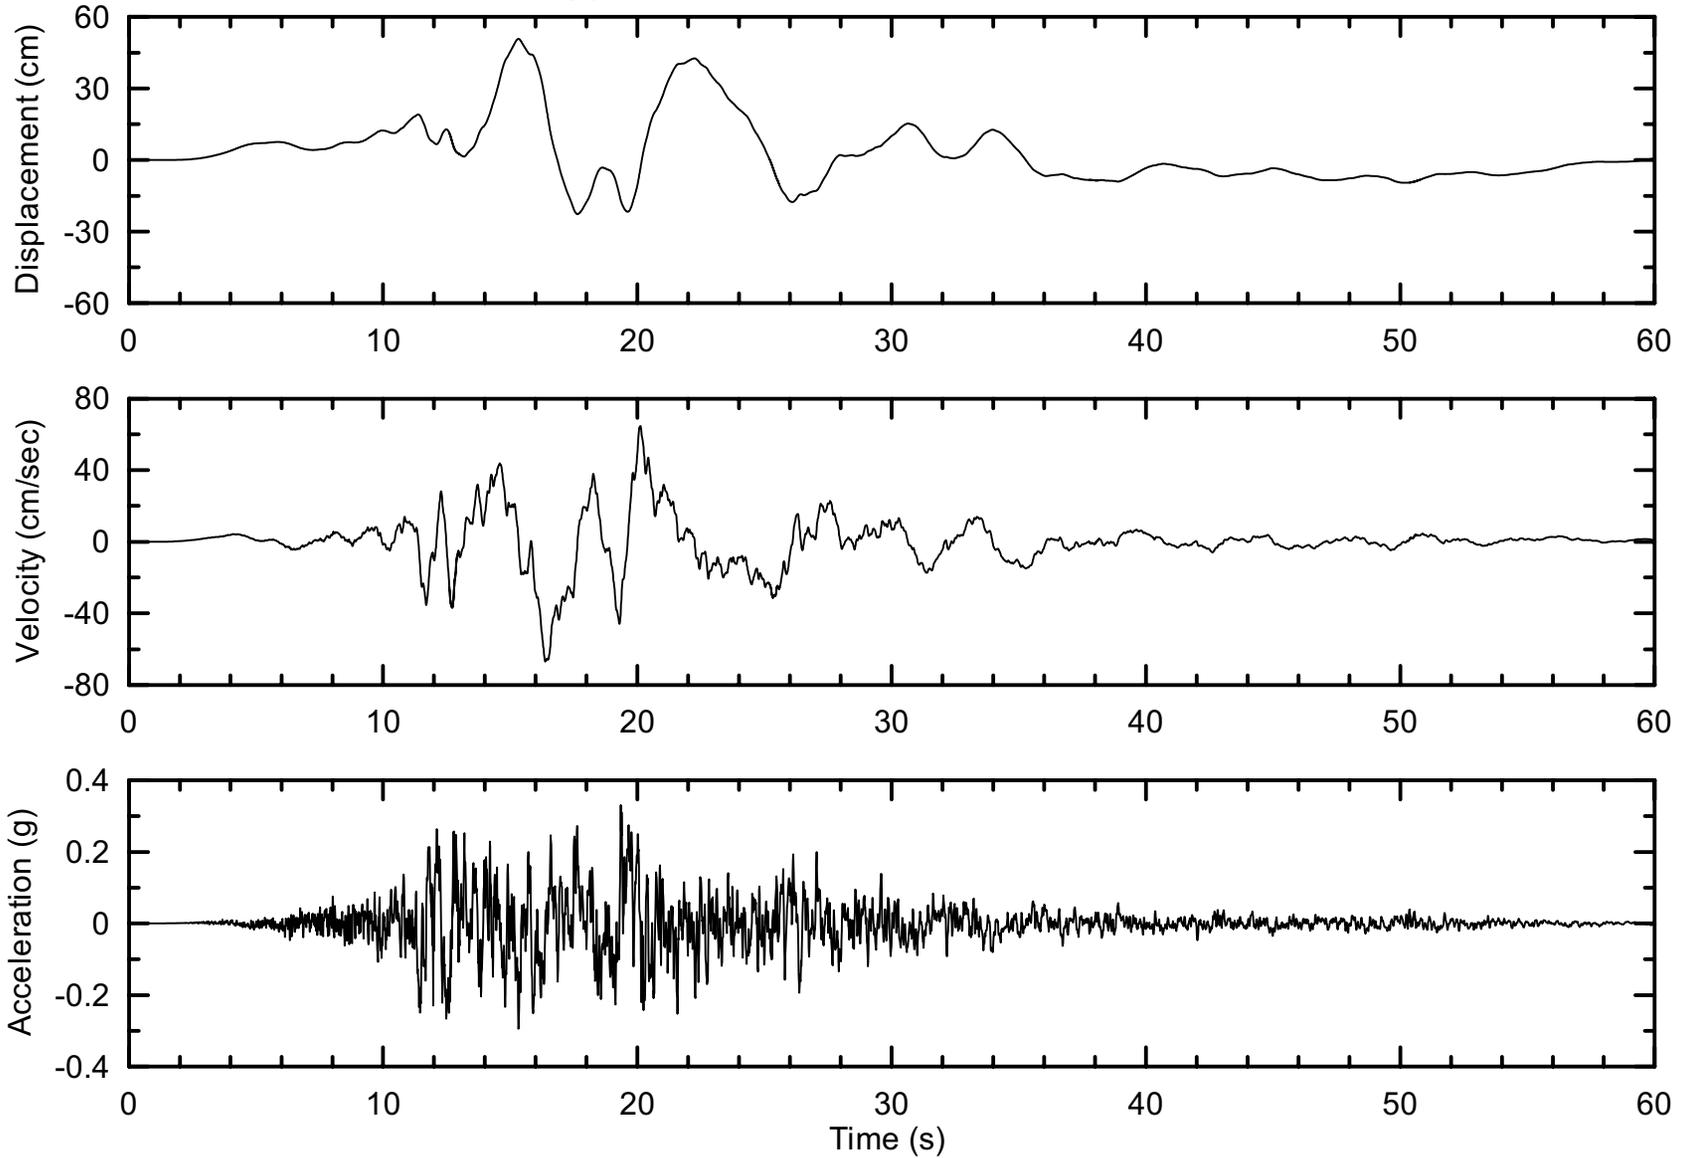
Project No. 26814957	Estates Dam Seismic Stability	San Andreas Fault Event Recommended Time History	Figure 6-15
URS

San Andreas Fault Event - Recommended Time History
 (Modified from 2002 Denali, Alaska Earthquake - Carlo, Alaska Station,
 Horizontal Component, 360 deg.)
