FINAL REPORT

Dynamic Stability Analysis of Estates Dam

Oakland, California

NOVEMBER 2006

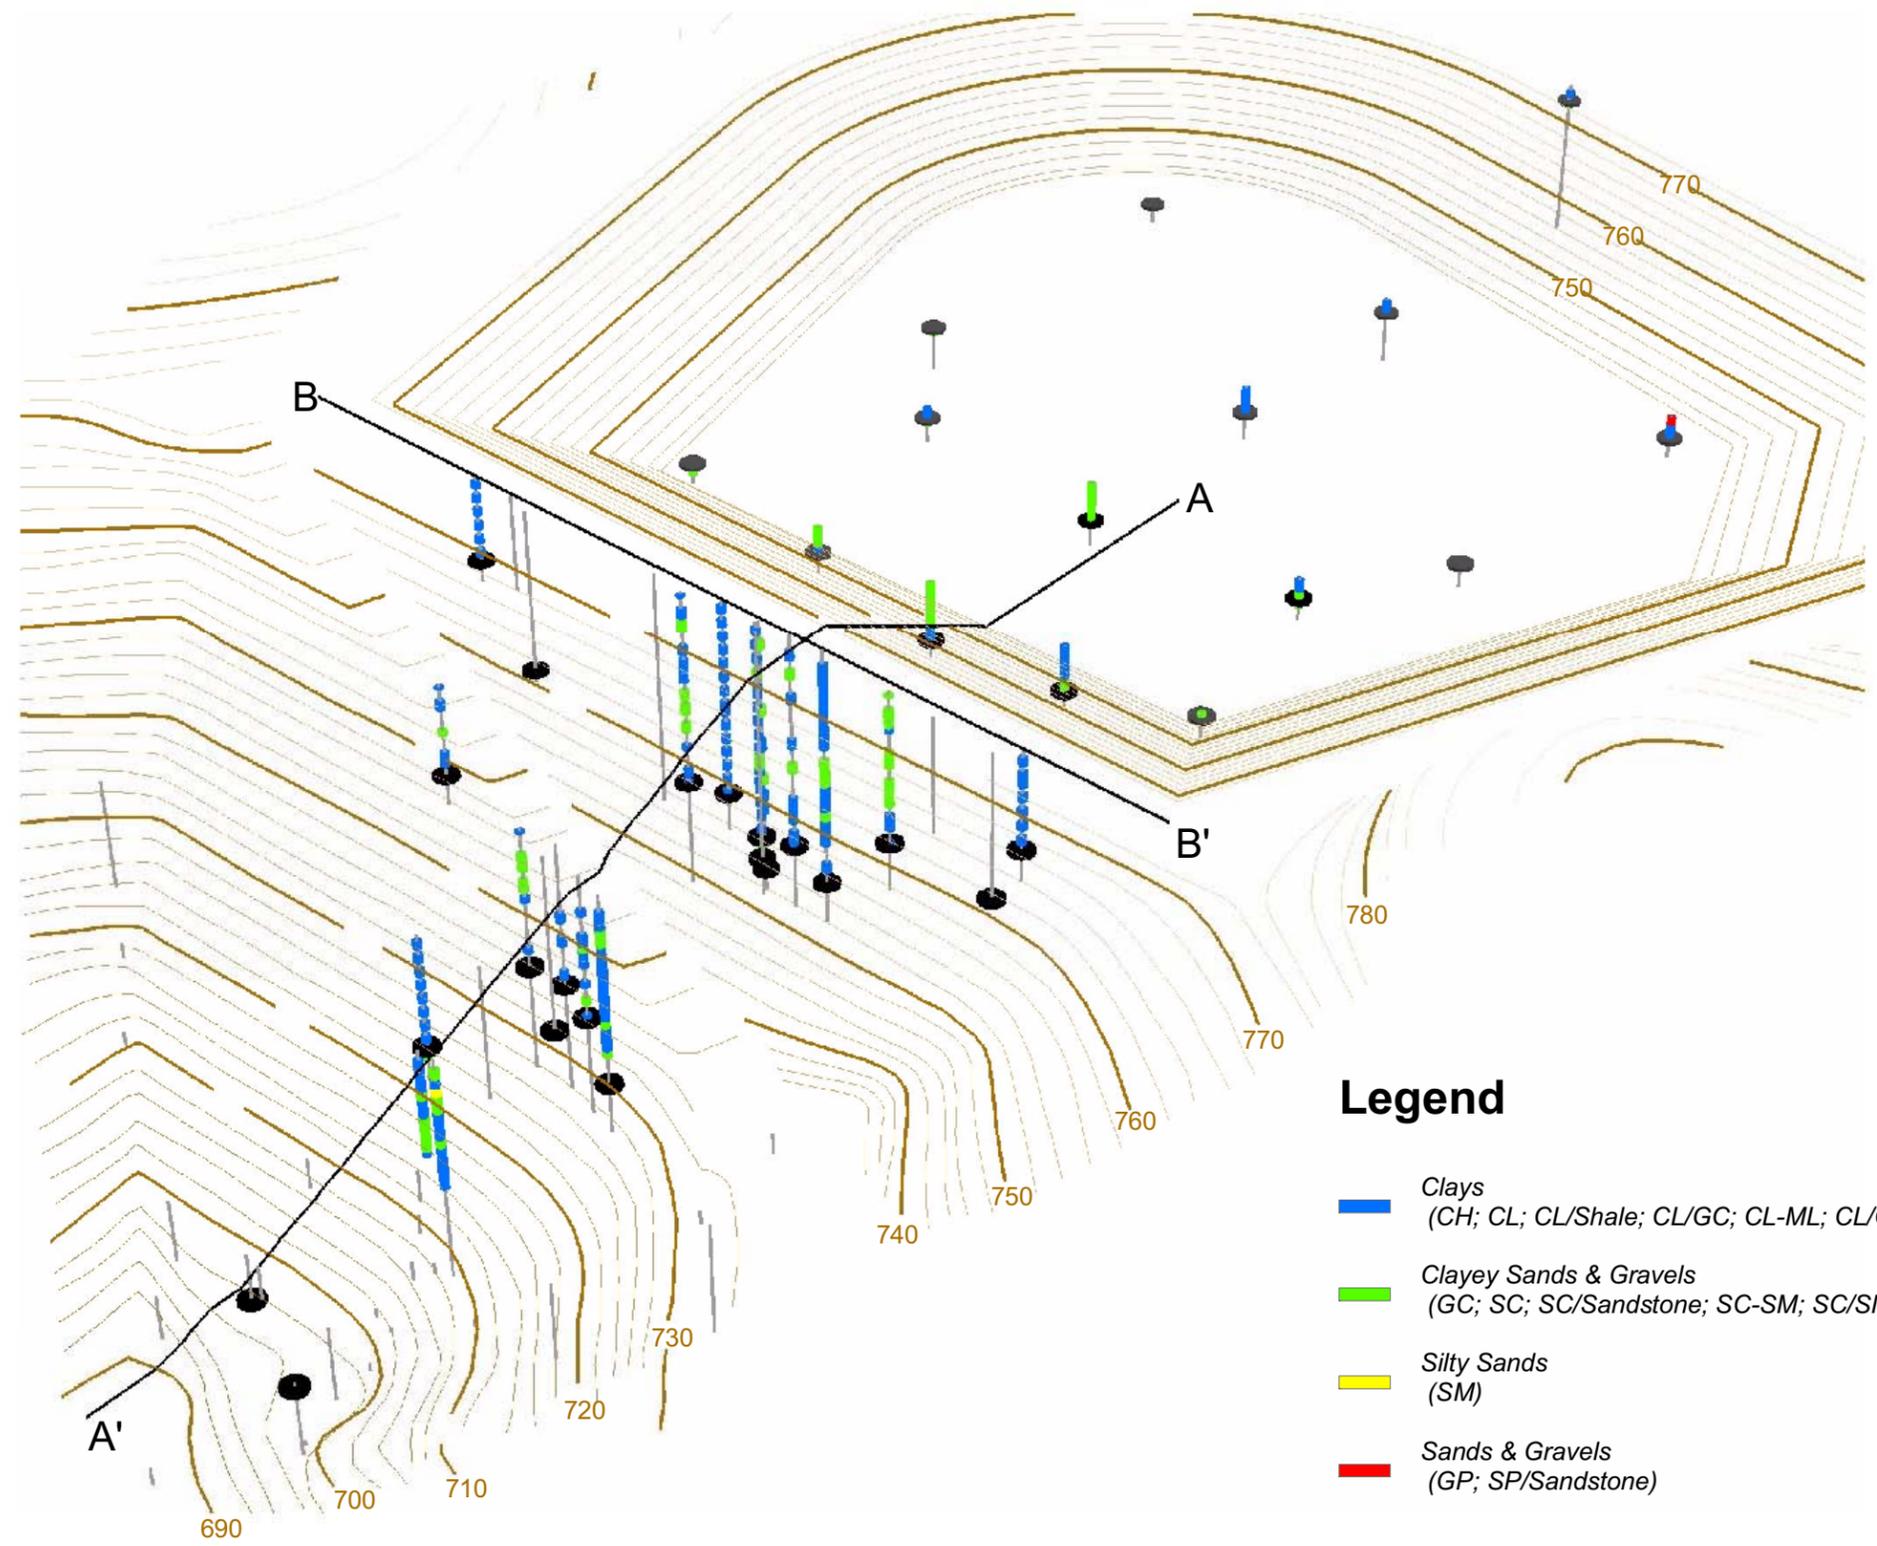
**Figure
7-2**

- █ Clays
(CH; CL; CL/Shale; CL/GC; CL-ML; CL/CH)
- █ Clayey Sands & Gravels
(GC; SC; SC/Sandstone; SC-SM; SC/SM)
- █ Silty Sands
(SM)
- █ Sands & Gravels
(GP; SP/Sandstone)

URS	Estates Dam Seismic Stability	GIS Model - Isometric View of Dam with Sample Classifications
	26814957

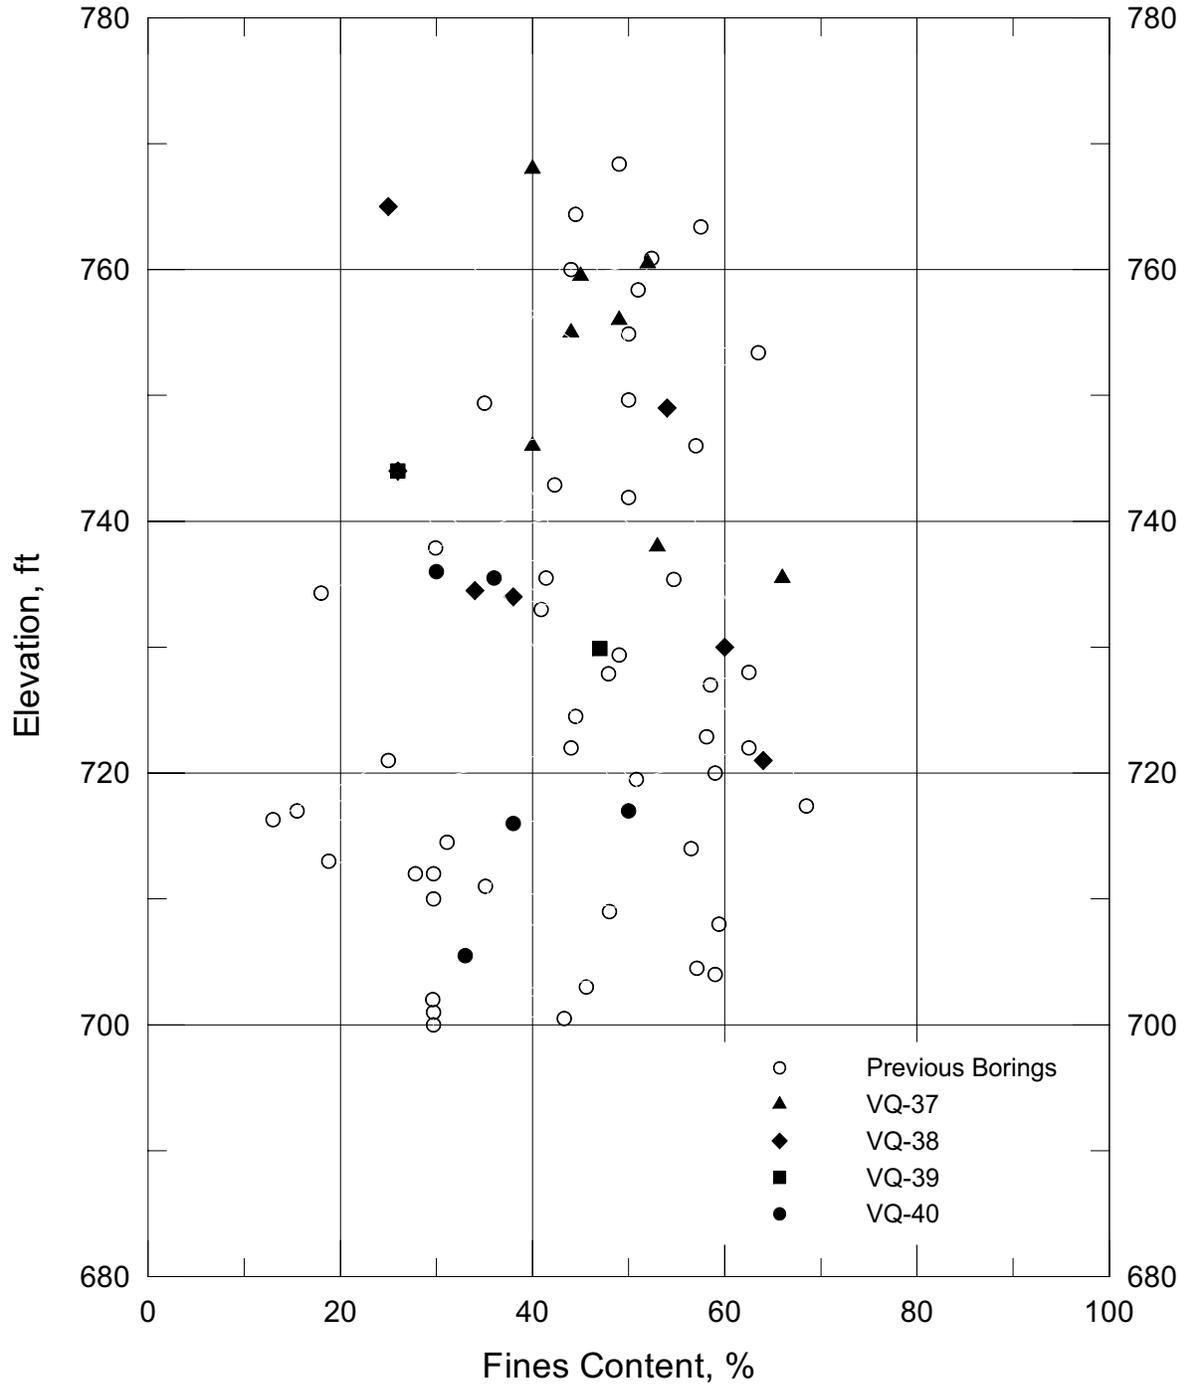
URS	Project No. 26814957	Fines Content Data From Current and Previous Investigations	Figure
	Estates Dam Seismic Stability		7-5

Estates Dam - Fines content

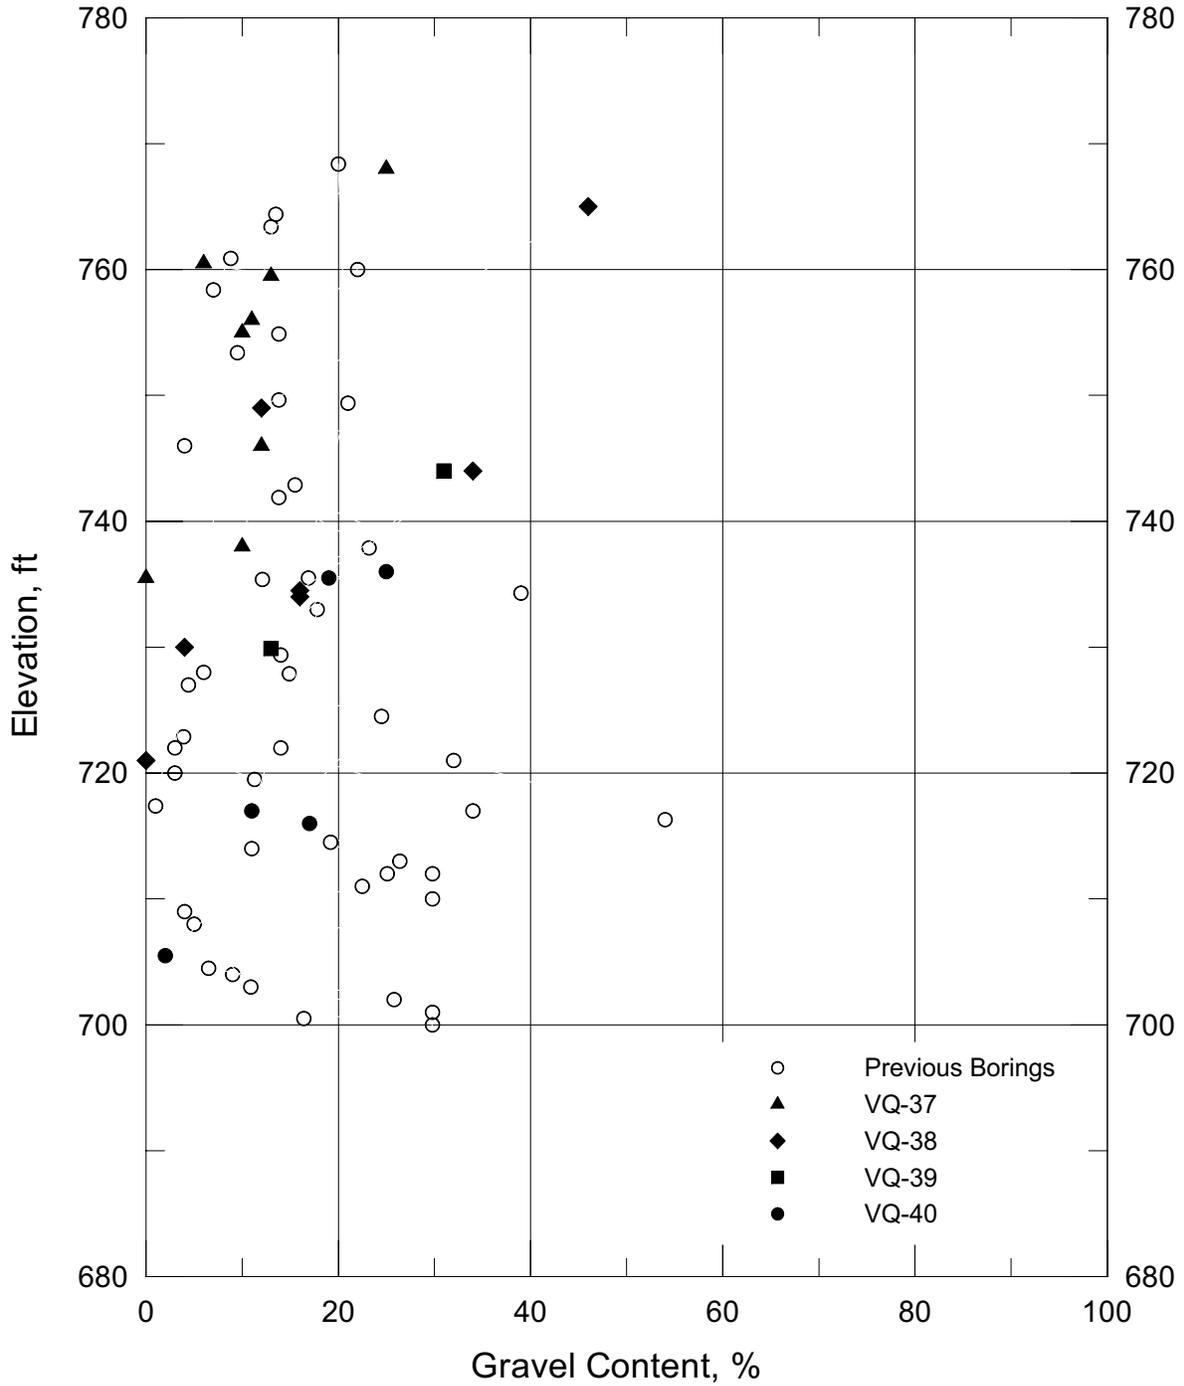
URS	Project No. 26814957	Gravel Content Data From Current and Previous Investigations	Figure
	Estates Dam Seismic Stability		7-6

Estates Dam - Gravel content

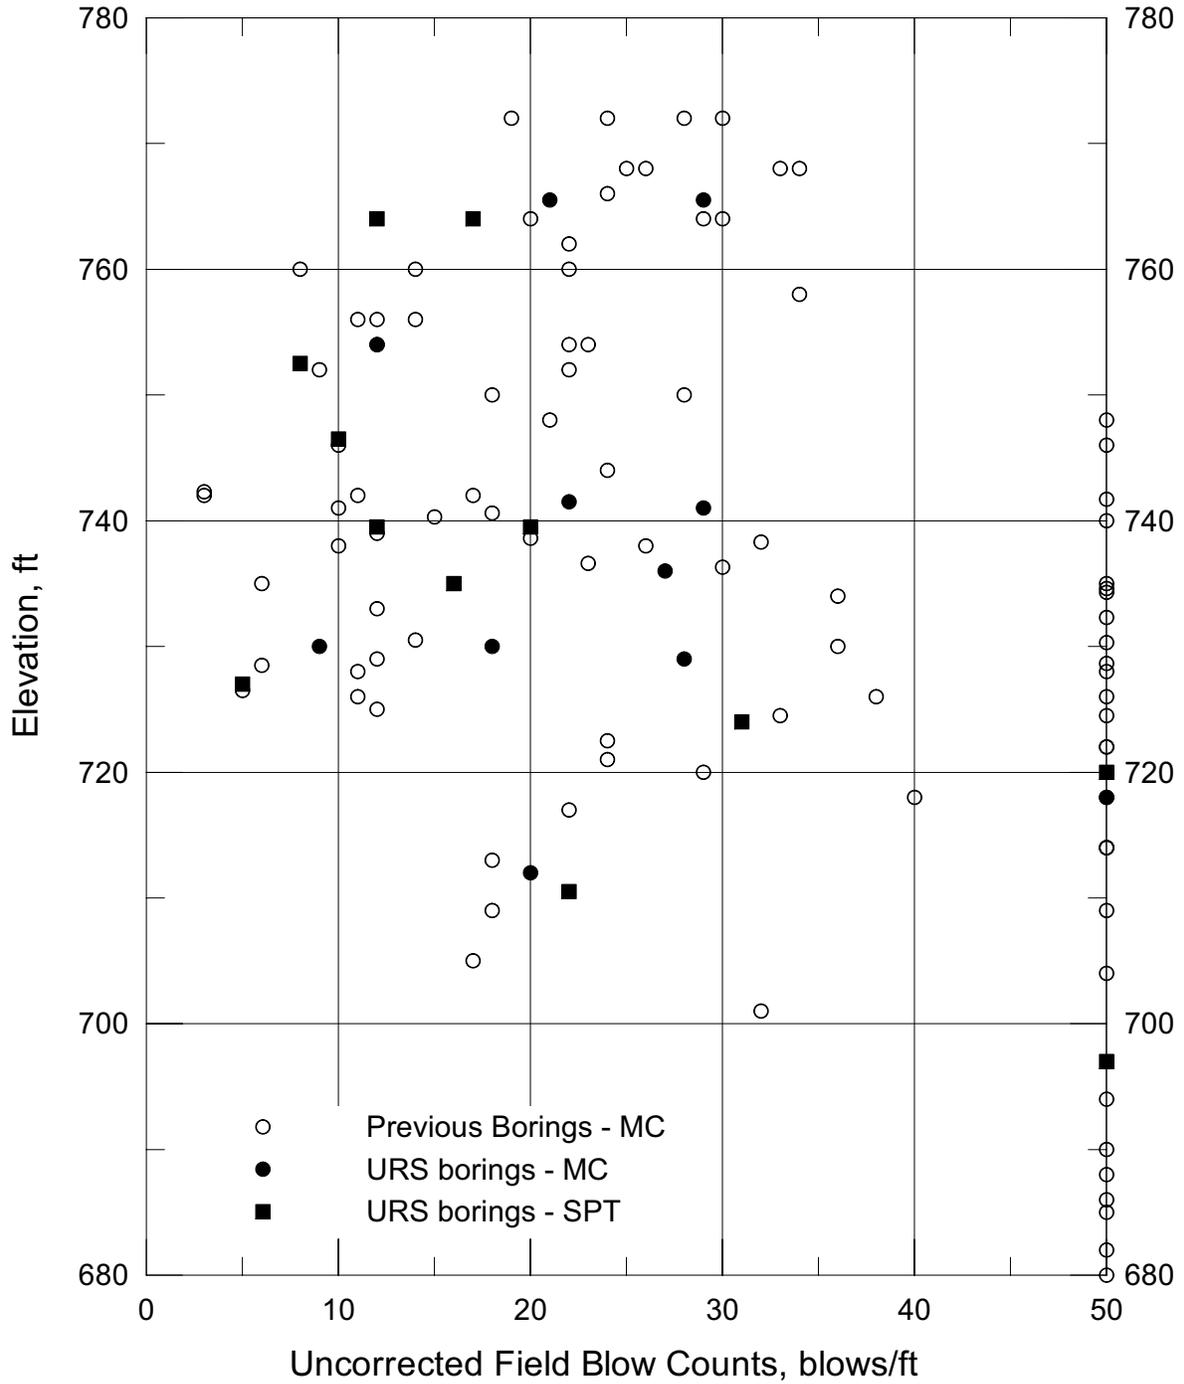
URS	Project No. 26814957	Blow Counts Data From Current and Previous Investigations	Figure
	Estates Dam Seismic Stability		7-7

Estates Dam - Blow Counts

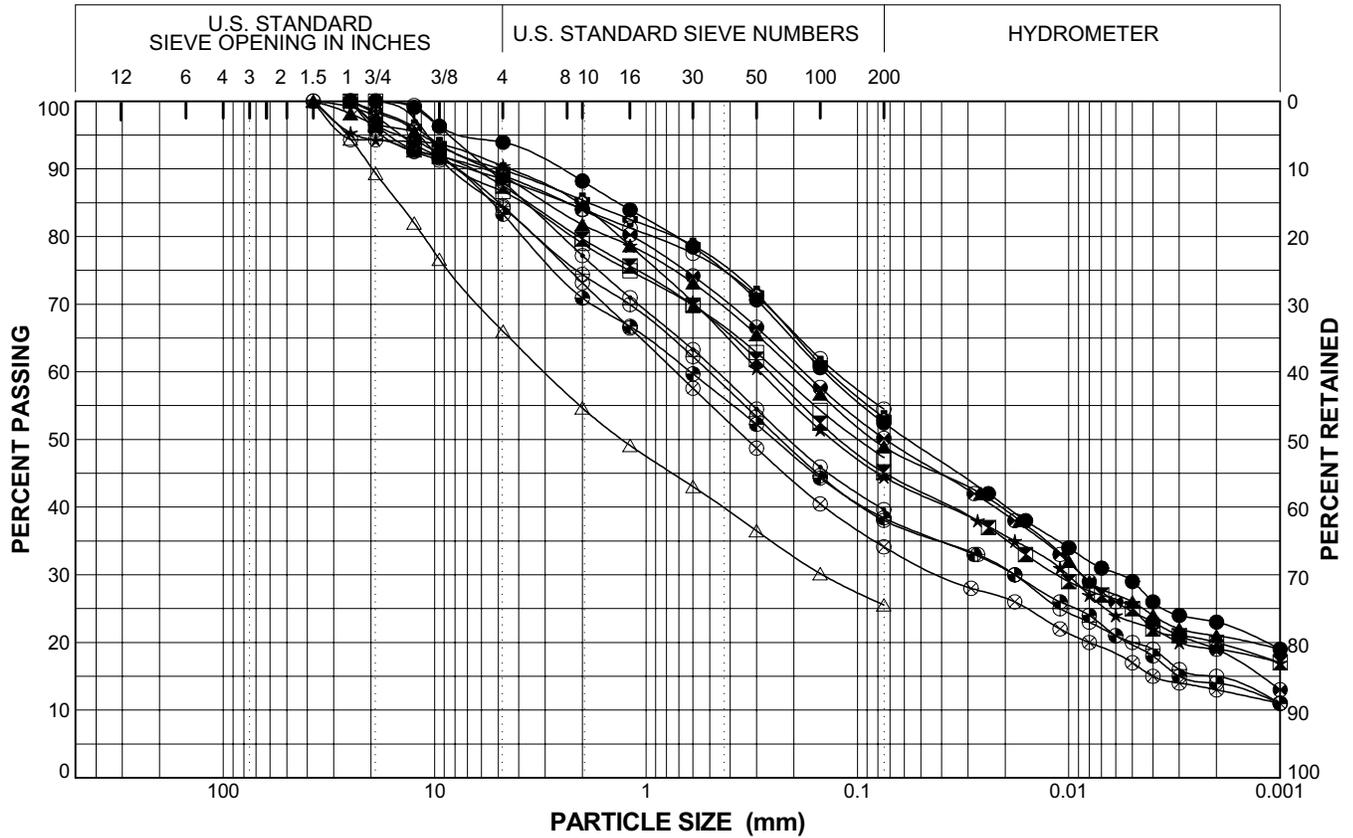
Figure 7-8

BOULDERS	COBBLES	GRAVEL		SAND			SILT OR CLAY
		coarse	fine	coarse	medium	fine

Boring Number	Sample Number	Depth (feet)	Symbol	Classification
VQ-37	5A	13.5-14.5	●	Sandy Clay (CL)
VQ-37	5B	14.5-15.5	⊠	Clayey Sand (SC)
VQ-37	6A	17.5-18.5	▲	Clayey Sand (SC)
VQ-37	6B	18.5-19.5	★	Clayey Sand (SC)
VQ-37	9B	28-29	⊙	Clayey Sand (SC)
VQ-37	11	35-37.5	⊕	Sandy Silty Clay (CL)
VQ-38	9	24-26.5	○	Sandy Clay (CL)

Boring Number	Sample Number	Depth (feet)	Symbol	Classification
VQ-38	10	29-31.5	△	Clayey Sand with Gravel (SC)
VQ-38	13A	39-40	⊗	Clayey Sand with Gravel (SC)
VQ-38	13B	40-41	⊕	Clayey Sand with Gravel (SC)
VQ-39	8A	25-25.5	□	Clayey Sand (SC)
VQ-40	9A	29.5-30.5	⊗	Sandy Clay (CL/SC)
VQ-40	9B	30.5-32	⊕	Clayey Sand with Gravel (SC)

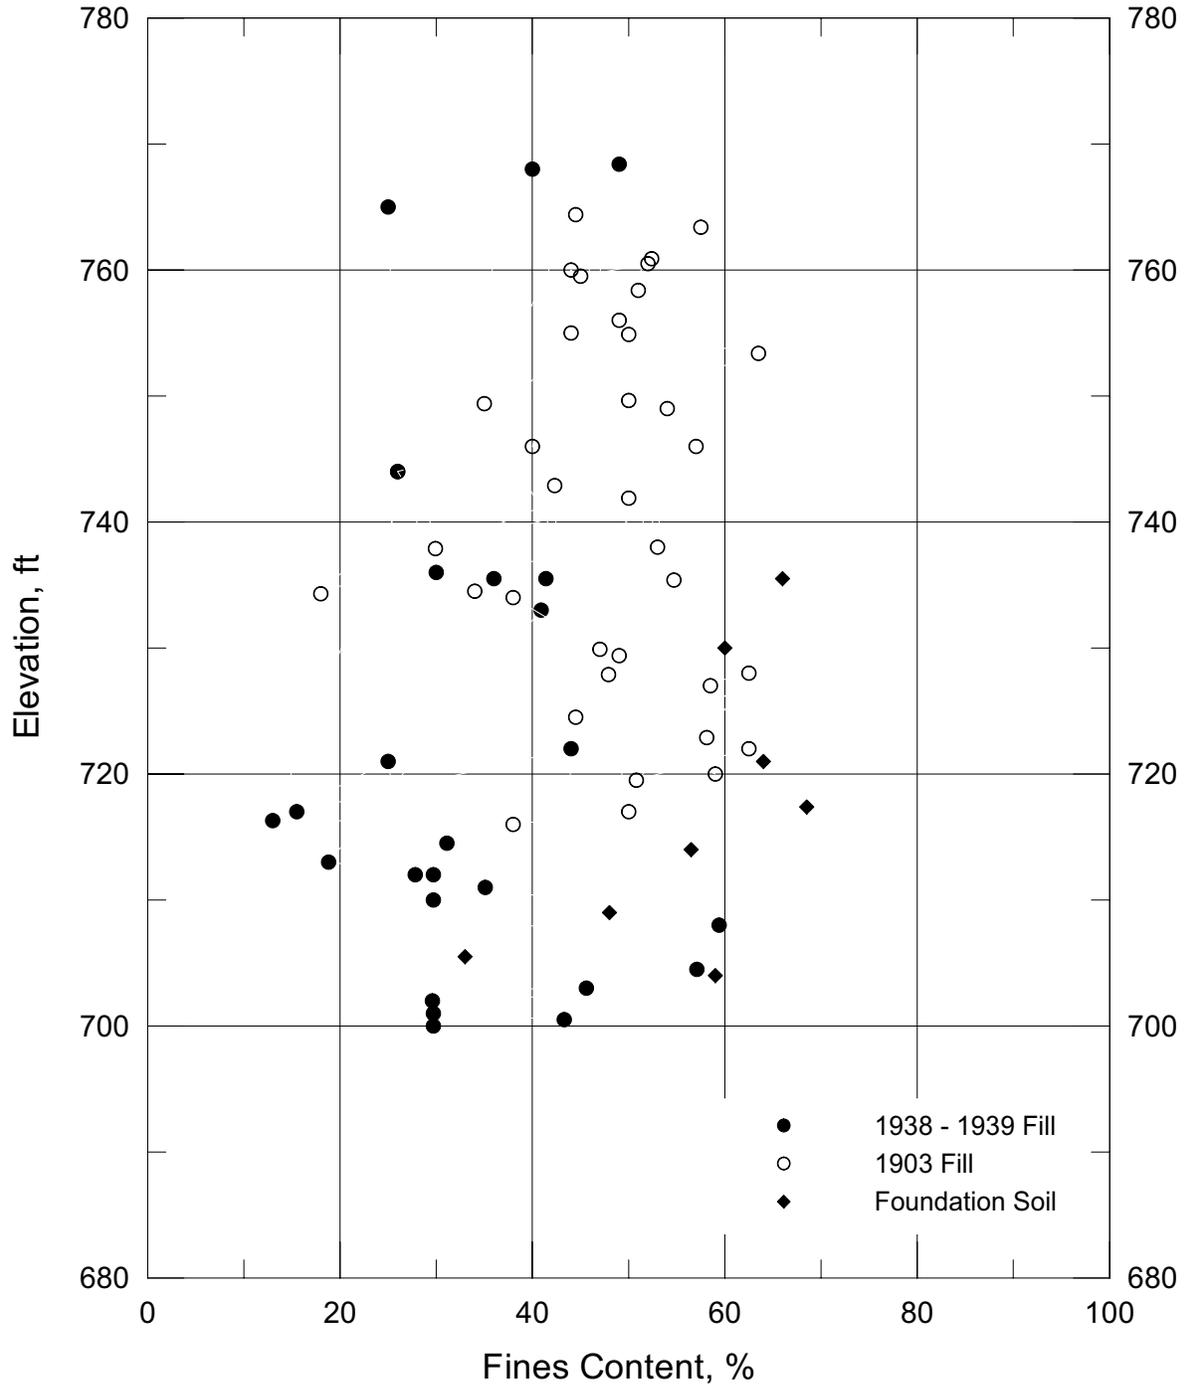
URS	Project No. 26814957	Fines Content of Embankment and Foundation Materials	Figure
	Estates Dam Seismic Stability		7-9

Estates Dam - Fines Content

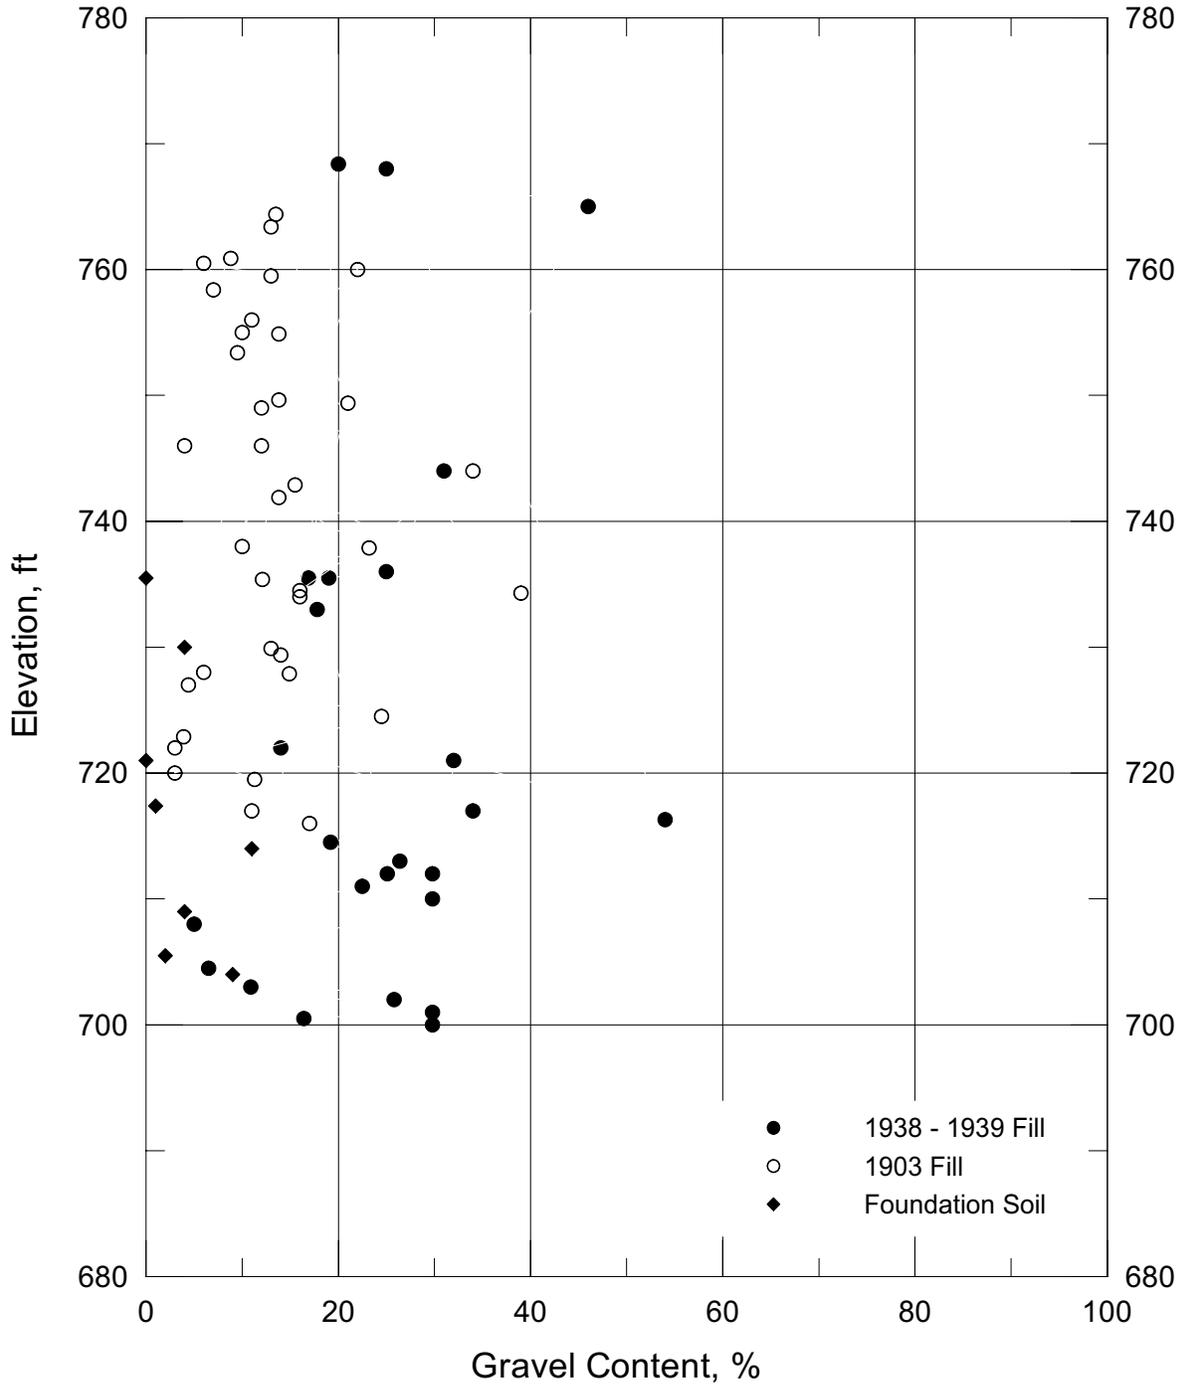
URS	Project No. 26814957	Gravel Content of Embankment and Foundation Materials	Figure
	Estates Dam Seismic Stability		7-10

Estates Dam - Gravel Content

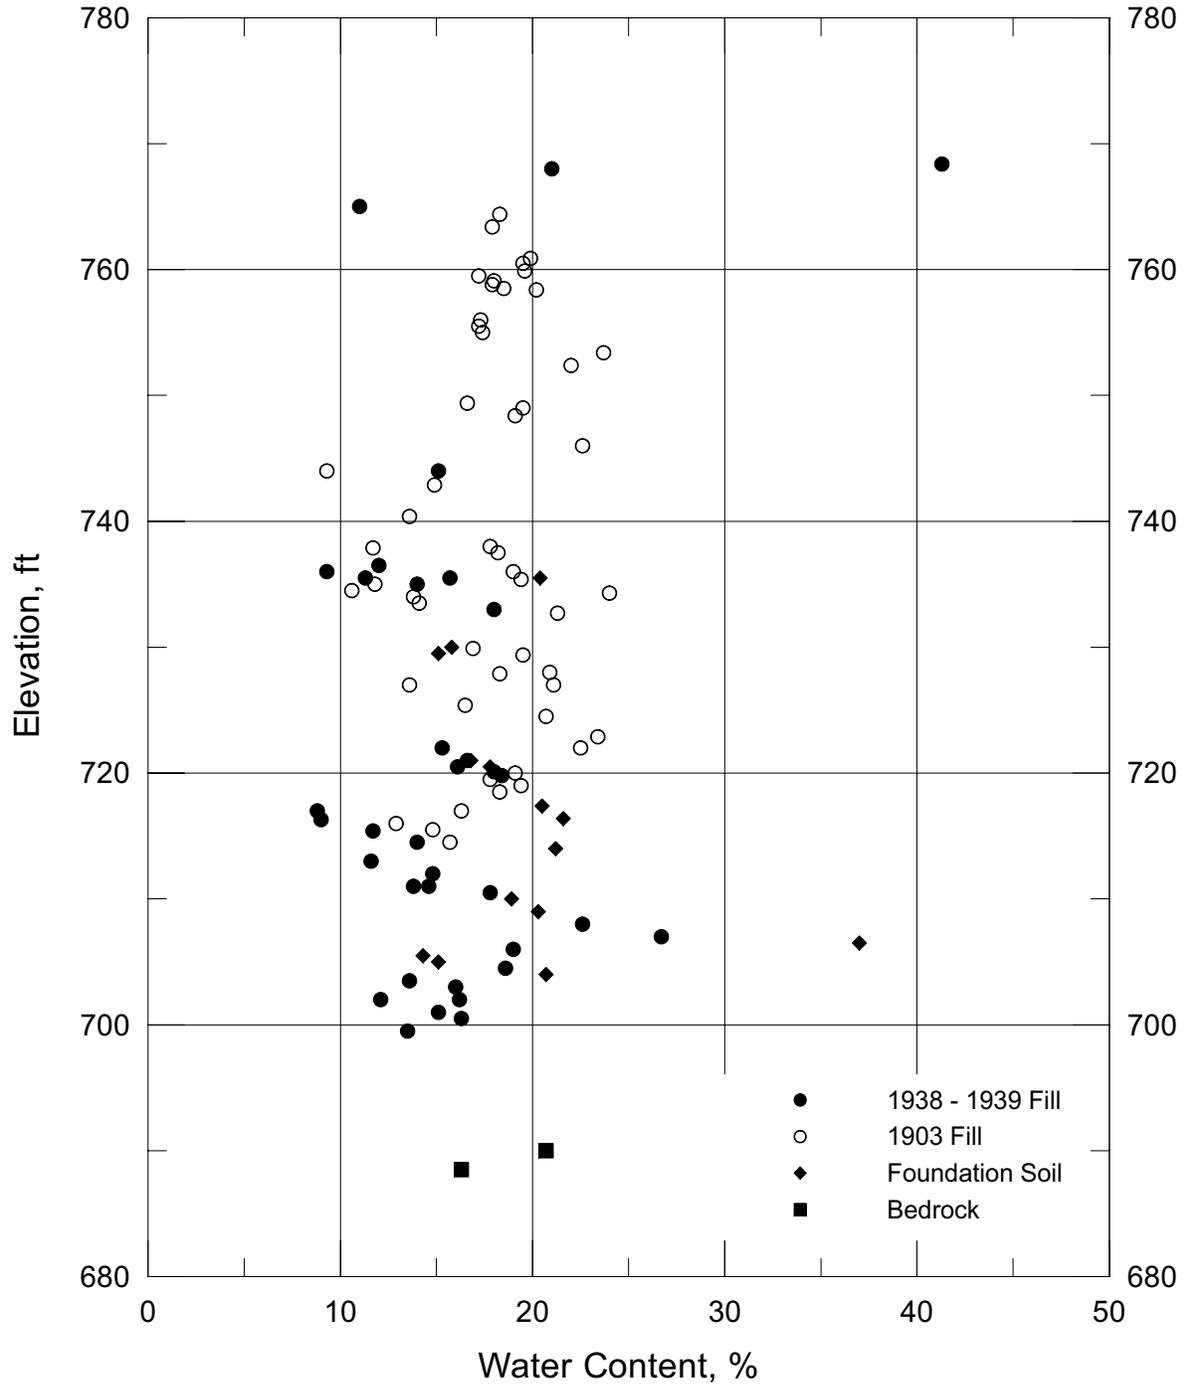
URS	Project No. 26814957	Water Content of Embankment and Foundation Materials	Figure
	Estates Dam Seismic Stability		7-12

Estates Dam - Water content

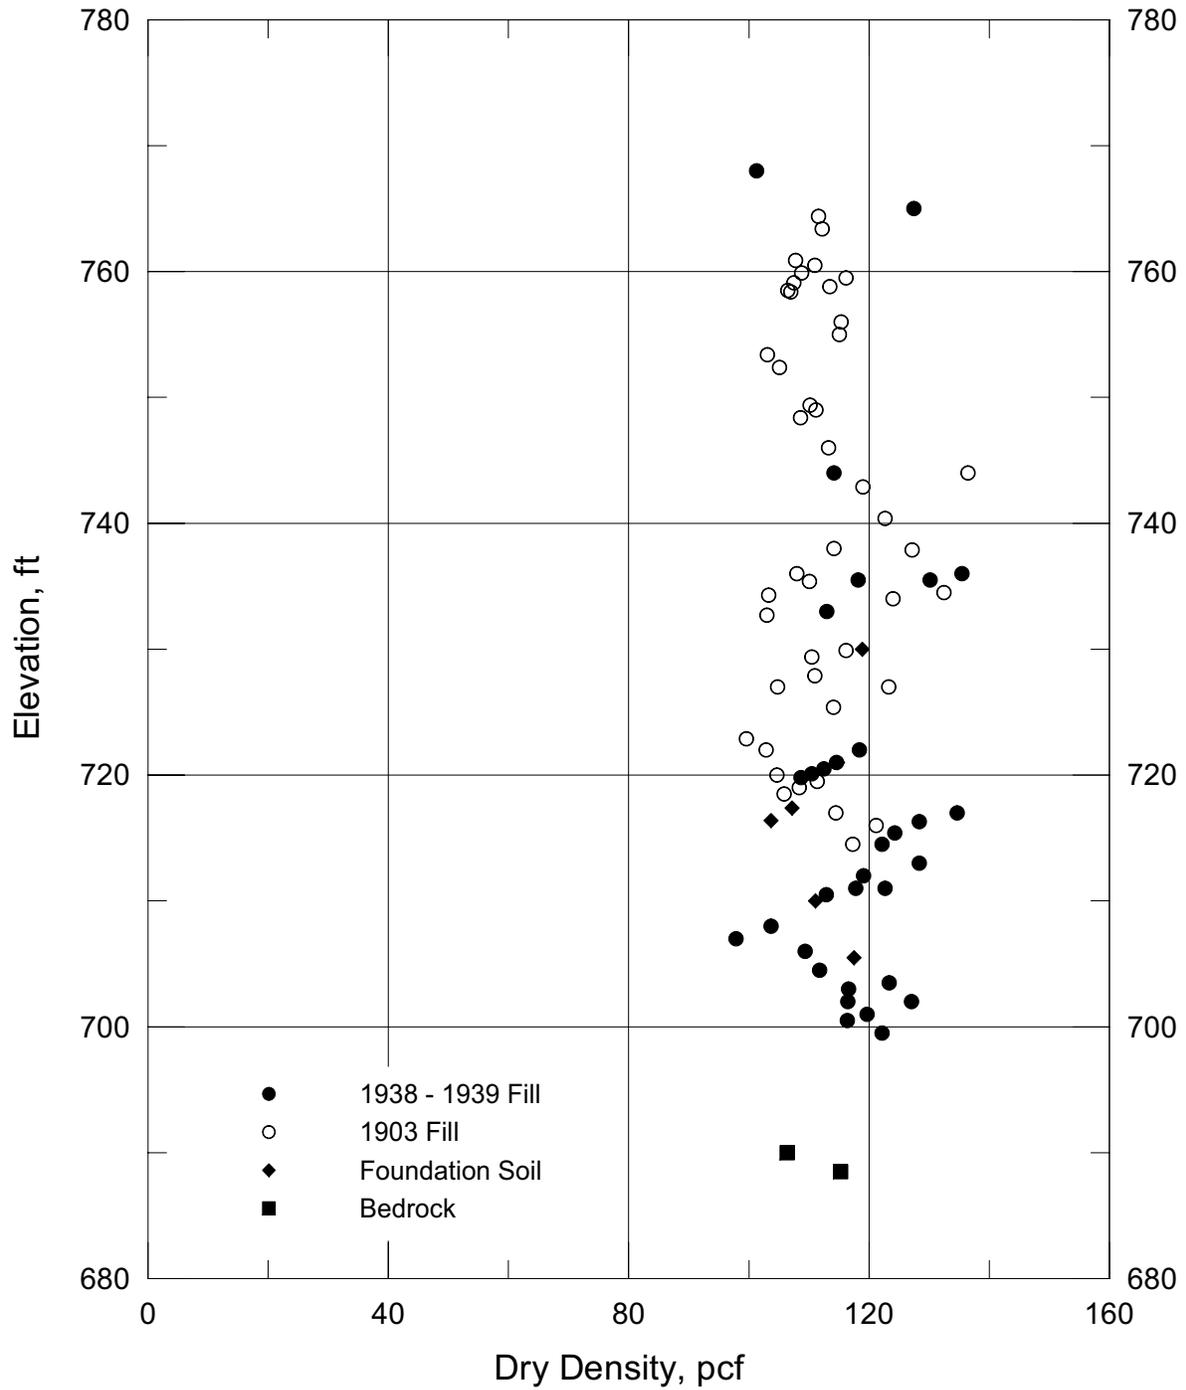
URS	Project No. 26814957	Dry Density of Embankment and Foundation Materials	Figure
	Estates Dam Seismic Stability		7-13

Estates Dam - Dry Density

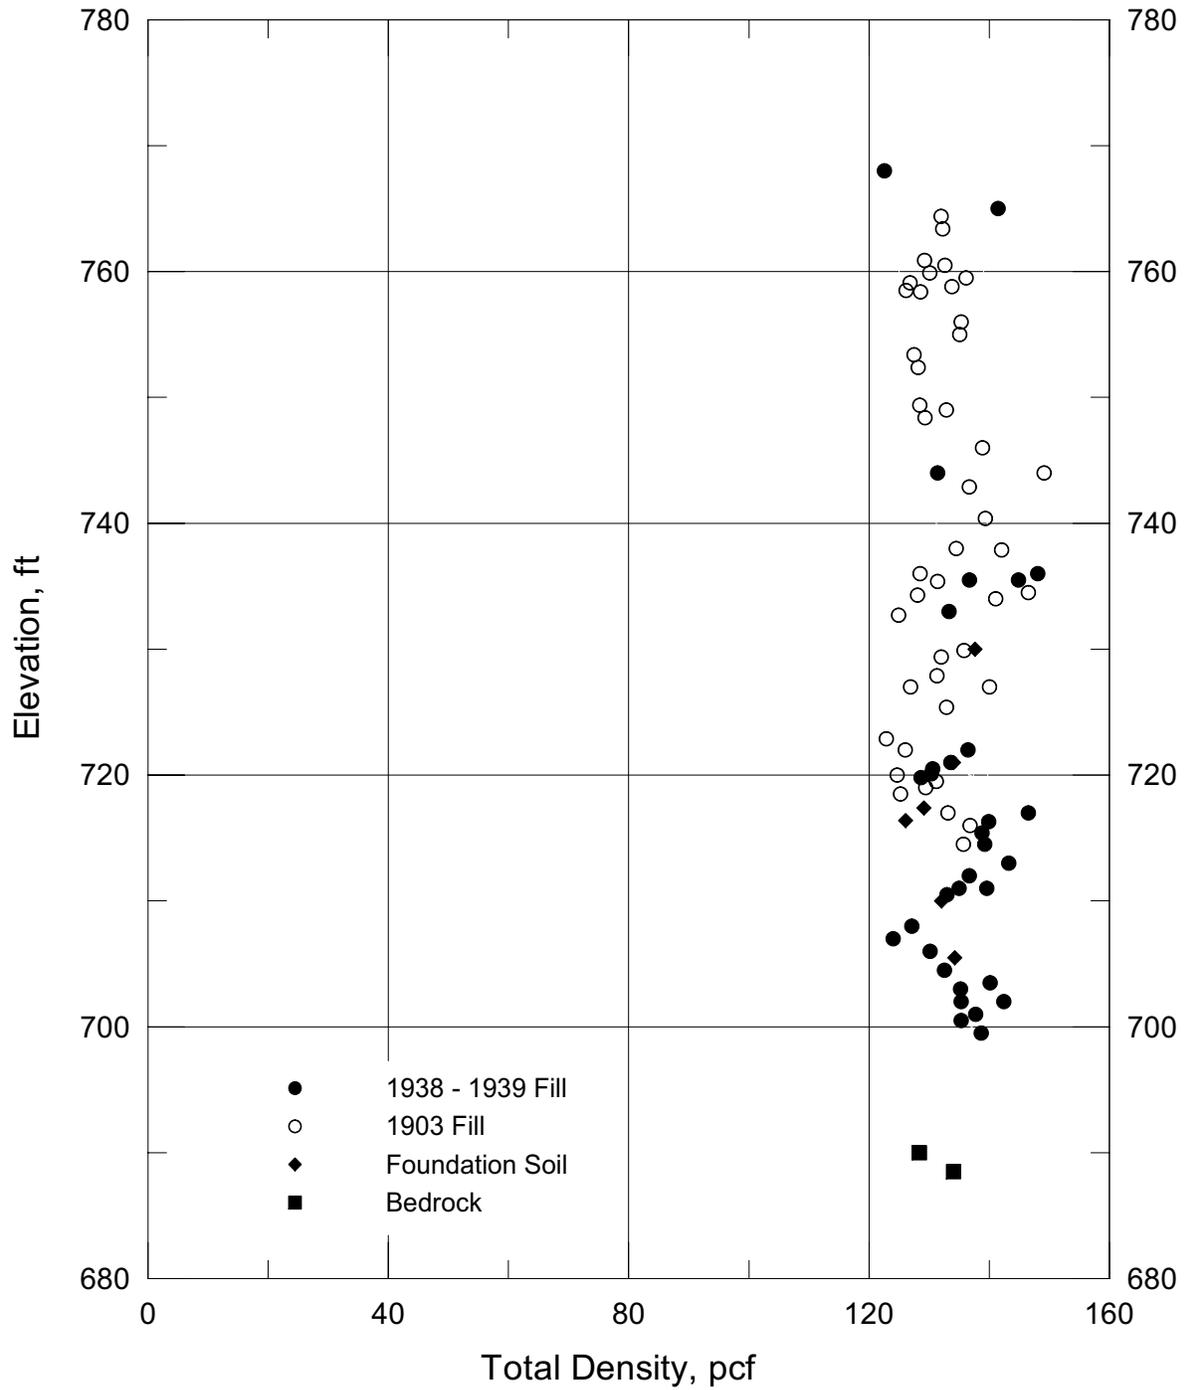
URS	Project No. 26814957	Total Density of Embankment and Foundation Materials	Figure
	Estates Dam Seismic Stability		7-14

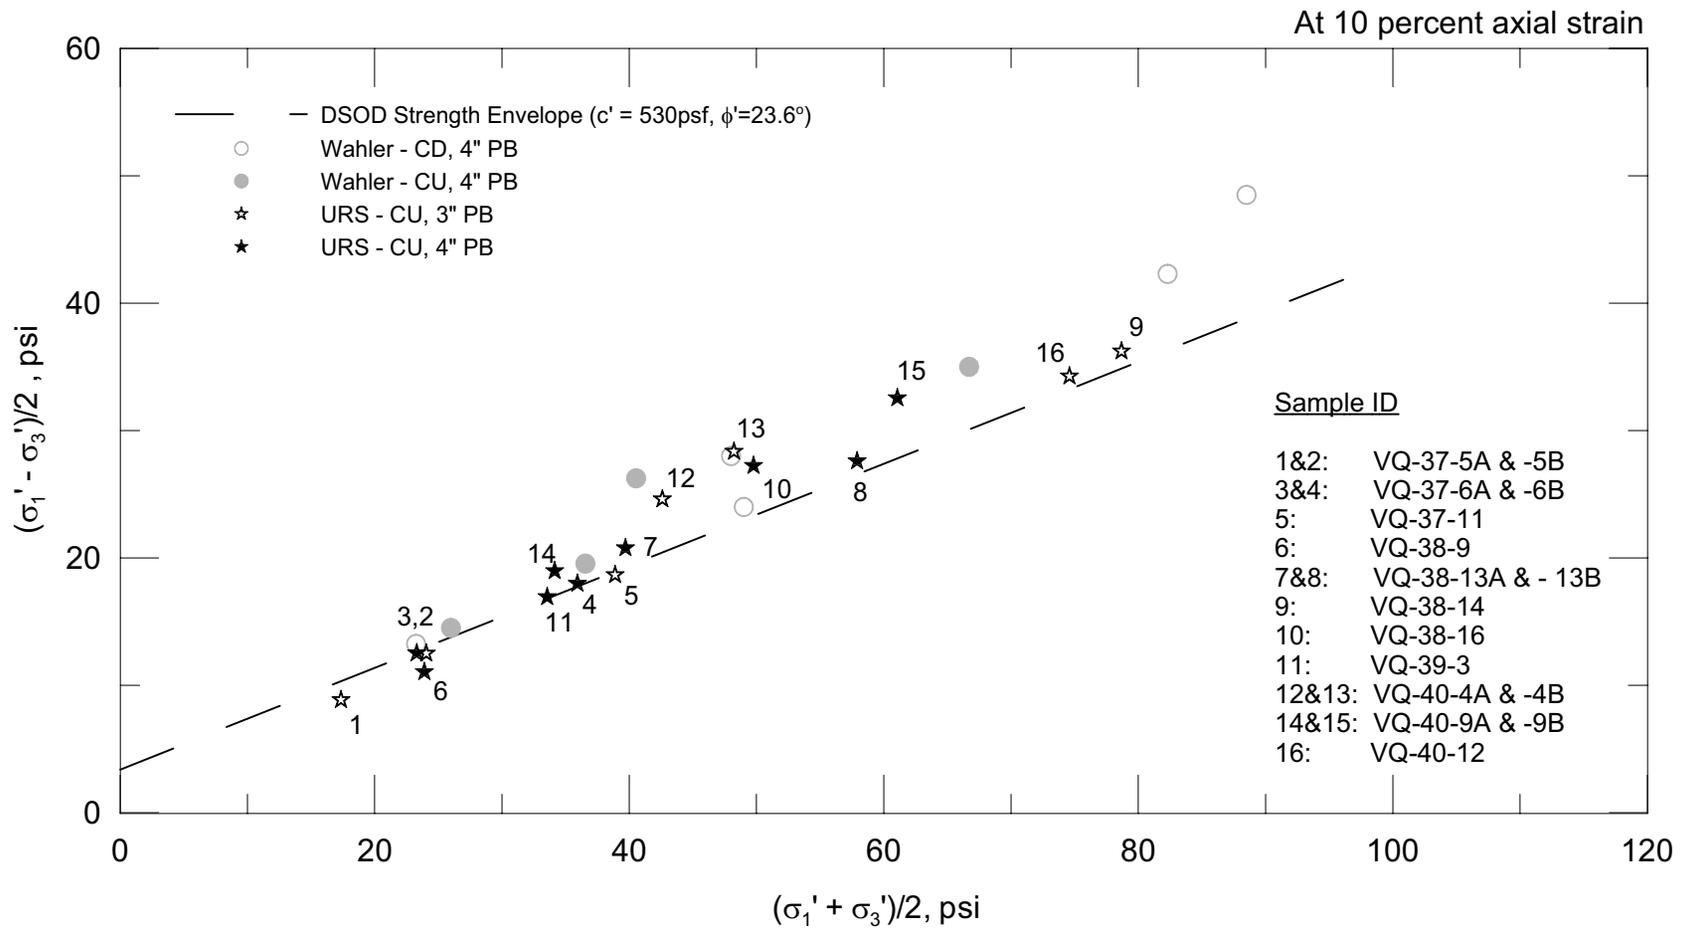
Project No. 26814957	Estates Dam Seismic Stability	Effective Stress Strength Data from Current and Previous Investigations	Figure
URS			7-15

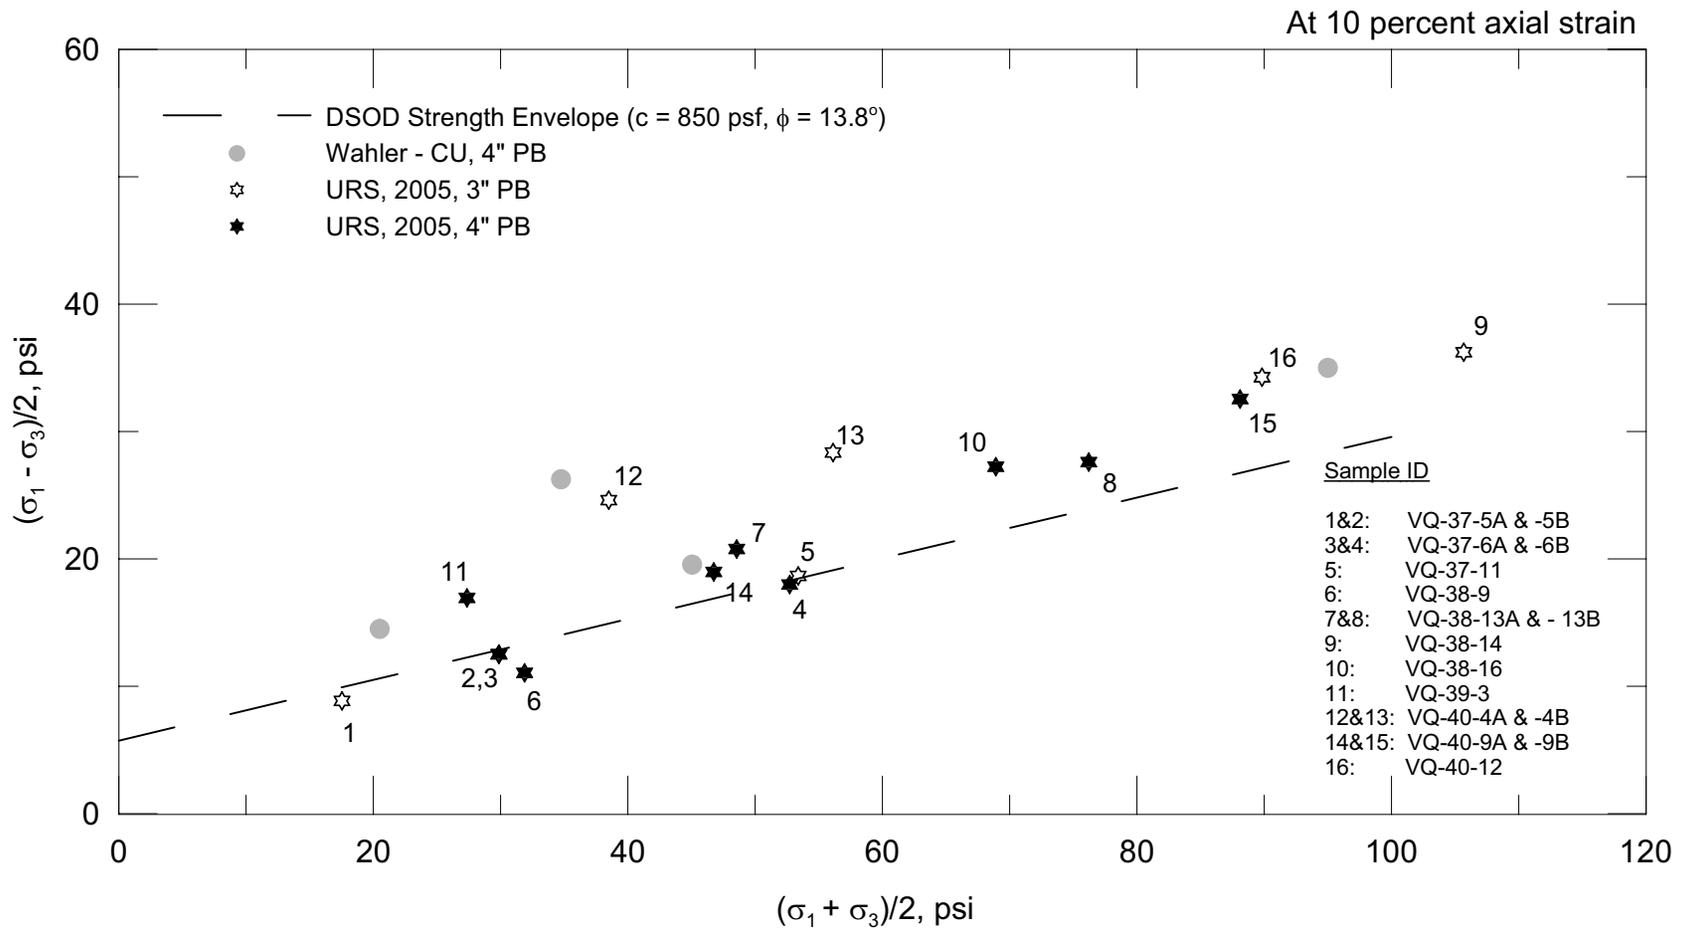
Project No. 26814957	Estates Dam Seismic Stability	Total Stress Strength Data from Current and Previous Investigations	Figure 7-16
URS

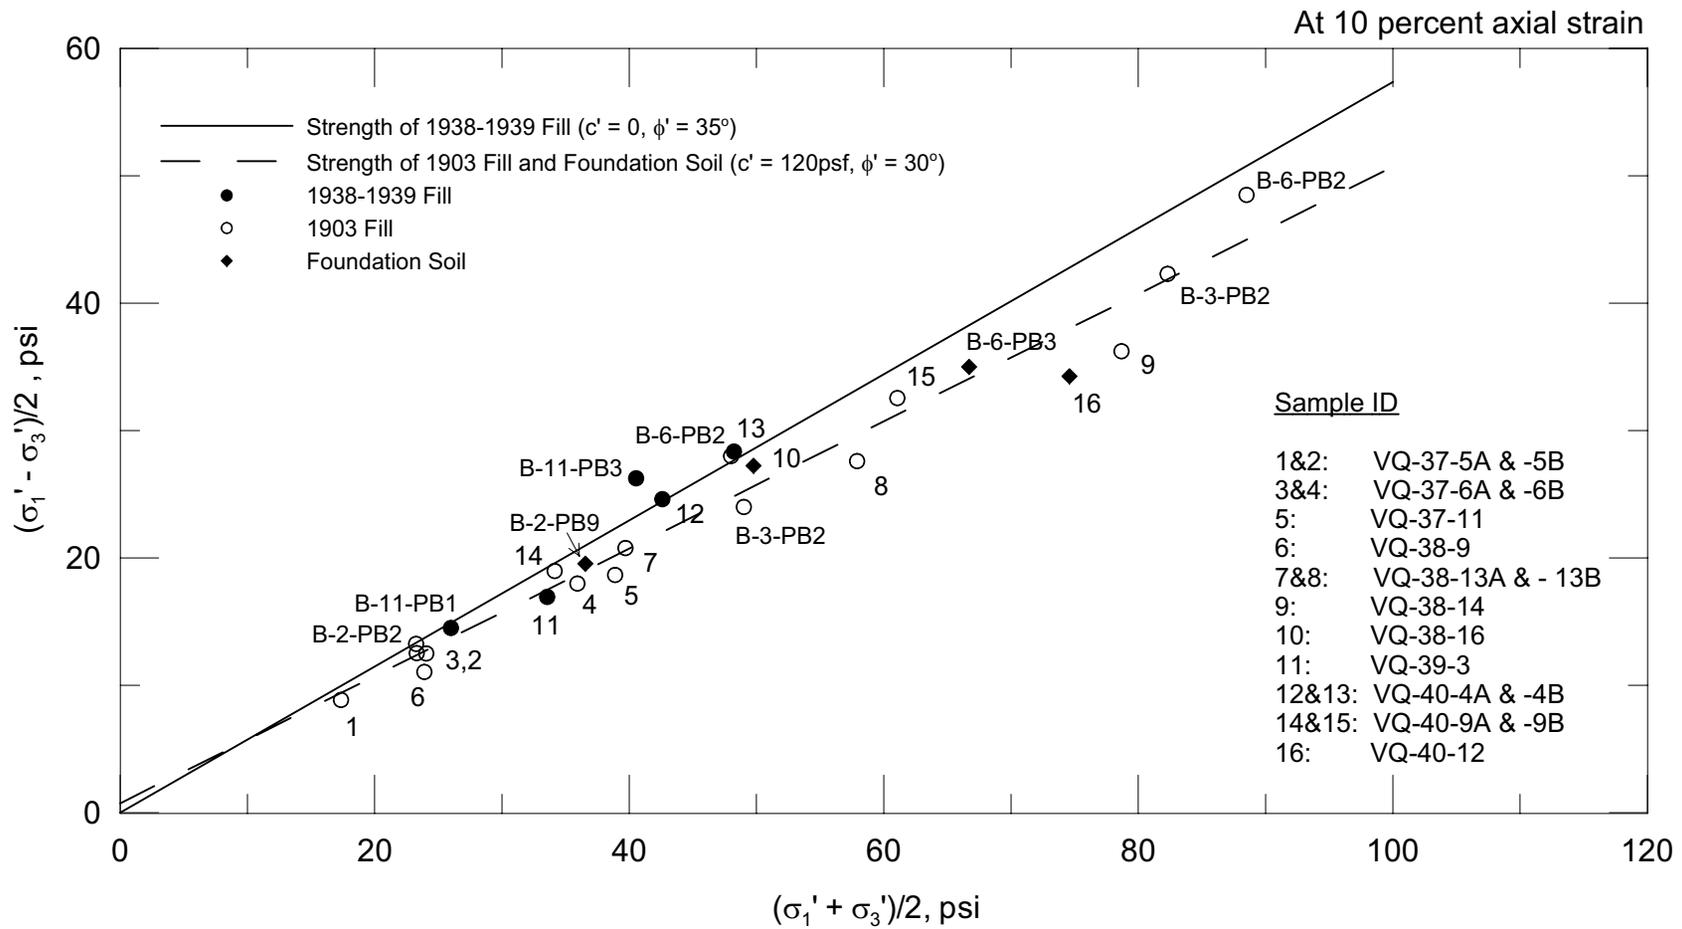
Project No. 26814957	Estates Dam Seismic Stability	Effective Stress Strength of Embankment and Foundation Materials	Figure
URS			7-17
