FINAL REPORT

Dynamic Stability Analysis of Estates Dam

Oakland, California

NOVEMBER 2006

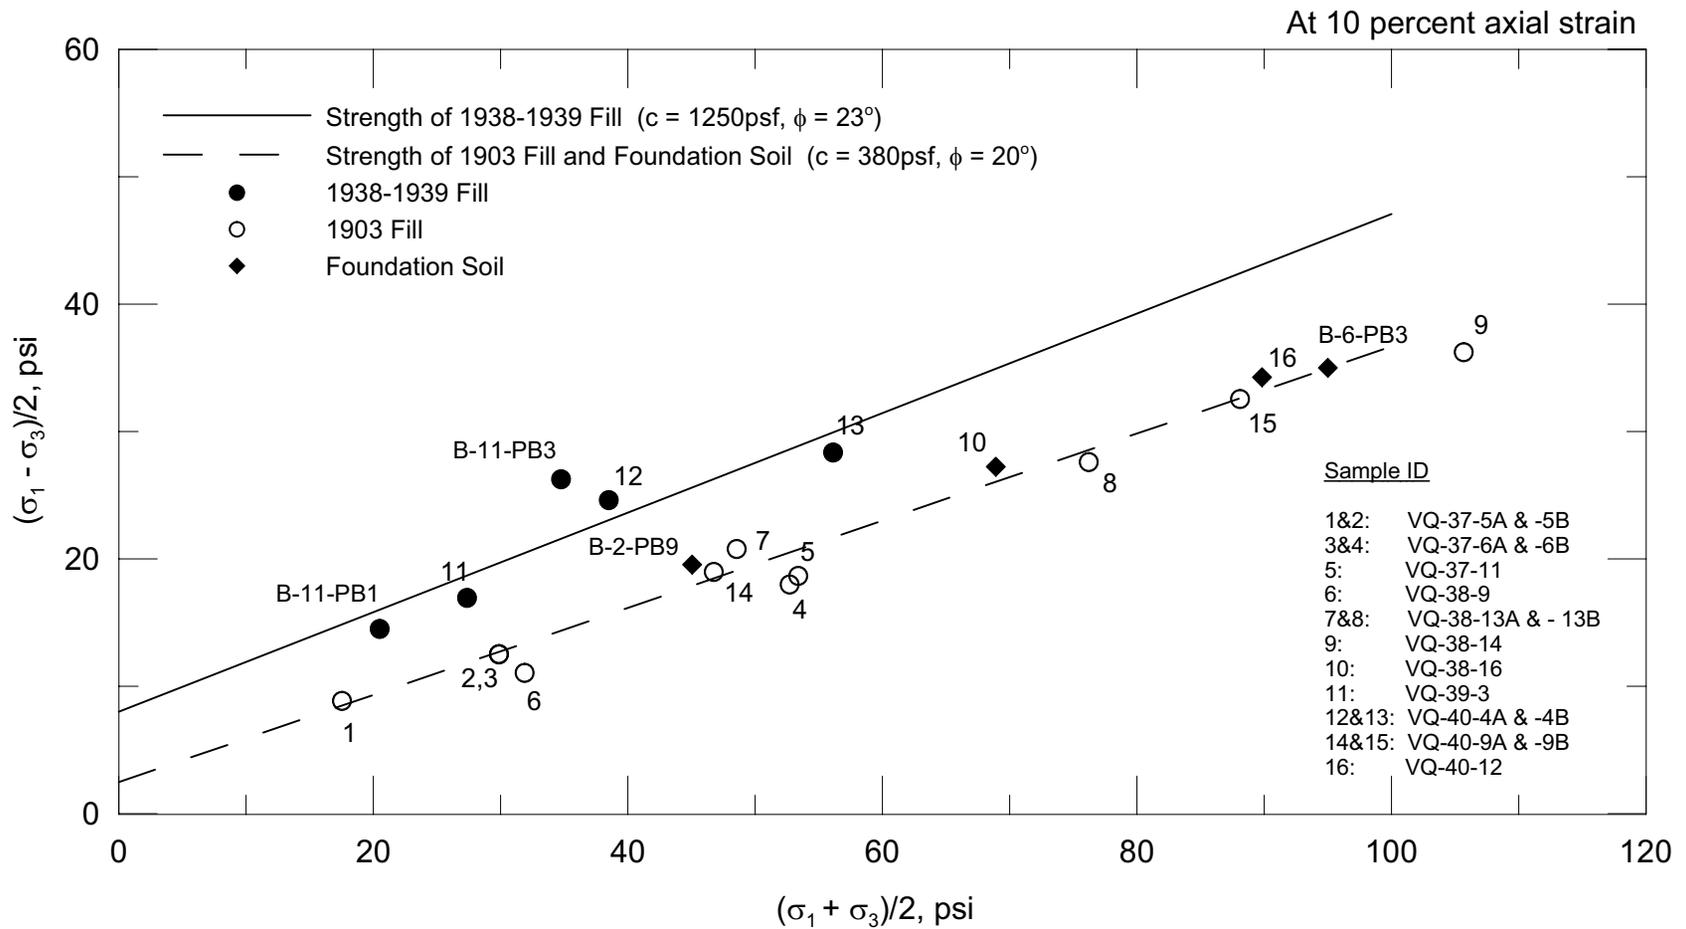
Project No. 26814957	Estates Dam Seismic Stability	Total Stress Strength of Embankment and Foundation Materials	Figure
URS			7-18

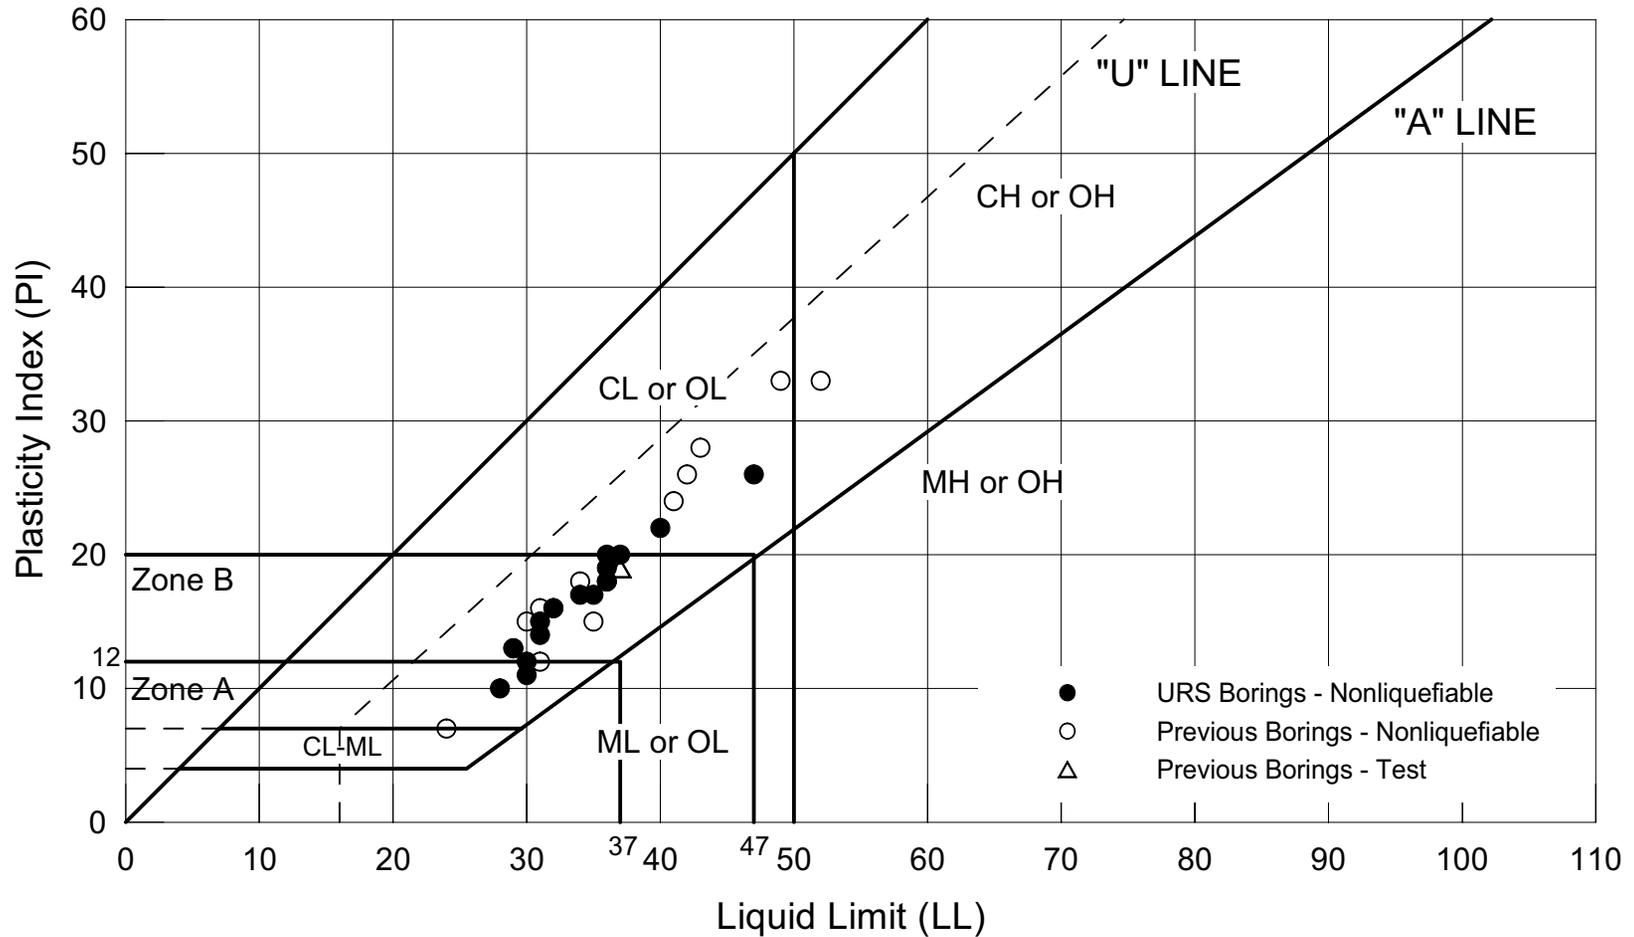
Project No. 26814957	Estates Dam Seismic Stability	Liquefaction Susceptibility Chart for Embankment and Foundation Materials	Figure 7-19
URS

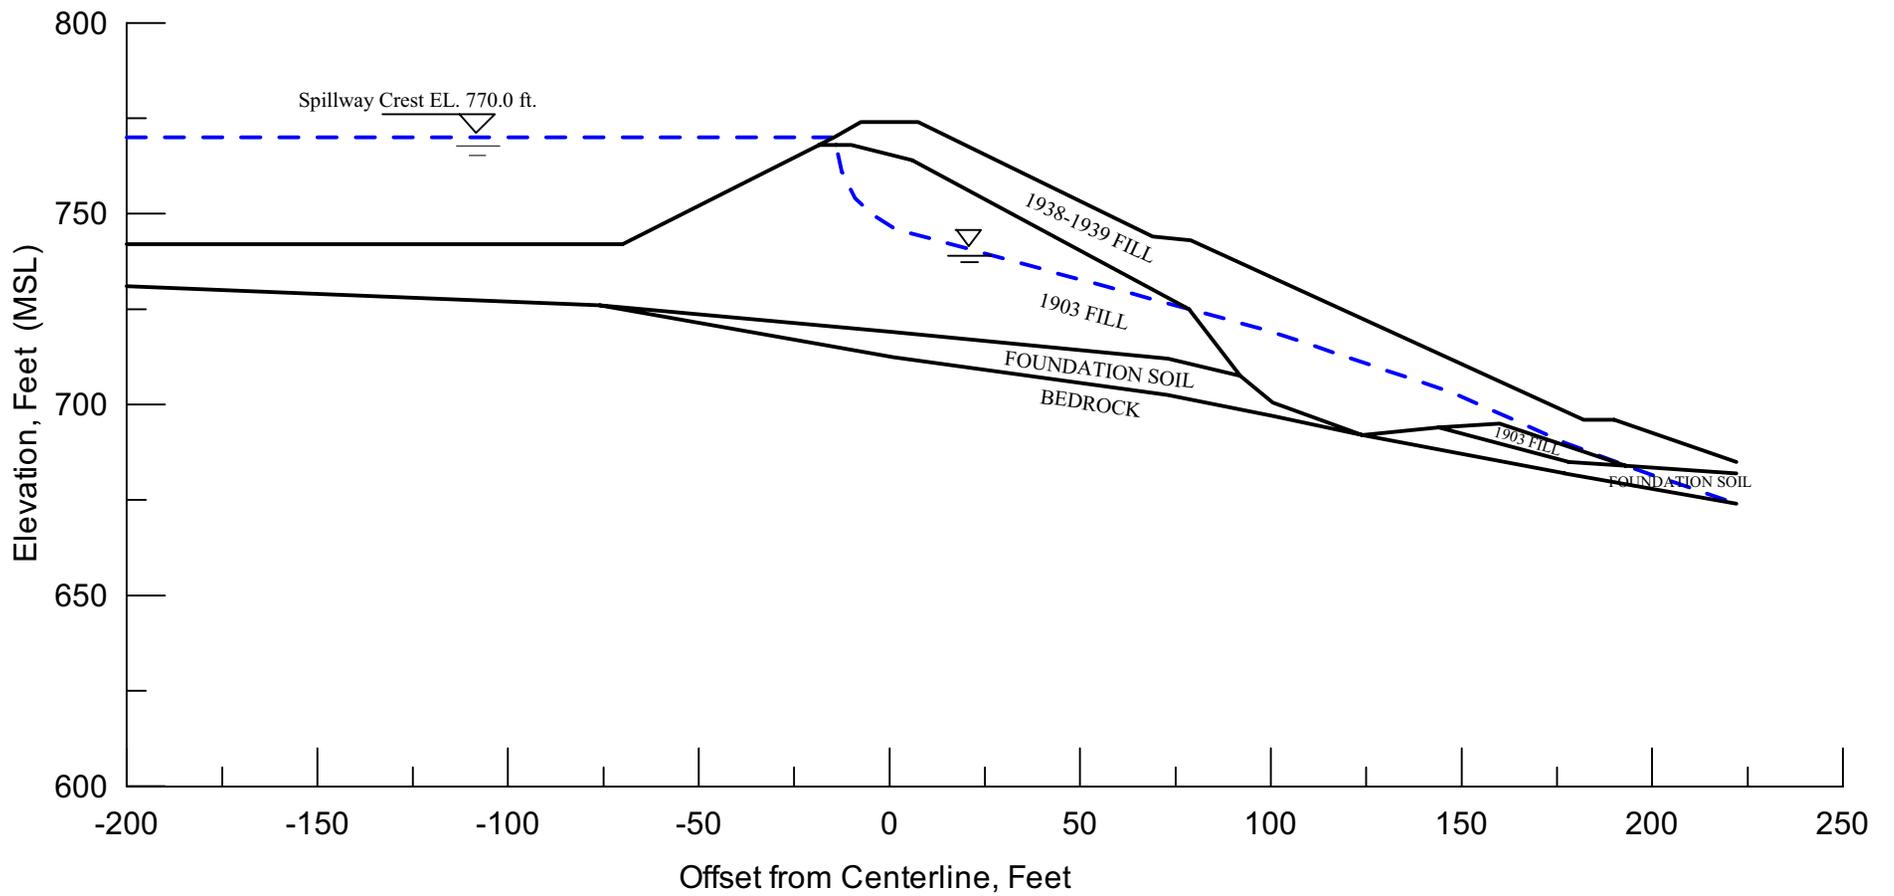
Project No. 26814957	Estates Dam Seismic Stability Analysis	Idealized Section A-A' For Slope Stability Analysis	Figure 9-2
URS

We performed analyses on the idealized cross-section labeled A-A' in Figure 9-1 and shown in Figure 9-2. It corresponds to the maximum section of the dam and was developed based on the subsurface information shown in Figure 7-3. A modified version of this section was also analyzed to consider uncertainty in the geometry of some of the dam zones. The modified section A-A' is shown in Figure 9-3. The modification reflects uncertainty in the extent of the 1938-39 fill in the "boggy" area where the 1903 fill was over-excavated during the dam raise.

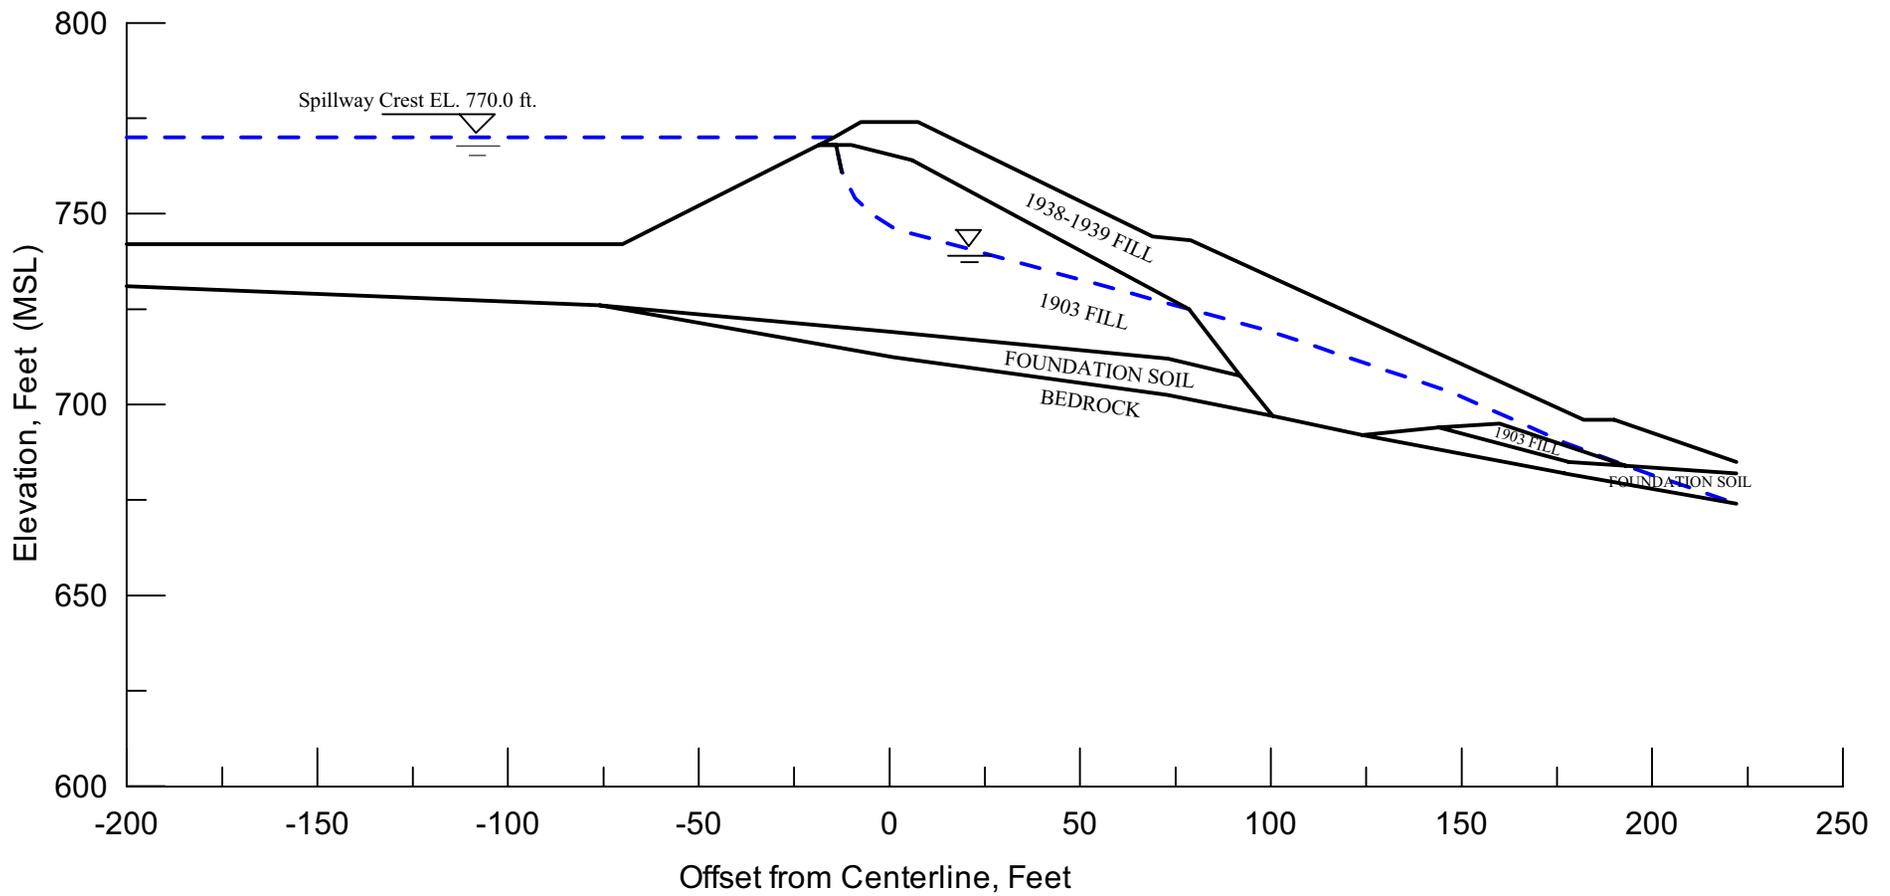
Project No. 26814957	Estates Dam Seismic Stability Analysis	Modified Section A-A' For Slope Stability Analysis	Figure
URS			9-3

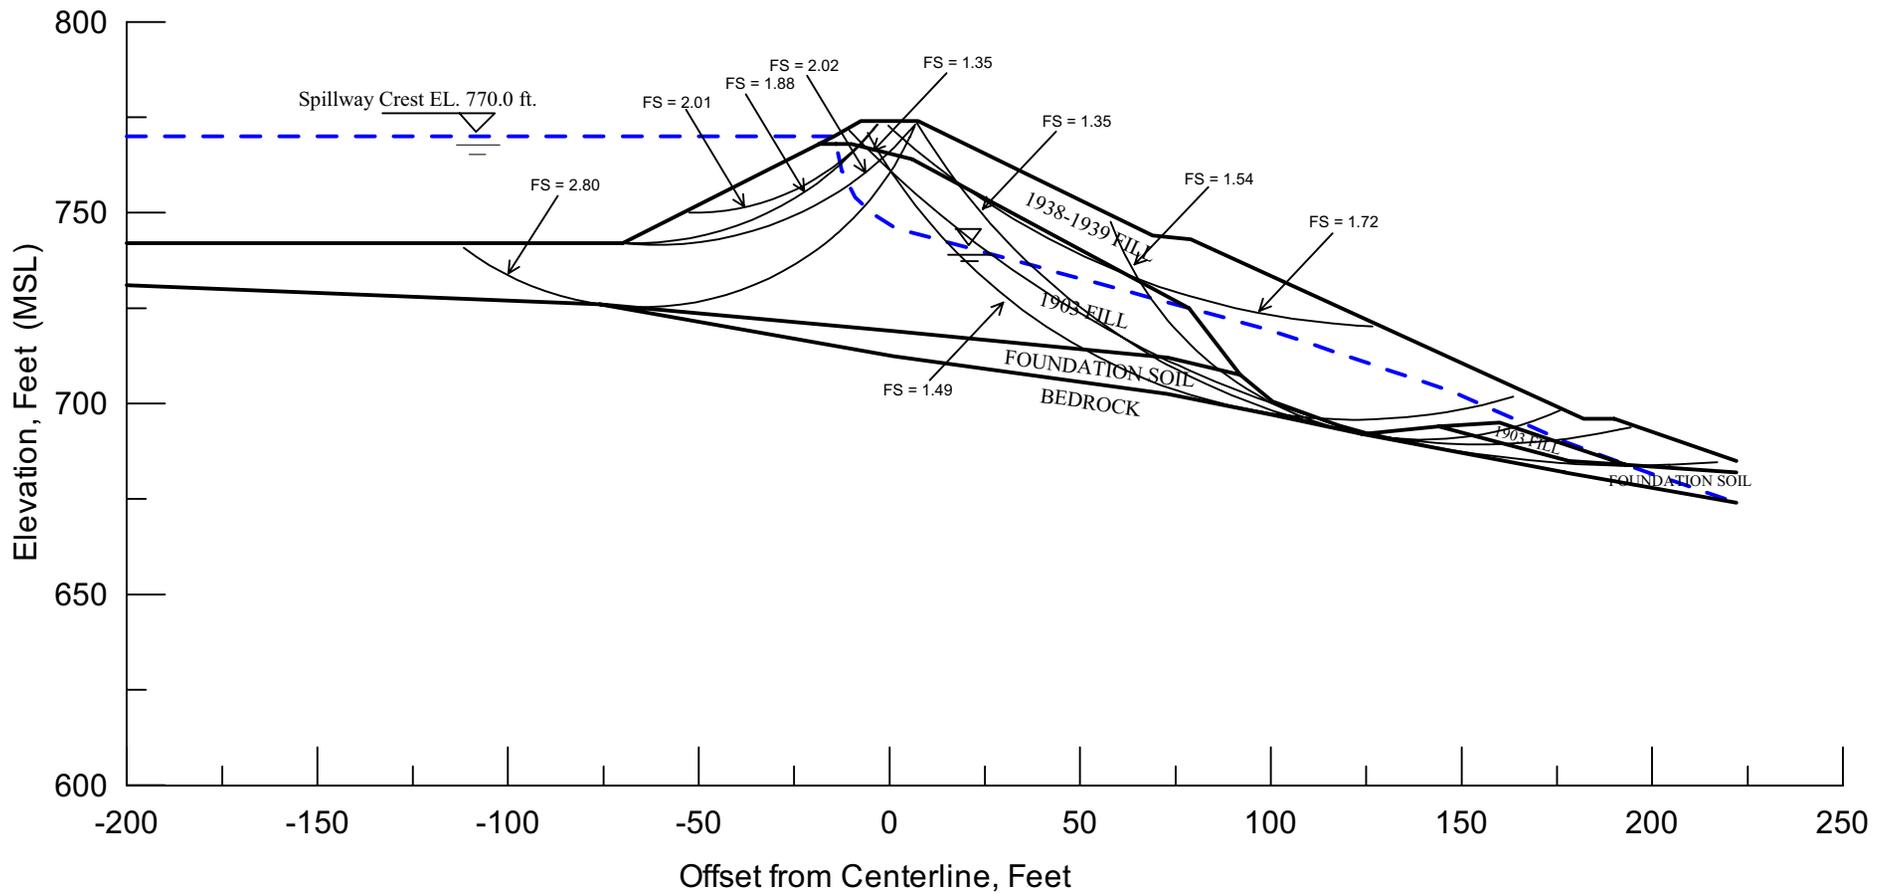
Project No. 26814957	Estates Dam Seismic Stability Analysis	Slope Stability Analysis Long-Term Condition	Figure 9-4
URS

The analysis results for sections A-A' and modified A-A' are presented in Figures 9-4 through 9-8. Under long-term static loading, the results for sections A-A' and modified A-A' are very similar. As shown in Figure 9-4, the computed factors of safety (FS) against slope instability for deep-seated sliding surfaces are about 2.8 and 1.4 for the upstream and downstream slopes,

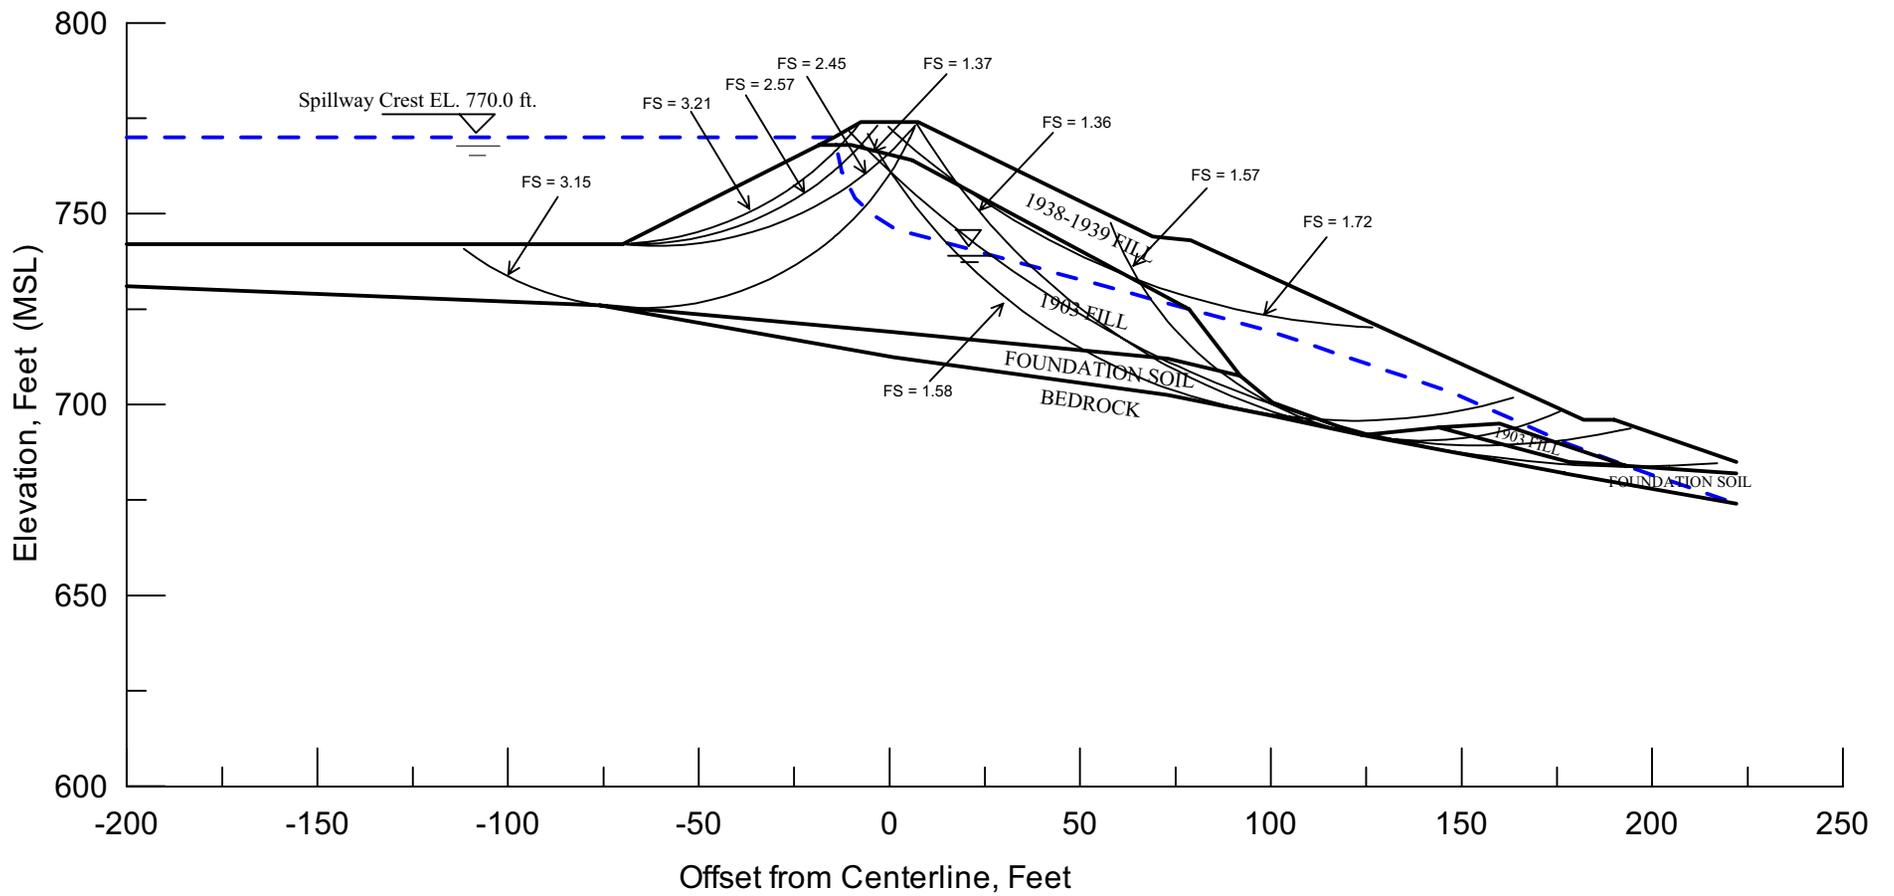
Project No. 26814957	Estates Dam Seismic Stability Analysis	Slope Stability Analysis Pre-Earthquake Condition	Figure
URS			9-5

For the pre-earthquake loading condition using undrained strengths, the computed FS values for deep-seated sliding surfaces are between 3.2 and 1.4 for the upstream and downstream slopes, respectively (Figures 9-5). For sliding surfaces passing through the crest and the upstream toe, the computed FS values are about 2.5. Under pseudo-static loading, the computed yield acceleration coefficients (K_y) for Section A-A' are equal to or greater than 0.15 for the downstream slope when pre-earthquake strengths are used (Figure 9-6). For the upstream slope, the computed pre-earthquake value of K_y for a sliding surface through the crest and the upstream toe is 0.34. For modified section A-A', the computed values of FS and K_y are slightly higher than those for Section A-A' under pre-earthquake loading (Figure 9-7). This is expected since the undrained strength of the 1938-39 fill is higher than that of the 1903 fill.

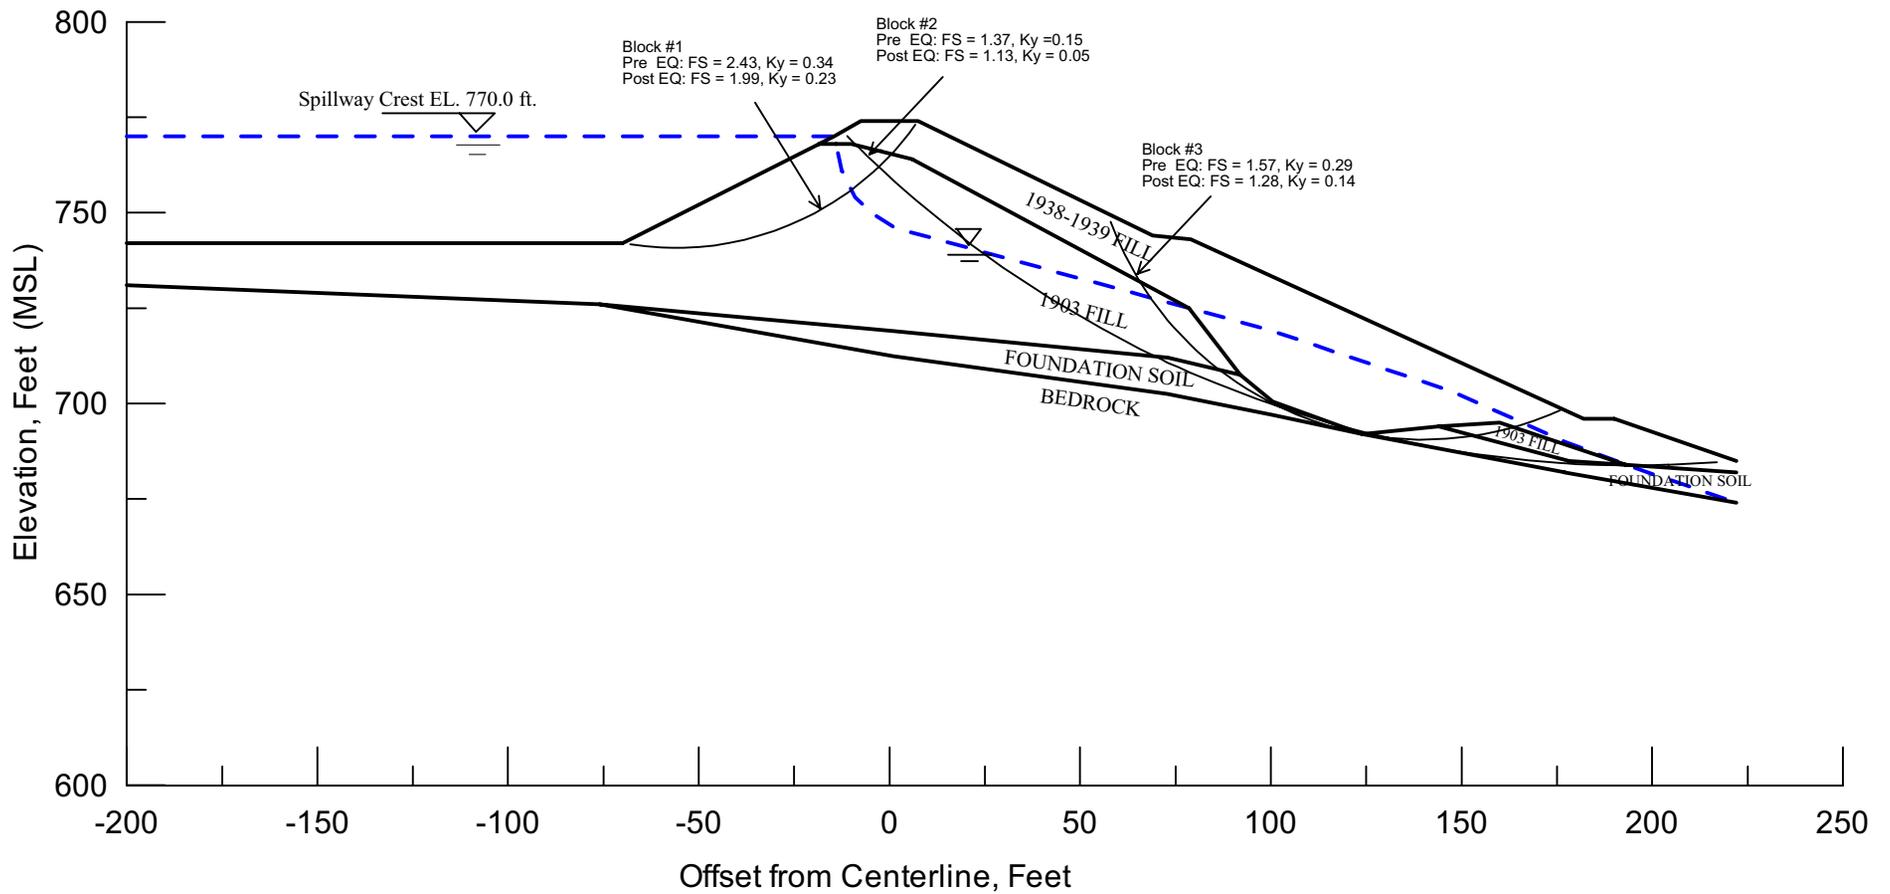
Project No. 26814957	Estates Dam Seismic Stability Analysis	Slope Stability Analysis Selected Critical Sliding Blocks Section A-A'	Figure
URS			9-6

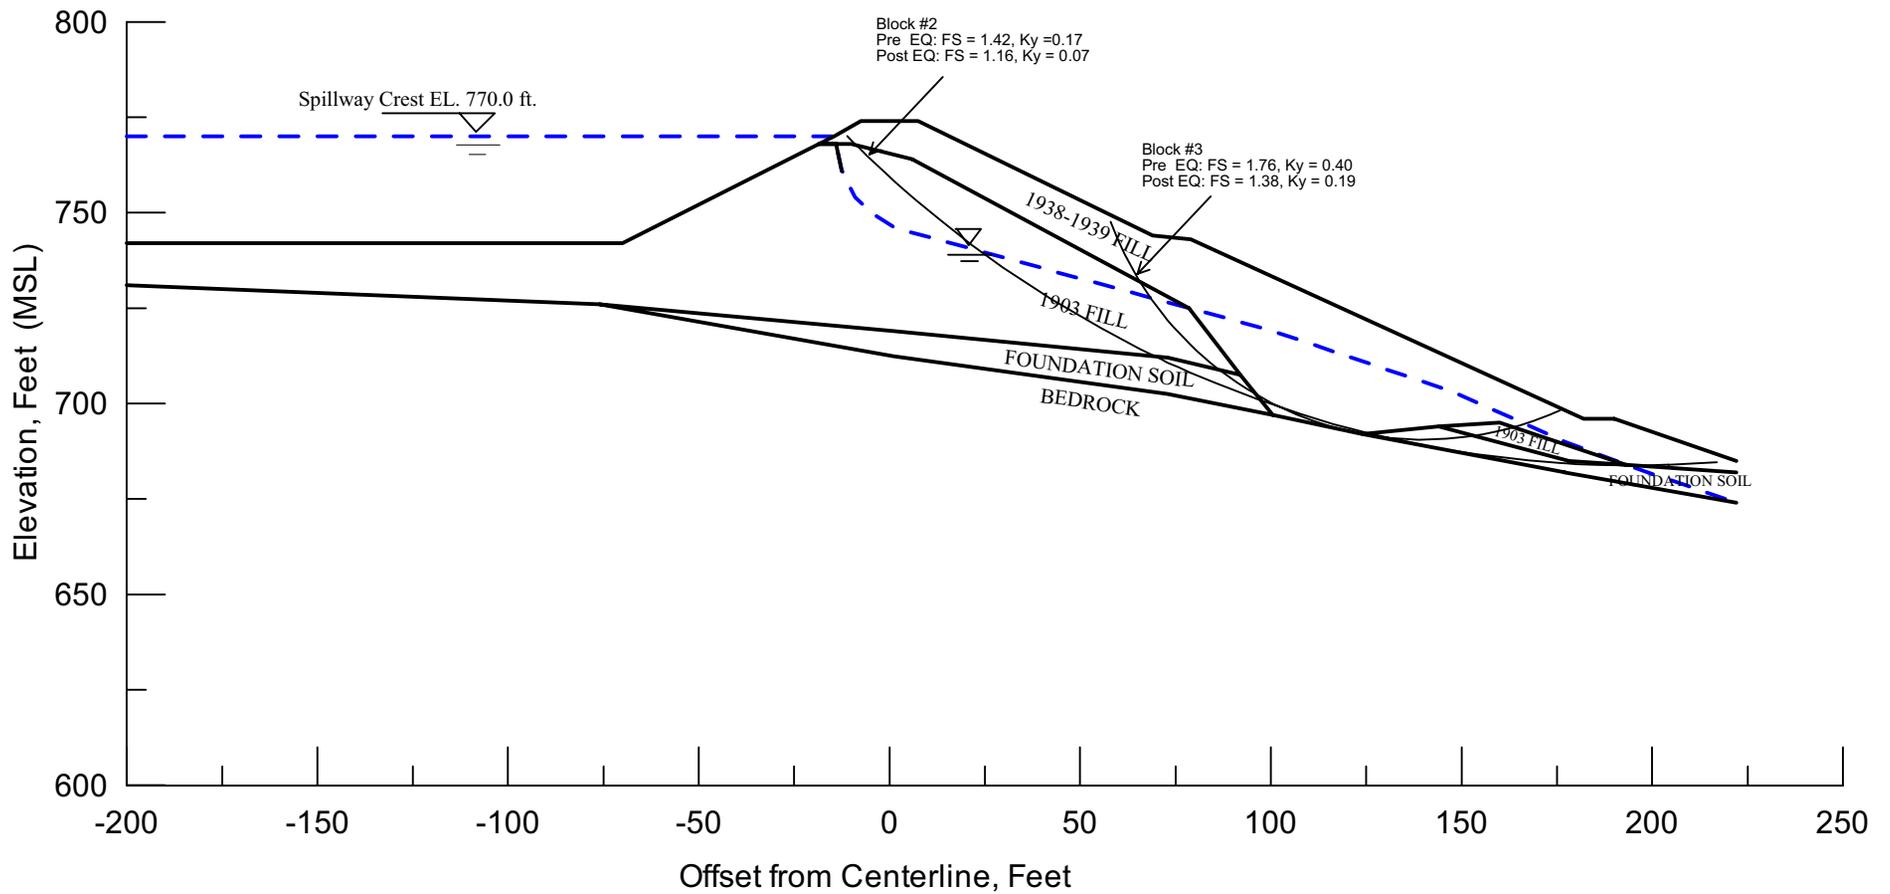
Project No. 26814957	Estates Dam Seismic Stability Analysis	Slope Stability Analysis Selected Critical Sliding Blocks Modified Section A-A'	Figure 9-7
URS

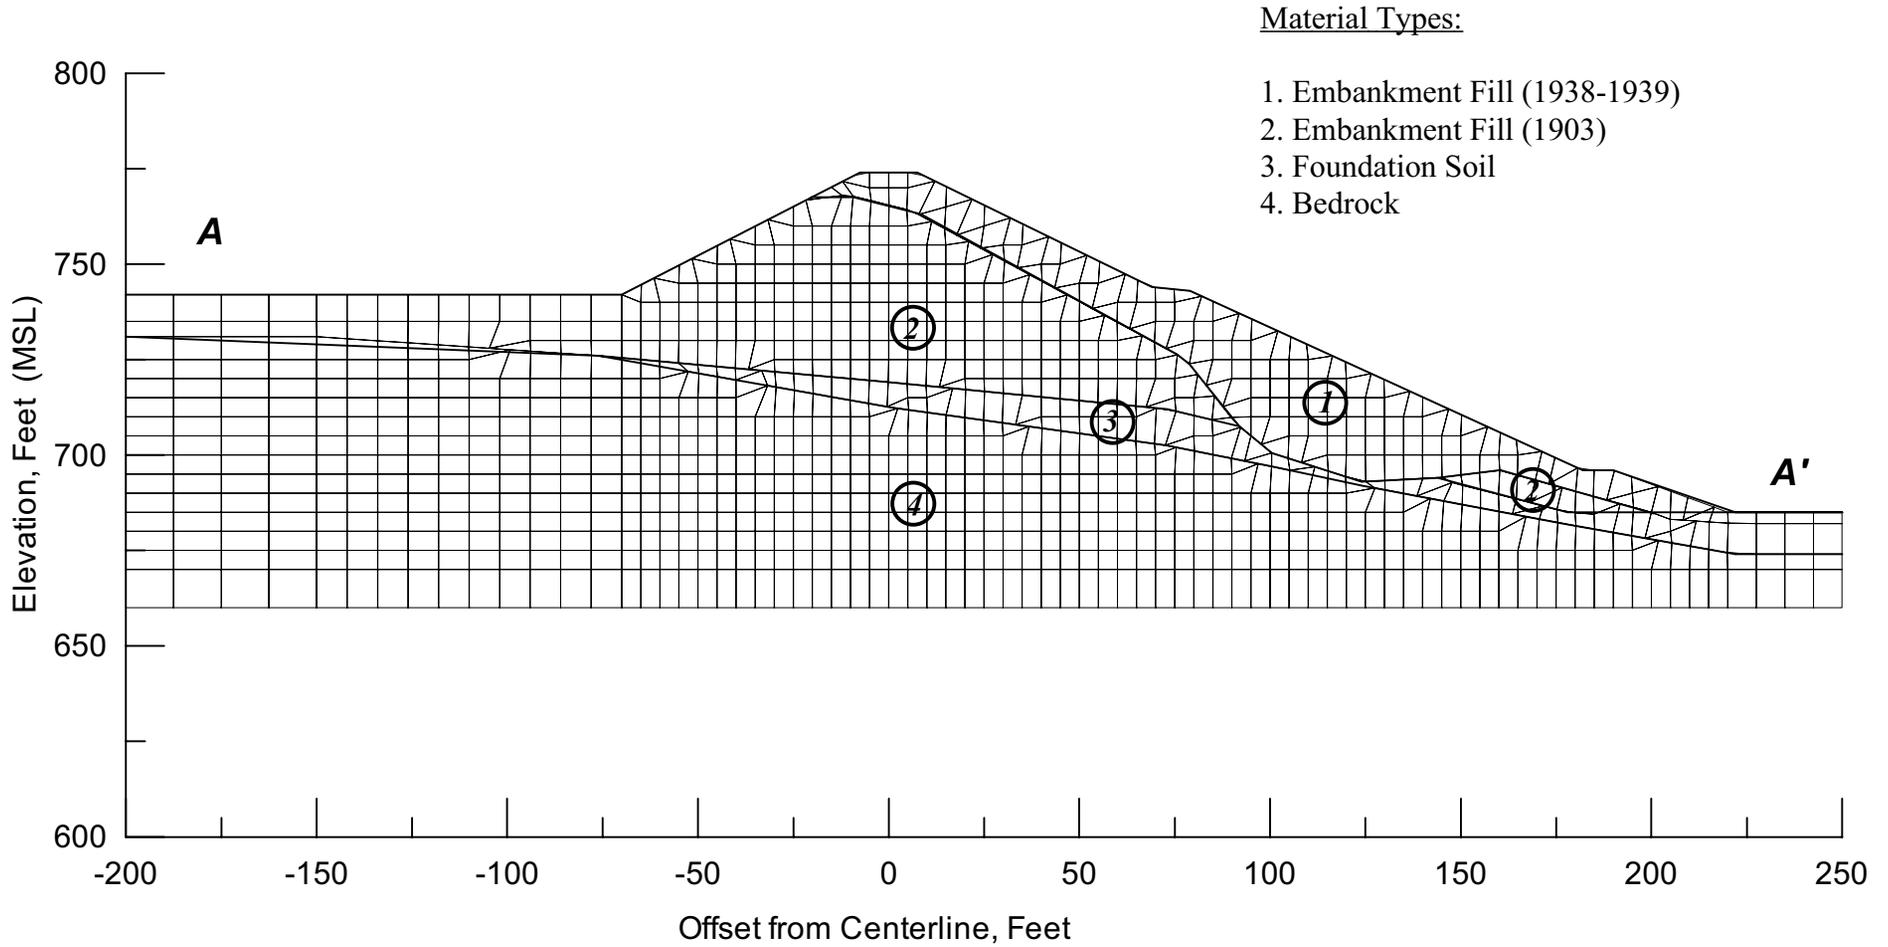
Project No. 26814957	Estates Dam Seismic Stability Analysis	Finite Element Mesh for Cross-Section A-A' QUAD4M Analysis	Figure
URS			10-1

The analyses of the dam's dynamic response in the decoupled approach are discussed in Section 10. Those analyses were performed using two-dimensional finite element procedures with the computer program QUAD4M (Hudson et al. 1994). The evaluation of pore pressures, and strength loss, and the seismic stability and deformation analyses are presented in Section 11. The timing of the development of excess pore pressures and strength degradation in the embankment fill and foundation soils were evaluated first. The degraded undrained strength of the fill and foundation soils was then used in slope stability analyses to calculate yield accelerations and post-earthquake stability. Seismically induced deformations of the dam were evaluated with Newmark-type procedures using the calculated yield accelerations and the results of the dynamic response analyses.

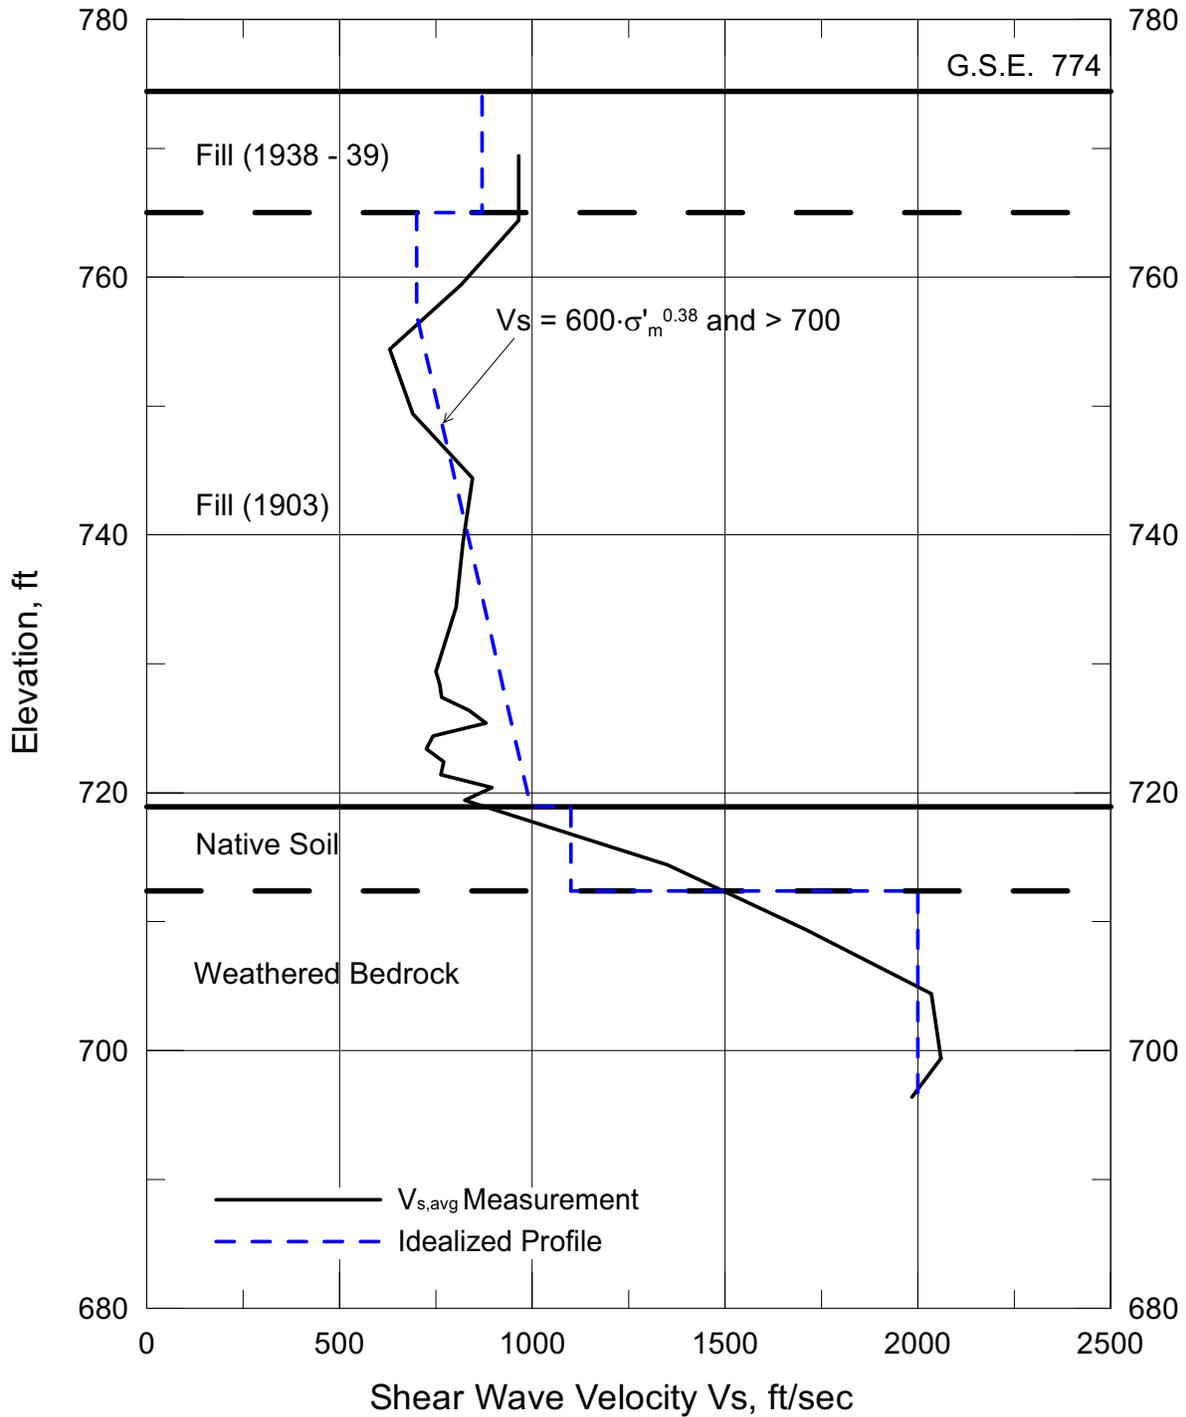
**Seismic Wave Velocity Profile and
Stratigraphy from Borings B-1, 2, and 3**

Figure 10-3 shows the seismic wave velocities measured in the 1980 Wahler investigations, along with the stratigraphy at the locations of borings B-1, 2 and 3. Down-hole geophysical surveys were performed in borings VQ-38 and 40 drilled for this investigation. The measured seismic wave velocities are shown in Figures 10-4 and 10-5. The figures also show the values of Poisson's ratio calculated from the measured shear and compression velocities (V_s and V_p) using the following equation:

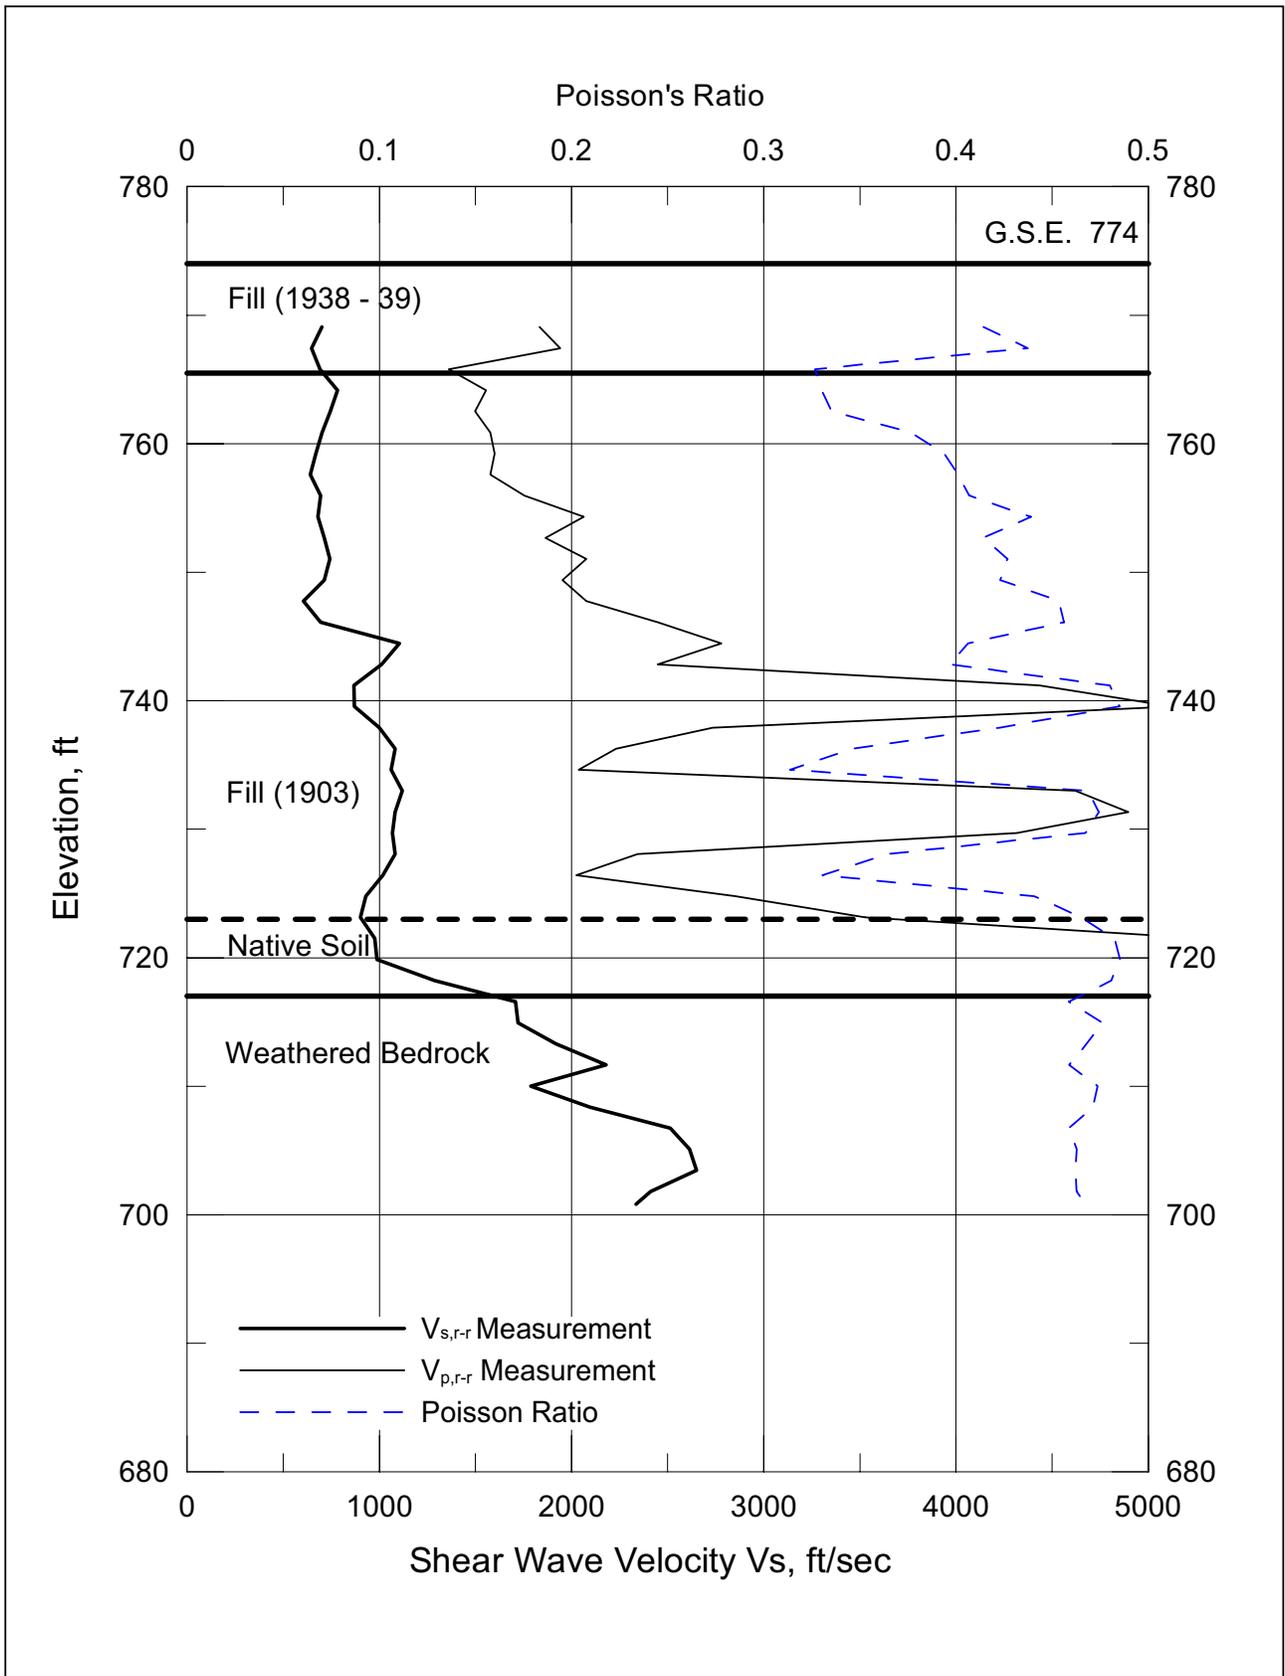
URS	Project No. 26814957	Seismic Wave Velocity Profile and Stratigraphy from Boring VQ-38	Figure
	Estates Dam Seismic Stability		10-4

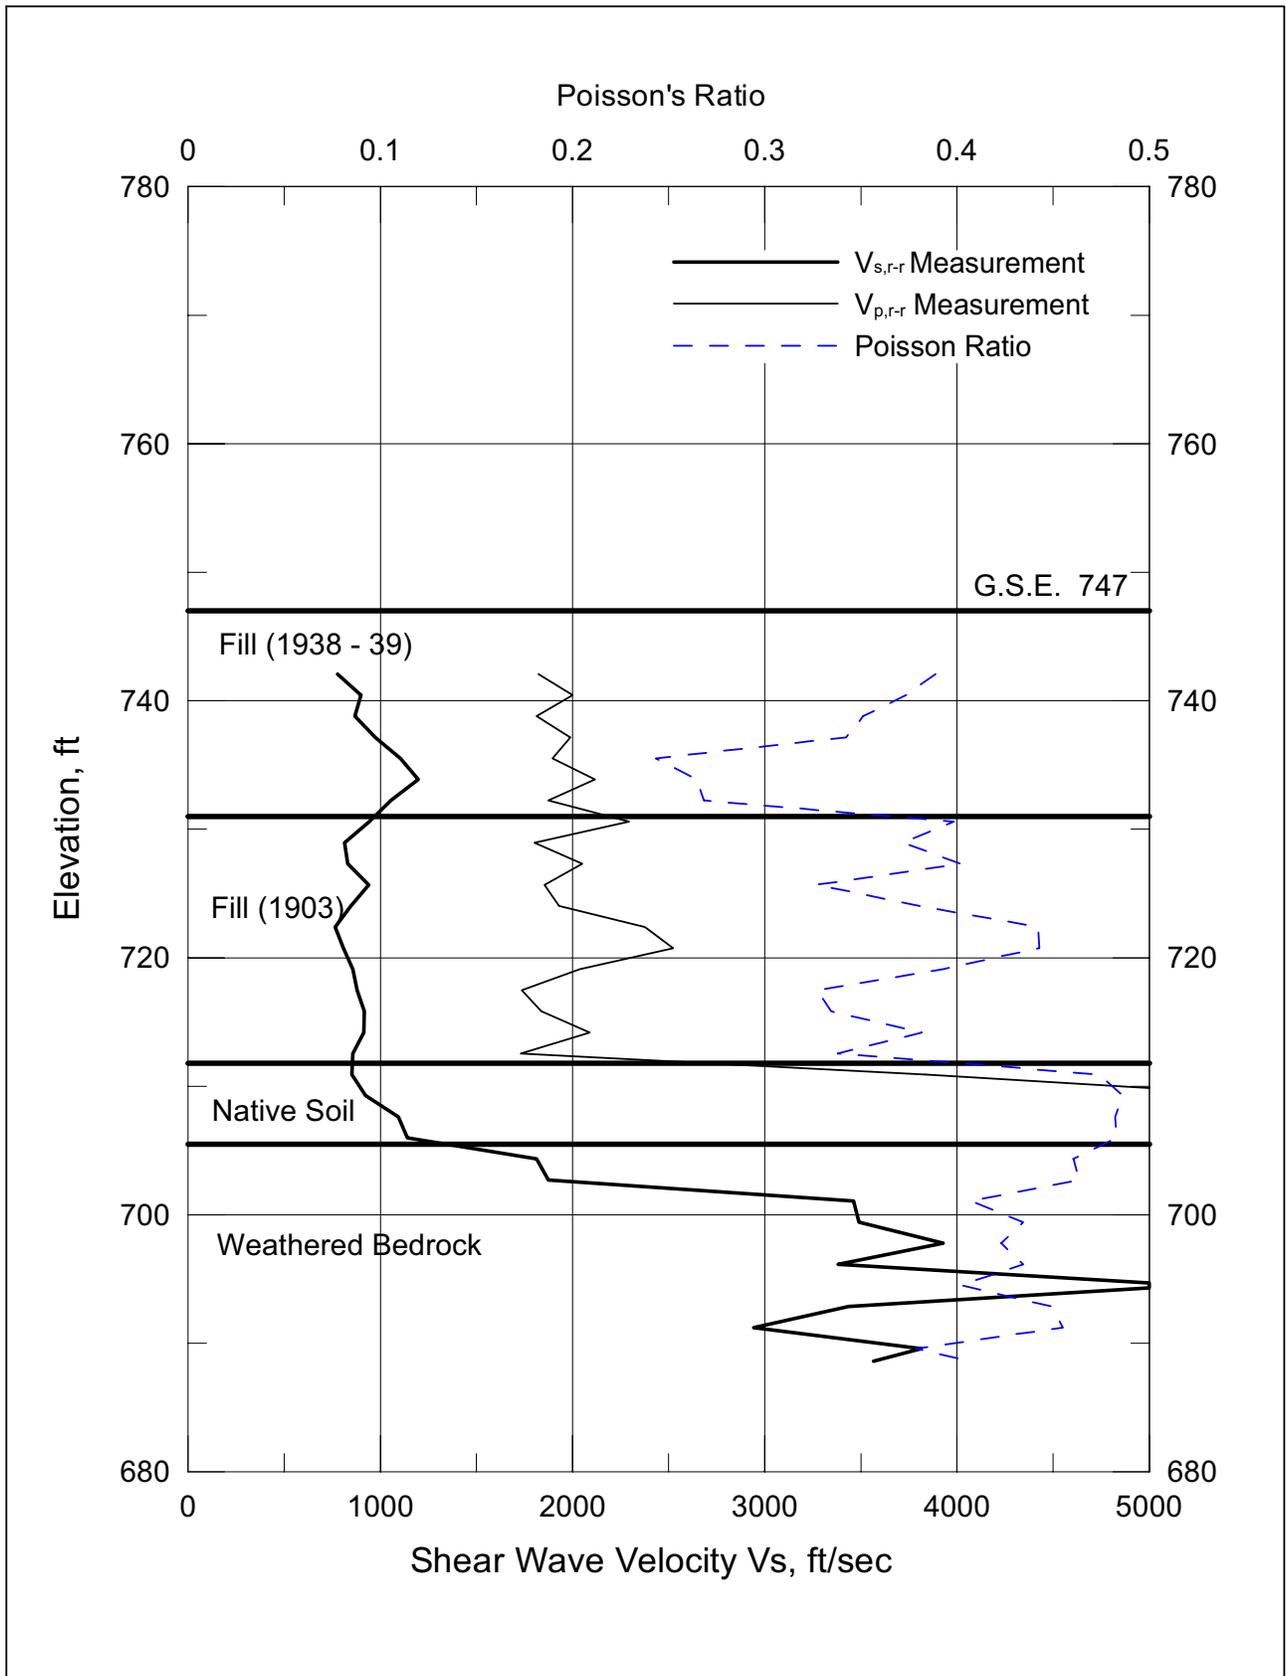
URS	Project No. 26814957	Seismic Wave Velocity Profile and Stratigraphy from Boring VQ-40	Figure
	Estates Dam Seismic Stability		10-5
