FINAL REPORT

Dynamic Stability Analysis of Estates Dam

Oakland, California

NOVEMBER 2006

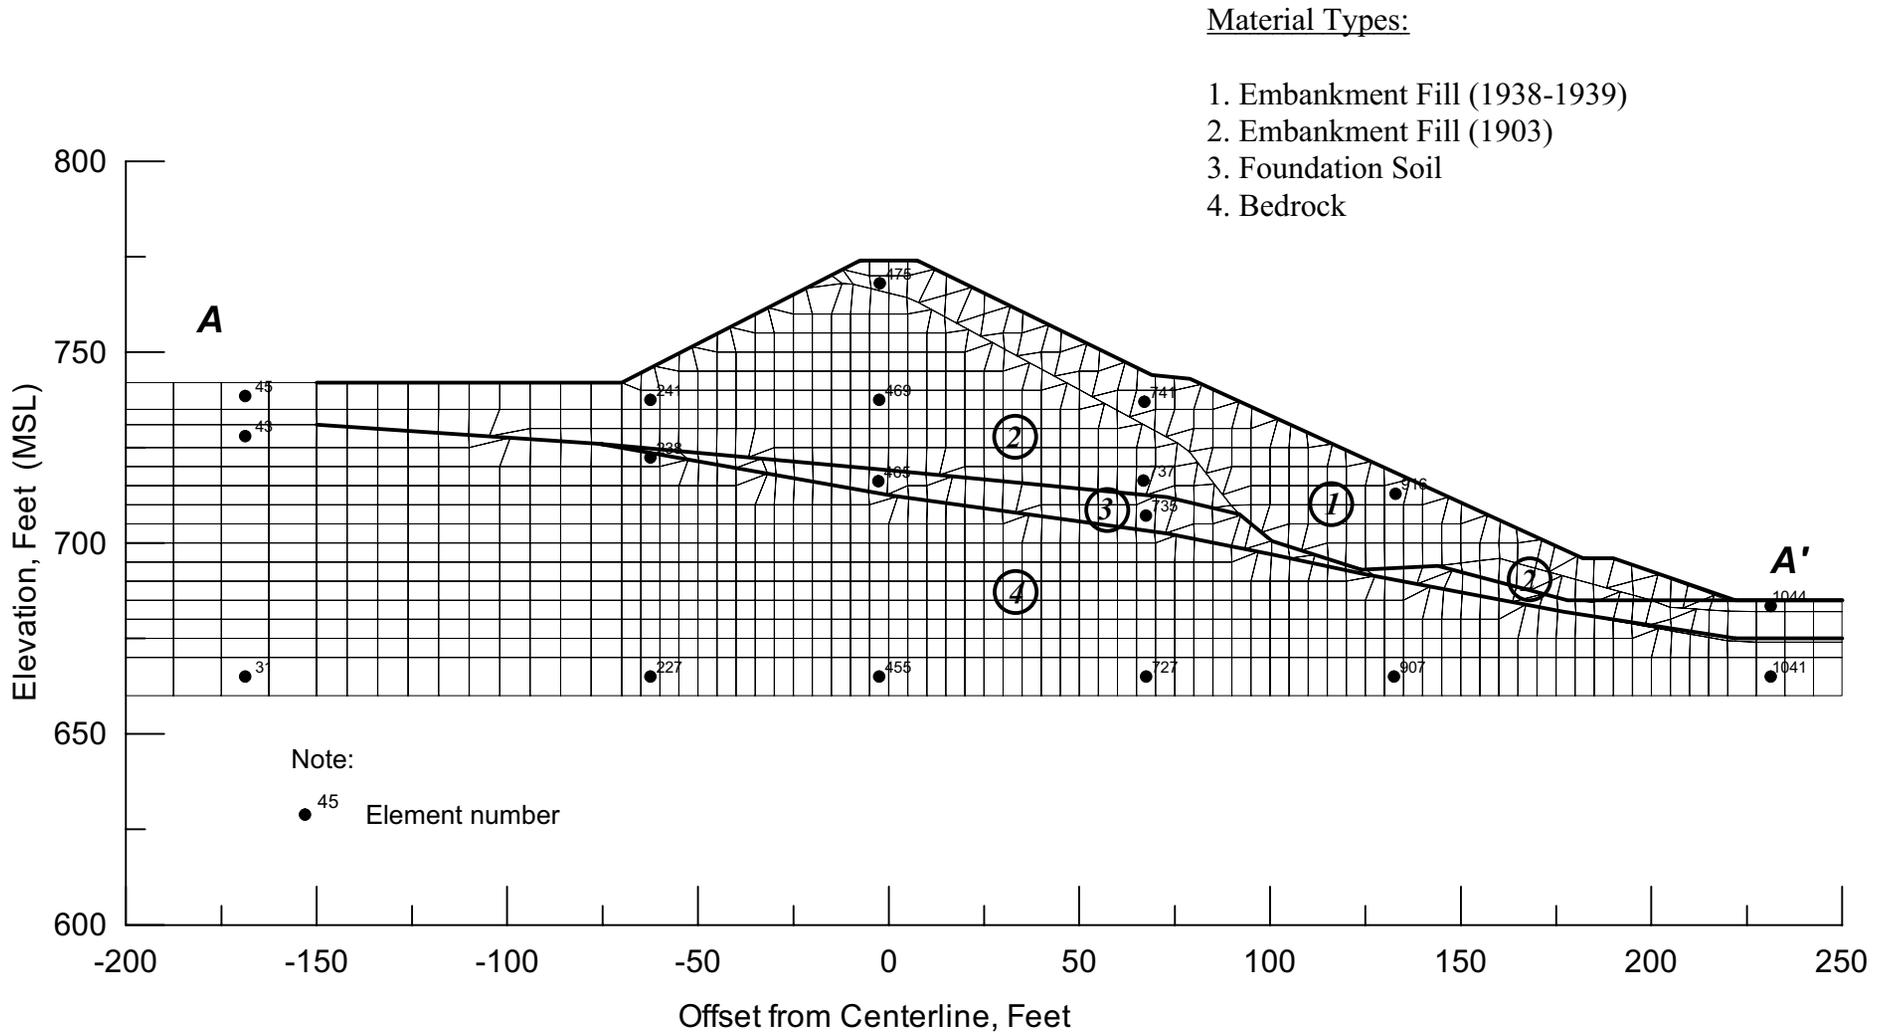
Project No. 26814957	Estates Dam Seismic Stability Analysis	Selected Element Locations For Stress Time-history Plots QUAD4M Analysis	Figure
URS			10-6

Figures 10-14 and 10-16 shows shear stress time histories within elements below the crest (see Figure 10-6 for locations). The calculated shear stresses generally correspond to a few cycles of high amplitude shear stress. Near the center and base of the dam, the amplitude of the stresses exceeds the static undrained strength of the materials, which is a limitation of equivalent-linear methods of dynamic response analysis. Figure 10-13 shows the time histories of average mass acceleration for the selected sliding blocks shown in Figure 10-8.

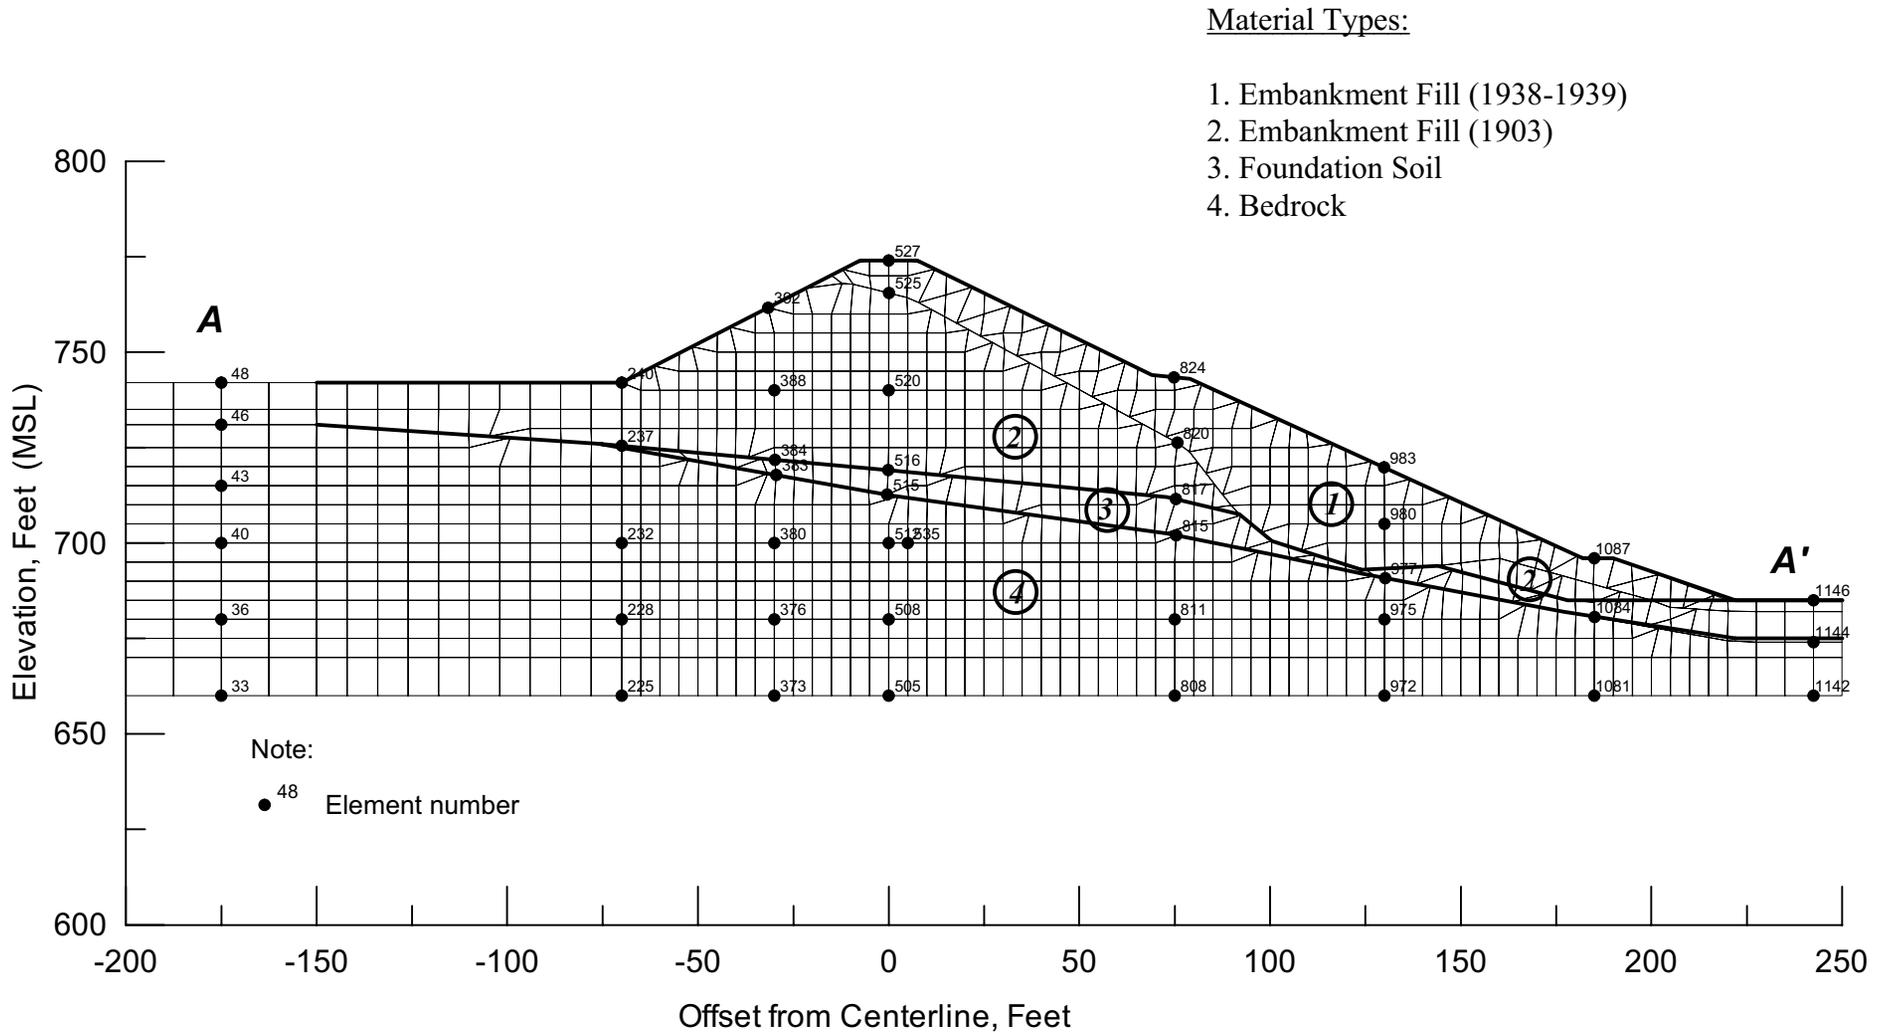
Project No. 26814957	Estates Dam Seismic Stability Analysis	Selected Nodal Points For Acceleration Outputs QUAD4M Analysis	Figure
URS			10-7

Figures 10-11 and 15 show the calculated peak accelerations within the embankment and foundation. Figure 10-12 shows acceleration time histories at nodal points below the reservoir (see Figure 10-7 for locations), and illustrates how the ground motions propagate upward through the foundation.

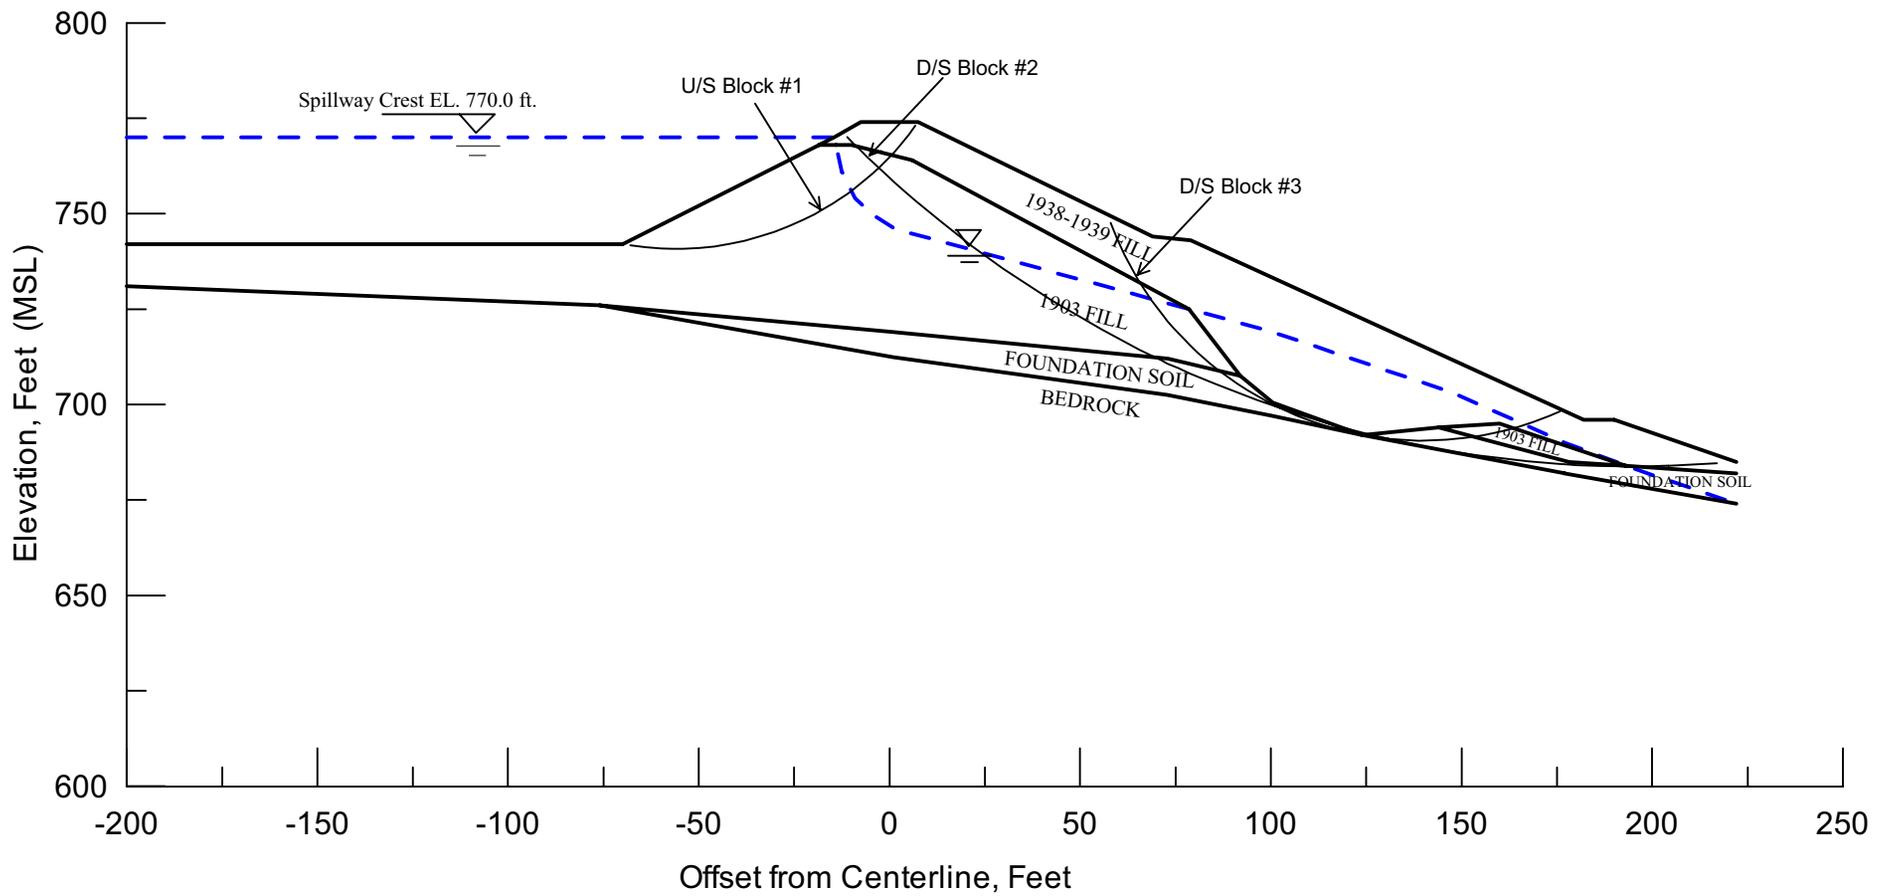
Project No. 26814957	Estates Dam Seismic Stability Analysis	Sliding Blocks for Newmark Deformation Analyses Cross Section A-A'	Figure
URS			10-8

The analysis results for the 1989 Loma Prieta Earthquake are presented in Figures 10-9 and 10-10. Figure 10-9 shows the calculated peak accelerations at the selected points within the dam during the earthquake. The calculated peak acceleration at the crest of the dam is approximately 0.18g. Figure 10-10 shows the time histories of average mass acceleration for the sliding blocks shown in Figure 10-8.

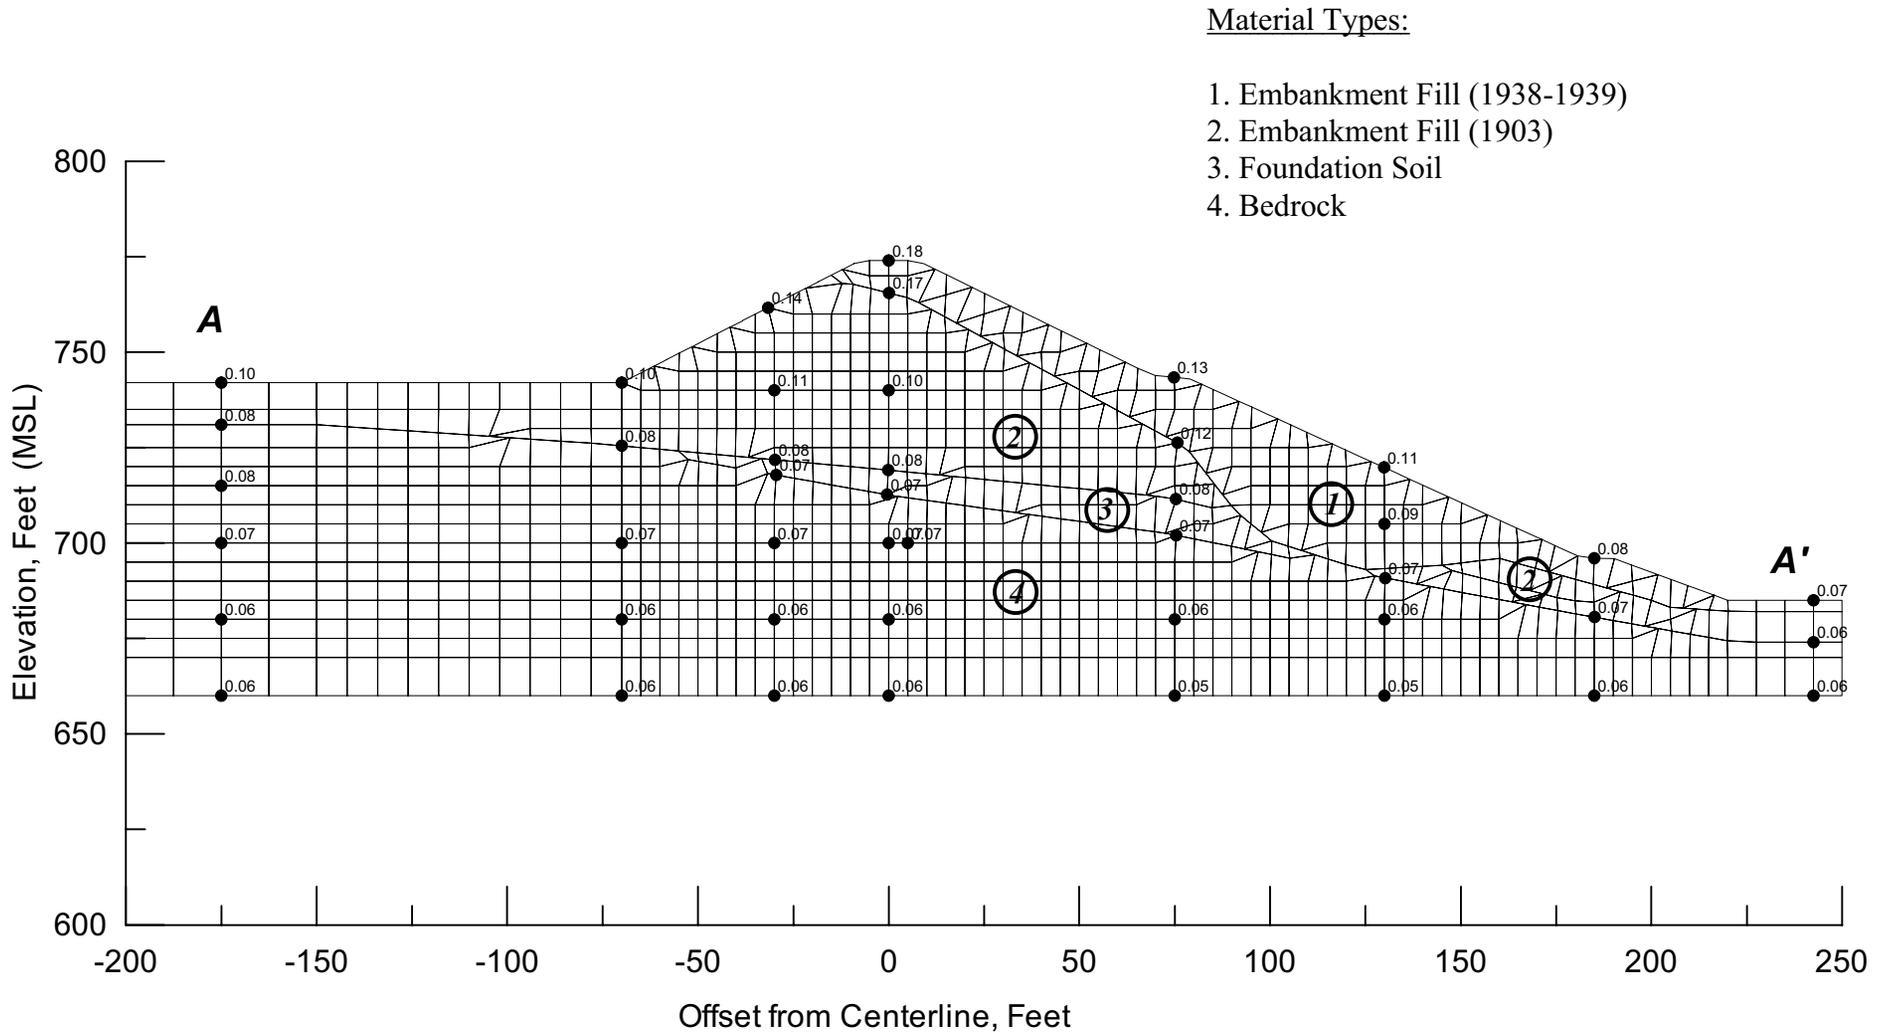
Note:
Horizontal acceleration in g's.

Project No. 26814957	Estates Dam Seismic Stability Analysis	Peak Horizontal Acceleration QUAD4M Analysis 1989 Loma Prieta Earthquake	Figure 10-9
URS

For the Loma Prieta earthquake, because the dynamic response of the dam is small (Figure 10-9), little strength degradation is expected during the earthquake and the peak mass acceleration for each block (Figure 10-10) is less than the corresponding yield acceleration (Table 11-2). Thus, the calculated deformations are nil, and it may be concluded that the calculated dynamic response and seismic deformations from the Newmark-type analyses are in good agreement with the known performance of the dam during that earthquake.

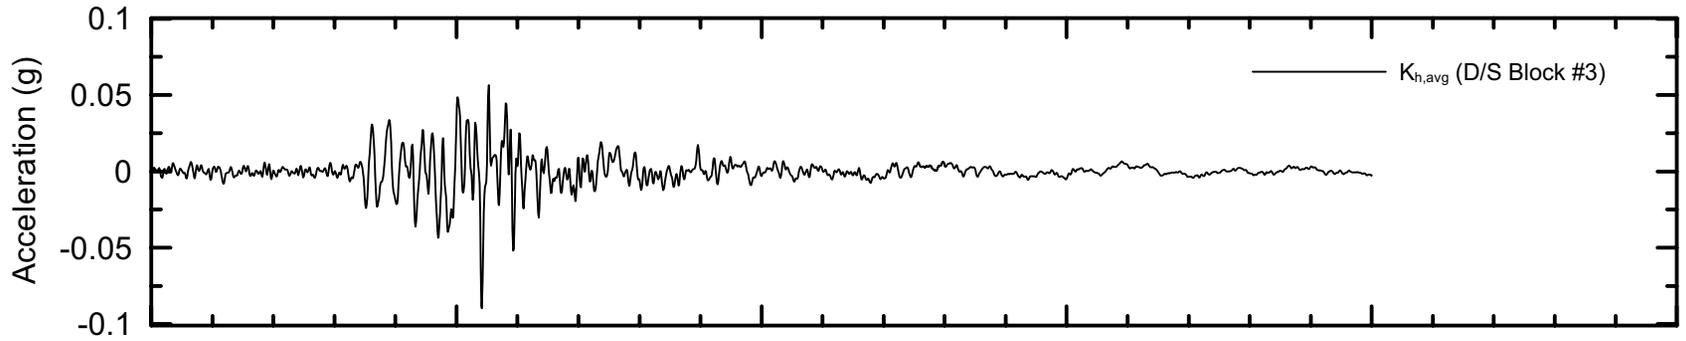
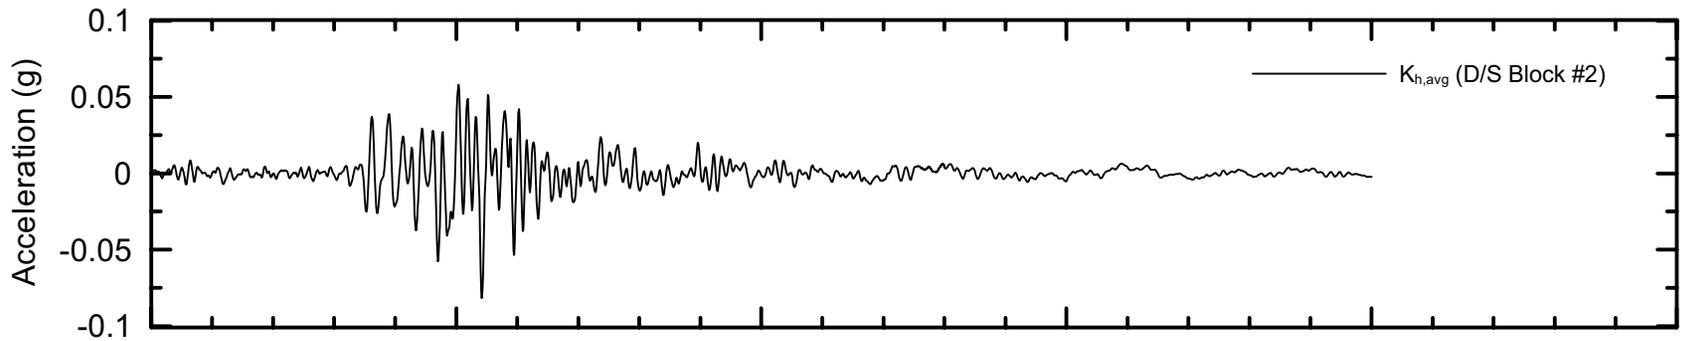
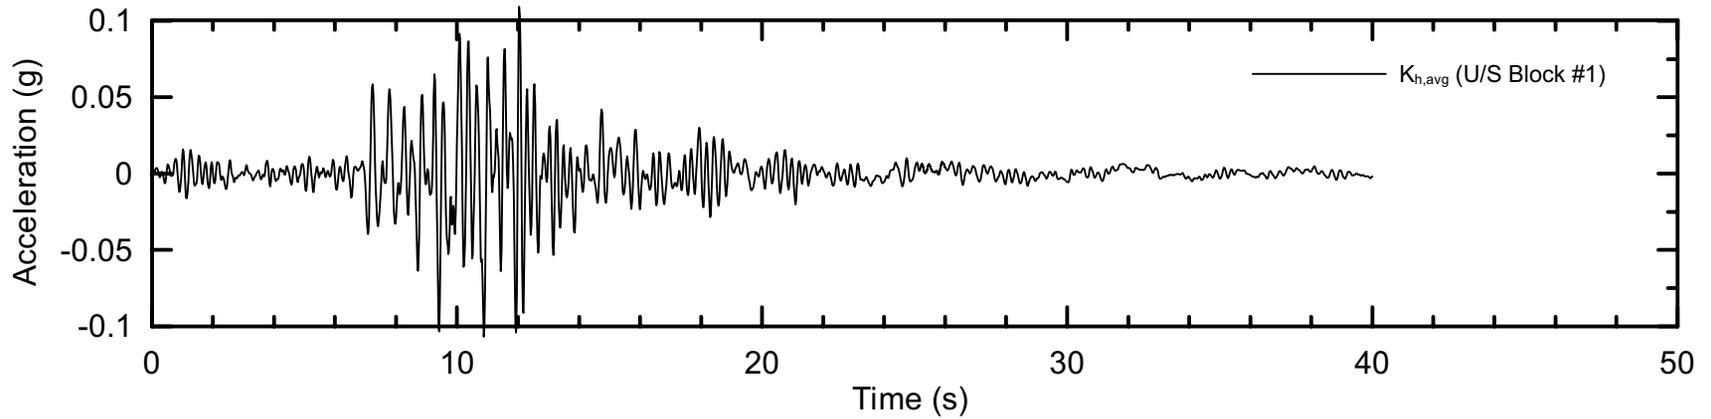
Project No. 26814957	Estates Dam Seismic Stability Analysis	Average Mass Acceleration QUAD4M Analysis 1989 Loma Prieta Earthquake	Figure 10-10
URS

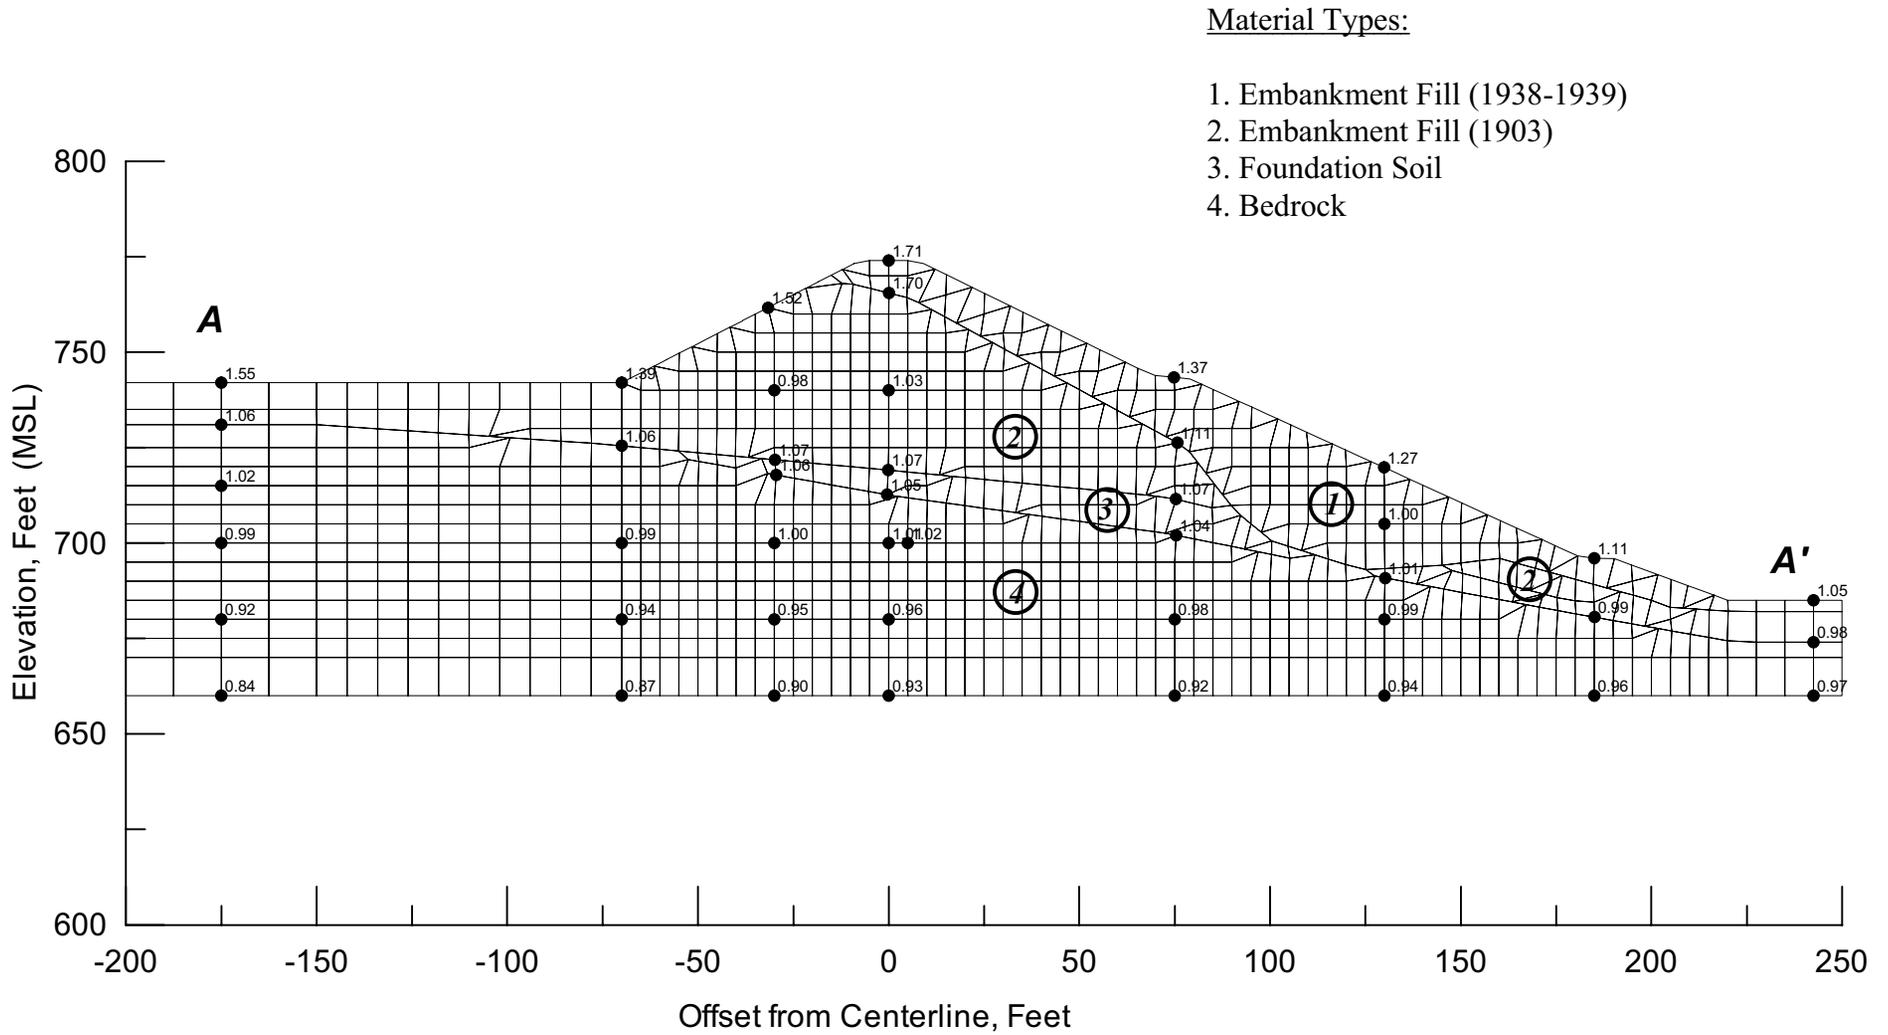
Note:
Horizontal acceleration in g's.

Project No. 26814957	Estates Dam Seismic Stability Analysis	Peak Horizontal Acceleration QUAD4M Analysis Cross-Section A-A' Hayward Fault Event TH #1	Figure 10-11
URS

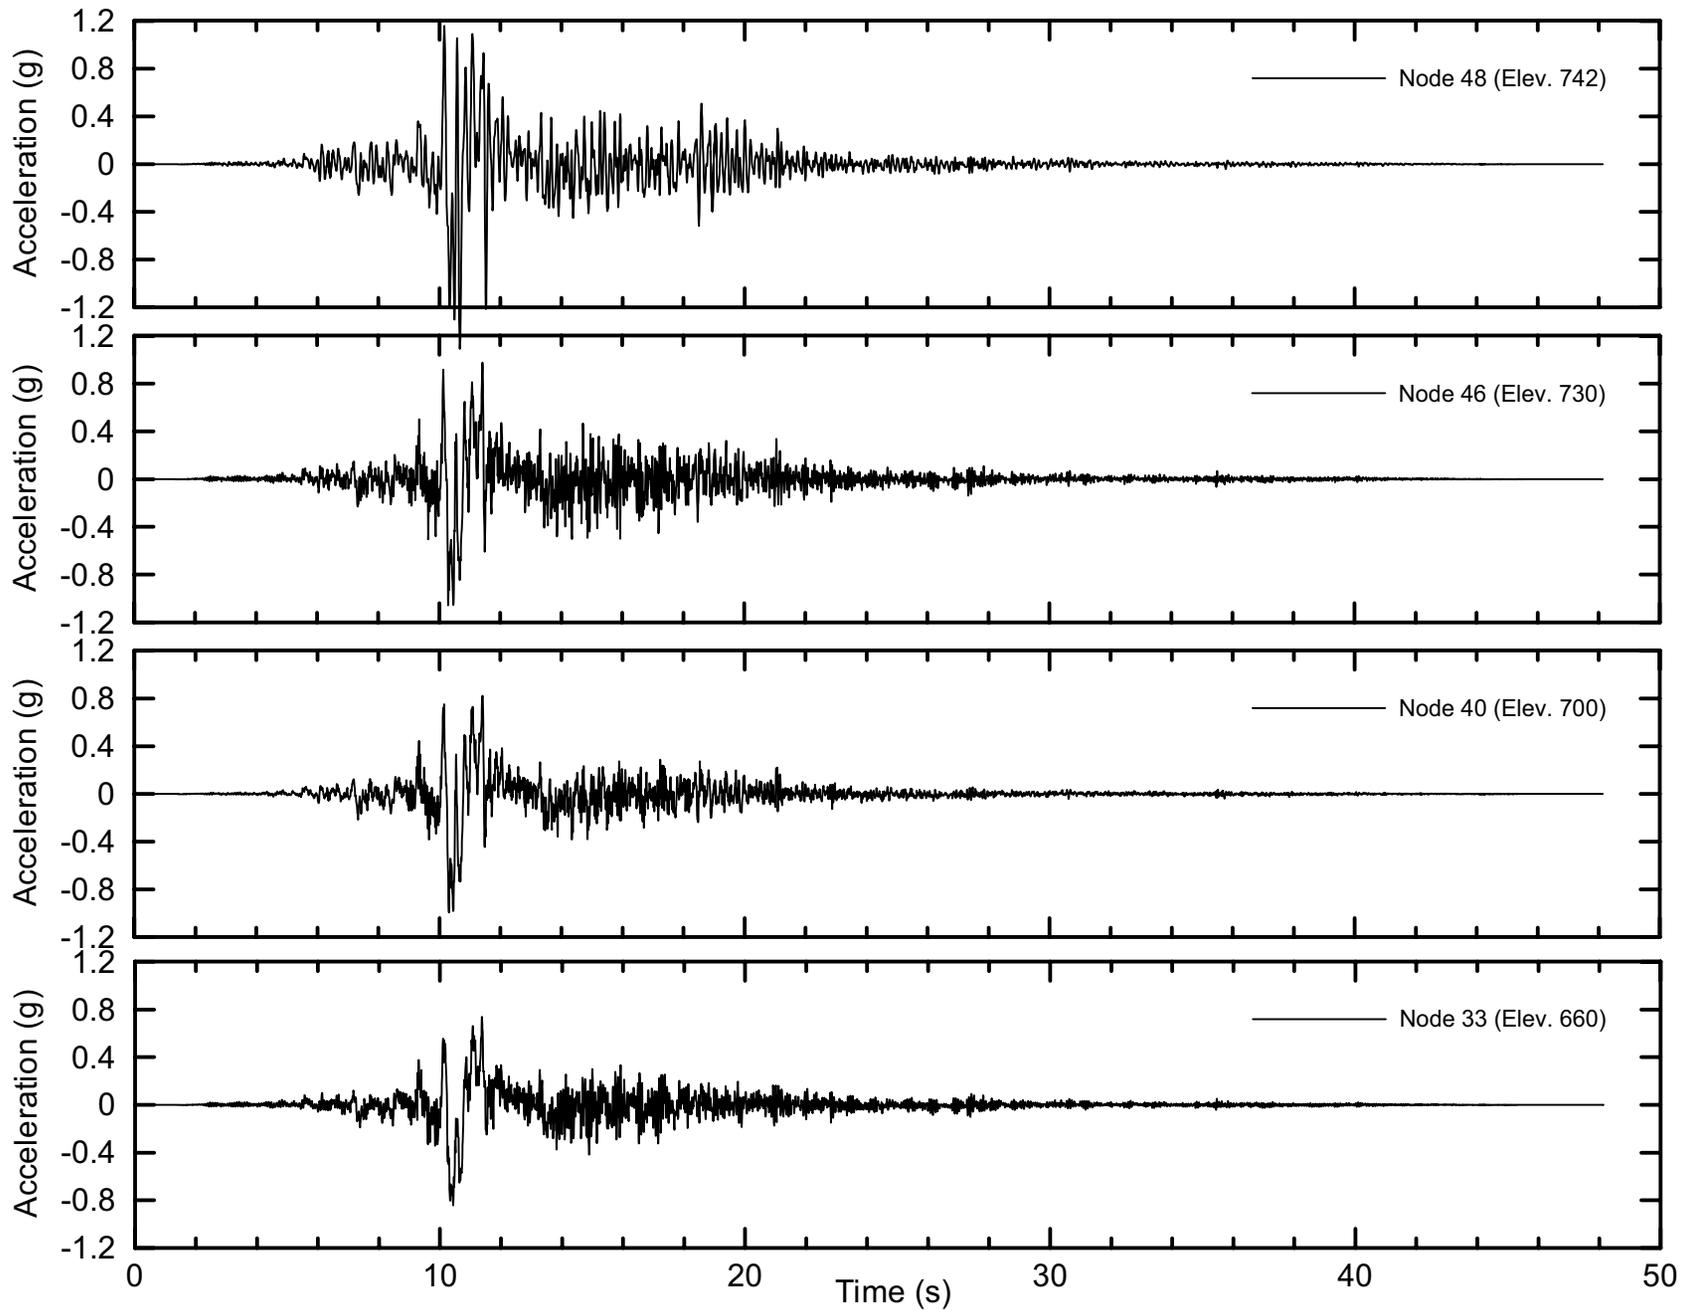
Project No. 26814957	Estates Dam Seismic Stability Analysis	Acceleration Time History 175 FT Offset Upstream QUAD4M Analysis Hayward Fault Event TH #1	Figure 10-12
URS

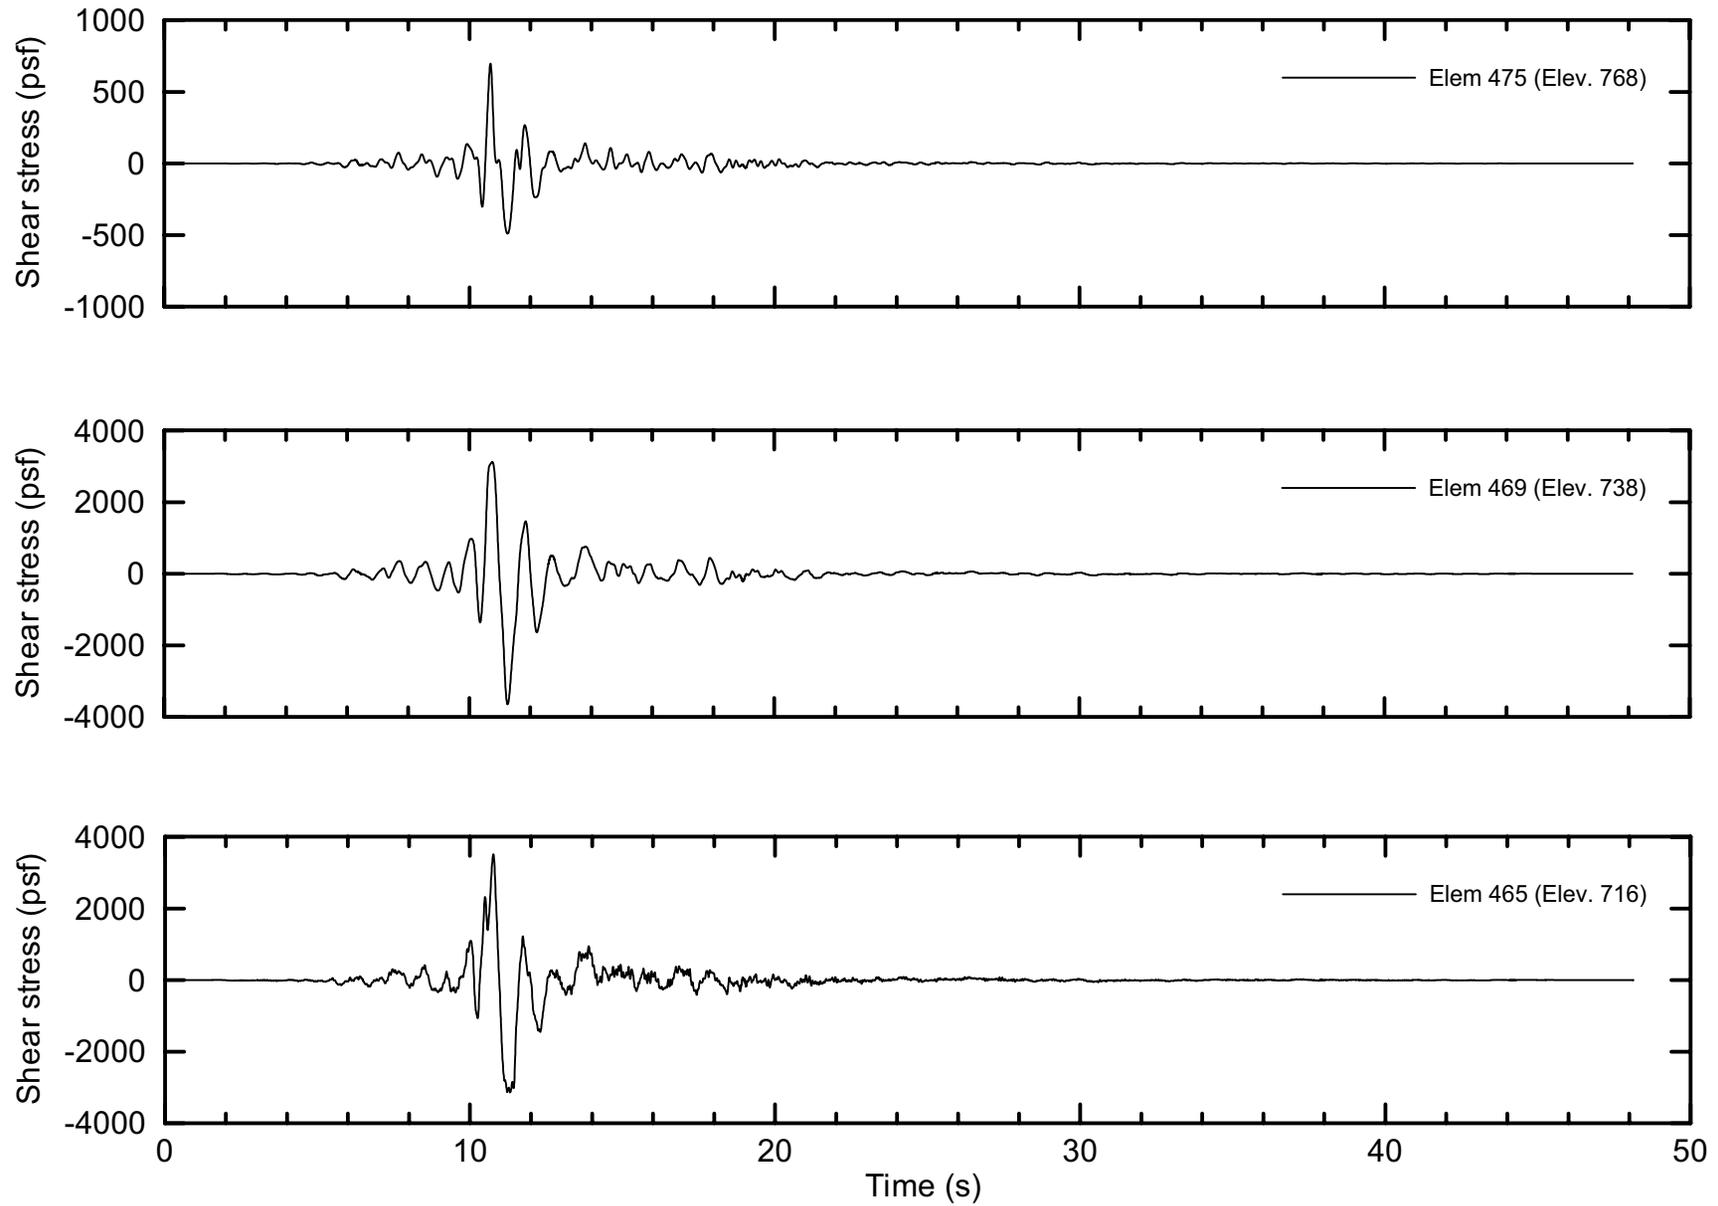
Project No. 26814957	Estates Dam Seismic Stability Analysis	Shear Stress Time History Beneath Crest Elements 465, 469, and 475 Hayward Fault MCE TH #1	Figure 10-14
URS

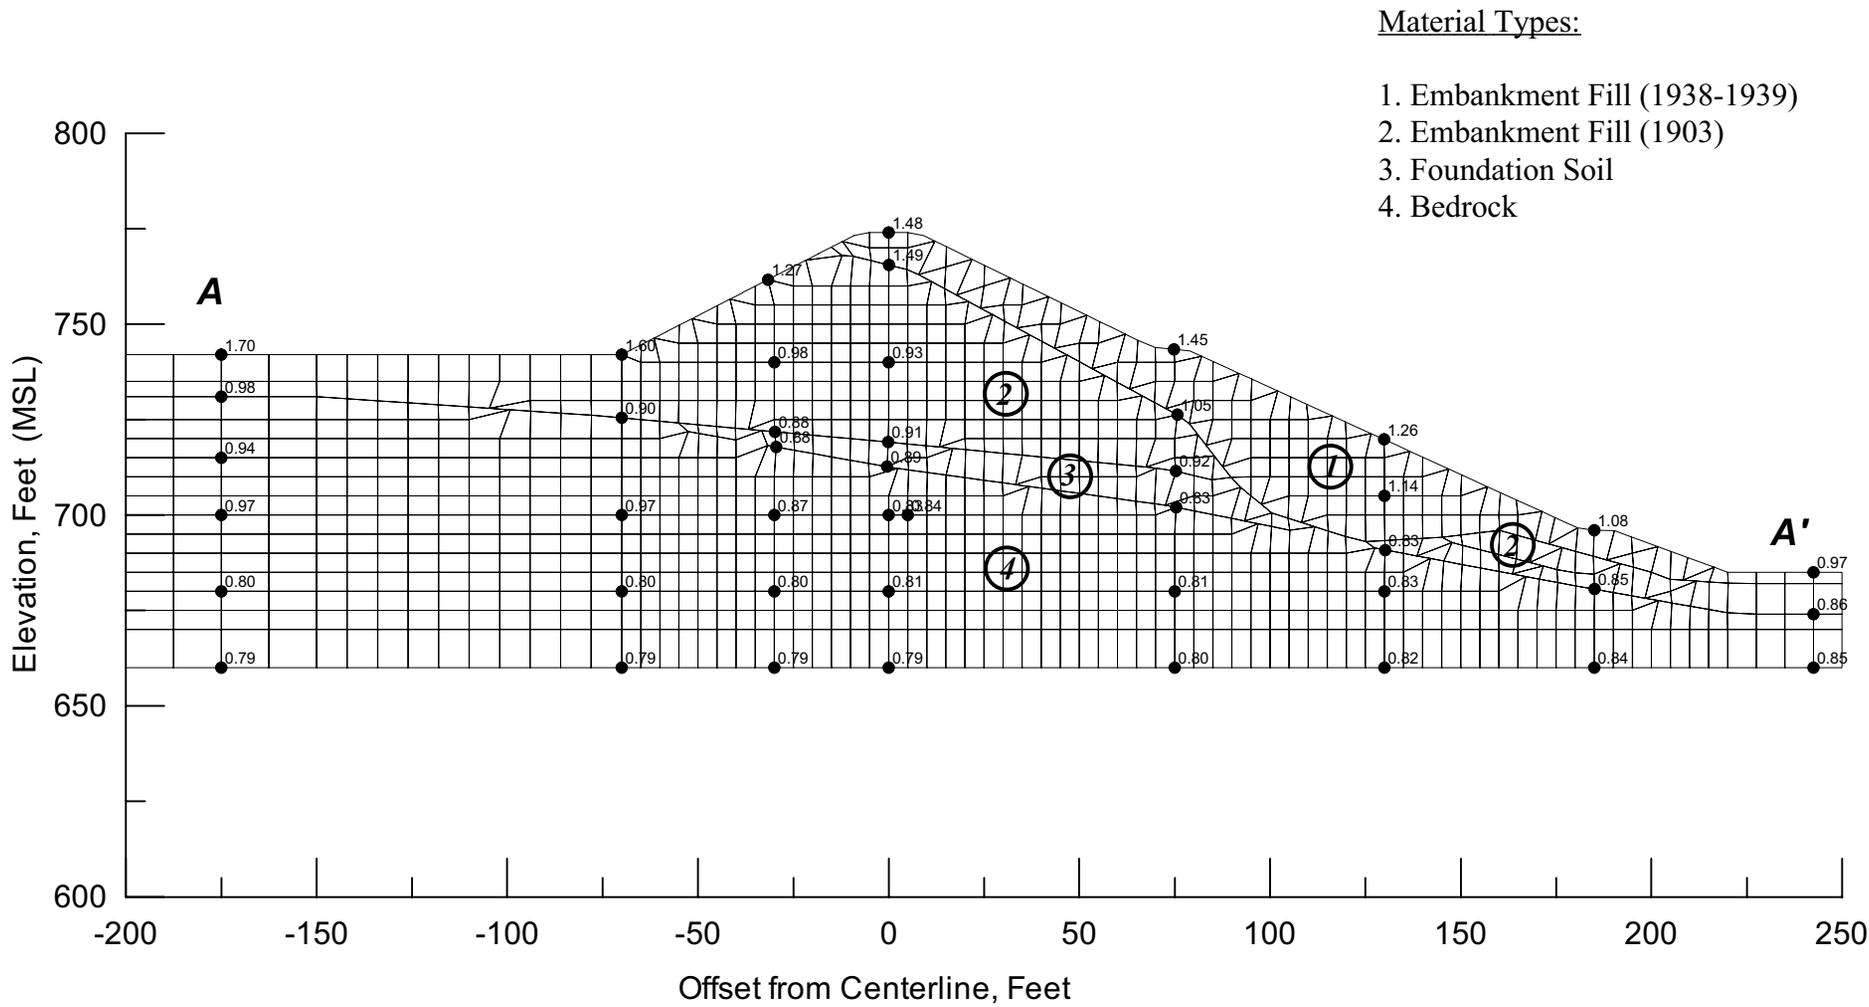
Note:
Horizontal acceleration in g's.

Project No. 26814957	Estates Dam Seismic Stability Analysis	Peak Horizontal Acceleration QUAD4M Analysis Cross-Section A-A' Hayward Fault Event TH #2	Figure 10-15
URS

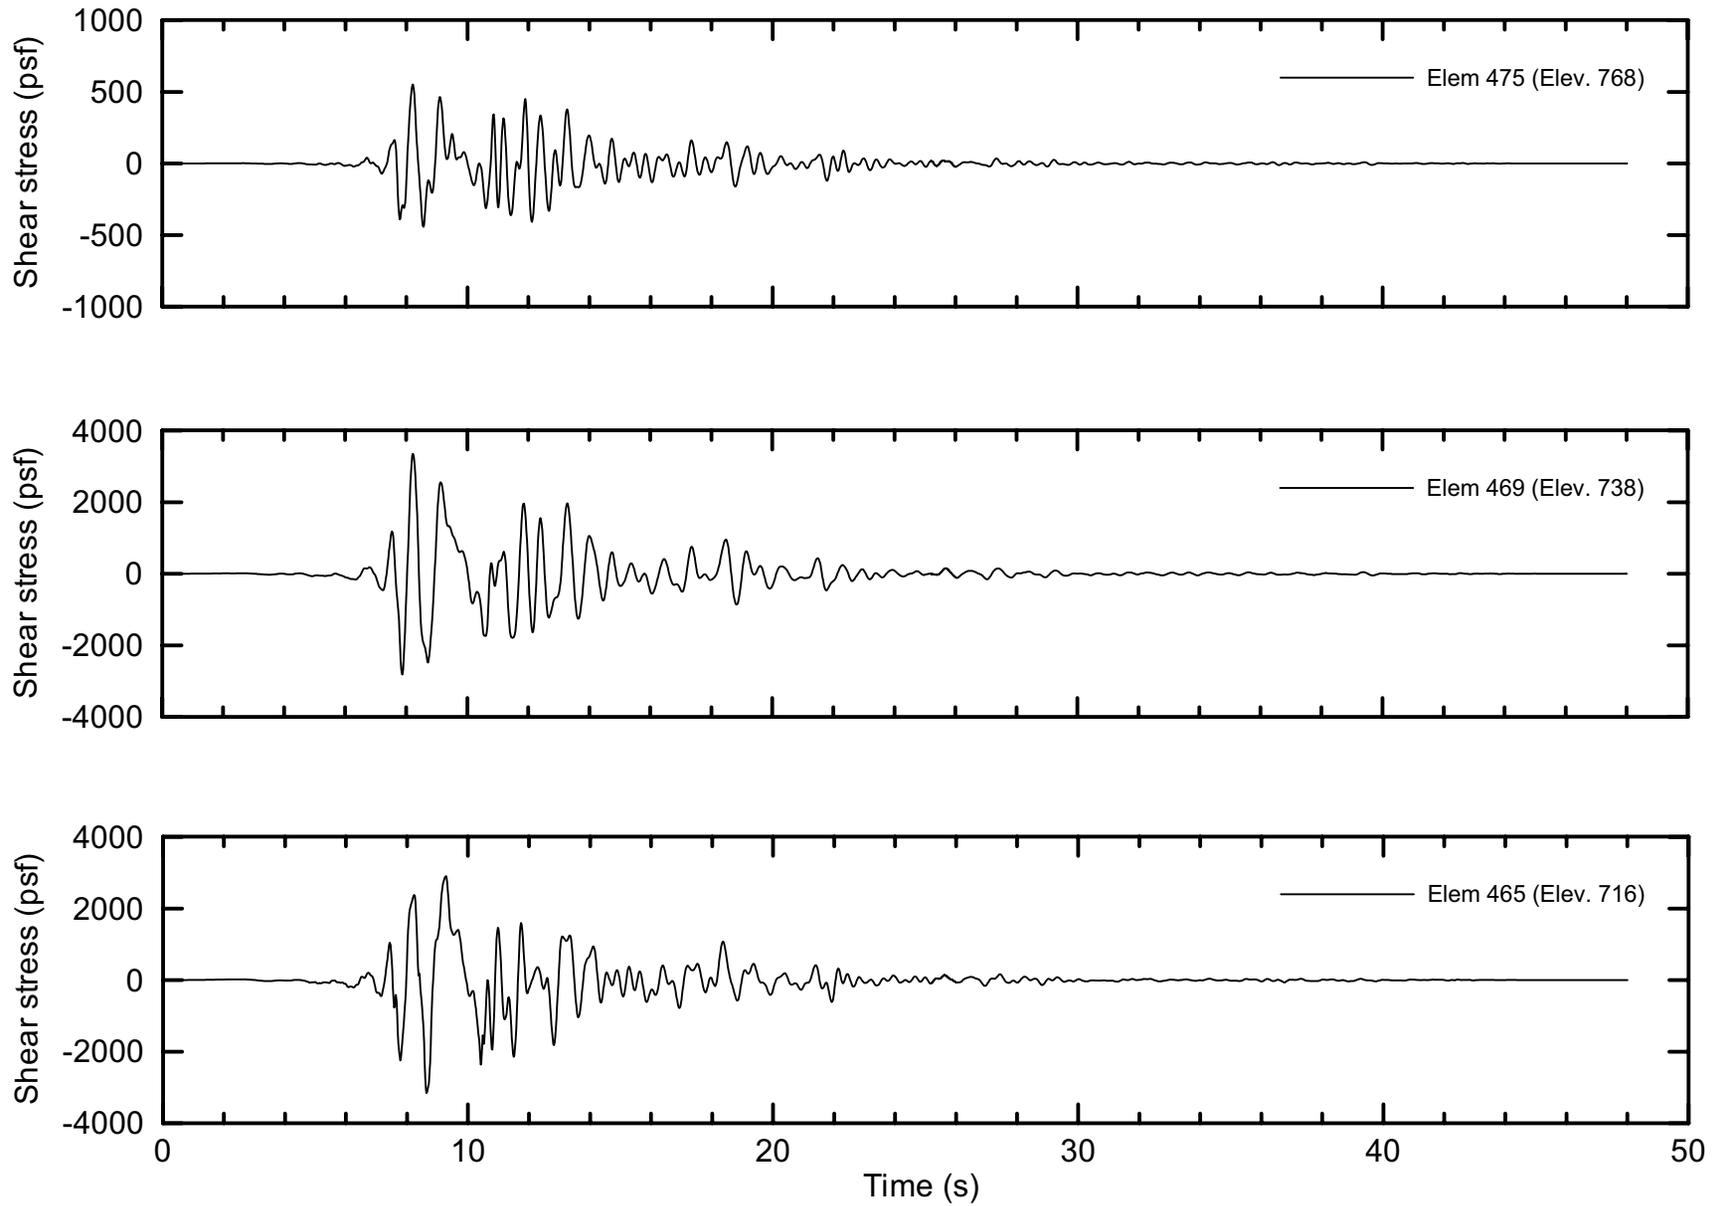
Project No. 26814957	Estates Dam Seismic Stability Analysis	Shear Stress Time History Beneath Crest Elements 465, 469, and 475 Hayward Fault MCE TH #2	Figure 10-16
URS

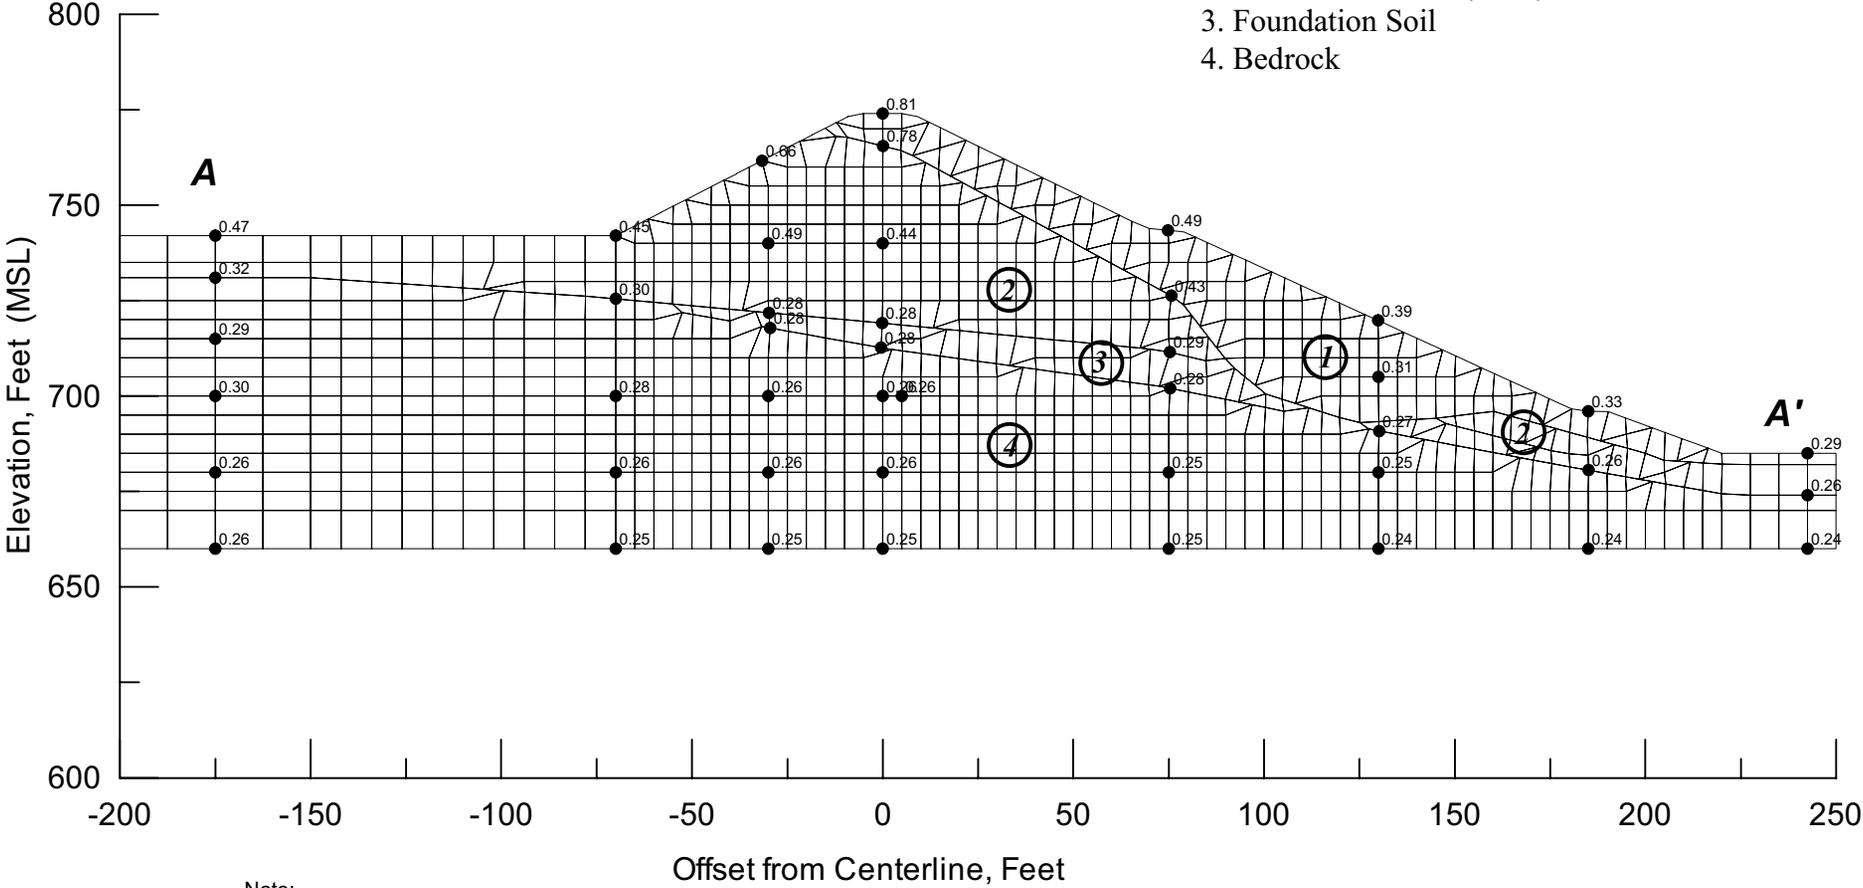
Note:
Horizontal acceleration in g's.

Project No. 26814957	Estates Dam Seismic Stability Analysis	Peak Horizontal Acceleration QUAD4M Analysis San Andreas Fault MCE	Figure 10-17
URS

The analysis results for the San Andreas Fault MCE are illustrated in Figures 10-17 and 10-18. As shown in these figures, this earthquake induces a dynamic response of the dam lower than that calculated for the Hayward Fault MCE. The calculated dam accelerations and shear stresses for the San Andreas event are significantly lower than those calculated for the Hayward event. Thus, the analyses indicate that the San Andreas Fault MCE is a less critical event than the Hayward Fault MCE regarding the seismic stability of the dam. The time histories of average mass acceleration for the selected sliding blocks are shown in Section 11.

Since the seismic response of the dam for the San Andreas event (see Figures 10-17 and 10-18) is smaller than that for the Hayward fault event, the dam deformations for the San Andreas event are expected to be lower than those for the Hayward event.
