FINAL REPORT

Dynamic Stability Analysis of Estates Dam

Oakland, California

NOVEMBER 2006

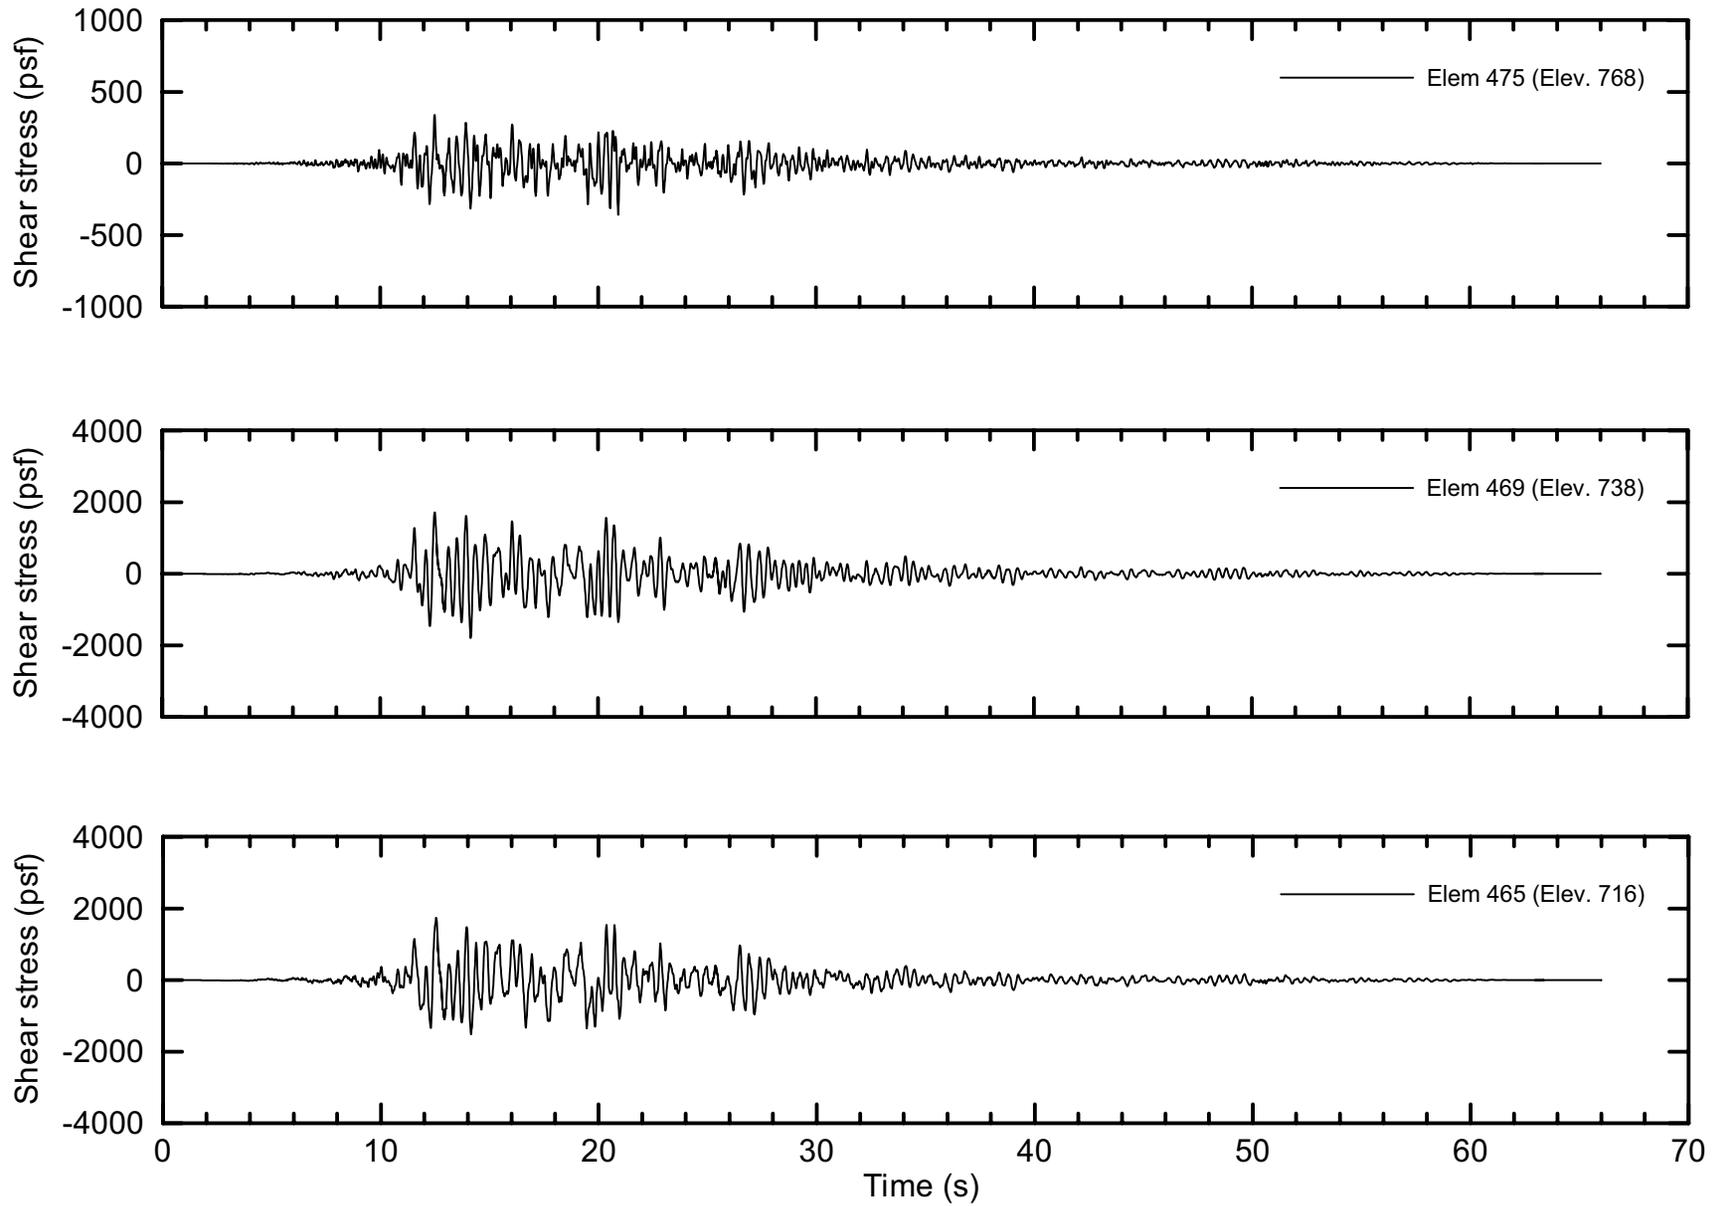
Project No. 26814957	Estates Dam Seismic Stability Analysis	Shear Stress Time History Beneath Crest Elements 465, 469, and 475 San Andreas Fault MCE	Figure 10-18
URS

The analysis results for the San Andreas Fault MCE are illustrated in Figures 10-17 and 10-18. As shown in these figures, this earthquake induces a dynamic response of the dam lower than that calculated for the Hayward Fault MCE. The calculated dam accelerations and shear stresses for the San Andreas event are significantly lower than those calculated for the Hayward event. Thus, the analyses indicate that the San Andreas Fault MCE is a less critical event than the Hayward Fault MCE regarding the seismic stability of the dam. The time histories of average mass acceleration for the selected sliding blocks are shown in Section 11.

Since the seismic response of the dam for the San Andreas event (see Figures 10-17 and 10-18) is smaller than that for the Hayward fault event, the dam deformations for the San Andreas event are expected to be lower than those for the Hayward event.

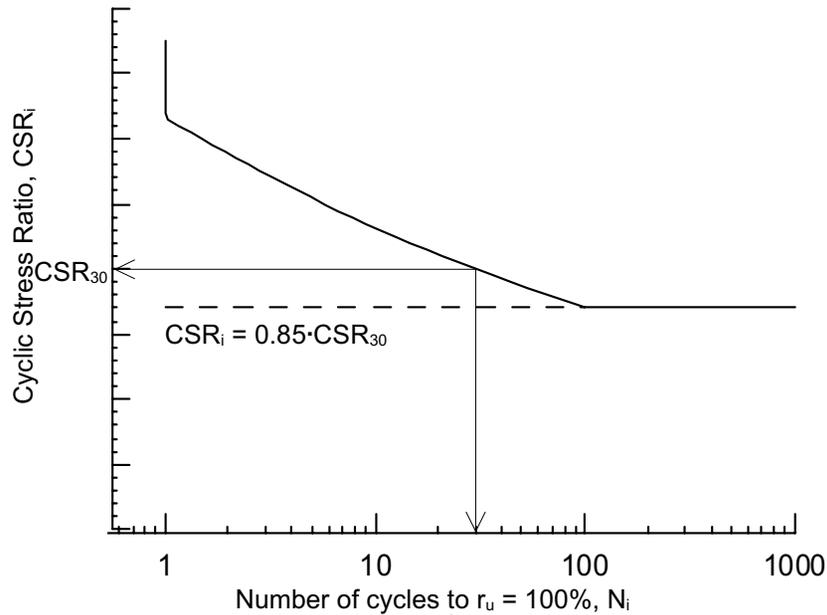
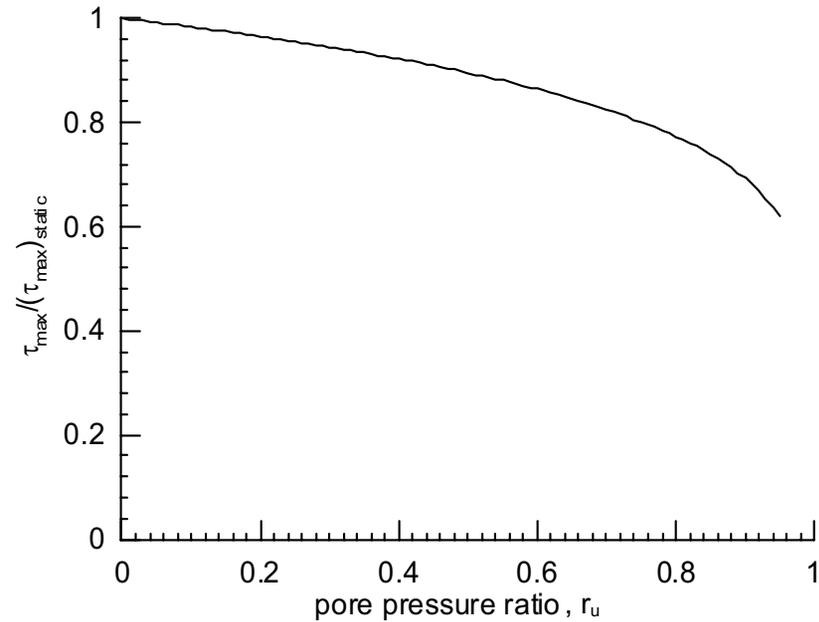
Cyclic Strength
 $CSR_{30} = 0.28, 0.56$

Strength Degradation

$$N_i = 30 \left(\frac{CSR_{30}}{CSR_i} \right)^{7.41} \quad 1 \leq N_i \leq 100$$

where $CSR_{30} = 0.28$ (1903 Fill and Foudation Soil)
 or
 0.56 (1938-39 Fill)

Project No. 26814957	Estates Dam Seismic Stability Analysis	Cyclic Strength and Undrained Strength Degradation of Saturated Embankment Fills and Foundation Soils	Figure
URS			11-1

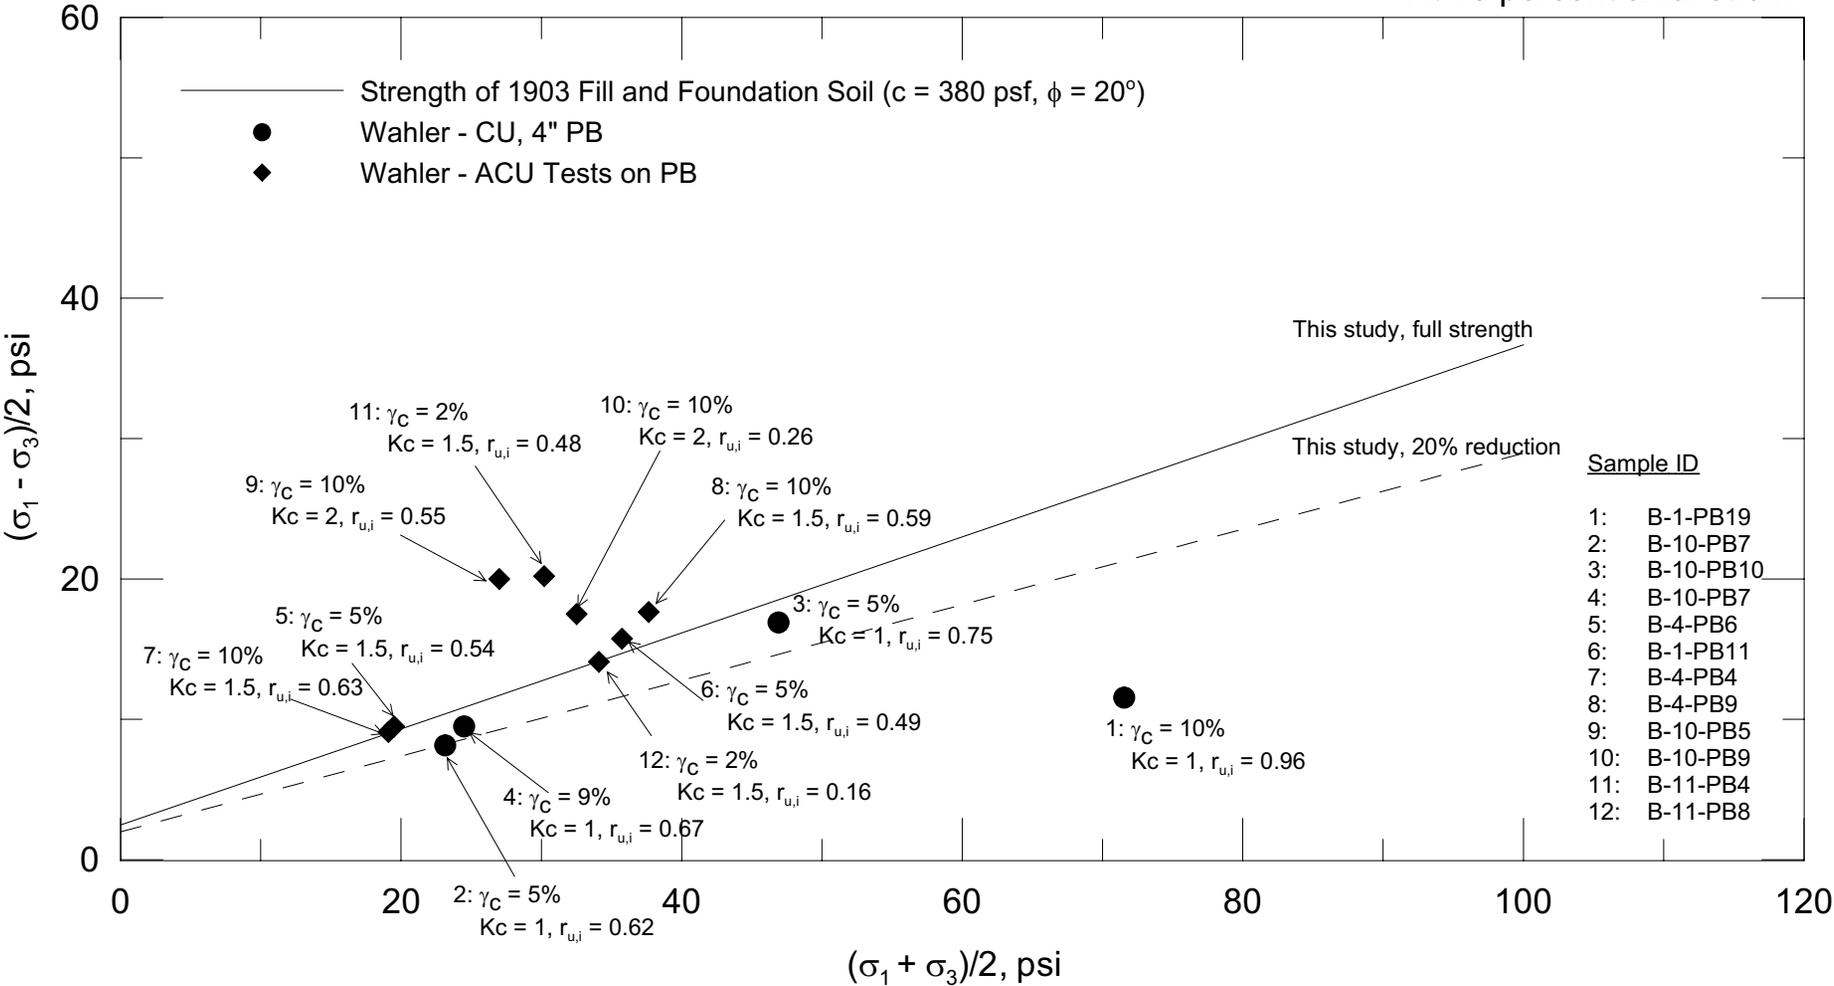
At 10 percent axial strain

Project No. 26814957	Estates Dam Seismic Stability Analysis	Total Stress Strength Data from Post-Cyclic Consolidated Undrained Triaxial Tests	Figure
URS			11-2

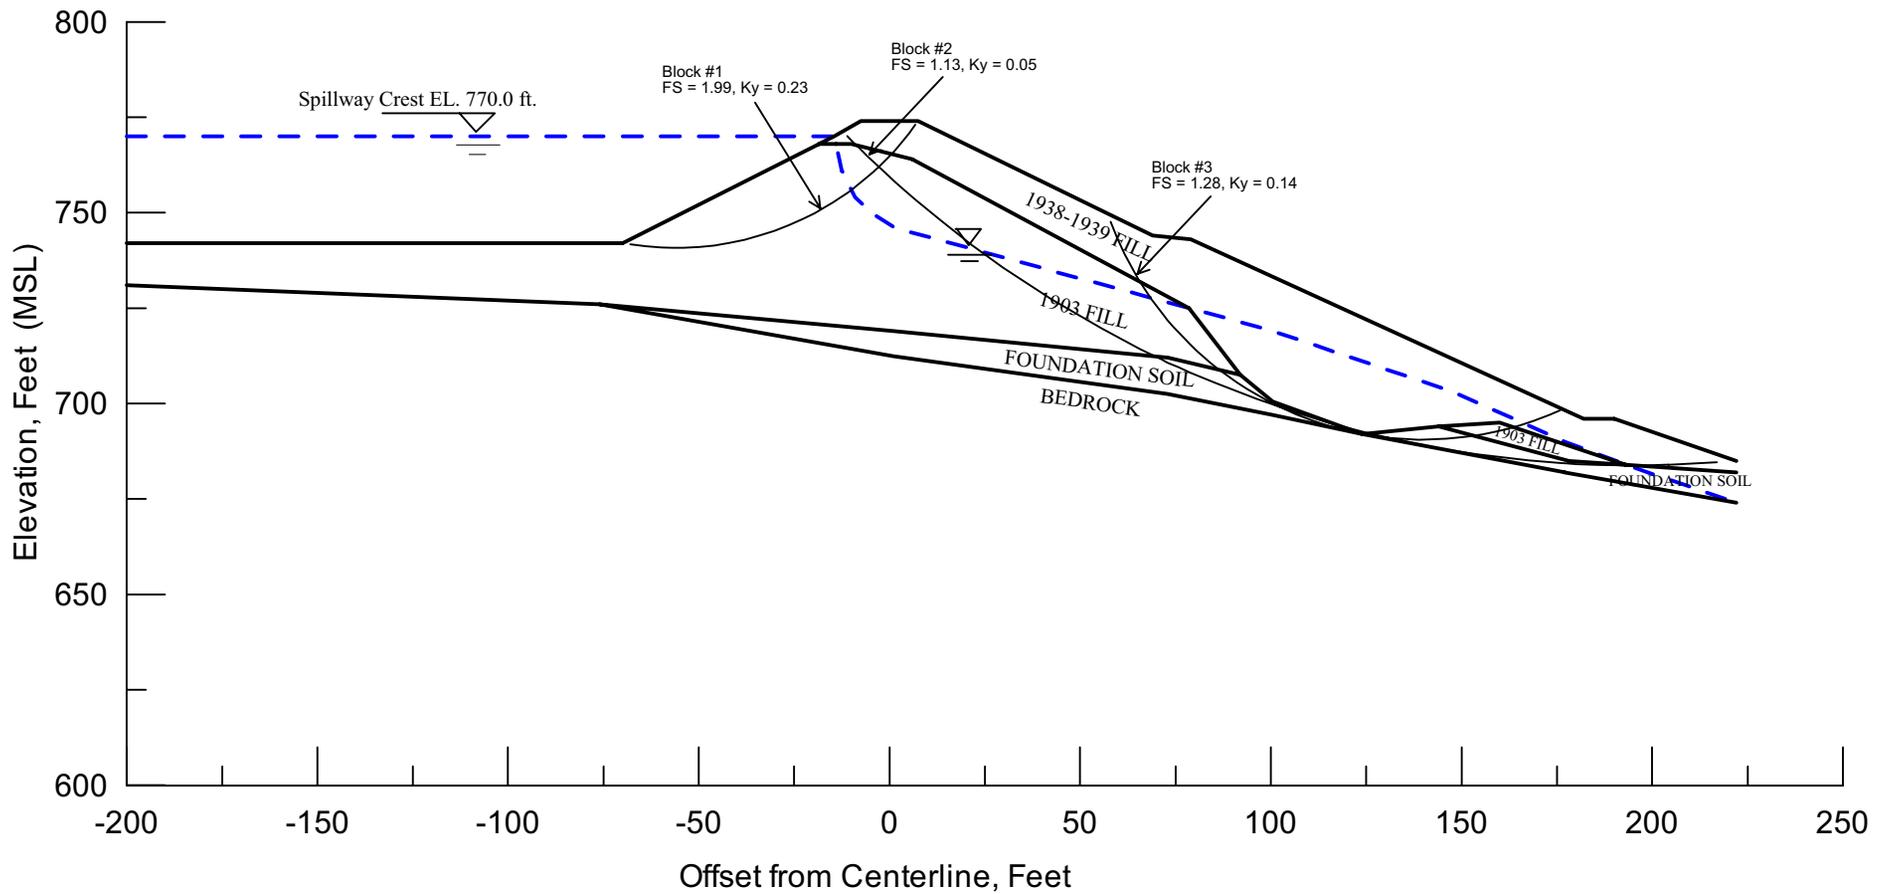
Project No. 26814957	Estates Dam Seismic Stability Analysis	Slope Stability Analysis Selected Critical Sliding Blocks Post-Earthquake Conditions	Figure
URS			11-3

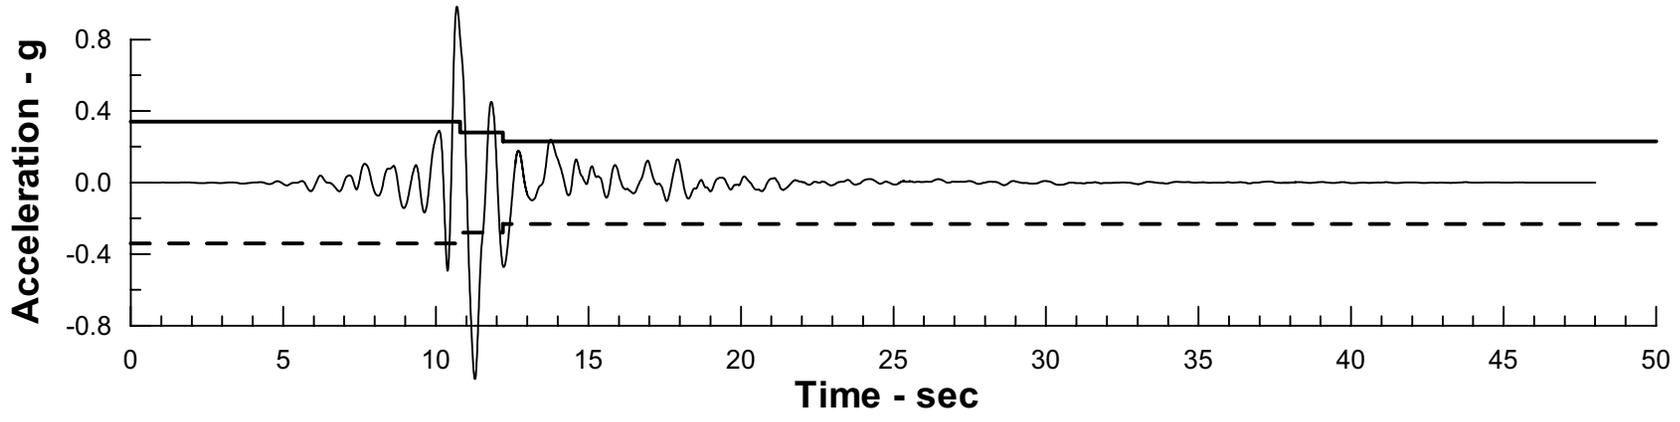
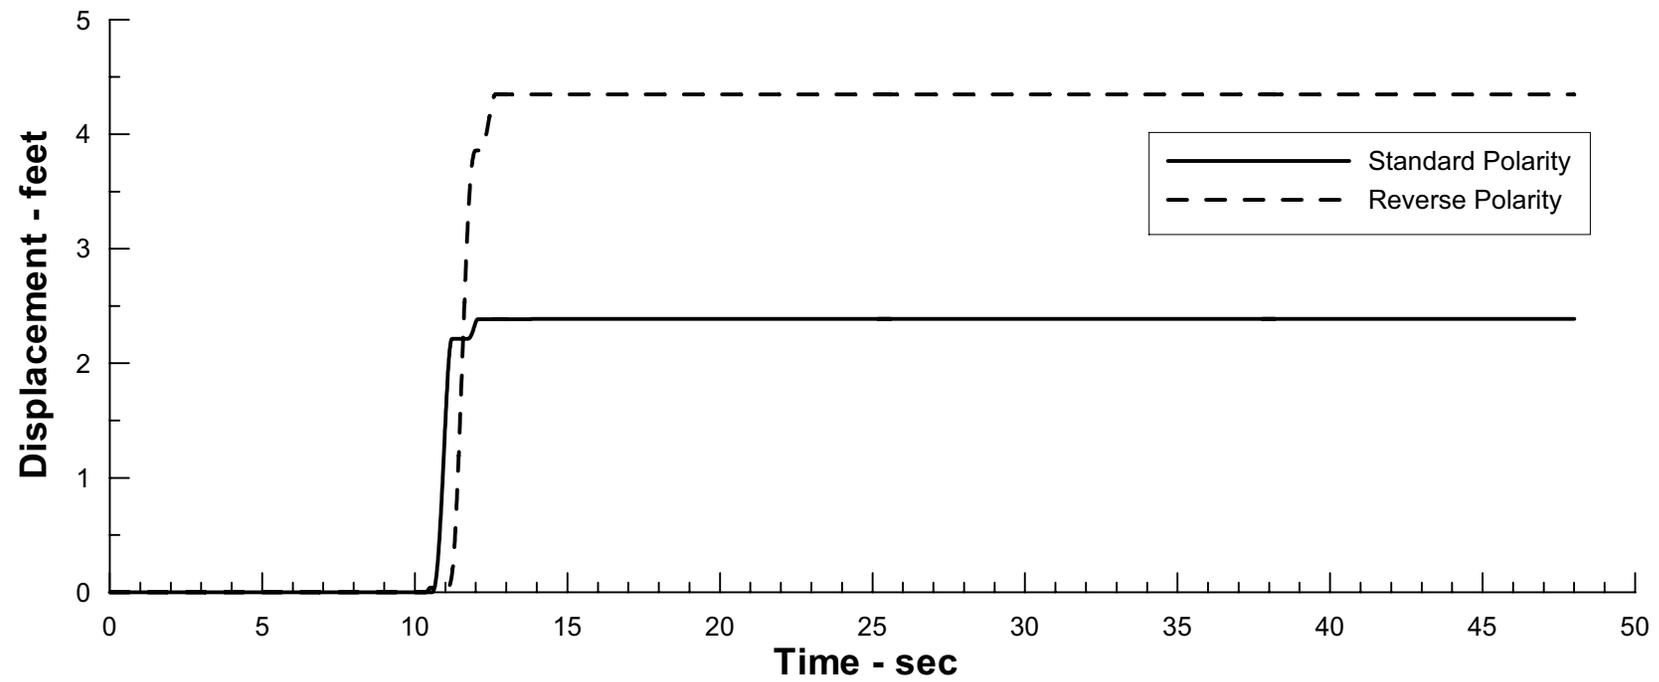
Project No. 26814957	Estates Dam Seismic Stability Analysis	Newmark Deformation Analysis Calculated Displacement U/S Block #1 Hayward Fault MCE TH #1	Figure 11-4
URS

Together with the results of the FLAC analyses presented in Section 12, the calculated dynamic response (e.g. acceleration and shear stress time histories) within the dam were used to estimate the timing of strength reduction of the materials during the earthquake shaking. The yield acceleration coefficients (see Table 11-2) and the timing of strength reduction were then used to develop time histories of yield acceleration for each potential sliding block. Those time histories are shown in Figures 11-4 through 11-9, together with the time histories of earthquake-induced average mass acceleration.

For Hayward fault MCE time history No. 1 (Figures 11-4 through 11-6), little strength reduction is assumed during the first 10.8 seconds of shaking and the yield acceleration for that period corresponds to that for pre-earthquake conditions. Between about 10.8 and 12.2 seconds, the yield acceleration corresponds to a 10% strength reduction. A yield acceleration corresponding to 20% strength reduction is used after about 12.2 seconds. Similarly, for Hayward fault MCE time history No. 2 (Figures 11-7 through 11-9), little strength reduction is expected during the first 8.5 seconds of shaking and the yield acceleration for that period corresponds to that for pre-earthquake conditions. Between about 8.5 and 9.5 seconds, the yield acceleration corresponds to a 10% strength reduction. A yield acceleration corresponding to 20% strength reduction is used after about 9.5 seconds.

The Newmark-type deformation analyses results are presented in Figures 11-4 through 11-9. The calculated displacements are summarized in Table 11-3. These calculated displacements correspond to horizontal translation of the center of mass of each sliding block. The corresponding vertical displacements can be obtained from the rotation of the block necessary to accommodate the horizontal displacements.

The displacements calculated for Hayward fault MCE time history No. 1 are shown in Figures 11-4 through 11-6. Horizontal displacements of 3 to 5 feet are calculated for the deep-seated downstream block No.2. Based on the geometry of the block, such displacements would correspond to downward vertical displacements of the crest of 2 to 4 feet. Smaller horizontal displacements (2 to 4 feet) are calculated for upstream block No. 1. Much smaller horizontal displacements (1 to 2 feet) are calculated for downstream block No. 3.

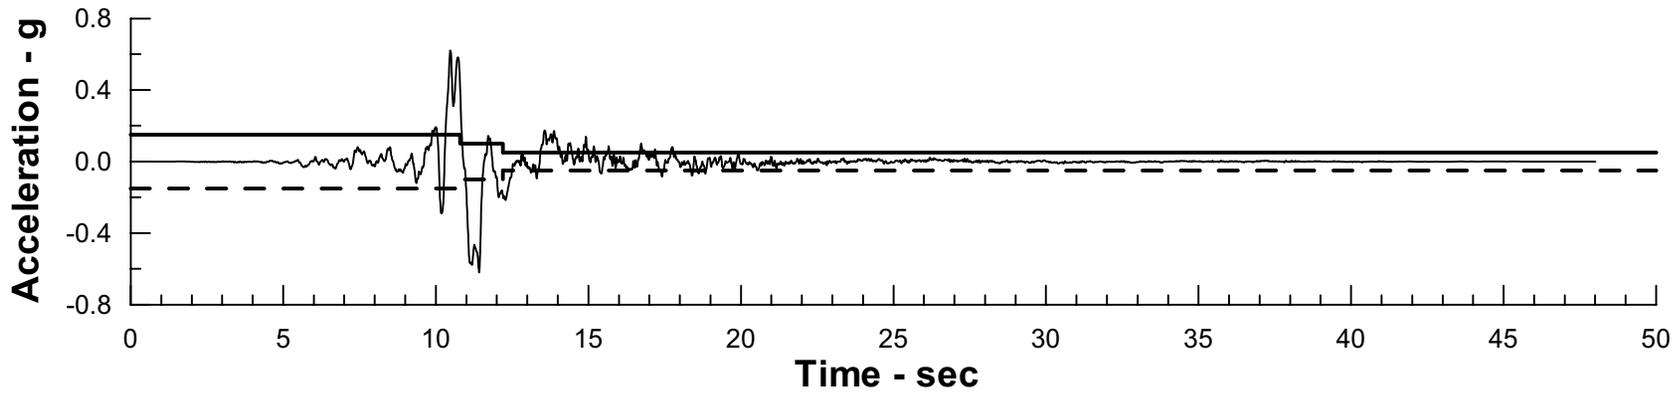
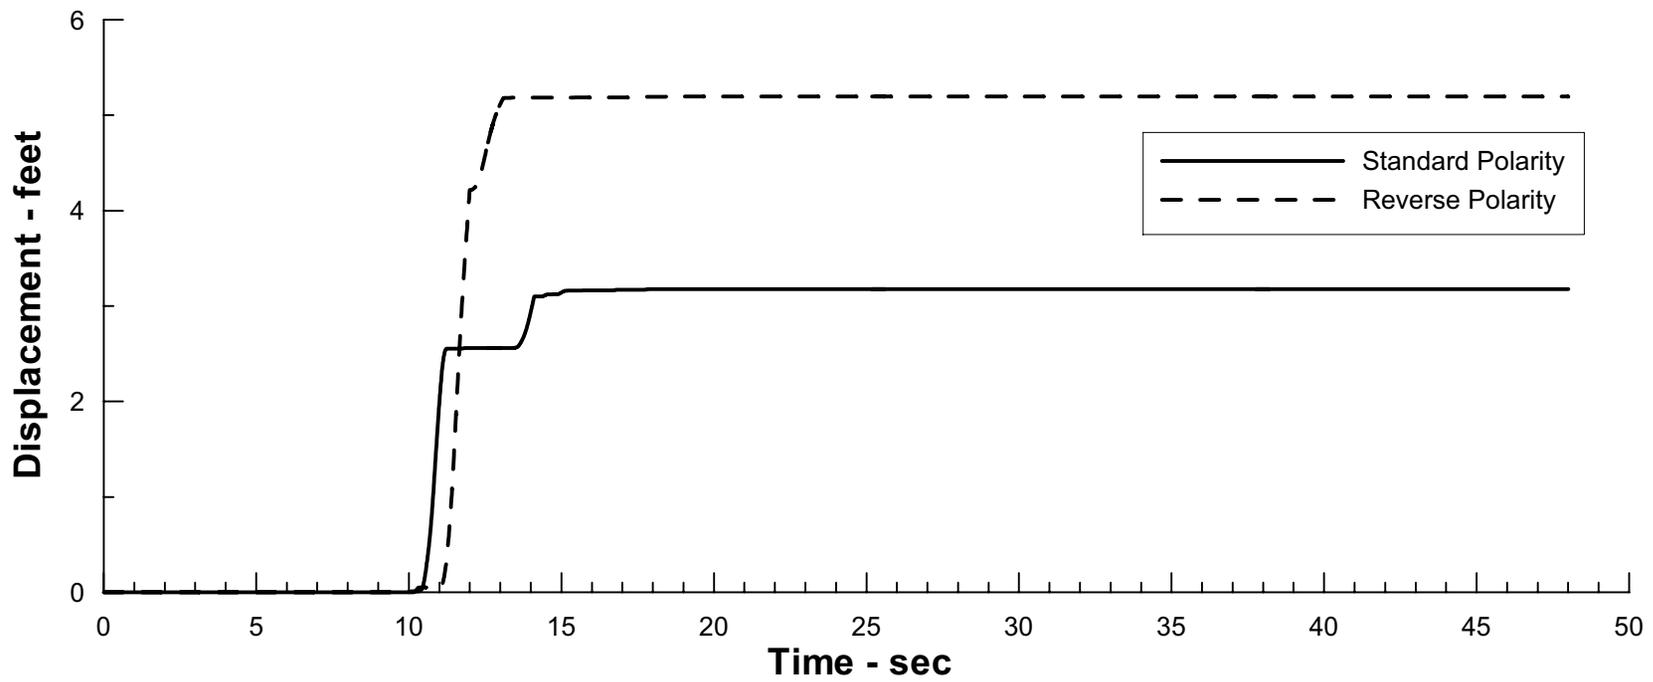
Project No. 26814957	Estates Dam Seismic Stability Analysis	Newmark Deformation Analysis Calculated Displacement D/S Block #2 Hayward Fault MCE TH #1	Figure 11-5
URS

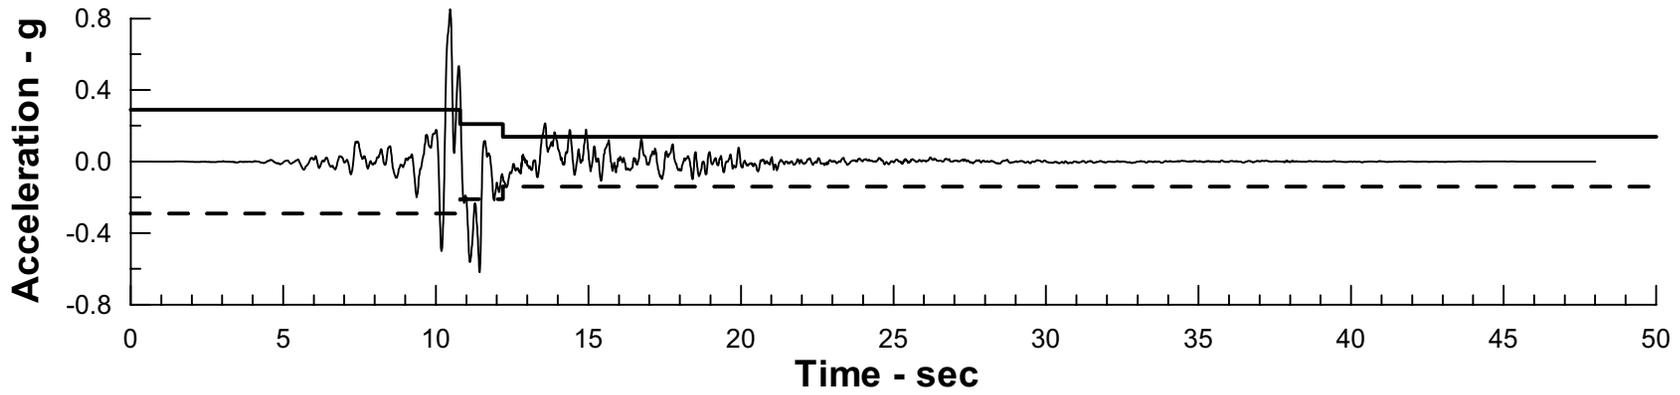
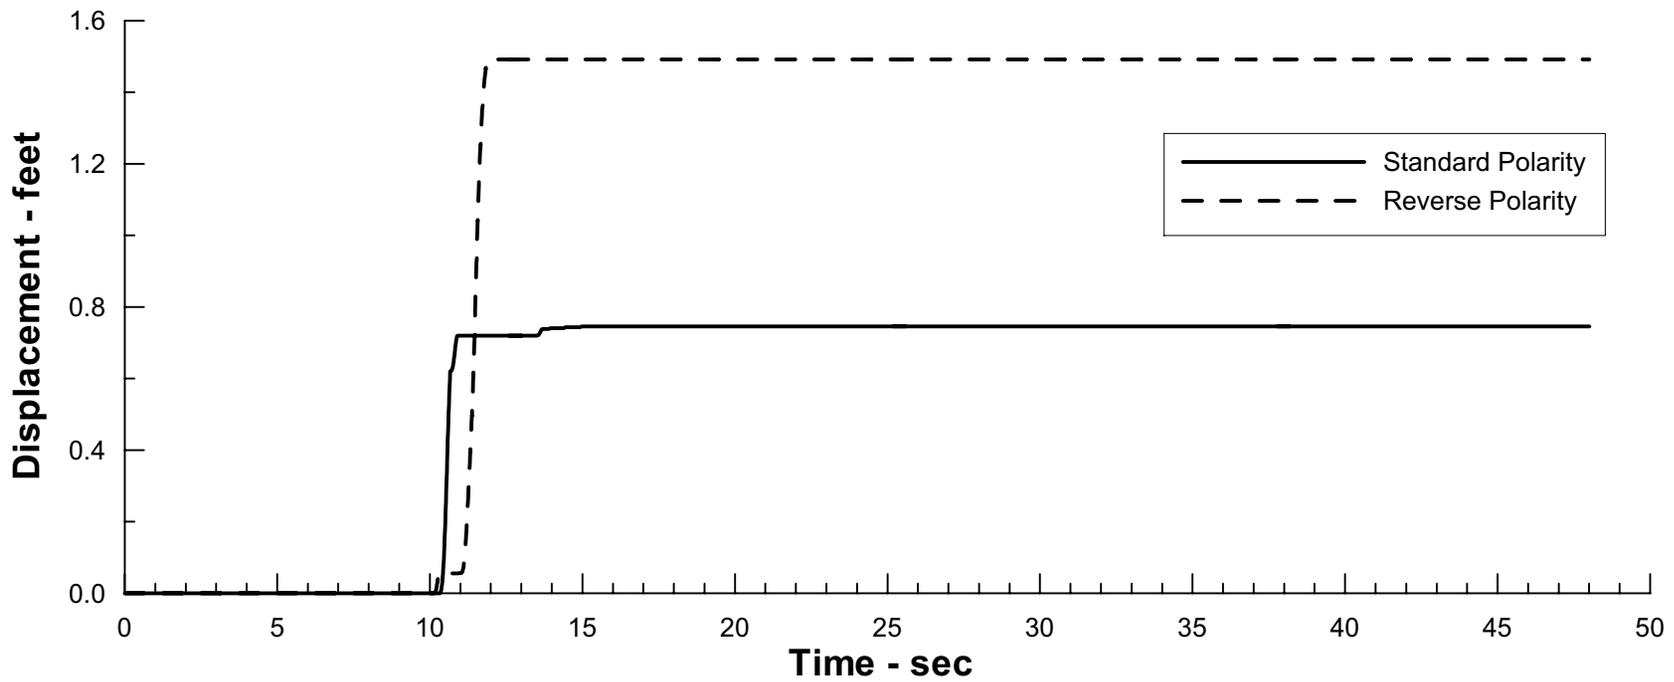
Project No. 26814957	Estates Dam Seismic Stability Analysis	Newmark Deformation Analysis Calculated Displacement D/S Block #3 Hayward Fault MCE TH #1	Figure
URS			11-6

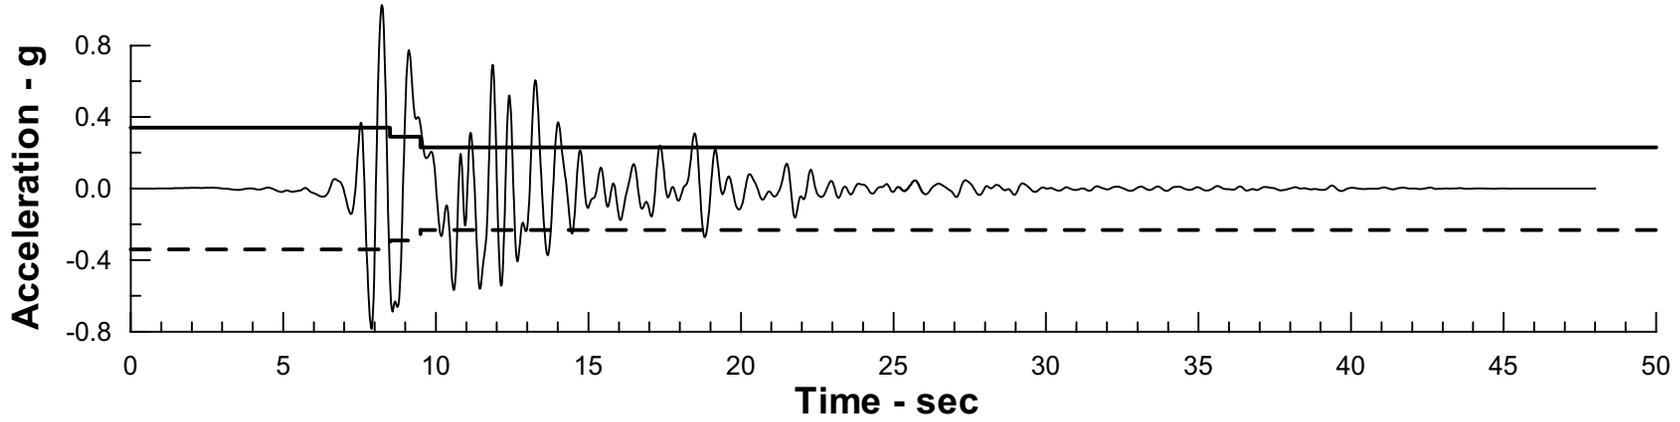
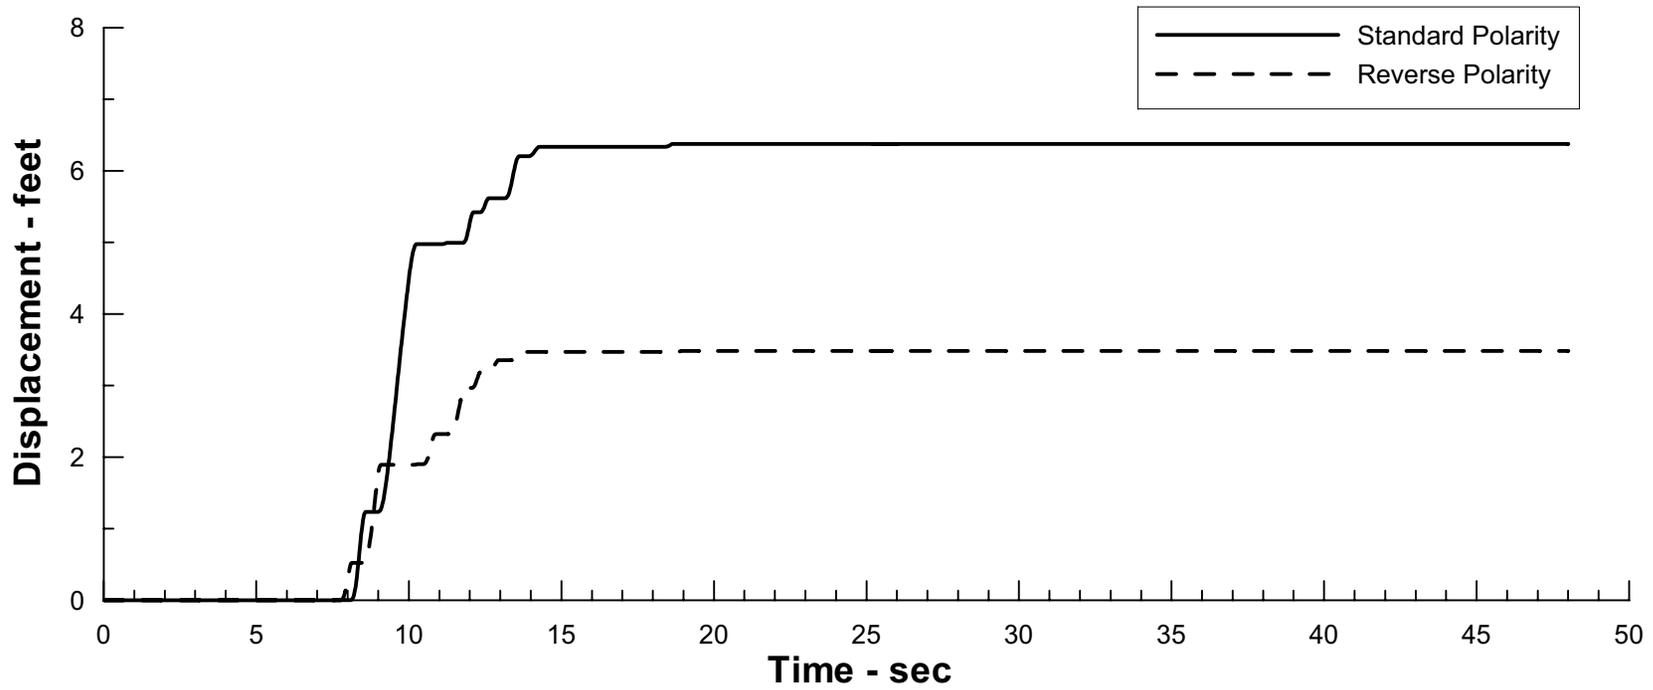
Project No. 26814957	Estates Dam Seismic Stability Analysis	Newmark Deformation Analysis Calculated Displacement U/S Block #1 Hayward Fault MCE TH #2	Figure
URS			11-7

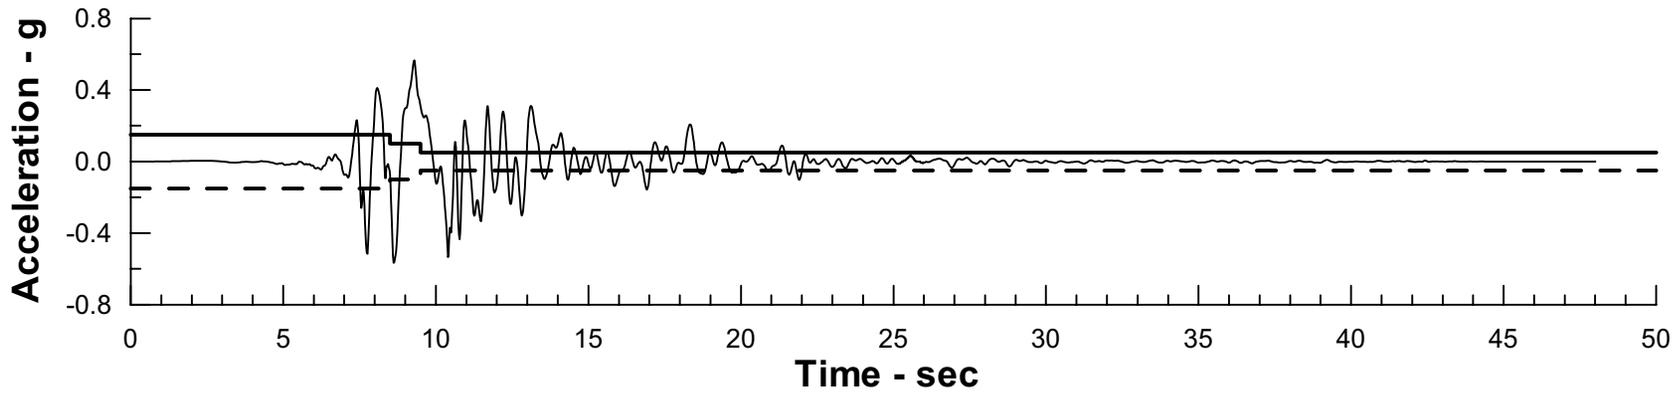
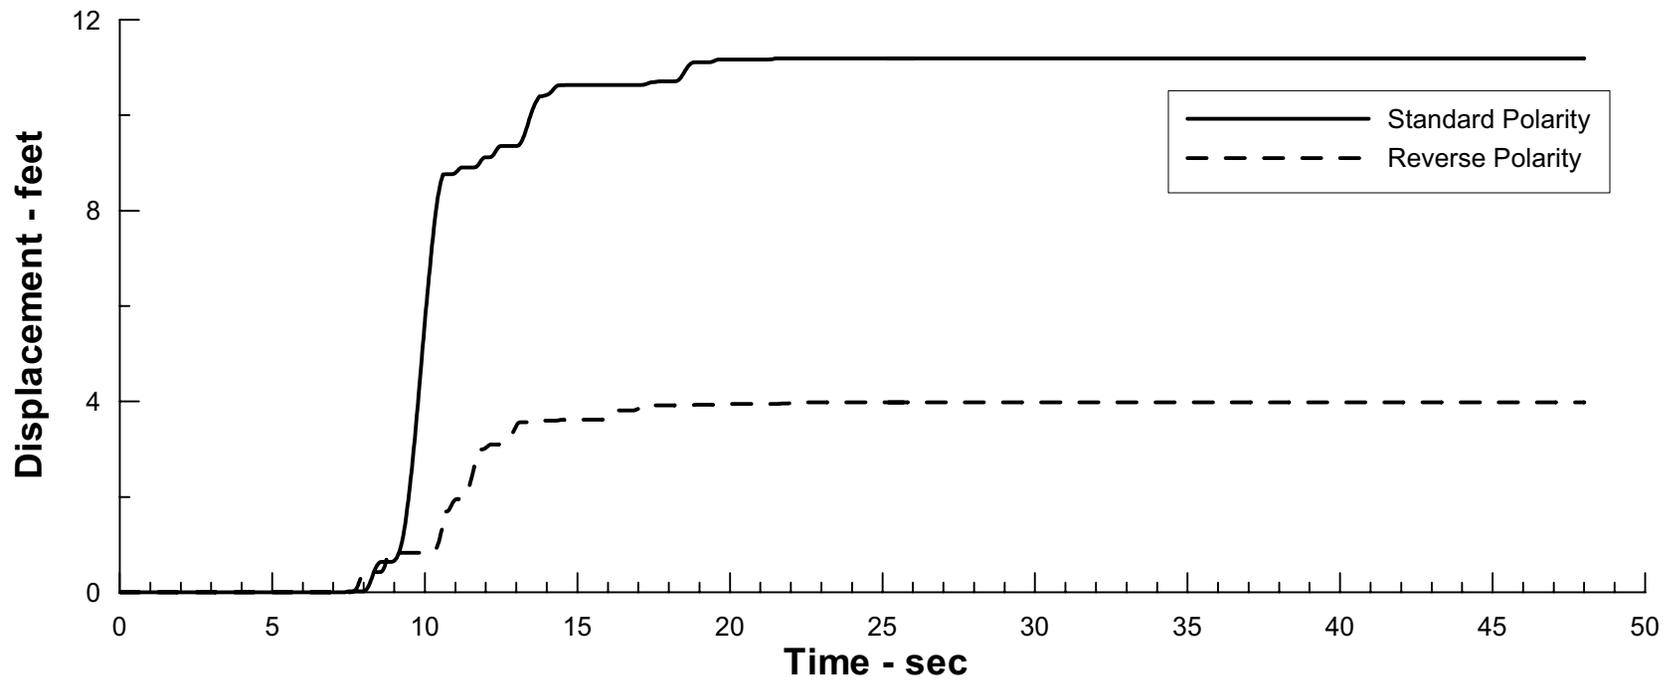
Project No. 26814957	Estates Dam Seismic Stability Analysis	Newmark Deformation Analysis Calculated Displacement D/S Block #2 Hayward Fault Event TH #2	Figure
URS			11-8

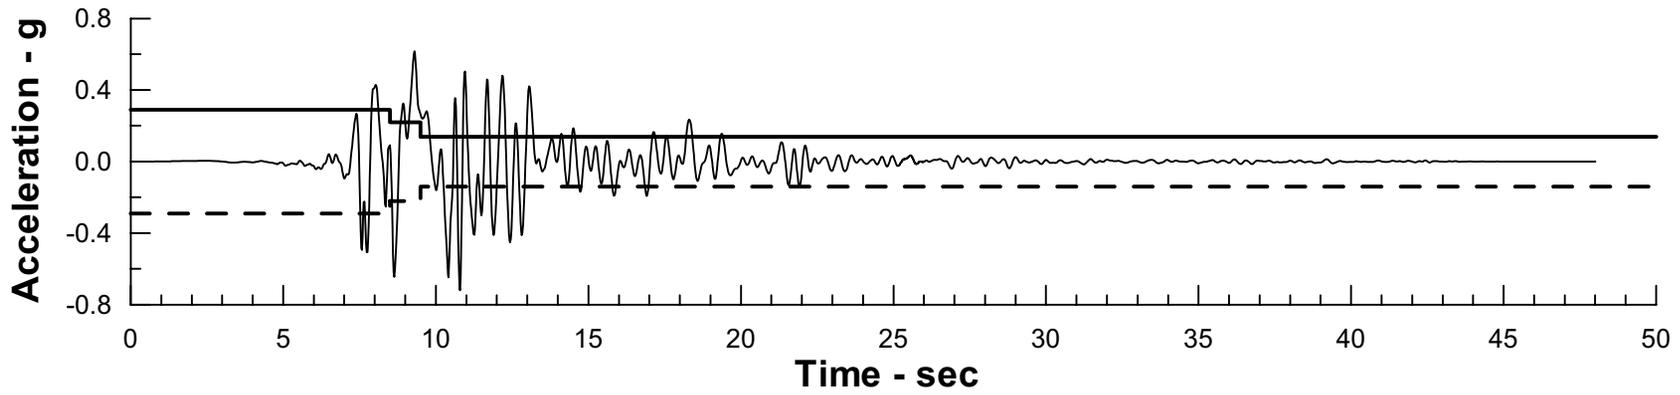
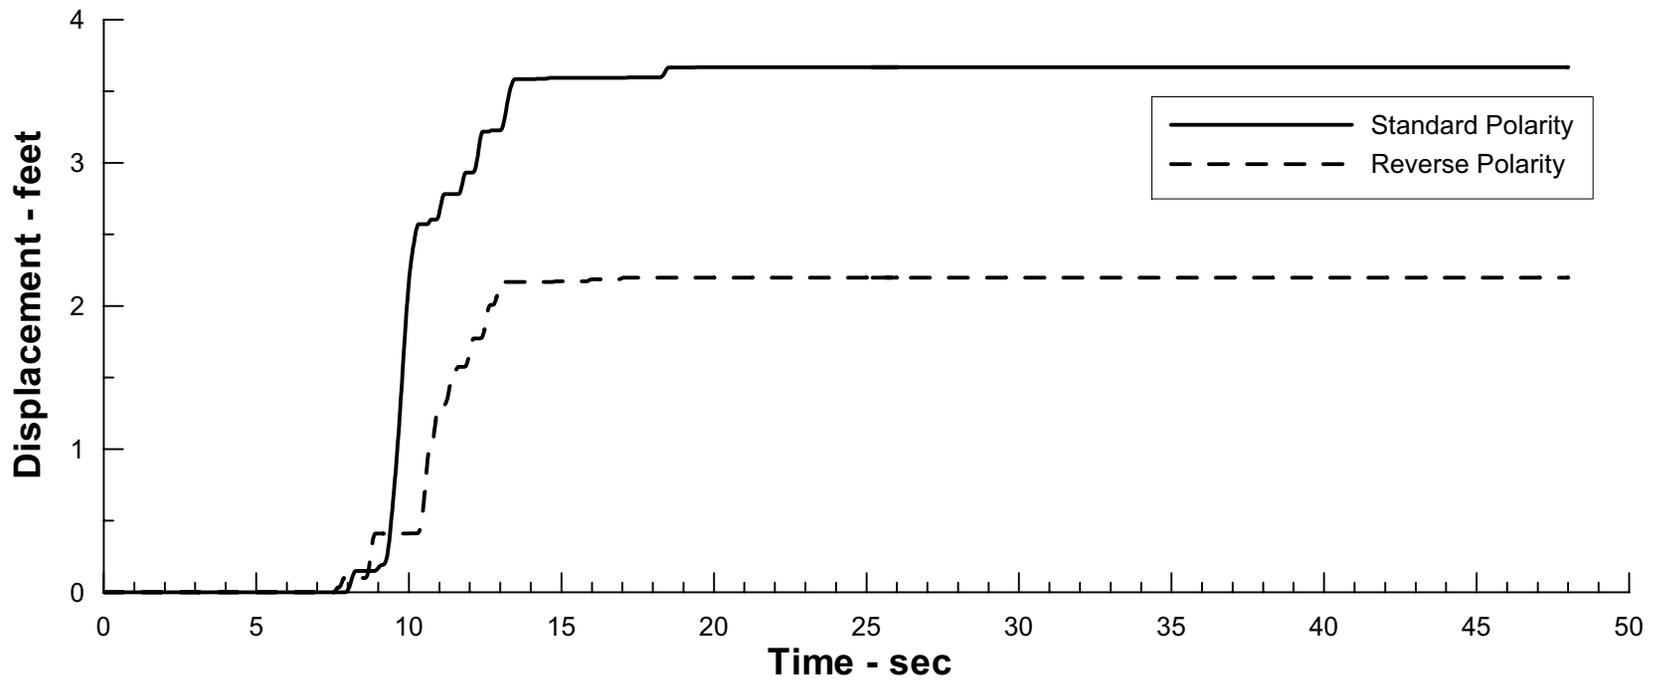
Project No. 26814957	Estates Dam Seismic Stability Analysis	Newmark Deformation Analysis Calculated Displacement D/S Block #3 Hayward Fault Event TH #2	Figure
URS			11-9

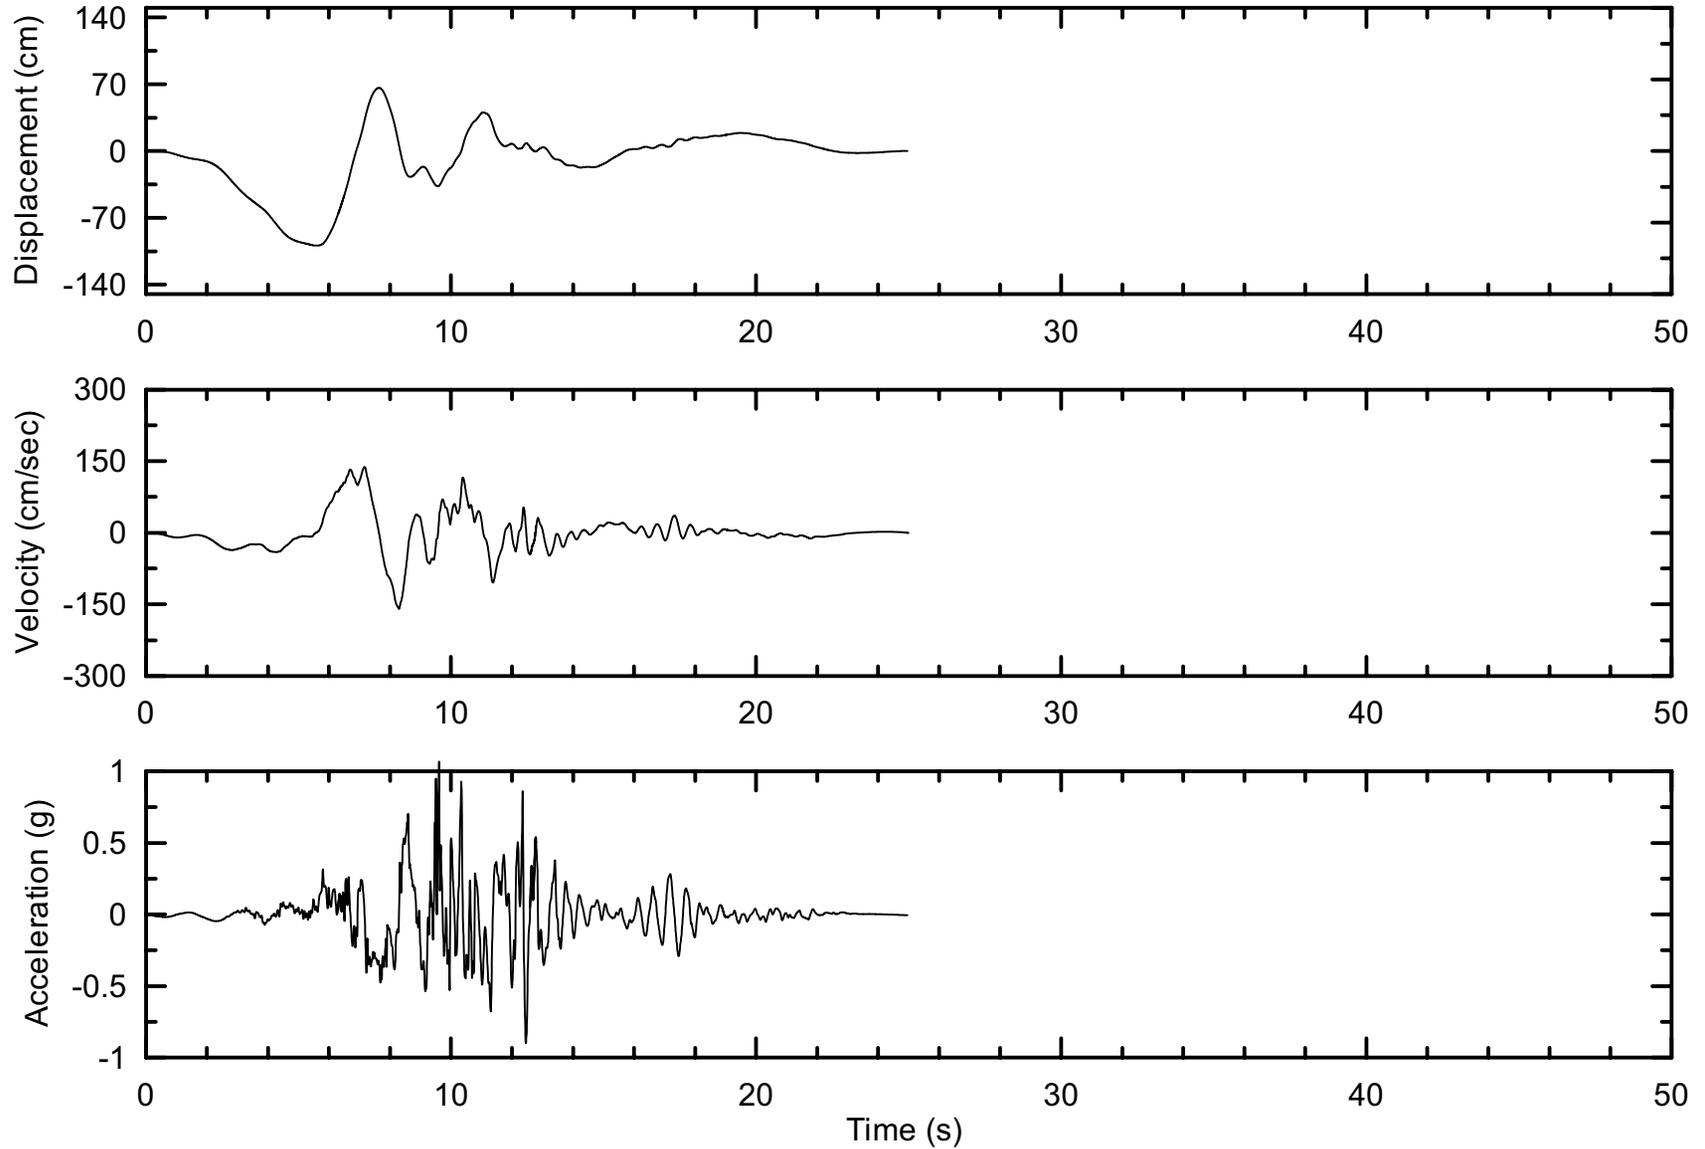
Hayward - Rodgers Creek Fault Event - Recommended Time History # 3
 (Modified from 1989 Loma Prieta, CA Earthquake - UCSC - LGPC Station,
 Horizontal Component, 040 deg.)

Project No. 26814957	Estates Dam Seismic Stability	Hayward - Rodgers Creek Fault MCE Recommended Time History #3	Figure 11-10
URS

To evaluate the sensitivity of the calculated seismic deformations to the details of the ground motion time histories, additional ground motion time histories were developed. Two additional spectrum-compatible acceleration time histories were developed for the Hayward fault MCE, using the same criteria and procedures presented in Section 6.4. The additional time histories (Nos.3 and 4) were based on the 040-degree component of the LGPC Station record of the 1989 Loma Prieta, California earthquake, and the 090-degree component of the Izmit Station record of the 1999 Kocaeli, Turkey earthquake. The recorded time histories were modified so that their spectra after modification closely match the recommended spectrum for the MCE. The acceleration, velocity and displacement time histories of the modified motions and the corresponding 5%-damped acceleration response spectra are plotted in Figures 11-10 through 11-13.

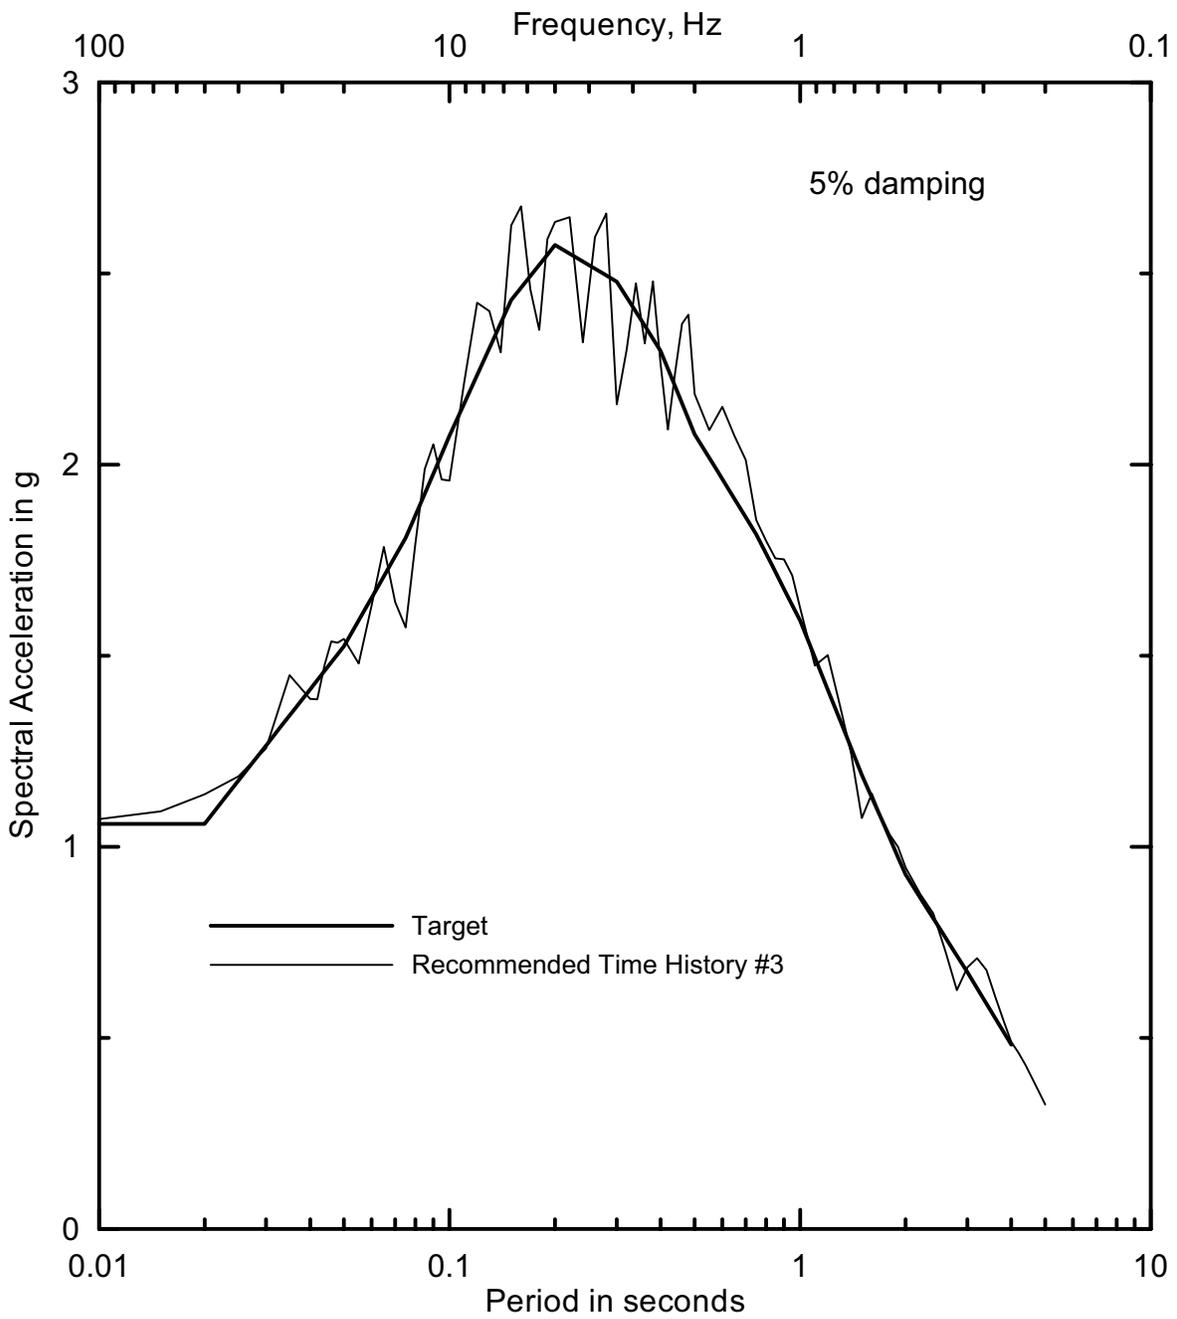
Project No. 26814957	Estates Dam Seismic Stability	Comparison of Acceleration Response Spectra for Hayward - Rodgers Creek Fault MCE Time History #3	Figure
URS			11-11
