FINAL REPORT

Dynamic Stability Analysis of Estates Dam

Oakland, California

NOVEMBER 2006

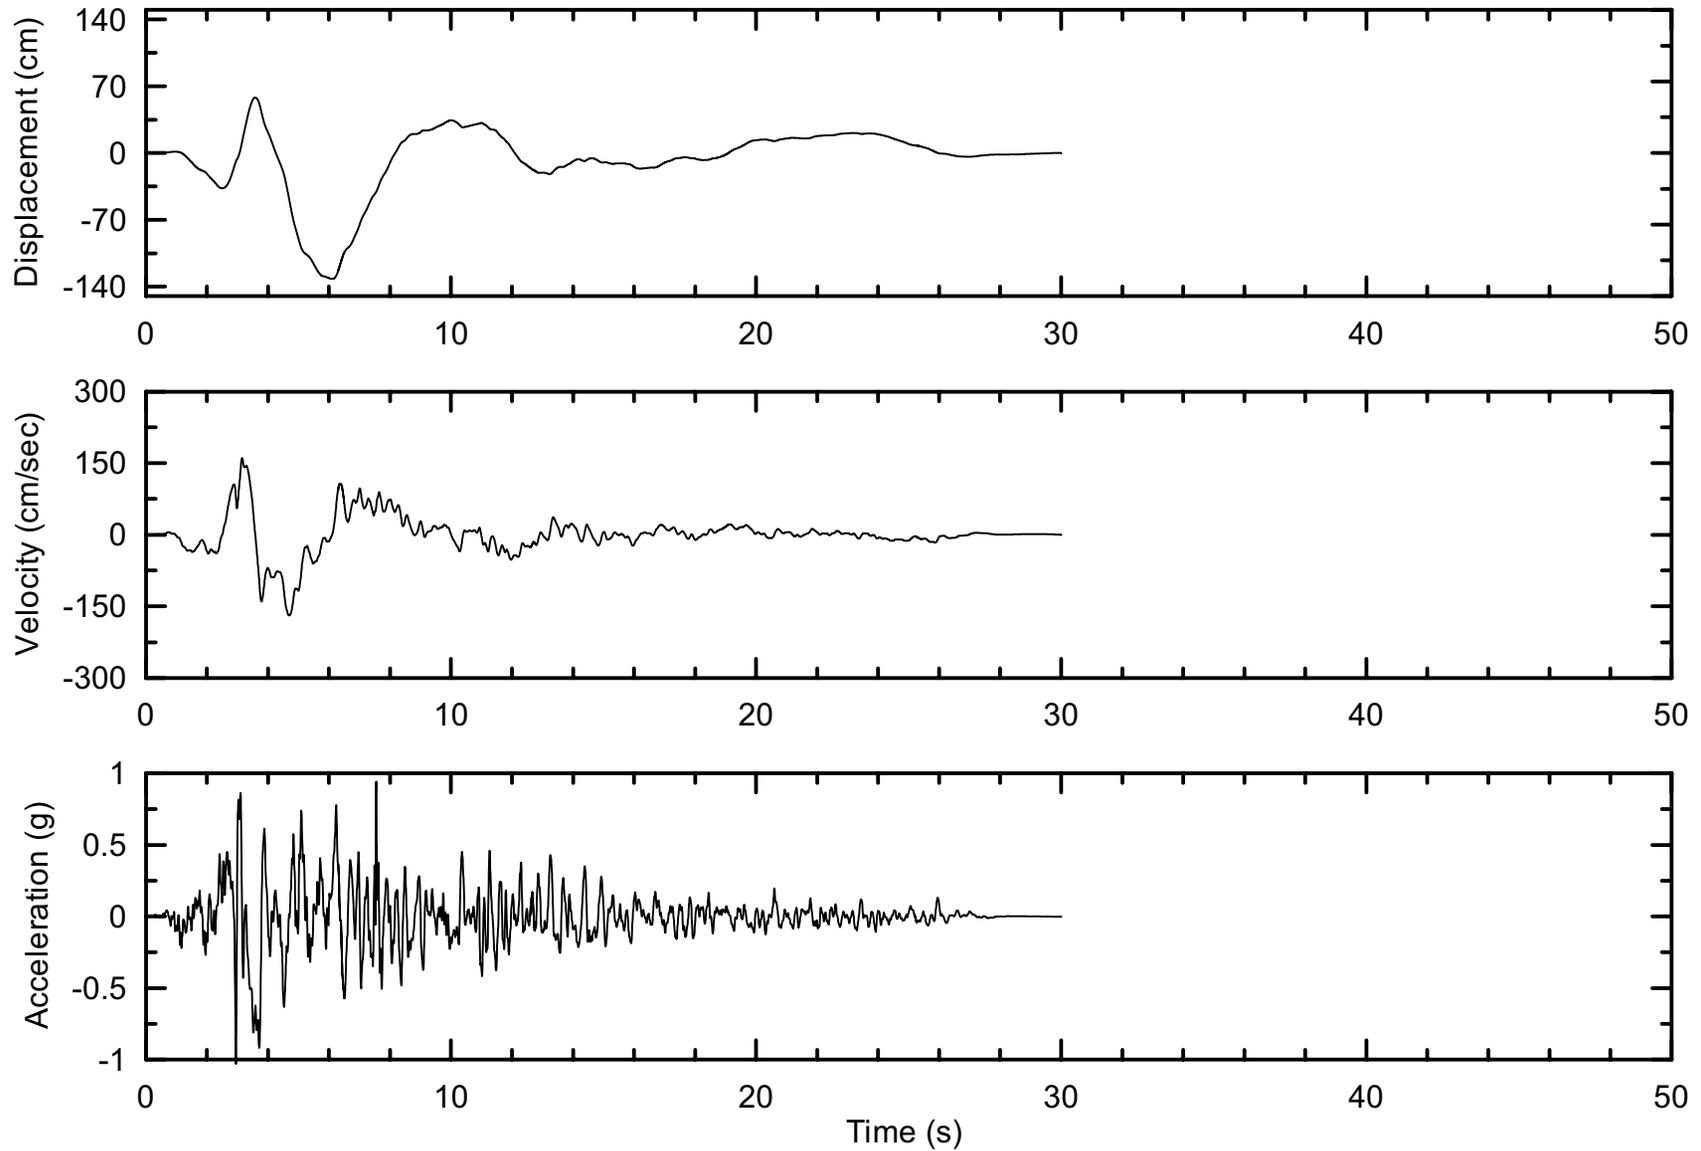
Hayward - Rodgers Creek Fault Event - Recommended Time History # 4
 (Modified from 1999 Kocaeli, Turkey Earthquake - Izmit Station,
 Horizontal Component, 090 deg.)

Project No. 26814957	Estates Dam Seismic Stability	Hayward - Rodgers Creek Fault MCE Recommended Time History #4	Figure 11-12
URS

To evaluate the sensitivity of the calculated seismic deformations to the details of the ground motion time histories, additional ground motion time histories were developed. Two additional spectrum-compatible acceleration time histories were developed for the Hayward fault MCE, using the same criteria and procedures presented in Section 6.4. The additional time histories (Nos.3 and 4) were based on the 040-degree component of the LGPC Station record of the 1989 Loma Prieta, California earthquake, and the 090-degree component of the Izmit Station record of the 1999 Kocaeli, Turkey earthquake. The recorded time histories were modified so that their spectra after modification closely match the recommended spectrum for the MCE. The acceleration, velocity and displacement time histories of the modified motions and the corresponding 5%-damped acceleration response spectra are plotted in Figures 11-10 through 11-13.

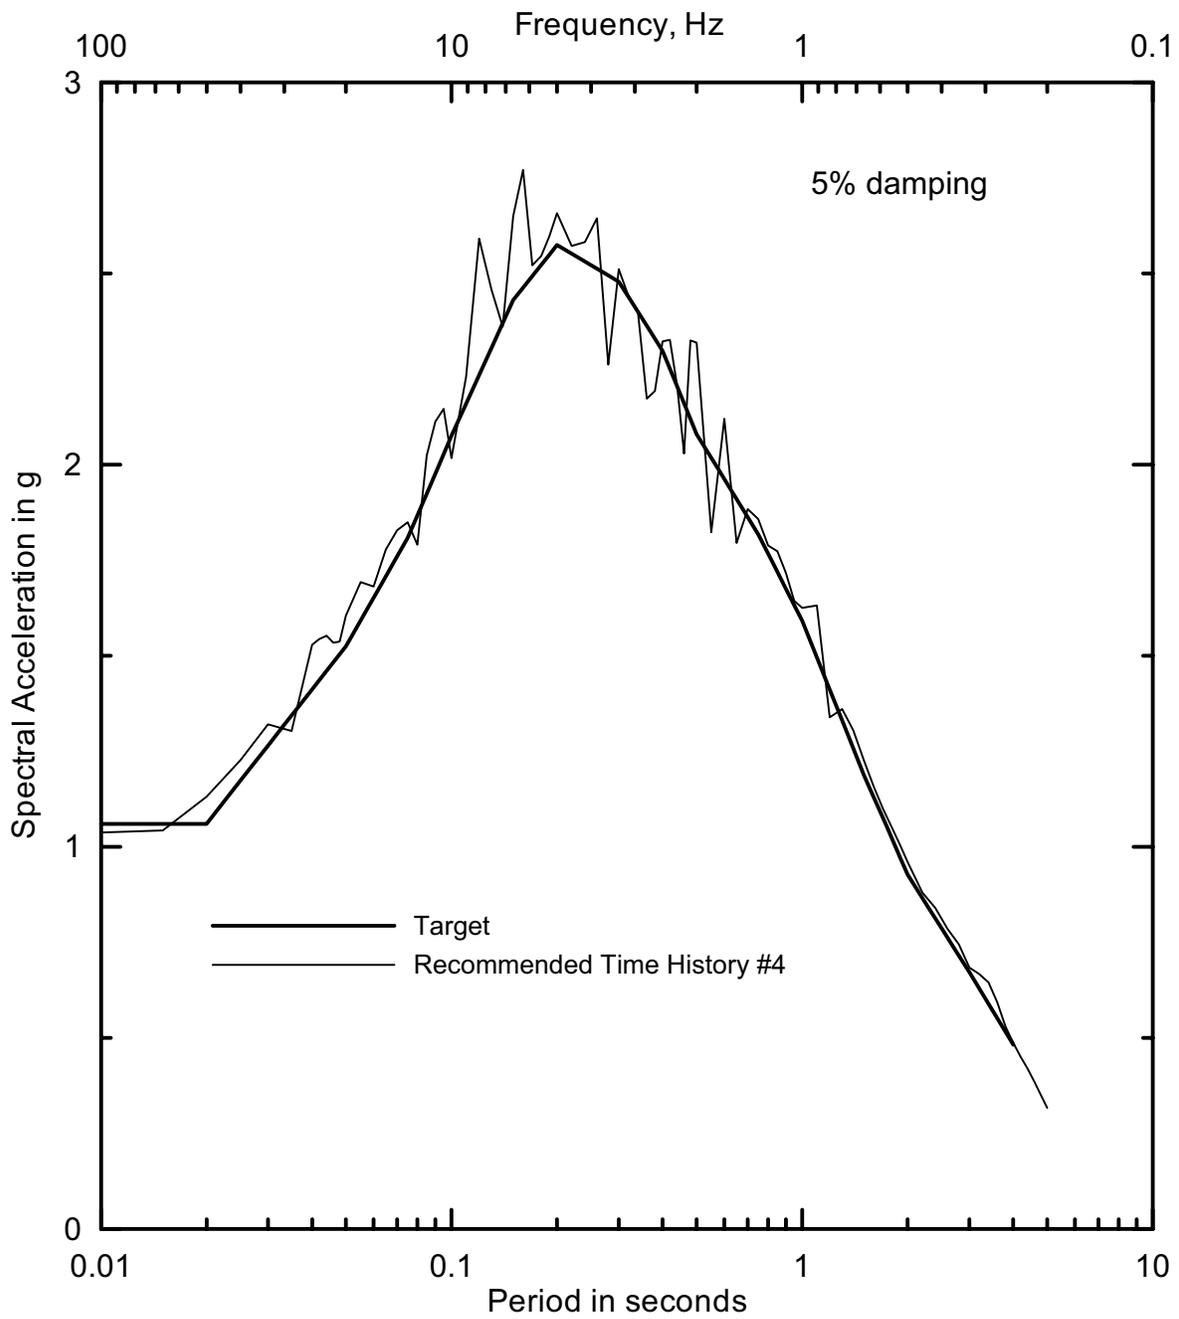
Project No. 26814957	Estates Dam Seismic Stability	Comparison of Acceleration Response Spectra for Hayward - Rodgers Creek Fault MCE Time History #4	Figure
URS			11-13

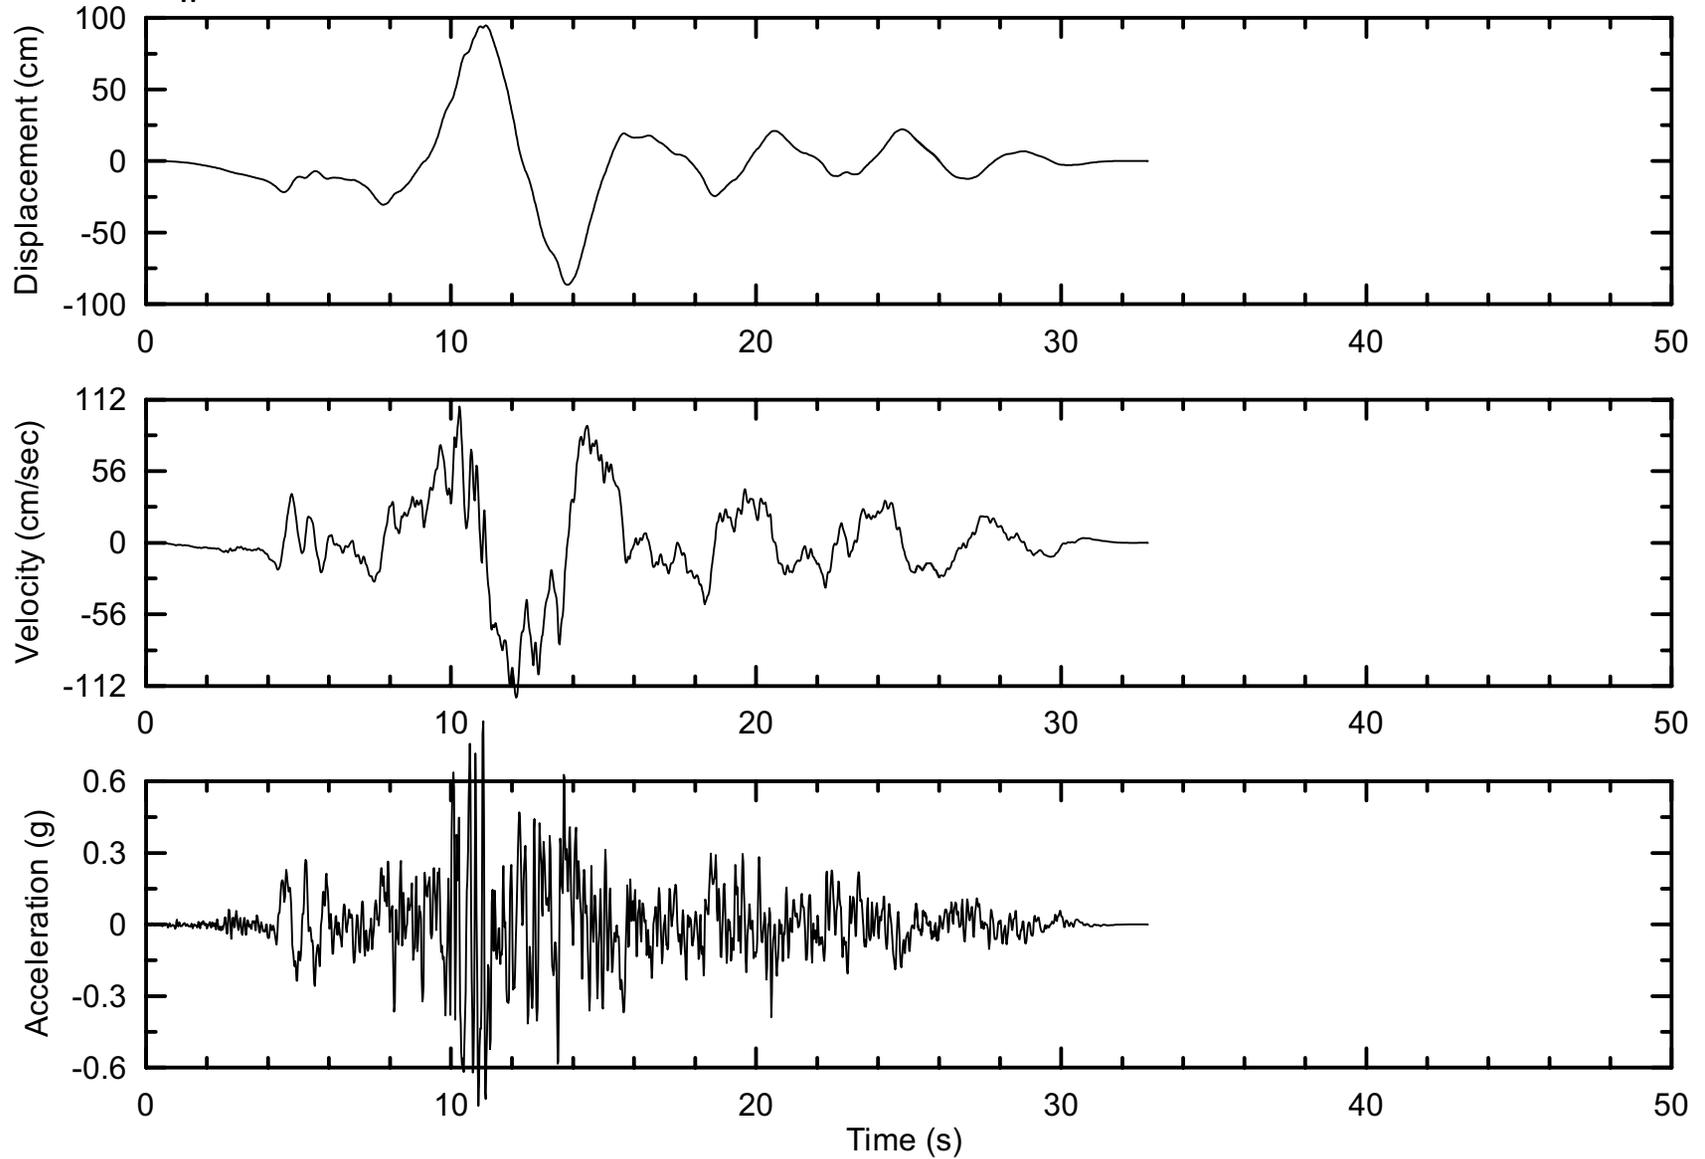
1978 Tabas, Iran Earthquake Time History
 at Tabas Station,
 $M_w = 7.4$, $R = 3$ km

Project No. 26814957	Estates Dam Seismic Stability	Recorded Time History 1978 Tabas, Iran Earthquake at Tabas Station, Horizontal Component, 344 deg.	Figure 11-14
URS

In addition, two recorded motions (without modification) were used for the sensitivity study. They are the 344-degree component of the Tabas Station record of the M 7.4 1978 Tabas, Iran earthquake and the 000-degree component of the LGPC Station record of the M 7 1989 Loma Prieta, California earthquake. The acceleration, velocity and displacement time histories of these records and the corresponding 5%-damped acceleration response spectra are plotted in Figures 11-14 through 11-17.

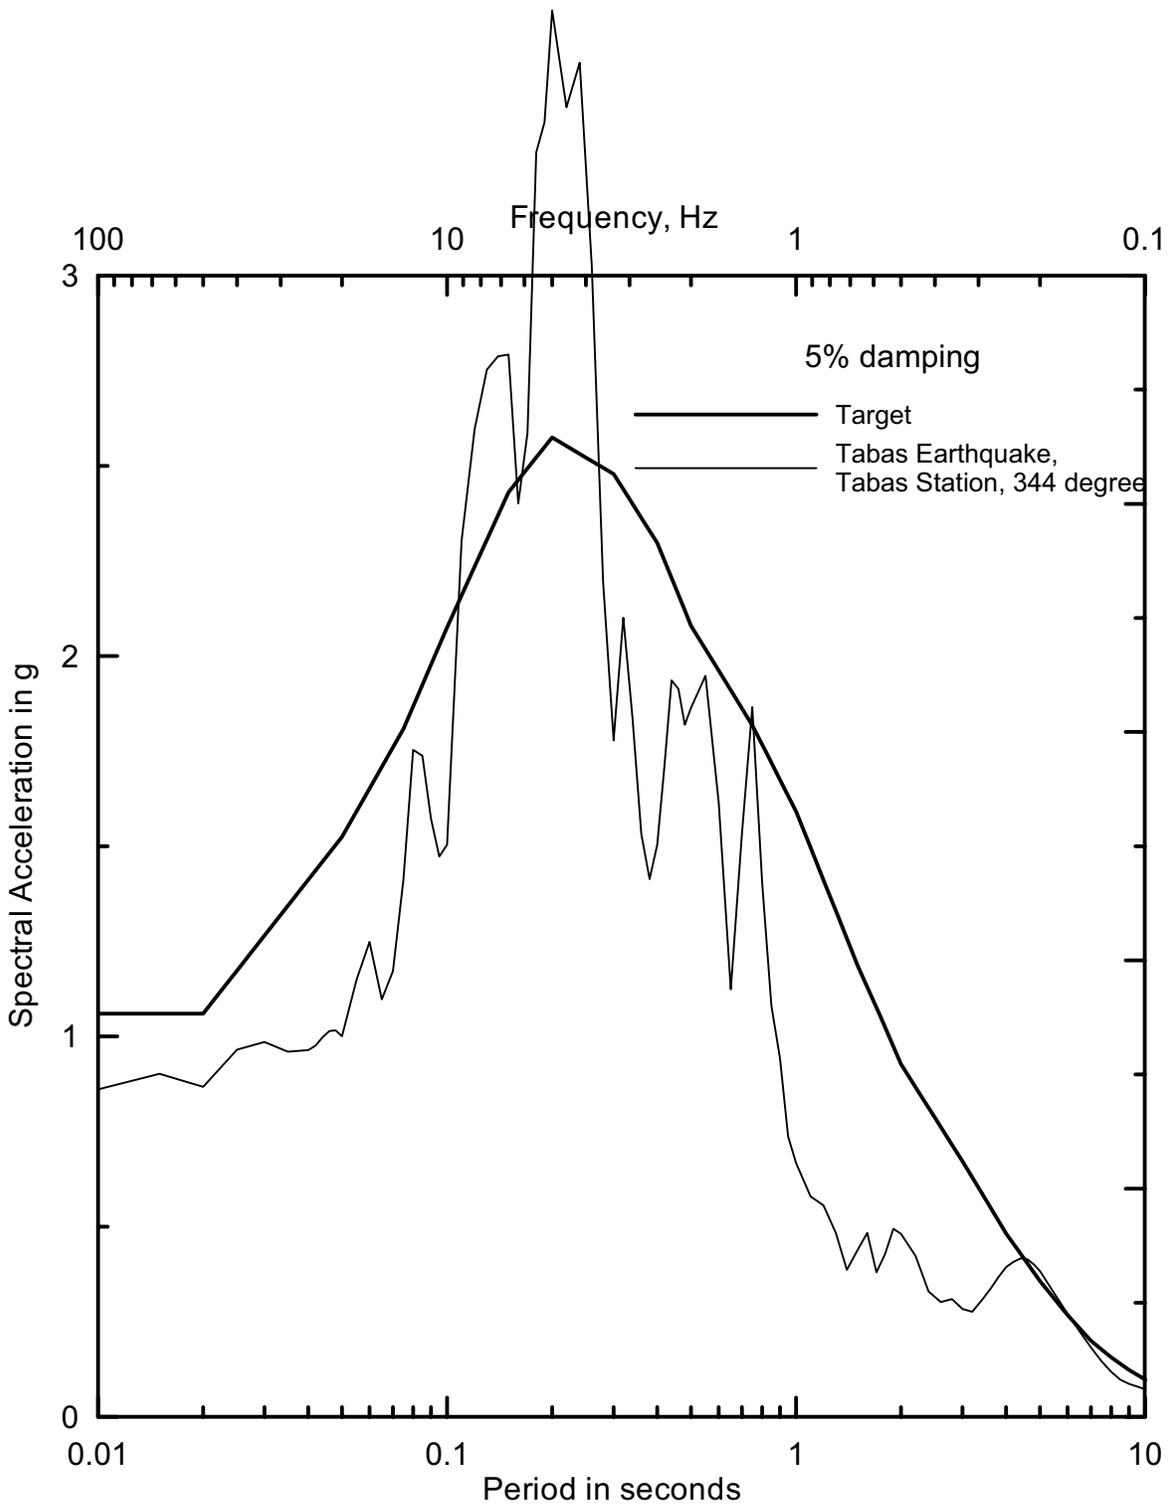
Project No. 26814957	Estates Dam Seismic Stability	1978 Tabas, Iran Earthquake at Tabas Station, Horizontal Component, 344 Degree	Figure 11-15
URS

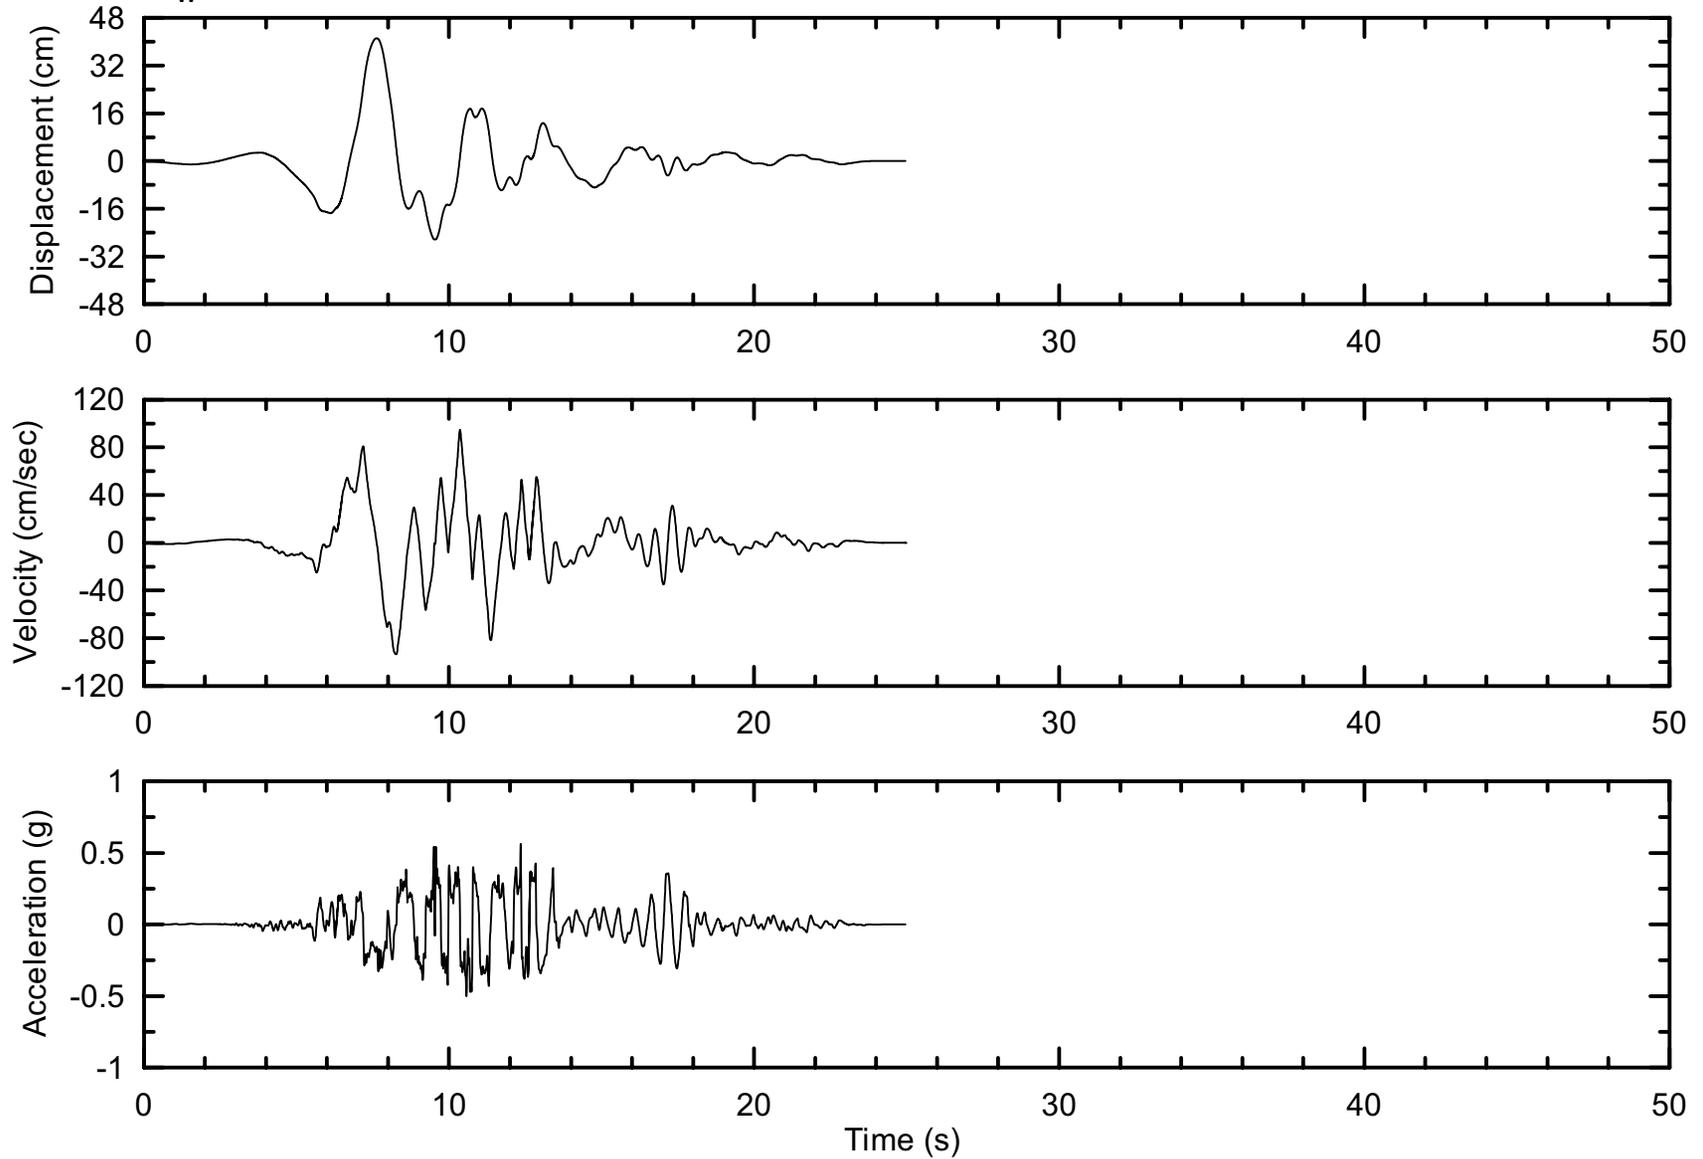
1989 Loma Prieta, CA Earthquake Time History
 Recorded at UCSC - LGPC Station, 000 degree
 $M_w = 7.0$, $R = 6.1$ km

Project No. 26814957	Estates Dam Seismic Stability Analysis	Recorded Time History 1989 Loma Prieta, CA Earthquake at UCSC - LGPC Station, Horizontal Component, 000 deg.	Figure 11-16
URS

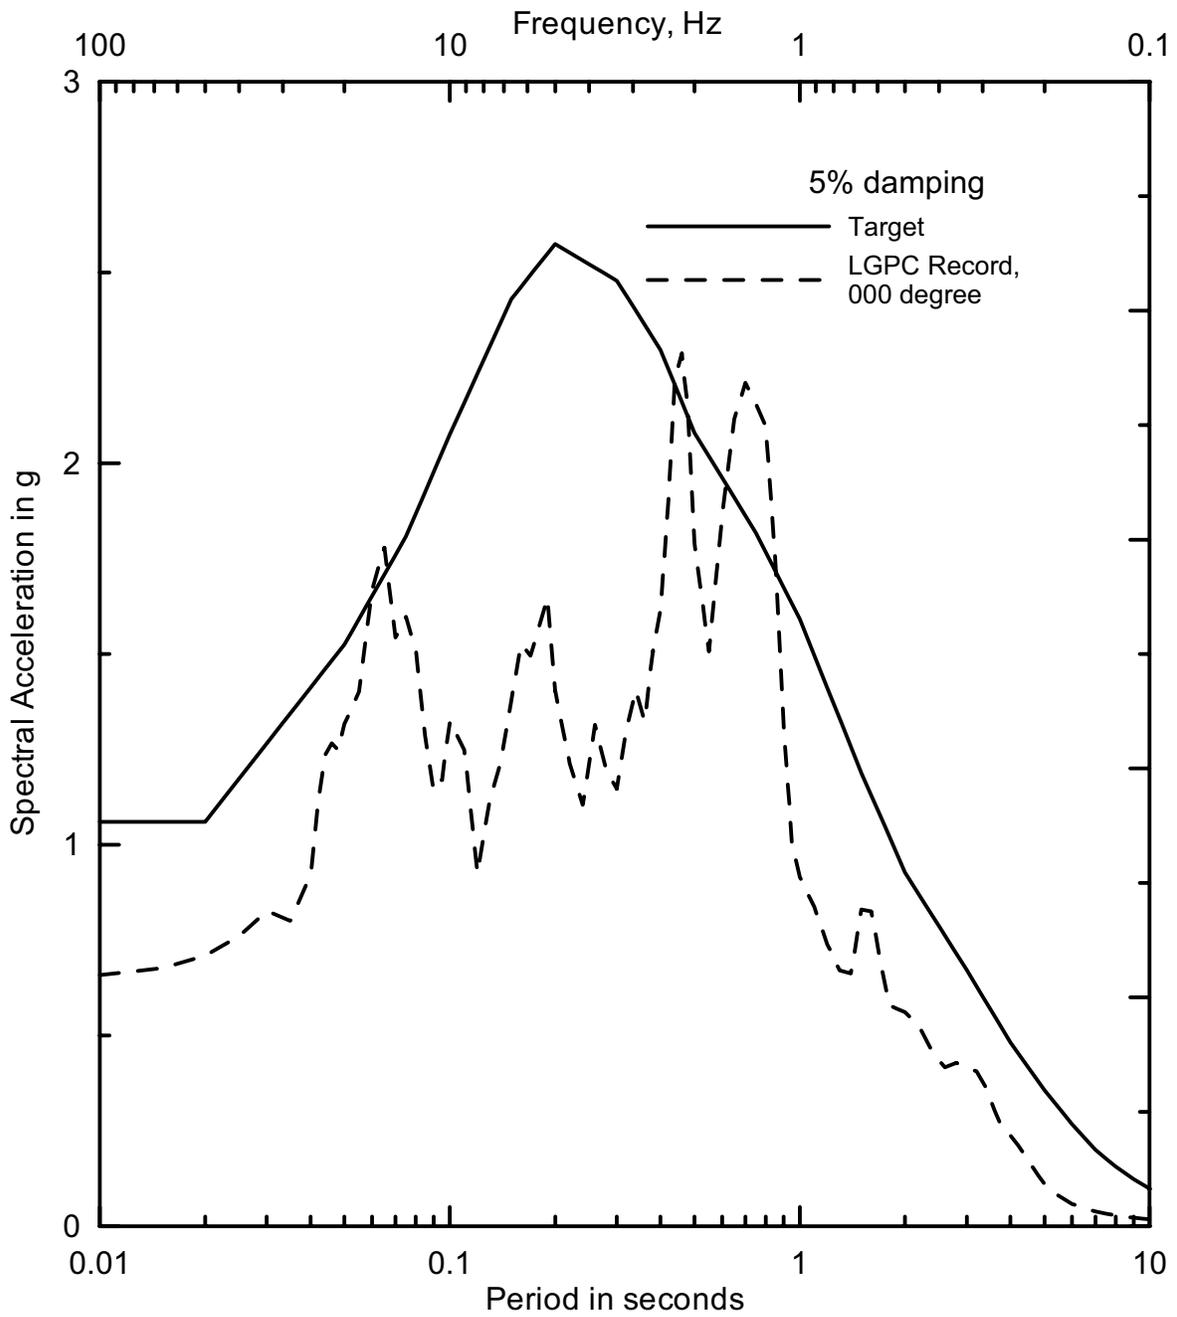
Project No. 26814957	Estates Dam Seismic Stability	1989 Loma Prieta, CA Earthquake at UCSC - LGPC Station, Horizontal 000 deg Component	Figure 11-17
URS

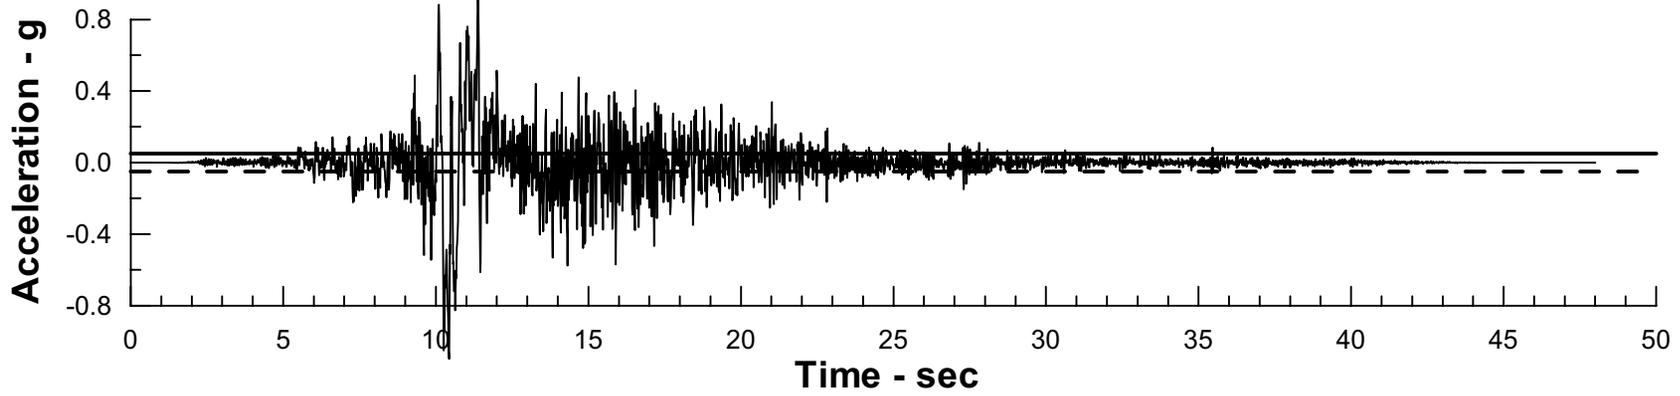
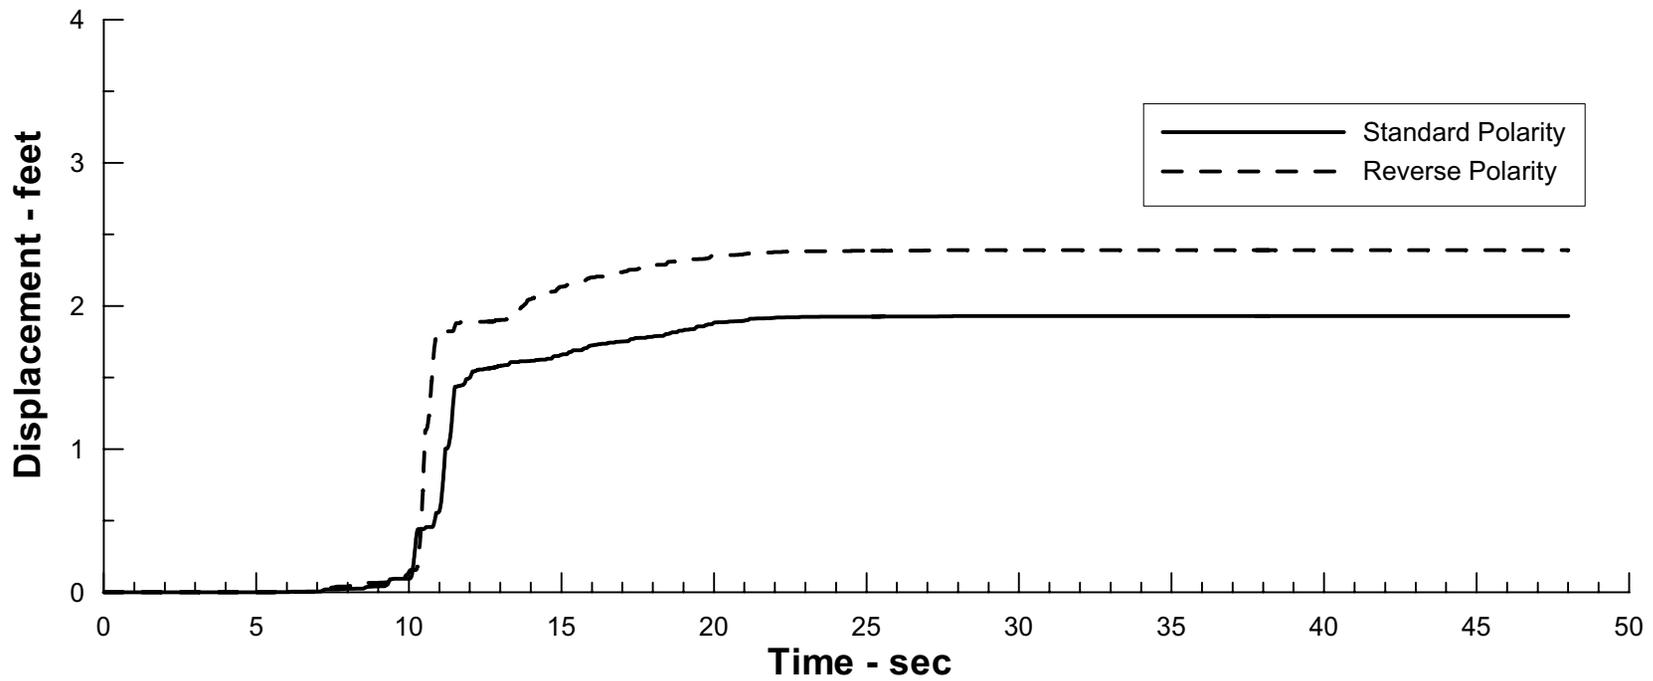
Acceleration time-history: Hayward Fault Event TH #1

Project No. 26814957	Estates Dam Seismic Stability Analysis	Simplified Newmark Analysis Calculated Displacement Assumed $K_y = 0.05$ Hayward Fault MCE TH #1	Figure
URS			11-18

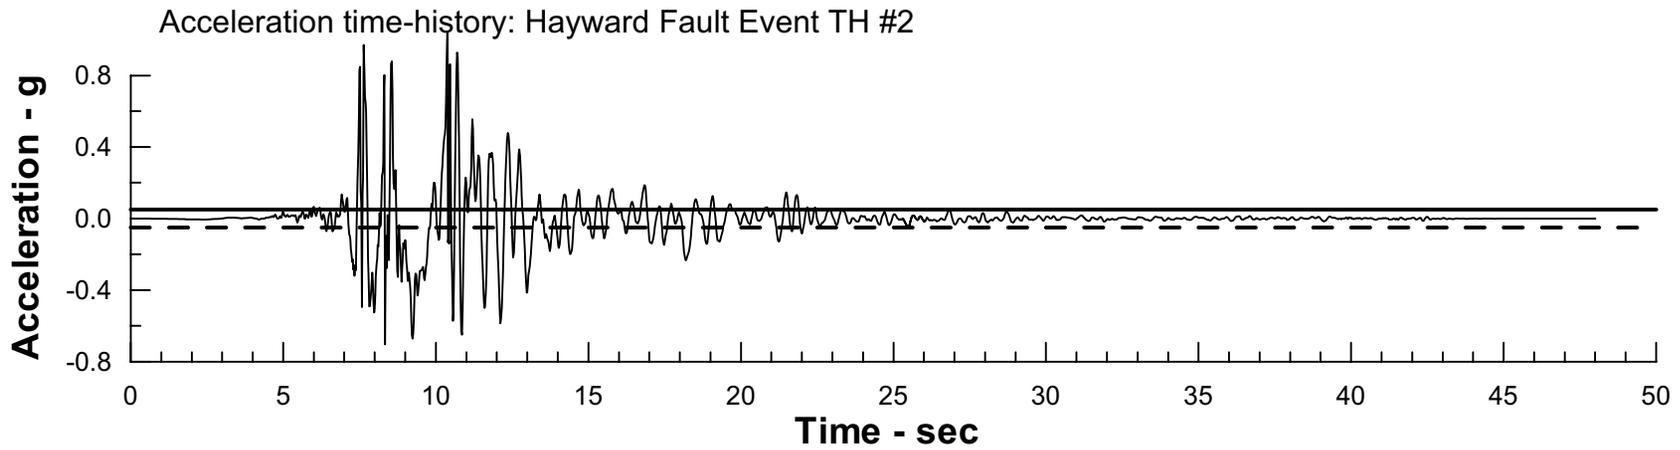
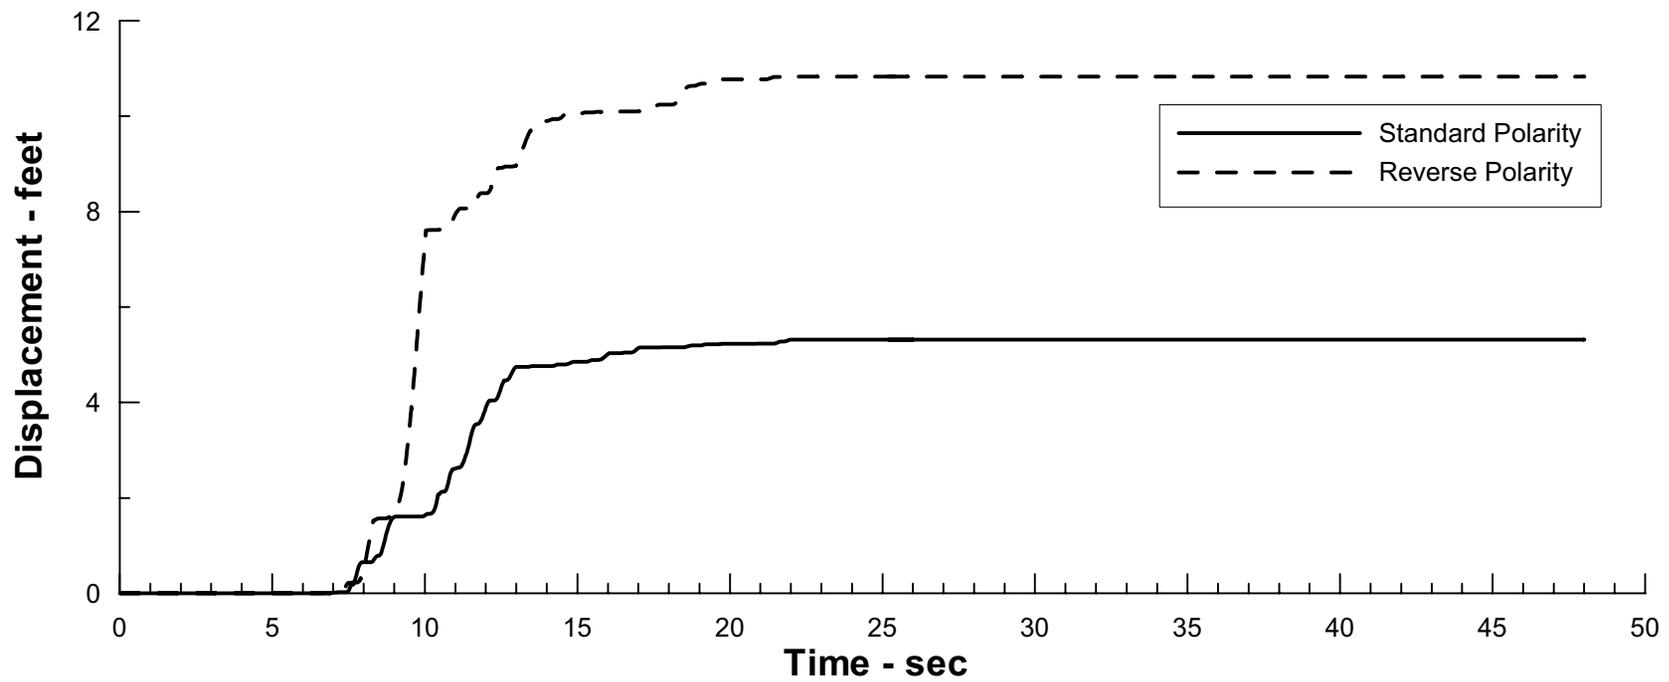
Project No. 26814957	Estates Dam Seismic Stability Analysis	Simplified Newmark Analysis Calculated Displacement Assumed $K_y = 0.05$ Hayward Fault MCE TH #2	Figure
URS			11-19

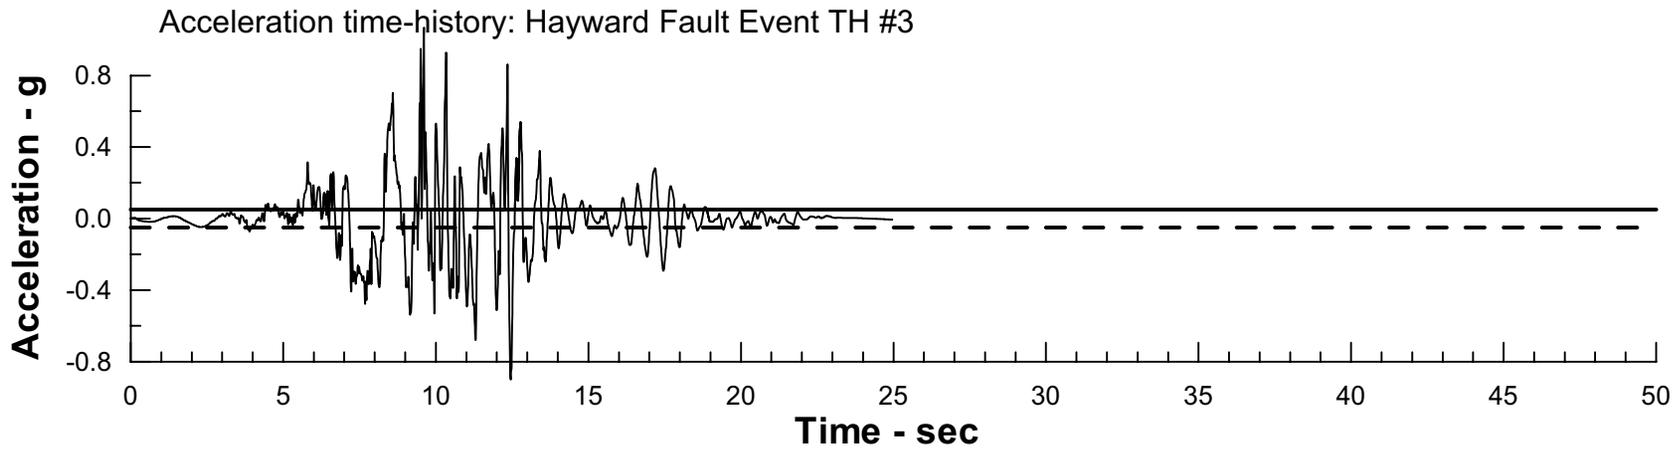
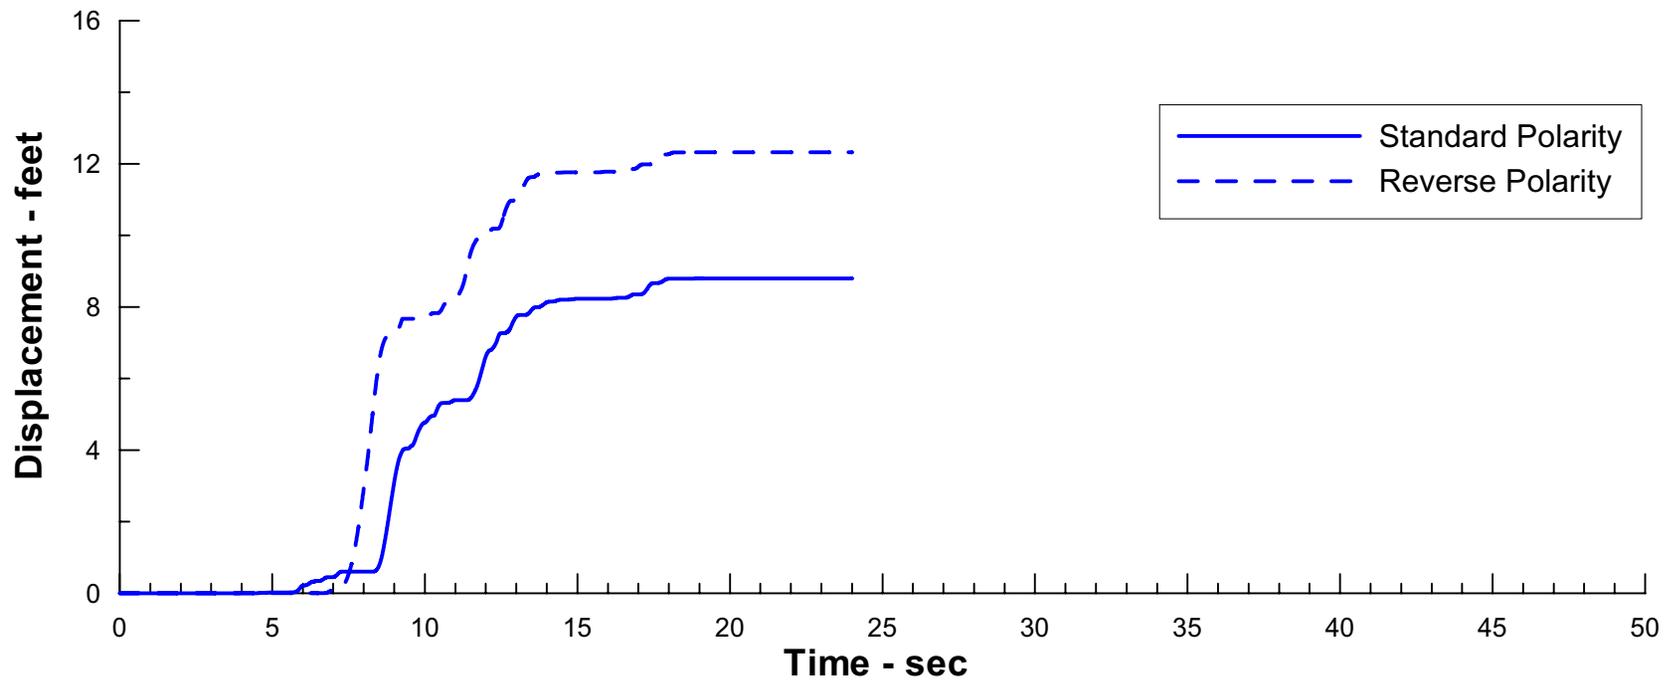
Project No. 26814957	Estates Dam Seismic Stability Analysis	Simplified Newmark Analysis Calculated Displacement Assumed $K_y = 0.05$ Hayward Fault MCE TH #3	Figure
URS			11-20

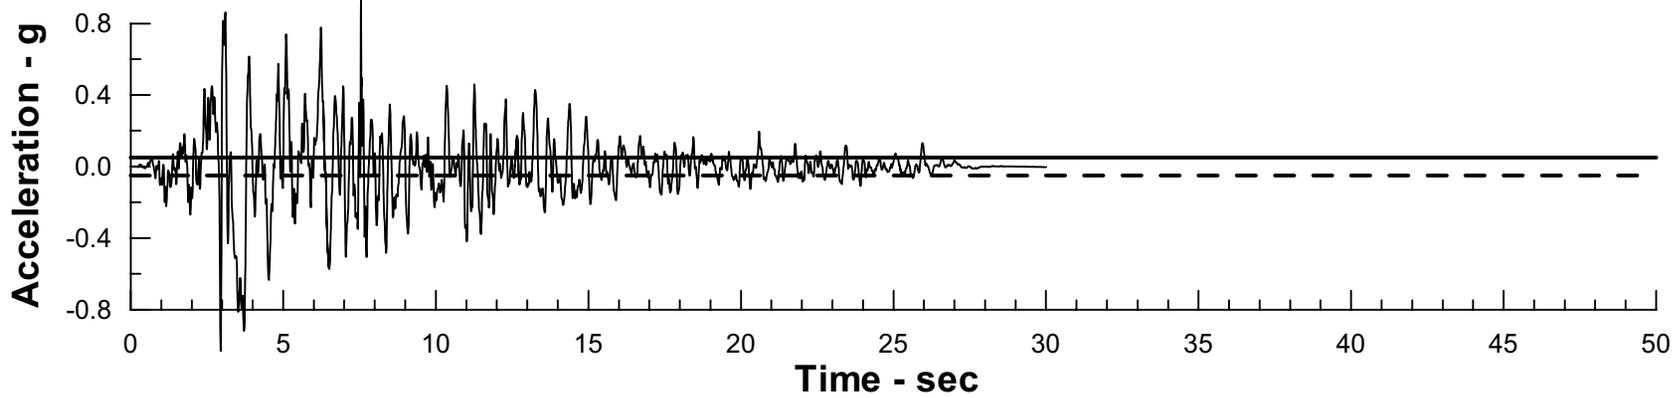
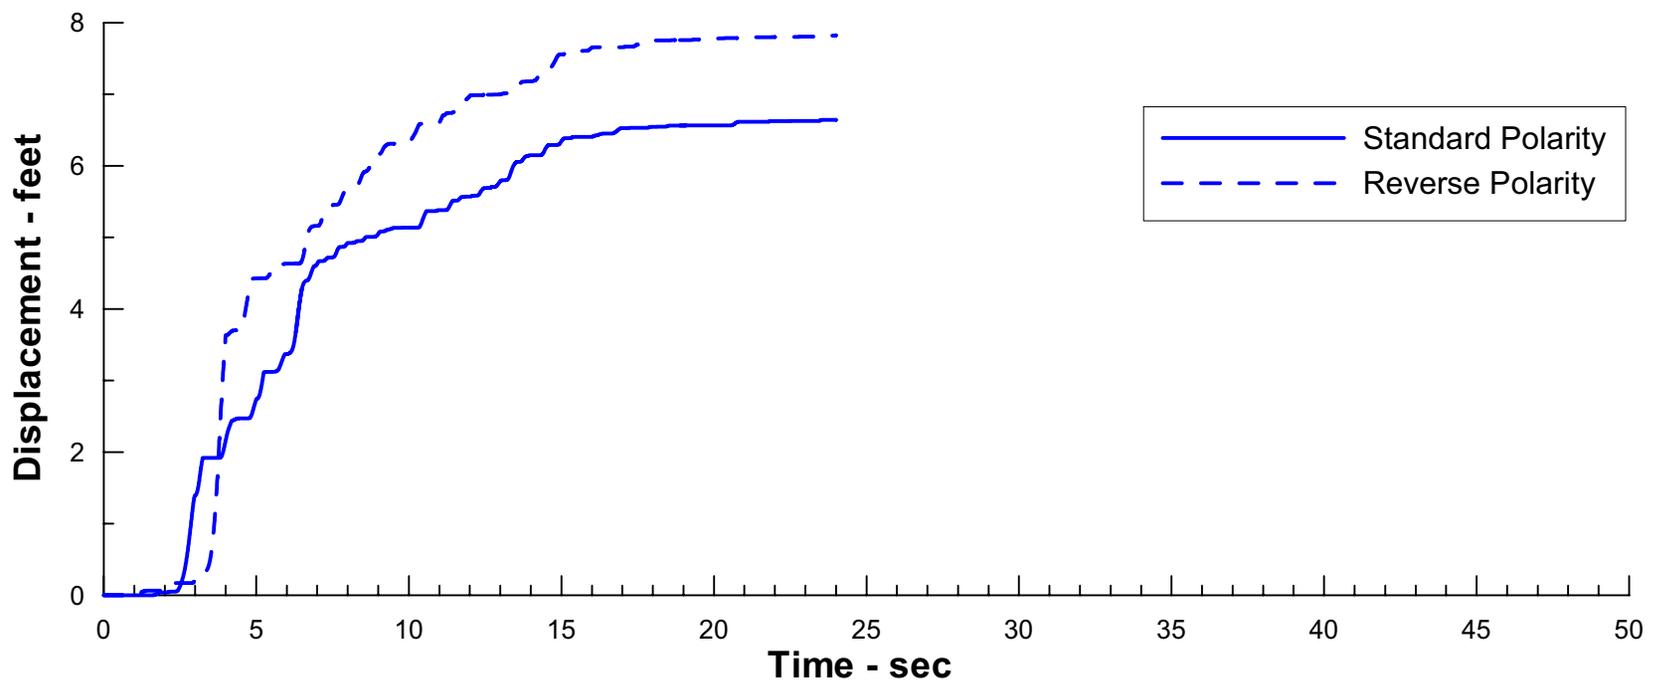
Acceleration time-history: Hayward Fault Event TH #4

Project No. 26814957	Estates Dam Stability and Deformation Analysis	Simplified Newmark Analysis Calculated Displacement Assumed $K_y = 0.05$ Hayward Fault MCE TH #4	Figure 11-21
URS

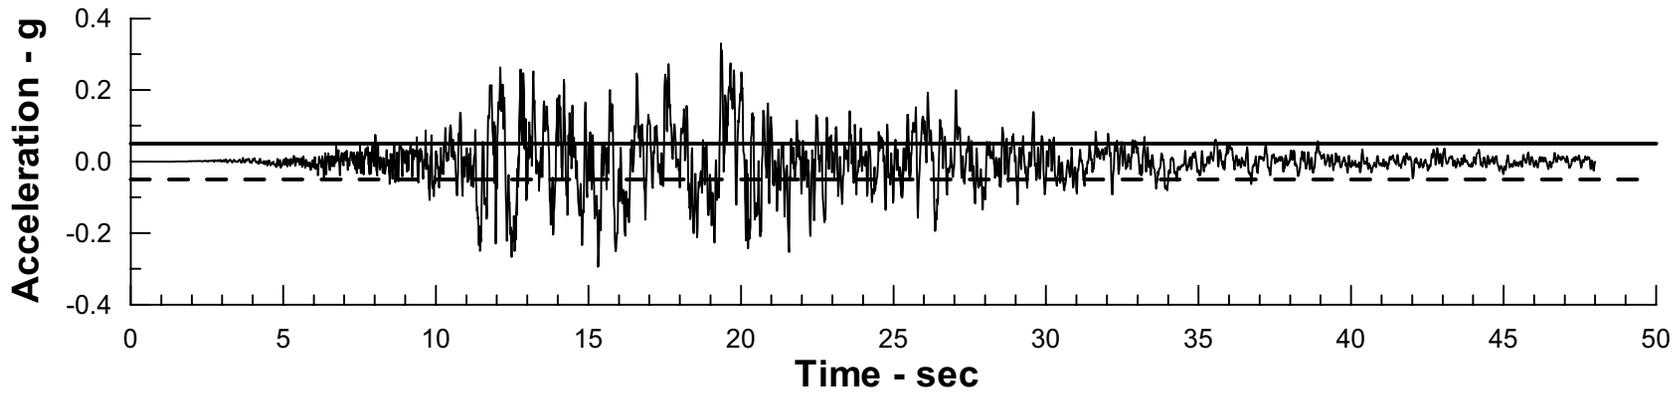
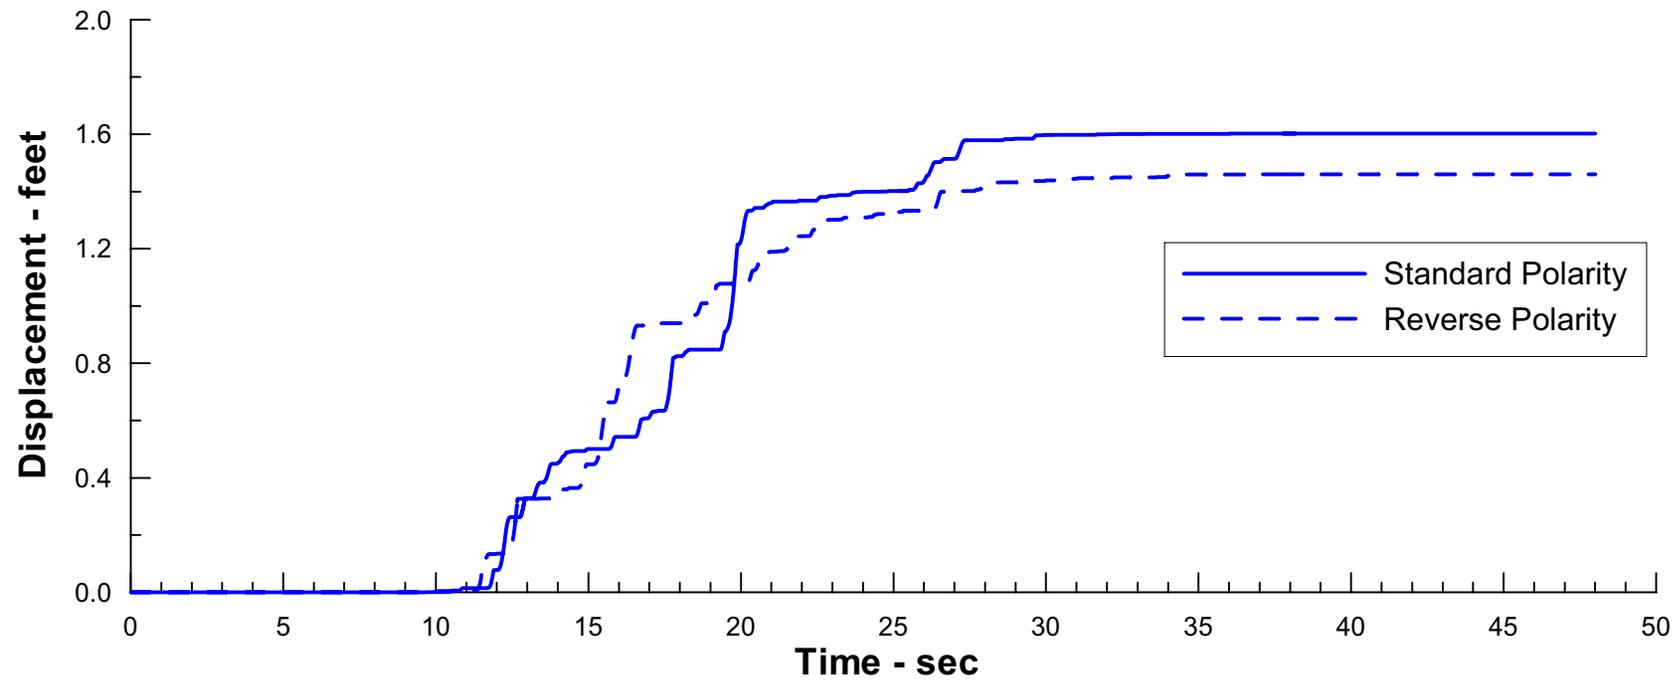
Acceleration time-history: San Andreas Fault MCE

Project No. 26814957	Estates Dam Seismic Stability Analysis	Simplified Newmark Analysis Calculated Displacement Assumed $K_y = 0.05$ San Andreas Fault MCE	Figure 11-22
URS

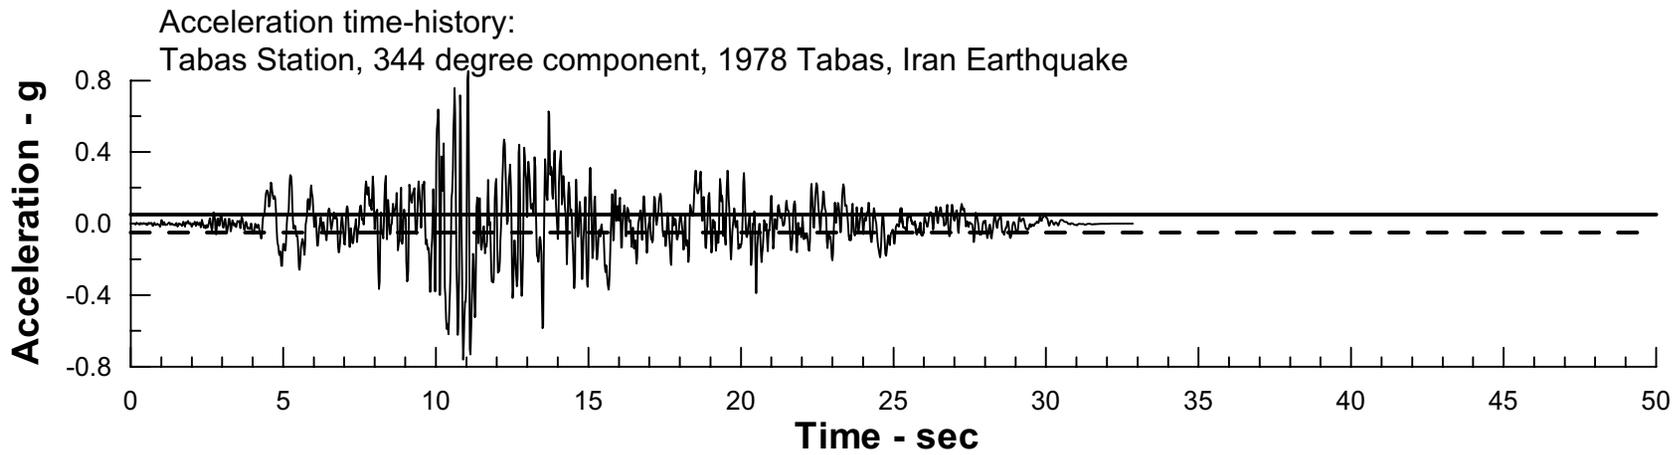
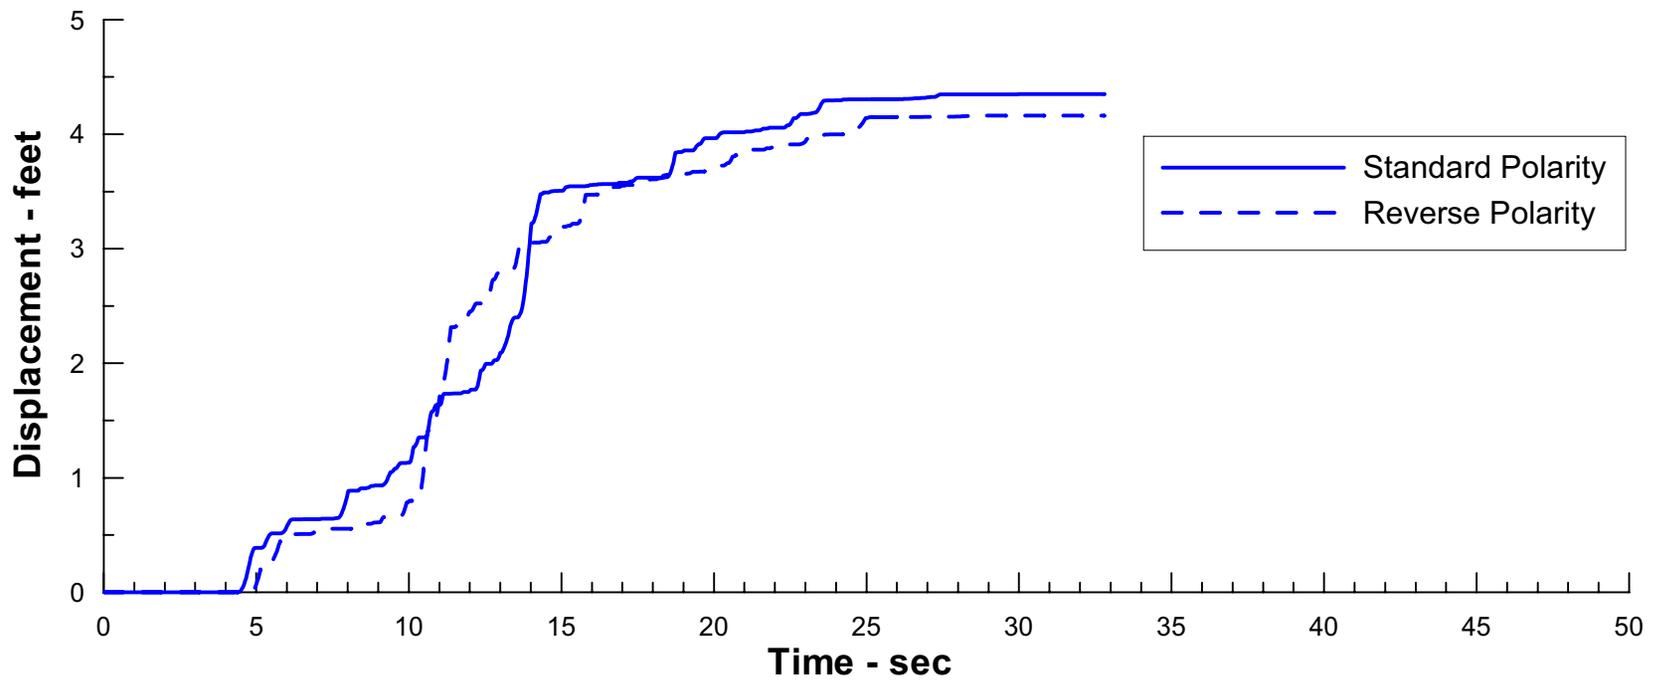
Project No. 26814957	Estates Dam Seismic Stability Analysis	Simplified Newmark Analysis Calculated Displacement Assumed $K_y = 0.05$ Tabas Earthquake, Tabas 344	Figure 11-23
URS
