FINAL REPORT

Dynamic Stability Analysis of Estates Dam

Oakland, California

NOVEMBER 2006

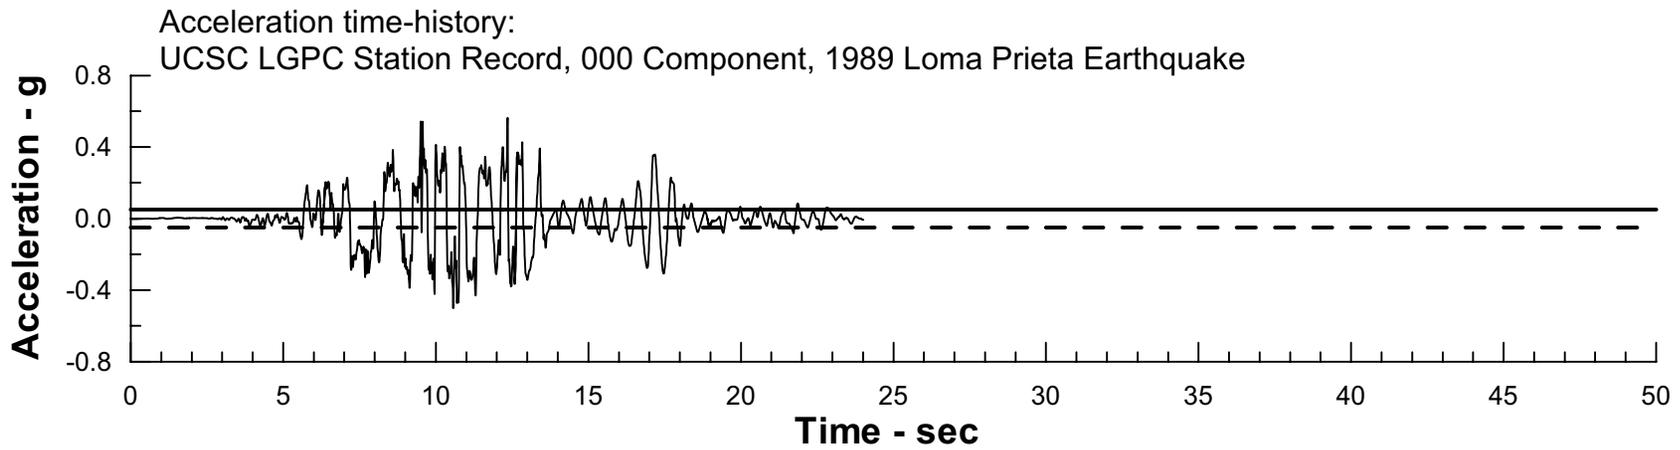
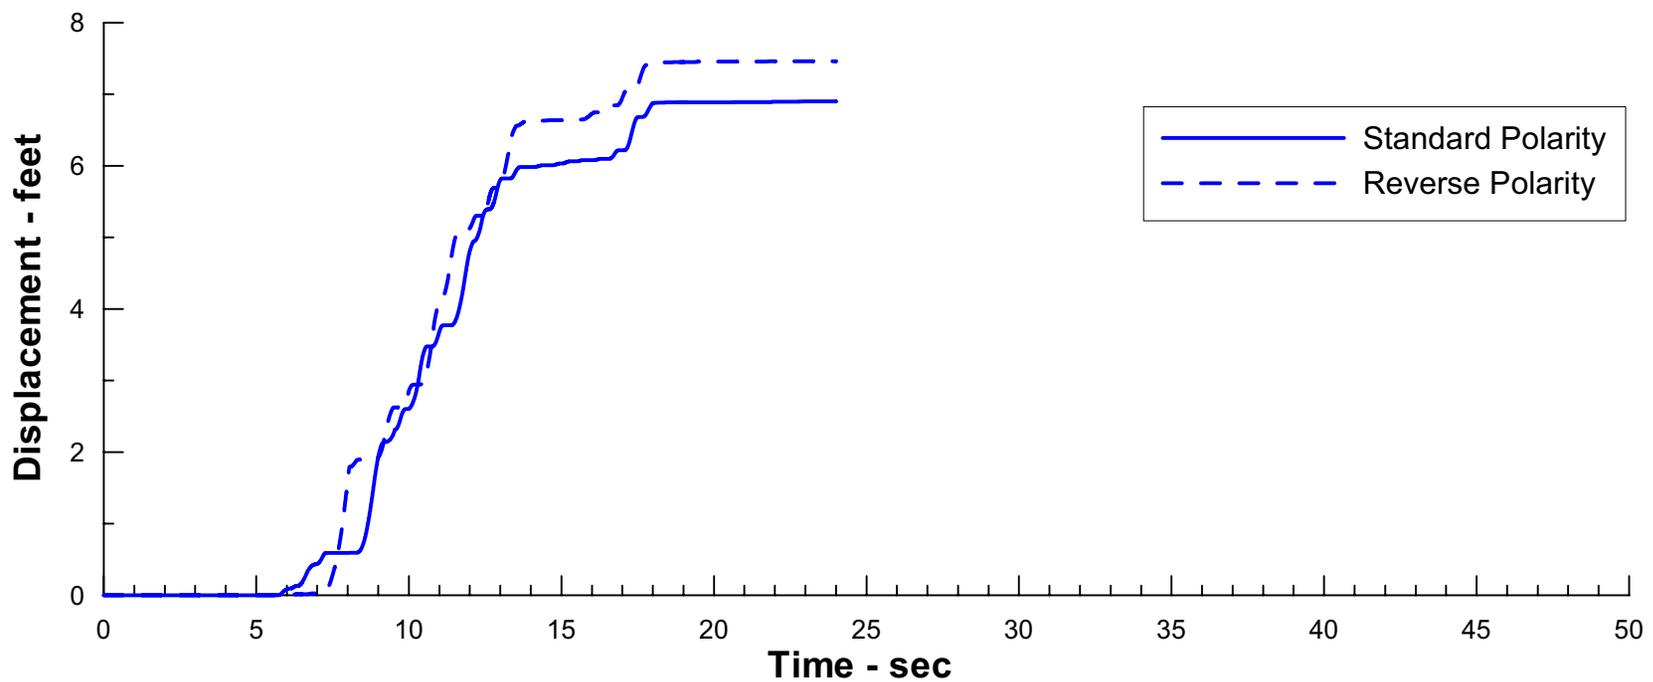
Project No. 26814957	Estates Dam Stability and Deformation Analysis	Simplified Newmark Analysis Calculated Displacement Assumed $K_y = 0.05$ Loma Prieta EQ, LGPC 000	Figure 11-24
URS

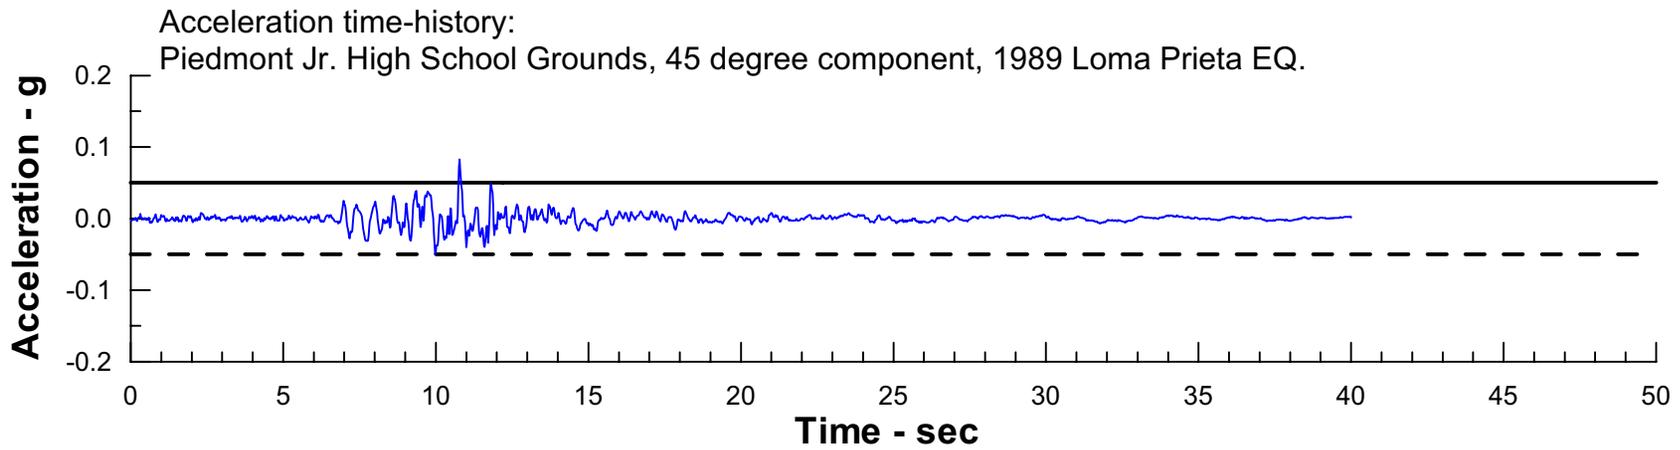
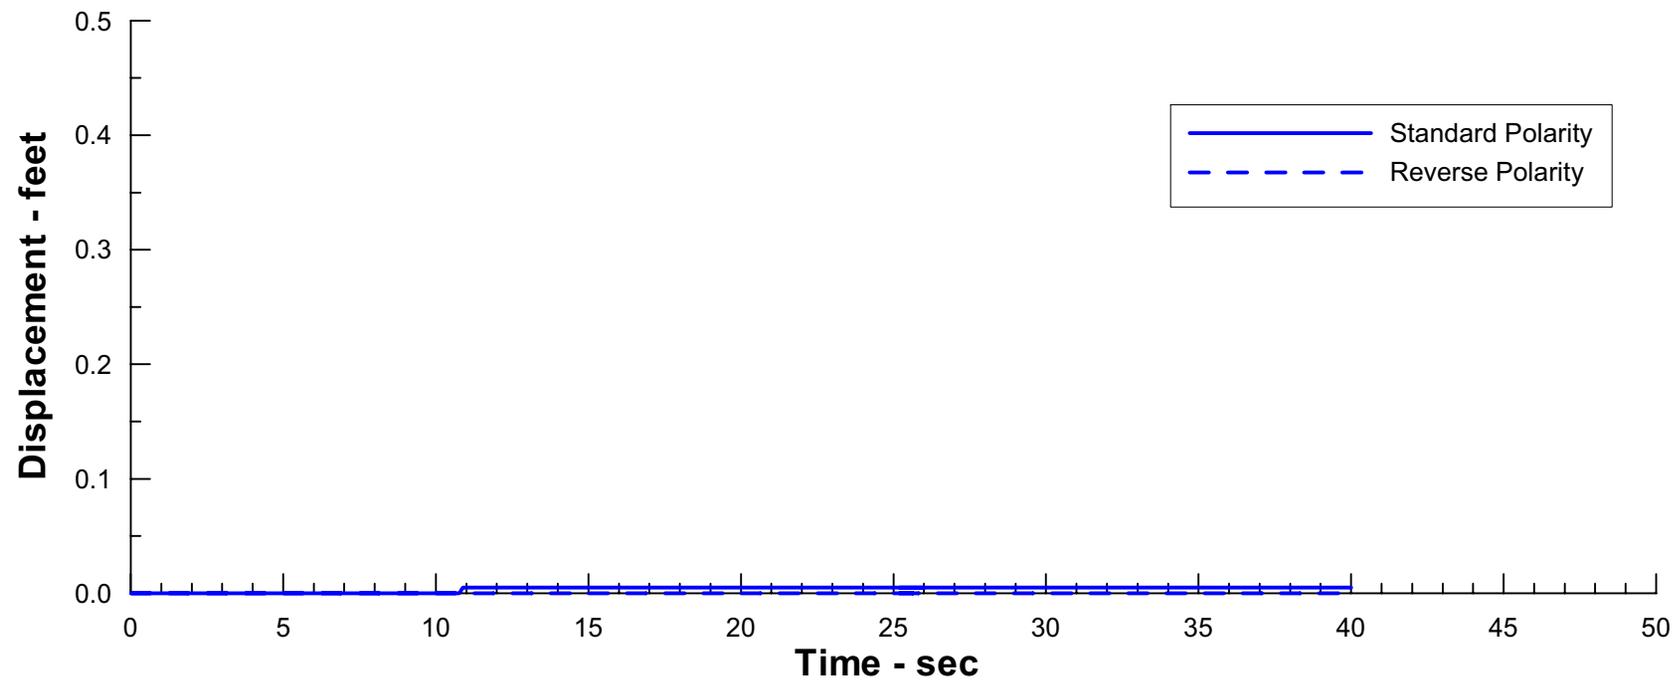
Project No. 26814957	Estates Dam Seismic Stability Analysis	Simplified Newmark Analysis Calculated Displacement Assumed $K_y = 0.05$ Loma Prieta Earthquake	Figure
URS			11-25

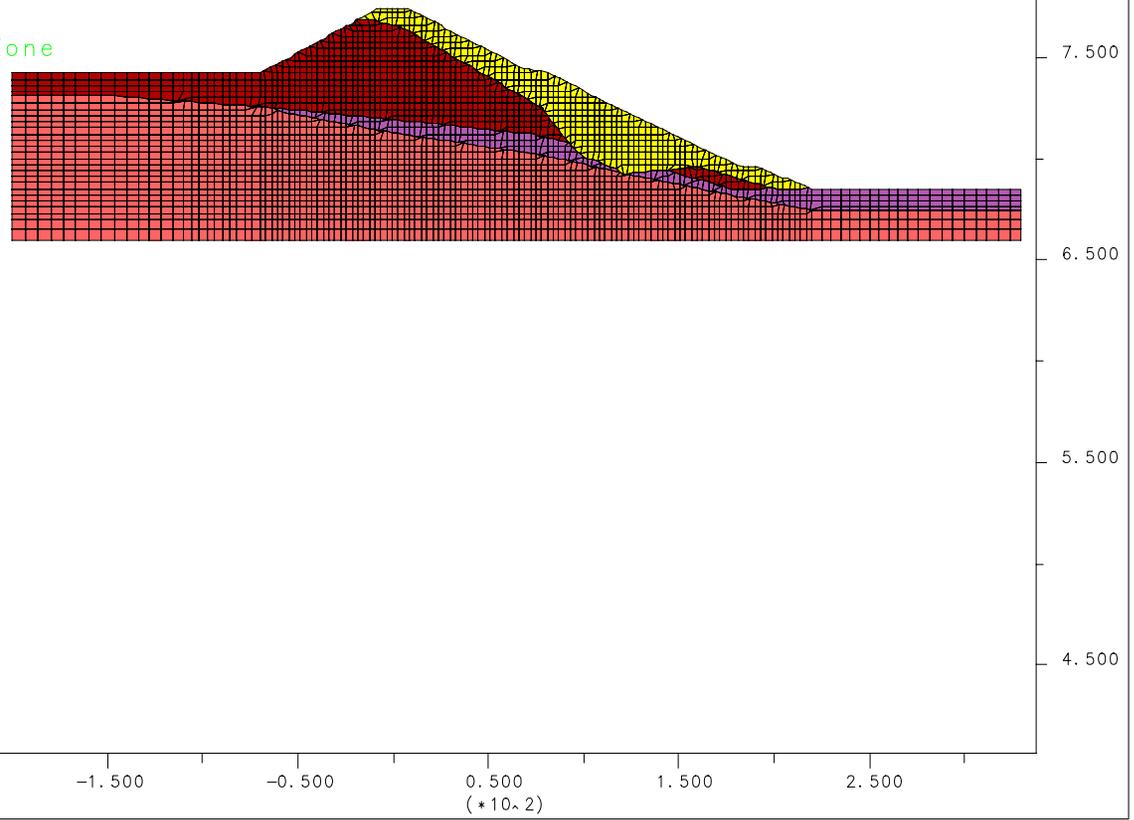
Foundation and Embankment Zone

- Bedrock
- 1903_Fill
- Foundation_Soil
- 1938_Fill

Grid plot

Project No. 26814957	Estates Dam Seismic Stability Analysis	Finite Difference Mesh for Cross-Section A-A'	Figure
URS		FLAC Analysis	12-1

The FLAC analyses were performed for section A-A'. The section was discretized using the mesh shown on Figure 12-1. A compliant boundary was specified along the base of the model to simulate the unbounded extent of the foundation bedrock beneath the dam. The earthquake motions are input as a stress time history at this boundary. Analyses were performed for both standard and reverse polarities of each ground motion time history.

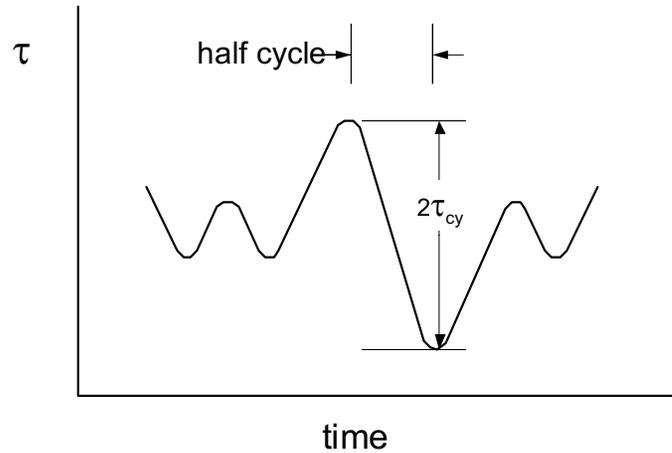
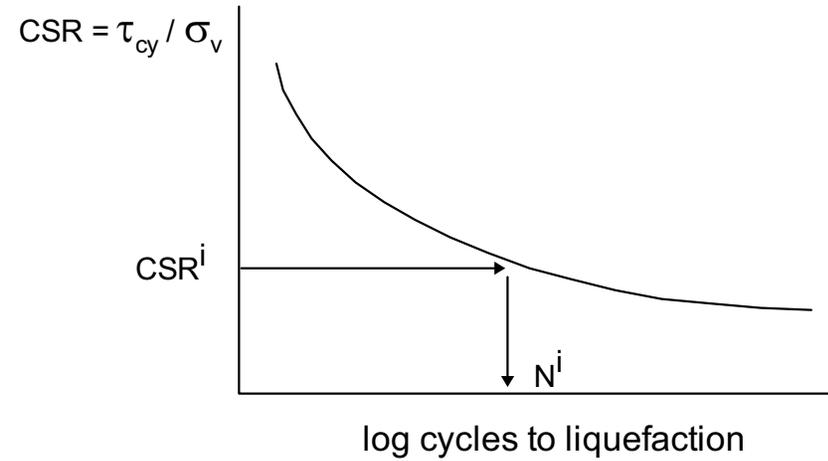
Shear Stress Time History

Cyclic Strength

The models for cyclic strength and undrained strength degradation of the saturated embankment and foundation soils are illustrated in Figure 12-3. The strength degradation of the materials is expressed through the ratio of post-cyclic strength to pre-cyclic (i.e. static) strength as a function of excess pore pressure ratio (see Section 11.2.1). As discussed in Section 11, the selected CSR₃₀ values are 0.56 for the 1938-1939 fill and 0.28 for the 1903 fill and foundation soils.

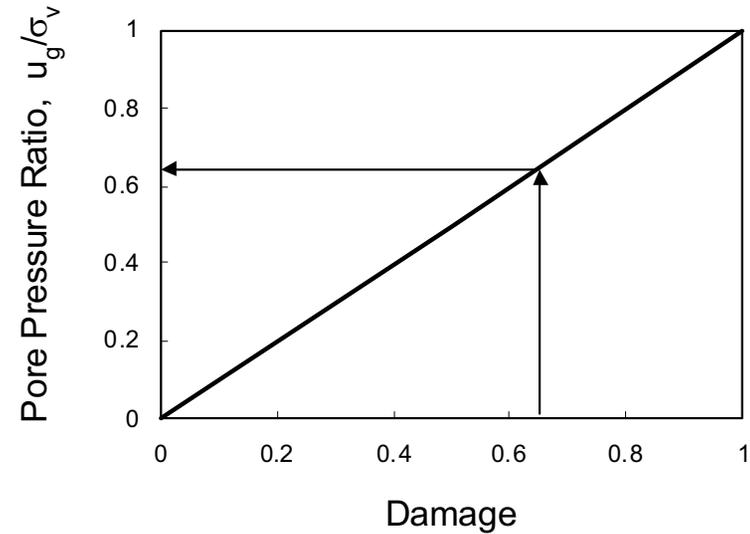
Project No. 26814536	Chabot Dam Seismic Stability Analysis	FLAC Analysis Pore Pressure Generation Model	Figure 12-2
URS

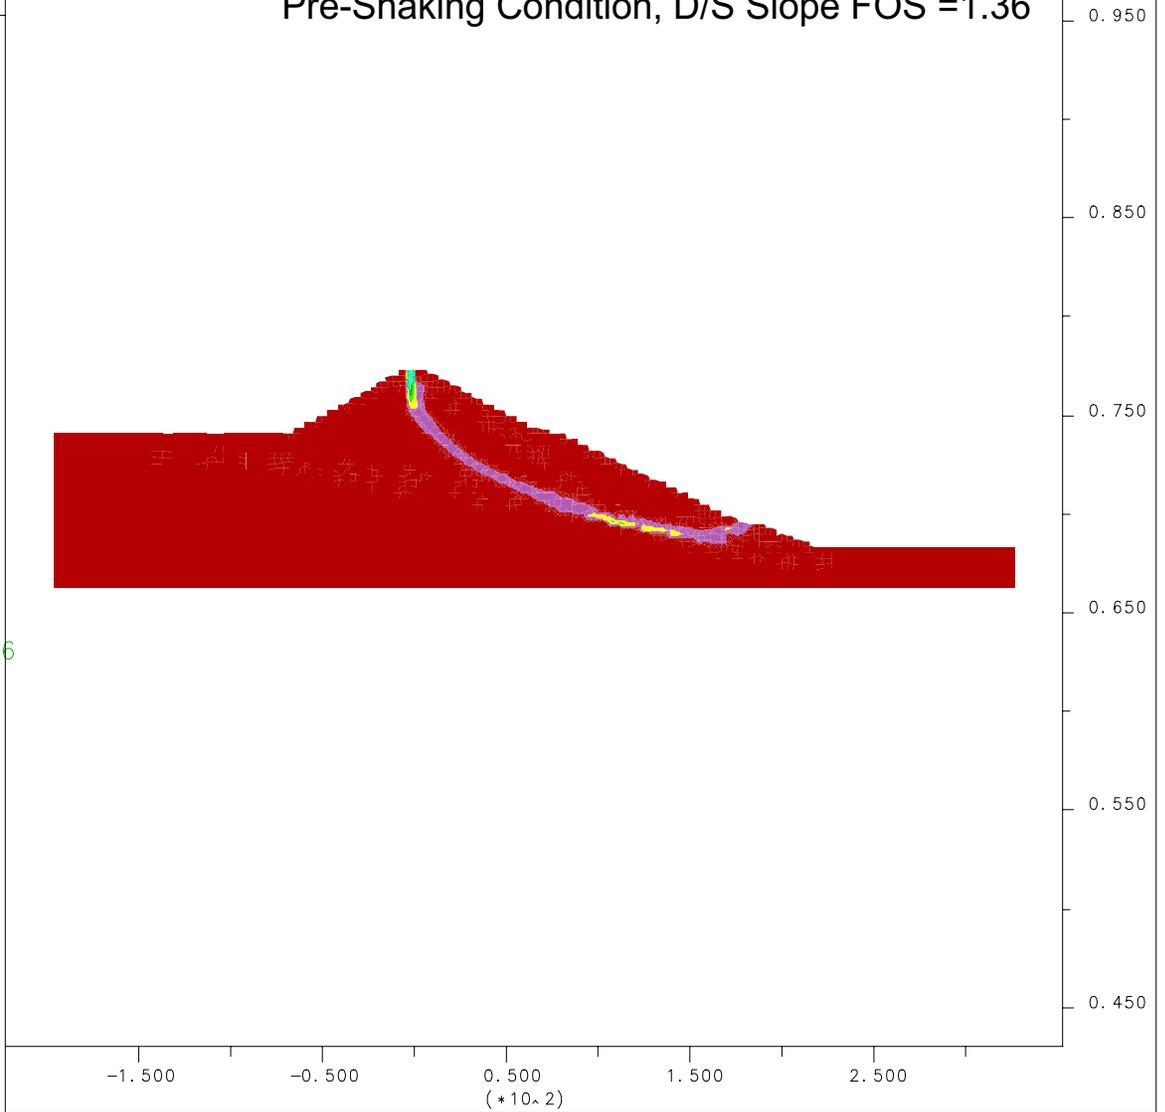
Pre-Shaking Condition, D/S Slope FOS = 1.36

Project No. 26814957	Estates Dam Seismic Stability Analysis	FLAC Static Analysis Downstream Slope Pre-Earthquake Stability	Figure 12-4
URS

Slope stability analyses were performed using the FLAC code to check that the geotechnical characterization modeled with the FLAC input parameters is consistent with that used for the decoupled analyses discussed in Section 11. The results of the FLAC stability analyses are shown in Figures 12-4 through 12-7. As shown in Figures 12-4 and 12-5, the FLAC analyses result in calculated factors of safety of 2.24 and 1.36 in the upstream and downstream directions, respectively, for the pre-earthquake condition. These values are in very good agreement with those calculated from the limit equilibrium analyses (2.43 and 1.37, as shown in Figure 9-6). As shown in Figures 12-6 and 12-7, under post-earthquake conditions, the FLAC calculated factors of safety for the upstream and downstream slopes are 1.97 and 1.12, respectively. These values are in excellent agreement with those calculated from the limit equilibrium analyses (1.99 and 1.13, as shown in Figure 11-3).

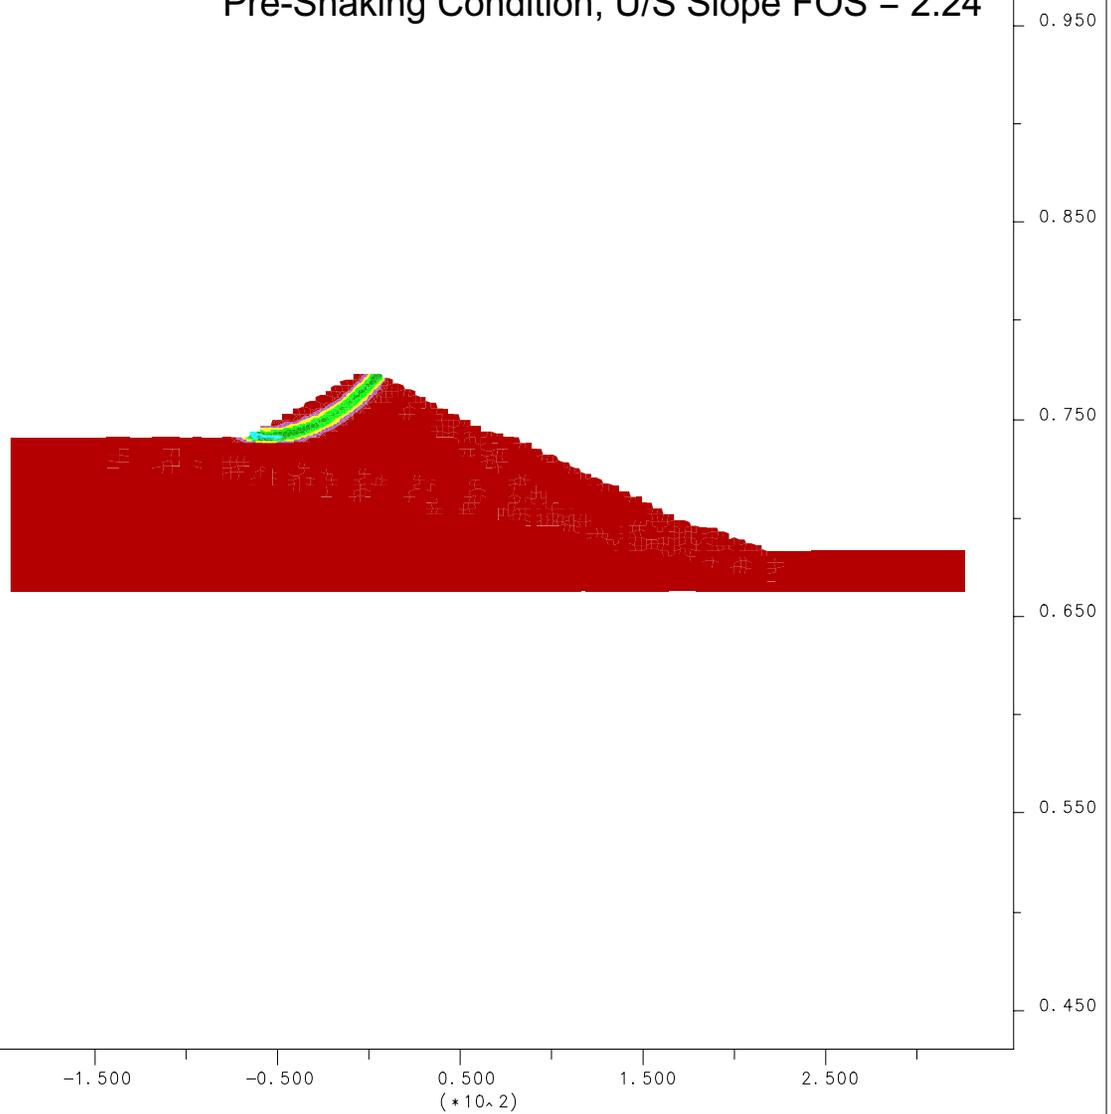
Pre-Shaking Condition, U/S Slope FOS = 2.24

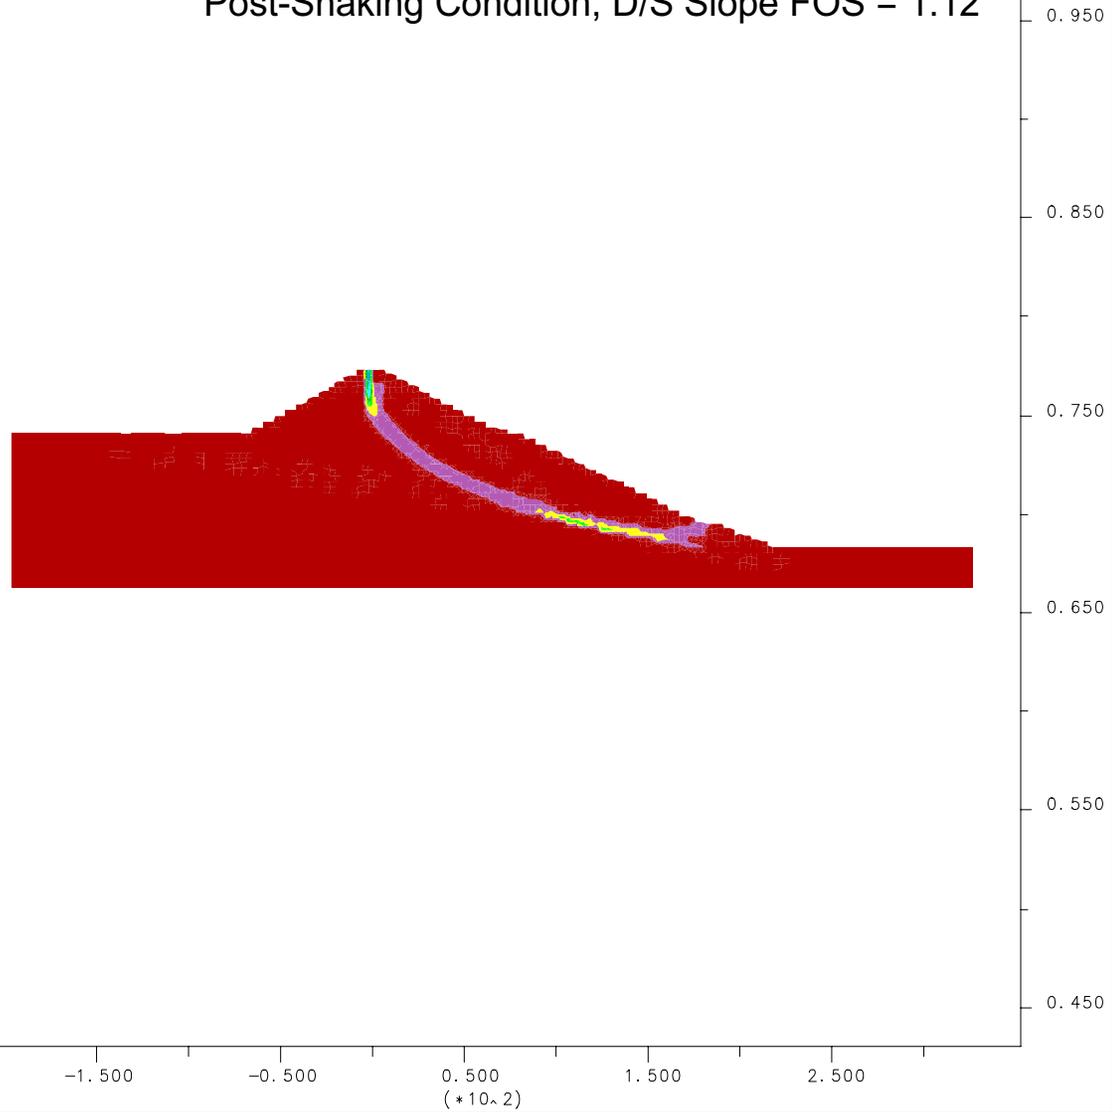
Post-Shaking Condition, D/S Slope FOS = 1.12

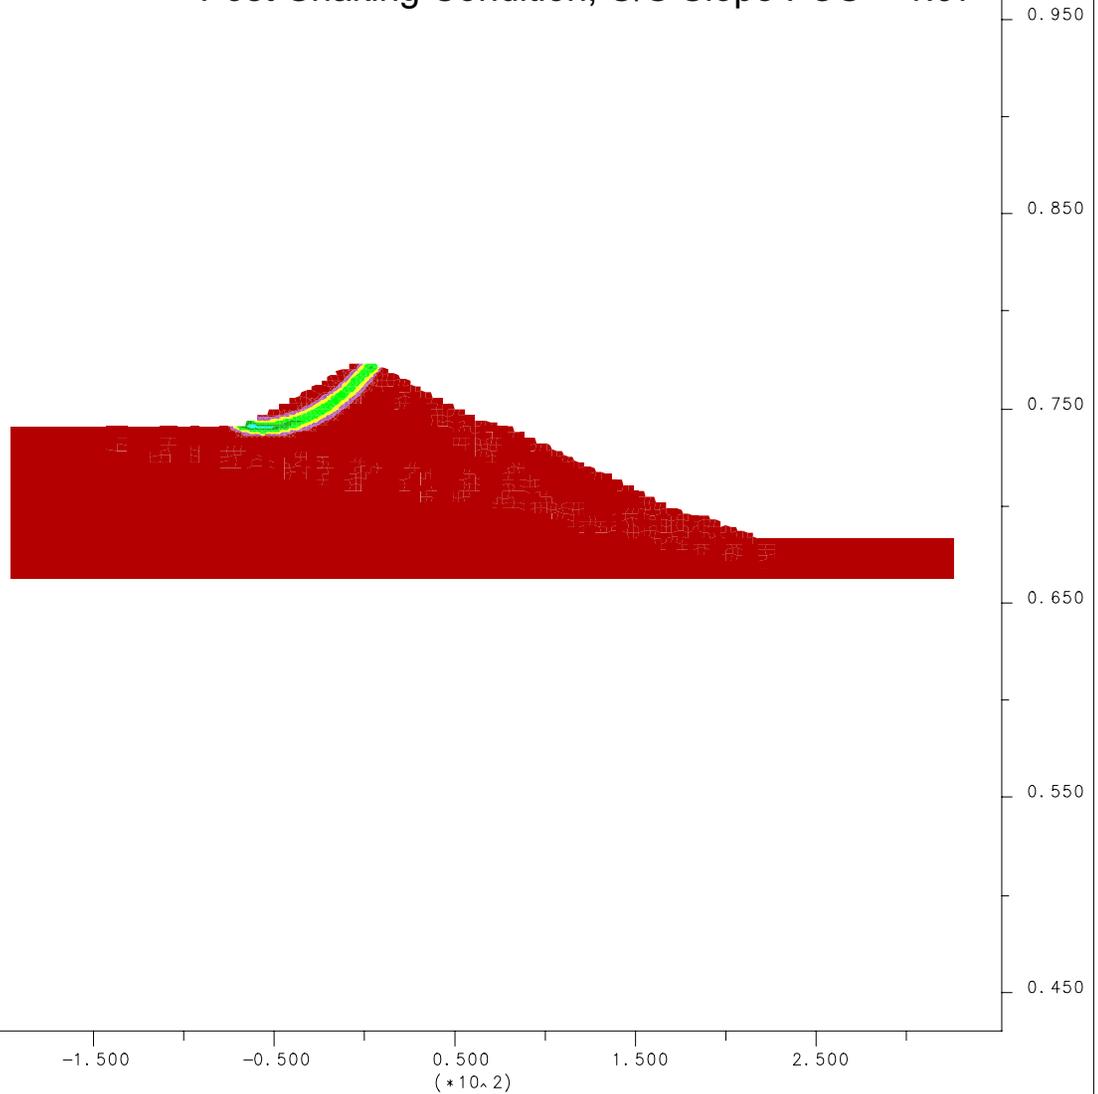
Post-Shaking Condition, U/S Slope FOS = 1.97

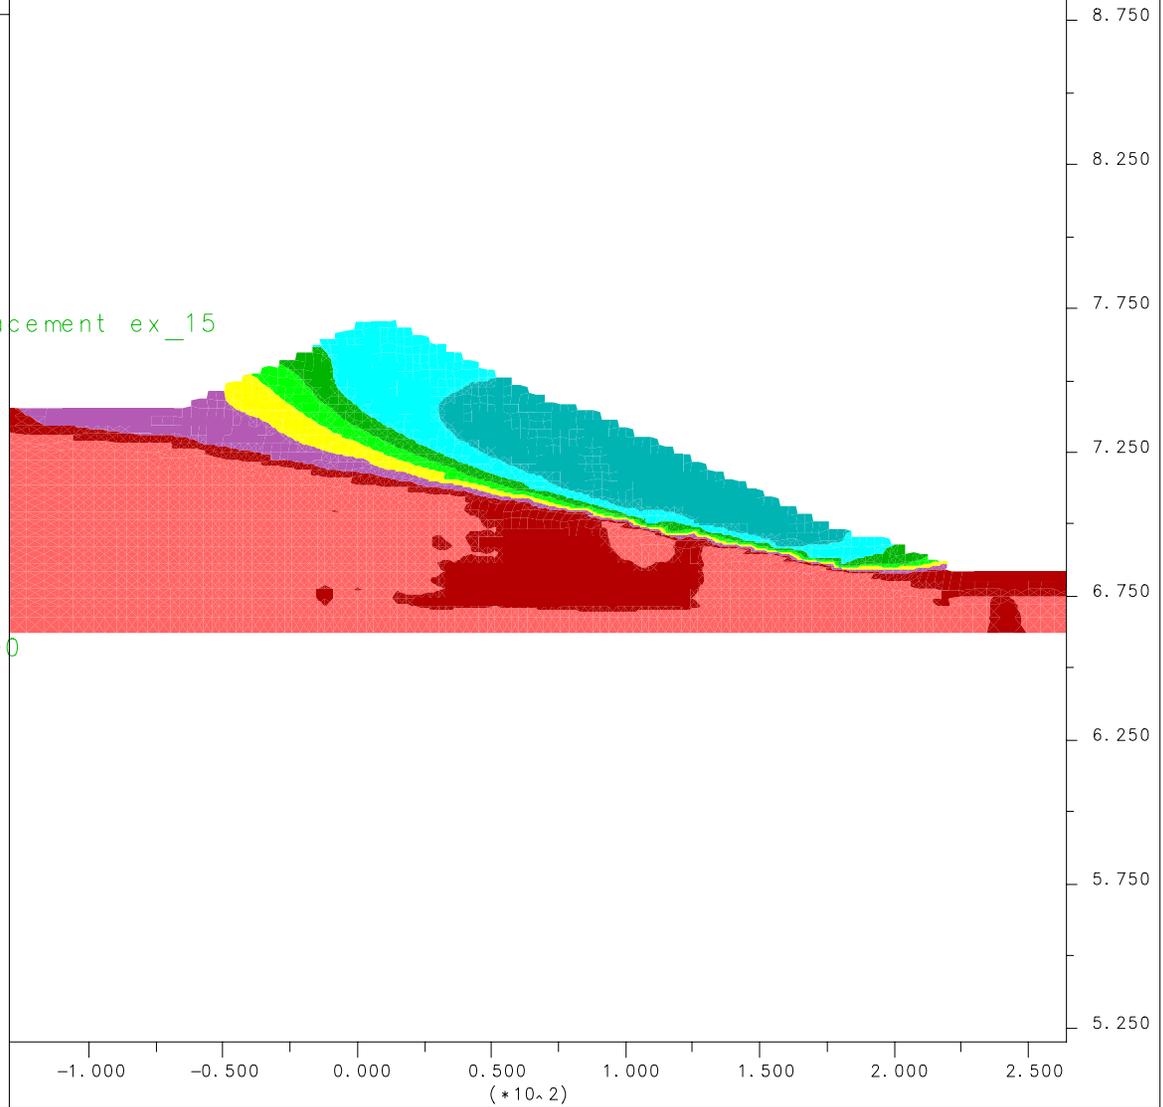
Project No. 26814957	Estates Dam Seismic Stability Analysis	FLAC Dynamic Analysis with Assumed Strength Degradation Permanent Horizontal Displacement Hayward MCE TH #1	Figure 12-8
URS

The FLAC analyses with assumed strength degradation were performed for Hayward fault MCE time histories No. 1 and 2. The analysis results are shown in Figures 12-8 through 12-16. For time history No. 1, the calculated horizontal displacement of the downstream slope and the vertical displacement at the crest are about 6 and 2 feet, respectively. Larger displacements, 10 feet horizontal and 5 feet vertical, were calculated for time history No. 2. From these figures, it may be seen that, by the end of the strong shaking, a sharp gradient in displacement has developed just above the bedrock beneath the downstream slope, indicating a concentrated shear zone along this surface. The majority of the downstream embankment above this sliding surface is displaced in the downstream direction, resembling a rigid sliding block. The calculated horizontal displacements of the downstream slope and vertical displacements of the crest are summarized in Tables 12-3 and 12-4.

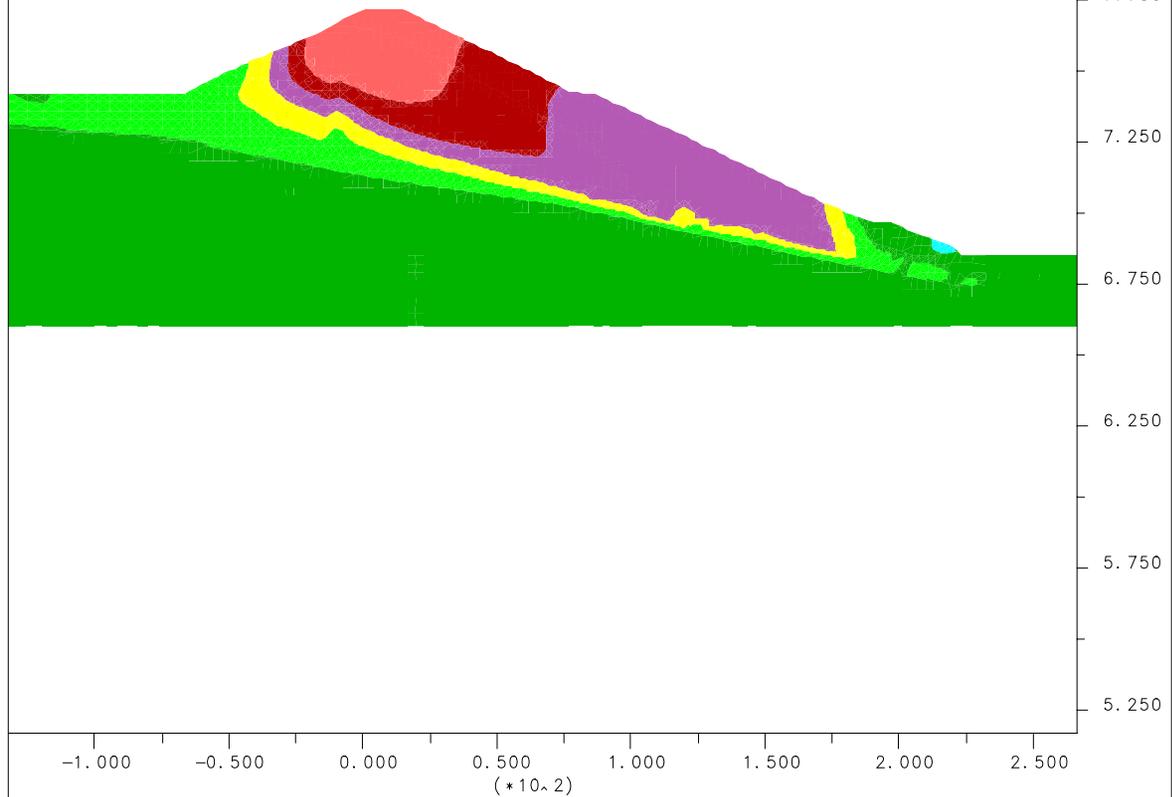
Project No. 26814957	Estates Dam Seismic Stability Analysis	FLAC Dynamic Analysis with Assumed Strength Degradation Permanent Vertical Displacement Hayward MCE TH #1	Figure 12-9
URS

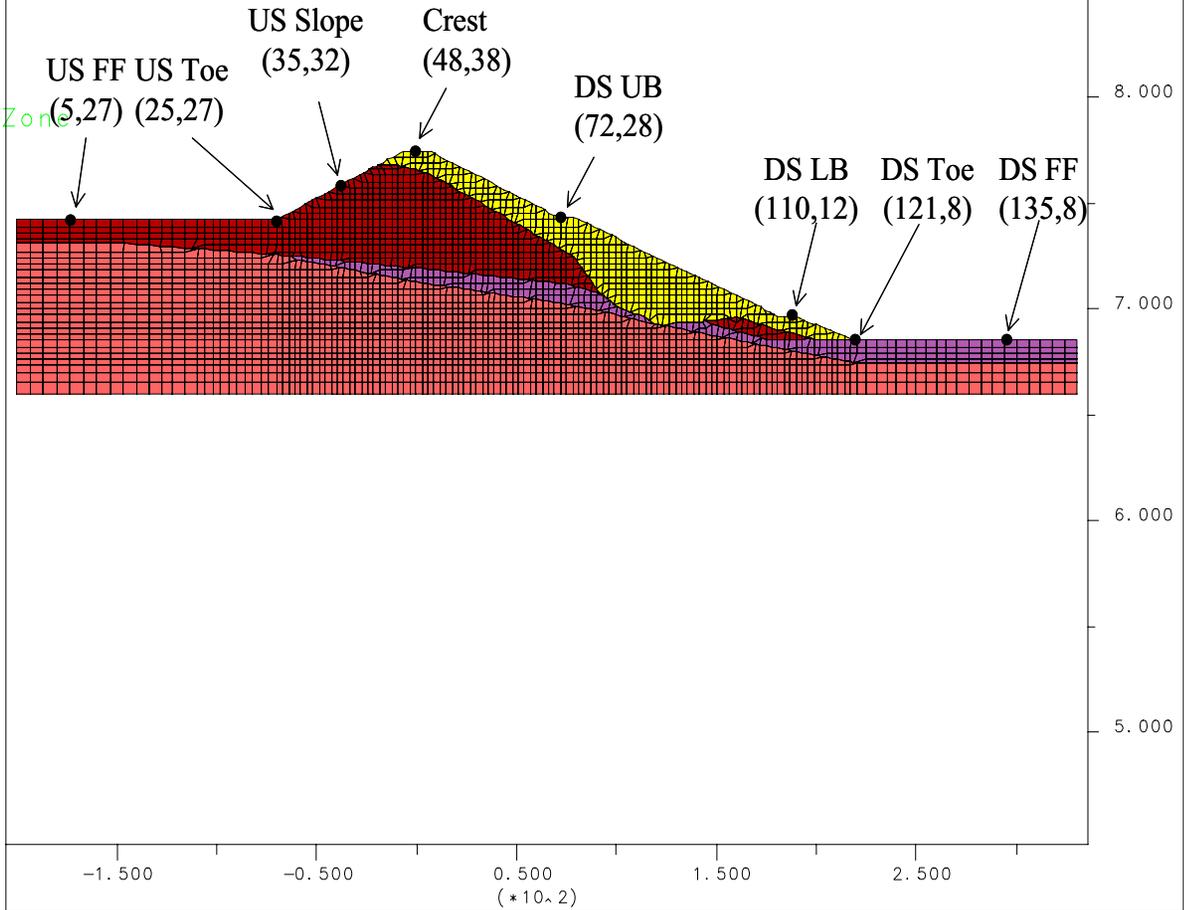
Locations of Displacement Time History

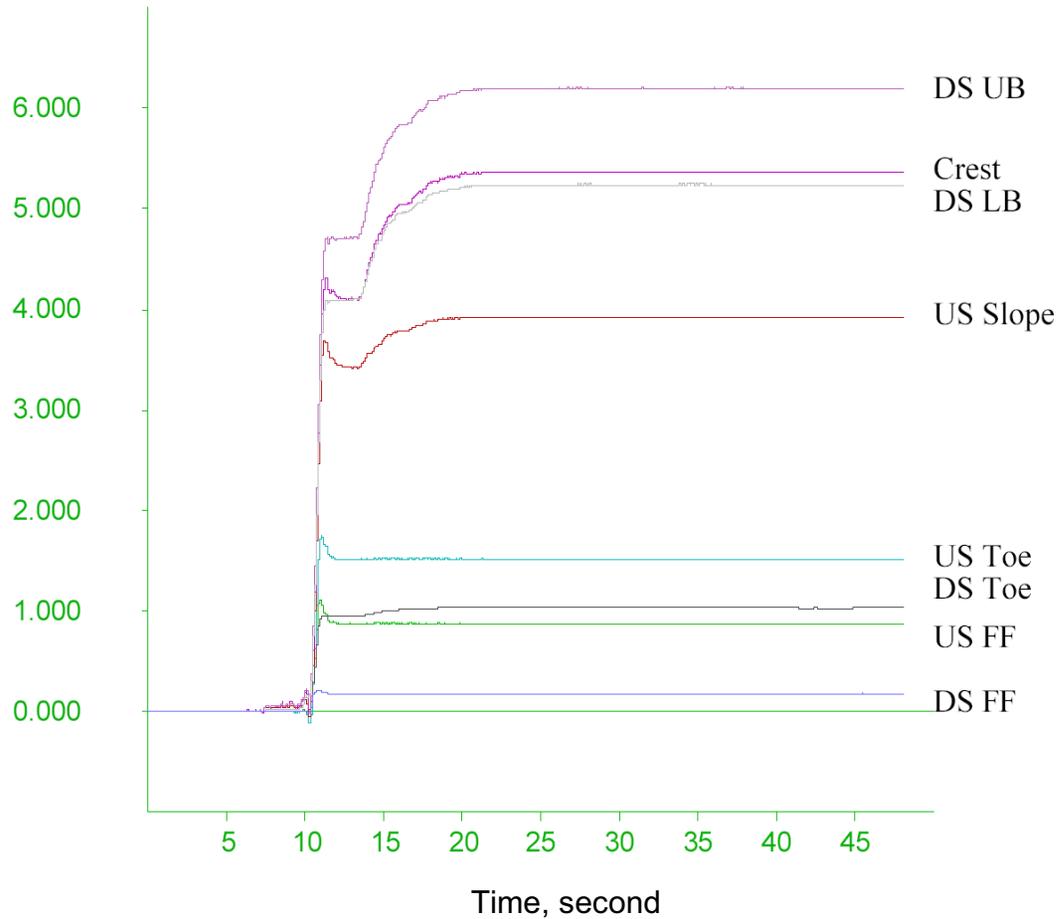
FLAC Dynamic Analysis
with Assumed Strength Degradation
Horizontal Displacement Time Histories
Hayward MCE TH #1

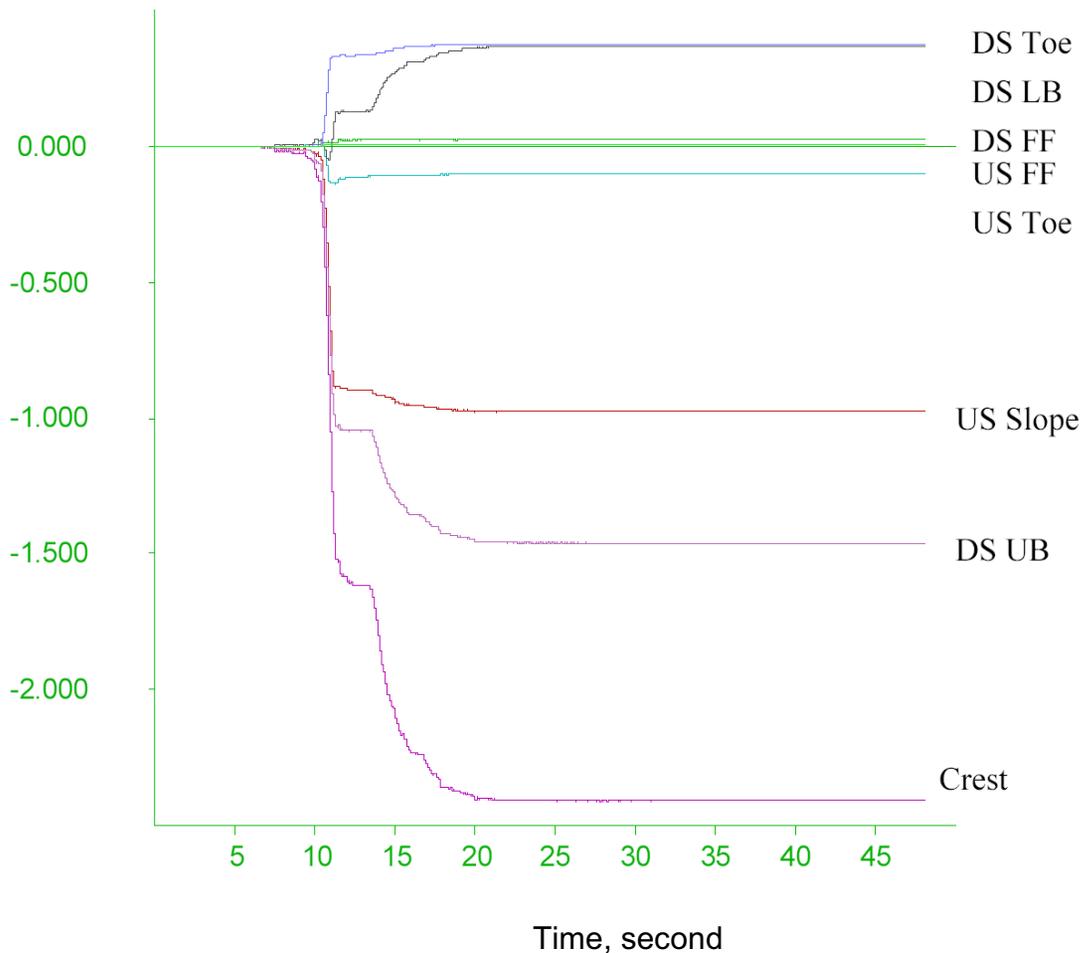
FLAC Dynamic Analysis
with Assumed Strength Degradation
Vertical Displacement Time Histories
Hayward MCE TH #1

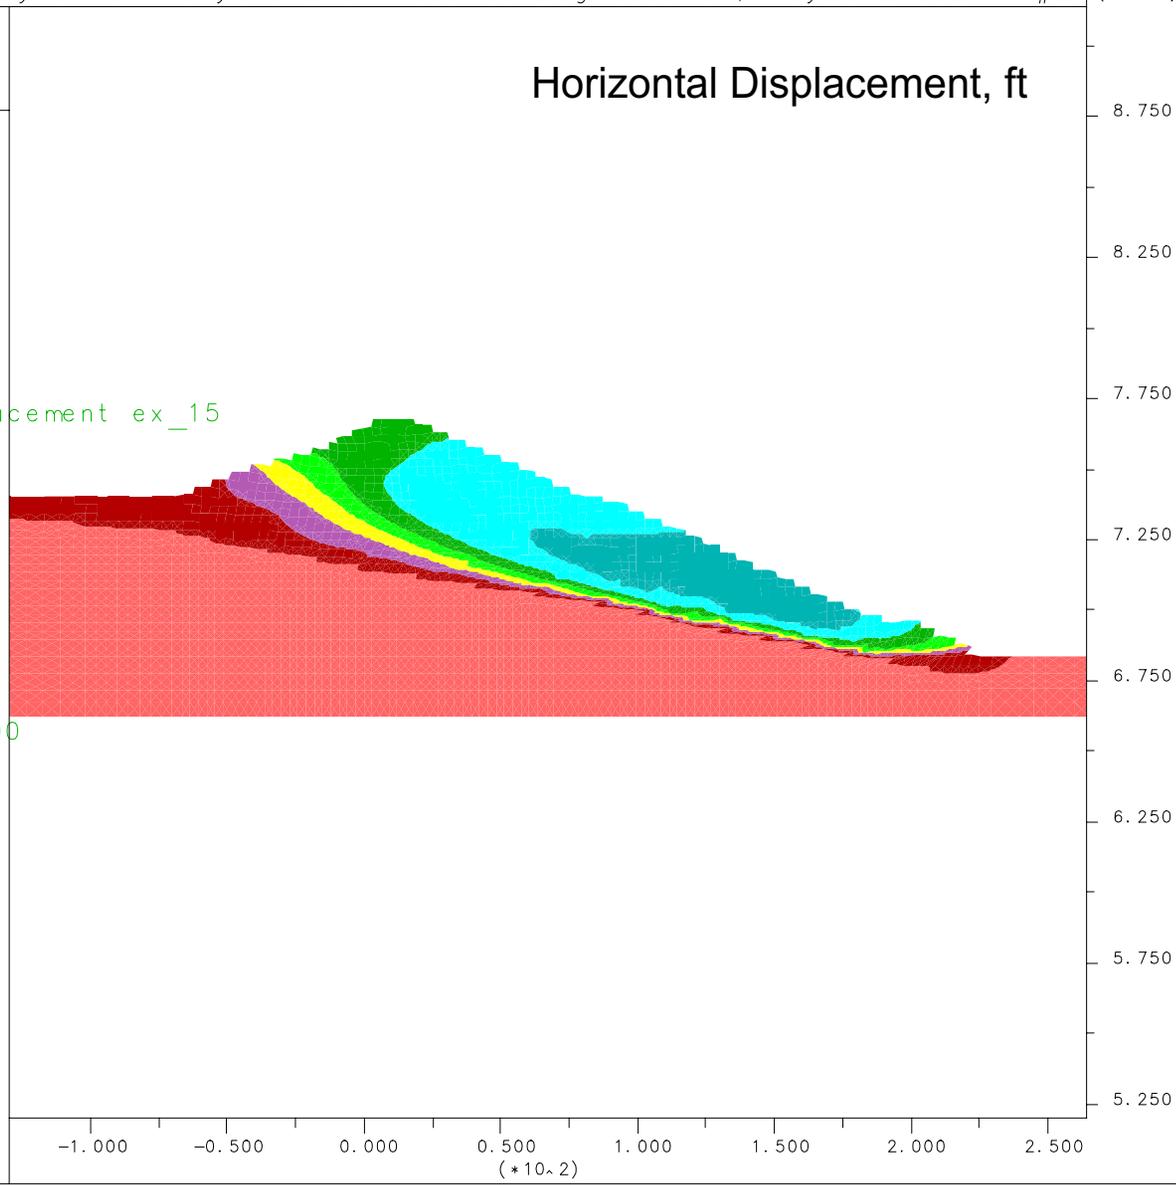
FLAC Dynamic Analysis
with Assumed Strength Degradation
Permanent Horizontal Displacement
Hayward MCE TH #2

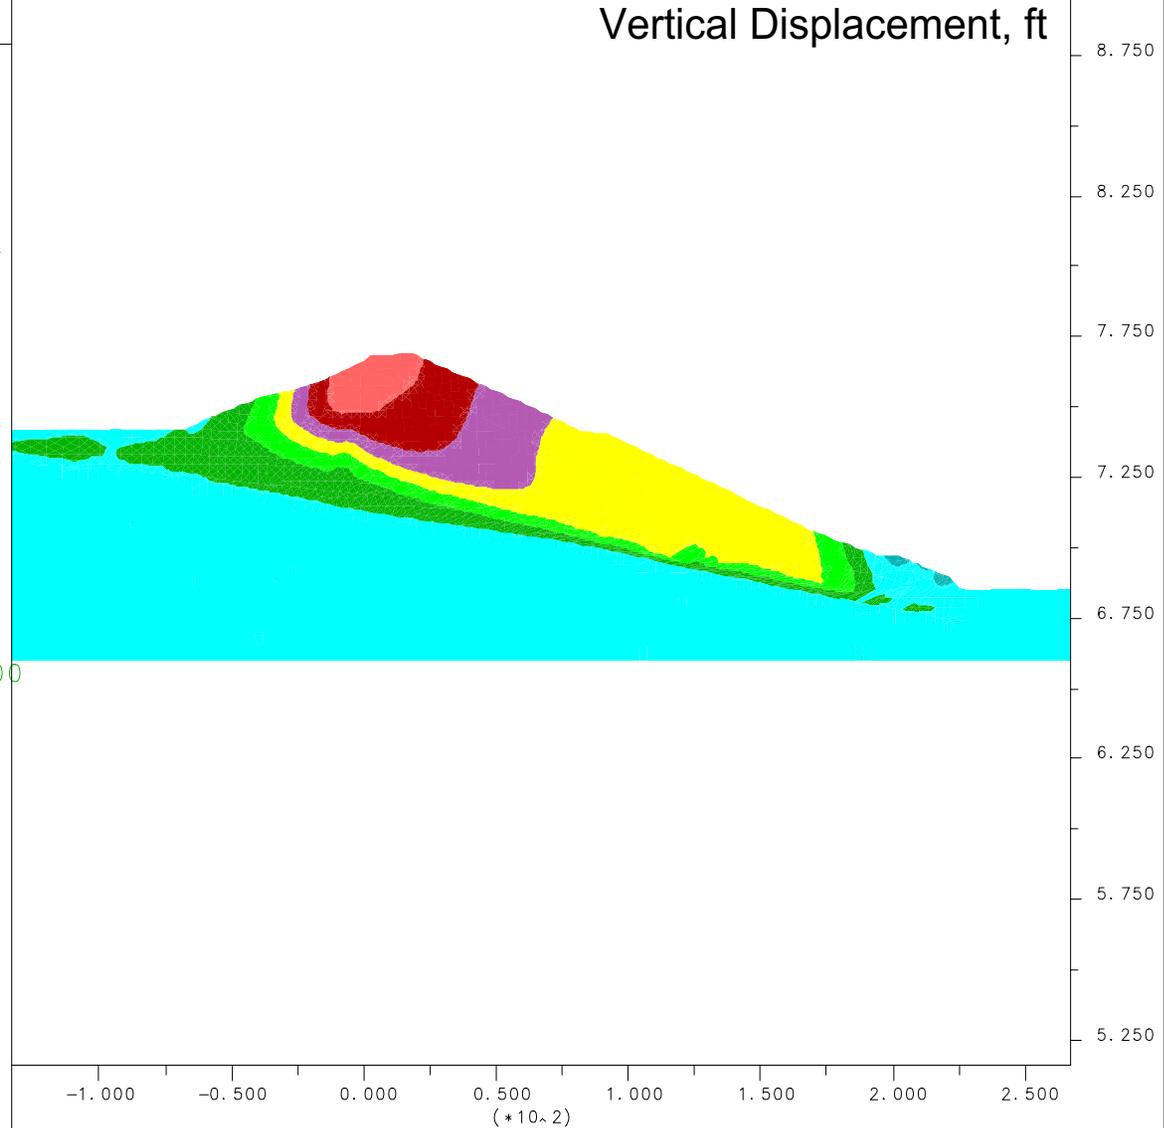
Project No. 26814957	Estates Dam Seismic Stability Analysis	FLAC Dynamic Analysis with Assumed Strength Degradation Permanent Vertical Displacement Hayward MCE TH #2	Figure 12-14
URS

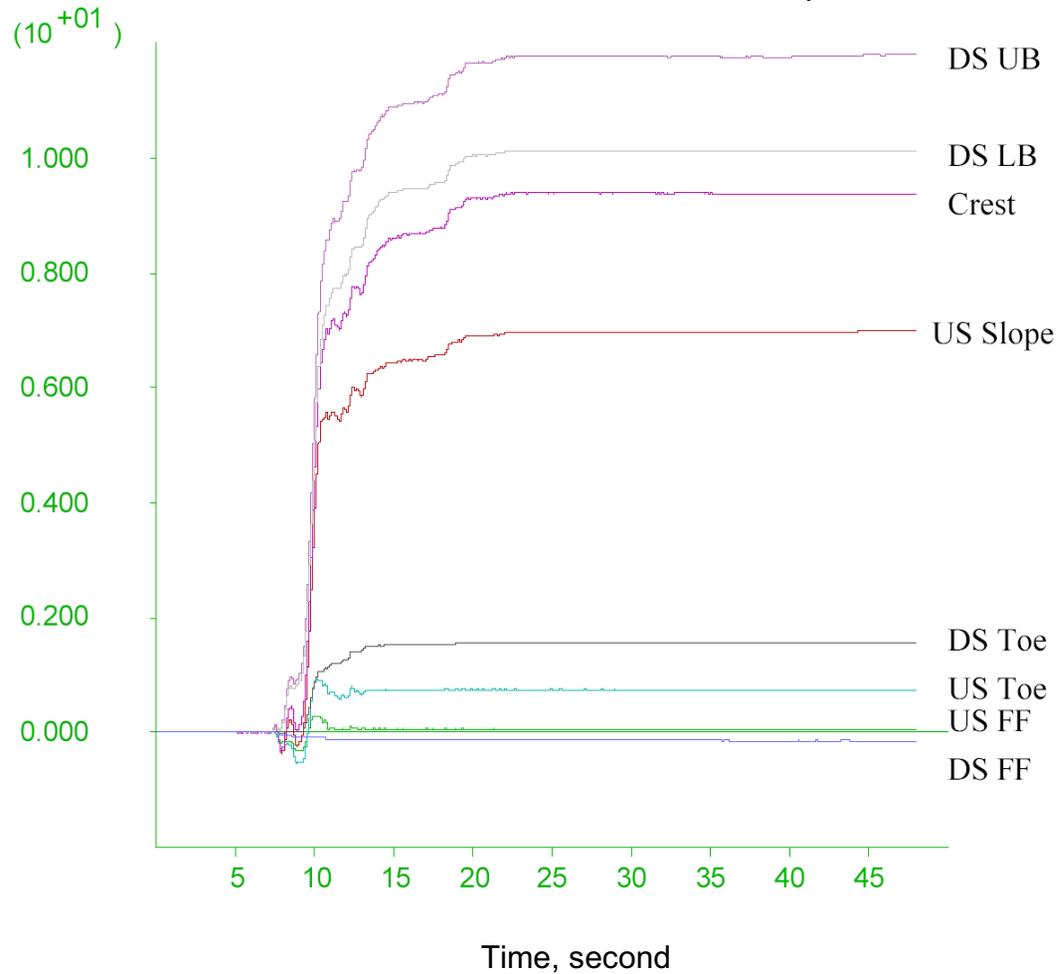
FLAC Dynamic Analysis
with Assumed Strength Degradation
Horizontal Displacement Time Histories
Hayward MCE TH #2

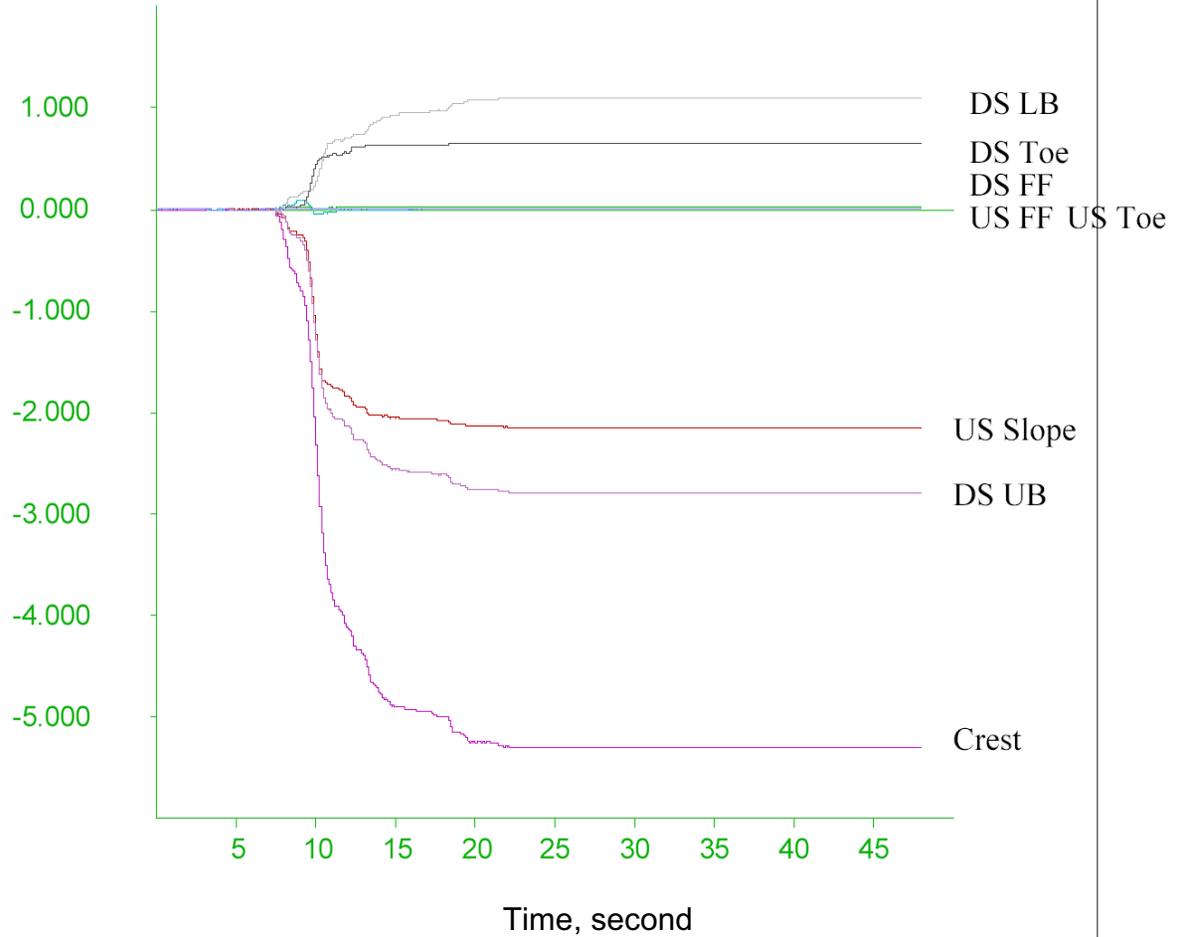
FLAC Dynamic Analysis
with Assumed Strength Degradation
Vertical Displacement Time Histories
Hayward MCE TH #2
