FINAL REPORT

Dynamic Stability Analysis of Estates Dam

Oakland, California

NOVEMBER 2006

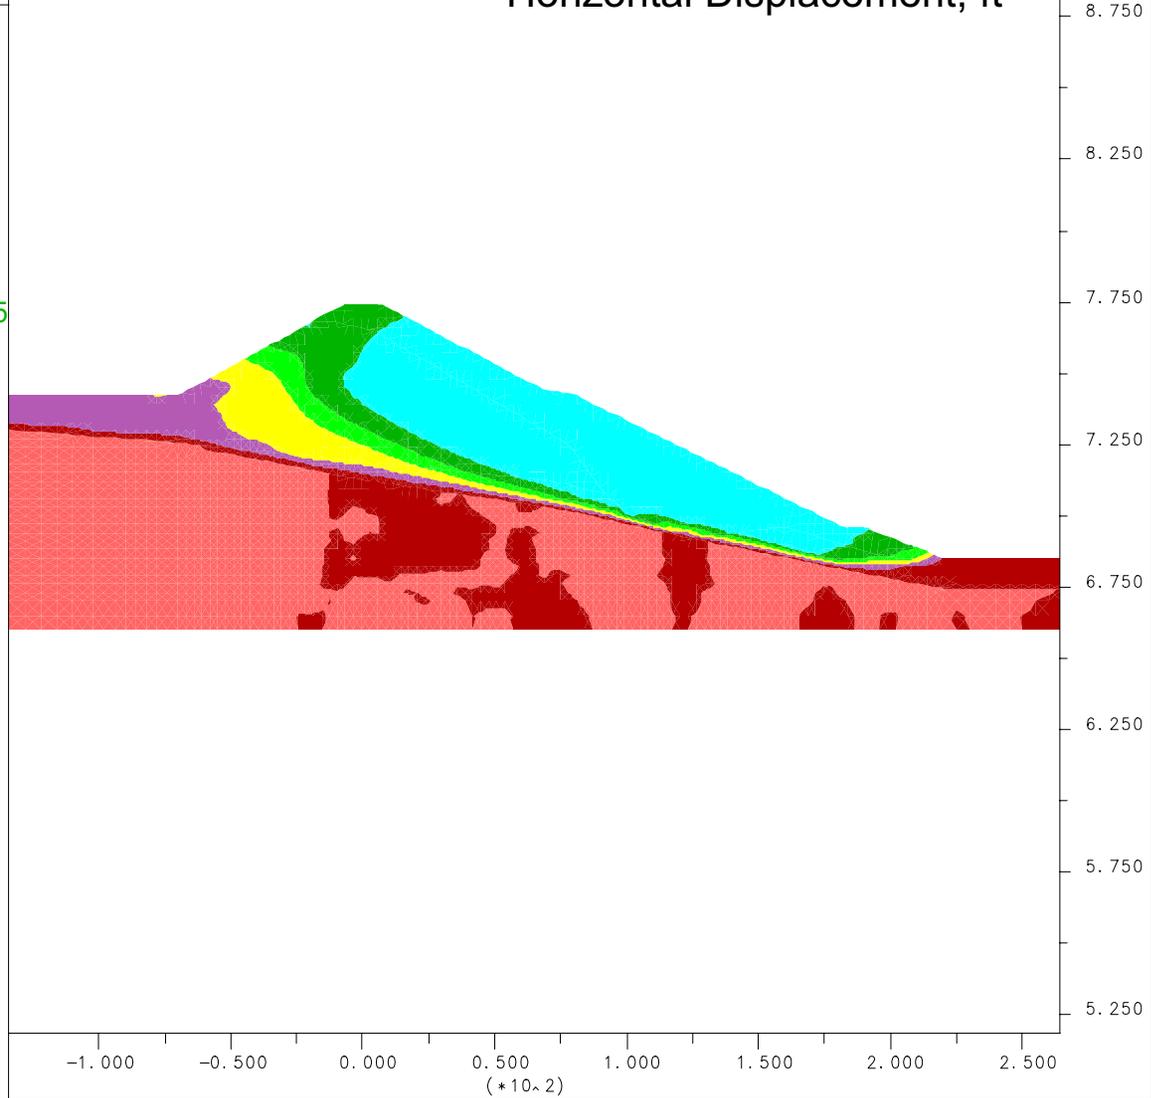
FLAC Dynamic Analysis
with Cyclic Degradation Model
Permanent Horizontal Displacement
Hayward MCE TH #1

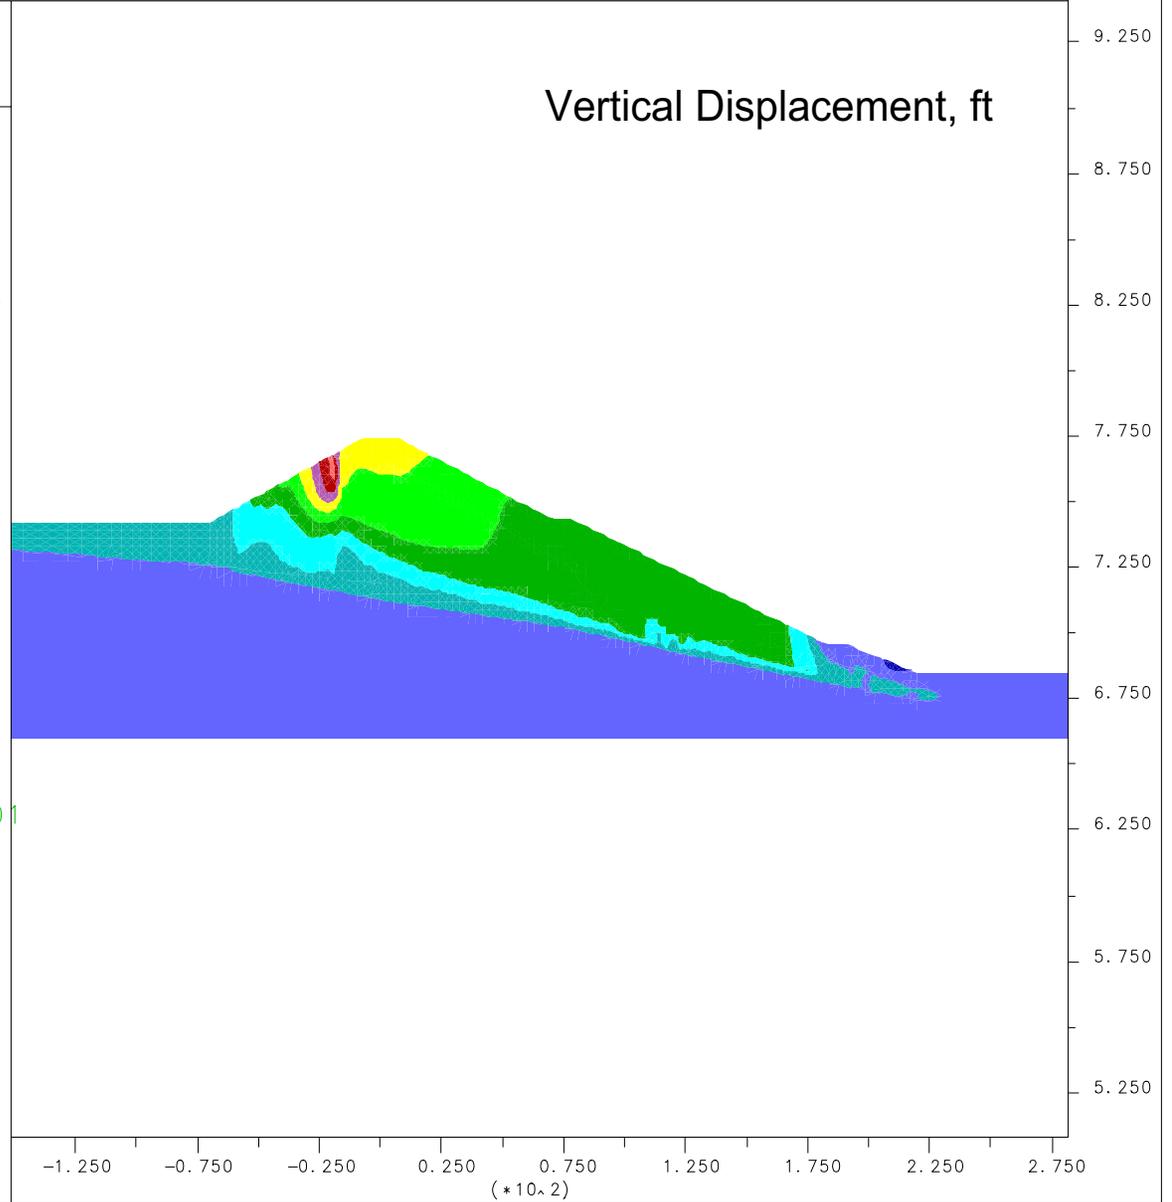
Project No. 26814957	Estates Dam Seismic Stability Analysis	FLAC Dynamic Analysis with Cyclic Degradation Model Permanent Vertical Displacement Hayward MCE TH #1	Figure 12-18
URS

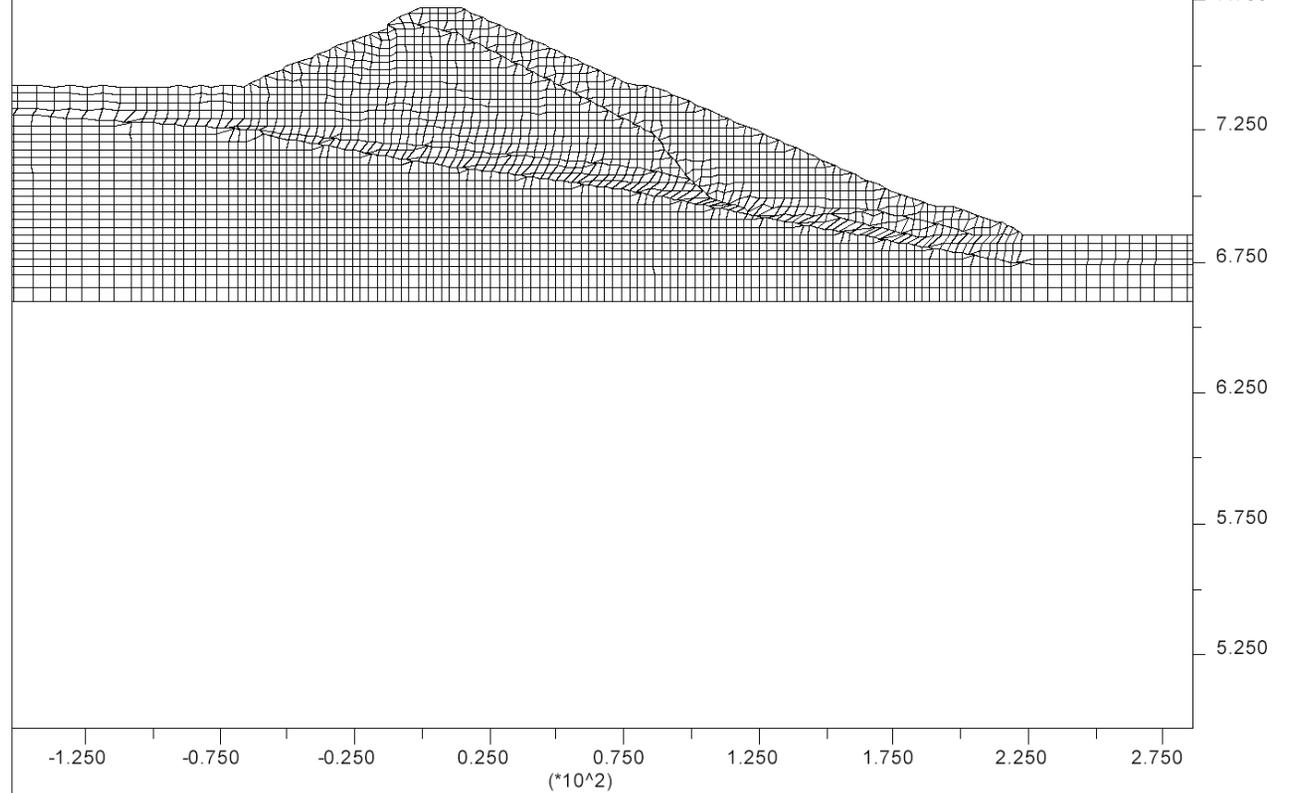
Magnification = 1.000E+00
 Max Disp = 8.166E+00

FLAC Dynamic Analysis
with Cyclic Degradation Model
Deformed Mesh
Hayward MCE TH #1

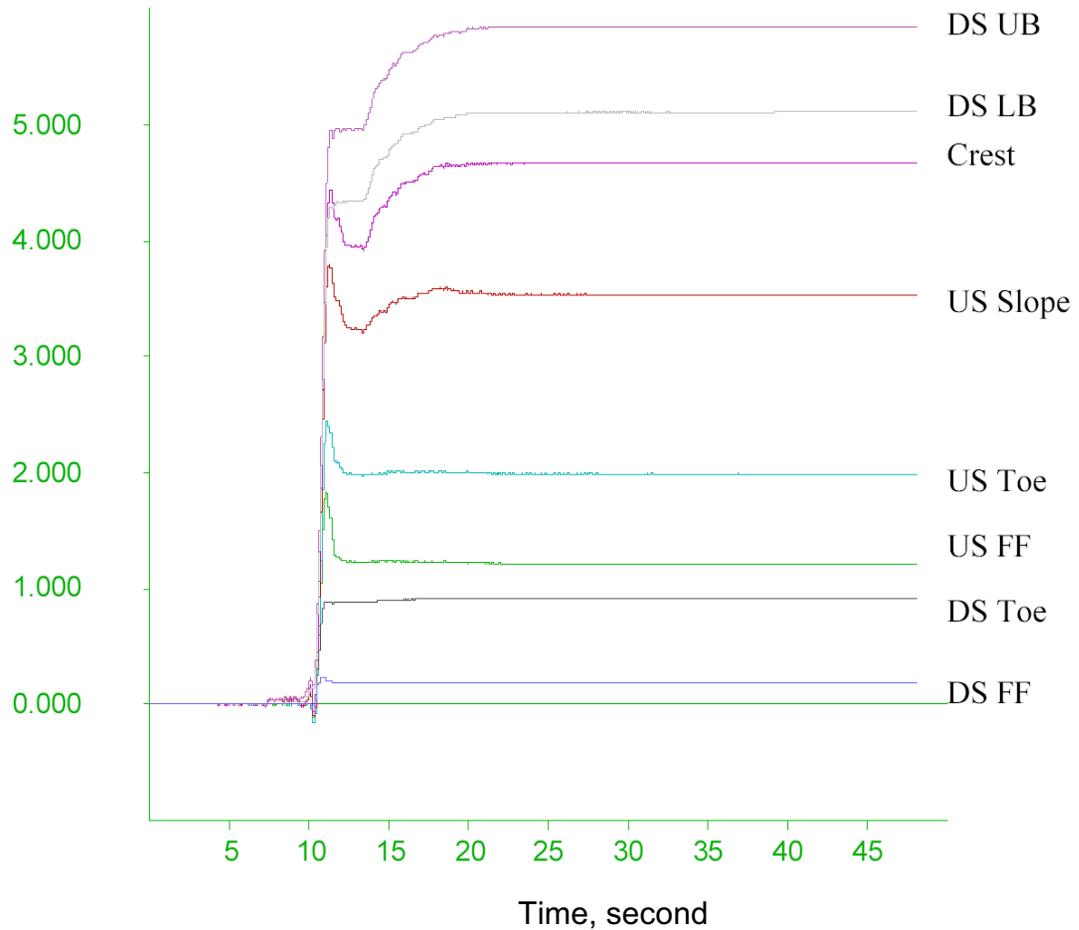
FLAC Dynamic Analysis
with Cyclic Degradation Model
Horizontal Displacement Time Histories
Hayward MCE TH #1

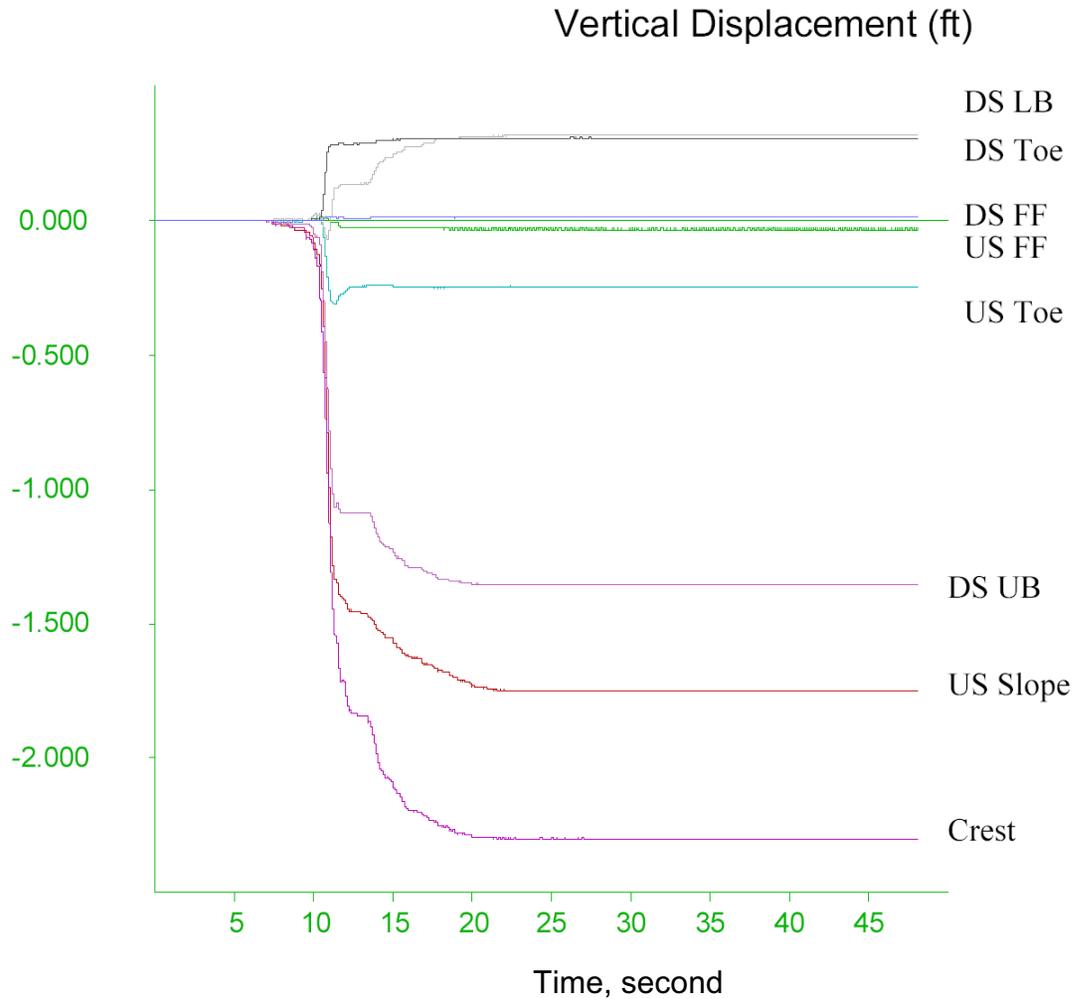
FLAC Dynamic Analysis
with Cyclic Degradation Model
Vertical Displacement Time Histories
Hayward MCE TH #1

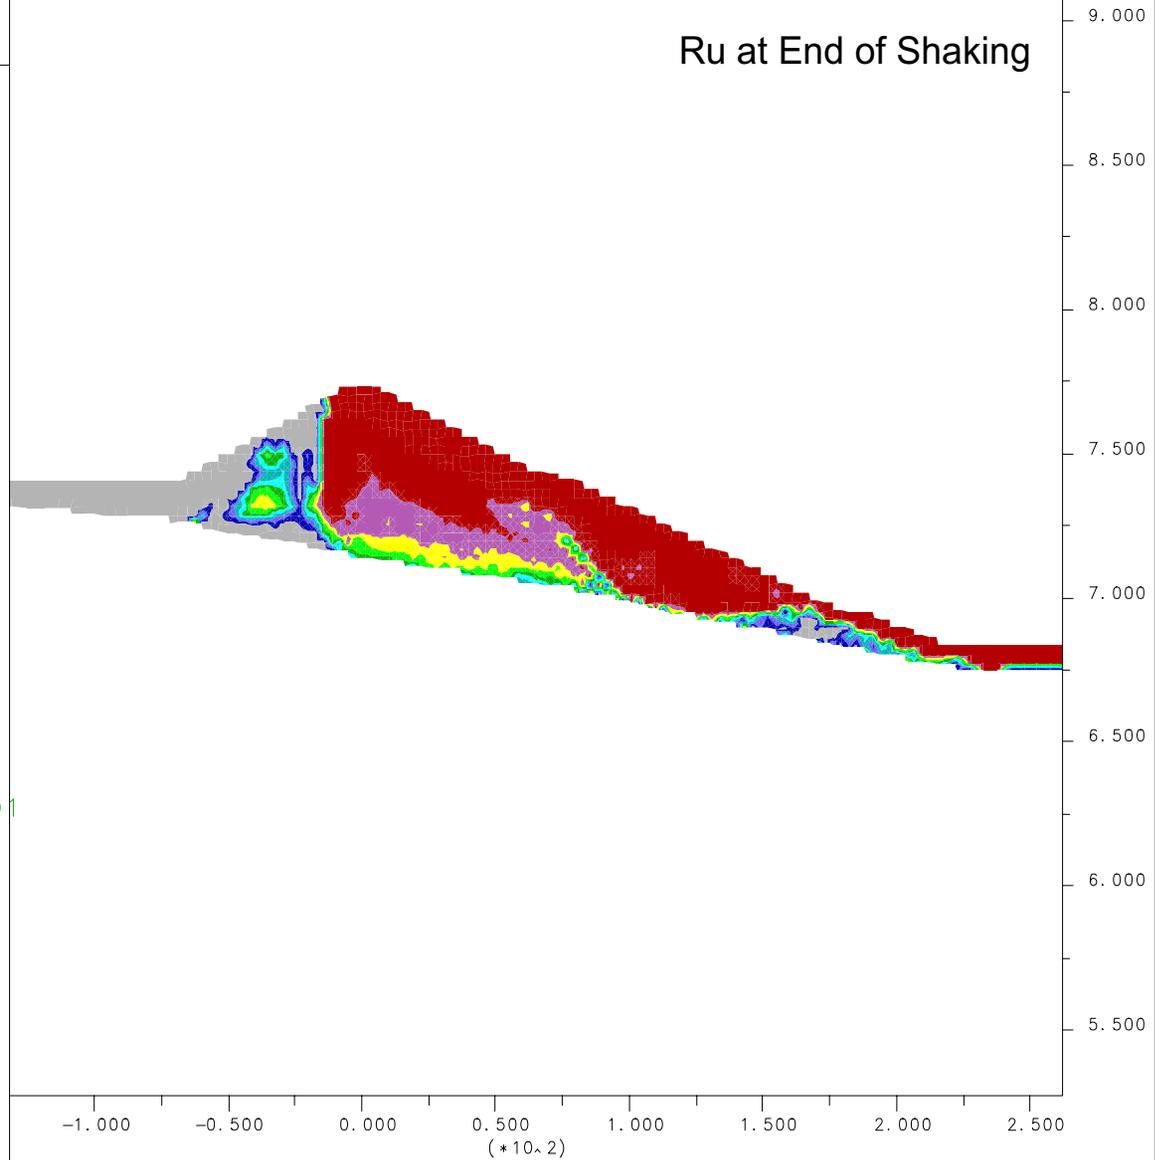
Ru at End of Shaking

FLAC Dynamic Analysis
with Cyclic Degradation Model
Excess Pore Pressure Ratio Contour
Hayward MCE TH #1

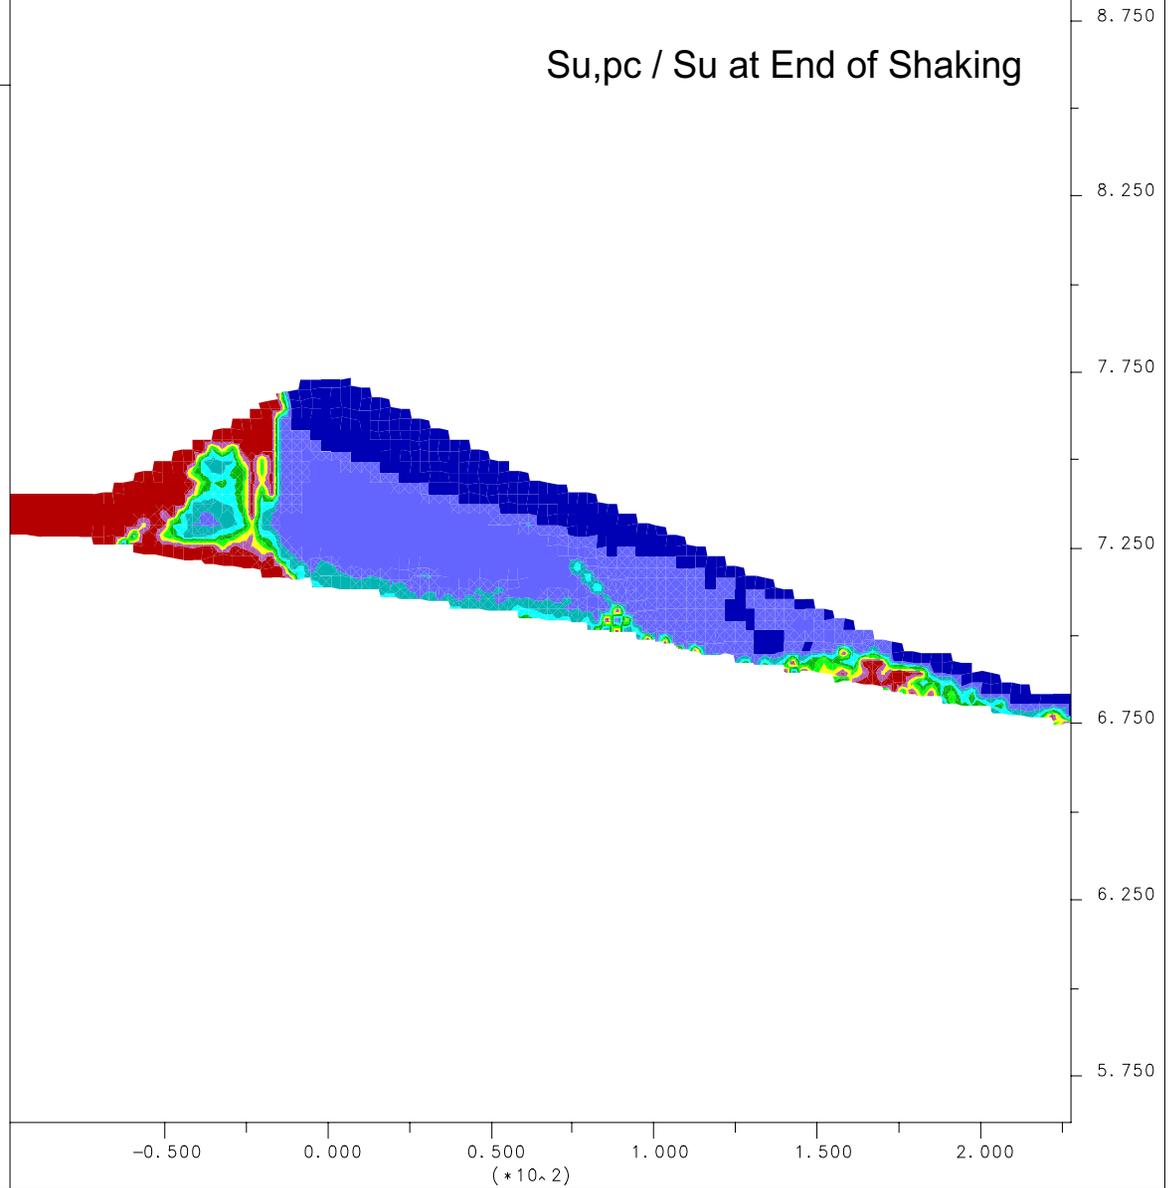
Su,pc / Su at End of Shaking

FLAC Dynamic Analysis
with Cyclic Degradation Model
Cyclic Degradation Contour
Hayward MCE TH #1

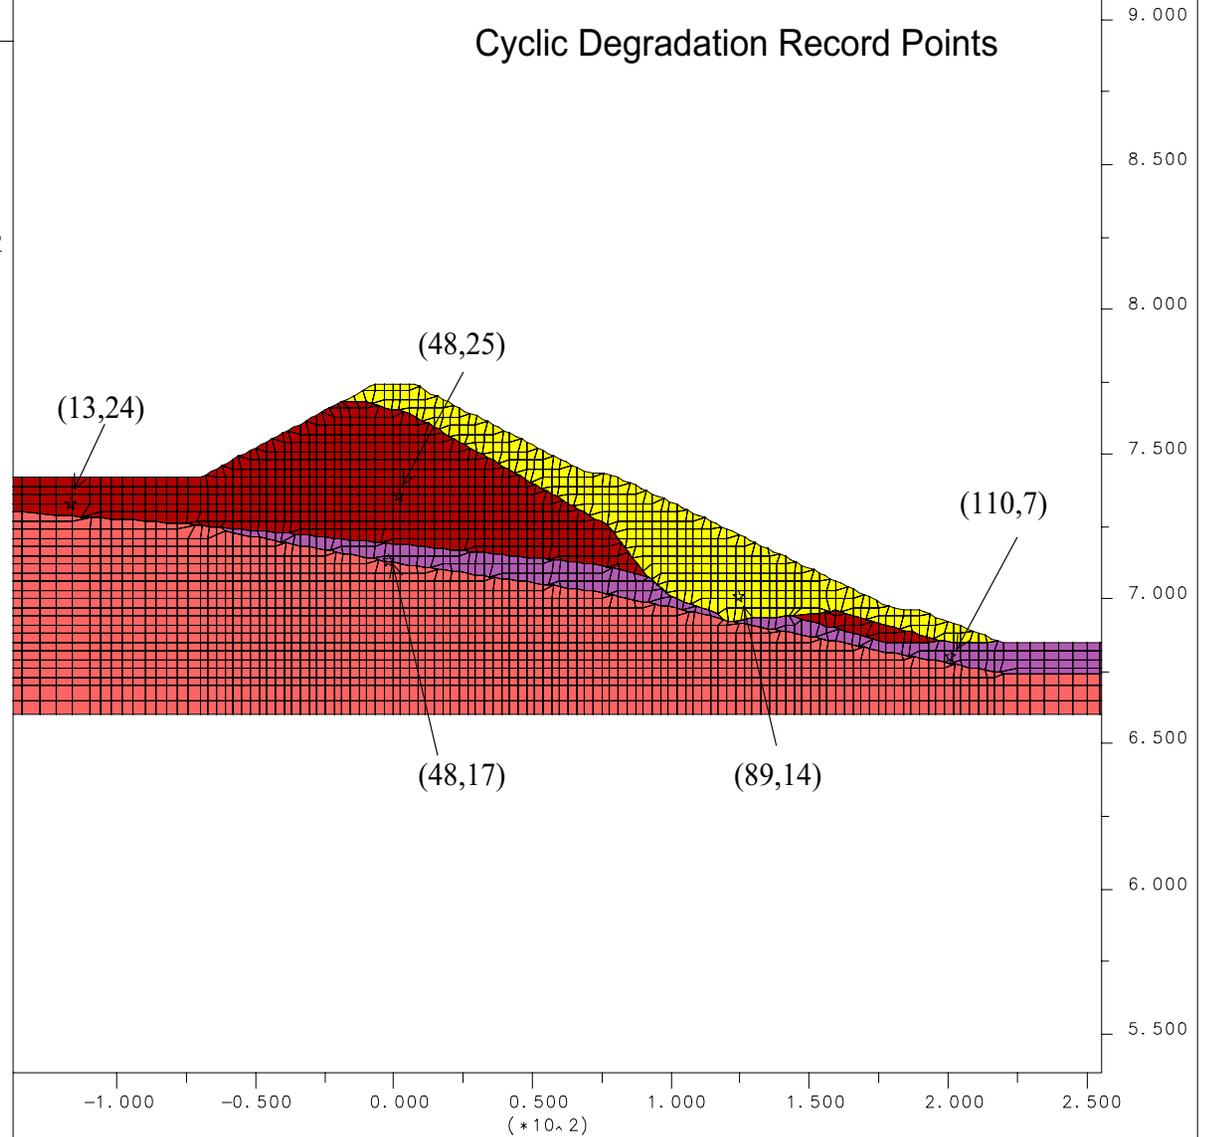
FLAC Dynamic Analysis
with Cyclic Degradation Model
Locations of Cyclic Degradation TH

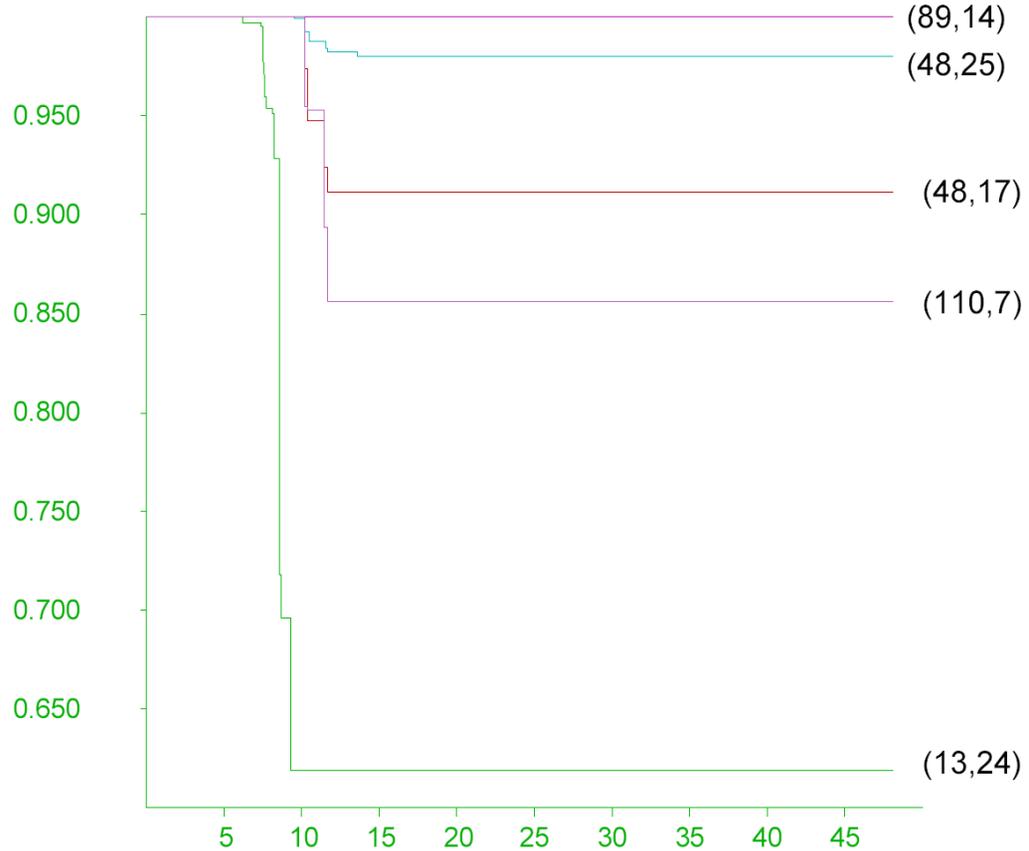
FLAC Dynamic Analysis
with Cyclic Degradation Model
Cyclic Degradation Time Histories
Hayward MCE TH #1

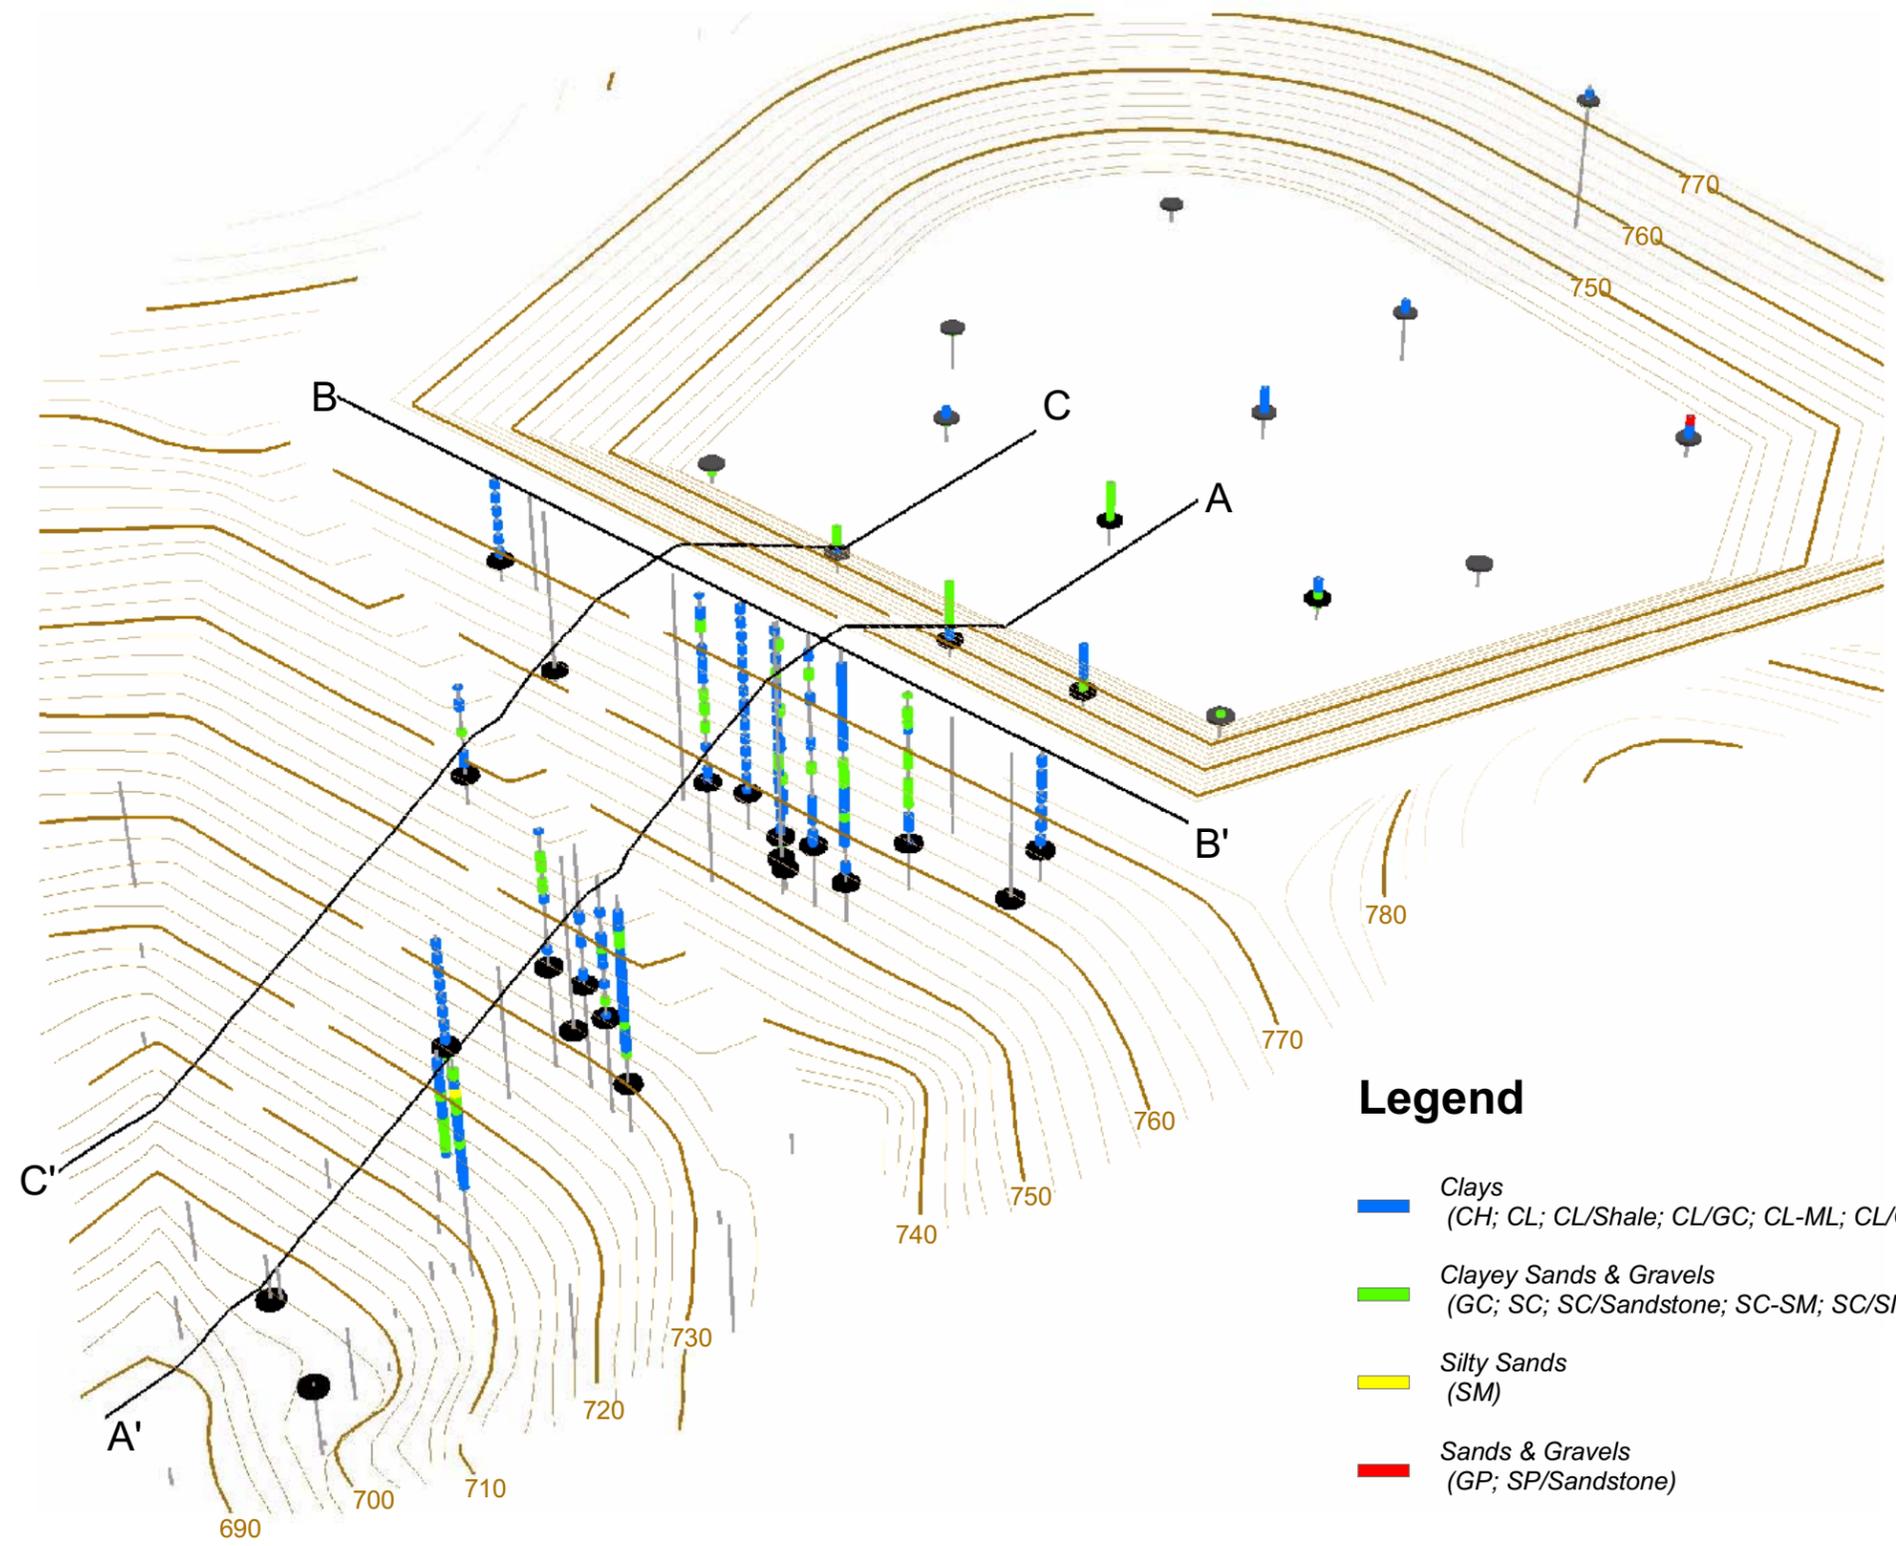
URS	Estates Dam Seismic Stability	Isometric View of Dam Geometry and Sections A-A' and C-C'	Figure 13-1
	26814957

As described in Section 3, the dam is located at the head of a ravine. As shown in Figure 13-1, the dam geometry is that of a relatively narrow wedge confined by the abutments on both sides. This geometry may have significant three-dimensional (3-D) effects on the overall stability and seismic performance of the dam. This section presents the analyses performed to assess such 3-D stability effects.

To estimate the time history of average mass acceleration for the critical 3-D sliding block, an additional 2-D section (Section C-C') was constructed and analyzed with QUAD4M. Section C-C' is located 55 feet to the right of section A-A' and is shown in Figure 13-6. Its location with respect to section A-A' is shown in Figures 13-1 and 13-7 through 13-9.

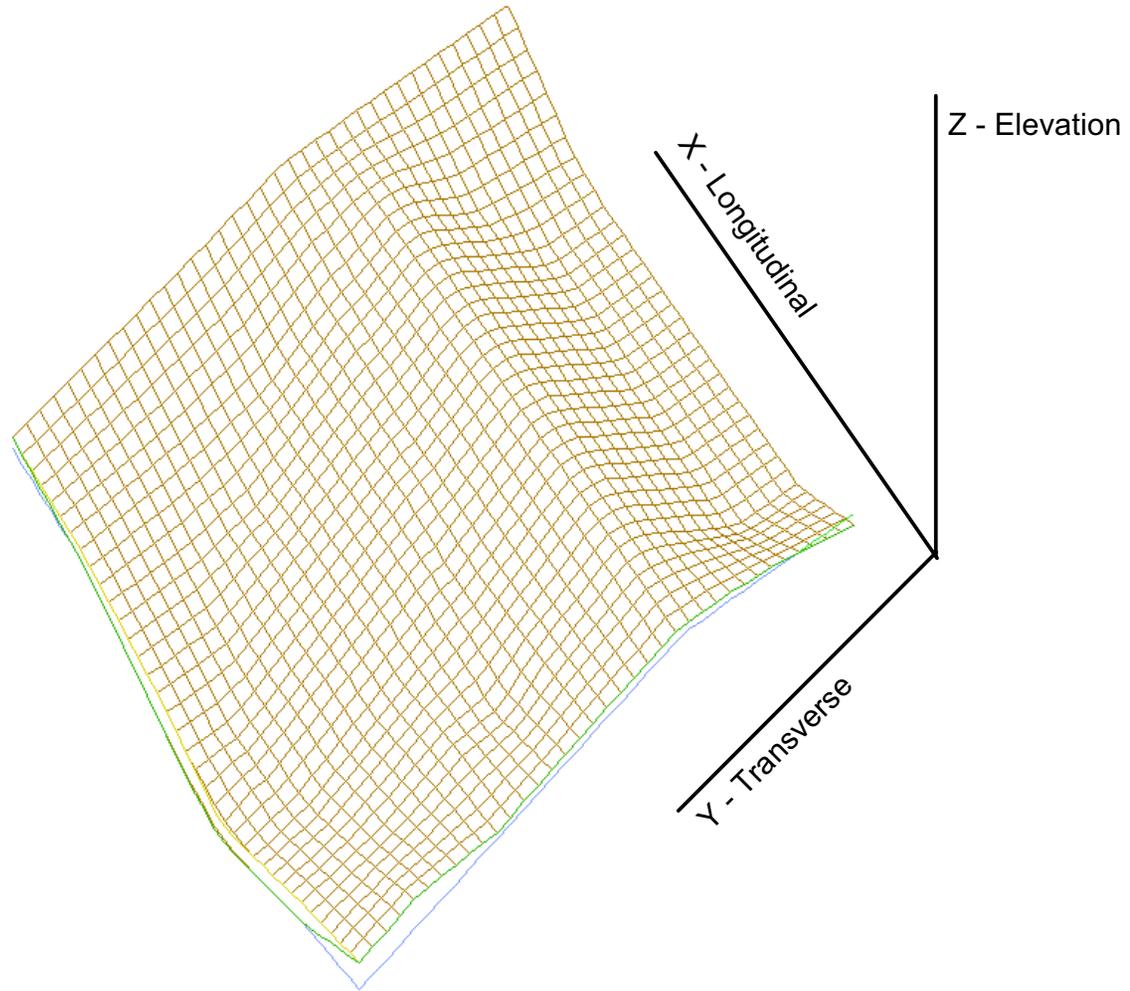
Project No. 26814957	Estates Dam Seismic Stability Analysis	Isometric View of the 3-D Dam Model 3-D Slope Stability Analysis	Figure 13-2
URS

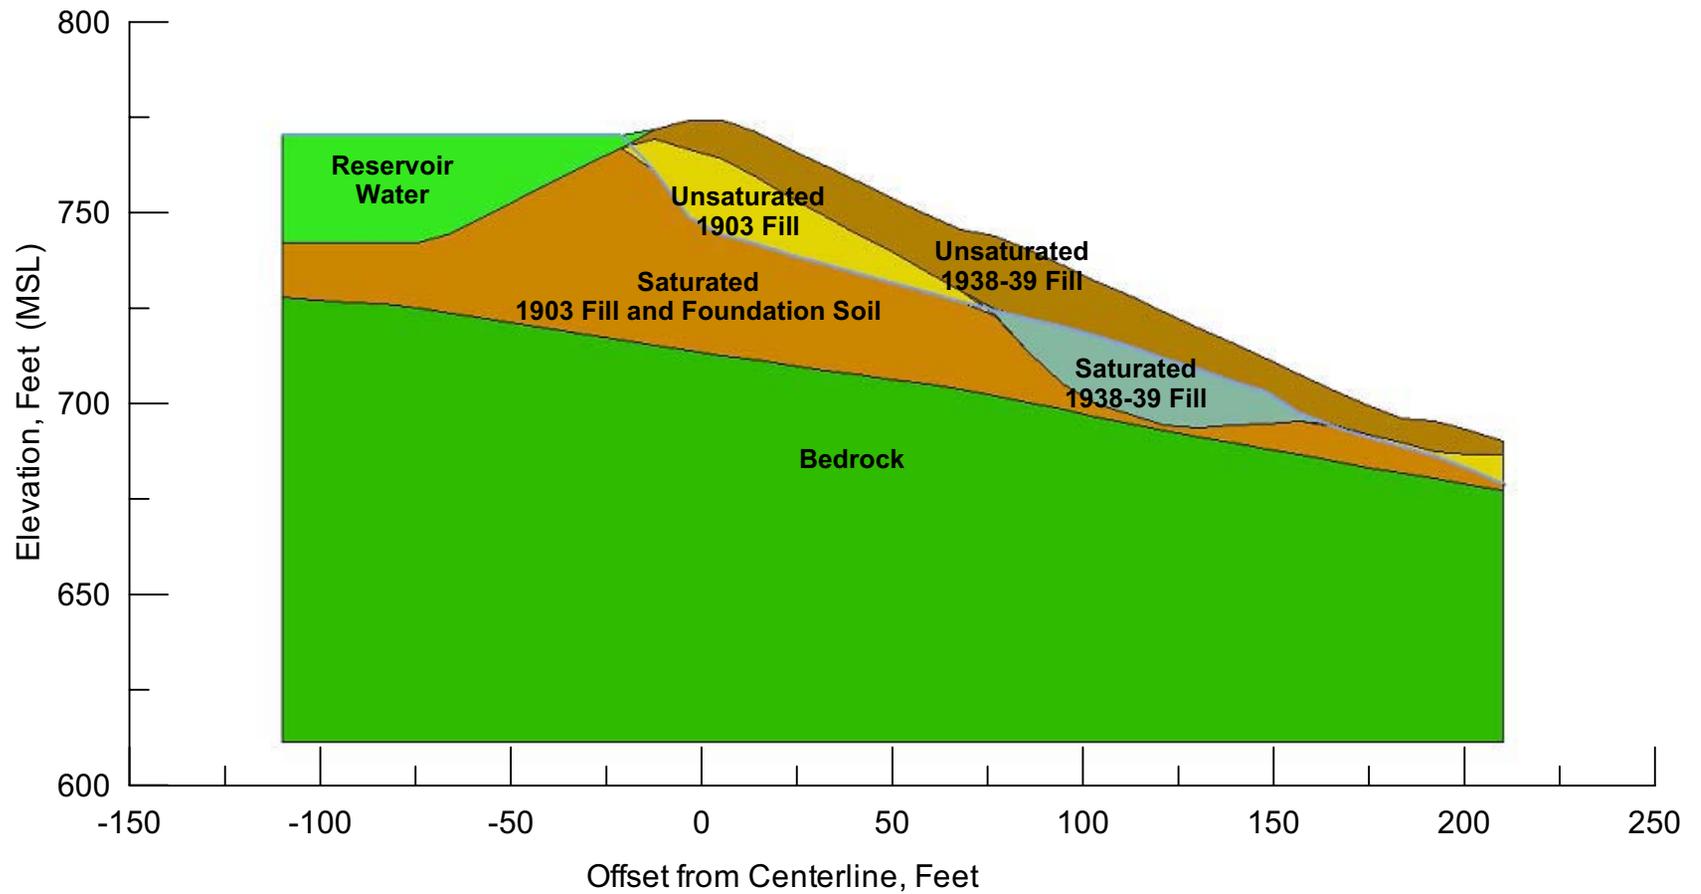
Section at Distance = 133 feet in Figure 13-4

Project No. 26814957	Estates Dam Seismic Stability Analysis	Example of Interpolated Transverse Cross Section From CLARA 3-D Slope Stability Analysis	Figure 13-3
URS

Based on the available geotechnical and piezometric data, nine transverse cross sections were developed along the length of the dam to define its 3-D geometry. These nine sections, which include section A-A' used for the 2-D stability analyses (see Section 9), were idealized and input to CLARA. From these data the program interpolated the various zone boundaries to create a 3-D model of the embankment and foundation as shown in Figure 13-2. Examples of the dam cross sections interpolated by CLARA are shown in Figures 13-3 and 13-4. The cross section shown in Figure 13-3 is cut 4 feet to the right of the section A-A'. The section shown in Figure 13-4 is cut parallel to and 5 feet downstream of the axis of the dam.

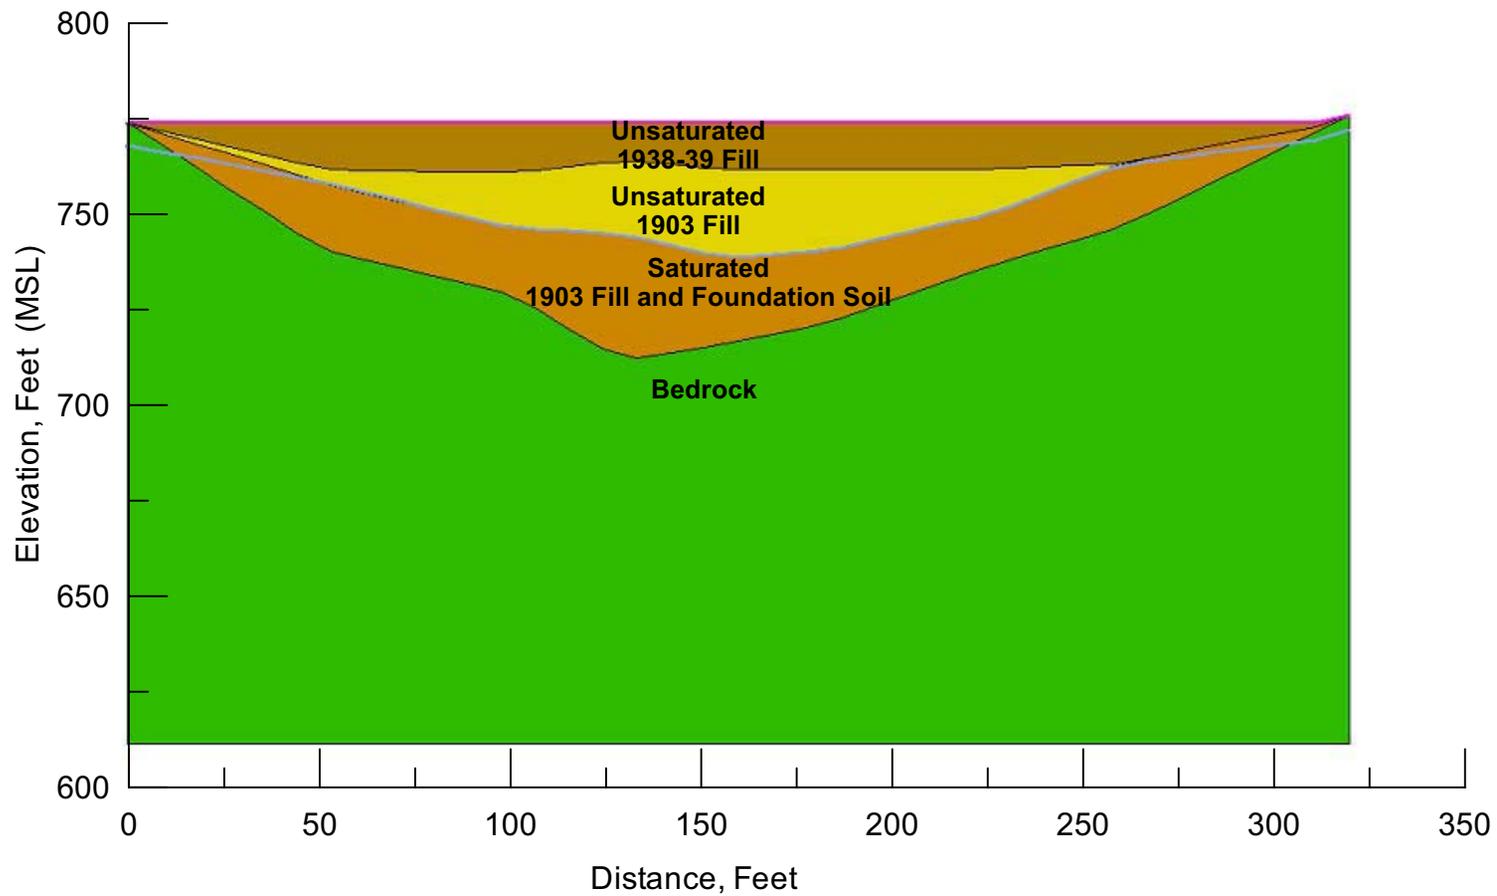
Section at Offset = 5 feet in Figure 13-3

Project No. 26814957	Estates Dam Seismic Stability Analysis	Example of Interpolated Longitudinal Cross Section From CLARA 3-D Slope Stability Analysis	Figure 13-4
URS

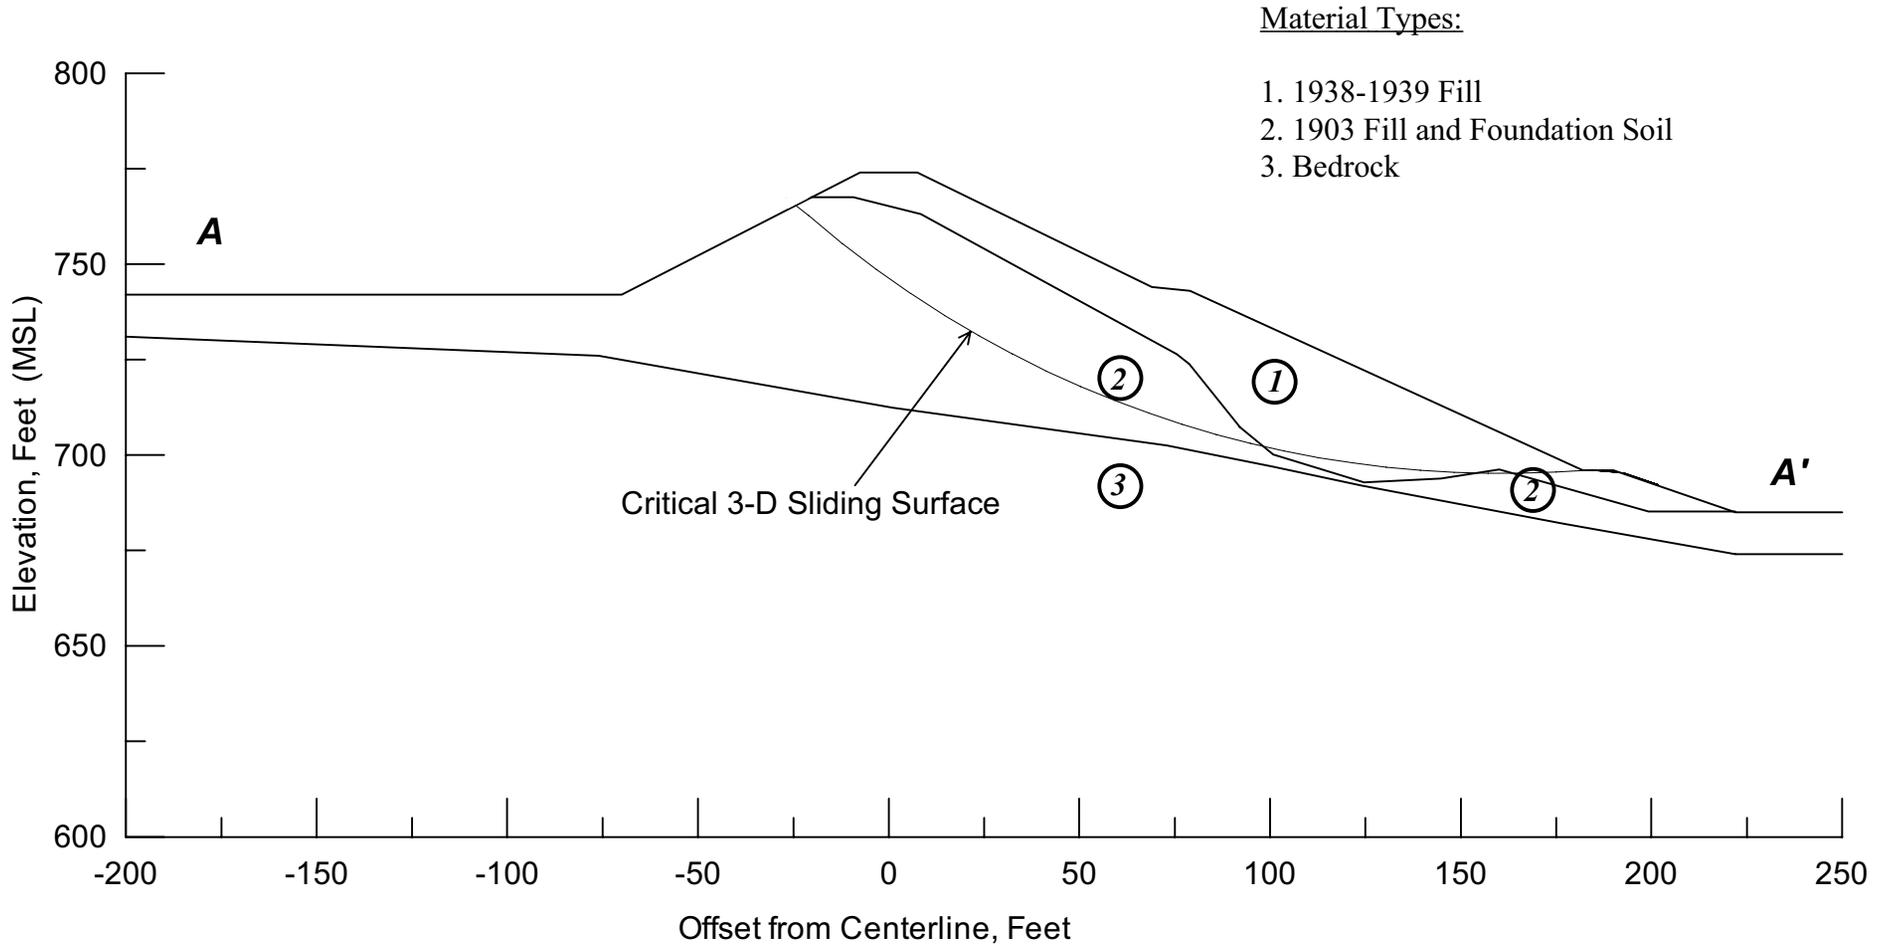
Section A-A' at Distance = 129 feet in Figure 13-4.

Project No. 26814957	Estates Dam Seismic Stability Analysis	Profile of Critical 3-D Sliding Block on Cross-Section A-A' 3-D Slope Stability Analysis Post-Earthquake Conditions	Figure
URS			13-5

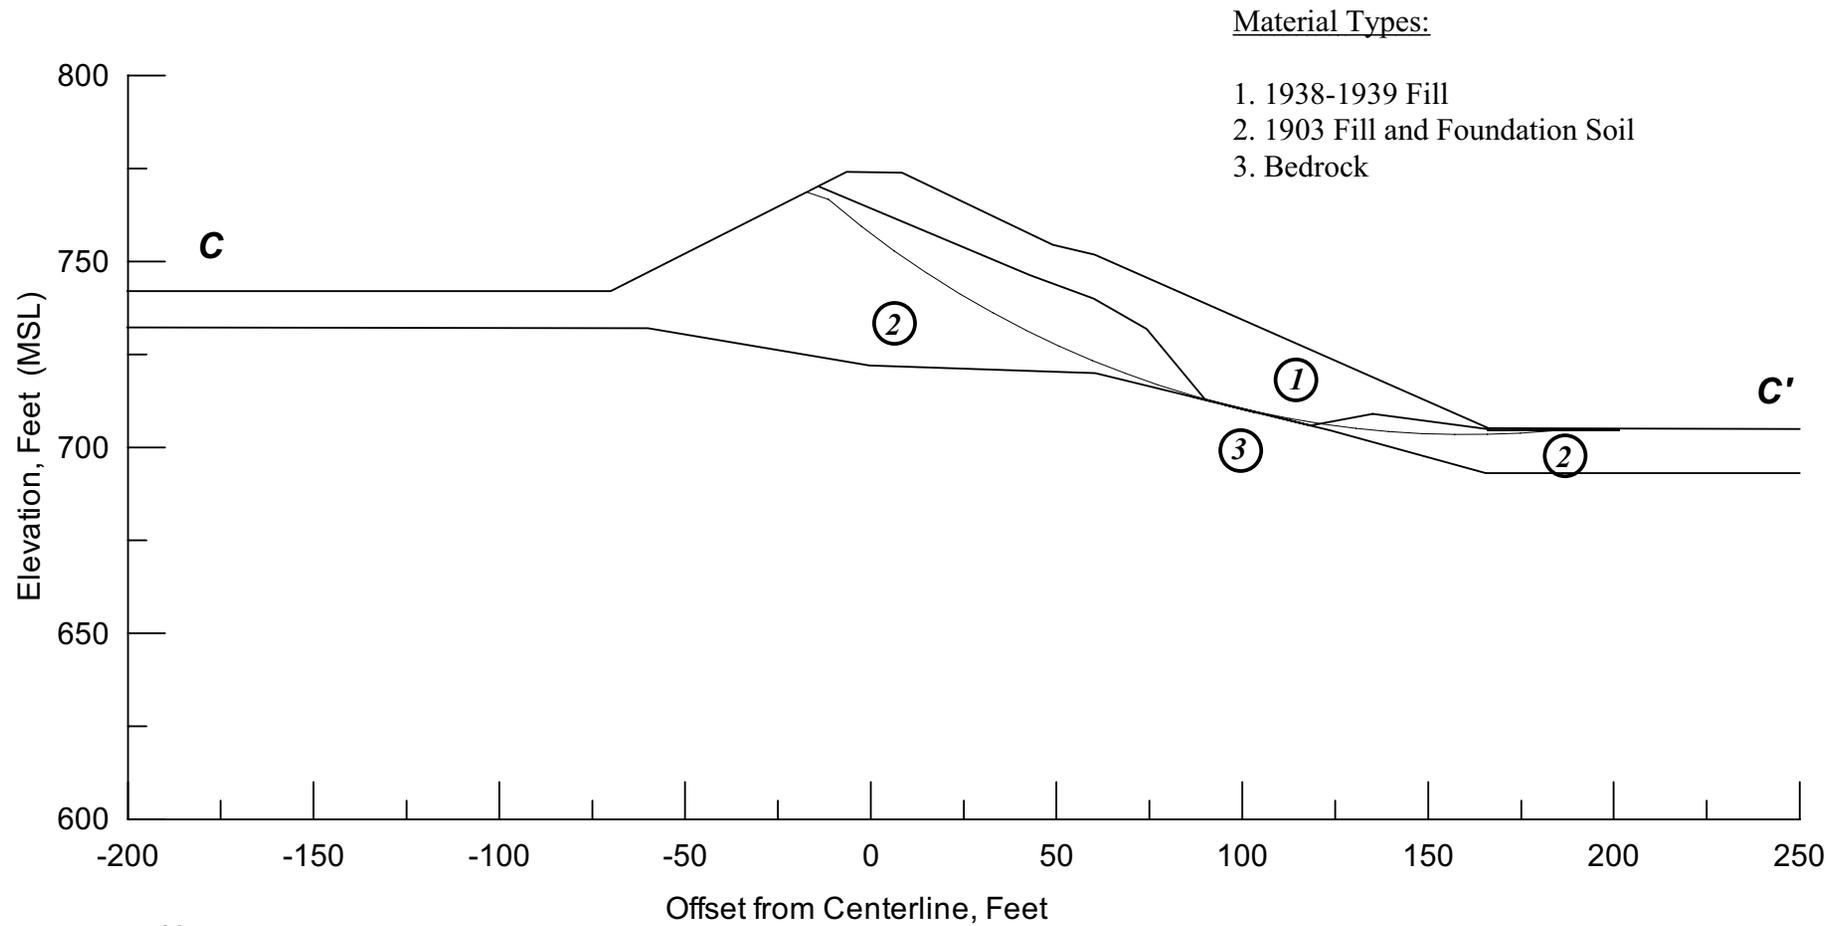
Project No. 26814957	Estates Dam Seismic Stability Analysis	Profile of Critical 3-D Sliding Block on Cross Section C-C' 3-D Slope Stability Analysis Post-Earthquake Conditions	Figure
URS			13-6
