FINAL REPORT

Dynamic Stability Analysis of Estates Dam

Oakland, California

NOVEMBER 2006

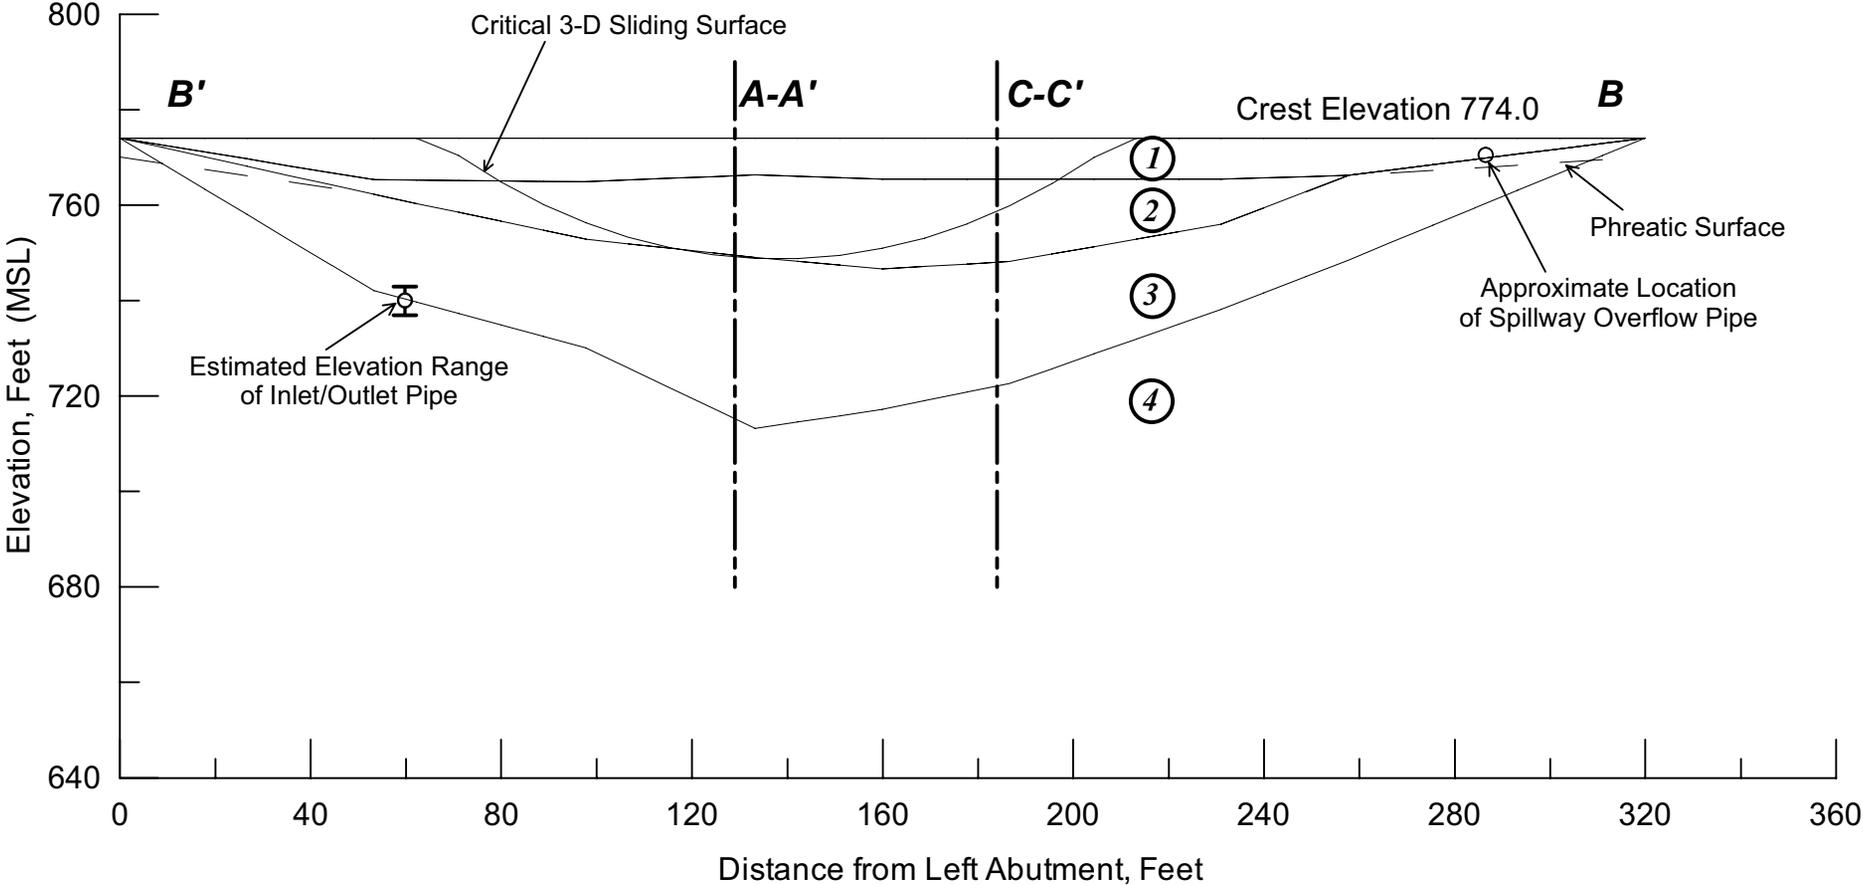
Project No. 26814957	Estates Dam Seismic Stability Analysis	Profile of Critical 3-D Sliding Block on Longitudinal Section at Offset = 0 3-D Slope Stability Analysis	Figure 13-7
URS

To estimate the time history of average mass acceleration for the critical 3-D sliding block, an additional 2-D section (Section C-C') was constructed and analyzed with QUAD4M. Section C-C' is located 55 feet to the right of section A-A' and is shown in Figure 13-6. Its location with respect to section A-A' is shown in Figures 13-1 and 13-7 through 13-9.

The spillway overflow pipe is located near the right abutment as shown in Figure 3-2. From manhole No. 1 to manhole No. 2 the pipe runs at a depth of about 5 feet below the ground surface. The estimated location of the pipe in section is shown in Figures 13-7 through 13-9. The foundation conditions beneath the pipe are not well known. Between the dam crest and the bend at the right dam groin (see Figure 3-2), the pipe appears to be founded near the bottom of the embankment fill or in natural ground, whereas downstream of the bend it is founded in natural ground. Based on its location, it seems unlikely that the pipe will be subjected to large ground displacements. However, small displacements are possible in response to the estimated displacements near the center of the downstream slope. Because of its steel construction, the pipe is likely to be capable of withstanding displacements of a few inches, although an in-depth assessment of this issue has not been made.

The inlet/outlet pipe is located near the left abutment as shown in Figure 3-2. The approximate location of the pipe is shown in Figures 13-7 through 13-9. It appears that beneath the dam crest the pipe is founded on bedrock. Downstream of the crest, the pipe foundation appears to transition from bedrock to foundation soil, to possibly embankment fill near the pumping plant. The available construction records indicate that the pipe was laid in a trench through the embankment and foundation materials and was encased in concrete from the reservoir inlet to the pumping plant. Based on the excavation slopes, it appears that the bottom of the trench was cut through competent materials. In view of its location, it seems unlikely that the pipe will be subjected to large displacements. However, small displacements are possible in response to the estimated displacements of the downstream slope, particularly where the pipe approaches the pumping plant. Because the pipe is of cast iron construction, it may not be able to tolerate displacements greater than a few inches without damage. Although rupture of the pipe is possible, the extent of damage to the pipe would be limited by the concrete encasement, and potential erosion from pipe leakage would likely be localized to the near-surface materials in the area of the pumping plant.

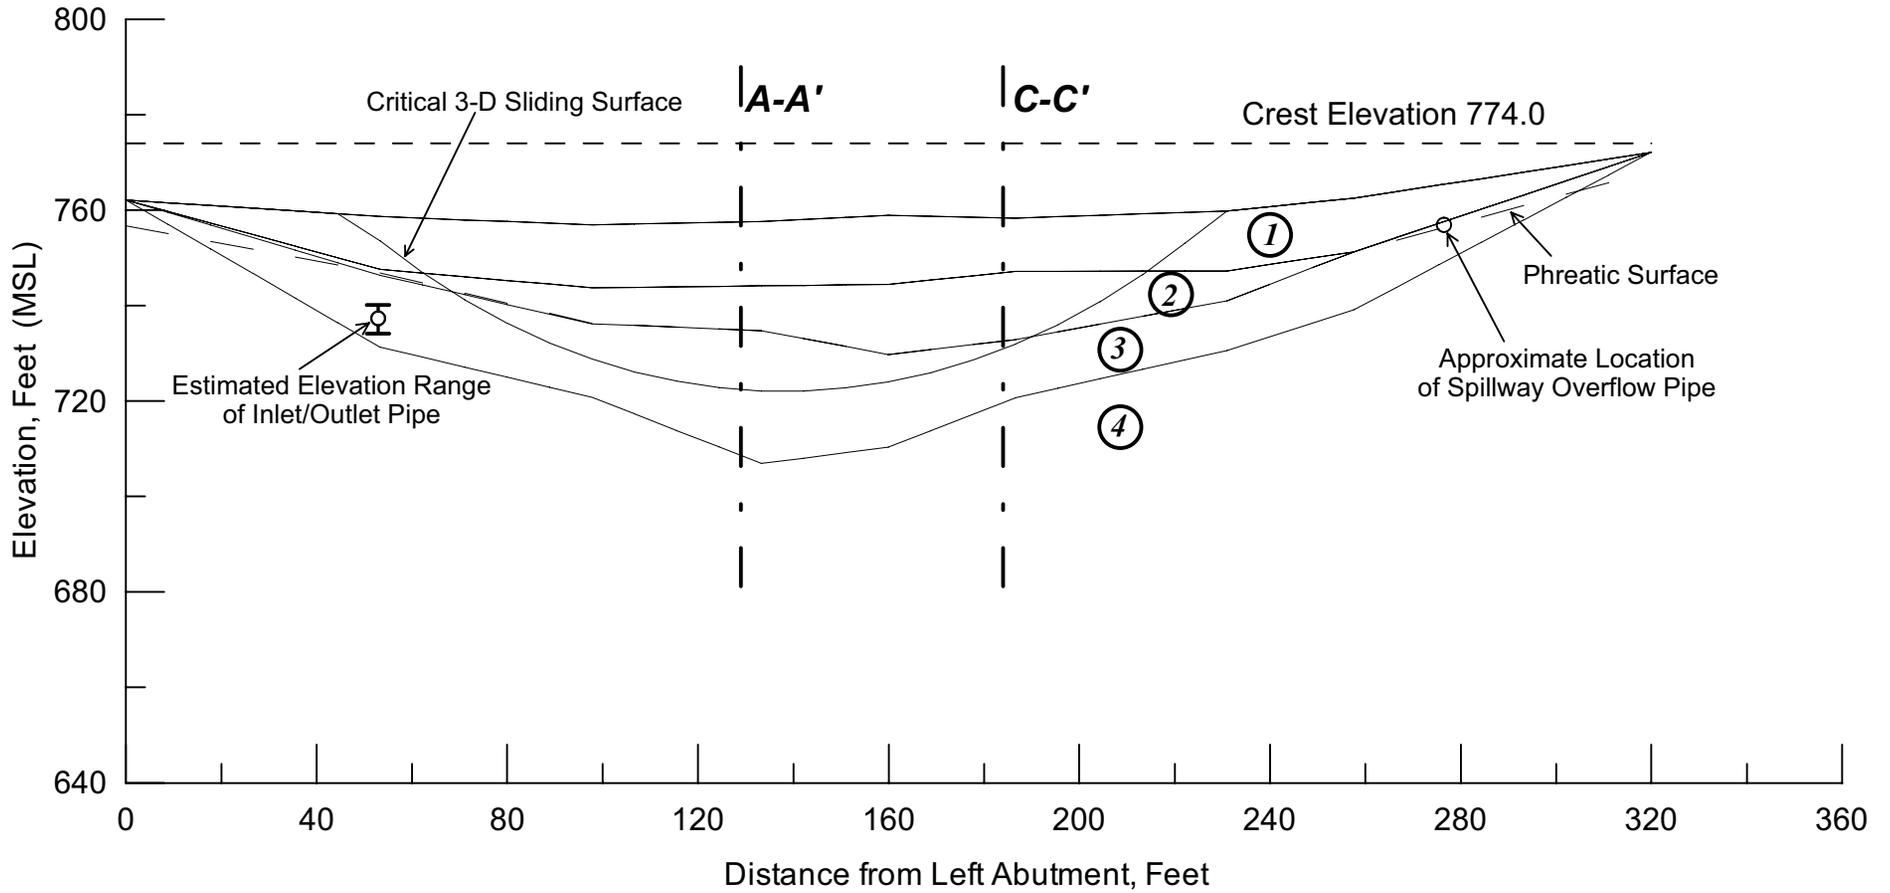
Project No. 26814957	Estates Dam Seismic Stability Analysis	Profile of Critical 3-D Sliding Block on Longitudinal Section at Offset = 40 ft 3-D Slope Stability Analysis	Figure 13-8
URS

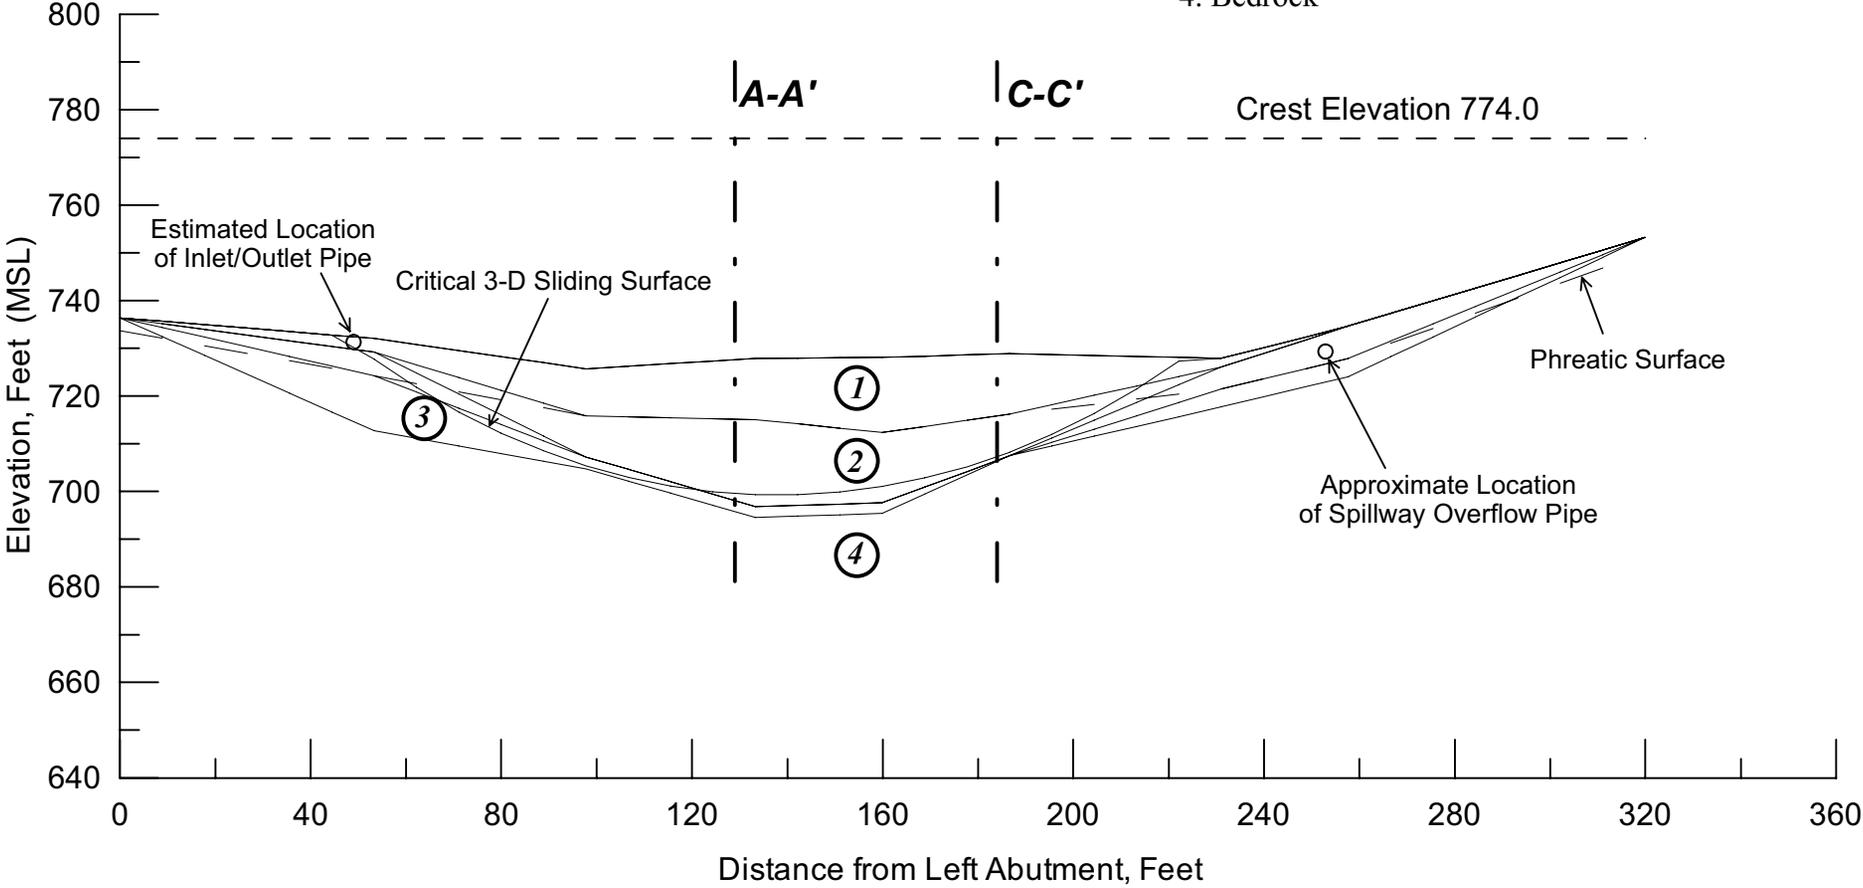
Project No. 26814957	Estates Dam Seismic Stability Analysis	Profile of Critical 3-D Sliding Block on Longitudinal Section at Offset = 110 ft 3-D Slope Stability Analysis	Figure 13-9
URS

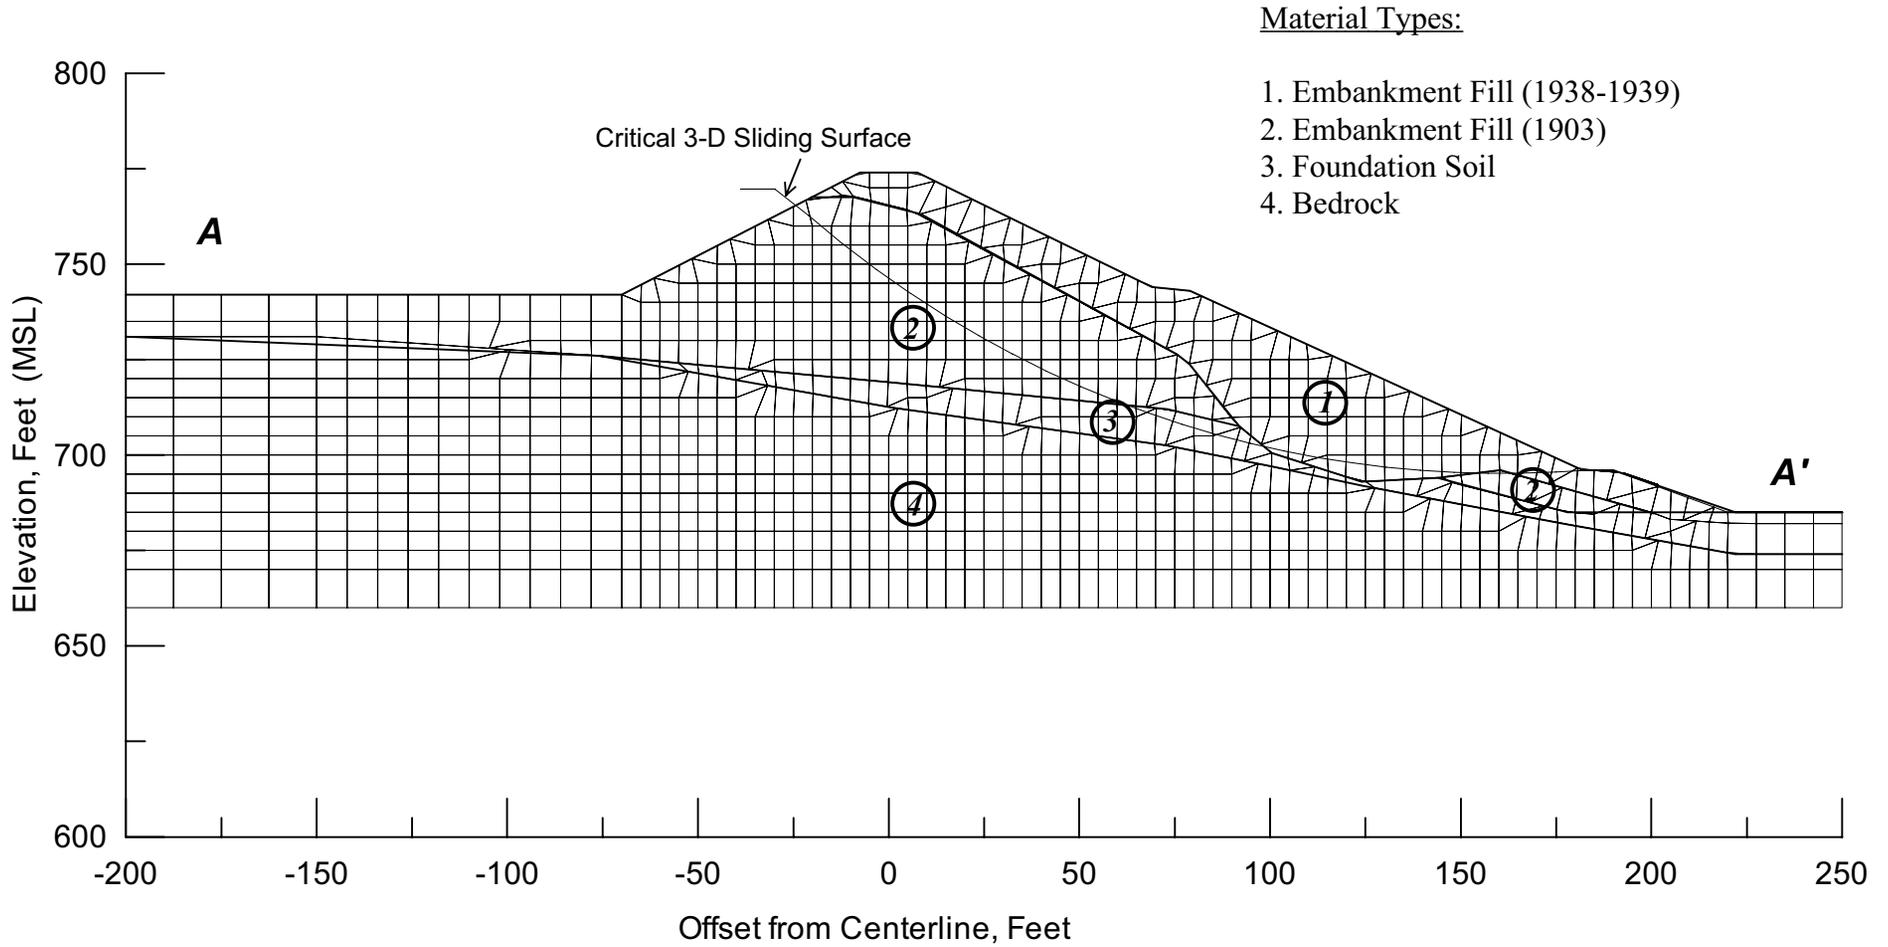
Project No. 26814957	Estates Dam Seismic Stability Analysis	Finite Element Mesh for QUAD4M Analysis Cross-Section A-A' and Critical 3-D Sliding Surface	Figure
URS			13-10

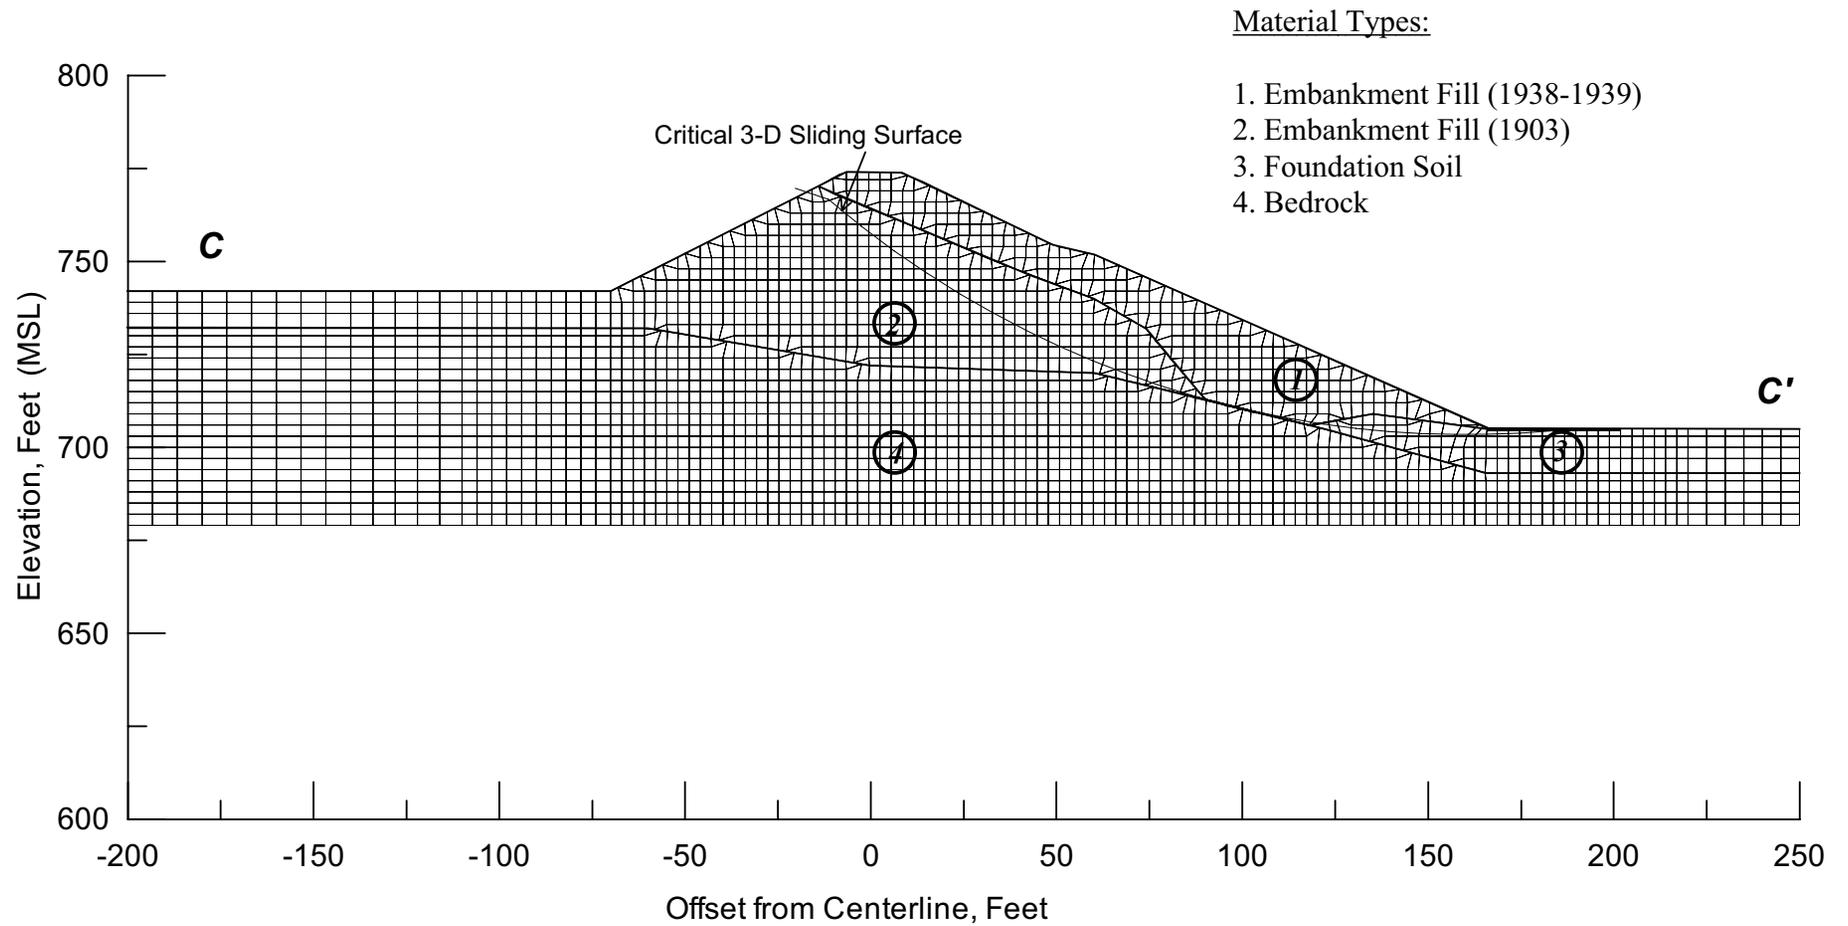
Project No. 26814957	Estates Dam Seismic Stability Analysis	Finite Element Mesh for QUAD4M Analysis Additional Cross-Section C-C' and Critical 3-D Sliding Surface	Figure
URS			13-11

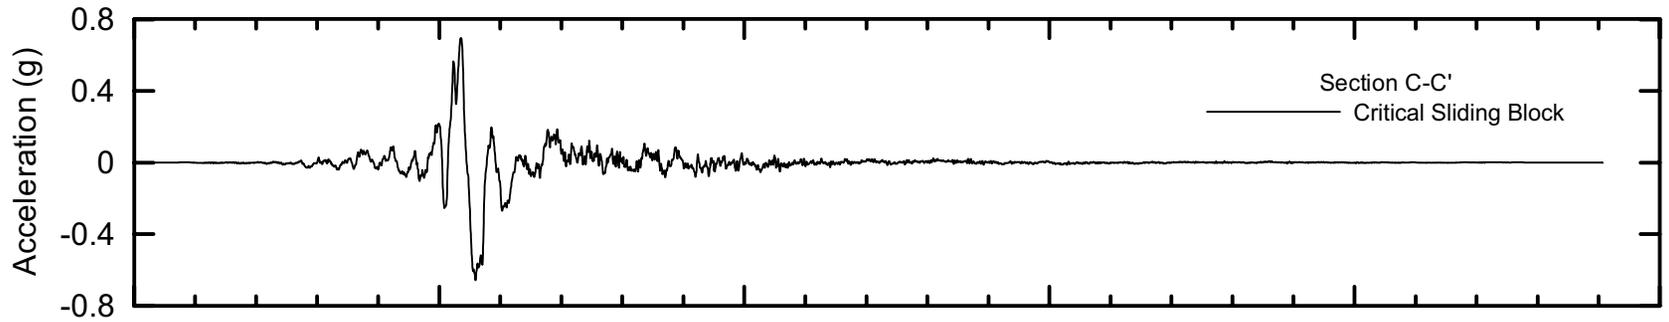
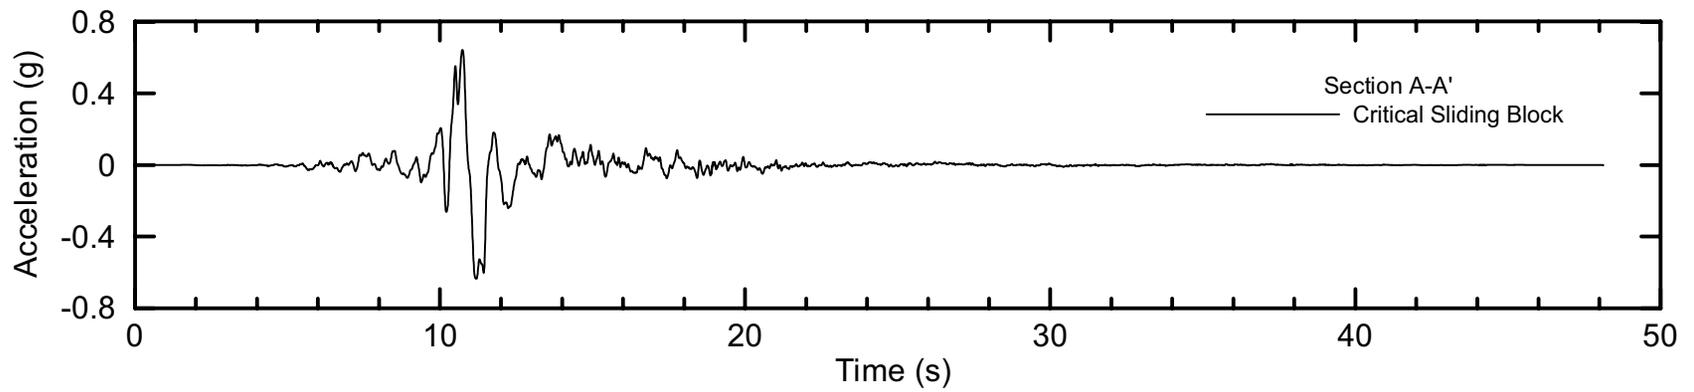
Project No. 26814957	Estates Dam Seismic Stability Check	Average Seismic Coefficient Downstream Blocks QUAD4M Analysis Hayward Fault MCE TH #1	Figure 13-12
URS

The computed average mass acceleration time histories for the 2-D sliding blocks are shown in Figures 13-12 and 13-13. The computed time histories for sections A-A' and C-C' are generally similar in amplitude and in-phase. Thus, it seems reasonable to use a weighted-average to estimate the overall 3-D average mass acceleration from these individual 2-D time histories. The weighted average mass acceleration time histories for the critical 3-D sliding block are shown in Figures 13-14 and 13-15.
