APPENDIX C

GEOPHYSICAL SURVEYS

PARDEE DAM PROJECT

Portola Geophysics
 900 Wayside Road Portola Valley, CA 94028
 SEISMIC REFRACTION SURVEY
 DATA AND INTERPRETED SUBSURFACE VELOCITY PROFILES
 PARDEE DAM RAISE
 AMADOR COUNTY, CALIFORNIA

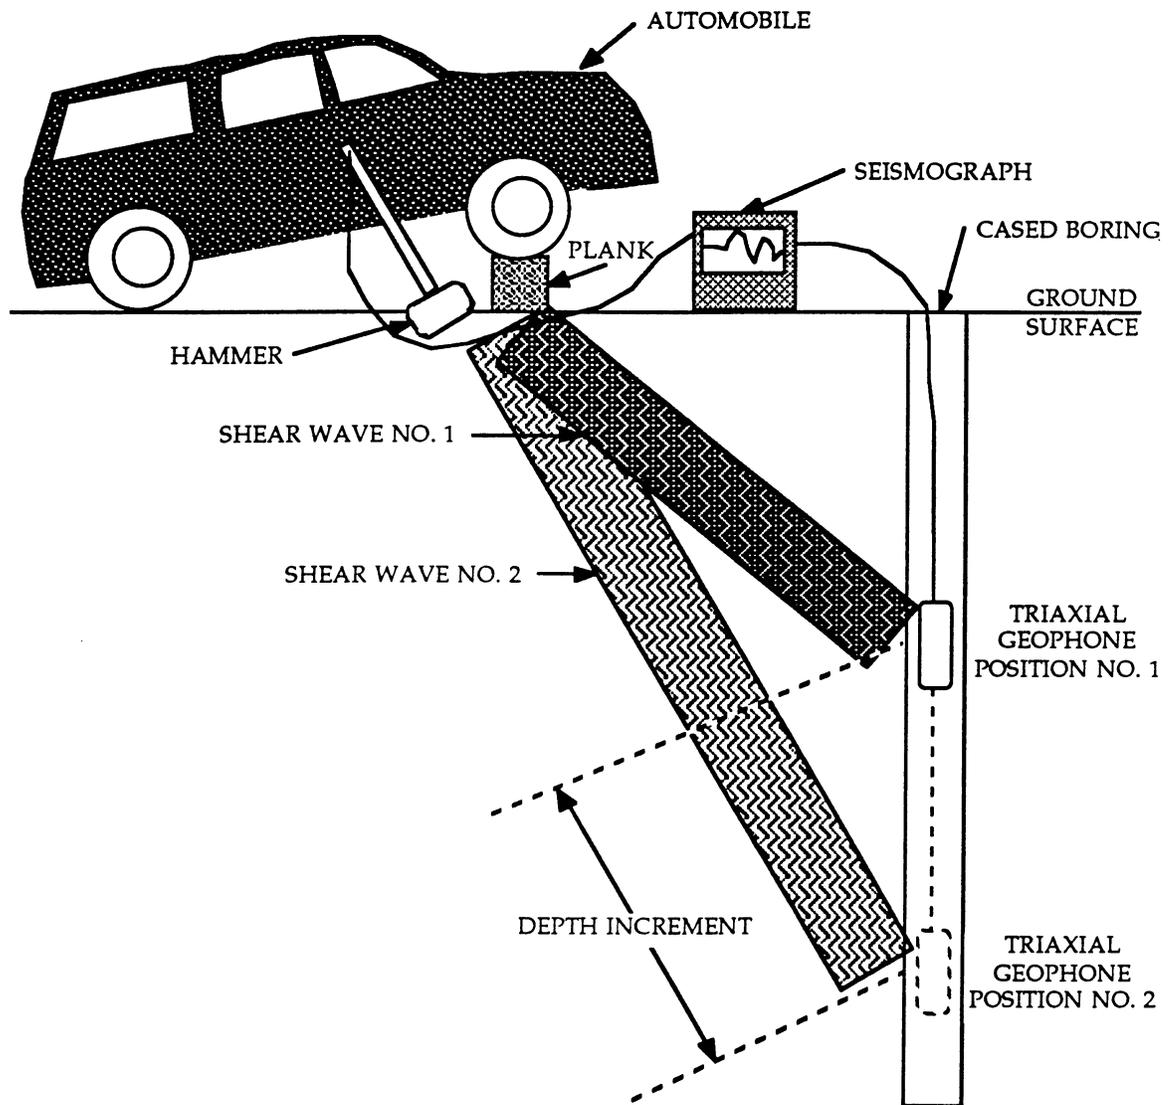
Typical Downhole Seismic Set-Up (Boring MD-7)

The geophone bundle was clamped against the inside of the borings at successive depth intervals by inflation of a pneumatic bladder. For Boring MD-7, a wooden plank (4-inch by 6-inch by 8 feet long) was placed perpendicular to the boring at a distance of 10 feet from the top of the boring (see sketch on following page). A 16-pound sledge hammer was impacted alternately at both ends of the plank to produce successive shear waves of reversed polarity, and then was impacted vertically on a metal plate at the ground surface to produce compression waves. For Boring MD-8, a heavy steel pry bar, with flattened tip, was driven two feet into the ground about 5 feet out from the boring, in line with the dip of the boring. A 16-pound sledge hammer equipped with seismograph/oscillograph triggering switch was impacted on a metal plate leaned against both sides of the pry bar to produce successive shear waves with reversed polarity. The hammer was also impacted vertically on a steel plate placed at the ground surface (also 5 feet from the top of the boring) to produce compression waves. The hammer impacts generated shear and compression waves which traveled through the subsurface materials and were received by the deployed geophone bundle at successive depths. The geophones were monitored and displayed graphically in analog form on an ABEM™ Terraloc Seismic System, portable 24-channel seismograph system. Paper records were produced, catalogued and returned to the office for data reduction and interpretation.

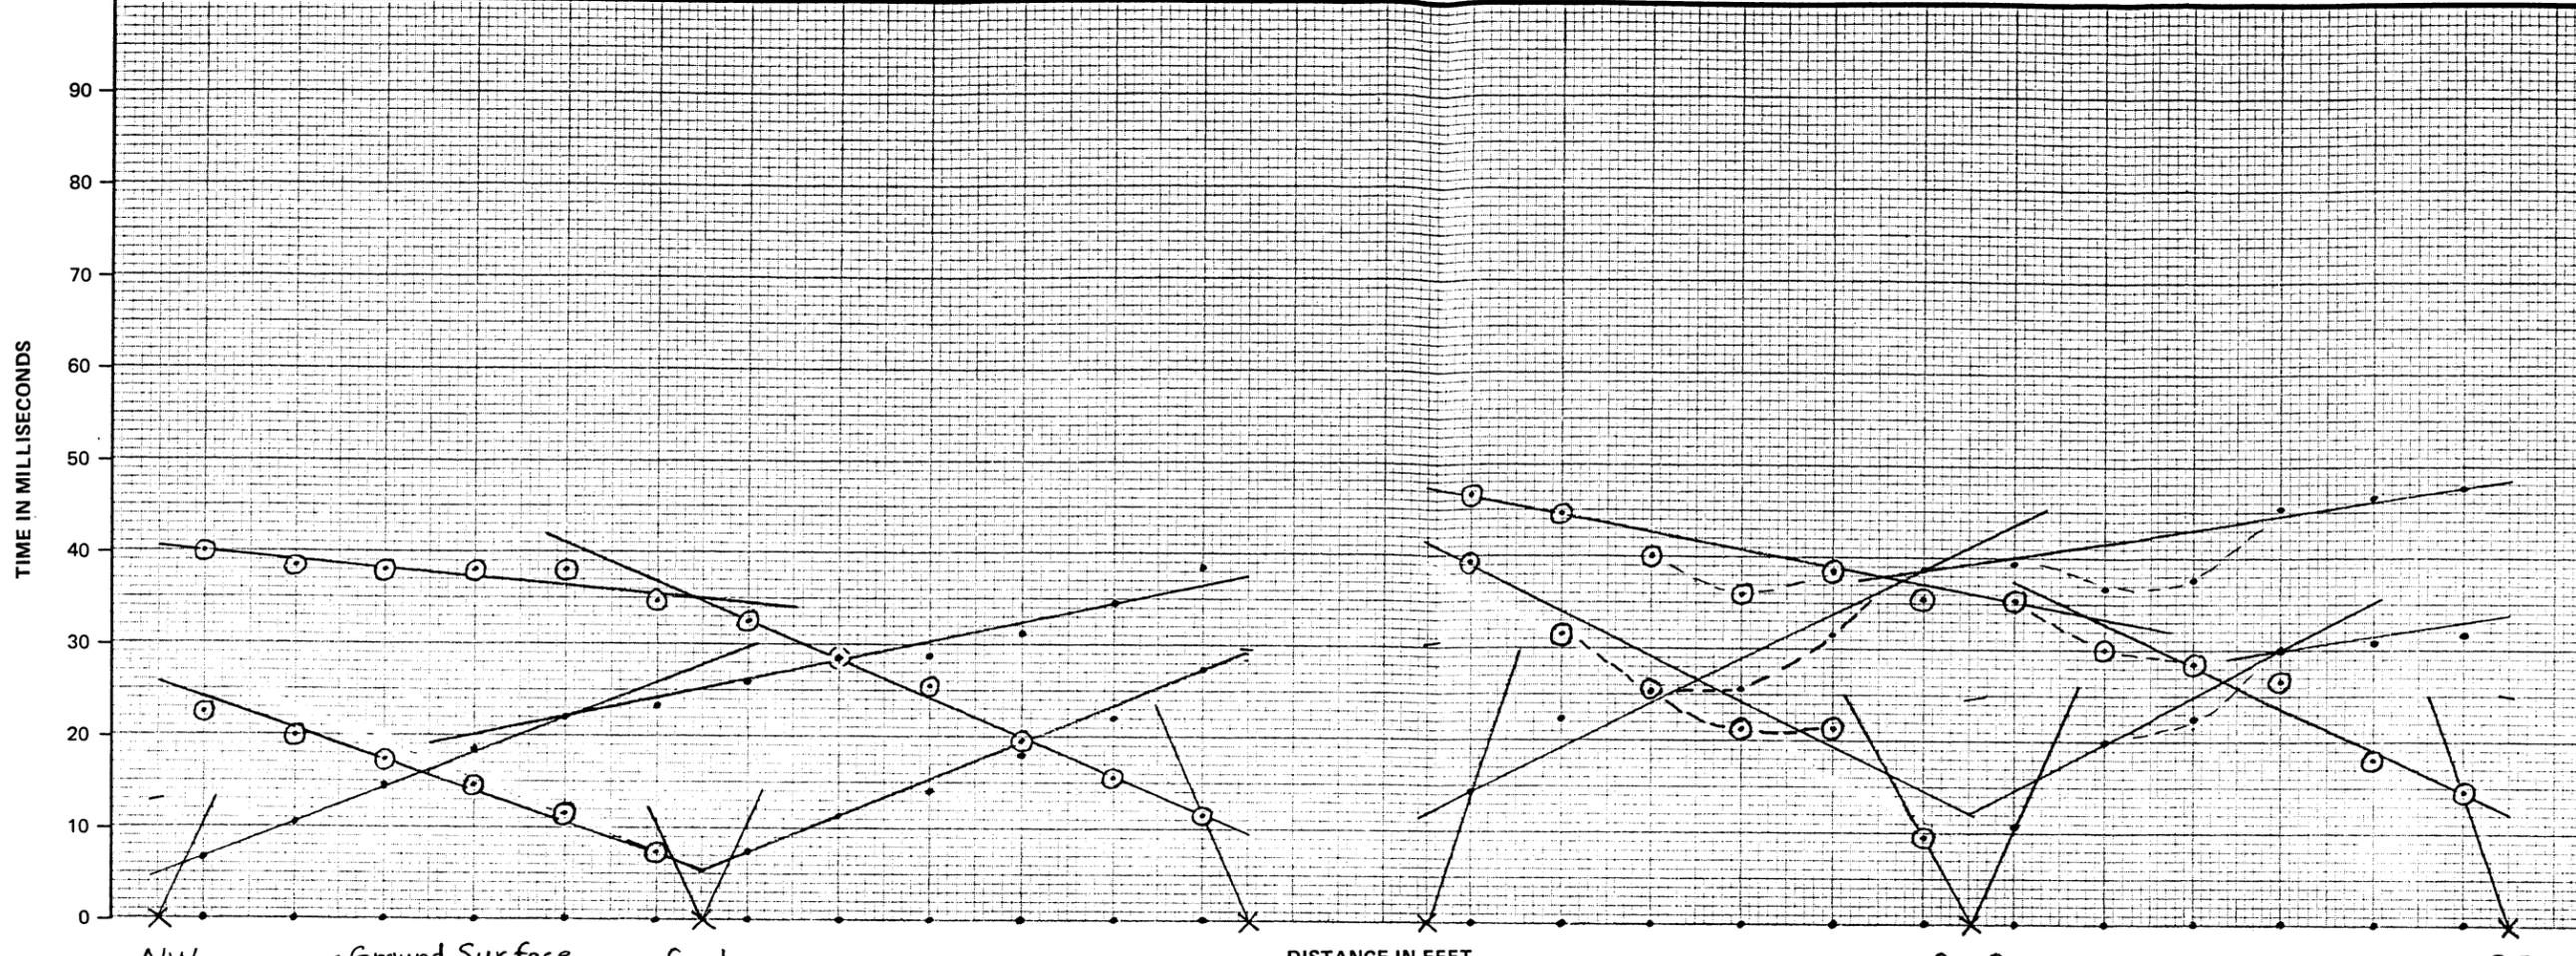
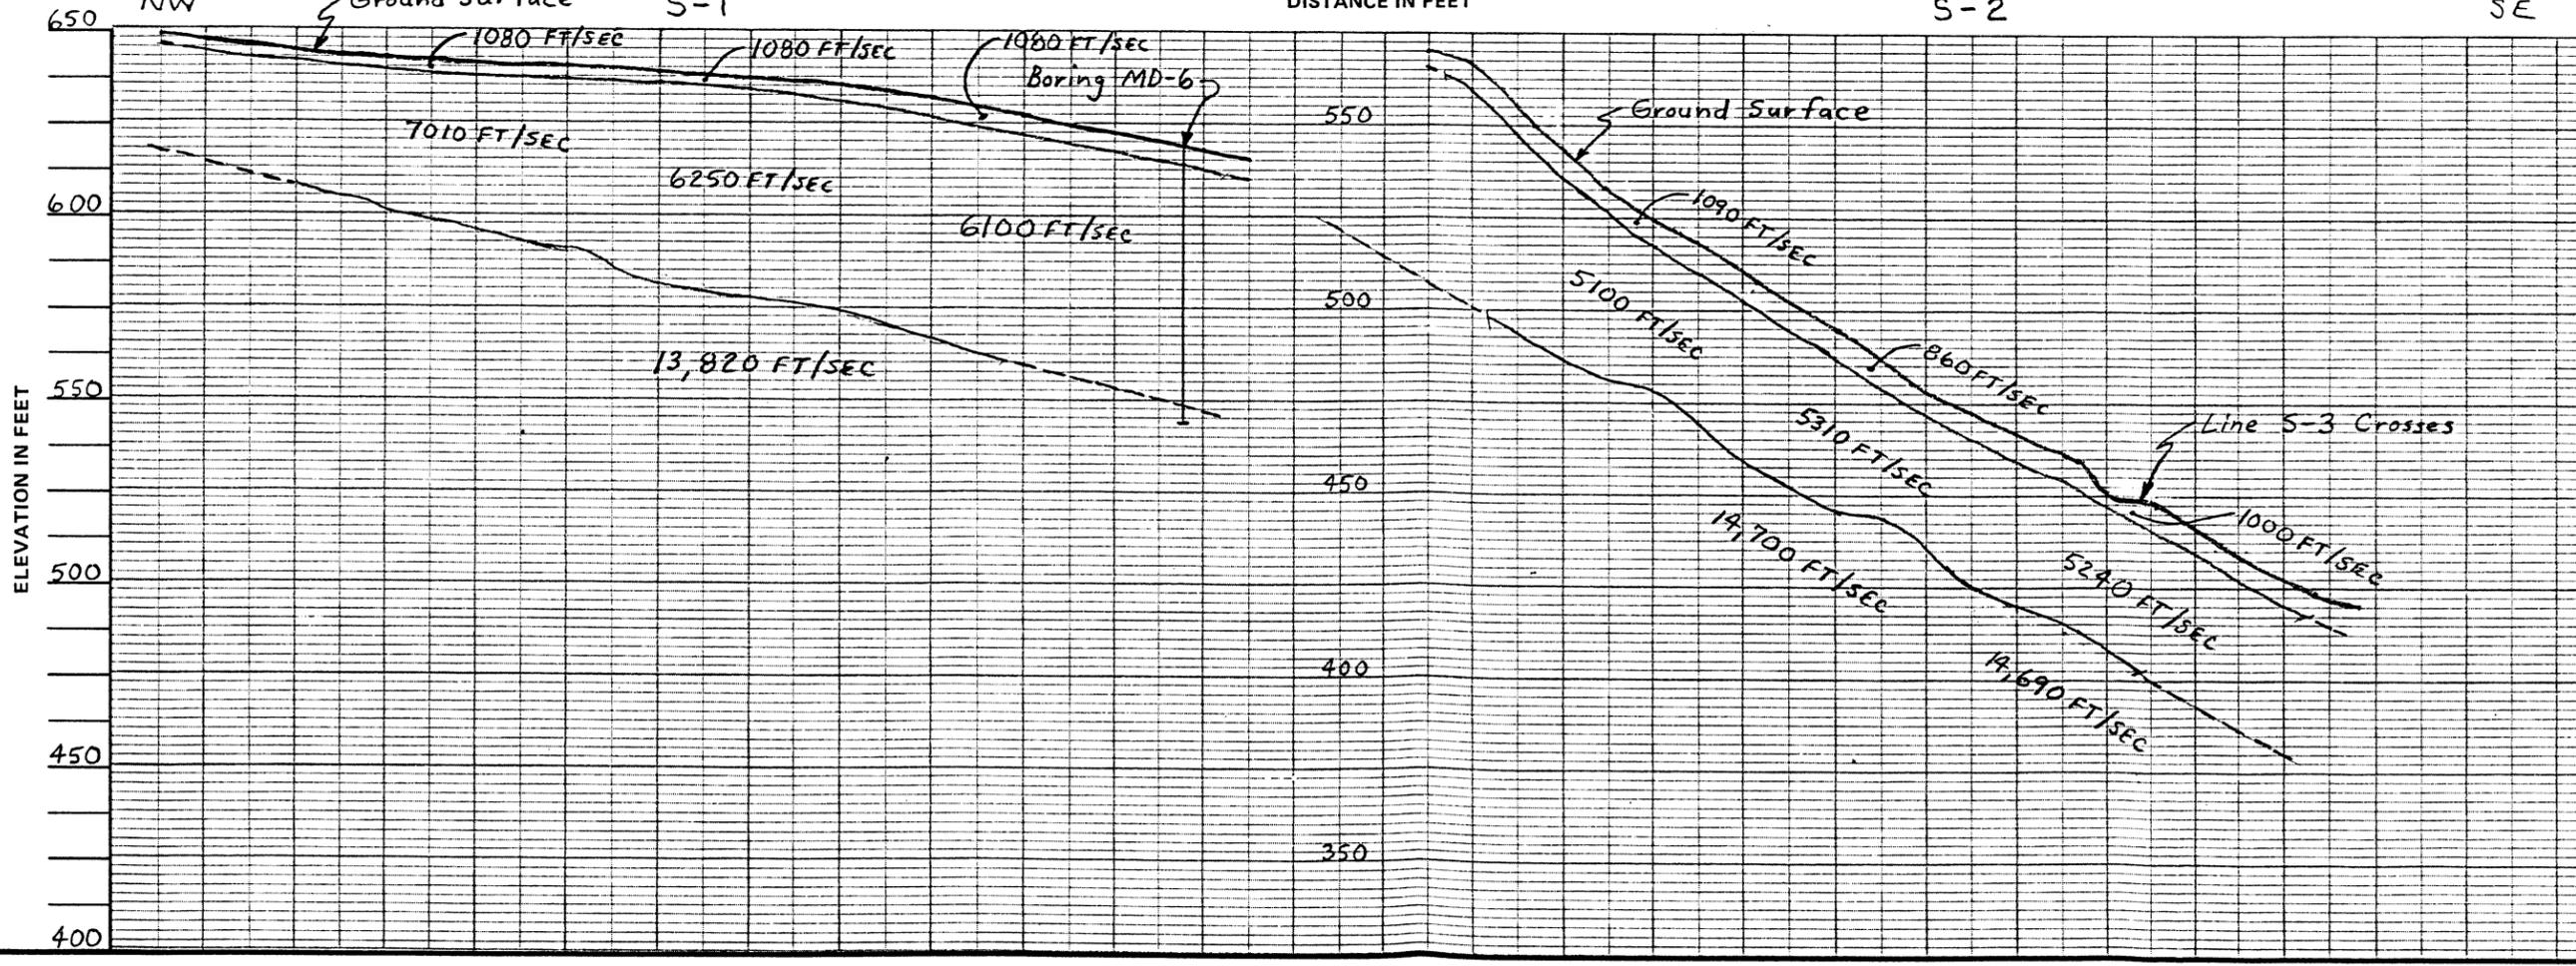
FIGURE NO.: 2

SEISMIC REFRACTION SURVEY
 DATA AND INTERPRETED SUBSURFACE VELOCITY PROFILES

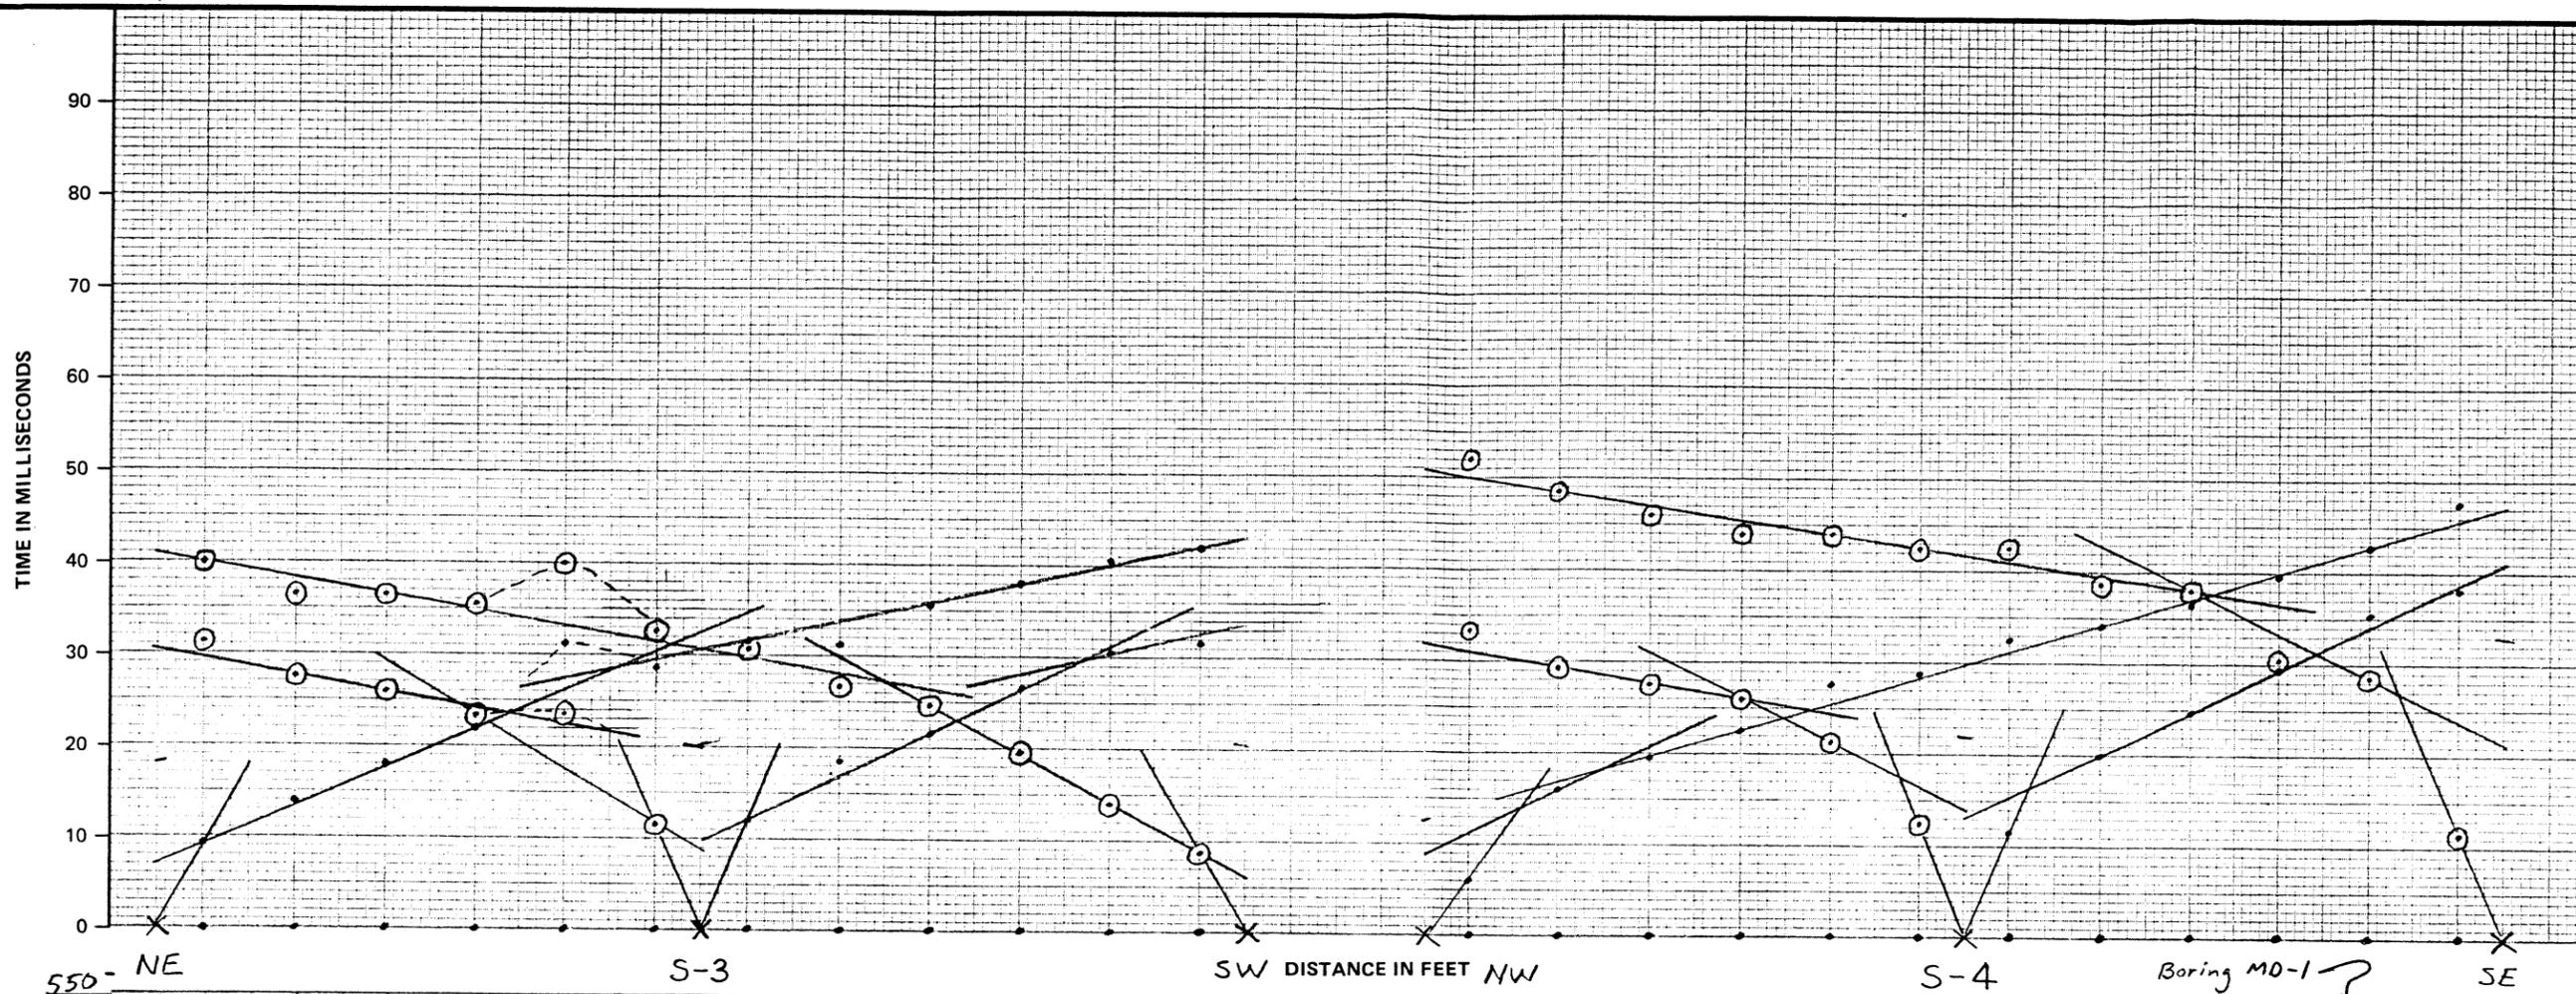
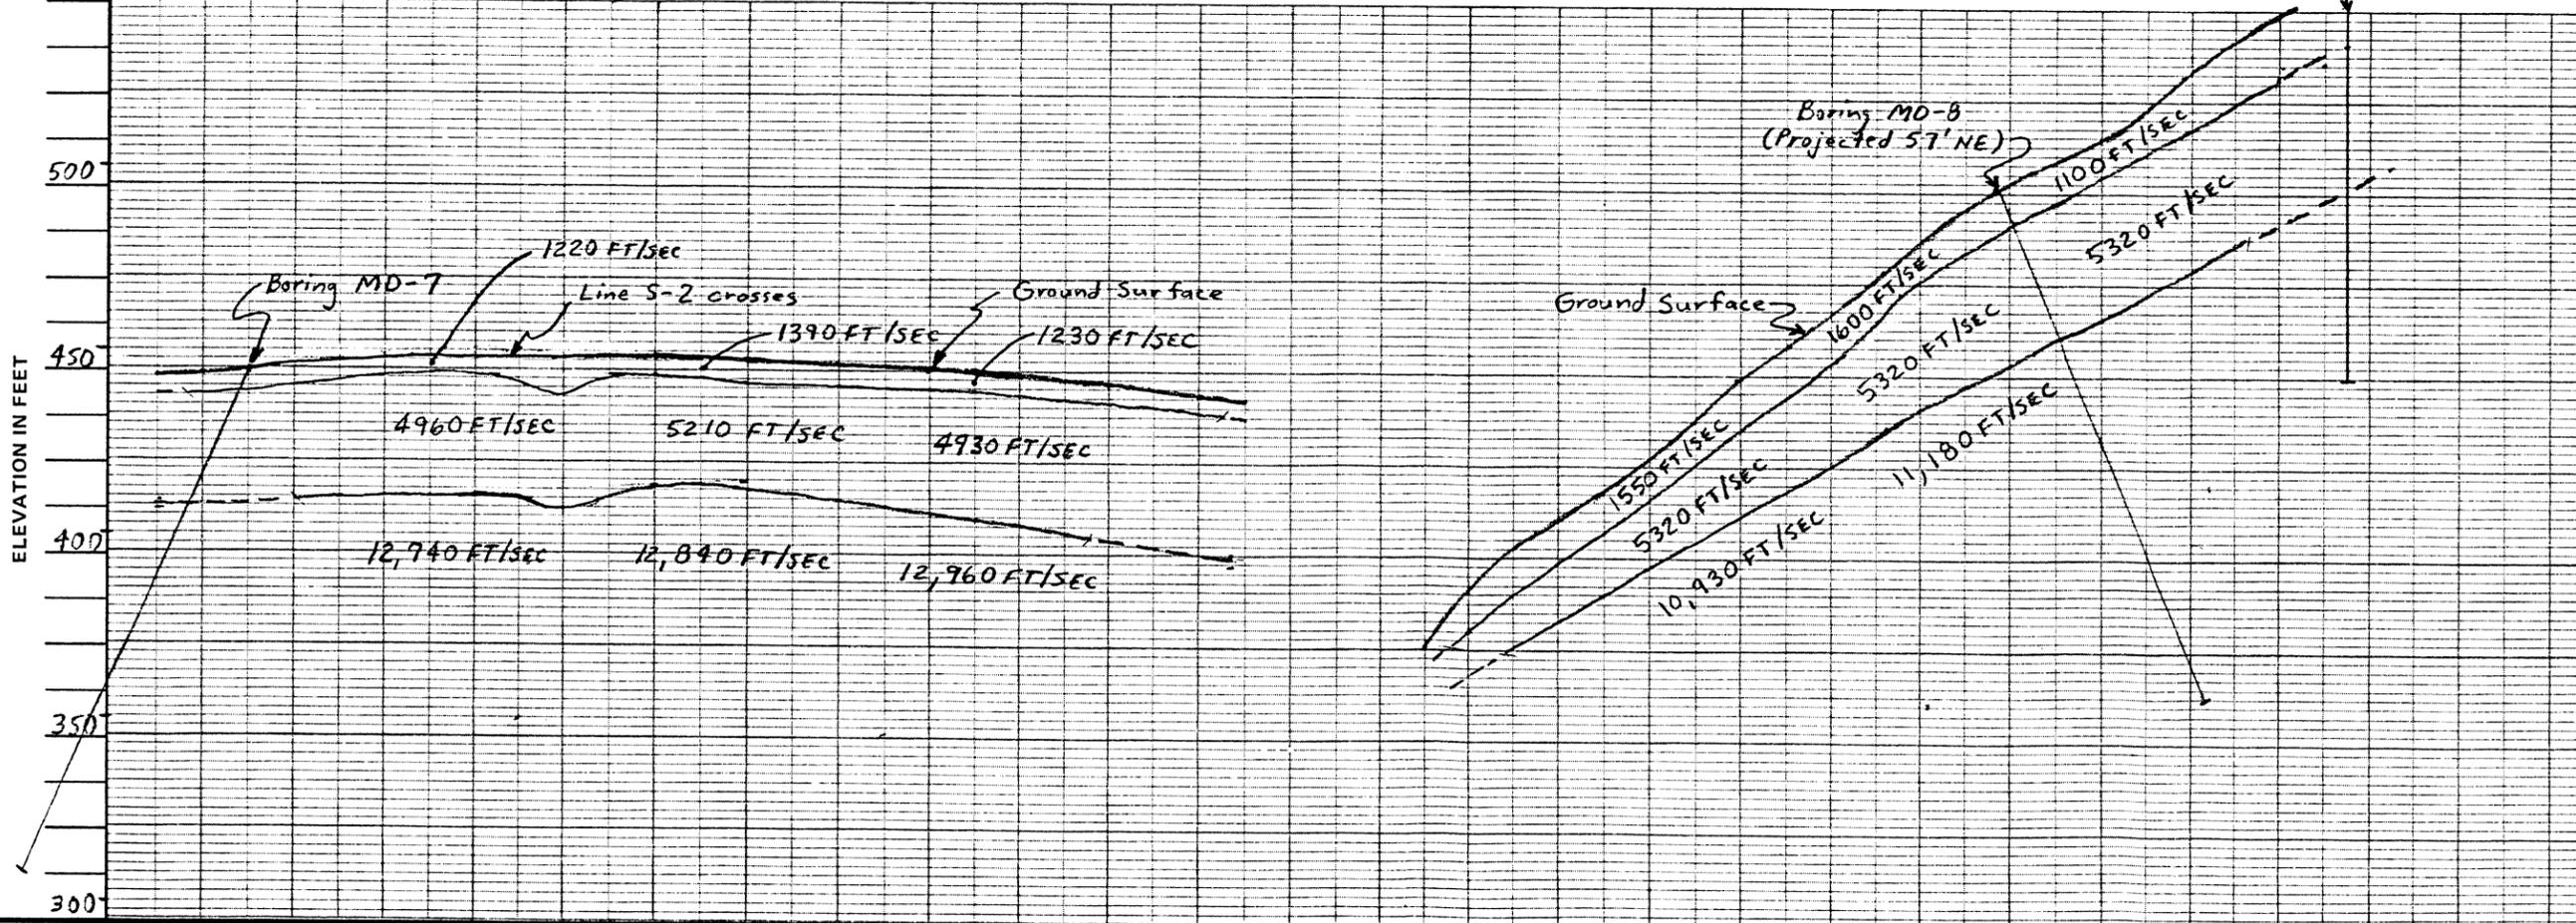
SEISMIC LINE NO.(S):
 S-3 & S-4
 DATE: 3/27/91
 PROJECT NO.: 3438F
 FIGURE NO.: 3

EXPLANATION
 1. TIME-DISTANCE GRAPHS AT TOP OF FIGURE REPRESENT SEISMIC REFRACTION SURVEY DATA; DOTS ON BOTTOM LINE OF GRAPHS REPRESENT GEOPHONE LOCATIONS, X'S REPRESENT SHOT POINT LOCATIONS.
 VERTICAL SCALE: 1" = 20 MILLISECONDS
 HORIZONTAL SCALE: 1" = 50 FEET
 2. SUBSURFACE VELOCITY PROFILES AT BOTTOM OF FIGURE REPRESENT INTERPRETATIONS OF SEISMIC REFRACTION DATA AND ARE INTENDED FOR DESIGN PURPOSES ONLY. VERTICAL AND HORIZONTAL SCALE: 1" = 50 FEET
 3. LOCATION OF SEISMIC LINES SHOWN ON FIGURE NO.(S) 1

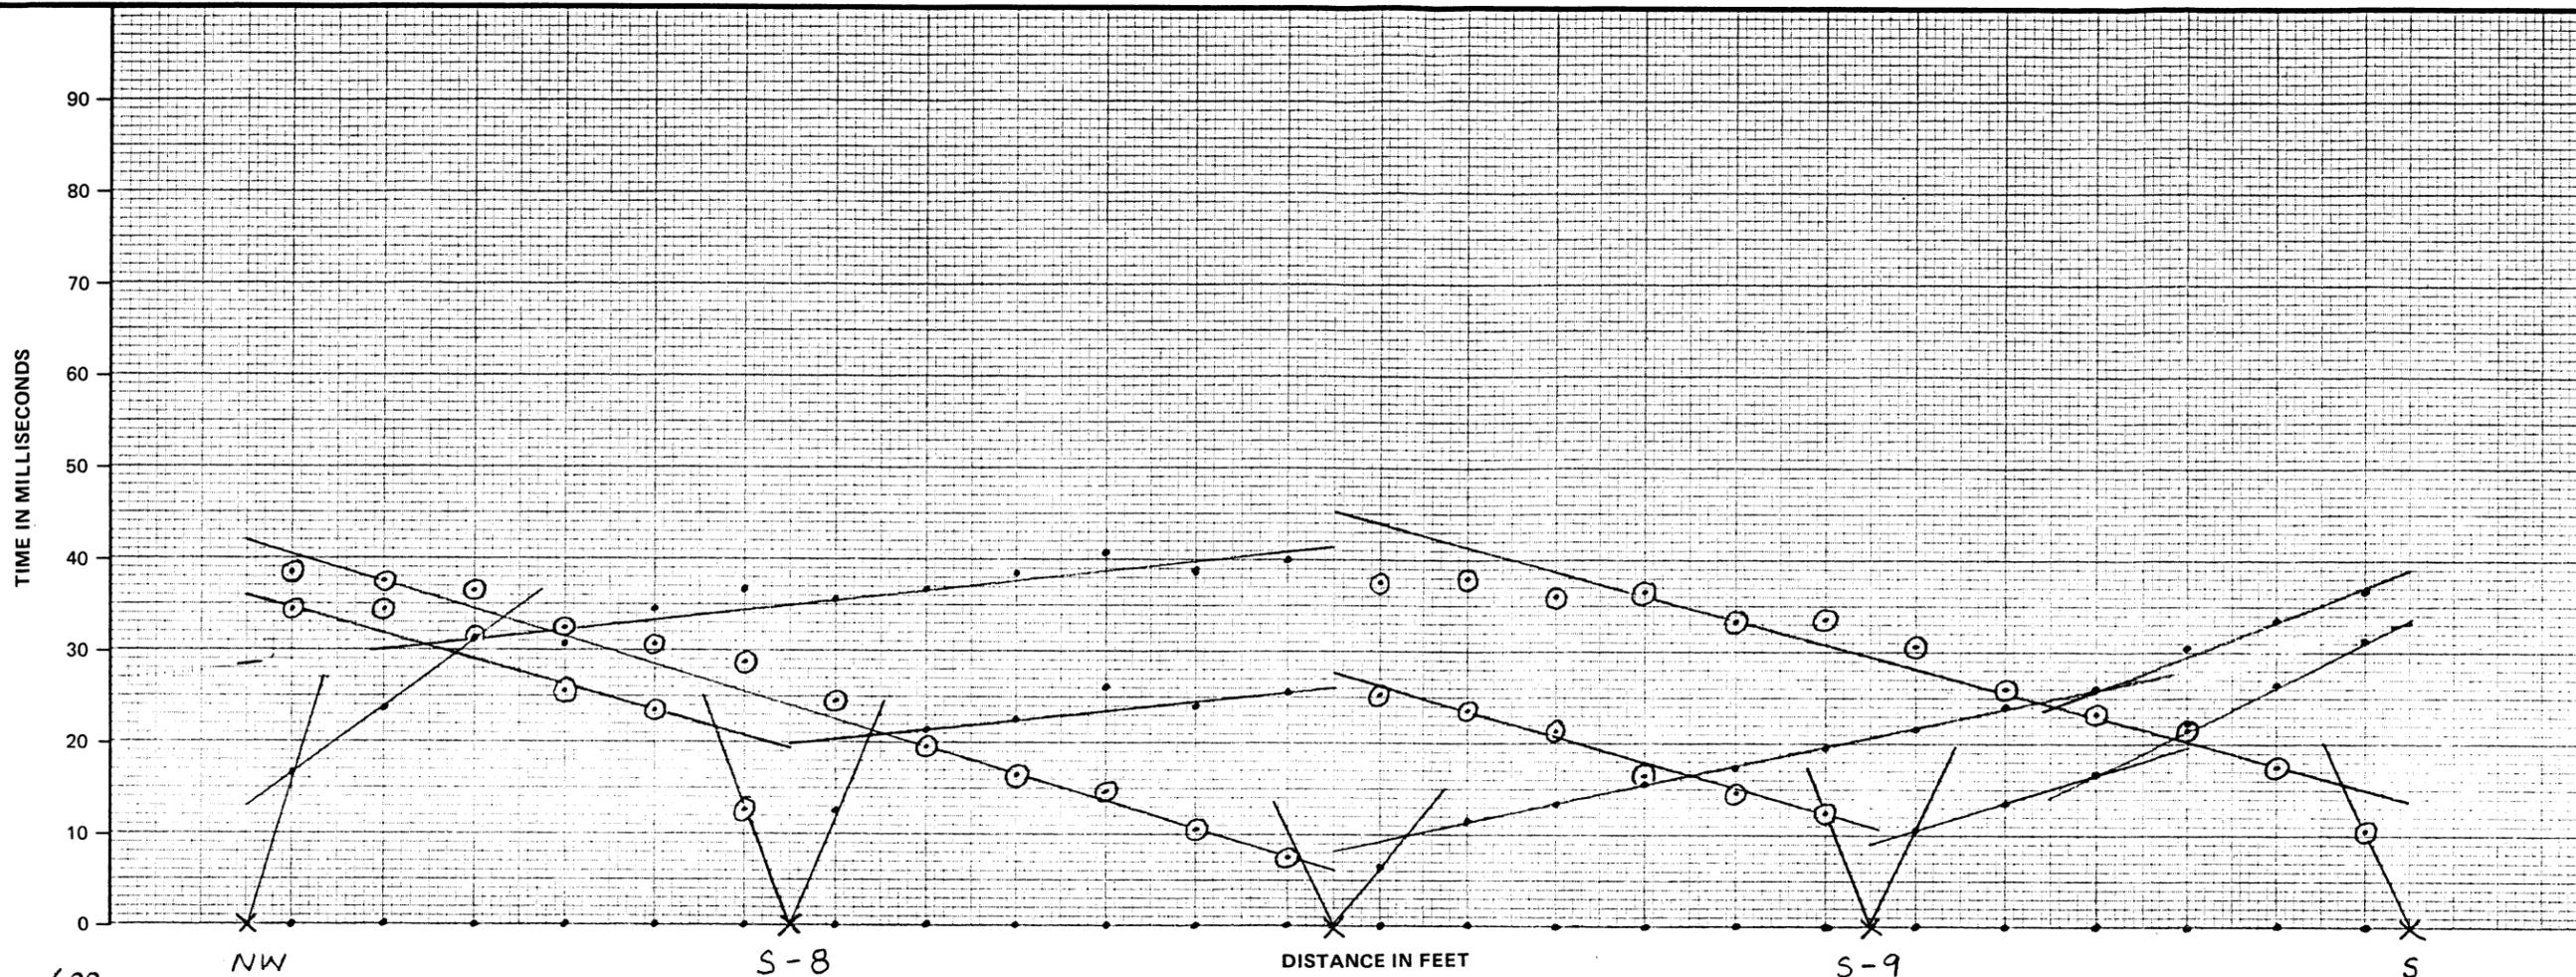
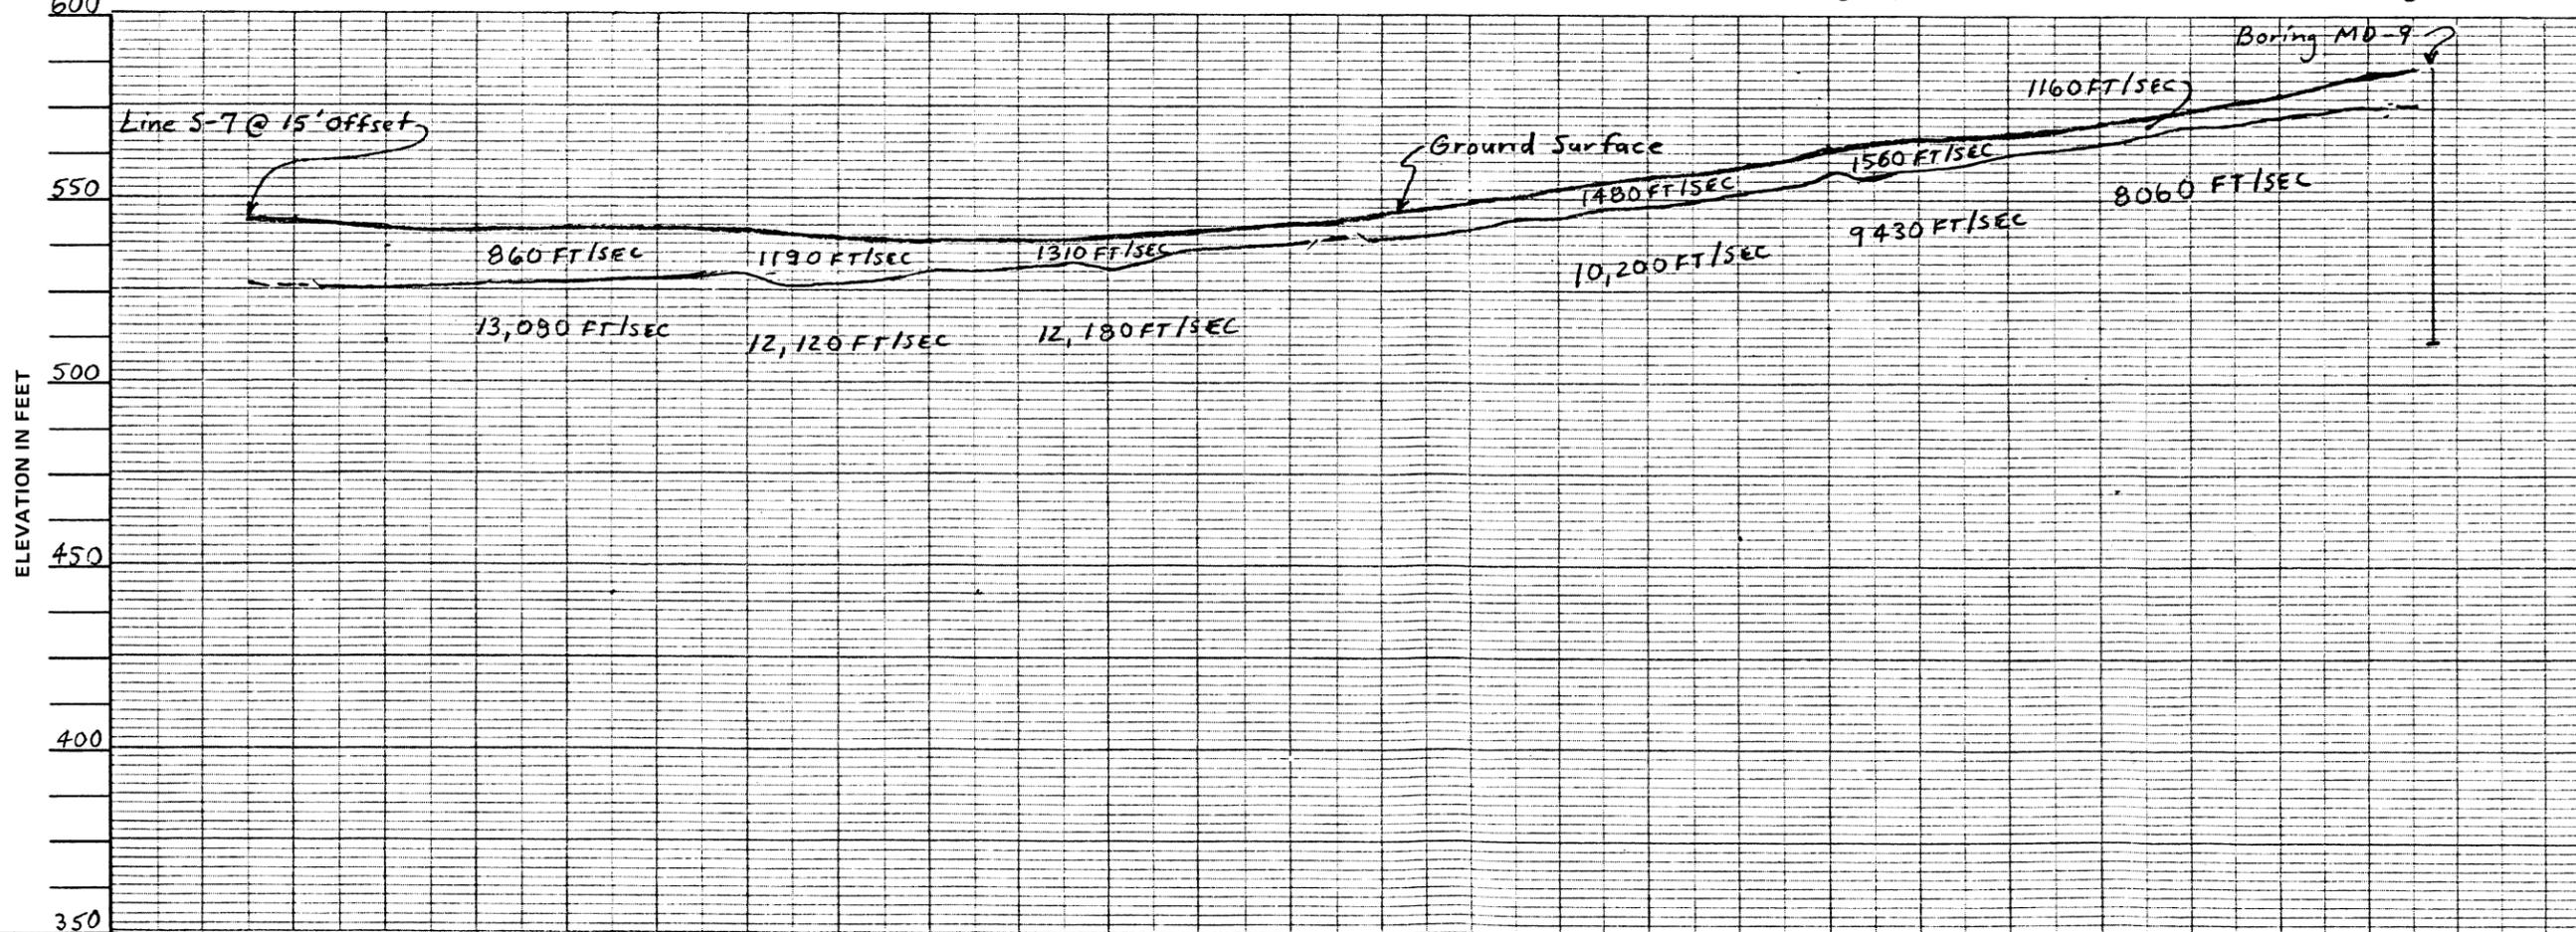
SEISMIC LINE NO. (S):
 S-8 & S-9
 DATE: 3/27/91
 PROJECT NO.: 3438F
 FIGURE NO.: 6

Portola Geophysics
 900 Wayside Road Portola Valley, CA 94028
 SEISMIC REFRACTION SURVEY
 DATA AND INTERPRETED SUBSURFACE VELOCITY PROFILES
 PARDEE DAM RAISE
 AMADOR COUNTY, CALIFORNIA

EXPLANATION
 1. TIME-DISTANCE GRAPHS AT TOP OF FIGURE REPRESENT SEISMIC REFRACTION SURVEY DATA; DOTS ON BOTTOM LINE OF GRAPHS REPRESENT GEOPHONE LOCATIONS, X'S REPRESENT SHOT POINT LOCATIONS.
 VERTICAL SCALE: 1" = 20 MILLISECONDS
 HORIZONTAL SCALE: 1" = 50 FEET
 2. SUBSURFACE VELOCITY PROFILES AT BOTTOM OF FIGURE REPRESENT INTERPRETATIONS OF SEISMIC REFRACTION DATA AND ARE INTENDED FOR DESIGN PURPOSES ONLY.
 VERTICAL AND HORIZONTAL SCALE: 1" = 50 FEET
 3. LOCATION OF SEISMIC LINES SHOWN ON FIGURE NO. (S) /

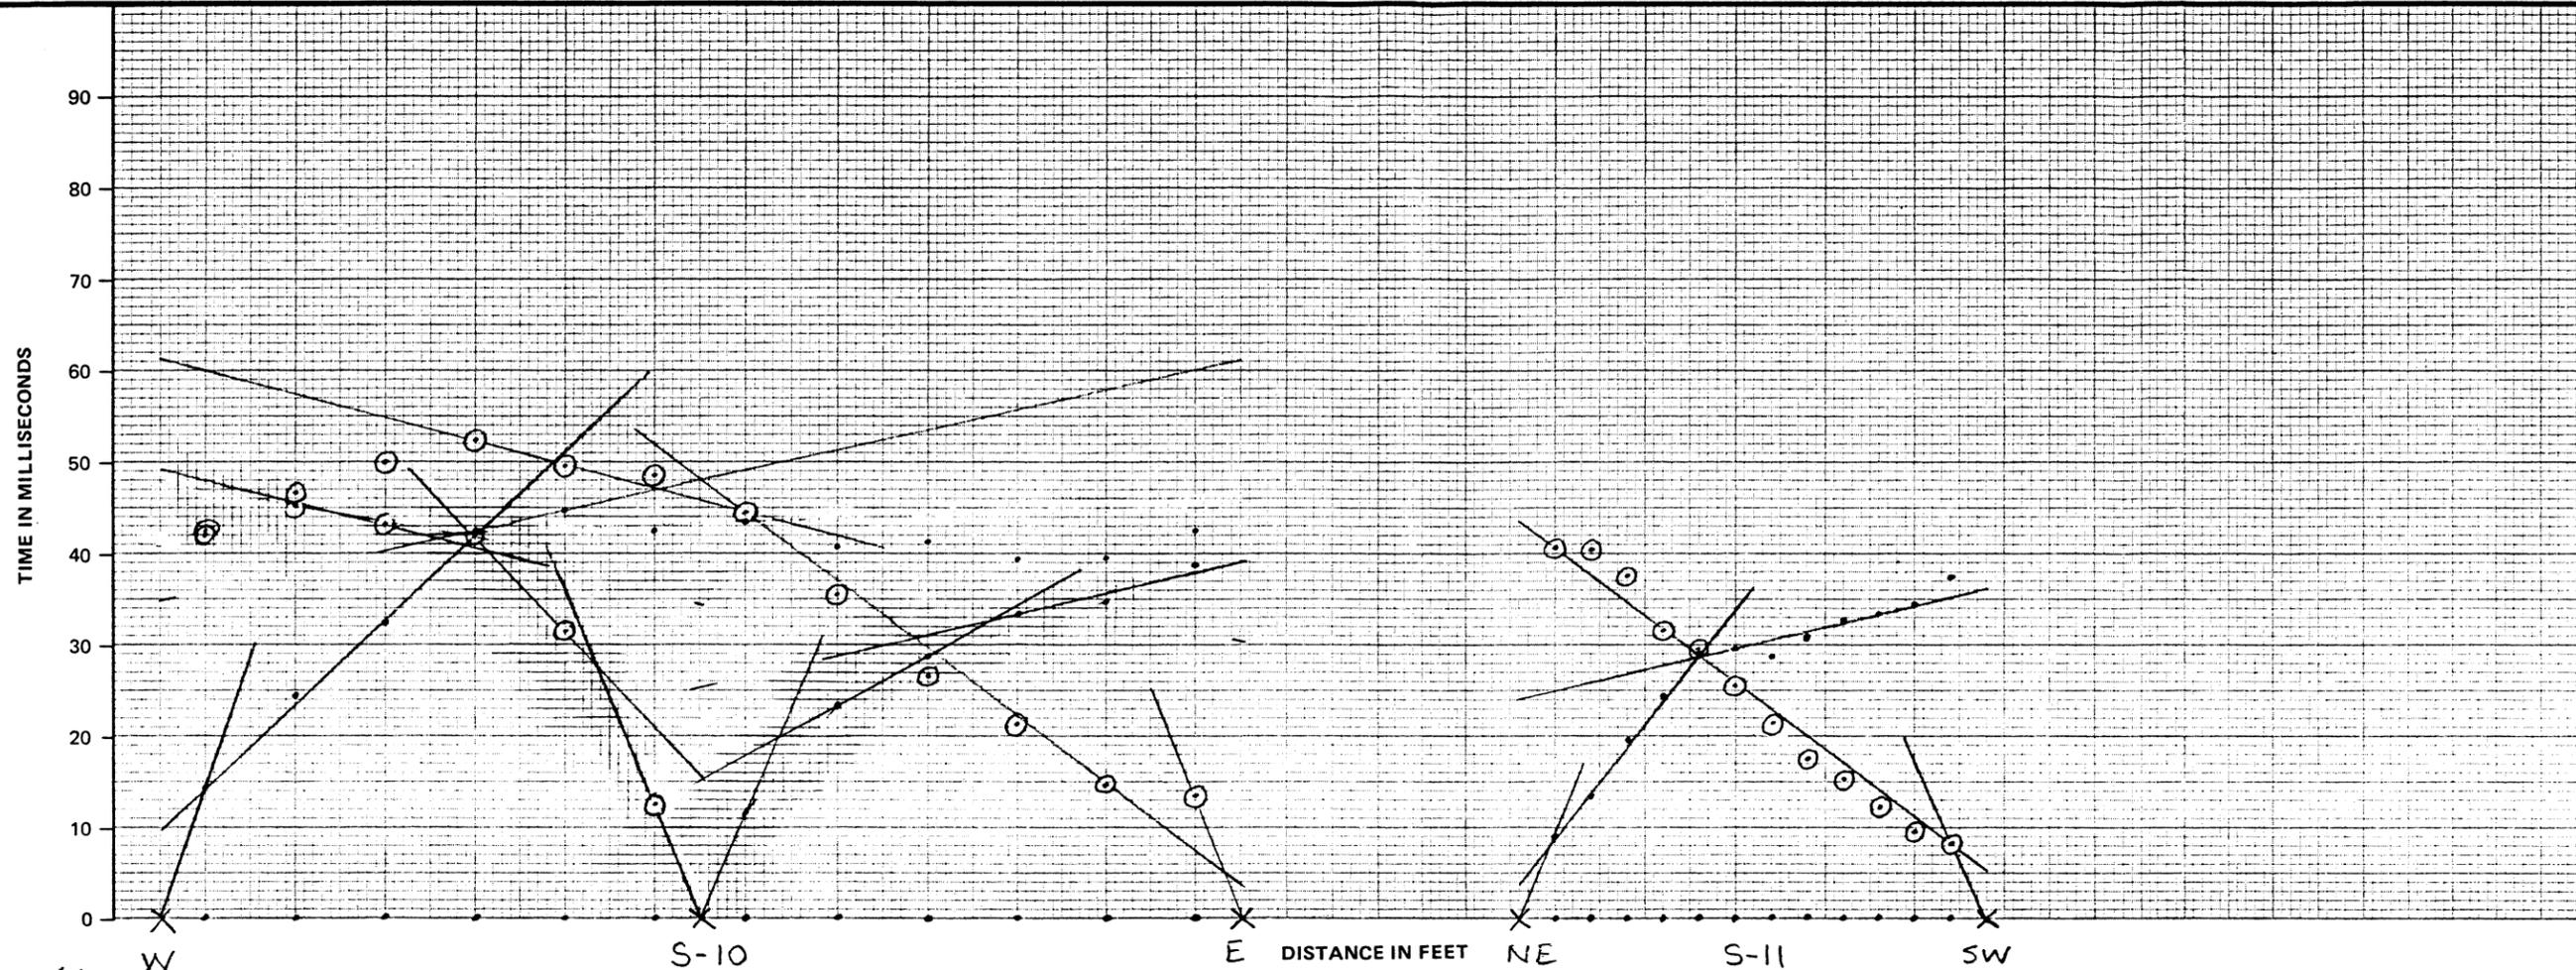
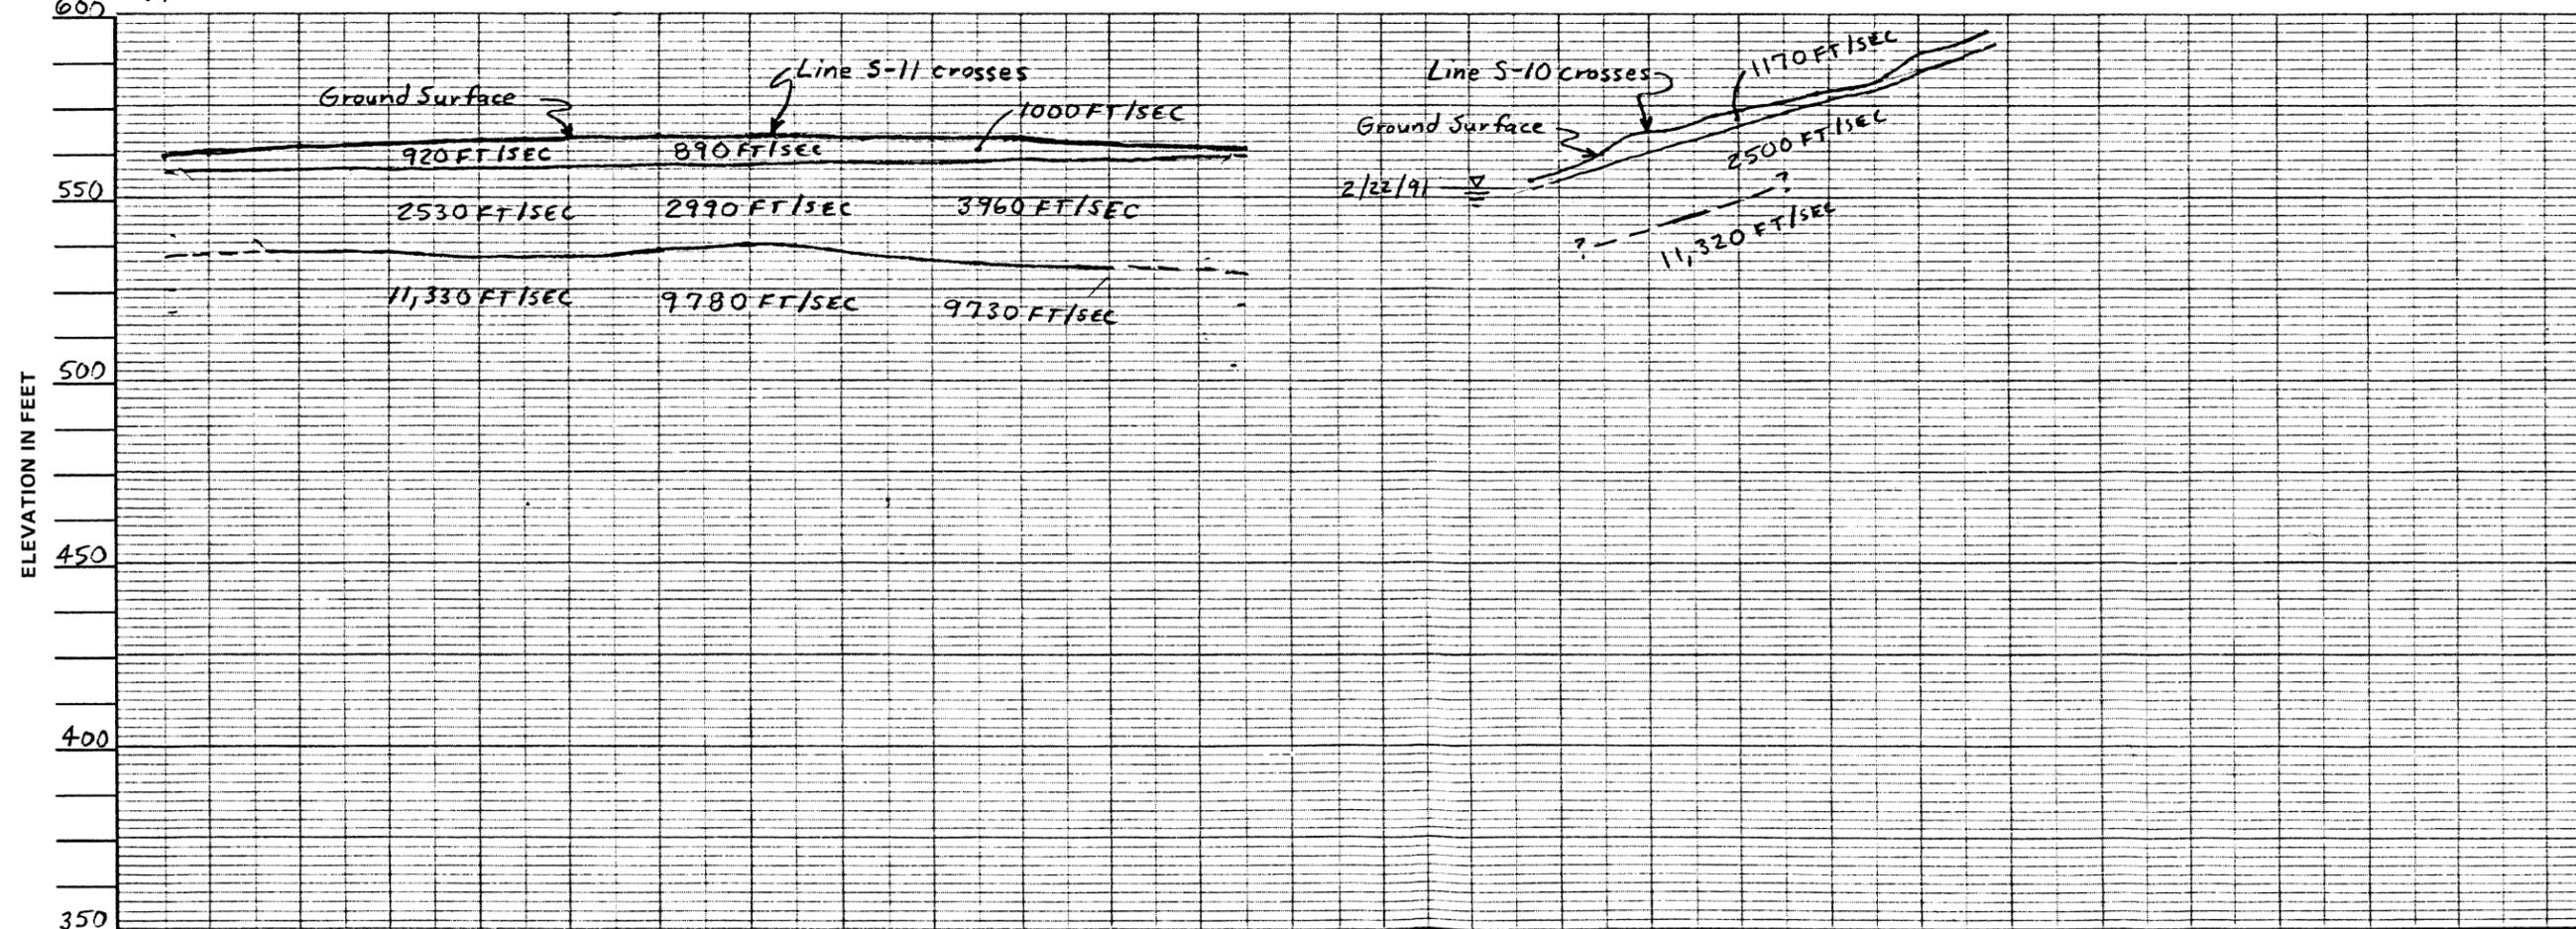
SEISMIC LINE NO.(S):
 S-10 & S-11
 DATE: 3/27/91
 PROJECT NO.: 3438F
 FIGURE NO.: 8

Portola Geophysics
 900 Wayside Road Portola Valley, CA 94028
 SEISMIC REFRACTION SURVEY
 DATA AND INTERPRETED SUBSURFACE VELOCITY PROFILES
 PARDEE DAM RAISE
 AMADOR COUNTY, CALIFORNIA

EXPLANATION
 1. TIME-DISTANCE GRAPHS AT TOP OF FIGURE REPRESENT SEISMIC REFRACTION SURVEY DATA; DOTS ON BOTTOM LINE OF GRAPHS REPRESENT GEOPHONE LOCATIONS, X'S REPRESENT SHOT POINT LOCATIONS.
 VERTICAL SCALE: 1" = 20 MILLISECONDS
 HORIZONTAL SCALE: 1" = 50 FEET
 2. SUBSURFACE VELOCITY PROFILES AT BOTTOM OF FIGURE REPRESENT INTERPRETATIONS OF SEISMIC REFRACTION DATA AND ARE INTENDED FOR DESIGN PURPOSES ONLY.
 VERTICAL AND HORIZONTAL SCALE: 1" = 50 FEET
 3. LOCATION OF SEISMIC LINES SHOWN ON FIGURE NO.(S) 7

Seismic refraction lines S-10 through S-13 were recorded on the abutments for a proposed dike to the far north of the existing dam in the locations shown on Figure 7. Results are presented in figures 8 through 9. These lines were 300 or 130 feet long each, and were recorded to interpret the depth to and characteristics (i.e., rippability) of the subsurface materials in the vicinity of the proposed dike to the north of the existing dam. Twelve geophones were spaced at intervals of 25 or 10 feet with hammer impacts 12.5 or 10 feet off both ends and at the center of each 25-foot spacing line.
