APPENDIX C

GEOPHYSICAL SURVEYS

PARDEE DAM PROJECT

Portola Geophysics
 900 Wayside Road Portola Valley, CA 94028
 SEISMIC REFRACTION SURVEY
 DATA AND INTERPRETED SUBSURFACE VELOCITY PROFILES
 PARDEE DAM RAISE
 AMADOR COUNTY, CALIFORNIA

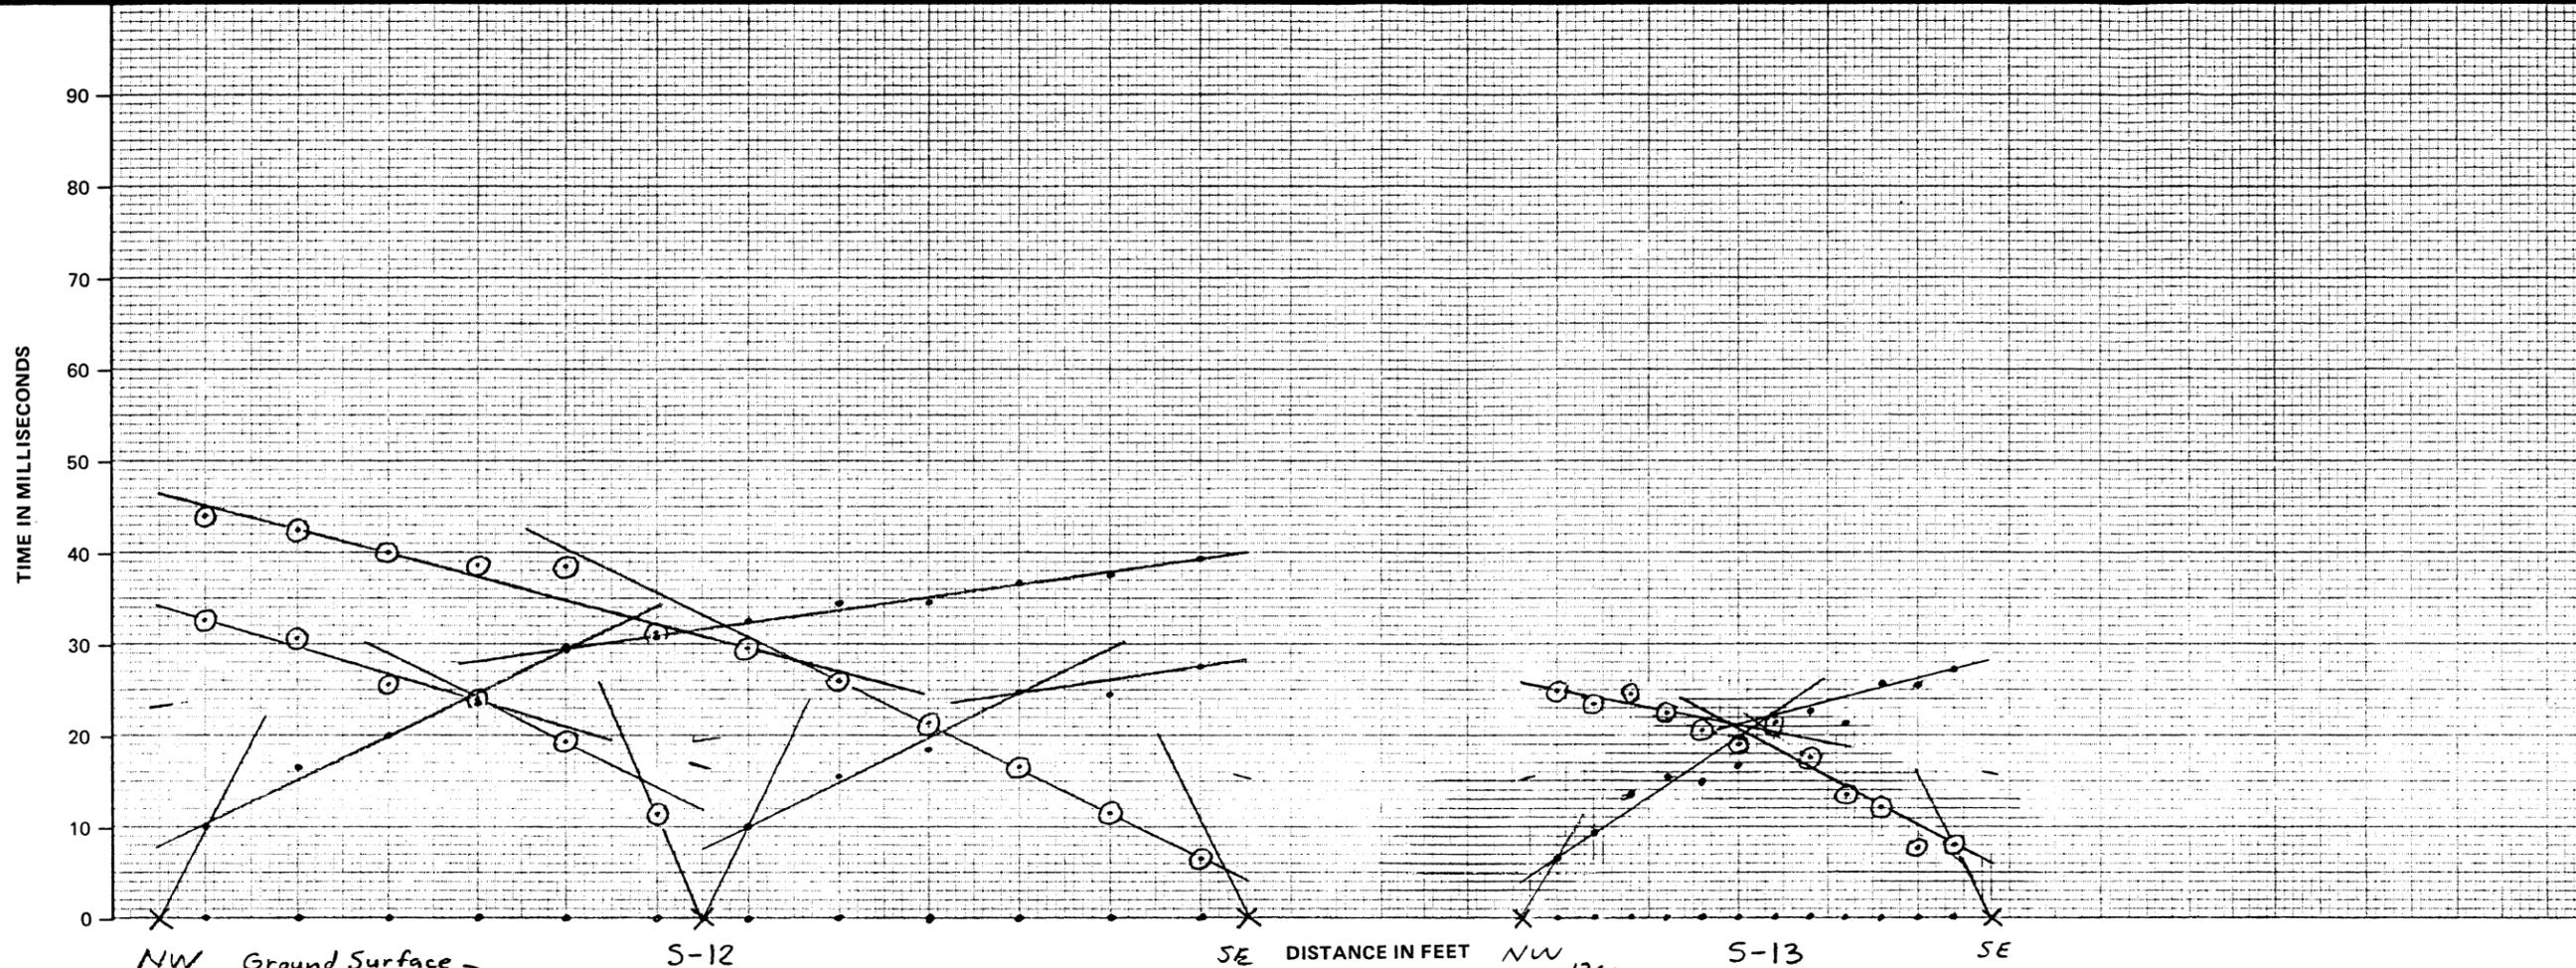
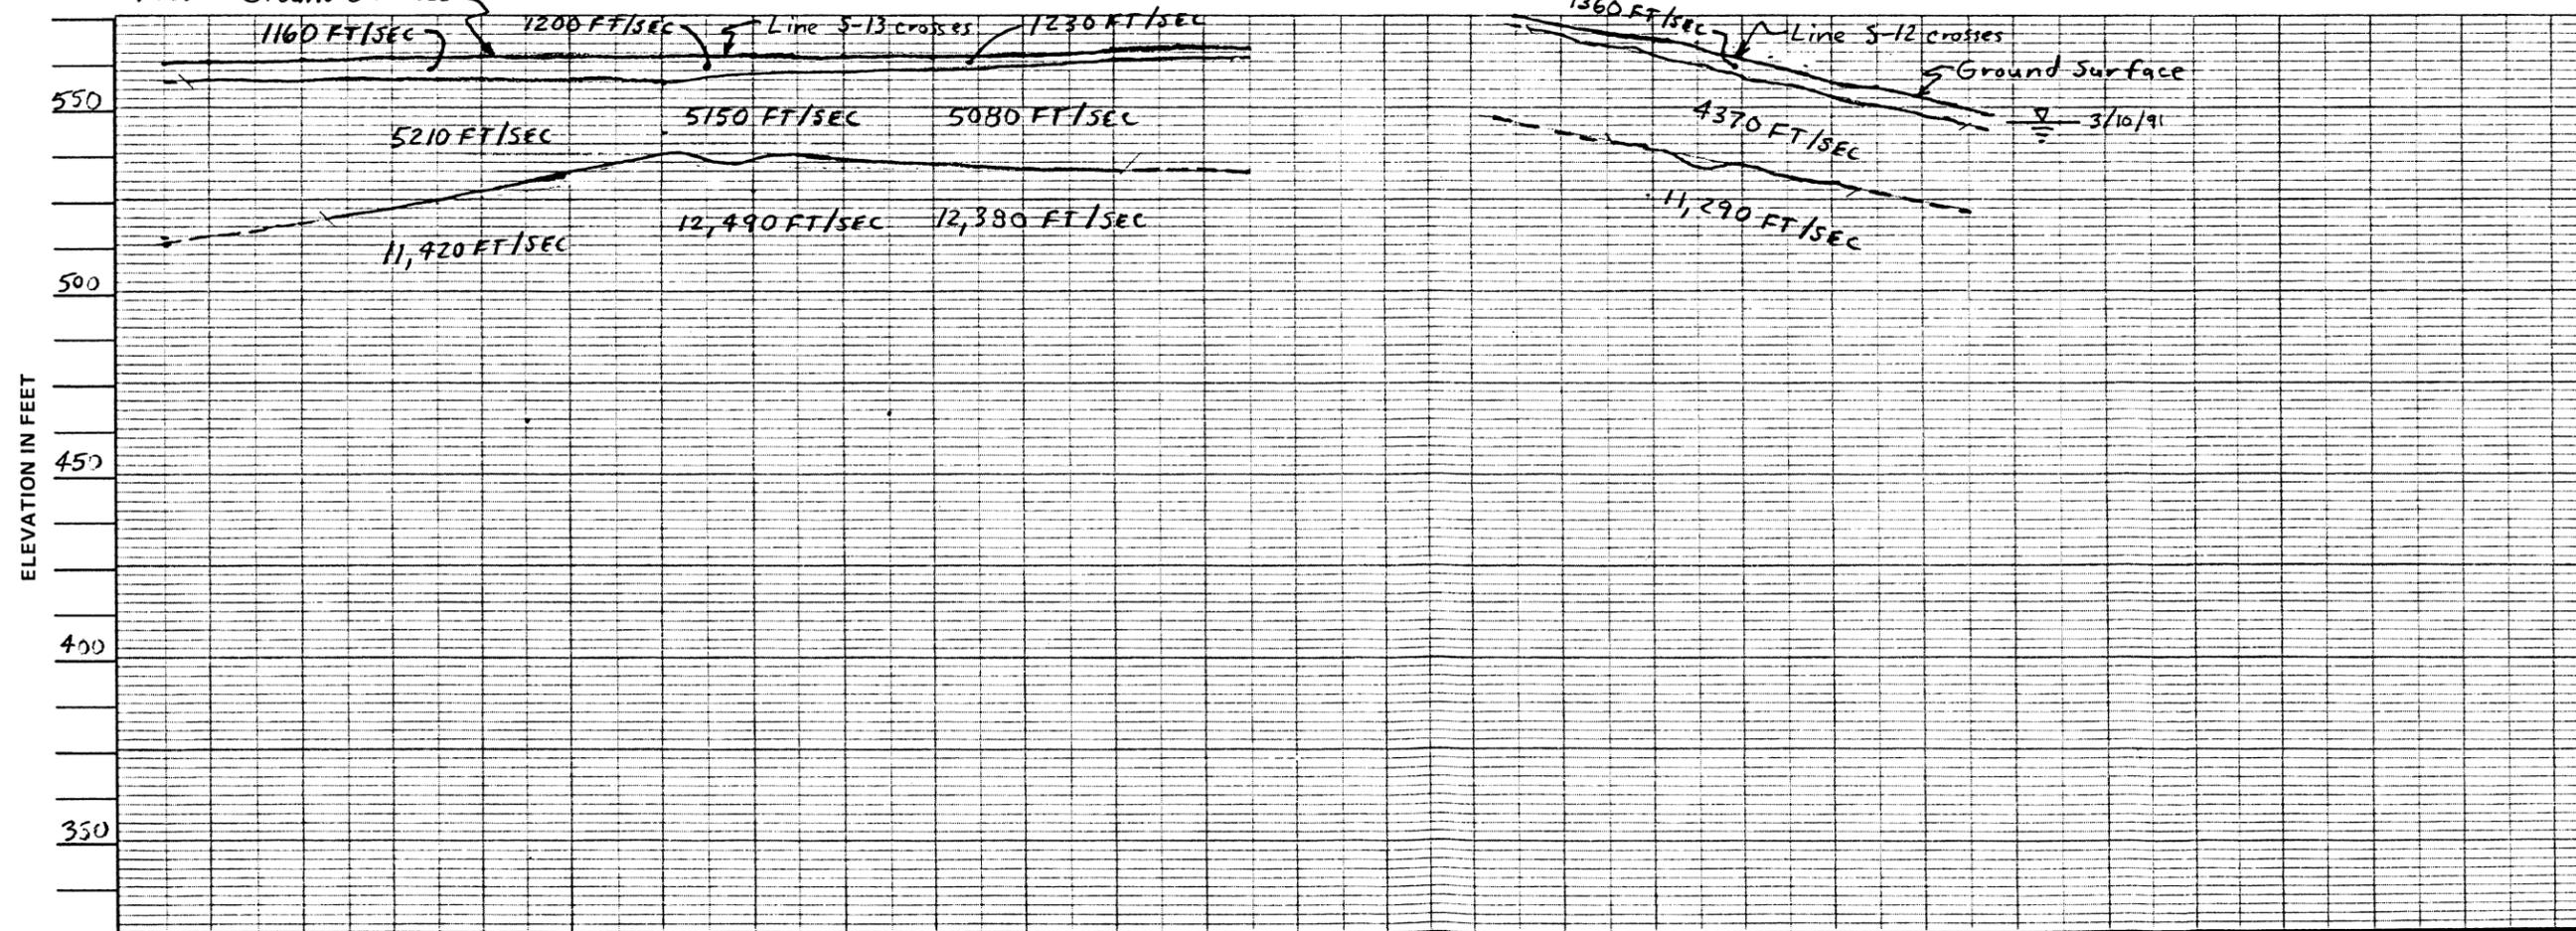
FIGURE NO.: 9

SEISMIC REFRACTION SURVEY
 DATA AND INTERPRETED SUBSURFACE VELOCITY PROFILES

Seismic refraction lines S-10 through S-13 were recorded on the abutments for a proposed dike to the far north of the existing dam in the locations shown on Figure 7. Results are presented in figures 8 through 9. These lines were 300 or 130 feet long each, and were recorded to interpret the depth to and characteristics (i.e., rippability) of the subsurface materials in the vicinity of the proposed dike to the north of the existing dam. Twelve geophones were spaced at intervals of 25 or 10 feet with hammer impacts 12.5 or 10 feet off both ends and at the center of each 25-foot spacing line.

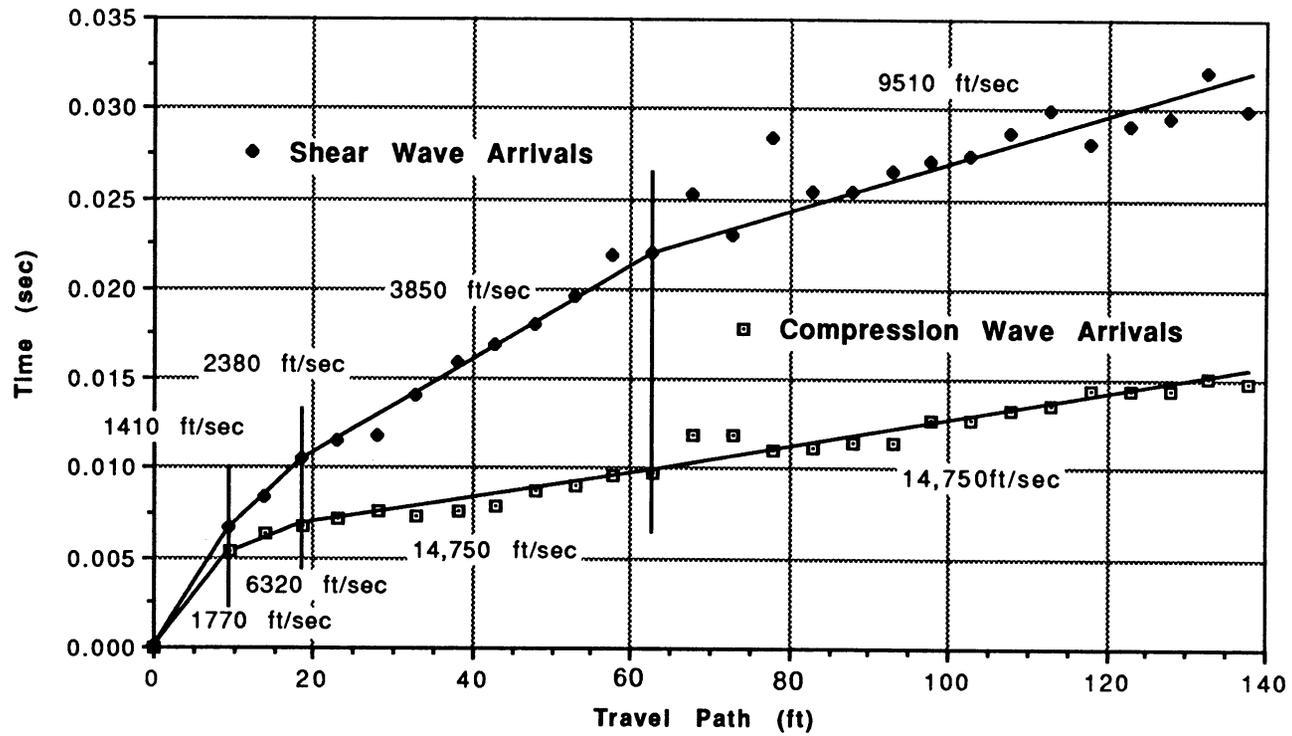
GEOPHYS. BY POS	SCALE AS SHOWN	PROJECT NO. 1170
APPROVED BY POS	DATE 3/28/91	FIGURE NO. 10

Downhole Seismic Survey, Boring MD-7

Boring MD-7 Downhole Seismic Results

Downhole seismic recording MD-7 was conducted in Boring MD-7 near the central portion of the right abutment of the existing dam in the location shown on Figure 1. Boring MD-7 was drilled at an inclination of 70° down from the horizontal toward the northeast. Although the boring was drilled to a depth of approximately 150 feet, the hole was surveyed to a depth (inclined) of 135 feet. Figure 10 presents survey results in terms of time-distance plots of shear and compression wave velocities. The plots reflect actual distance from the offset energy source to the geophone. In order to correlate this information with boring logs, the assumption is made that velocities for the longer angular distance are representative of the velocities within the vertical depth intervals surveyed. Table 1 lists shear and compression wave velocities as a function of depth interval.

<u>Depth Interval (ft.)</u>	<u>Shear Velocity (ft./sec.)</u>	<u>Compression Velocity (ft./sec.)</u>
0.0 - 4.7	1410	1770
4.7 - 14.1	2380	6320
14.1 - 56.6	3850	14,750
56.6 - 127.3	9510	14,750

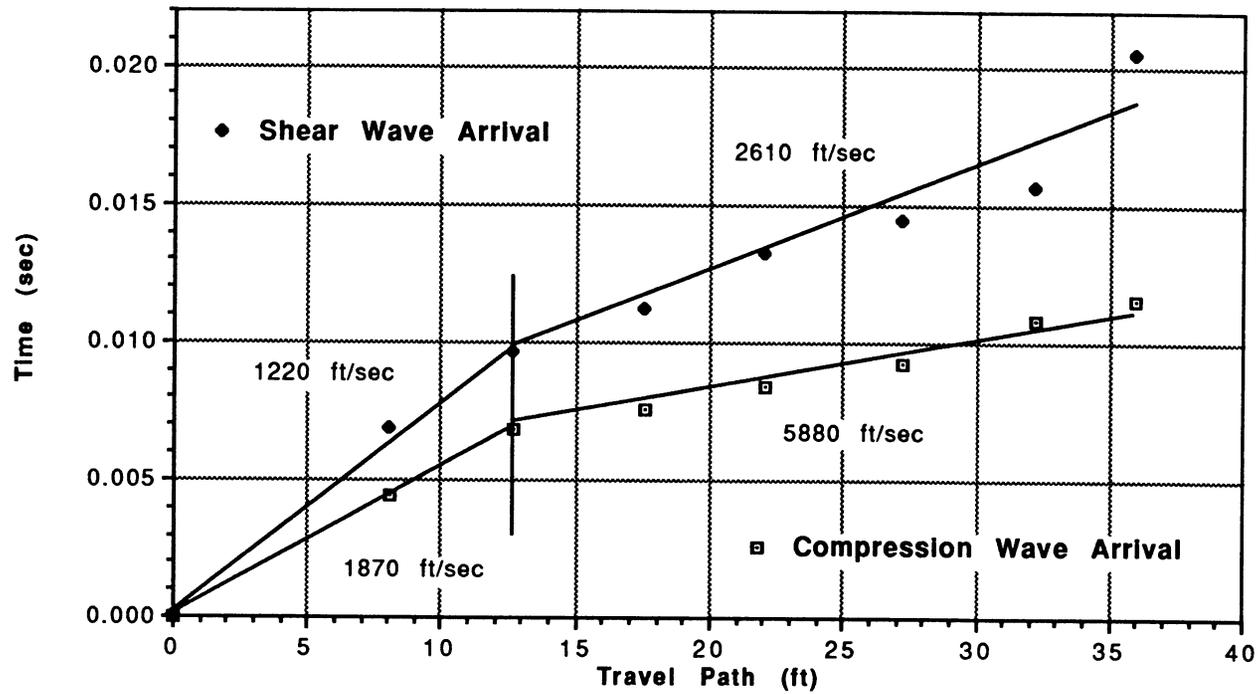
Downhole Seismic Survey, Boring MD-8

Boring MD-8 Downhole Seismic Results

<u>Depth Interval (ft.)</u>	<u>Shear Velocity (ft./sec.)</u>	<u>Compression Velocity (ft./sec.)</u>
0.0 - 9.4	1220	1870
9.4 - 32.1	2610	5880
