RE: Request for Jurisdictional Determination EBMUD 39th Avenue Reservoir Replacement Project, Oakland, California

39th Avenue Reservoir Replacement Project, Oakland, CA Request for a Jurisdictional Determination

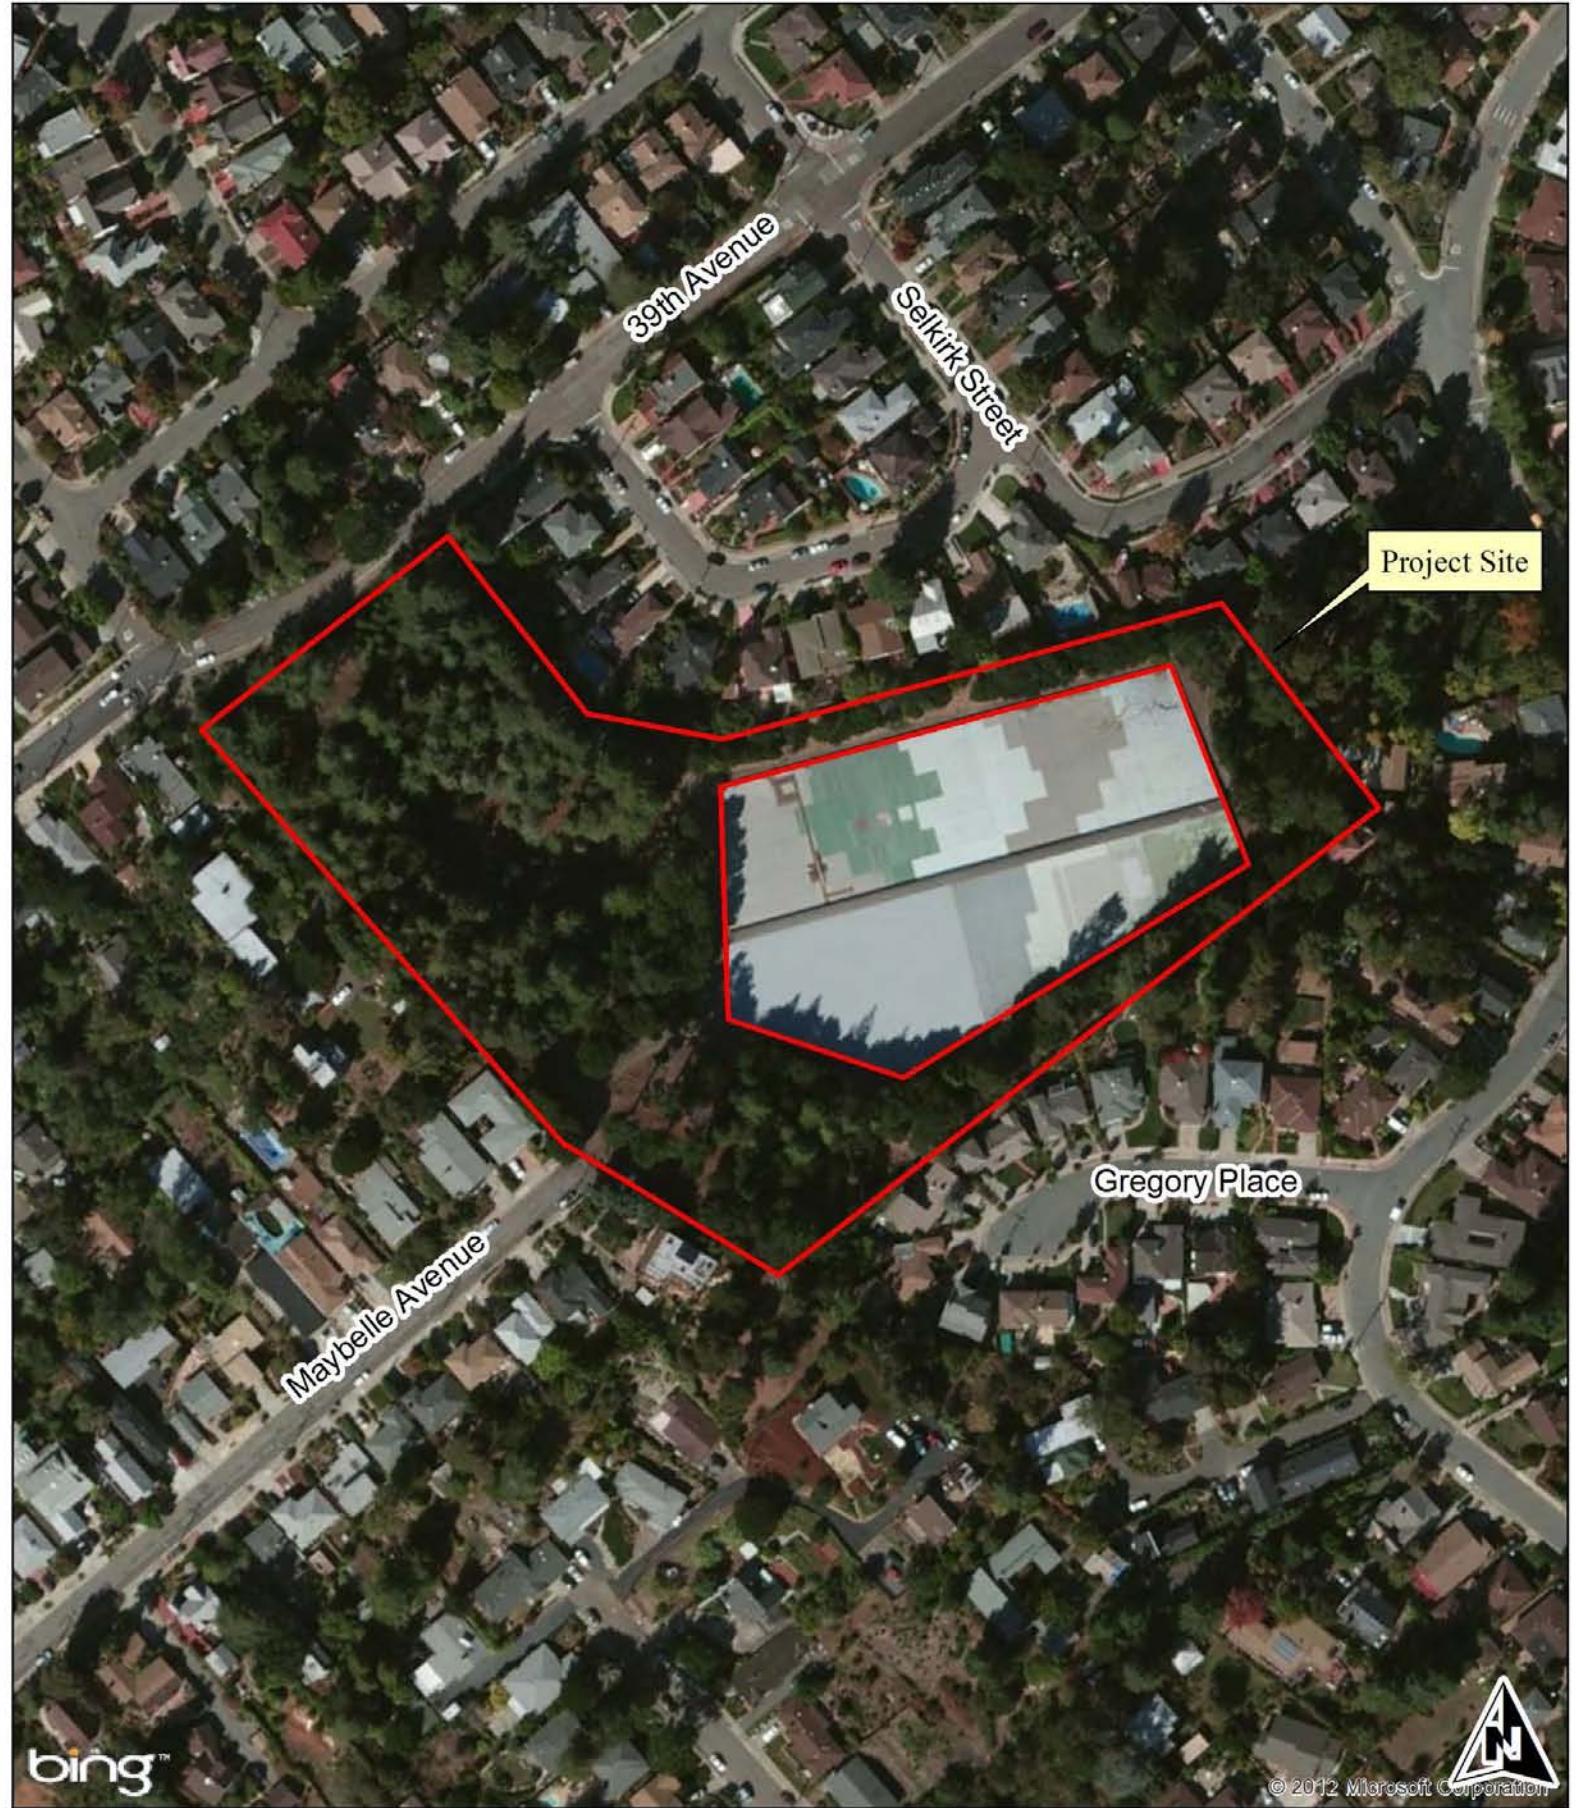
Monk & Associates Environmental Consultants 1136 Saranap Avenue, Suite Q Walnut Creek, California 94595 (925) 947-4867 ^o 50 100 200 300 400 500 Figure 3. Aerial Photograph of the 39th Avenue Reservoir Replacement Project 4290 Maybelle Avenue, Oakland, California

surrounding area on all sides of the project site except the northwestern edge is dominated by residential housing. Figure 3 provides an aerial photograph showing the surrounding land use.

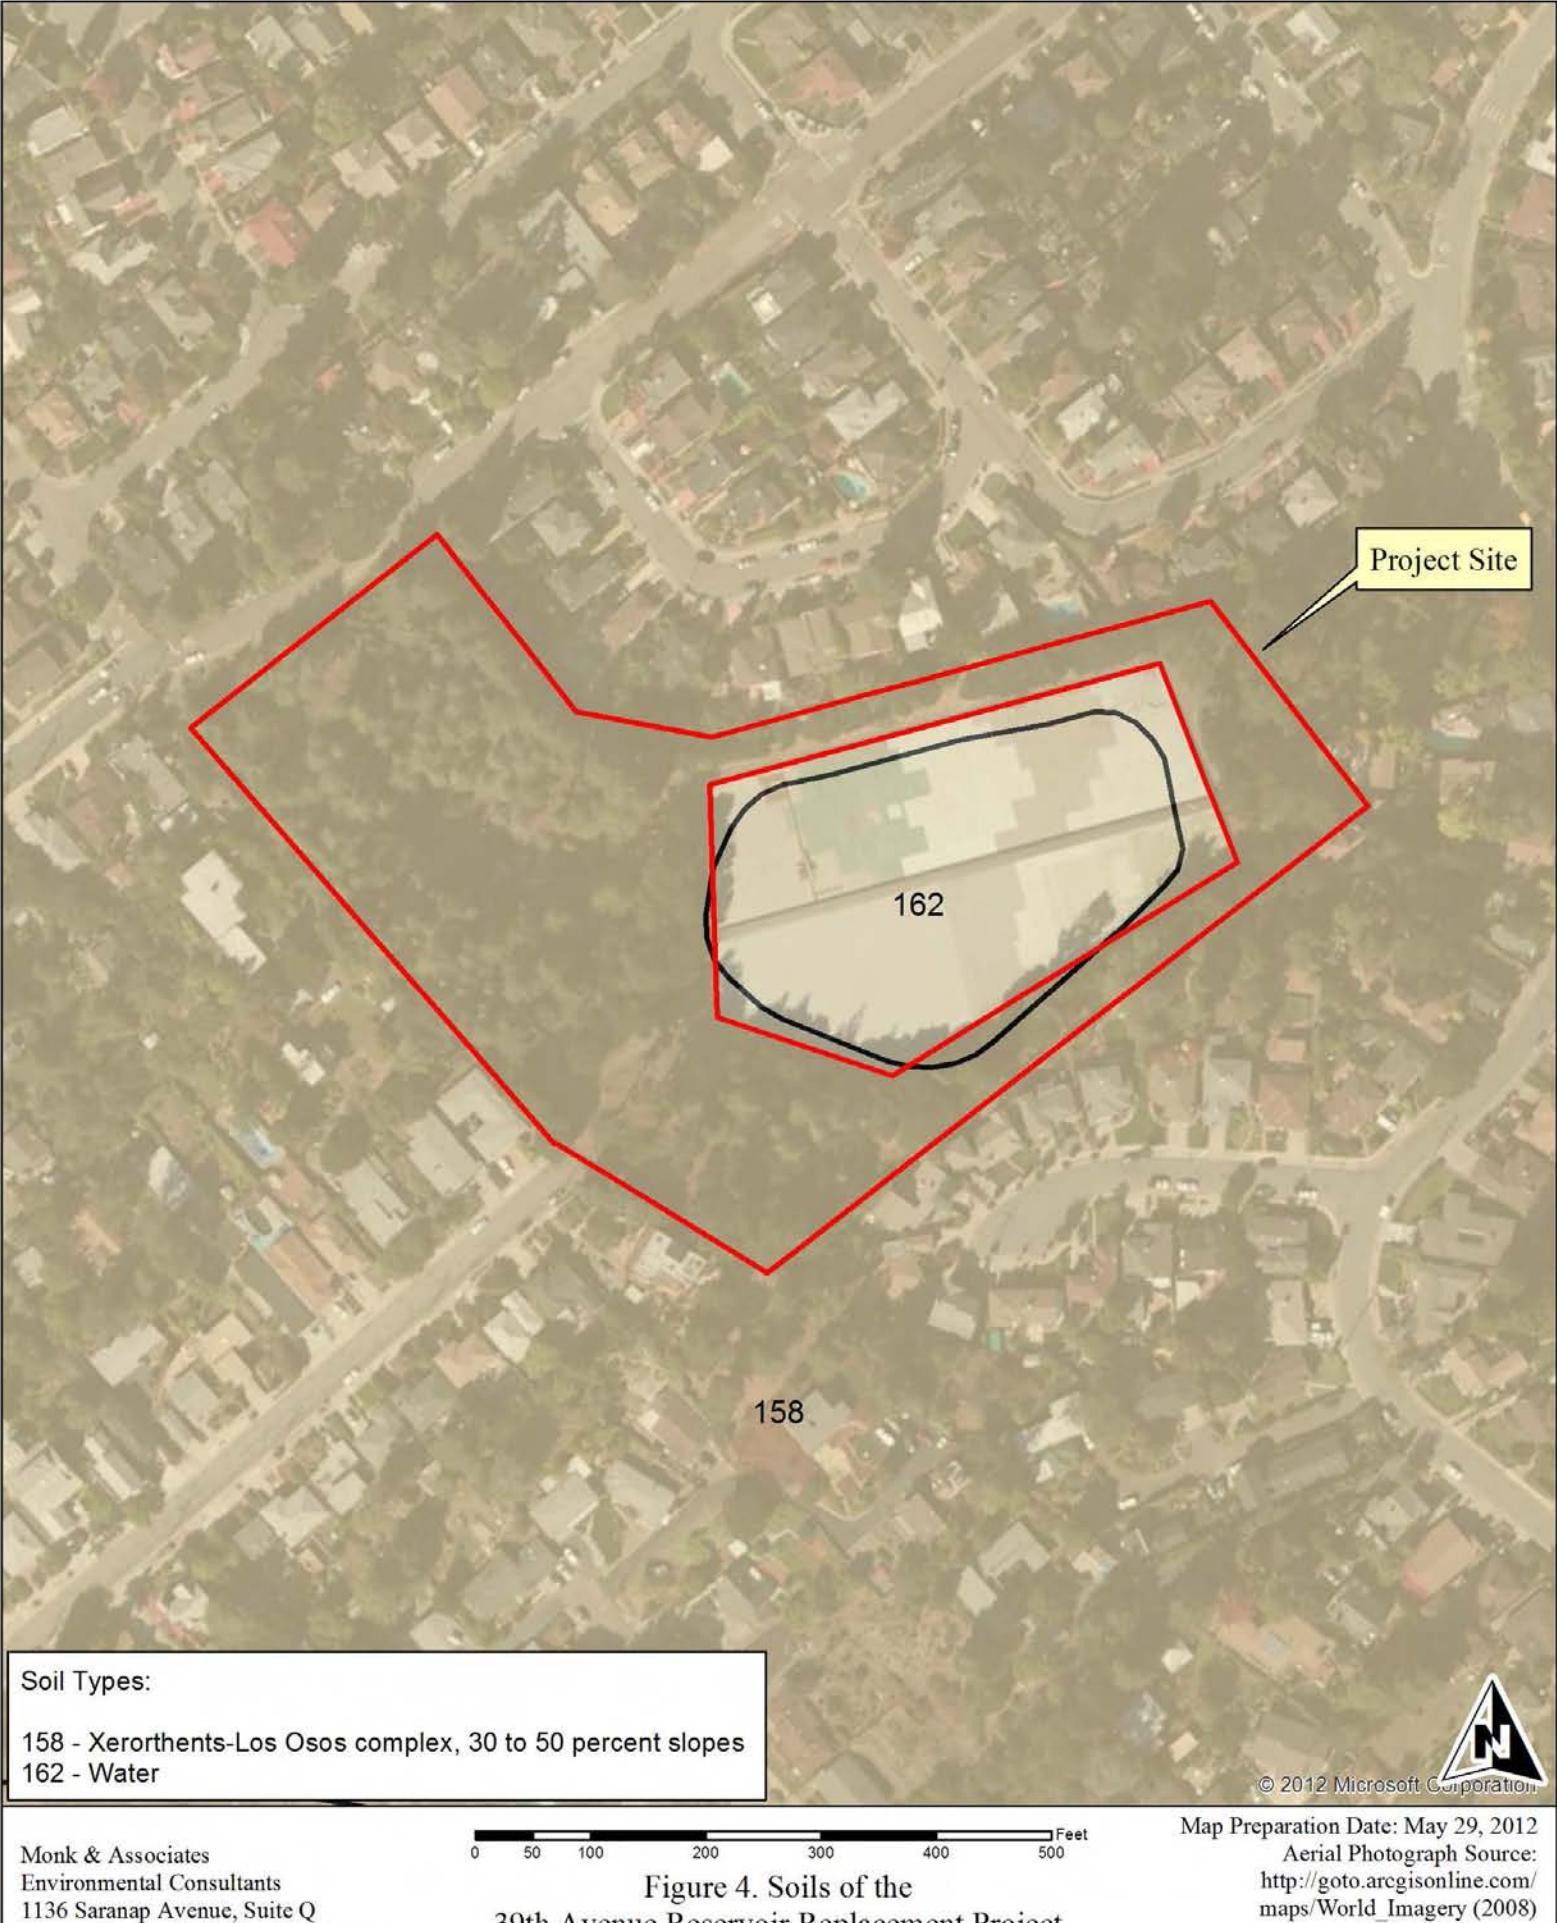
The Natural Resources Conservation Service (NRCS) mapped one soil series, Xerorthents-Los Osos complex, 30 to 50 percent slopes, on the project site. Figure 4 provides a map of the soil type mapped on the project site. This soil complex is found in areas used mainly for residential developments that have a density of two to four single-family dwellings per acre on moderately sloping topography. The parent material typified by this complex is variable due to its high use in urban construction. Very slow to slow permeability and rapid runoff is characteristic of the soil types within this complex and the typical vegetation currently associated with them is residential and urban landscaping and horticultural features.

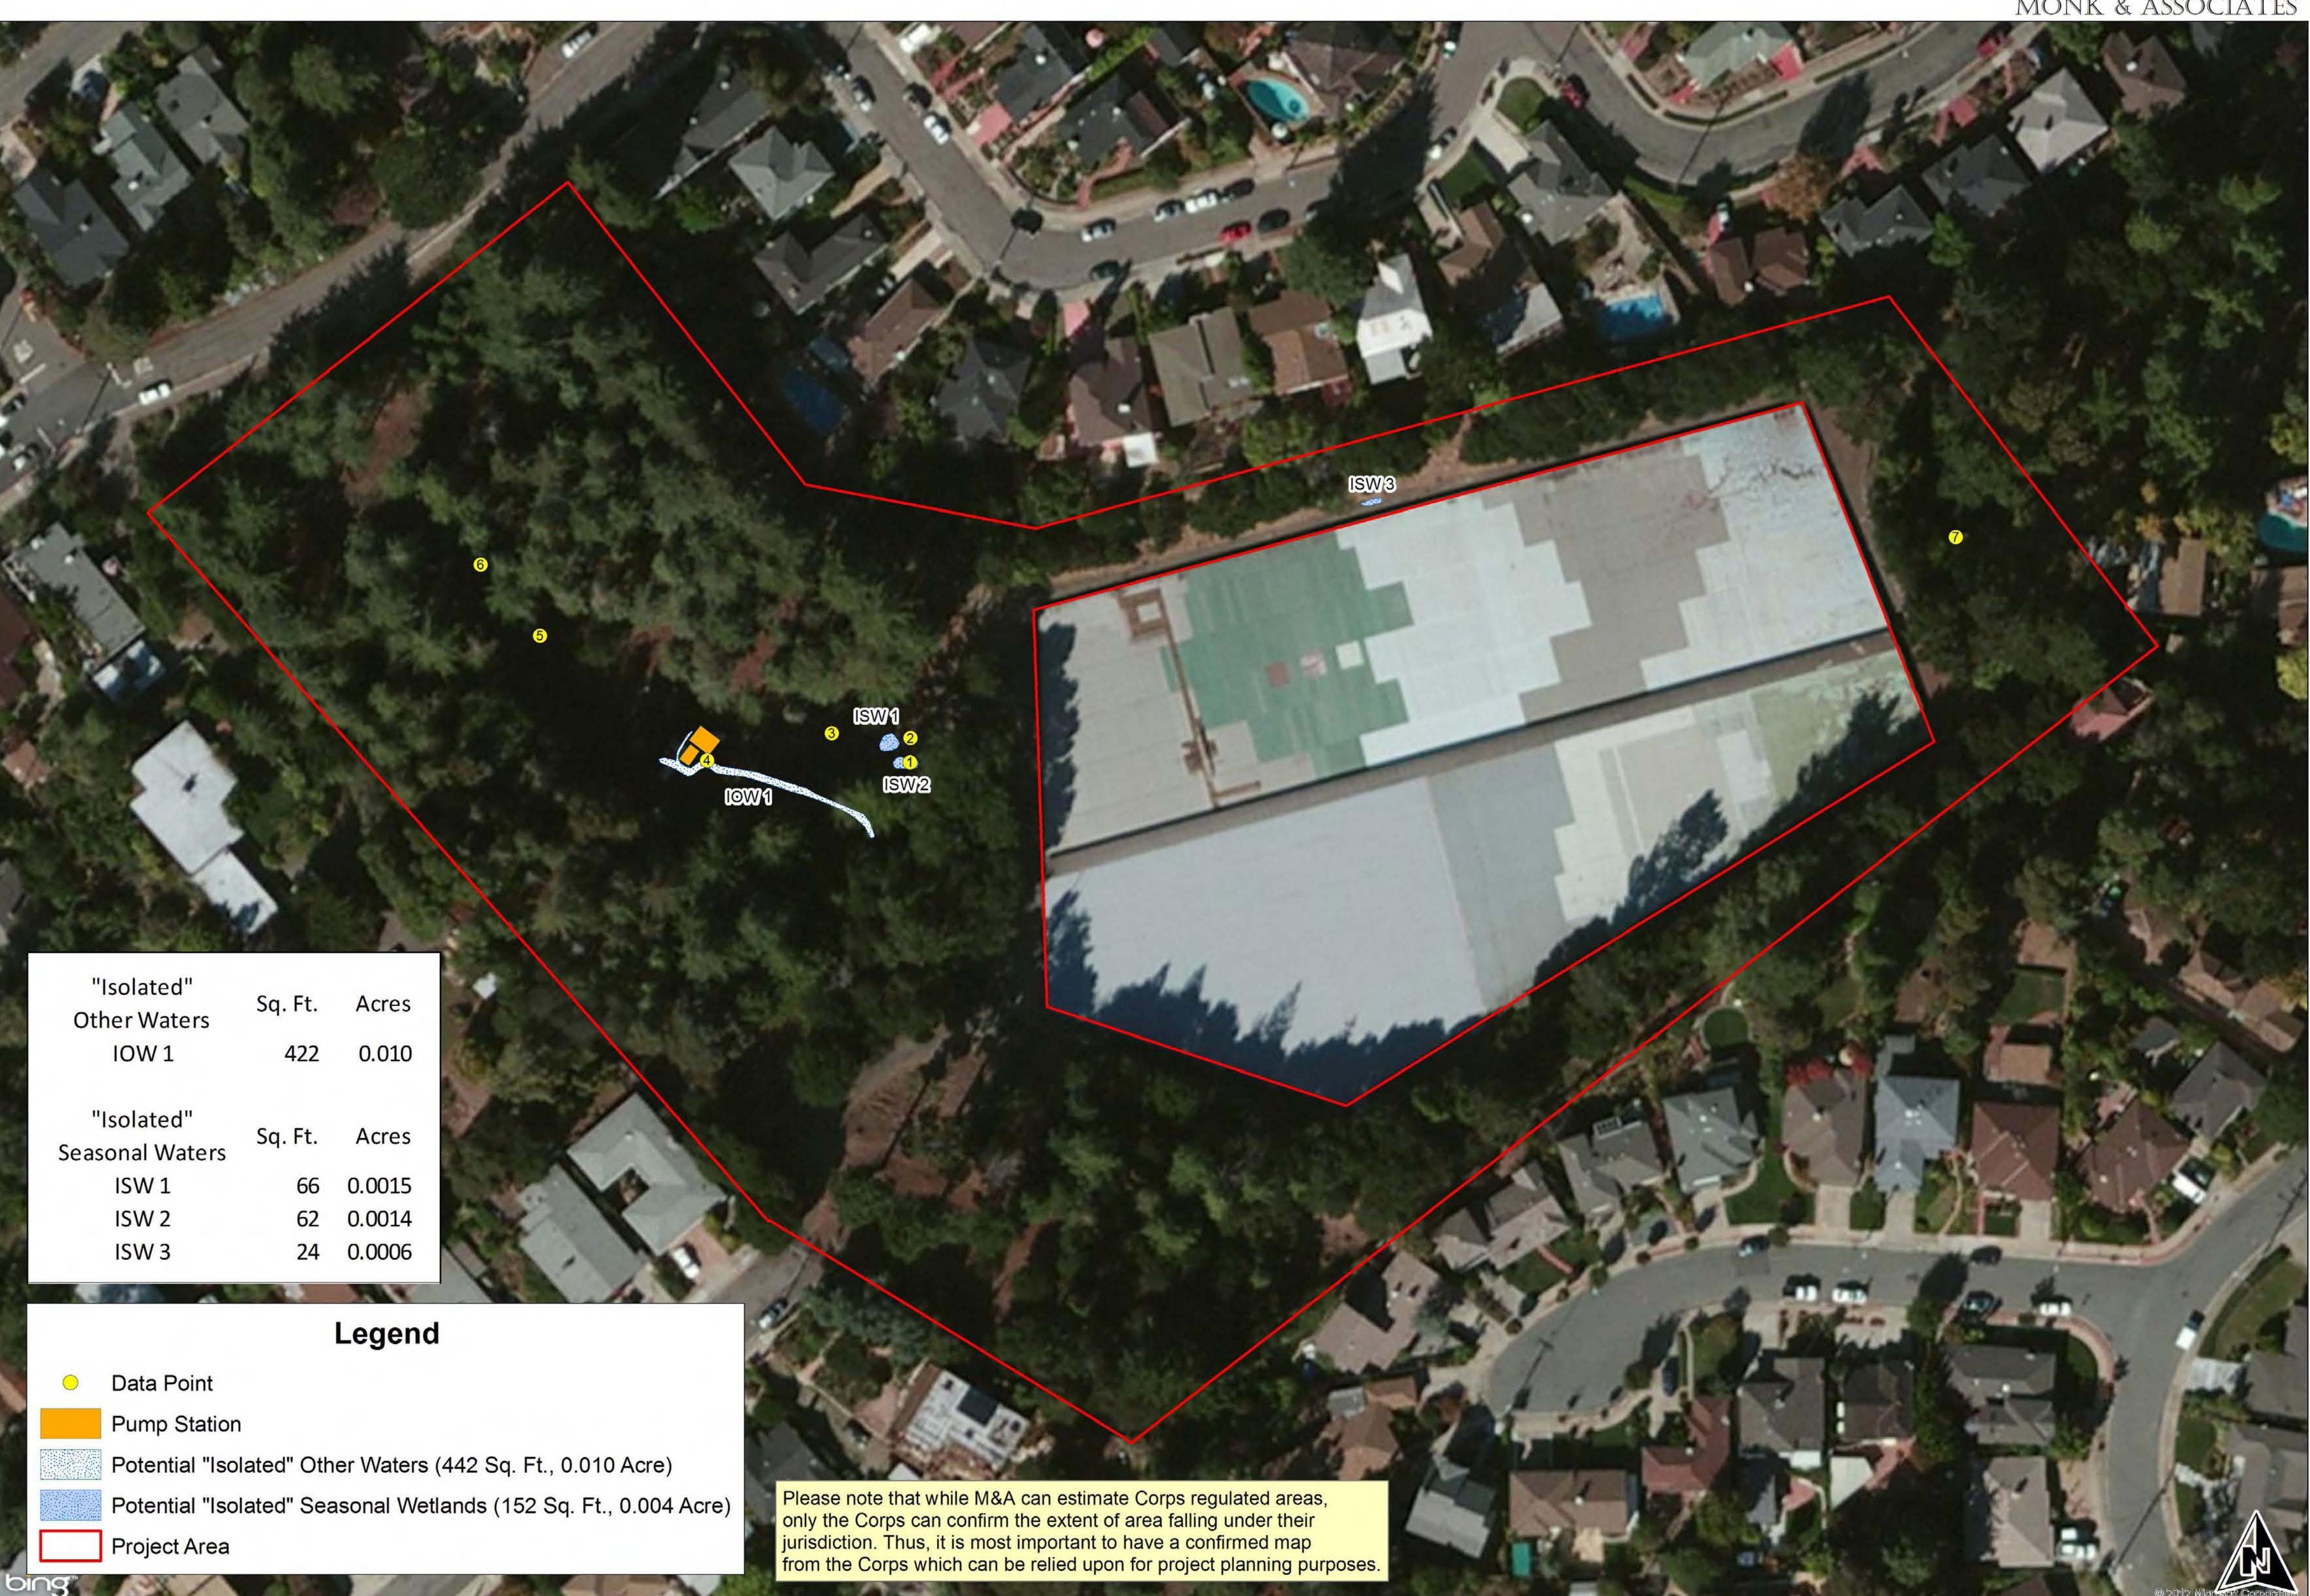
Sheet 1. Preliminary Wetland Delineation Map 39th Avenue Reservoir Replacement Project Oakland, California

reservoir. This feature appears to be fairly new, developing due to a broken irrigation pipe from the backyard of an offsite residence (ISW3 on Sheet 1).

The small potential seasonal wetland (ISW3 on Sheet 1) on the northern boundary of the project site, adjacent to the paved road supports non-native species such as wart cress (*Lepidium didymum*)(UPL), prostrate spurge, common vetch and scarlet pimpernel (*Anagalis arvensis*)(FAC), and native species such as black nightshade (*Solanum americanum*)(UPL). Wetland taxa that occur within this feature include the non-native species everlasting cudweed (*Pseudognaphalium luteoalbum*)(FAC) and hyssop loosestrife (*Lythrum hyssopifolia*)(OBL) and the native species toad rush (*Juncus bufonius* var. *bufonius*)(FACW). As for all areas mapped as seasonal wetlands, this feature is dominated by hydrophytic vegetation.

IOW 1	422	0.010
"Isolated" Seasonal Waters	Sq. Ft.	Acres
ISW 1	66	0.0015
ISW 2	62	0.0014
ISW 3	24	0.0006
