# Local Hazard Mitigation Plan 2023

East Bay Municipal Utility District

The East Bay Municipal Utility District (EBMUD) 2023 Local Hazard Mitigation Plan (2023 LHMP) is an update to its 2018 Local Hazard Mitigation Plan (2018 LHMP) and reflects EBMUD’s most current system upgrades, improvements, and mitigation measures to reduce community exposure to hazards and to improve reliability of its services to the public.

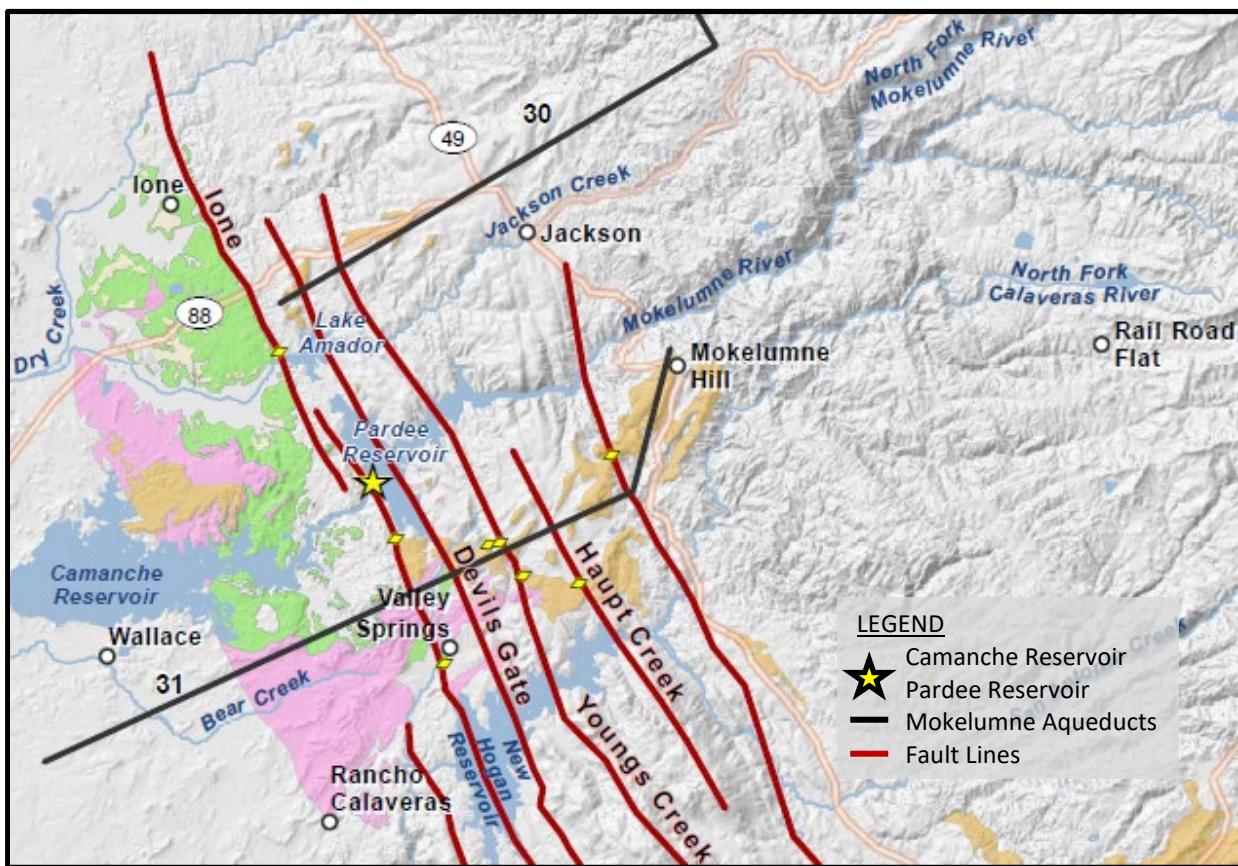
**Figure 4.2. EBMUD Facilities Outside of the Bay Area**

EBMUD's facilities outside the Bay Area include the Mokelumne Aqueducts, Pardee, and Camanche Reservoirs (see Figure 4.2). Each of these facilities is described in more detail below.

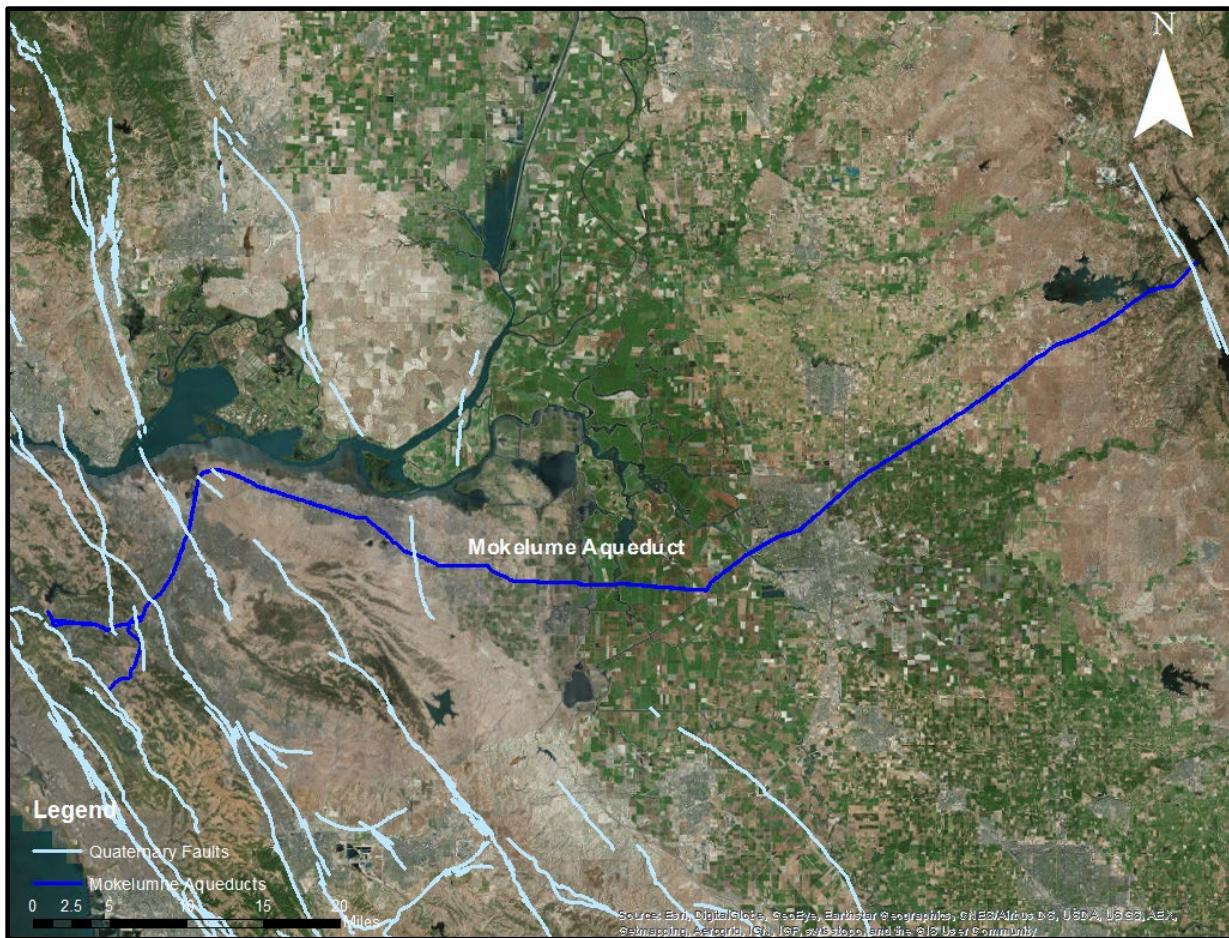
**Figure 4.3. Mokelumne Aqueduct**

Near the community of Clements, the Mokelumne Aqueducts are joined by the Freeport Regional Water Authority/Folsom South Canal Connection system, a system of pumping plants and pipelines that delivers water from the Sacramento River to the Mokelumne Aqueducts to supplement the Mokelumne River supply during drought periods.

Once the Mokelumne Aqueducts water reaches the EBMUD service area in Walnut Creek, it is delivered directly to water treatment plants or transferred into one of five terminal storage reservoirs located in the EBMUD service area.

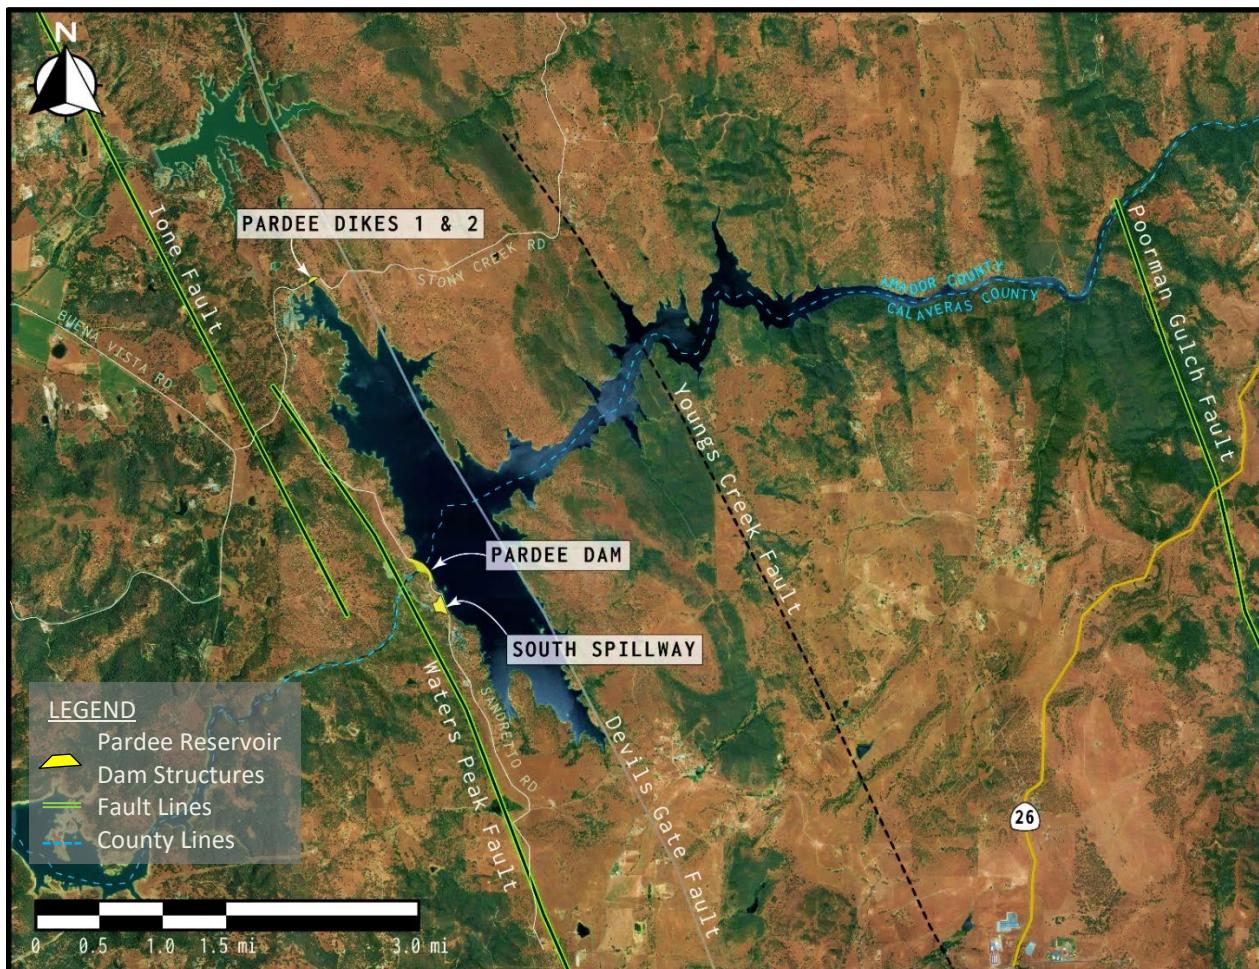
**Figure 4.4. Pardee Reservoir and Dam**

Pardee Reservoir's storage capacity is 203,795 acre-feet at the spillway crest elevation of 567.65 feet (local datum). At this elevation, the reservoir has a surface area of approximately 2,200 acres (3.4 square miles) and 37 miles of shoreline. The total drainage area above Pardee Dam is approximately 577 square miles.

The dam is classified as “High Hazard” under Federal Energy Regulatory Commission (FERC) Guidelines and “Extremely High Hazard” under the California Division of Safety of Dams (DSOD) Guidelines.

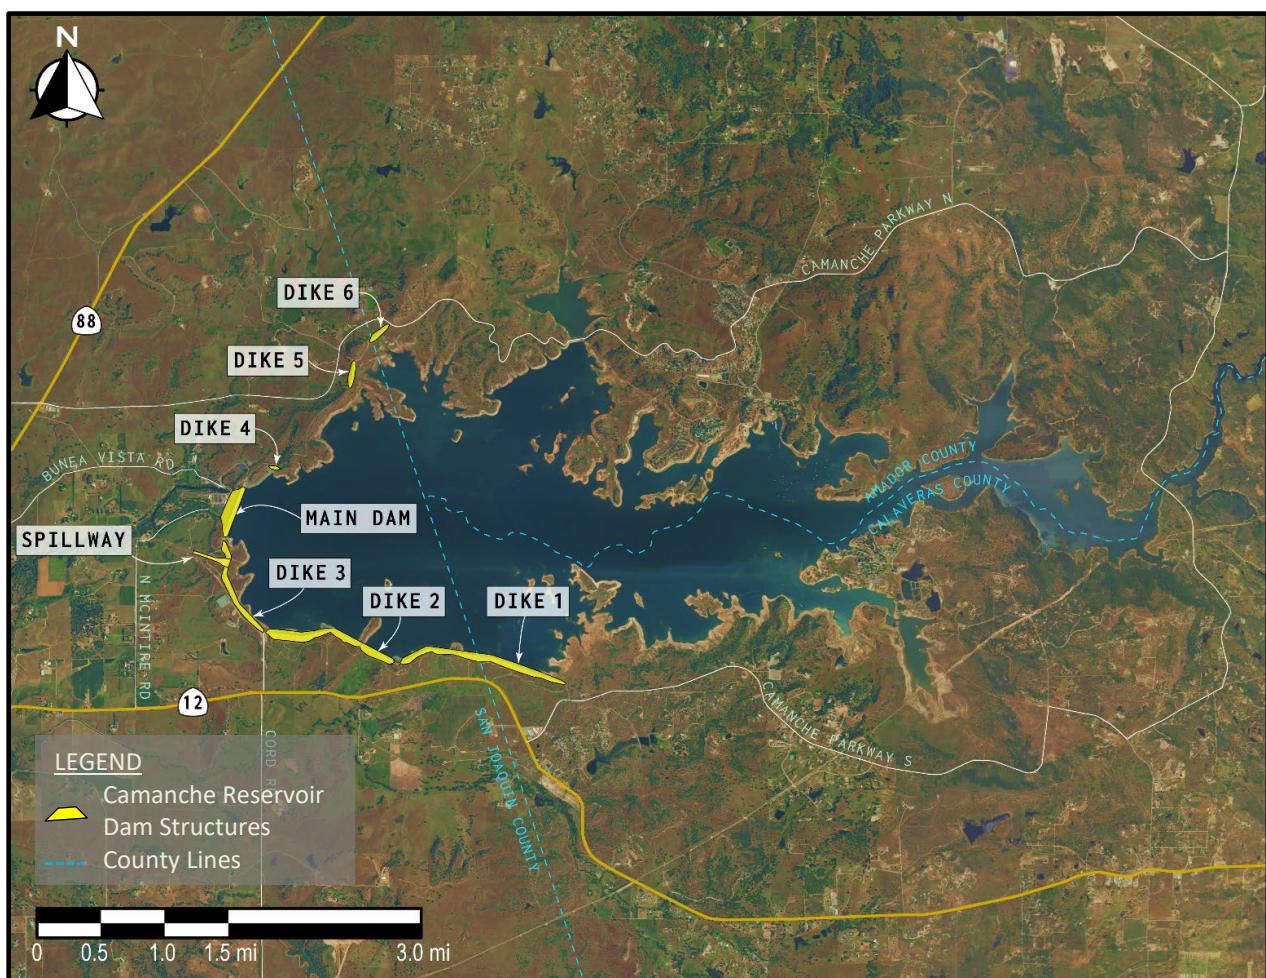
Figure 4.5. Camanche Reservoir

Camanche Reservoir, with a storage capacity of 417,120 acre-feet at the spillway crest elevation of 235.5 feet, was completed in 1964 to provide for multiple beneficial uses. At this elevation, the reservoir has a surface area of approximately 7,400 acres. The drainage area above the reservoir is 620 square miles. The reservoir is located within Amador, Calaveras, and San Joaquin Counties on the Mokelumne River approximately 14 miles east of the community of Lodi. The reservoir is created by a main dam and six earth dikes: three on the north side and three on the south side. An un-gated concrete overflow spillway is located south of the main dam. A three-unit, 10.7-megawatt powerhouse is at the base of the main dam. The dam is classified as “High Hazard” under FERC Guidelines and “Extremely High Hazard” under the DSOD Guidelines.

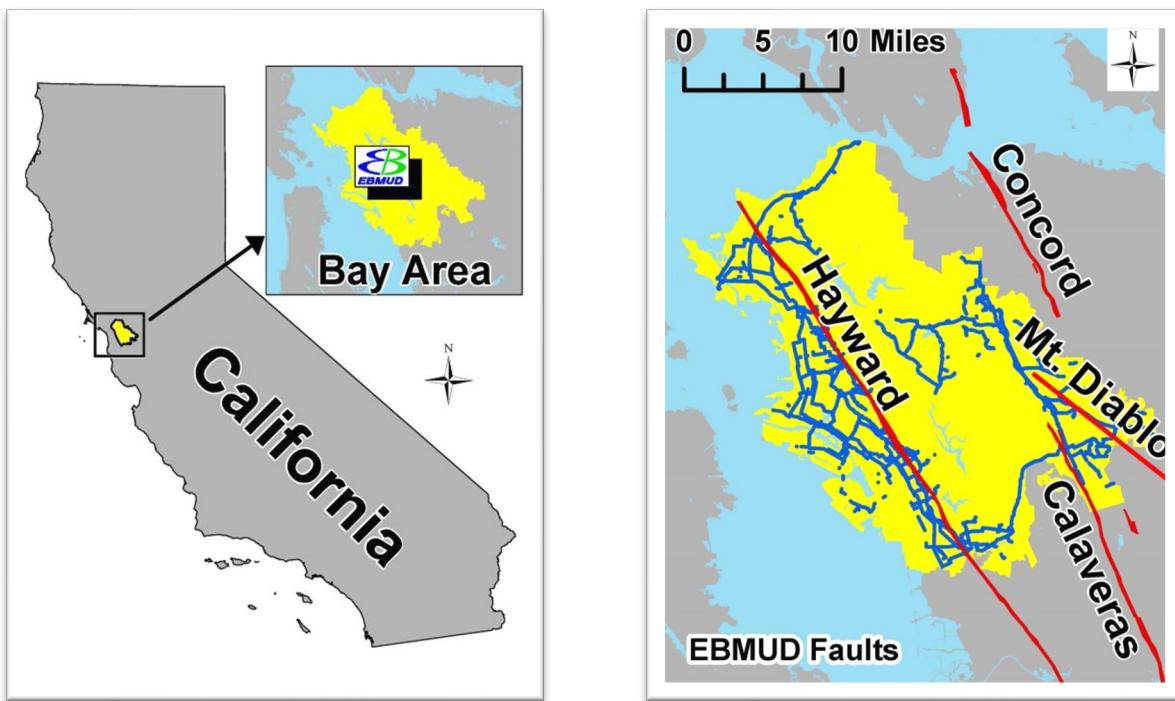
**Figure 6.1. EBMUD Service Area and Faults**

Calaveras, and Concord Faults. Although outside the service area, the San Andreas Fault will also subject pipelines to significant ground motion.

The highly active Hayward Fault dominates the EBMUD risk profile. Current earthquakes forecasts for the Hayward Fault consider combined rupture of the Northern and Southern Hayward Fault up to Mw 7.0, a combined Hayward-Rodgers Creek Fault Zone rupture producing a Mw 7.25 earthquake, and a floating rupture of Mw 6.9 that could occur anywhere along the fault zone without regard to defined segmentation boundaries. With the last major earthquake occurring in 1868 (149 years ago), the next major earthquake is due at any time. The economic losses from a similar earthquake occurring today would likely exceed \$165 billion in damages (Brocher, 2008) in the Bay Area.

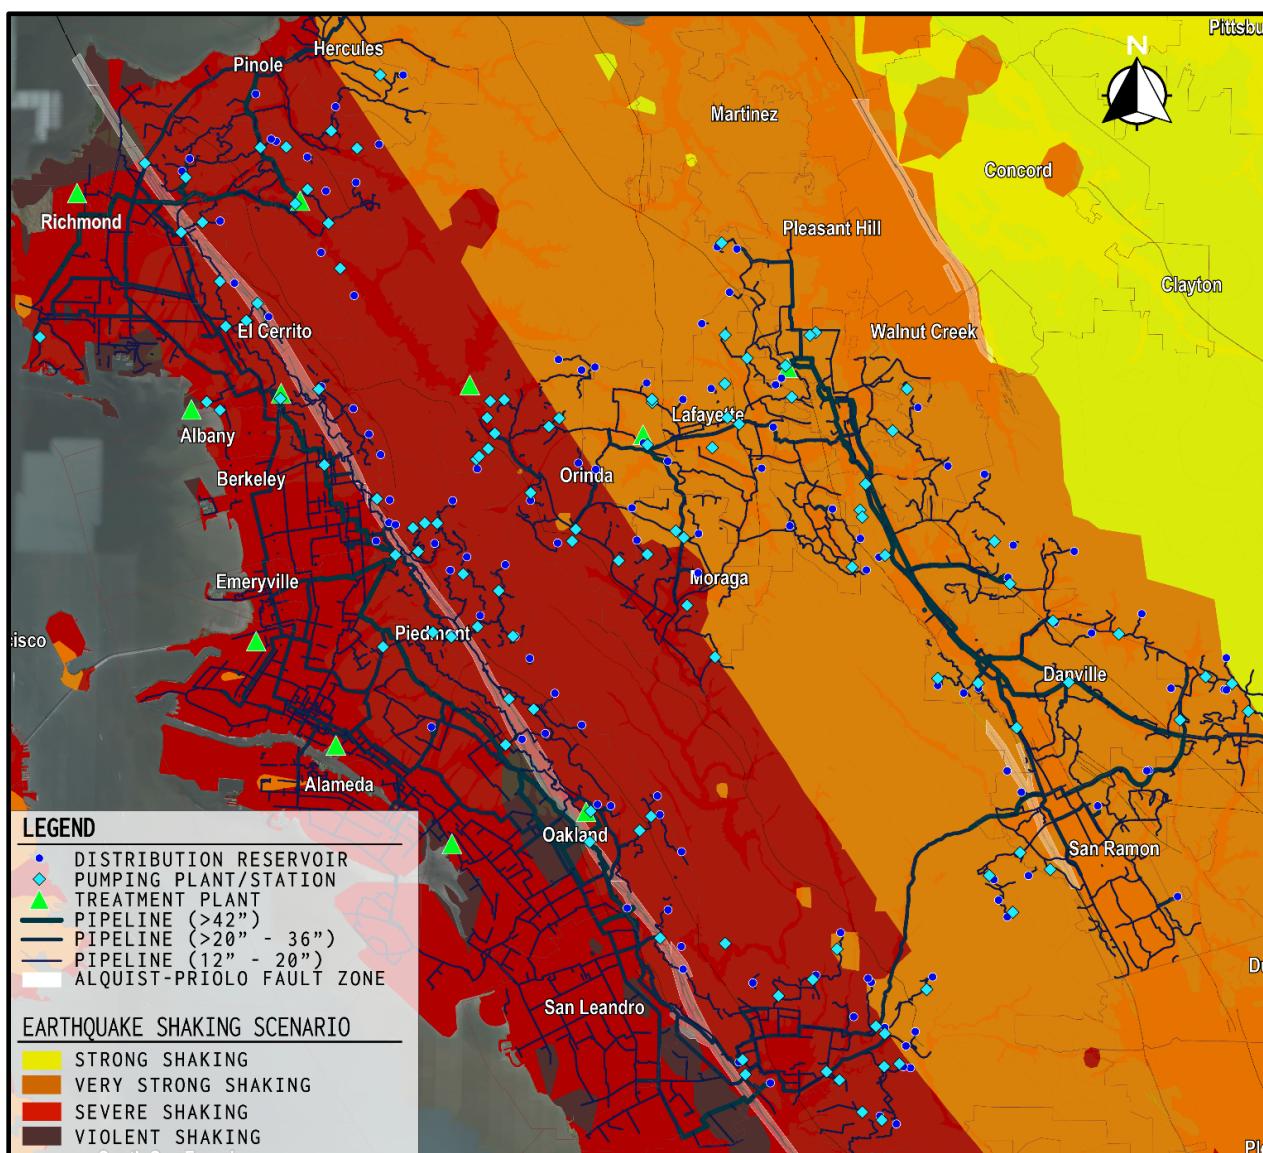
**Figure 6.3. Hayward (North and South) – Mw 7.0 Shaking Intensity and Distribution Infrastructure**

Most of EBMUD's water and wastewater system facilities are exposed to either extremely high ground shaking levels (peak accelerations greater than 60% g with a 10% chance of being exceeded in the next 50 years) or high ground shaking levels (peak accelerations greater than 50% g), while less than 5% are exposed to moderate shaking (peak accelerations of greater than 30% g). A Shaking Hazard Map is available on the ABAG Resilience Program website: MTC/ABAG Hazard Viewer Map (<https://abag.ca.gov/our-work/resilience/data-research/hazard-viewer>).

The map shows the shaking severity level for the majority of EBMUD's service area. A magnitude Mw 7.0 earthquake on the Hayward fault would result in MM shaking severity levels ranging from Strong to Very Violent for most of the service area, as shown in Figure 6.3 below.

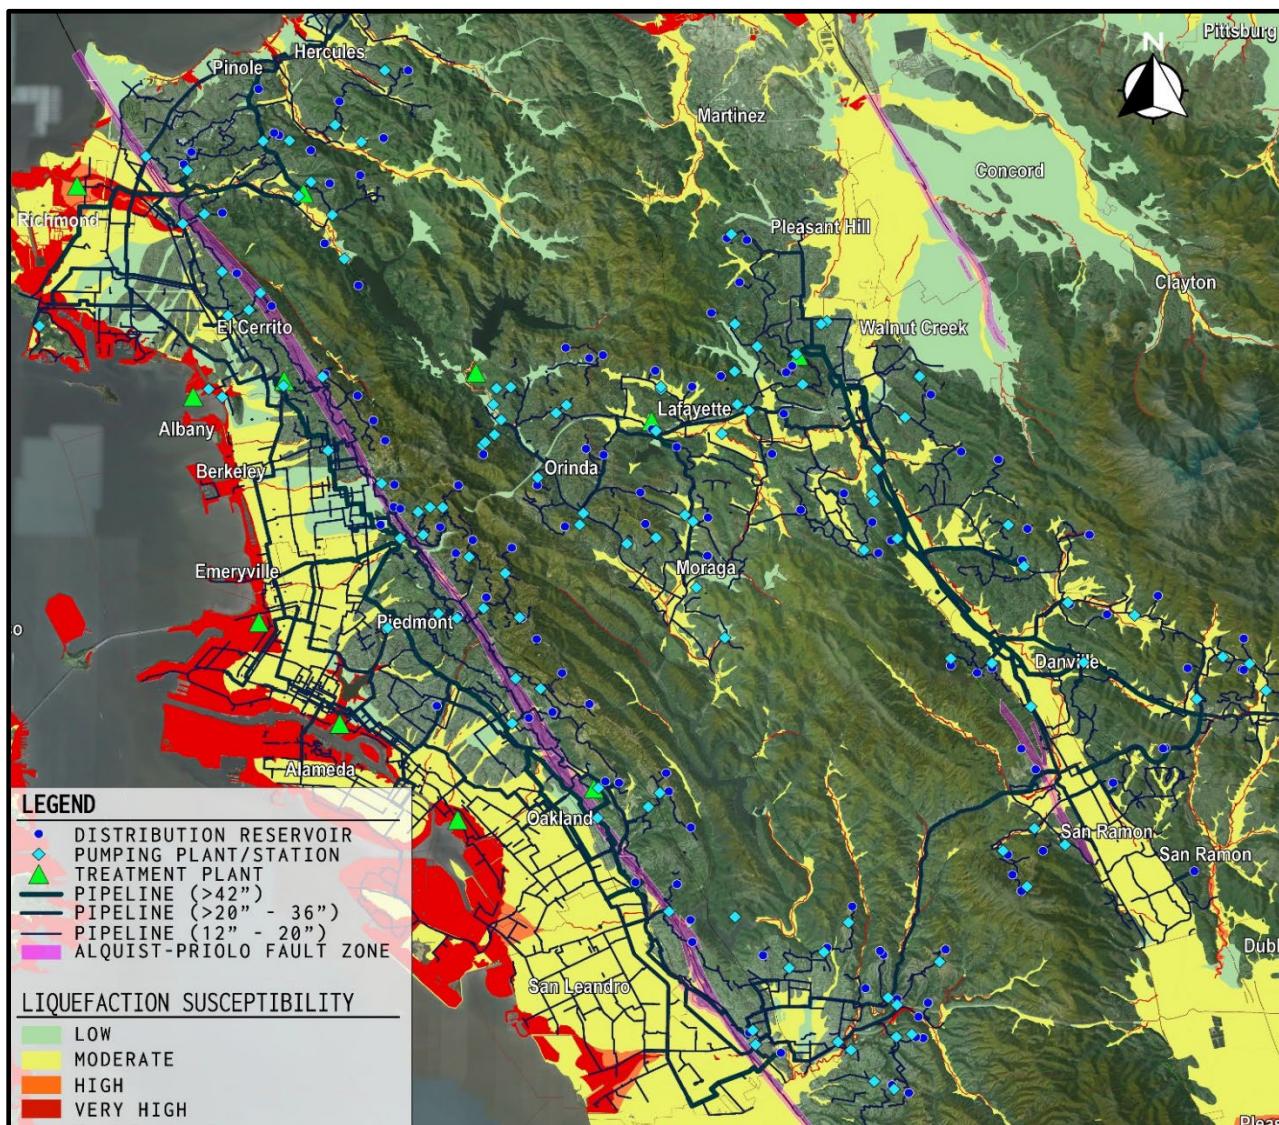
**Figure 6.4. Hayward (North and South) – Mw 7.0 Liquefaction Susceptibility and Distribution Infrastructure**

There is a significant correlation with the areas of moderate-to-very high liquefaction mapped by USGS and CGS. Based on USGS mapping, approximately 100 facilities are in areas mapped as having Very High susceptibility to liquefaction, fewer than 10 facilities are in areas mapped as having High susceptibility to liquefaction, and over 200 facilities are in areas mapped as having Moderate susceptibility to liquefaction. Thus, roughly 25-30% of EBMUD's facilities should be expected to be subject to liquefaction.

The majority of wastewater facilities, including the MWWTP and WWFs, are located in areas prone to liquefaction and liquefaction-induced lateral spreading. Figure 6.4 shows EBMUD's distribution system overlain with liquefaction susceptibility maps and an interactive liquefaction susceptibility map is available on ABAG's website.

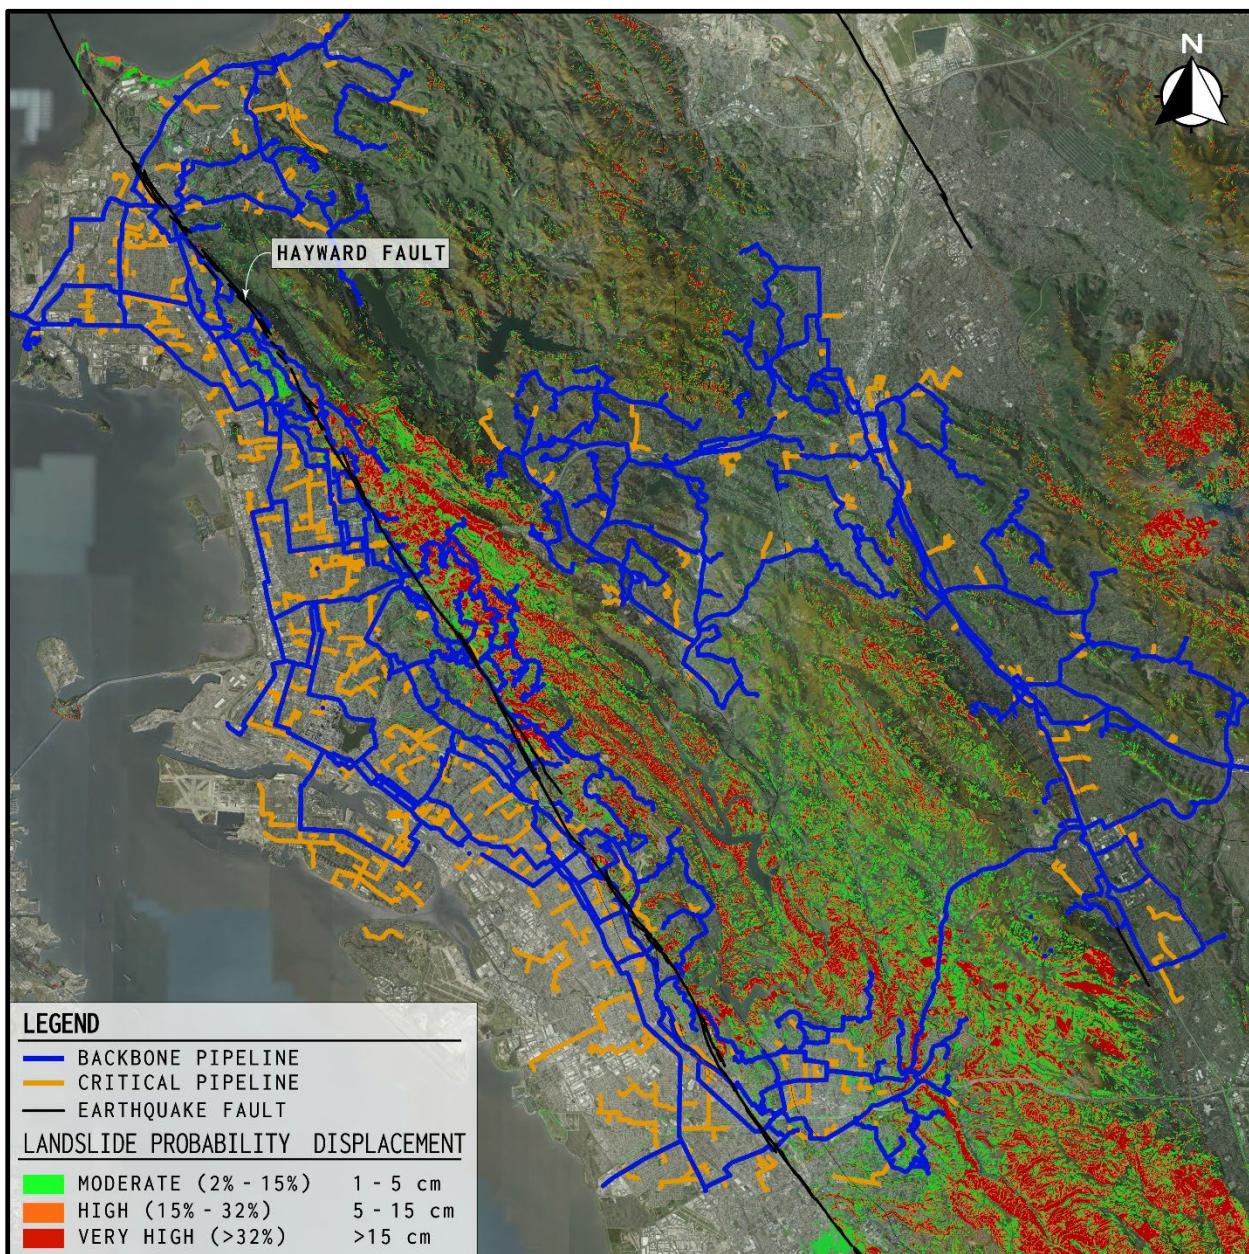
**Figure 6.5. Hayward (North and South) – Mw 7.0 Earthquake-Induced Landslide Probability and Estimated Displacements**

Figure 6.5 below and was obtained from a recent USGS publication and is available from the following URLs:

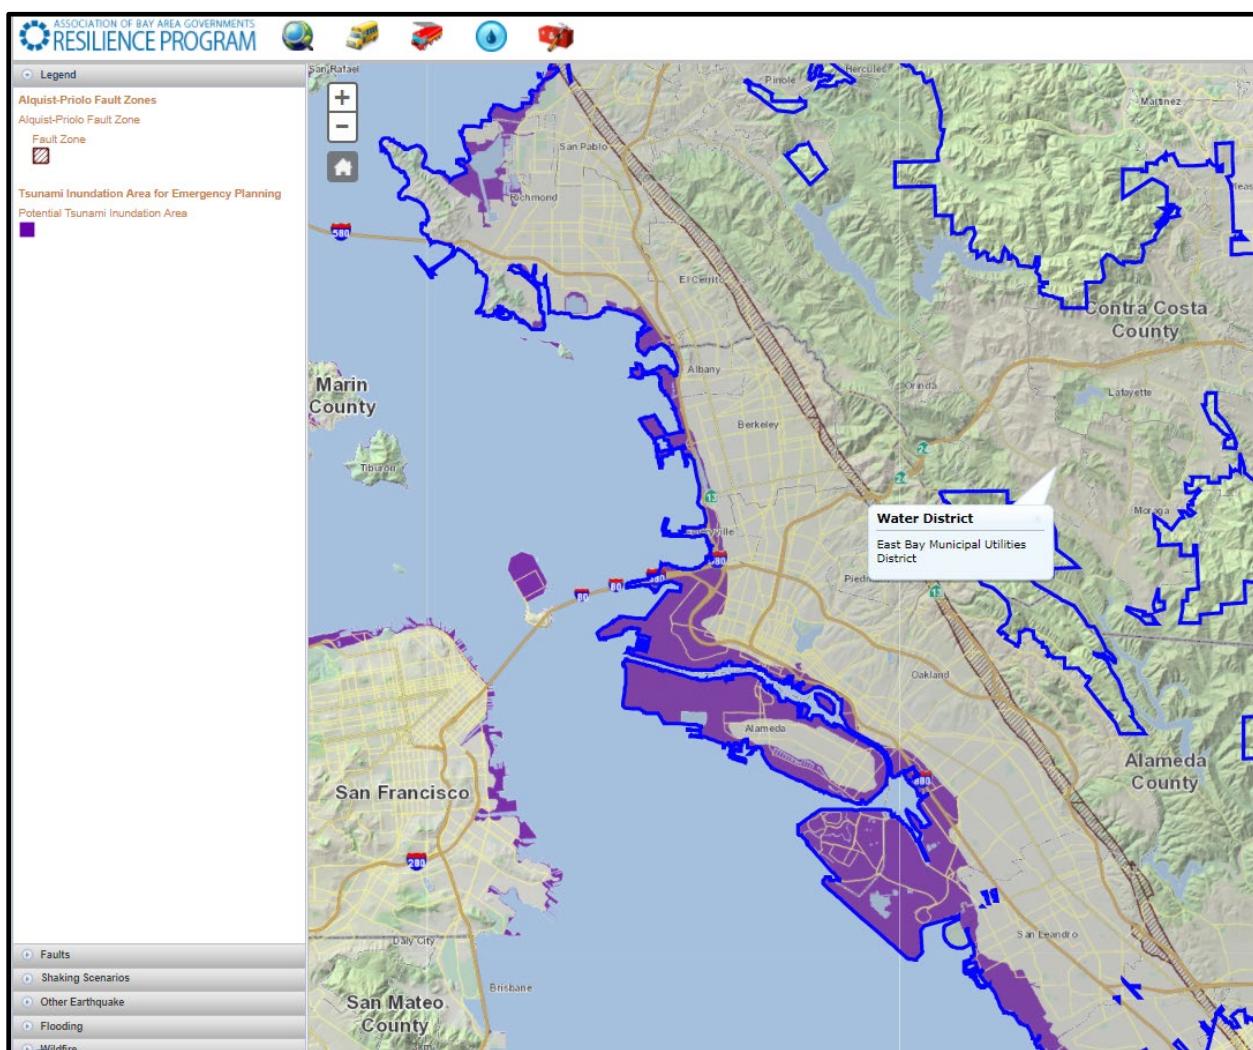
**Figure 6.6. Tsunami Inundation for EBMUD Service Area**

The MWTP specifically evaluated two scenarios in 2014 – an Eastern Aleutians, Alaska Mw 9.2 earthquake and a Mw 7.0 rupture of the offshore Point Reyes Thrust Fault. The Alaskan earthquake scenario would provide approximately 5 hours to evacuate before the arrival of the wave. A tsunami from the Point Reyes earthquake would arrive in tens of minutes, giving little or no time to evacuate; however, water levels are not expected to be high enough to flood facilities. There is a Tsunami Response Plan in place for the MWTP and all other low-lying areas that are within the mapped Tsunami Hazard areas (see Figure 6.6).

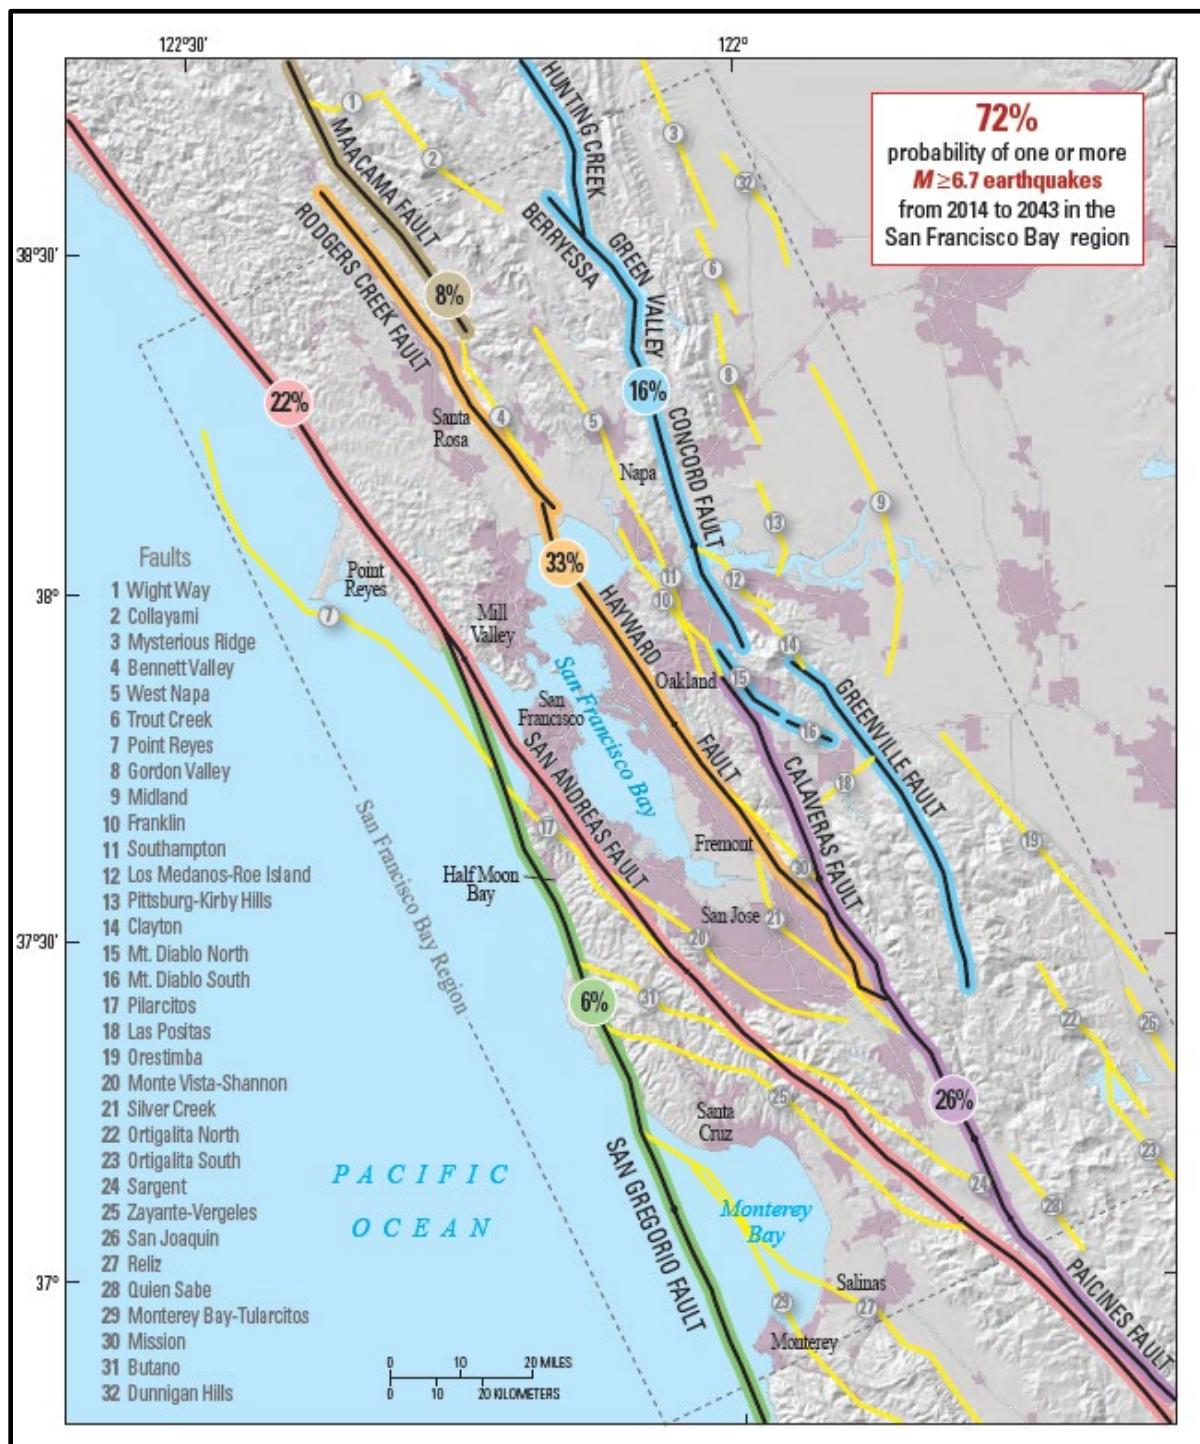
Figure 6.7. Regional Faults

Figure 6.7 below depicts the major faults in the Bay Area and their associated probability of occurrence of one or more Mw 6.7 or greater earthquake from 2014 to 2043. There is a 72% probability of experiencing such an event in the San Francisco Bay Region. The Hayward-Rodgers Creek Fault system has the highest probability (33%) for a large rupture (Mw>6.7) on the major faults in the region.

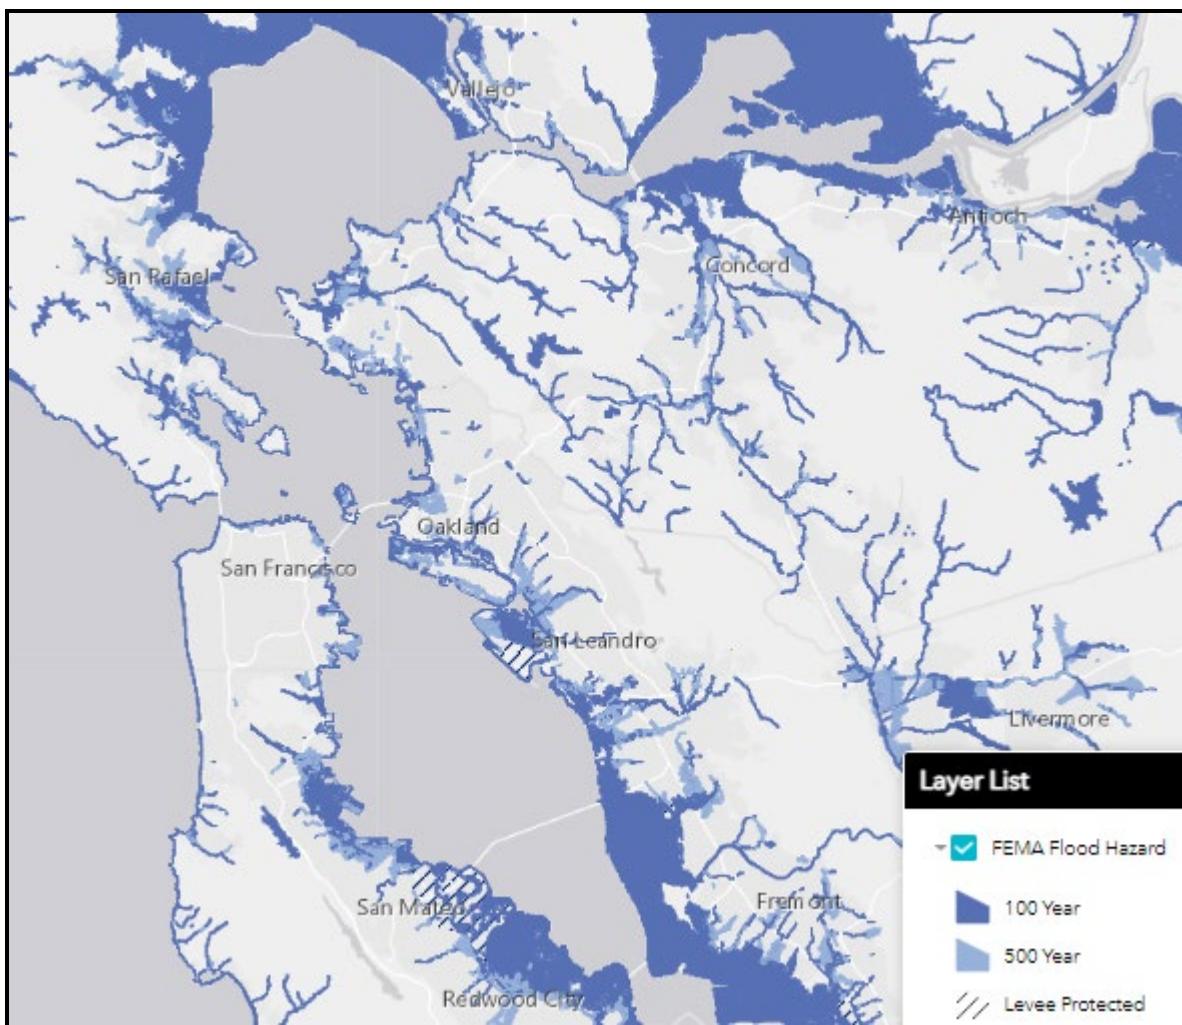
**Figure 6.8. EBMUD Service Boundary Flood Zone**

FEMA prepares 100-year flood maps, called the Flood Insurance Rate Maps (FIRMs), which indicate floodplain boundaries and are the common reference when describing flood hazards. Figure 6.8 below, prepared by the ABAG Resilience Program, shows the FEMA flood zone within the EBMUD service boundary.

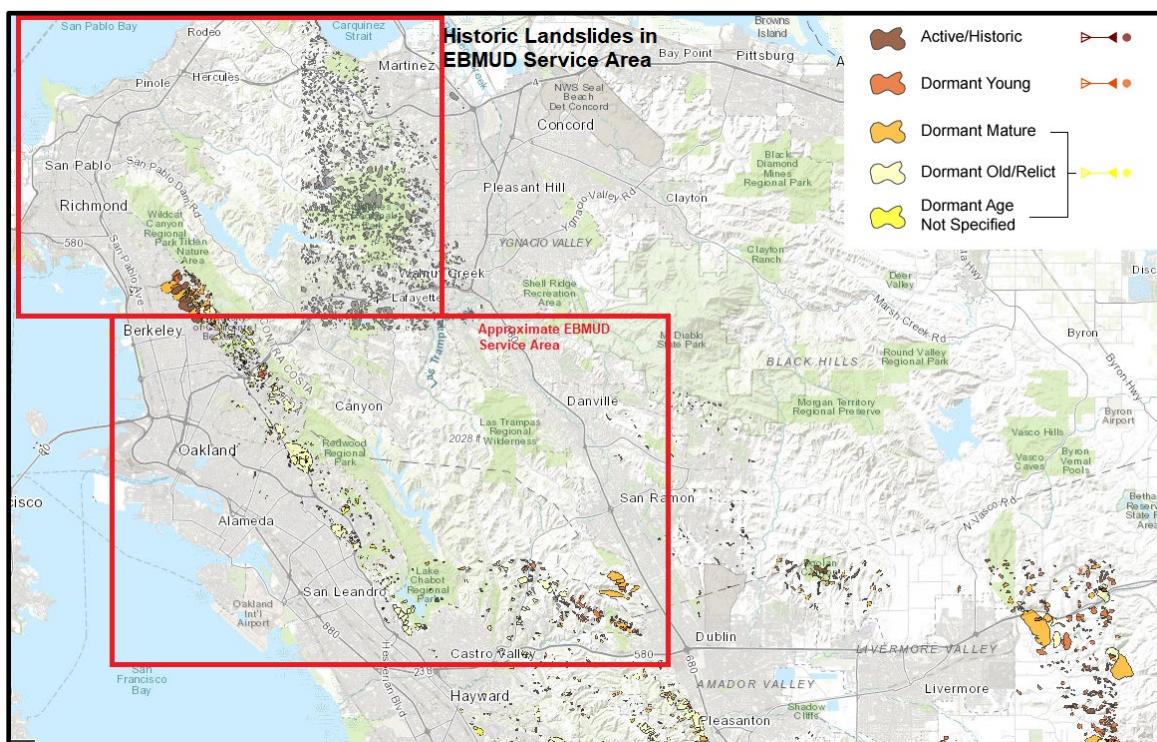
Figure 6.9. Historic Landslides in EBMUD Service Area

Repair costs for future landslides can vary depending on the location and extent of the landslide. Based on past landslide impacts to EBMUD facilities, the repair costs could range from thousands of dollars to millions of dollars. More information on these hazards can be found at: <https://maps.conservation.ca.gov/cgs/lsi/app/>

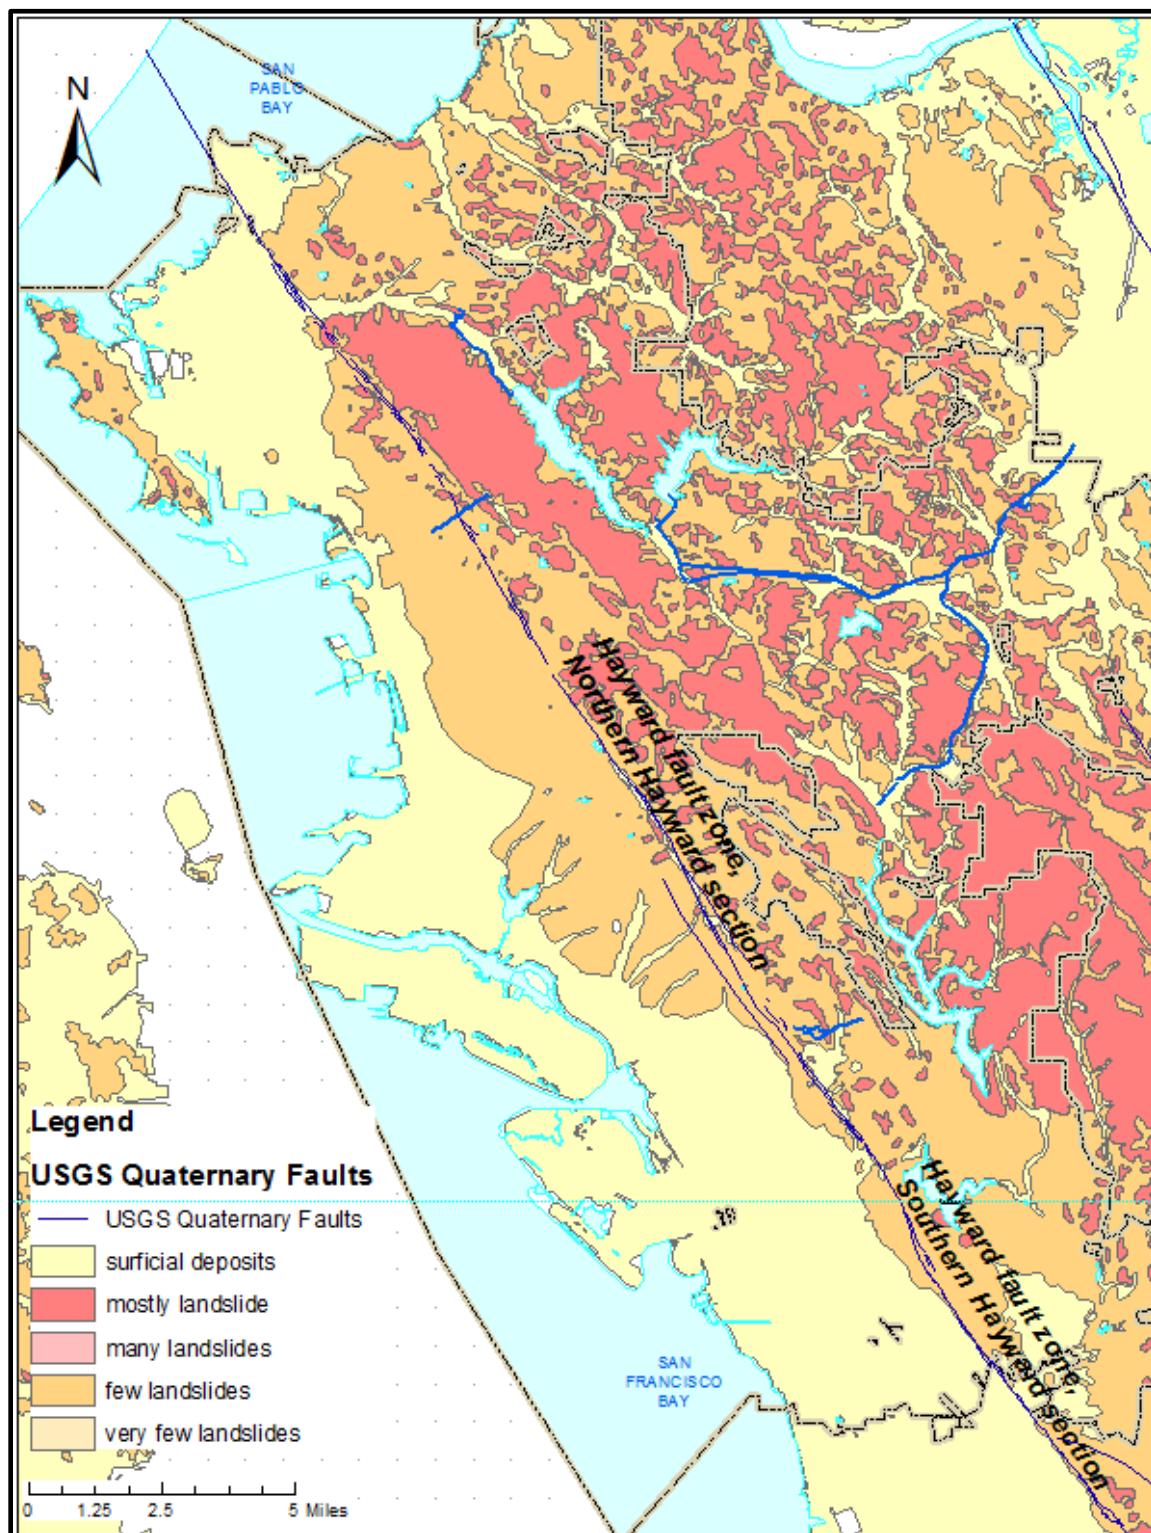
**Figure 6.10. Deep Seated Landslide in EBMUD Service Area**

Reference: Susceptibility to Deep-Seated Landslides in California, 2011, C. J. Wills, F. G. Perez and C. I. Gutierrez (California Geological Survey), Susceptibility to Deep-Seated Landslides in California, 2011
